Ruperra Castle (Castell Rhiw'r Perrai) Caerphilly Glamorgan

Historic Building Recording

CA Project: CR1627

CA Report: CR1627_1

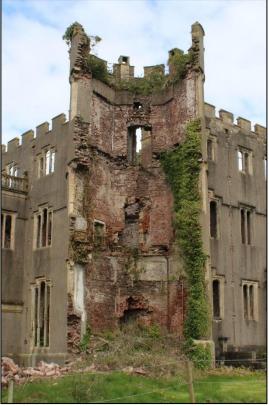
- 4.16. The south-east tower partially collapsed in 1982, leaving the internal elevations exposed (Photo 11). This event followed the emergence of cracks along the length of the tower that precipitated the failure. Cracks of similar nature are also apparent within each of the other three towers, which are currently all still standing.

Photos 10 and 11: Overview of south-west tower, looking south-east, and south-east tower, looking north-west

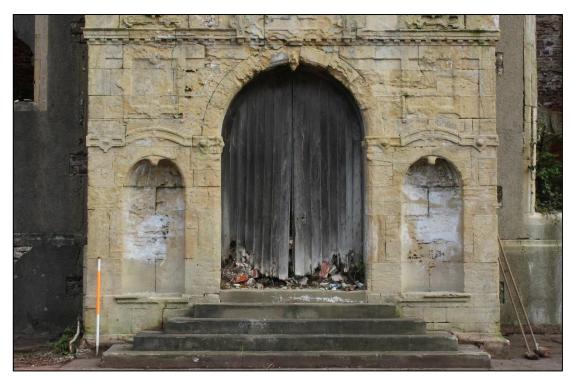
- 4.24. To either side of the door are two identical niches which incorporate semi-circular shell motif heads, both heavily weathered (Photo 19). Above each niche is a band of strapwork that is moulded to follow the curve of the niche below. Above these are two further panels, both blind (Photo 18). Further embellishment is provided through the incorporation of dentils as part of a shallow cornice, directly above the door surround. The door is approached via a set of stone steps that appear to be a relatively recent addition.

Photo 18: Overview of lower portions of south porch

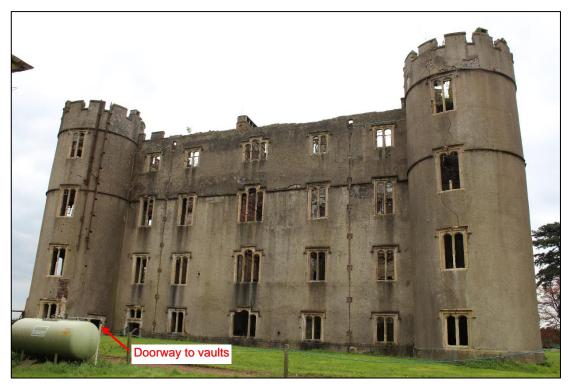
Photo 28: North elevation

4.34. The north elevation is missing the majority of its crenelations (Photo 28). It is curious that such wholesale removal has occurred, and it is therefore likely to have been carried out as a planned removal rather than as a direct consequence of the 1941 fire. Certainly, all the building's embattlements were still *in situ* seven years after the fire had occurred (Fig. 15). Evidence for ongoing maintenance is visible on the north-east tower. A patch of modern cementitious cement render has been applied adjacent to the lower ground floor window (Photo 29). Formerly, there was a wall abutted to this part of the tower (Fig. 14) that was evidently removed after 1949¹⁰ and was clearly applied following this removal to fill the resultant gap in the building's render.

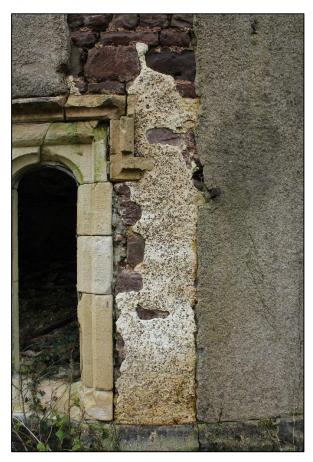
Photo 29: Evidence of patch repair following removal of wall, north-east tower

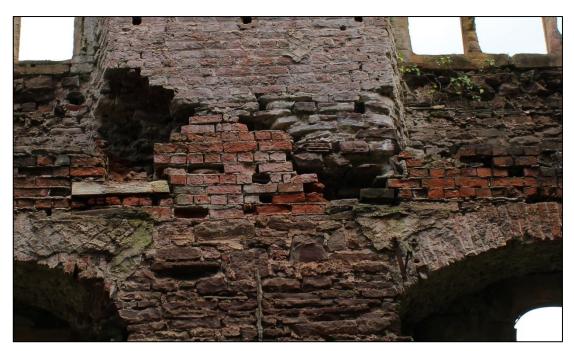
Photo 50: Detail of red brick repairs within the south wall of Cell A
