Whitford Point Lighthouse

NPRN 34289

Report on RCAHMW Survey Work, 2023-2024

May 2025

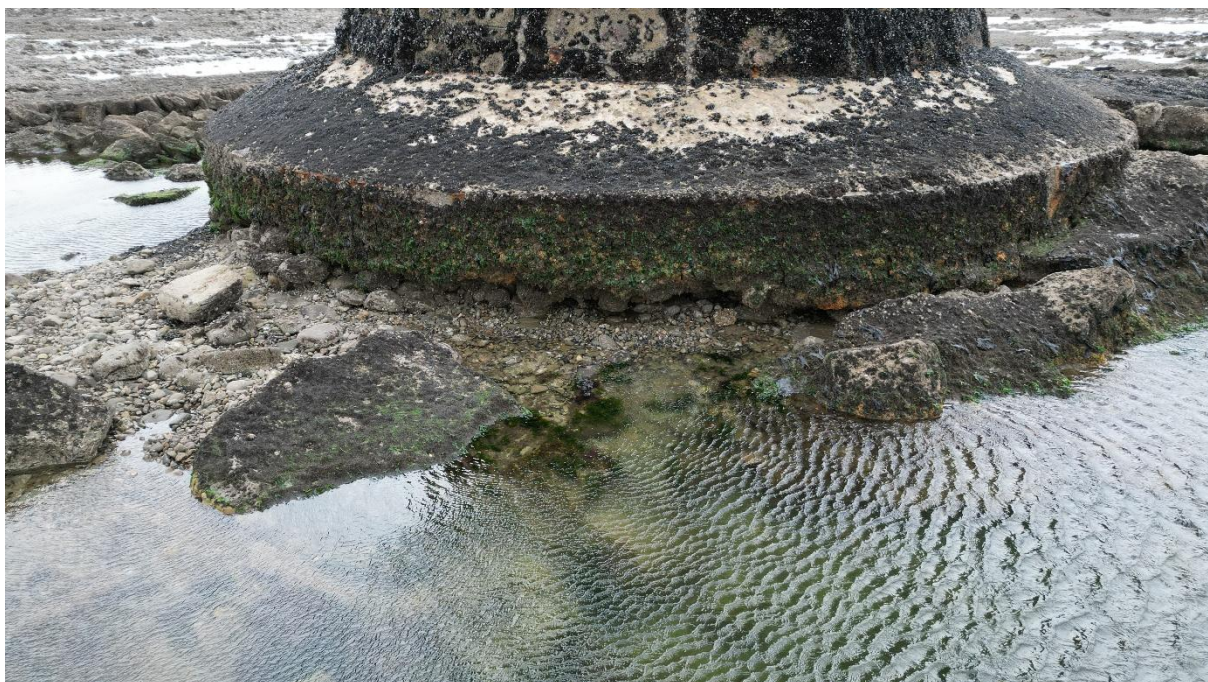
The lowest cast-iron ring of the tower section is partially encased in a concrete collar, 9.8m in diameter (Figure 2.5). This is subject to erosive undercutting on its eastern side, which reveals its original vertical thickness to be c. 1.6m. The collar slopes gently downwards from the base of the cast-iron tower for 1.3m, with a fall of 0.6m, its outer extent is formed by a vertical face c. 0.8m in height. The outer vertical face of the collar is in turn protected by a pitched stone apron. The main part of the apron is c. 27.5m in total diameter and is formed from 'ribs' of stonework radiating outwards from the collar, infilled with well-laid closely packed smaller stones. A further set of larger header stones around the outside of these was intended to ensure the integrity of the outer edge of the apron. The junction between the collar and the apron is covered with a further layer of stonework and mortar. This upper apron extends outwards for 2.5-3m from the edge of the collar, but now only survives in two small areas on the western side of the lighthouse (Figure 2.6). It is unclear from historic photos of the lighthouse if the upper apron originally extended all the way around the collar, or was only placed along the western side.

Figure 2.5: The collar surrounding the base of the lowest cast-iron ring of Whitford Point Lighthouse, photographed on the 17/08/2023 (© Crown Copyright: RCAHMMW).

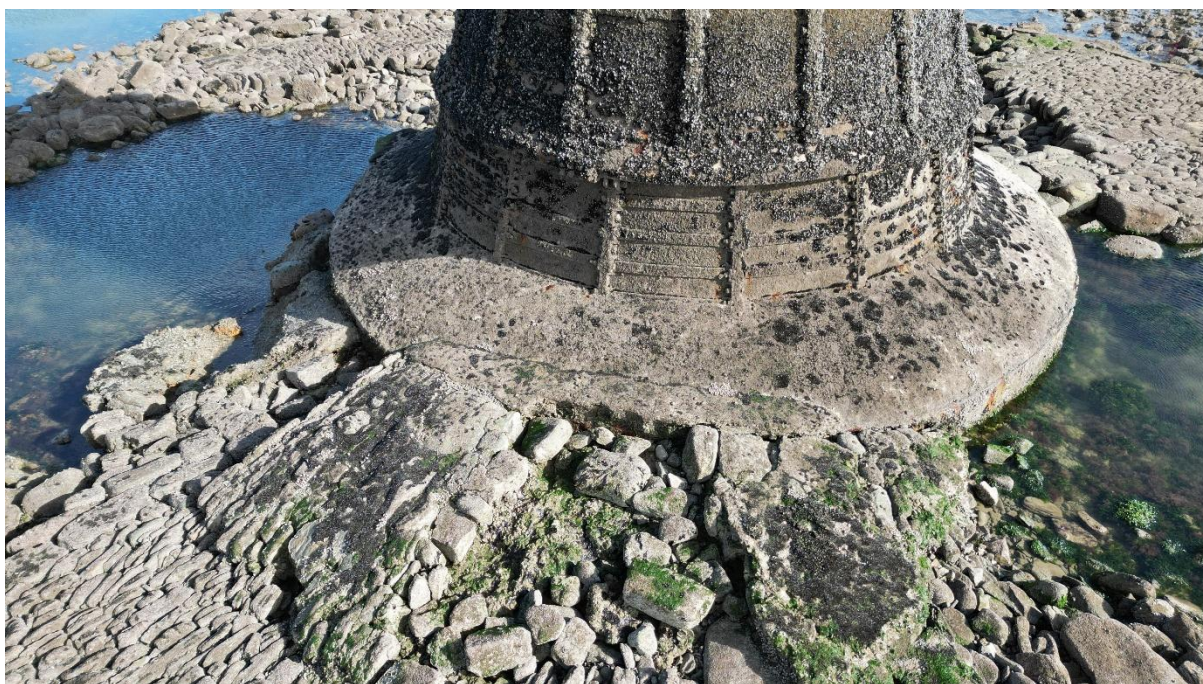
Figure 2.6: Surviving sections of the upper apron on the western side of Whitford Point Lighthouse, photographed on 17/10/2024 (© Crown Copyright: RCAHMW).

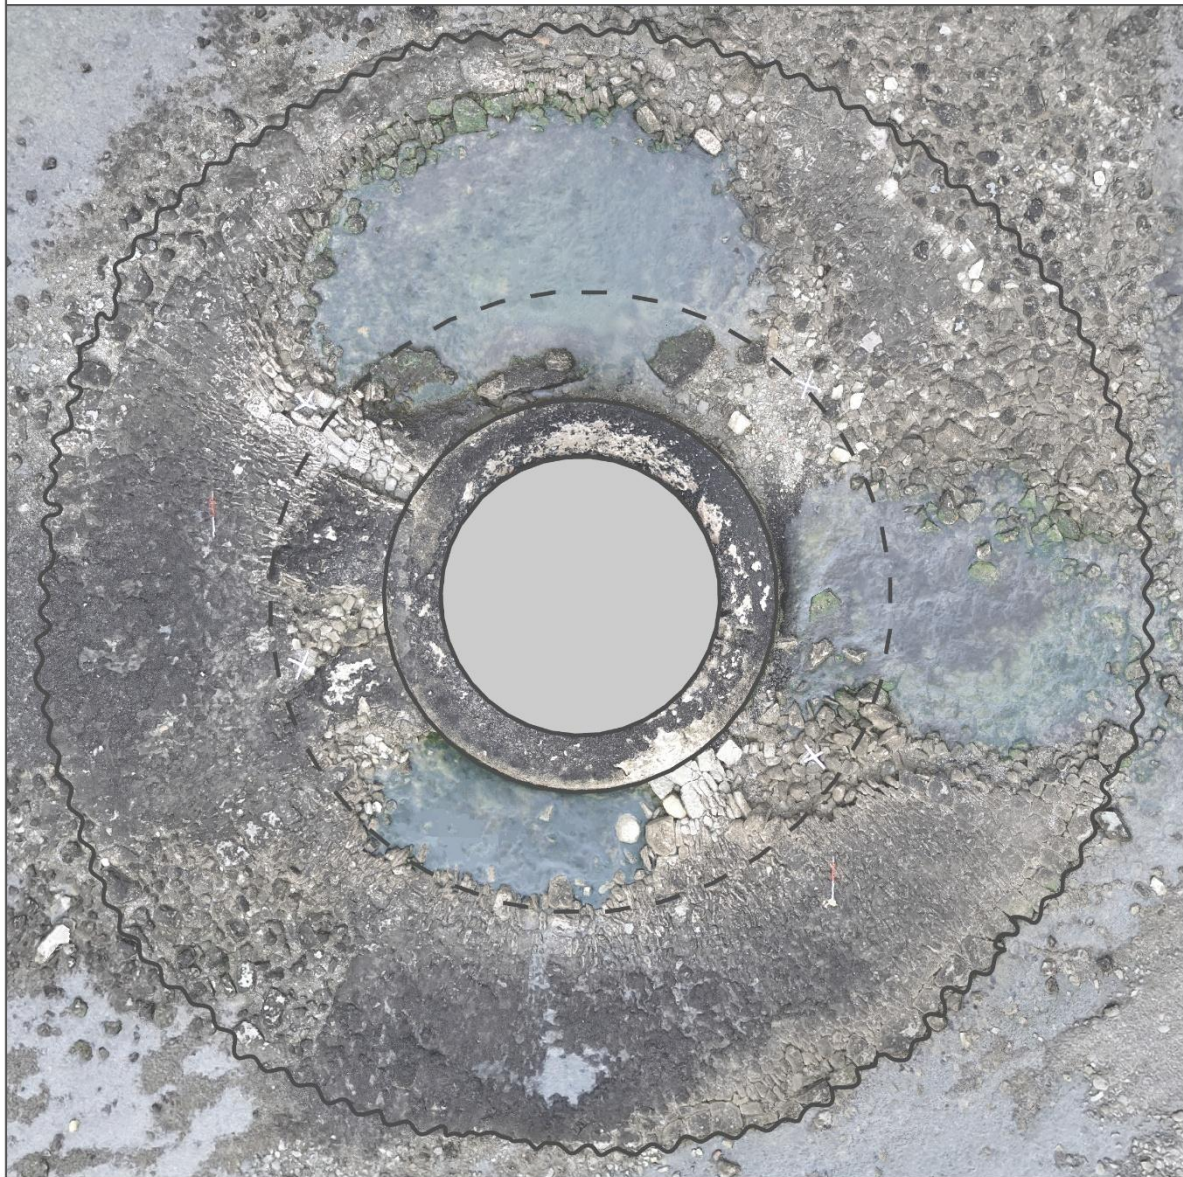
NPRN 34289 Whitford Point Lighthouse Orthomosaic, August 2023

Figure 4.1: Annotated Orthomosaic of Whitford Point Lighthouse derived from a photogrammetry survey on 17/08/2023 (© Crown Copyright: RCAHMW).

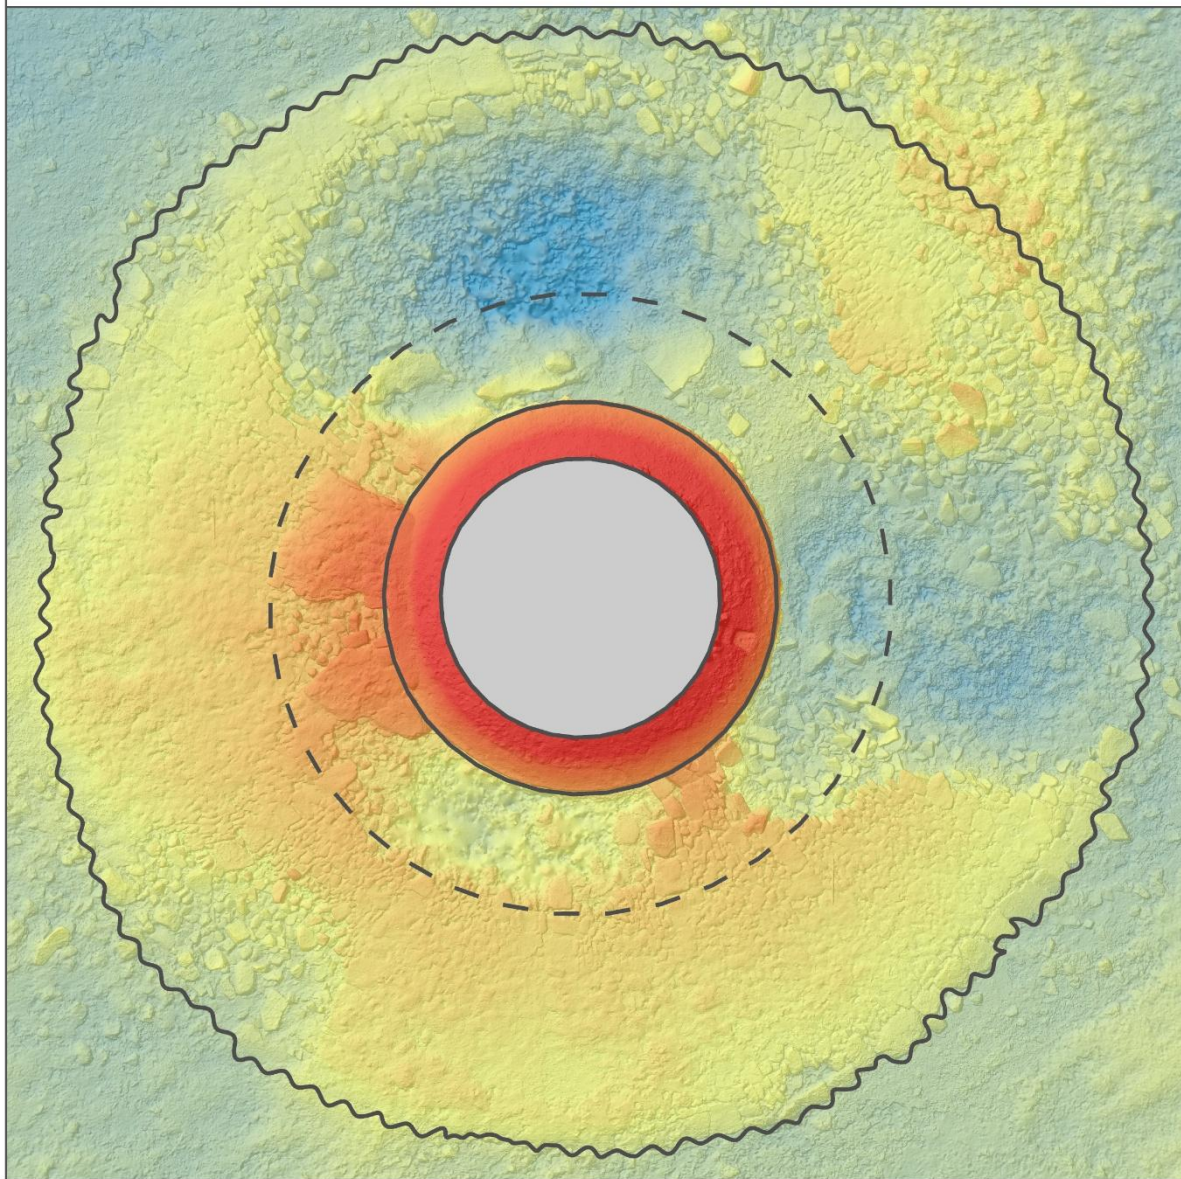
NPRN 34289 Whitford Point Lighthouse Digital Surface Model, August 2023

The erosion of the apron and associated scouring just described have caused a reduction in the height of material around much of the base of the lighthouse. By contrast, in one area, on the northeast edge of the apron, there is a build-up of loose stones and rubble that have raised the height of the recorded surface in that area, relative to the surrounding undamaged apron. This probably represents material that has been pulled out of the erosion/scour areas and deposited on the northeast edge of the apron.

Figure 4.2: Annotated DSM of Whitford Point Lighthouse derived from a photogrammetry survey on 17/08/2023 (© Crown Copyright: RCAHMW).

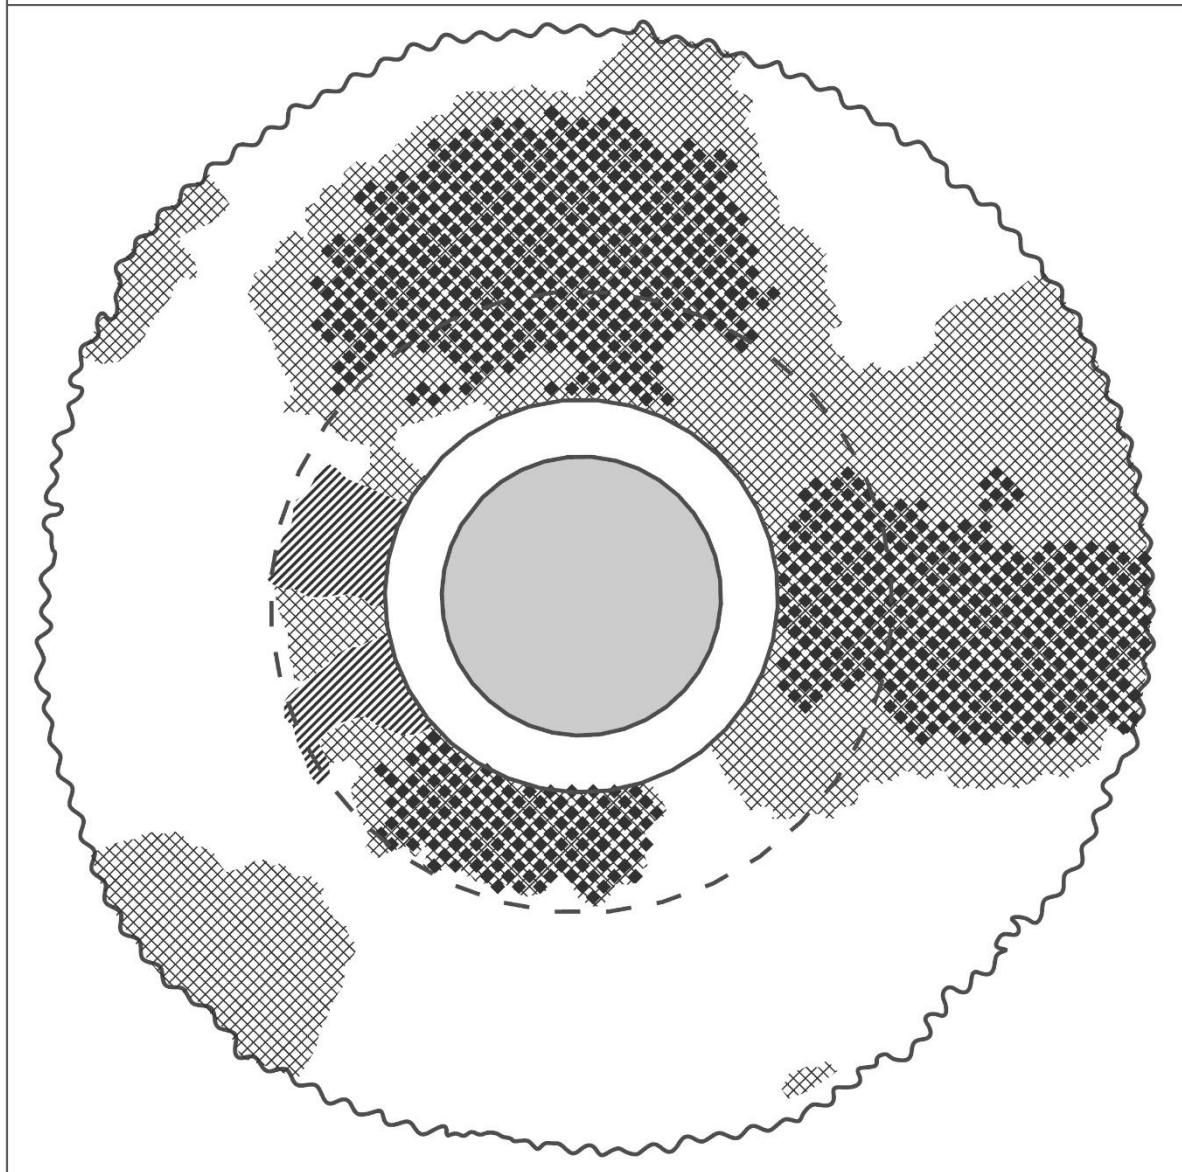
NPRN 34289 Whitford Point Lighthouse **Plan of damaged areas to lighthouse base, August 2023**

The results of the survey presented below are instructive. Water-filled scour pools, indicating the deepest areas of erosion impact, account for 23% of the total area of the stone apron. Large scour pools have formed on the northern and eastern sides, with a smaller pool on the southern side of the lighthouse. The visible extent of the scour pools is the same for 2023 and 2024. Meanwhile, areas of damage to the structural integrity of the stone apron affect just over 49% of the total area. These are primarily around the edges of the main scour pools where the stonework is undergoing a process of dislocation and displacement. Further, more localised areas exist on the southwest and northwest edges of the apron. This figure increased by 0.5% between August 2023 and October 2024, reflecting very localised changes. The upper apron has been subject to much greater loss, and now only survives in one area on the western side of the lighthouse, representing only 10% of its original area, assuming that it once occupied the entire circumference of the collar.

As noted, the scour pools and erosion are most extensive on the eastern and northern sides of the lighthouse (Figures 4.1 – 4.6). The eastern scour area is visibly undercutting the collar, potentially by as much as 0.5m from the vertical outer edge of the collar. The same process is evidence on the northern side of the collar where a 0.5m deep undercut is observable. The scour pool on the southern side of the collar has not yet started to undercut the collar, based on the observations in August 2023.

Figure 4.3: Interpretation of Orthomosaic and DSM of Whitford Point Lighthouse, derived from a photogrammetry survey on 17/08/2023 (© Crown Copyright: RCAHMW).

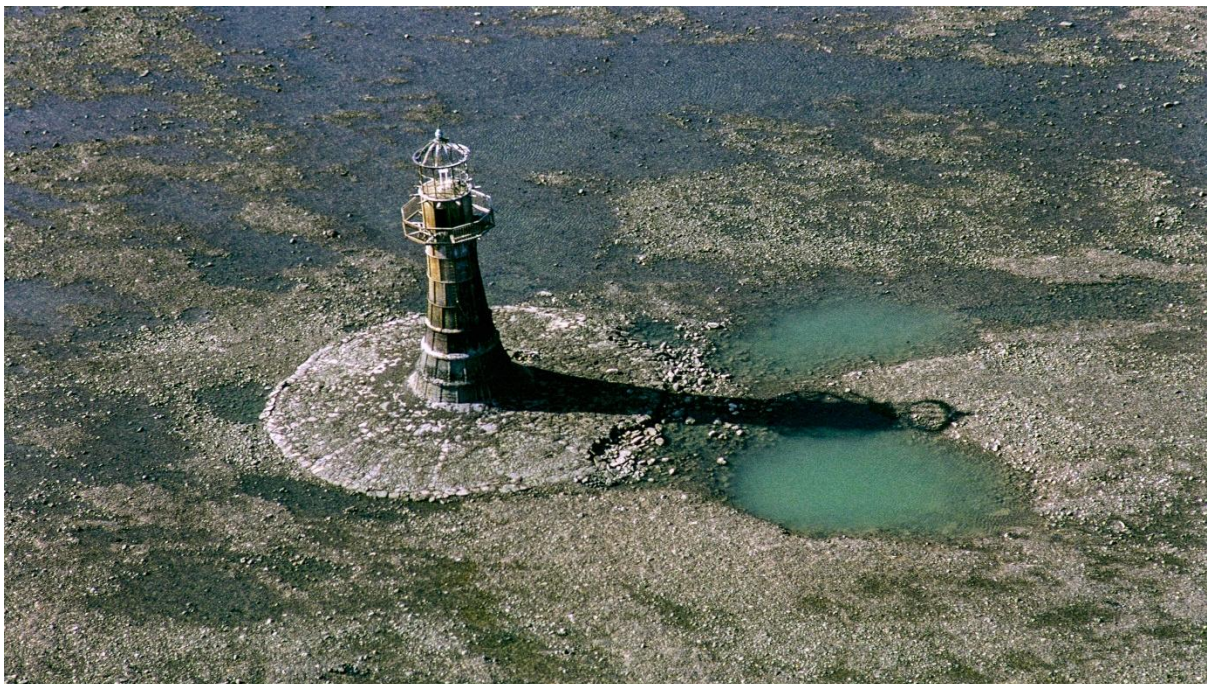
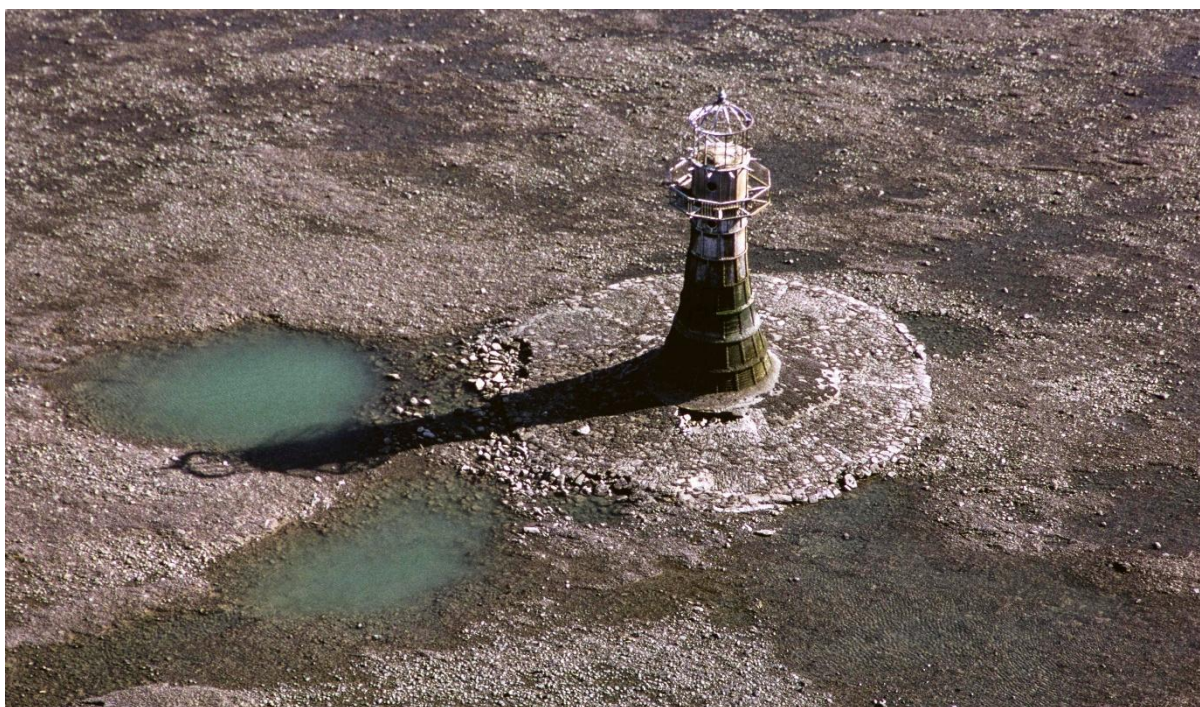
Figure 4.8 and 4.9 make it clear that the large scour pools within the foreshore to the east of the lighthouse are well formed by the mid-1990s. Moreover, the western edges of the scour pools are starting to erode the eastern edge of the stone apron. Reference to Figure 4.8 illustrates that the stone apron appears largely free of erosion damage on its southern and western sides in the areas that would become badly impacted in subsequent decades. There is a suggestion of some dislocation of stones from the outer southwestern edge of the apron, associated with a small scour pool within the adjacent foreshore. By contrast, Figure 4.9 offers a view of the lighthouse from the north. This shows that the process of erosion to the stone apron is underway on the northern side of the lighthouse, characterised by the loss of stonework from the area where the collar and apron meet.

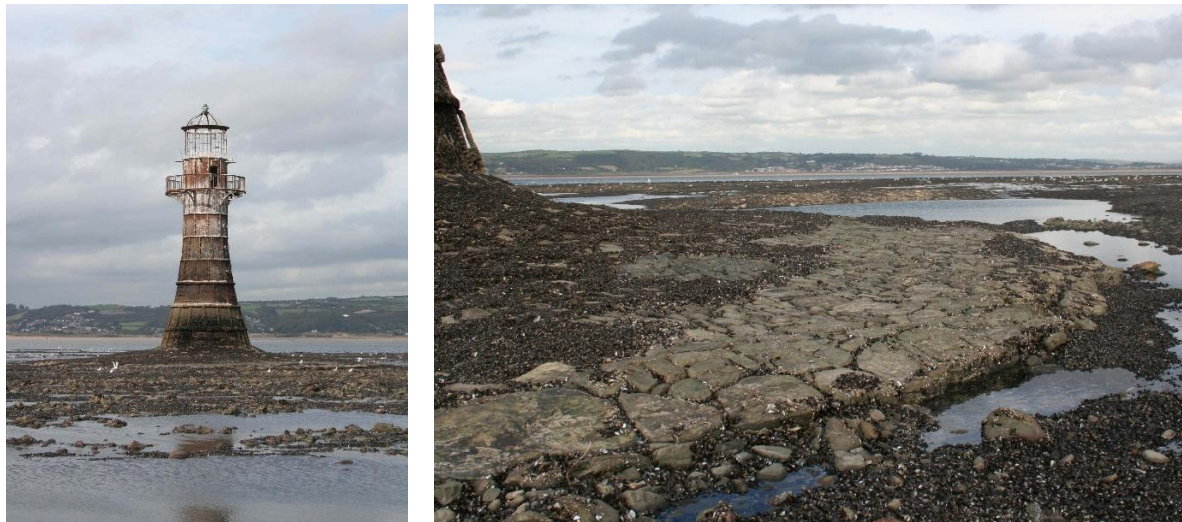
Aerial images from 2002 and 2003 show the lighthouse at high tide. Ground-level photography from 2006, and aerial photography from 2008 therefore form the main record for this decade. The ground-level photography was undertaken by Dave Leighton in 2006 during a site visit to the lighthouse (Figure 4.10) and includes a general image, and a detail of the apron. Both these images are taken from the south side of the lighthouse. The only visible damage is to an area of disturbed stonework on the southwestern outer edge at a point that corresponds with a larger area of damage in the 2023 survey. The detail of the apron stonework is also instructive, in charting the decrease in mussel coverage on the one hand, and because the photo gives coverage of an area that was subject to the southern scour pool by 2023, but which appears undamaged in 2006.

Figure 4.10: Ground-level photos of Whitford Point Lighthouse, viewed from the south, in 2006 (© Crown Copyright: RCAHMW). Left: General view, archive No. 6309802.⁸ Right: Detail of stone apron, archive No. 6309852 (© Crown Copyright: RCAHMW).⁹

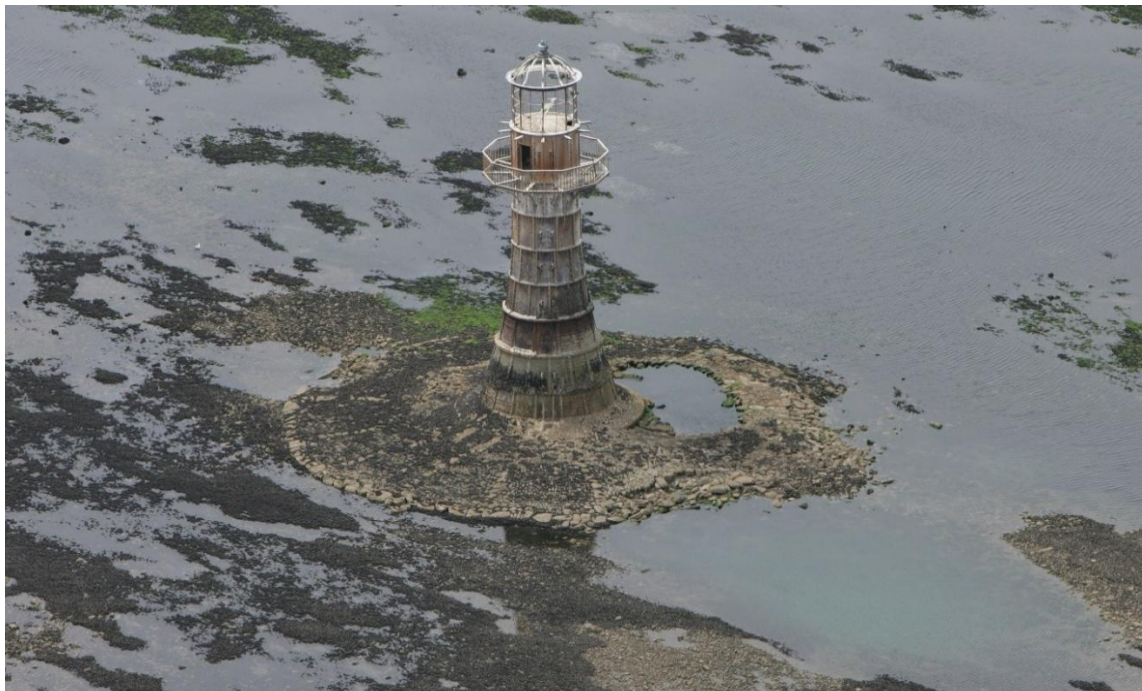
The aerial images from 2008 taken by Toby Driver are especially useful (Figure 4.11). Shot from the southeastern side of the lighthouse, they clearly show that the northern scour pool and area of erosion, beginning to be visible in 1994 was extensive and well-formed by this point. An area of damage to the edge of the apron is also visible on the southeastern side, which would have been out

of shot in the 2006 images. On the southwestern edge of the apron, the damage thought visible in the 2006 ground-level photograph is clearly observable, while a possible area of damage, which became more pronounced in subsequent years, is hinted at along the junction of the collar and upper apron.

Figure 4.11: Aerial photo of Whitford Point Lighthouse, viewed from the southeast, taken by Toby Driver on 20/06/2008, archive No. 6458875 (© Crown Copyright: RCAHMW).¹⁰

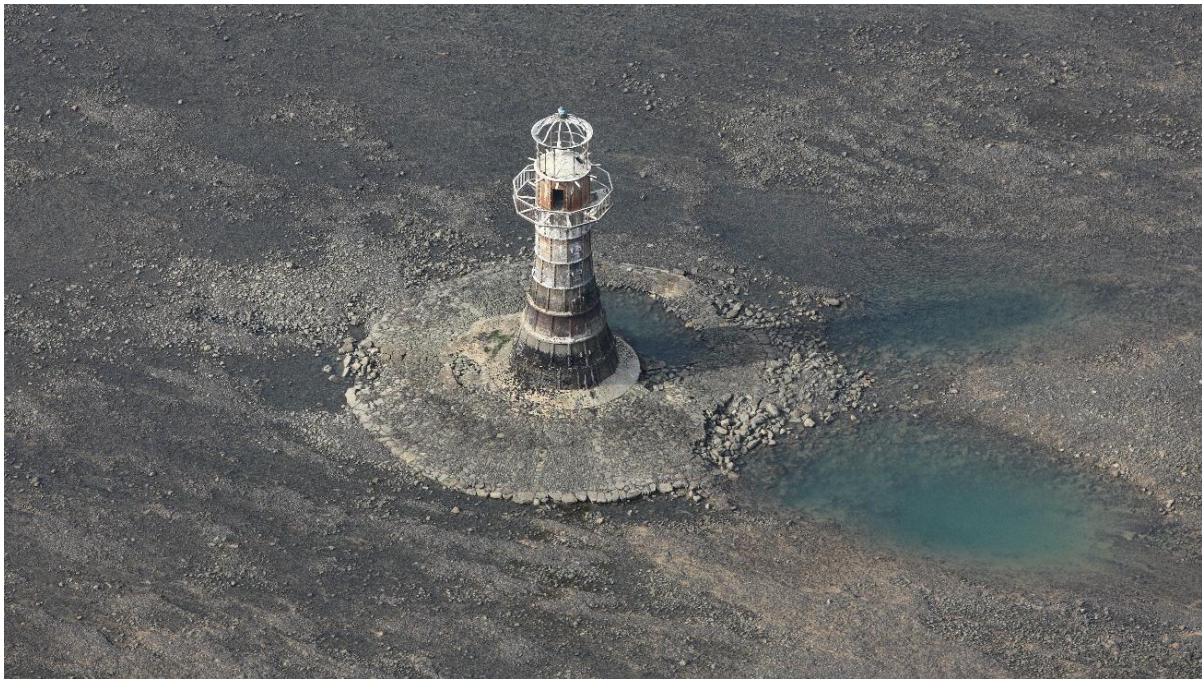
A clear, oblique, aerial image of the lighthouse was taken by Toby Driver in 2010 as part of the RCAHMW flying programme (Figure 4.12). This shows the well-established northern scour-pool and associated erosion. Clear, developing damage to the eastern side of the apron edge is also visible. This appears related to the substantial, deep scour pool, to the east of the lighthouse apron, noted as present in the 1990s (above), which is impacting on the eastern edge of the apron. The patch of damage on the southwestern edge of the apron is visible, along with a scour pool to the southwest of the apron itself. The small area of damage at the upper apron/collar junction on the southwestern side of the lighthouse, possibly visible in the 2008 image, is confirmed as present in this 2010 photograph.

Figure 4.12: Aerial photo of Whitford Point Lighthouse, viewed from the southeast, taken by Toby Driver on 02/03/2010, archive No. 6462393 (© Crown Copyright: RCAHMW).¹¹

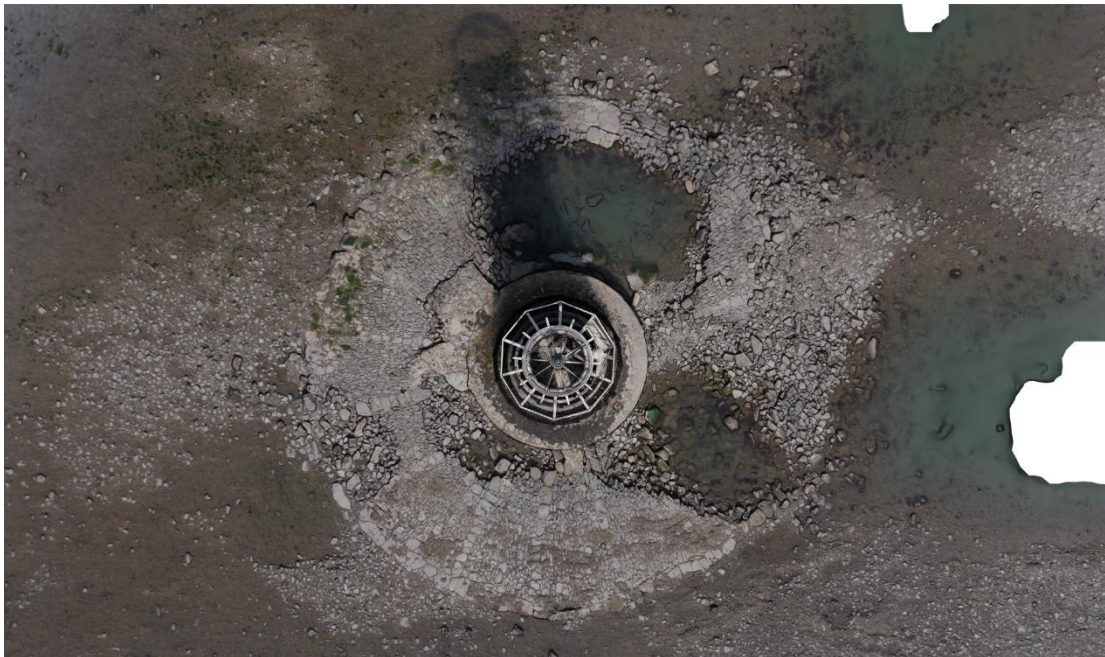
The first 3D digital survey of the lighthouse was undertaken in April 2018 by Hamish Fenton using a kite-based system.¹² This work was not completed as part of a recording scheme, but nevertheless provides an excellent record of the structure and apron at that point in time. It provides a helpful bridge between the aerial images from 2010, and the RCAHMW survey of August 2023. Fenton's survey (Figure 4.13) illustrates that all the main areas of erosion and scour visible in 2023 were established by 2018. In particular, the eastern area has developed rapidly from the situation in 2010 to comprise a large area, filled with water, and with associated loss of the apron edge around its eastern side. The apron between the eastern and northern erosion areas has suffered loss, especially adjacent to the collar, it is better preserved further away from the collar. The northern erosion area itself appears relatively stable. On the southern side of the lighthouse, erosion damage is developing in the area adjacent to the collar that was first confirmed in the 2010 aerial images. Damage to the southwestern edge of the collar has increased, compared to 2010. Finally, reference

to Fenton’s 2018 survey indicates the undercutting of the collar associated with the northern and eastern erosion areas.

Figure 4.13: Orthomosaic of Whitford Point Lighthouse, derived from a photogrammetry survey by Hamish Fenton on 18th April 2018 (Image courtesy of Hamish Fenton).¹³

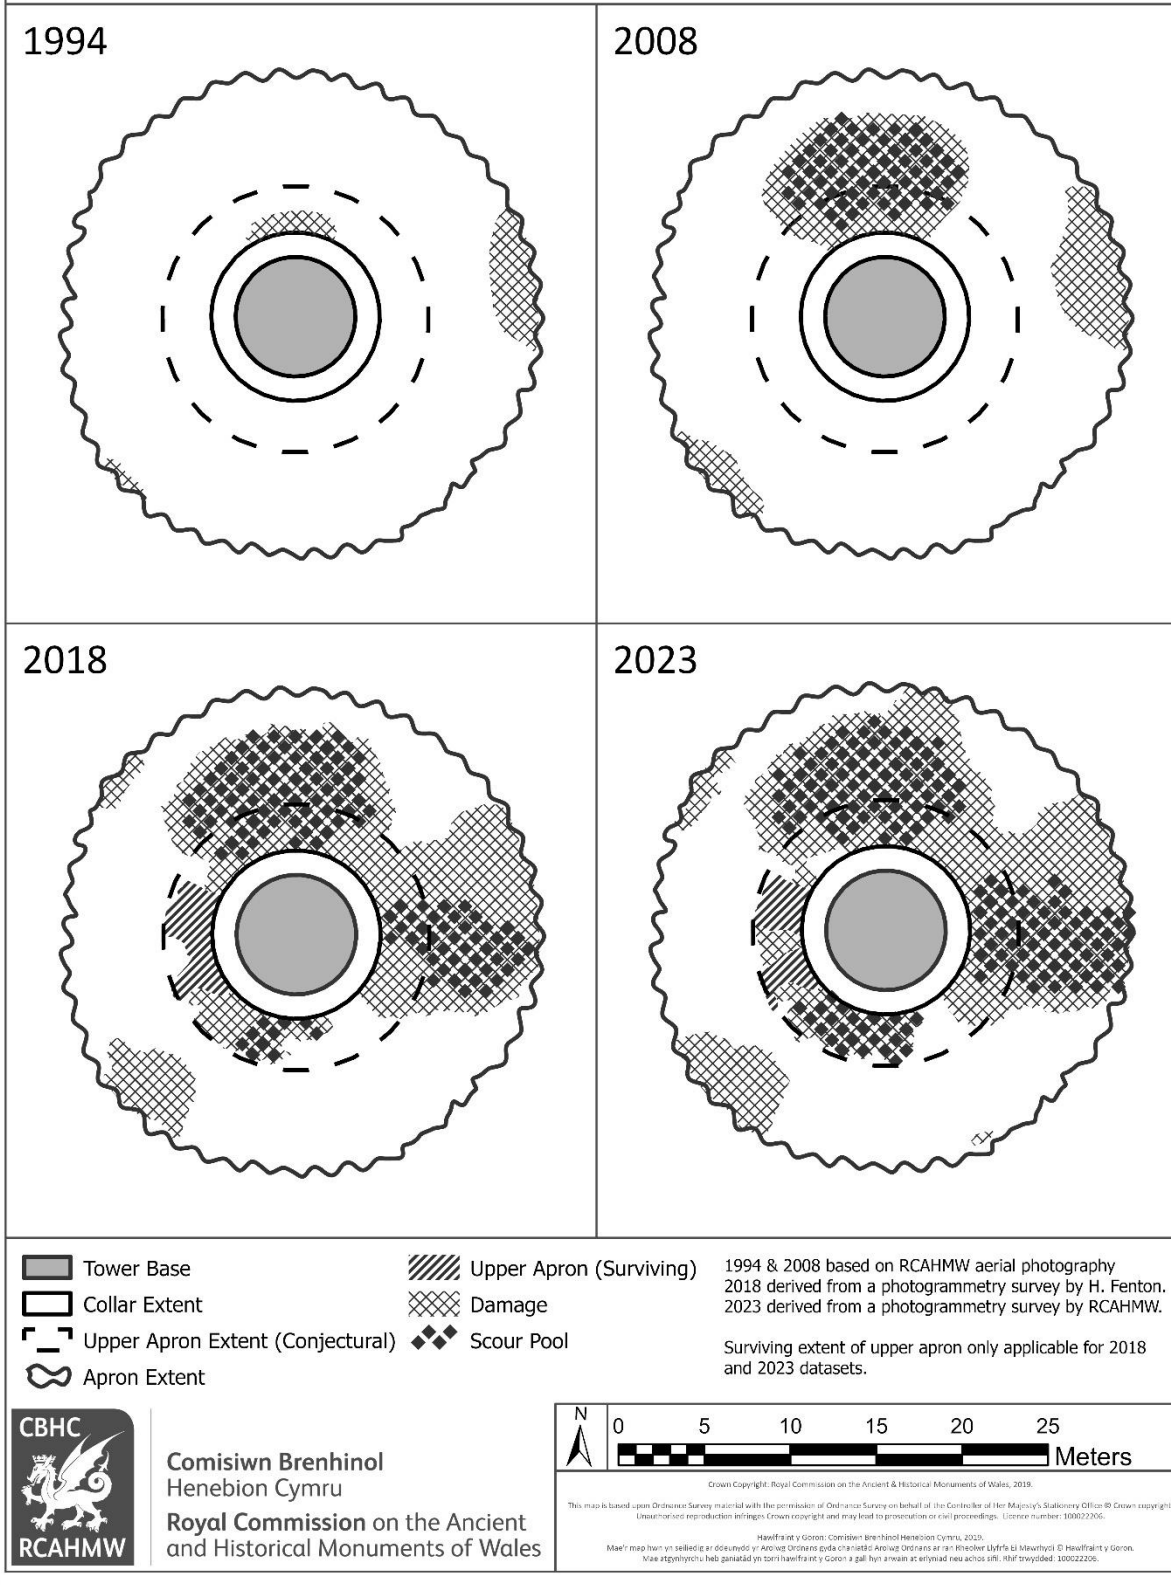
NPRN 34289 Whitford Point Lighthouse **Progression of damage to lighthouse base, 1994-2023**

Combining the two sets of data outlined in Sections 4.1 and 4.2 allows a set of overall observations regarding the development and progression of erosion damage to the base of Whitford Point Lighthouse (Figure 4.14). These overall observations are based on using the August 2023 RCAHMW survey as a known baseline against which the information contained within the available historical images can be compared. Three main areas of damage to the base of the lighthouse can be demarcated based on the August 2023 survey; on the northern, eastern and southwestern sides, and it is simplest to address each of these in turn (below).

Figure 4.14. Overall progression of erosion damage to the stone apron of Whitford Point Lighthouse between 1994 and 2023 (© Crown Copyright: RCAHMW).

RCAHMW aerial images from the mid-1990s make it clear that the area of erosion on the northern side of the lighthouse has started to form by 1994, characterised by an area of missing stonework from the apron. By 2008 the erosion is well-established with clear and significant loss of material from the apron. By contrast, increase between 2008 and 2023 appears to be relatively small. Reference to the 2018 photogrammetry survey illustrates undercutting of the apron in this area, which it is suggested was already happening by 2008.

An area of developing damage to the northwestern edge of the apron is present in the 2023 survey, which can be identified as being tentatively present in 2018.

The eastern erosion area within the apron appears to have developed since the 2008/2010 aerial images. There is no suggestion of it in the 1994 aerial images or the 2006 ground-level photographs, although damage to outer-apron edge may have been out of shot. In 1994, 2008 and 2010 damage is restricted to the edge of the apron. But, by 2018 the eastern erosion area is well-developed with a significant associated scour pool and undercutting of the collar. This trajectory continues through to the 2023 and 2024 surveys with observable increase to this erosion area. There is also loss of material from between the northern and eastern areas in the period between 2018 and 2023. The eastern erosion area illustrates the speed with which significant loss of material can occur, in this case in the eight years between the 2010 aerial photographs and the dataset captured by Hamish Fenton in 2018.

Intriguingly, the 2023/2024 surveys identified an area of the northeastern apron edge with a pile of loose stones on it, assumed to have been deposited there following scouring from the northern or eastern areas. Reference to the 2018 data shows that this pile of stones was greater in extent in 2018 than in 2023/2024. It may therefore have been created during the scouring of the eastern erosion area between 2010 and 2018, before now reducing in coverage.

In 1994, damage in this area is restricted to the possible dislocation of stonework from the outer-edge of the apron on its southwestern side. The same area exhibits a development of the same damage in 2008. By 2010 there is some suggestion of loss of material where the apron and collar meet, and this is clearly the case by 2018 when a large area of erosion damage is visible from the apron/collar area on the southern side of the lighthouse. The depth of this is illustrated by the formation of a scour-pool within it. The extent of material missing from the southwestern edge of the apron has also increased by 2018. This process continues to the 2023 and 2024 surveys, with an increase to the erosion damage and scour-pool, as well as the apron edge. As with the eastern area, this demonstrates the rapidity with which significant loss can occur, in this case between 2010 and 2018, with continuation through to 2023 and 2024.
