Project PD24-108

Report 2076

# Holt Presbyterian Church

Level 3 Historic Building Recording

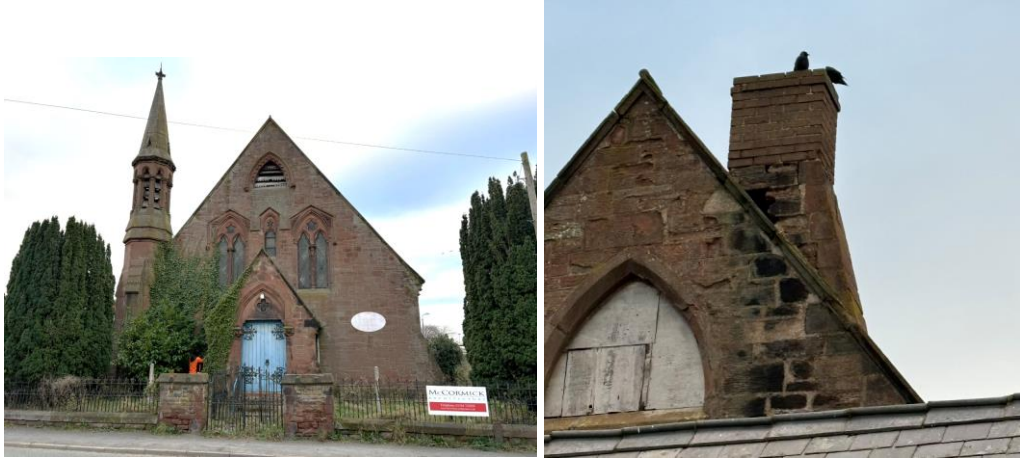
- 2.9. The eastern gable contains an ornate gable vent set within a gothic-style first pointed arch (Figure 6). It features three windows: two large lancet-style windows, each with two lights, and a pentagonal motif window within the tracery. Below this, there is a central gabled entrance porch showcasing an ornate doorway flanked by columns that support a sandstone early English first pointed-style arch, which is topped by a quatrefoil window. The porch also includes two side windows, each featuring two lights contained within first pointed-style arches, separated by a sandstone mullion with diamond-pattern leaded glass panels.

- 2.10. The visible portion of the west-facing gable (Figure 7) of the church features a blocked-up window or gable vent set within a single pointed arch. Atop the coping stones of the gable parapet is the stack of a narrow chimney, which appeared to be heavily damaged at the time of the survey, missing some blocks from its lower courses above the coping stones. This chimney stack likely originates from the original structure, as the flue incorporated within the gable shows no signs of later modification. However, the upper part of the chimney appears to have been altered, with 20th-century red brickwork that is consistent with phase 2 of the building's modifications.

*Figure 6: (Left) East-facing exterior elevation of the church (Heneb photo PD24-108\_073)*

*Figure 7: (Right) West-facing gable of the church with chimney stack (Heneb photo PD24-108\_077)*

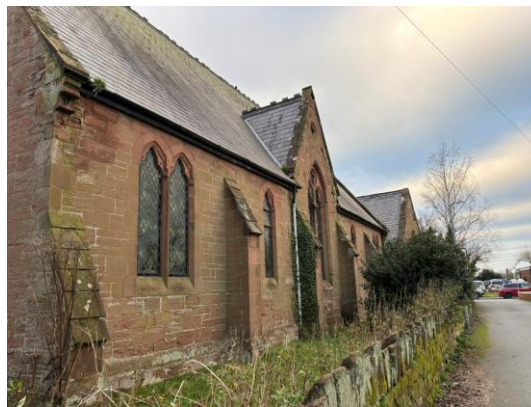
- 2.11. The windows of the side elevations of the church (Figure 8) comprise gothic-style first-pointed arches with foliated capitals and diamond pattern stained-glass panes. The layout of the windows is mirrored on each side of the church comprising a central tall double light window with a quatrefoil light in the arch and a secondary upper vent or circular window within a side gable (W3, 8) (Figures 11, 17 – 19). On either side of the church is a further mirrored pattern of four short single lights (W2, 4, 7 and 9) and four short double lights (W1, 5, 6 and 10).

*Figure 8: North-facing exterior elevation of the church (Heneb photo PD24-108\_071)*

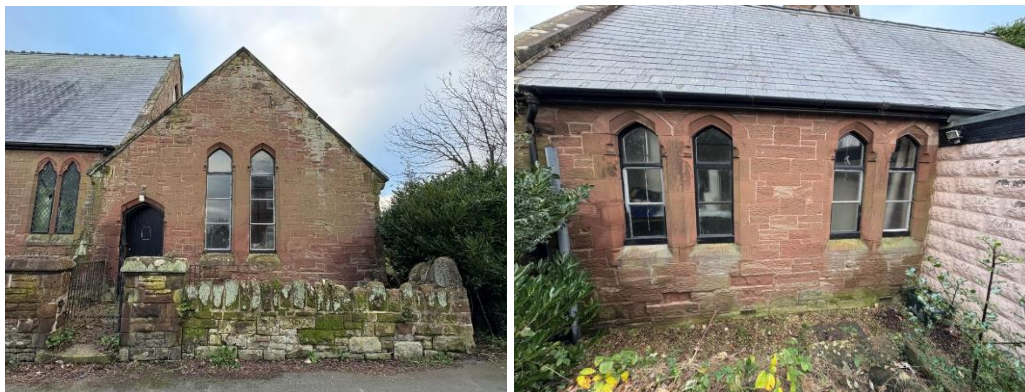
- 2.12. The external elevations of the schoolhouse (Figures 9 and 10) are comparable to the church but with a less ornate design, with four sets of simple lancet windows containing timber frame lights typical of the late Victorian period (Figures 17 – 19, W17-20). The windows have chamfered sandstone frames with single-pointed arches and a chamfered sill. The schoolhouse is accessed externally through a doorway from the north (Figure 9) which is contained within a chamfered sandstone frame with a pointed segmental arch (Figure 19 D6). This door was mirrored on the south-facing gable of the schoolhouse but had only been accessible from the interior at the time of the survey (Figures 15 and 19 D5).

*Figure 9: (Left) North-facing gable elevation of rear school room (Heneb photo PD24-108\_066)*

*Figure 10: (Right) West-facing elevation of school room showing windows 19 and 20 (Heneb photo PD24-108\_065)*

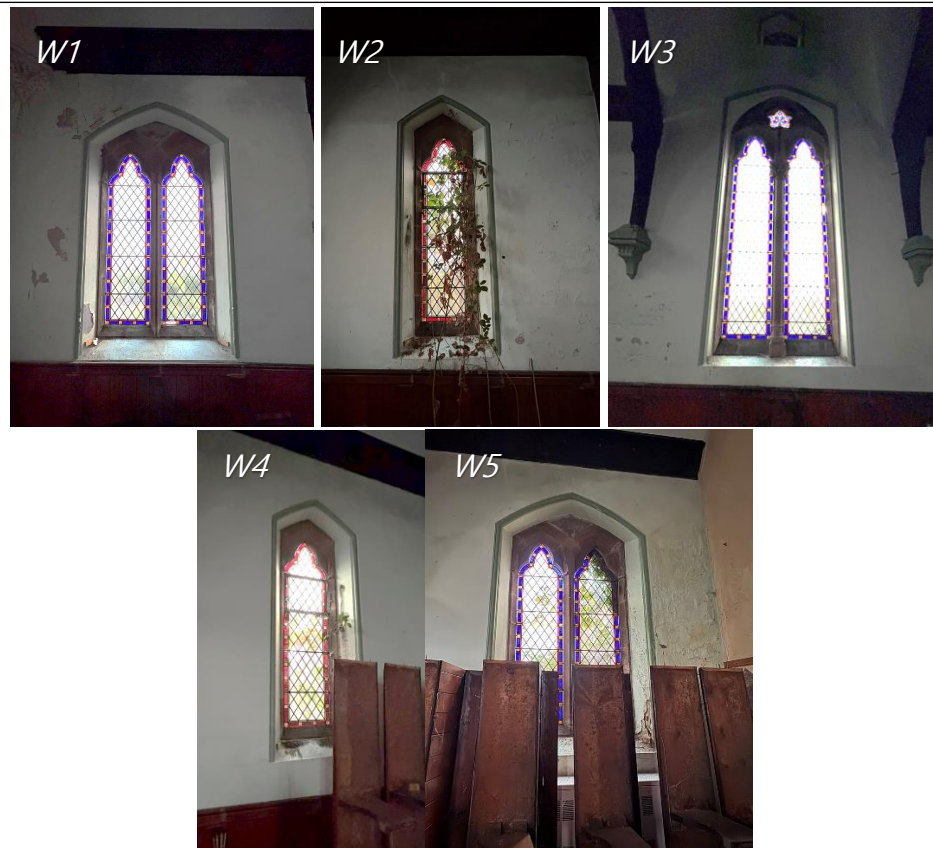
Figure 11: Windows within the southern church elevation (Heneb photo PD24-108\_011-015)

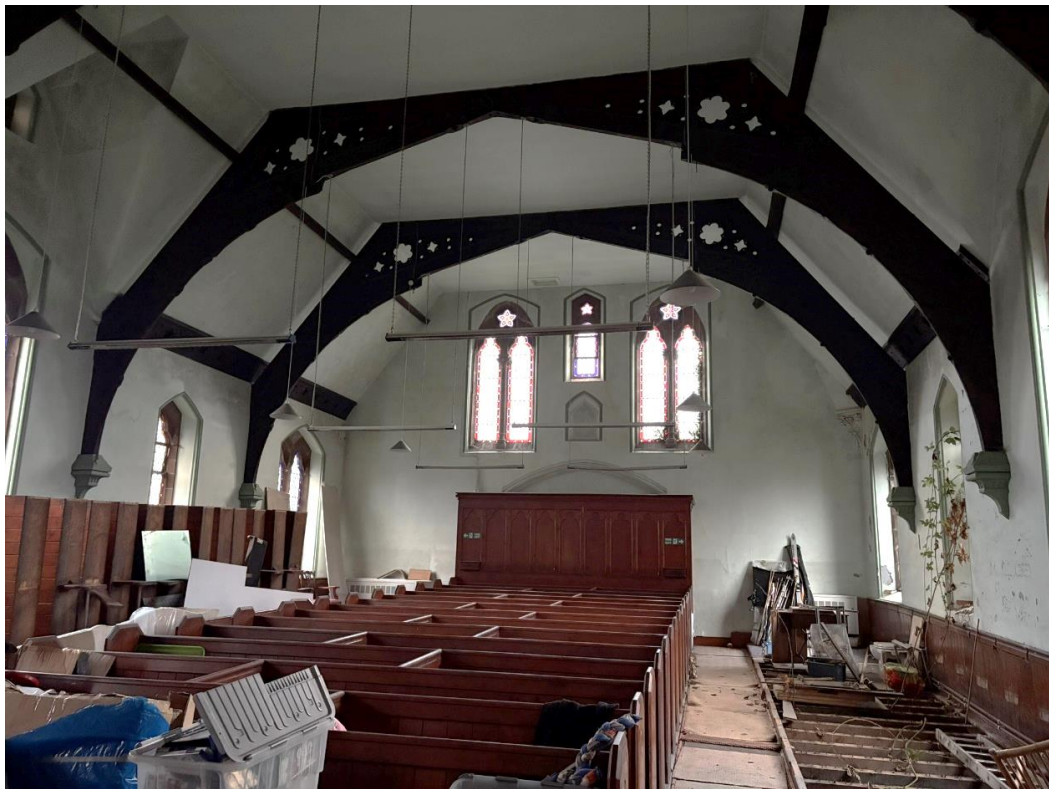
- 2.13. The interior of the church features four ornate timber pointed roof trusses set onto painted stone corbels (Figure 12 and Figure 13). Above these trusses is a flat-topped vaulted ceiling made of lathe and plaster, which has been partially exposed in the southwest corner due to a collapse. The masonry walls of the church were rendered, probably using a lime-based plaster, and are complemented by timber dado panels. It is noticeable that the dado slopes gently toward the west, reflecting the subtle incline of the nave leading to the western pulpit.

- 2.14. Much of what is likely to be Lockwood's original internal design remains largely intact, including an eastern timber lobby (Figure 12), the western pulpit (Figure 13), and most of the sloping pews. However, two rows of pews along the southern wall have been removed due to increased damage from dampness and vegetation. This removal uncovered underlying deposits beneath the pews and aisles, which consisted of soil rich in lime mortar, with no visible evidence of earlier features.

*Figure 12: Church interior looking east (Heneb photo PD24-108\_001)*

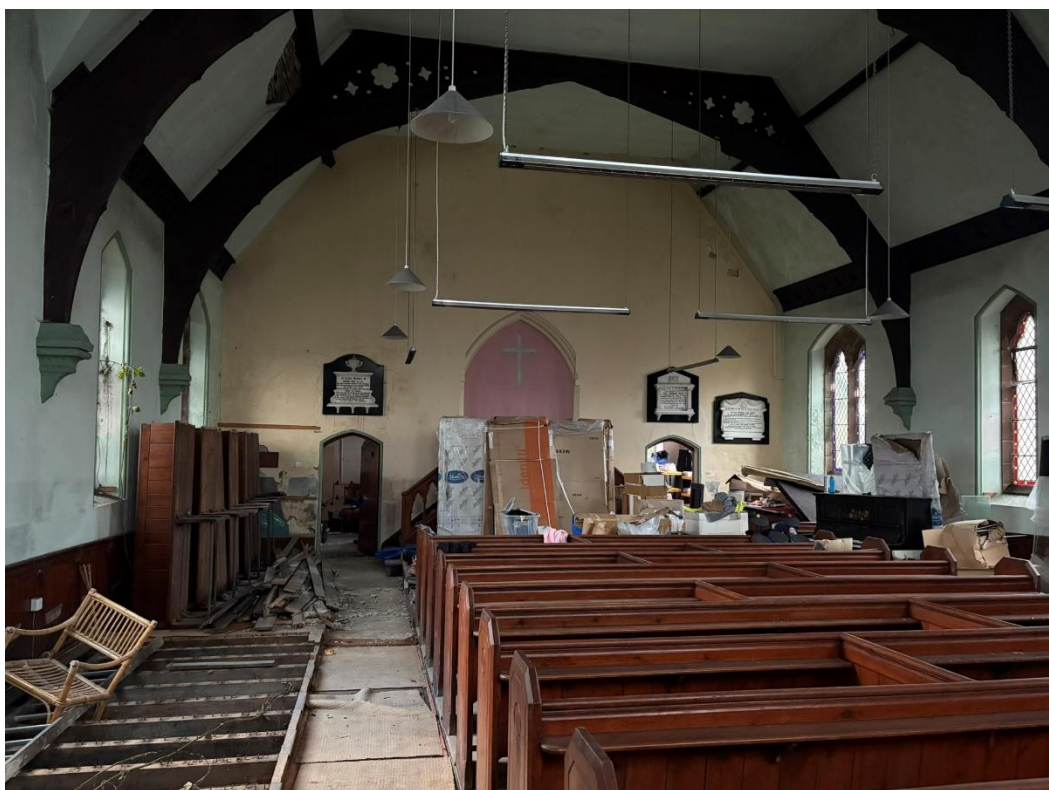
- 2.15. The pulpit is a raised timber structure with a lectern positioned on a platform with a surrounding stage area. Behind the pulpit, within the western gable, is a tall decorative recess with a first-pointed arch, containing a fixed cross (Figure 13). The western internal gable also features three memorial plaques which are detailed in Section 1 (Historic background).

- 2.16. On either side of the pulpit are short first-pointed arched doorways leading to the schoolroom at the back of the church (Figure 13). Both doorways have ornate stone frames and large original timber doors with wrought iron fittings.

*Figure 13: Church interior looking west (Heneb photo PD24-108\_039)*

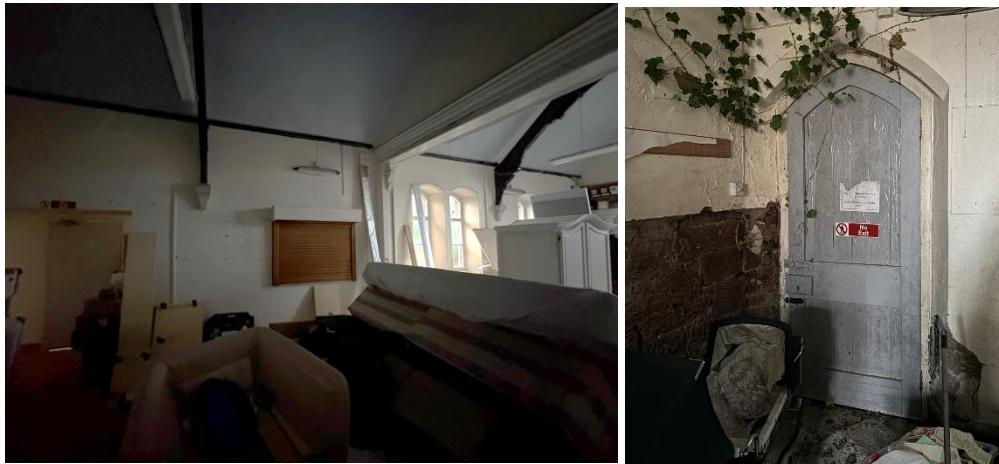
- 2.18. The interior of the schoolroom features a vaulted ceiling with two largely decorative timber trusses supported on ornate corbels (Figure 14). The school room is divided by a central flat-topped arch adorned with decorative mouldings. This may have once formed part of an internal timber classroom division, a common feature in Victorian schools. However, no remnants of the associated fittings are visible due to modern rendering. The presence of an external chimney stack suggests that there was probably a small fireplace in one or both of the schoolrooms, but this has since been blocked up. As a result, no evidence of it was found during the survey, again due to the modern internal rendering.

- 2.19. There may have originally been two additional lancet-style windows in the southern half of the western elevation that were modified and blocked during the construction on the phase 2 extension, however, these were not evident due to the internal rendering (Figure 14).

*Figure 14: (Left) Interior of school rooms looking west (Heneb photo PD24-108\_060)*

*Figure 15: (Right) Interior view of schoolroom doorway on the southern elevation (Heneb photo PD24-108\_042)*

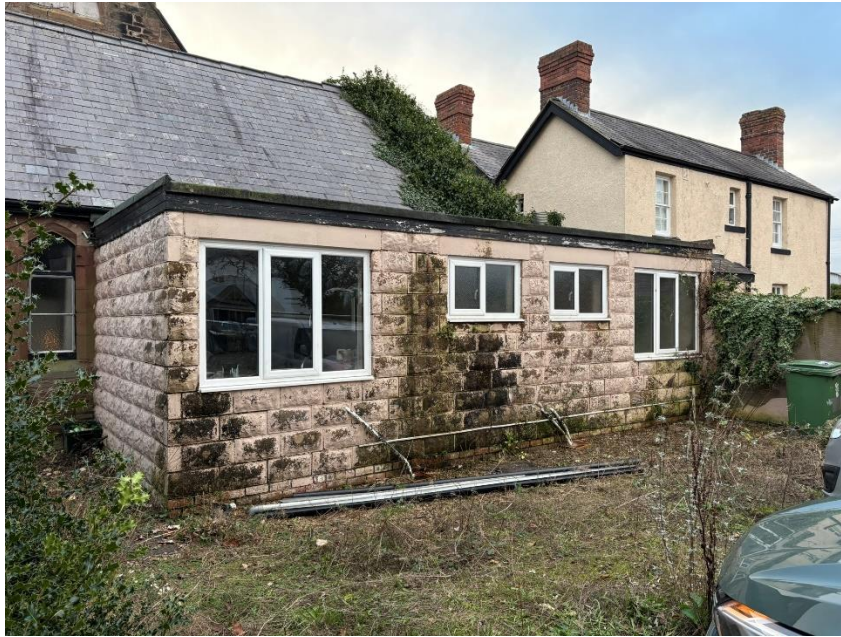
- 2.22. Externally the structure consists of a simple concrete breezeblock construction with UPVC windows with concrete lintels (Figure 16). The structure has a relatively flat roof, sloping slightly towards the schoolrooms.

*Figure 16: 20th-century extension (Heneb photo PD24-108\_063)*
