LLWYN CELYN
Stanton
Crucorney Fawr
Gwent
19/17995/DISCON

PHOTOGRAPHIC
SURVEY

PART 1:
THE HOUSE

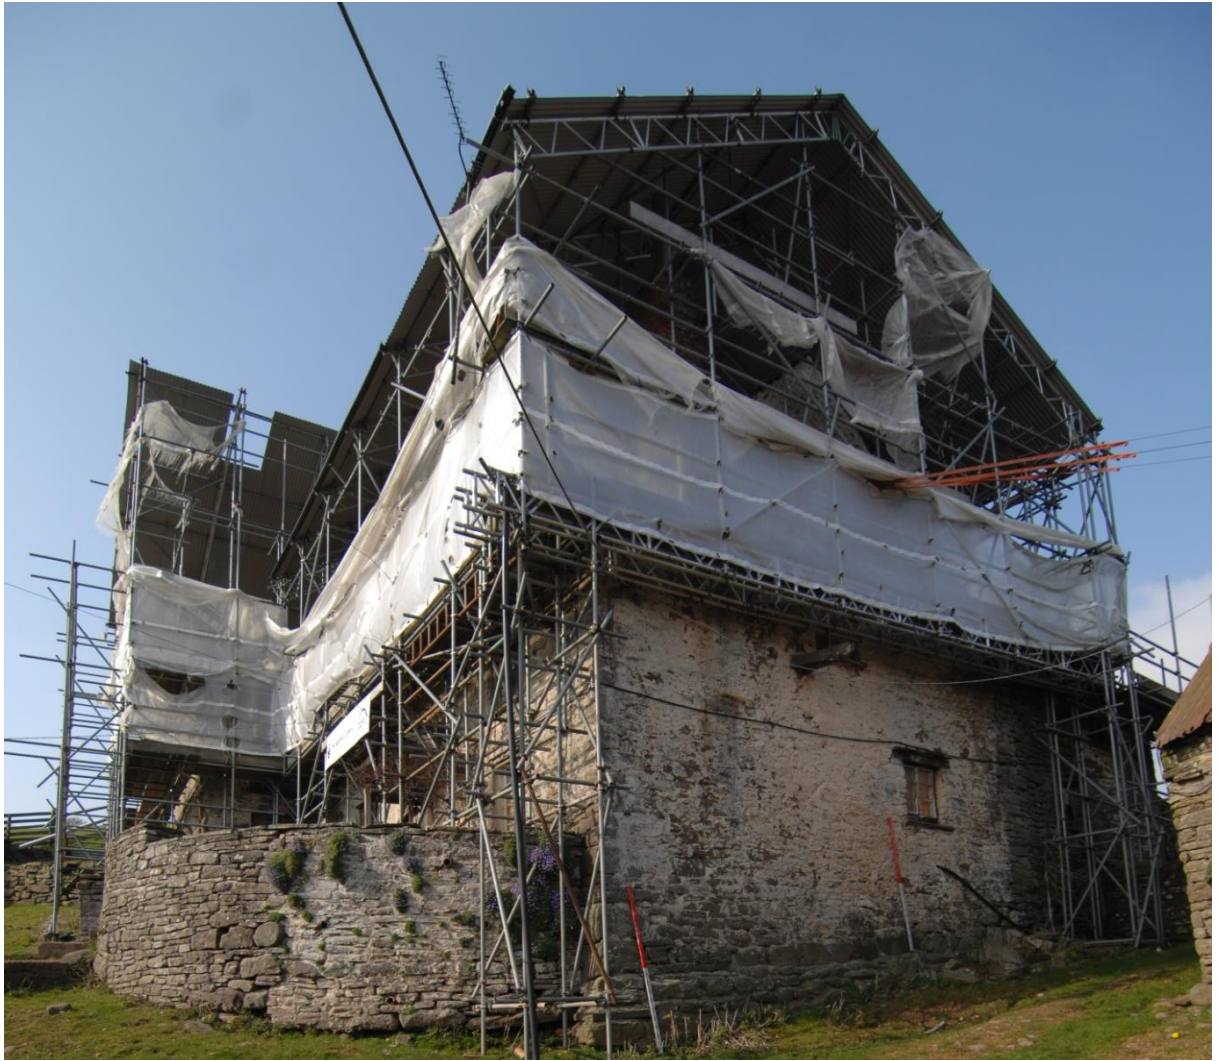
Pl.3: The scaffolded house from the south-east in 2016.

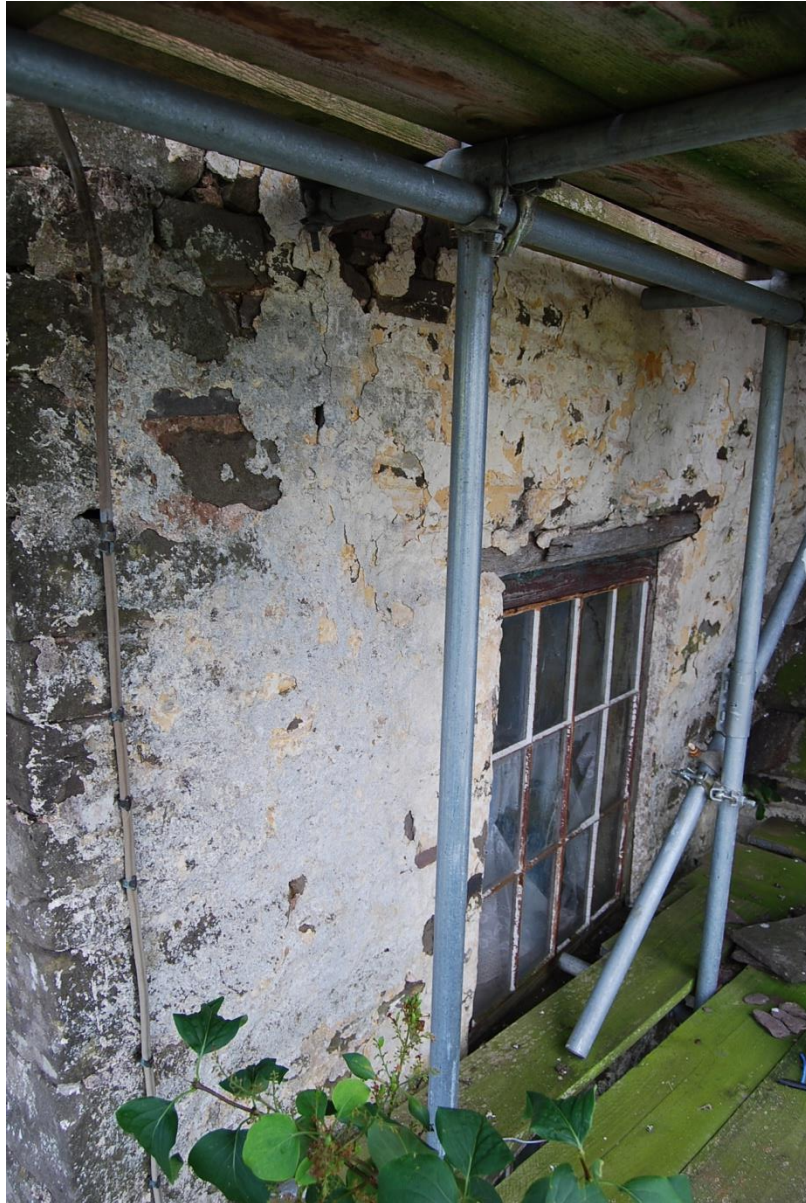
Pl.11: Detail of limewashed butter-pointed render finish.

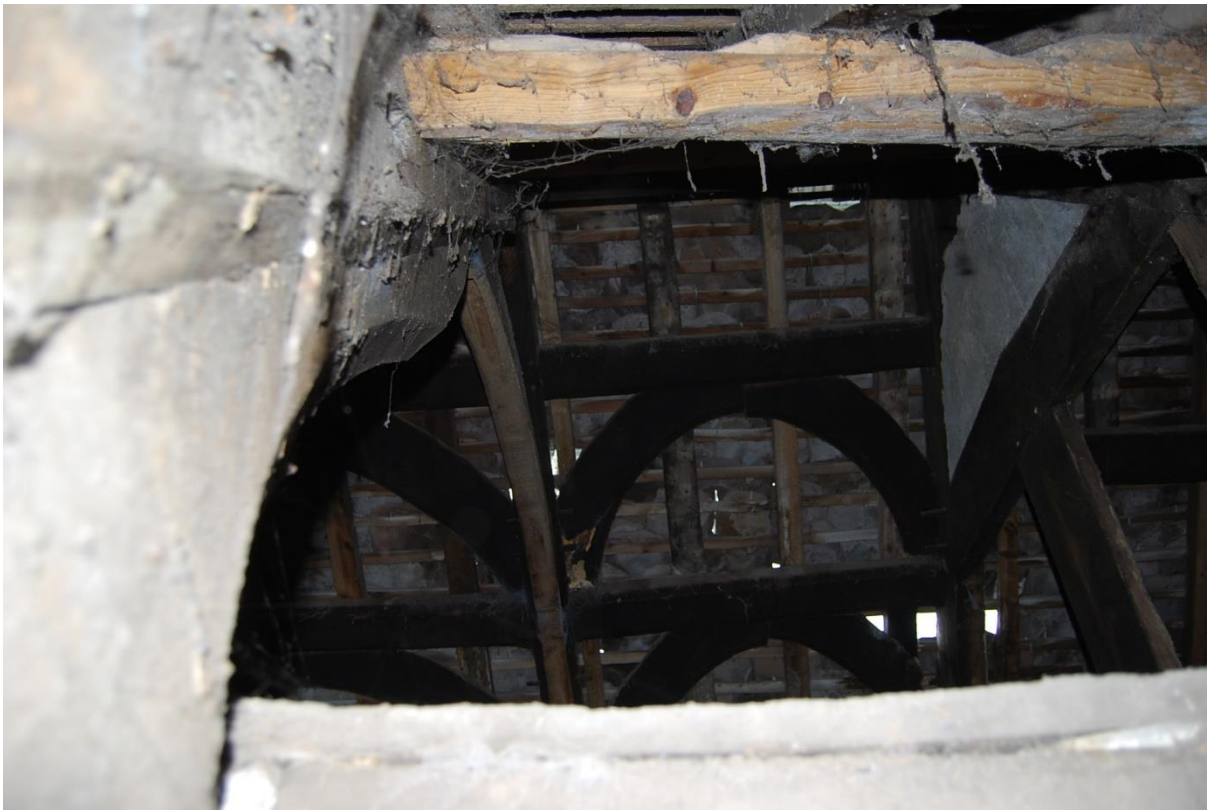
Pl.21: Part of the Solar roof structure viewed through a broken ceiling.

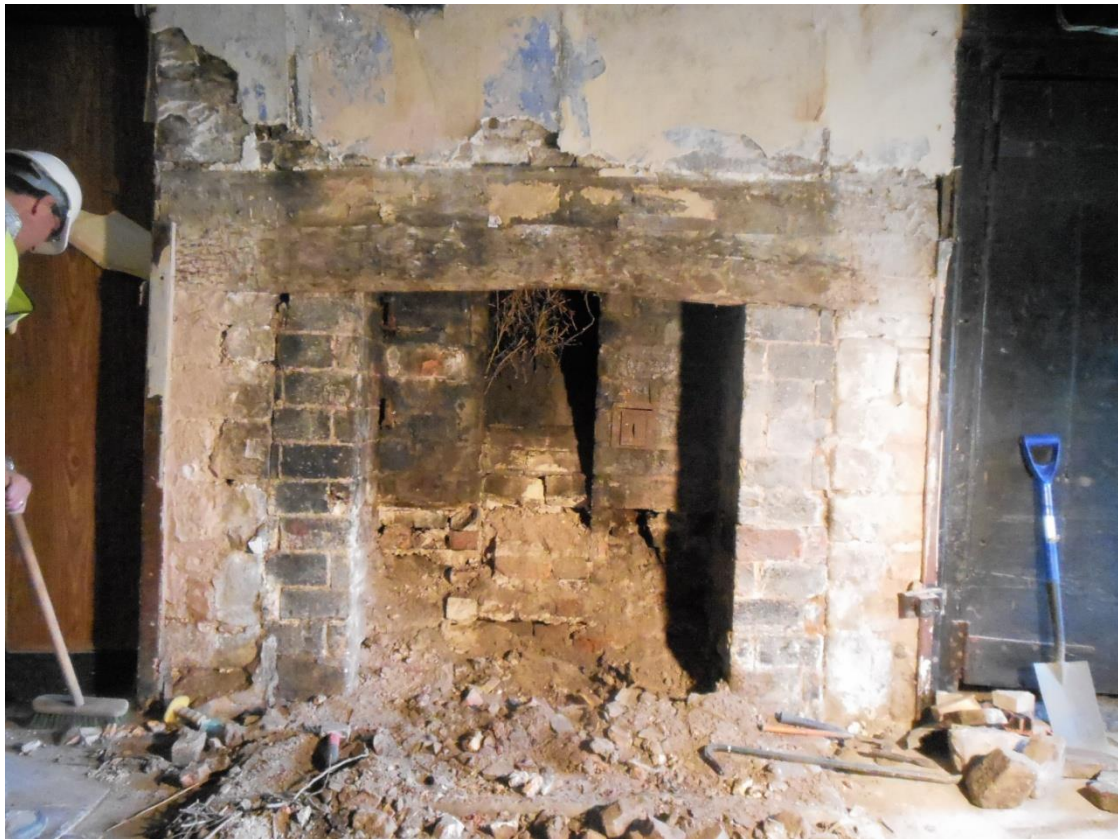
Pl.31: Initial phase of fireplace explorations in the hall in 2015.

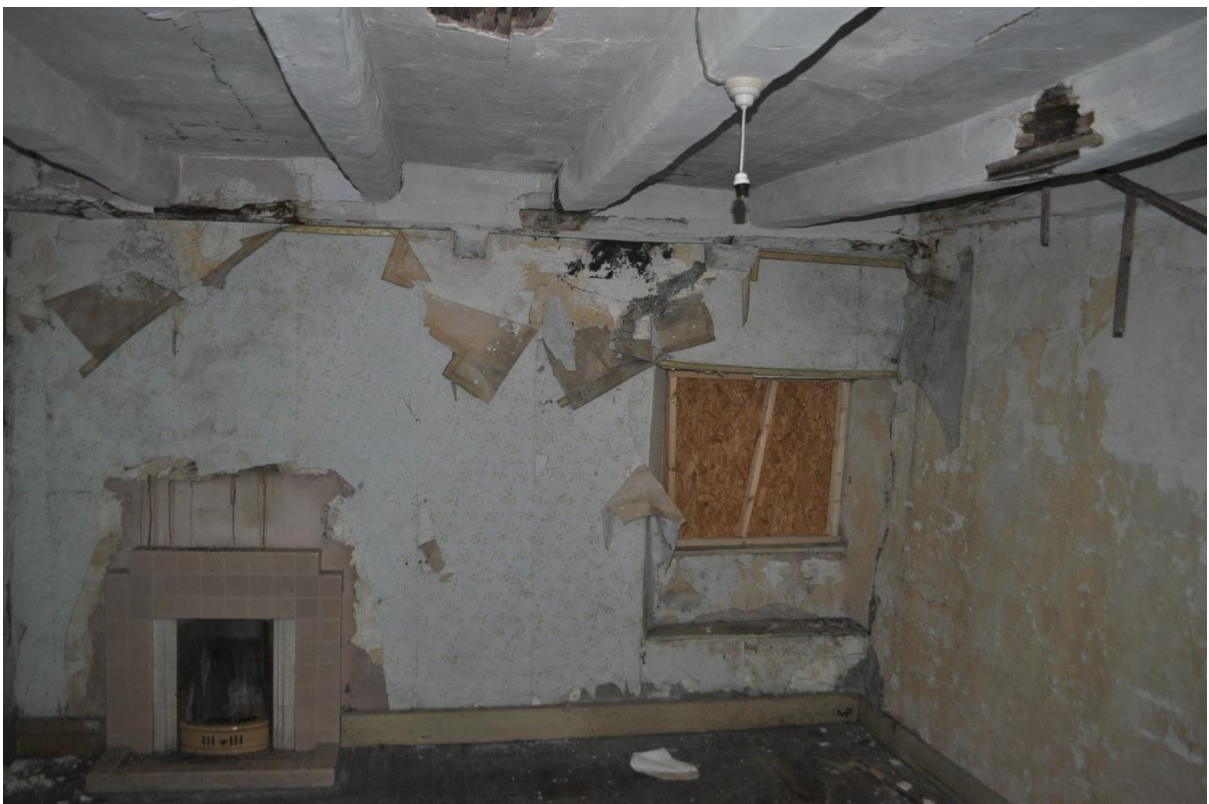
Pl.54: The west wall of the central first floor room in the Solar wing after clearance.

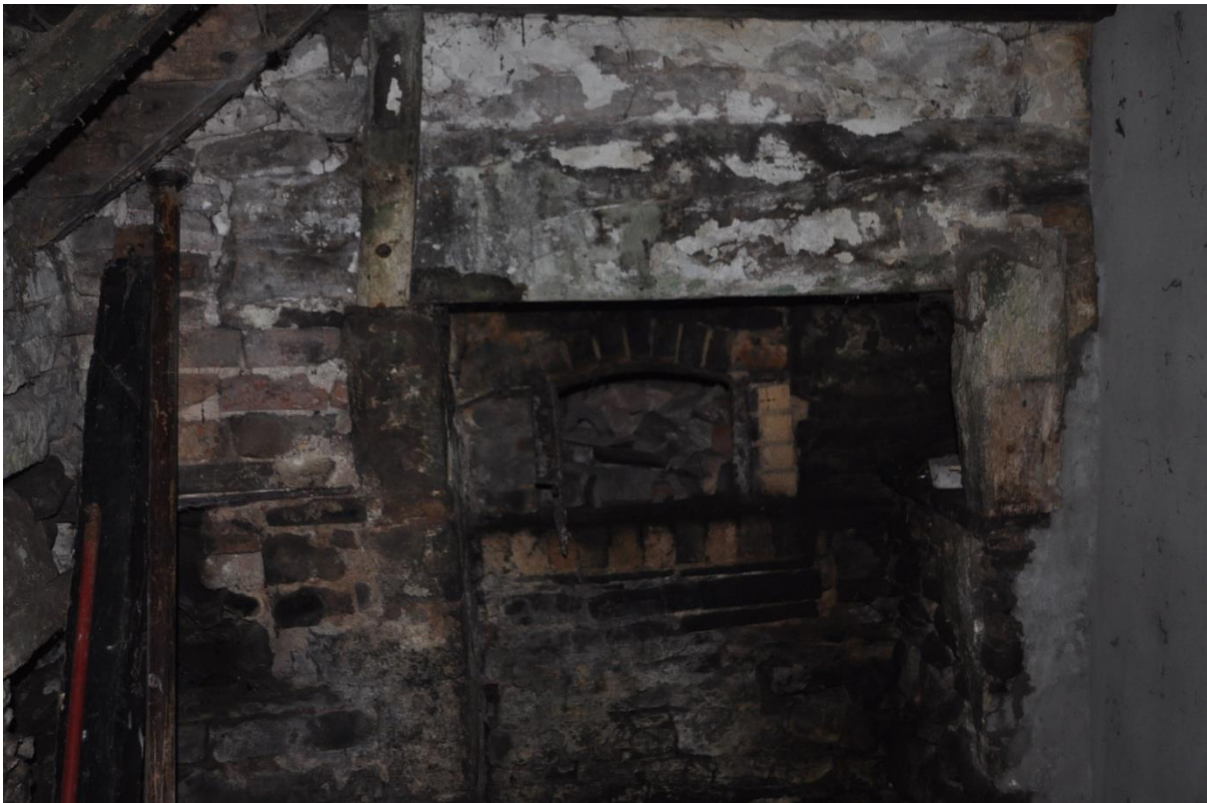
Pl.63: The exposed fireplace and bread oven in G8).
