Llwyn Celyn Stanton Cwmyoy Crucorney Fawr Gwent

An Architectural & Archaeological Analysis

February 2020 Mercian Heritage Series No. 1517 Llwyn Celyn Stanton Cwmyoy Crucorney Fawr Gwent NGR: SO 309 218

Planning Application: 15/12532/FUL Ref: Condition 7 (Level 4 Buildings survey).

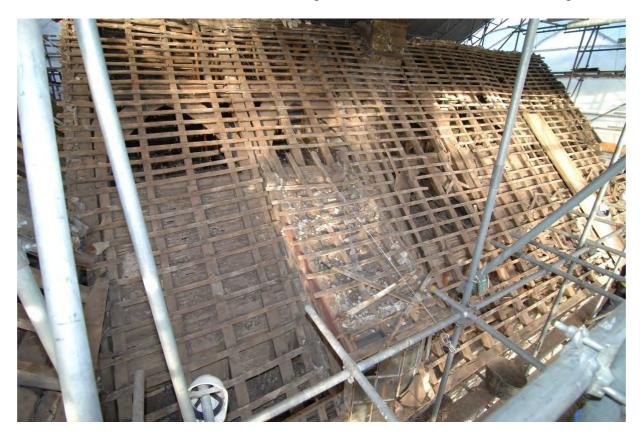
Pl.10: The south slope of the Hall Range roof, under repair in 2016.

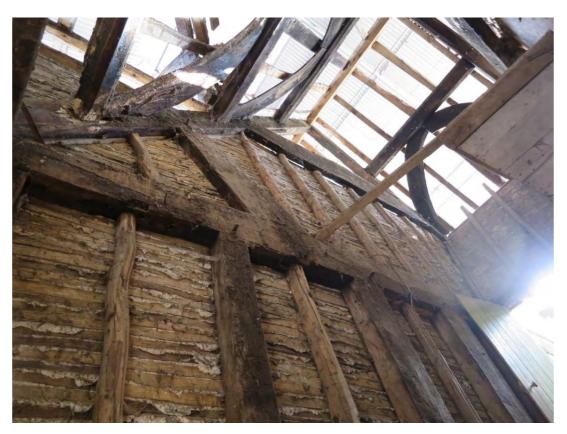
The two bays over the former services at the eastern end of this range have a very different roof design, with an ephemeral truss set close to the east gable wall. This is evidently not medieval and there was evidence of fire damage in this area – which led to the replacement of most of the first-floor structure and probably accounted for scorching on the east face of the last of the medieval trusses.

Pl.11: Closed truss between the screens passage bay and the services, from the west, 2016.

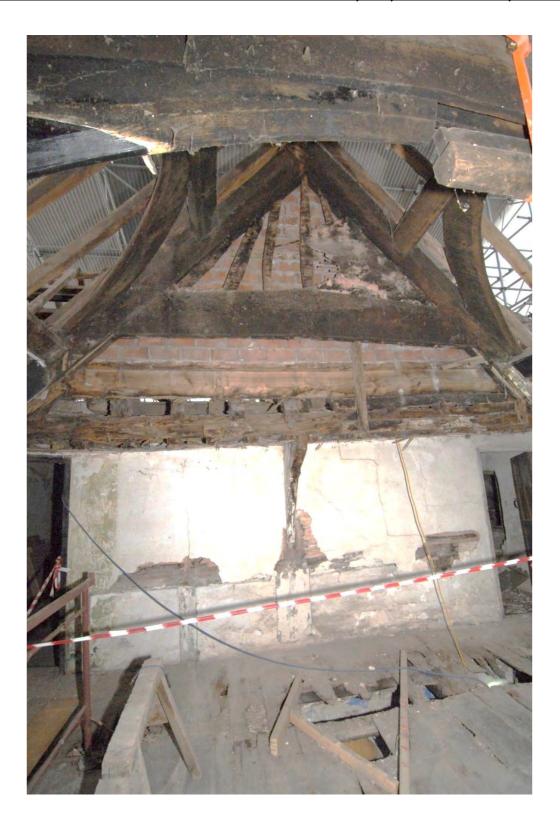
Pl.14: The west end of the roof over the Hall Range after the removal of the inserted first floor ceiling and corridors. This shows the smoke-blackened end truss, with a later brick skin externally. The timber below its collar is the (replaced) outer wall-plate of the roof of the Solar Range, supported mid-way by a primary bracket tenoned into the cross-frame between the two ranges.

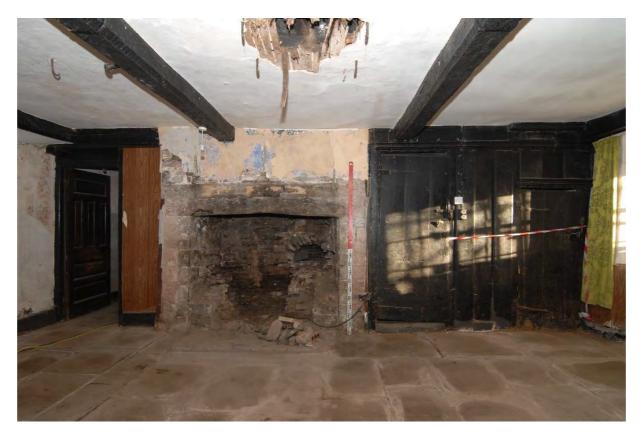
Pl.19: The east end of the hall during the early stages of the restoration, showing the opened up fireplace with the bread oven within. To the right is re-used plank-and-muntin boxing in the secondary stairs. Note that the ceiling joists are plastered over at this time.

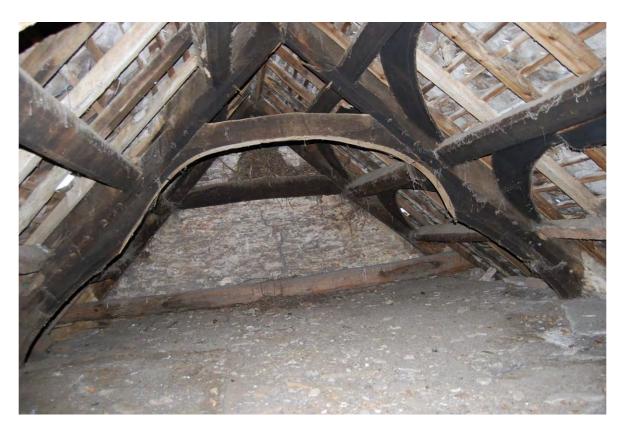
Pl.28: The roof over the southern part of the Solar, showing a mutilated arch-braced truss in the foreground and the gable truss beyond. The attic floor is inserted.

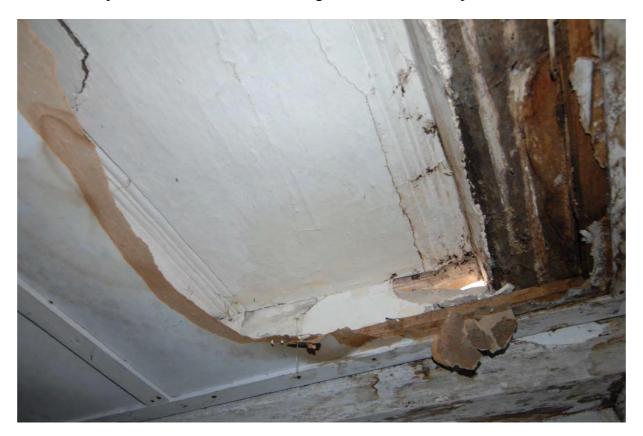
Pl.33: Detail of surviving fluted ceiling and earlier chamfered joist in south first-floor room.

In the Solar wing an attic was inserted above the southern first-floor chamber; the date is unclear but traces of simple fluted 'finger' decoration was found to survive — in poor condition — above the modern fibre-board ceiling. Such decoration is typical of the 17th century but there was evidence that the joists were neatly chamfered. Again, there appears to have been two phases of alterations. Both of the rooms on the first-floor of the Solar were provided with new fireplaces in their west walls, indicating they would have been bedchambers. The ground floor rooms remained unheated and could have become ancillary buildings rather than integral parts of the house.

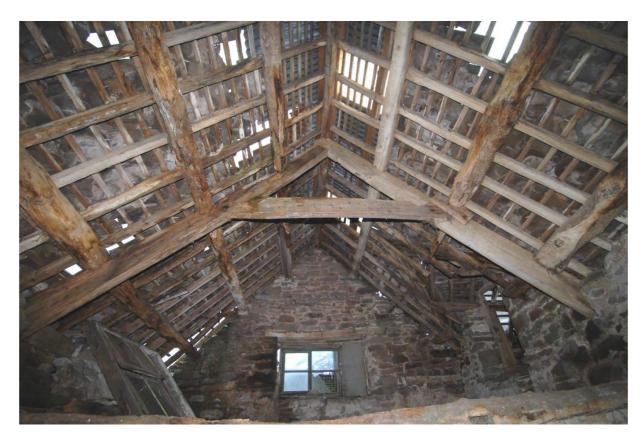
Pl.47: Part of the attic and roof structure of the Cider House prior to restoration.

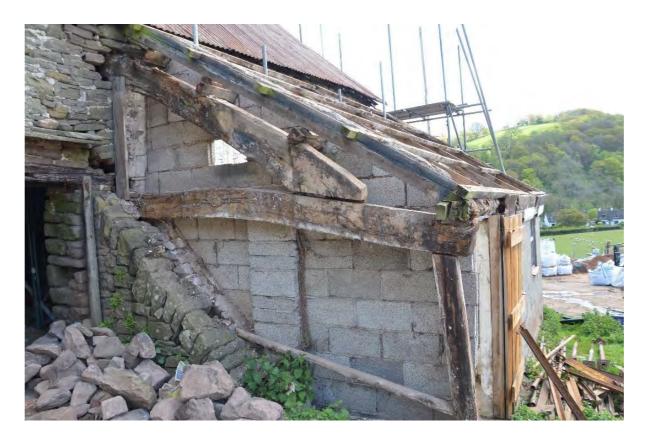
Pl.60: The exposed side frame of the Shelter Shed, discovered during the restoration works.
