LLWYN CELYN  
Stanton  
Crucorney Fawr  
Gwent  
19/17995/DISCON

PHOTOGRAPHIC  
RECORD  
DURING WORKS  
2016-2018

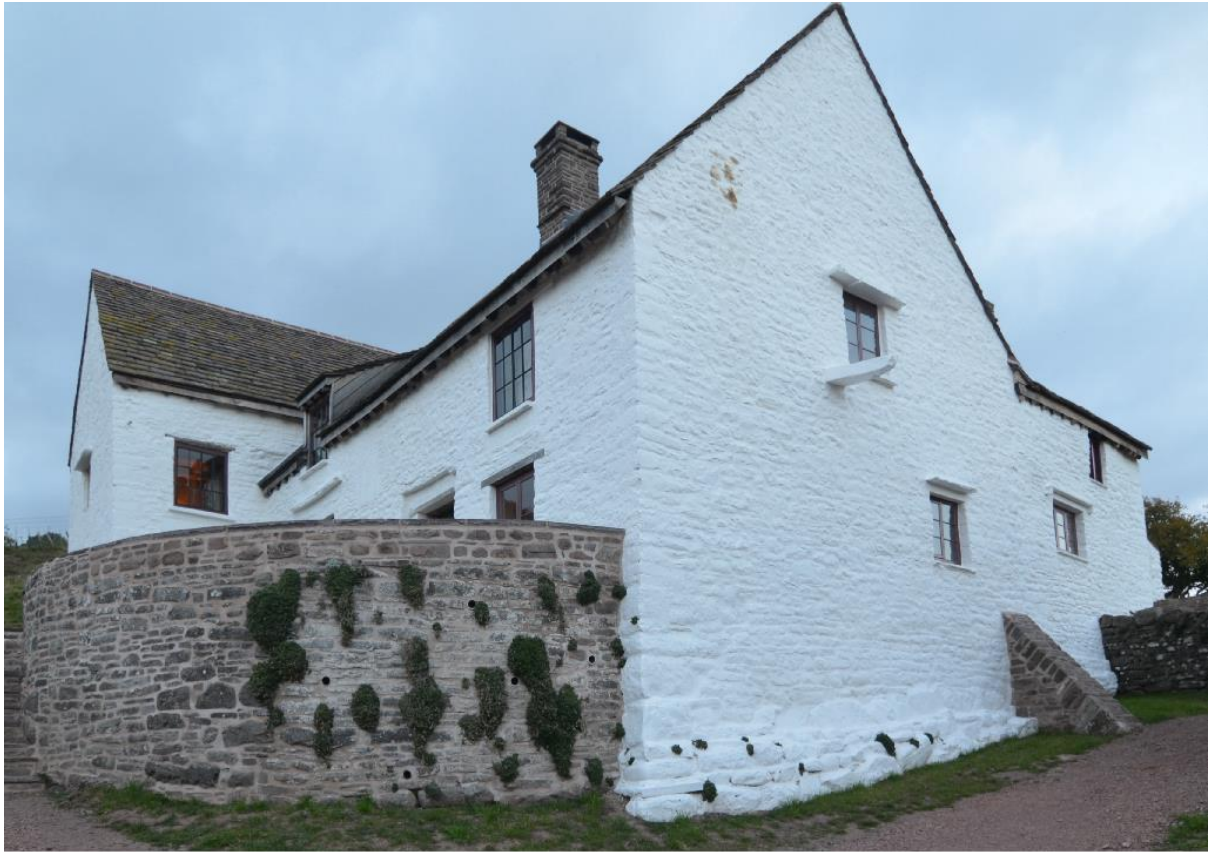
Pl.1: The restored house from the south-east, 2018.

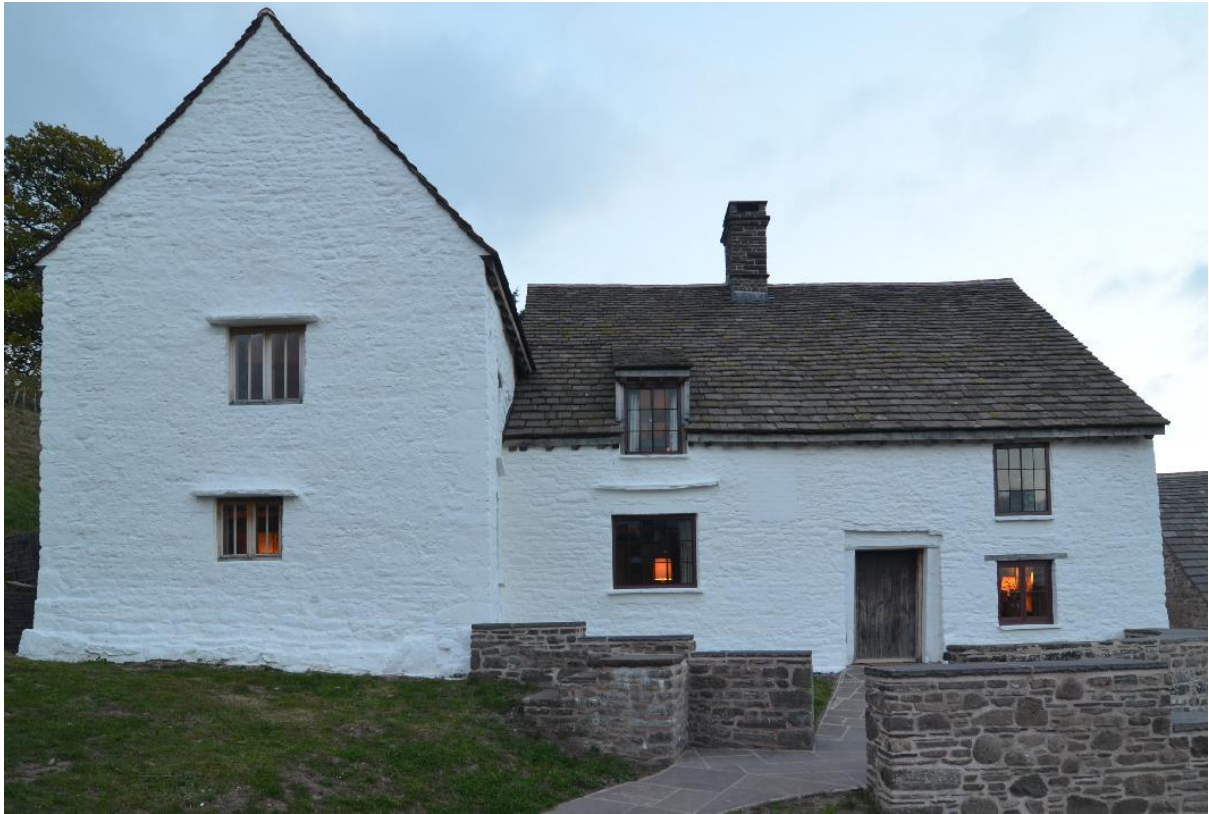
Pl.3: South elevation of the restored house, 2018.

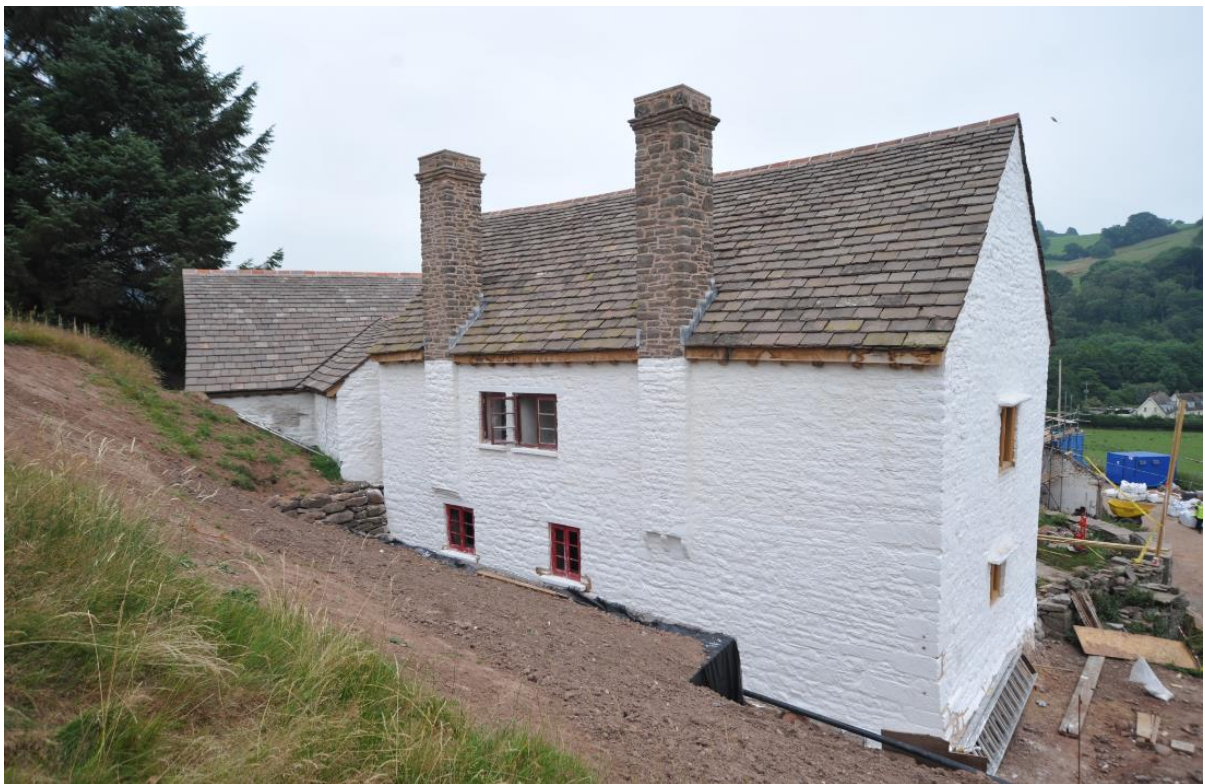
Pl.4: West elevation of the Solar, 2017.

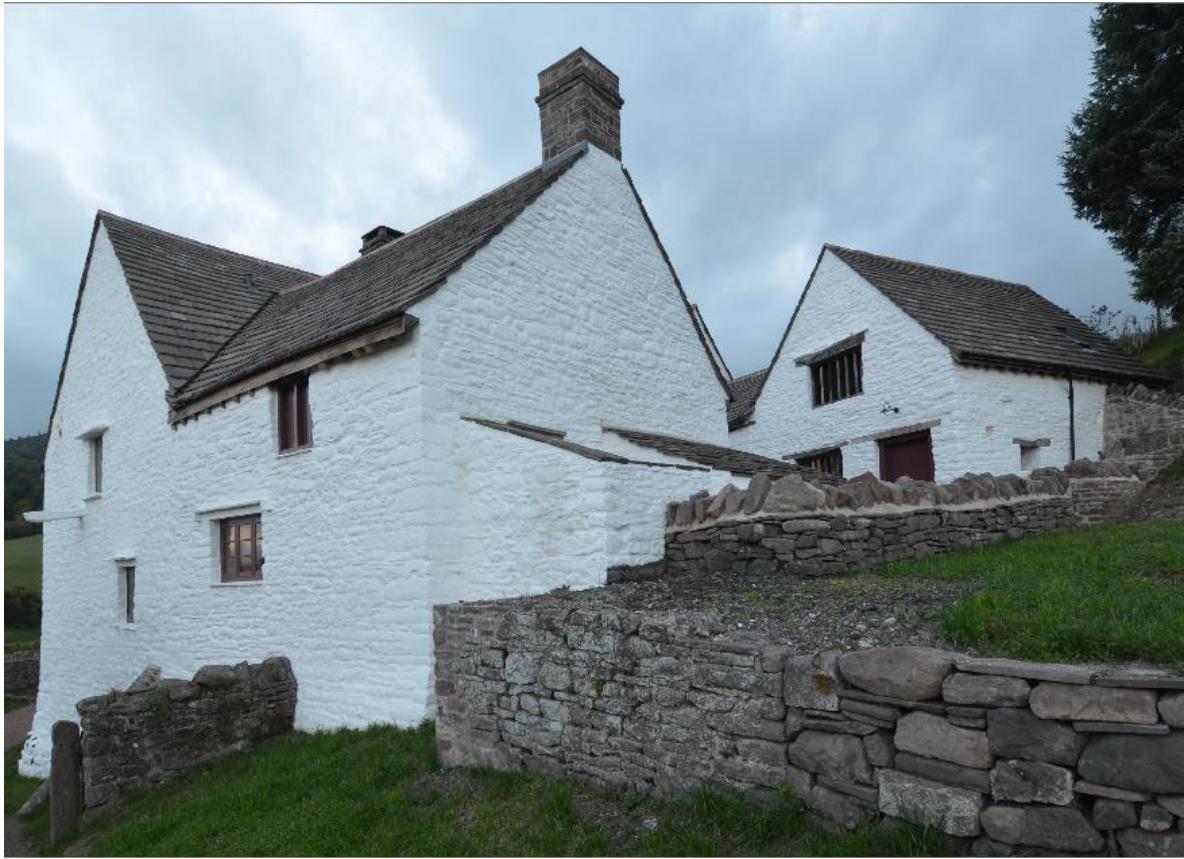
Pl.5: The restored house from the north-east, 2018.

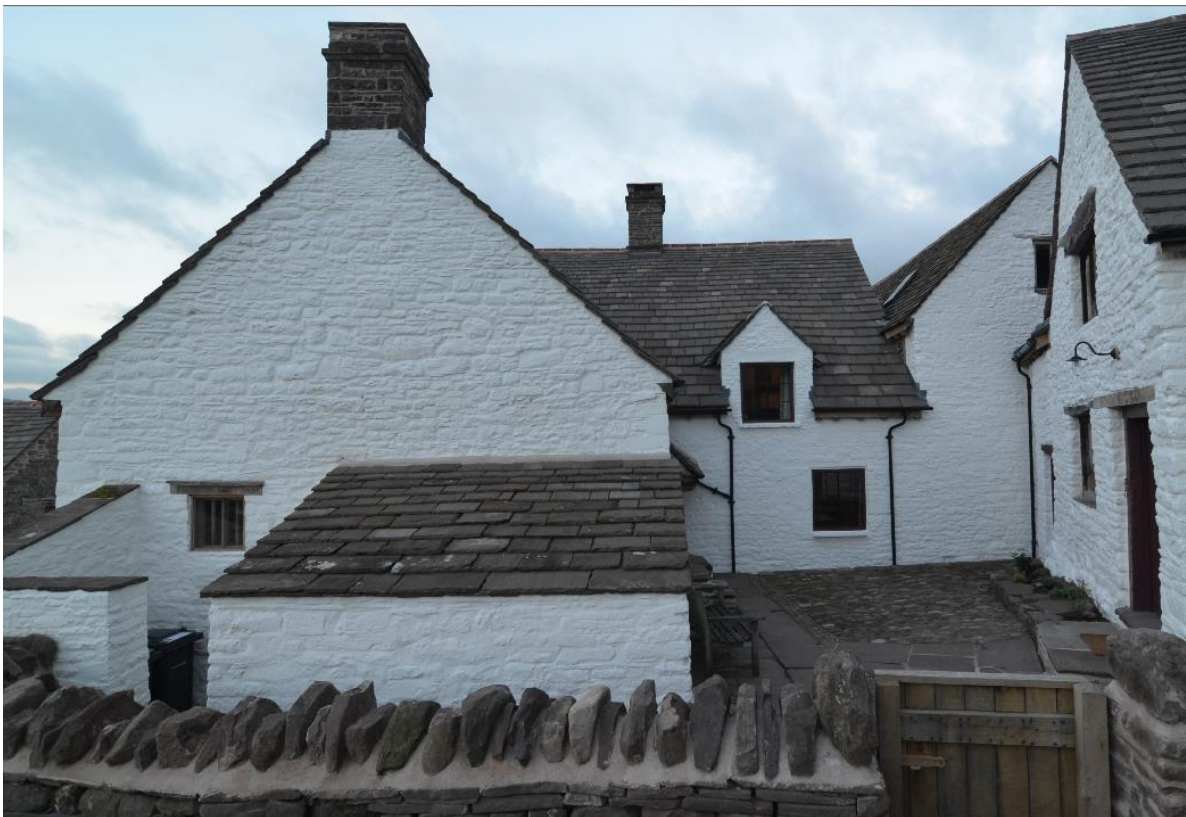
Pl.6: Rear, or north, elevation of the restored house, 2018.

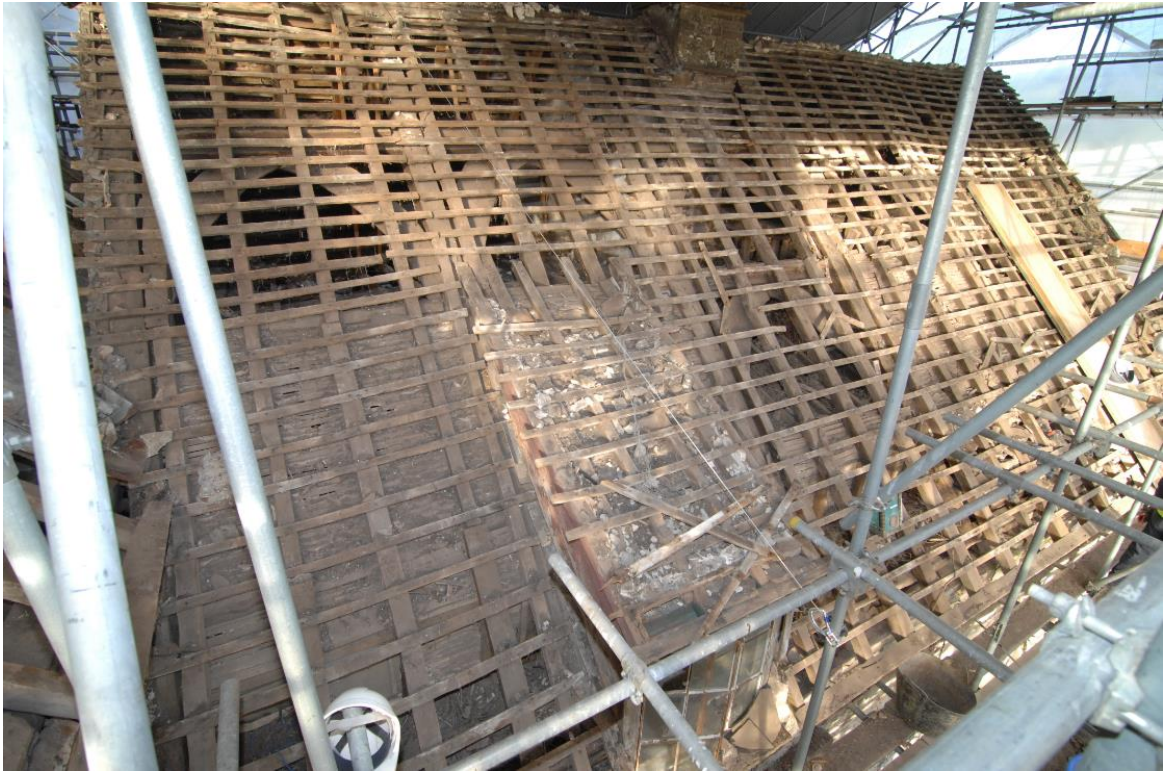
Pl.7: South slope of roof of Hall Range stripped, 2016.

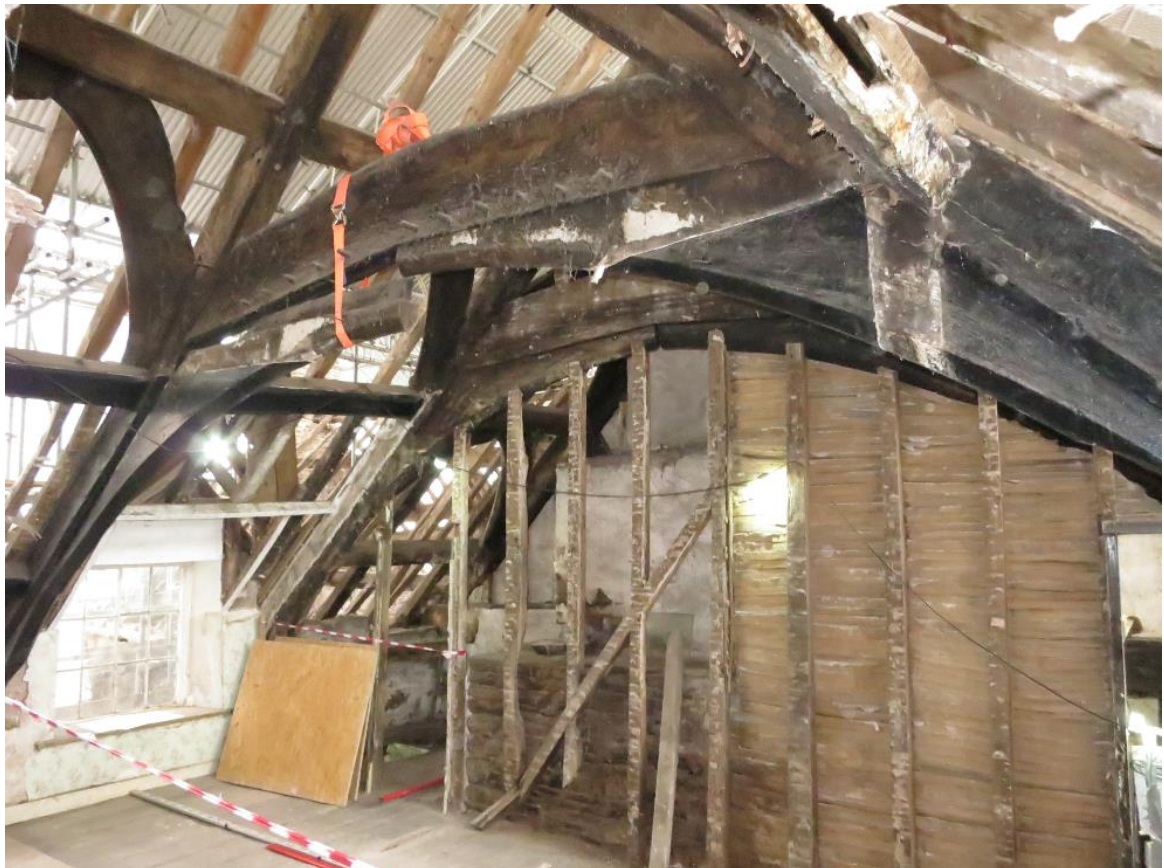
Pl.8: Part of the roof over the former hall in the Hall Range, 2016.

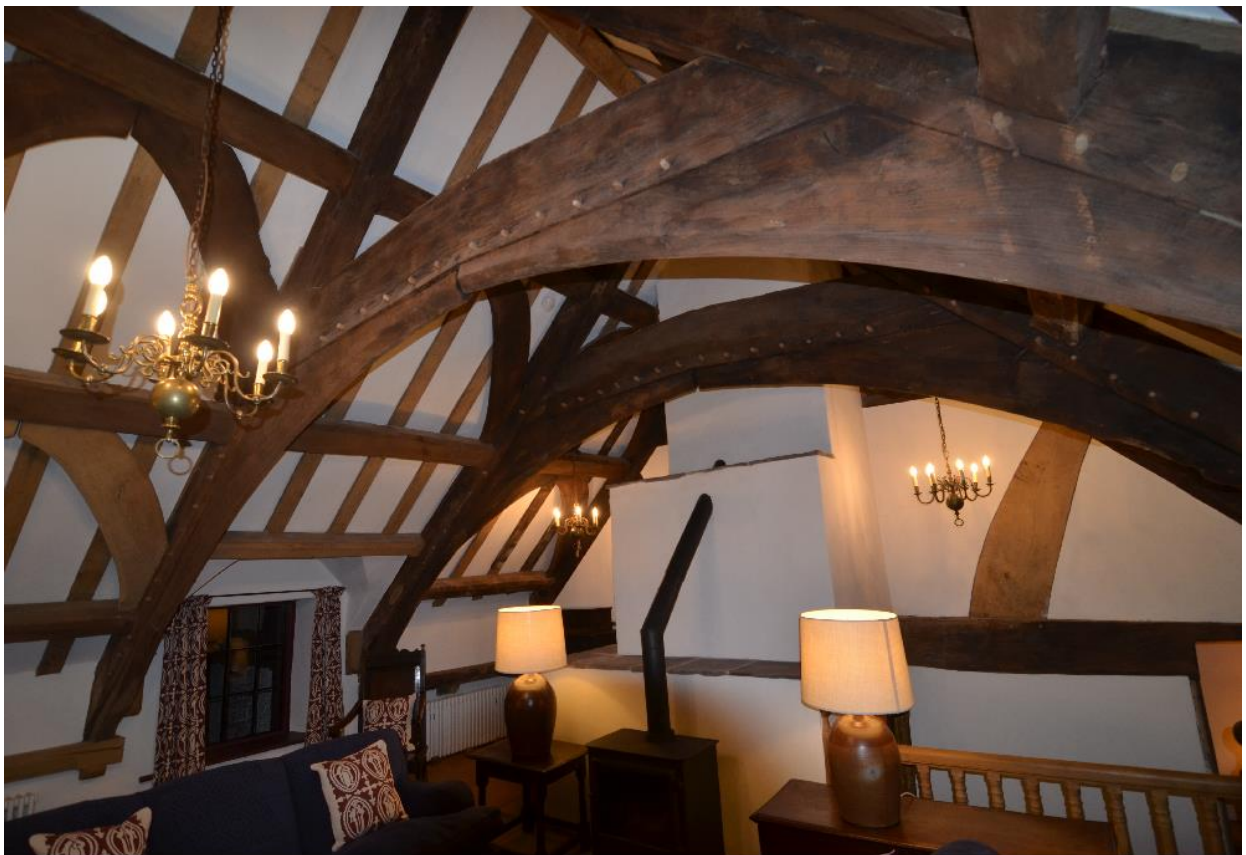
Pl.12: Exposed and restored roof over the Hall range, looking east.

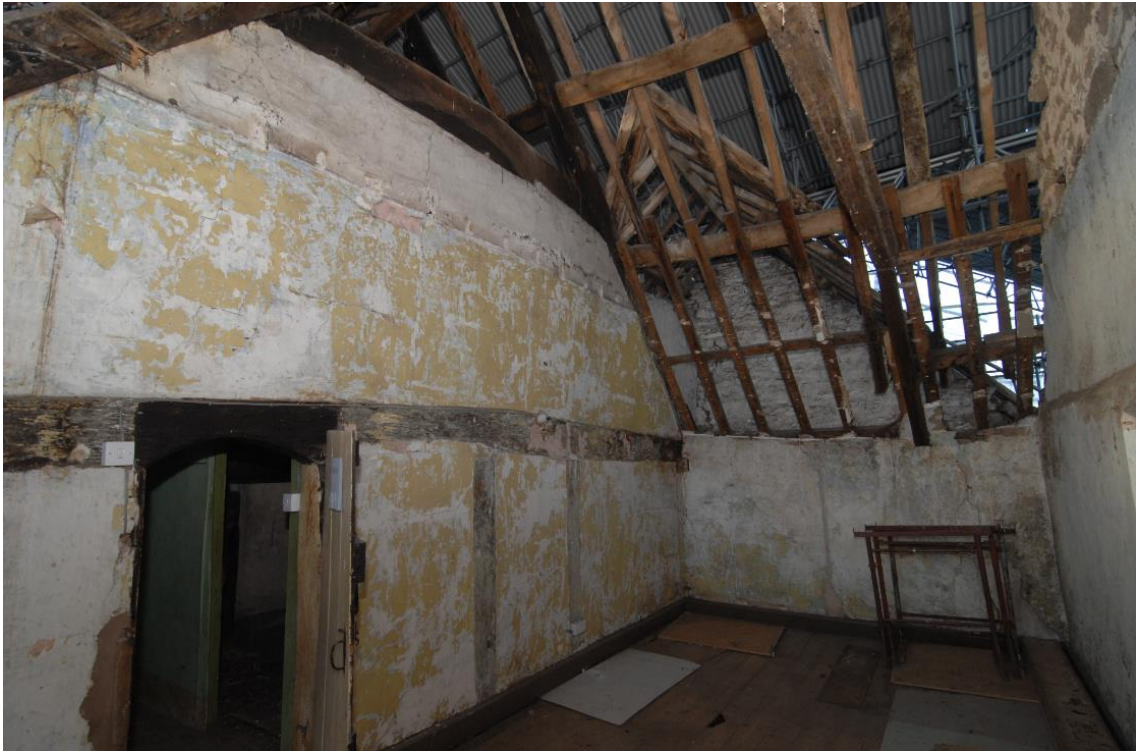
Pl.13: Remodelled roof over the Services, looking north-west, 2016.

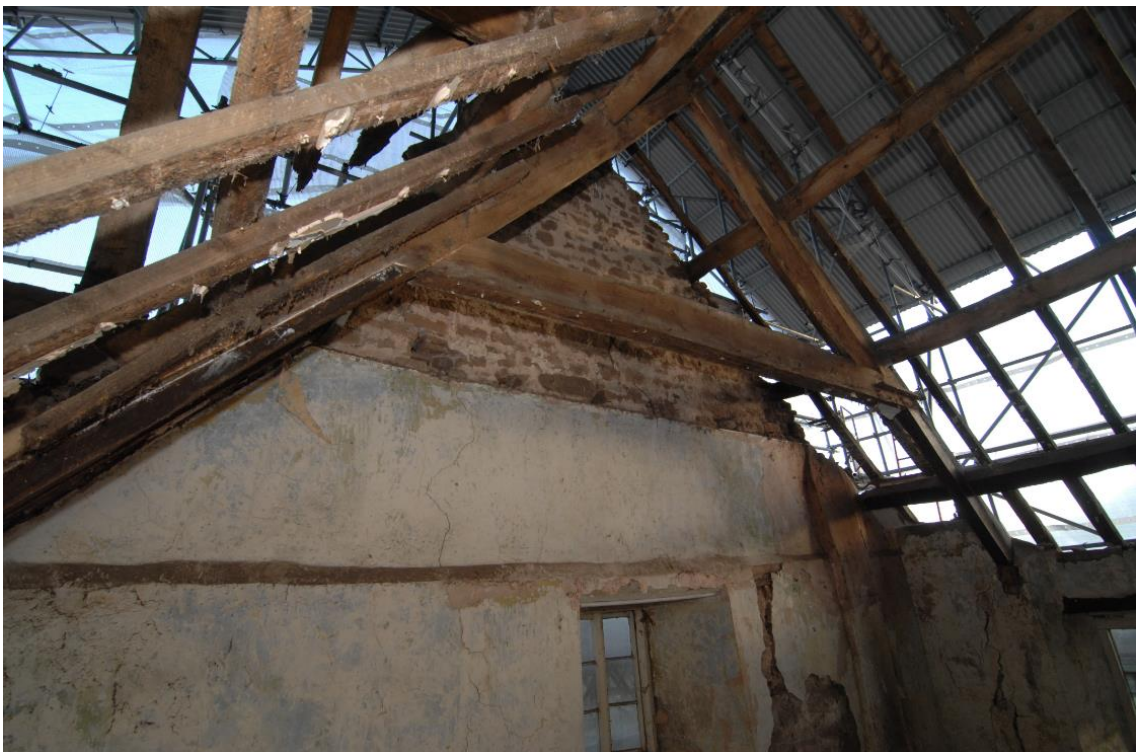
Pl.14: Exposed east gable of the roof over the Services, 2016.

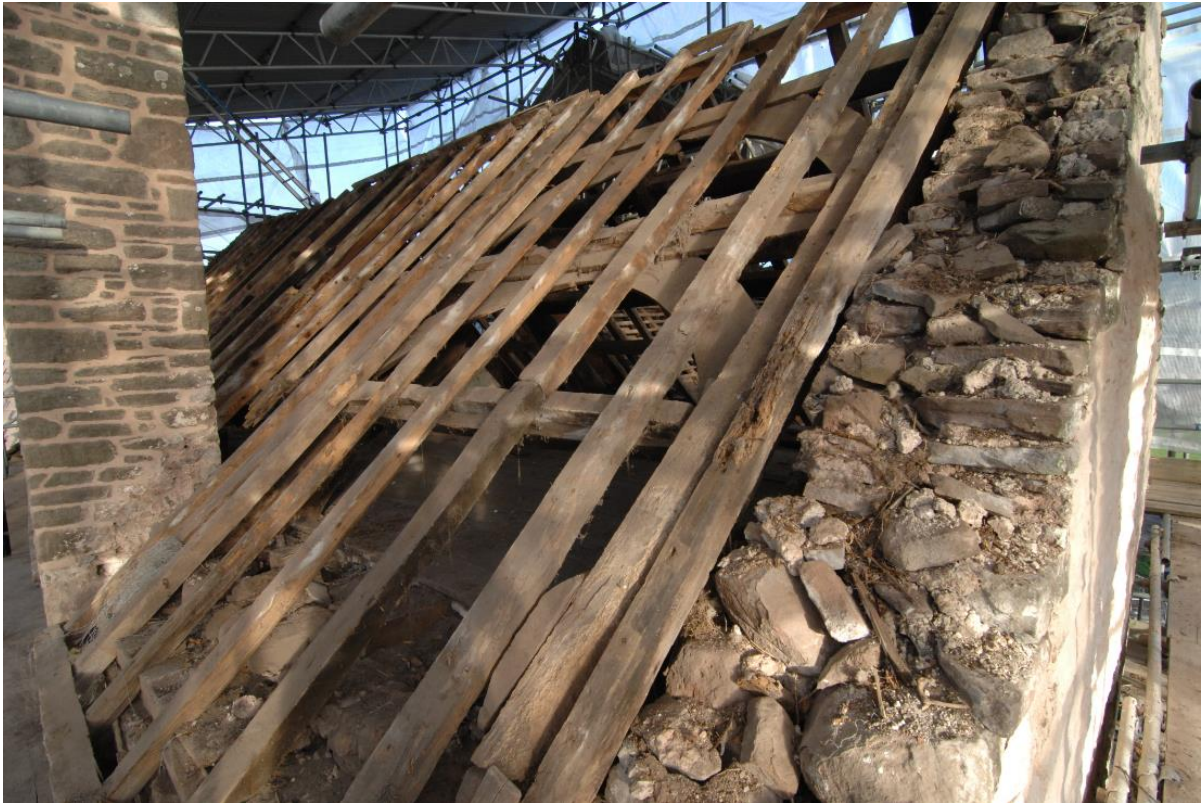
Pl.15: South-western corner of the Solar roof, stripped ready for repair, 2016.

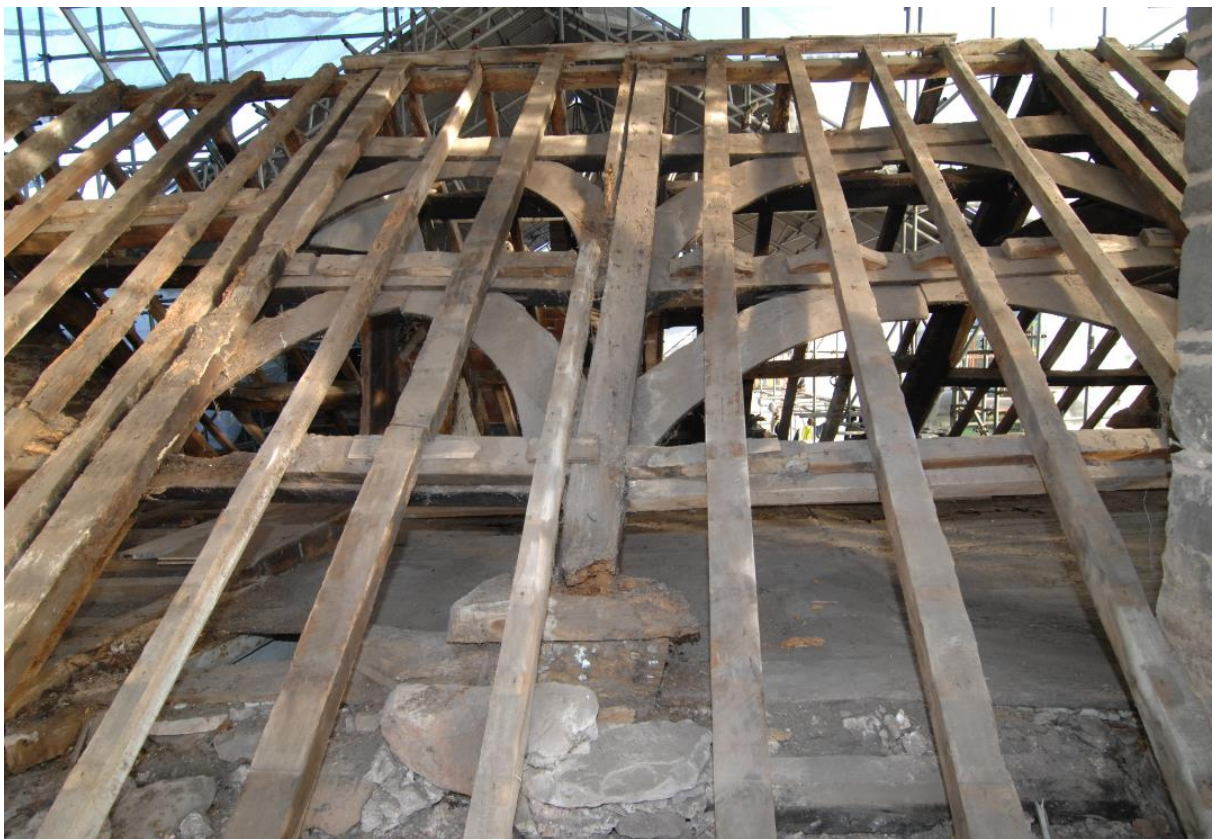
Pl.15: Central section of the west slope of the Solar roof.

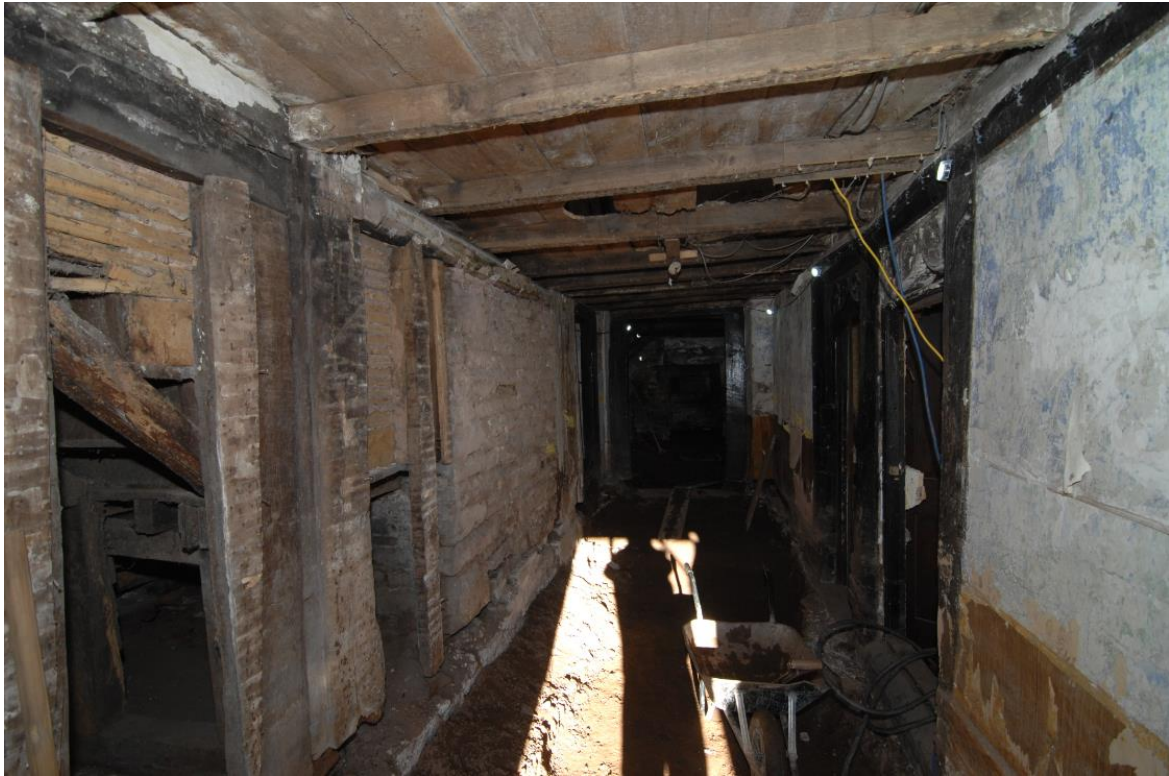
Pl.16: The entrance hall (G2), looking north in 2016.

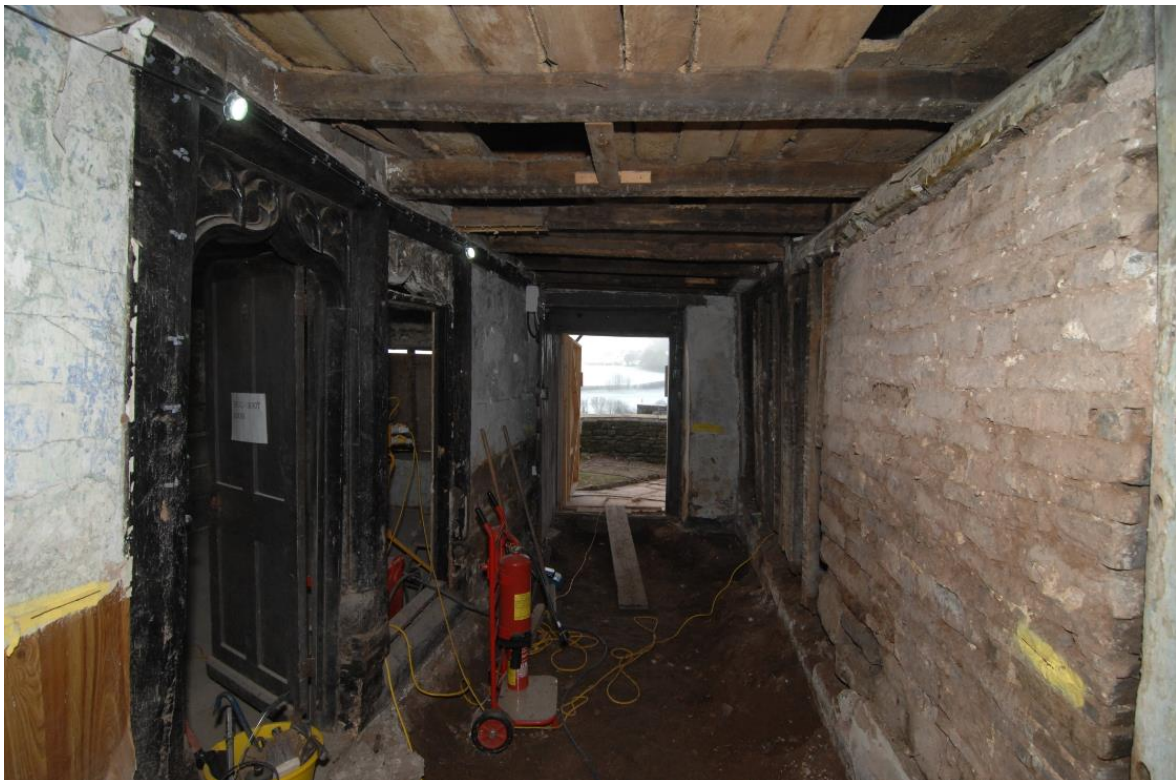
Pl.17: The entrance hall, looking south, 2016.

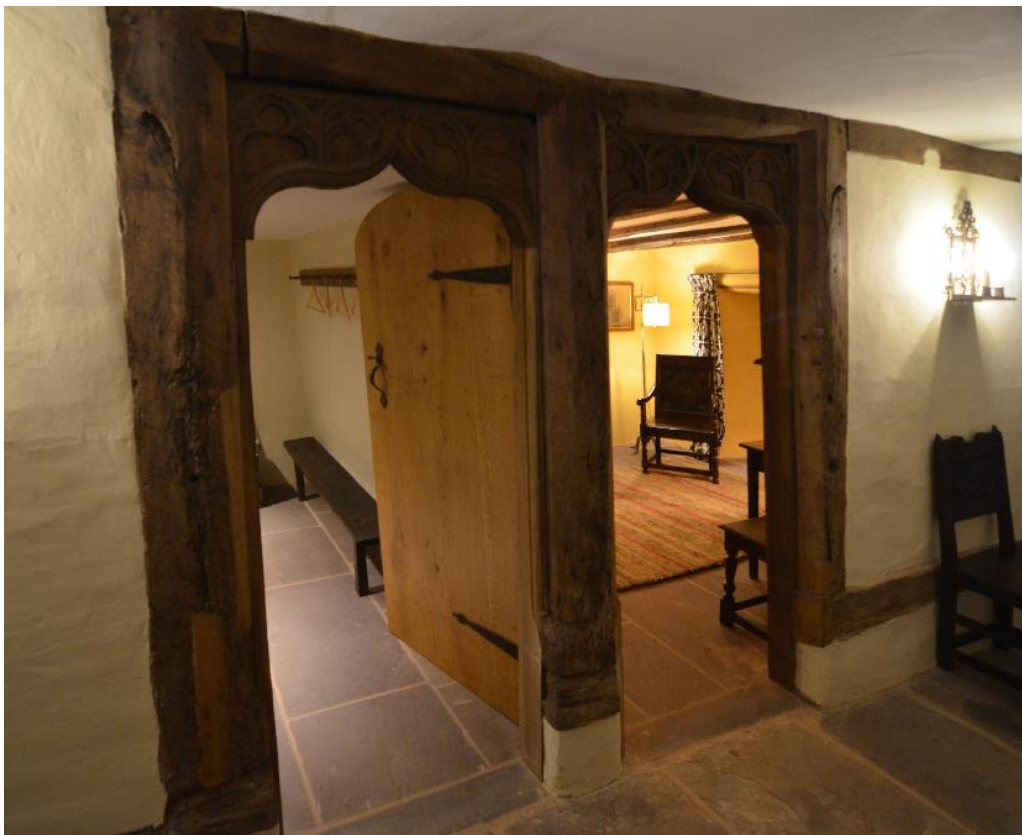
Pl.21: The service doors, 2018.

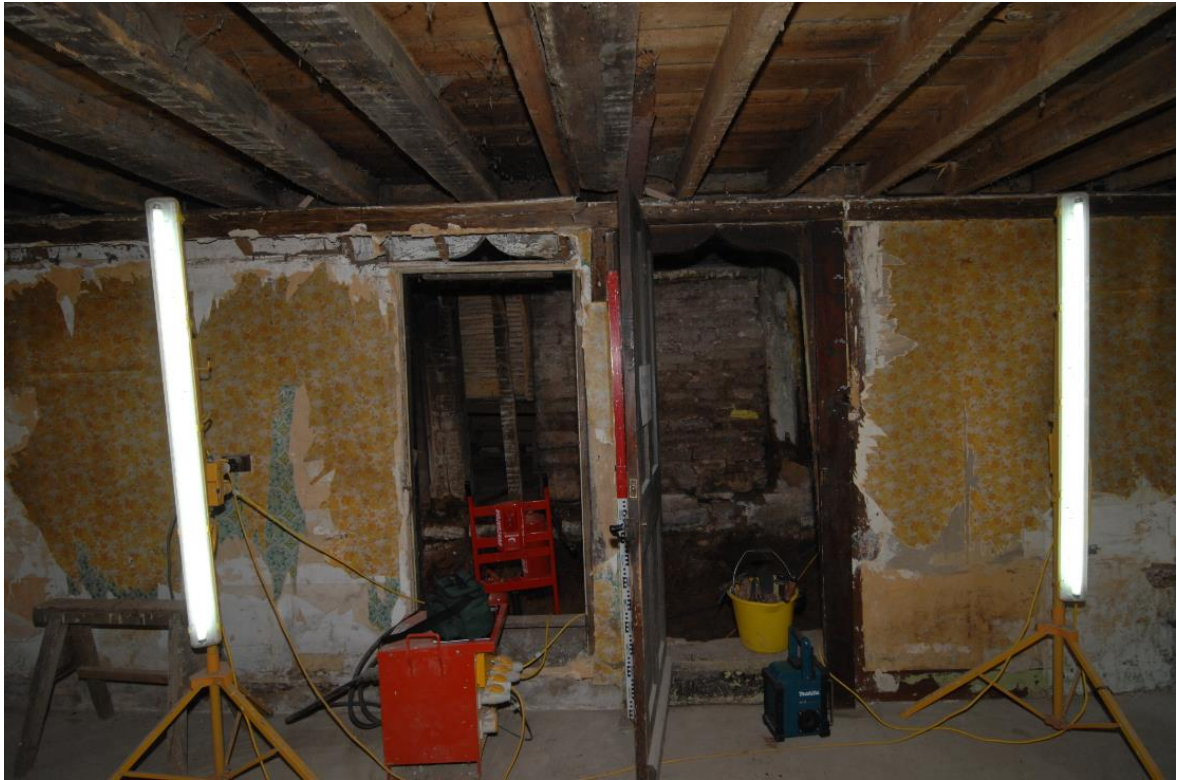
Pl.22 : The former services looking to the paired screens passage doorways, 2016.

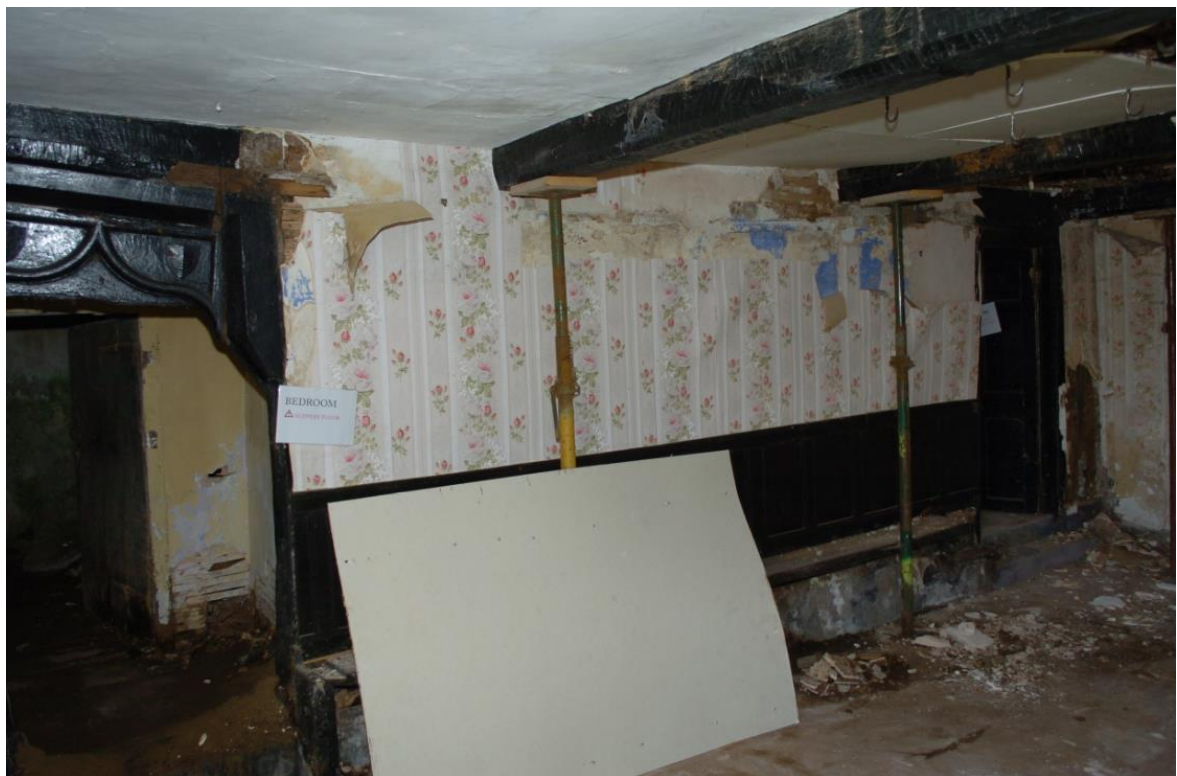
Pl.23: Dais end of the hall early in the project.

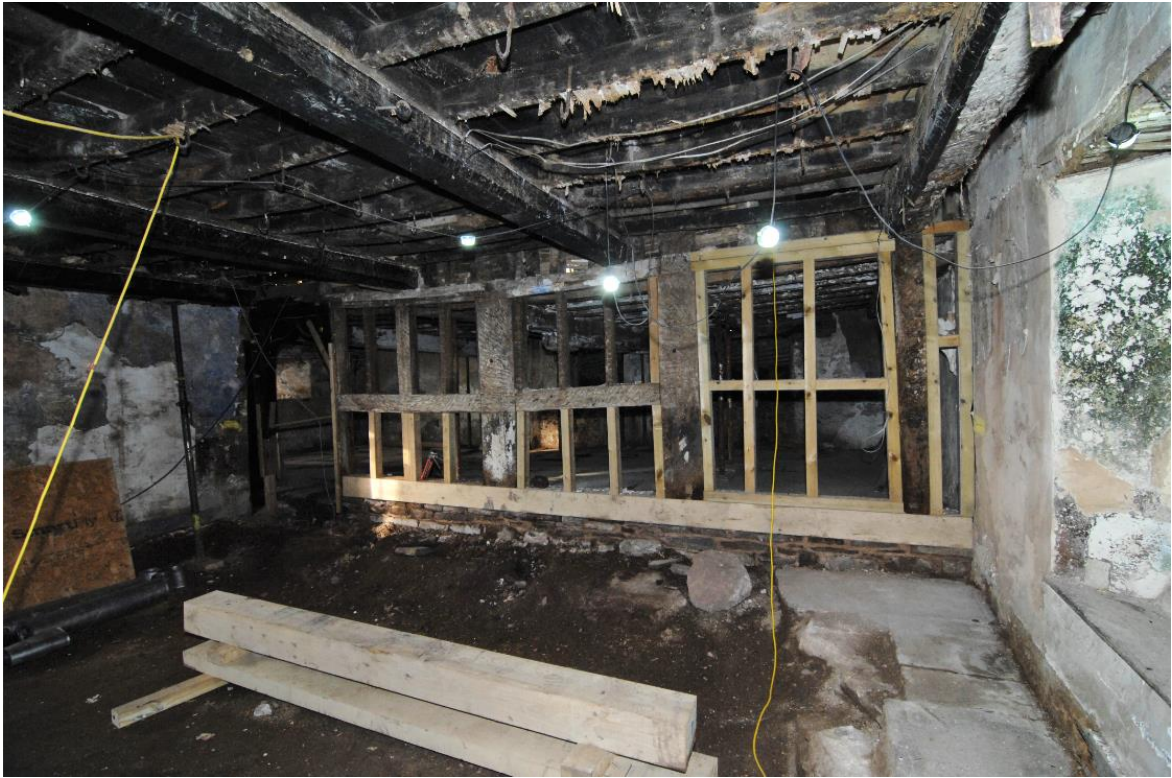
Pl.24: The hall, looking west to the exposed dais end frame.

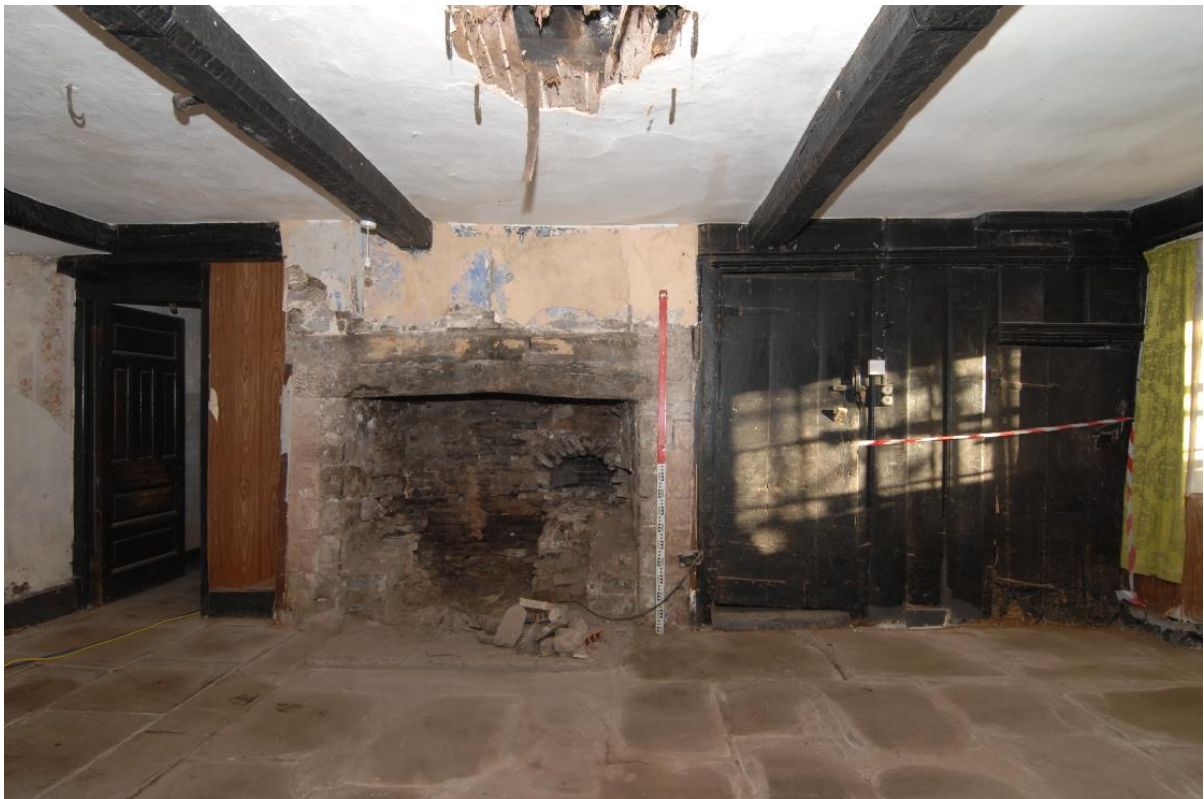
Pl.25: The hall, looking east 2016.

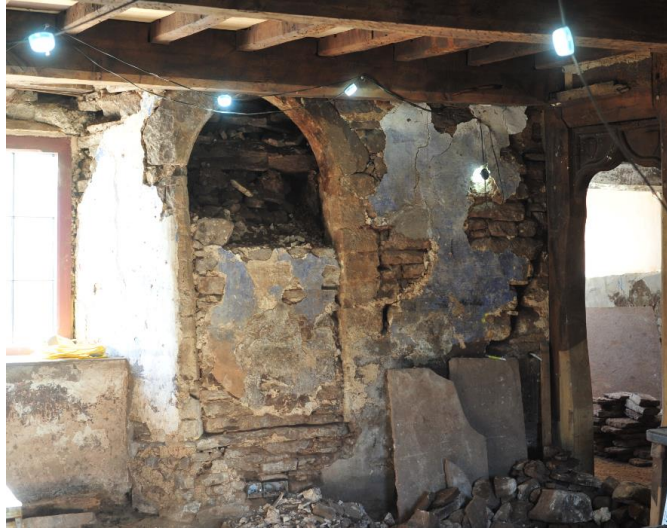
Pl.29: Doorway found on the inner face of the south wall near the dais end of the hall, 2017.

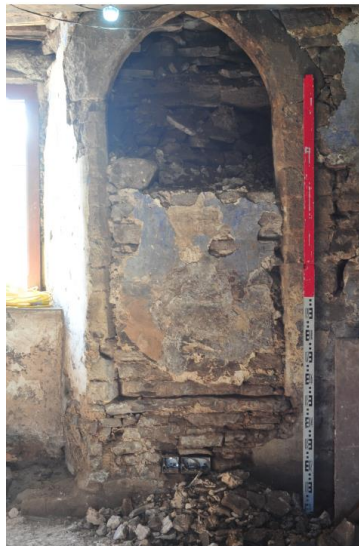
Pl.30: The doorway.

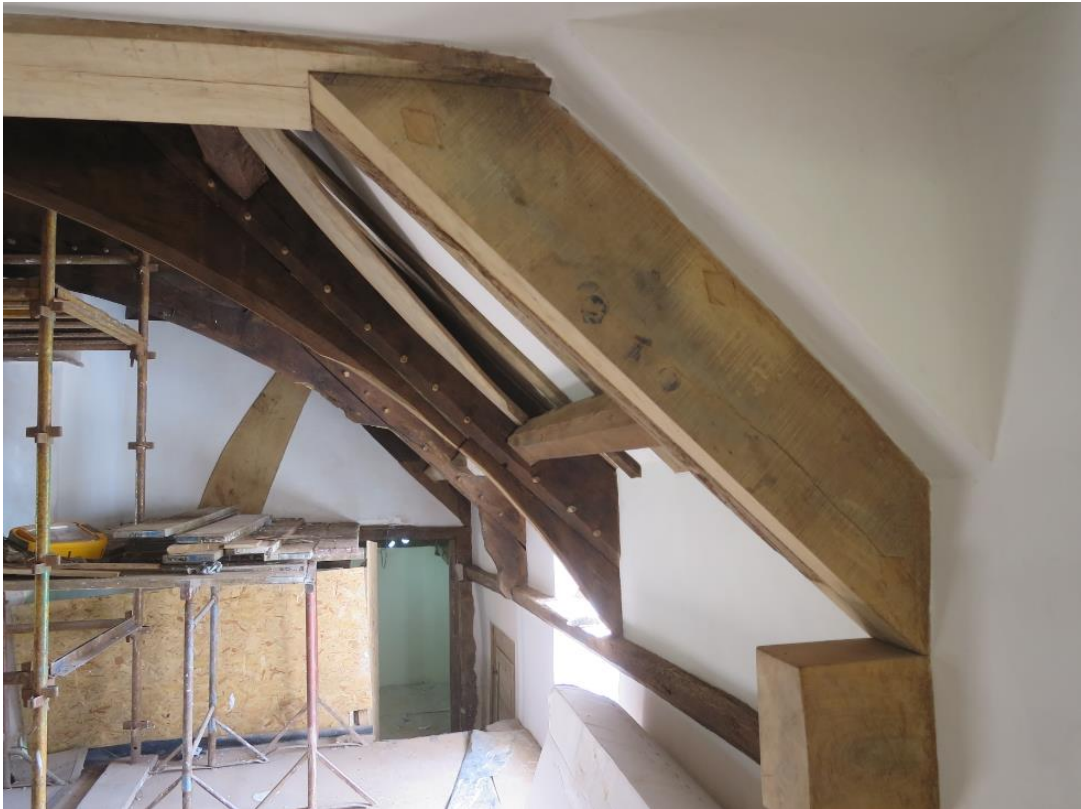
Pl.36: Upper portion of the Hall section during repairs, looking east, side corridor removed.

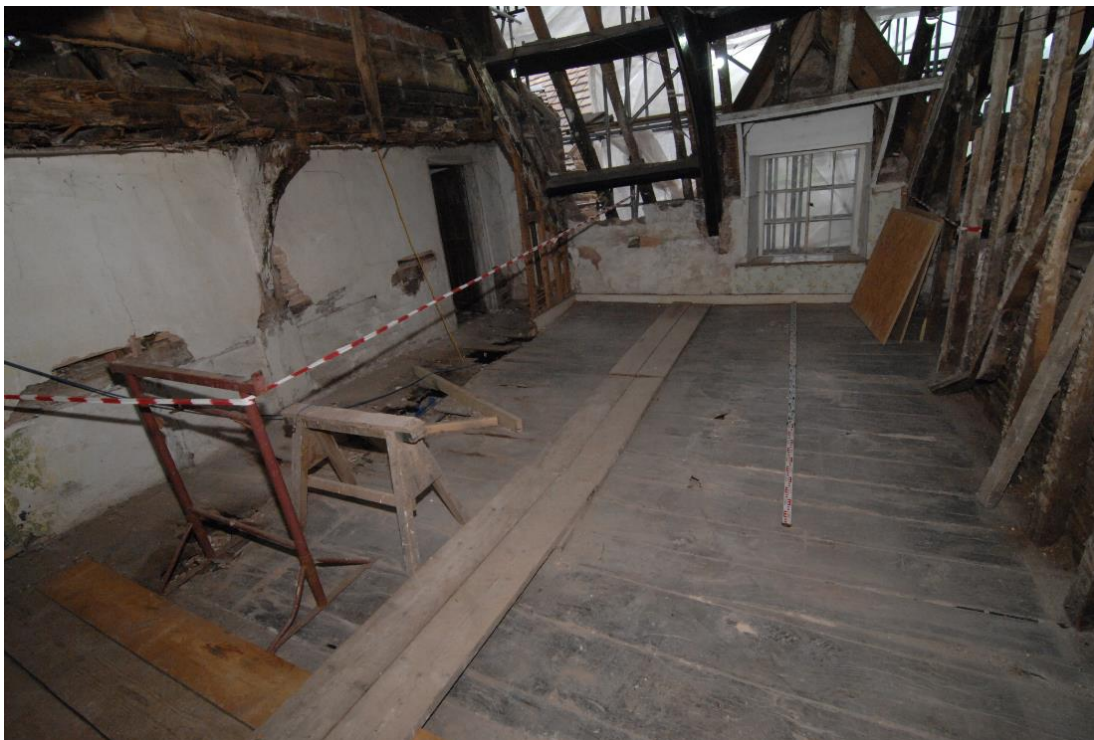
Pl.37: Western portion of the Hall section at first-floor level after removal of cross-corridor.

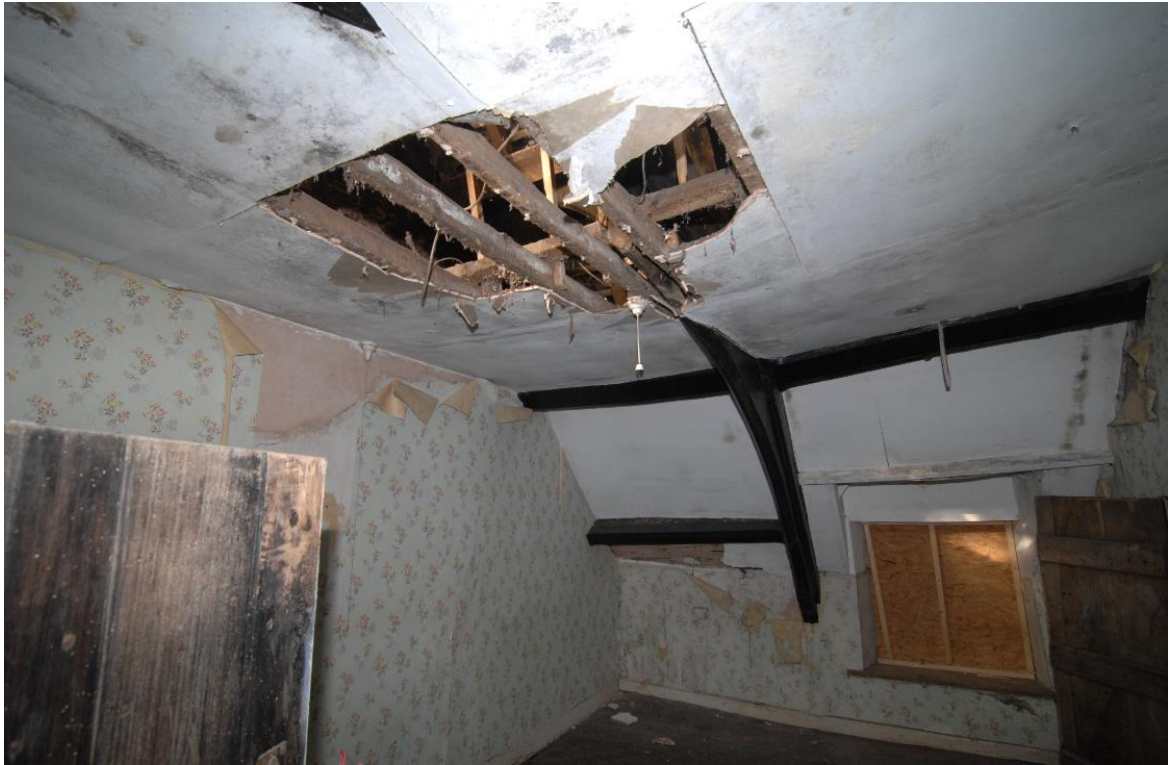
Pl.38: Chamber over hall prior to removal of partitions.

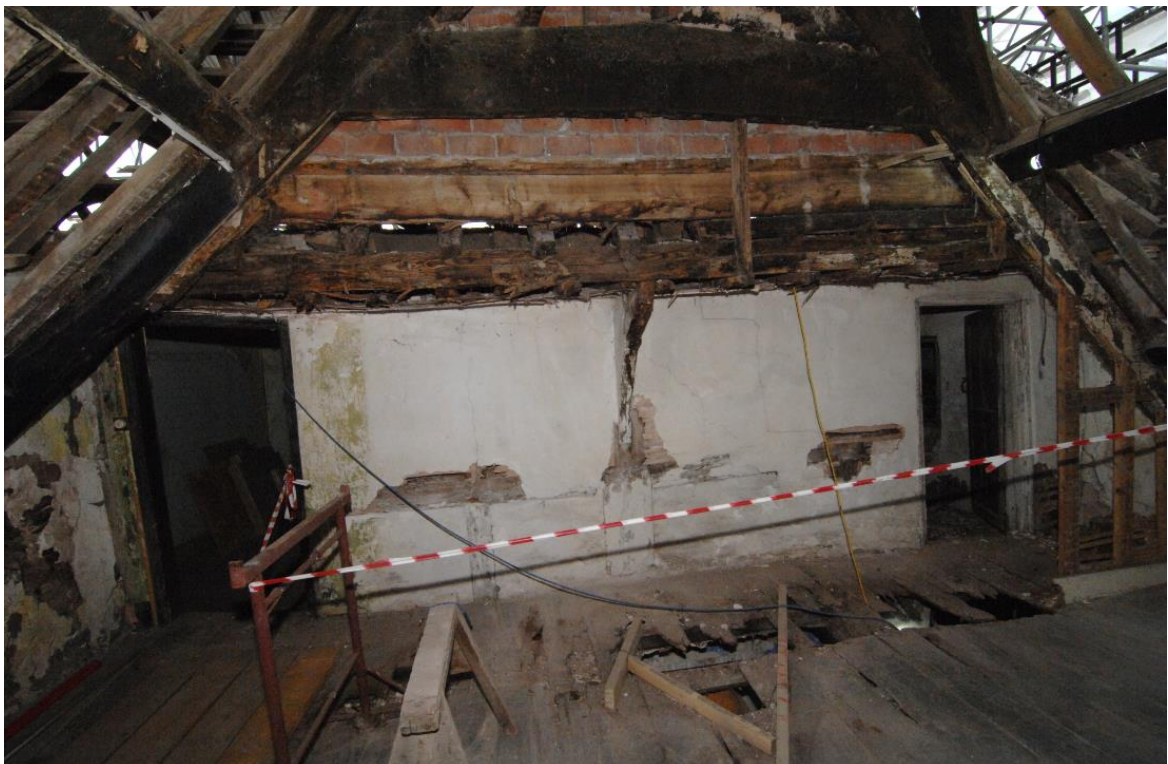
Pl.39: West end of first-floor over hall after removal of corridors.

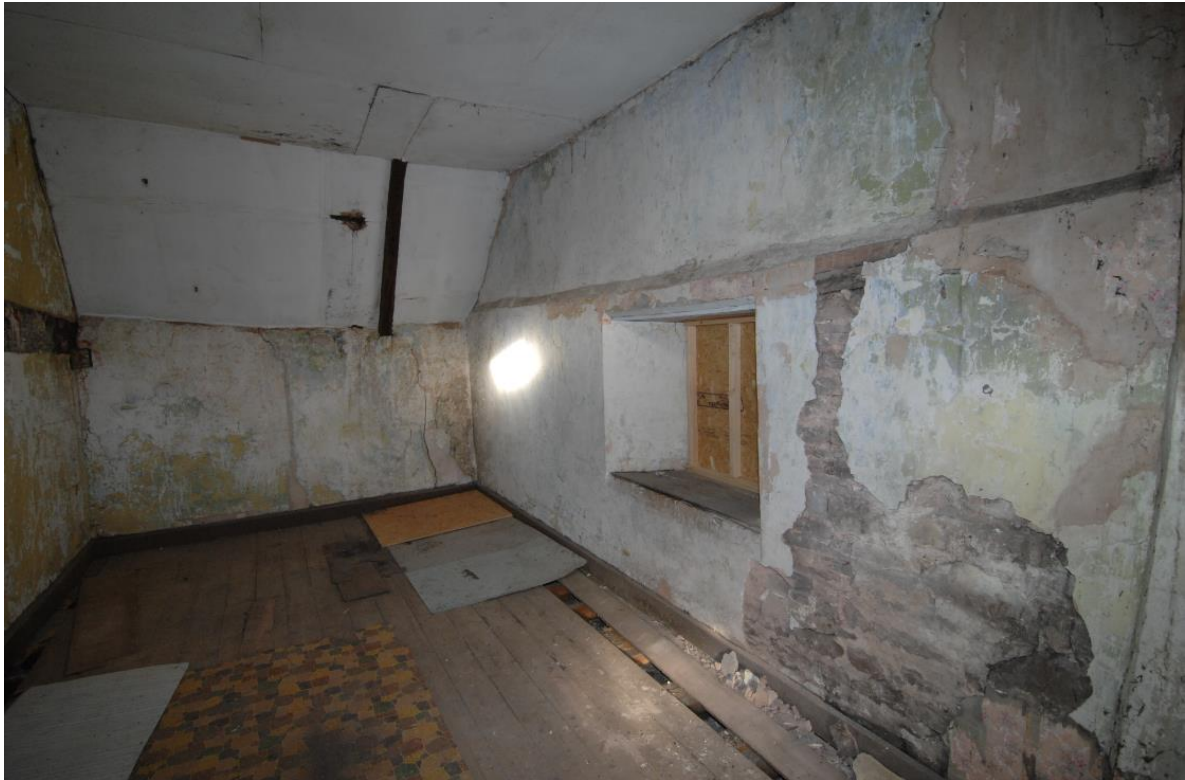
Pl.40: Bedroom over services after clearance but in advance of repairs.
