LLWYN CELYN  
Stanton  
Crucorney Fawr  
Gwent  
19/17995/DISCON

PHOTOGRAPHIC  
RECORD  
DURING WORKS  
2016-2018

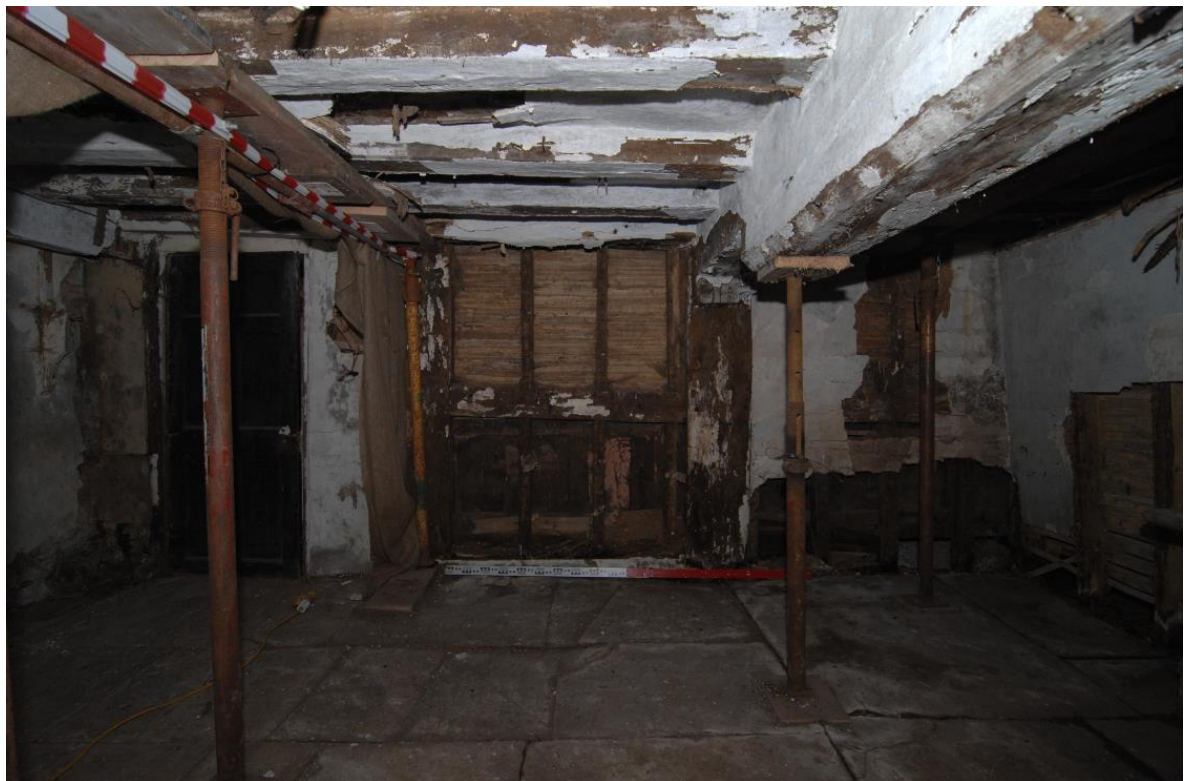
Pl.41: Northern ground-floor room in solar wing, looking east to the hall.

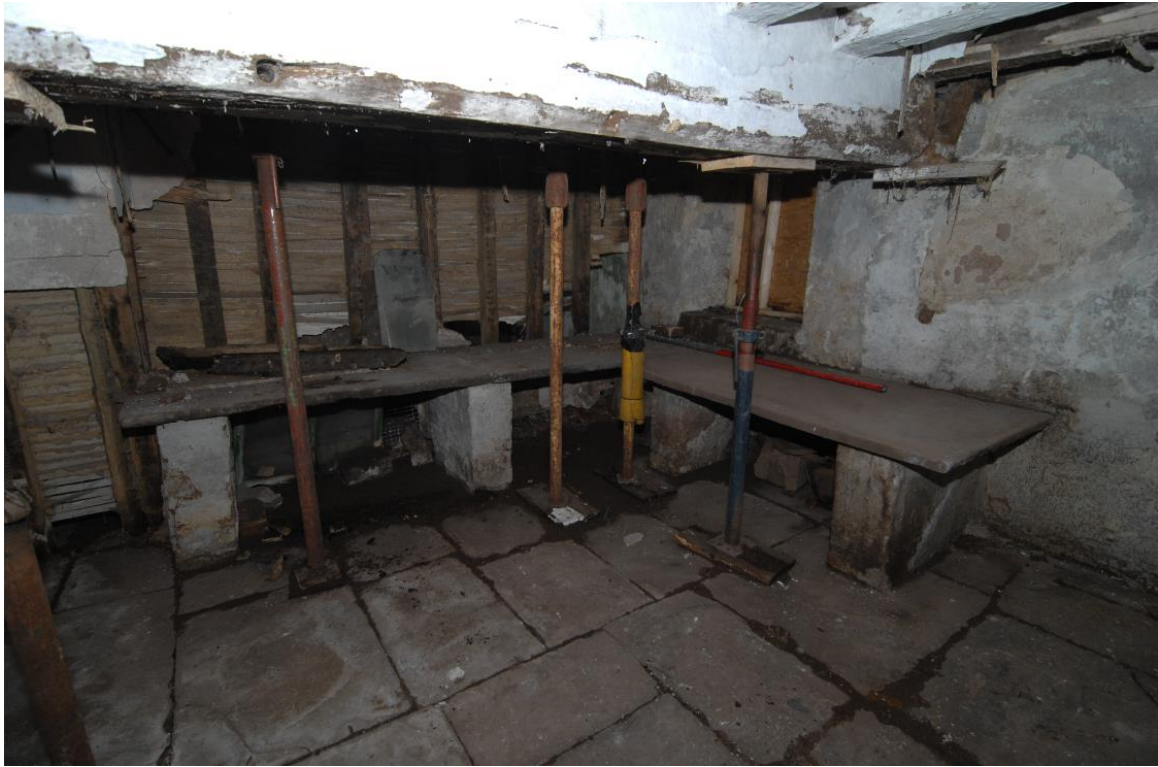
Pl.42: South-western corner of the northern Solar room, 2016.

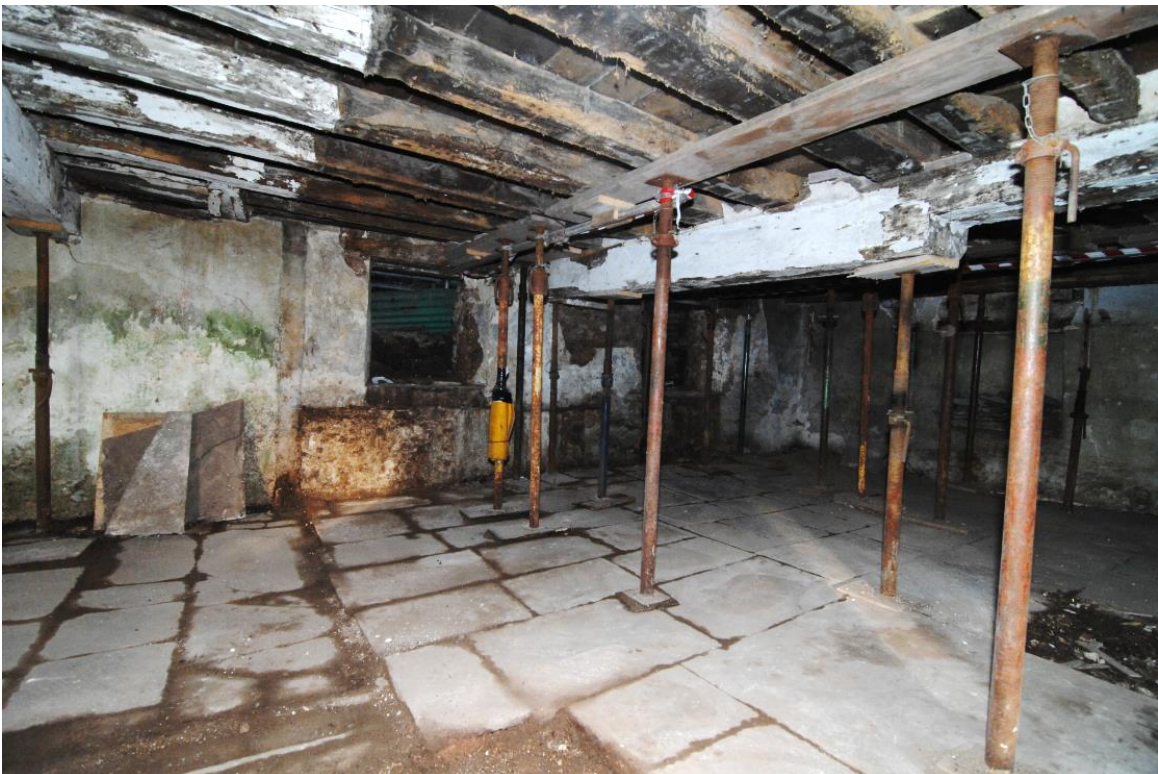
Pl.43: Ground-floor of solar, looking north-west after removal of inserted partitions, 2017.

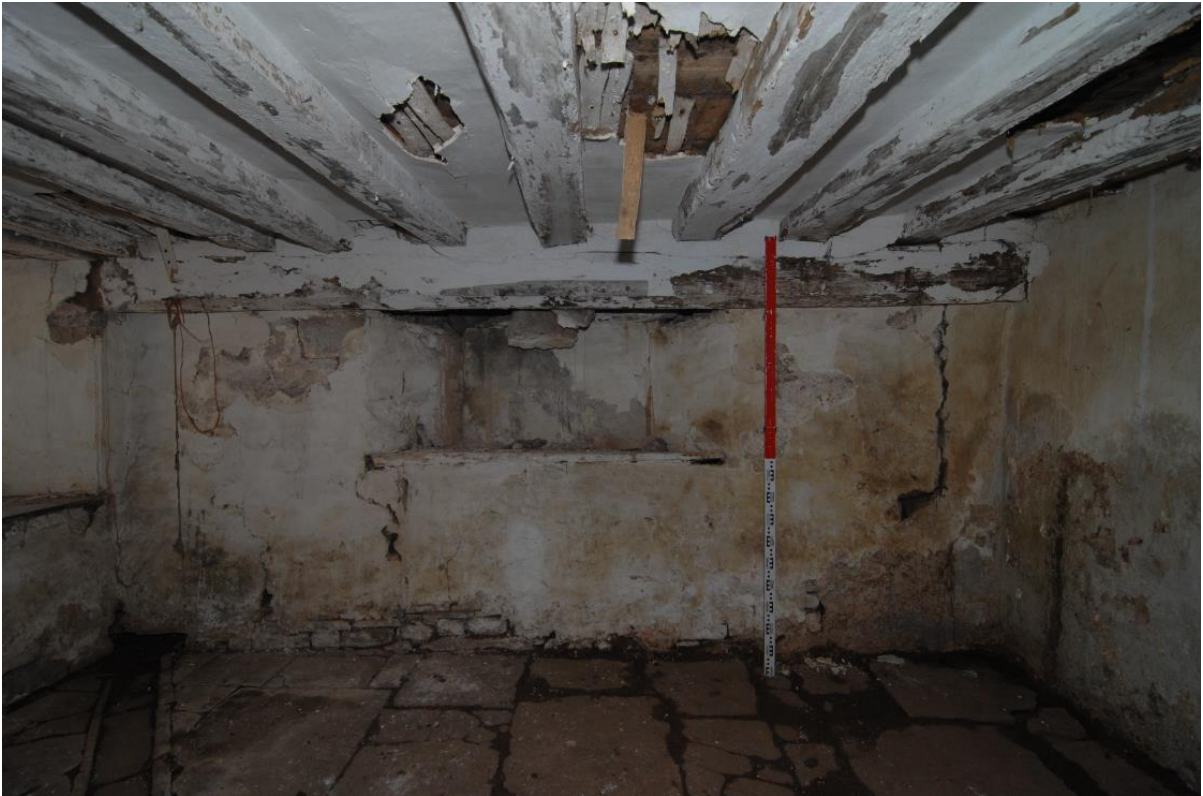
Pl.44: South end of the south ground-floor room in the solar, 2017.

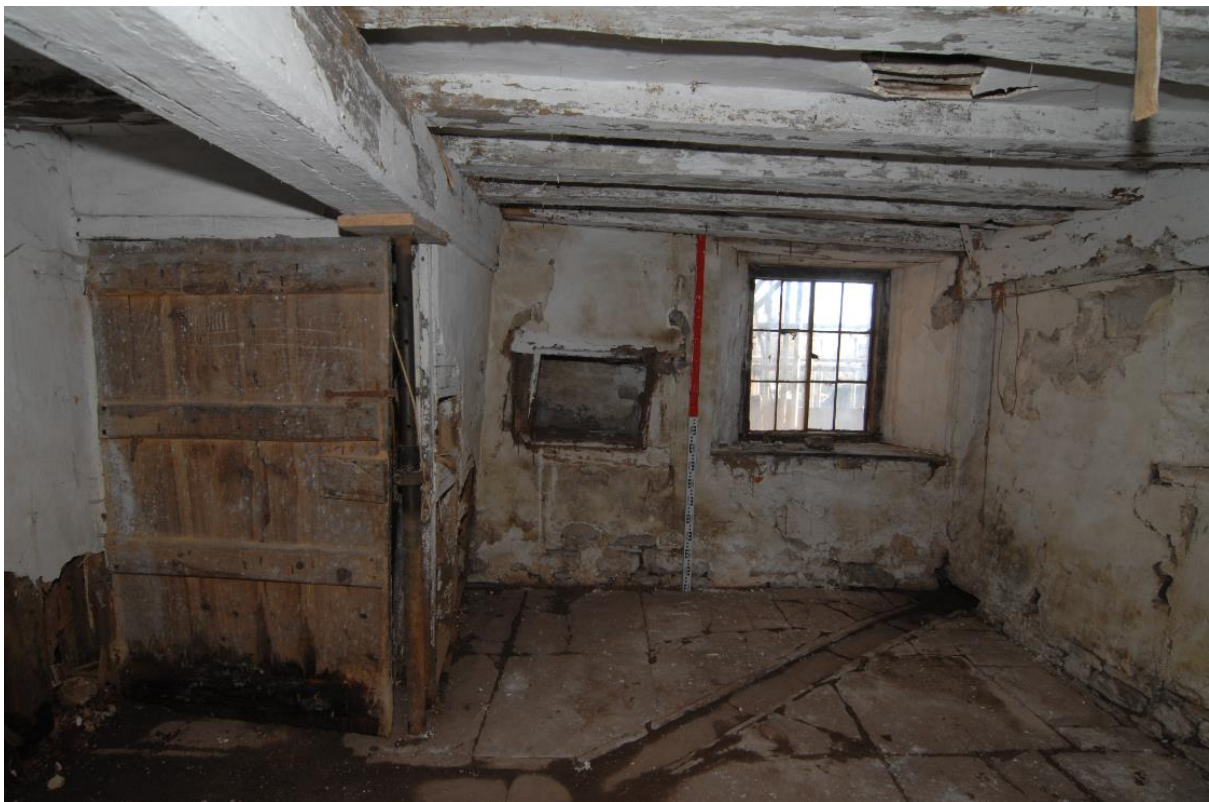
Pl.45: East side of the south ground floor room in the solar, the door lobby led to the hall.

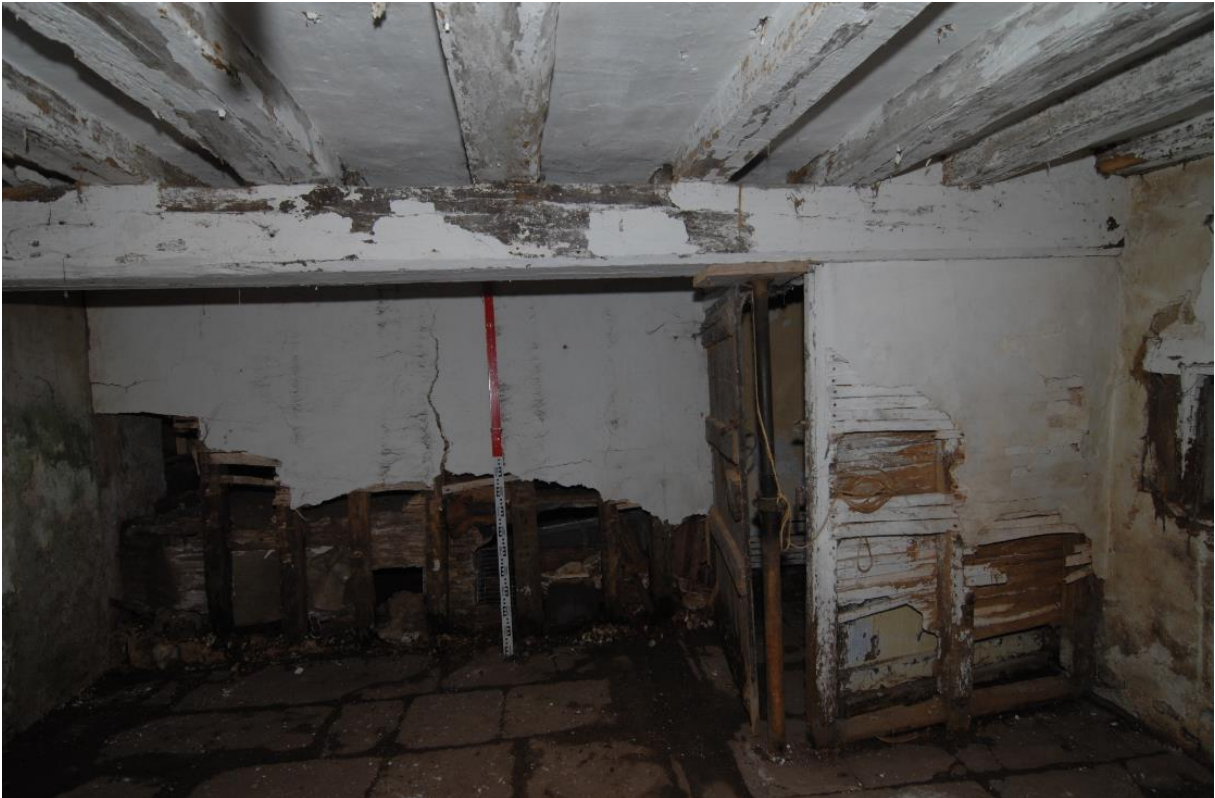
Pl.46: North wall of south ground-floor room of the solar prior to removal, 2016.

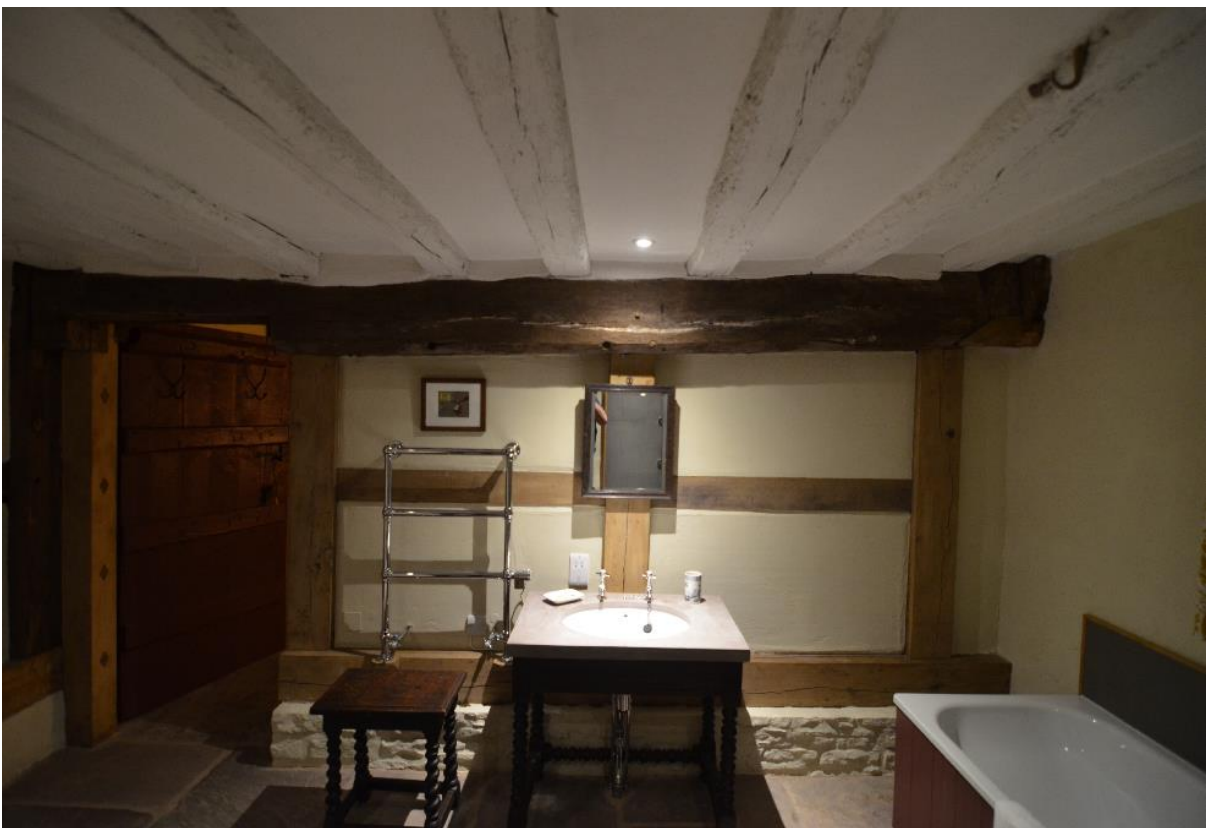
Pl.47: The restored cross-frame between the two ground-floor solar rooms, 2018.

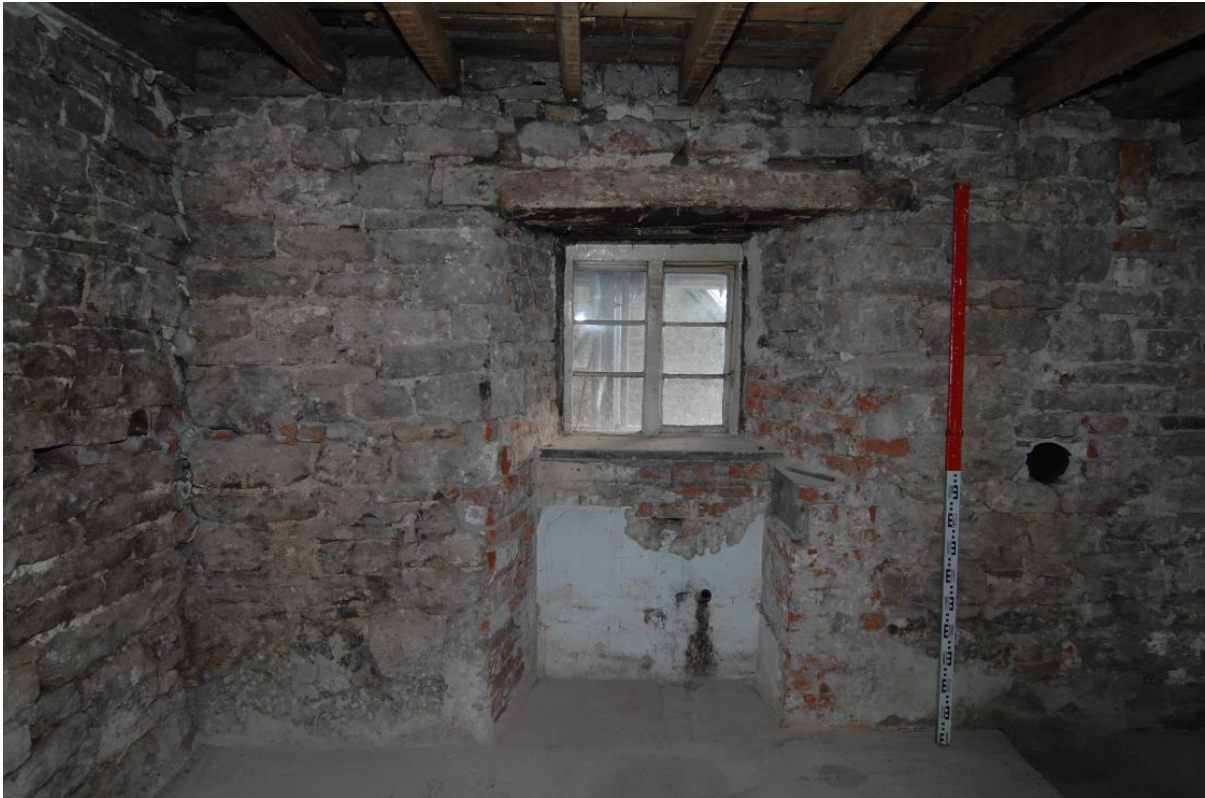
Pl.48: Exposed inner masonry of the western first-floor wall of the solar, south end., 2017.

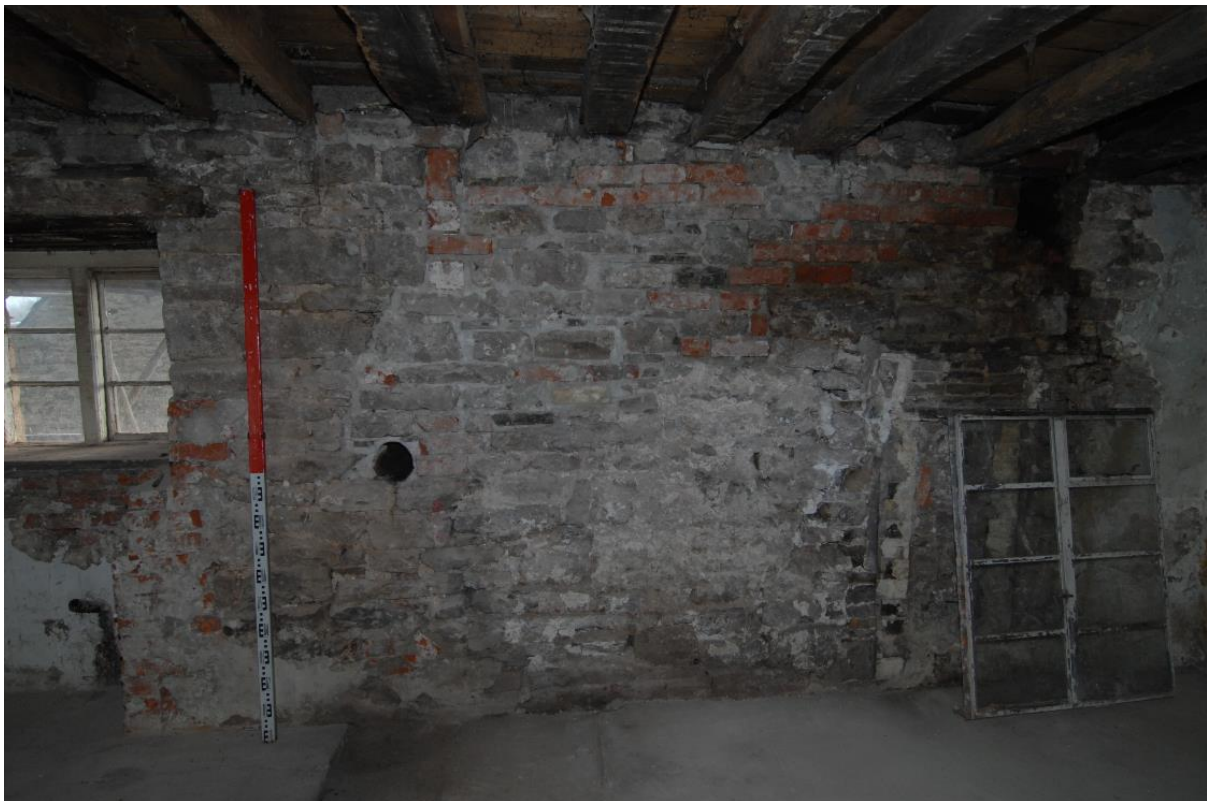
Pl.49: Exposed inner masonry of the western first-floor room of the solar, middle, 2017.

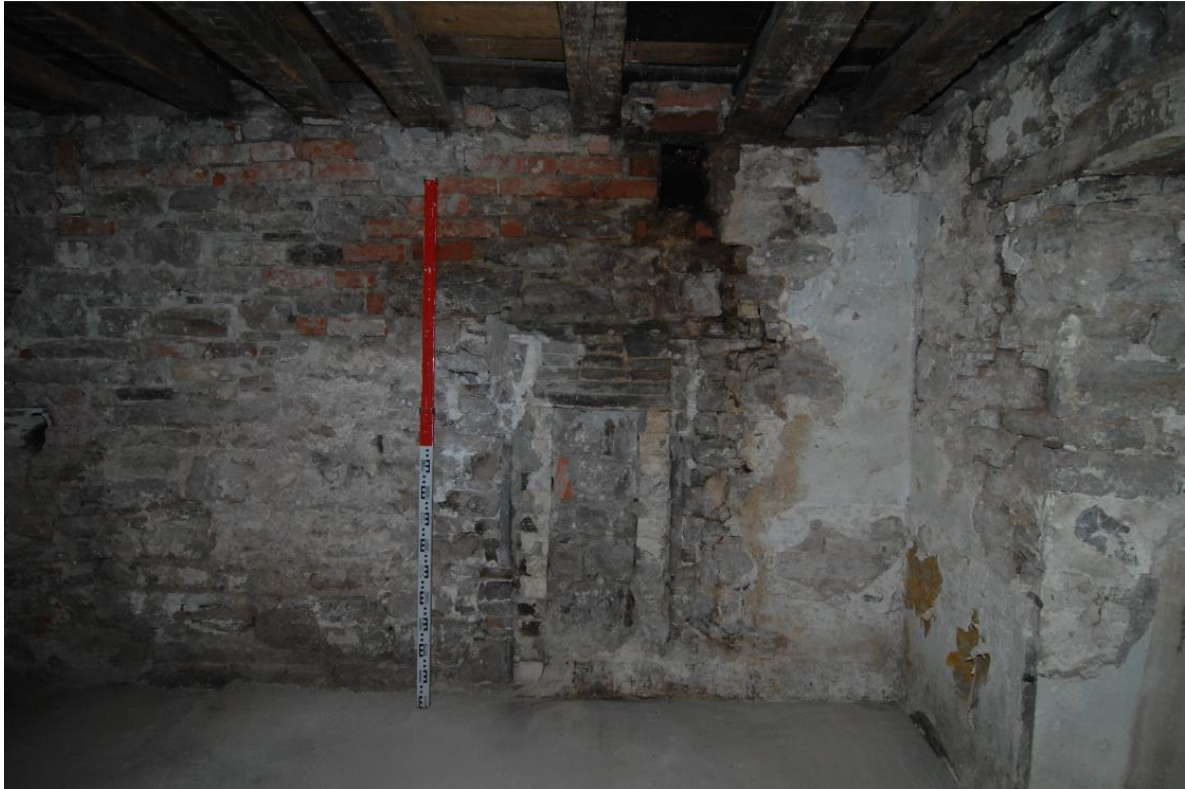
Pl.50: Exposed inner masonry of the western first-floor room of the solar, north end, 2017.

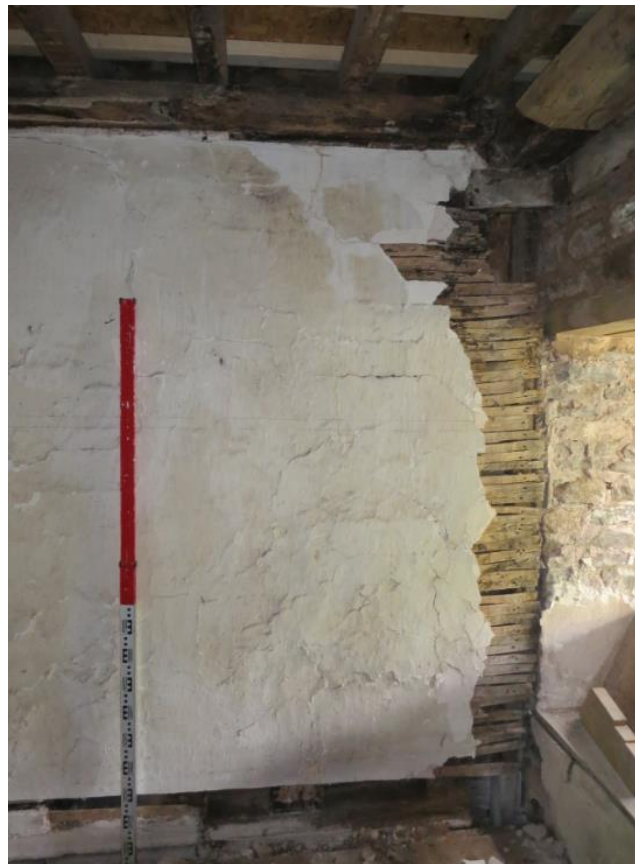
Pl.53: Western end of cross-frame at first-floor level in the solar range, and position of the primary doorway through it – replaced by one at opposite end.

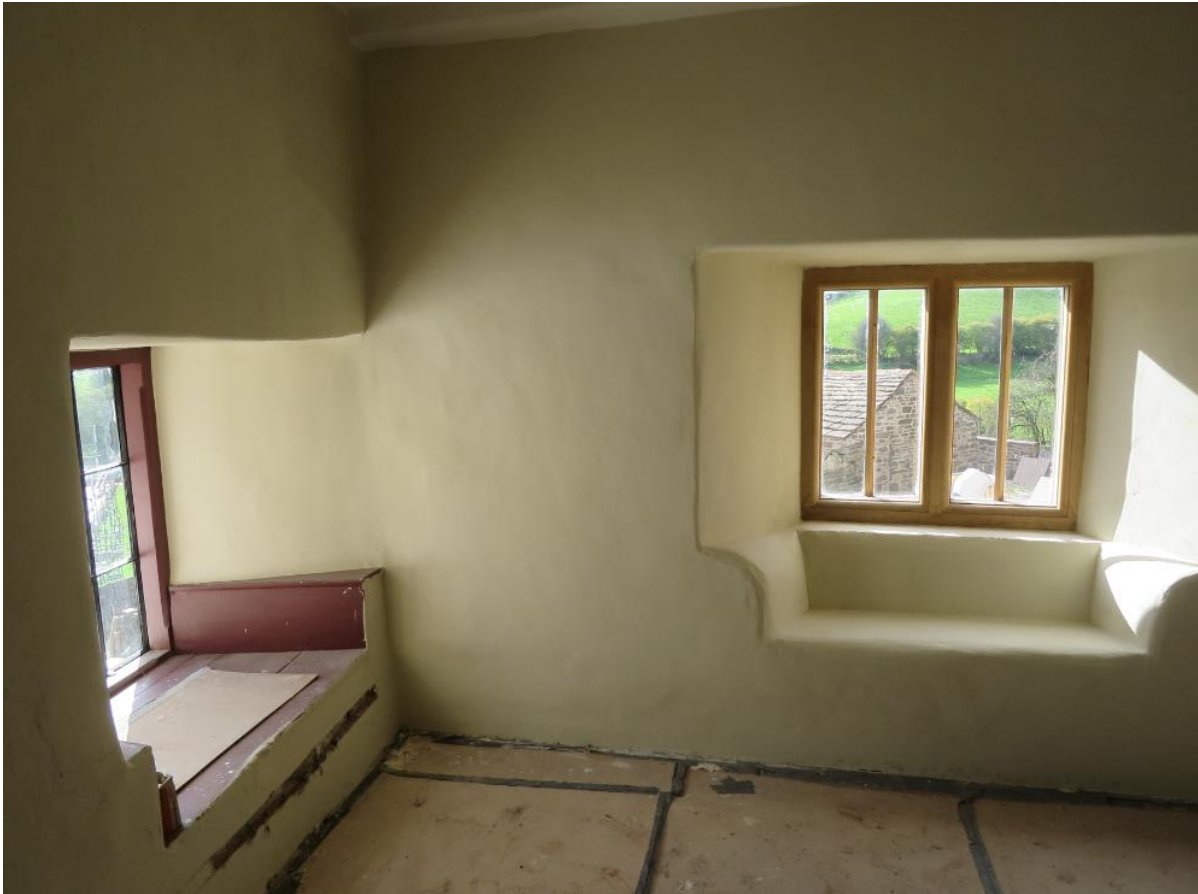
Pl.54: South end of first-floor solar room, with restored window opening in gable end, 2017.

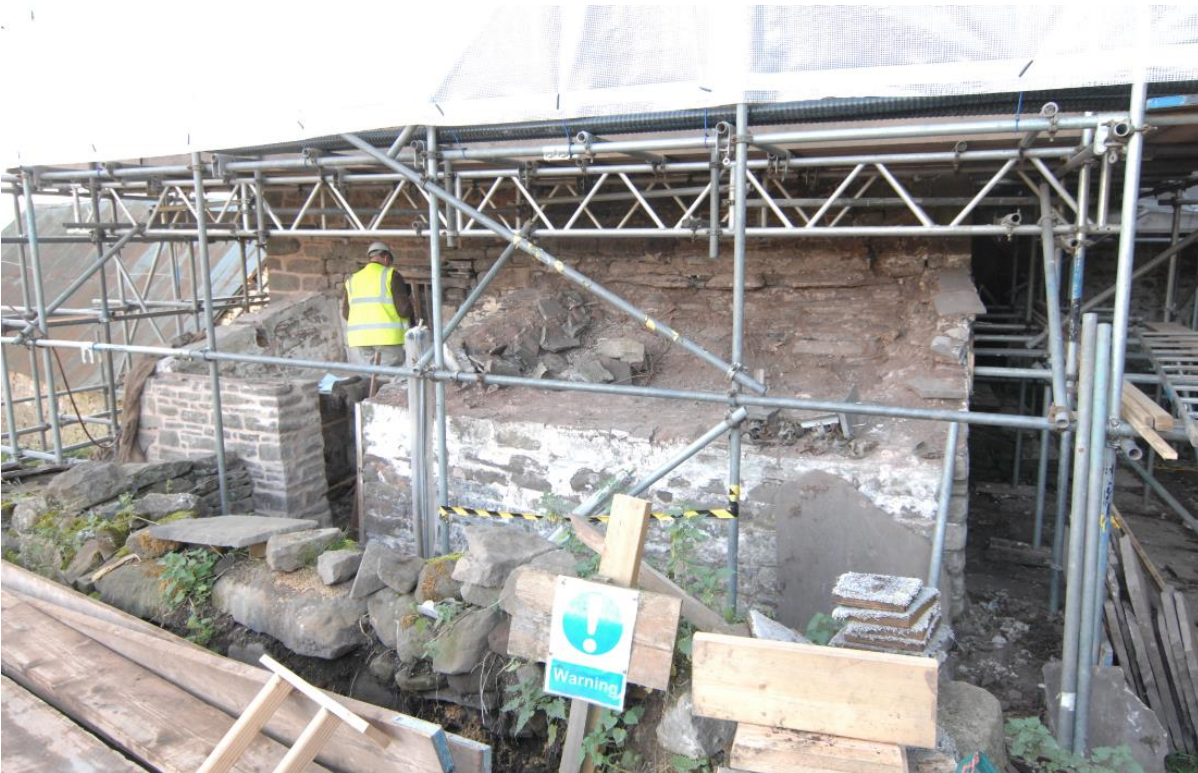
Pl.55: Work in progress on north gable end of the Rear Wing.

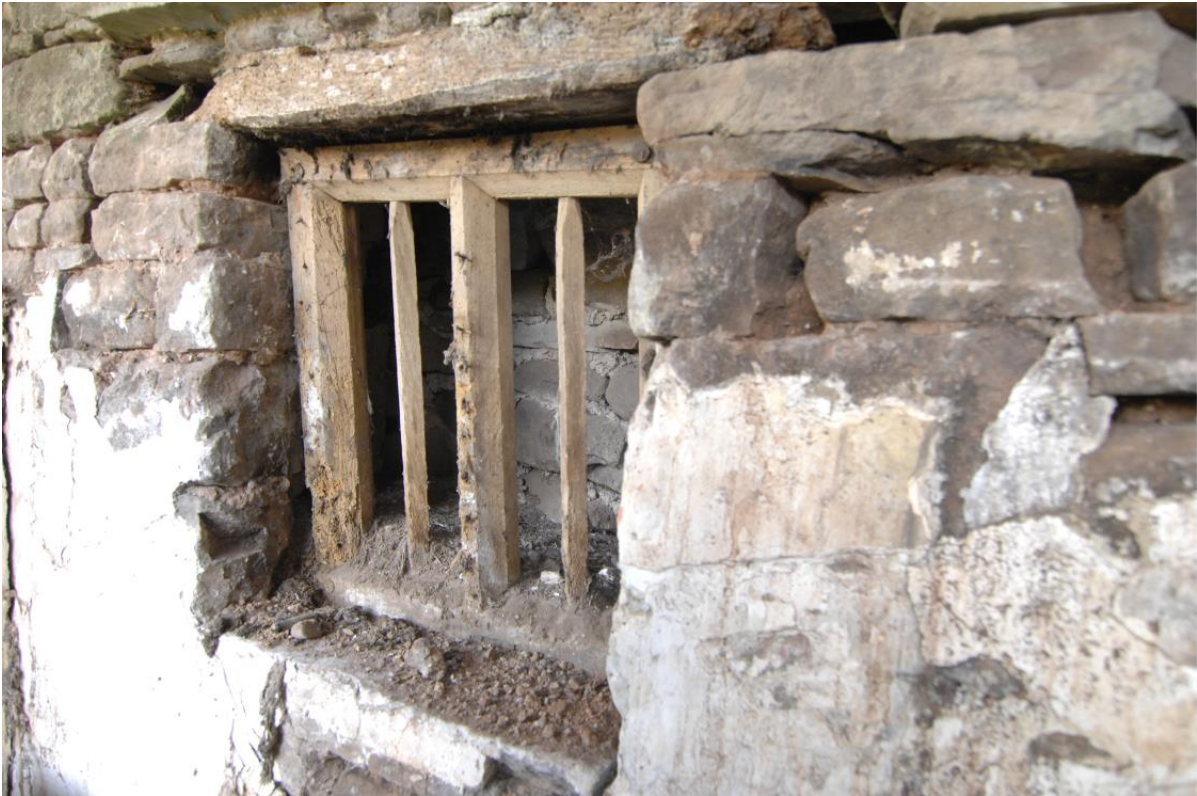
Pl.56: Rediscovered mullioned window in north gable end of the Rear Wing.

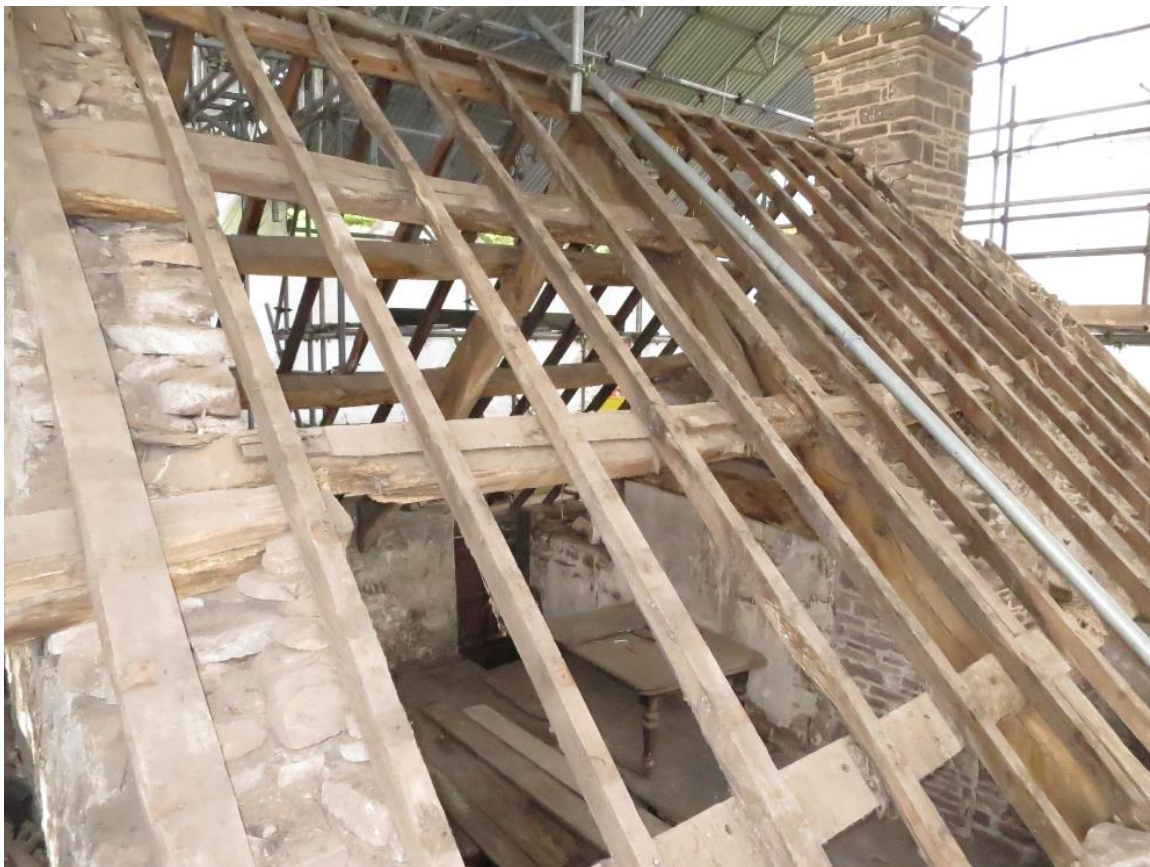
Pl.57: East roof slope of Rear Wing after de-slating, 2017.

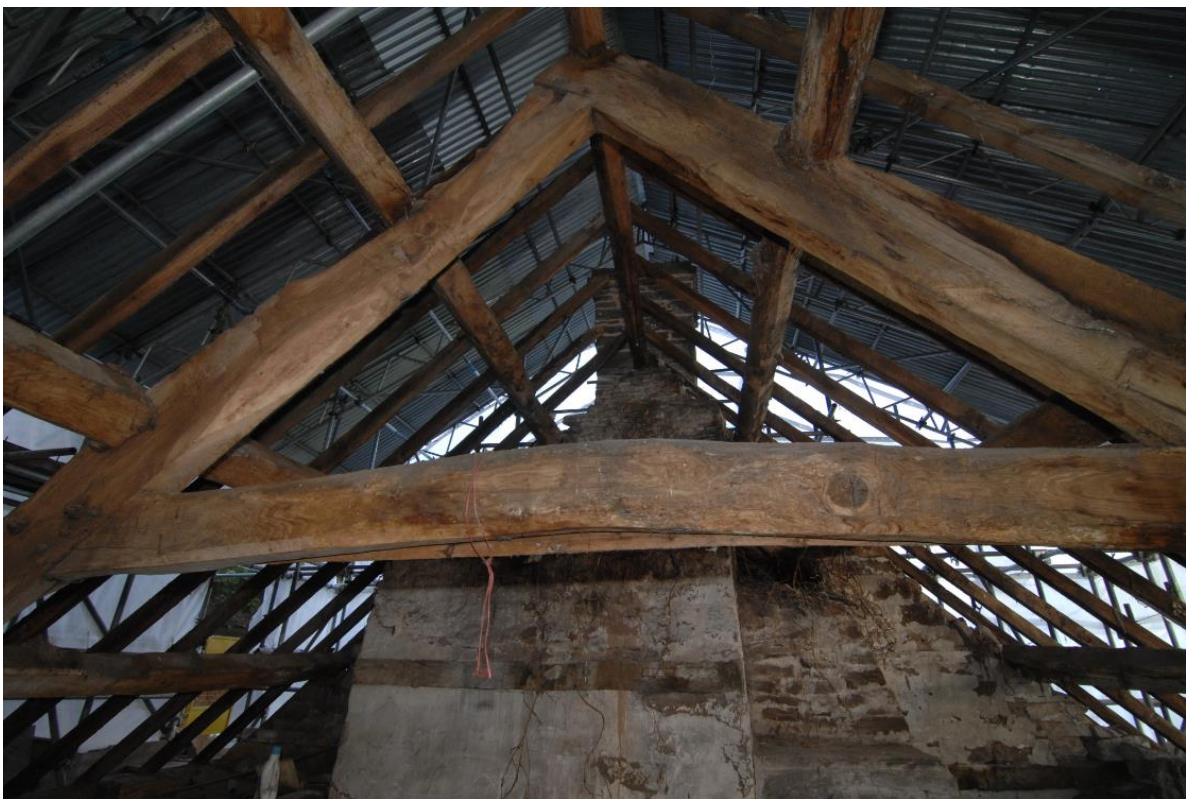
Pl.59: Roof truss of the Rear Wing.

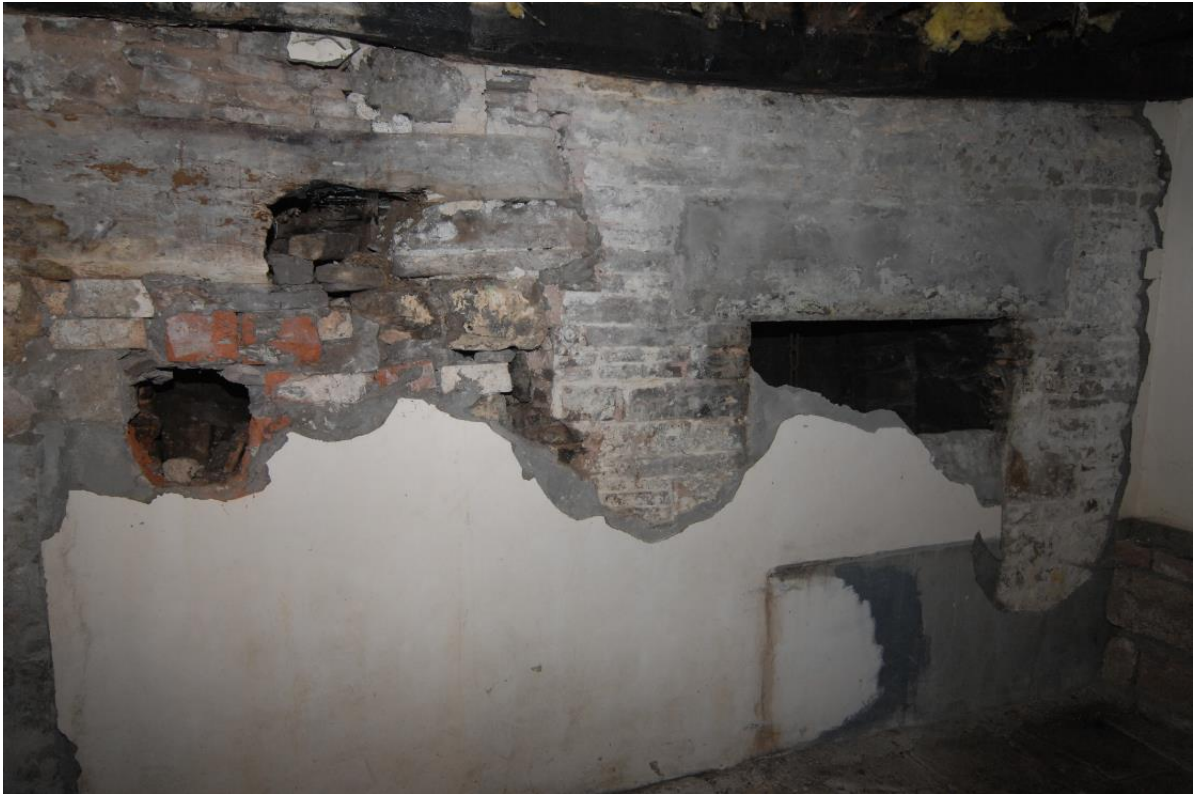
Pl.60: Beginning of internal strip of north gable wall (G8) in the Rear Wing, 2017.

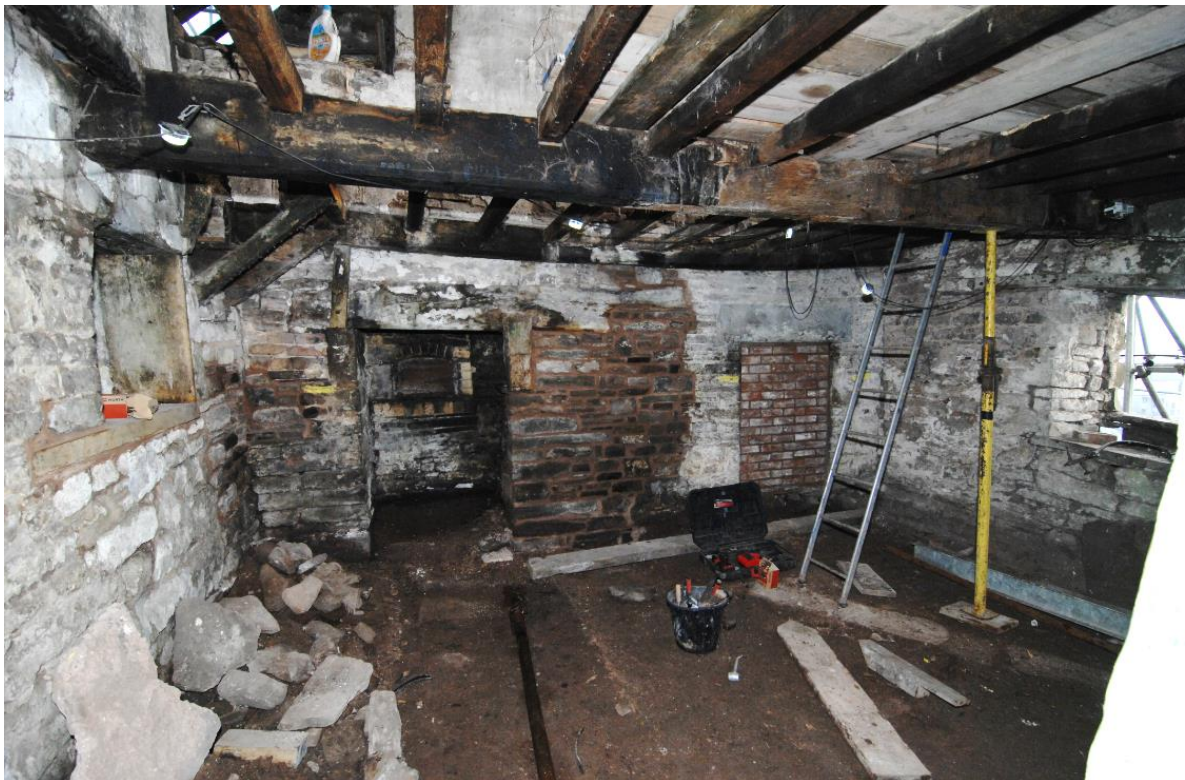
Pl.61: Stripping out work continuing, ground-floor, looking north.

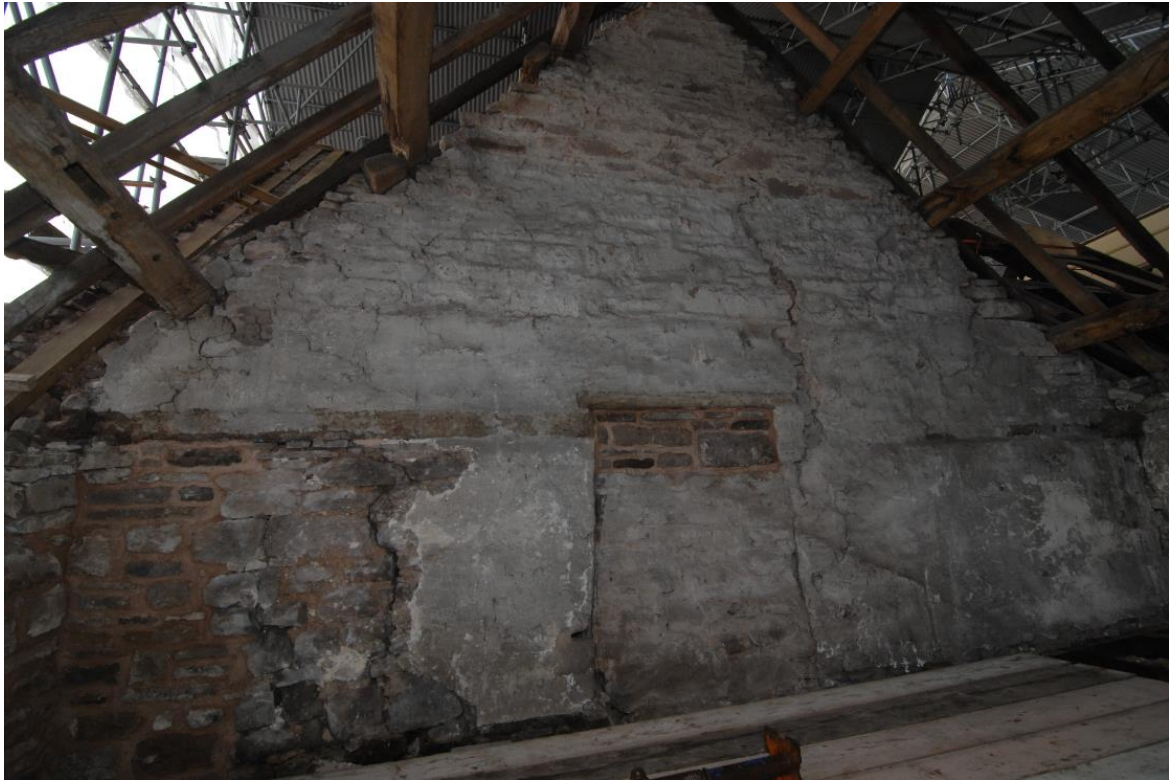
Pl.62: Upper floor or loft of Rear Wing, looking south towards the original house.

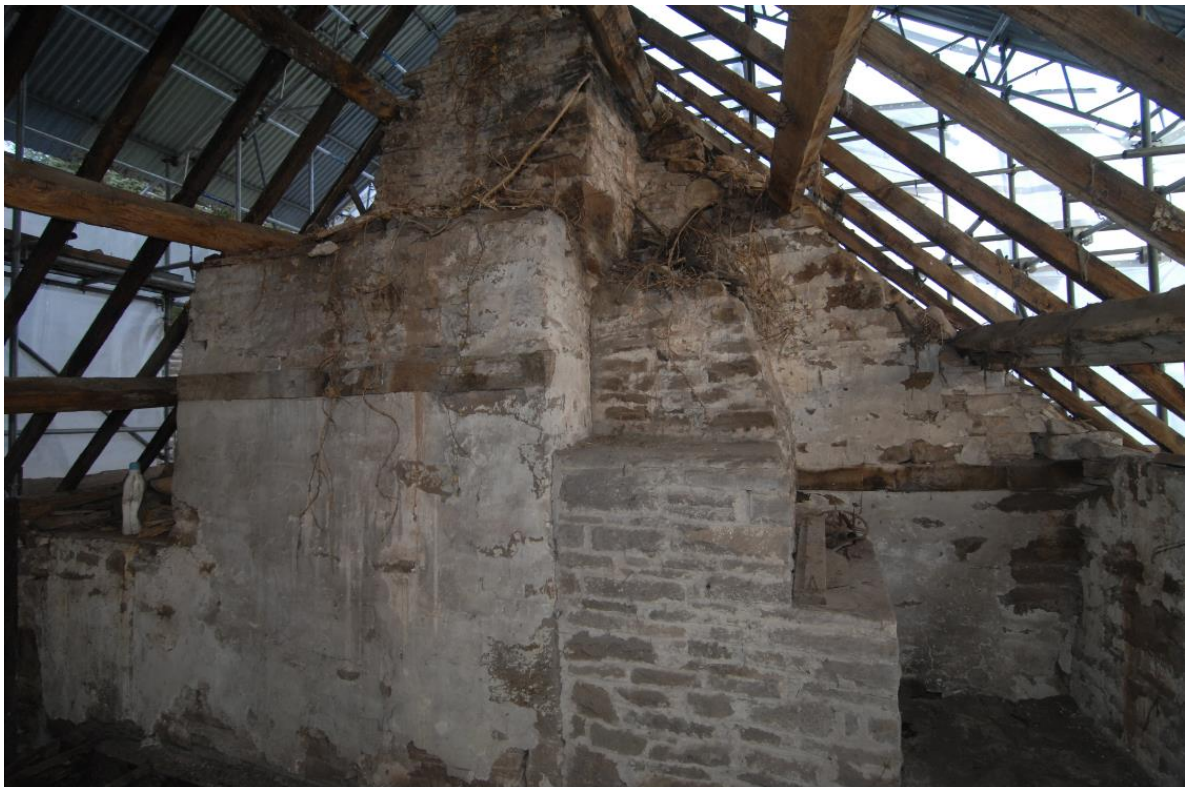
Pl.63: Upper floor of Rear Wing looking north to stack and gable.

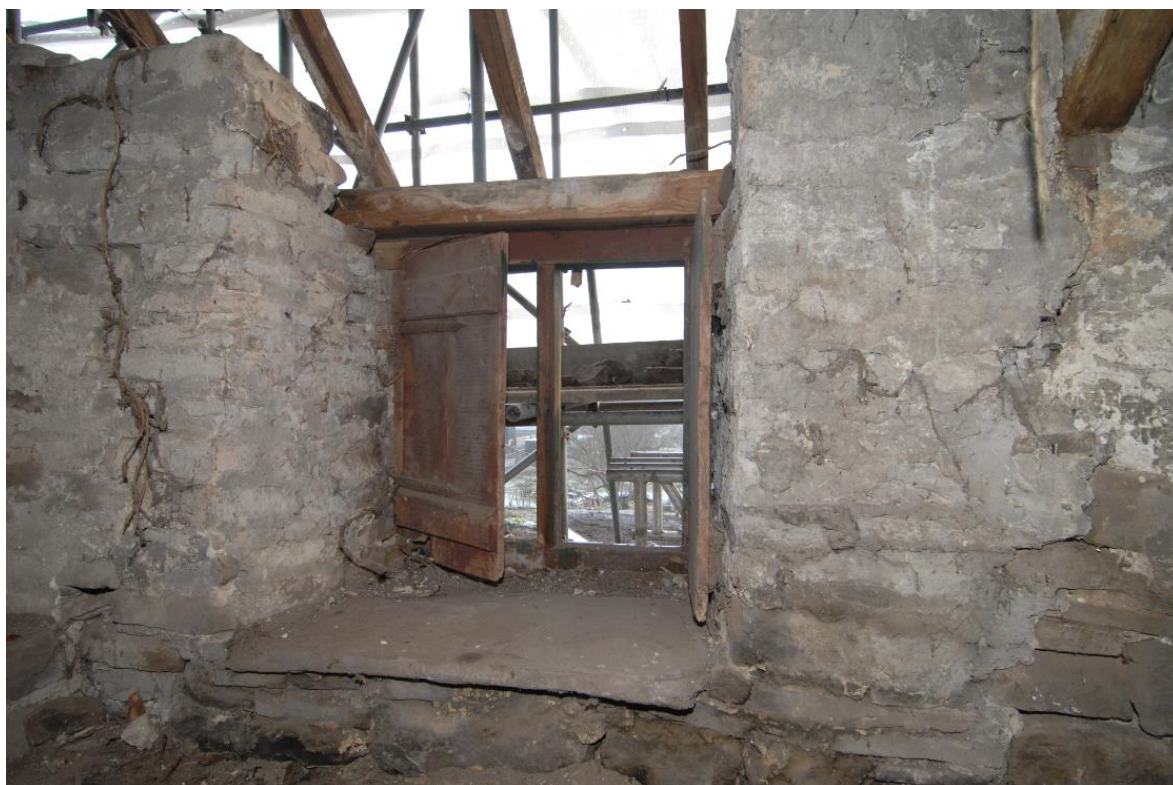
Pl.64: Dormer gable in east slope of the roof of the Rear Wing.

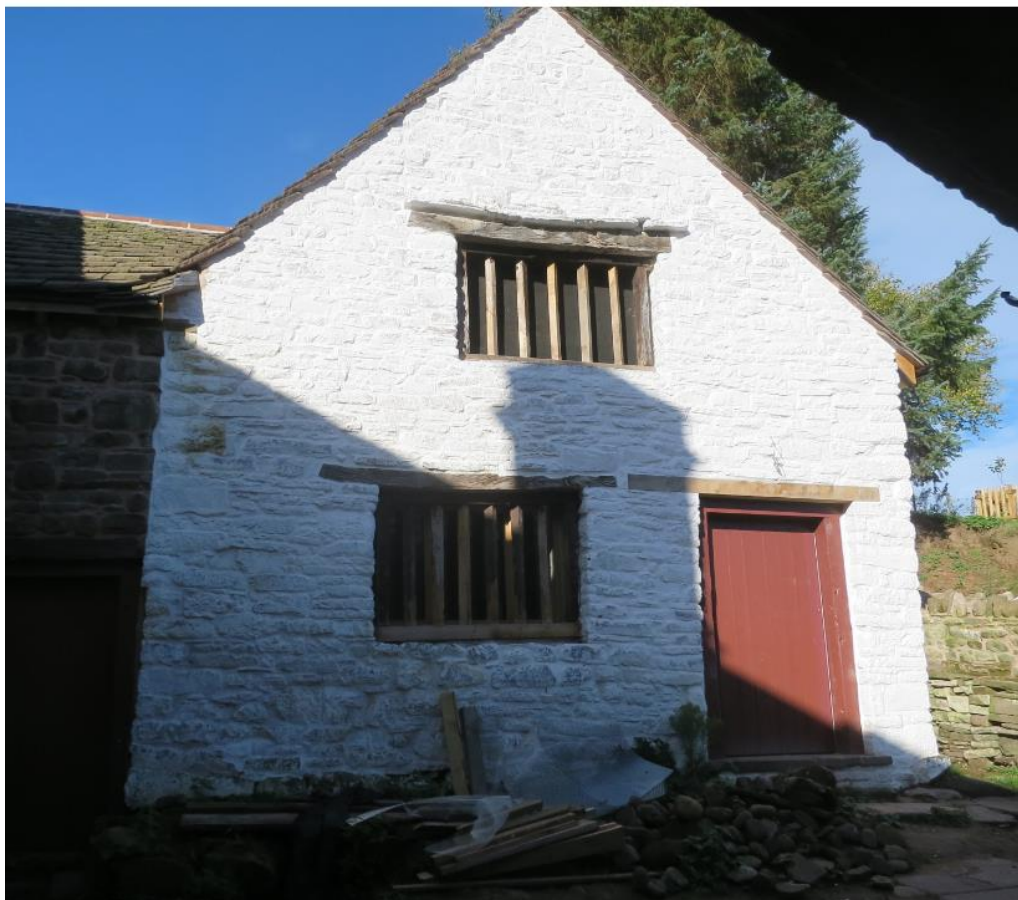
Pl.66: Restored front of Apple Store, 2017.

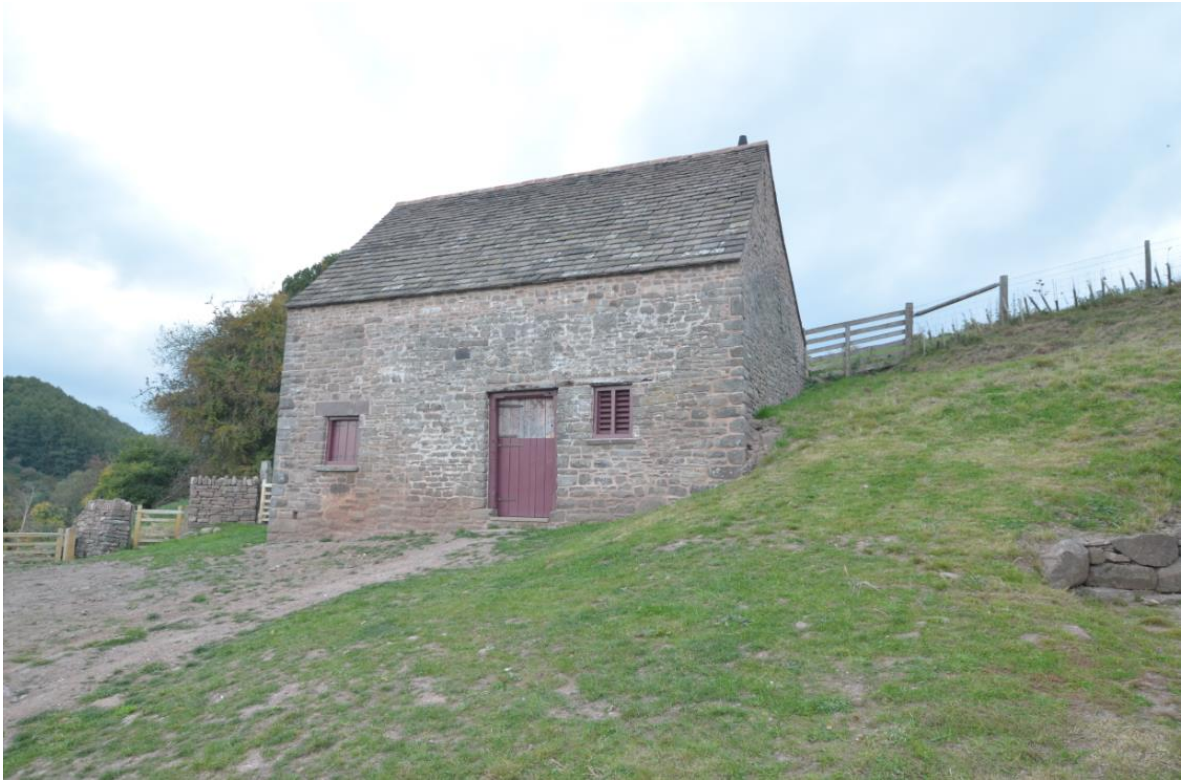
Pl.67: Restored and raised West Barn or Stable, Building E, from the east.

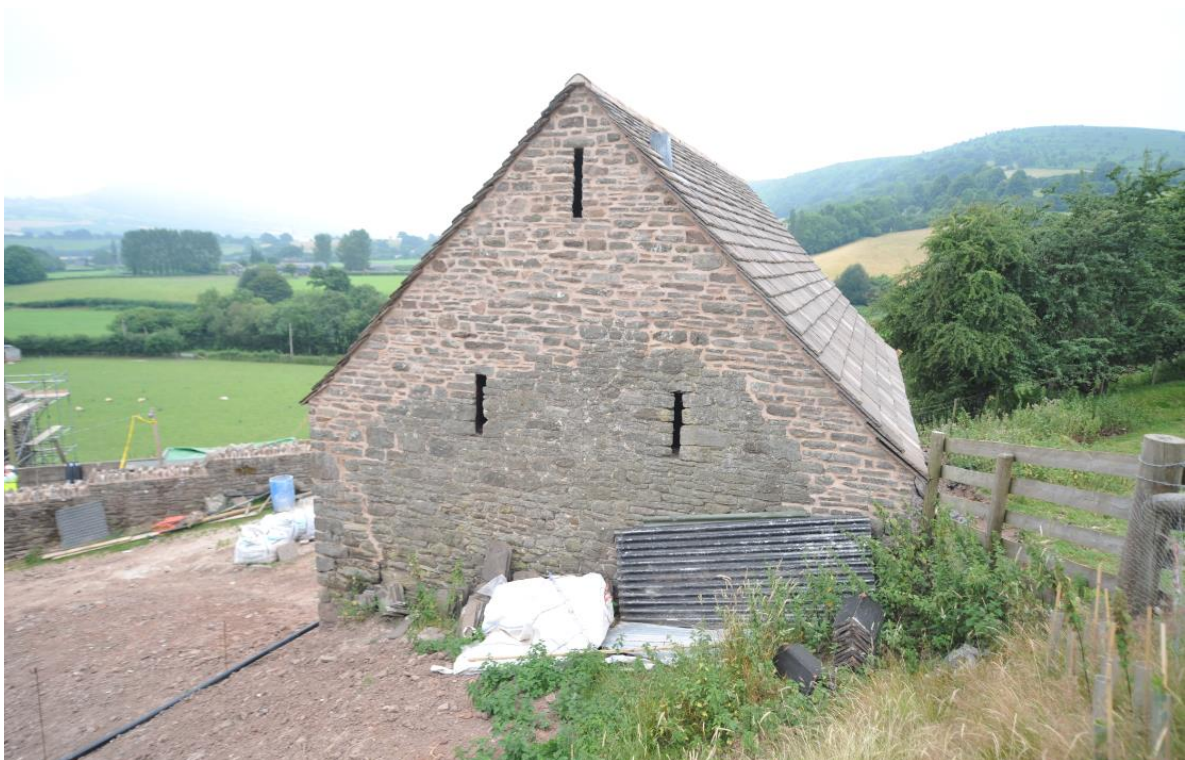
Pl.68: Restored Stable from the north; note raised gable.
