LLWYN CELYN  
Stanton  
Crucorney Fawr  
Gwent  
19/17995/DISCON

PHOTOGRAPHIC  
RECORD  
DURING WORKS  
2016-2018

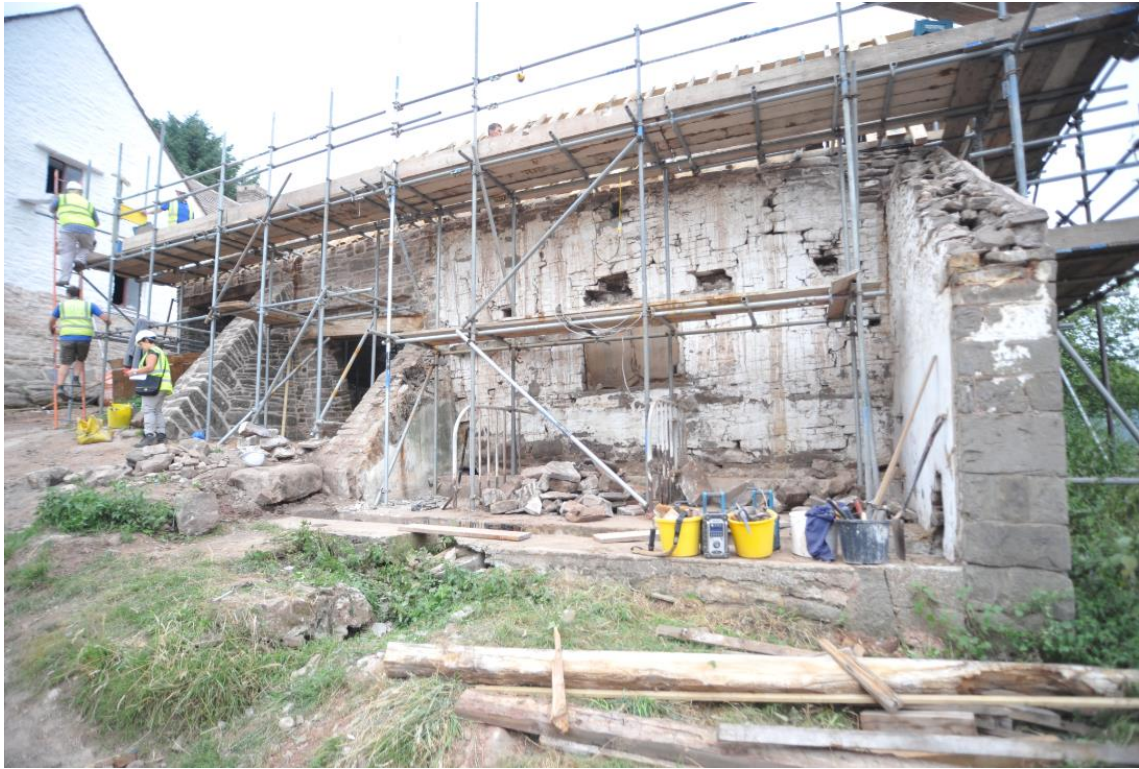
Pl.69: South side of Beast House (Building F) during works, Shelter Shed largely removed.

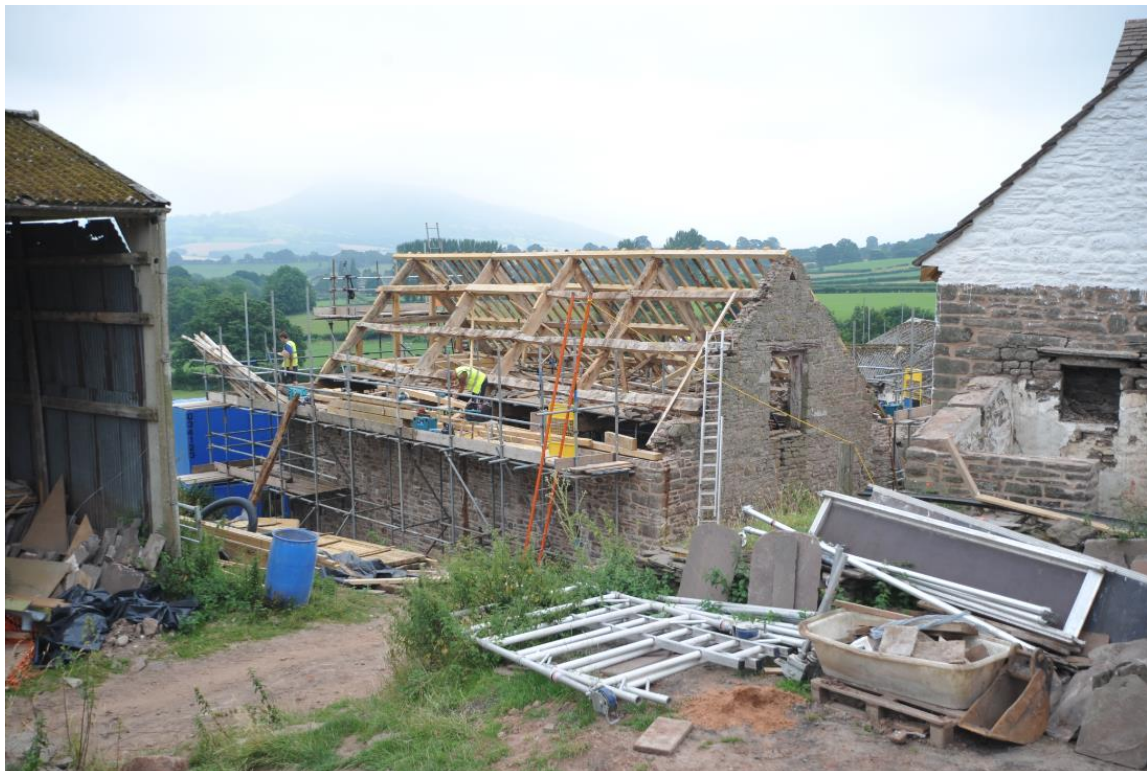
Pl.70: The Beast House from the north-west, 2016, works in progress on roof.

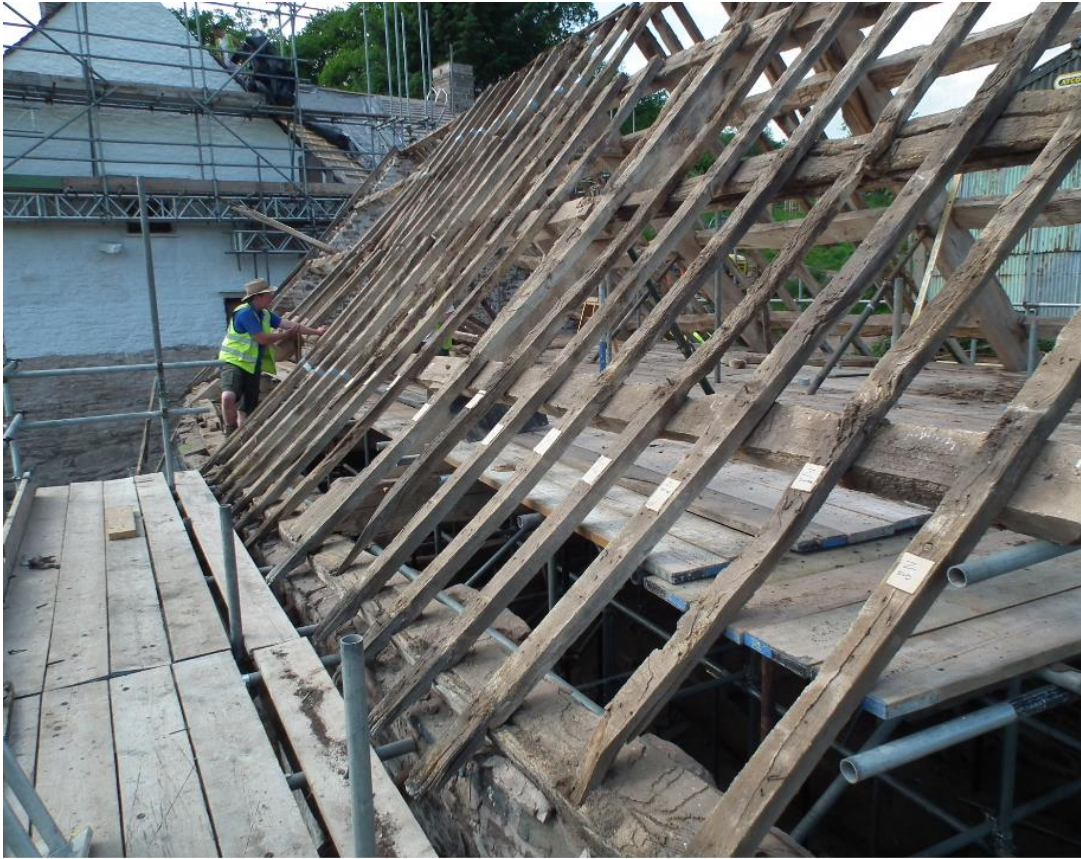
Pl.71: South slope of Beast House roof after being stripped.

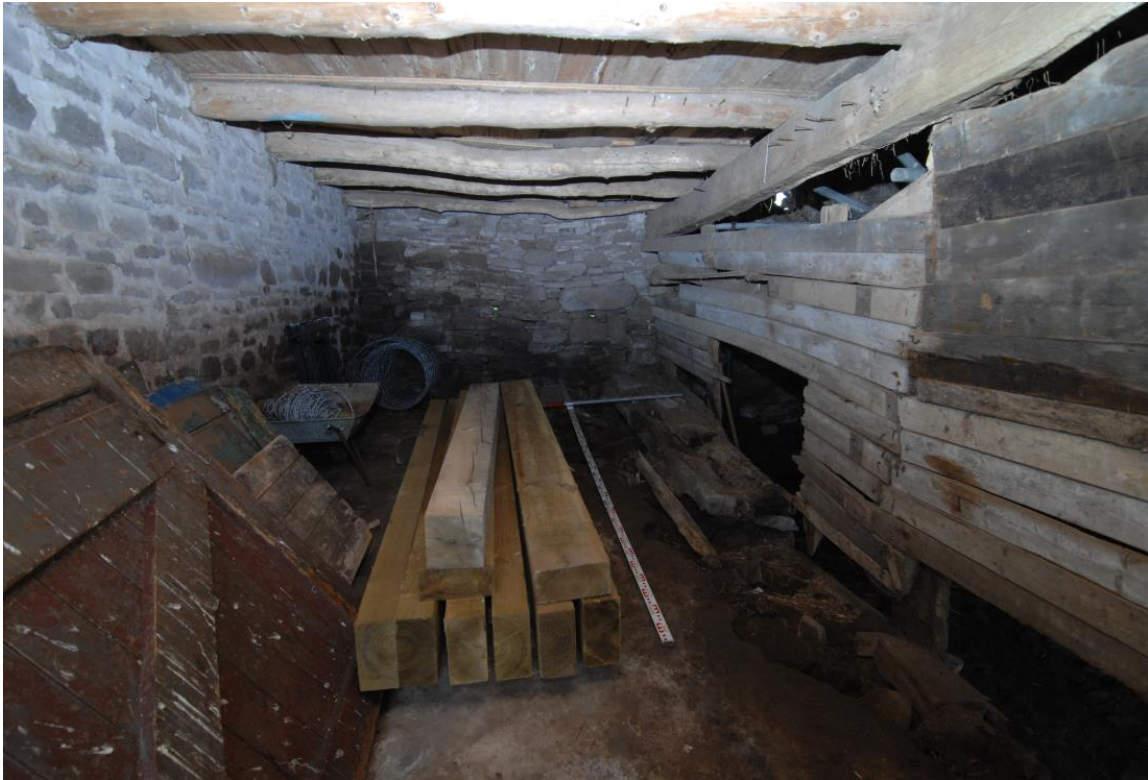
Pl.73: Northern bay of Beast House prior to restoration.

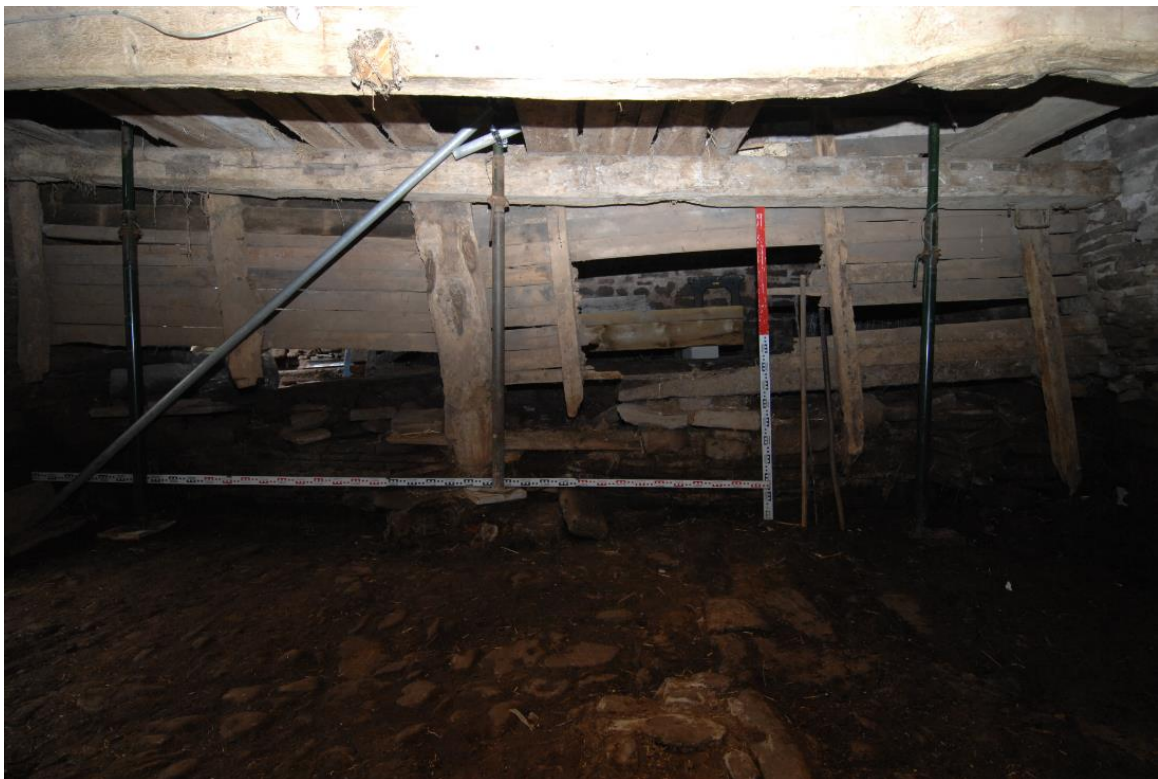
Pl.74: View west in Beast House to revetment wall and boarded cross frame, 2016.

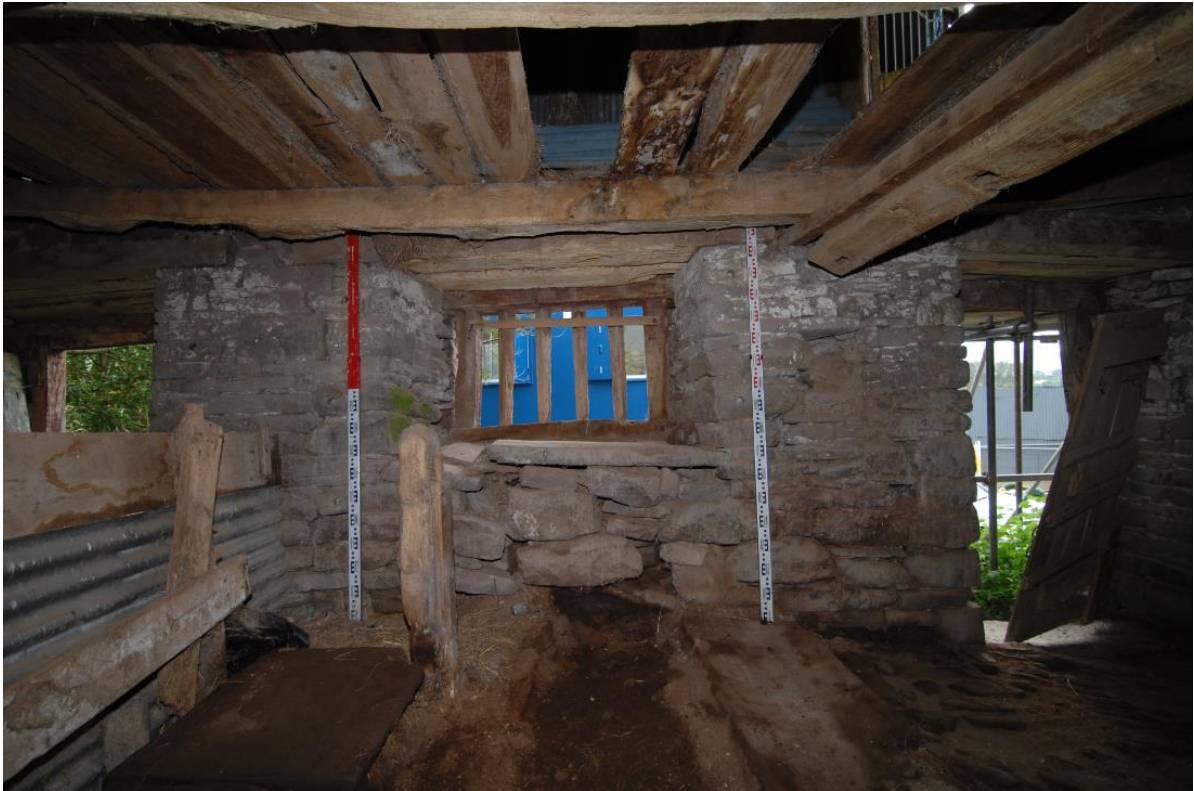
Pl.75: Internal view of the east gable frame of the Beast House at ground-floor level, 2016.

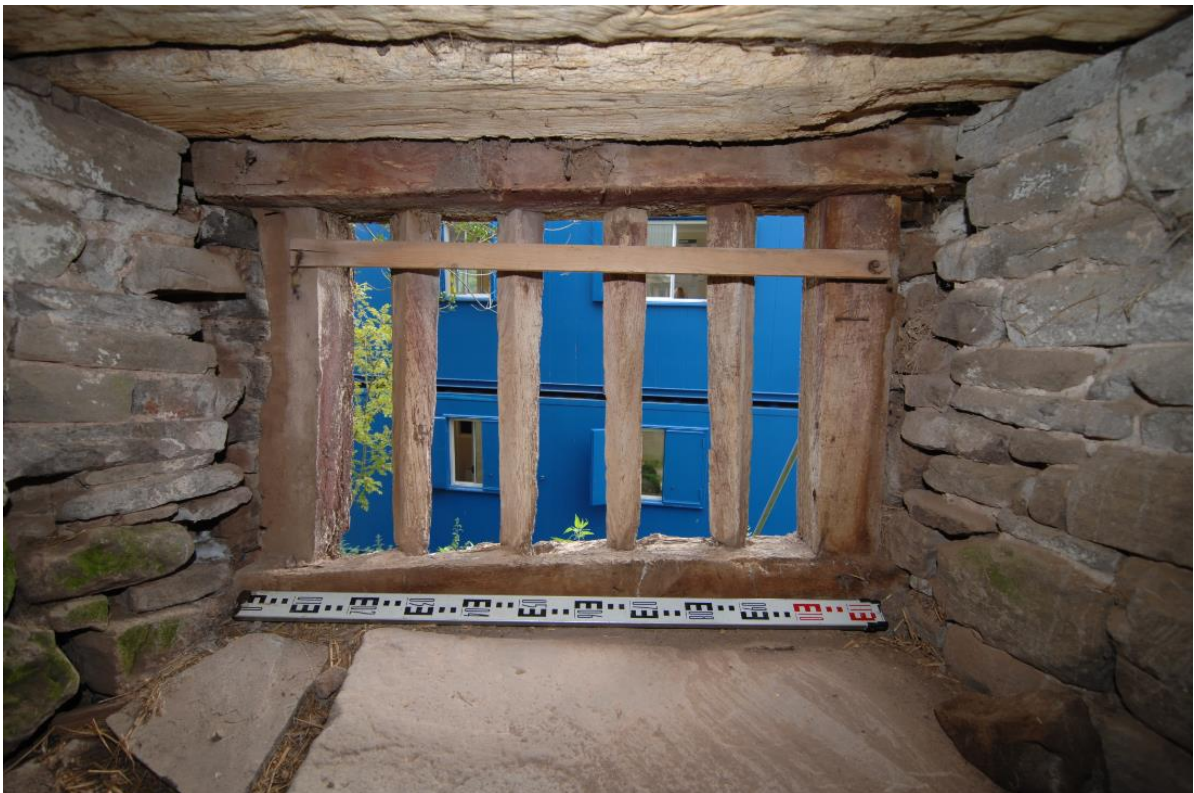
Pl.76: Detail of internal reveal of east gable window of the Beast House.

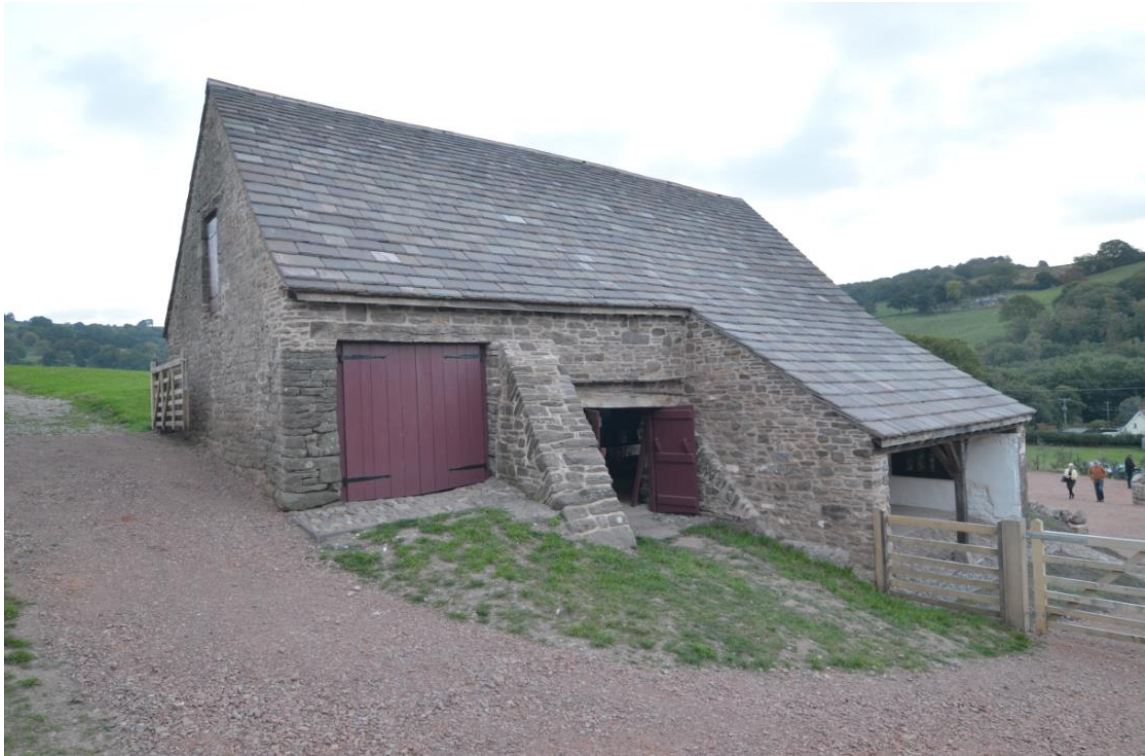
Pl.77: Restored Beast House and rebuilt Shelter Shed (Building G) from the south-west.

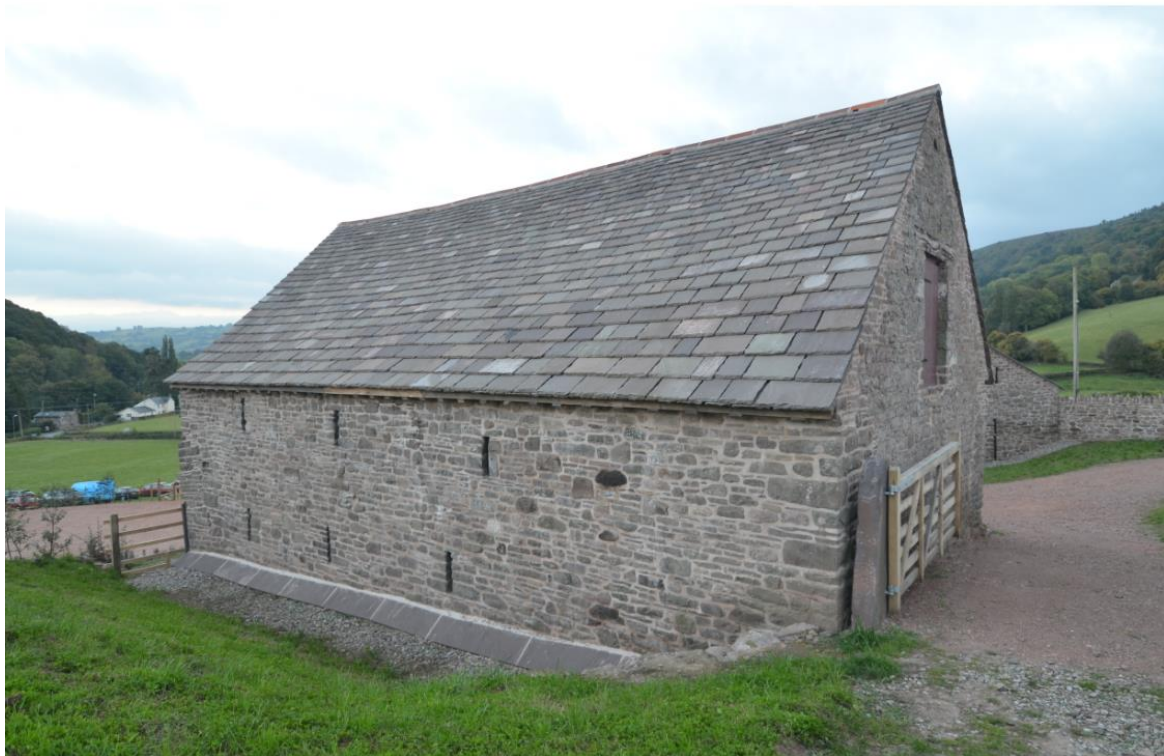
Pl.78: Restored Beast House from the north-west, 2017.

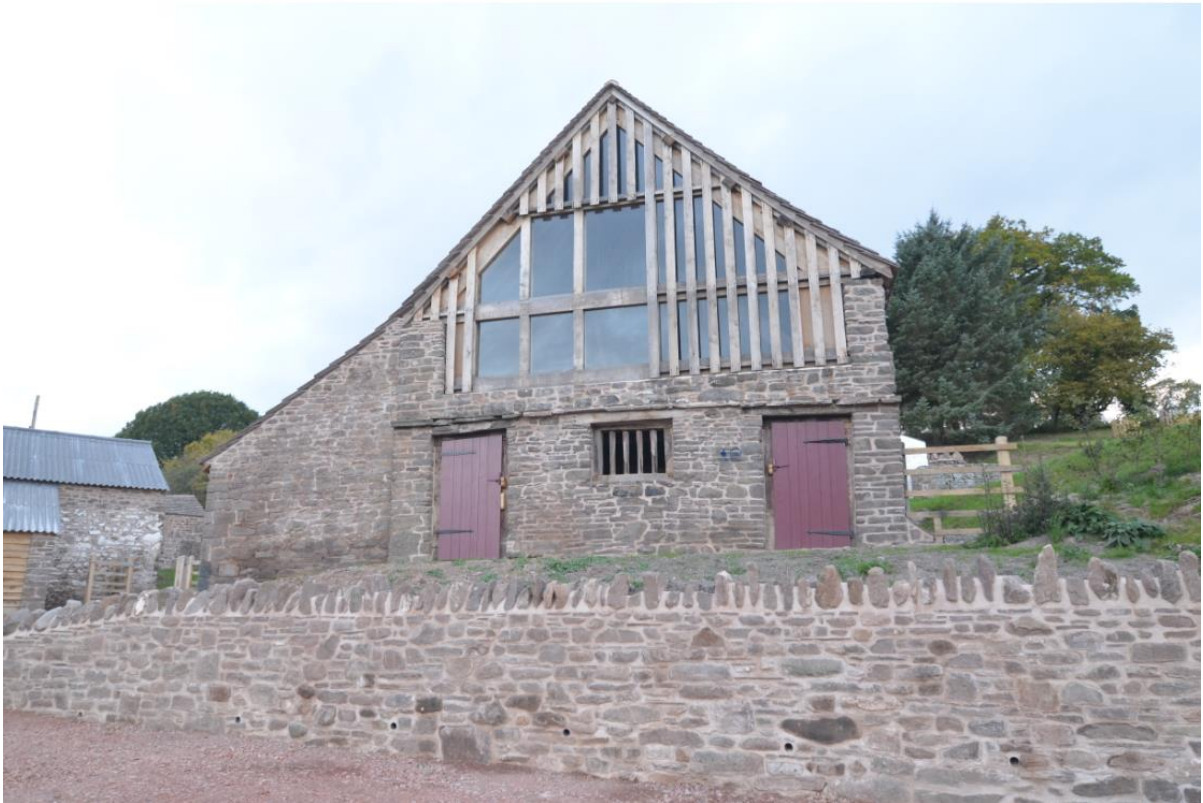
Pl.79: East gable of restored Beast House.

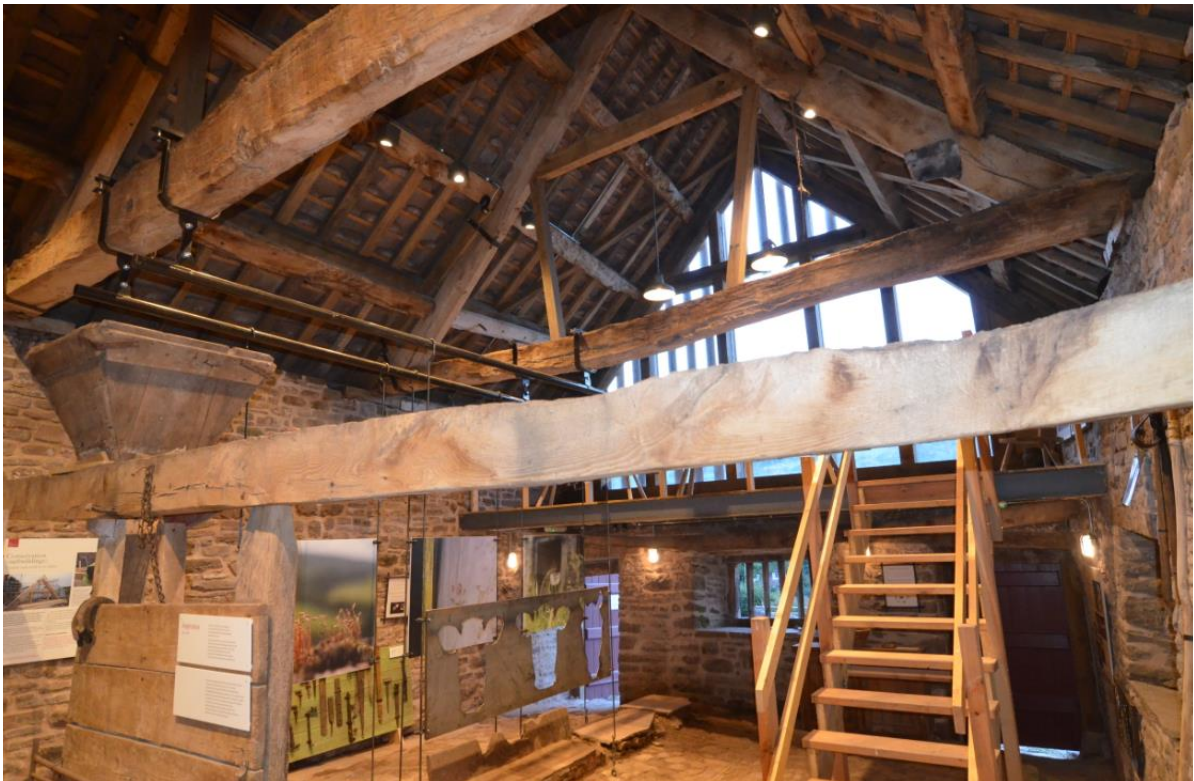
Pl.80: The restored interior of the Beast House.

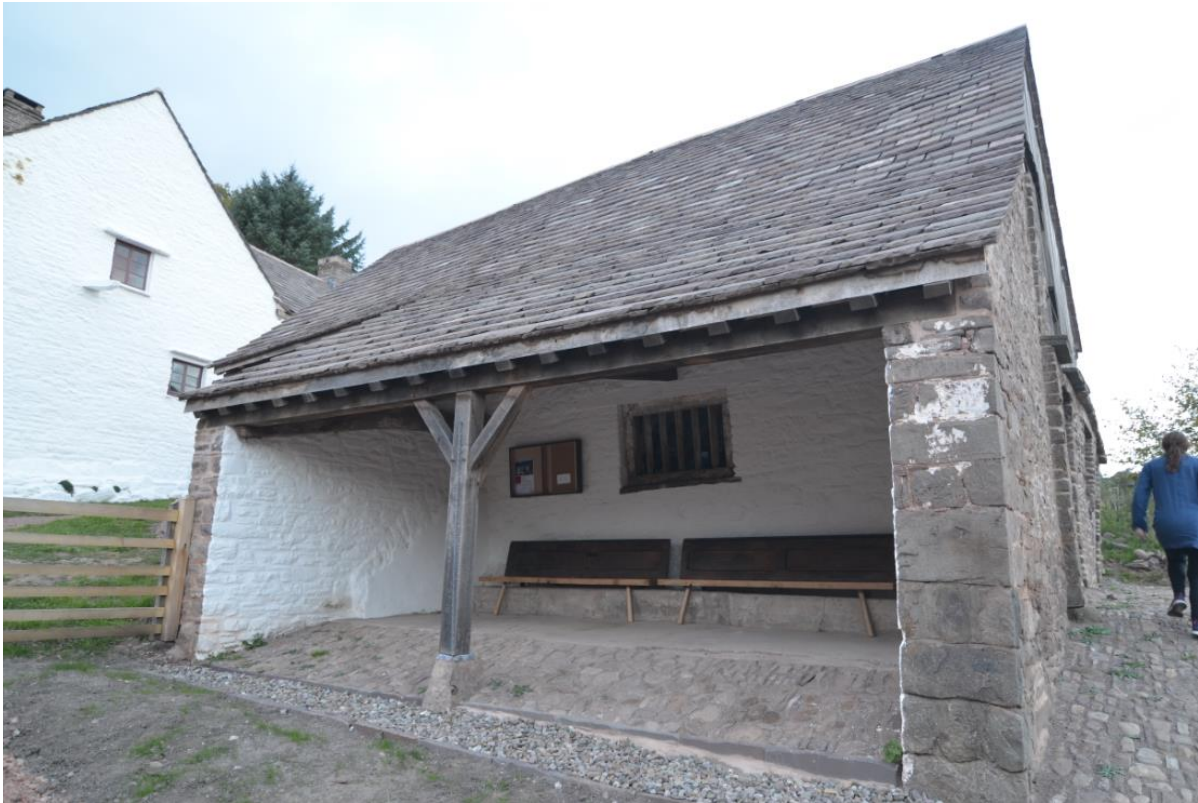
Pl.81: The rebuilt Shelter Shed (Building G).

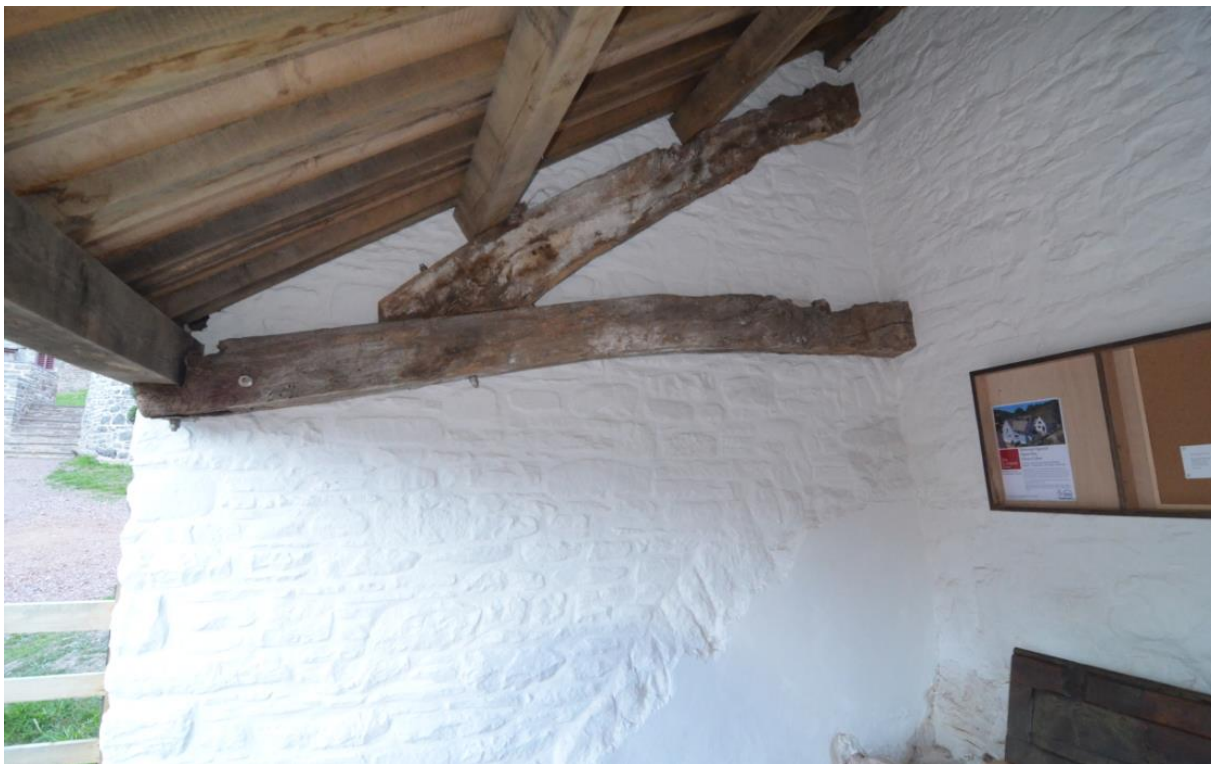
Pl.82: Re-set truss and part frame of earlier structure of Shelter Shed.

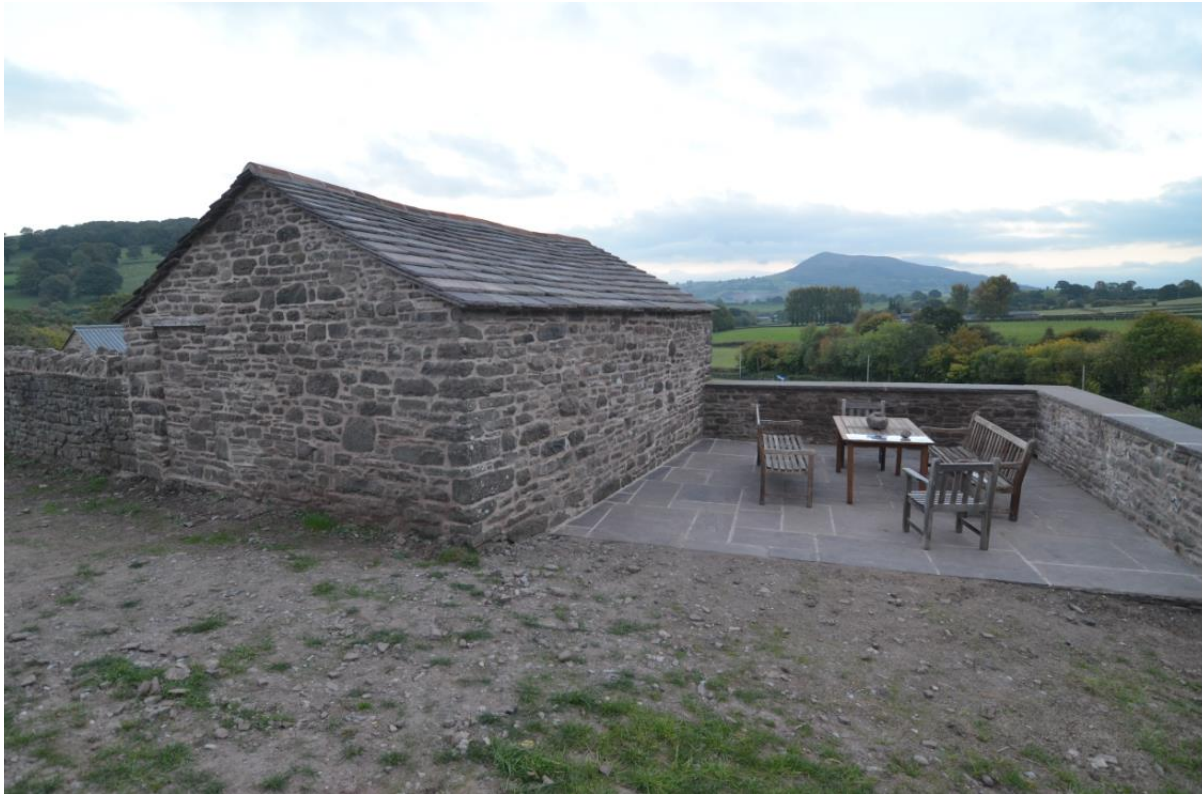
Pl.83: View of the Corn Drier (I, left) and site of Piggery (Building H) from the north-west.

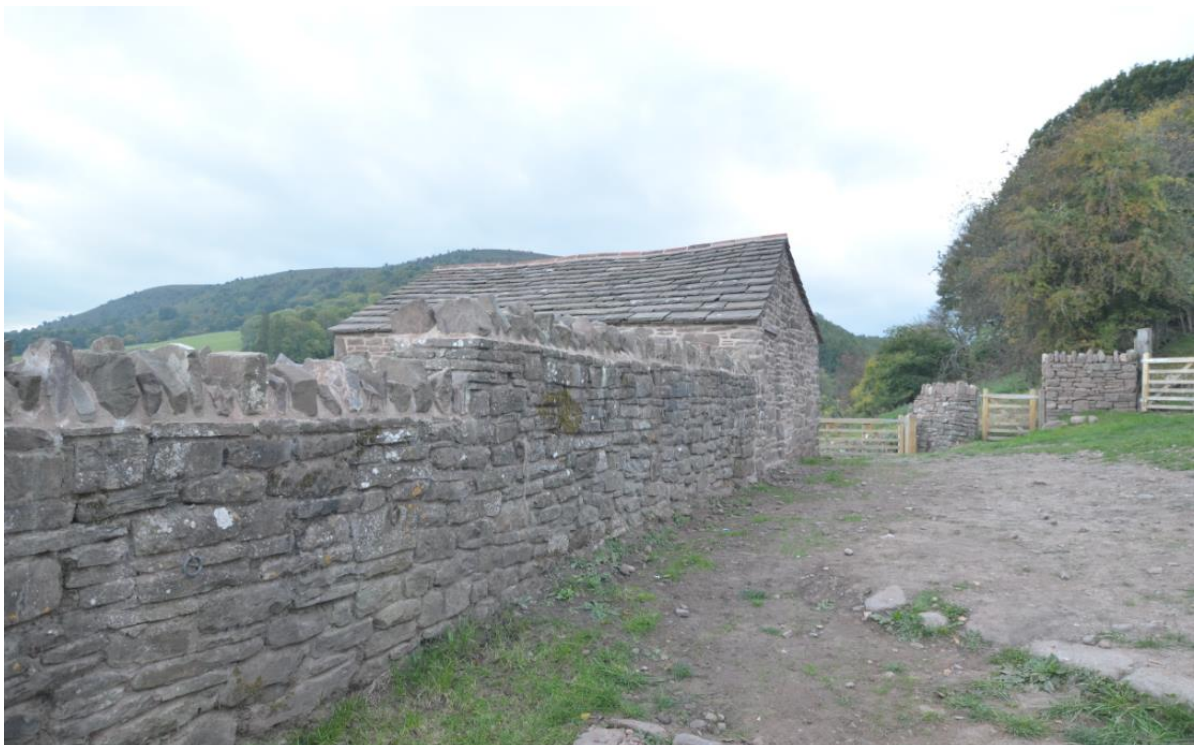
Pl.84: General view westwards towards the restored Corn Drier.

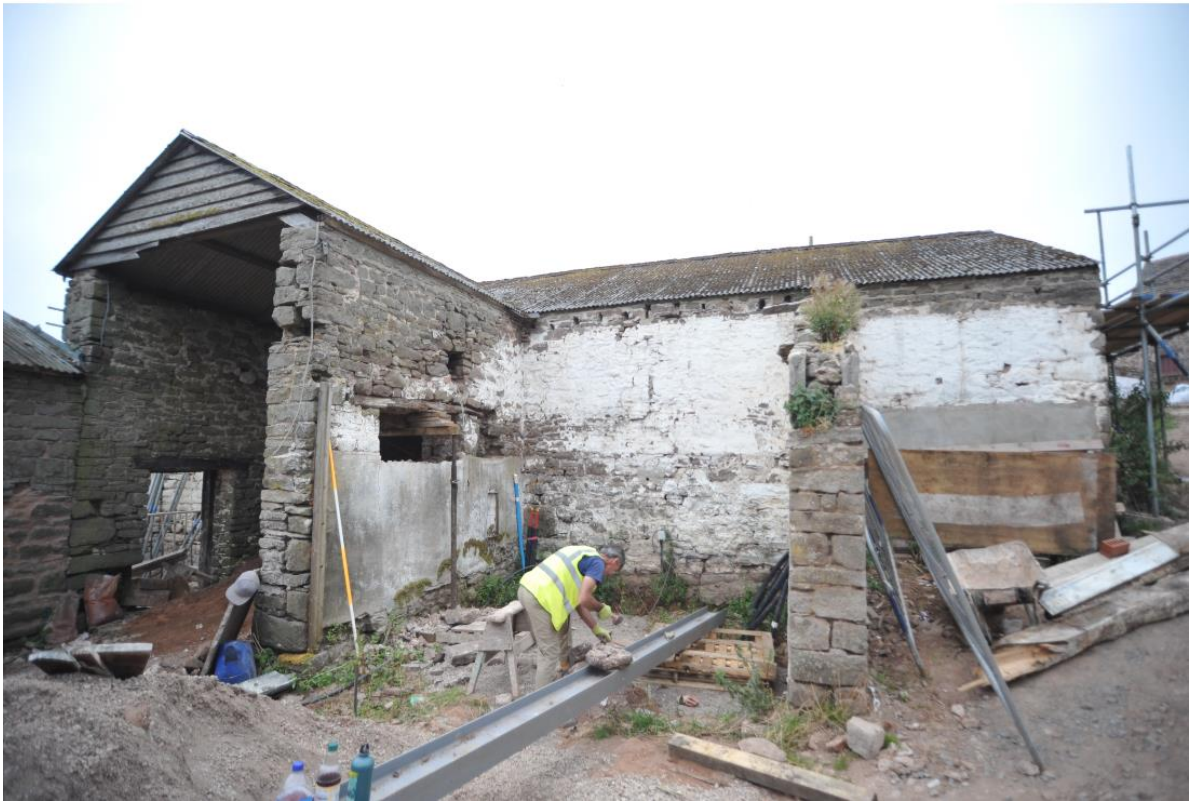
Pl.85: Threshing Barn (Building J) from the east under restoration.

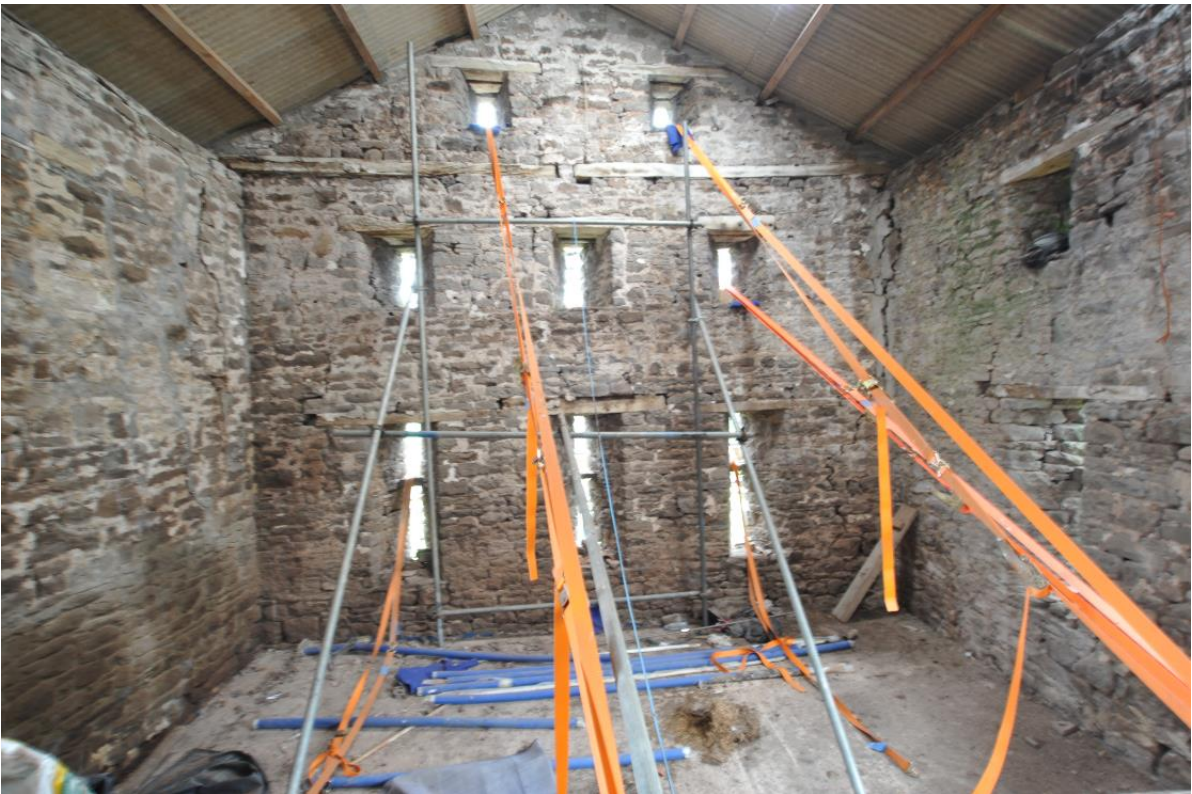
Pl.86: Stabilisation works within the Threshing Barn, looking north.

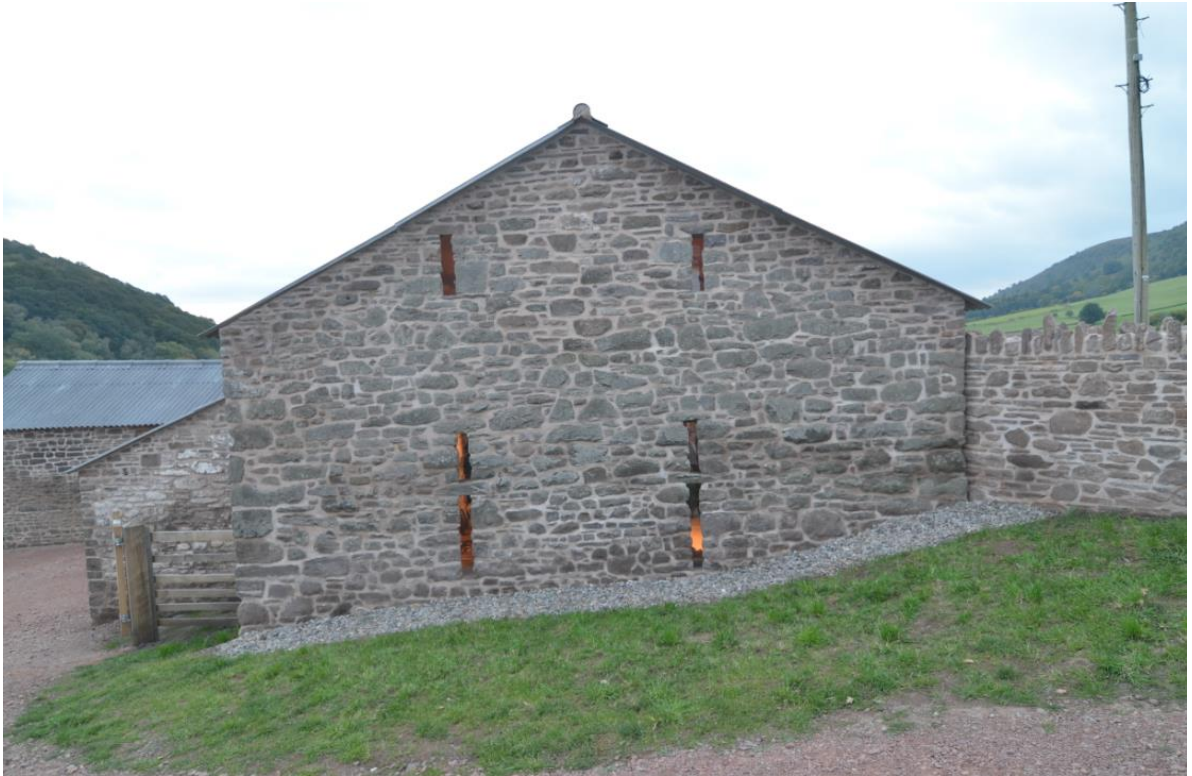
Pl.87: The north gable of the restored Threshing Barn.

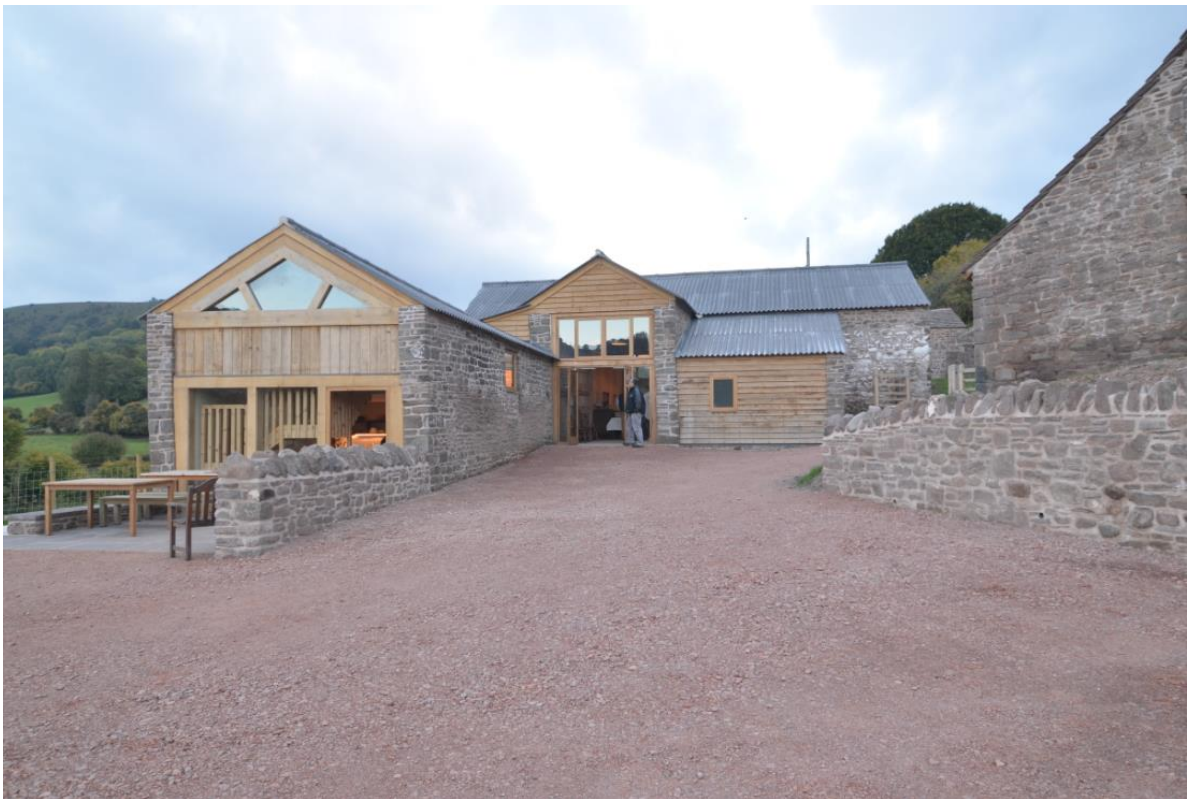
Pl.88: View of the eastern farm buildings from the east.
