**LLANSADURNEN PARISH CHURCH,
CARMARTHENSHIRE
(SN 2816 1026)
ARCHAEOLOGICAL WATCHING BRIEF**

November 2009

RHIF YR ADRODDIAD / REPORT NO. 2009/83
RHIF Y PROSIECT / PROJECT RECORD NO. 98515

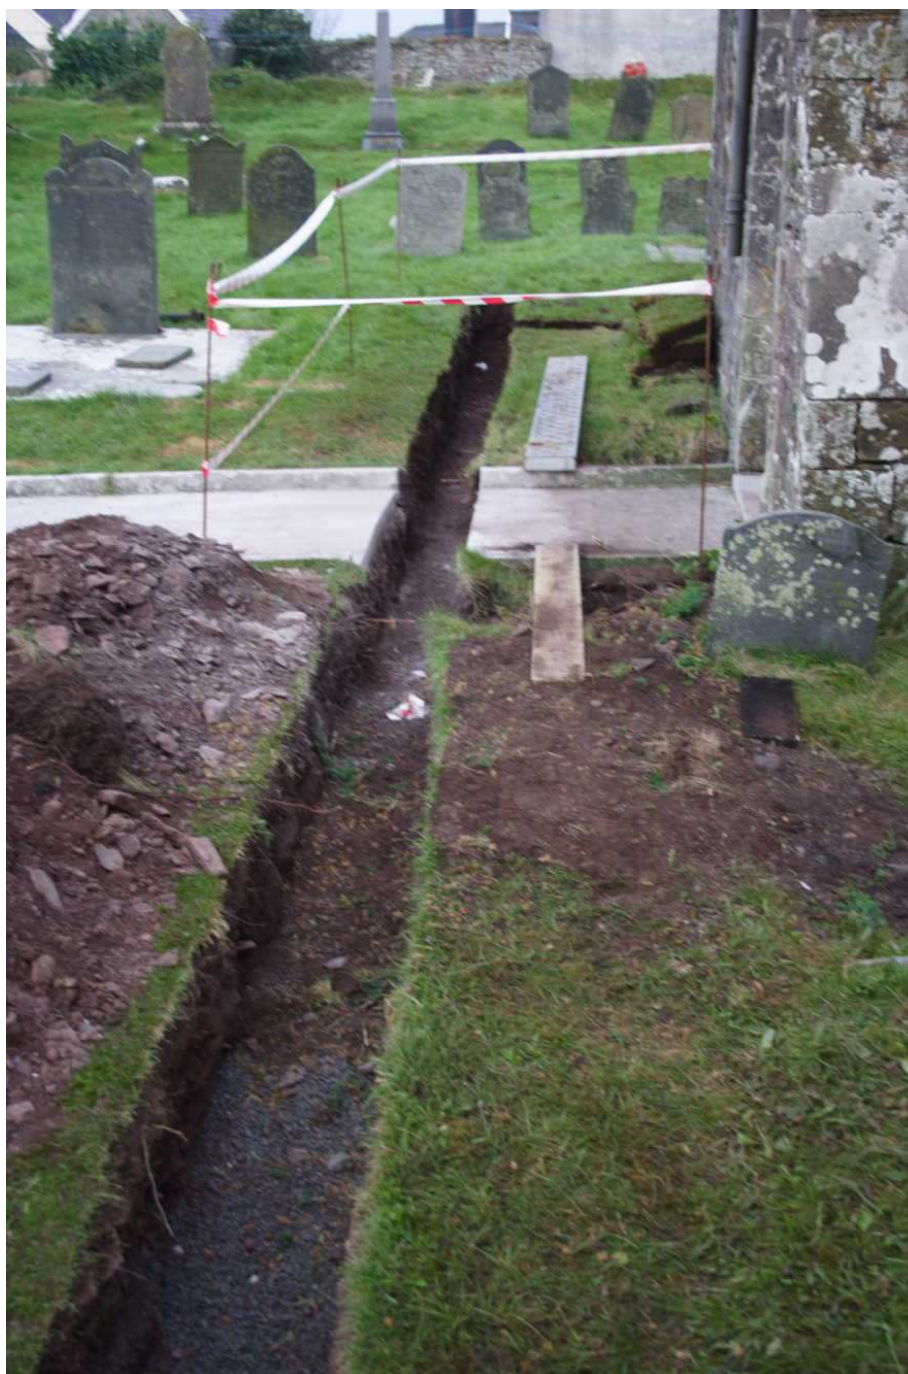
The excavation of the drainage trench revealed dark brown silt clay topsoil, which was 0.15m in depth and contained occasional flecks of mortar. Underlying this layer the topsoil was a mixed mortar layer 0.15m in thickness containing rare pieces of roofing slate and occasional small sub angular stones. This layer appeared to be a building debris layer, which possibly relates to the rebuilding of the church in 1859.

The natural subsoil was revealed at a depth of 0.30m below the top of the churchyard's ground surface grass surface and was comprised a light reddish brown silt clay containing rare flecks of mortar and rare pieces of disarticulated human bone.

Photo. 1: West facing section of Drainage pipe cut.

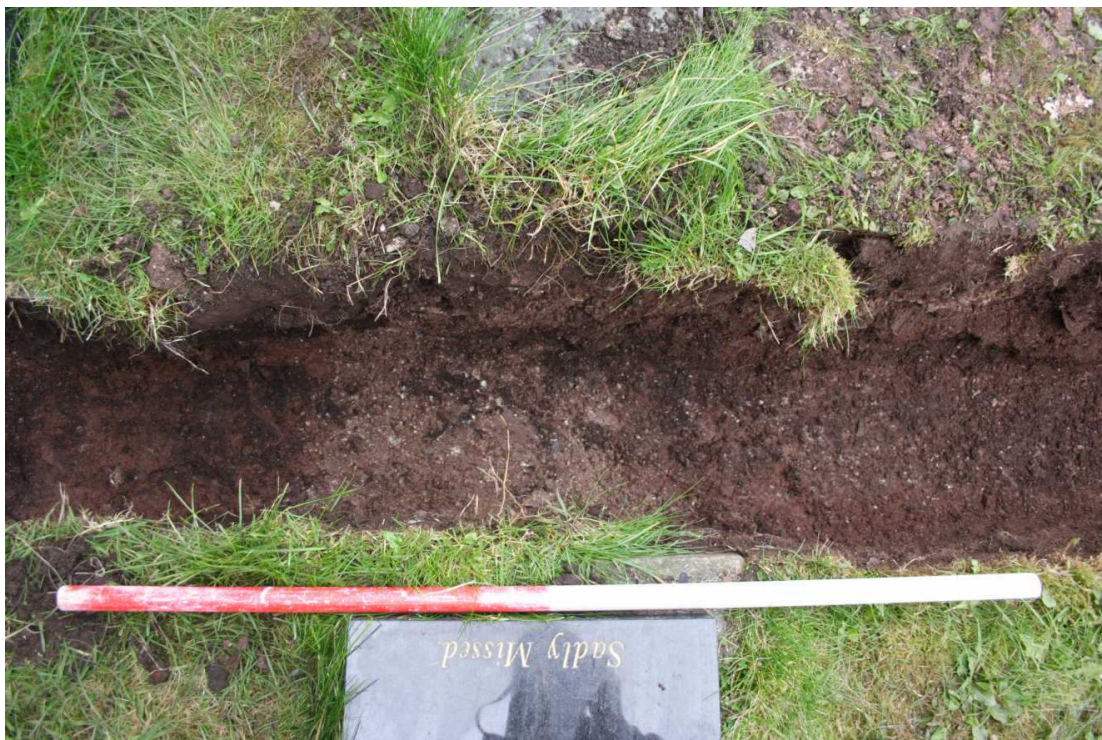
A linear line feature measuring 0.41m in width and 0.38m in length was observed to be running northeast to southwest across the trench disappearing under either side. Due to the trench being relatively small it is difficult to discern whether this was a possible grave cut. It was noted that the fill of the feature was a light reddish brown silt clay which contained 40% mixed with mortar, and building debris, perhaps suggesting which would suggest that this feature was possibly created after the post-dates the 1859 rebuilding of the church and that the back fill of the feature fill of the feature has come from the backfilling of the disturbed upper layers included material from the building debris layer seen at a higher level.

Photo. 2: Probable 19th century grave cut revealed in Drainage cut on south end of church.
