**NORTH WEST WALES DENDROCHRONOLOGY PROJECT 2009-2012**  
**PROSIECT DENDROCHRONOLEG GOGLEDD ORLLEWIN CYMRU**

**Cwm Farm, Cwm Cynfal, Ffestiniog, Gwynedd**

**ARCHITECTURAL RECORD /COFNOD PENSARNIOL**

### Building Record

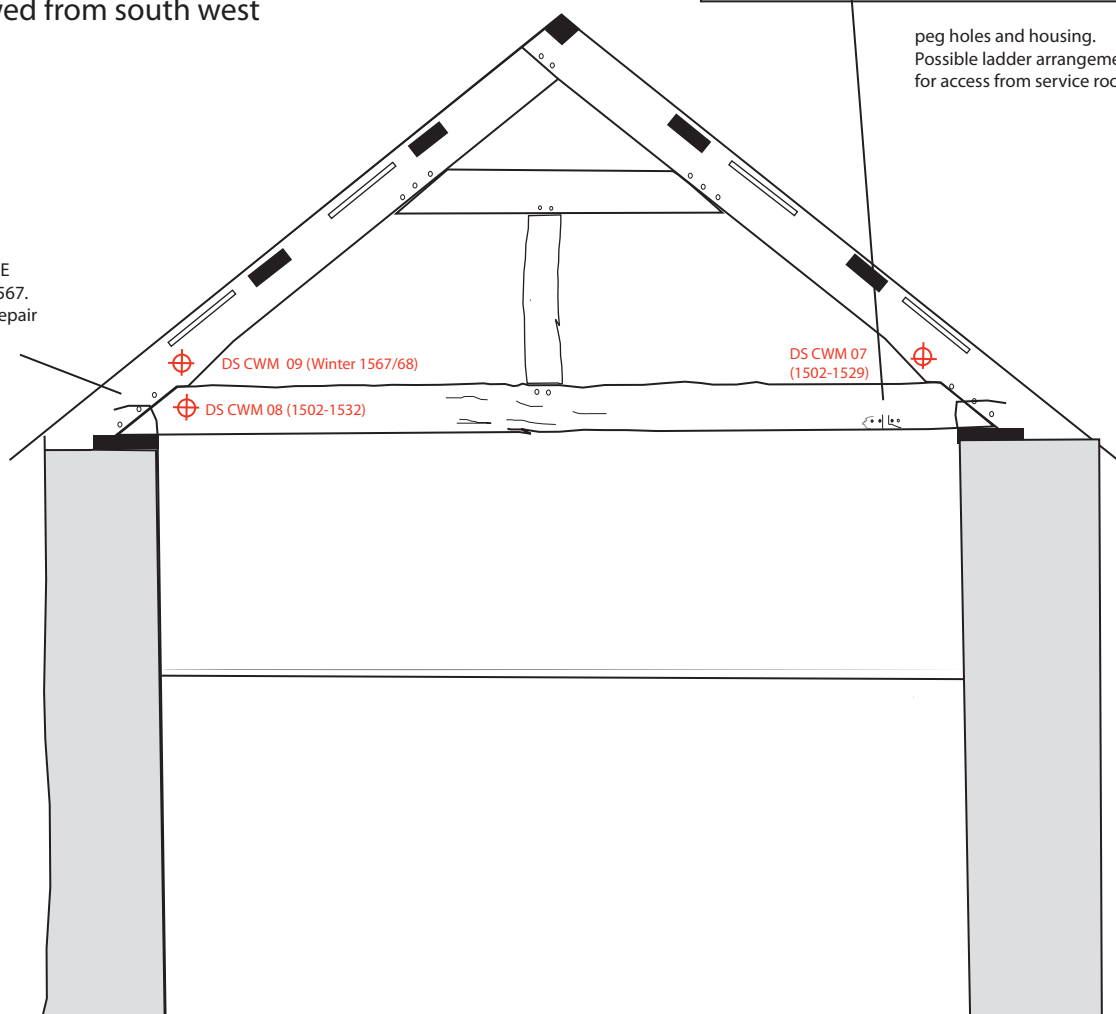
Figure 7 CC - Truss 3 [T3]  
Cwm Farm, Cwm Cynfal, Ffestiniog, Gwynedd

- 6.1.5 A repair to the roof is suggested by the erosion of timbers at the south- west end where there is clear evidence of rafters being moved and this is confirmed by the 1567 principal rafter NW being inserted, most likely as a repair. It is not clear if the first floor was completely separated by the secondary masonry attached to the chimney stack, but since opened to allow access to [FF7]. Certainly, the 'service end' of the building appears to have been relegated to a non-domestic ancillary use because of this until recently. The owner recalls a former occupant relating that animals were kept in this separated end of the building end, amongst other uses, during the 20thC. At some time a door was let into the front façade, to the left of the main door. This created a lobby entry, which remained until recently.

Truss 3 viewing northwards  
collar, king strut & tie beam.  
Evidence of quite severe weather  
erosion with PR west replaced c1567.

Principal rafter E  
dated winter 1567.  
Replacement/repair

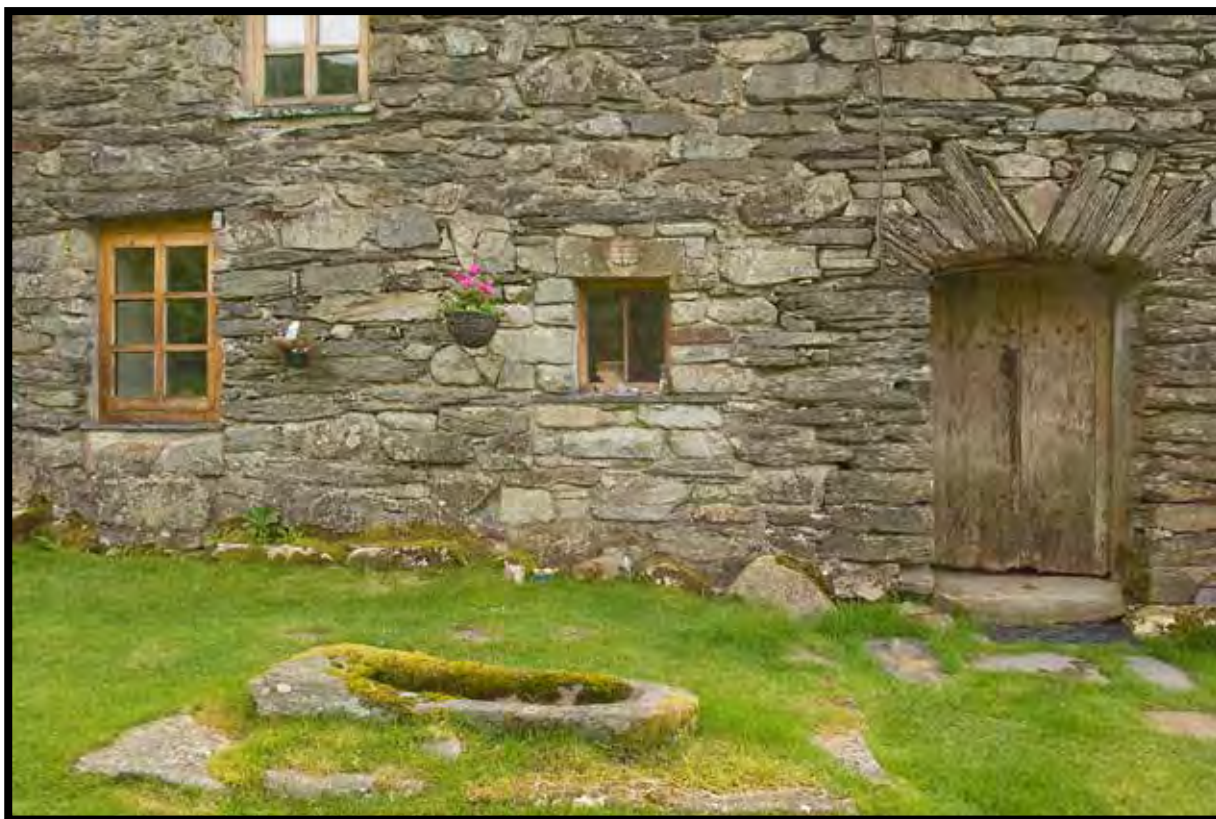
Plate 3: Window alterations

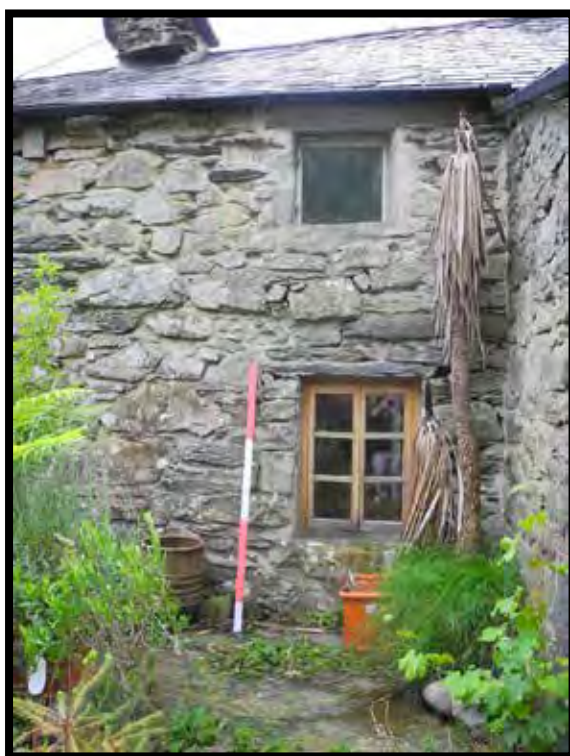
To the right are a ground floor window that lights the hall. The masonry has clearly been altered and reduced in size. (plate 09) Above this a small metal casement window has been inserted into the wall to eave level at a later date. Disturbed masonry and lintel of re-used timber. A small outshut with pitched roof has been added to the south-east corner of the building. A lean to single storey extension was added to the NE gable in the 19<sup>th</sup>C. This partially obscures the external chimney. Above the roof of this outshut are two small windows, original phase, either side of the chimney breast with modern oak casements (Plate 7)

Plate 9: Hall & 1<sup>st</sup> Fl window, rear elevation; first floor window

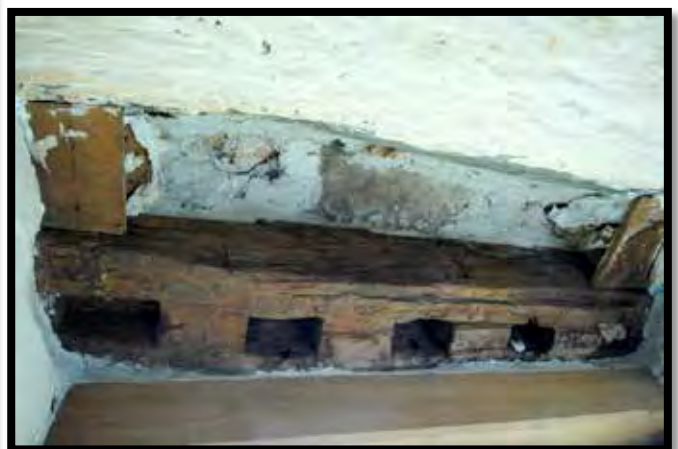
- 4.2.2 Room [GF3] (Plate 11) occupies the hall as floored over with inserted chimney. It is lit by two windows on NW wall. The northernmost with oak lintel (Plate 10) still exposed with mortises to house five mullions now gone. Modern oak casement windows now in situ. Opposite, on southern wall, is a further oak casement. Masonry changes on exterior show window reduced or altered at some time. (Plate 9)
- A fine dais partition to north-eastern end of room in almost complete condition. (Plate 12) (figures 8,9). It is not fixed to the wall at either end and does not retain outer doorposts but clearly had them. It has two shallow round arches formed out of the head beam at either end

Plate 10: Mullion lintel in hall window

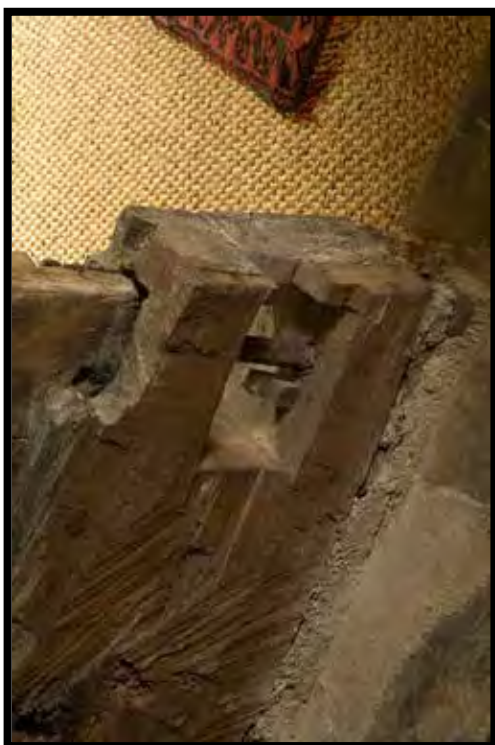
and is fitted with 6 posts and 5 planks/panels. The cill has been crudely truncated at the bottom (Plate 13-16) of the inner door posts of the screen to afford a more convenient circulation. The partition posts are decorated with a plain stopped chamfer while the head beam also has a chamfer interrupted by 'nailhead' bosses. (Plate 16) The head beam and the joists that formerly sat in the housings cut out of the top of the head beam do not now meet, being raised approximately 110mm to sit on later inserted pine beam.) These joists were originally pegged into the head beam and sailed on to meet the bottom of the partition that travelled down from the truss [T1] directly above. This formed a canopy of around 380mm. (Plate 17) A bench was fixed to the partition and is clearly indicated by an arrangement of mortises. The partition has been moved back slightly. The joists over the partitions are now seated into a large, pine beam, squared and chamfered. This beam also supports the widely spaced and rather crude joists of the later floor that divided hall into ground and first floor spaces, running from this beam to the inserted chimney stack.

Plate 15: Truncated cill

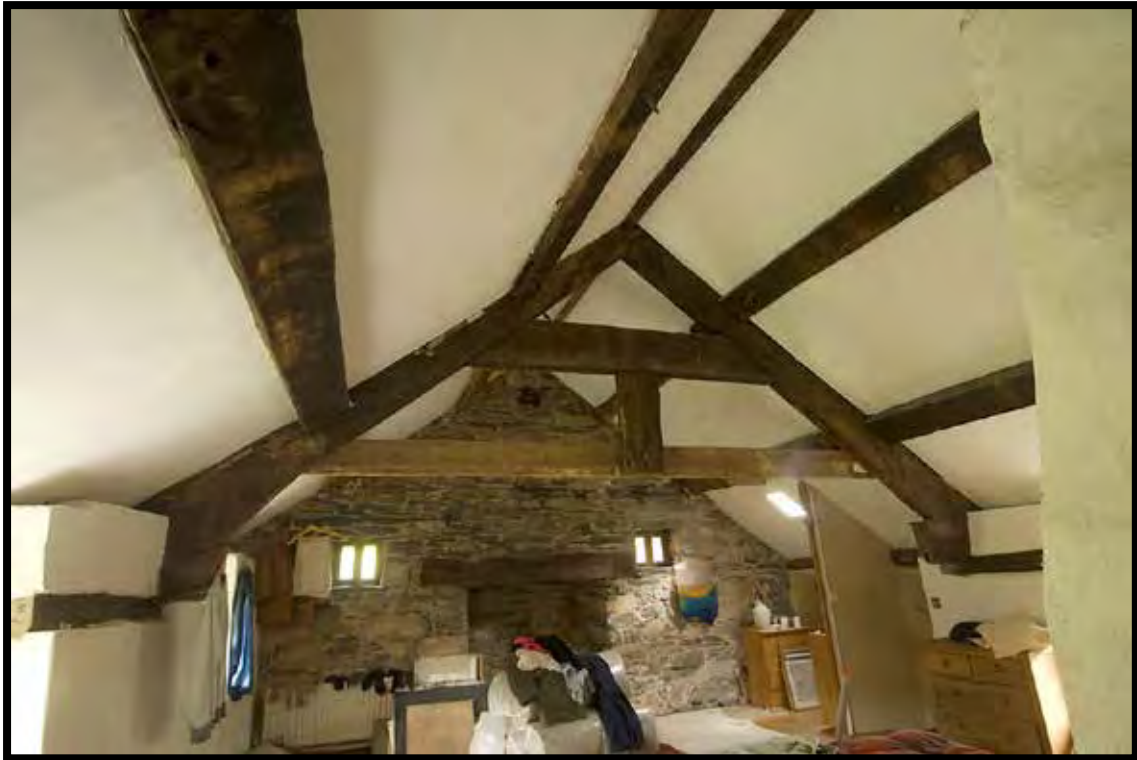
- 4.3.2 Truss [T1] displays holes and grooves for staves and wattle that formed a closed truss within the A frame and a continuous mortise slot underneath the tie-beam for a partition below, possibly boarded rather than wattle and daub or a mixture of post and wattle. This truss has been severely truncated leaving just a stump of the tie-beam at either end. A portion of the post dropping from collar to tie beam was removed at the same time. A softwood, tie beam has been attached with bolts at a higher level to afford a more convenient circulation

Plate 19: Truss 1. Lost tie beam to collar, post and tie beam truss.

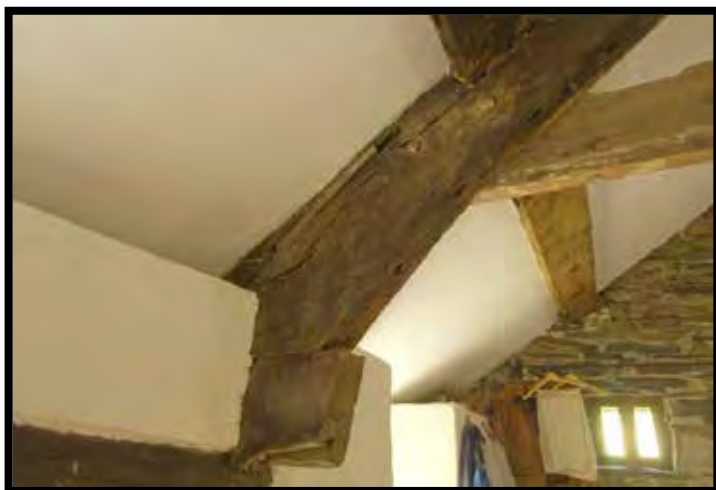
Plate 22: T1 – truncated tie beam

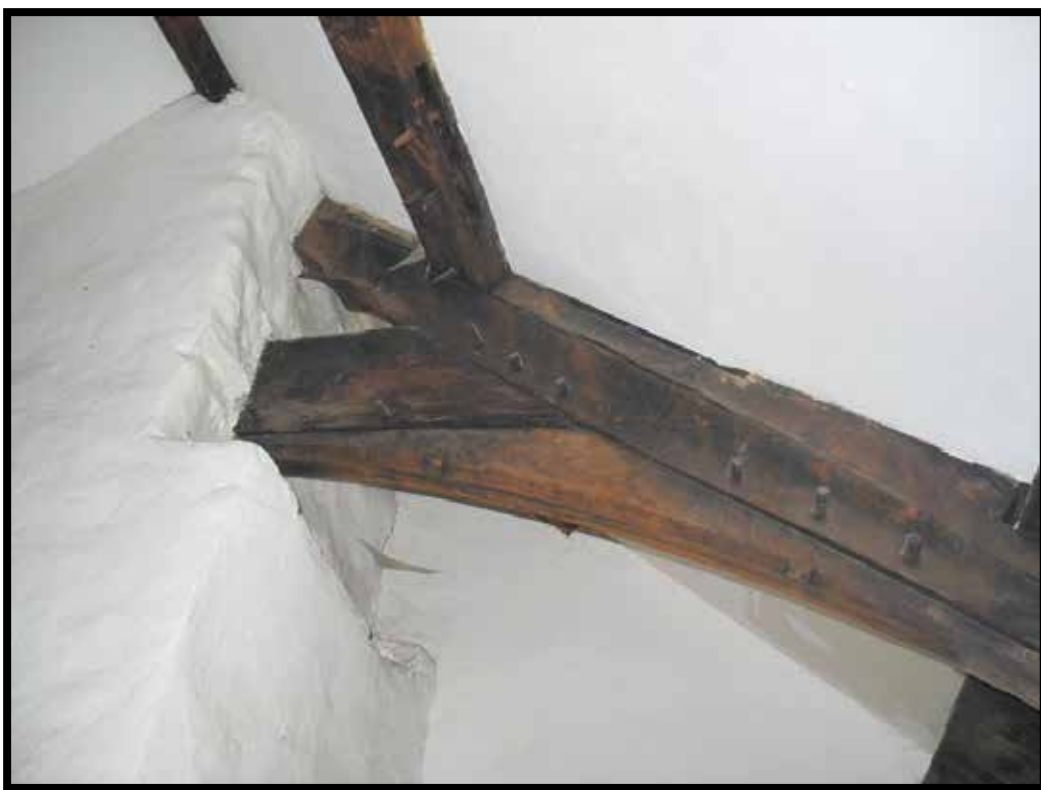
Plate 25: T2W: Pegs, wind brace mortise; smoke black

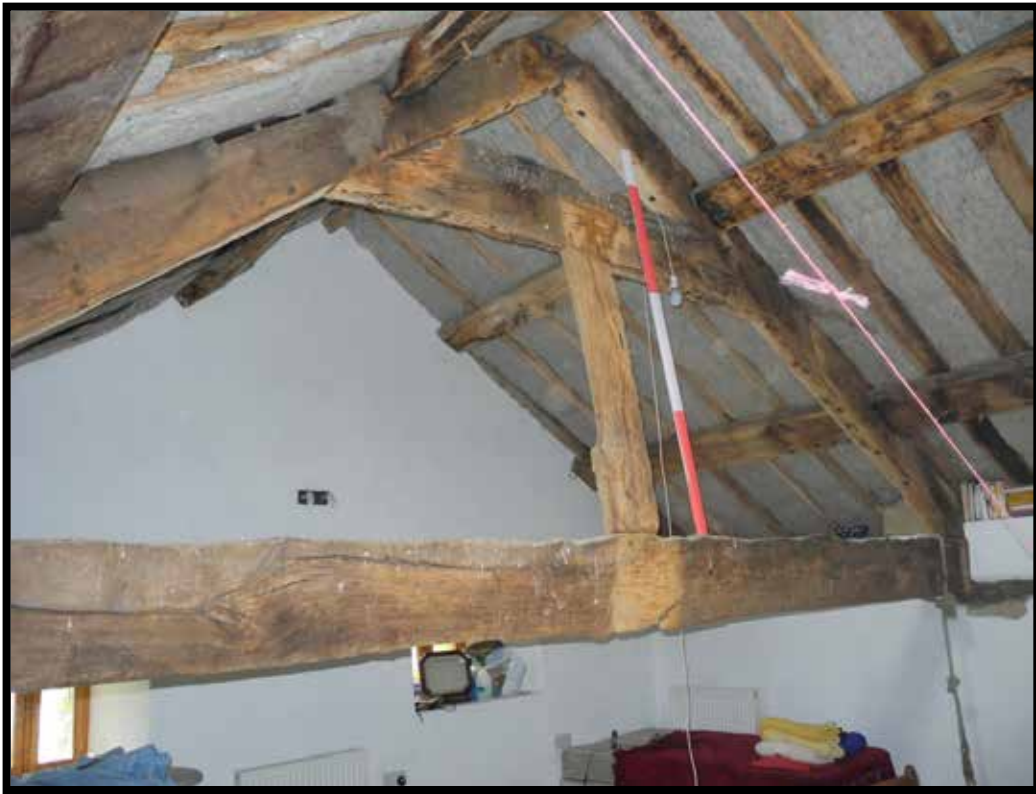
Plate 28: T3: From NE

- 4.3.6 Room [FF7] has truss [T3]. Similar to [T1], with collar, post and tie beam but showing considerable signs of wear/ erosion and distortion. (Plates 28, 29) It is holed and grooved in the same way as [T1] for staves and wattle to form another closed screen to ground floor level. It is not clear whether a post and panel or a post and wattle screen dropped below the tie beam. The NW principal of [T3], has dated with dendrochronology, to a precise felling date of the winter of 1567/68. Given the context of the truss and rafters it is probable that this date is explained by a repair/replacement. The rafters have been removed and re-positioned with some replacements. Some rafters 127mm wide.

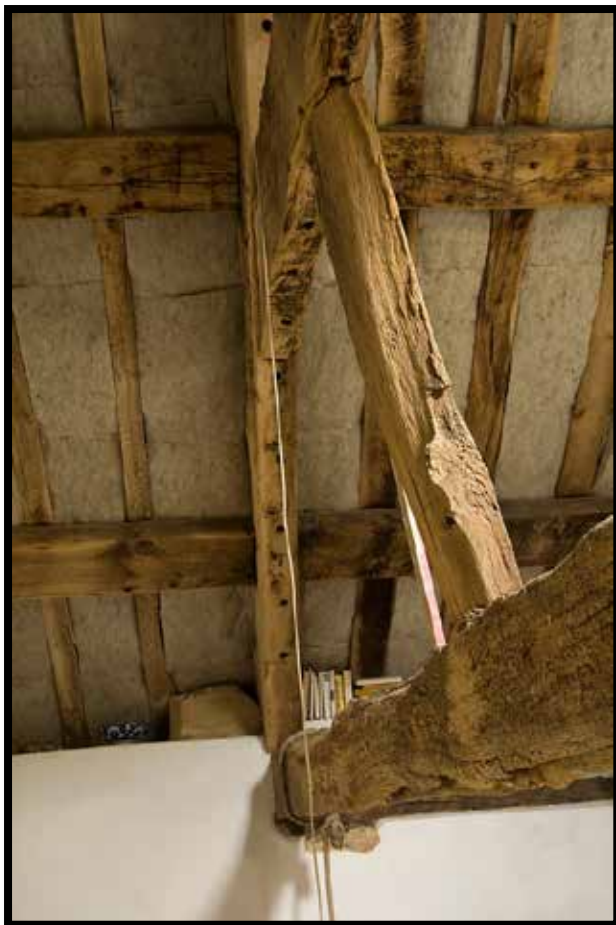
Plate 29: T3: truss showing erosion, stave holes

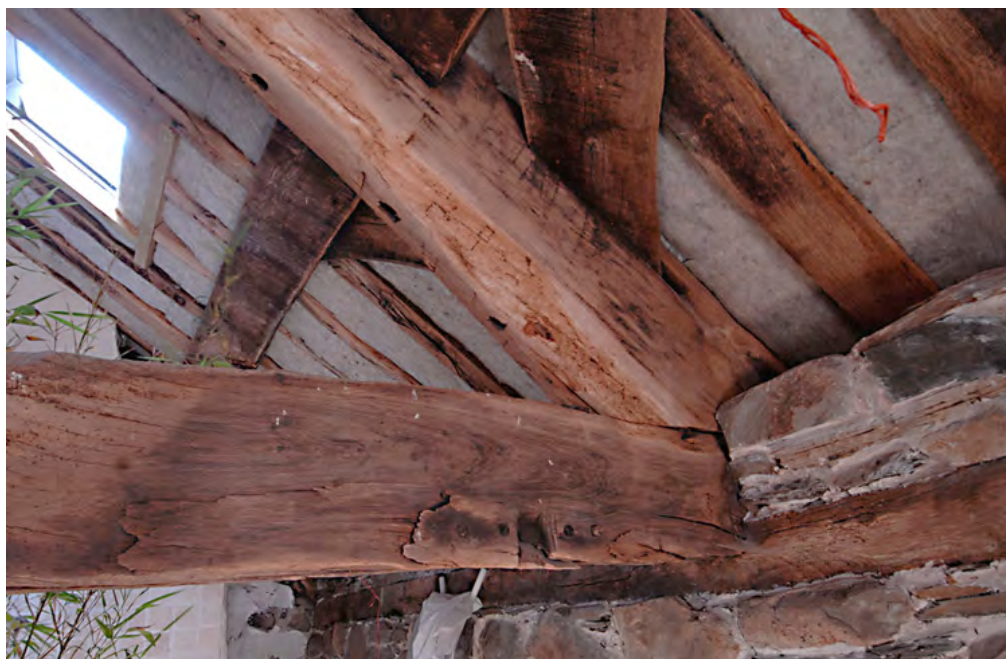
- 4.3.8 The evidence of the mortises for wind bracing both on principals and purlins indicate that every truss was wind braced on both sides. Those that were visible from the hall were cusped while the two that exist on the service side of [T3] have only a plain board. (Plate 30, 33) This may be later. Remnants of the wind brace tenons remain in several of the mortises throughout the roof. On T3 SW side is a curious set of peg holes and rough housing (Plates 31,32) (figure 7).

Plate 31: T3: base of principal and tie-beam; housing & peg holes?

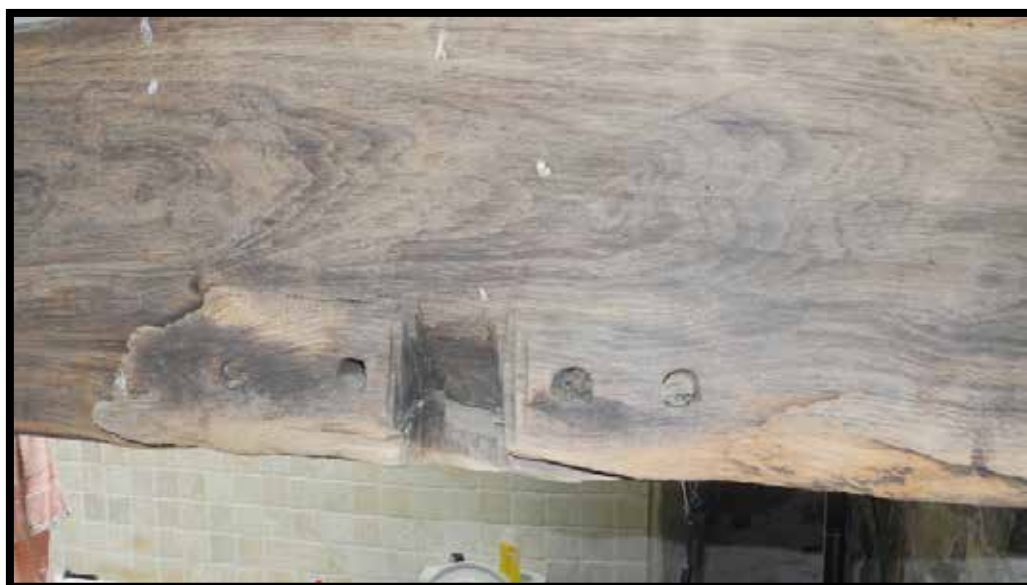
Plate 32: T3: base of principal and tie-beam; housing & peg holes –close-up
