Paine & Stewart

**Gwydyr Uchaf Chapel, Llanrwst, North Wales:
Treatment of the painted decoration**

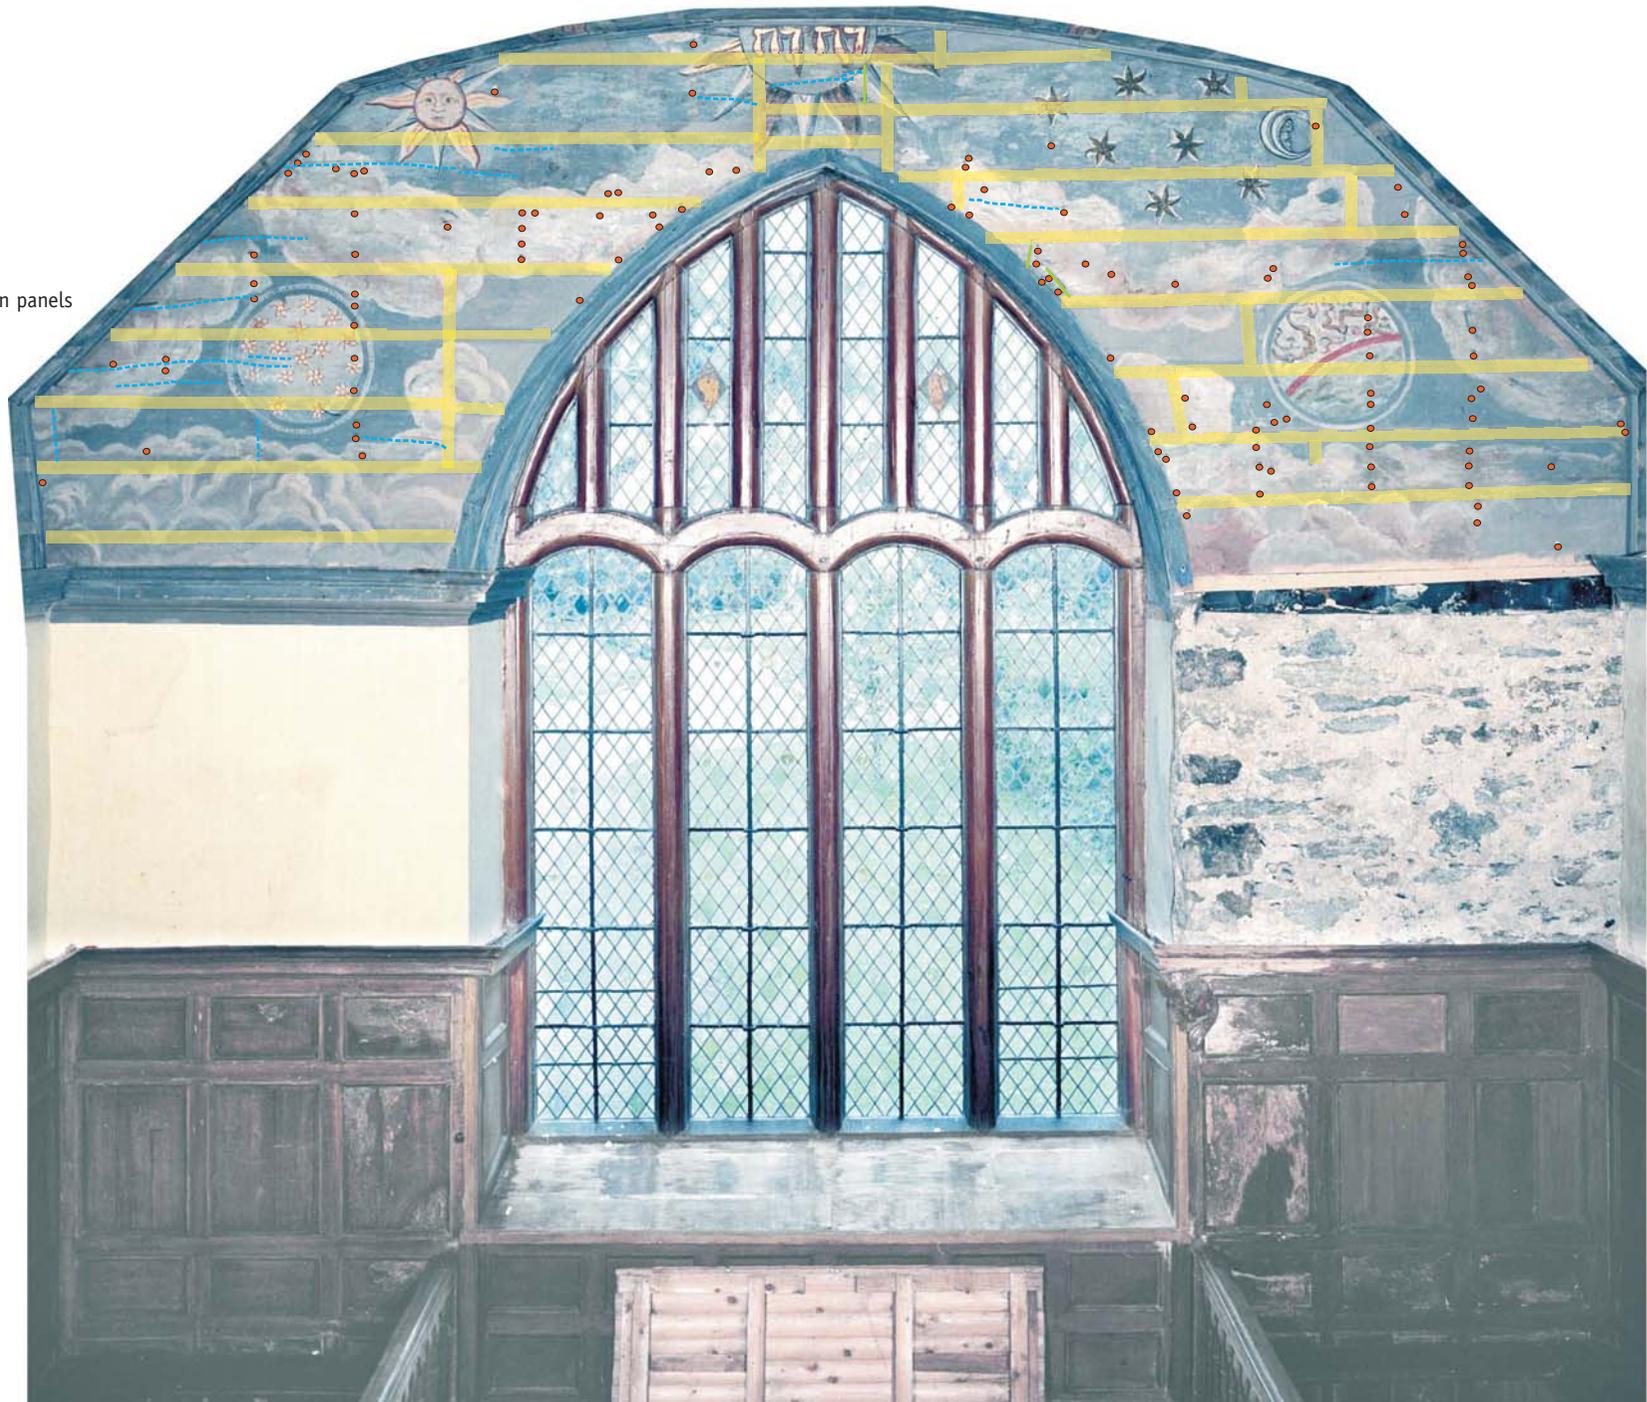
Figure 2: overall photograph of the east wall decoration, showing aspects of condition

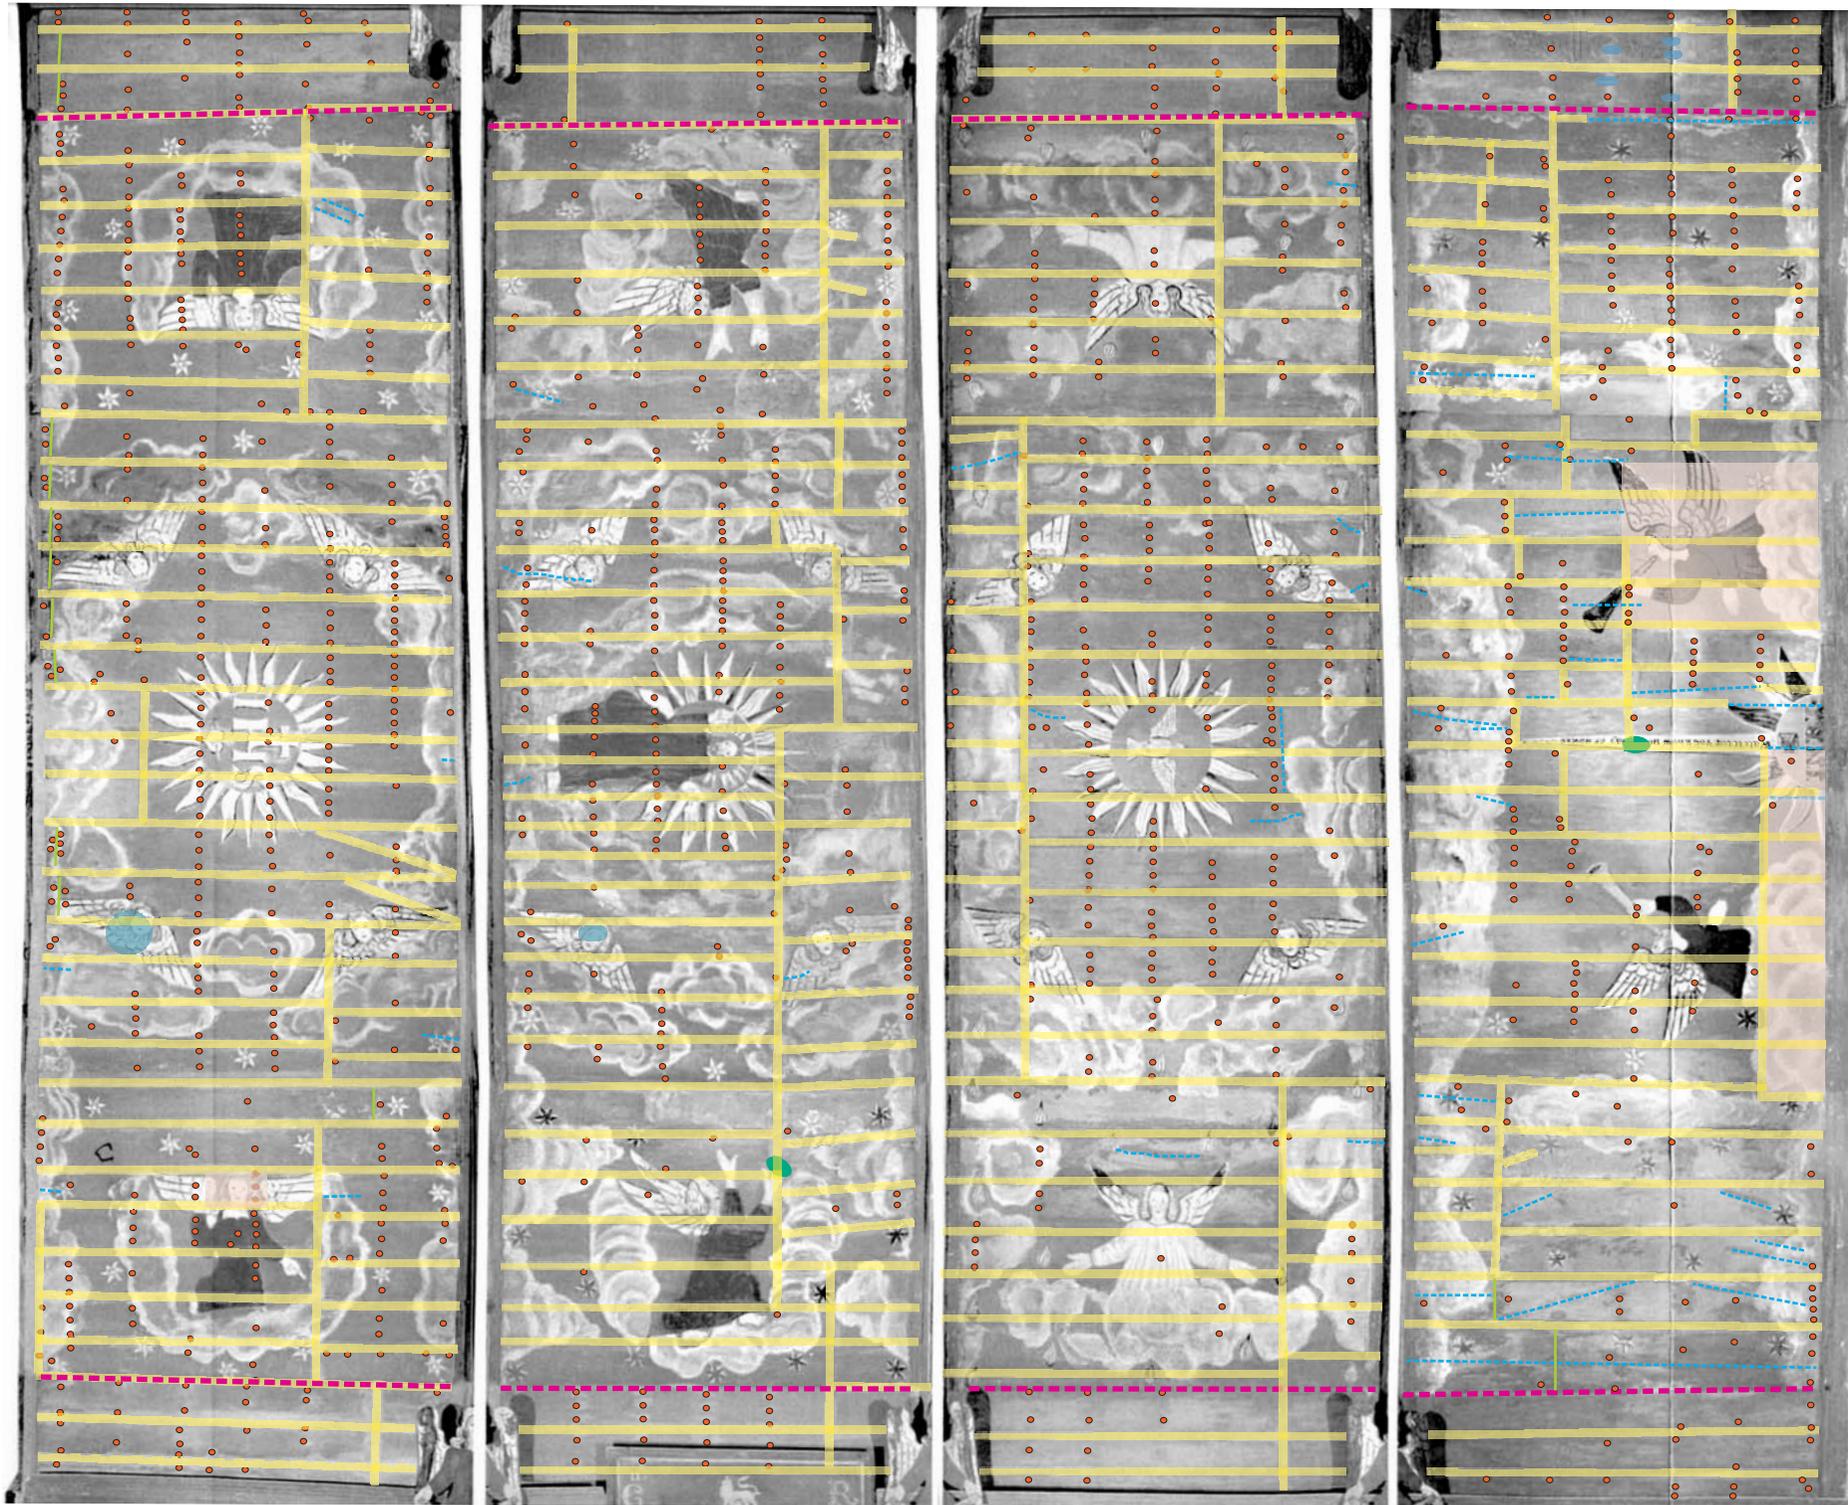
Figure 2. The ceiling, showing a range of condition phenomena

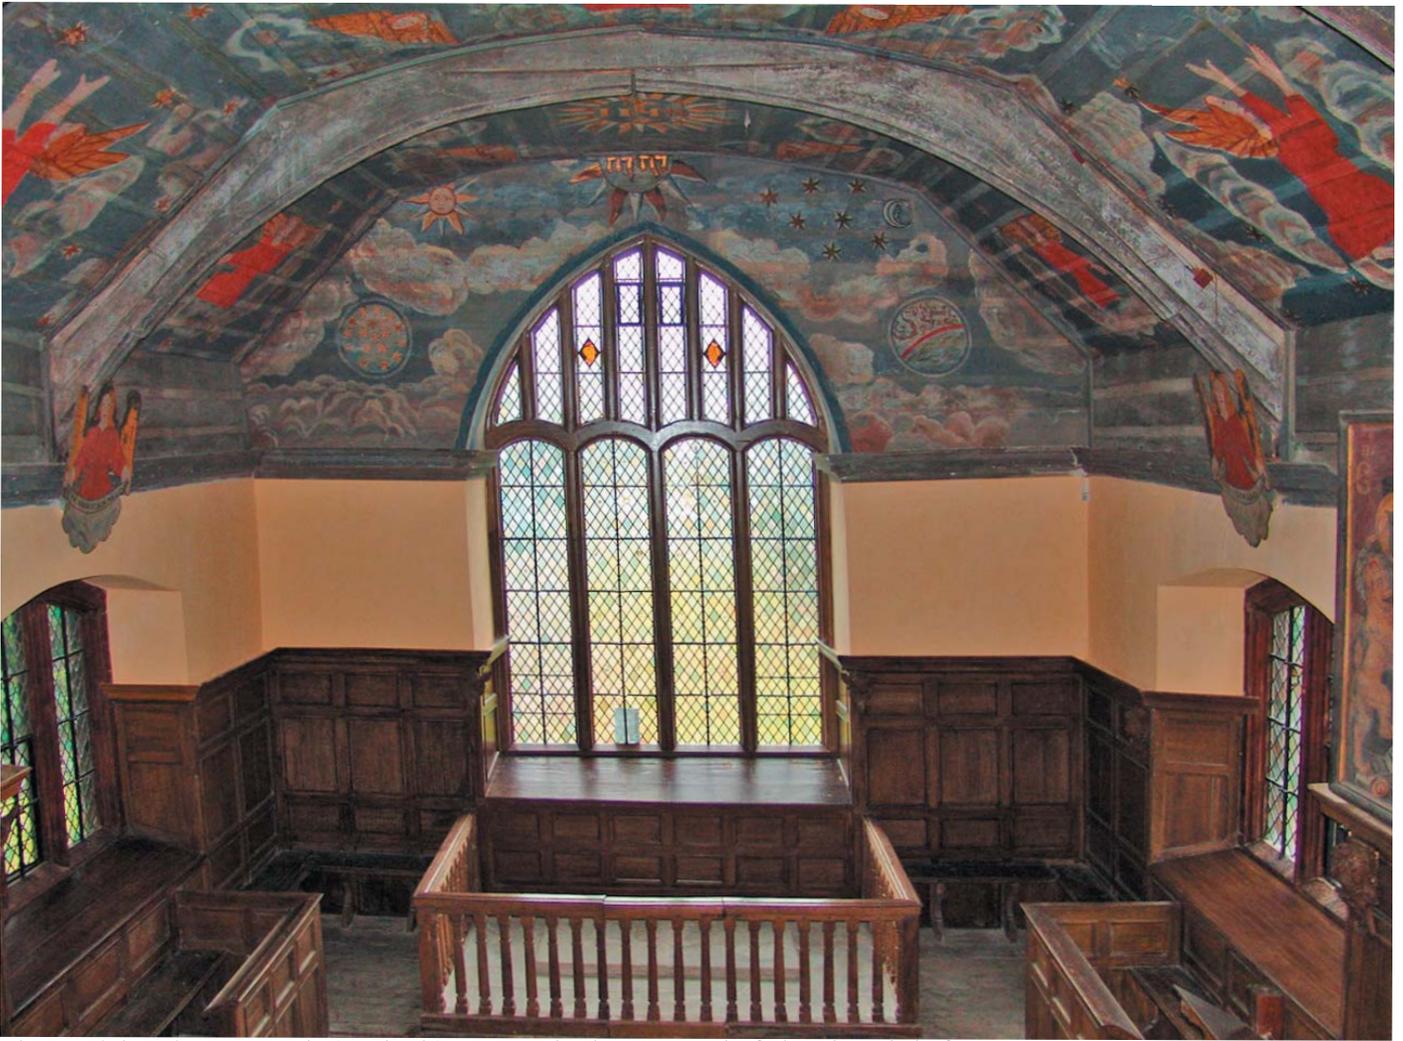
Plate 1 (above). A general view looking towards the east end of the chapel, before conservation. (Photo: Paine and Stewart 2006)

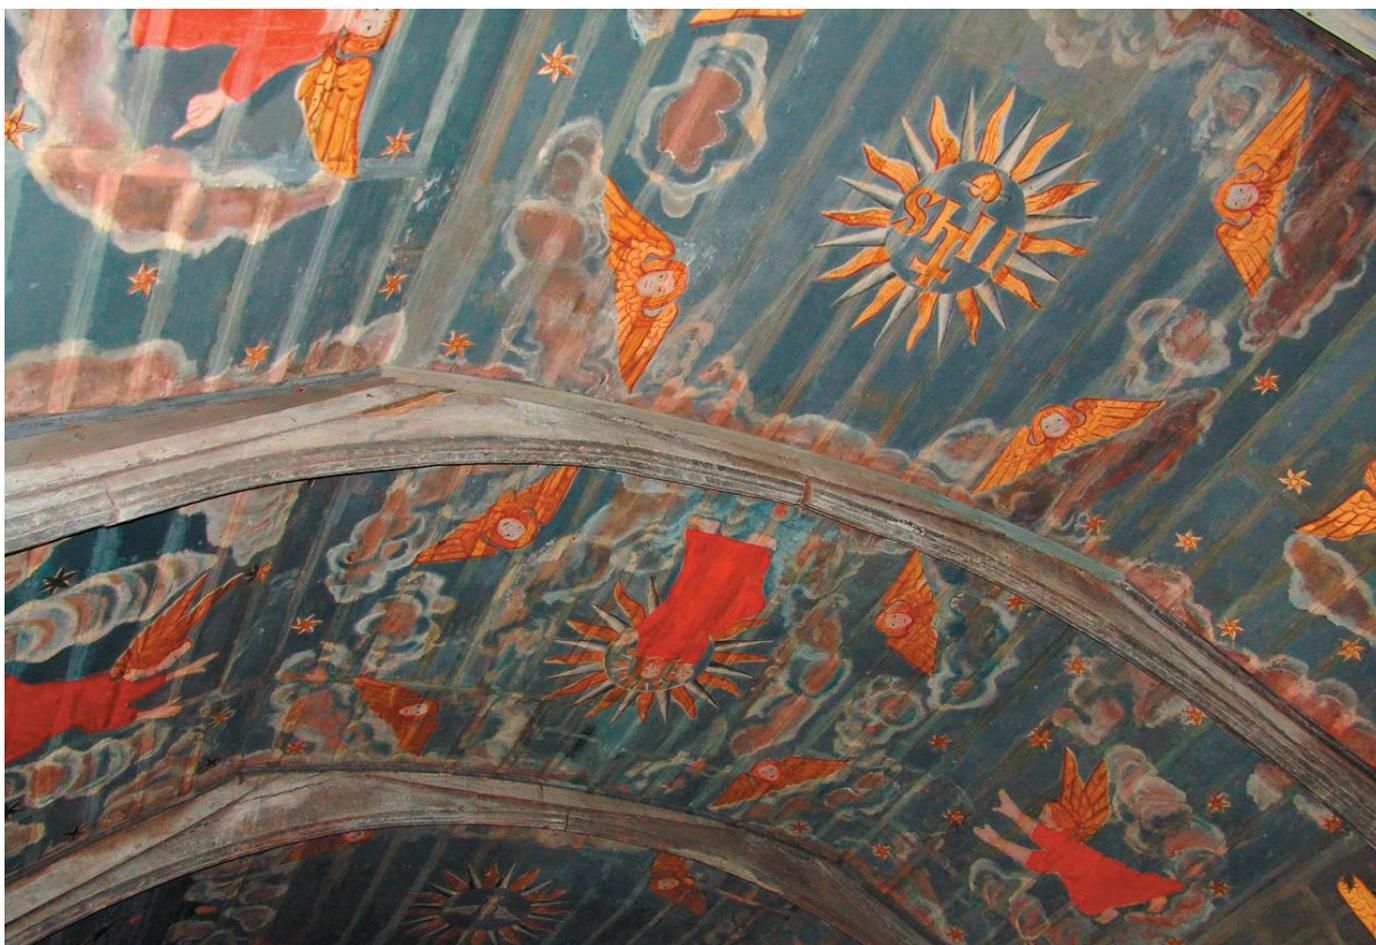
Plate 4 (above). General view of the ceiling, showing condition before conservation and cleaning. (Photo: Paine and Stewart 2006)

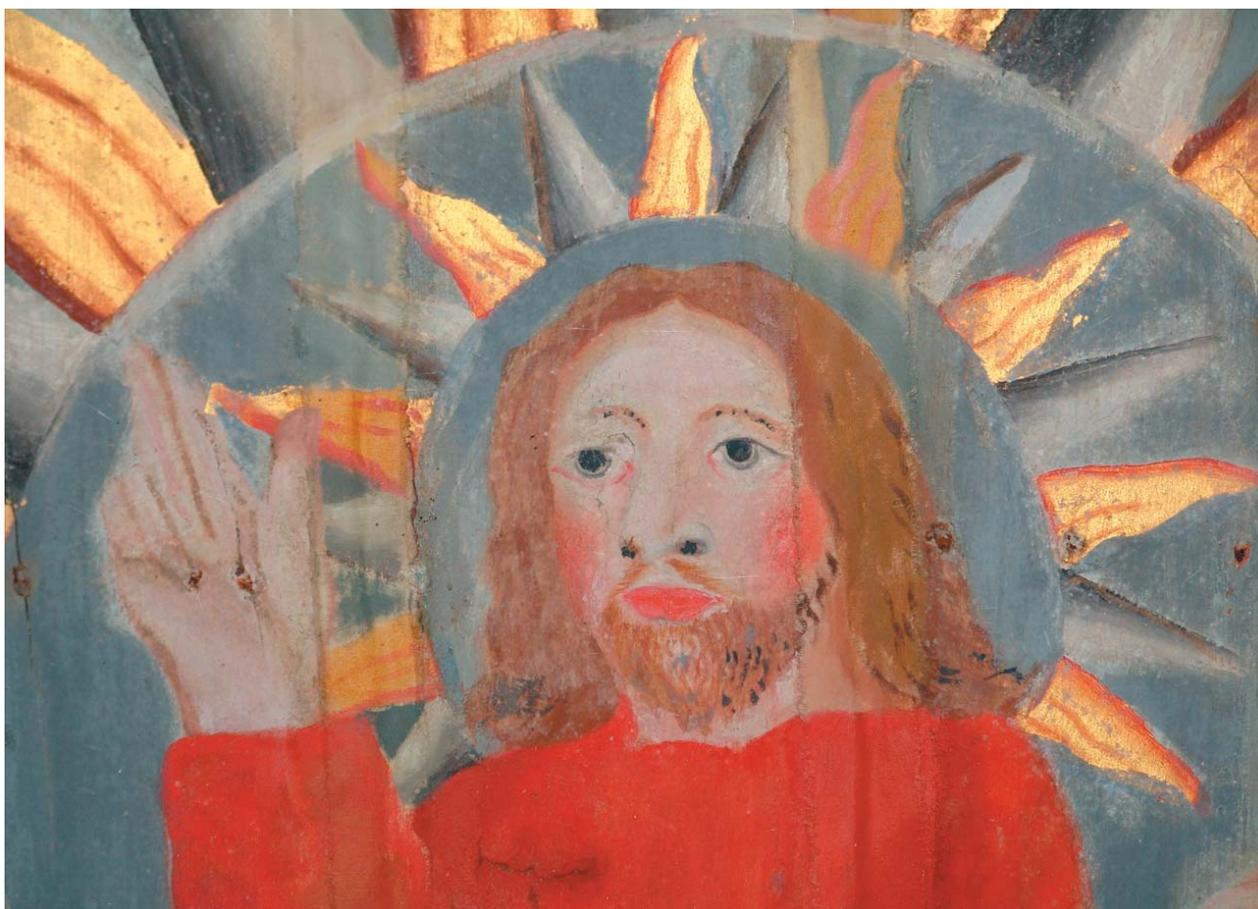
Plate 5 (below). Detail of the Christ figure, before conservation, showing the extent of past restorations; applied strips of canvas, added grey/blue painted background and rusting nails predominate. (Photo: Paine and Stewart 2006)

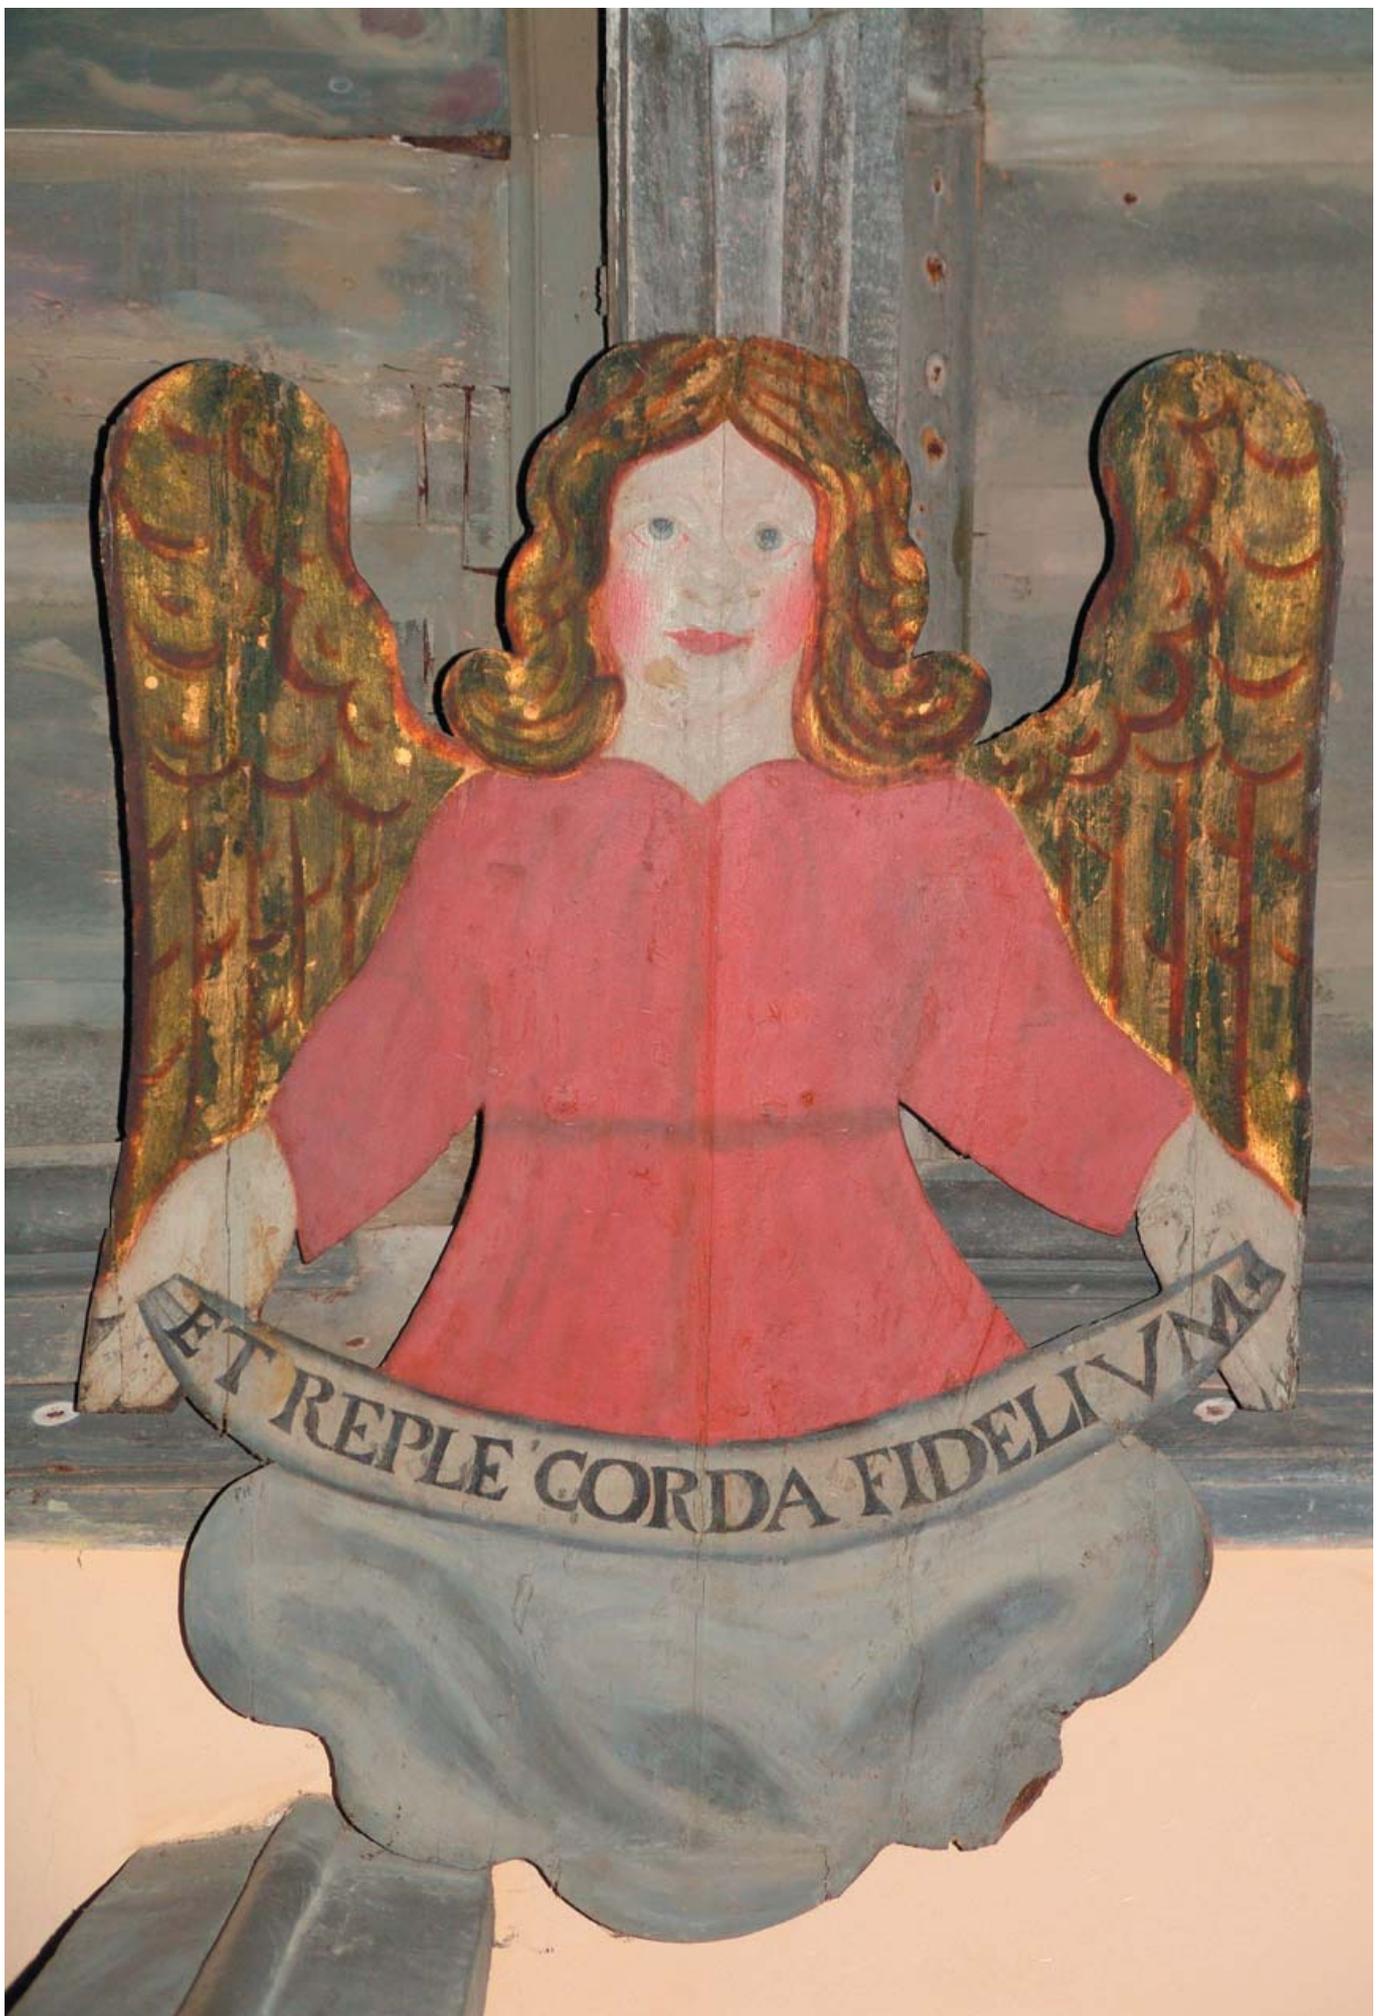
Plate 6 (above). At the base of each roof truss there are flat wooden panels, cut and decorated to form angel figures, displaying Latin text banners. Photographed here before conservation and cleaning. (Photo: Paine and Stewart 2006)

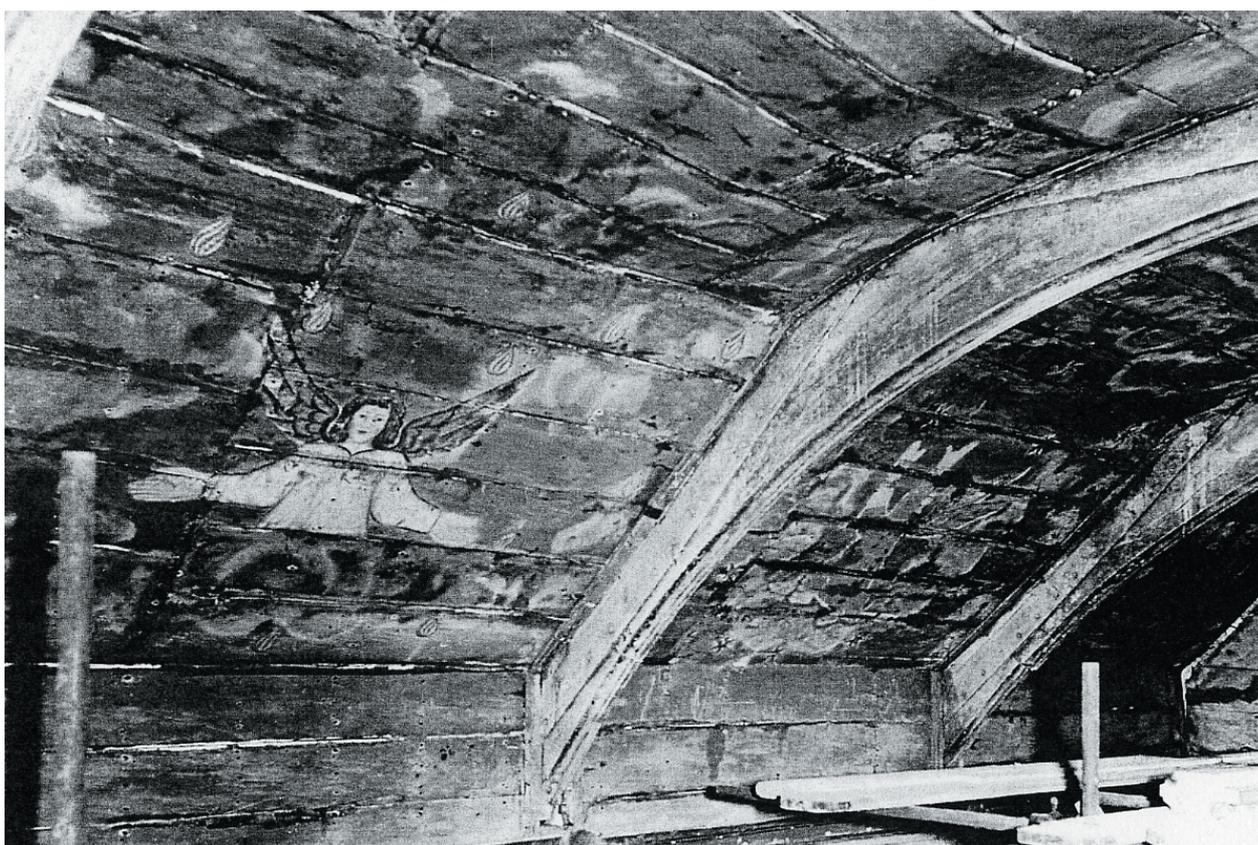
Plate 8 (below). Circa 1952, looking towards the southern side of the ceiling. (Photo: CADW)

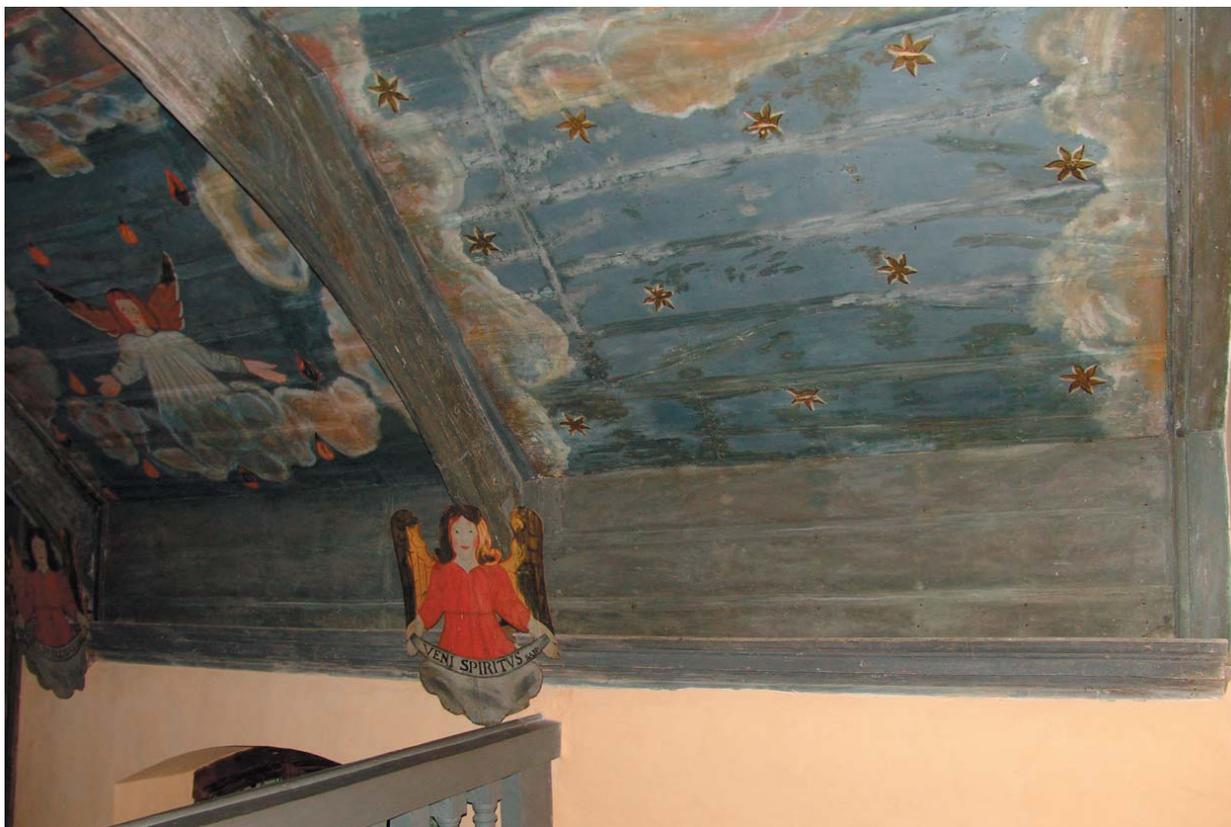
Plate 9 (above). The short lengths of planks (typically around 2 metres in length) used to cover the ceiling can be noted. Also note the poorly applied restoration from the 1950s. (Photo: Paine and Stewart 2006)

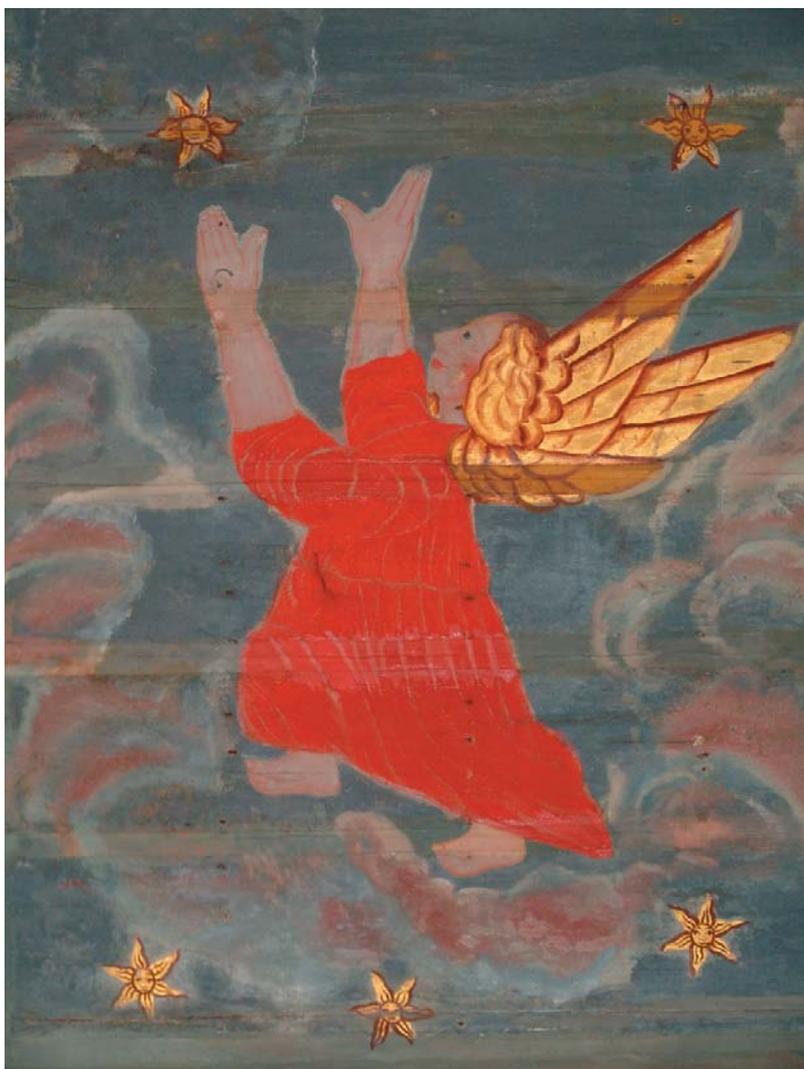
Plate 10 (below). Detail of the ceiling, before conservation, showing the nature of the support and aspects of original technique. (Photo: Paine and Stewart 2006)

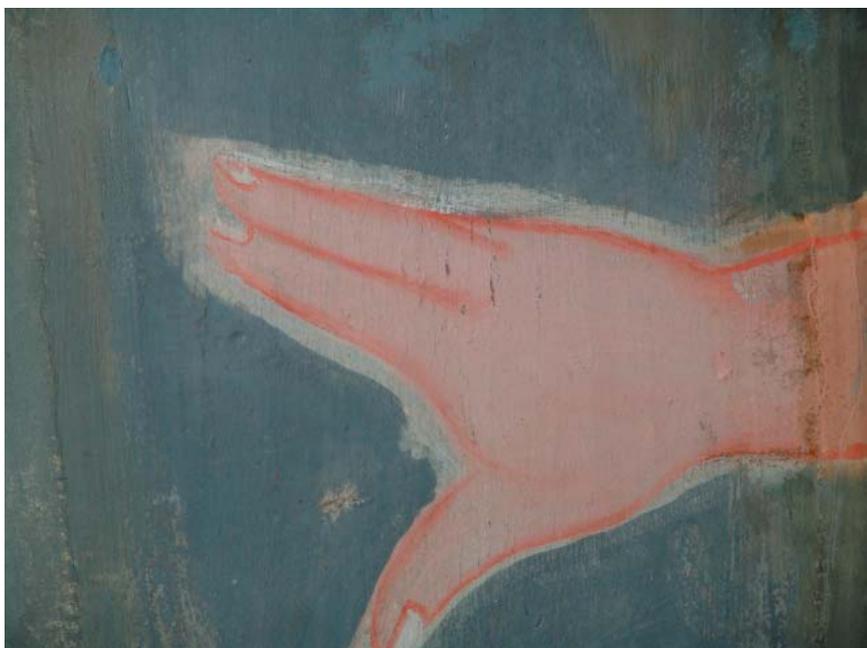
Plate 11 (above). Detail of a hand, which is quite competently painted. Note the in-painting of the darker blue background colour – this is part of the extensive (probably) 19th- century restoration. (Photo: Paine and Stewart 2006)

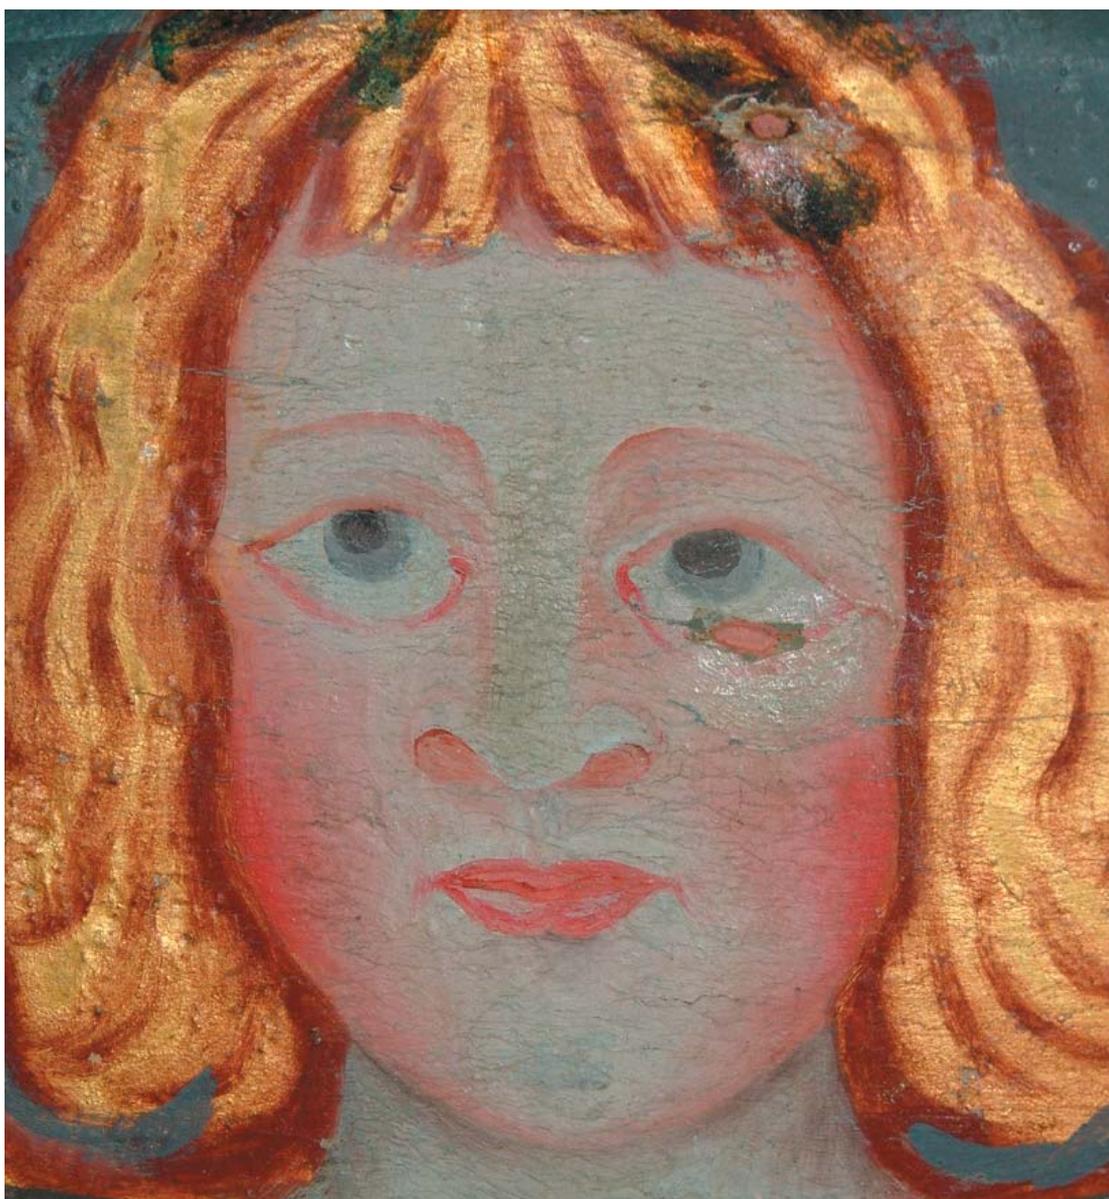
Plate 12 (below). The quality of the original painting can be clearly noted in this largely unrestored head of an angel. The emphasis of the lower eye lid is typical of all the figure drawing. (Photo: Paine and Stewart 2006)

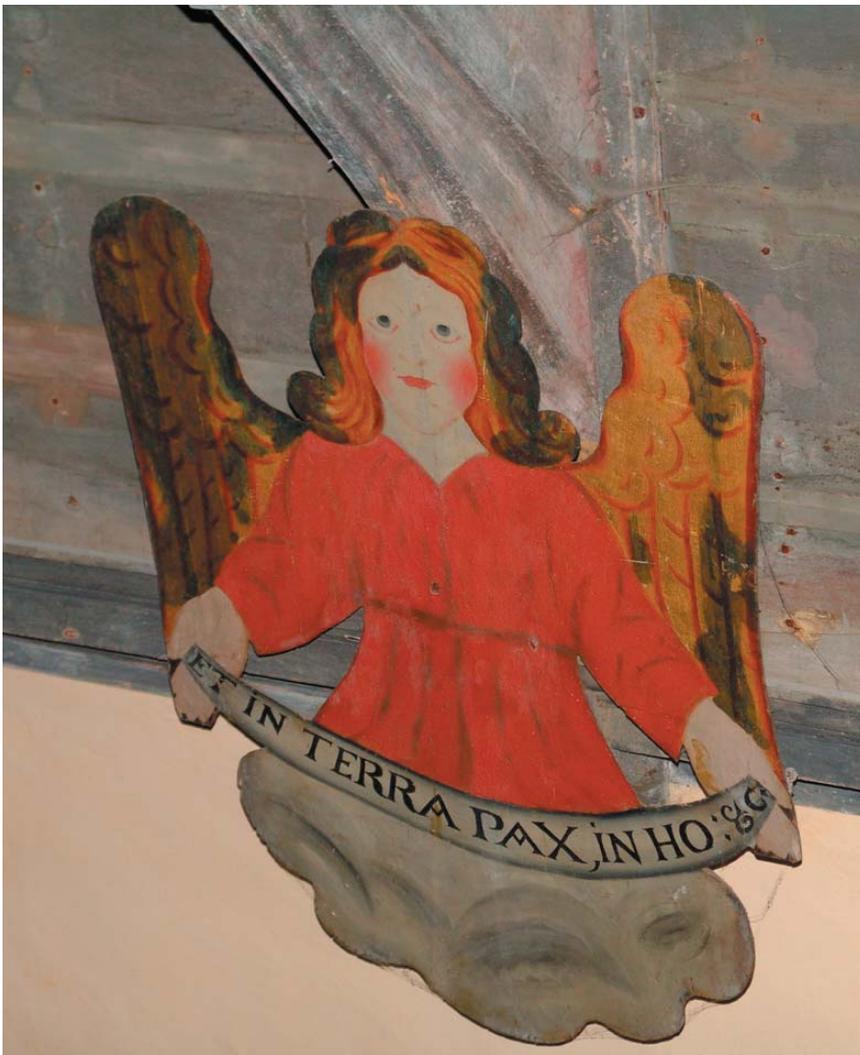
Plate 13 (left). There are 6 painted angel panels located at the springing of each of the roof trusses. (Photo: Paine and Stewart 2006)

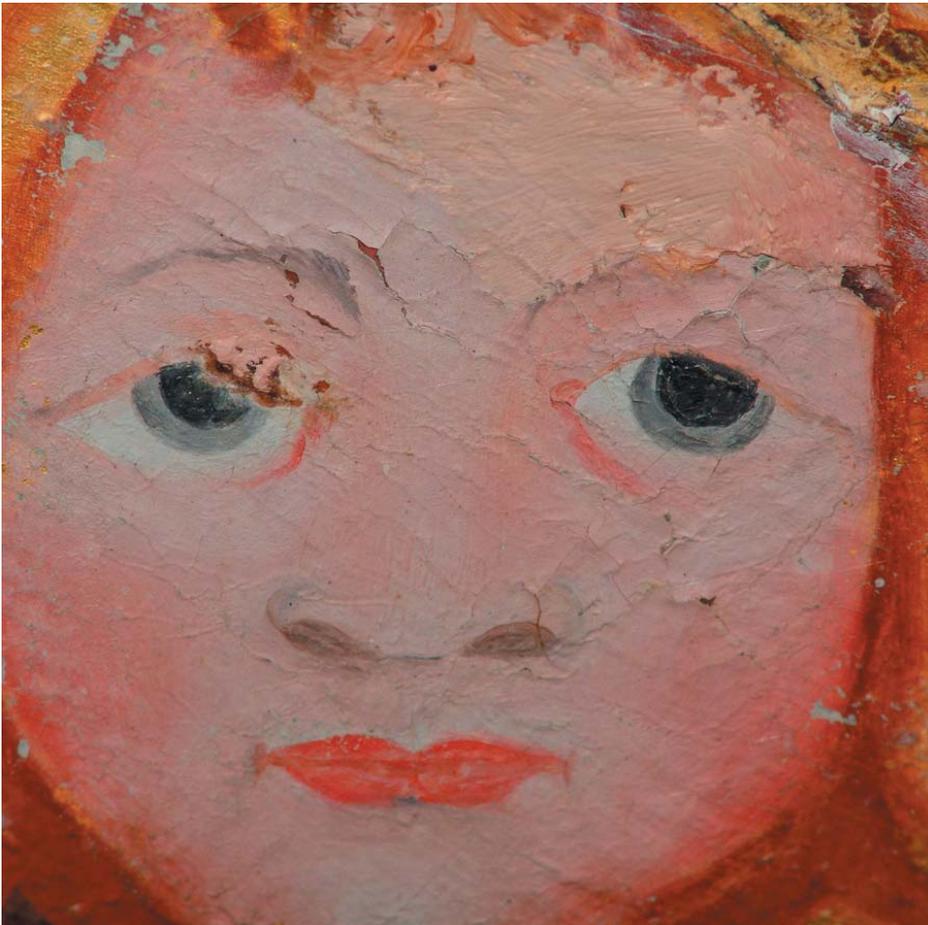
Plate 17 (below). Note the flaking of the paint layer, which appears to be largely original, other than some retouching within a part of the forehead. (Photo: Paine and Stewart 2006)

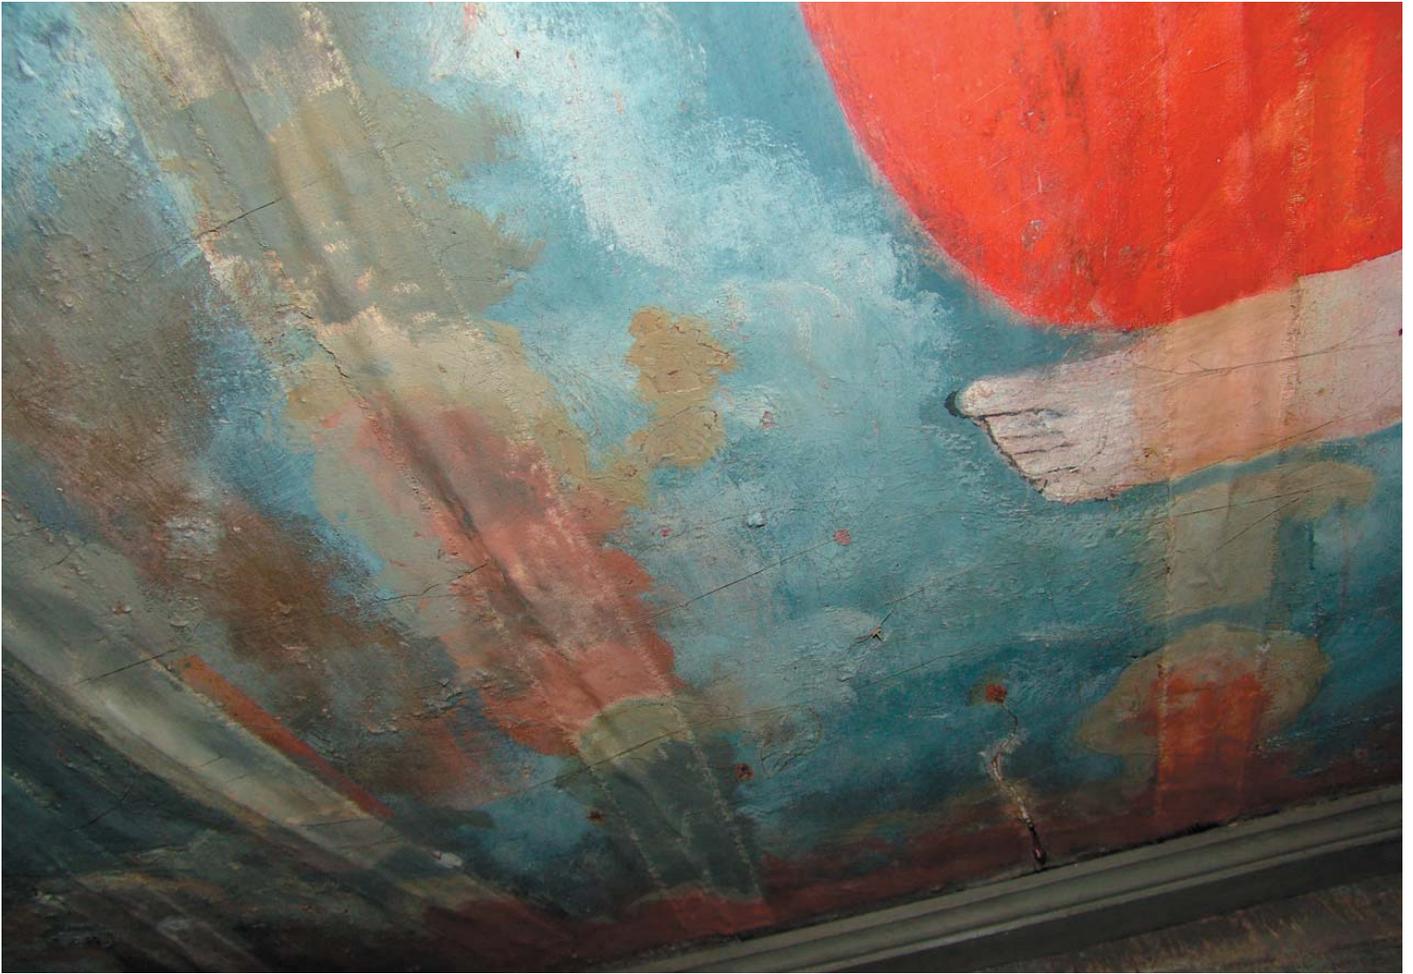
Plate 18 (above). Evidence for past restorations can be clearly noted here, specifically, canvas strips, over-painting and nails. (Photo: Paine and Stewart 2006)

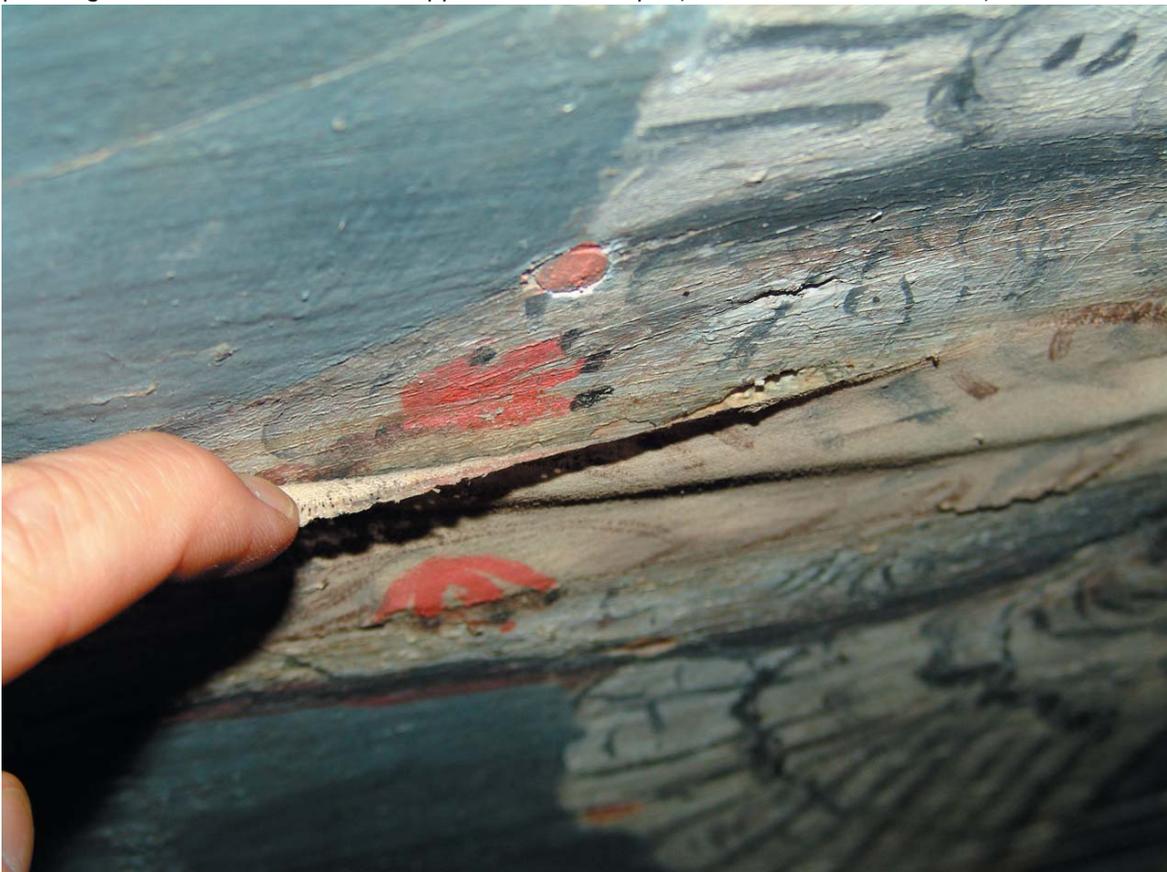
Plate 19 (below). A number of the canvas strips were found to be delaminating from the wooden support. Original painting can be seen beneath the applied canvas strip. (Photo: Paine and Stewart 2006)

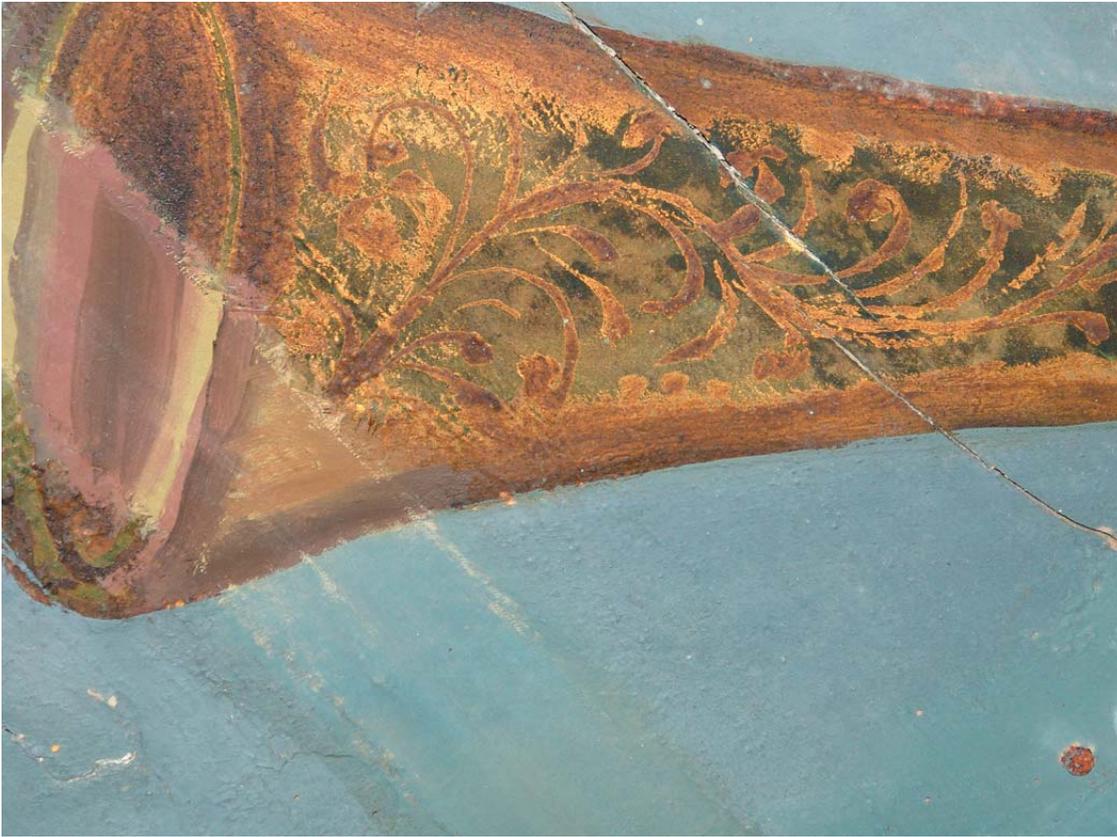
Plate 20 (above). The original painting of the angels trumpet contrasts markedly with the leaden quality of the 1950s restoration. It is details like this that would appear to contradict the claim made in 1800 that the ceiling paintings were “most miserably executed”. (Photo: Paine and Stewart 2006)

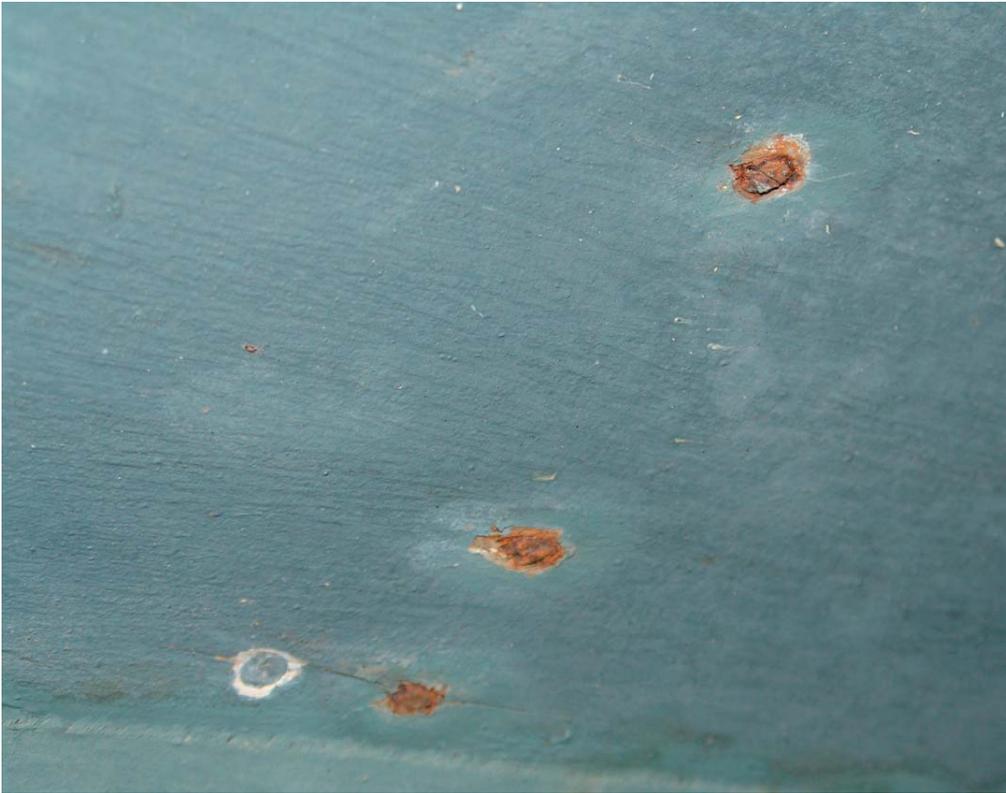
Plate 22 (above). Detail of nails here shown before treatment. (Photo: Paine and Stewart 2006)
