Paine & Stewart

**Gwydyr Uchaf Chapel, Llanrwst, North Wales:
Treatment of the painted decoration**

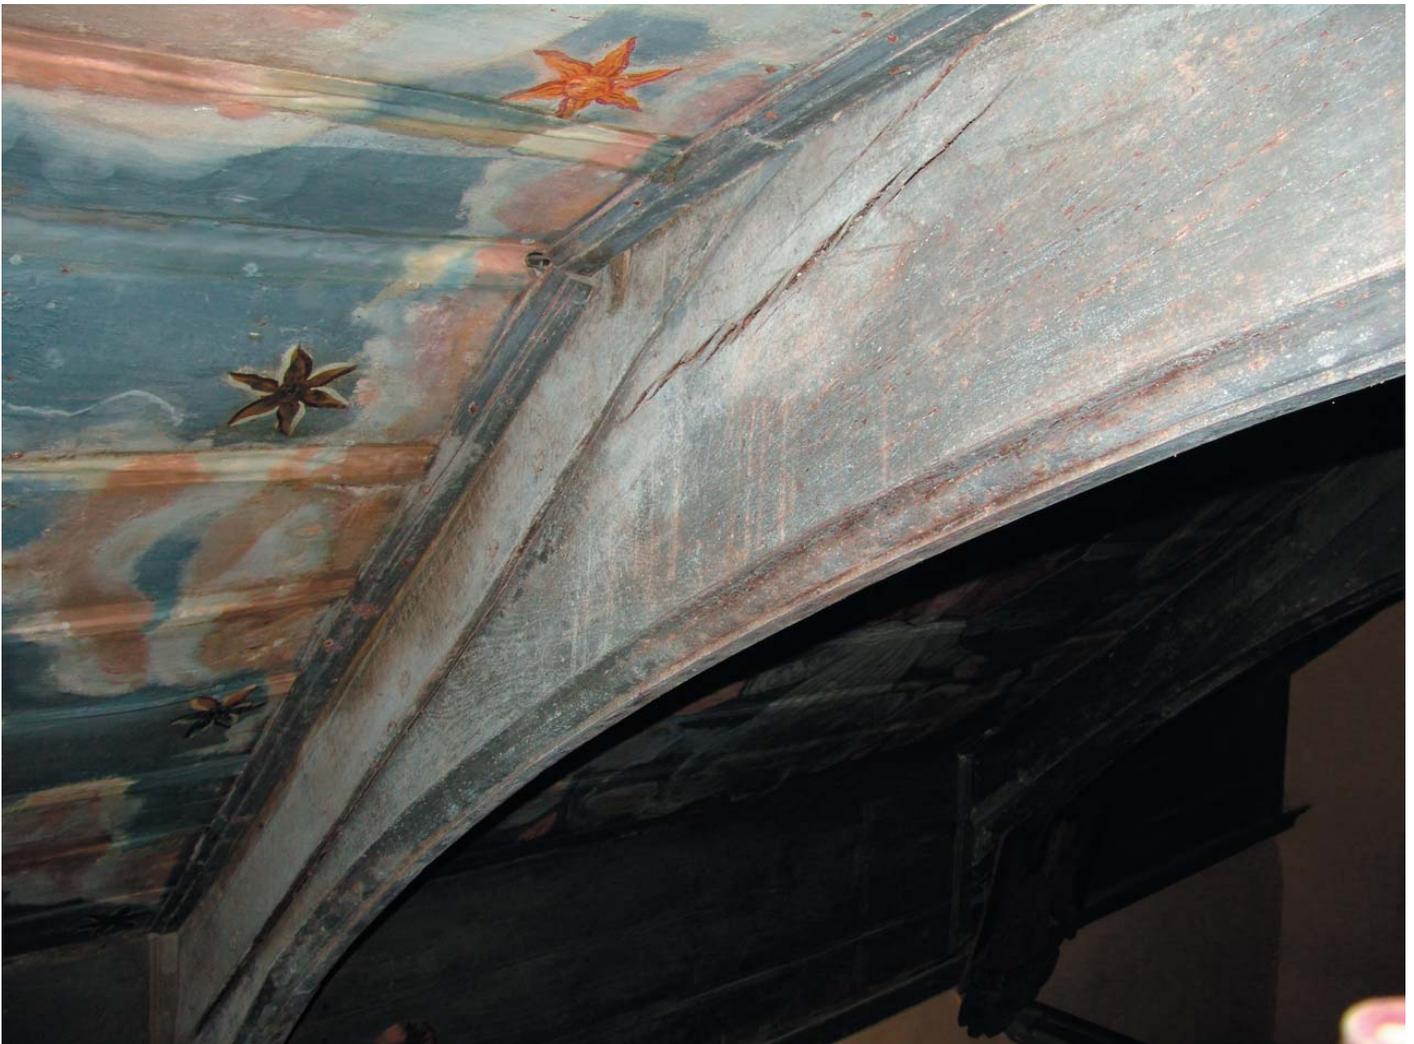
Plate 23 (below). There was much evidence for blanching within areas of the cross beams. The causes of this are unclear but may well be the consequence of the failure of a previously applied coating. (Photo: Paine and Stewart 2006)

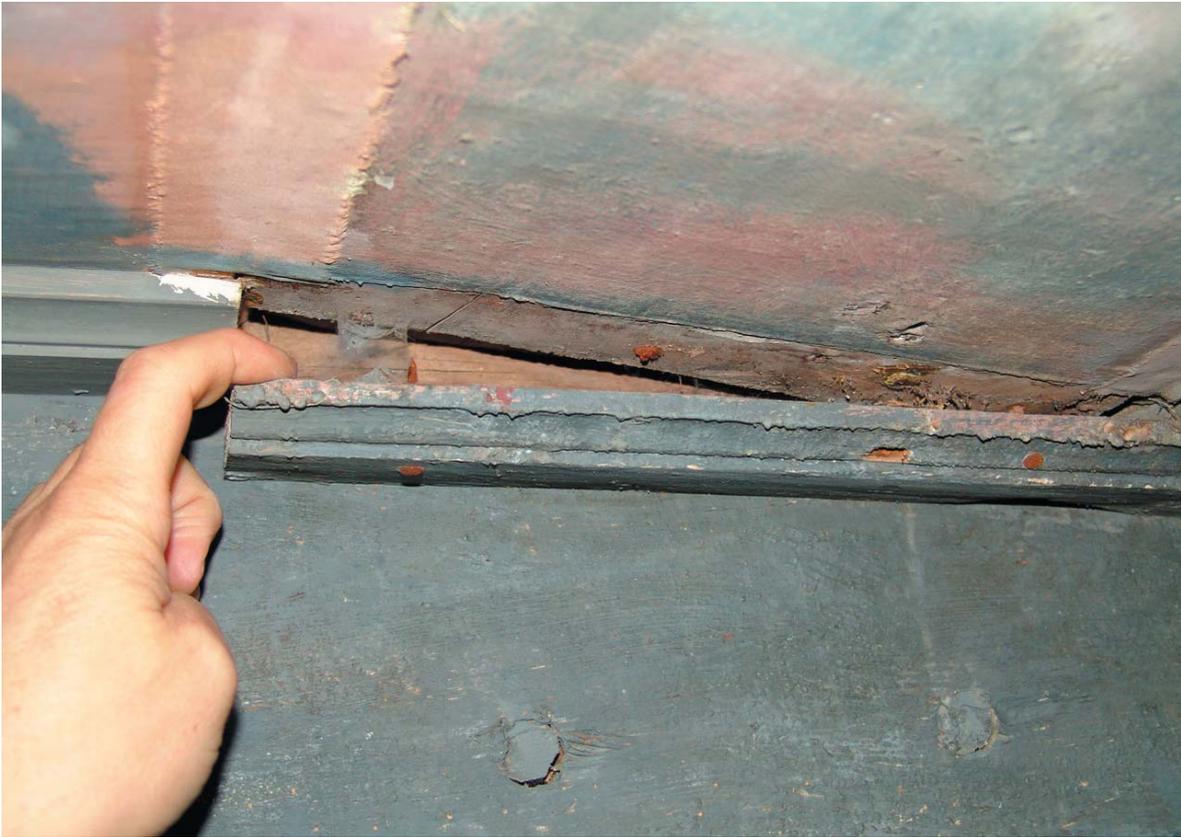
Plate 24 (above). While many of these edging strips (between ceiling planks and trusses) are replacements, the principal for such elements is probably an original one, since the decoration does not appear to extend beneath them. (Photo: Paine and Stewart 2006)

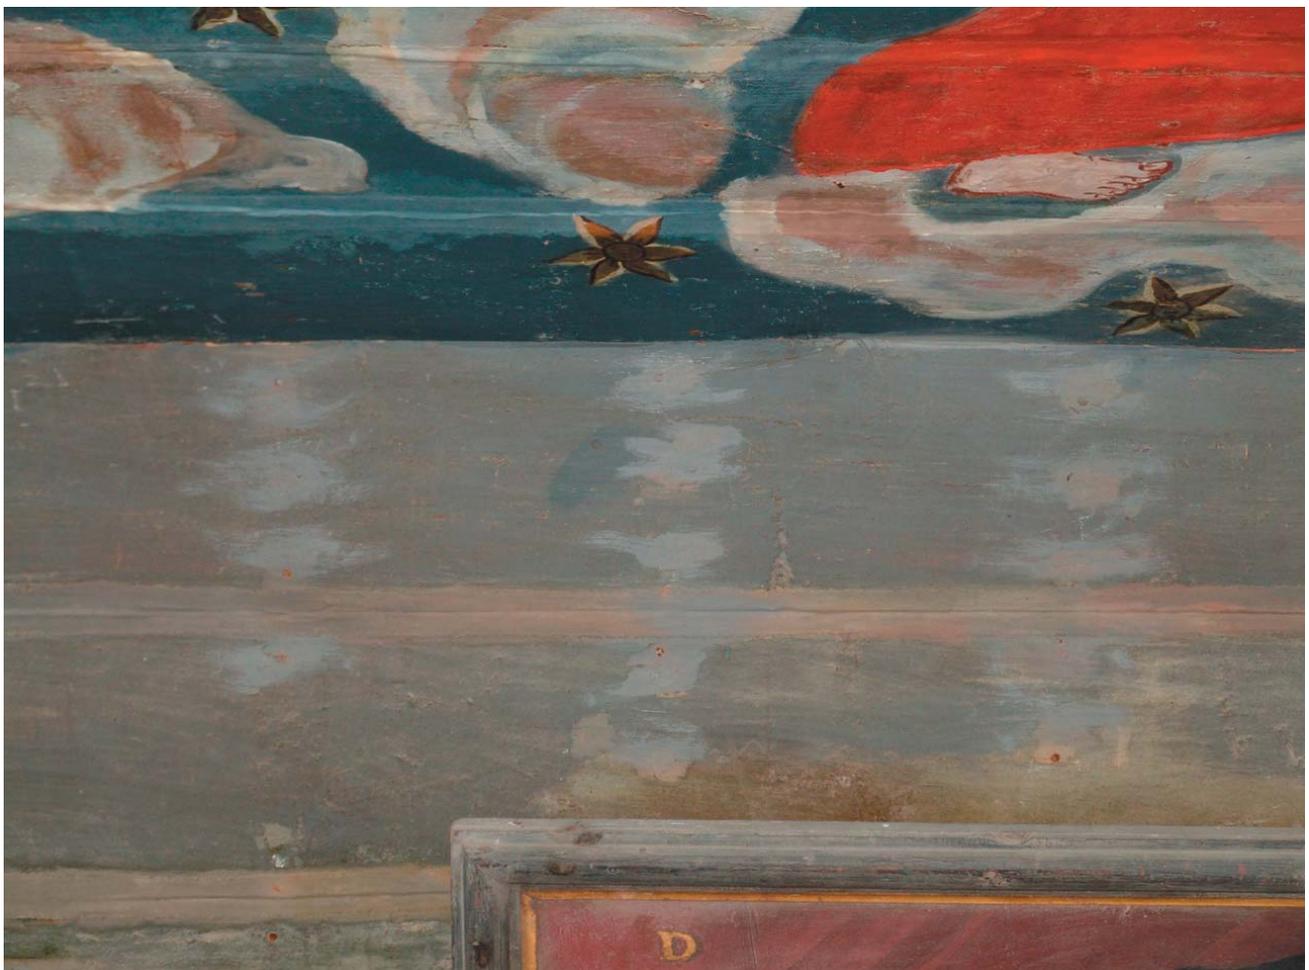
Plate 25 (below). The crude nature of the 1950s restoration can be noted here in the poor quality retouching of exposed nail heads. (Photo: Paine and Stewart 2006)

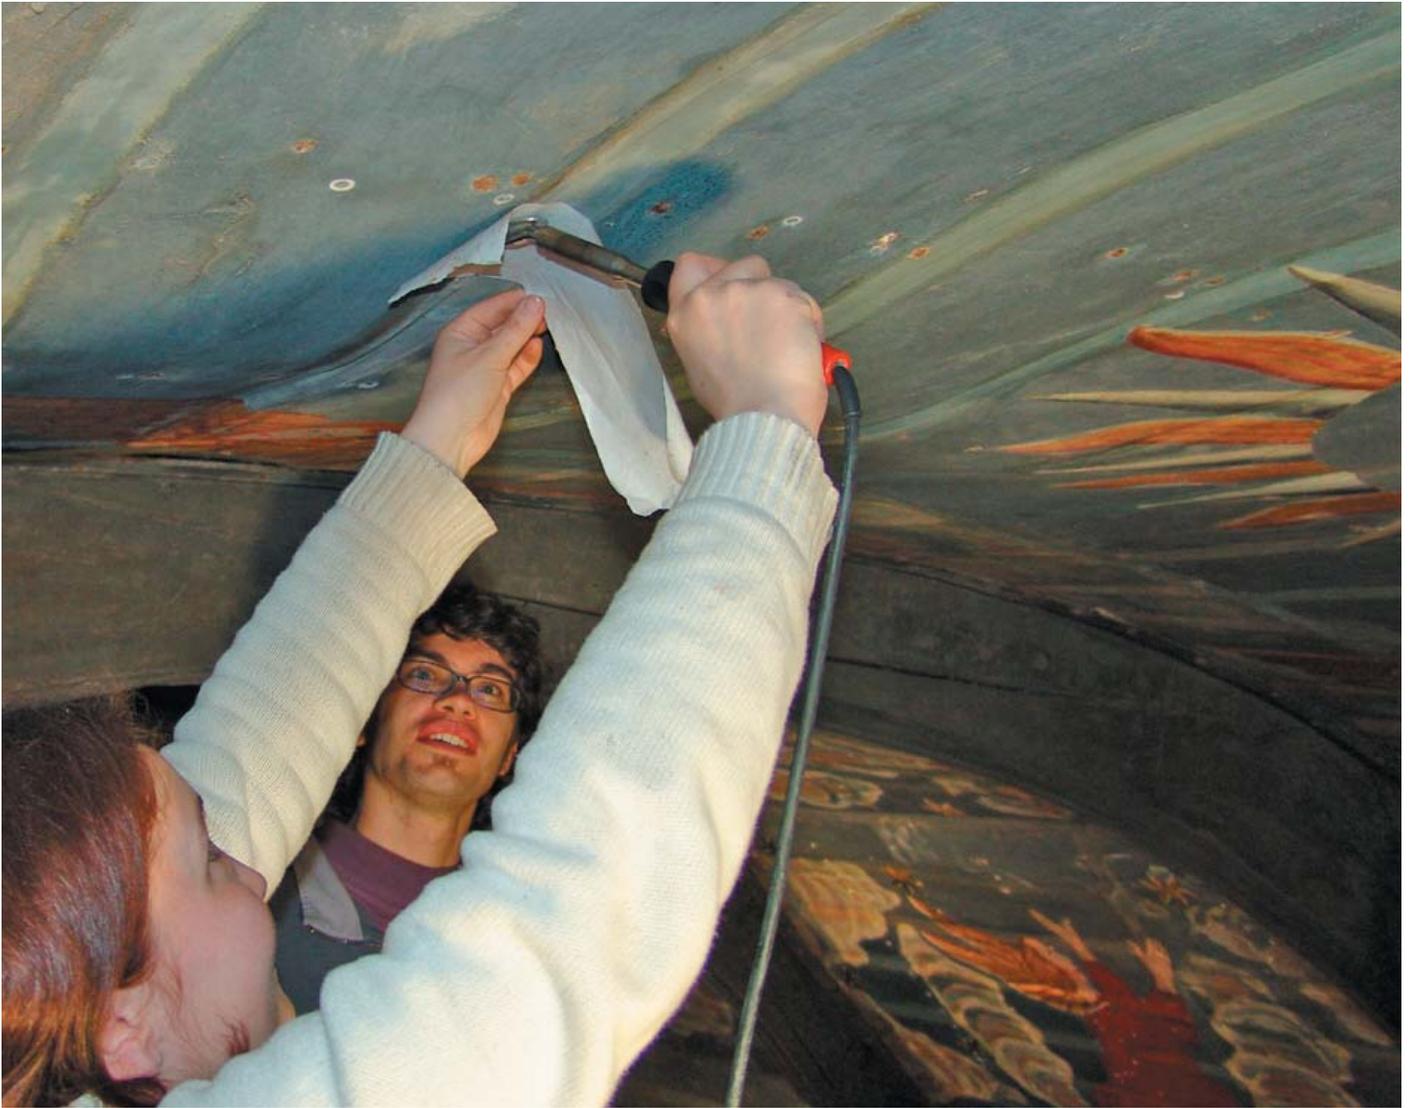
Plate 26 (above). Conservator Aneta Szemiel and James White attending to the readhesion of a detaching canvas strip using a heated spatula. *(Photo: Paine and Stewart 2006)*

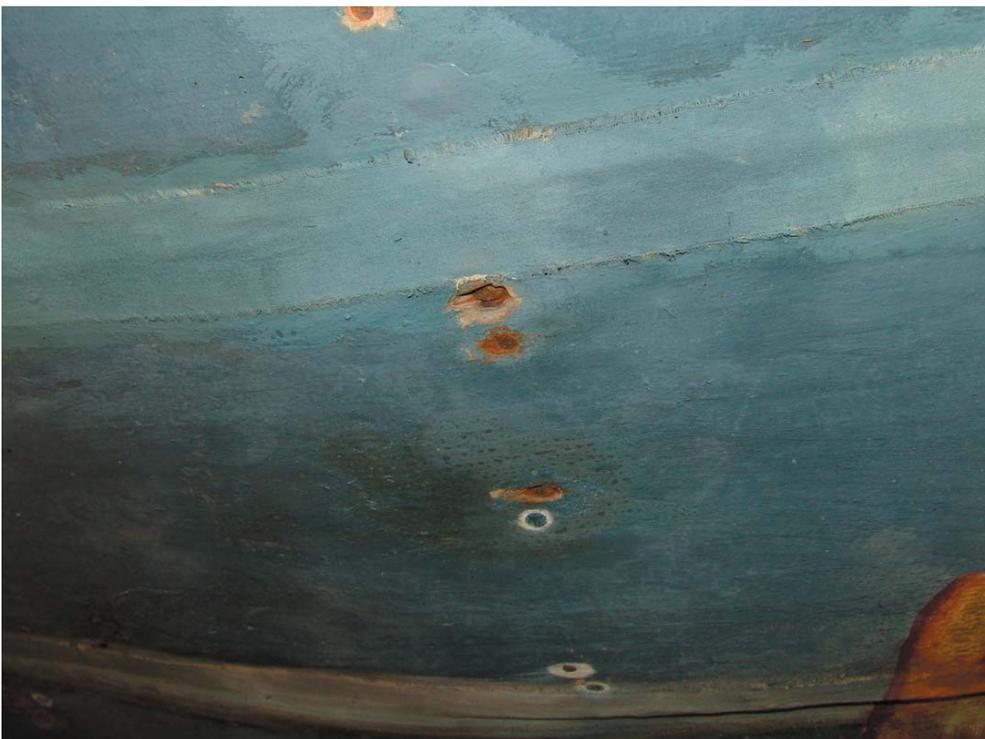
Plate 27 (below). Throughout the ceiling there were over 3500 rusting nails that required treatment. *(Photo: Paine and Stewart 2006)*

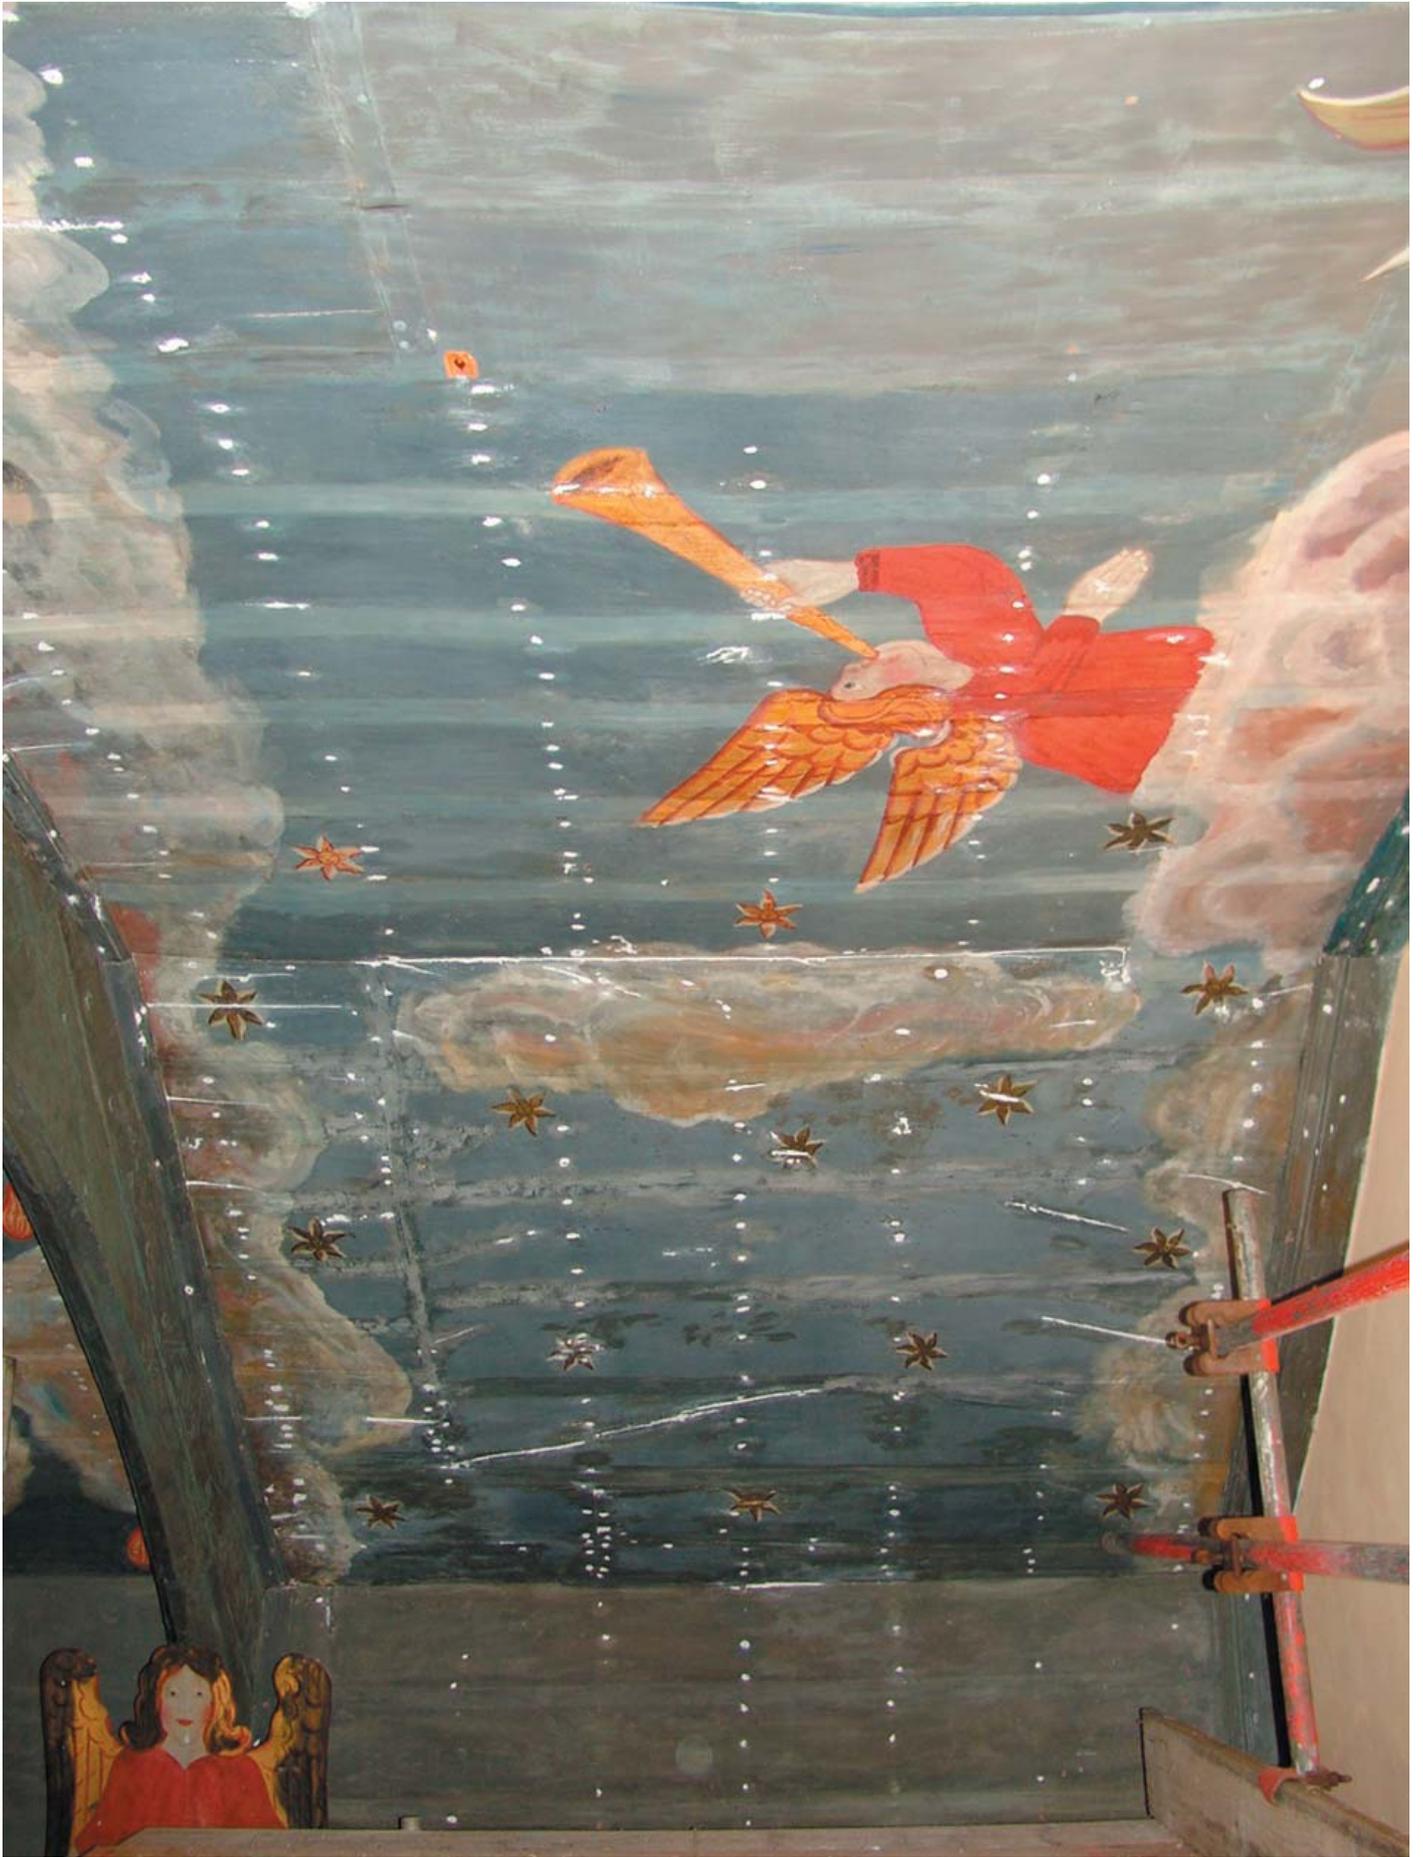
Plate 28 (above). General view of the western end of the ceiling, showing work in progress, with multiple nail heads treated, filled and awaiting final retouching, (Photo: Paine and Stewart 2006)

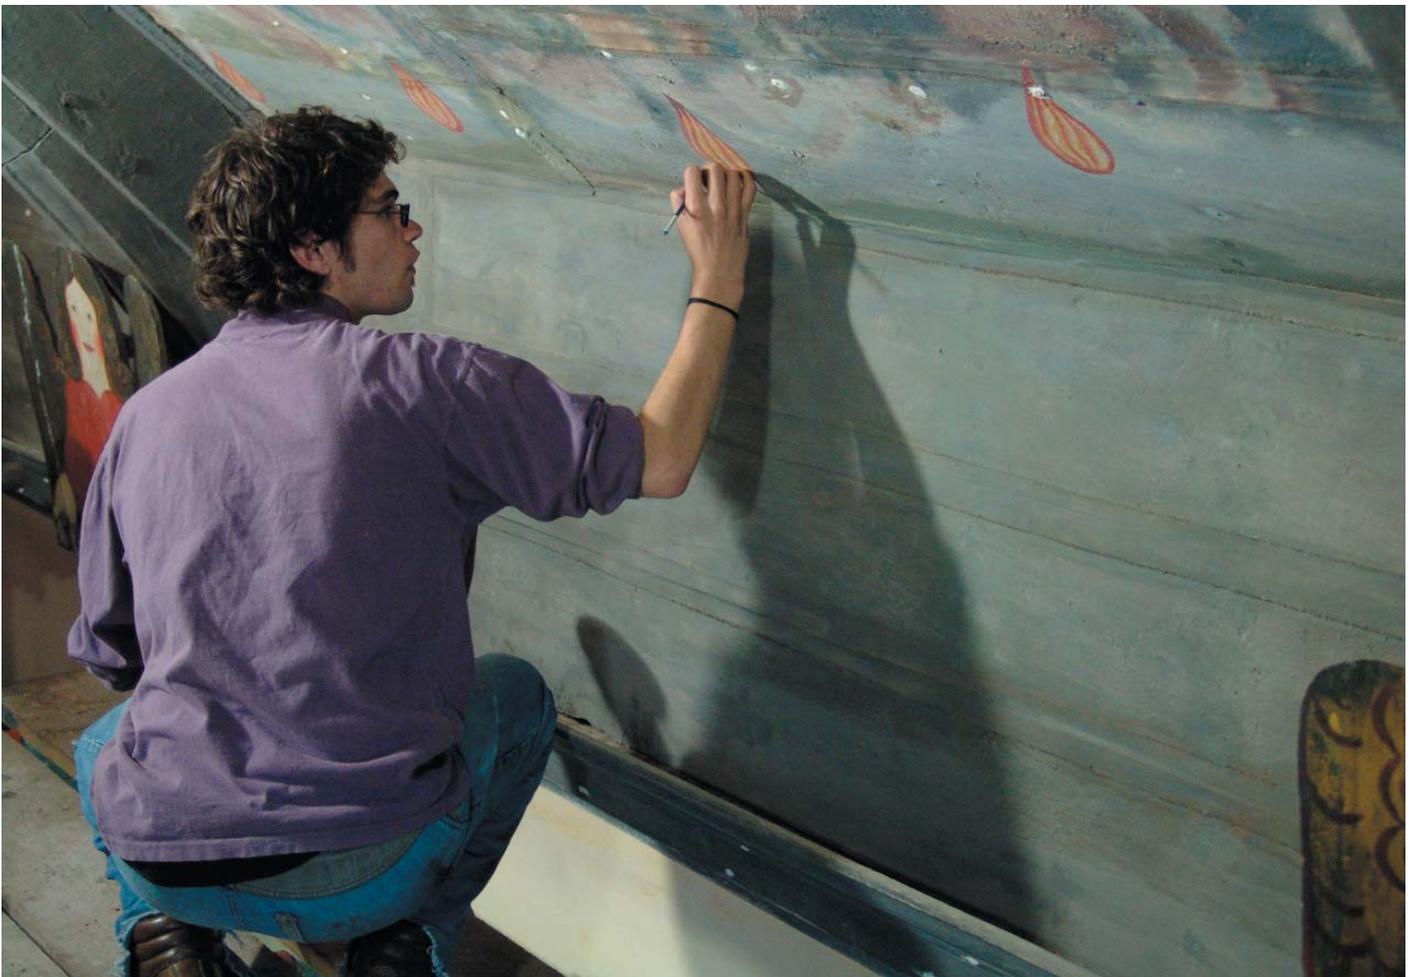
Plate 38 (below). Conservator James White retouching nails heads with a casein-based paint. (Photo: Paine and Stewart 2006)

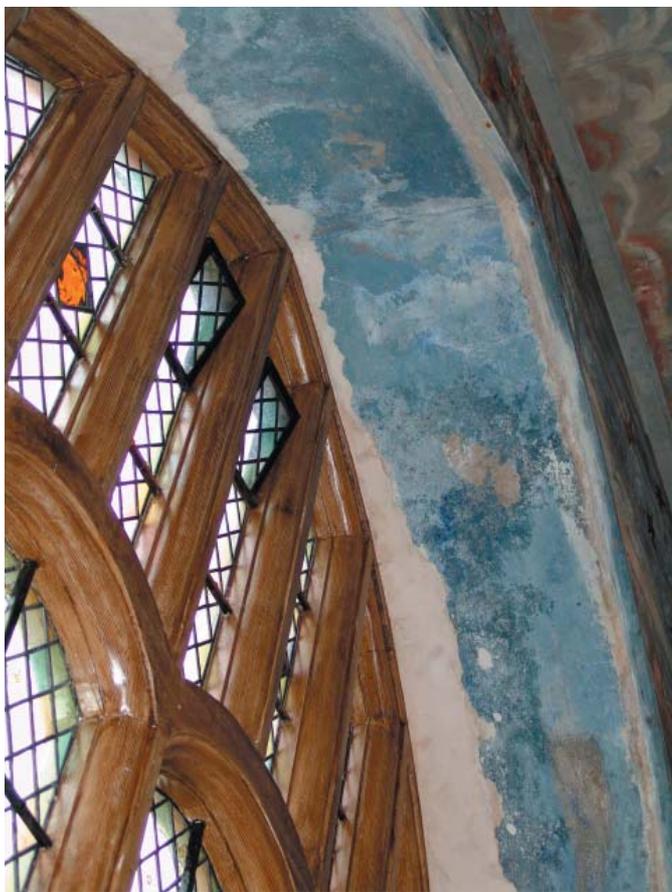
Plate 39 (above left). Detail of the repaired window splay at the east end. (Photo: Paine and Stewart 2006)

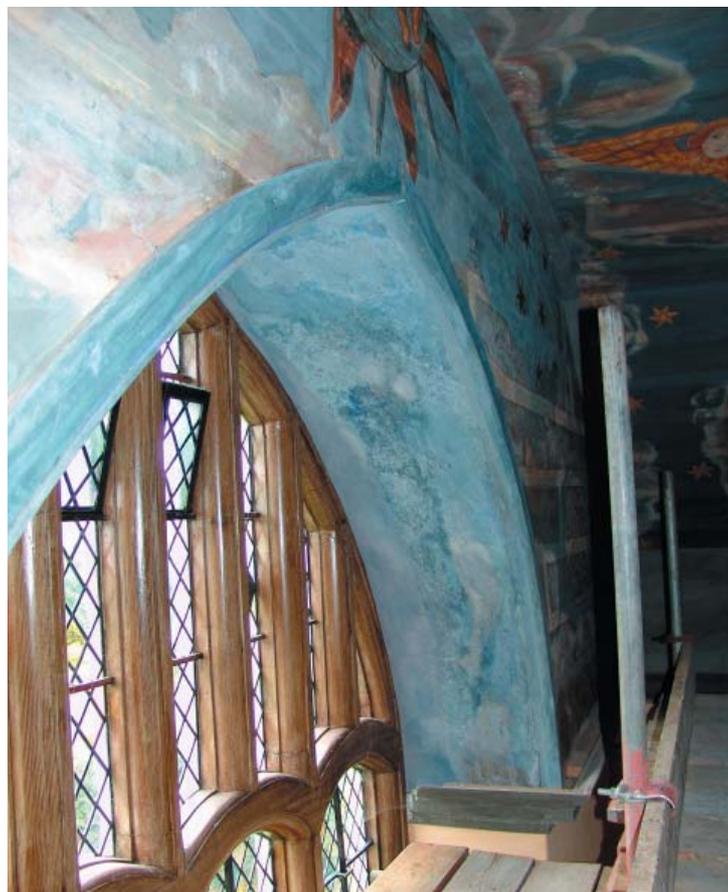
Plate 40 (above right). General view after reintegration of the plaster repairs. (Photo: Paine and Stewart 2006)

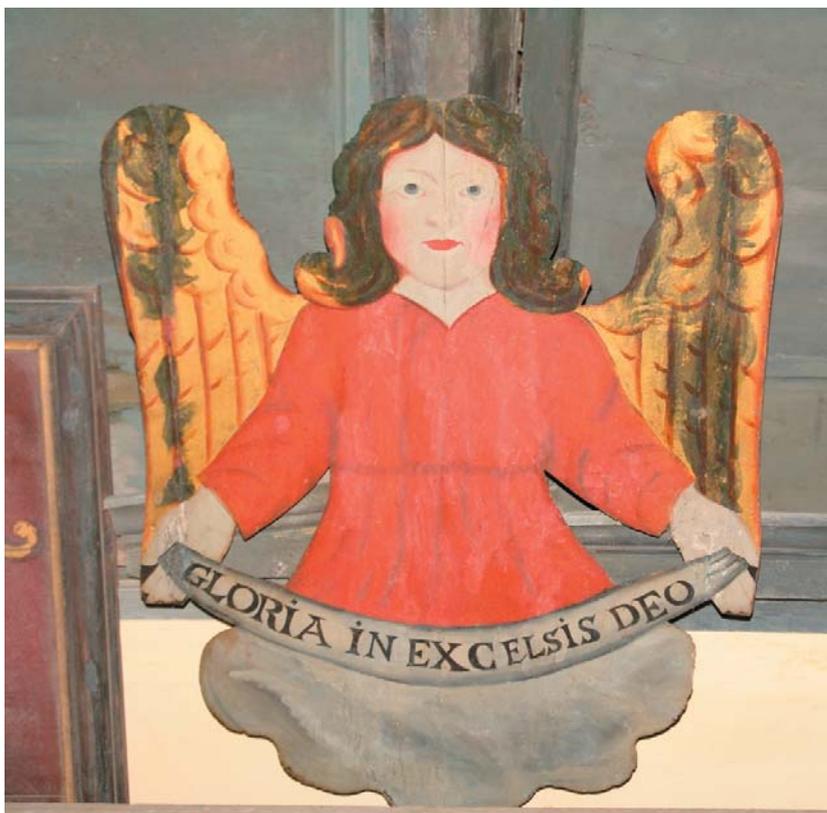
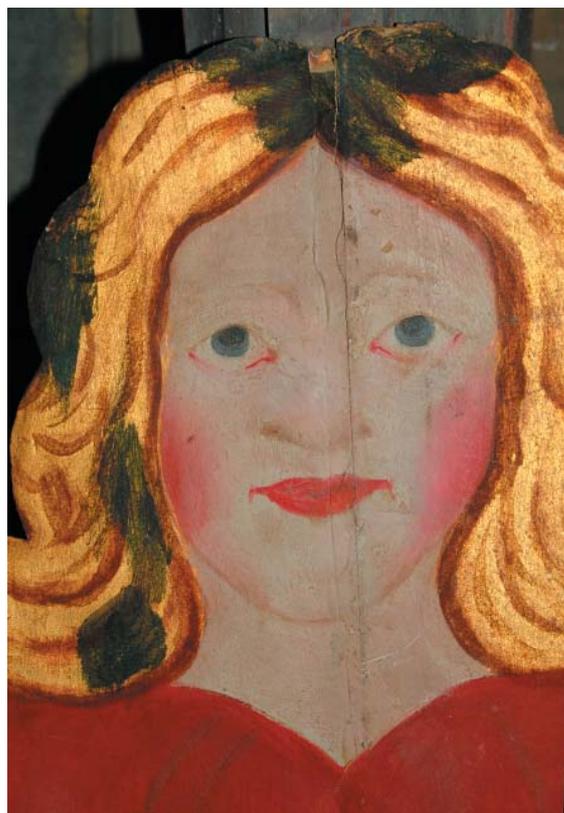
Plate 42 (below right). Detail of a panelled angel's head. (Photo: Paine and Stewart 2006)

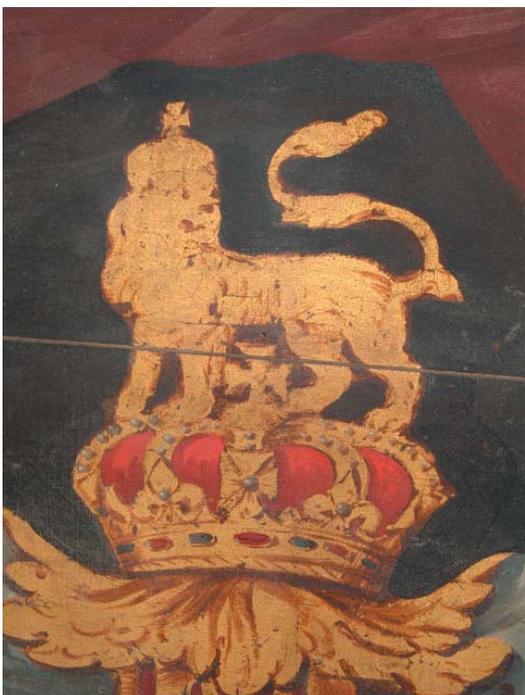
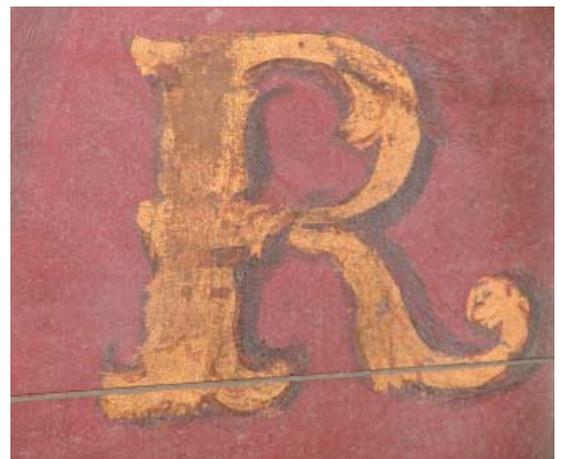
Plate 45 (below right). Detail from the arms. (Photo: Paine and Stewart 2006)

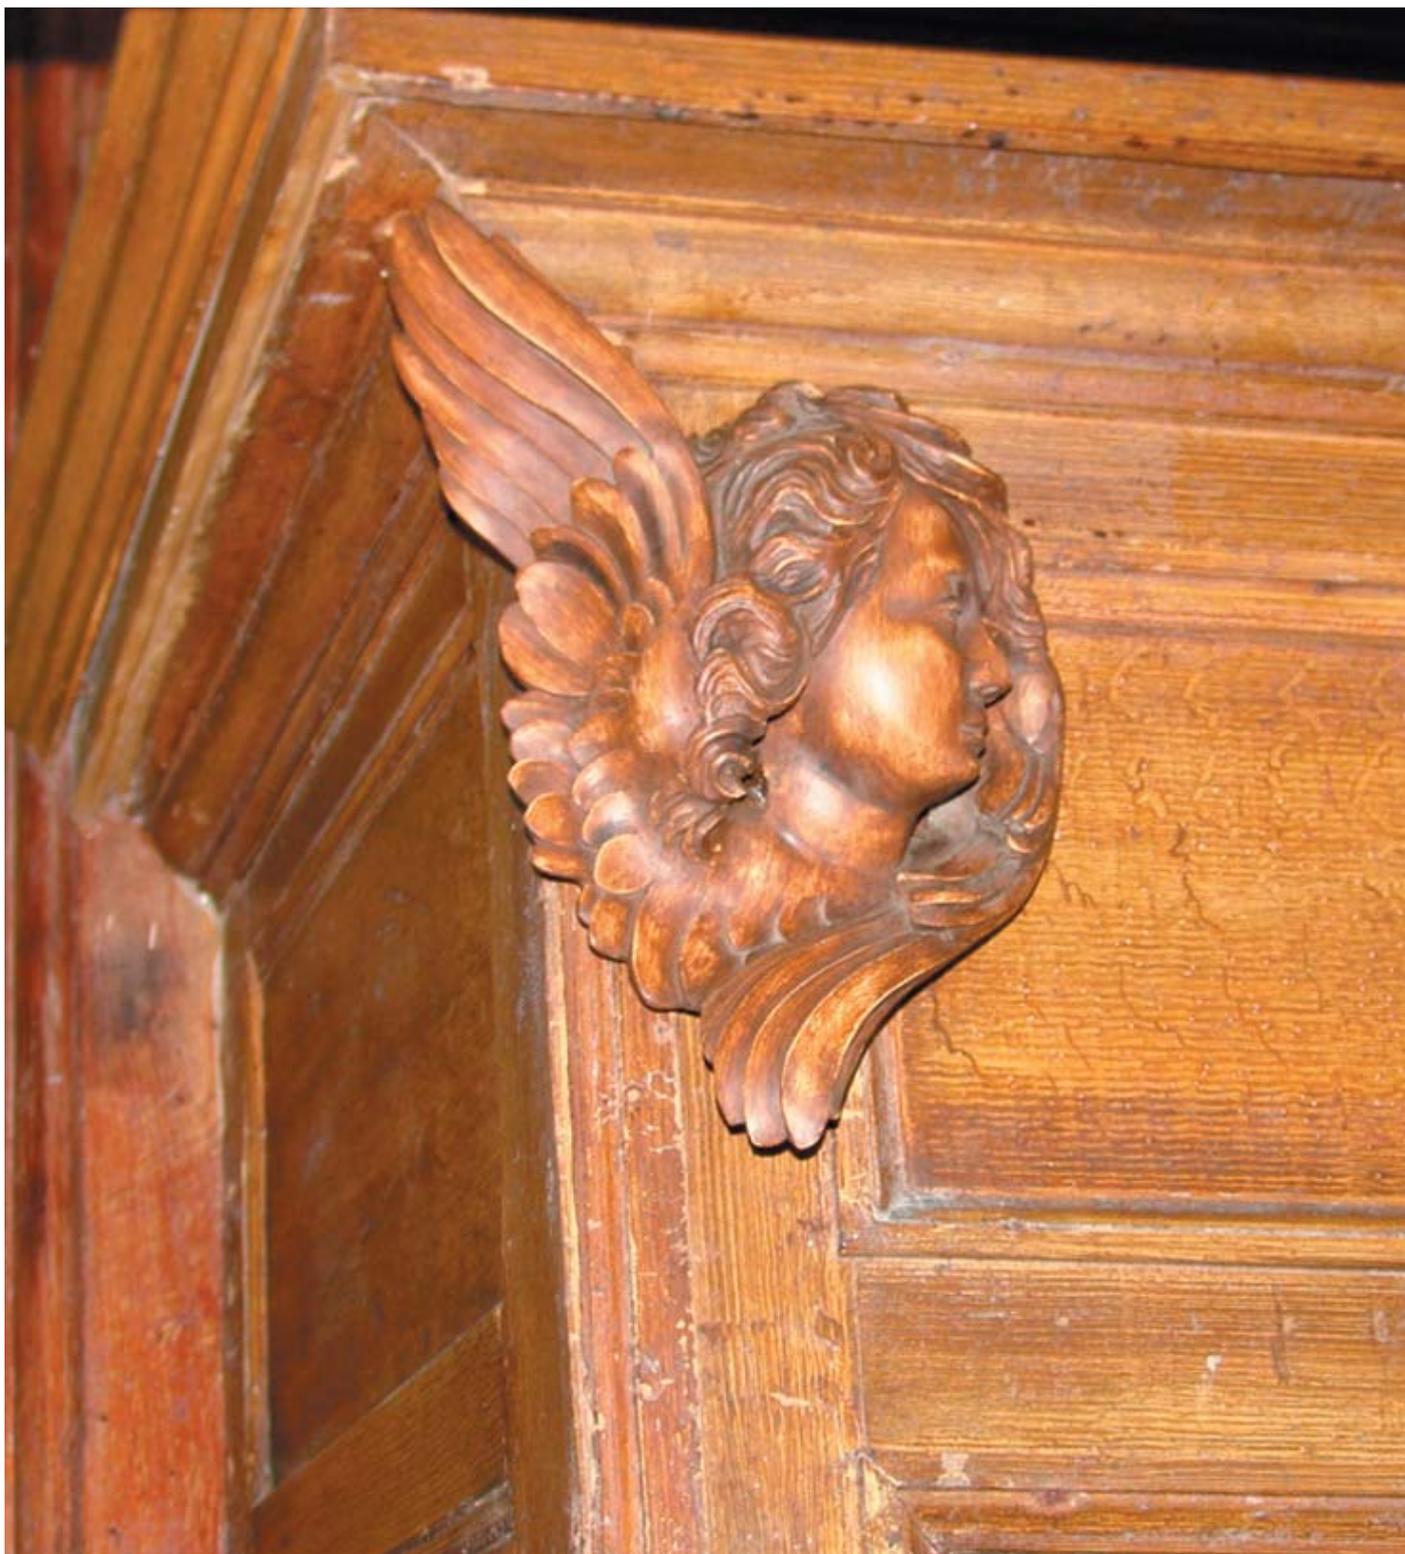
Plate 46 (above). Because of a recent theft, a replacement wooden angel head was commissioned from Mr. Louis Esposito. (Photo: Paine and Stewart 2006)

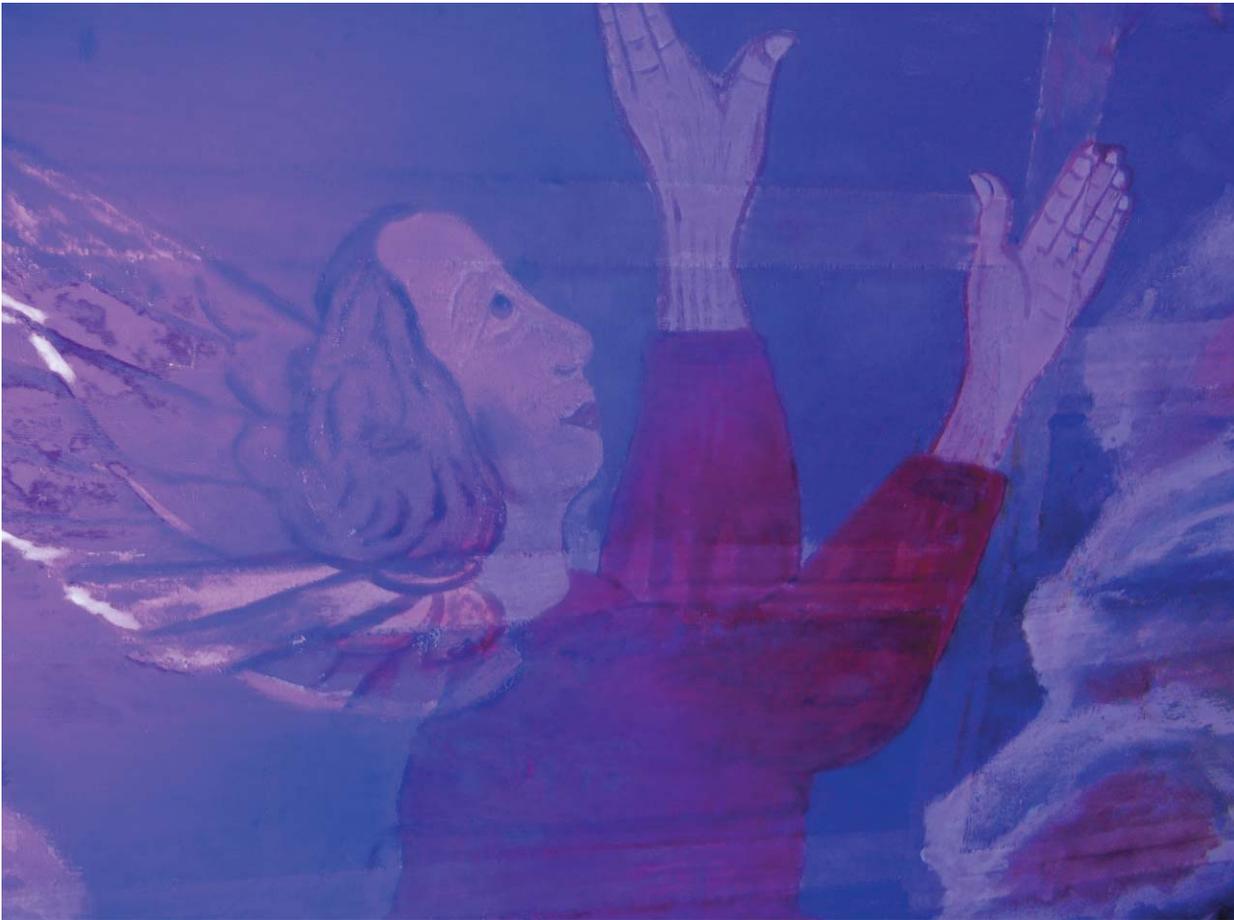
Photo 1 (above). An area of the ceiling photographed under UV illumination + 2B filtration. Owing to rather high ambient light levels, the amount of information that could have been elicited by this technique was limited. However, it does indicate clearly those areas of previous restoration and the added canvas strips.
