An Initial Site Evaluation **“The Old Cutter” Site**

Moel-y-Don
Anglesey

Date of evaluation: 20th September 2014

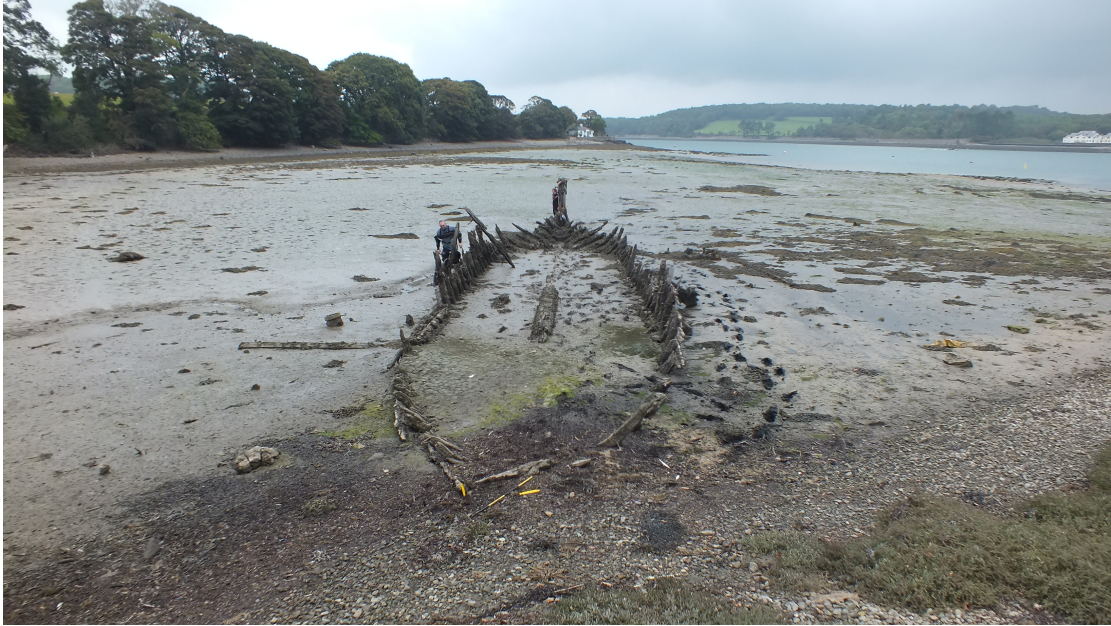
Fig 1.

Figure 1 shows the overall scale of this site, the bow is in the foreground, (a scale pole is visible at the bow) with the stern in the distance. Behind the Menai Straights can be seen at low water.

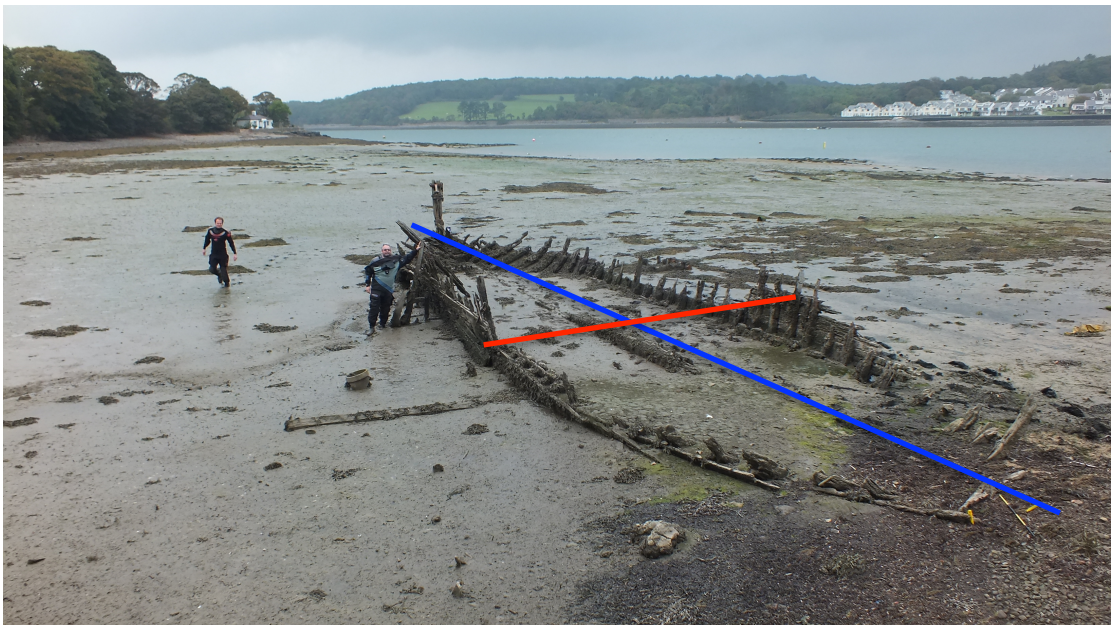
Fig 2.

Figure 2 clearly shows the starboard side of the site, whilst Figure 3 shows the port side elevation, with scaling visible on the upright sternpost. The overall length of this site, as shown in Figure 2 is 23.400m (blue line) whilst at it mid-point, again shown in Figure 2 it measures 4.600m (red line).

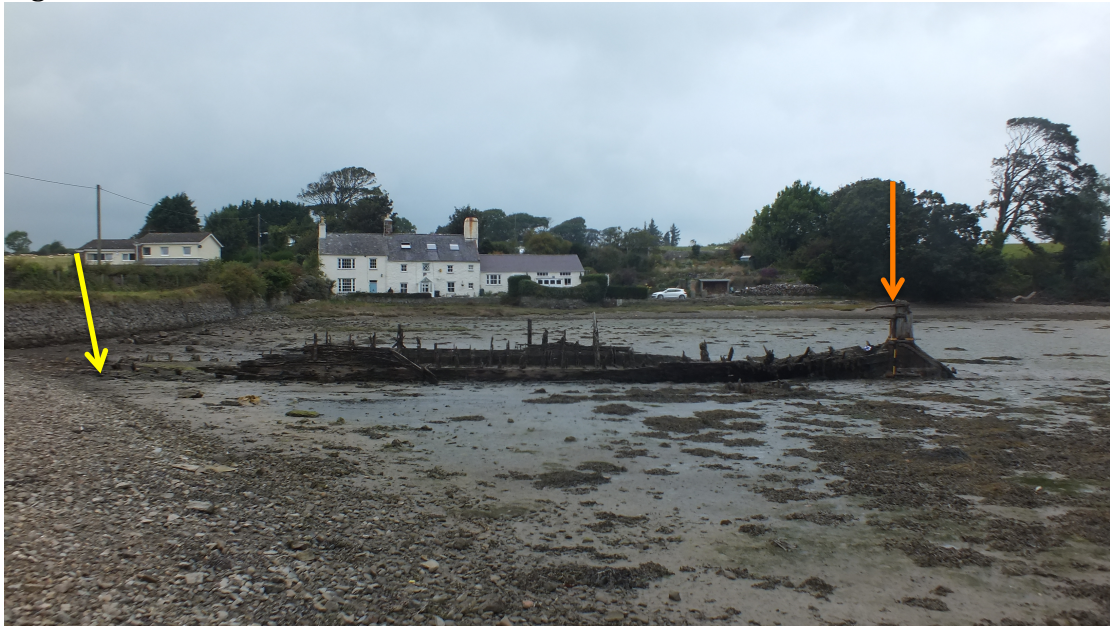
Fig 3.

In Figure 3 the yellow arrow shows the GPS position recorded for the bow, whilst orange arrow shows the GPS position of the sternpost (not the true end of the site):

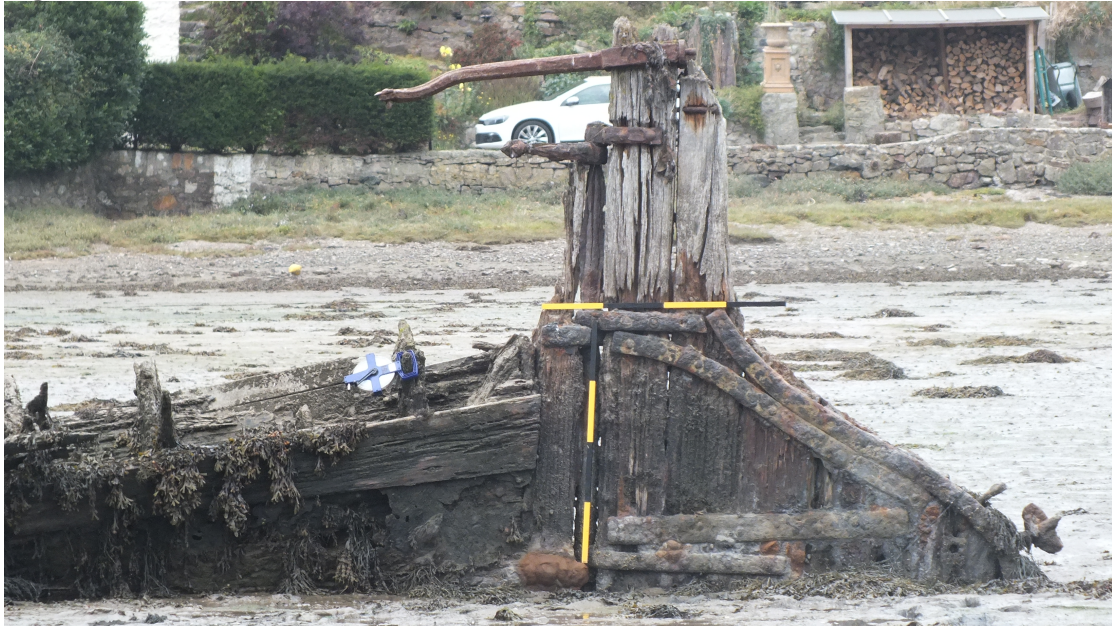
Fig 4.

The most prominent feature of this site is the sternpost and rudder, which remain upright and in situ, with many of the iron fixings still in place, as demonstrated in Figure 4. The height of this feature is approximately 2.260m. Figure 5 and 6 show the feature from a forward position and starboard position, respectively.

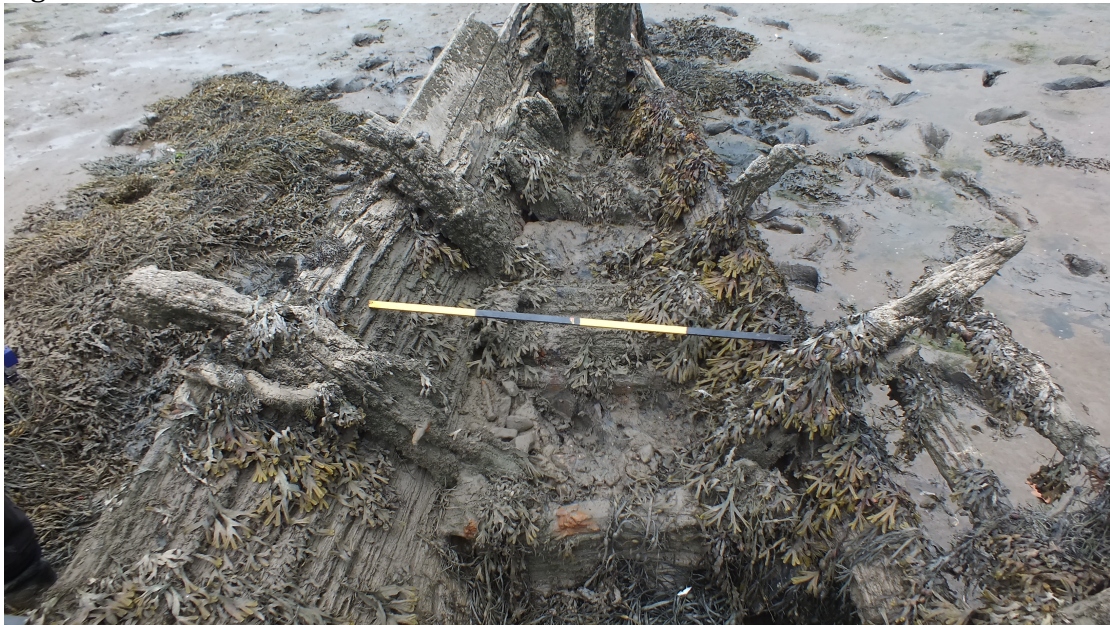
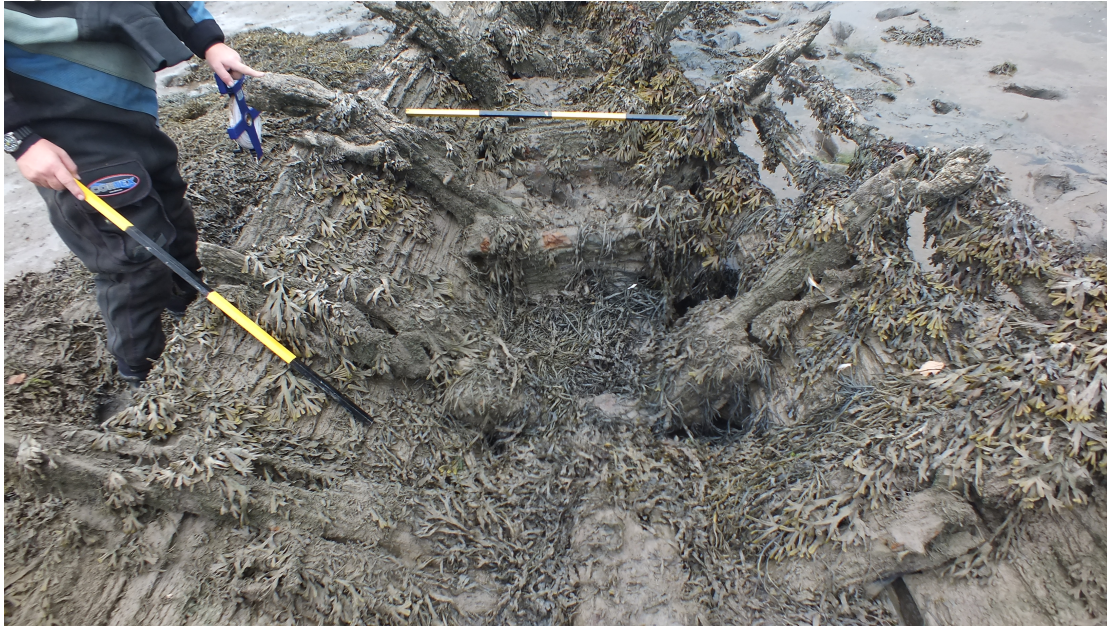
The stern section of the site is arguably the most intact, and most stable section. Figures 7 and 8 show the internal view of this area, which is covered in a moderate layer of seaweed and in-filled with gravel.

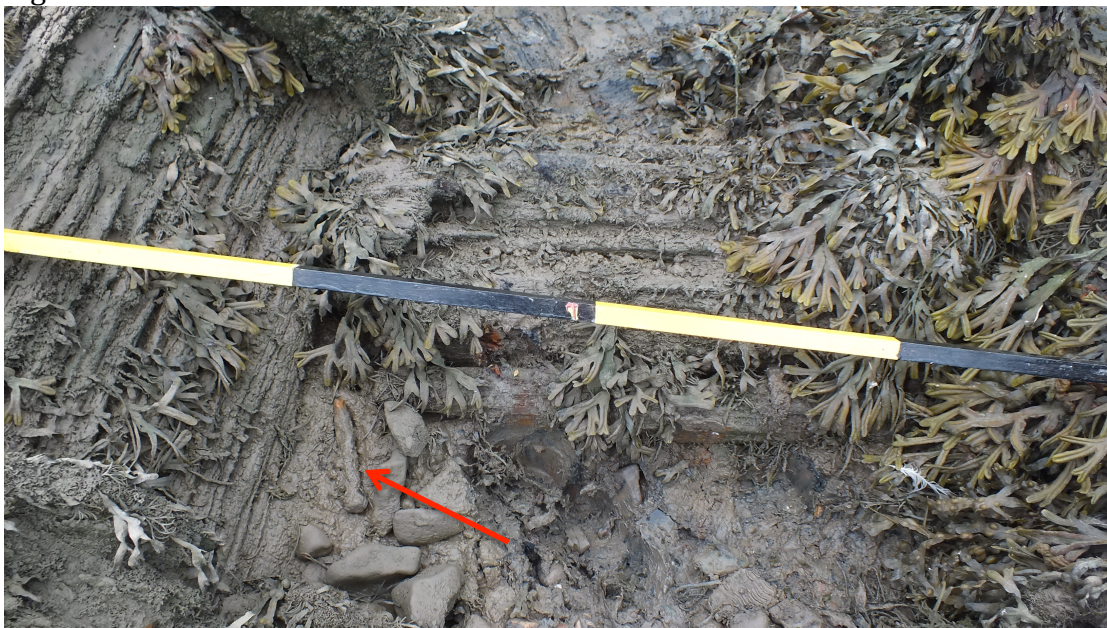
Fig 9.

Figure 9 demonstrates the coverage of seaweed and gravel more clearly. Also in this photograph it is possible to see that some of the iron fittings have become displaced and are lying in the vicinity of the site (red arrow).

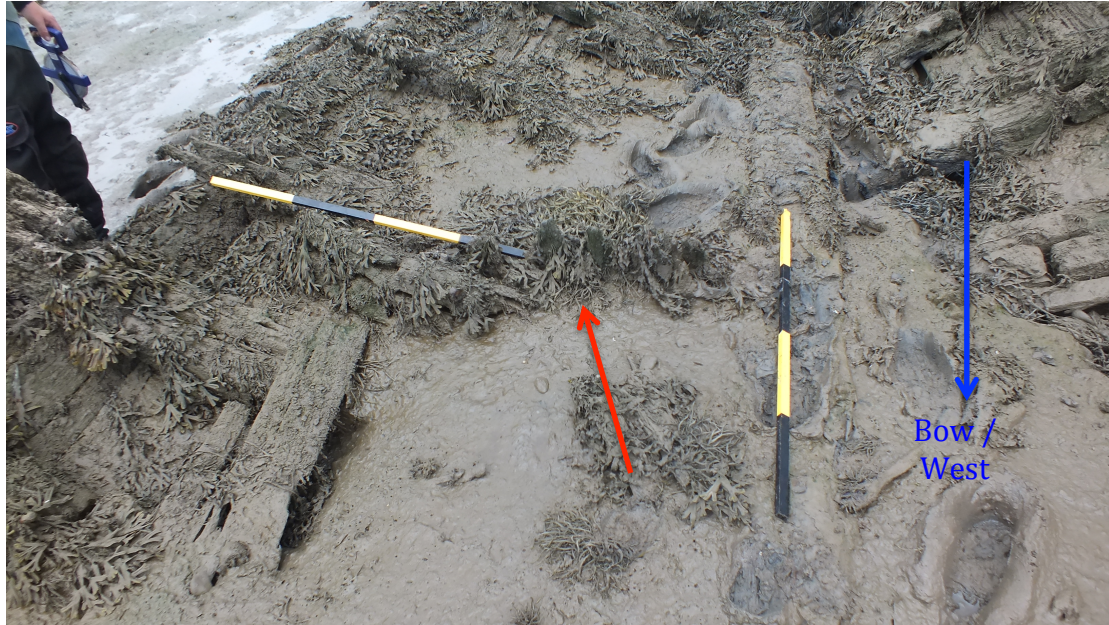
Fig 10.

As you progress forward of the site more features of the site become evident. Figure 10 shows part of the keel emerging from the mud and there is, what it thought to be, the remains of a bulkhead / partition visible (red arrow), although this is more clearly demonstrated in Figure 11.

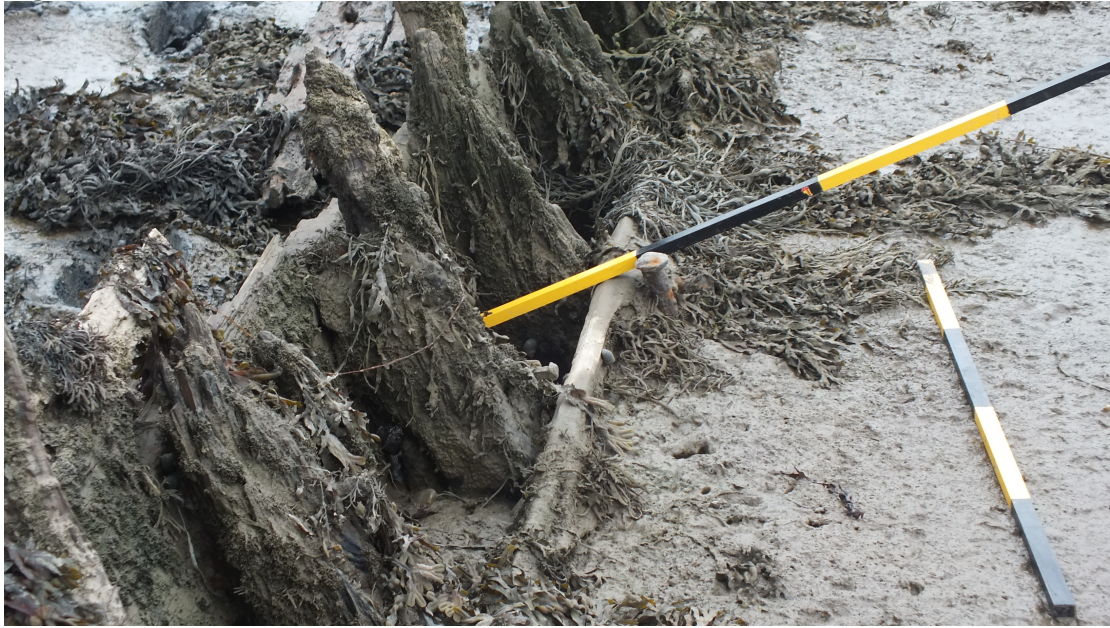
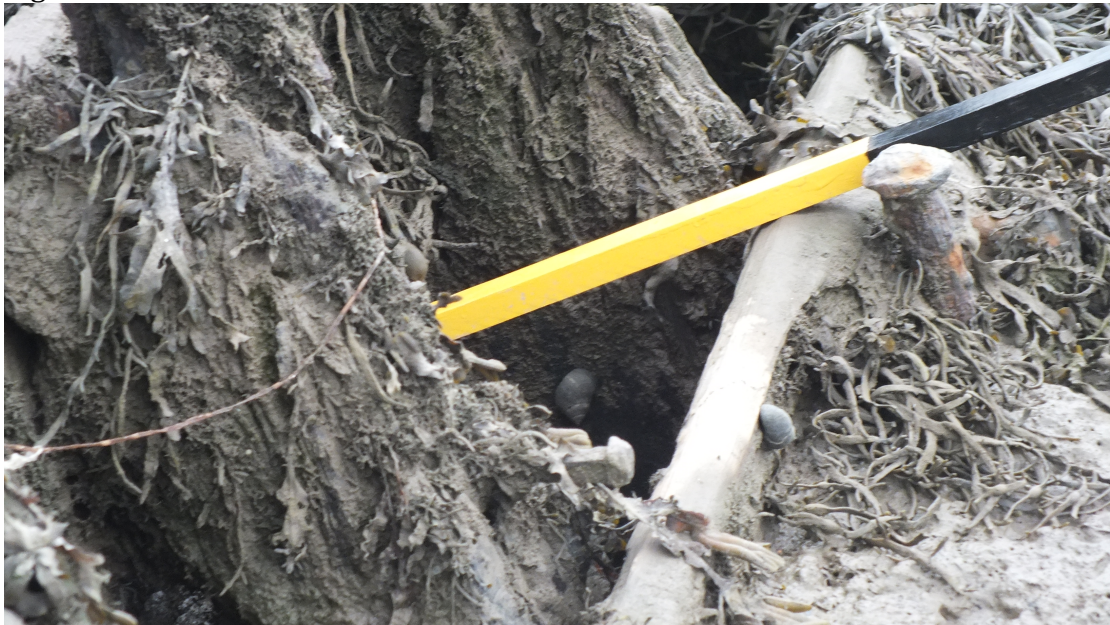
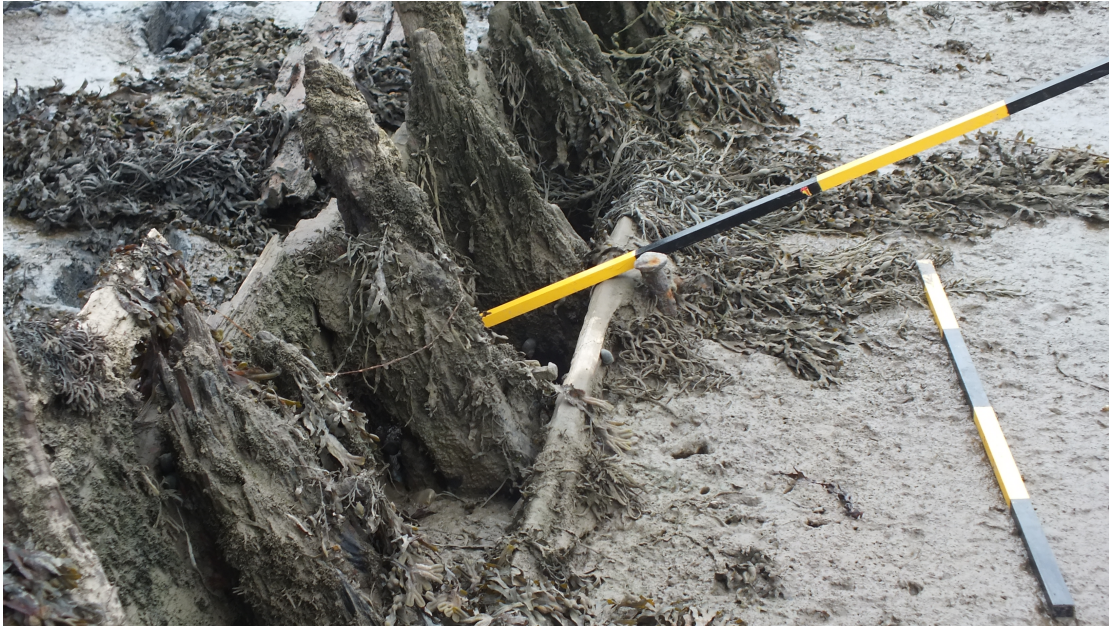
Figures 12, 13 and 14 show the two layers of planking with the frame between them, evident on the Port side of the site and how the layers interconnect with the timber frame.

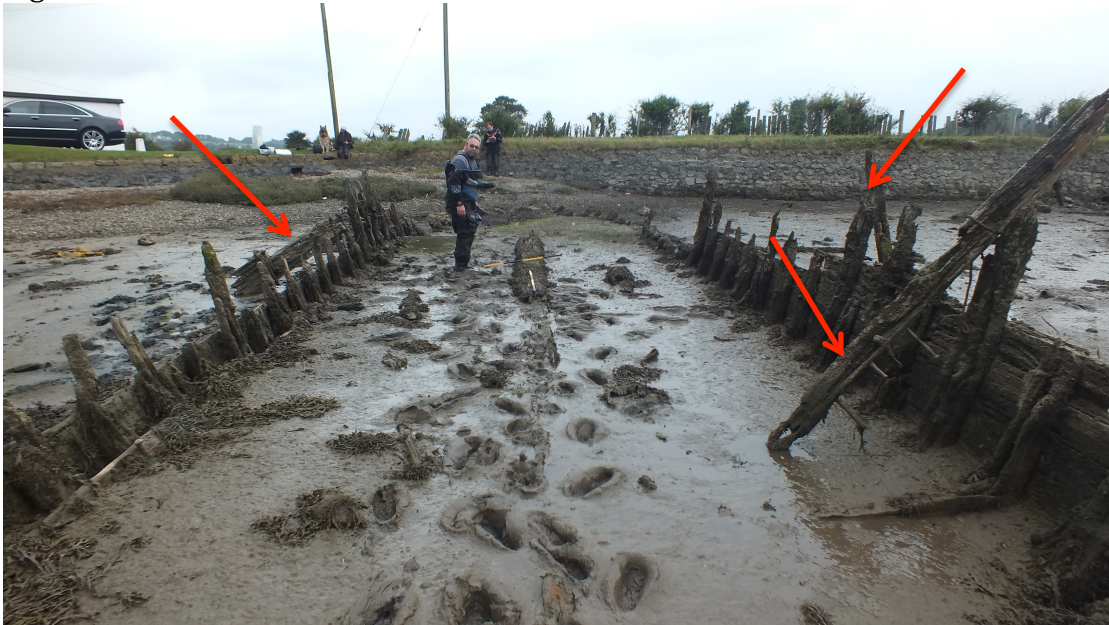
Fig 15

Figure 15 is taken from the stern, looking towards the bow along the line of the keel. This picture is highly instructive in regards to the conditions on the site. Clearly, the bow is considerably more broken than the stern. Timbers have become loose and are out of situ (red arrows). The depth and viscosity of the mud is also evident through the footprints seen in the picture that have failed to collapse in despite having been made sometime earlier.
