## Assessment and Scheduling Enhancement Maenan Abbey, Llanrwst

Project No. G2213

Report No. 1039

Prepared for : Cadw

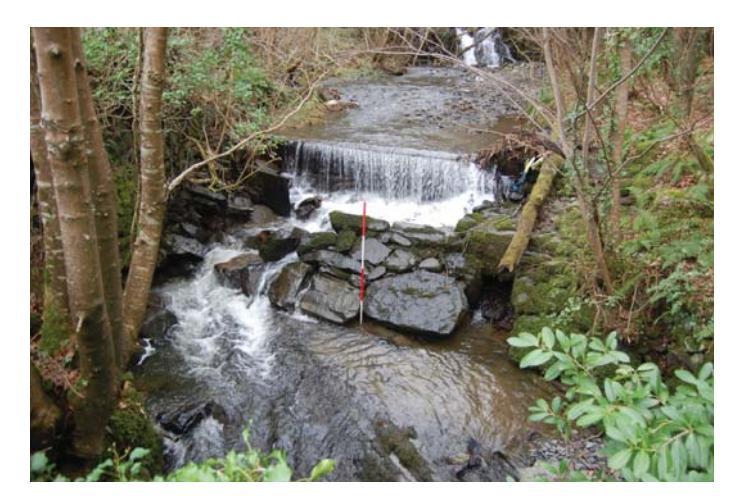
The dam referred to is presumably that recorded in the present project as PRN 34134, which is interpreted as a weir of essentially a single phase of building, although some repairs may have been made, and probably 19<sup>th</sup> century in date. The 1788 map shows no indication of a pond, with a building immediately on one side of the stream and a field boundary on the other, giving no obvious room for a pond in this location. By 1890, when the weir had been constructed, the OS map does show a pond and the outline of this remains consistent through to the modern digital map, probably because it has never been resurveyed. The maps show the pond filling the base of the quarry (PRN 34136) on the southern side of the stream, yet on the ground the topography suggests that this would have been impossible. The weir would not have allowed a much higher water level than at present but the ground level within the quarry is much higher. Some of this is due to piles of stone, but this seems more likely to be rubble from the quarrying than recently dumped material. Even discounting this the

Plate 5: Weir (PRN 34134), from the SW

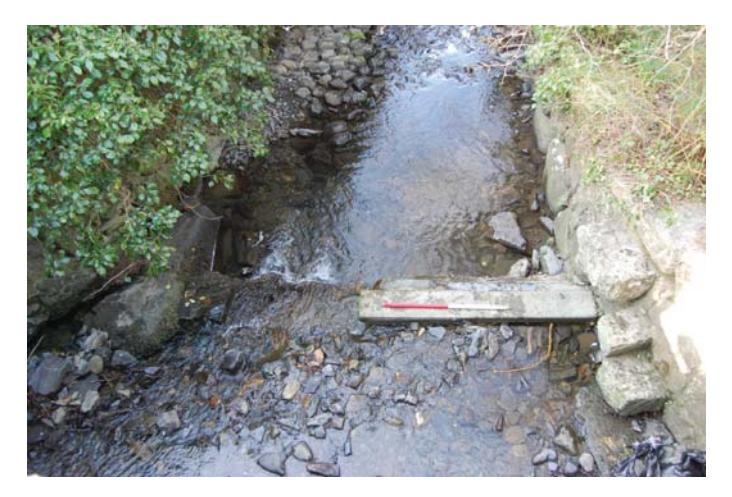
Running across the stream at this eastern end is a small weir or dam (050) (plate 16). This is only 0.4m high and its upper parts are constructed of concrete blocks but these are set on stones and it is possible that the concrete blocks and apron of concrete below the stones are later repairs and that the structure was originally entirely of cut stone blocks. This is likely because stone steps (042) (plate 17) are set in the northern wall of the channel at this point. There are 3 steps and a large flat slab in the base of the stream, giving access to the pool behind the weir to collect water before it was piped from higher up the stream directly to the houses.

Plate 16: Weir, part of PRN 34147, from the NE

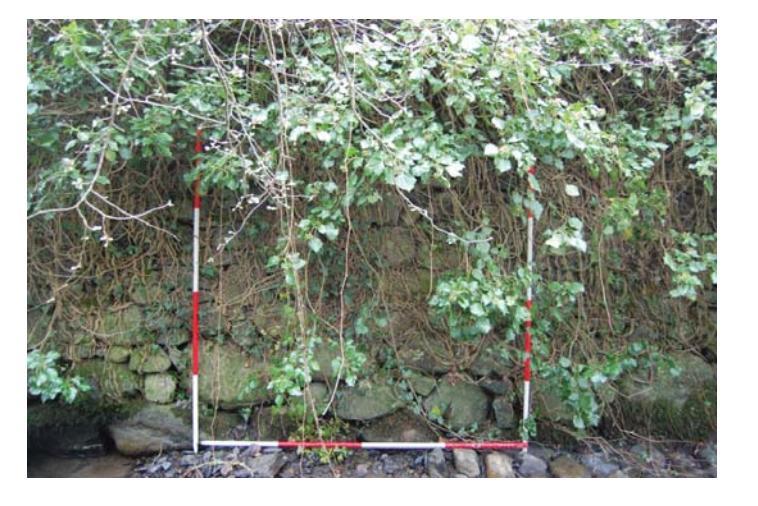
Plate 18: Large boulders forming wall foundation (002) and upper wall (003), from the N

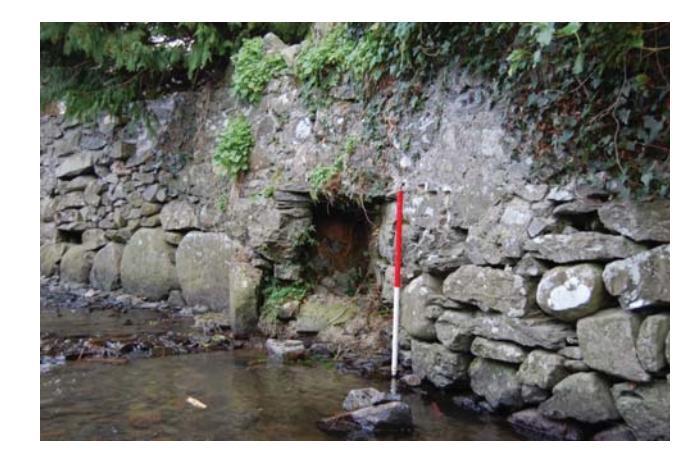
The next 5m of wall has been rebuilt on a concrete pad but after this the large boulders (020) continue with the modern wall built over the top. After a very poor repair (021) the modern wall ends and the earlier wall still survives (022). This is a mortared wall with irregular stone blocks and slabs similar to the other walls that probably date to the 19<sup>th</sup> century. This wall is also built over the boulder foundation and to the west it extends over a well-built drystone wall (024) with angular blocky stones. Under wall (022) is entrance to a large drain (023) (plate 28), which seems to have been built at the same time as this part of the wall. A breach must have been made in the existing wall (024) and part of the wall was rebuilt to curve SE to form one side of the drain; a few stones at the base can be seen continuing the original line. A boulder, possibly taken from the boulder foundations, was moved and set into the cobbles on the eastern side of the drain mouth to deflect water away and prevent it flowing back up the drain. The drain has a large slab lintel visible, which was built as an integral part of wall (022). The drain is now blocked with concrete so it is not possible to see far inside, but the drain was 0.4m high internally so it must have been a major outflow, possibly for sewage.

The large drain (023) is certainly of mid 19<sup>th</sup> century date. The foundation plan of the house shows the main drain running from the south of the house directly towards (023) and the plan notes that the drain is running to "the outfall". The visible angle of the drain suggests that it was deliberately built to take this new main drain and that this was not a reused earlier outfall.

Plate 28: 19th century outfall (023), from the N

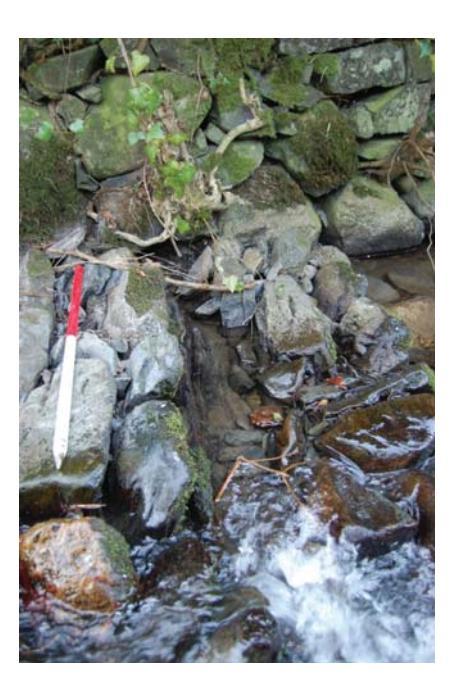
The function of the beams was probably to resist lateral movement of the cobbles, especially when battered by boulders during floods (David Austin pers. com.). The timbers are therefore an integral part of the cobbling. Unfortunately this device intended to strengthen the cobbling over time has created a significant weakness. All the eroded gaps in the cobbles seem to have started from a timber slot. As the timbers rot they present a weakness exploited by the water. Once erosion has started at the beam a small waterfall is created which undermines and dislodges cobbles and works its way gradually downstream. In one erosion hollow a piece of timber was found. This was of exactly the same size and shape as the *in situ* timbers and is almost certainly part of a beam and probably originated from the eroded timber slot adjacent to which it was found.

Plate 31: Timber beam (052) set into wall (002), from the NW

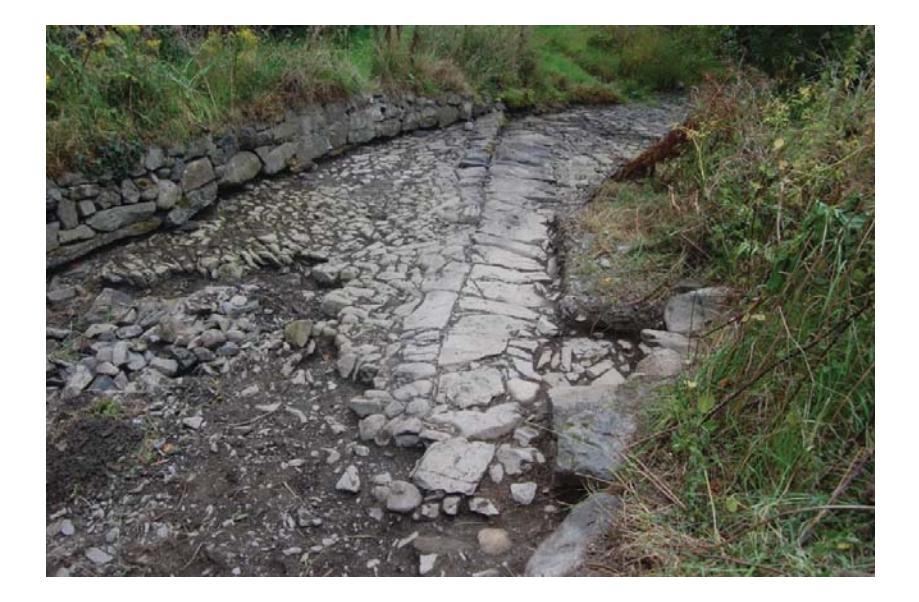
Plate 32: Stone 'weir', PRN 32589, from the E
