Archaeology Wales

Nantcribbau Farm, Forden Powys

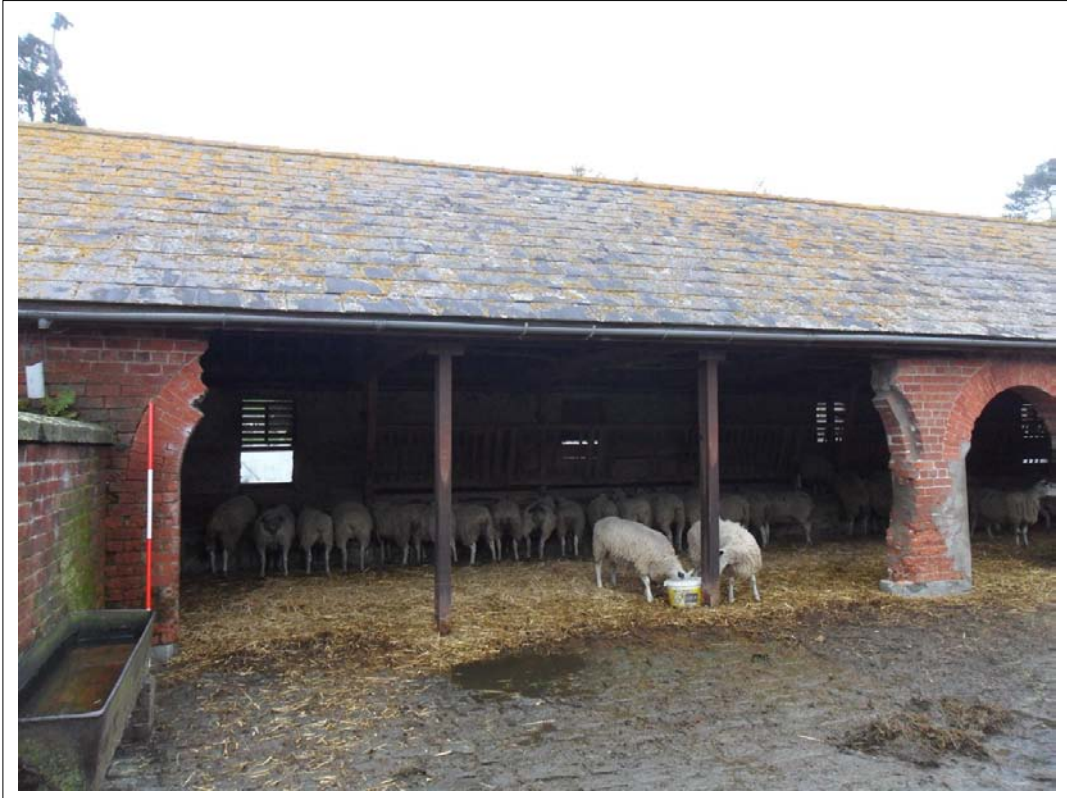
Plate 21: View of damaged/removed arched entrances into single storey animal range. Brickwork replaced with steel bars. Scales 1x2m Looking north

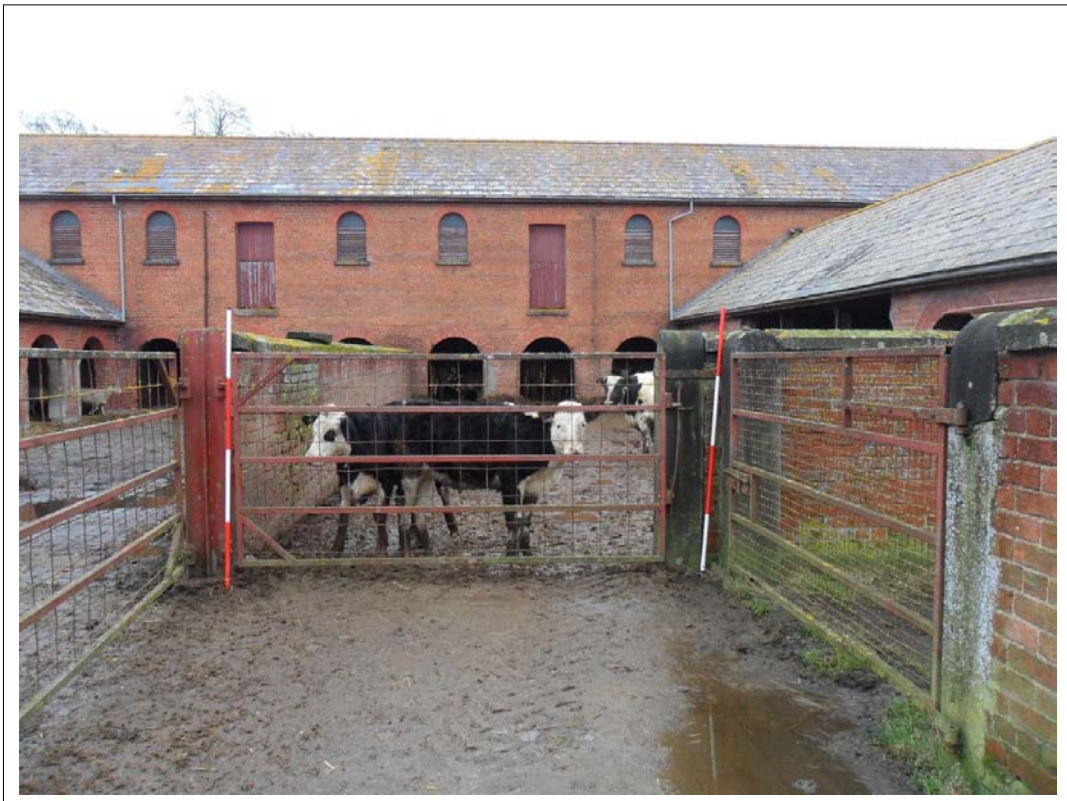
Plate 22: View of gated entranceway into further courtyard area adjacent to further animal range, Scales 2x2m, Looking north east

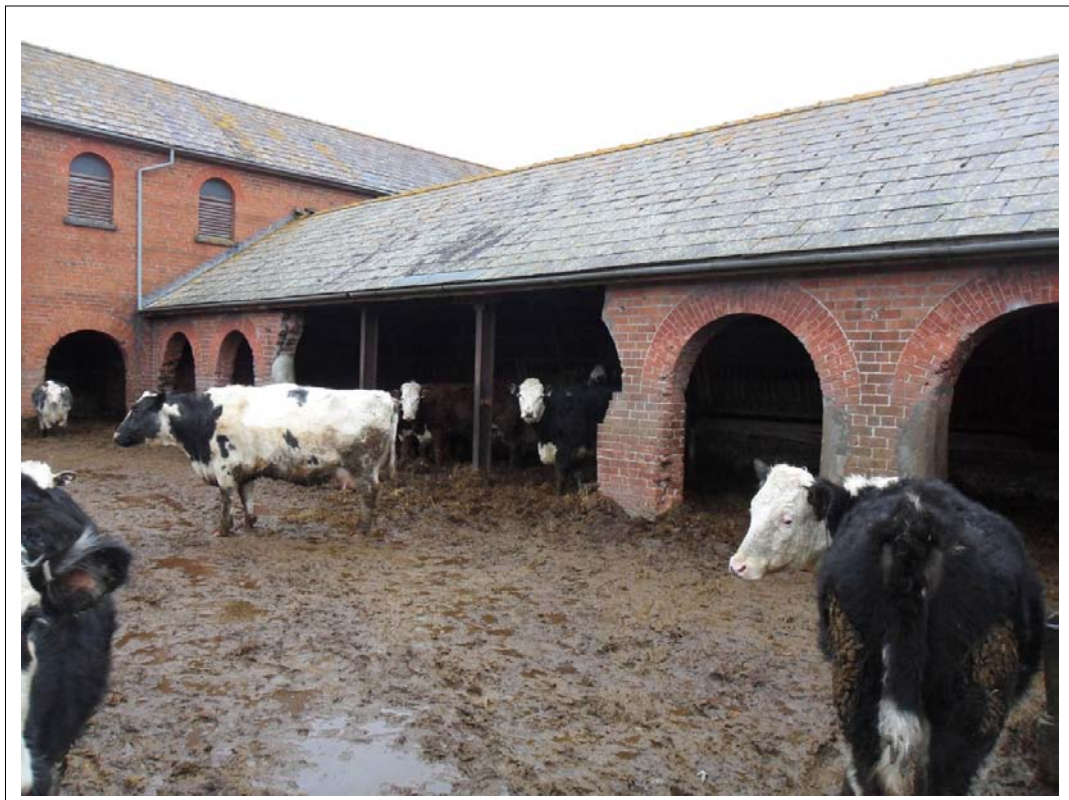
Plate 24: Note two brick archway pillars removed from this animal range also
Repair made in same steel bars. Looking east

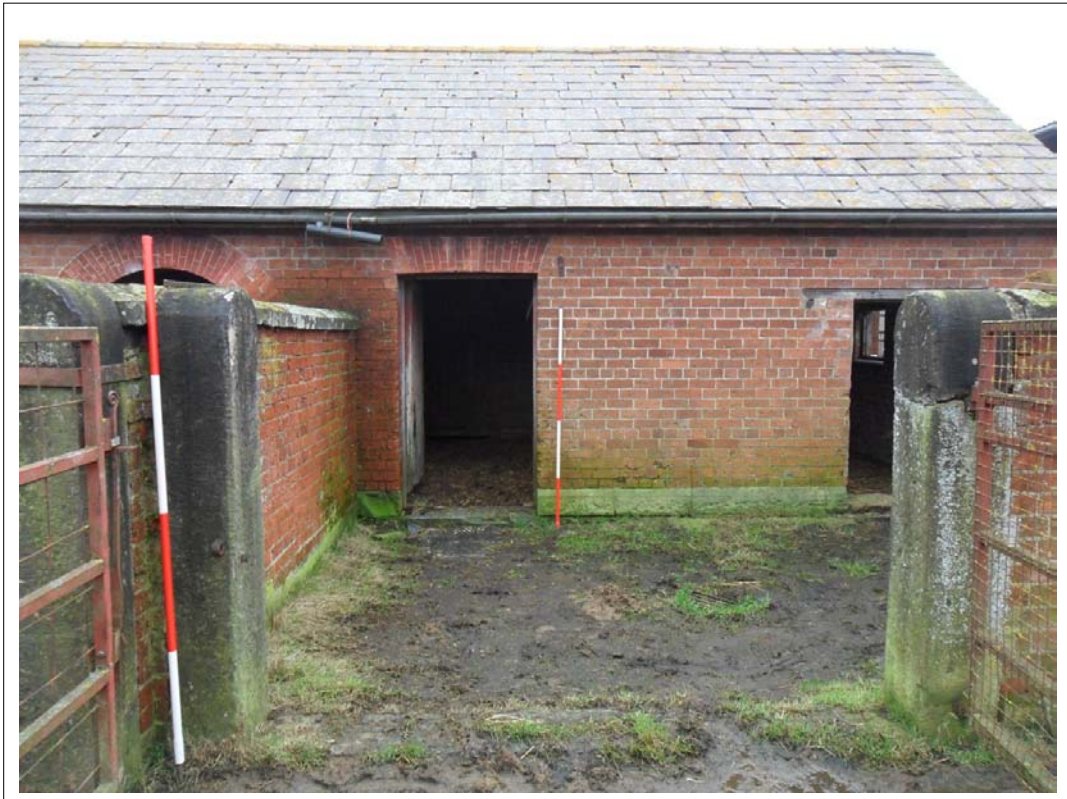
Plate 25: View of small enclosed yard area at south western end of second animal range, mirroring that located opposite on first animal range. Scales 2x2m, Looking south east

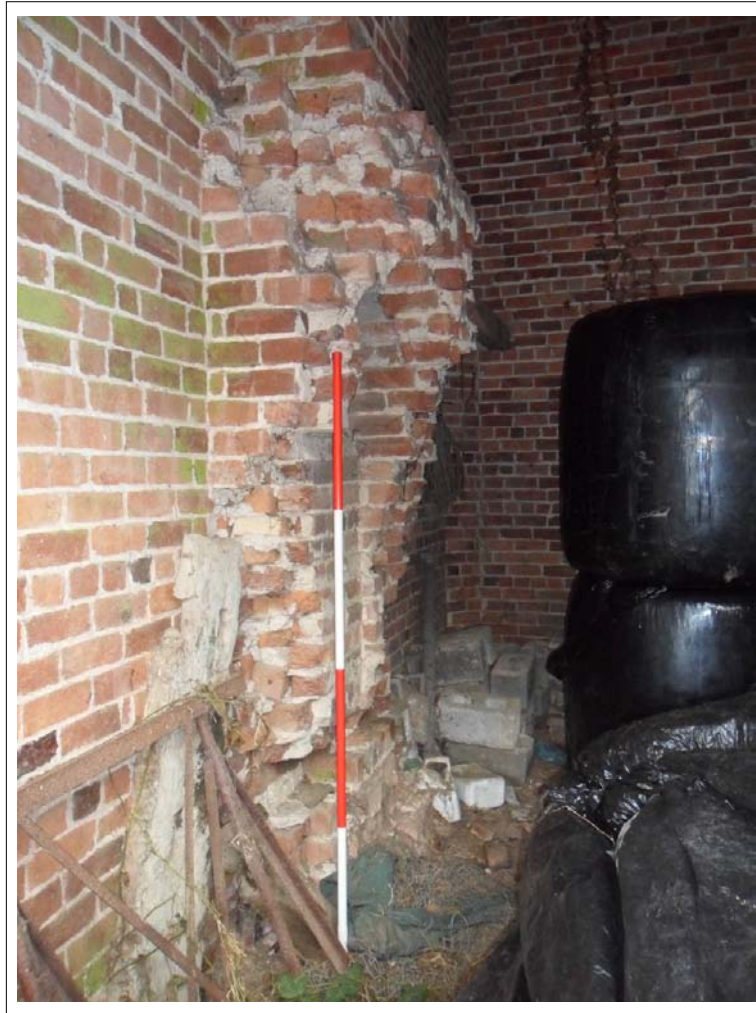
Plate 75: View of damaged/removed fireplace within groundfloor room, north western edge of complex
Scale 1x2m

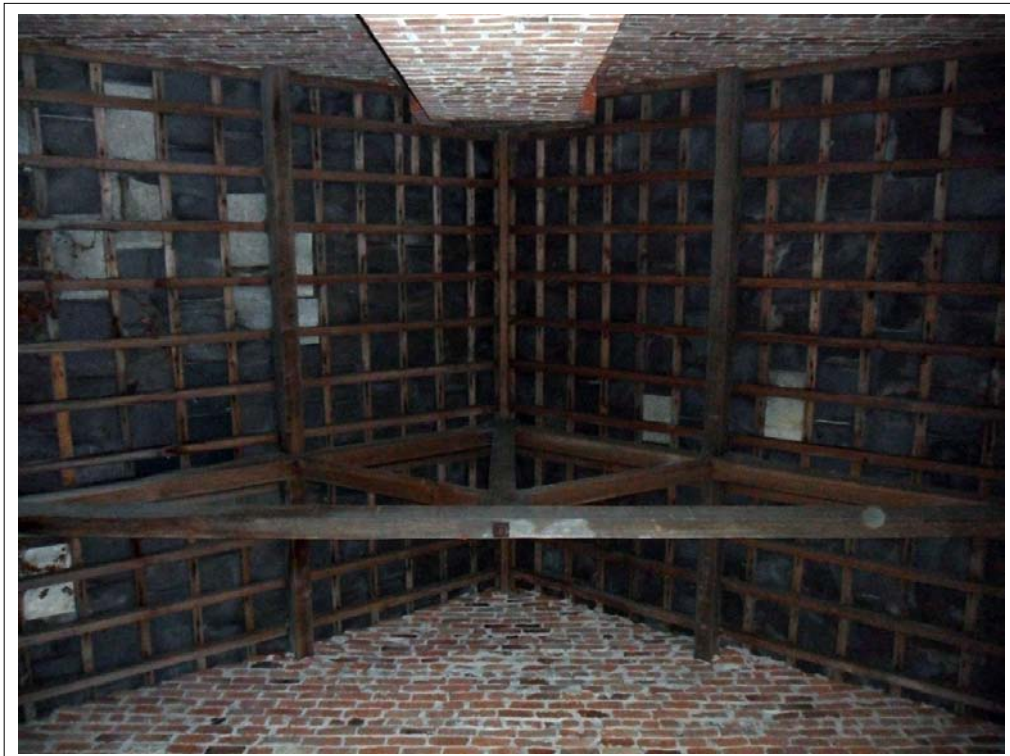
Plate 76: Detail of roof and rafter construction in room with damaged/removed fireplace. Note no upper level.

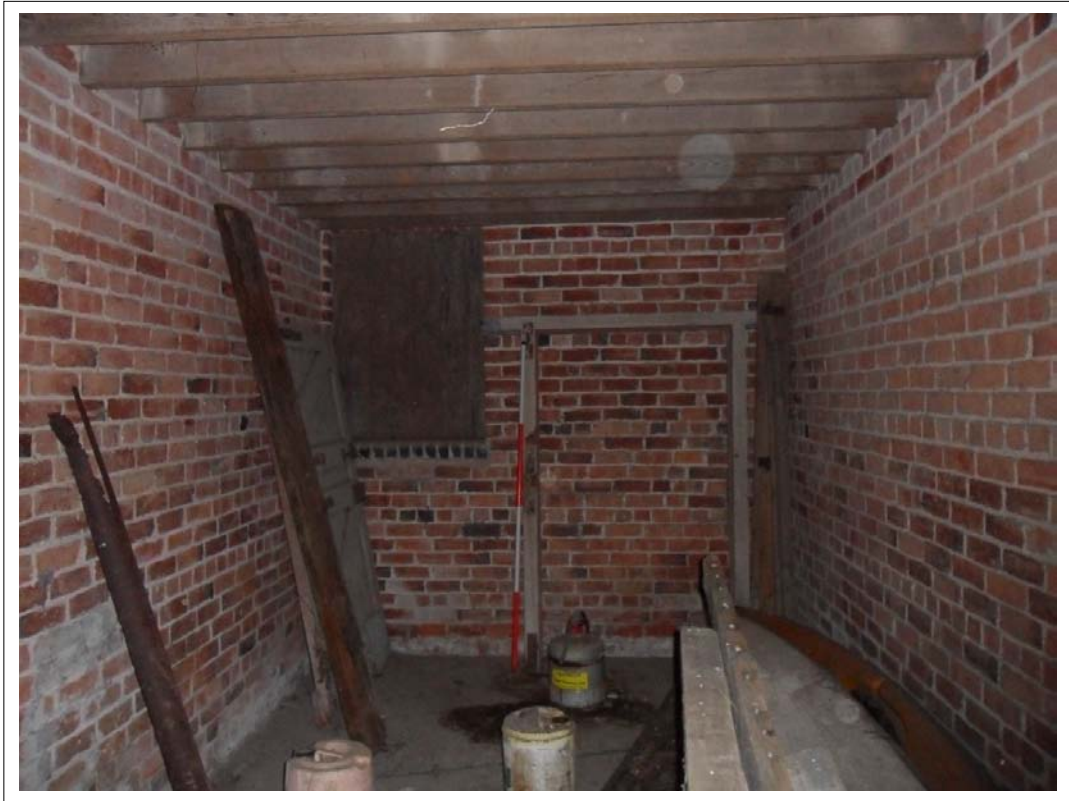
Plate 77: View inside room at north eastern end of covered porch area
Scale 1x2m
