Pwll-y-Llygod Bridge, Trimsaran, Carmarthenshire

Level 3 Historic Buildings Record & Watching Brief Report

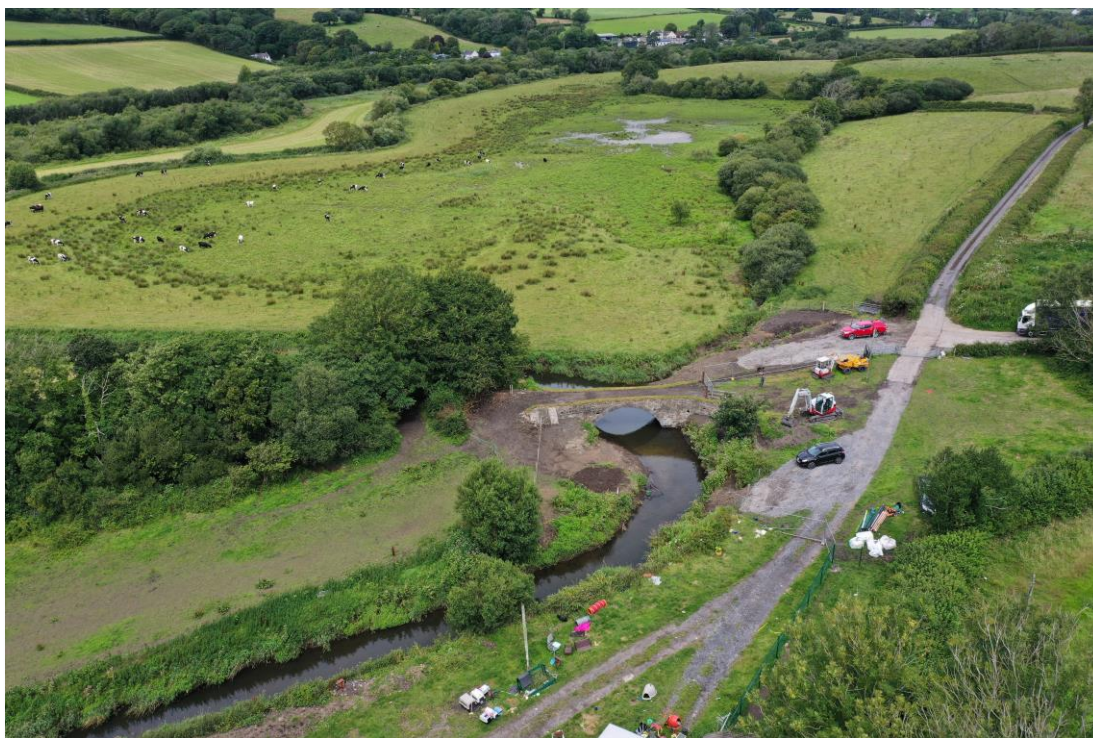
Fig. 1 – Post-work aerial photograph of Pwll-y-Llygod

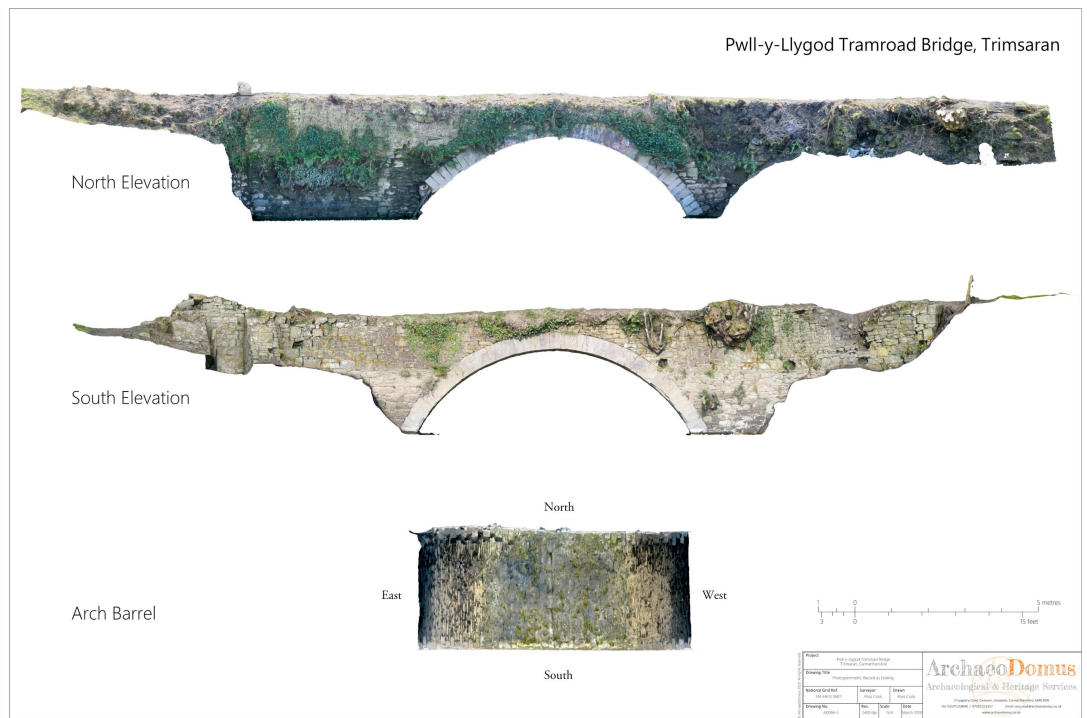
Fig. 6 – Photogrammetric orthoplanes of Pwll-y-Llygod.

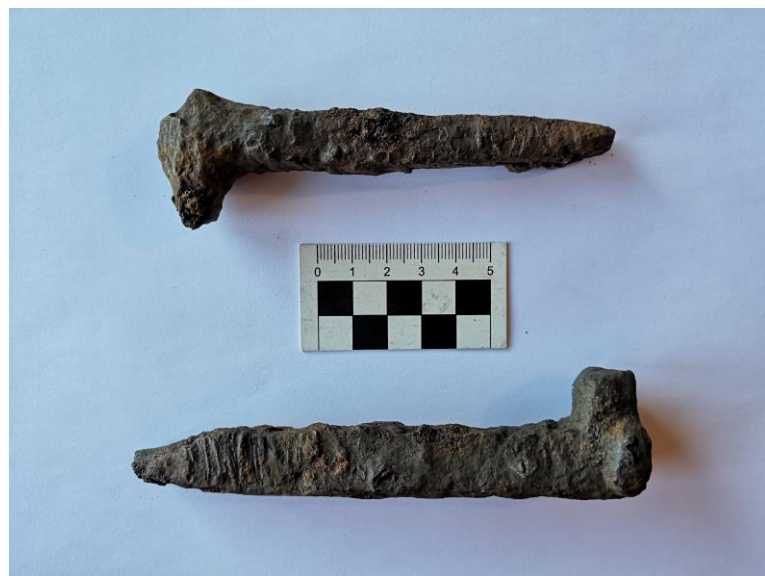
Fig. 8 – Railway spikes. Cut (top; FN001) and dog (bottom; FN002).

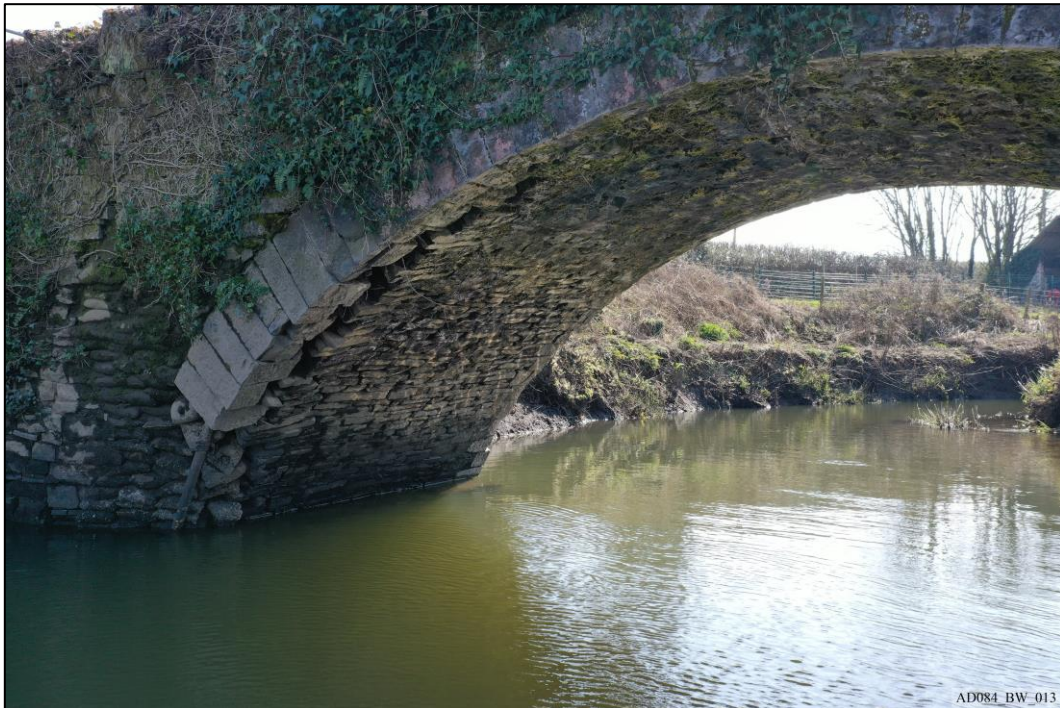
Plate 13 – Pre-works – Arch and barrel vault of east abutment, viewed from north, showing damage.

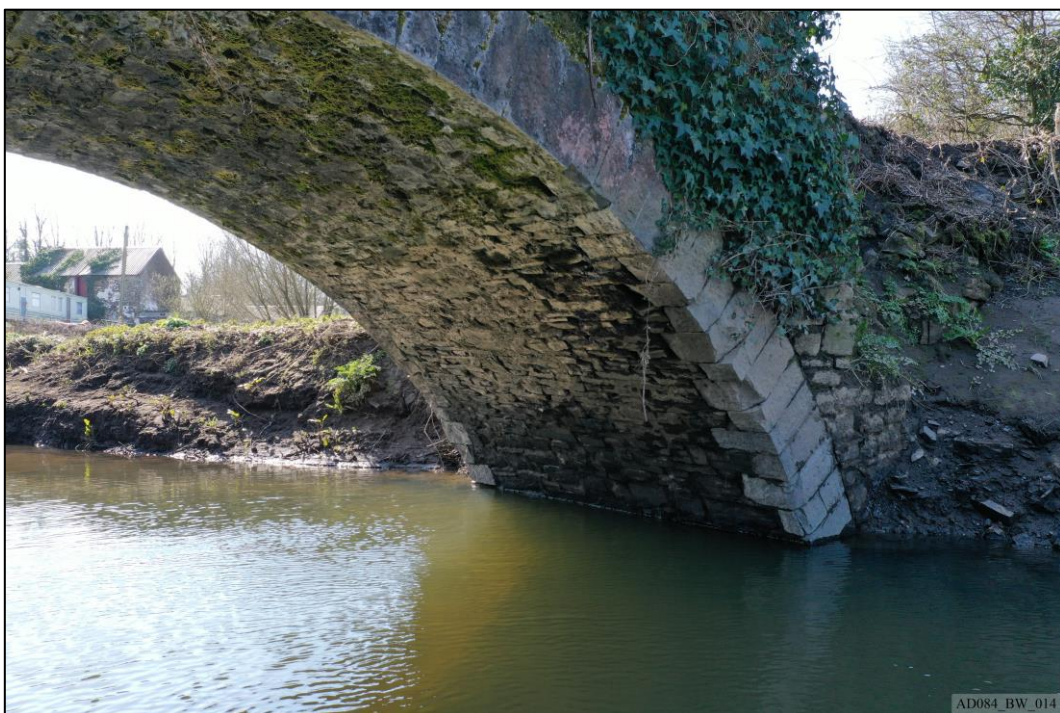
Plate 14 – Pre-works – Arch and barrel vault of west abutment, viewed from north, showing damage.

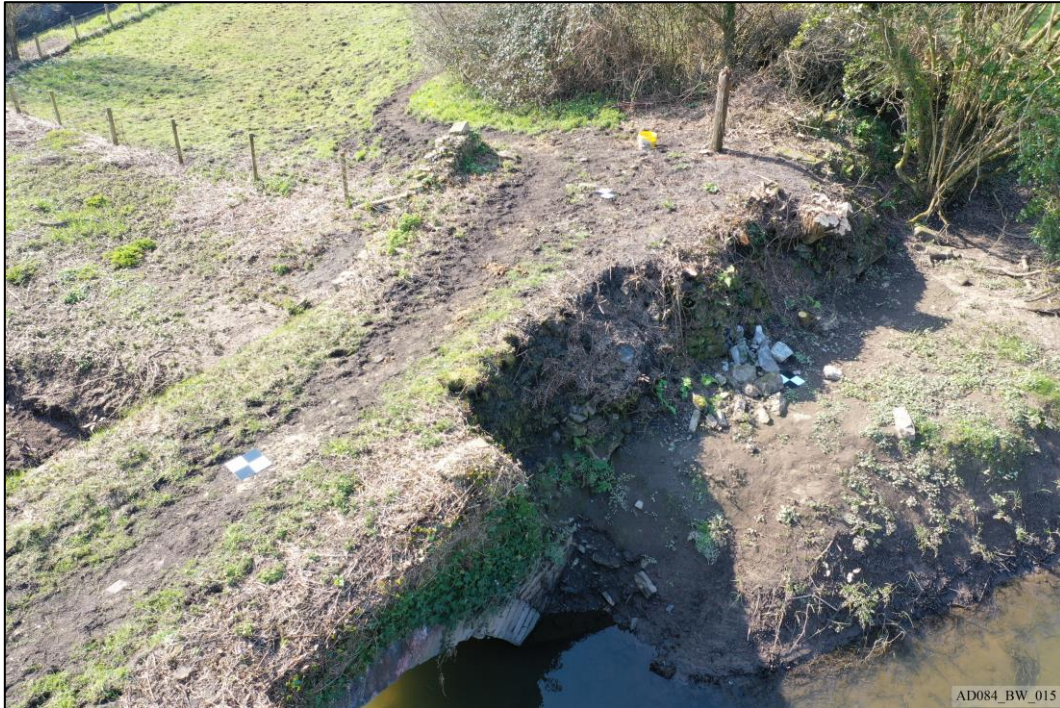
Plate 15 – Pre-works – North elevation, west spandrel and wing wall collapse.

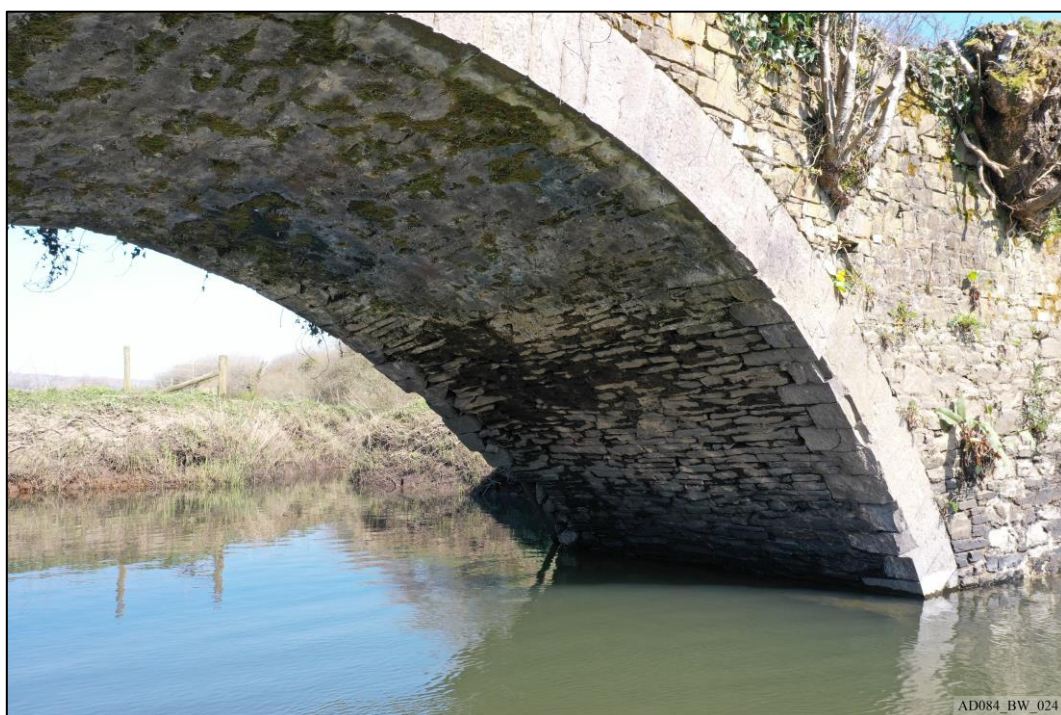
Plate 24 – Pre-works – Arch and barrel vault of west abutment, viewed from south, showing damage.

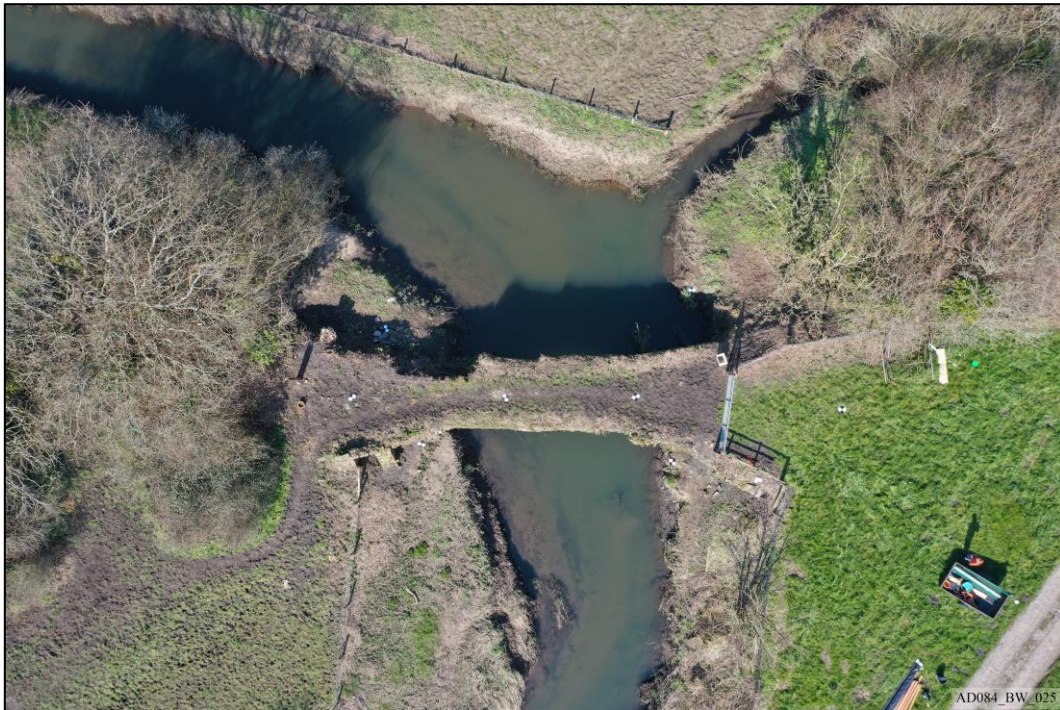
Plate 25 – Pre-works – Nadir view, after clearance works.

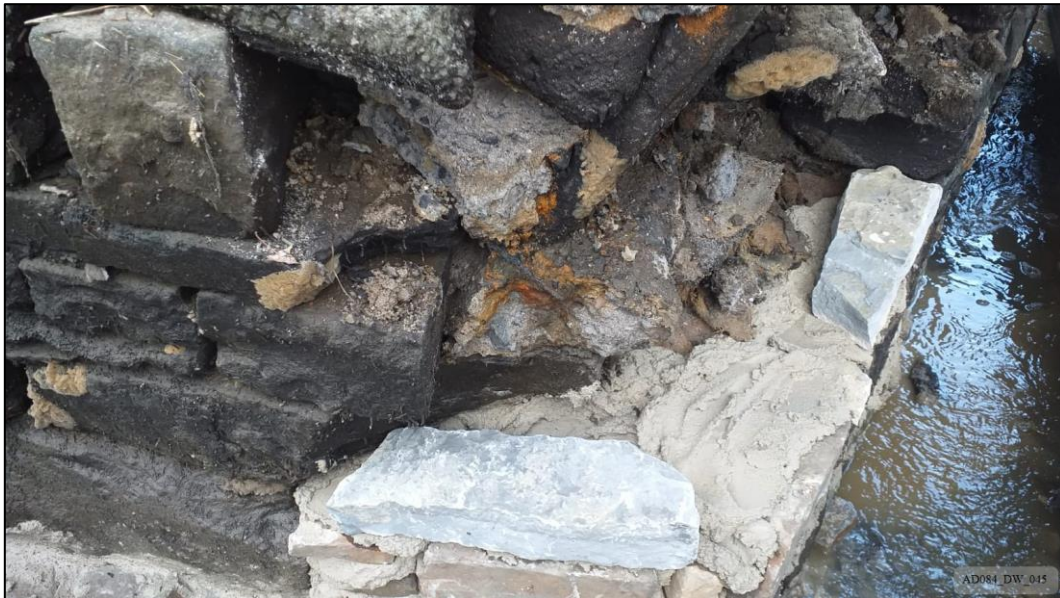
Plate 45 – During works – North elevation, showing repair to east abutment.

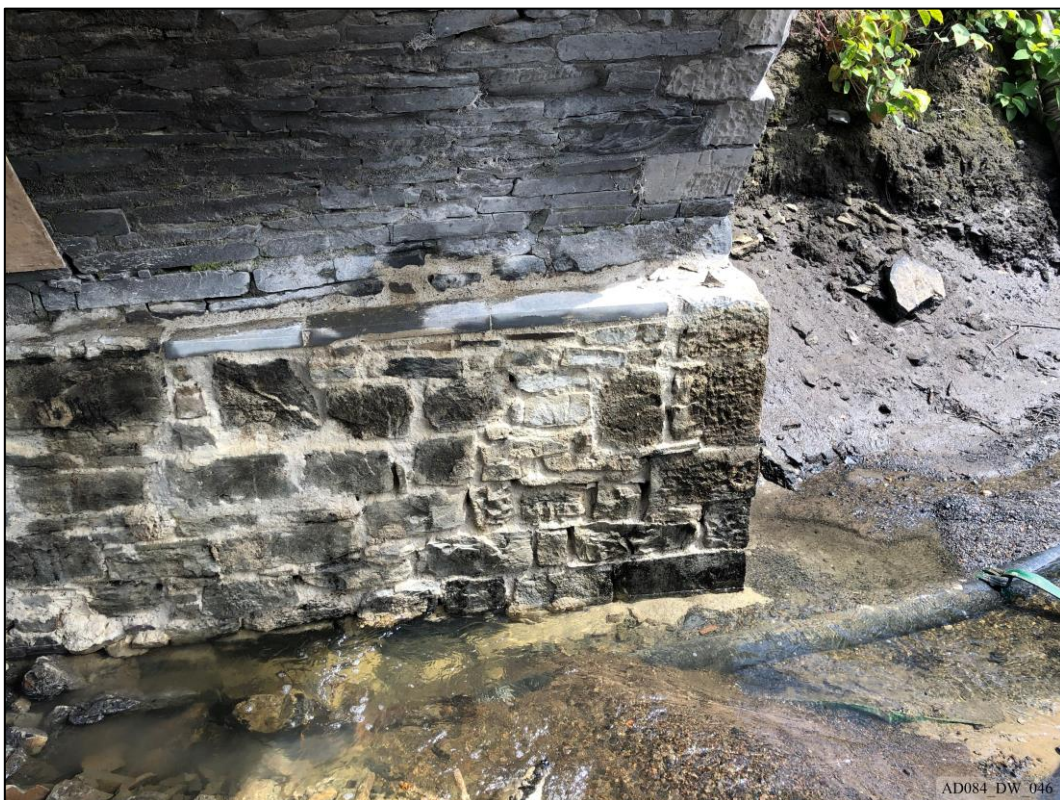
Plate 46 – During works – View east, showing repair to east abutment.

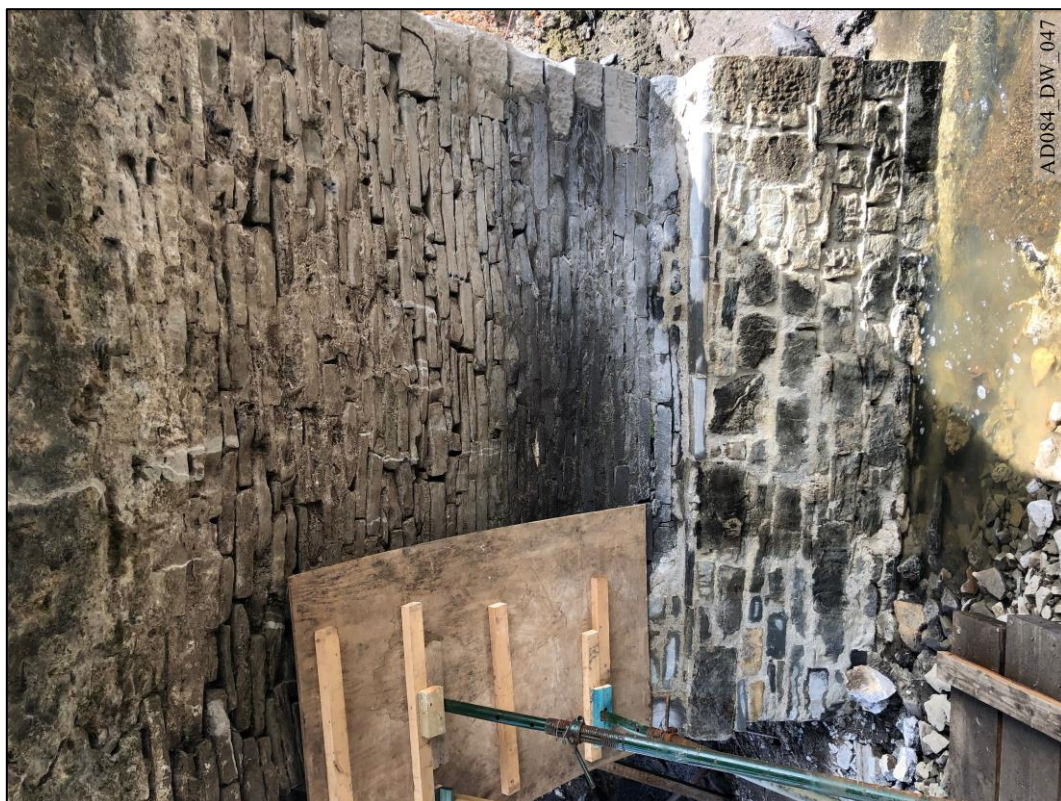
Plate 47 – During works – View east, showing repairs to east abutment.

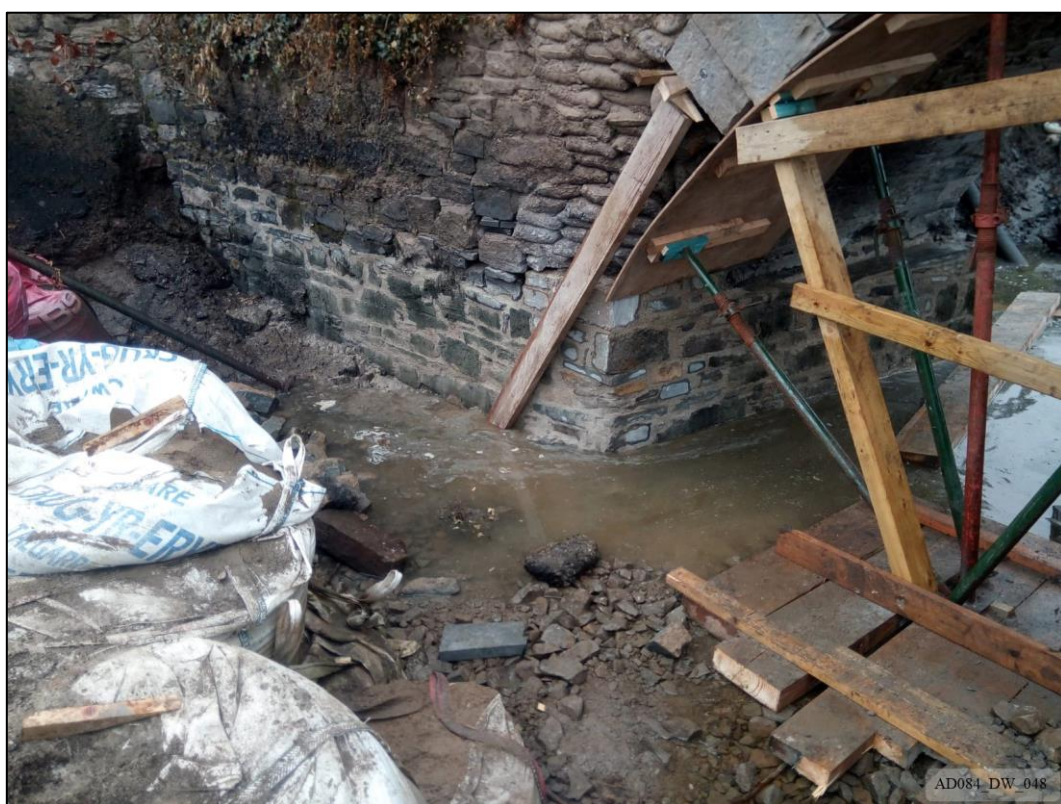
Plate 48 – During works – North elevation, showing repair to lower east abutment.

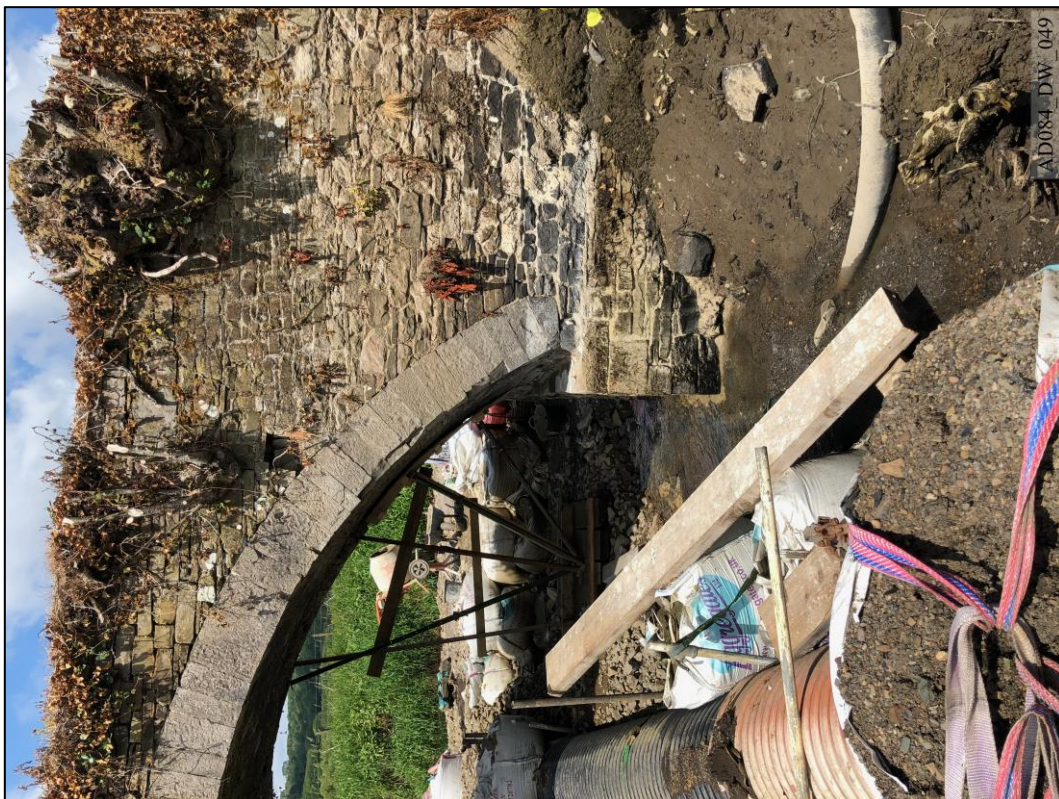
Plate 49 – During works – North elevation, showing repaired lower abutment.

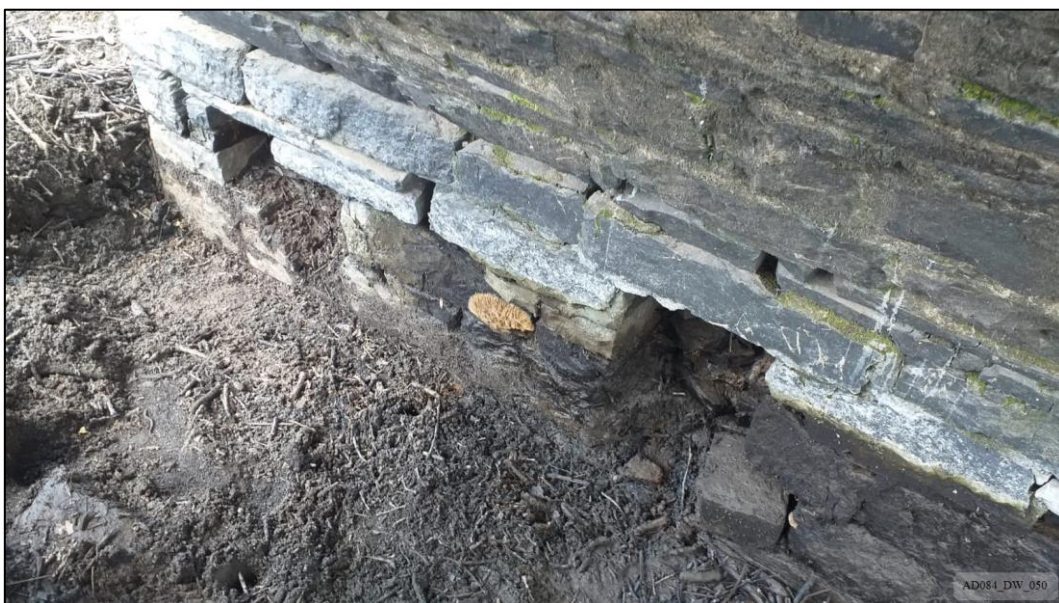
Plate 50 – During works – View east, showing lower abutment.

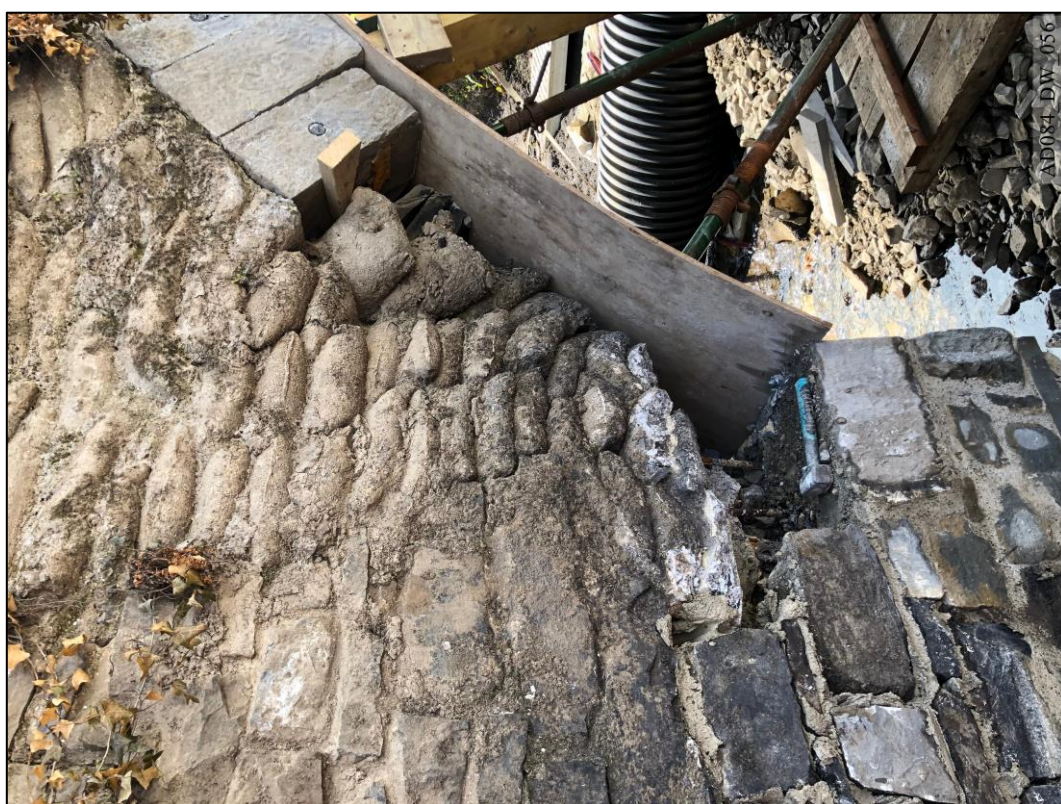
Plate 56 – During works – North elevation, showing east spandrel repair and arch former.

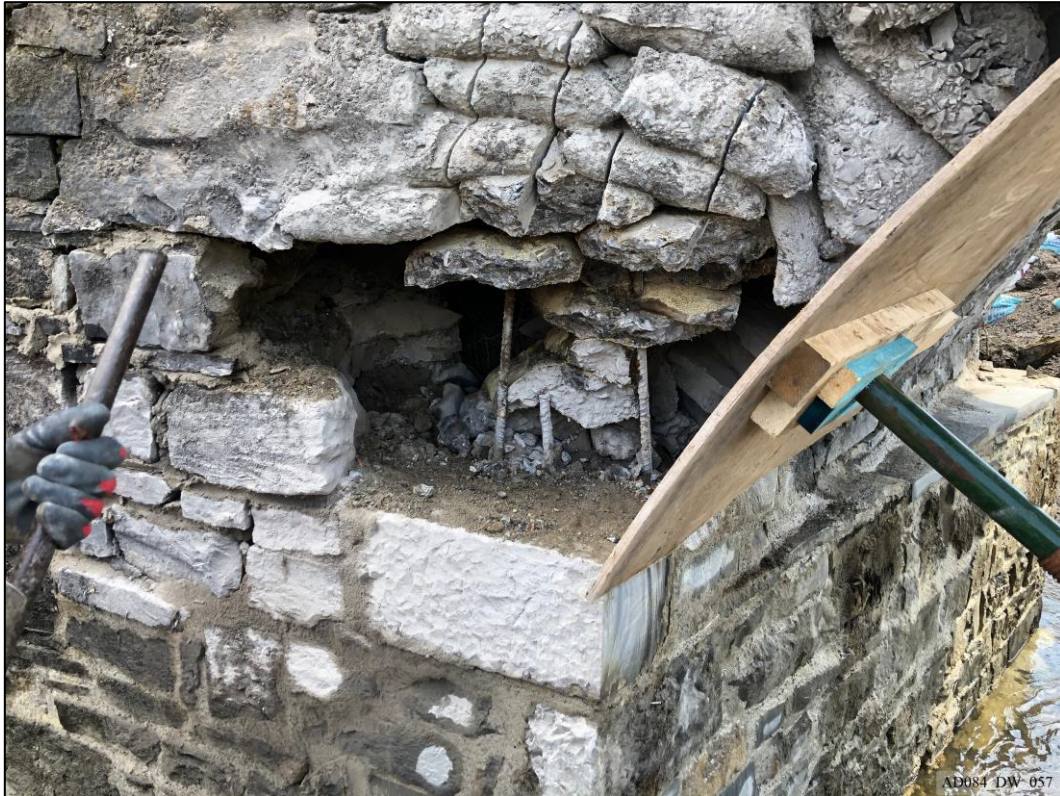
Plate 57 – During works – North elevation, showing removal of east spandrel repair.

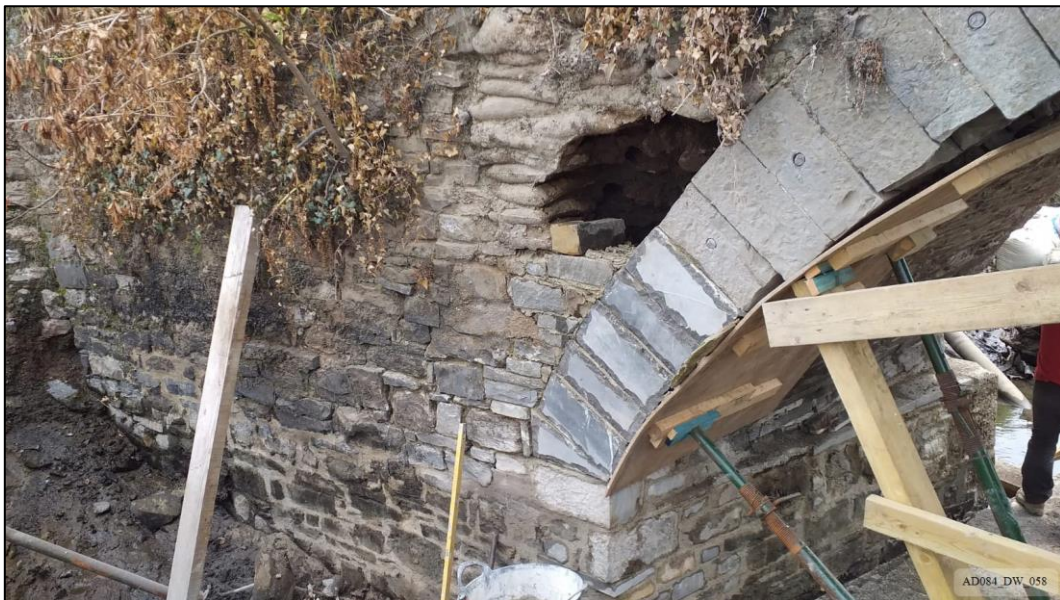
Plate 58 – During works – North elevation, showing removal of east spandrel repair and masonry rebuild.

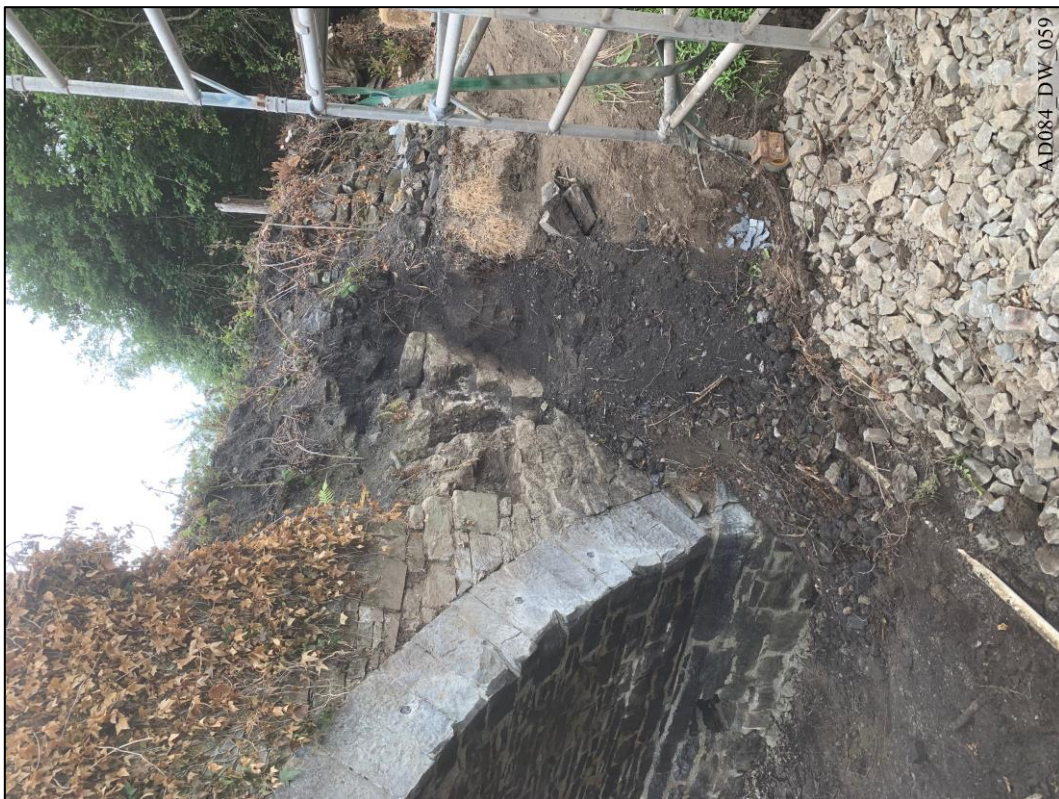
Plate 59 – During works – North elevation, cleaning and dismantling of west spandrel and wing wall.

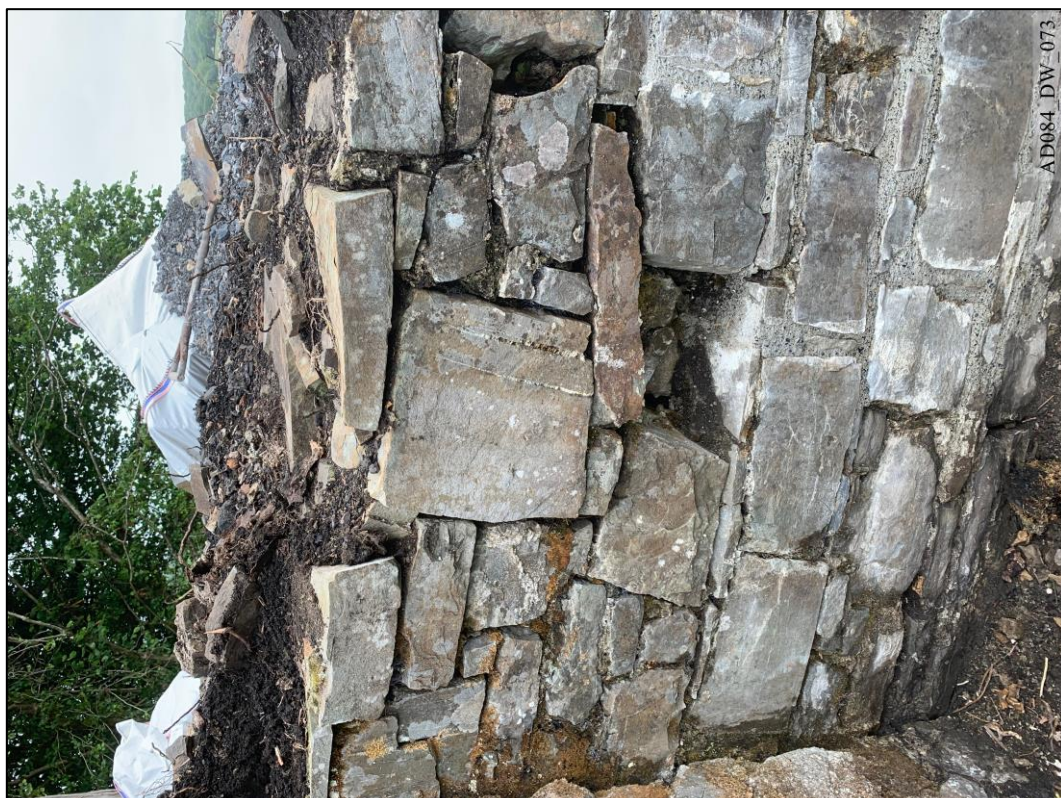
Plate 73 – During works – South elevation, showing west wing wall masonry deterioration.

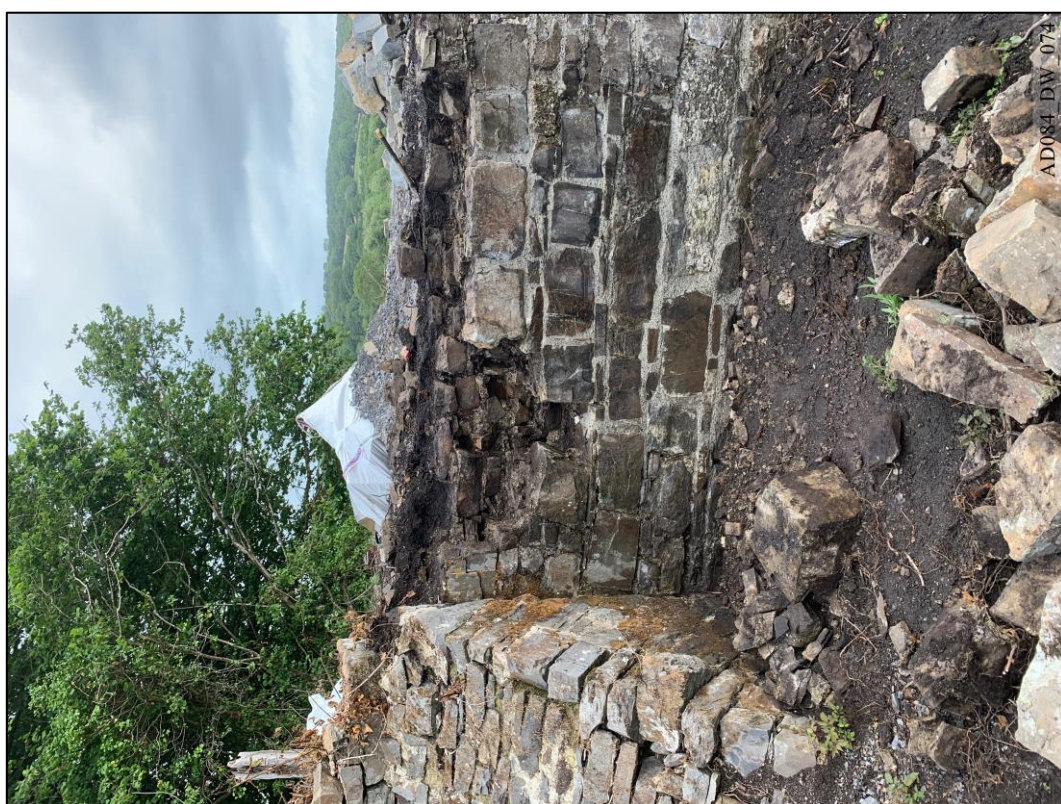
Plate 74 – During works – South elevation, showing dismantling of deteriorated masonry.

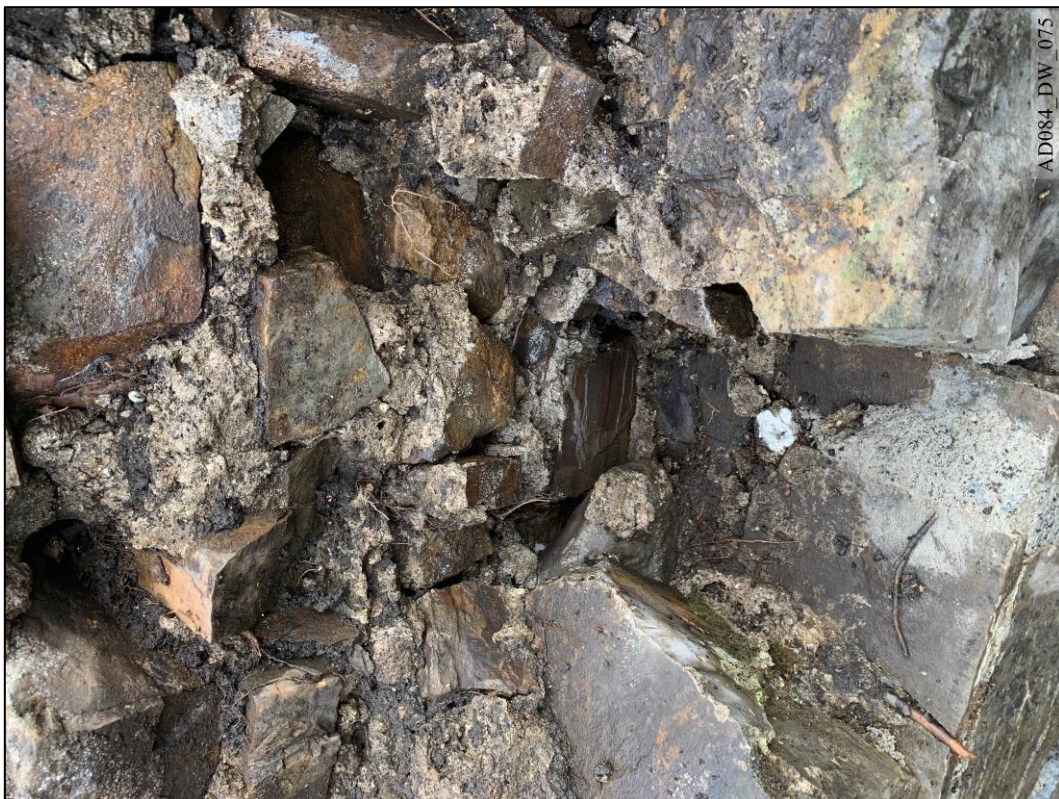
Plate 75 – During works – South elevation, showing core masonry to west wing wall.

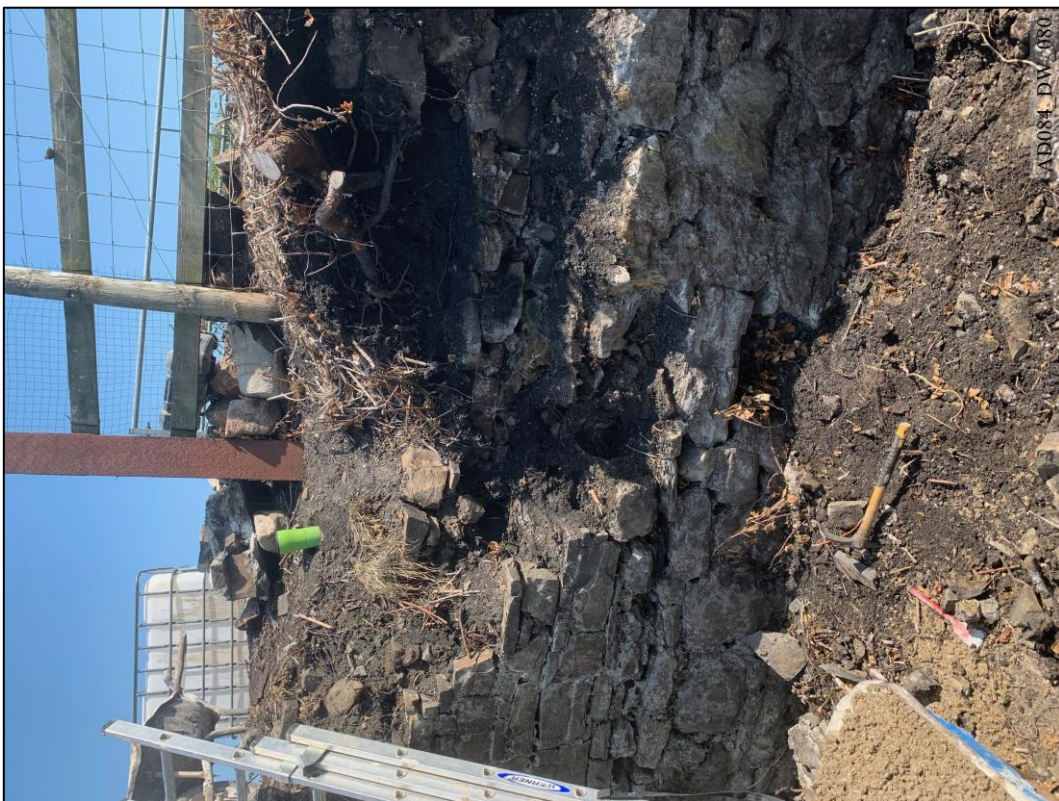
Plate 80 – During works – South elevation, showing damage to east wing wall.

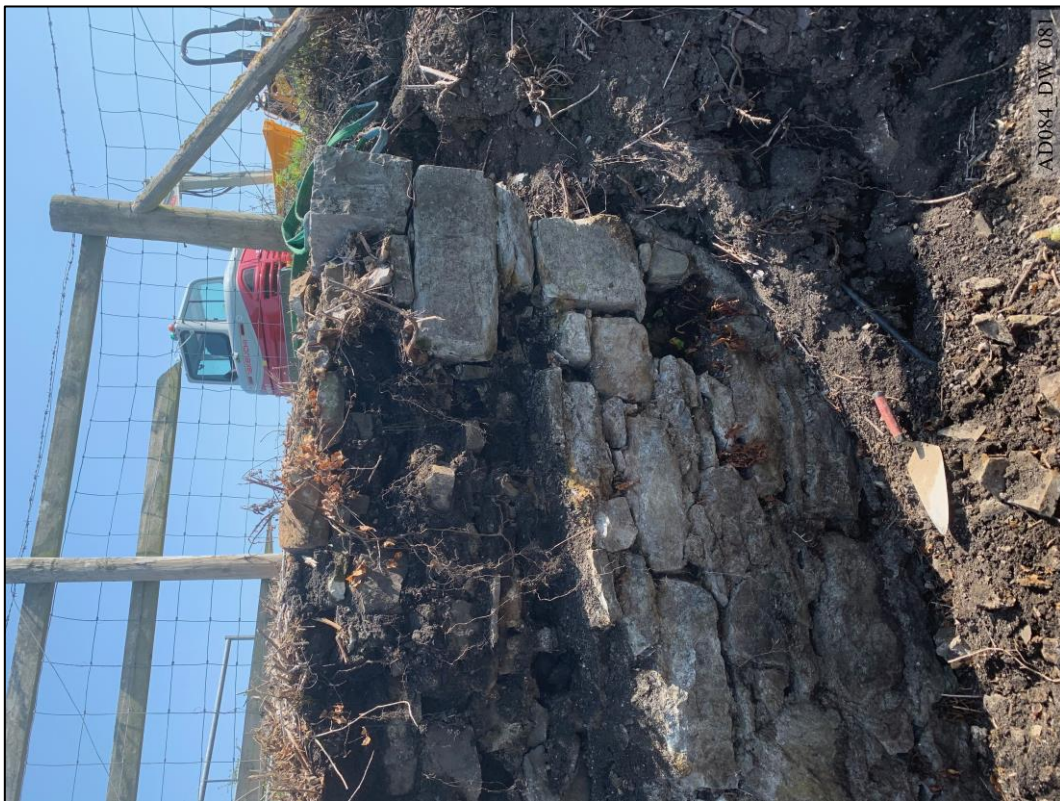
Plate 81 – During works – South elevation, showing damage to east wing wall.

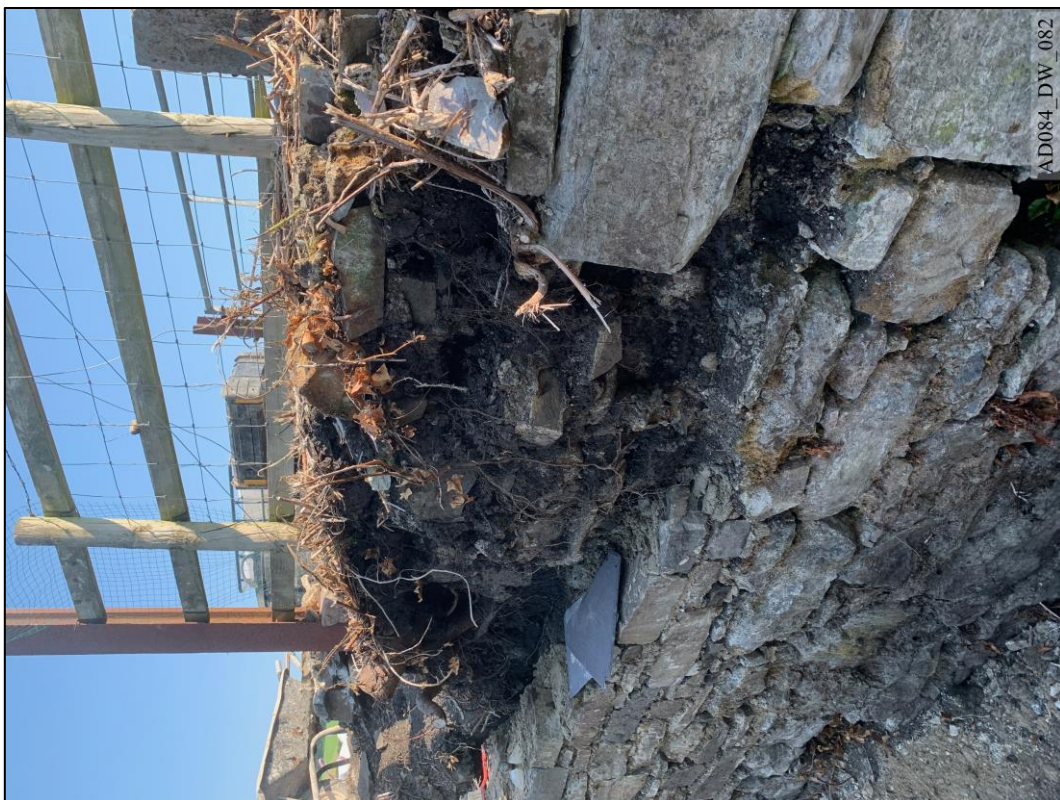
Plate 82 – During works – South elevation, showing partial dismantling of east wing wall.

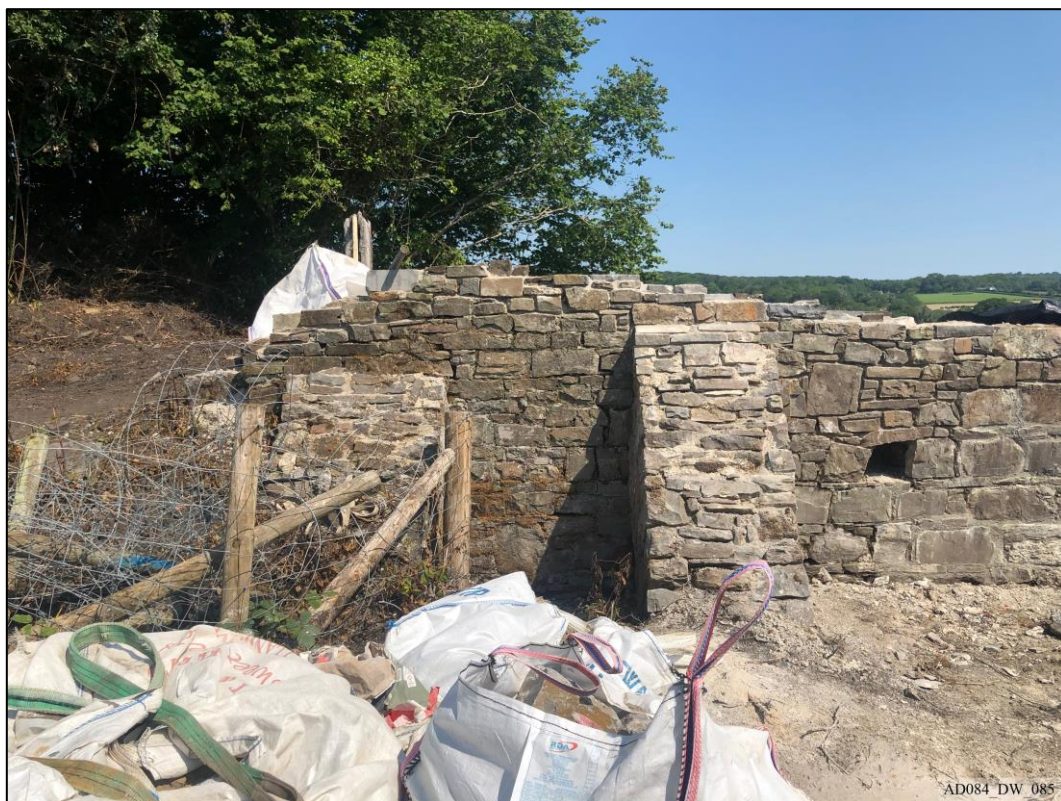
Plate 85 – During works – South elevation, showing repair of buttresses to west wing and retaining wall.

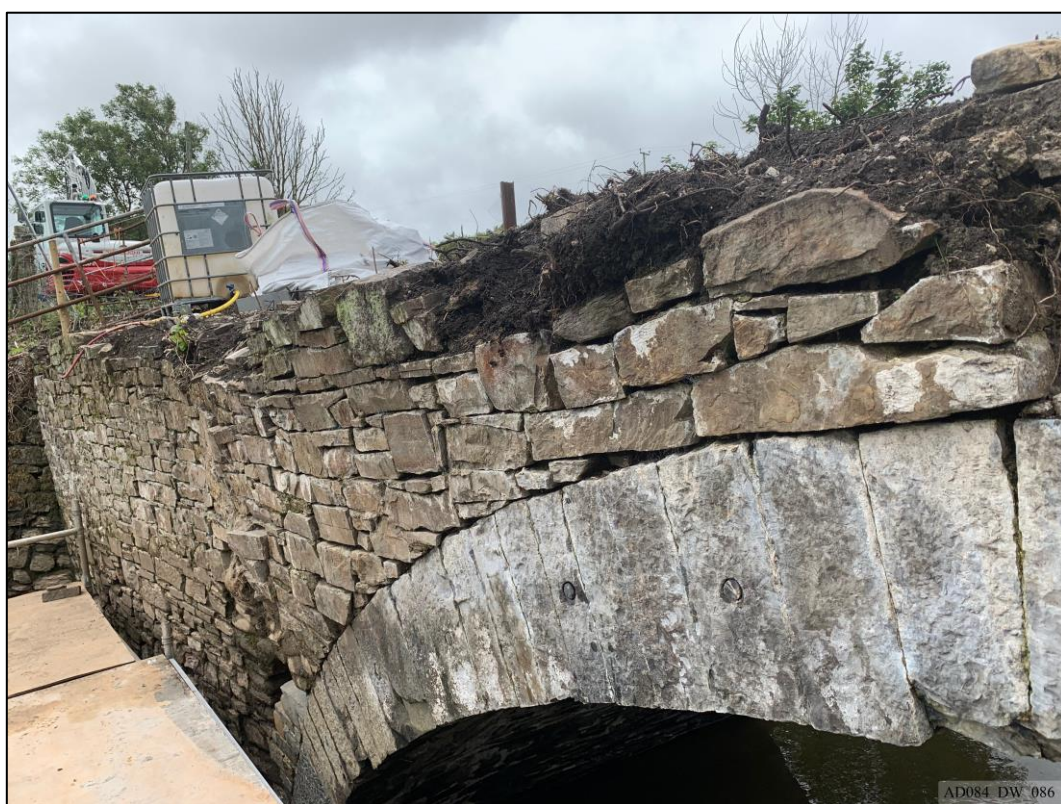
Plate 86 – During works – North elevation, showing bulge in masonry to east spandrel.
