Parke, Merrion, Castlemartin, Pembrokeshire

Level 3 Historic Buildings Record & Watching Brief Report

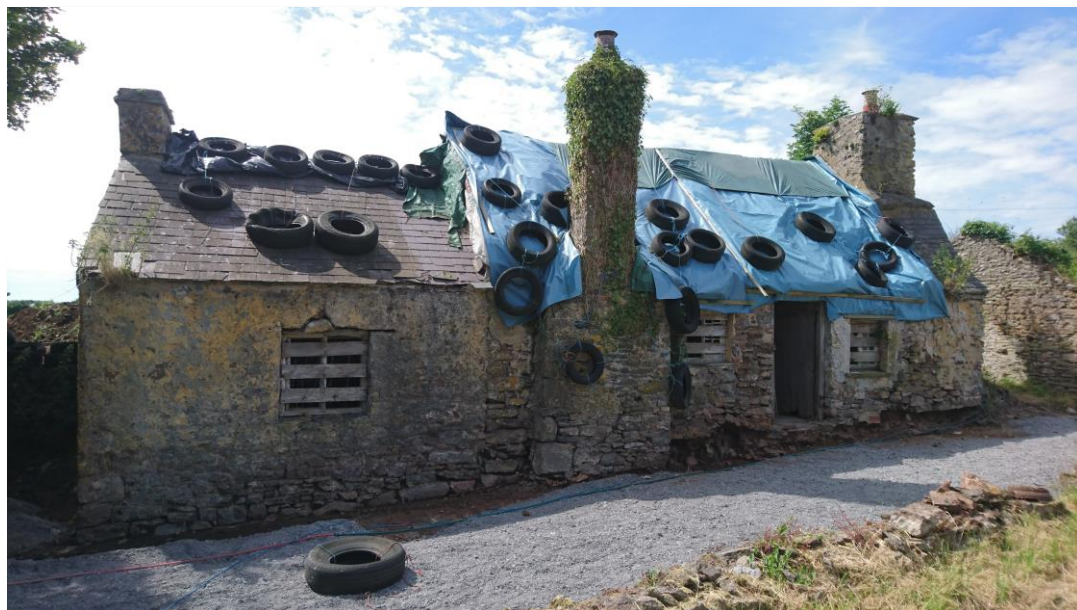
Fig. 1 – Parke Cottage.

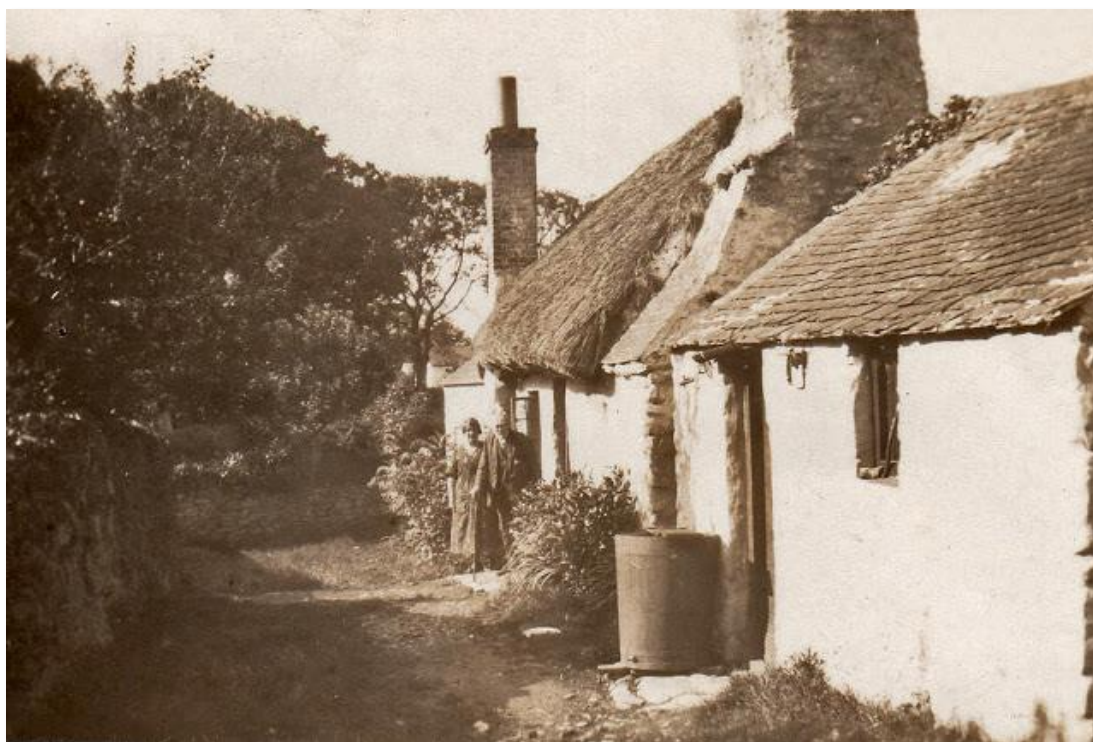
Fig. 6 – Parke in 1911, with unknown couple at door.

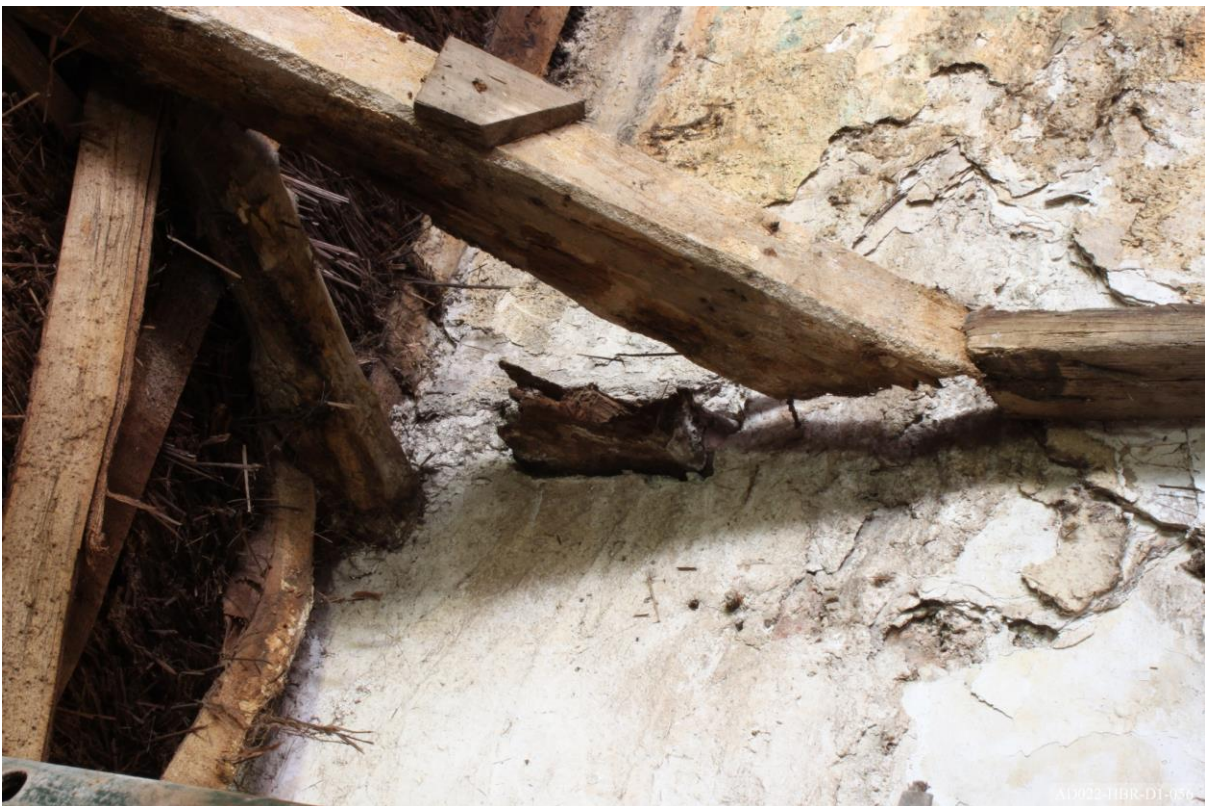
Plate 56 – View towards west of cottage, showing decayed end of west principal rafter to truss 4.

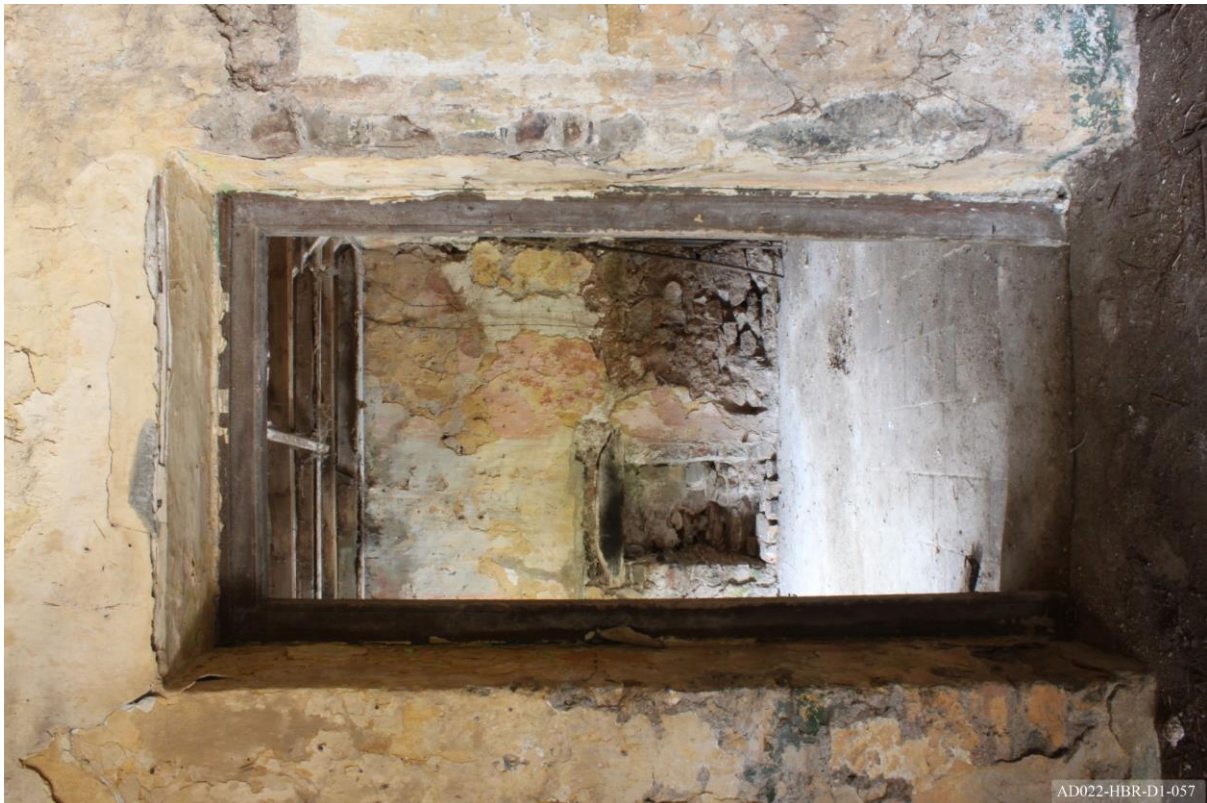
Plate 57 – View towards south of cottage, showing doorway to extension.

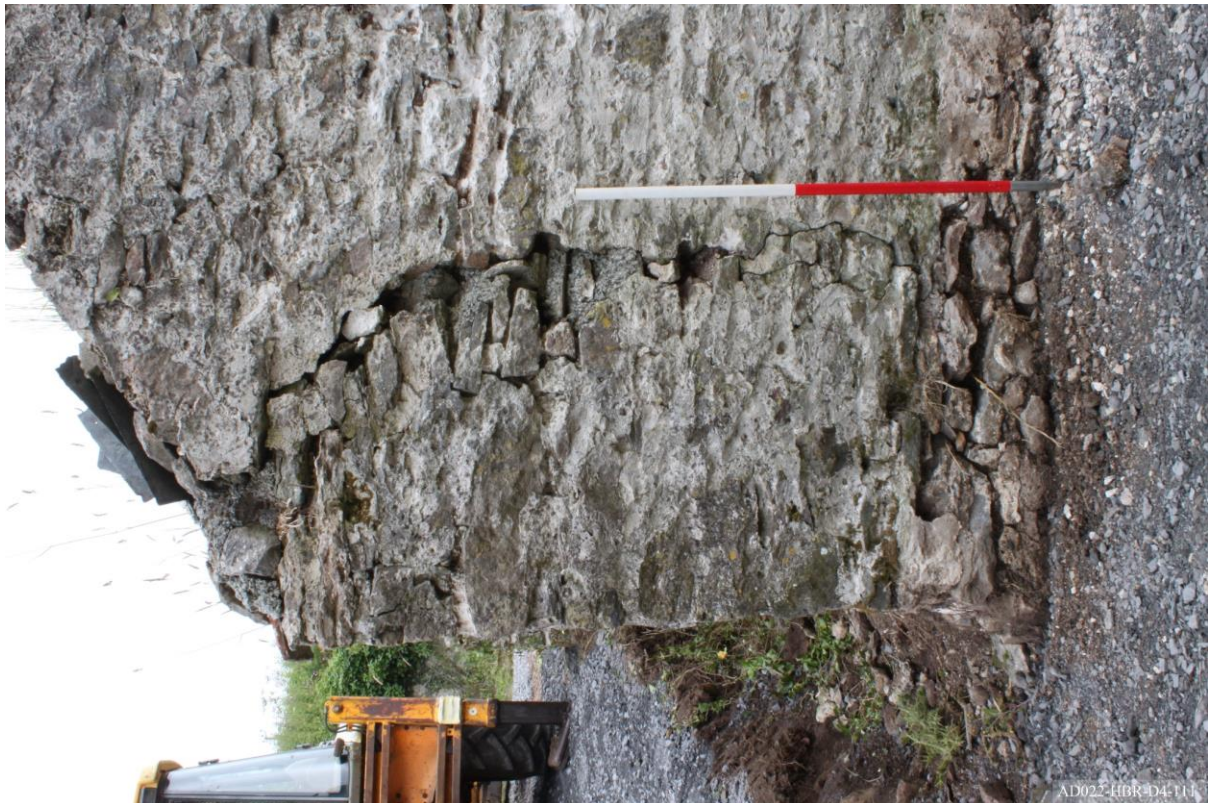
Plate 111 – View of south elevation of HB1, showing subsidence crack.

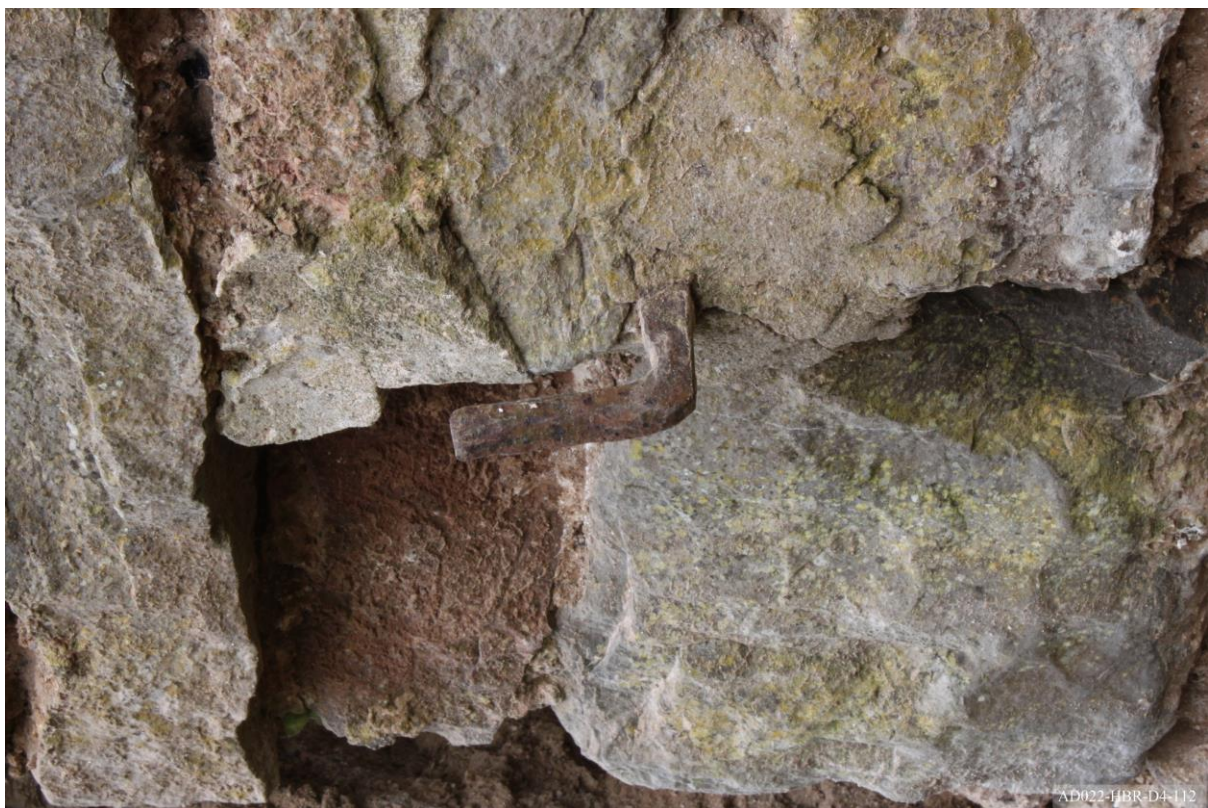
Plate 112 – Pintle of former gate to south elevation of HB1.

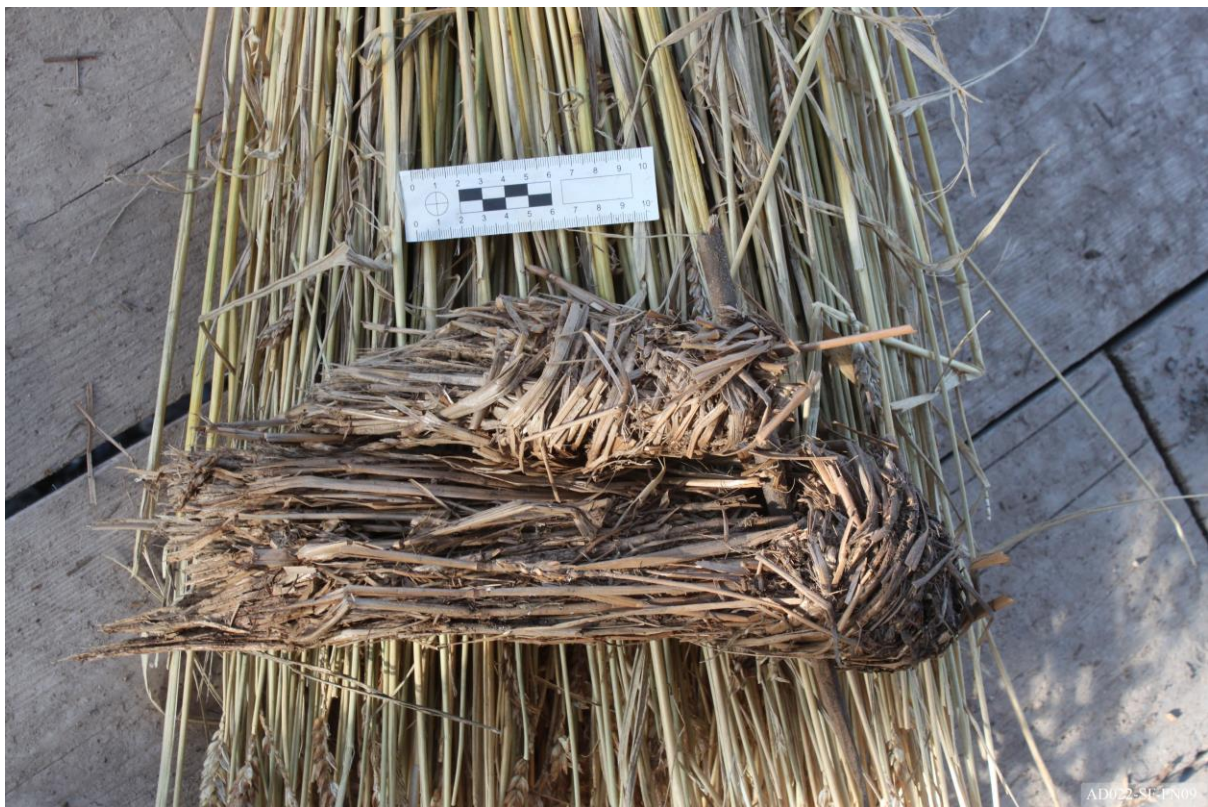
Plate 162 – ‘Stuff’ or ‘Thrust’ Thatch used to repair thatched roofs. FN09.

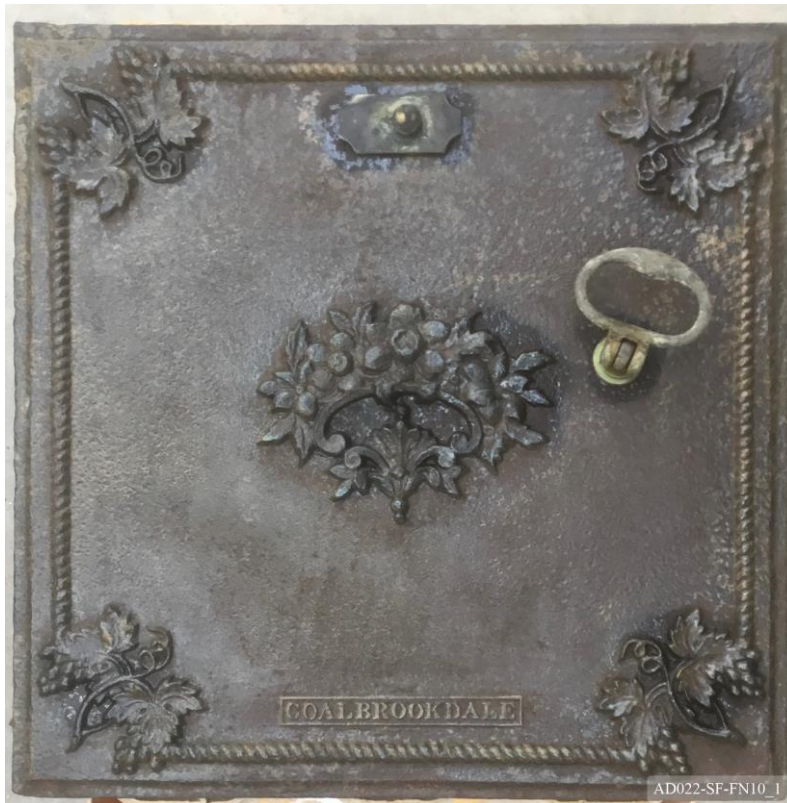
Plate 164 – Cast iron oven door with ‘Colebrookdale’ in relief lettering. FN10.
