**LEVEL 2 BUILDING RECORDING OF
CHAPEL BARN AT
PANT GLAS, LLANISHEN,
MONMOUTHSHIRE, NP16 6QQ
LISTED BUILDING CONSENT:
DC/2017/00053 (Monmouthshire)**

Report by: Trysor

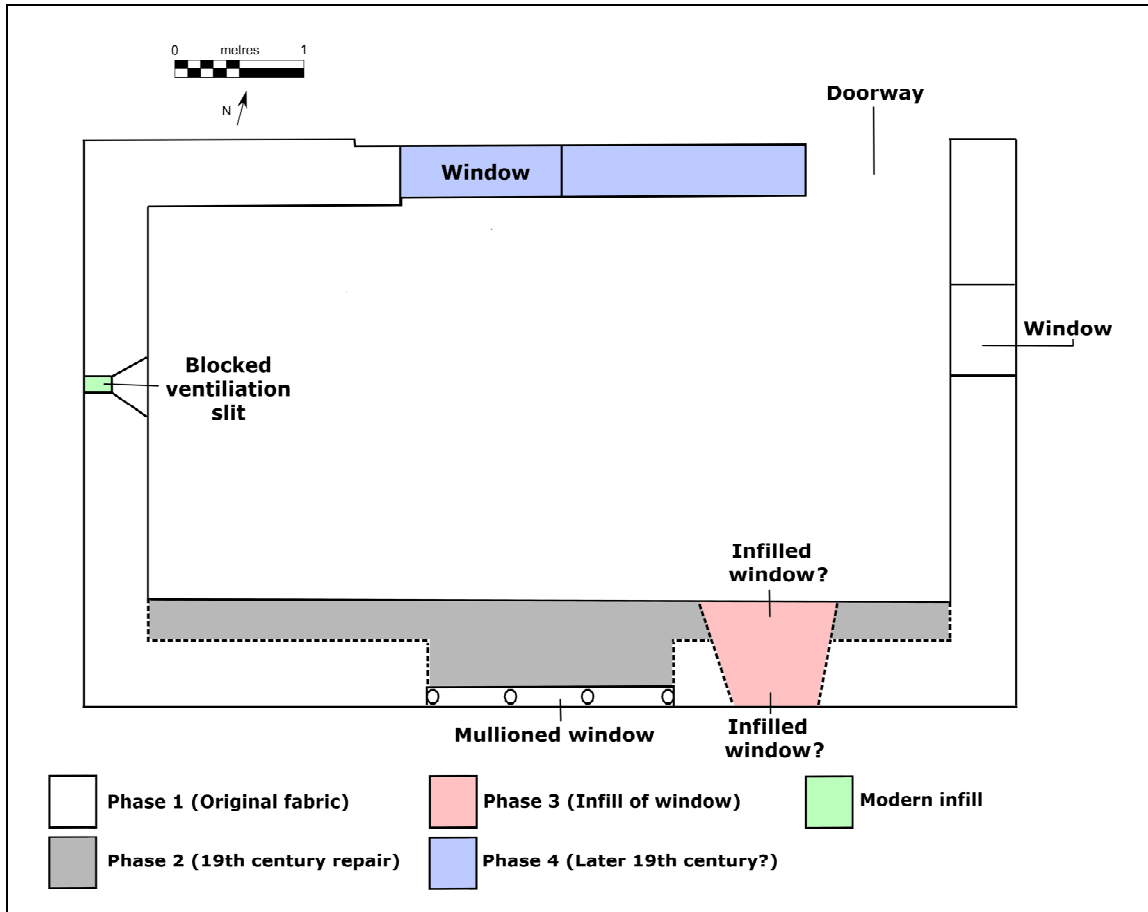
Figure 8: Plan of Chapel Barn.

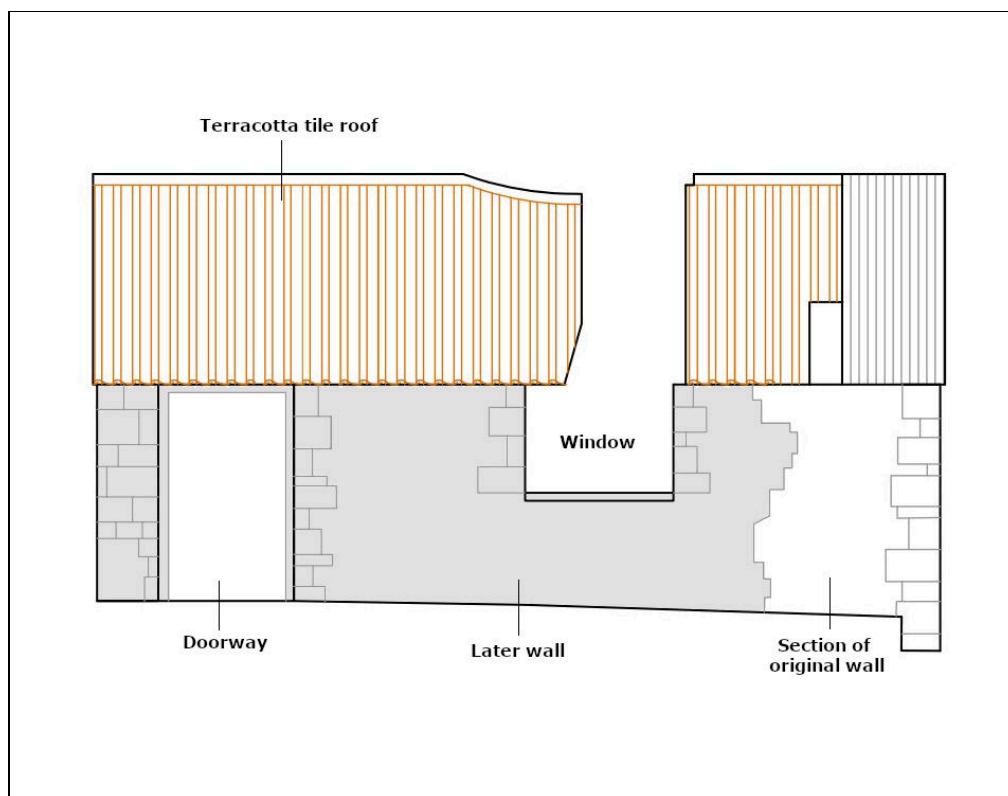
Figure 11: The northern elevation, showing the original wall in white and the later wall in grey. Most of the terracotta roof tiles recorded on this elevation when drawn in 2017 have now been lost. (Source: Heron Associates, 2017. Originally drawn at 1:50 but not to scale here, and with annotations by Trysor, 2020).
