Upper Neuadd Dam Brecon Beacons National Park Powys

Historic Building Recording

> CA Project:5587 CA Report: 15679

September 2015

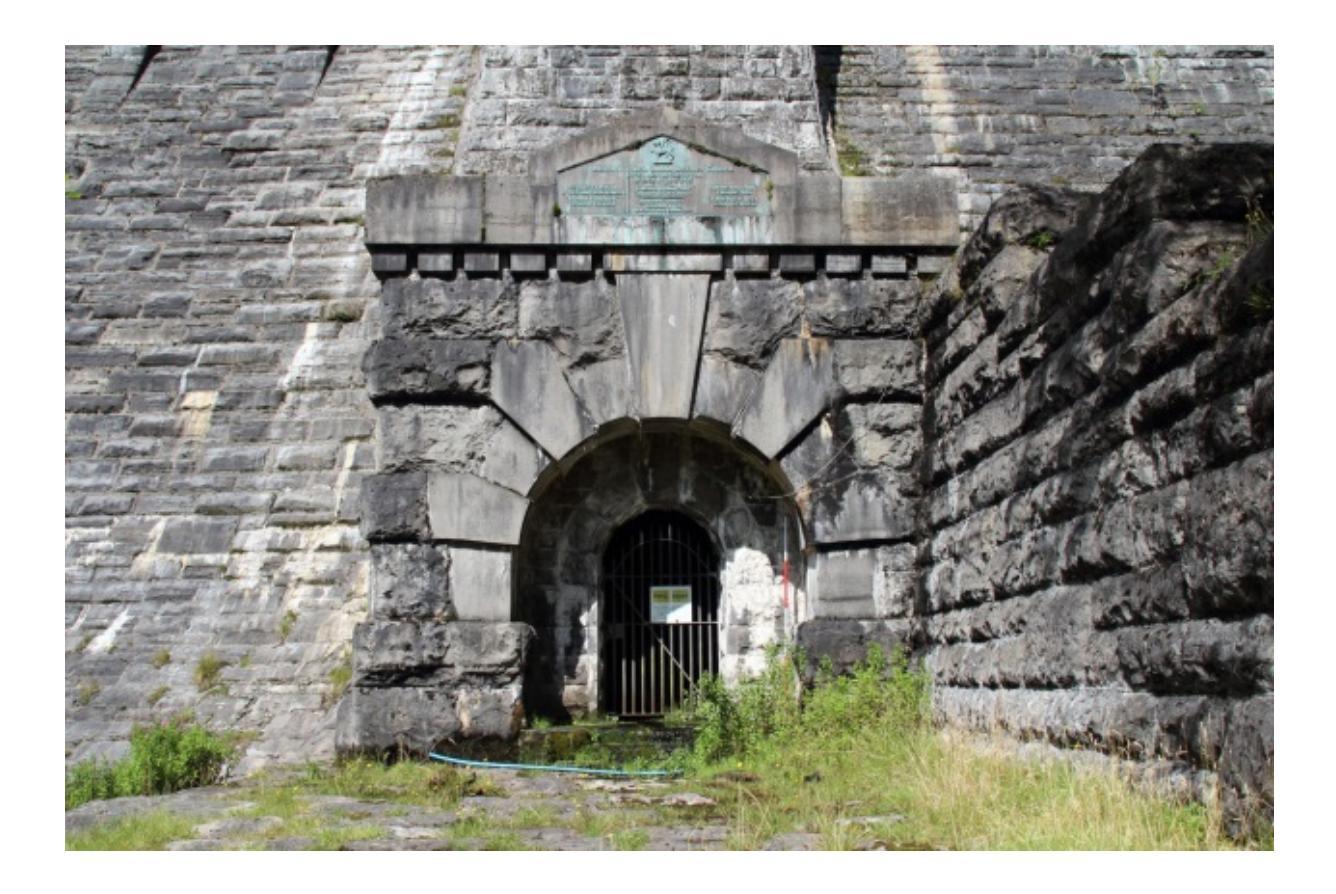
Figure 3. The south elevation of the tunnel building (scale 2m)

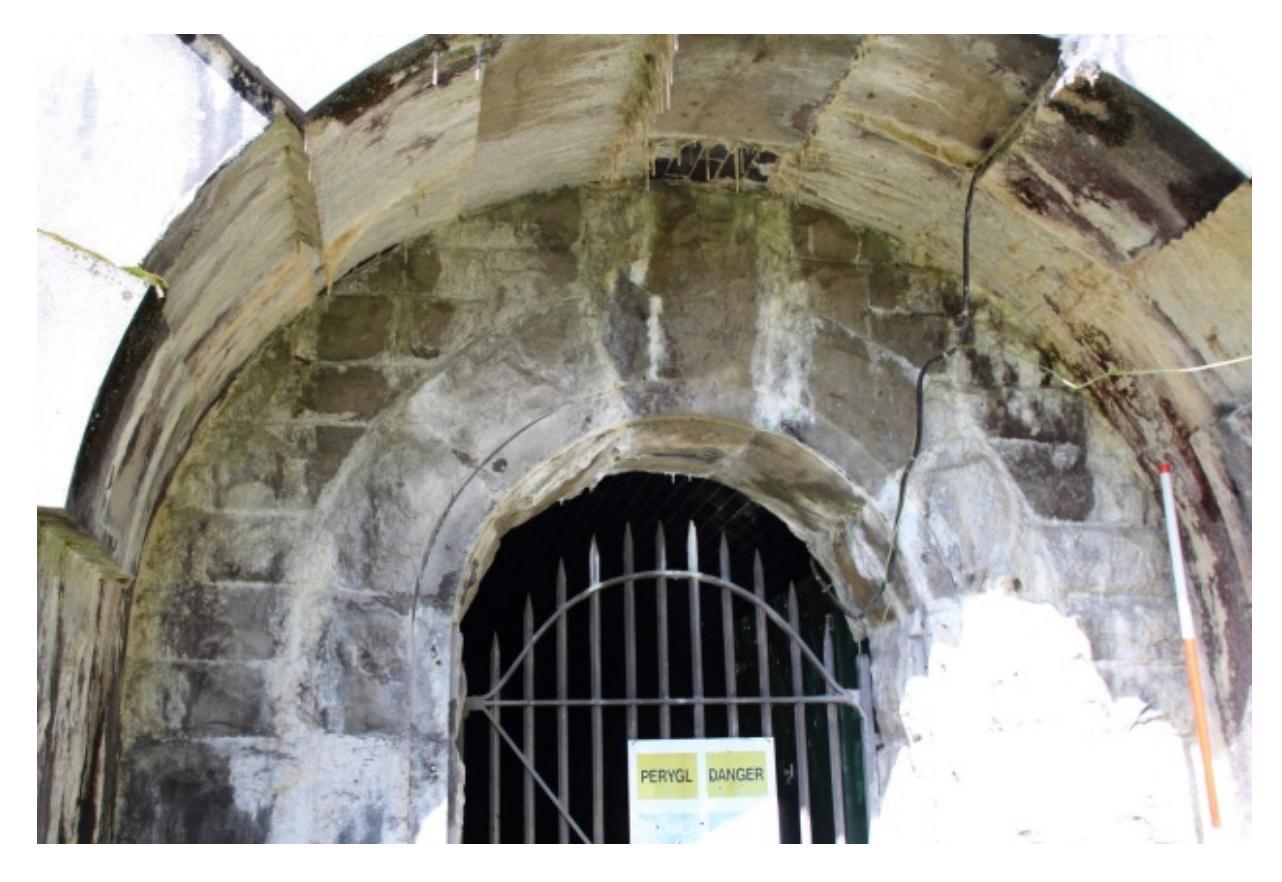
Figure 4. Detail of the arches of the doorway into the tunnel building (scale in 0.5m divisions)

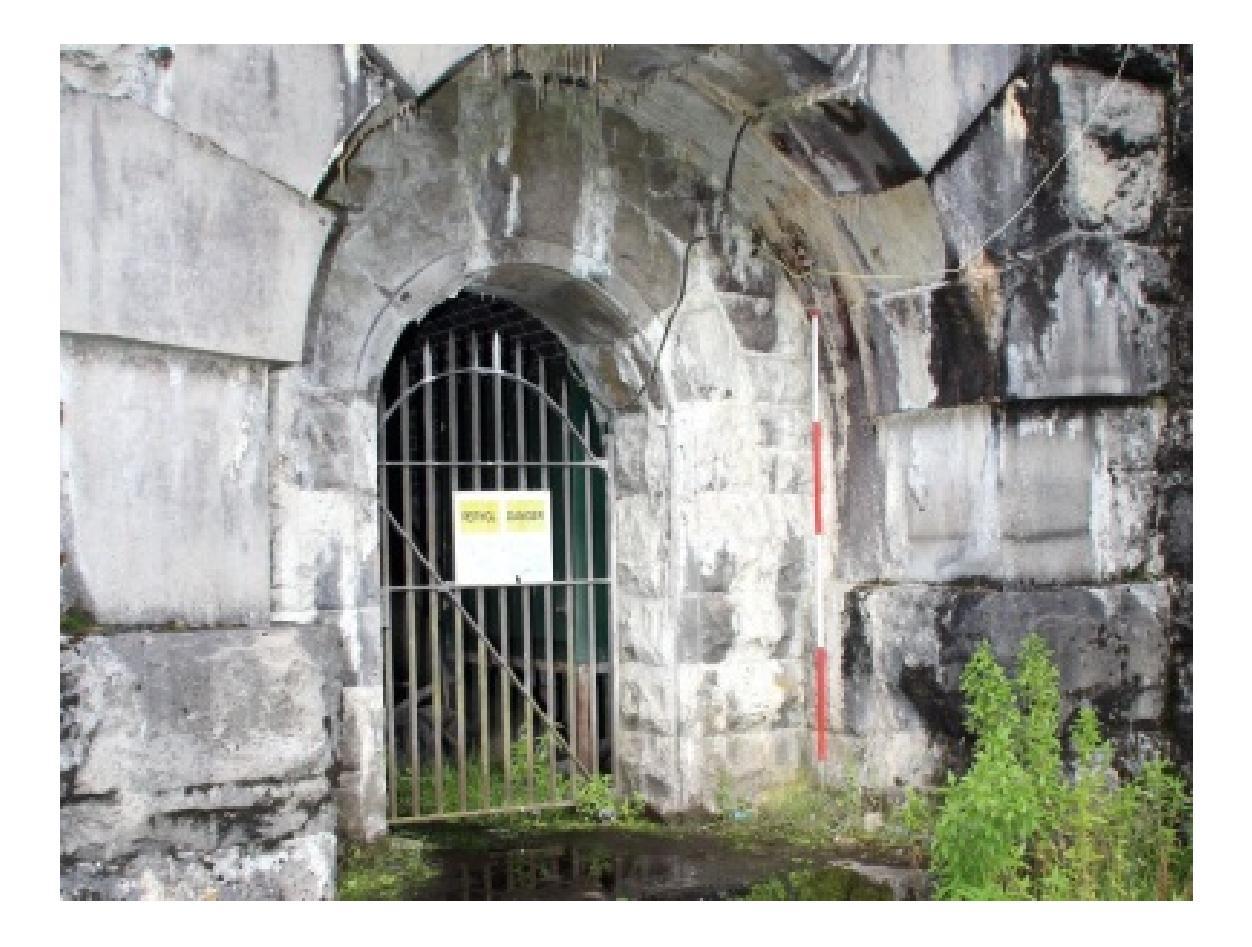
Figure 5. The treatment of the jambs of the inner doorway to the tunnel building (scale 2m)

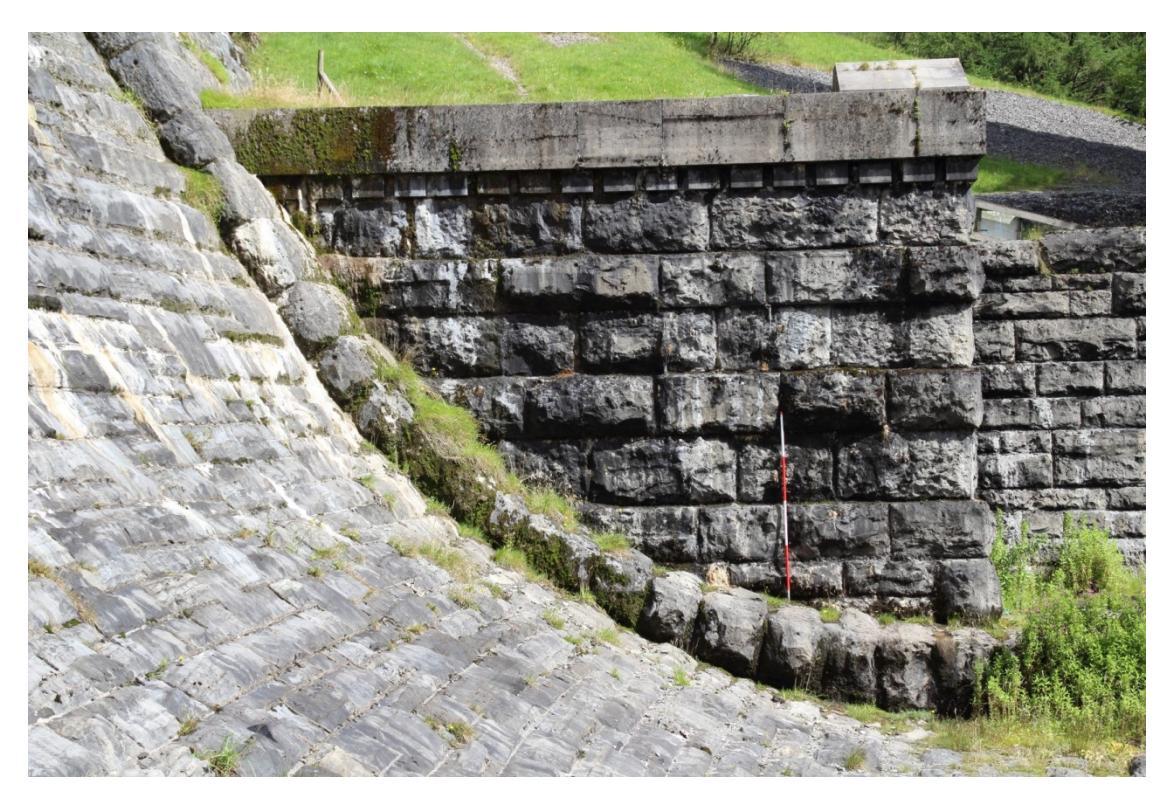
Figure 6. The western elevation of the tunnel building (scale 2m)

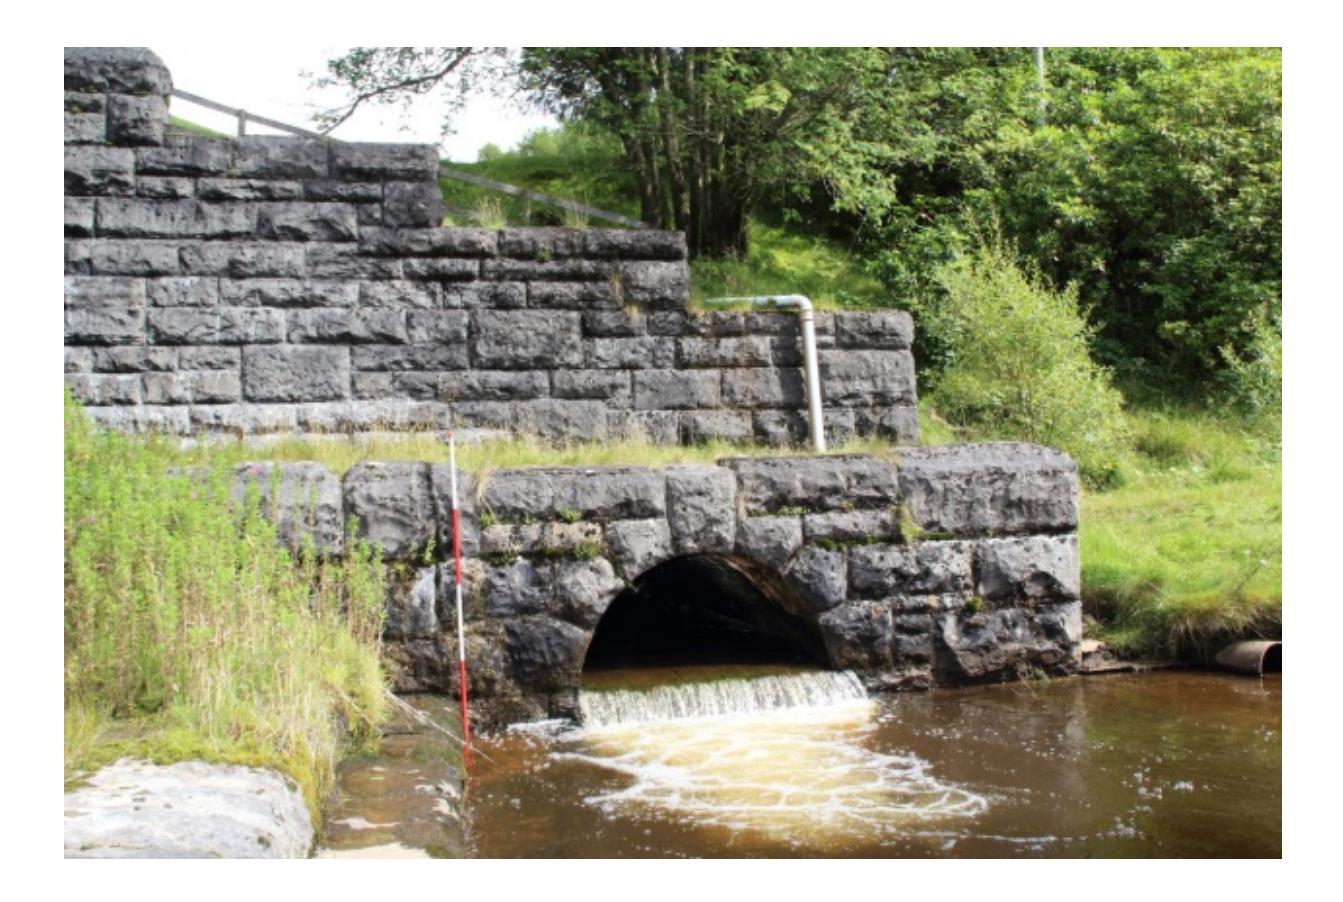
- 4.2 As the eastern retaining wall will be altered this was photographed on both sides and, as well as general views, a series of straight-on exposures were made to allow the construction of a photomontage elevation record (Figs 7 and 8).

Figure 7. The eastern retaining wall from the spillway base and the lower outfall (scale 2m)

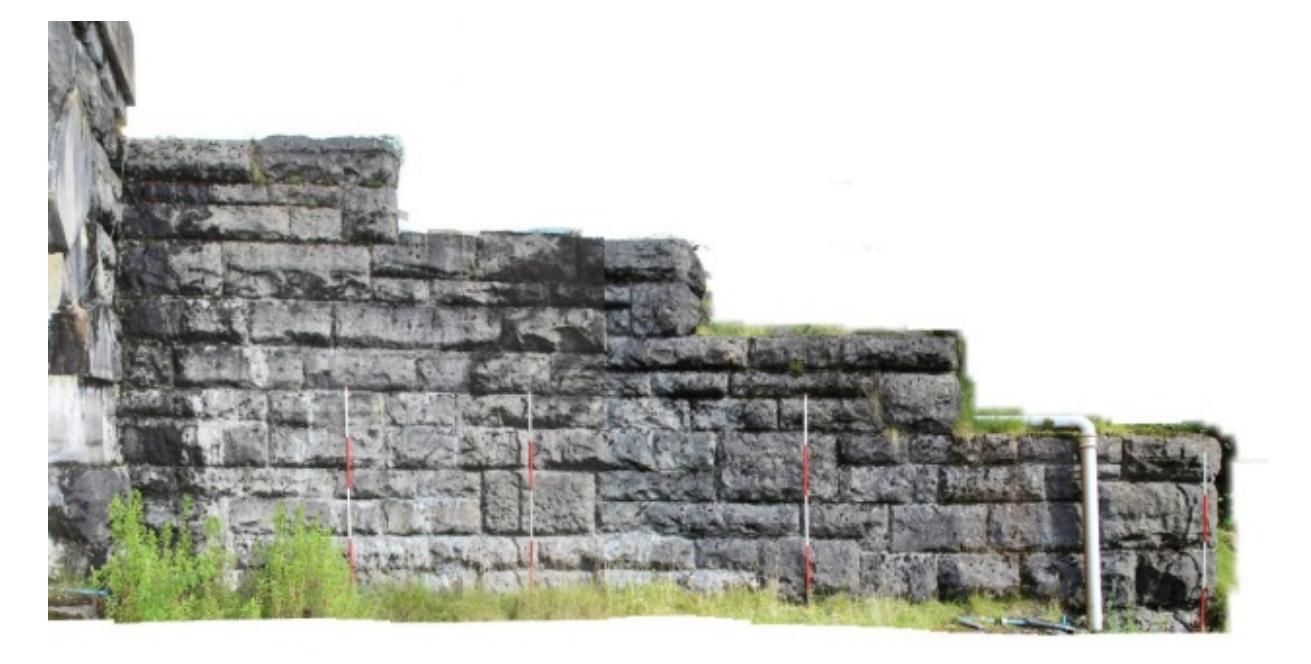
Figure 8. Photomontage elevation of the eastern retaining wall

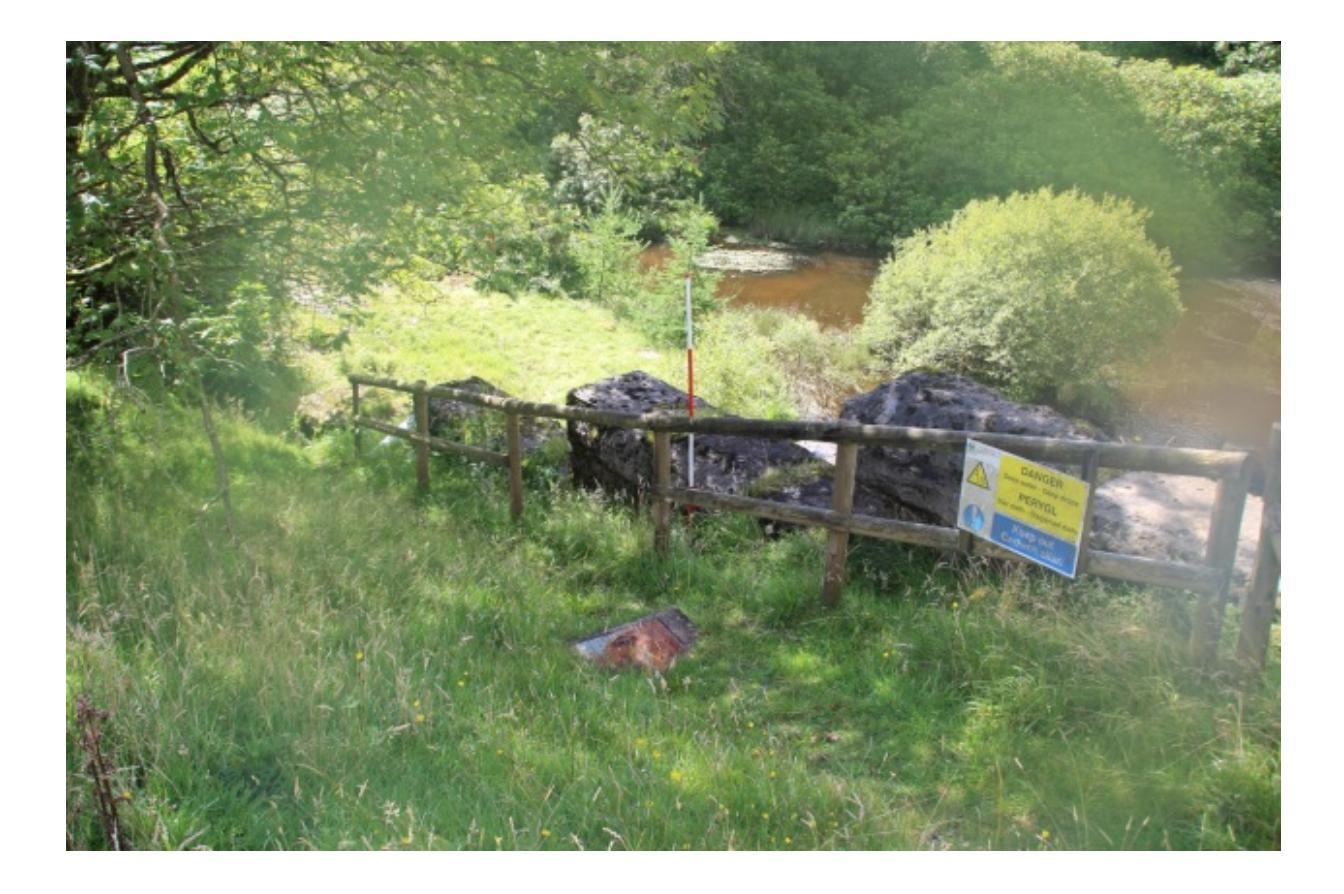
Figure 10 The top of the retaining wall and the grassy area beyond, which will be terracreted, looking south-west (scale 2m)

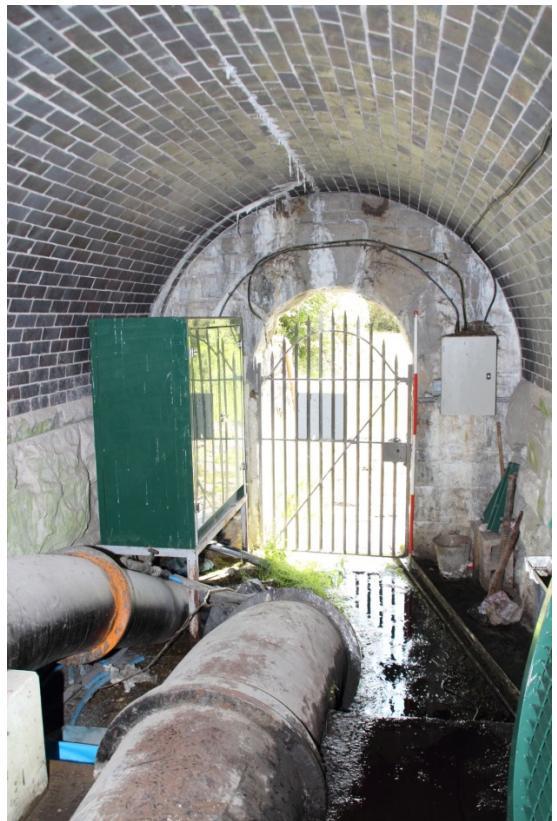
- 4.4 Inside the tunnel building the tunnel is nearly all brick-lined concrete, with some rock-finished stone work near the entrance (Fig. 11). It contains two large steel pipes which orginally took water from different levels of the reservoir. The western one still

Figure 11 The south end of the tunnel just inside the entrance, looking south (scale 2m)

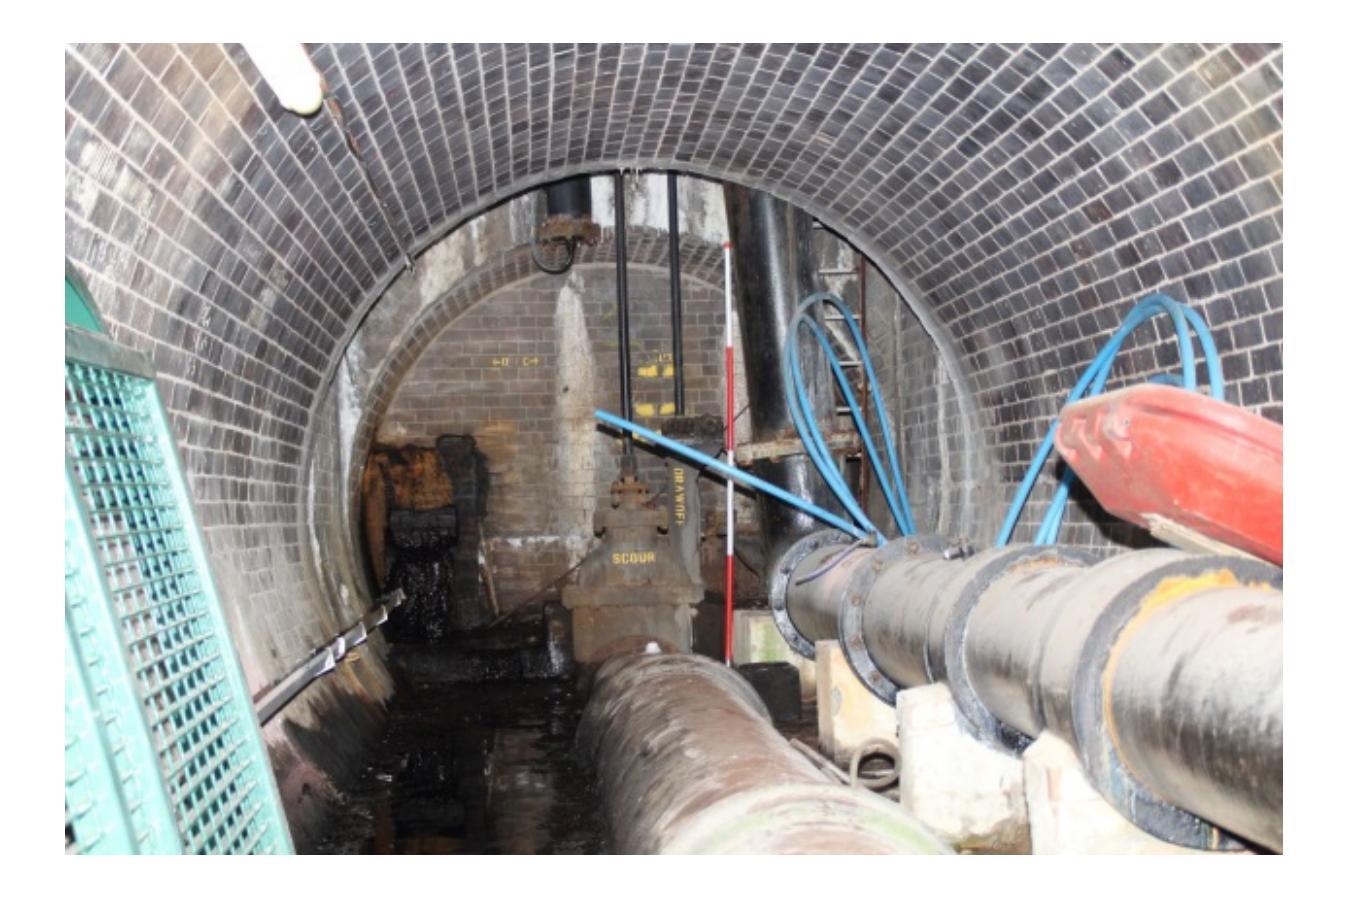
Figure 12 The north end of the tunnel showing the base of the shaft in the tower and the pipework and control gear. The tunnel is to be driven through the brick work at the far end

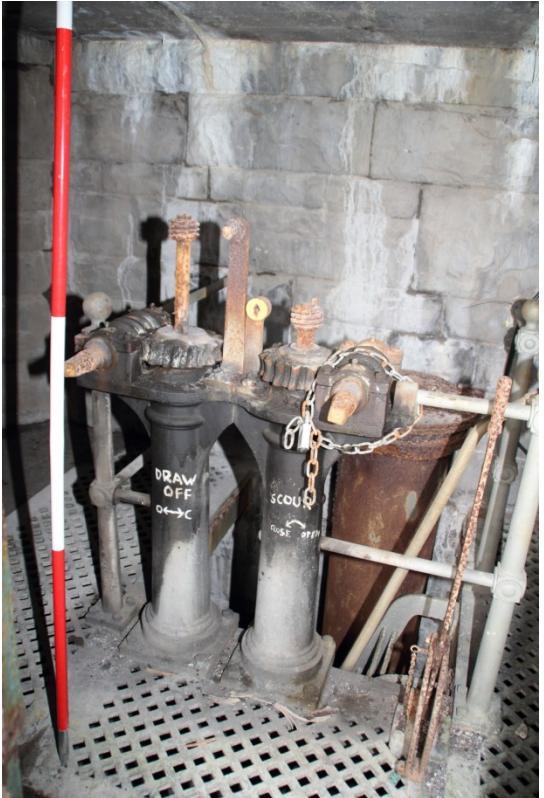
does it seems, feeding the present outfall below the apron. Both had valves controlled from the tower at walkway level (Figs 12-13). Another large-bore pipe rose up into the shaft at the north end rising into the tower. This has been long disconnected (Fig. 14).

Figure 13. Control mechanisms for the valves in Fig. 12, over the shaft in the east tower at walkway level, looking S (scale in 0.5m divisions)

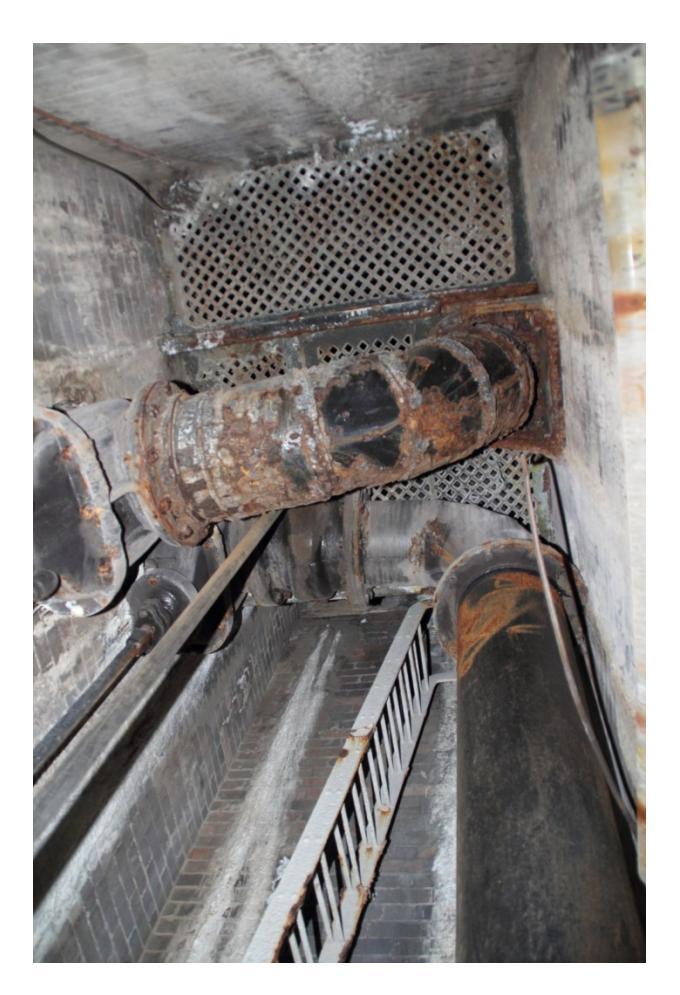
Figure 14. Looking up into the shaft in the east tower, at the end of the tunnel to the grating shown in Fig. 13

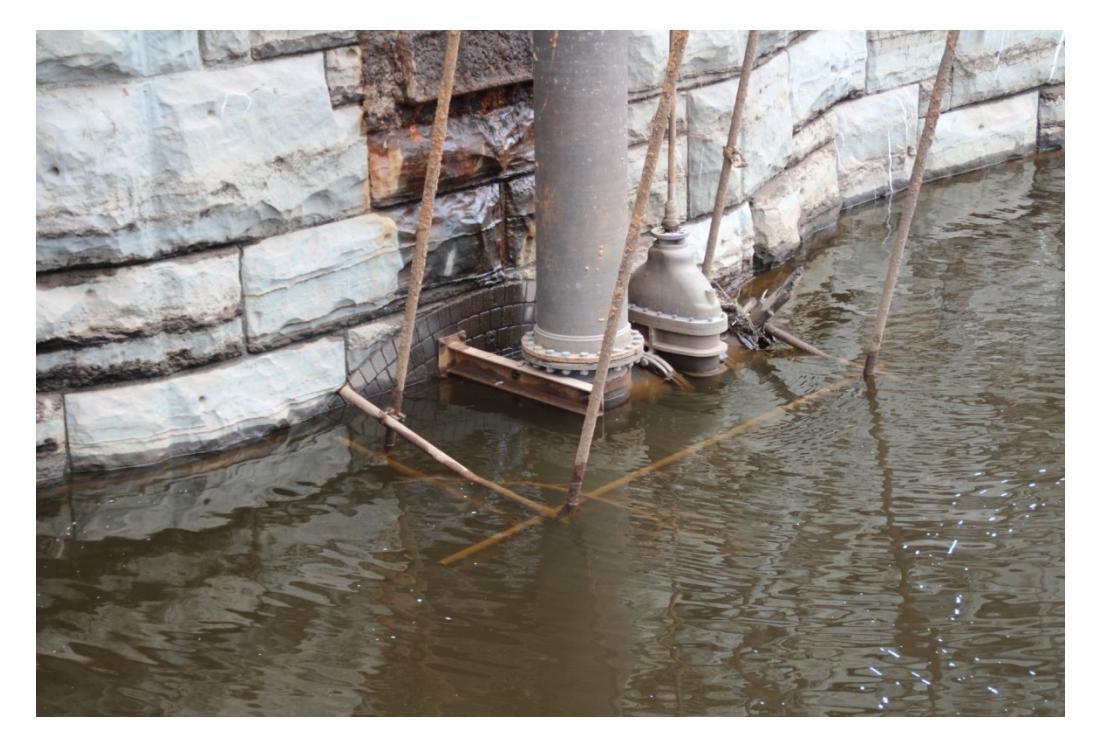
Figure 15. The brick voussoirs of the tunnel visible on the north side of the dam and the pipe, valve and control gear, looking south-west

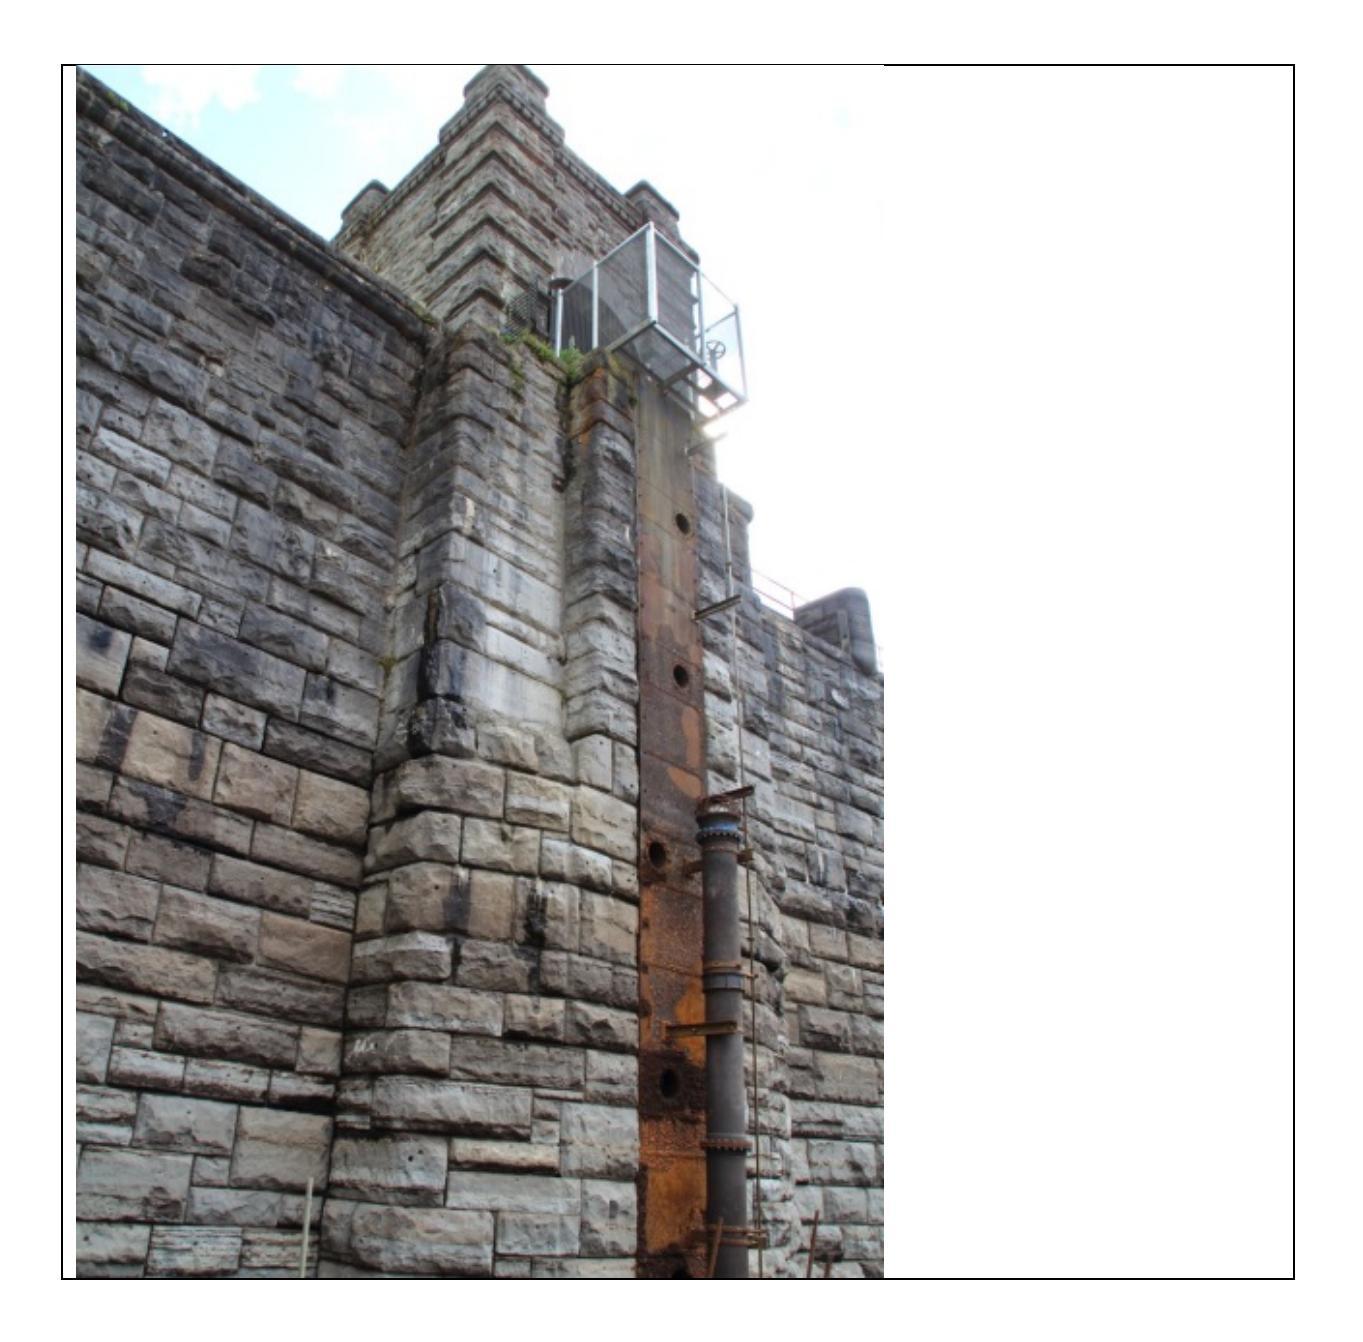
- 4.5 The northern end of the tunnel to be opened up is just visible above the present water level on the north side of the dam. More pipes and control gear remain here (Fig. 15).
- 4.6 This all appears to be part of a level control system, now not functioning (Fig. 16).

Figure 16The north face of the east tower, showing inset steel duct and now-redundantpresumed level control valve sites, looking south-west
