WAUN HIR, CARMARTHENSHIRE: ARCHAEOLOGICAL EVALUATION

RHIF YR ADRODDIAD / REPORT NO. 2012/28
RHIF Y PROSIECT / PROJECT RECORD NO. 102768

Mawrth 2012
March 2012

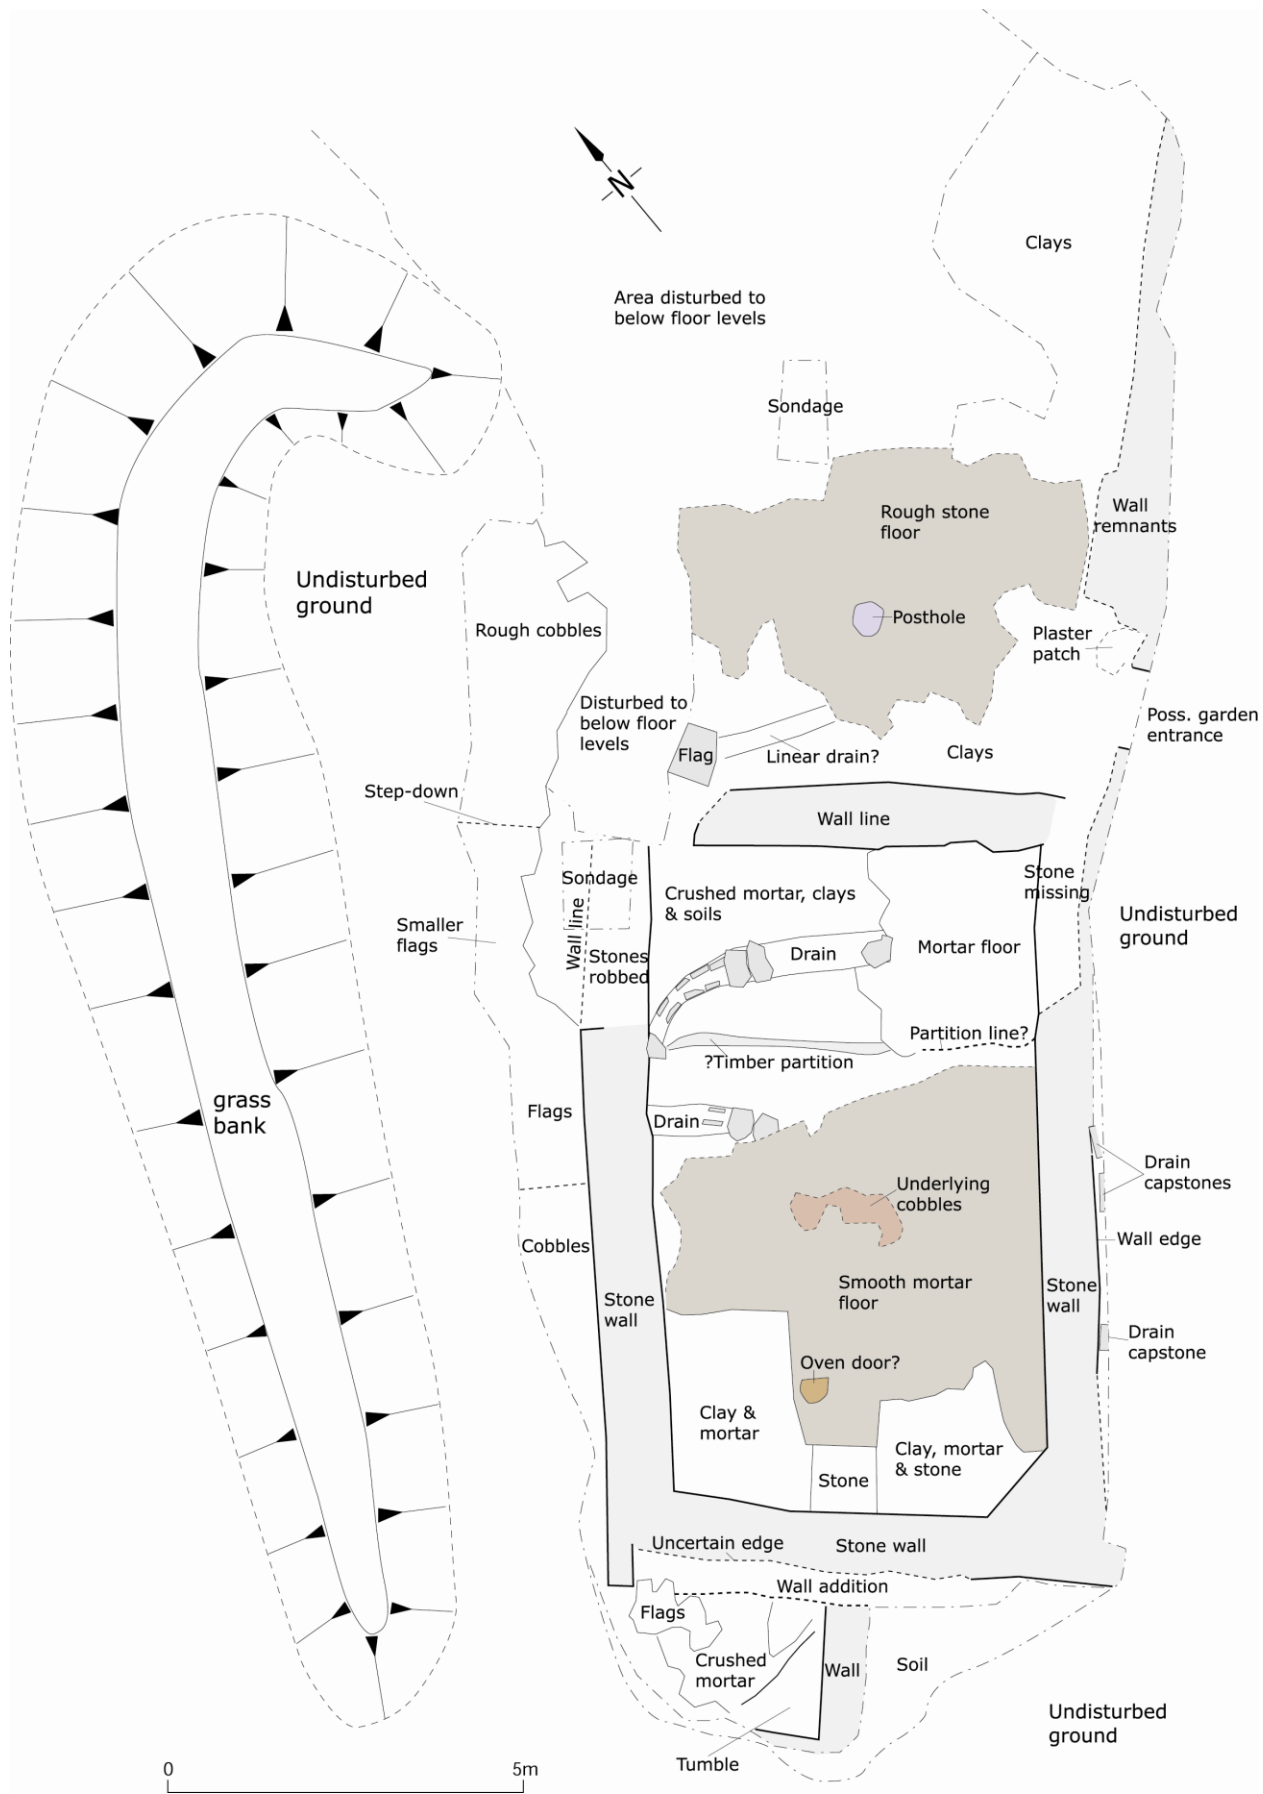
Figure 5: Plan of archaeological remains revealed by the unauthorised excavation.

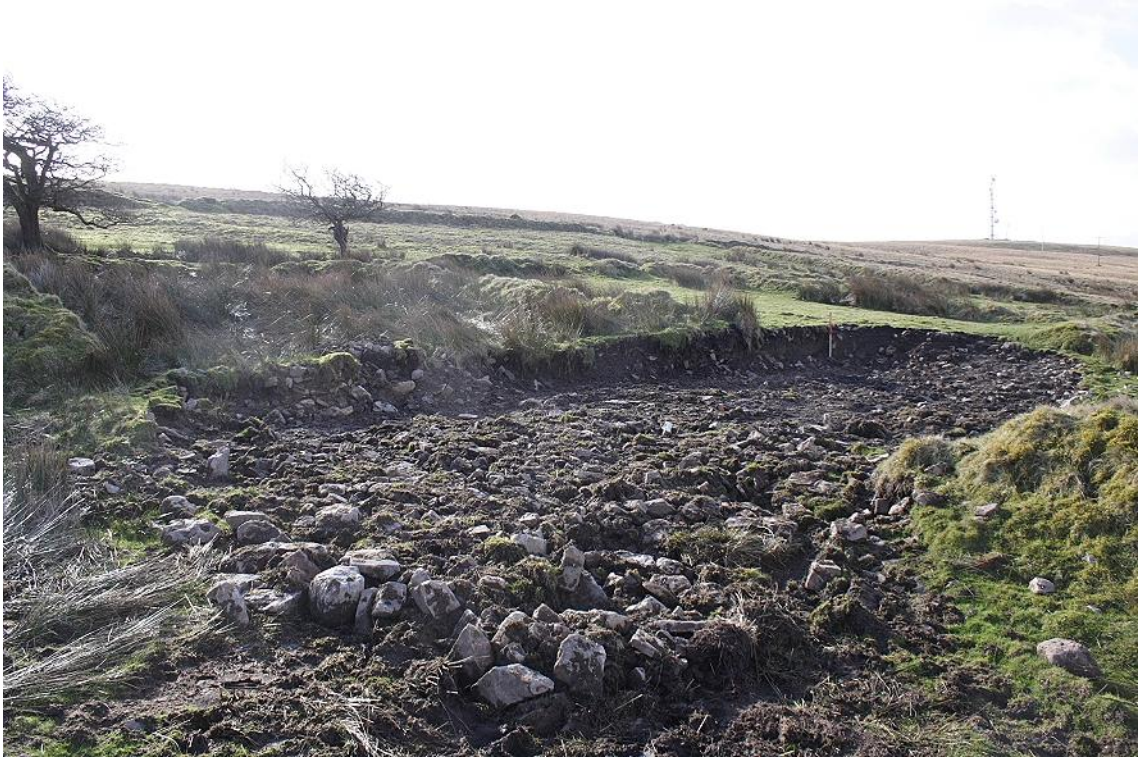
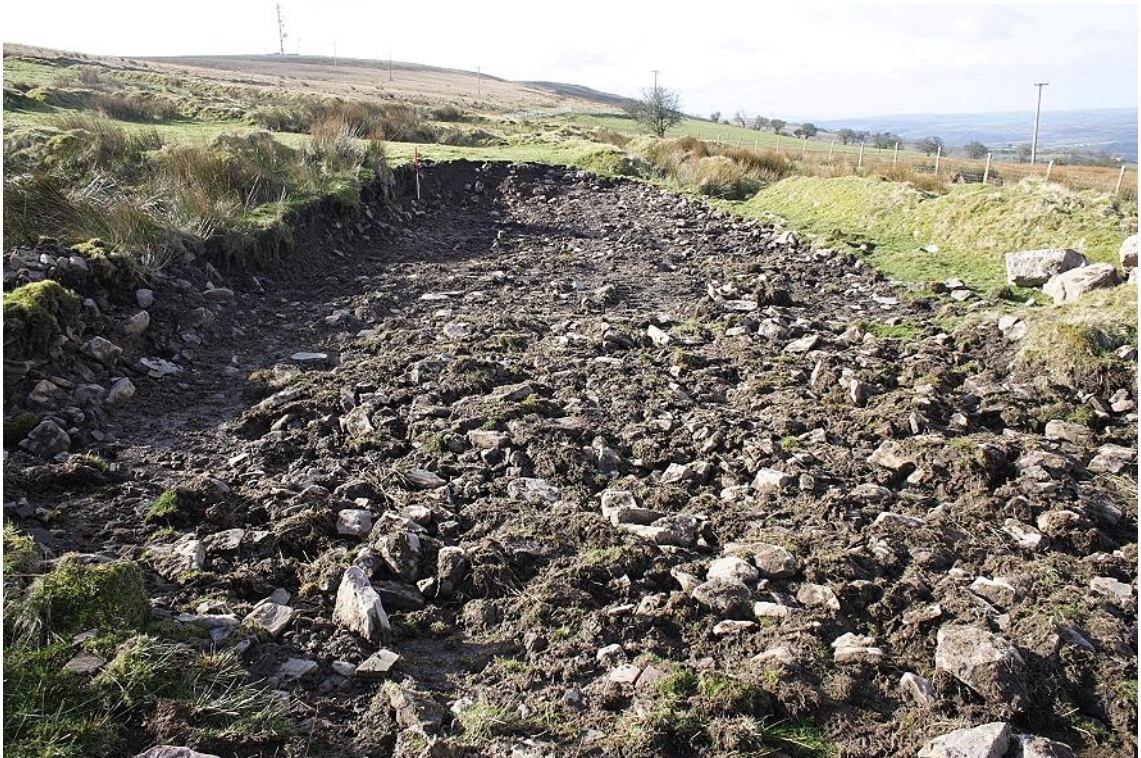
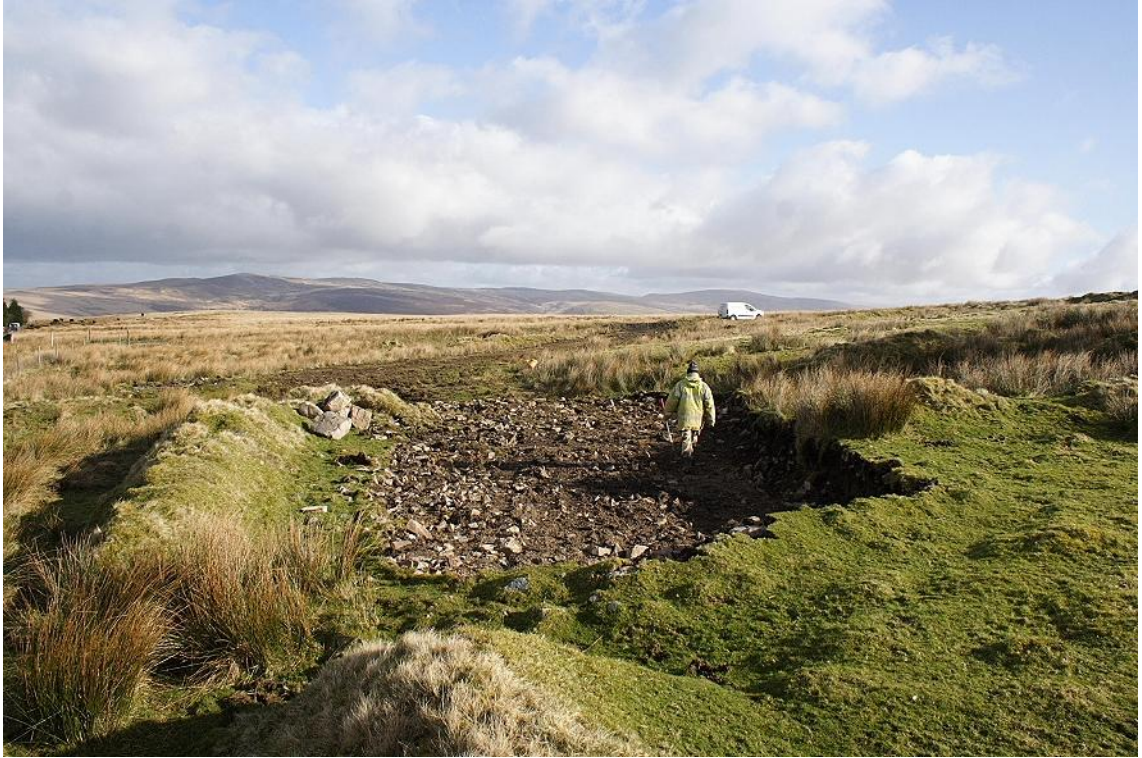
The area affected by the unauthorised excavation covered a roughly rectangular area measuring c.19m SW - NE by c.7m NW - SE (photos 7 - 9). This was concentrated on the area of the building remains. It would appear that material that had initially been removed from the site had been returned and spread over the affected area. This had left a disturbed topsoil deposit of mixed soil and stone rubble of varying thickness up to 0.5m thick, thinning to the southwest. The original depth of deposits removed was greater than this.

Photo 7: View of the site after the unauthorised excavation, but prior to the archaeological evaluation work. Facing S.

Photo 8: View of the site after the unauthorised excavation, but prior to the archaeological evaluation work. Facing SW.

Photo 9: View of the site after the unauthorised excavation, but prior to the archaeological evaluation work. Facing NE.

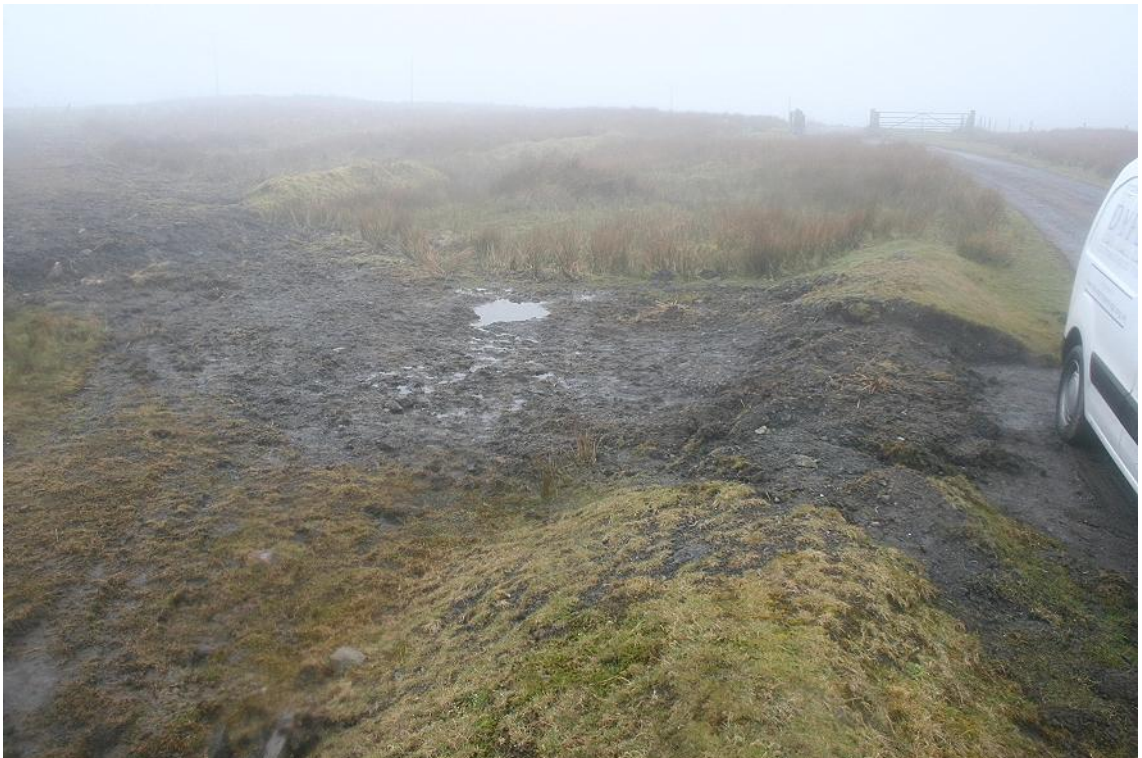
The excavation was clearly concentrated on the remains of the building. The surrounding field banks and enclosures still survive remarkably well. One section of bank has been removed and subsequently replaced (photo 10), presumably to gain access to a former trackway that cut across the site. As the trackway is a feature that post-dates the farmstead complex anyway this section of bank is also likely to have been a relatively recent section as well, although it does appear to lie within the Scheduled area.

Photo 10: View of damage to the modern bank at the northeast end of the modern trackway across the site. Facing WNW.

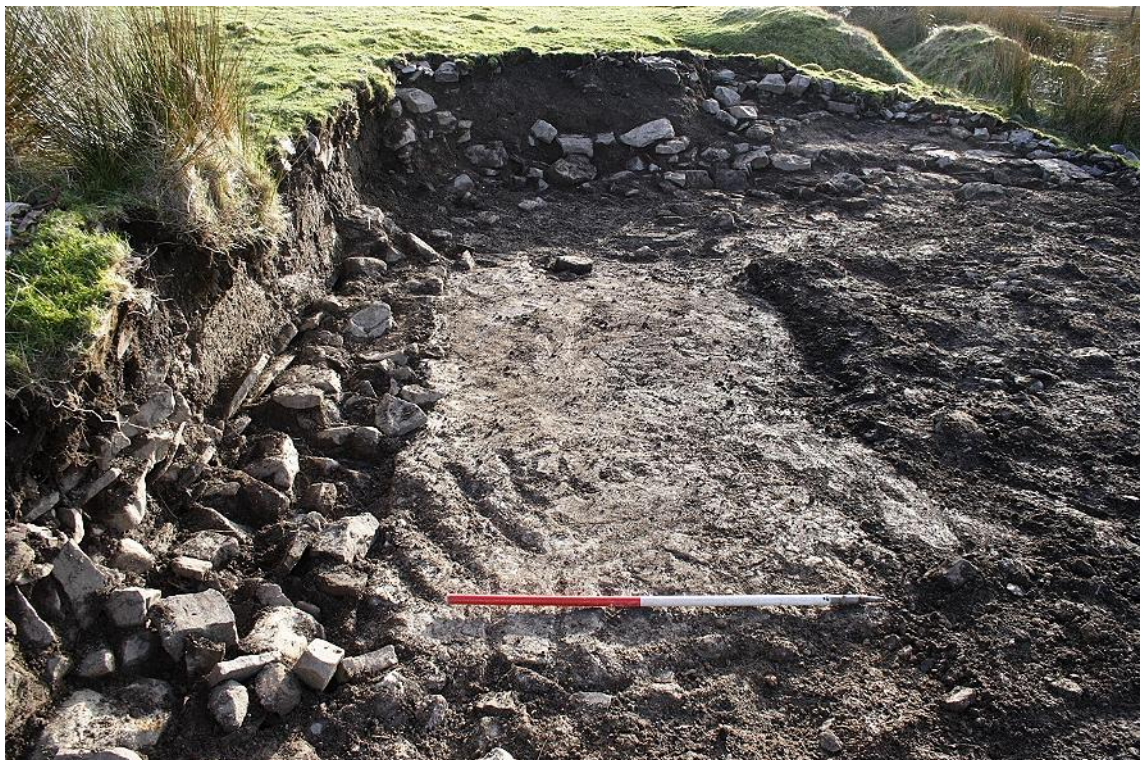
Photo 12: Archaeological evaluation in progress, cleaning the southwest end of the building. Tooth marks from the digger bucket can be seen in the mortar floor just above the scale. Facing SW, 1m scale.

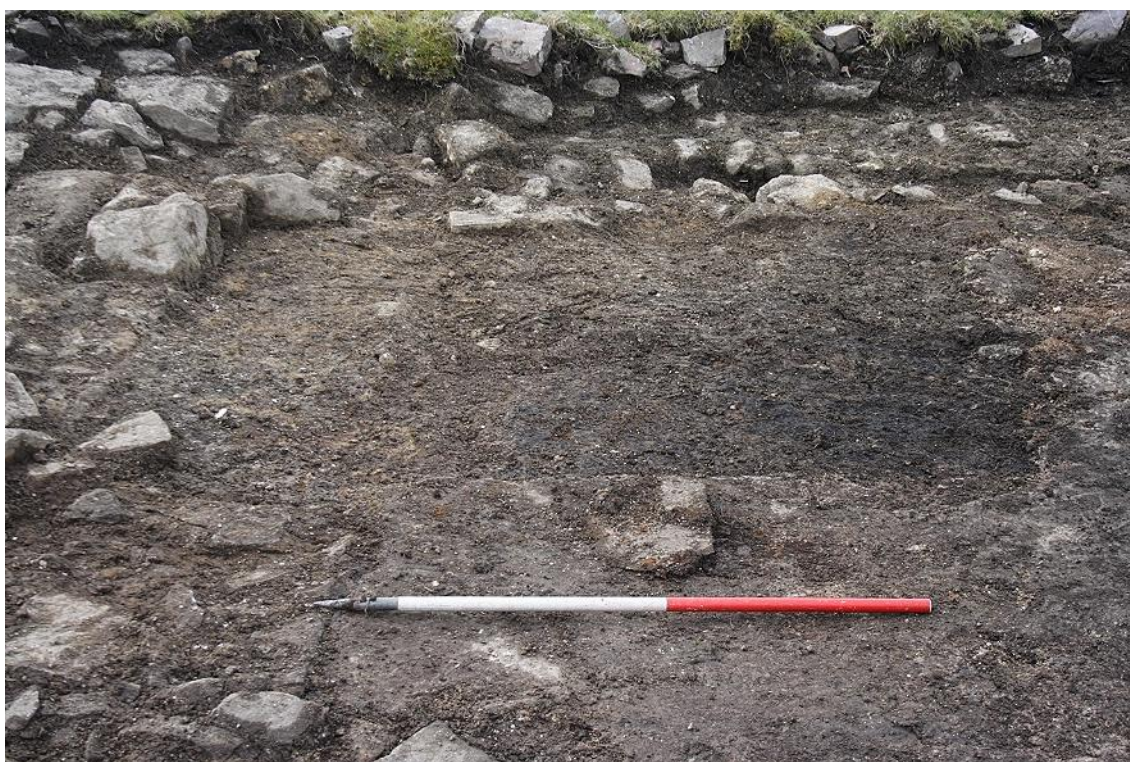
The mortar floor to the southwest is missing in patches, revealing cobbling beneath. It also stops short of the south-western gable wall. In the southeast corner is a roughly square patch 1.5m by 1.3m without a smooth mortar floor surface, although the floor does still consist of a rough clayey-mortar and stone deposit, the stones become more plentiful and visible along the north-western edge. In the southwest corner is a rectangular area 1.9m by 1.25m of similar rough clayey-mortar material with a distinct edge to the smoothed mortar floor around it (photo 14). In between these two patches, against the southwestern gable wall, is a small patch 0.65m square of flat stones laid in lime-mortar. The precise function for these areas is unclear although it is likely they are associated with the main fireplace and cooking activity that seems most likely to have taken place against this gable wall, although no fireplaces were identified. An iron oven door, 0.3m wide and 0.25m high, lay in front of these areas (photo 14), suggesting an oven, or a bread oven, may have stood close by.

Photo 14: Rectangular area of rough ground in the southwest corner of the mortar floor. Possible oven door visible just above the scale. Facing NW, 1m scale.

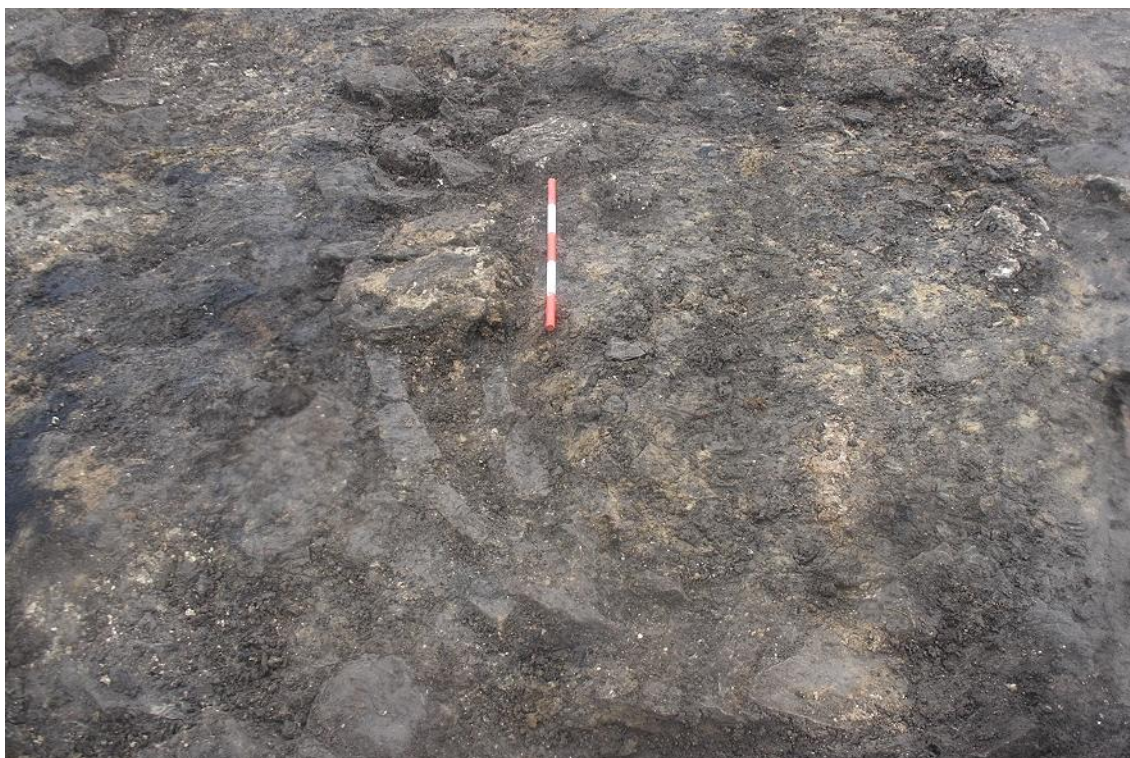
These walls enclosed a rectangular area 6.7m SW - NE by 3.9m NW - SE, with a rounded internal corner to the southeast. A straight linear feature 0.1m wide ran the width of this space that would appear to be the remains of a room partition, the width of the linear suggesting a timber partition. This is borne out by differences in the floor deposits on either side, with an area 4.6m wide to the southwest covered by a relatively well-preserved smooth mortar floor (photo 13), and an area 2m wide to the northeast with the partial remains of a rougher mortar floor (photo 18).

width of this room. However, where it has been removed it has revealed the remains of a stone-lined and capped culvert running underneath the floor (photo 18). This culvert, 0.35m wide, runs SE – NW before curving round to the west, to run out under the outer wall of the building, roughly at the point where the presumed entrance is. Close to this point a second culvert is just visible running underneath the floor of the southwestern room to exit under the wall at the point of the presumed entrance. Both culverts are presumably also linked to the stone-capped drain visible running along the outside of the south-eastern wall (photo 17), helping to drain water running off the higher ground to the southeast.

Photo 18: Looking at the disturbed floor levels at the northeastern end of the Southwest Compartment. A curving under-floor drain is visible to the bottom left of the scale. Facing SE, 0.5m scale.

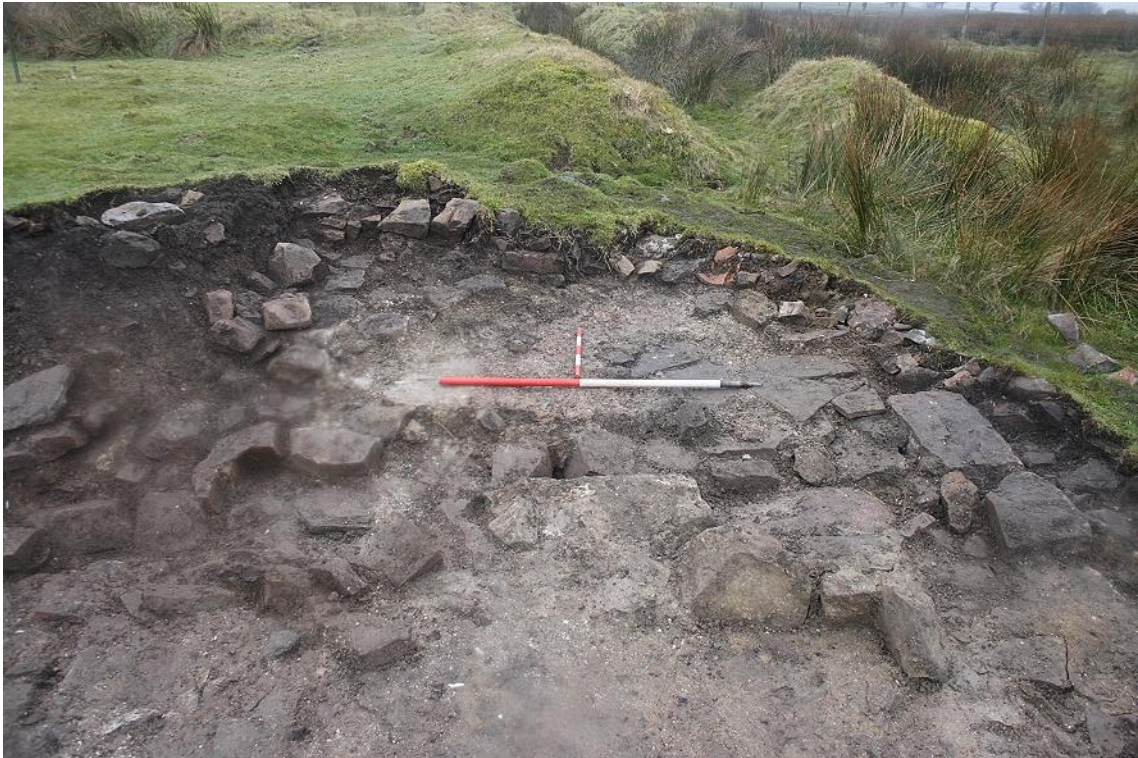
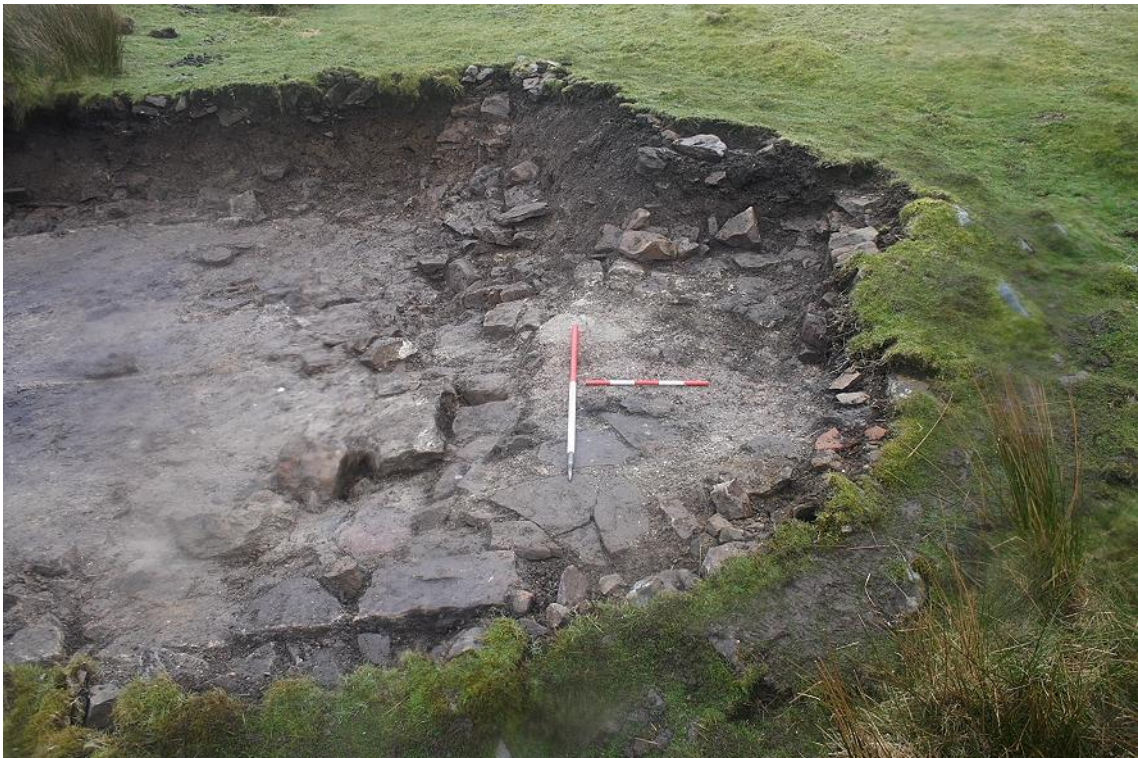
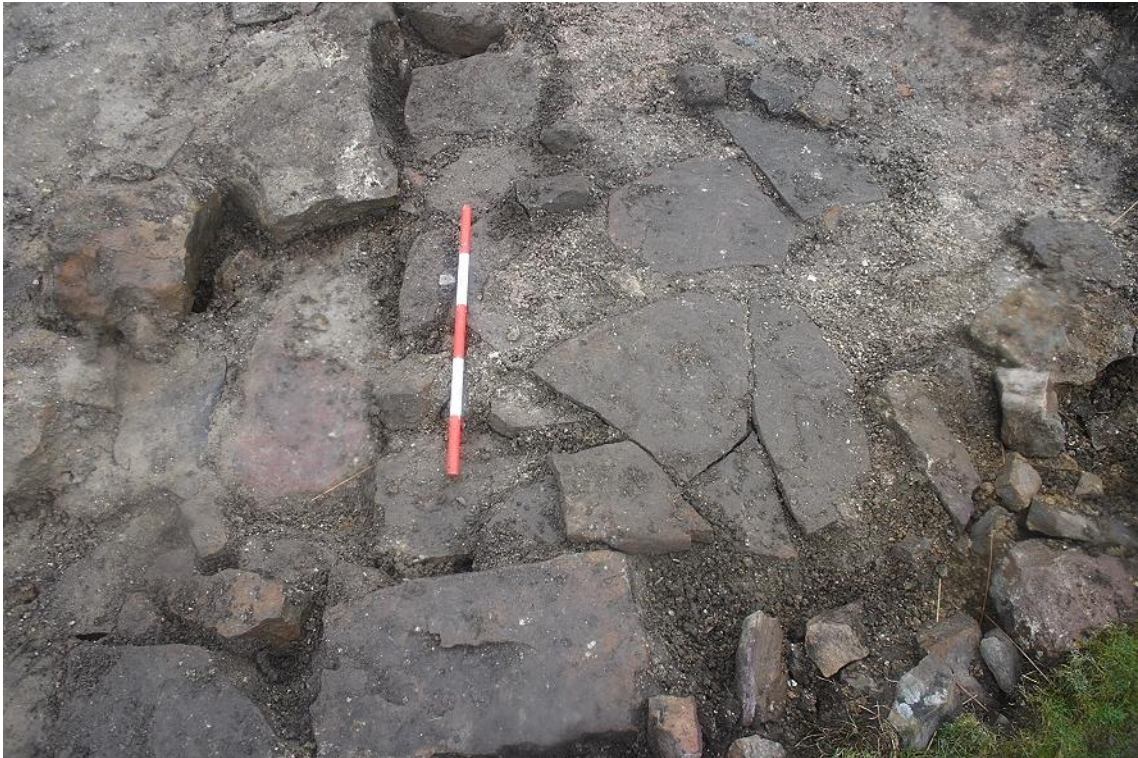
Attached to the external side of the southwestern corner of the building were the remains of a small structure (photos 19 – 21). Roughly midway along the southwest gable a clay-bedded stone wall projected at a right angle for c.1.3m, before seeming to return northwest, although this area was only partially uncovered. Assuming that the main northwest wall continues in a straight line, this would enclose an area 1.9m NW- SE by 1.3m SW – NE. Remnants of a stone slab floor, bedded in lime-mortar were visible. This floor, which was 0.1m higher than the mortar floor of the main building, appeared to project over the line of the outer skin of the southwest gable wall of the main building (photo 21). The function of this structure is unclear, it is possible it may be associated with a fireplace or bread oven at the southwestern end of the main building, or it may represent the remains of a gable entry into the building.

Photo 19: Remains of the small attached structure on the southwest corner of the building. Facing SW, 1m & 0.5m scale.

Photo 20: Remains of the small attached structure on the southwest corner of the building. Facing SE, 1m & 0.5m scale.

Photo 21: Flooring of the attached structure overlying the outer edge of the gable wall of the main building. Facing SW, 0.5m scale.

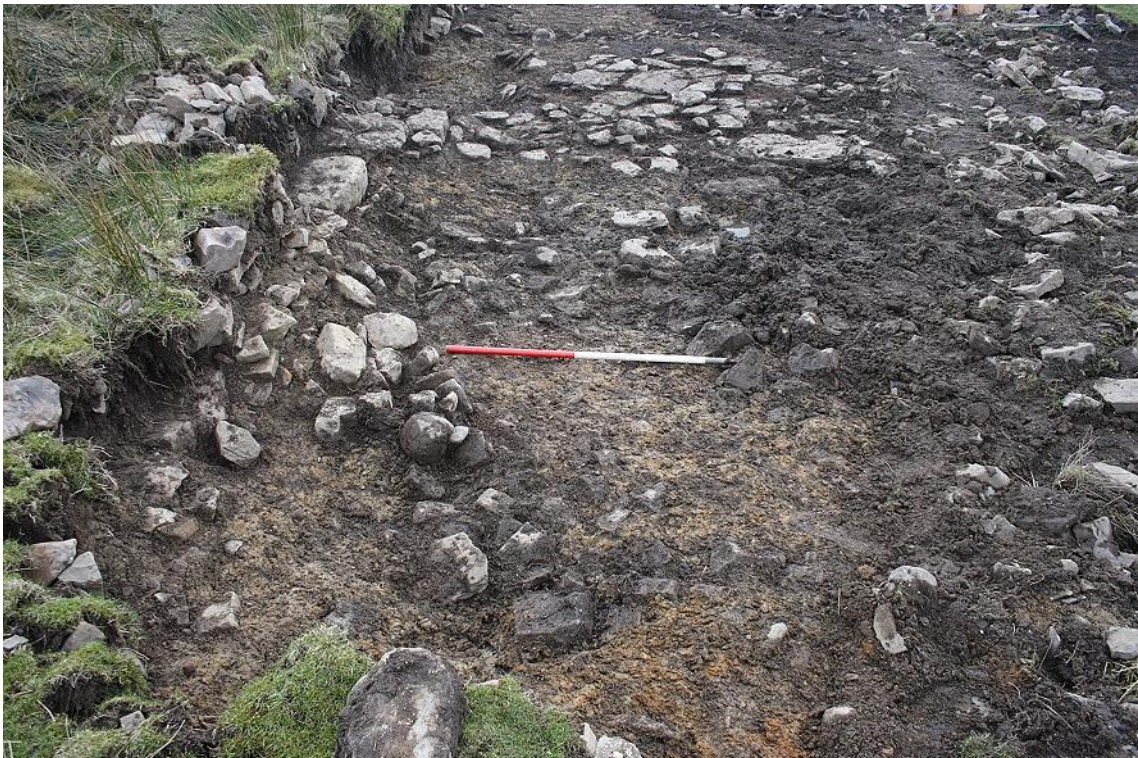
The area to the northeast of this is represented by a mottled light yellow-brown silty-clay (photo 22). It is unclear if this represents a natural subsoil or a further floor level. The unauthorised excavation in much of this area has gone below the surviving floor levels.

Photo 22: Disturbed floor remains at the north-eastern end of the building, the approximate location of the 'outshot'. Facing SW, 1m scale.

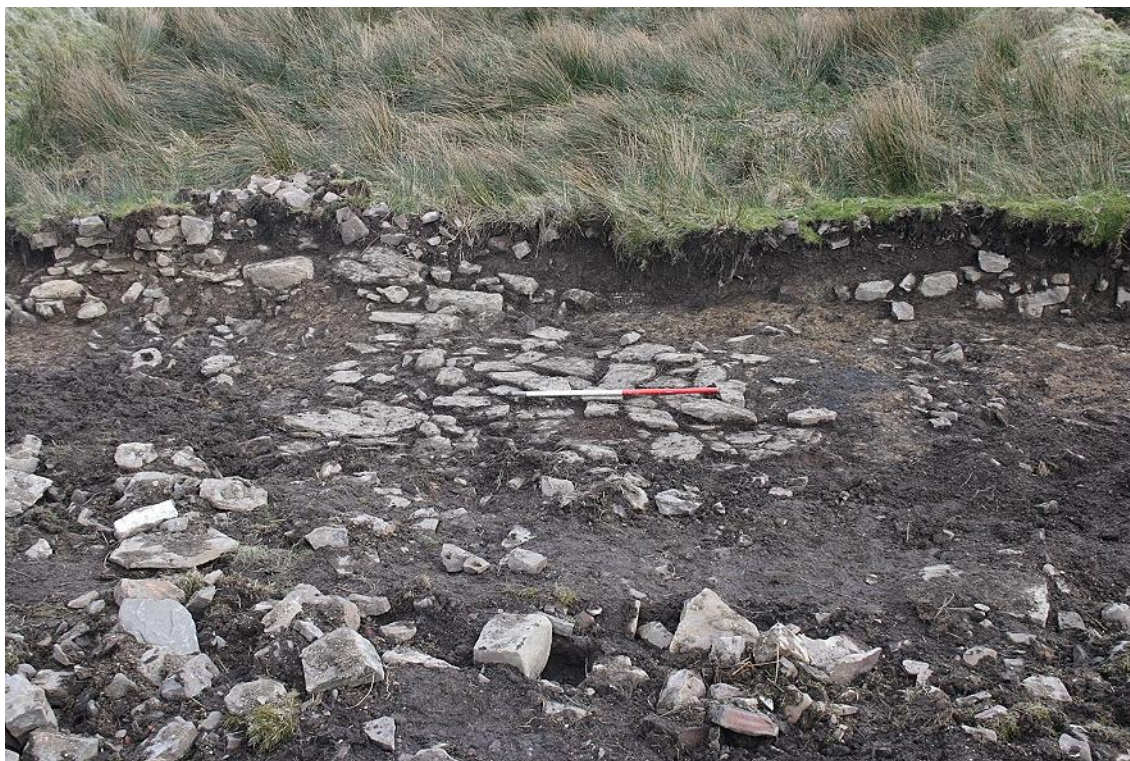
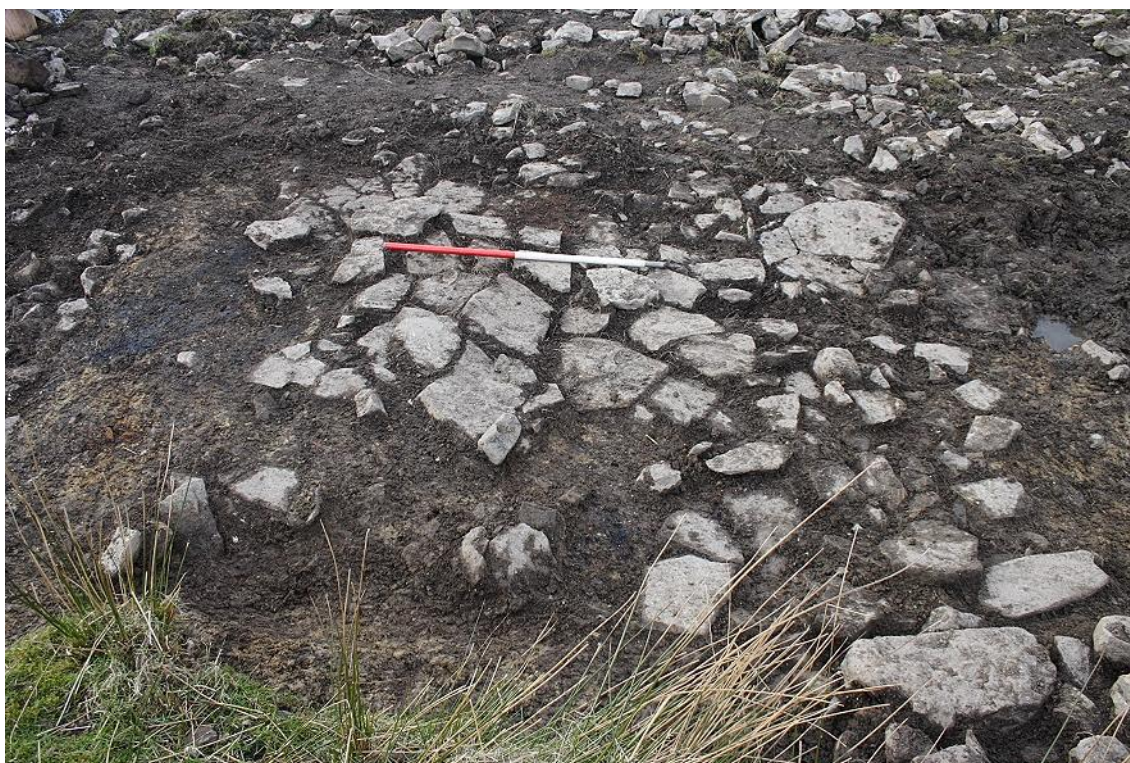
An area of rough stone-paved flooring survives almost immediately beyond the cross partition wall (photos 23 & 24). This covers an area roughly 4m by 3m. These stone slabs are unworked, but with a roughly flat side laid facing upwards, varying in size from 0.2m to 0.6m across. They are set in a silty-clay deposit with patches of blackened sandy-clay amongst the stones. A single posthole, 0.35m in diameter was identified amongst the stones. The surface is not level across this area, but it is not clear as to what degree these stones have been disturbed by recent activity. There is a possible straight edge visible amongst the stones along its north-eastern side that may represent the remnants of a wall line, c.0.6m wide, although this is not clearly represented in the section behind.

Photo 23: Rough stone flooring at the north-eastern end of the building. Facing SE, 1m scale.

Photo 24: Rough stone flooring at the north-eastern end of the building. Facing NE, 1m scale.

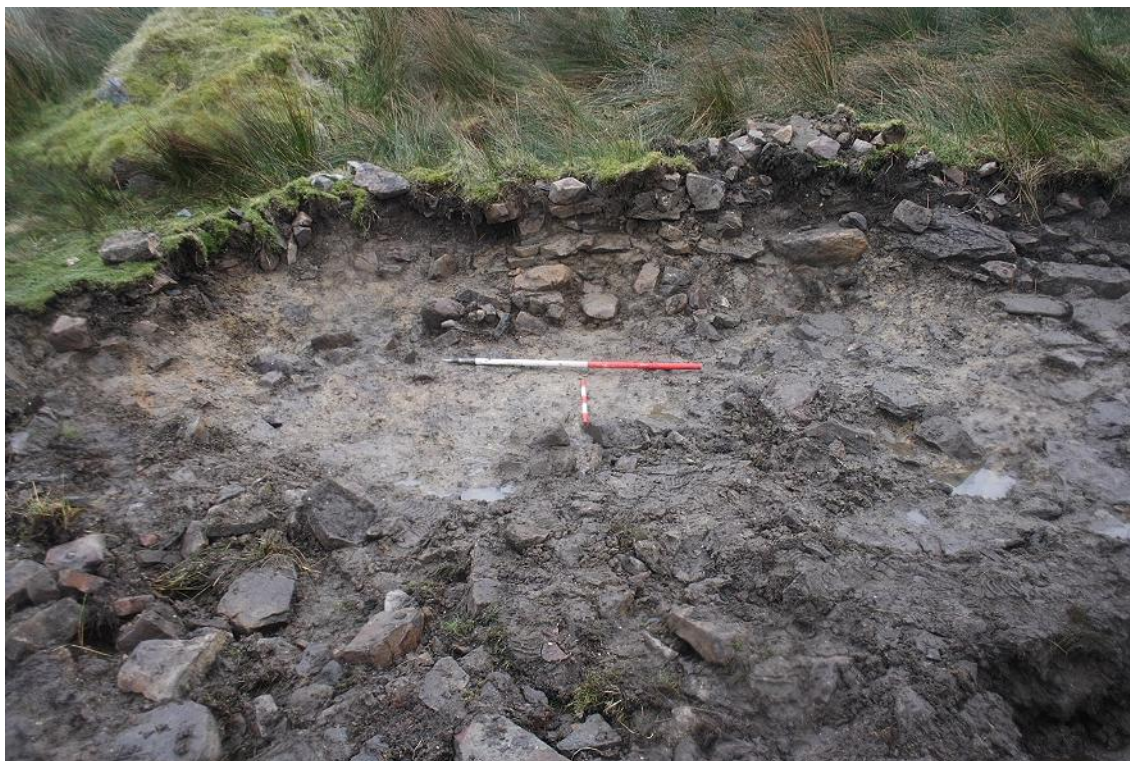
Photo 25: Disturbed floor and wall remains in the section at the north-eastern end of the building, the approximate location of the 'outshot'. Facing SE, 1m & 0.5m scale.

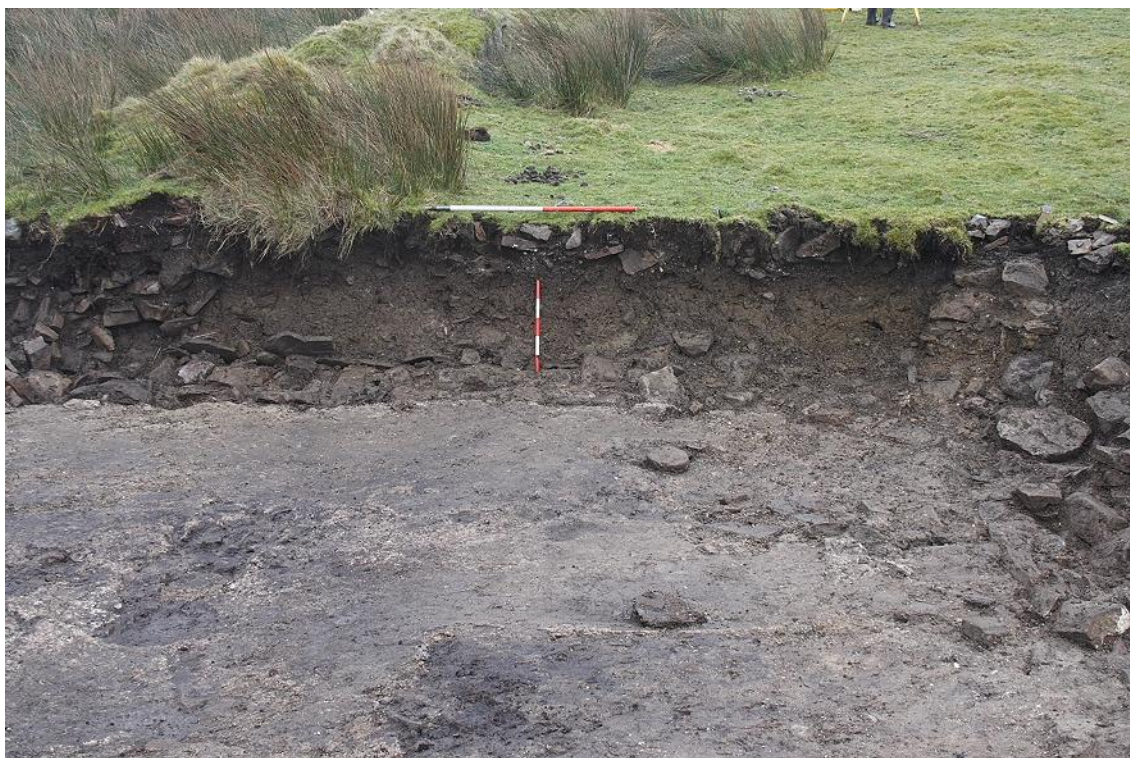
Photo 26: Section at south-western end of the building, showing depths reached by the unauthorised excavation. Facing SE, 1m & 0.5m scale.

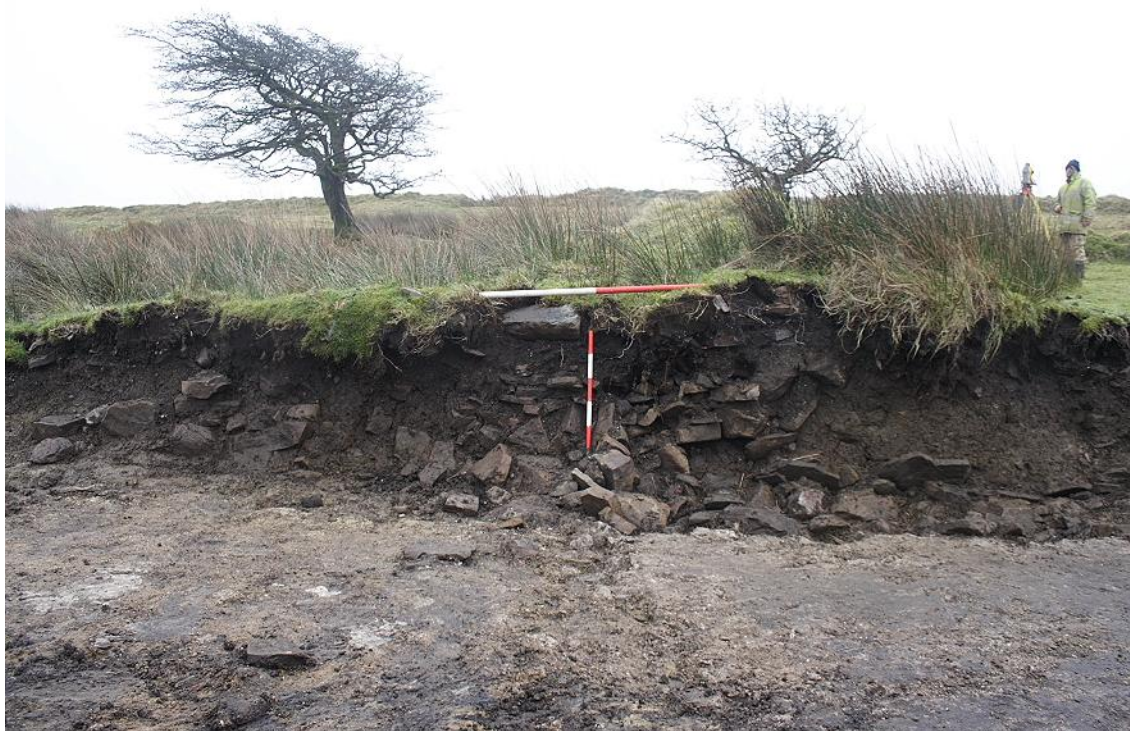
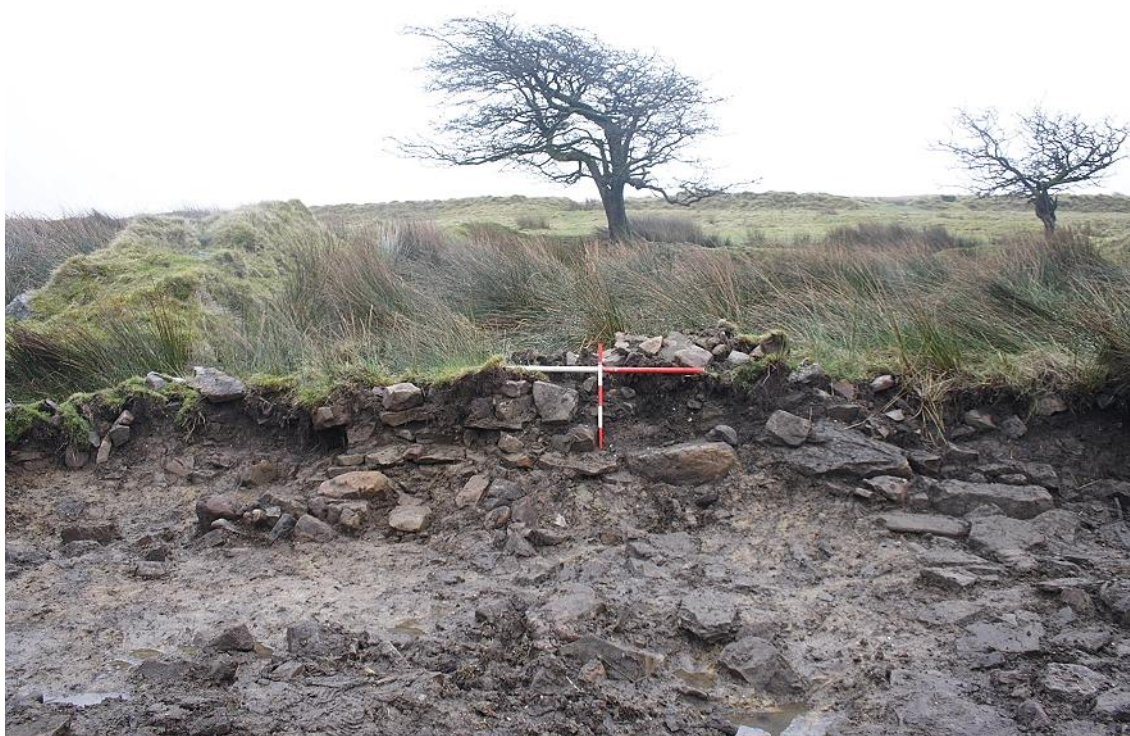
This compartment comprised the area of the building to the southwest of the cross partition wall. The external walls had been removed down to ground floor level in all but the southeast corner, which still stood 0.6m high. The walls were all built of random rubble, bedded in clay, and varied in thickness. Along the southeast side the wall measured 0.5m thick, although backed by a stone-capped drain topped by 0.4m depth of soil (photos 16 & 17). This wall measured 8m long to the cross partition wall, although the line then continued to the northeast. Along the northwest side of the building the wall measured 0.7m wide (photo 15). It survived for a length of 7.4m but to the northeast the line of the wall had been removed. The Scheduling description records a possible entrance in this wall. This was not clearly visible in the revealed remains, although changes in the external surface suggest a possible entrance c.4.6m up from the southwest corner. The southwestern gable wall was up 0.9m wide but appears to have been built 0.6m wide with an extra thickness subsequently added to on its external side (photos 20 & 21). The northeast cross partition wall measured 0.6m wide extending 3.5m with the north-western end truncated (photos 27 & 28).

Photo 27: Section showing remains of the partition wall. Facing SE. 1m & 0.5m scale.

Photo 28: Section showing area of former northeast gable wall and outshot attachment. Facing SE, 1m & 0.5m scale.

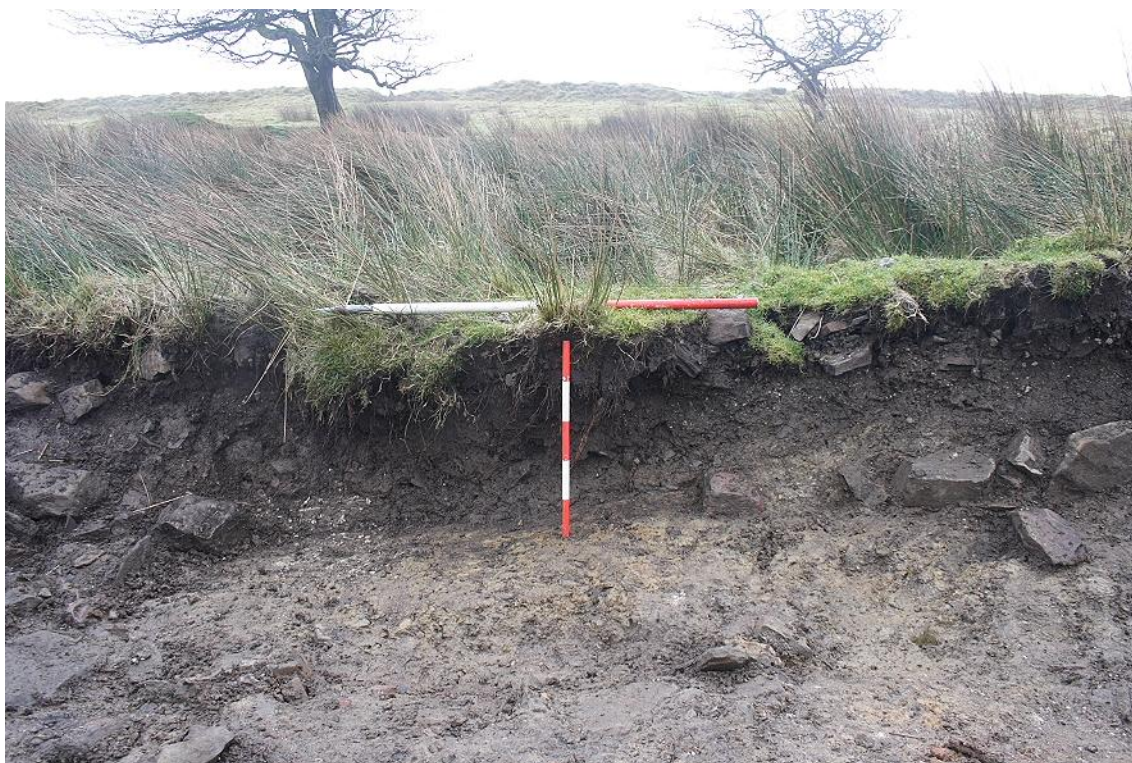
The area to the northeast of the main partition wall is more heavily disturbed than the area to the southwest. As a result the only external wall that is visible is the continuation of the southeastern wall (photos 22 & 25). The stonework of this wall disappears immediately beyond the cross partition wall for a distance of 1.55m. The inner line of the boundary is represented by a shallow gully however, and there is a difference between a yellow clay visible along the line of the wall and more mottled yellow-brown silty-clay to the west. This gap in the stonework may represent an entrance from the building into the presumed garden enclosure to the rear (photos 23 & 29).

Photo 29: Section showing gap in stonework and possible entrance to the garden. Facing SE, 1m & 0.5m scale.
