**NEW ROAD FARM
VARTEG ROAD
BLAENAVON**

ENVIRONMENTAL STATEMENT

SEPTEMBER 2005

TITLE: **ENVIRONMENTAL STATEMENT**

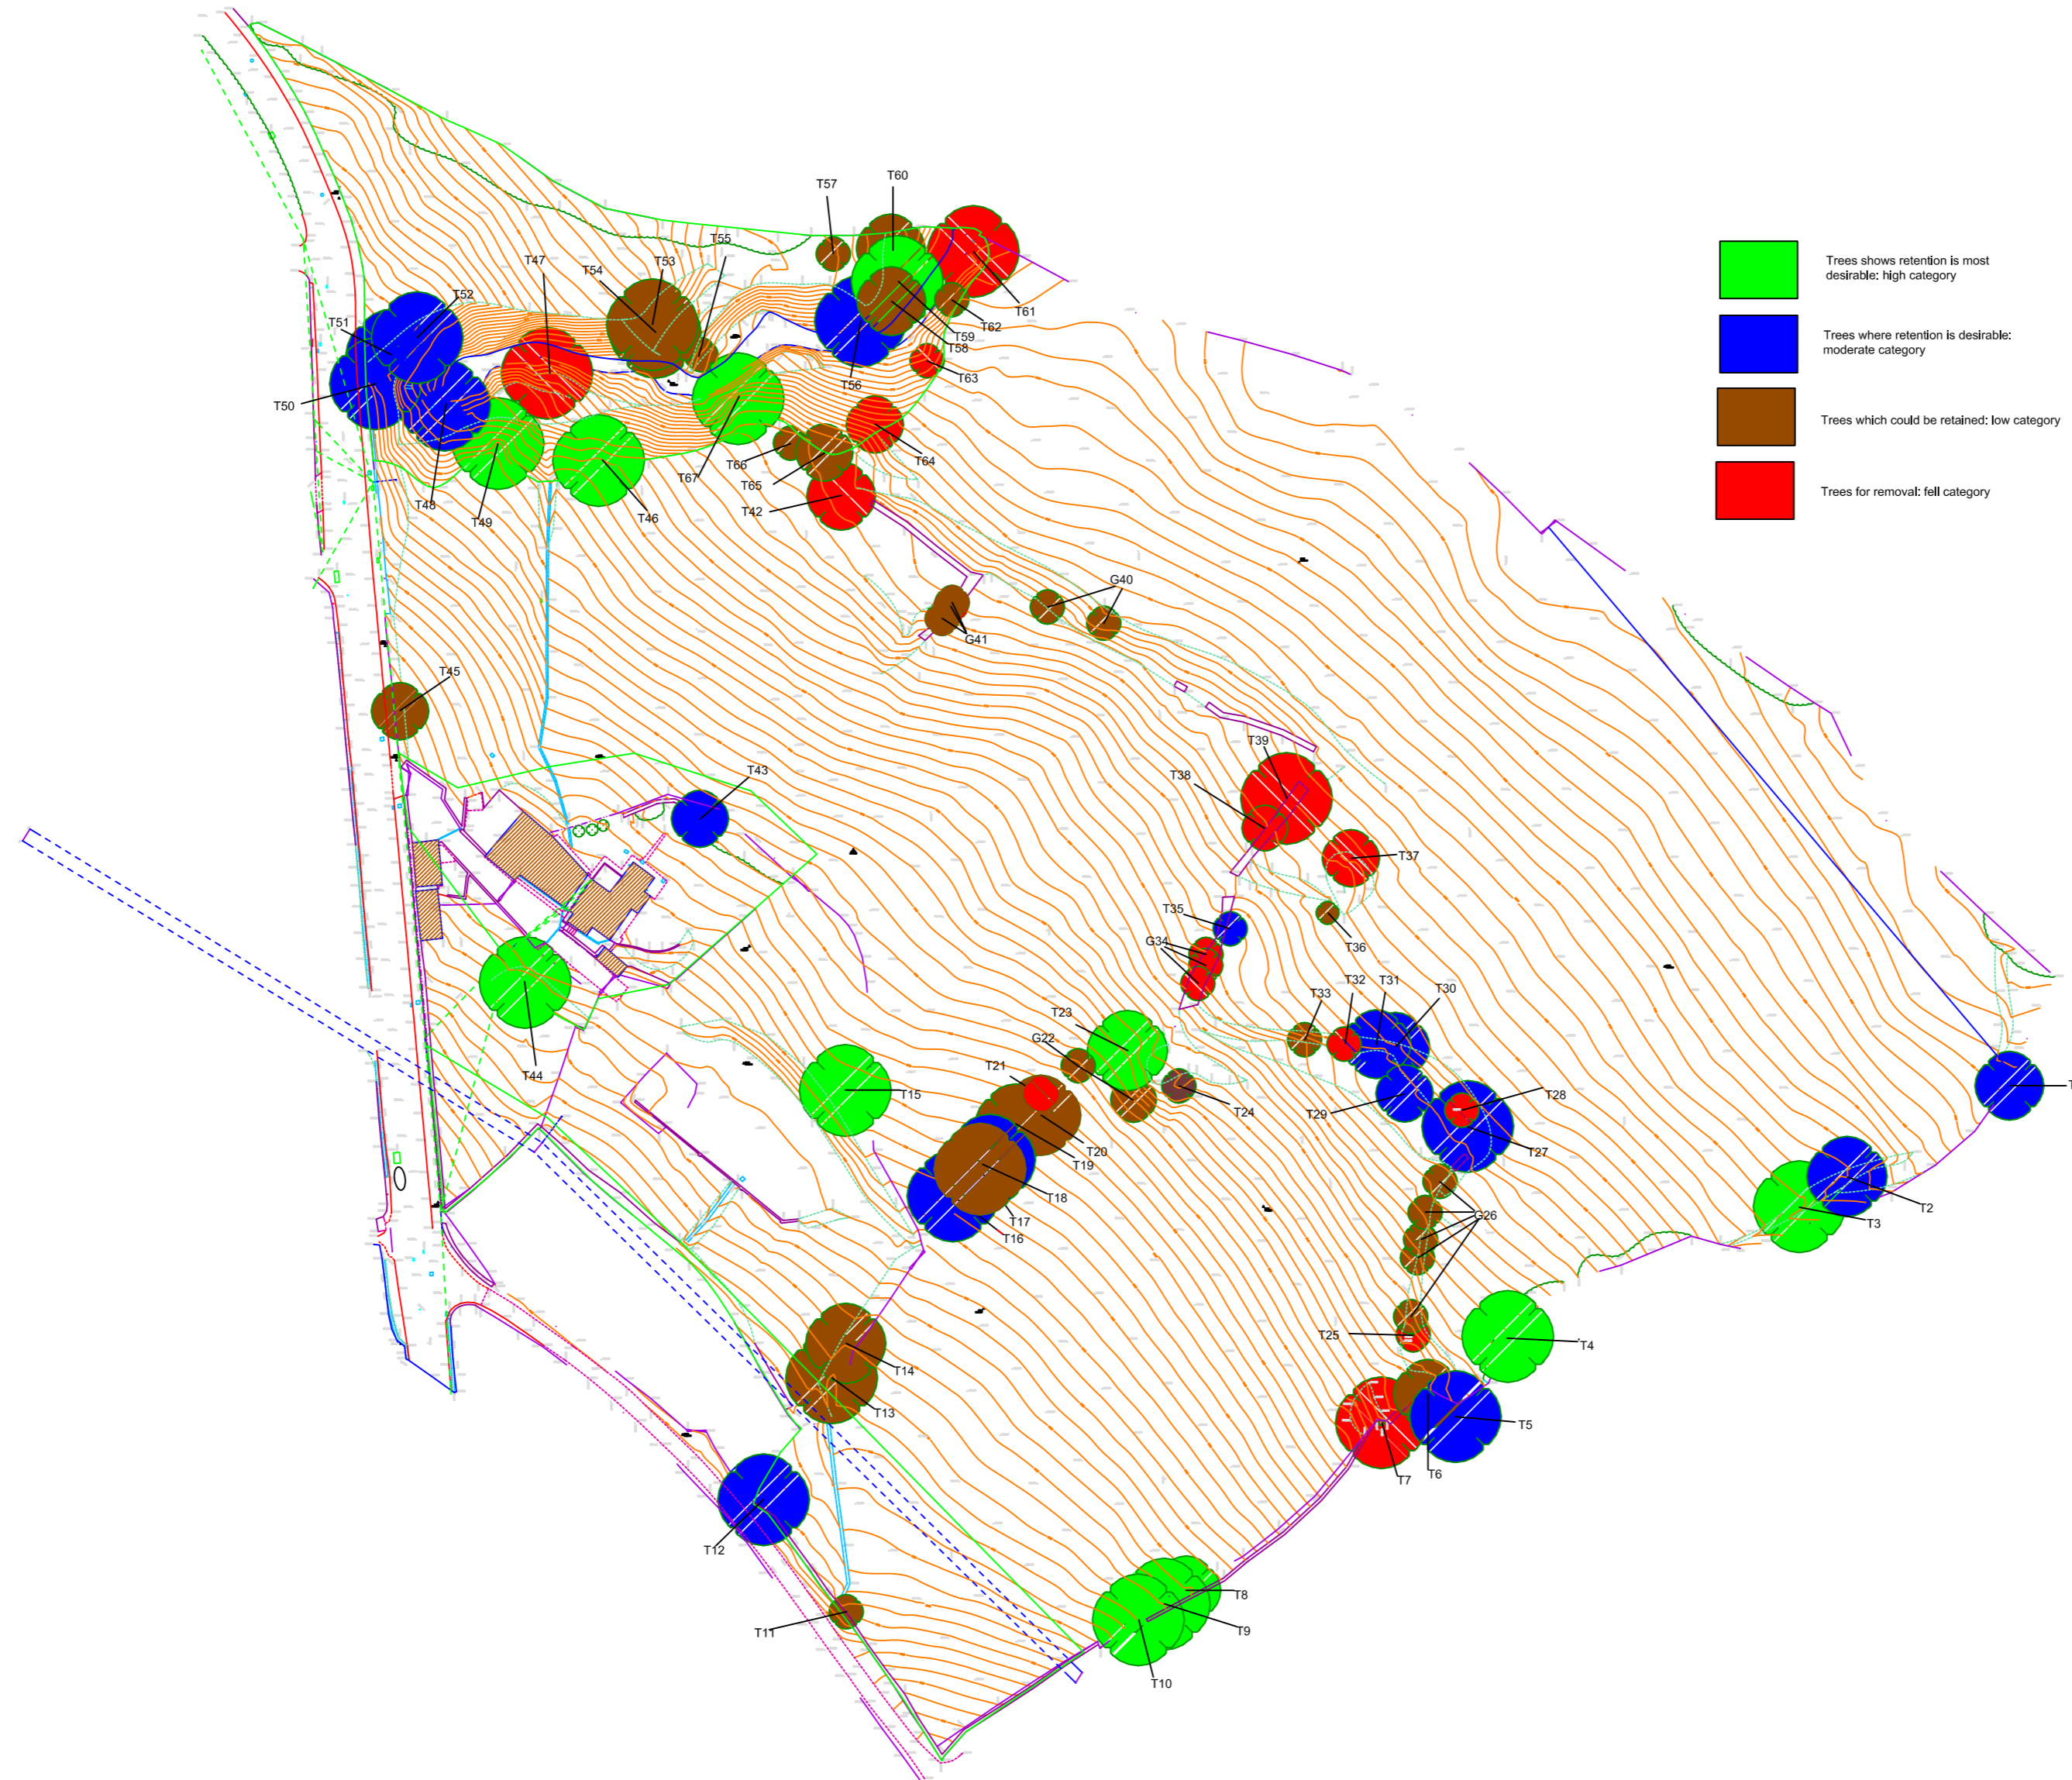
- Trees shows retention is most desirable: high category
- Trees where retention is desirable: moderate category
- Trees which could be retained: low category
- Trees for removal: fell category

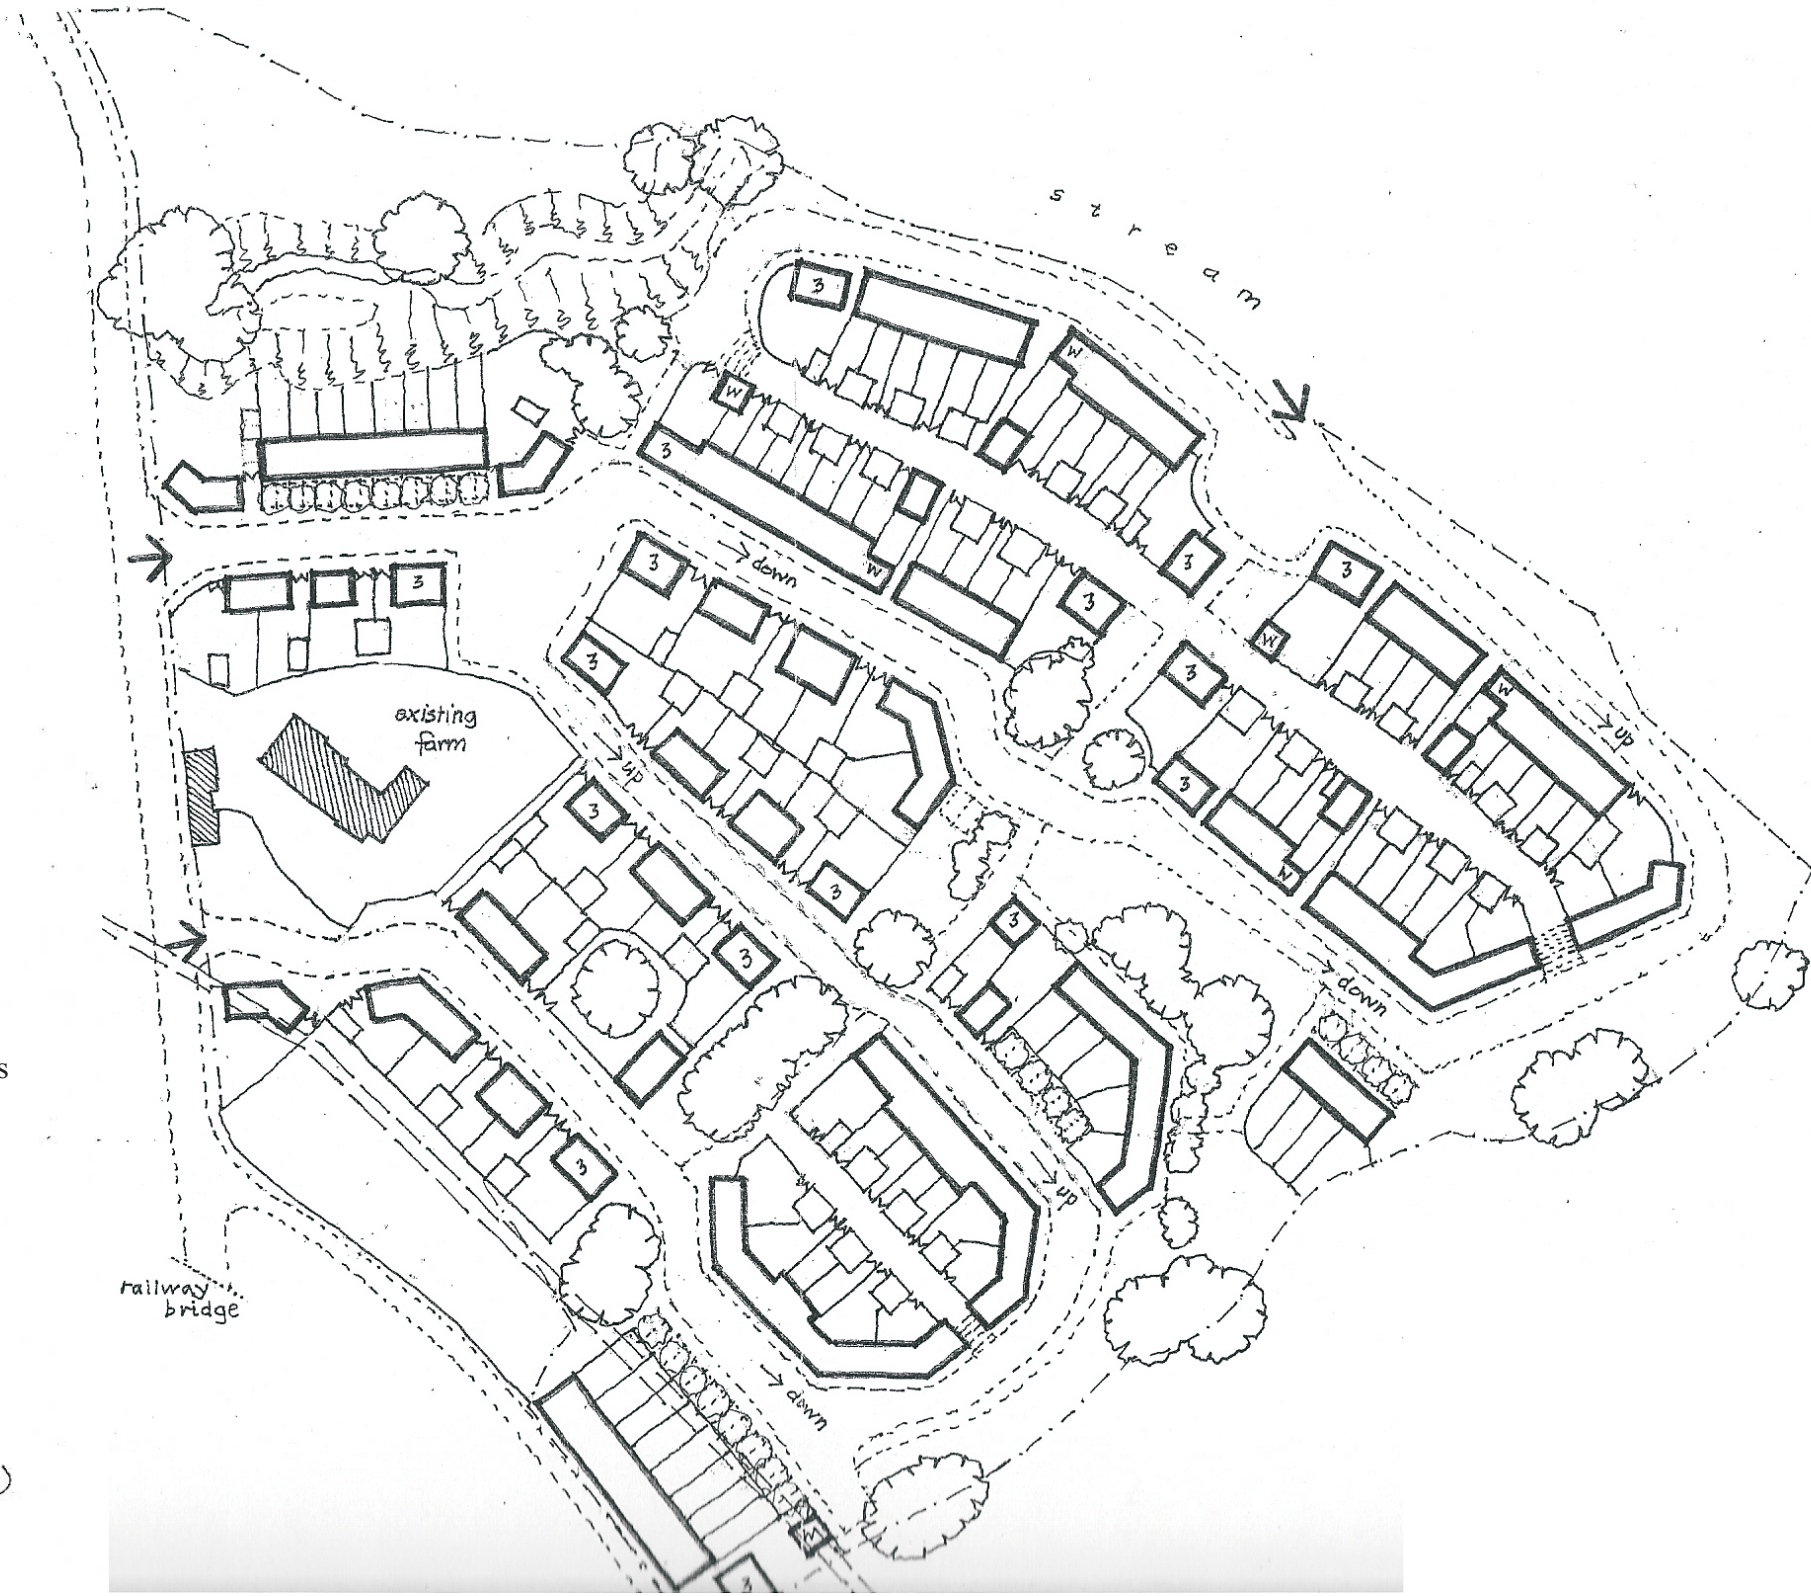
Title:
Proposed development
layout

Proposed site access (vehicles and pedestrians)
