**LEVEL 1 BUILDING RECORDING FOR  
PROPOSED TWO STOREY EXTENSION TO  
EXISTING DWELLING AT LITTLE PENTRE  
TWIN ALLWYS ROAD, GOVILON, NP7 9RT  
PLANNING APPLICATION:  
18/16325/FUL (BBNPA)**

November 2018

Trysor Project No. 2018/640  
HER Event Record- GGAT PRN E006131

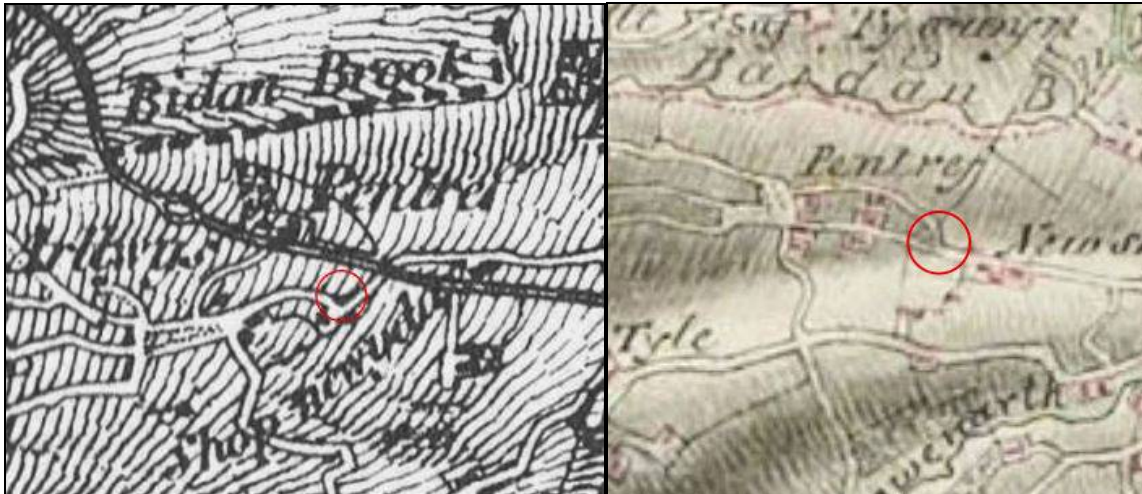
Figure 3: The 1832 1:63360 map (left), shown alongside the 1813 Ordnance Survey's Original Surveyors drawings. The present site of Little Pentre is ringed in red on the 1832 map. It is not clear whether a building is shown at the location. The 1813 map seems to show "Pentref" further south than the present Pentre Farm and does not appear to show any building at the site of Little Pentre, the probable location of which is ringed in red here also. (Note: the 1:63360 map shown here is based on the 1832 edition but has later features added, including the railway line built in 1862 which runs south of Pentre Farm).

8.2 The 1:63360 map published by the Ordnance Survey in 1832 (Sheet 42) gives a slightly clearer picture, see figure 3. It may show a building at the present site of Little Pentre (ringed is in red) but it is not possible to be certain.

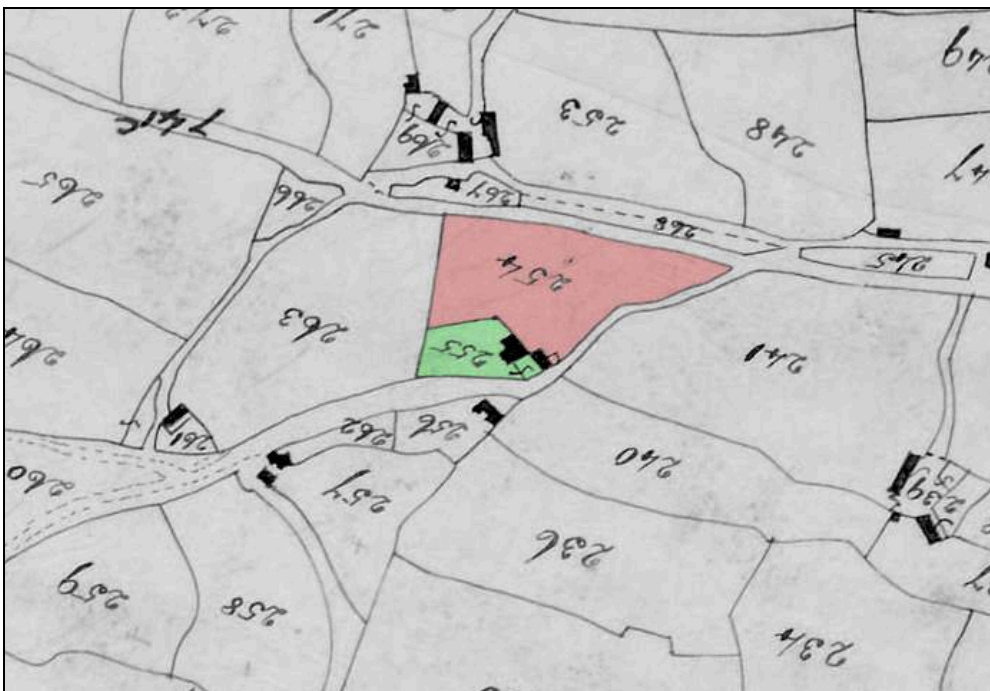
Figure 4: Little Pentre Farm as shown on the tithe map of 1843  
The map has been turned upside down to put north at the top.

8.3 The Llanwenarth parish tithe map of 1843, see figure 4, shows Little Pentre in detail. The two buildings are shown within field parcels 255 and 254. Parcel 255 (shaded green) is the unnamed "house and garden" described as a part of Pentre Farm on the tithe apportionment. Parcel 254 (shaded red) was a field known as Cae Graig (Rock Field) and forms part of Little Pentre today. The house is presumably the larger, L-shaped building to the left, with the smaller rectangular building to the right representing the barn which has been later converted into a dwelling and subsequently incorporated into the present Little Pentre cottage.

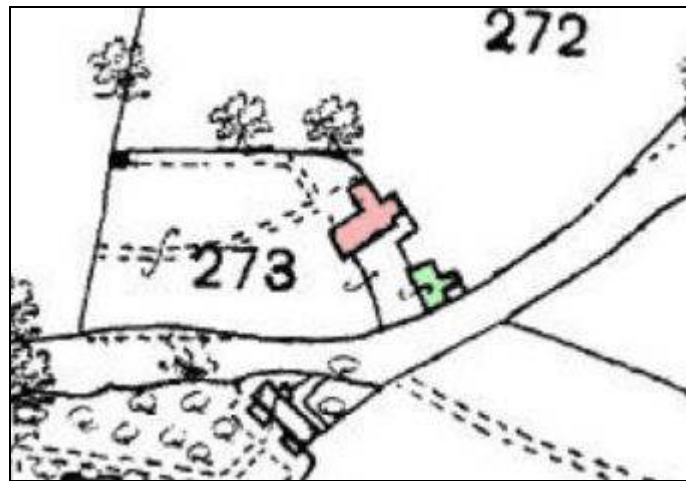
Figure 5: The 1880 1:2500 Ordnance Survey map shows the original house (red) to the northwest of the barn (the present cottage – shaded green). Note the extension added to the northeast side of the barn.

8.4 The 1880 Ordnance Survey 1:2500 scale map, see figure 5, also shows the house and barn at Little Pentre, though the map does not name the property. A similar picture is shown on the 1901 1:2500 scale map, which also shows both buildings in use. The 1957 1:25000 scale Ordnance Survey map also shows two buildings in use here, but the 1960 edition of the 1:2500 scale map shows the house at Little Pentre as an abandoned building.

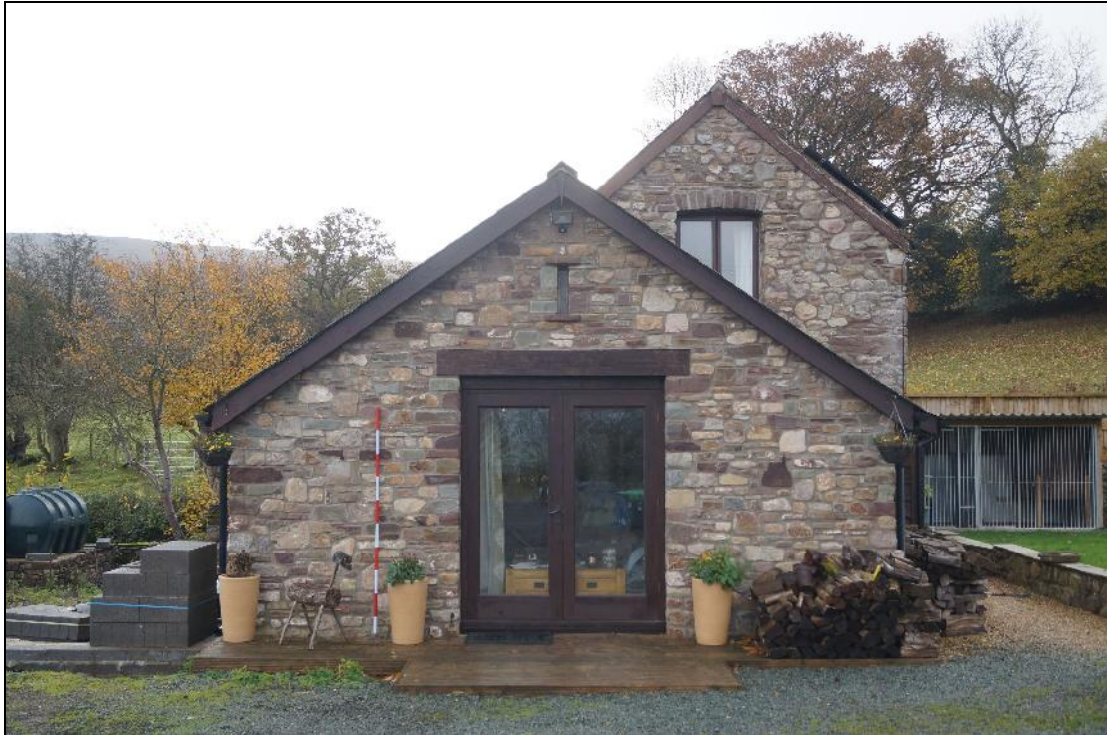
Plate 1: LPT2018\_001, Little Pentre cottage. The part of the building in the foreground is a modern extension. The 19<sup>th</sup> century barn, converted into a cottage in the 20<sup>th</sup> century, is behind the modern addition. Looking south-southeast.

Photo Number	Description	Date Taken	Direction
LPT2018_001	Little Pentre cottage. The part of the building in the foreground is a modern extension. The 19 <sup>th</sup> century barn, converted into a cottage in the 20 <sup>th</sup> century, is behind the modern addition.	13/11/2018	Looking south-southeast.
LPT2018_002	Little Pentre cottage showing the 19 <sup>th</sup> century converted barn. The ground floor doorways are original, the upper floor window appears to be a later insert into a rebuilt upper gable wall.	13/11/2018	Looking southeast.
LPT2018_003	A view of the south-southwestern lateral wall of Little Pentre cottage. The original doorways are the only features. Note that the wallplate has been raised by over 0.40 metres, presumably during the 20 <sup>th</sup> century conversion. The roof and chimney are modern therefore.	13/11/2018	Looking north-northeast
LPT2018_004	A closer view of the doorways in the south-southwestern wall of Little Pentre cottage. The stonework of this wall is original and characterised by coursed Old Red Sandstone and some green sandstones, typical of the area.	13/11/2018	Looking north-northeast

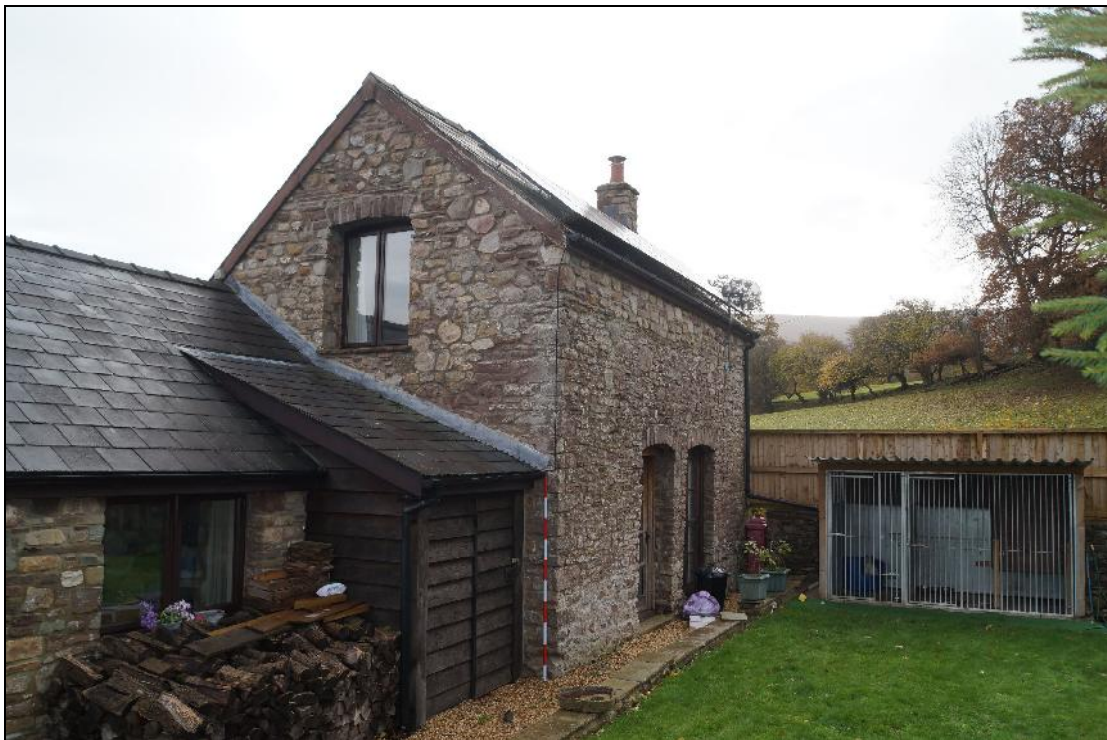
Plate 2: LPT2018\_002, Another view, looking southeast, of Little Pentre cottage showing the 19<sup>th</sup> century converted barn. The ground floor doorways are original, the upper floor window appears to be a later insert into a rebuilt upper gable wall.

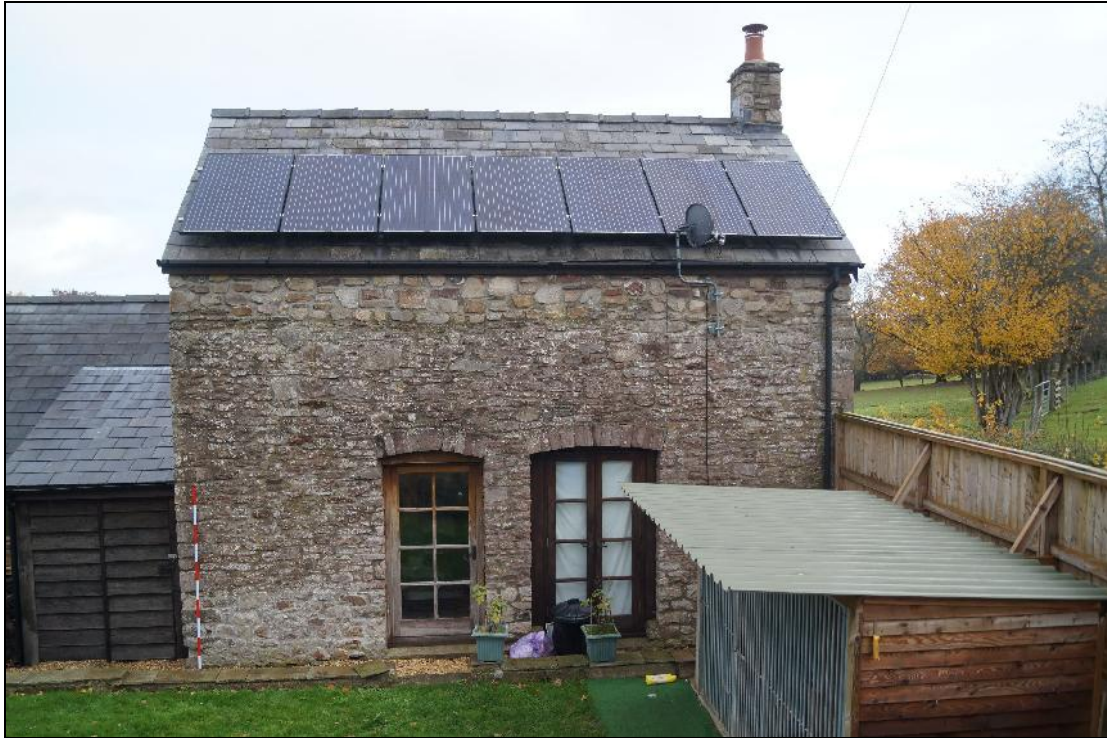
Plate 3: LPT2018\_003, A view of the south-southwestern lateral wall of Little Pentre cottage, looking north-northeast. The original doorways are the only features. Note that the wallplate has been raised by over 0.40 metres, presumably during the 20<sup>th</sup> century conversion. The roof and chimney are modern therefore.

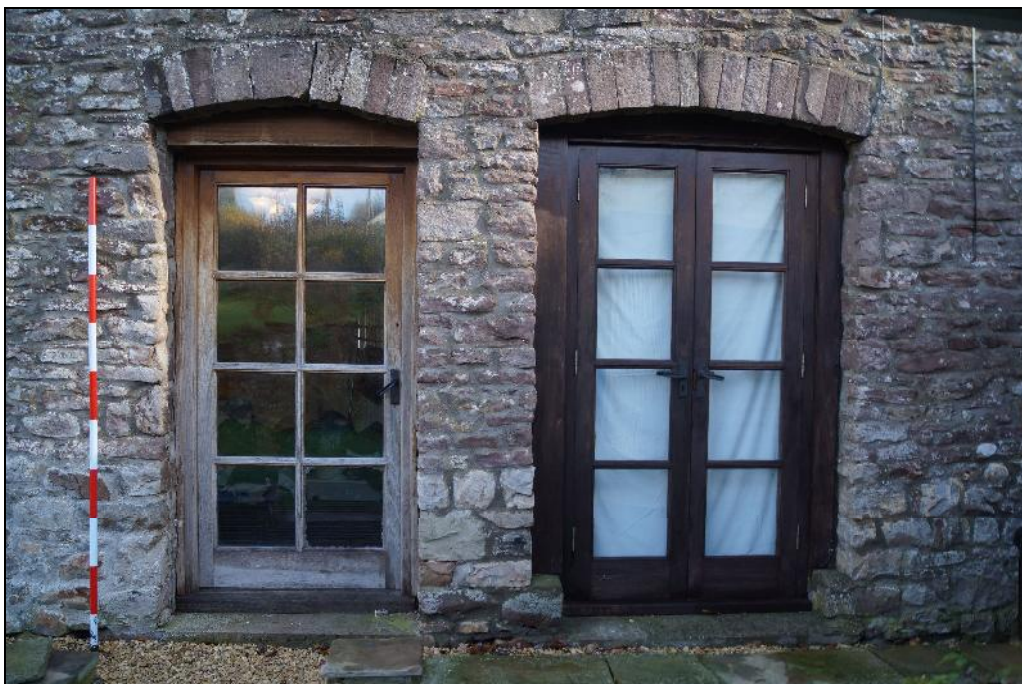
Plate 4: LPT2018\_004, A closer view of the doorways in the south-southwestern wall of Little Pentre cottage. The stonework of this wall is original and characterised by coursed Old Red Sandstone and some green sandstones, typical of the area. Looking north-northeast.

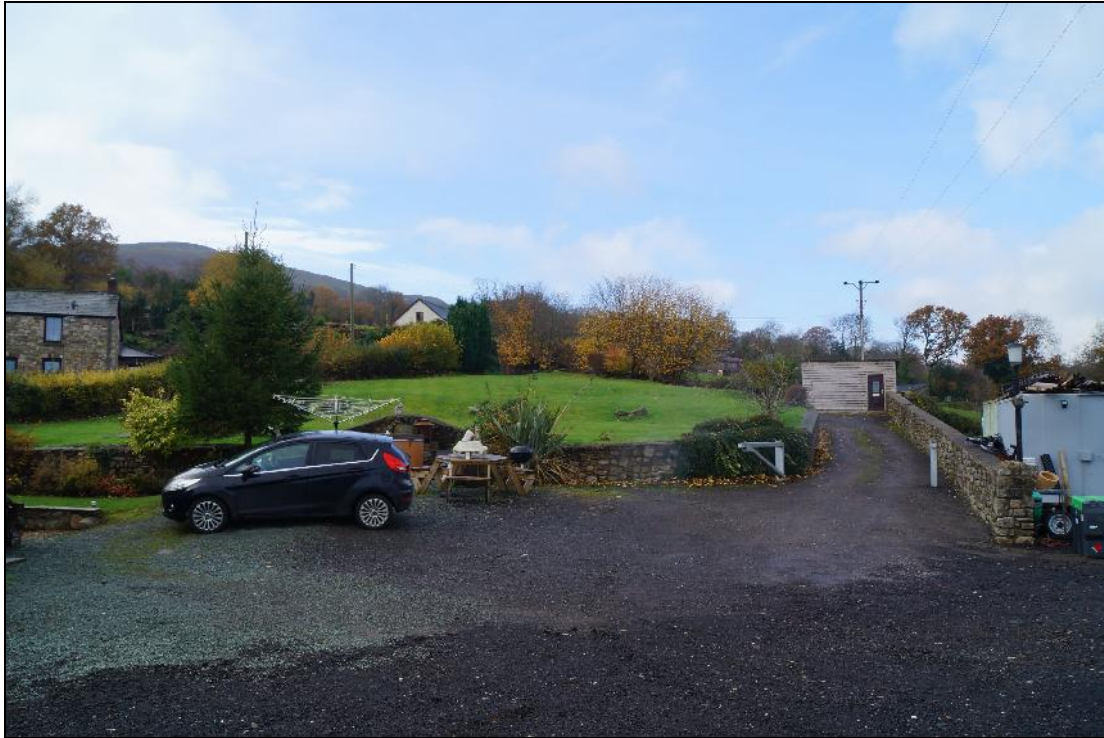
Plate 5: LPT2018\_005, A view of the garden area of Little Pentre showing the position where the original house stood until the 20<sup>th</sup> century. Looking southwest.

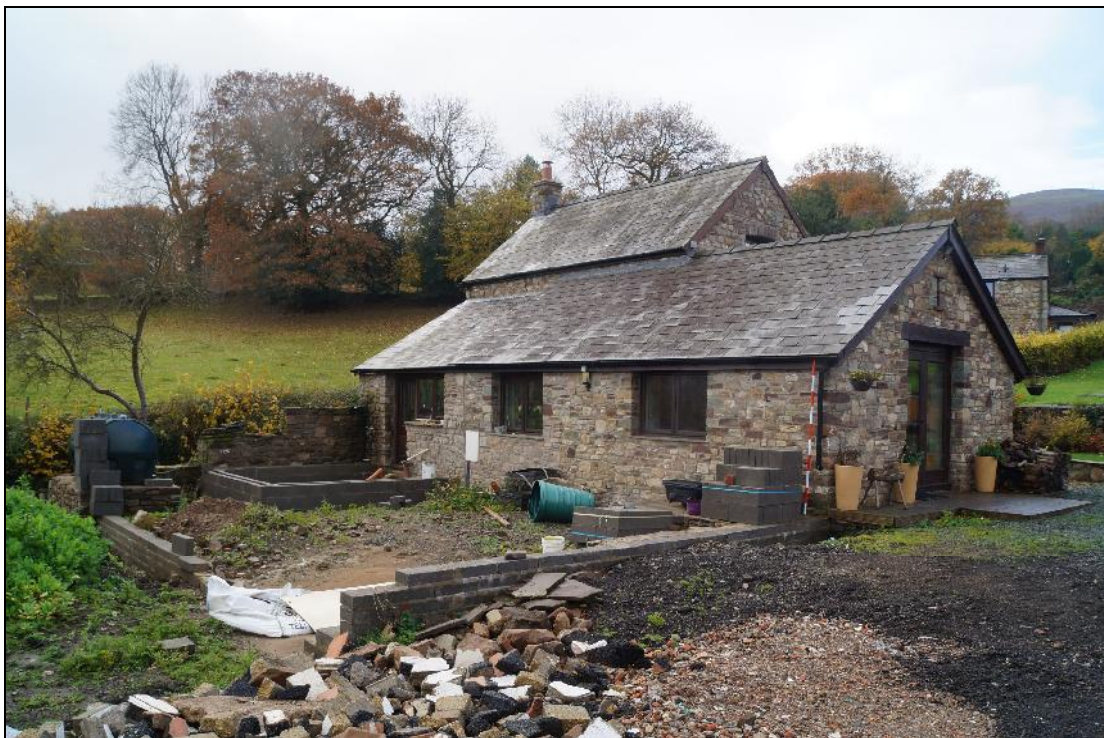
Plate 6: LPT2018\_006, A view of Little Pentre farmhouse, looking southwest. The modern extension blocks the view of the original barn attached to its north-northeastern side. The door and window in the left hand side of the modern extension are however in a section of the building that seems to have been added to the barn by the late 19<sup>th</sup> century as a lean-to extension.

<b>Photo Number</b>	<b>Description</b>	<b>Date Taken</b>	<b>Direction</b>
LPT2018_006	A view of Little Pentre farmhouse. The modern extension blocks the view of the original barn attached to its north-northeastern side. The door and window in the left hand side of the modern extension are however in a section of the building that seems to have been added to the barn by the late 19 <sup>th</sup> century as a lean-to extension.	13/11/2018	Looking southwest
LPT2018_007	The earlier extension off the east-northeast lateral wall of the original barn can be seen clearly here. A wall joint is visible to the left of the scale rod. The wall to the left of that joint appears to be late 19 <sup>th</sup> century wall. The wall to the left is a modern addition.	13/11/2018	Looking west-southwest
LPT2018_008	A view of the east-northeastern side of Little Pentre cottage showing the extension to the original barn. Note the change in roof height at the left side of the extension. The roof of the 19 <sup>th</sup> century addition is slightly lower than that of the purely modern extension to its right. This difference is seen inside also.	13/11/2018	Looking west-southwest

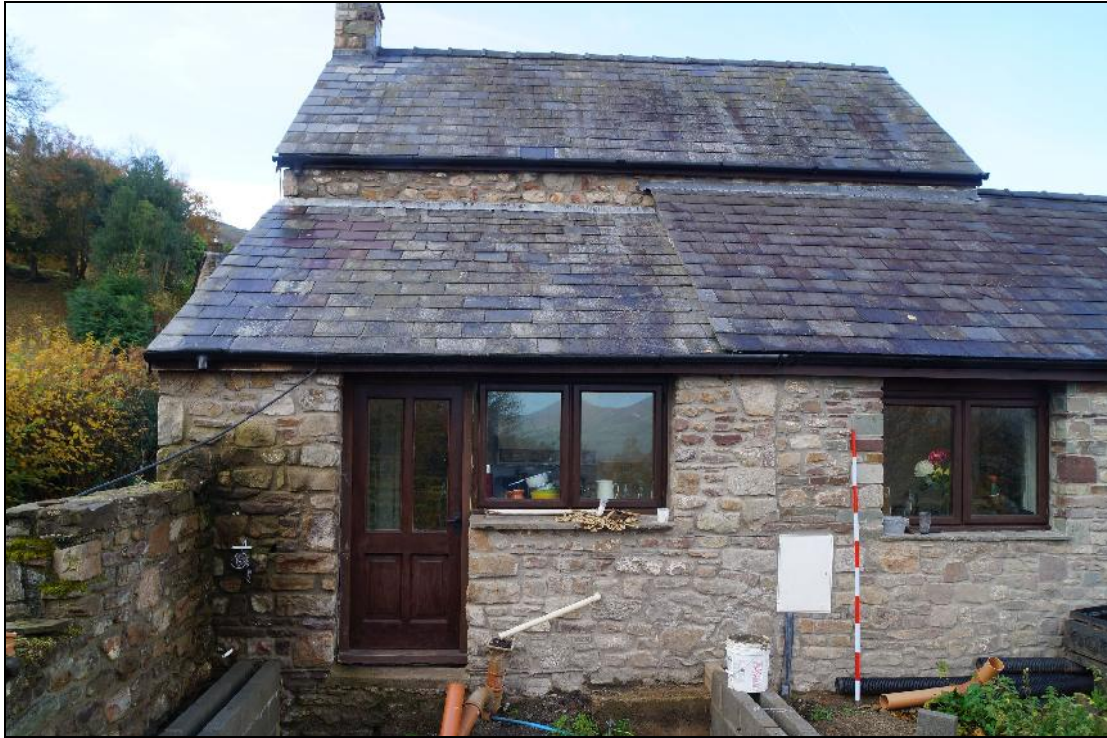
Plate 7: LPT2018\_007, The earlier extension off the east-northeast lateral wall of the original barn can be seen clearly here. A wall joint is visible to the left of the scale rod. The wall to the left of that joint appears to be late 19<sup>th</sup> century wall. The wall to the left is a modern addition. Looking west southwest.

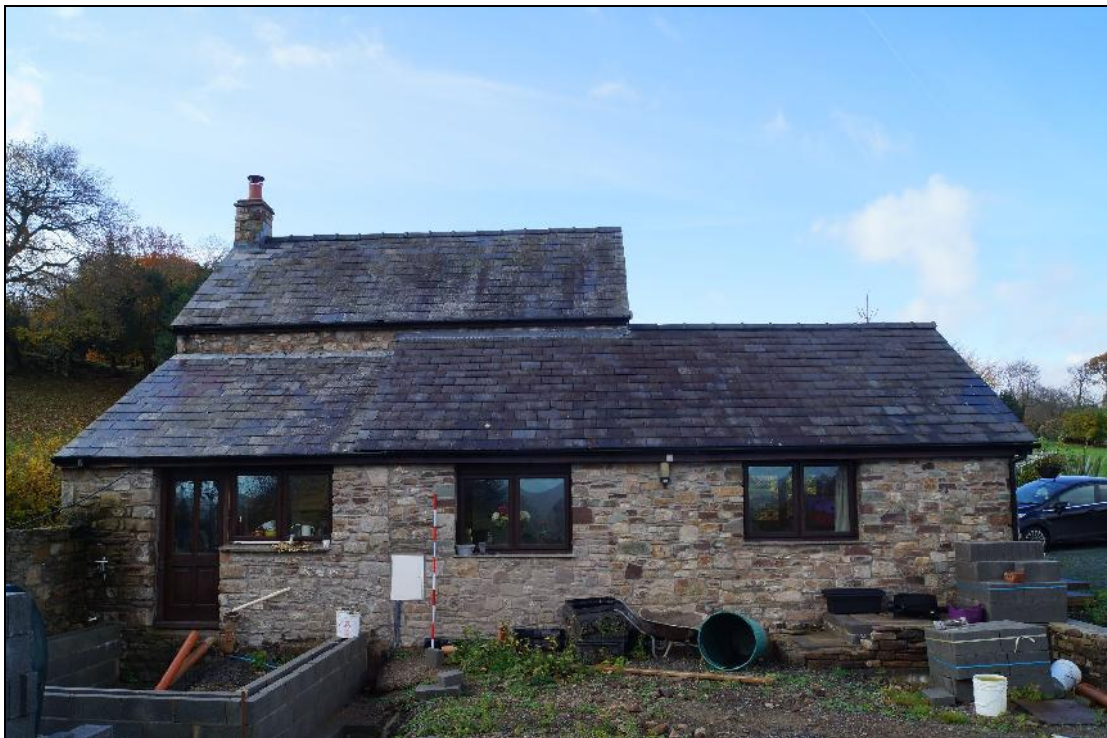
Plate 8: LPT2018\_008, A view of the east-northeastern side of Little Pentre cottage showing the extension to the original barn looking west-southwest. Note the change in roof height at the left side of the extension. The roof of the 19<sup>th</sup> century addition is slightly lower than that of the purely modern extension to its right. This difference is seen inside.

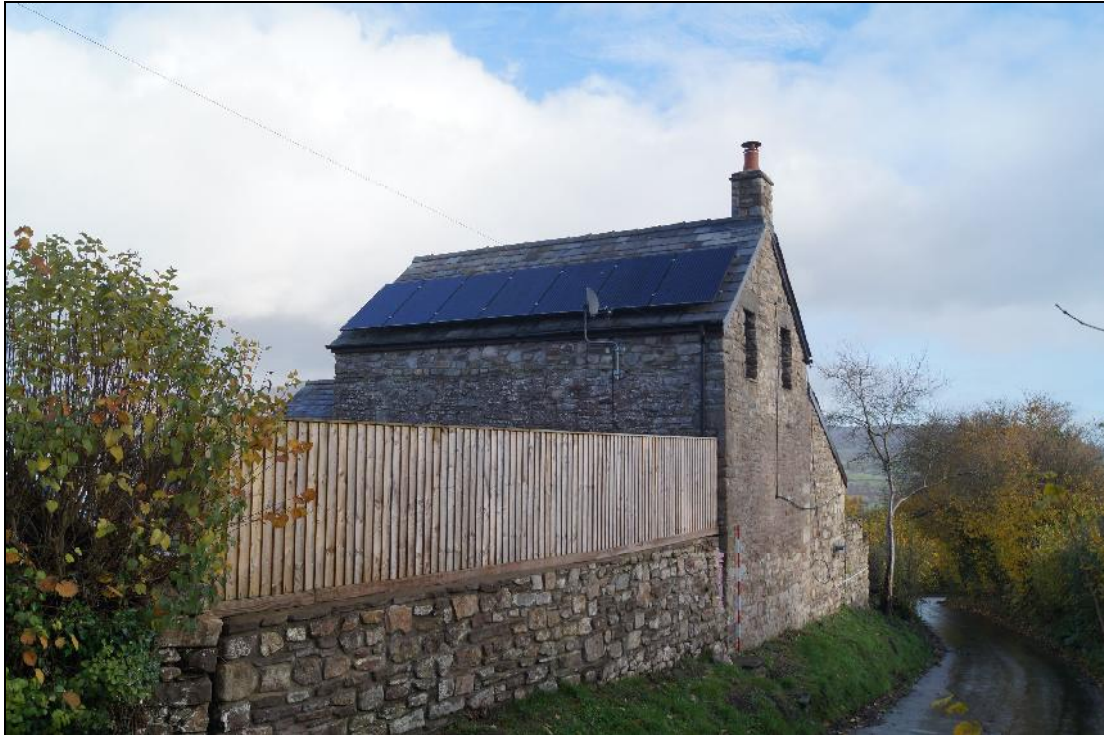
*Plate 9: LPT2018\_009, A view of Little Pentre cottage from the road which passes to the south, looking northeast. This shows the west-southwest side of the original barn and the south-southeast-facing gable wall. The windows in the first floor were undoubtedly added when the roof was raised in the 20<sup>th</sup> century.*

LPT2018_009	A view of Little Pentre cottage from the road which passes to the south. This shows the west-southwest side of the original barn and the south-southeast-facing gable wall. The windows in the first floor were undoubtedly added when the roof was raised in the 20 <sup>th</sup> century.	13/11/2018	Looking northeast
LPT2018_010	Another view of the south-southeast facing gable wall.	13/11/2018	Looking northeast
LPT2018_011	Another view of the south-southeast facing gable wall.	13/11/2018	Looking north-northeast

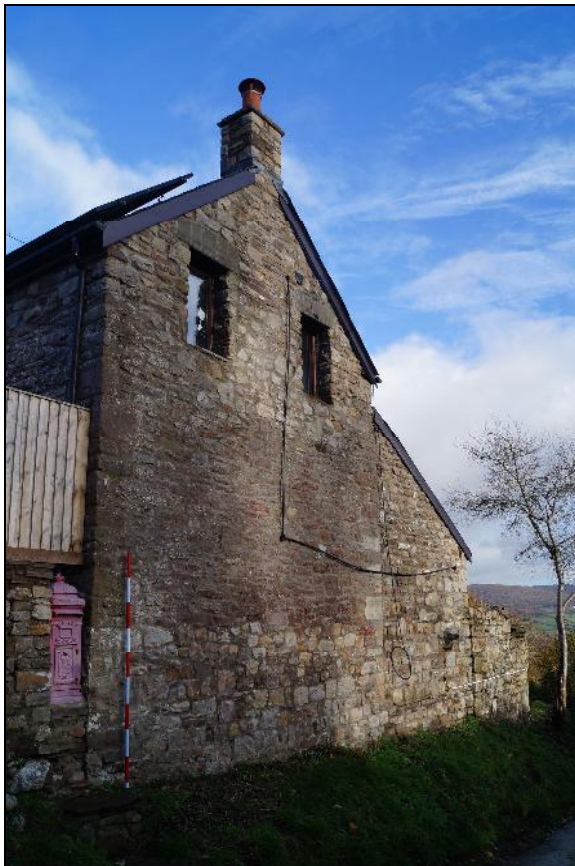
*Plate 10: LPT2018\_010 Another view of the south-southeast facing gable wall, looking northeast.*

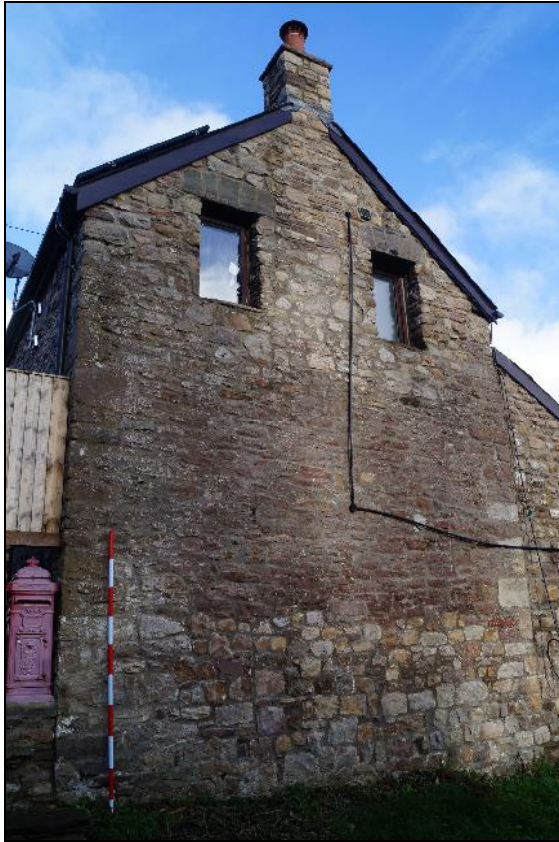
*Plate 11: LPT2018\_011 Another view of the south-southeast facing gable wall, looking north-northeast.*

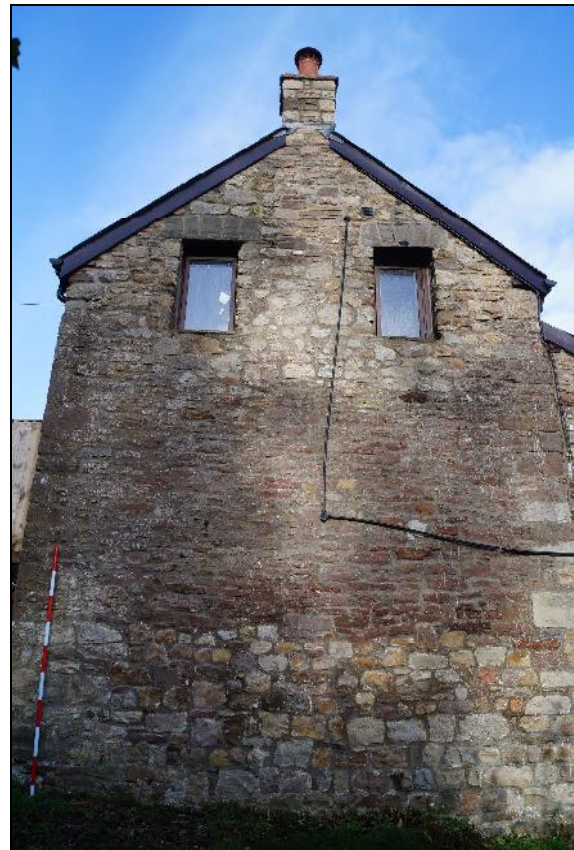
*Plate 12: LPT2018\_012 Another view of the south-southeast facing gable wall, looking northwest. The raised wallplate level is visible beneath the eaves either side. The windows must have been added after the wallplate was raised. The difference in the stonework is also evident in the upper part of the wall, and the modern chimney visible. The original Old Red Sandstone stonework is seen in the ground floor wall, with larger blocks used to build the original foundation or base of the wall for strength.*

Photo Number	Description	Date Taken	Direction
LPT2018_012	Another view of the south-southeast facing gable wall. The raised wallplate level is visible beneath the eaves either side. The windows must have been added after the wallplate was raised. The difference in the stonework is also evident in the upper part of the wall, and the modern chimney visible. The original Old Red Sandstone stonework is seen in the ground floor wall, with larger blocks used to build the original foundation or base of the wall for strength.	13/11/2018	Looking north northwest
LPT2018_013	Another view of the south-southeast facing gable wall.	13/11/2018	Looking northwest.
LPT2018_014	Another view of the south-southeast facing gable wall, showing the south-southeast-facing wall of the late-19 <sup>th</sup> century extension in the centre and the probably 19 <sup>th</sup> century garden wall to the right.	13/11/2018	Looking northwest.

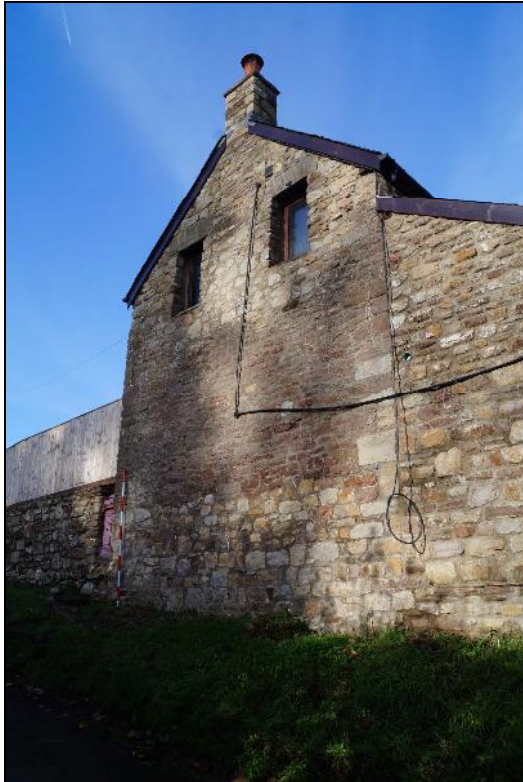
*Plate 13: LPT2018\_013 Another view of the south-southeast facing gable wall, looking northwest.*

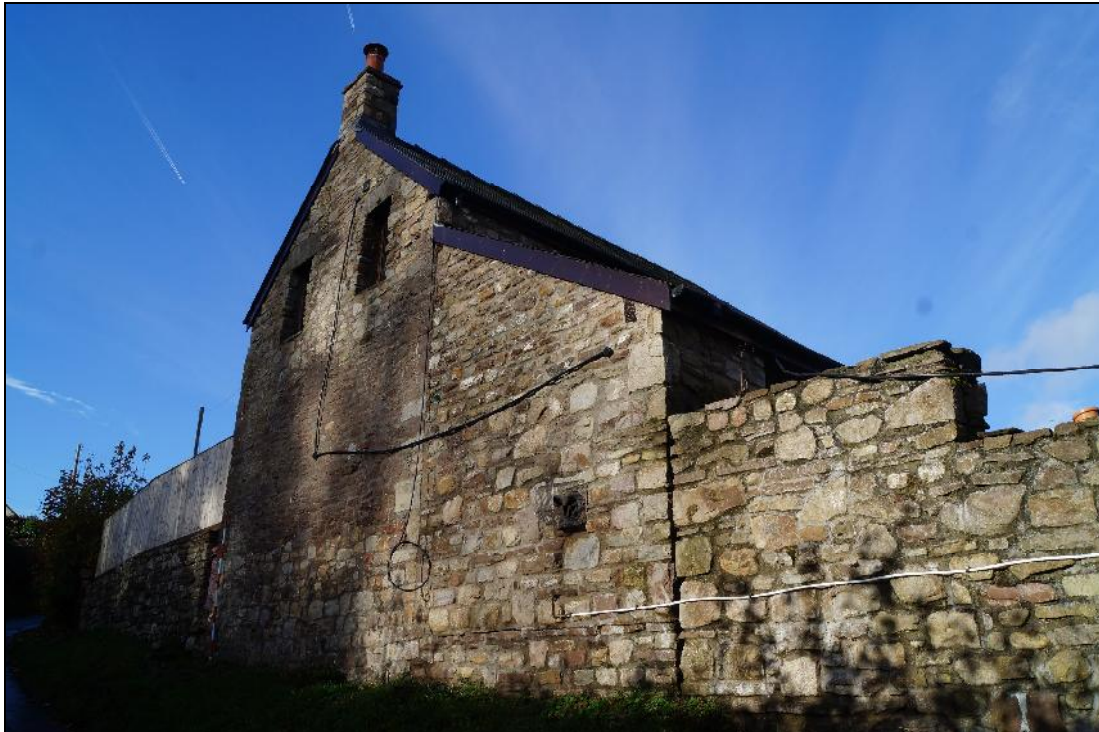
*Plate 14: LPT2018\_014, Another view of the south-southeast facing gable wall, looking northwest and showing the south-southeast facing wall of the late-19<sup>th</sup> century extension in the centre and the probably 19<sup>th</sup> century garden wall to the right.*

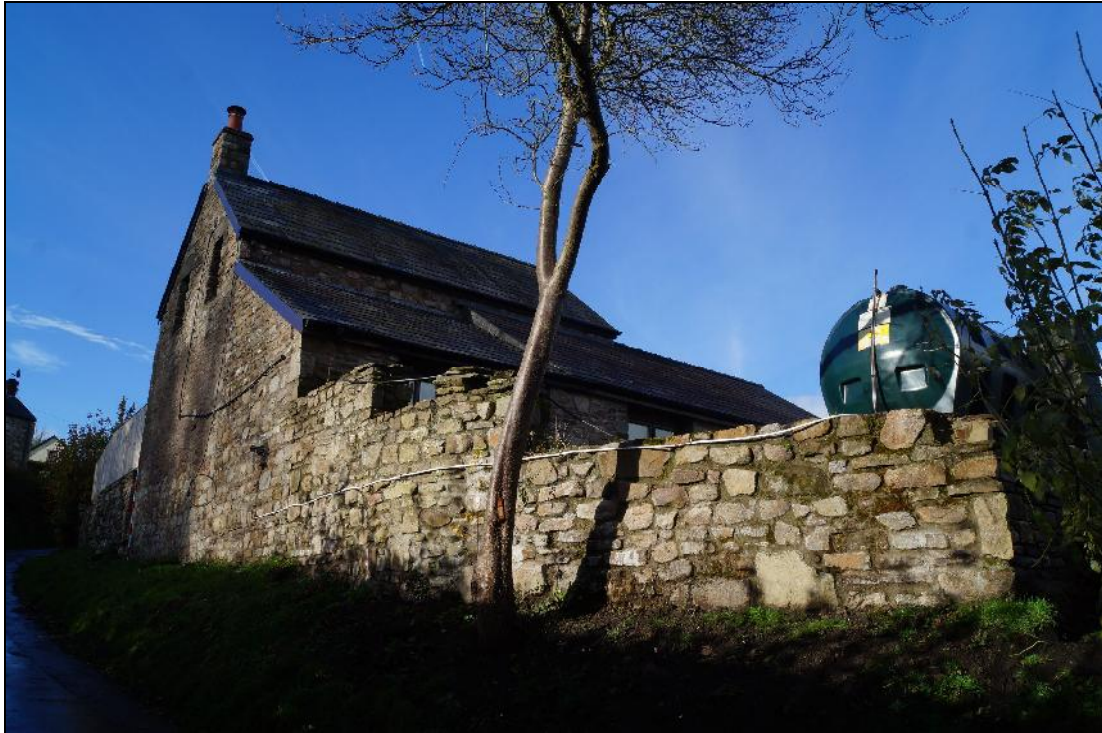
Plate 15: LPT2018\_015, Another view of the south-southeast facing gable wall, looking west-southwest and showing the south-southeast facing wall of the late-19<sup>th</sup> century extension in the centre and the probably 19<sup>th</sup> century garden wall to the right.

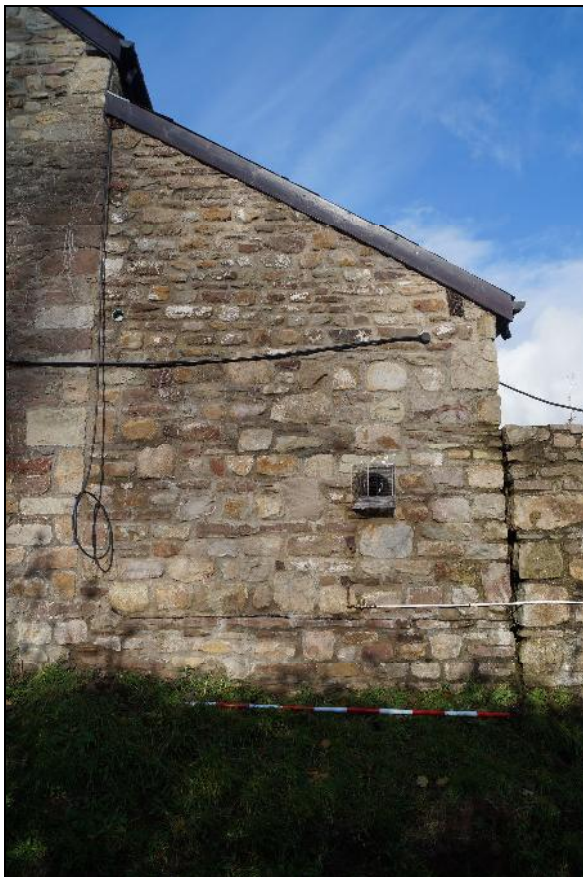
Plate 16: LPT2018\_016 A close up of the south-southeast wall of the late 19<sup>th</sup> century extension. A damp-proof course is visible low in the wall, suggesting it may have been modified or rebuilt in modern times. The gap between the building and the garden wall to the right may also support the idea that the extension has been modified. Looking north-northwest.

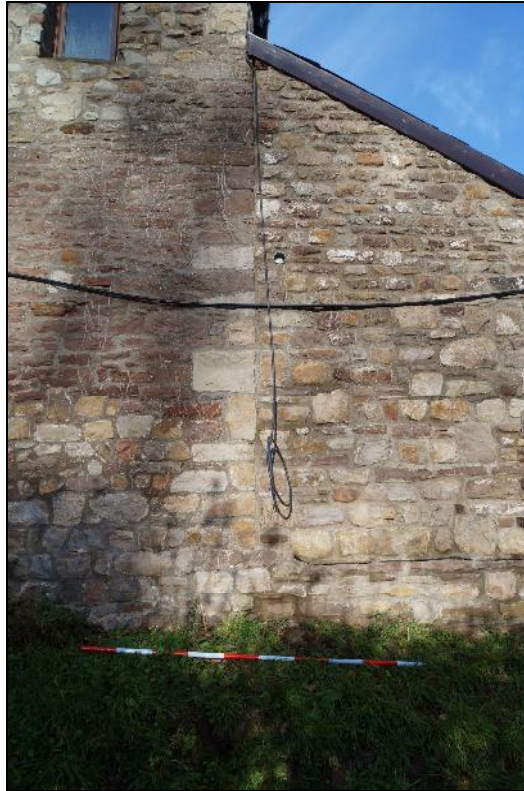
Plate 17: LPT2018\_017, The joint between the original barn and the late-19<sup>th</sup> century extension is seen here. Note the quoin stones of the barn. Looking north-northwest.

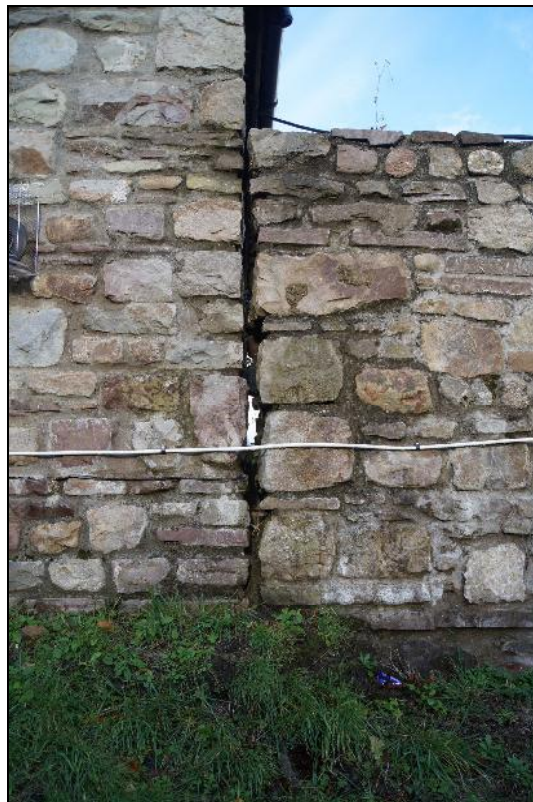
Plate 18: LPT2018\_018, This gap between the late-19<sup>th</sup> century extension and the garden wall suggests that one or the other may have been rebuilt in modern times.

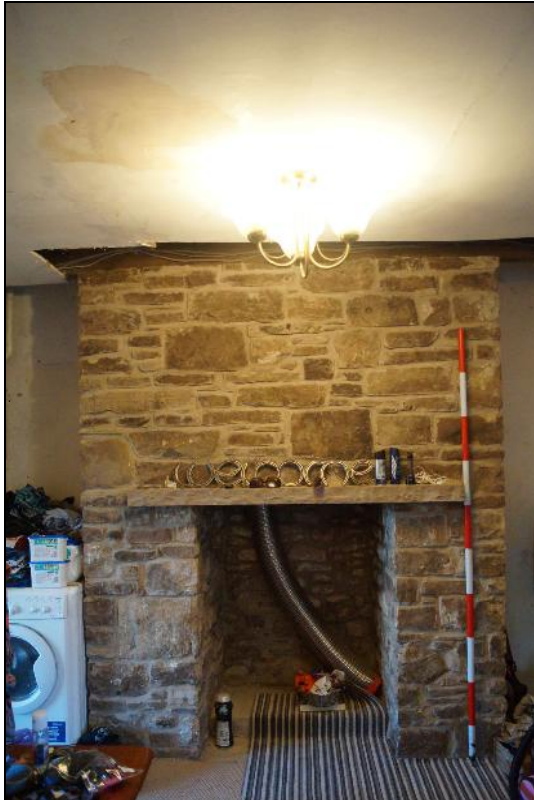
*Plate 19: LPT2018\_019, inside the original barn is evidence of the 20<sup>th</sup> century conversion into a dwelling. This stone fireplace in the south-southeast gable wall is not an original feature and was added in at some point in the 20<sup>th</sup> century. Looking south-southeast.*

9.4 It seems likely that the stone fireplace built against the southeast gable wall was inserted when the conversion to a dwelling occurred, as well as the wooden stairs leading to the heightened first floor. Both remain in use.

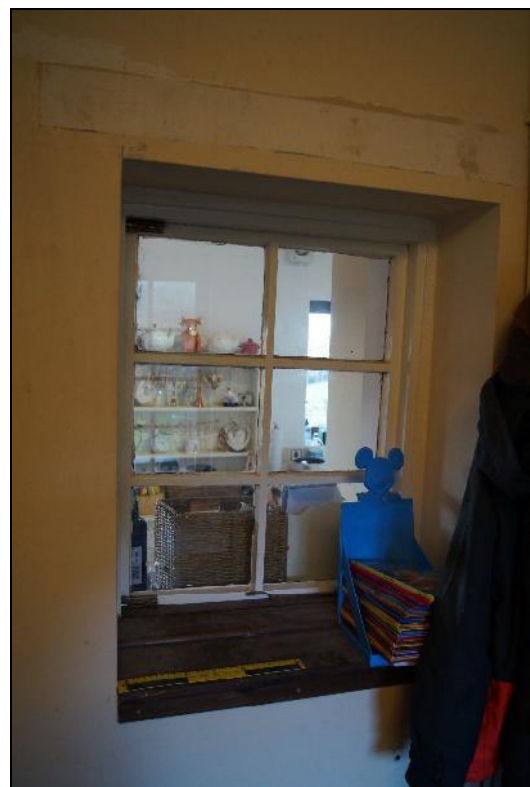
*Plate 20: LPT2018\_023, An original window survives in the east-northeast wall of the original barn, now as an internal feature between the barn and the 20<sup>th</sup> century extension added to the outside of the wall. Looking east-northeast.*

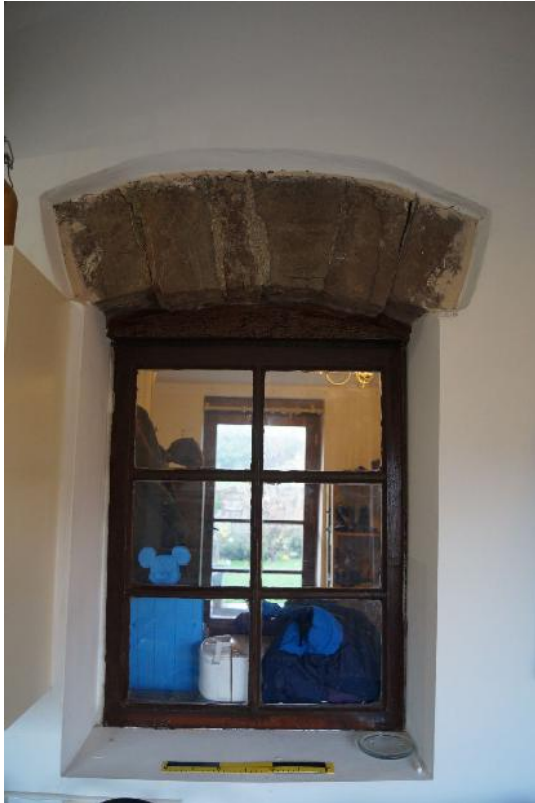
*Plate 21: LPT2018\_024, A reverse view of the window shown in Plate 20, looking west-southwest from the modern kitchen.*

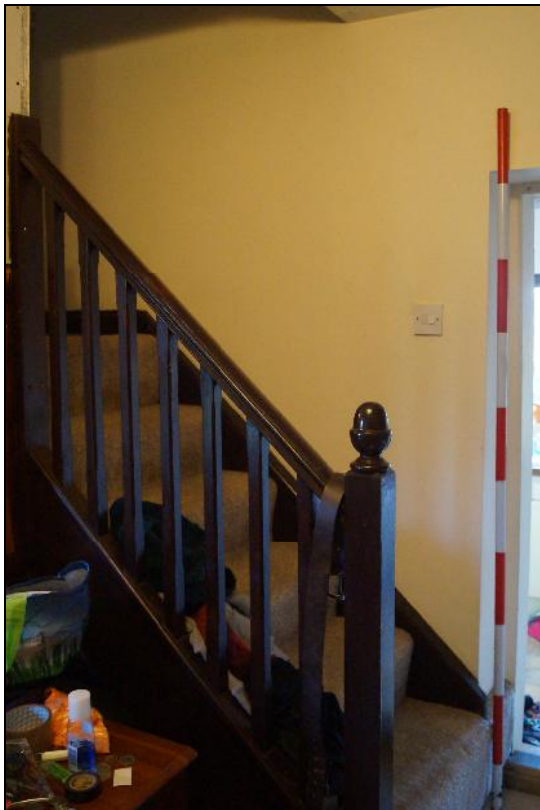
*Plate 22: LPT2018\_025, A view of the staircase which was added when the barn was converted into a cottage during the 20<sup>th</sup> century. The original staircase seems to have survived. Looking east-northeast.*

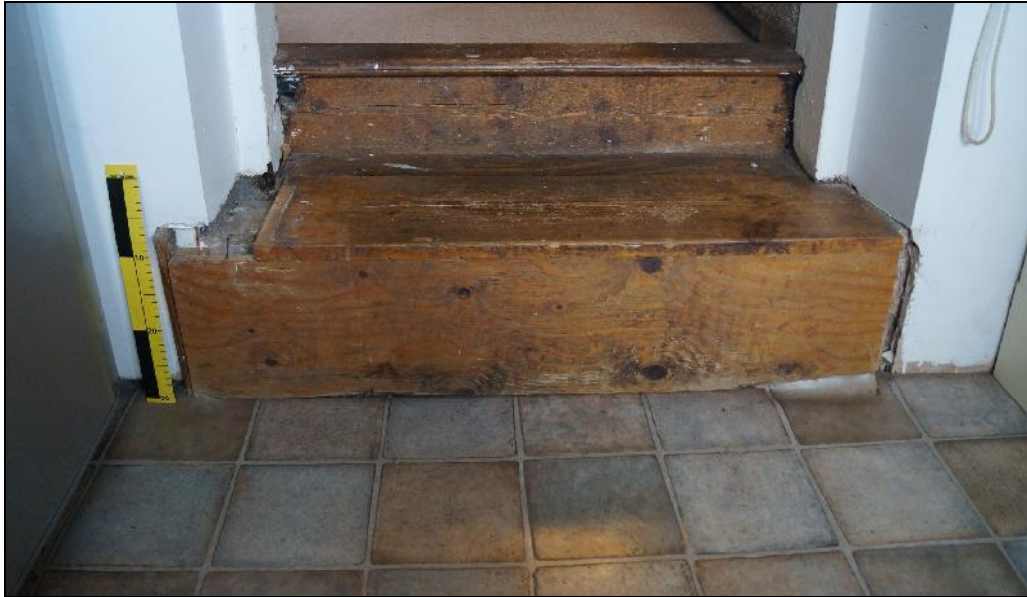
Plate 23: LPT2018\_026, Wooden steps leading from the original barn down to the first extension added to the building, probably in the late 19<sup>th</sup> century. Looking west-southwest.

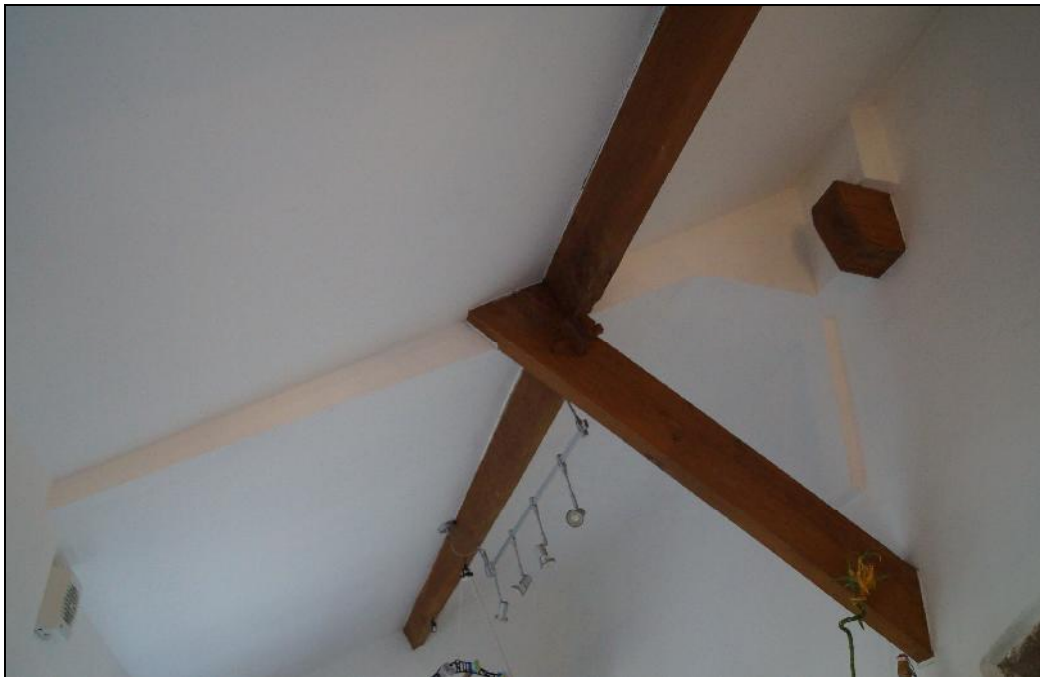
Plate 24: LPT2018\_028, An internal view of the ceiling inside the kitchen extension showing the change in rafter height. The lower ceiling reflects the height of the late 19<sup>th</sup> century extension to the building, the higher ceiling is modern. Looking south.

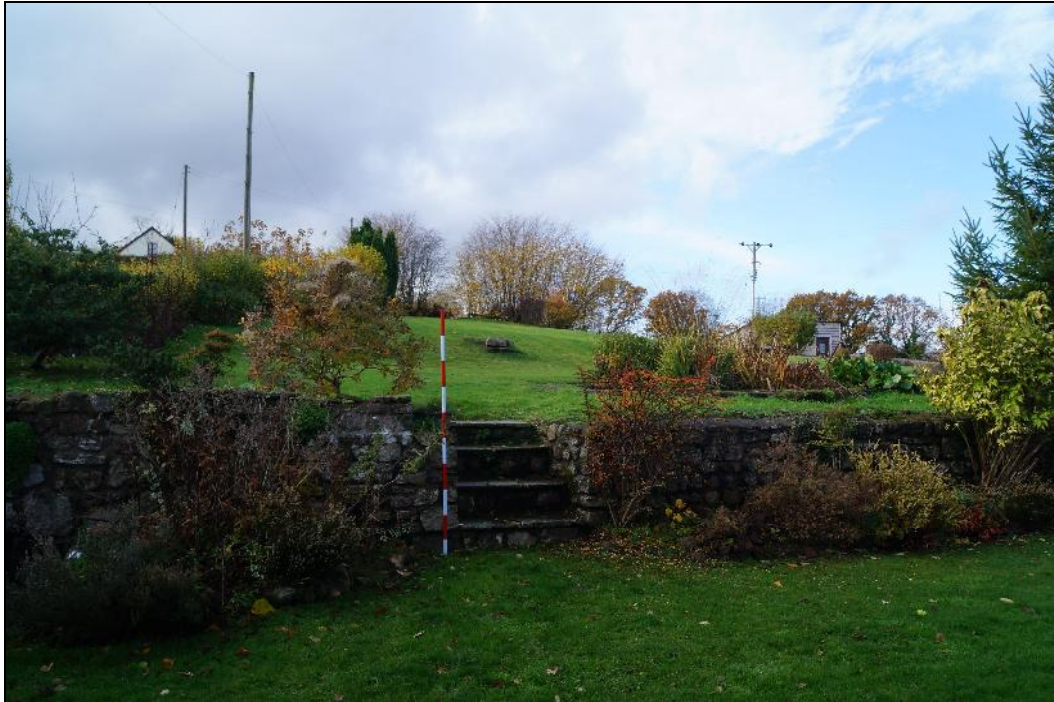
Plate 25: LPT2018\_040, A view of the garden to the west-southwest of the original barn, looking west. The revetment wall shown here is shown on late 19<sup>th</sup> century Ordnance Survey maps and is probably an original 19<sup>th</sup> century feature. It connected to the now lost house to the right of this photograph.

9.8 The area around the present dwelling has been altered in the past, but it is thought likely that the garden to the west-southwest of the house retains much of the form of the original layout, including a revetment wall which divides it into two parts and which incorporates a flight of stone steps leading from the lower garden, closest to the cottage, up to the upper part of the garden. This wall line is shown on 19<sup>th</sup> century Ordnance Survey maps.

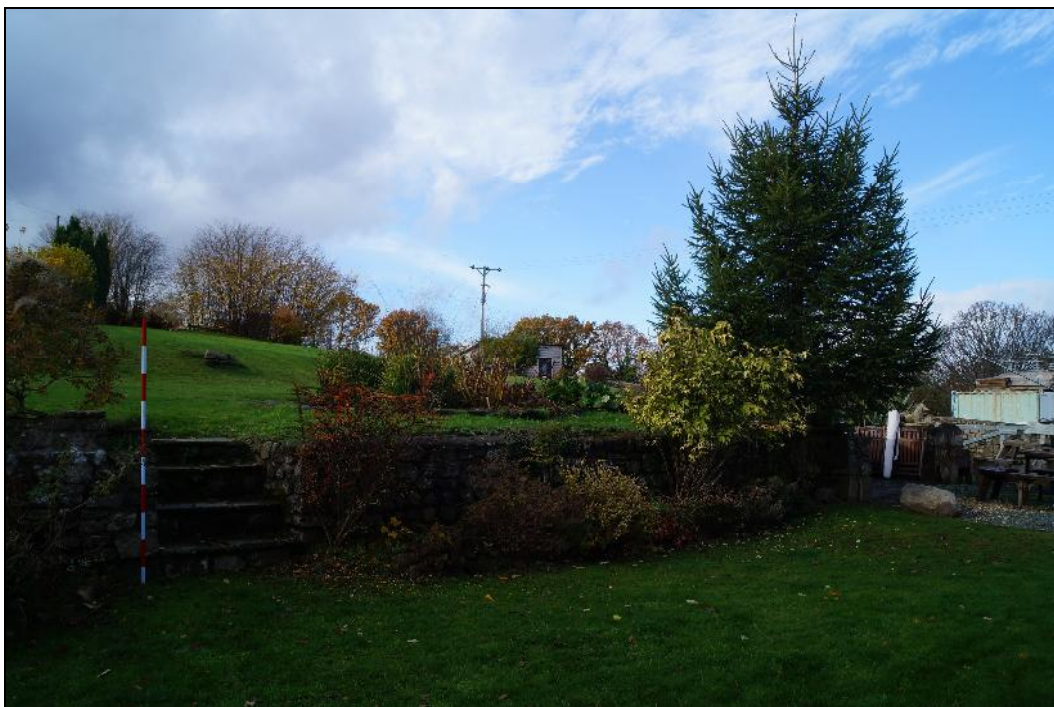
Plate 26: LPT2018\_041, Another view of the garden to the west-southwest of the original barn, looking west-northwest. The now lost house stood to the right of the fir tree.

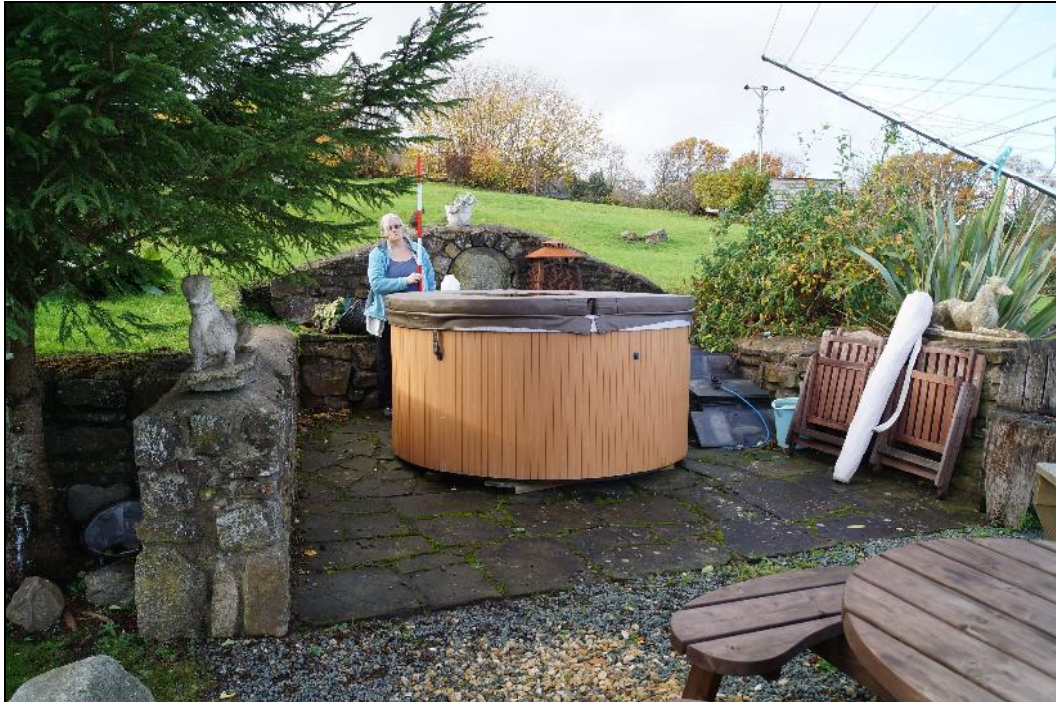
Plate 27: LPT2018\_042, This garden feature, to the right of the conifer in Plate 26, reflects the position of the original house at Little Pentre. Looking west-southwest.

8.5 Google Earth satellite images throw some light on the later history of the original house at Little Pentre. The 2004 image shows that the bases of the external wall of the house had been retained as a feature alongside the garden of the property. This building evidently measured about 13 metres long by 5 metres wide. The 2010 image shows that most of the house foundation wall had been removed and this appears to correspond with the period when the modern extension was added to the present dwelling. By 2018 only the southwest end of the original house foundation survived in the garden, retained as a garden feature (see Plate 27).
