**LEVEL 1 BUILDING RECORDING FOR  
PROPOSED TWO STOREY EXTENSION TO  
EXISTING DWELLING AT LITTLE PENTRE  
TWIN ALLWYS ROAD, GOVILON, NP7 9RT  
PLANNING APPLICATION:  
18/16325/FUL (BBNPA)**

November 2018

Trysor Project No. 2018/640  
HER Event Record- GGAT PRN E006131

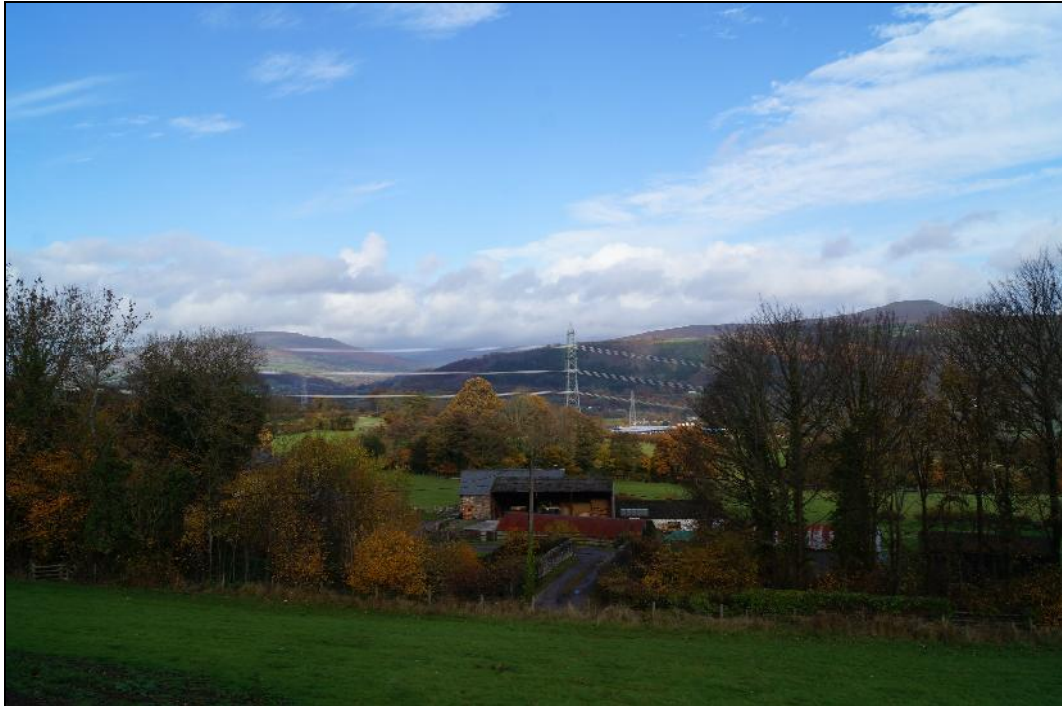
*Plate 29: LPT2018\_044, A view from the garden to the northern side of Little Pentre cottage, looking north towards Pentre Farm. Note the bridge across the now disused bed of the London & North West Railway, which was built between Pentre Farm and the cottage at Little Pentre during the second half of the 19<sup>th</sup> century.*
