# Tynewydd, Llansilin, Powys Historic Environment Desk-Based Assessment

Trysor Project No. 2017/547

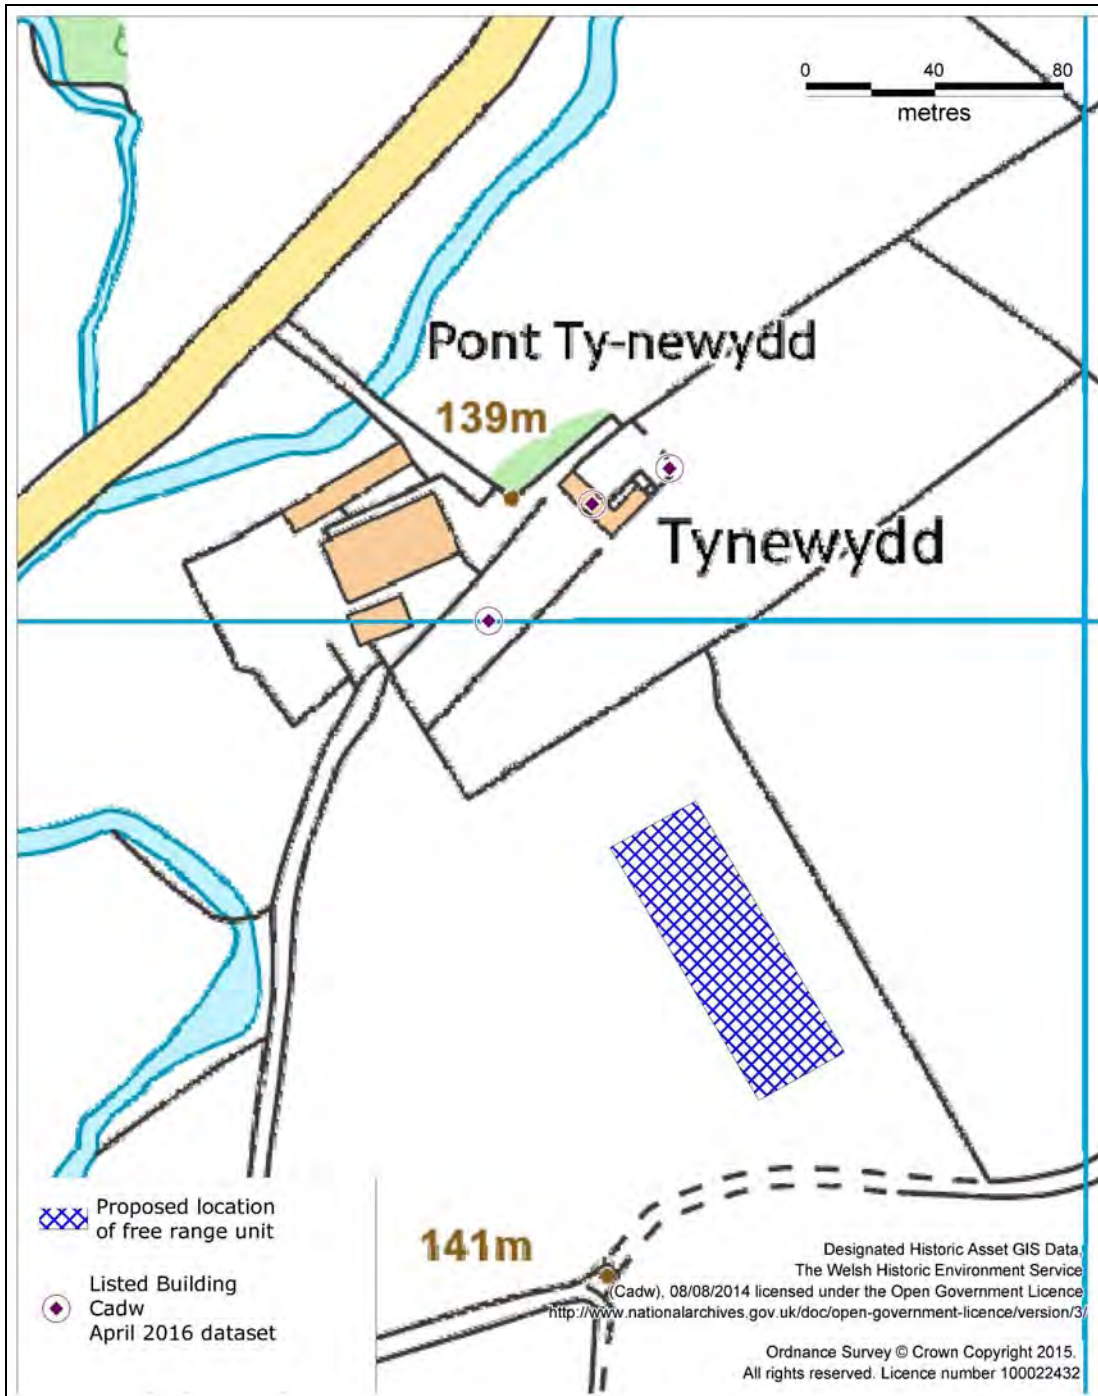
Figure 2: Selected location of the free range unit by Trysor after field visit. This is location which would offer the least impact, but before further mitigation.

4.2 As part of the desk-based assessment, Trysor visited the site and assessed a range of possible locations for the proposed development. The location shown in Figure 2 is that selected in which the development would have the least impact.

4.3 In this proposal the unit would be cross-contour with the southeastern end of the unit terraced into the slope, and built parallel to the mature field boundary hedge to the northeastern side of the site, thus reducing the visibility of the building in the landscape. Only the gable end of the building would be visible from the direction of Tynewydd house (ID number 1), reducing visual impacts on the listed buildings within the farmstead building group.

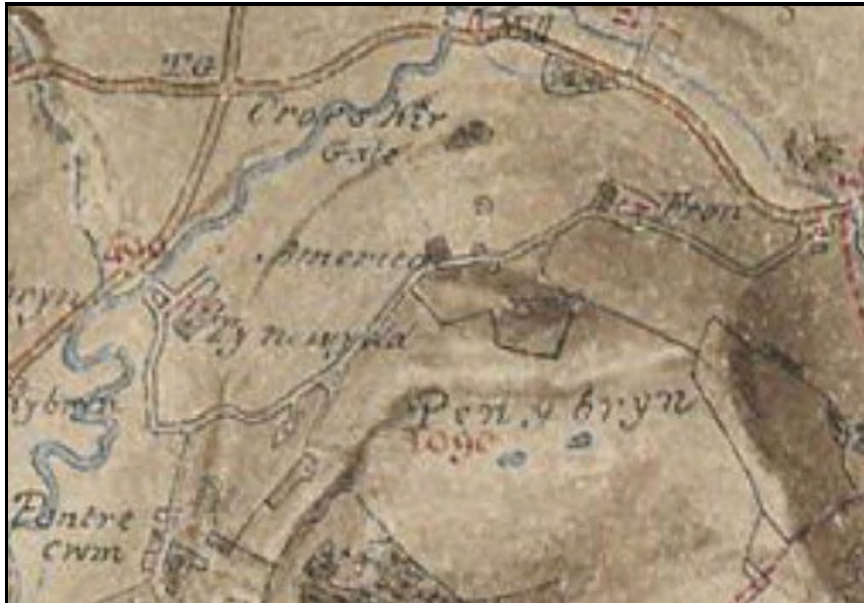
Figure 3: Excerpt from the 1830 Oswestry Sheet of the OS Original Surveyors Drawings. Tynewydd is shown, with its walled garden to the southwest of the house just discernible.

- 8.3 Historic mapping charts the development of the holding since the first half of the 19<sup>th</sup> century. Tynewydd is shown on the 1830 Ordnance Survey Original Surveyor's Drawings, see Figure 3. The Original Surveyors Drawings represent the first detailed map series of the whole country. They do not map field boundaries in detail and no details of any field system are shown on the 1830 map around Tynewydd farm or the development site.

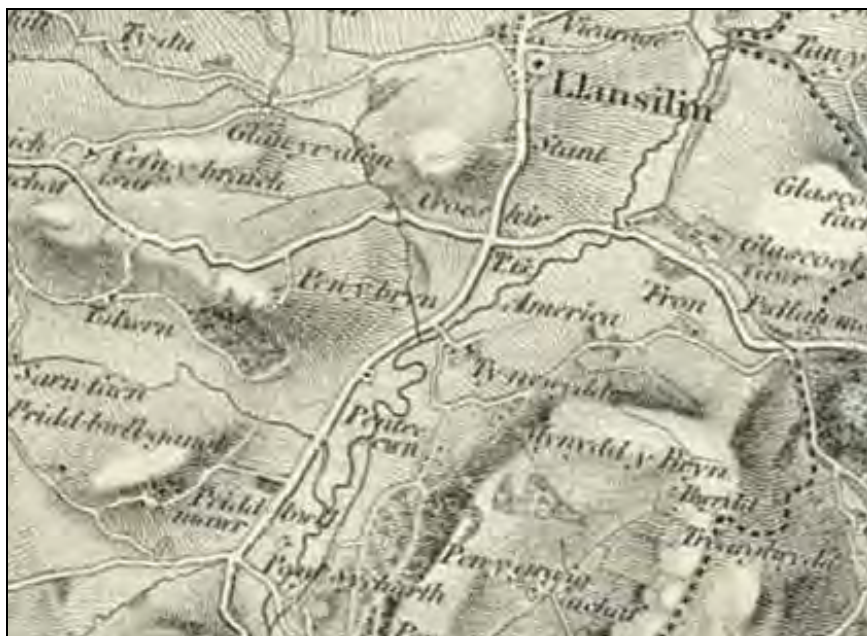
Figure 4: The 1838 1 inch to 1 mile map shows the house and garden a little more clearly.

- 8.3.1 The Ordnance Survey published their 1 inch to 1 mile scale First Series map for the area in 1836 (Sheet 60), see Figure 4. This map is based on the 1830 survey. This again does not map field systems. Tynewydd is

shown in greater detail on this map, however, and the house and its attached walled garden are more clearly represented.

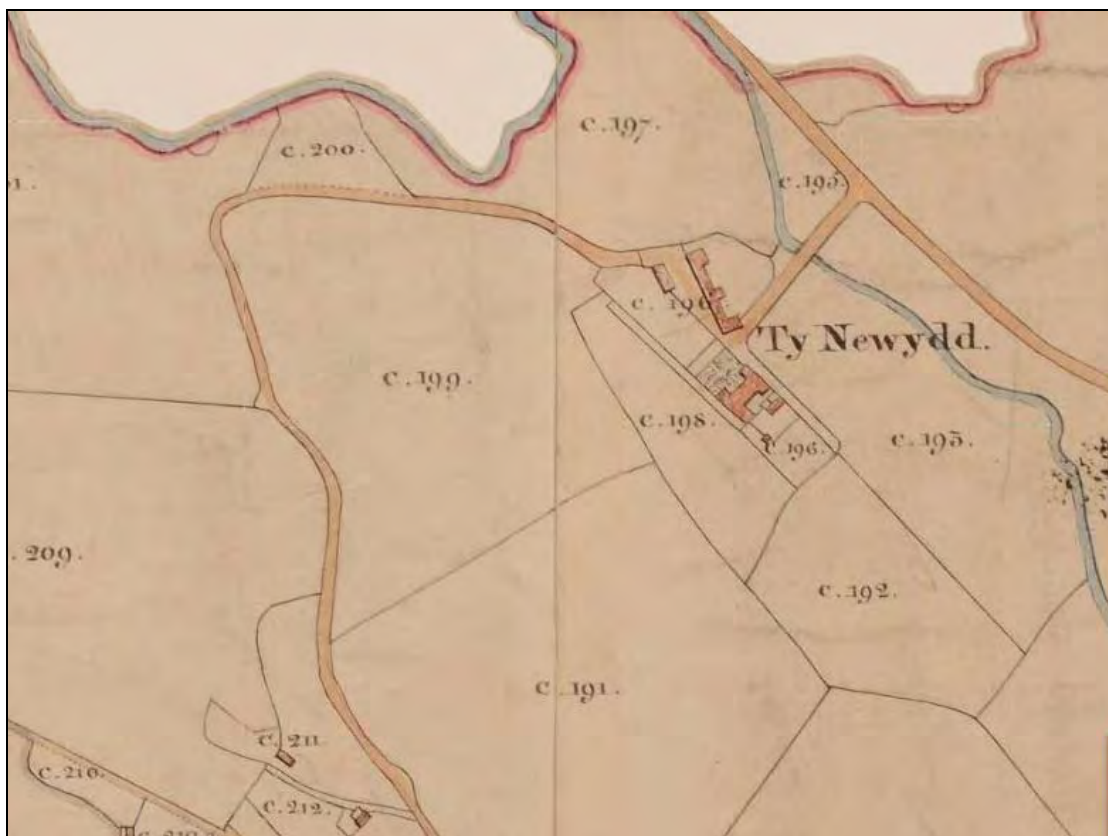
*Figure 5; An excerpt from the Llansilin parish tithe map of 1841. The proposed development site lies within field parcel C.199. Parcel C.198 was known as “Orchard” at this time. North is to the right.*

8.3.2 The first detailed map of the field system of the area is the tithe map for Sycharth township, drawn for the Llansilin parish tithe survey of 1841. This map is the first to show a clear depiction of the field system of the district, see Figure 5. It also clearly shows the layout of the buildings at Tynewydd. The house is distinctively H-shaped, indicating that the northern end of the western wing may have been truncated during the mid- to late-19<sup>th</sup> century, although the 1874 1:2500 scale Ordnance Survey map seems to show that this “northern wing” may have been a later extension to the main house. The tithe map also shows a long outbuilding range to the southwest of the house, which was replaced by modern farm buildings during the 20<sup>th</sup> century.

8.3.3 The accompanying tithe schedule lists field parcel C.199 as a 7 acre arable field on Tynewydd Farm, which was at that time a 135 acre holding. The field name is difficult to read on the schedule but appears to be “Bolfast Issa.” It should be noted that parcel C.198 was known as “Orchard”. The owner of Tynewydd at that time was John Wynn-Eyton (of Leeswood, Flintshire) and the occupier was one Jane Morris, widow.

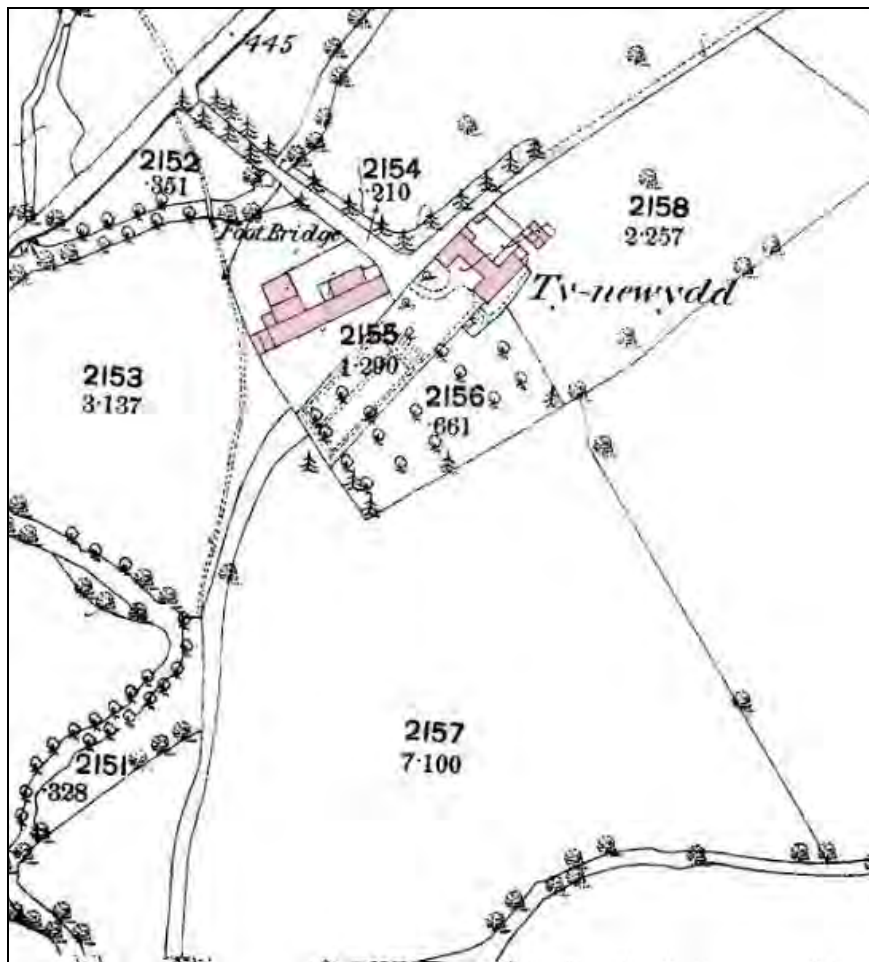
*Figure 6; The 1874 1:2500 scale Ordnance Survey Map shows the house and outbuildings clearly. Note that the "Orchard", parcel 2156, was planted with trees at this time, a mixture of conifers and deciduous trees.*

8.3.4 The First Edition 1:2500 scale Ordnance Survey map of 1874 shows the landscape around the proposed development site to be similar in most respects to the picture presented by the 1841 tithe map, see Figure 6. Later editions of the 1:2500 map show a very similar picture. It appears that it was not until the final quarter of the 20<sup>th</sup> century that the historic farm buildings to the west of the house were replaced by modern agricultural buildings.

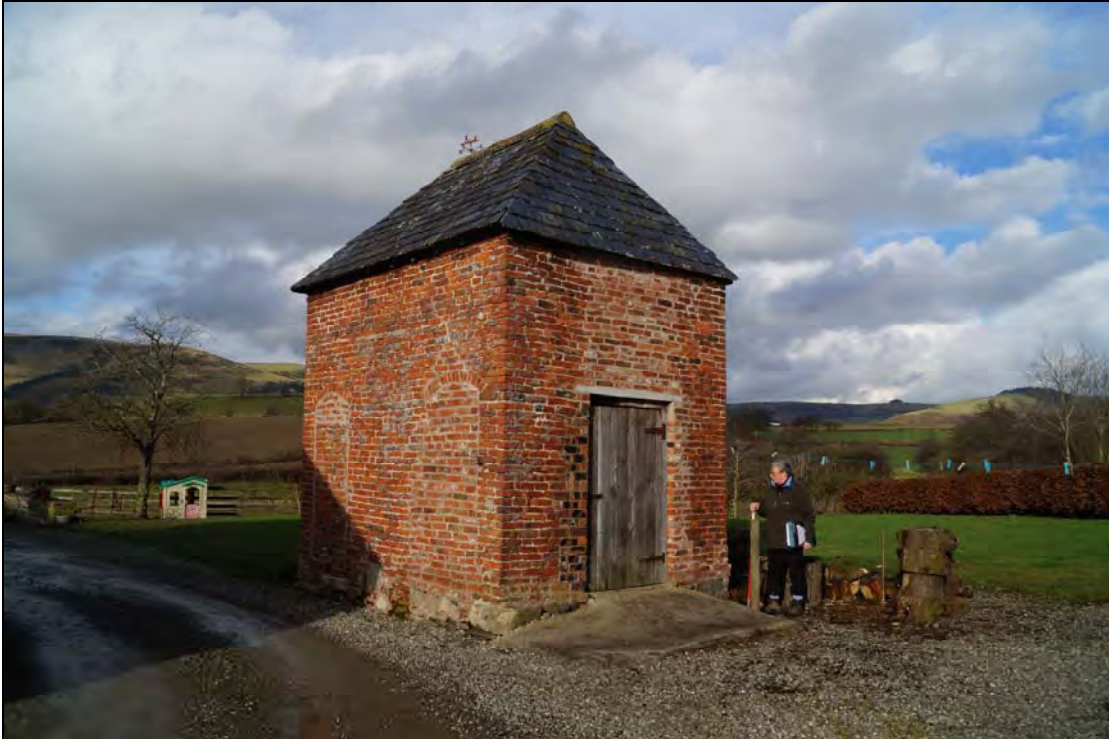
*Plate 1: One of the most important key views of the "latrine" (ID number 4) is that looking north. From this distance the detail of the brickwork can be appreciated, including the blocked-up double doorway on the southwestern side, to the left in the photograph. The building cannot be appreciated from a distance.*

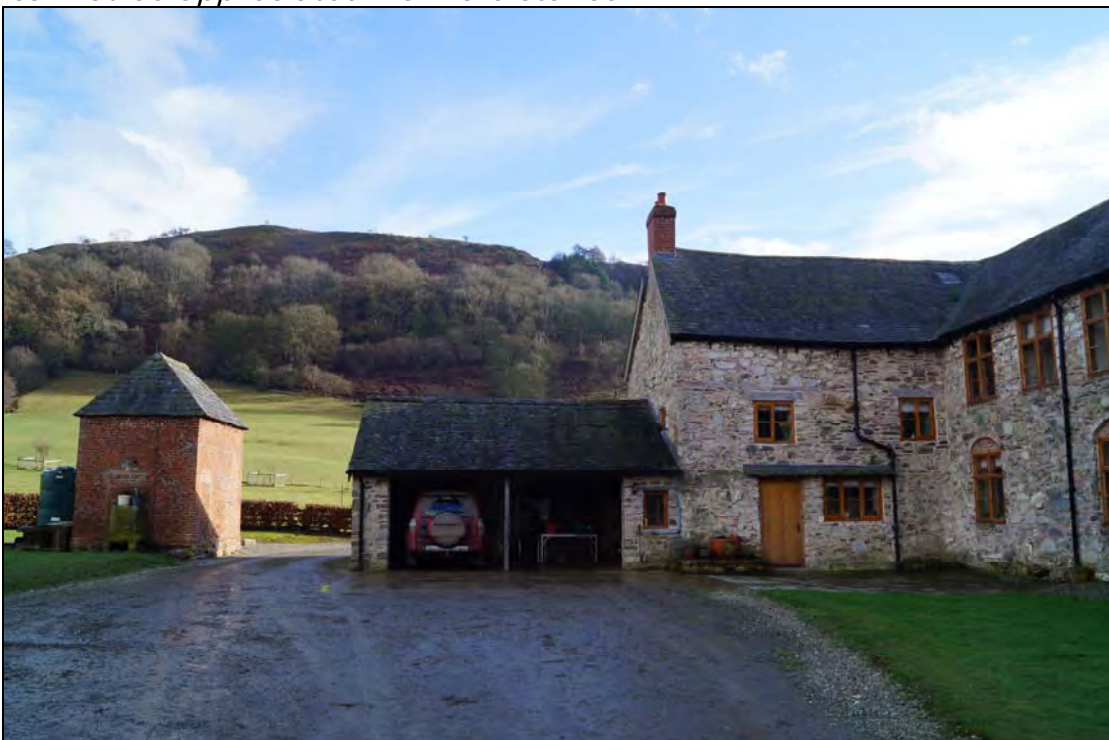
*Plate 2: This view, looking east-southeast, gives an idea of the relationship between the "latrine" and Tynewydd house. The intervening garage is a modern addition. The garage abuts the original early 17<sup>th</sup> century house, with the wing springing off its front wall at the extreme right of the photograph being a late 17<sup>th</sup> century addition, part of the 1684 enlargement of the homestead.*

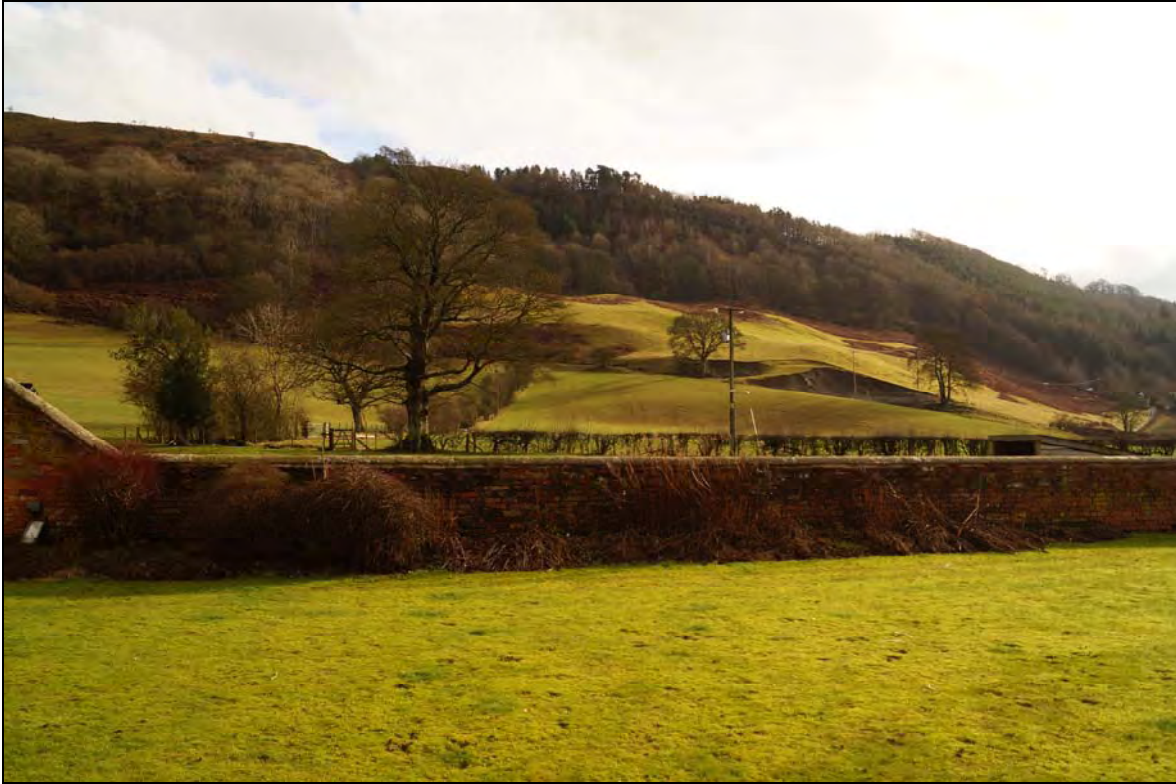
*Plate 3: This view, looking south-southeast towards the proposed development site. The replanting of the “Orchard” parcel behind the wall and the strengthening of the hedgerow seen just above the wall would lessen the impact of the development markedly.*

The proposed development would be in relatively close proximity and its gable end of the proposed building would be visible when looking south-southeast out of the garden. The replanting of the adjacent former Orchard field with deciduous trees, and the strengthening of the field boundary to the eastern side of the "Orchard" would significantly reduce the visibility of the proposed development and lessen the visual impact and any impact on the setting of the garden to Very Low (see Figure 11).

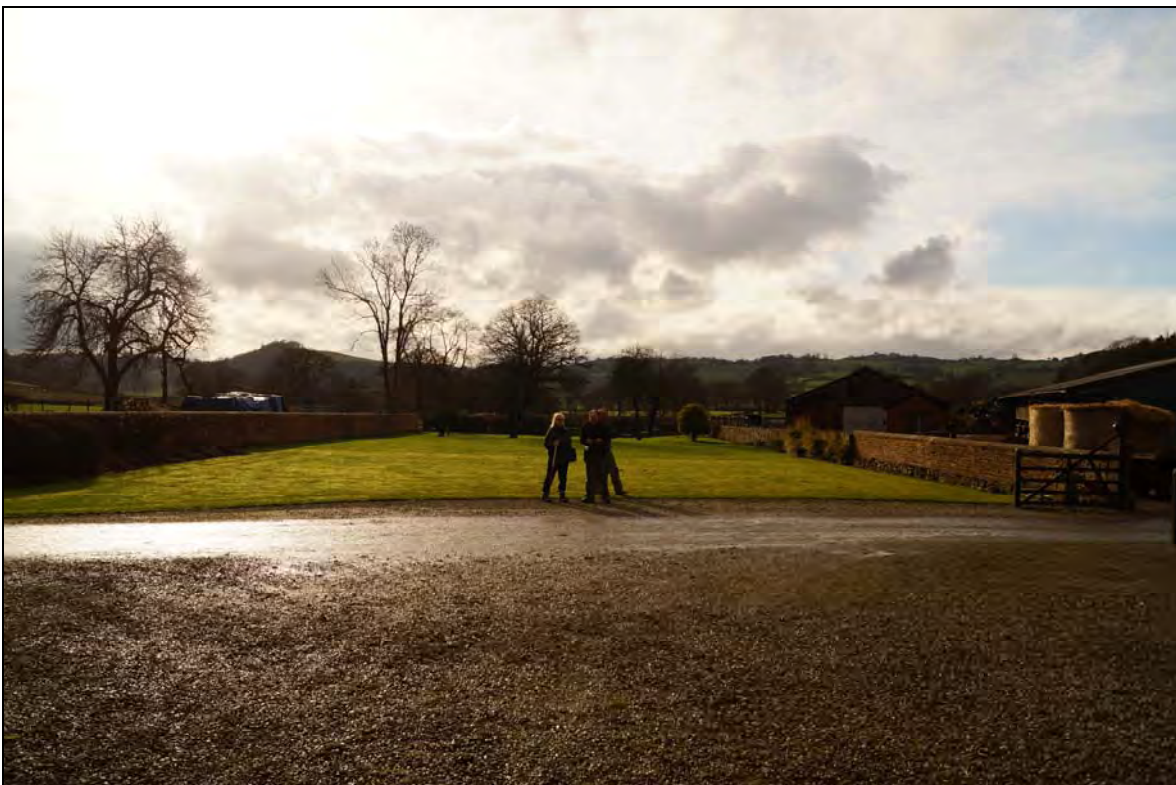
*Plate 4: This view, looking southwest from the front of the house, shows the key view of the garden, from an historic and modern perspective. Note the modern farm buildings to the right, which have already impacted on the setting of the garden. The proposed development does not affect this view.*

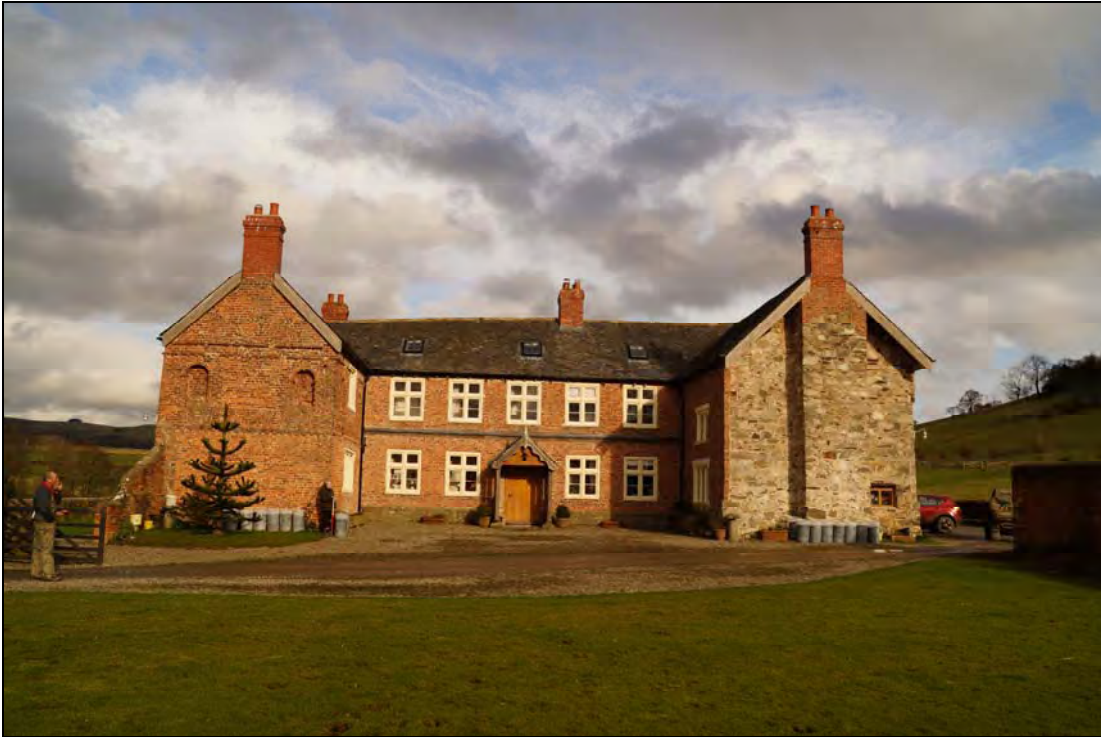
*Plate 5: The key view of the house from the garden to the southwest, including the main entrance into the residence. This view would be unaffected by the development.*

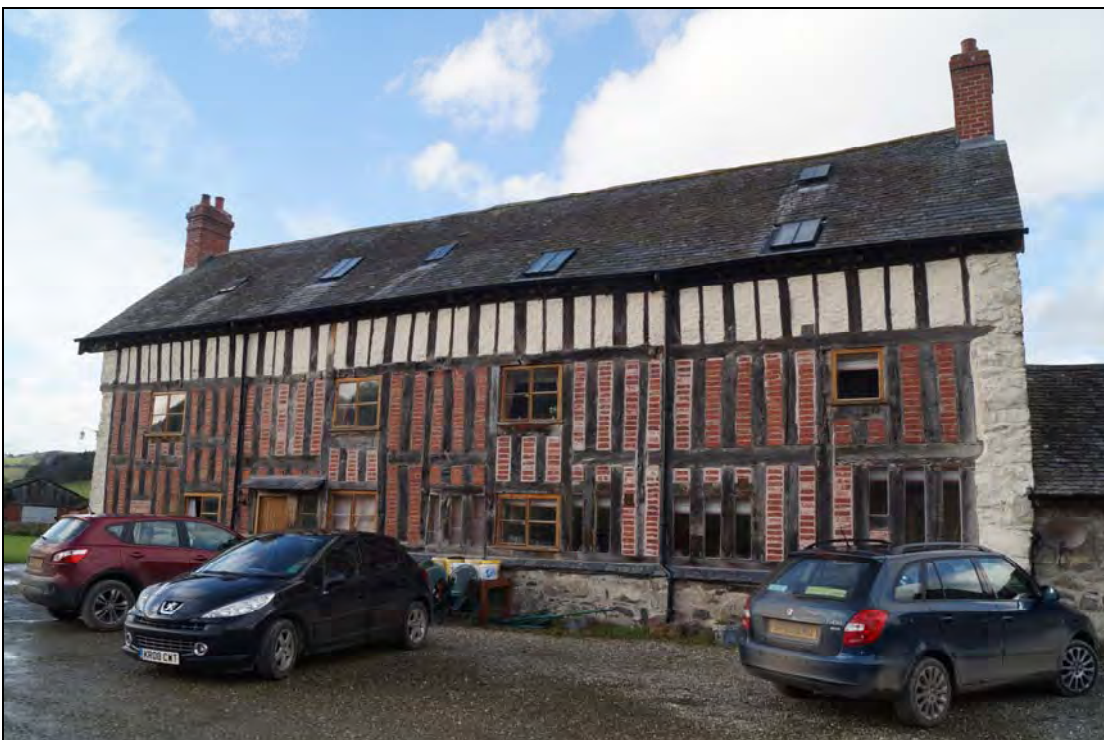
*Plate 6: The southeastern side of the house is the original homestead, with stone gable walls and a timber-framed, brick-filled lateral wall. It can only be fully understood and appreciated from close-up. The detail cannot be appreciated from distance. This key view would not be affected by the proposed development.*

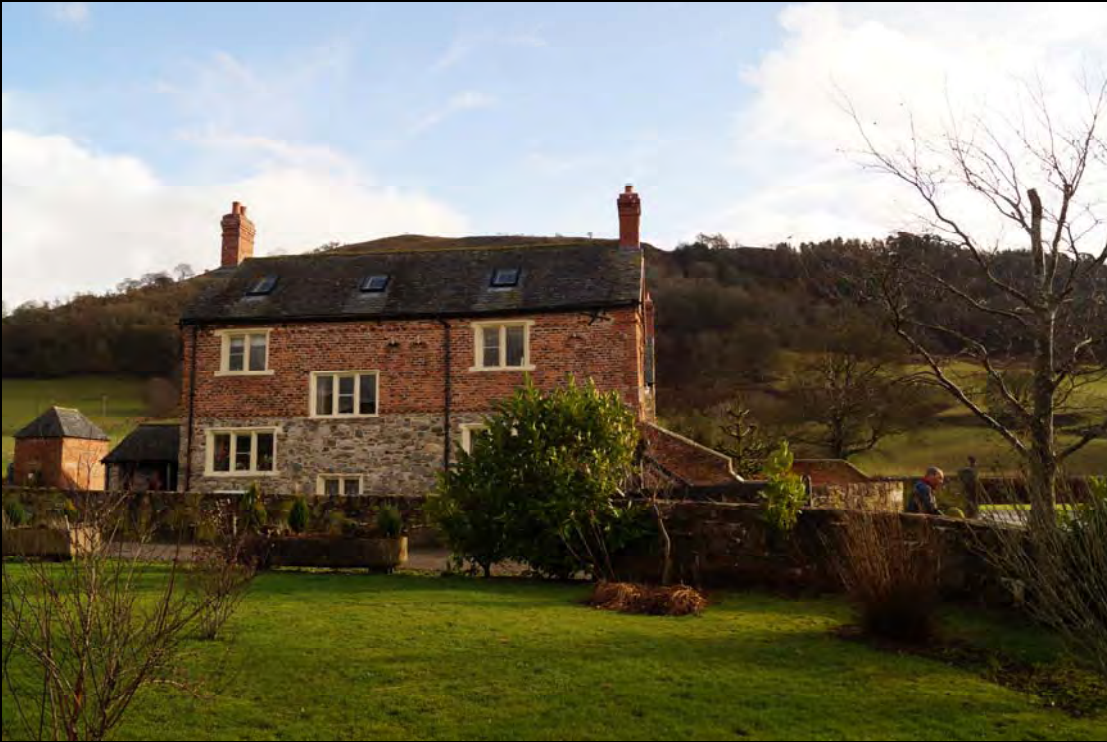
*Plate 7: Viewed from the northwest, the façade of the late 17<sup>th</sup> century extension is seen. The gable end of the proposed free-range egg unit would be visible from this location, to the right of the house. However, mitigation such as tree planting in the “Orchard” field and the strengthening of the hedgerow between the “Orchard” and the development site would screen views of the new building and restore historic landscape features shown on 19<sup>th</sup> century Ordnance Survey maps.*

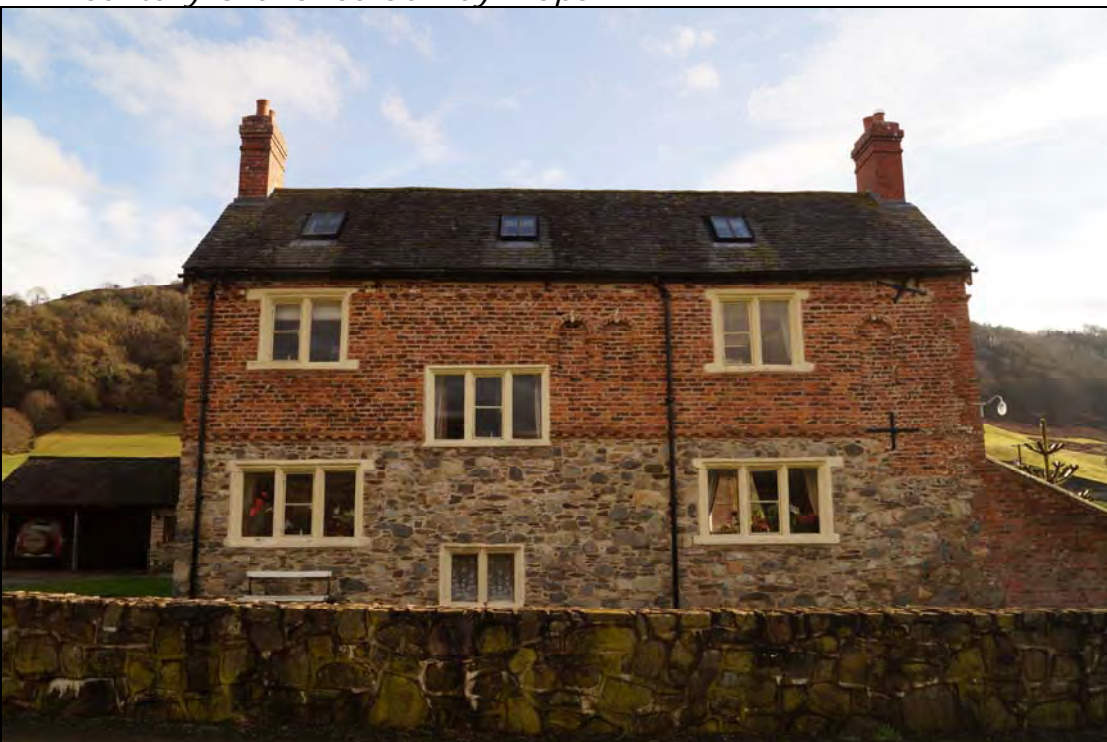
*Plate 8: The key view of the northwest façade of the house would be from directly in front of the building and at close range in order to understand the architectural detail. The house itself would block views of the development.*

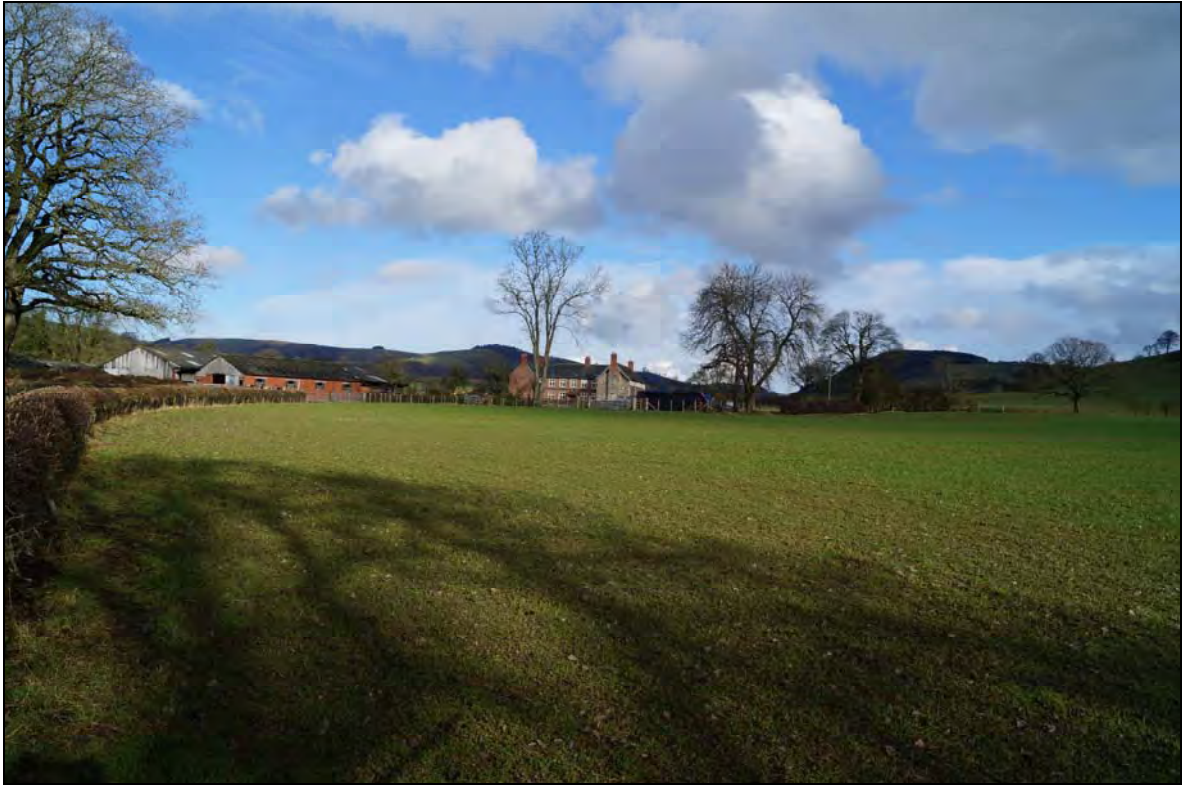
*Plate 9: A view of Tynewydd house and modern farmstead buildings from the south-southwest. The proposed development would be at the far right side of the view.*

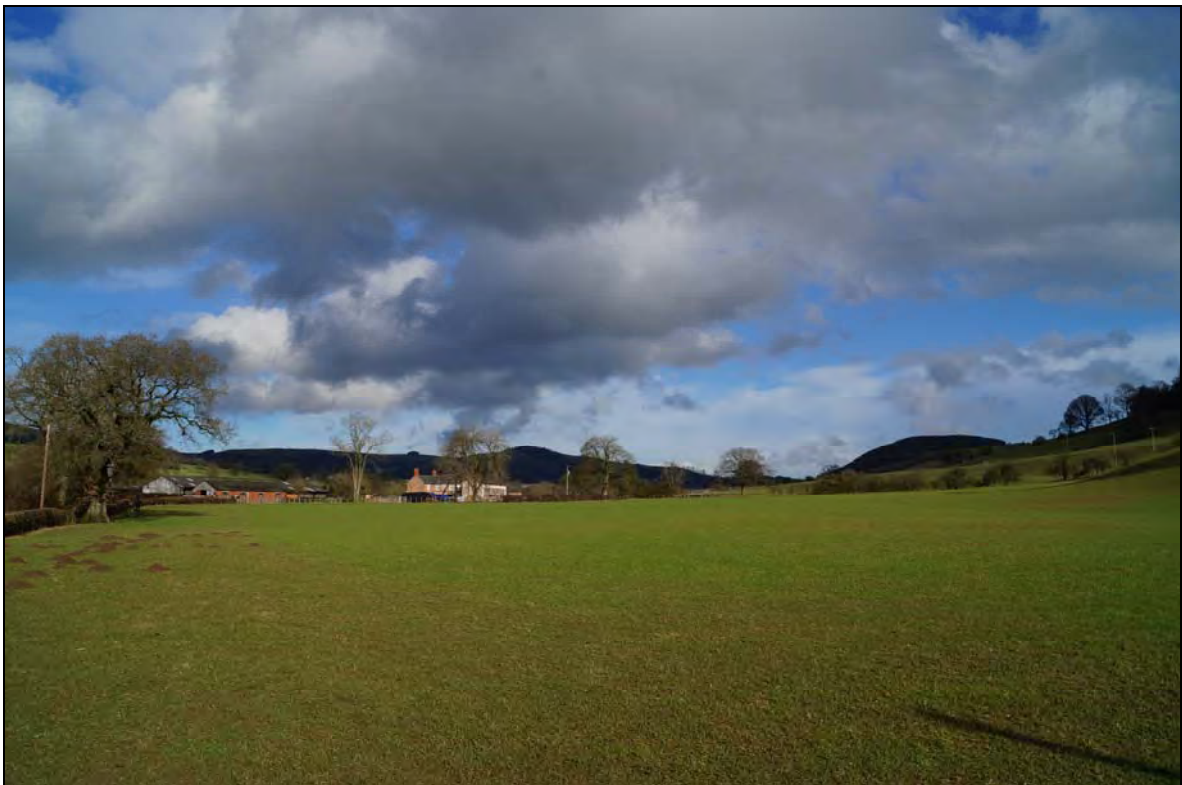
*Plate 10: A view from the south-southwest, further away from the house than Plate 9. The proposed development would be located to the right hand side of the field, with its southern end terraced into the slope visible at the extreme right edge of the image.*

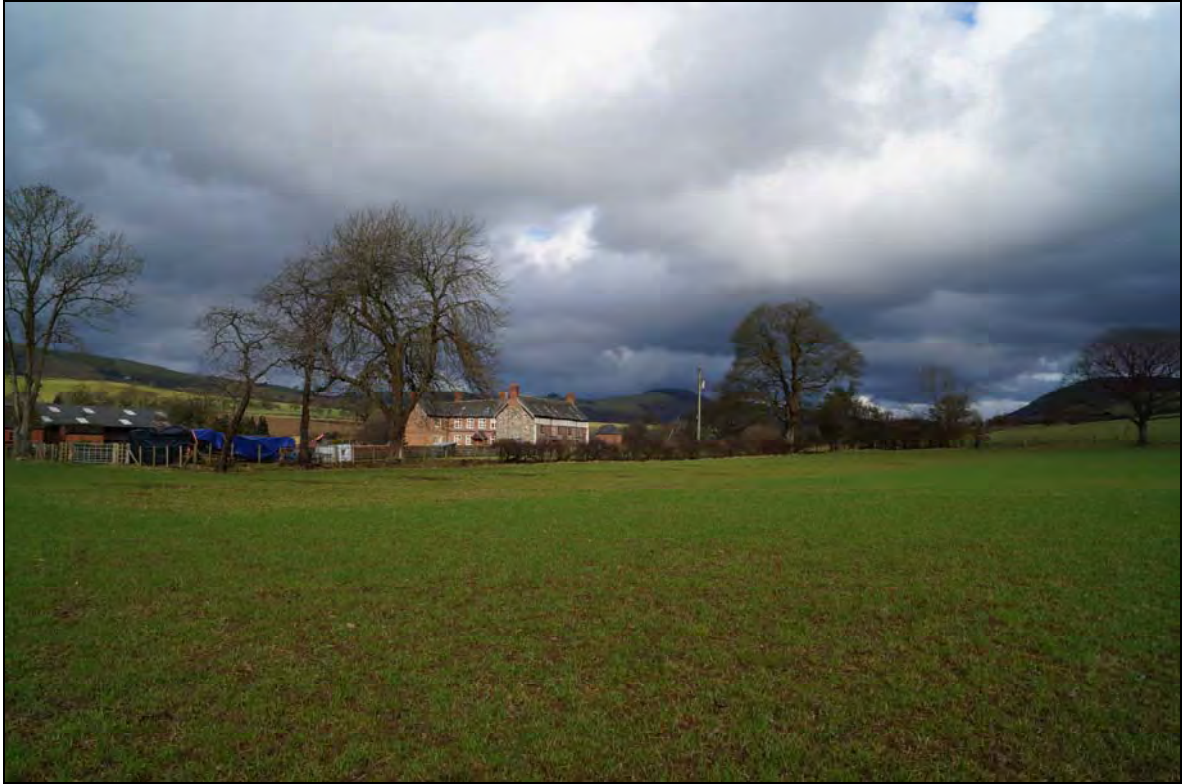
*Plate 11: The development area would be to the right of this view of Tynewydd house, with the north-northwestern end of the free-range egg unit extending approximately as far as the tree at the right edge of the image. At this range detail the architectural detail and importance of the house cannot be appreciated.*

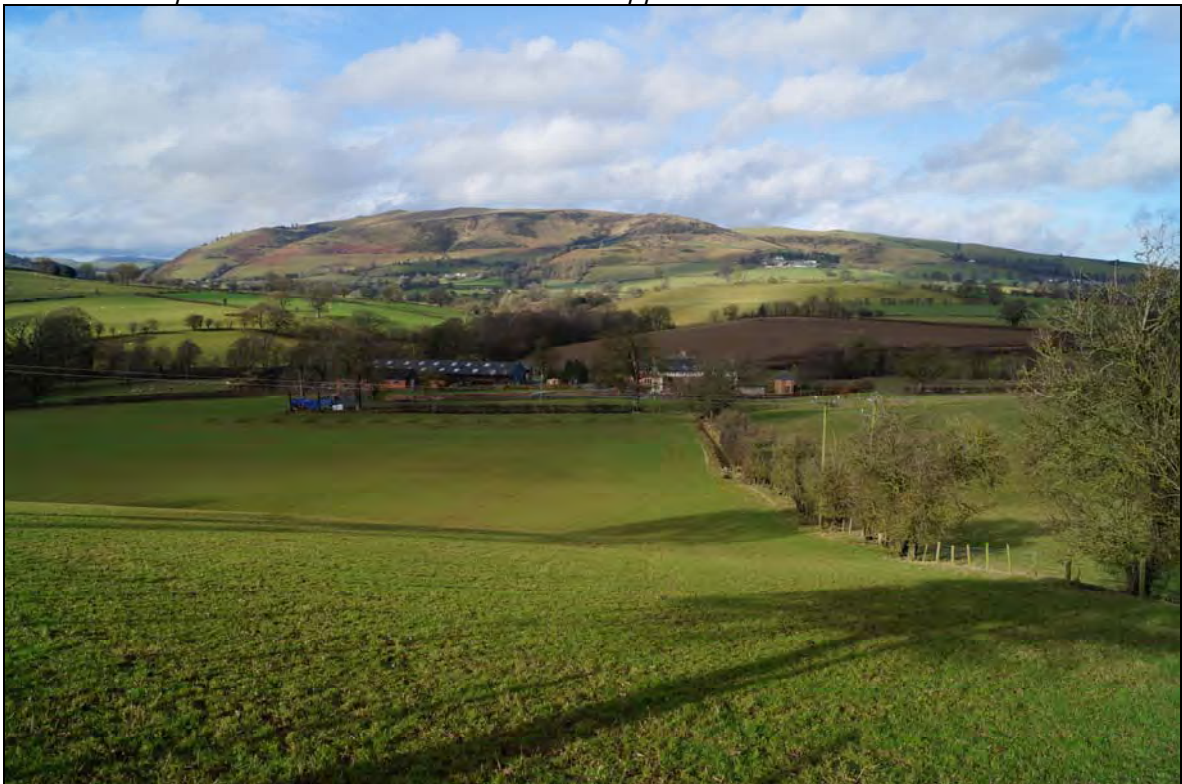
*Plate 12: Looking north-northwest from the edge of the field in which the proposed development would occur. The new free-range egg unit would be terraced into the slope in the foreground to lessen its visual impact. The hedgerow and mature trees block the view of the house, but at this distance it is not possible to understand or appreciate the listed structures at Tynewydd, therefore the new building would not represent a significant impact on their setting.*

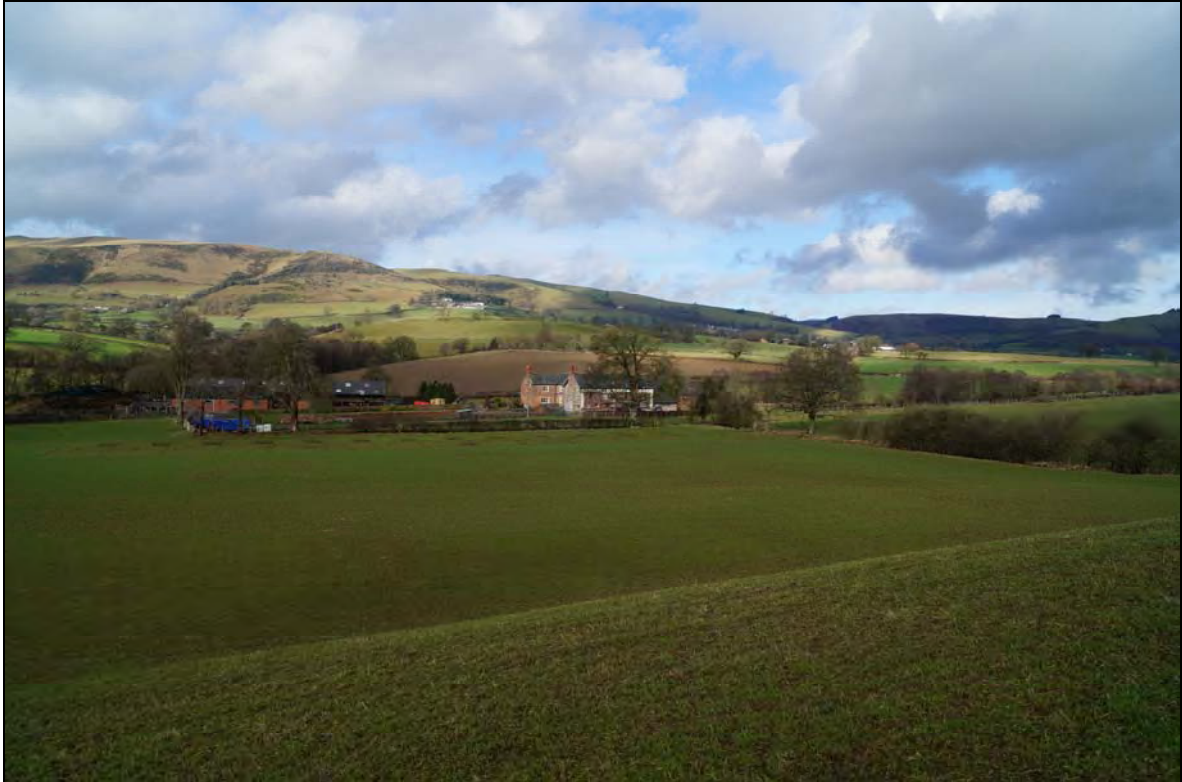
Plate 13: A similar photograph to Plate 12, looking northwards towards Tynewydd

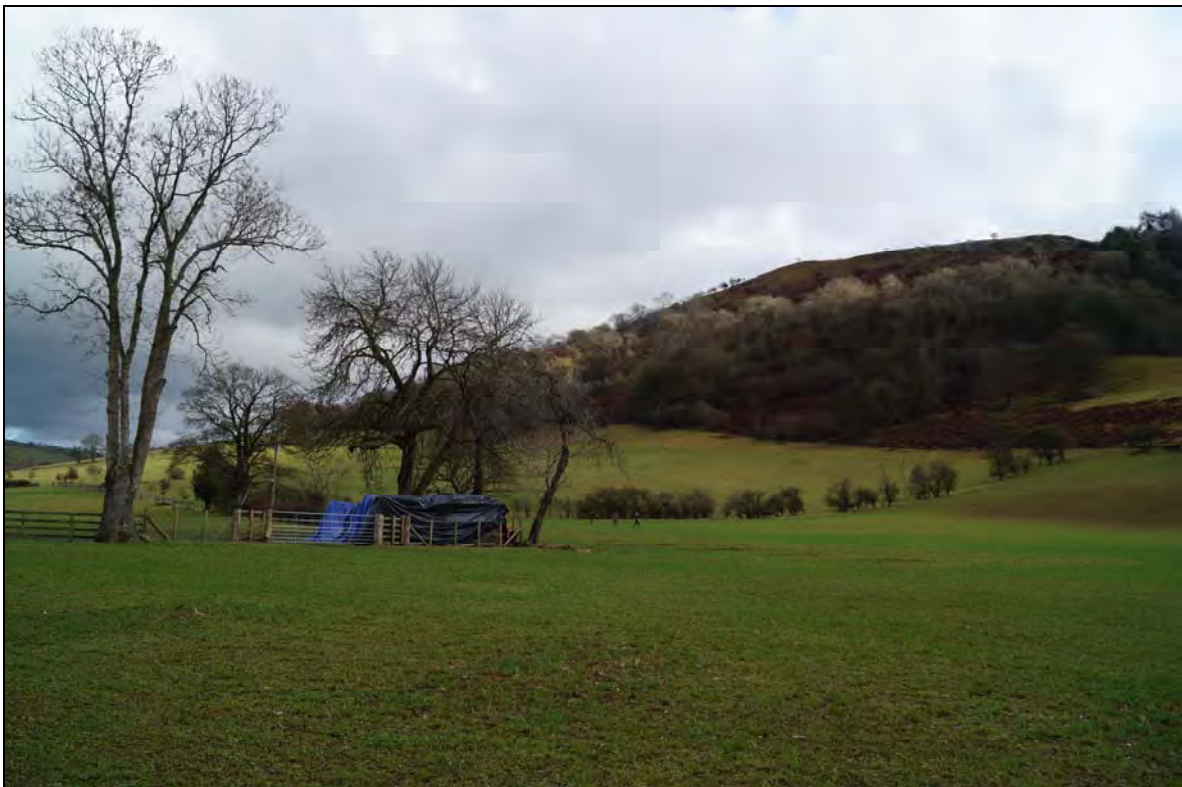
Plate 14: A view looking towards the proposed development site, showing the slope at the southeastern corner of the field into which the southeastern corner of the free-range egg unit would be terraced. The northwestern end of the building would extend out into the field to approximately the position where the figures are standing just below the centre of the image.

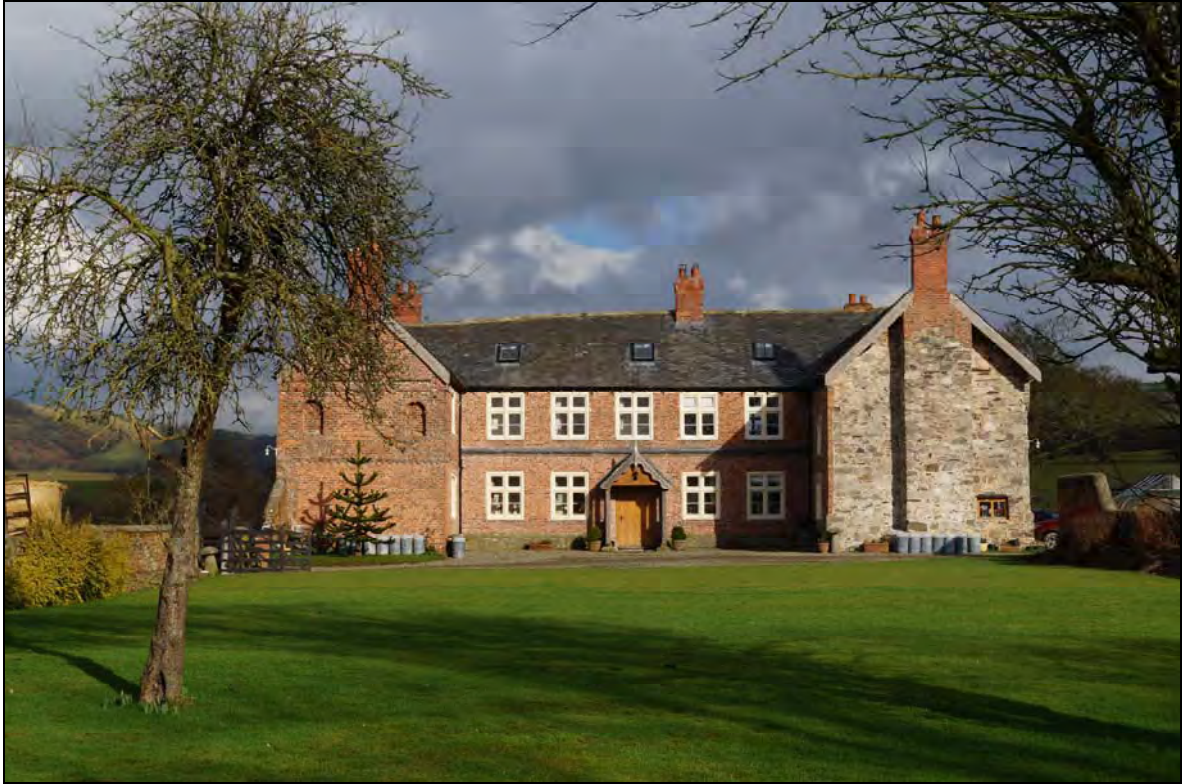
*Plate 15: A key view of the southwestern side of the house viewed from within the associated garden. This view would be unaffected by the proposed development.*

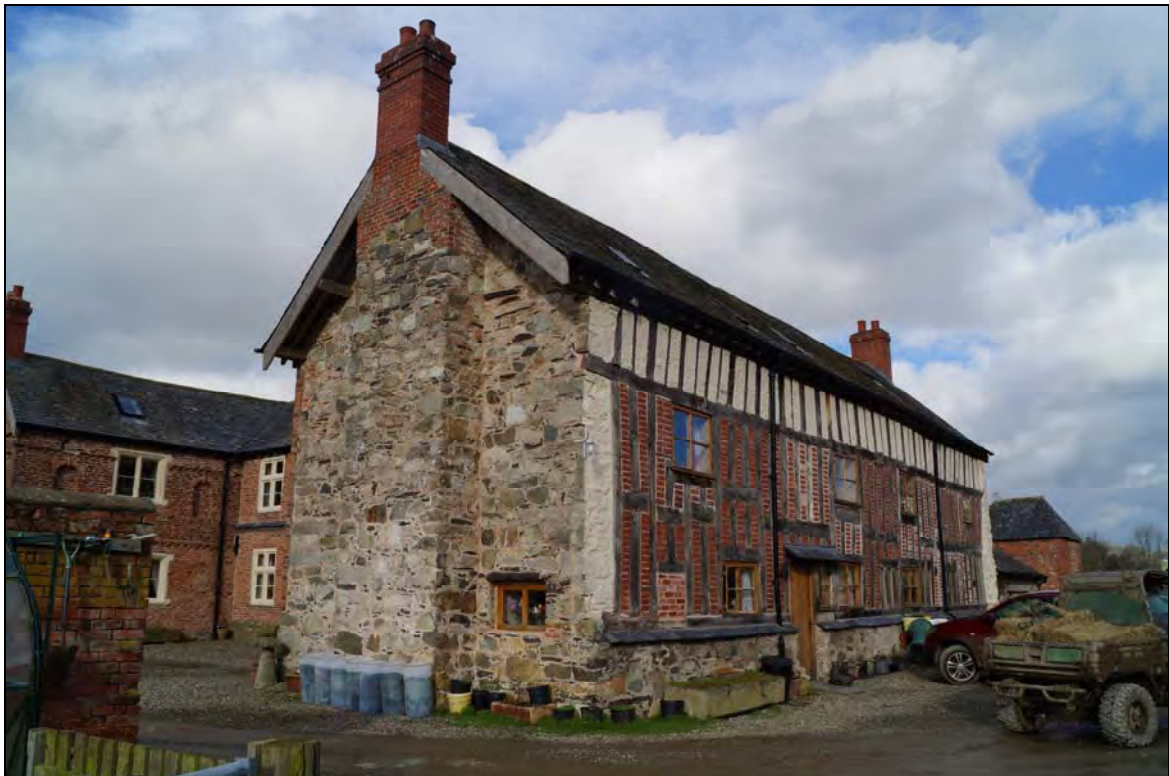
*Plate 16: A key view of the southeast side of the house, where the oldest part of the dwelling is revealed. Only close up views allow an observer to understand and appreciate this detail and these views would not be affected by the proposed development.*

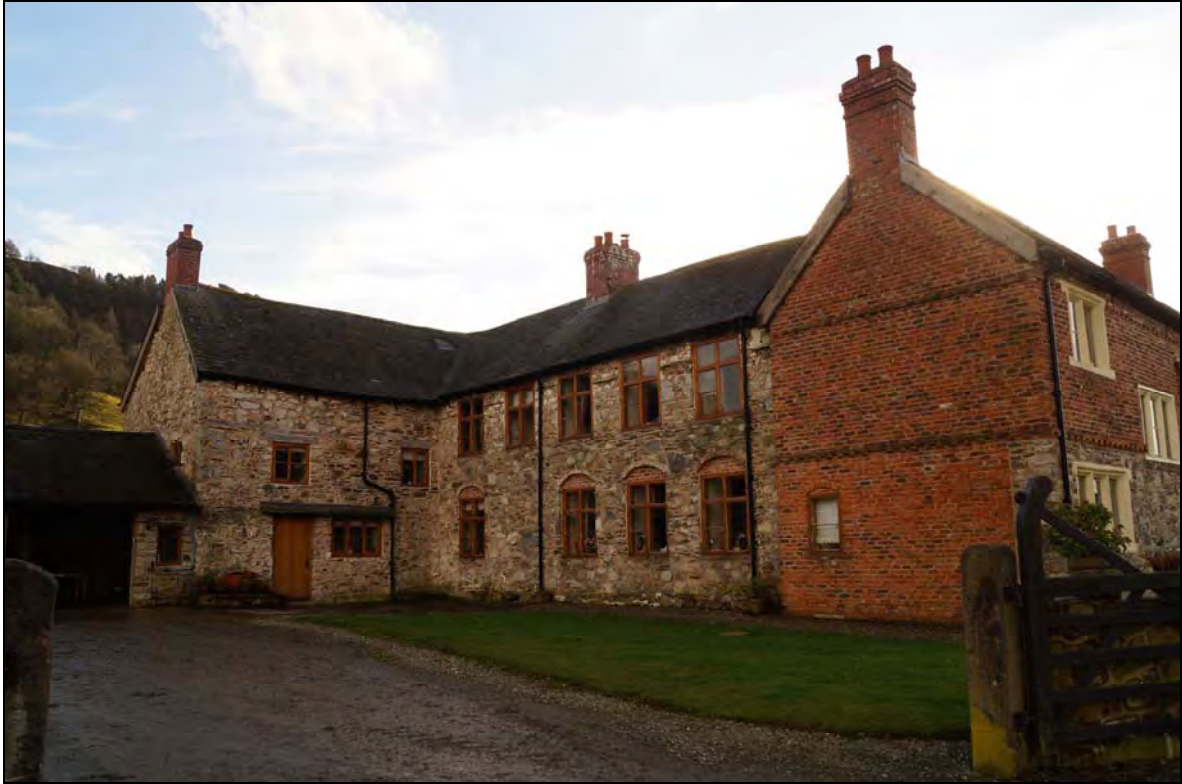
*Plate 17: A key view of the northeastern side of the house, which would not be affected by the proposed development.*

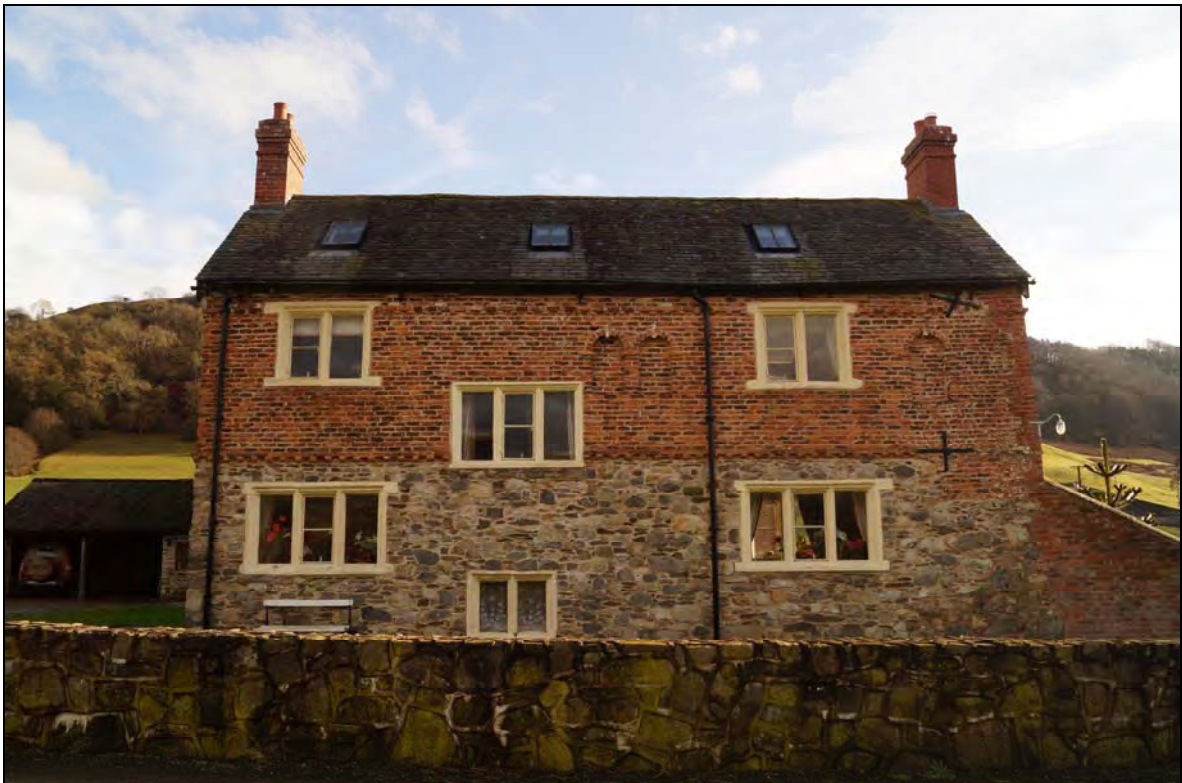
*Plate 18: The architectural detail on the northwestern side of the house also has to be seen at close quarters to be understood and appreciated. The proposed development would not impact on this view.*
