# Tynewydd, Llansilin, Powys Historic Environment Desk-Based Assessment

Trysor Project No. 2017/547

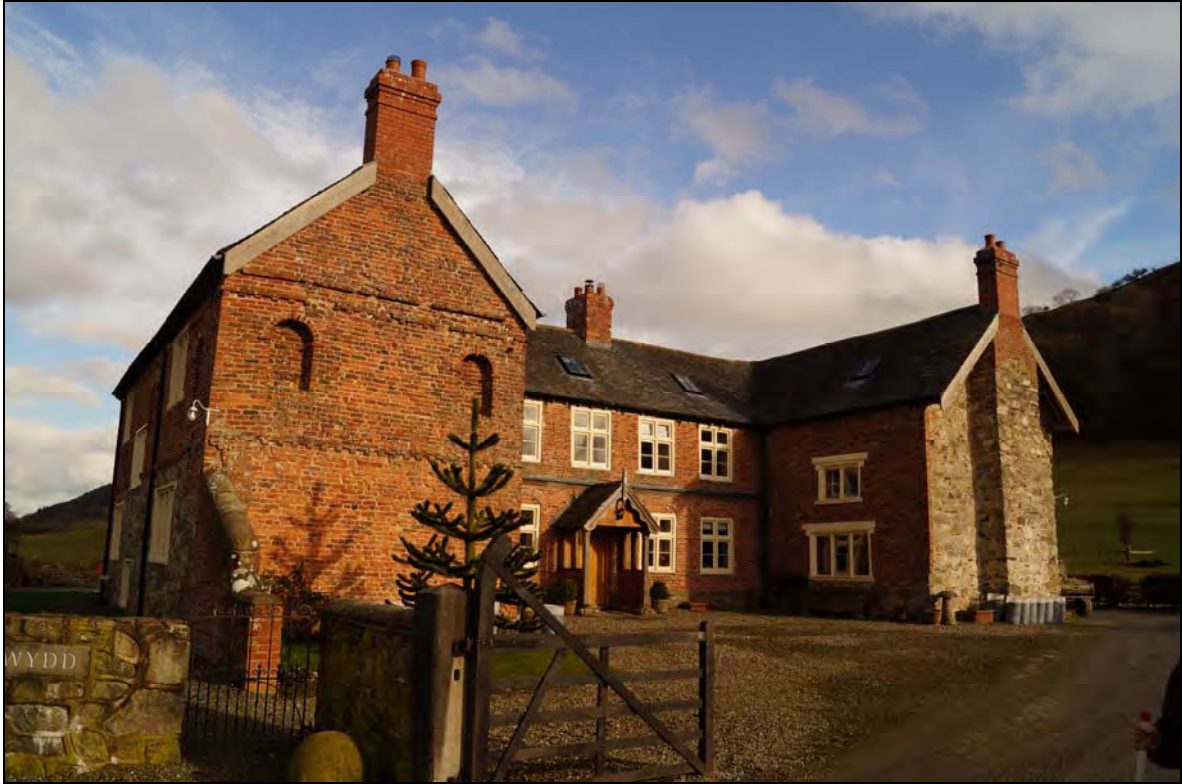
*Plate 19: Another view of the southwest-facing side of the house and the main entrance. In modern times, the removal of most of the garden wall has opened this view up. The wall previously blocked the view and created a private space in front of the house. The development would not affect this view, which is important to the understanding and appreciation of the house.*

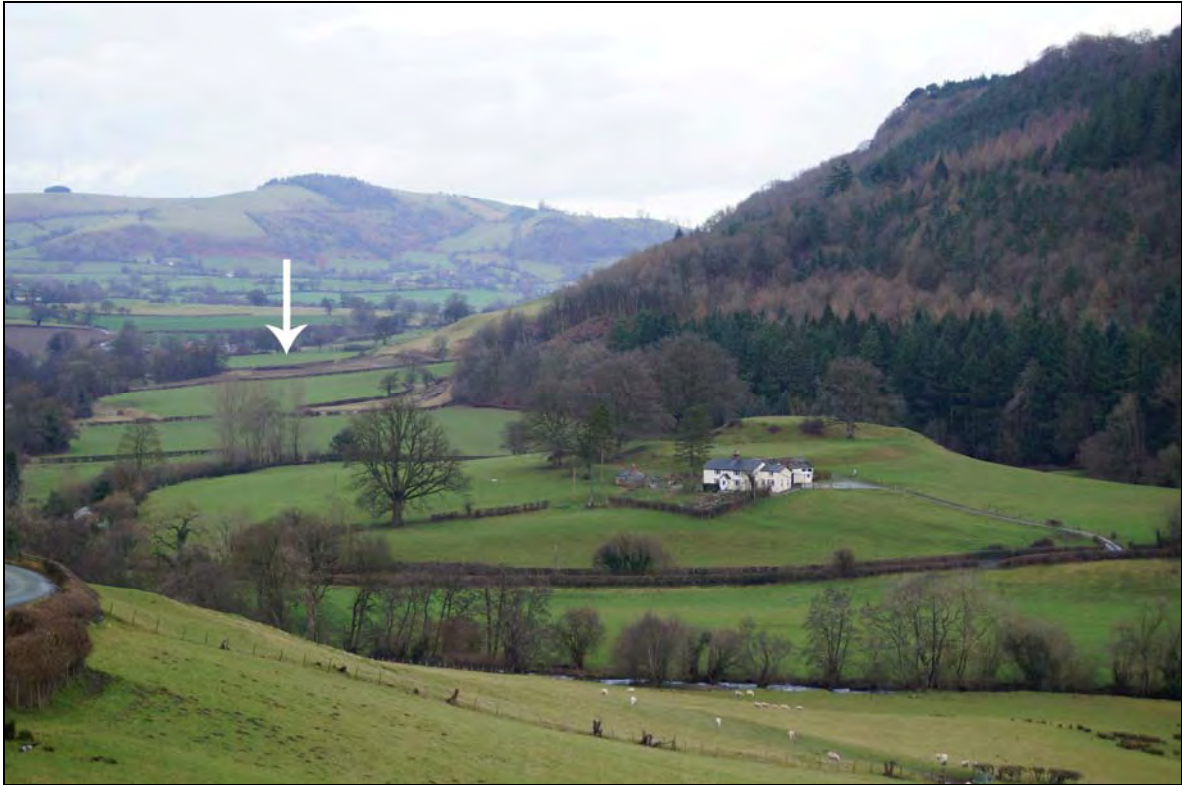
*Plate 20: Tynewydd is visible left of centre in this view looking north-northeast along the Cynllaith valley. The scheduled earthwork castle of Sycharth is centre right. The proposed development would be located in the green field to the right of Tynewydd (marked with an arrow). The visual impact of the development on Sycharth would be Low, but the addition of a new hedgerow on the southern side of the proposed building would help screen the new building and reduce the impact to Very Low.*

11.4 There is part of one Scheduled Monument within the 1km assessment area. The Sycharth Mound and Bailey Castle, (ID number 11, see plates 20, 21 & 23) would experience a Low indirect visual impact and no impact on setting. The proposed shed would be partially visible from eastern side of the top of the motte, but through trees.

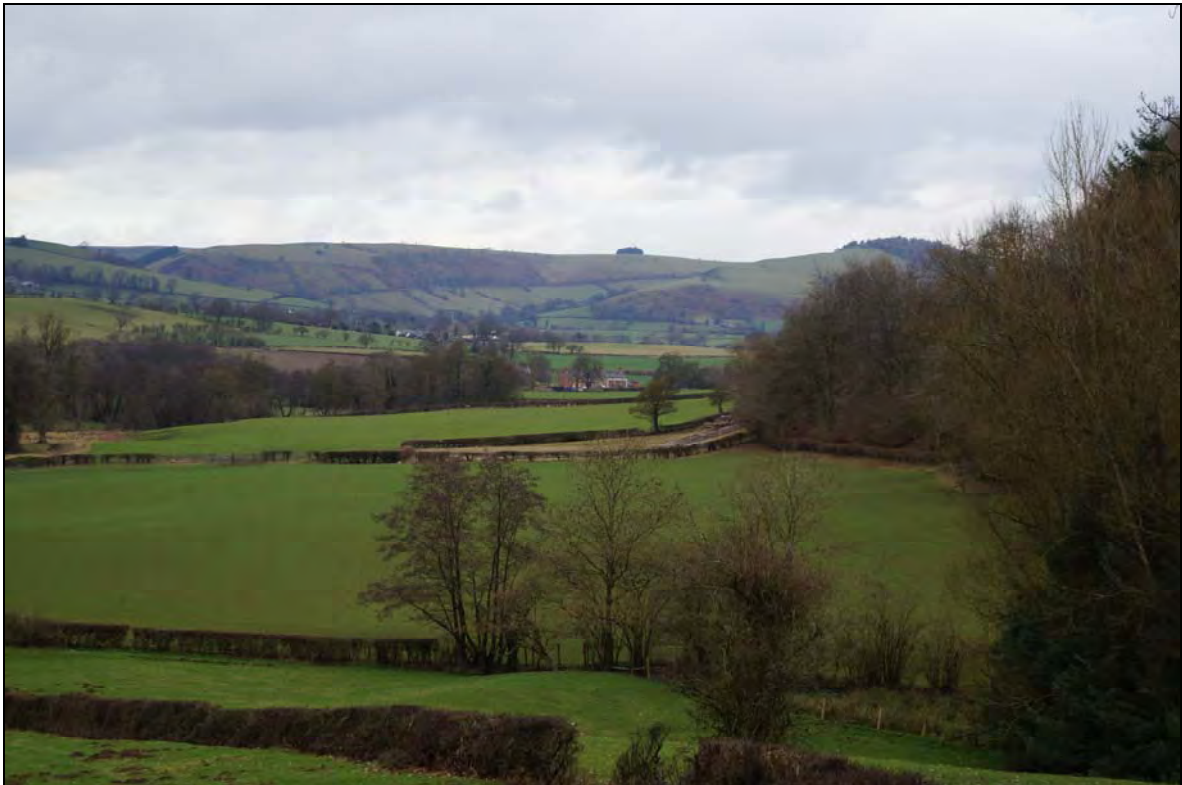
Plate 21: A view looking north to Tynewydd, see at the centre of the photograph. The view is from the top of Sycharth castle mound. The trees to the right of Tynewydd would screen the new building from view from the castle.

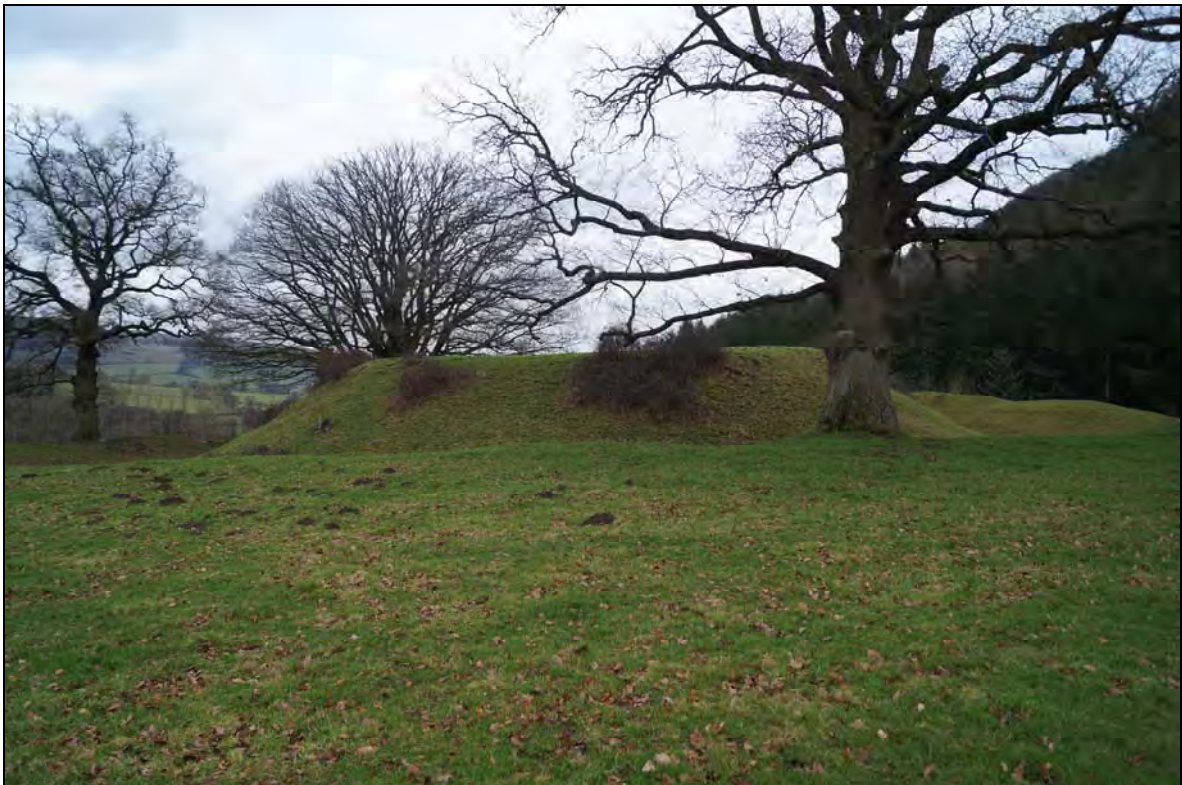
Plate 23: The castle motte at Sycharth. The proposed development would not impact on key views of the motte.

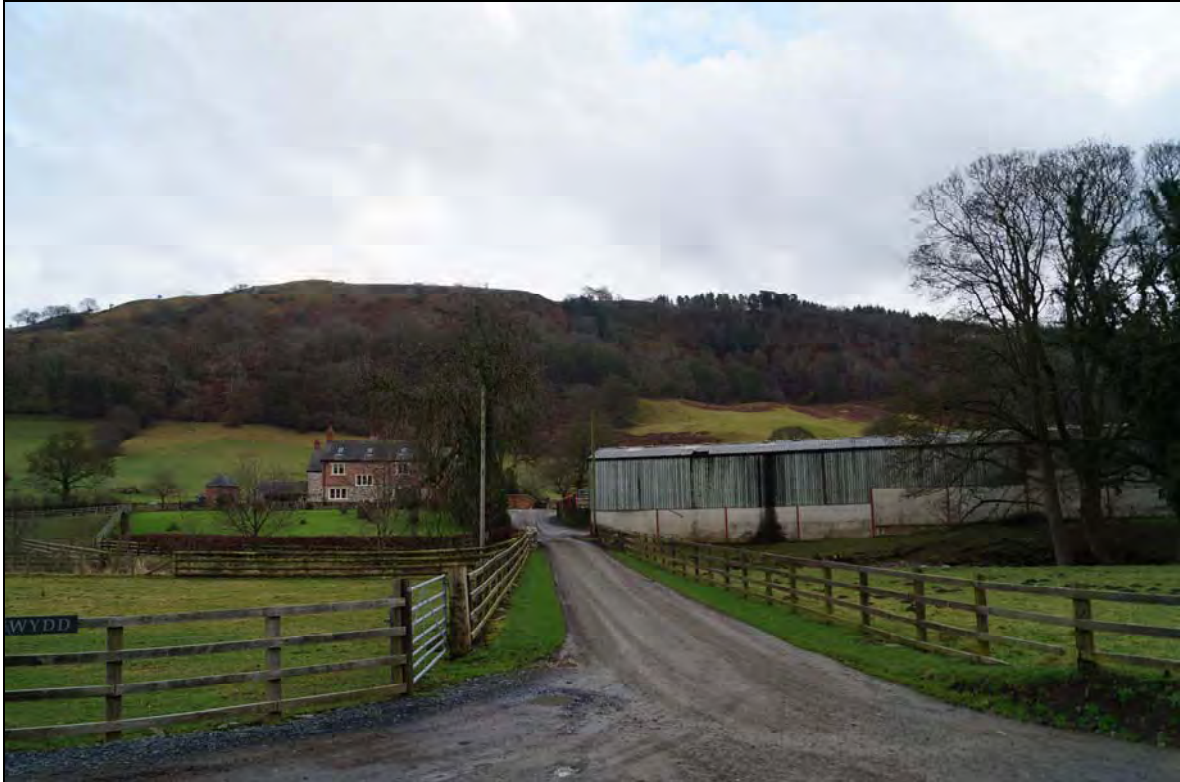
*Plate 24: The view from the entrance to the access lane to Tynewydd, to the west-northwest of Tynewydd. The combination of trees and buildings would obscure any view of the free-range egg unit from this direction. The gable end of the new building would perhaps be visible beyond the lane, but tree planting in the "Orchard" and hedgerow strengthening would close that view off within a few years.*

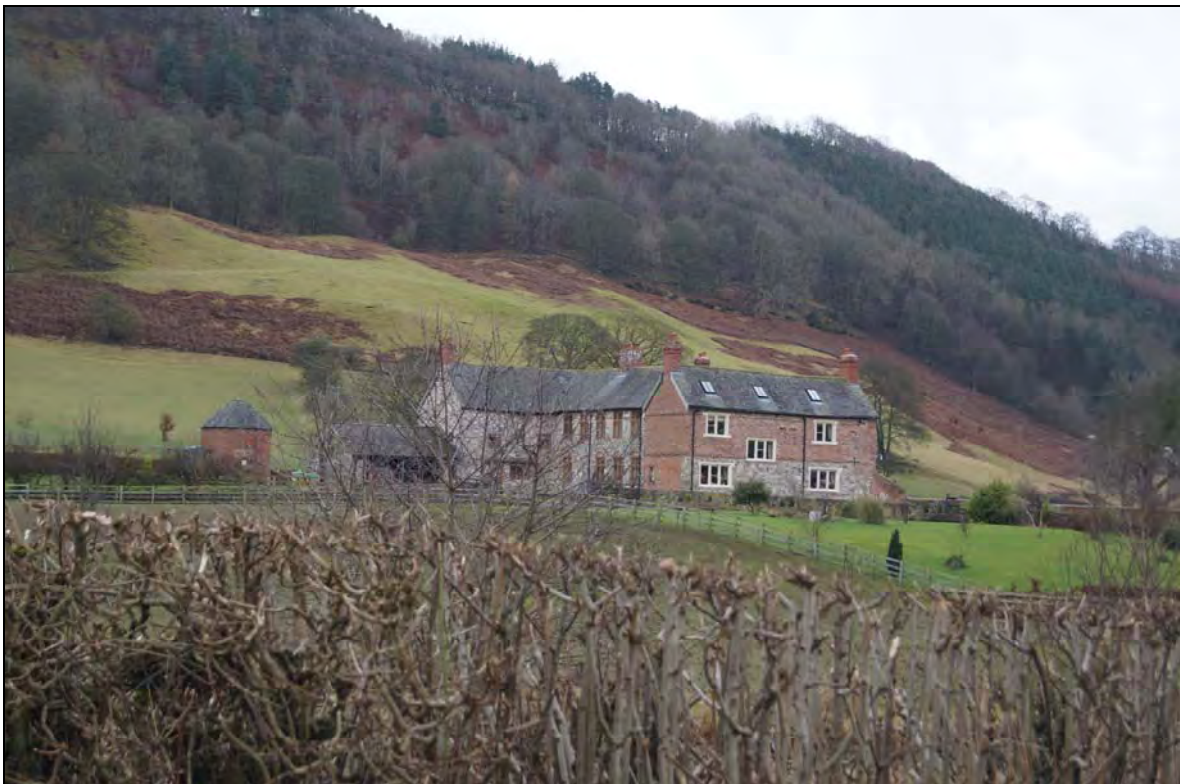
*Plate 25: A view of the house at Tynewydd, and the former latrine to the left, looking from the Llansilin road to the northwest. The house would block the view of the proposed development completely from this direction.*

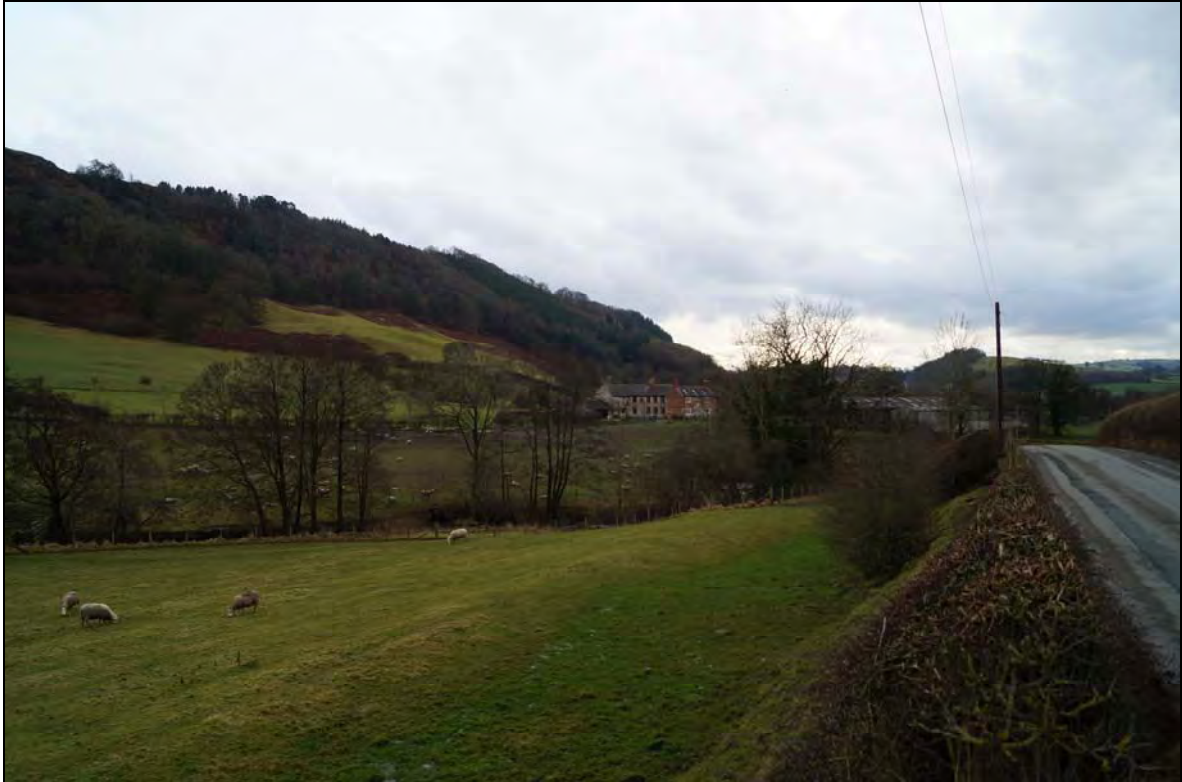
*Plate 26: A view looking southwards towards Tynewydd from the Llansilin road. The house, trees and hedges would block the proposed free-range egg unit from this direction. Even in winter, with no leaves on the trees, the building would be virtually invisible.*

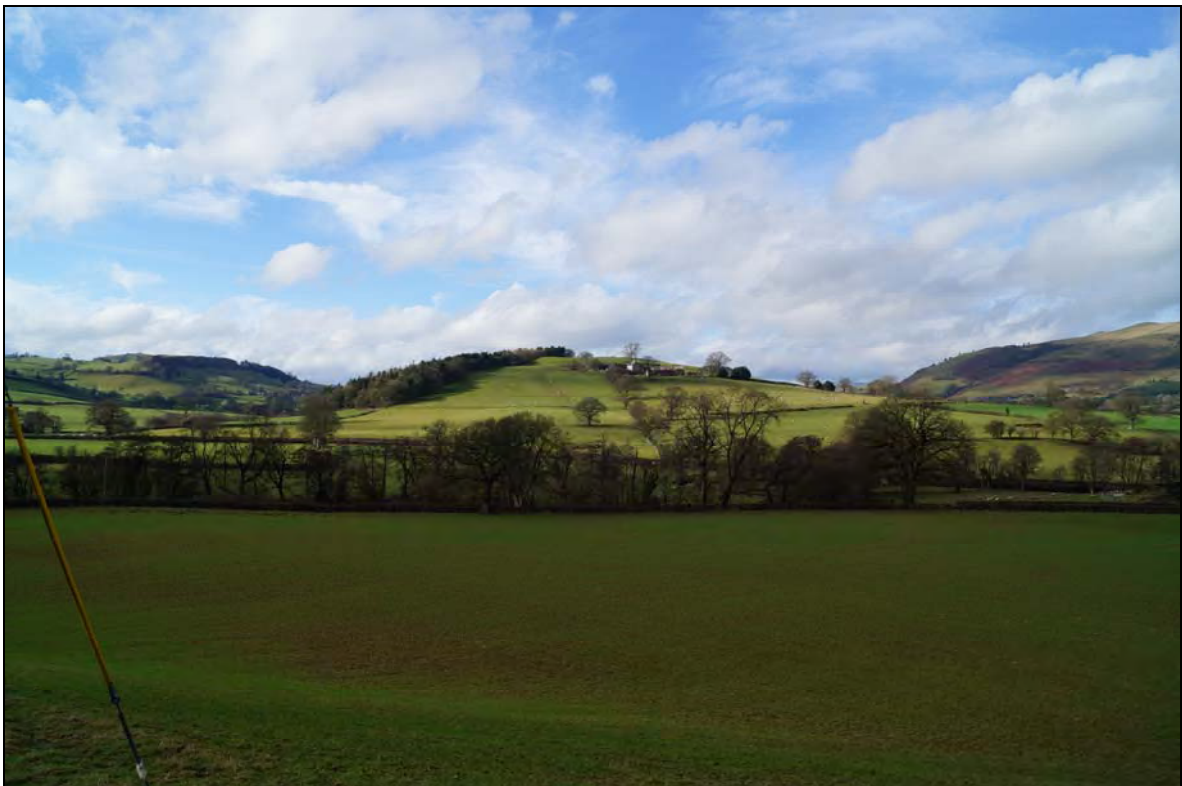
*Plate 27: The view looking west-northwest from the slope above the proposed development site to the listed buildings at Penybryn (ID numbers 2 & 11). At this distance, it is clear that there would not be a significant visual impact or any impact on the setting caused by the proposed development with regard to the listed house and barn at Penybryn.*

- 7.2.3 The nearby house of Penybryn (ID number 11, see plate 27 for long-range view) with its contemporary cruck-framed barn (ID number 2), is also notable. Penybryn is thought to have originated as a hall house but has been subject to later modifications. Both the house and barn are listed buildings, reflecting their importance.
