CPAT Report No 1263

Tŷ-uchaf, Cwm Llech, Llangynog, Powys

Survey and excavation

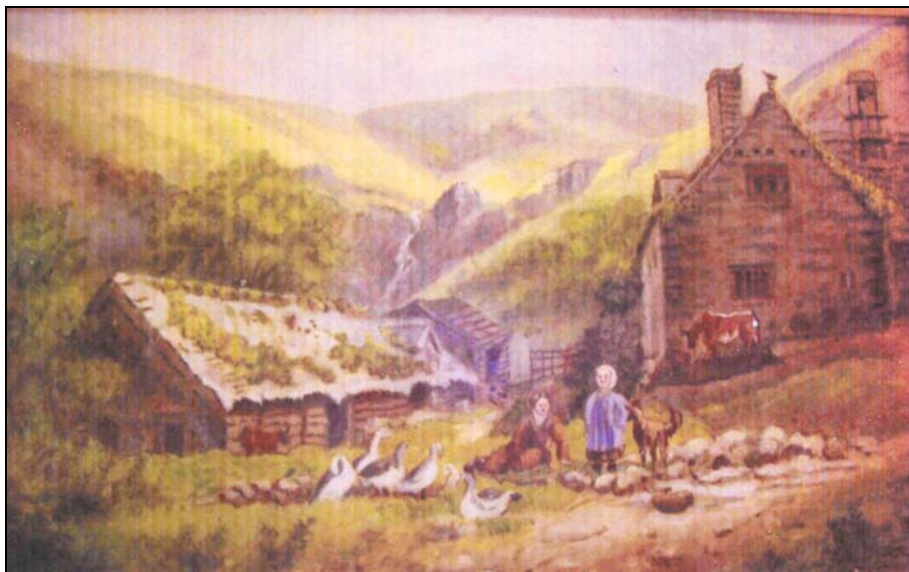
Fig. 2 An undated, probably 19th-century painting of Tŷ-uchaf
(private collection)

- 2.2 The house is depicted in an undated, but probably 19th-century painting (Fig. 2), the detail of which appears to be particularly accurate. This shows eastern gable of the house with a row of nesting holes above the first-floor window, which are now lost, as is the dormer window just visible on the south side. The roof of the rear wing extends beyond the chimney and follows the same line above what was a byre. Beyond the farmyard scene the outbuildings include a weatherboarded barn and a cartshed, with the shafts of a cart just visible. The Ordnance Survey mapping of 1887 (Fig. 3) shows the farm to comprise an L-shaped house, with two buildings to the south (the barn and cartshed) and a further building to the north, beyond a track.

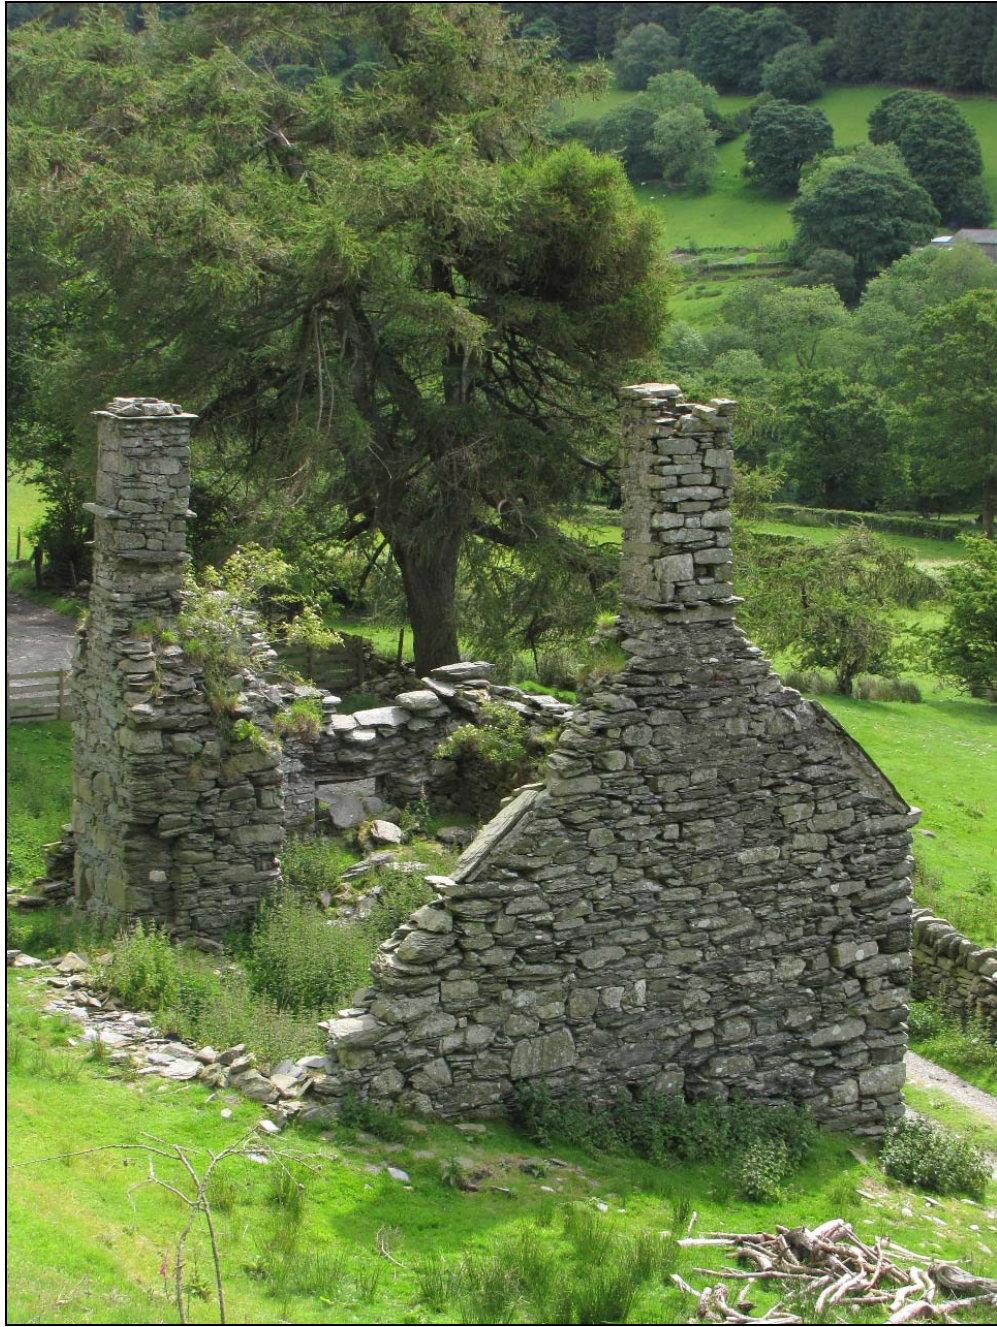
Fig. 5 Tŷ-uchaf viewed from the west. Photo CPAT.

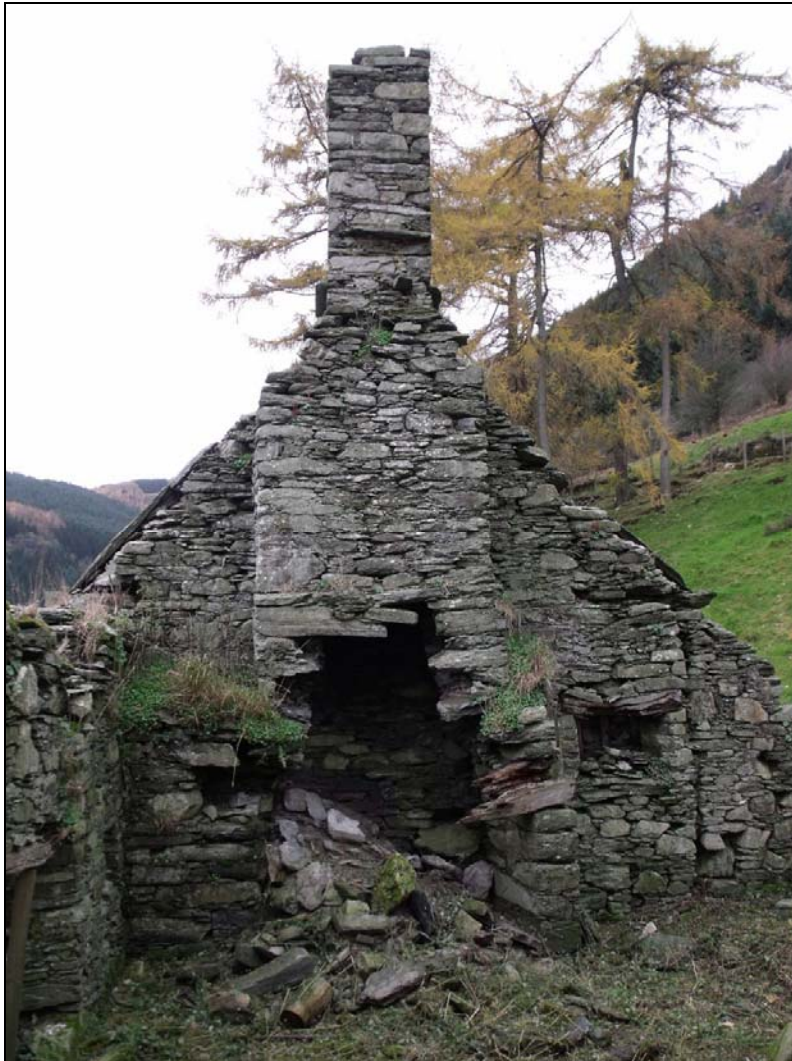
Fig. 6 The collapsed fireplace in the western gable. Photo CPAT 3729-0013

- 3.5 The following description is taken in part from comments by Richard Suggest, RCAHMW. Tŷ-uchaf is set upon a massively revetted earthwork platform, with the housing having been built parallel with the contour of the slope, while the rear, northern wing, incorporating the byre, is cut into the slope behind. The building was of one-and-a-half storeys and appears to be of a single build, dating from 1665, constructed using local stone, with a slate roof. The house was rectangular in plan and divided into two rooms on each floor by a timber-framed partition, now lost, but recorded in the 1930s. This separated the kitchen or hall to the west from a parlour wing to the east. Both rooms contain massive chimney pieces which form the dominant feature of the ruins, incorporating rough limestone quoins and distinctive drip courses at stack level. That in the parlour was freestanding whilst the kitchen fireplace has been modified at a later date by the insertion of a brick-lined bread oven.

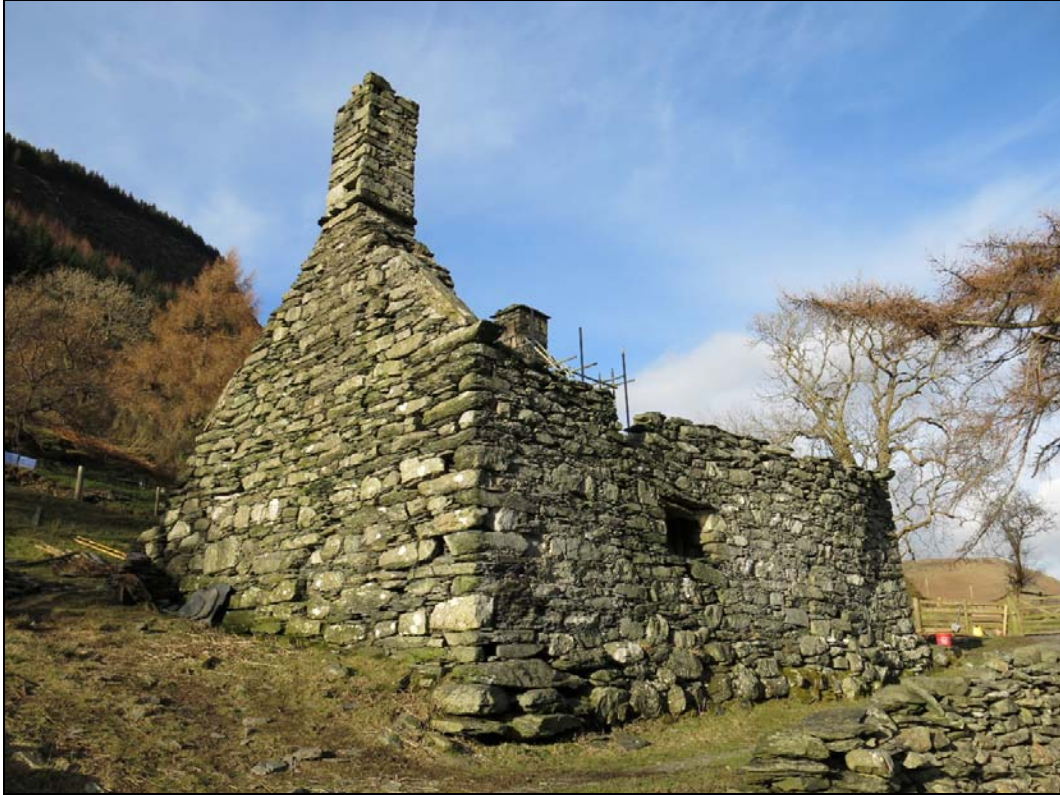
Fig. 7 Tŷ-uchaf, viewed from the south-west, showing the main house standing on a stone-revetted platform. Photo CPAT 3789-0058.

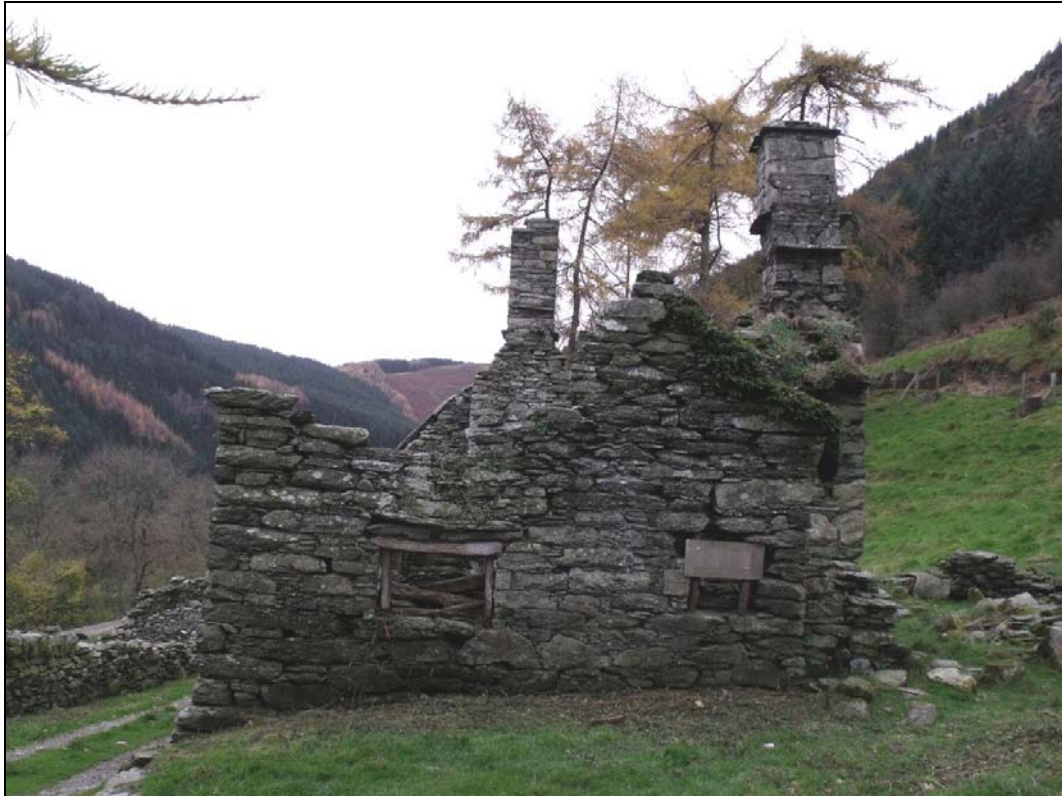
Fig. 8 The partially collapsed eastern gable wall. Photo CPAT 3729-0001

- 5.2 The interior of the house was filled to varying degrees by collapsed masonry, particularly where the upper part of the eastern gable had fallen inwards, where the rubble was up to 0.9m thick. The areas around both fireplaces also contained substantial amounts of rubble, all of which was removed carefully by hand. A significant number of artefacts were recovered from the rubble, including pottery, bottle glass, leather footwear and a range of iron objects and nails, all of which dated from the 19th century. It is probable that at least some of this material was derived from the collapse of the first-floor. Roofing slate was also common, in a variety of sizes, together with numerous roofing nails. The slates were mostly found around the inner edge of the walls, suggesting that the collapsing roof timbers had hinged on the wall plates and gables before discharging their load. There was surprisingly little evidence for wall plaster within the rubble and no window glass or structural timber, perhaps indicating that the windows and oak frame had been removed and reused elsewhere.

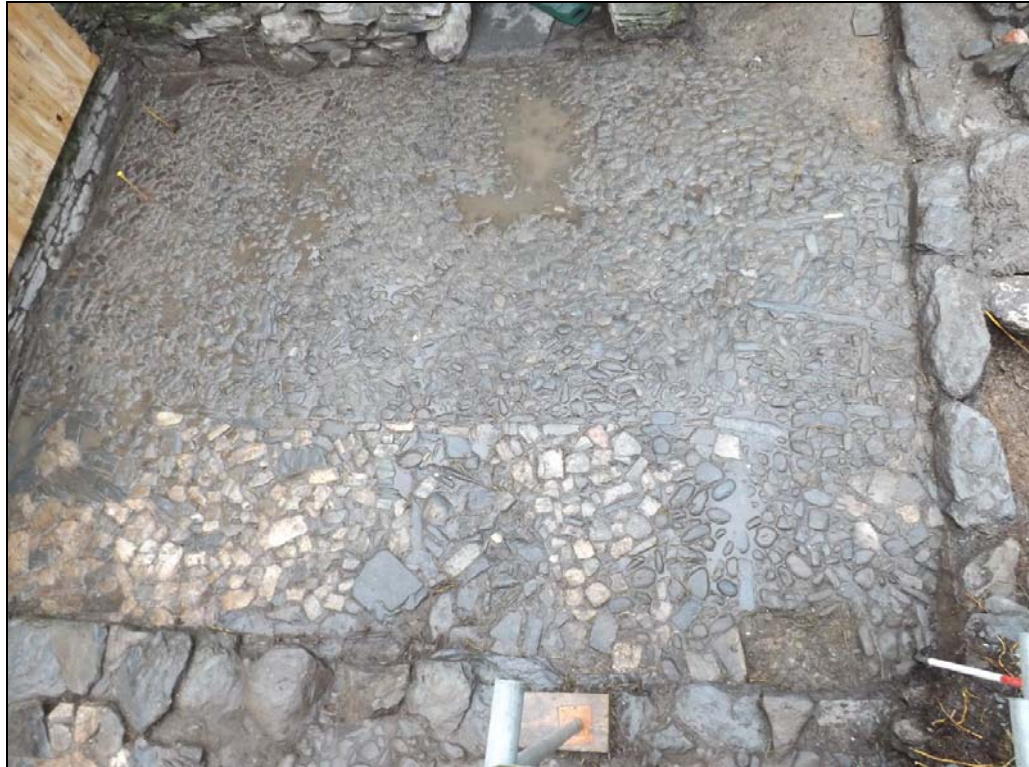
- 5.4 The floor of the parlour was well-preserved and had been laid carefully, with the cobbles packed tightly. Although there was no patterned design within the floor it did contain several deliberate lines, as well as an area against the partition where quartz cobbles predominated (see Fig. 24). To the right of the fireplace the lack of cobbling may be associated with the position of a winding staircase. A roughly rectangular area in front of the partition lacked any cobbles and marked the position of the original doorway between the two main rooms. The position of a later door in the centre of the partition, recorded in 1934, was not obvious.

Fig. 9 The cobbled floor in the parlour. Photo CPAT 3800-0059

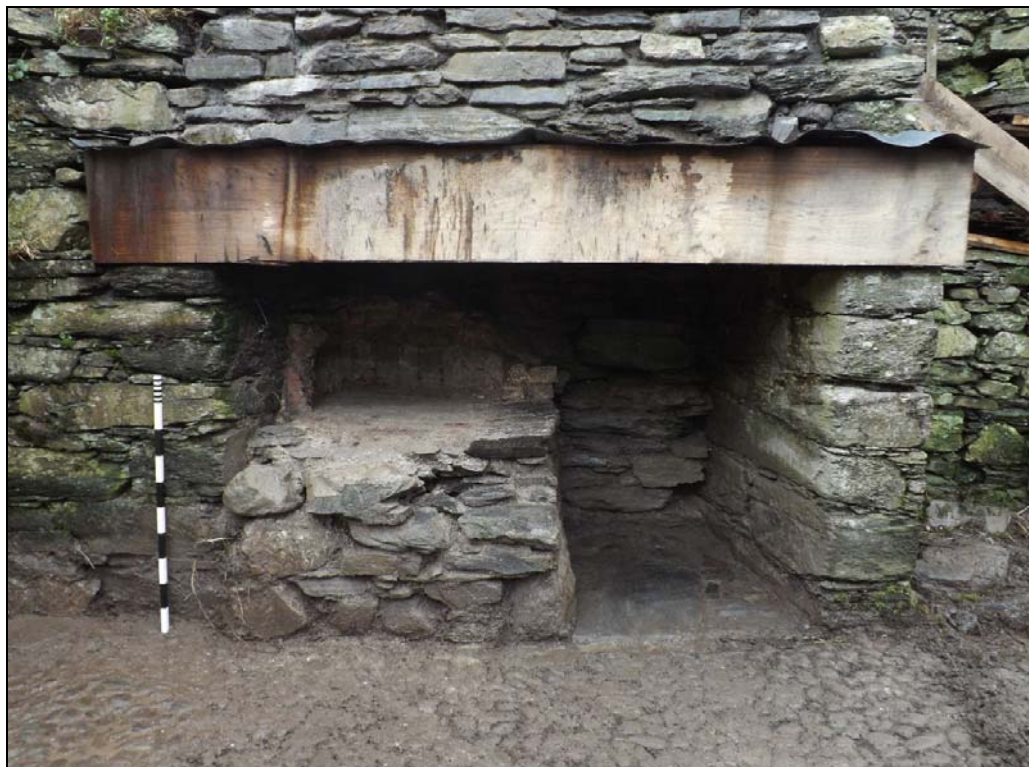
- 5.5 The fireplace was floored with large slabs, half of which remained hidden beneath the plinth for an inserted bread oven. This was roughly circular and had a brick floor and the remnants of a brick-lined dome. The rear wall of the fireplace contained a recess, presumably for kindling and tapers.

Fig. 10 The repaired fireplace in the parlour with the inserted bread oven on the left.
Photo CPAT 3800-0011

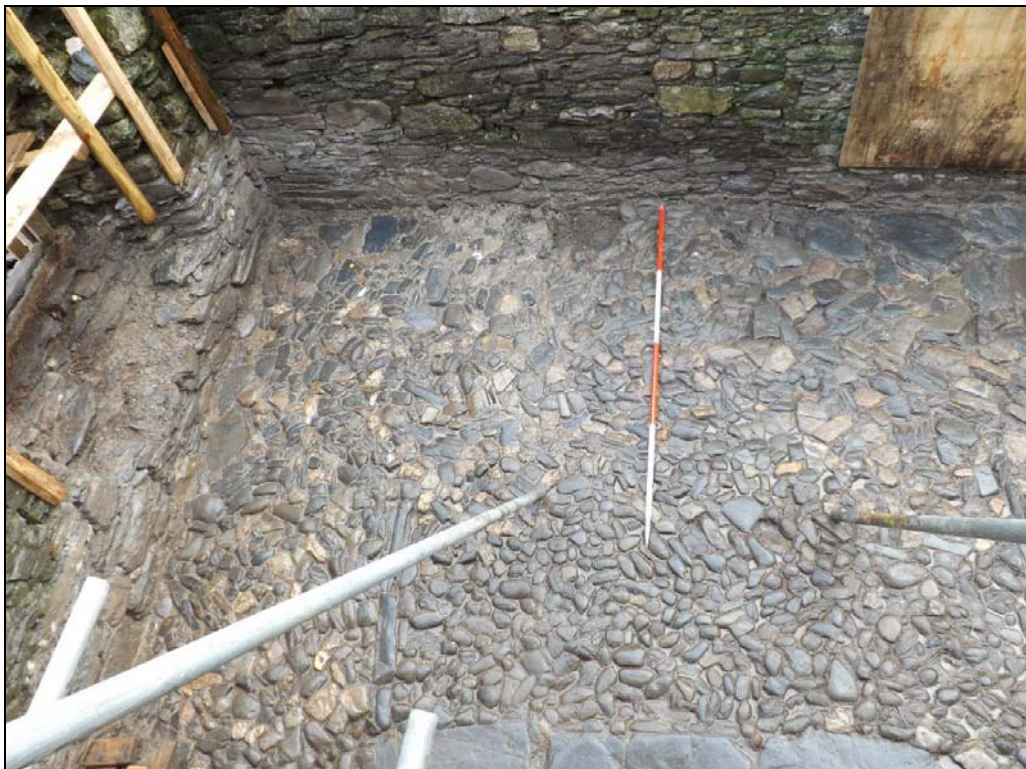
- 5.6 The floor of the kitchen was at a slightly higher level than that in the parlour, there having been a step up along the partition. There was an area of large slabs in front of and within the fireplace and a patch of smaller slabs against the partition, while the remainder of the floor was formed from larger cobbles than those used in the parlour. The floor had been patched against the southern wall, which had evidently moved outwards while the building was still occupied, leaving a gap at its base. The position of the outer door, alongside the chimney, was marked by a threshold slab, the cobbled flooring continuing beyond into the passage within the byre (see below). Some pottery was recovered from between the cobbles and this was generally earlier than that in the rubble, a few sherds dating from the 18th century. An iron band from the base of a wooden bucket was found fused by rust onto the cobbles adjacent to the window.

Fig. 11 The cobbled floor in the kitchen. Photo CPAT 3800-0038

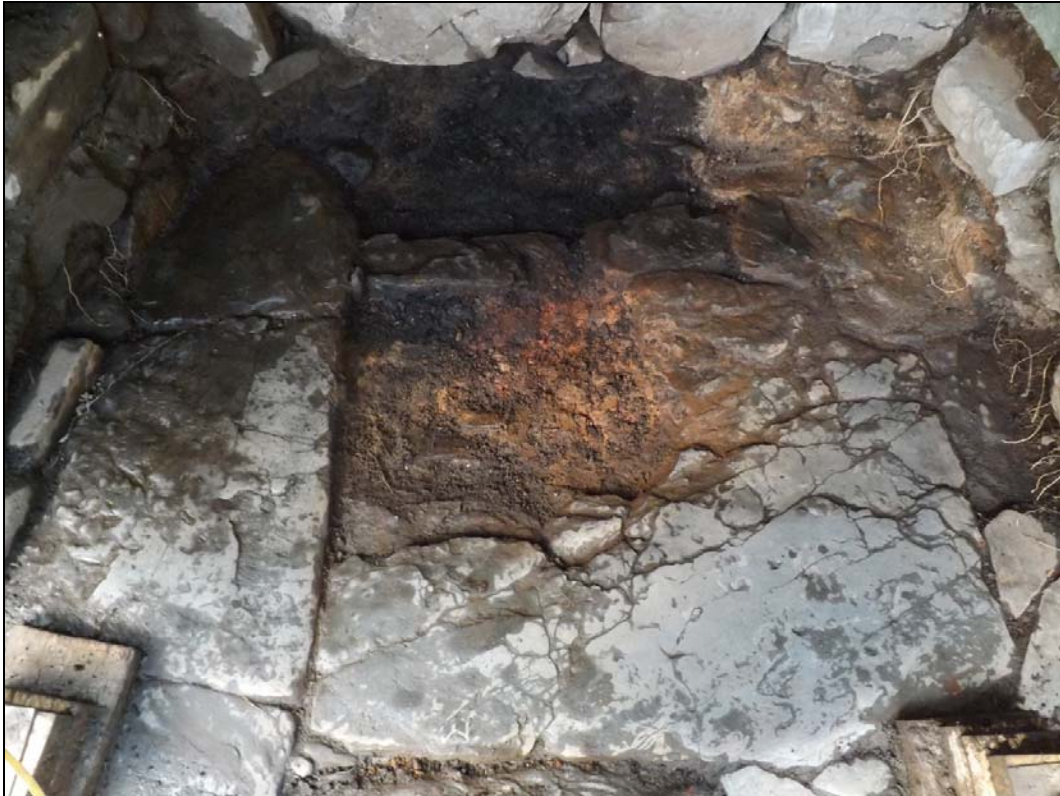
- 5.7 The fireplace had originally had a fire placed directly onto the slabbed floor, which at this point was heavily affected by heat. At a later date a smaller fireplace appears to have been inserted, within a construction of roughly-built stonework which had unfortunately been badly damaged by collapsing masonry. Part of this structure can be seen in one of the photographs taken by M F H Lloyd (1934). As in the parlour, there is a small recess at the rear of the fireplace.

Fig. 12 The original floor in the kitchen fireplace. Photo CPAT 3800-0087

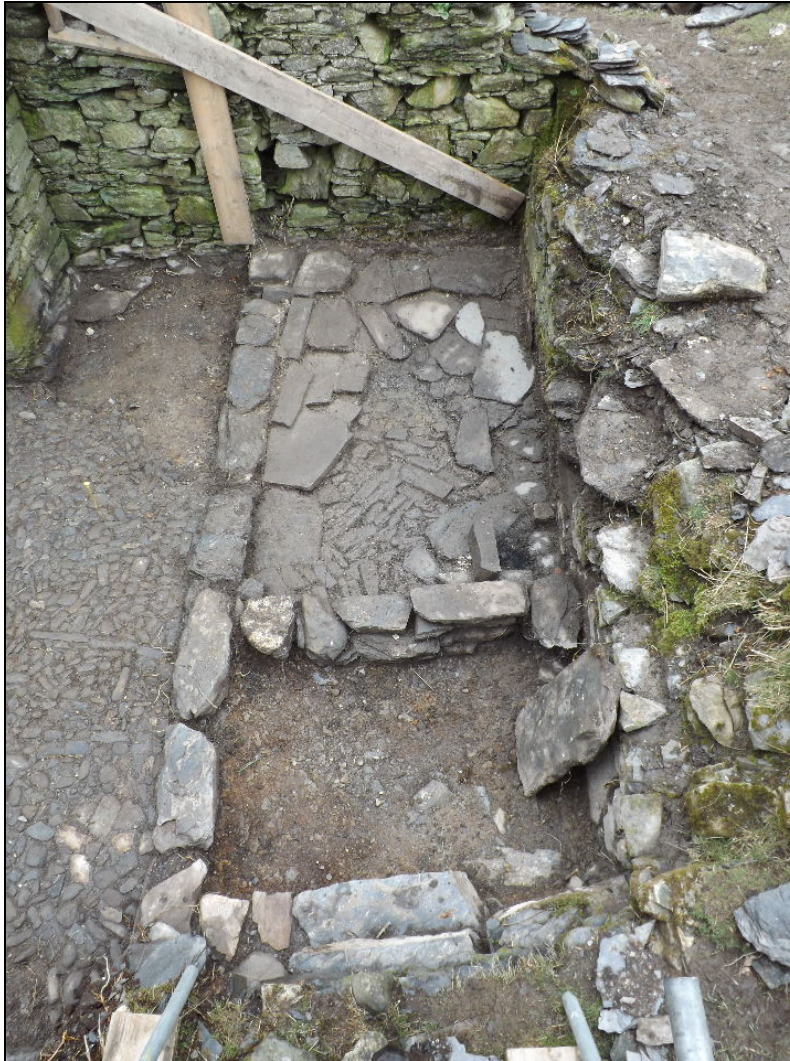
- 5.8 The outshut was divided unequally and the larger, western room had a cobbled floor, although this had later been overlain by a rough slabbed floor. In the angle between the outer wall and the partition were the collapsed remains of a slate-slabbbed bench or low shelf which had been supported on lime-mortared bricks and stone. The slate had evidently broken when the building collapsed and but was clearly associated with a discrete area of ash and cinders which lay both above and beneath the slate, suggesting the position of a coal fire, perhaps for heating a small copper. The smaller room had no flooring but two large slabs at the eastern end had the appearance of steps leading upwards towards the chimney (see Fig. 13). Fragments of window glass were recovered came from a discrete area of the outshut, suggesting that the room, being below ground at the rear of the house, had been lit by a roof light.

Fig. 13 The dairy/pantry outshut showing the later flooring in the larger room. Photo CPAT 3800-0114

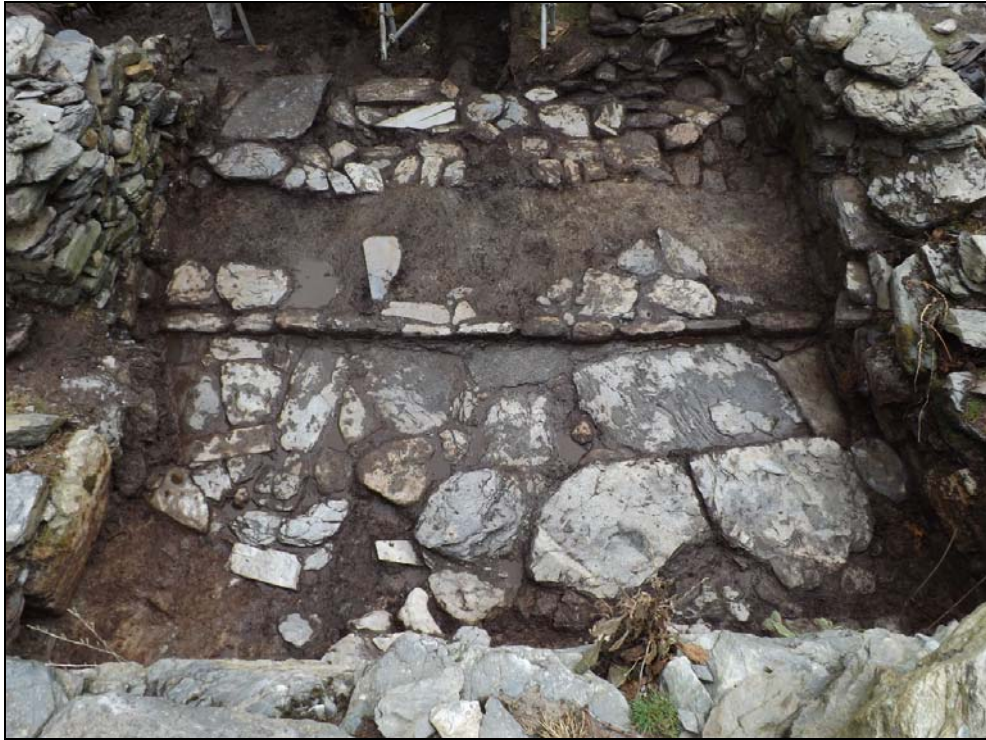
Fig. 14 The later flooring in the byre with the edge-set stones marking the side of the manure passage. Photo CPAT 3800-0009

- 5.11 The byre was later substantially refurbished and reorganised. A rough slabbed floor was laid at the feeding end of the stalls and a slab-floored manure passage was introduced in the rear third of the building. A floor of smaller slabs was laid in the feeding passage along the rear of the kitchen chimney, this clearly acting as a feeding passage. This was evidently the arrangement described by Lloyd and Richards in 1934.

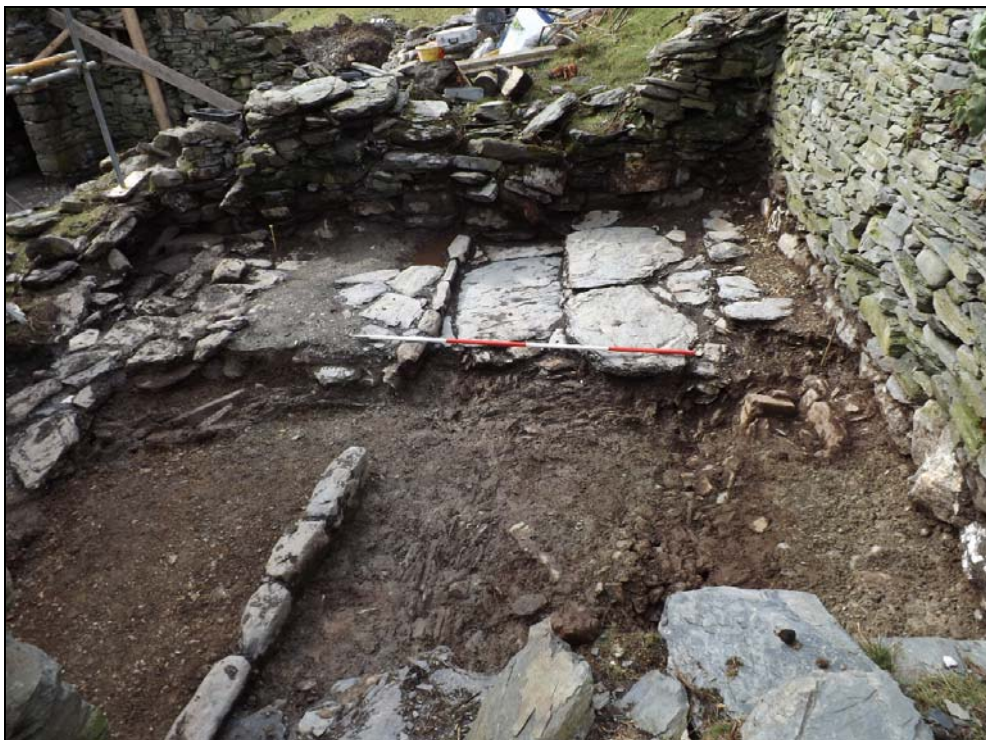
- 5.10 Internally, the byre floor appears to have originally been unsurfaced and sloped towards the house. A number of drains were apparent, filled with edge-set stones, one catching natural runoff towards the area of the byre and others taking animal waste out through the main entrance, adjacent to the house. A number of stakeholes were apparent, presumably for tethering posts. Soil layers which accumulated in this phase contained the earliest pottery found at Tŷ-uchaf, including sherds of 18th-century slipware.

Fig. 15 The original earthen floor of the byre with drains filled by edge-set stones. Photo CPAT 3800-0108

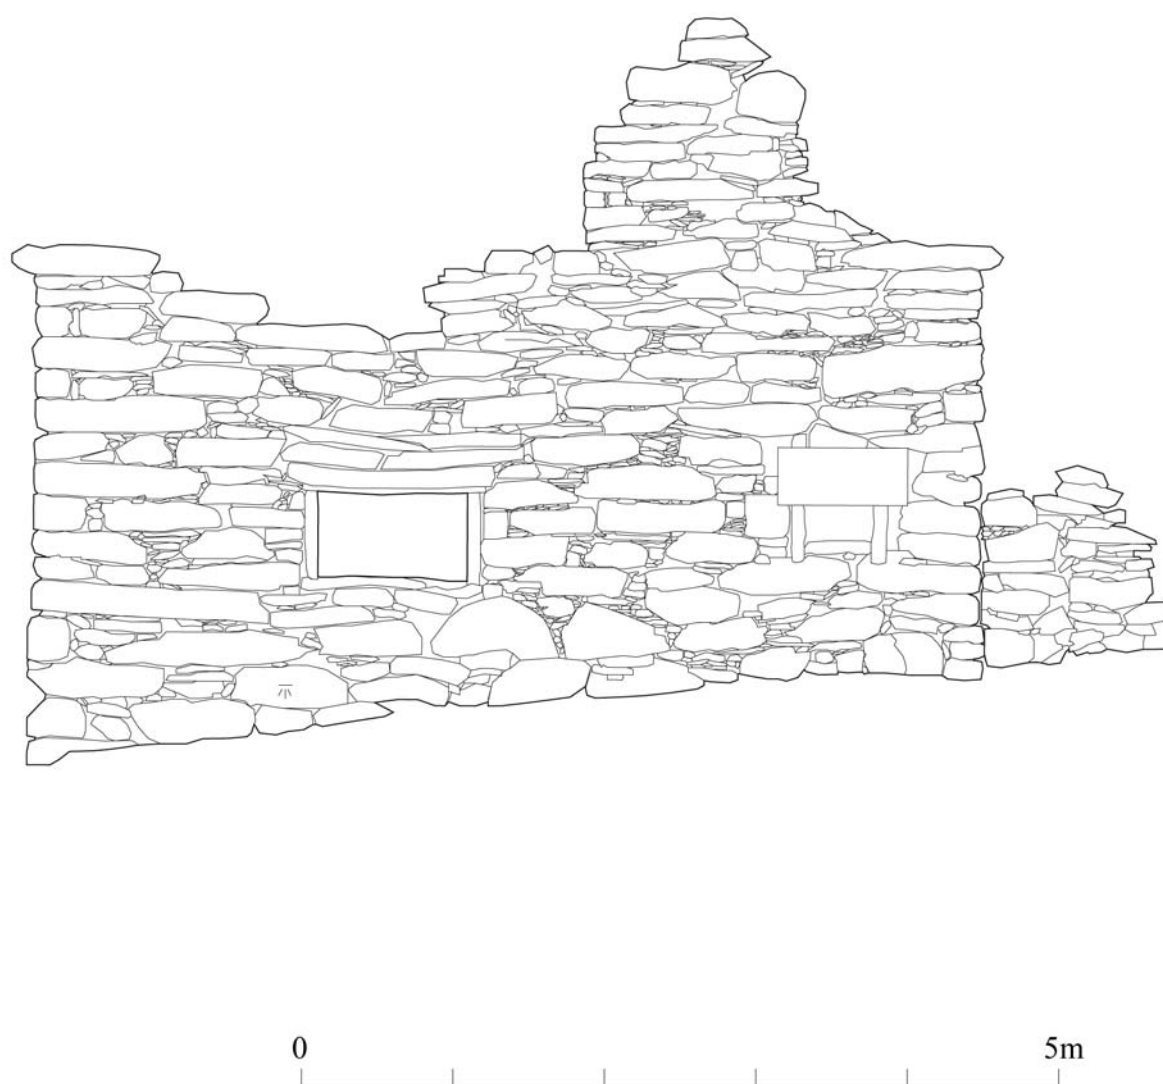
Fig. 21 East external elevation of the house
