Erwallo Uchaf, Pontfadog, Denbighshire

Level 3: Archaeological Building Recording

Report No. 1672

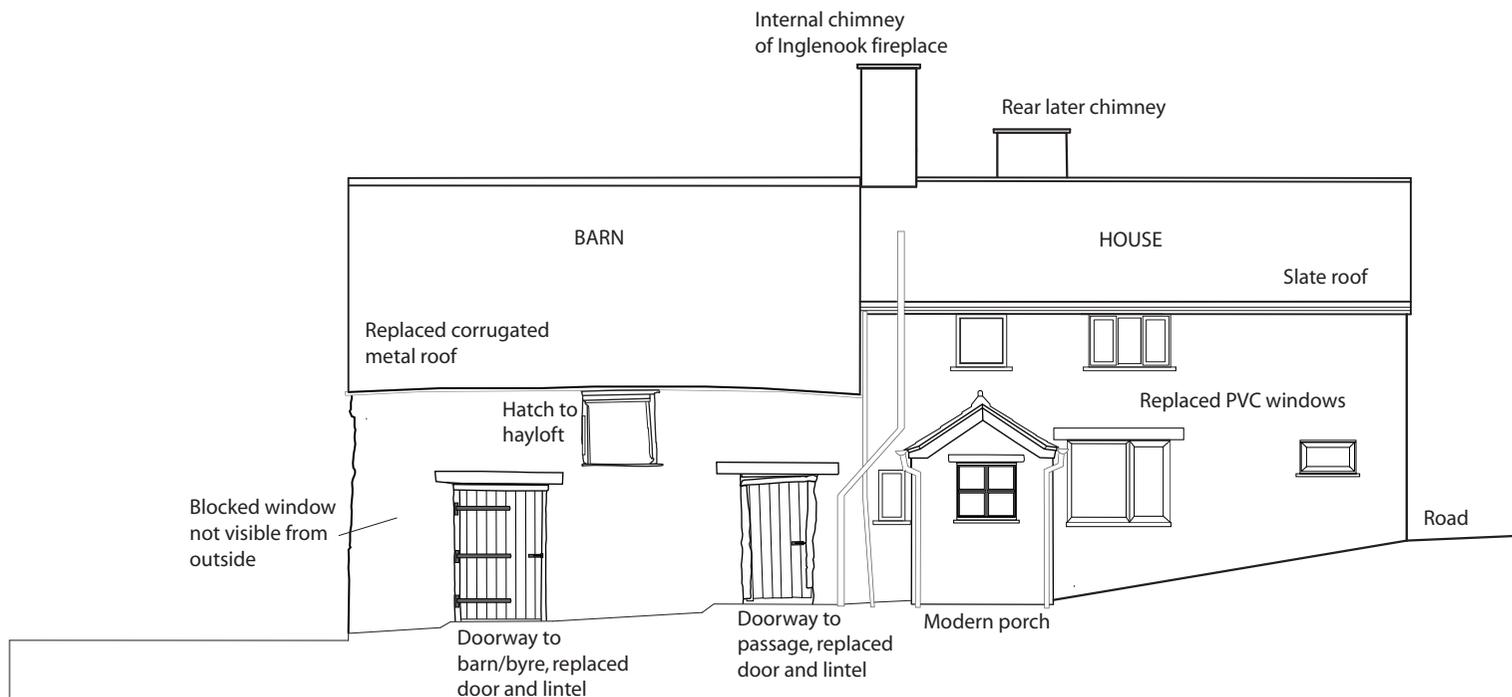
Figure 10
Existing Front Elevation.
Original drawings by
JPH Architects, adjusted
by Author

SOUTH-EAST (FRONT) ELEVATION

The south-eastern elevation was comprised of the front of the house and adjoined barn, two distinct parts of the building, with the same roof line in height, but the roof was in two parts with differing pitches. The barn roof was steeper in pitch than the house roof. The house had a tall stone chimney on the south-western end. One large window was on the ground floor of the house, with a smaller window to the north-east. Two windows were on the first floor of the house. All the windows were modern replaced PVC windows. The barn had two replaced wooden doors with replaced wooden lintels in good condition; the door to the north-east was slightly taller in height and narrower in width. An open (non-glazed), square, window-hatch to the first floor loft of the barn had a rotten wooden frame of some age, obscured with black paint.

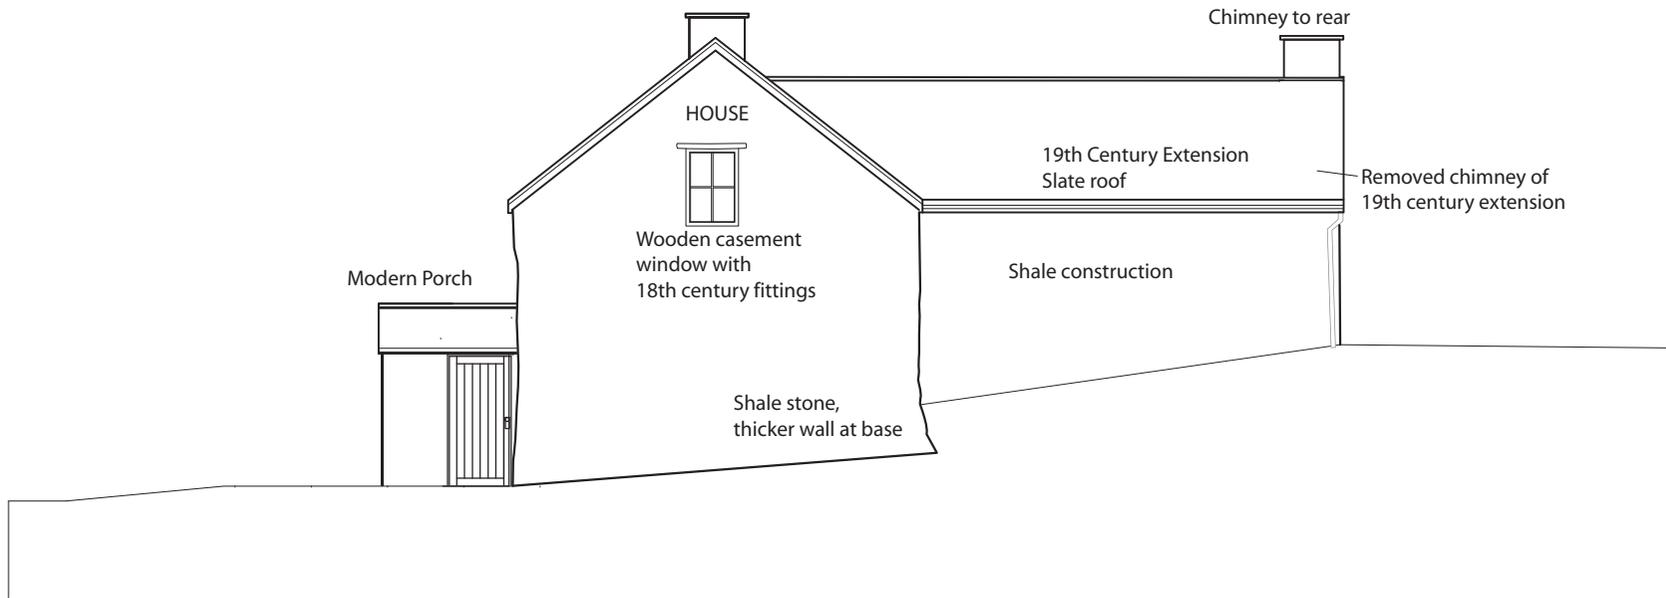
Figure 11
Side Elevation (road side)
Original drawings by
JPH Architects, adjusted
by Author

NORTH-EAST (SIDE) ELEVATION

The north-east elevation was comprised of the gable-end of the house, built from roughly dressed and irregularly coursed shale of varying sizes. The stonework was thicker at the base of the wall, built onto the bedrock. Although obscured with white paint, a distinct change in the thickness of the fabric of the wall could be seen on a roughly diagonal line, increasing with height to the north-west, and could possibly be an earlier wall remnant incorporated into the present building. A wooden casement window of four lights with wooden lintel was in the first floor.

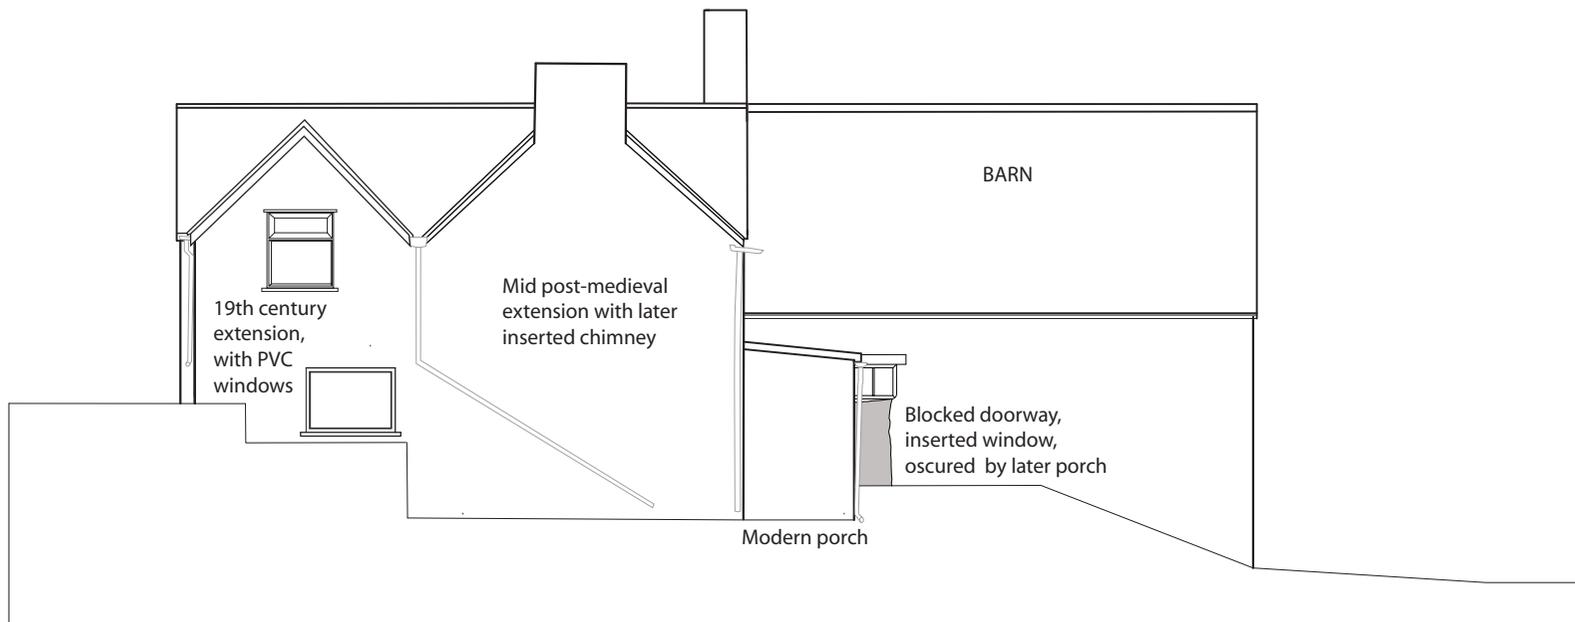
Figure 12
Rear Elevation.
Original drawings by
JPH Architects, adjusted
by Author

NORTH-WEST (REAR) ELEVATION

The north-west facing elevation of the house was comprised of the rendered gable end of the 19th century extension, with a replacement PVC window on each floor. This adjoined the larger gable end of the house, also rendered stone, with a shale internal chimney stack and slate roof.

The north-west elevation of the barn was built from roughly dressed, irregularly coursed shale, painted white, with a replaced metal sheeting roof. The height of the wall increased to the south-west as the hillside sloped steeply downwards. One doorway, opposite the north-eastern barn doorway on the south-eastern elevation, had been blocked, with a wide high wooden-framed double-lighted window with wooden lintel in good condition. This had been obscured by the later addition of the modern porch to the house.

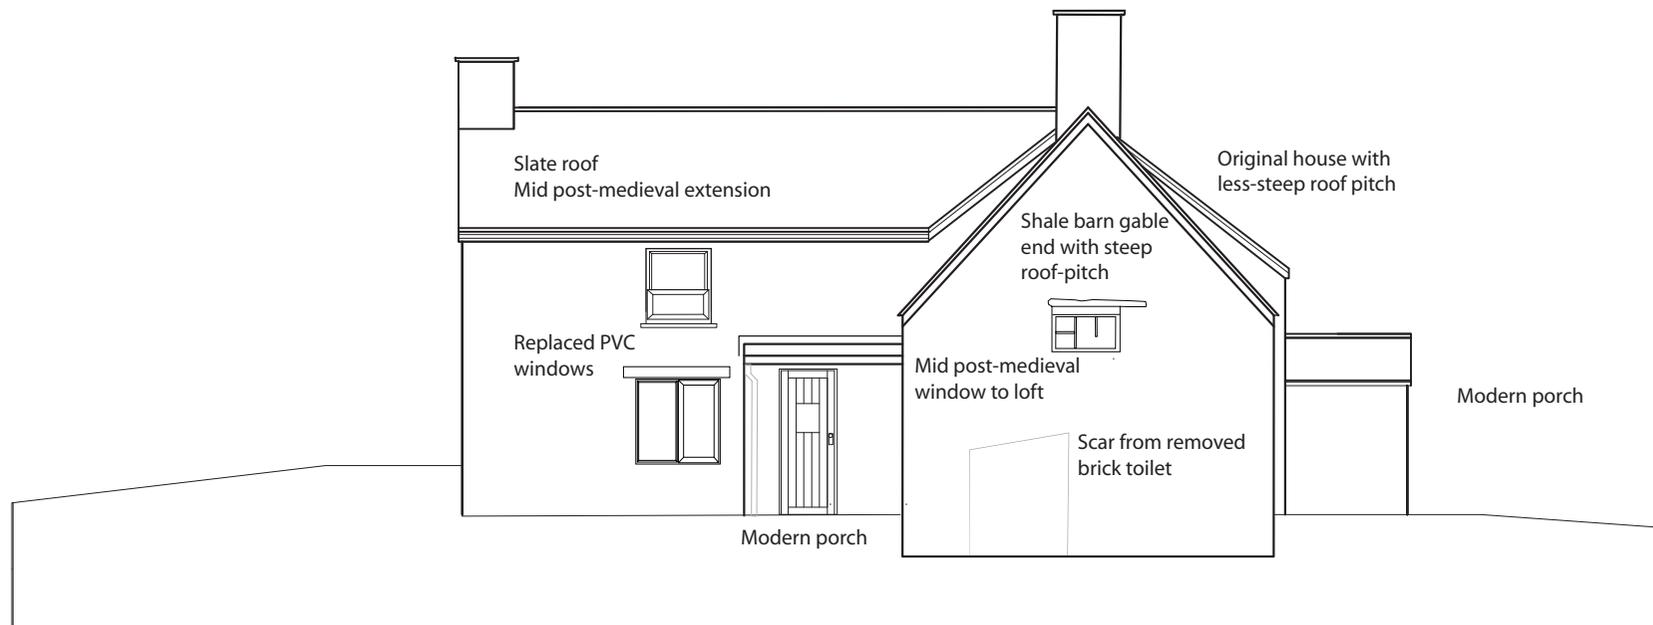
Figure 13
Side Elevation.
Original drawings by
JPH Architects, adjusted
by Author

SOUTH-WEST (SIDE) ELEVATION

The south-western elevation of the side of the house again showed it to be built from shale painted white, with two replaced PVC windows, one with a replaced timber lintel on the ground floor and one on the first floor. The porch to the house was a modern rendered construction, with plastic sheeting roof.

The south-western elevation of the barn was the gable end, constructed from shale painted white. A scar on the ground floor was that of a demolished toilet, with associated brick debris. On the first floor one wide window with an original wooden frame and lintel was seen to have the remains of six glazed lights, now only partially surviving.

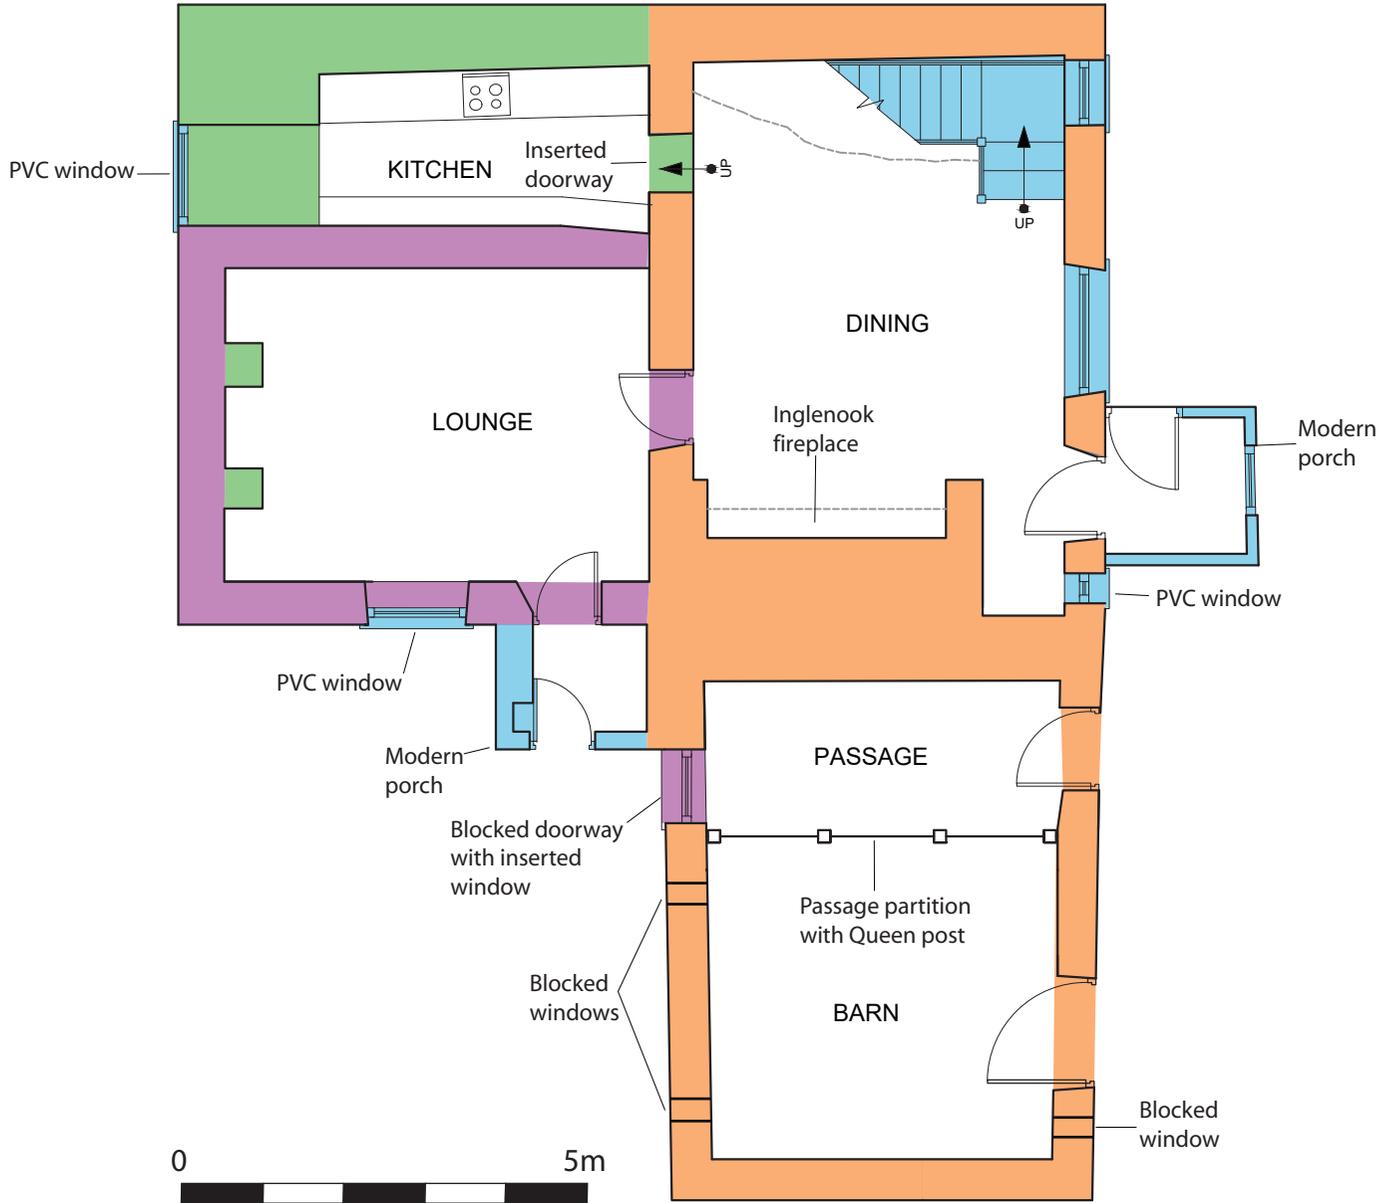
Figure 14
Phased plan - Ground Floor

- Key**
- Medieval to early Post-medieval
 - Early to mid Post-medieval
 - Late Post-medieval to early C19 (pre 1839)
 - Post 1975

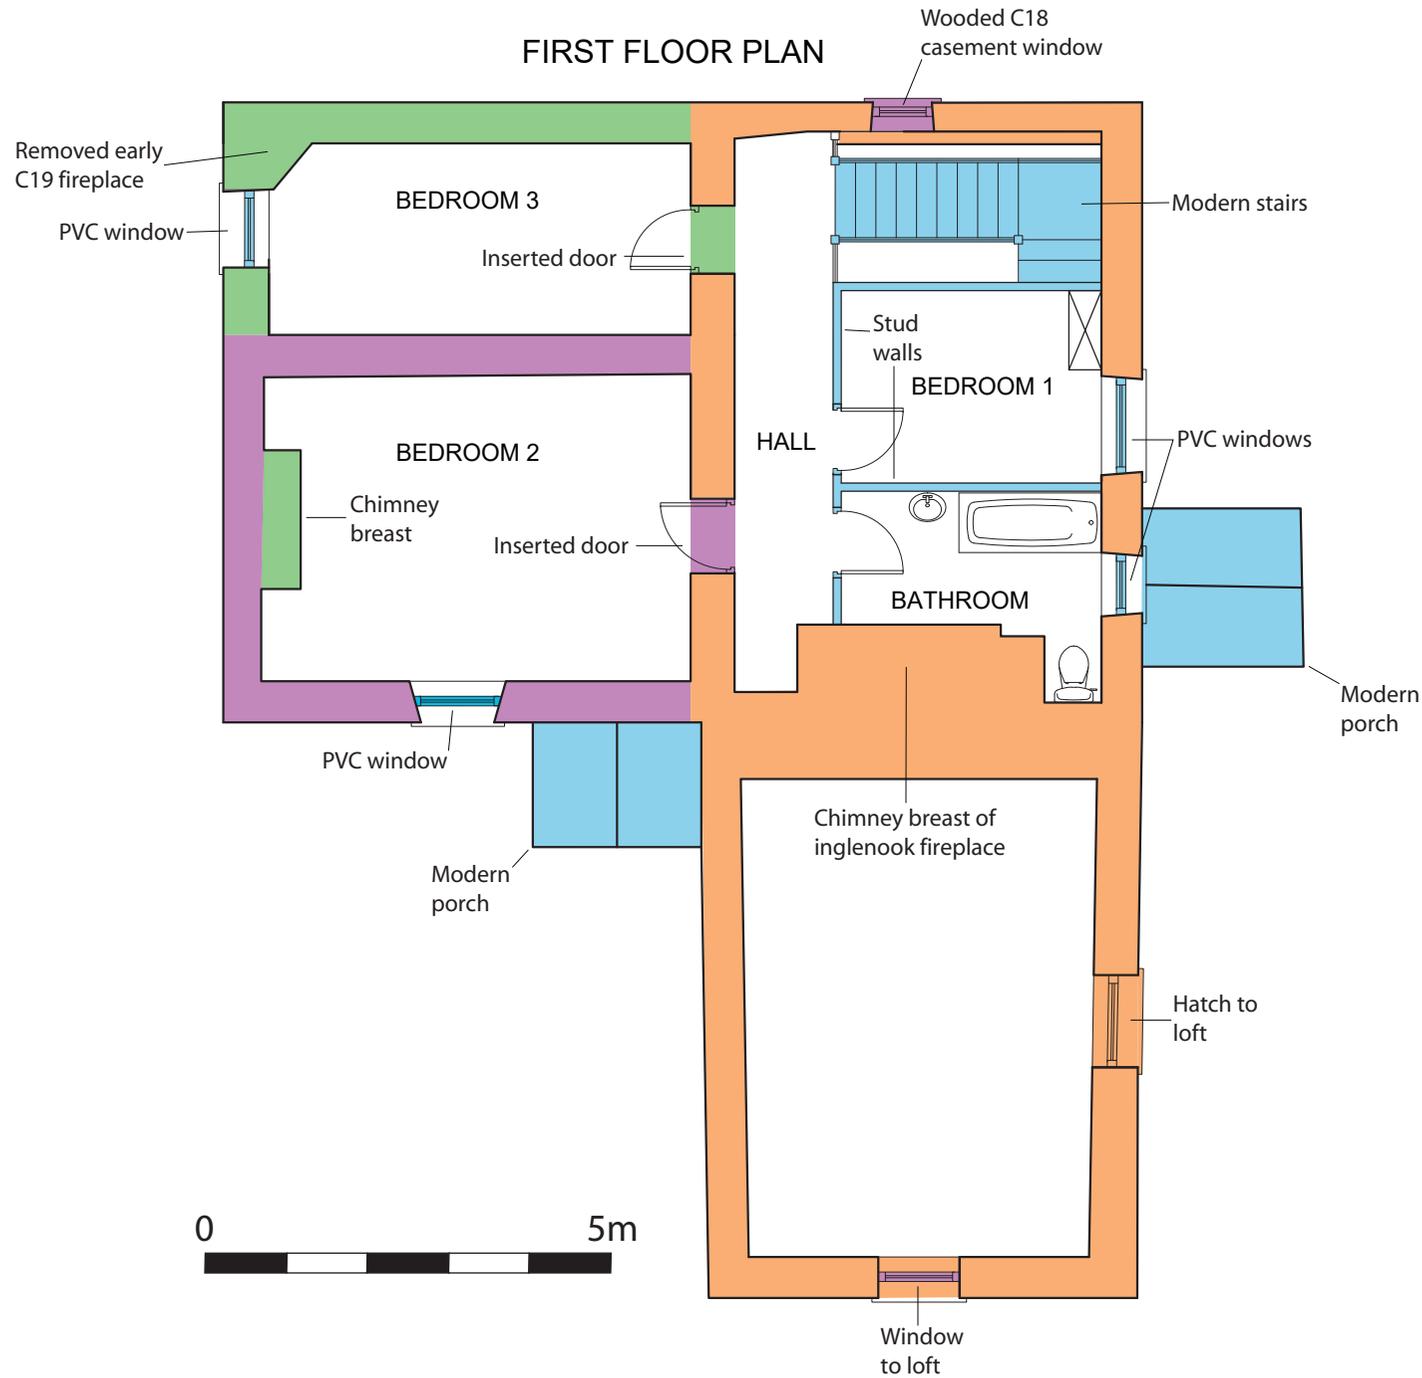
Figure 15
Phased plan - First Floor

- Medieval to early Post-medieval
- Early to mid Post-medieval
- Late Post-medieval to early C19 (pre 1839)
- Post 1975 / modern

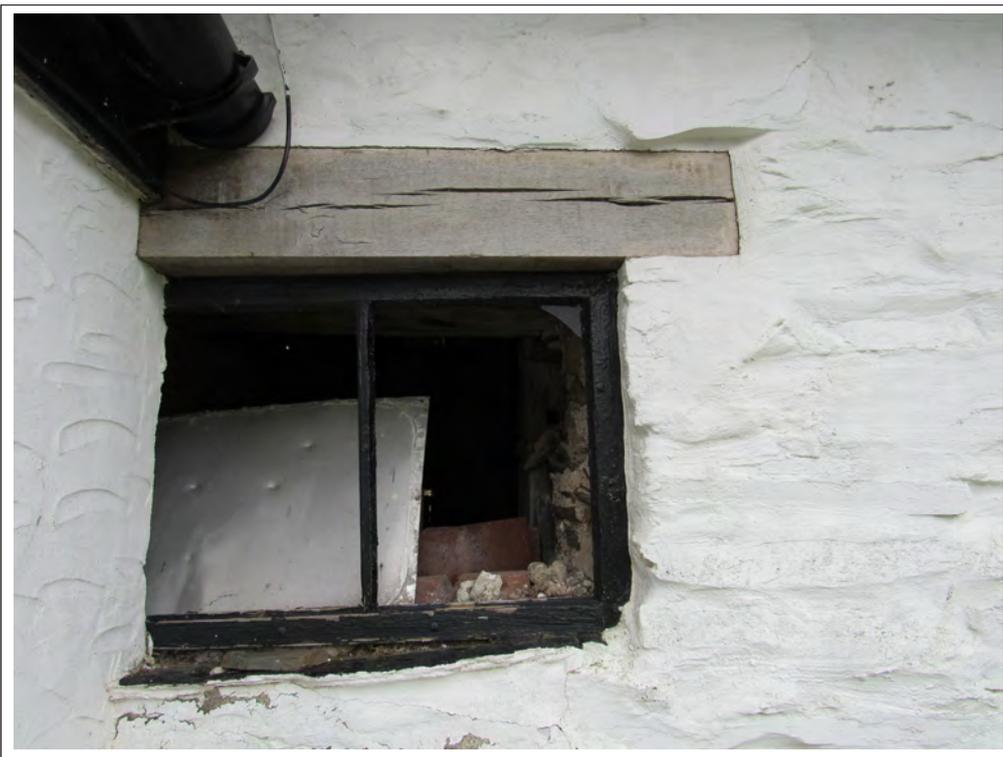
Plate 27. Barn north-west elevation window blocked by porch. View SE.

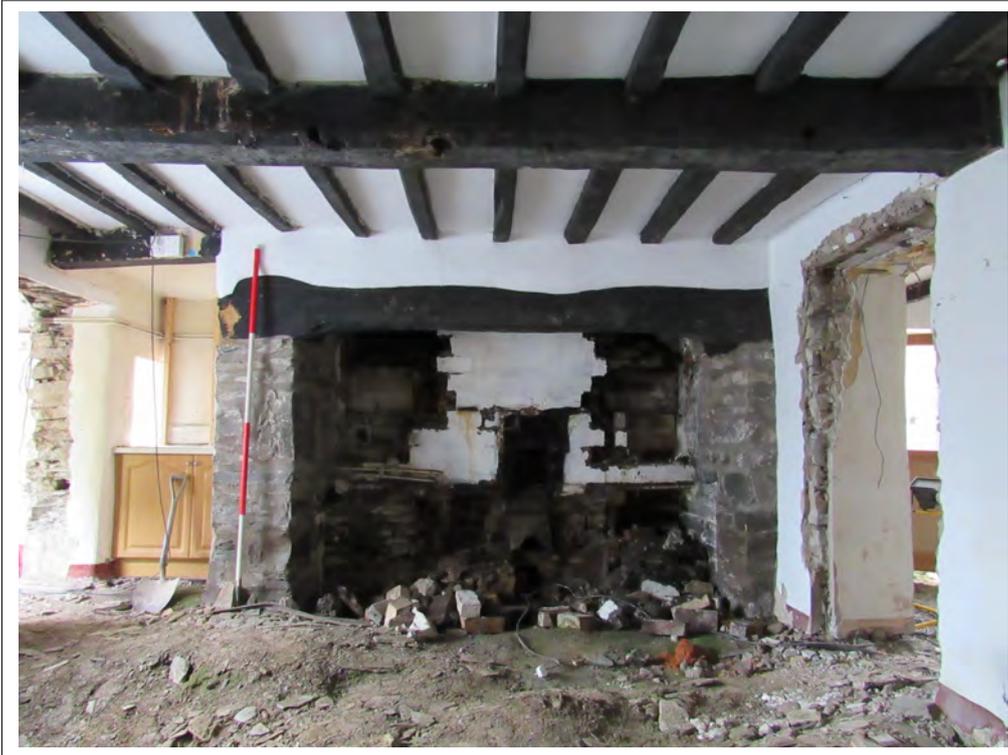
Plate 45. Dining room fireplace. View SW. 2m scale

The dining room had a large shale ingle-nock fireplace 3.2m in overall width from the north-western wall of the dining room, 1.03m in depth and with a timber mantel 0.36m in diameter. A corridor survived to the south-eastern wall of the fireplace (the south-eastern wall being 0.45m thick), which led to the entrance porch. The entrance door was removed, leaving a void 1.05m in width and 1.8m in height, showing the south-eastern shale house wall to be 0.52m in thickness. The ceiling had a chamfered main beam running south-east to north-west that was 0.26m in diameter. The fireplace mantle and main beam had occasional peg holes, possible from cooking machinery. To the north-east, the bedrock was visible, with the wall being substantially thicker at the base. The stairs were a 20th century addition, with a steel beam supporting the floor above them testament to 20th century refurbishment. The south-east elevation had one large PVC window with a steel lintel supporting the

main beam, and a smaller replacement PVC window on the stairs using an original wooden lintel. The fireplace had the remains of a later brick structure inserted, possibly from a removed stove. On the north-western side of the room, two doorways led to the lounge and kitchen respectively, showing the stone wall 0.5m in thickness that had been punched through to reach the extensions.

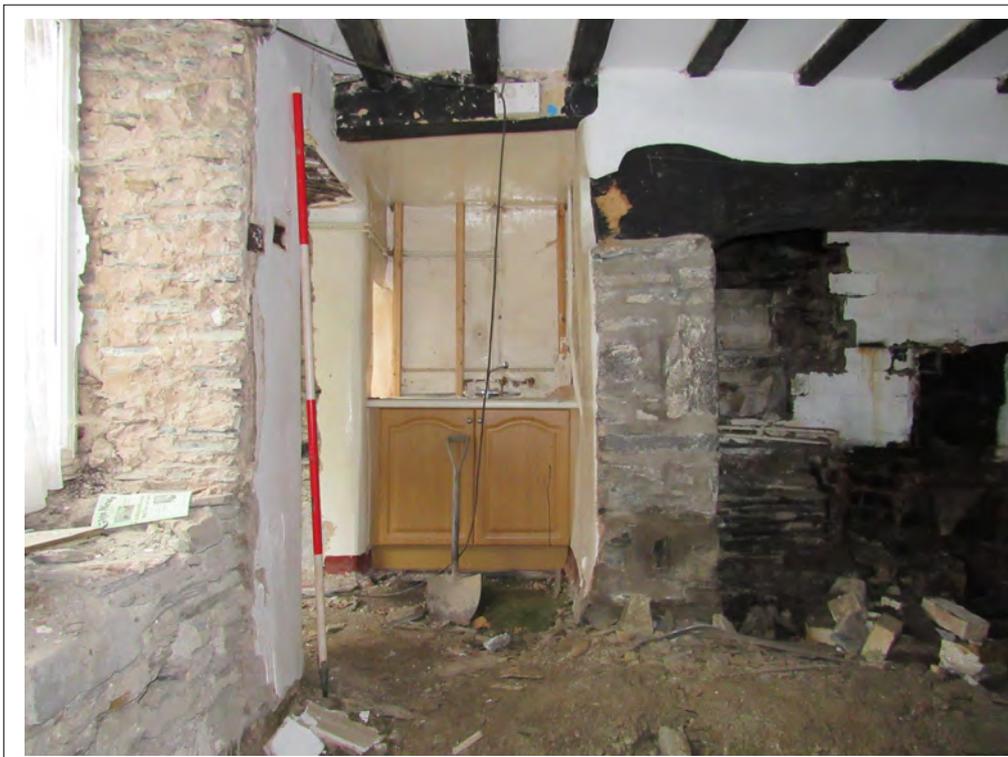
Plate 46. Dining room fireplace. View SW. 2m scale

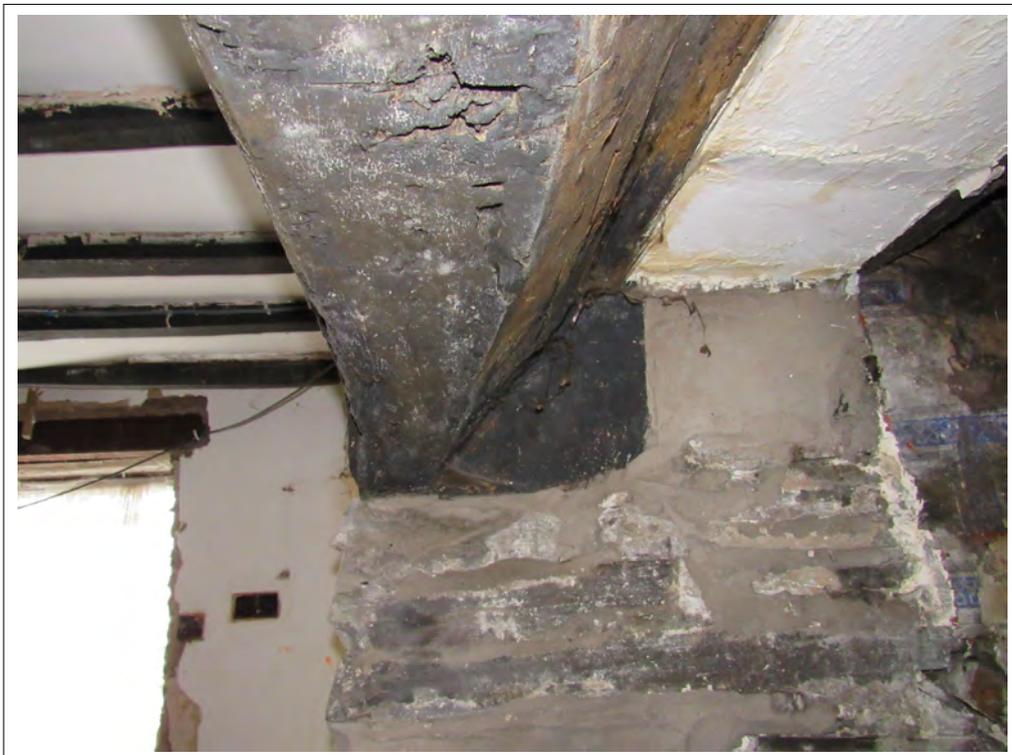
Plate 54. Dining room fireplace mantel. View SE.

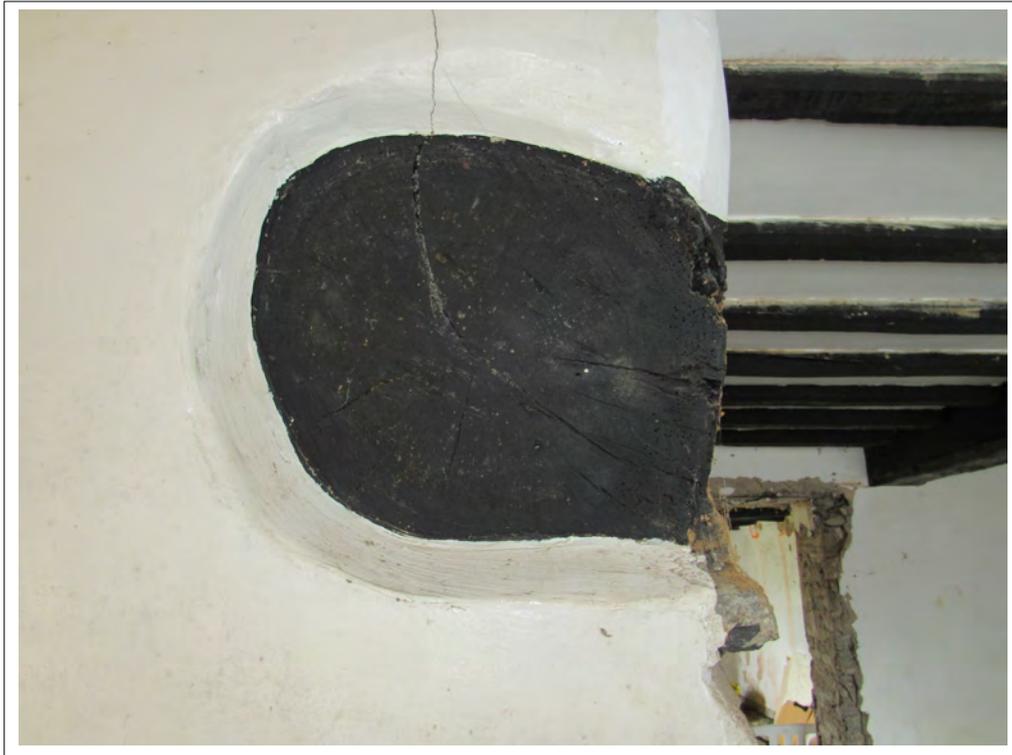
Plate 55. Dining room fireplace mantel. View NW

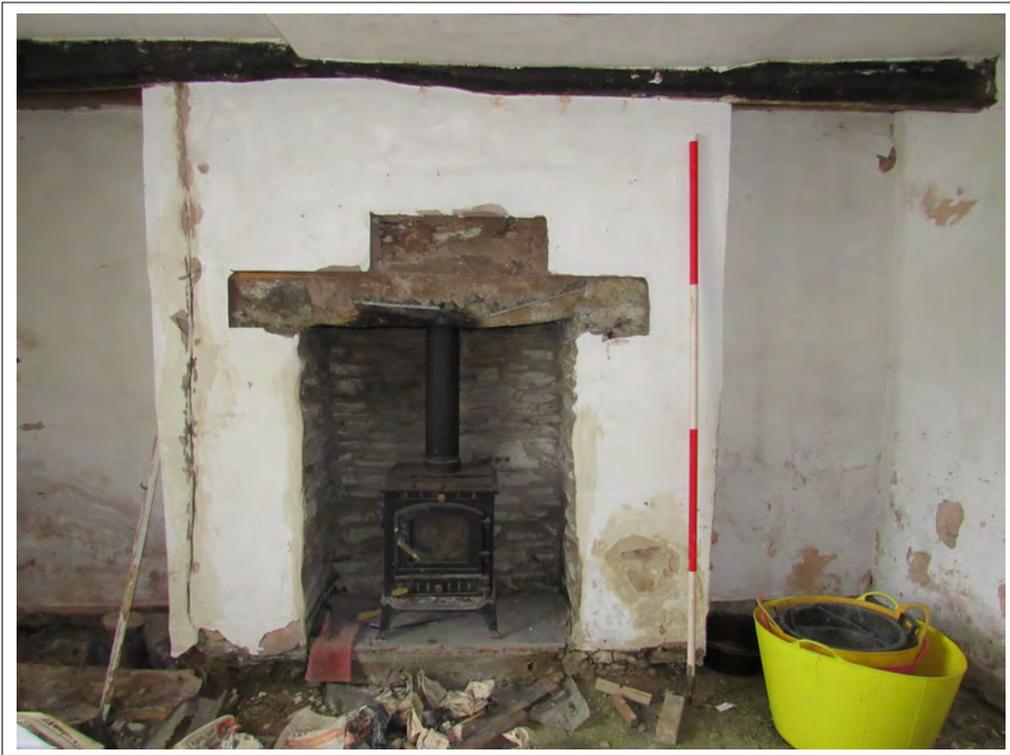
Plate 61. Lounge fireplace. View NW. 2m scale

The lounge was constructed from shale with a natural beamed ceiling running north-east to south-west. The beams were slightly chamfered in places but mainly un-worked. A stone fireplace 1.68m in width with parallel sides appeared as a later insertion on the north-western wall, with a charred wooden mantel and modern stove. The window on the south-western wall, which was 0.5m in thickness, had an original timber lintel and angled sides, appearing as an original opening with a modern PVC window inserted. The doorway to the exterior on the south-western wall led to a modern rendered porch.

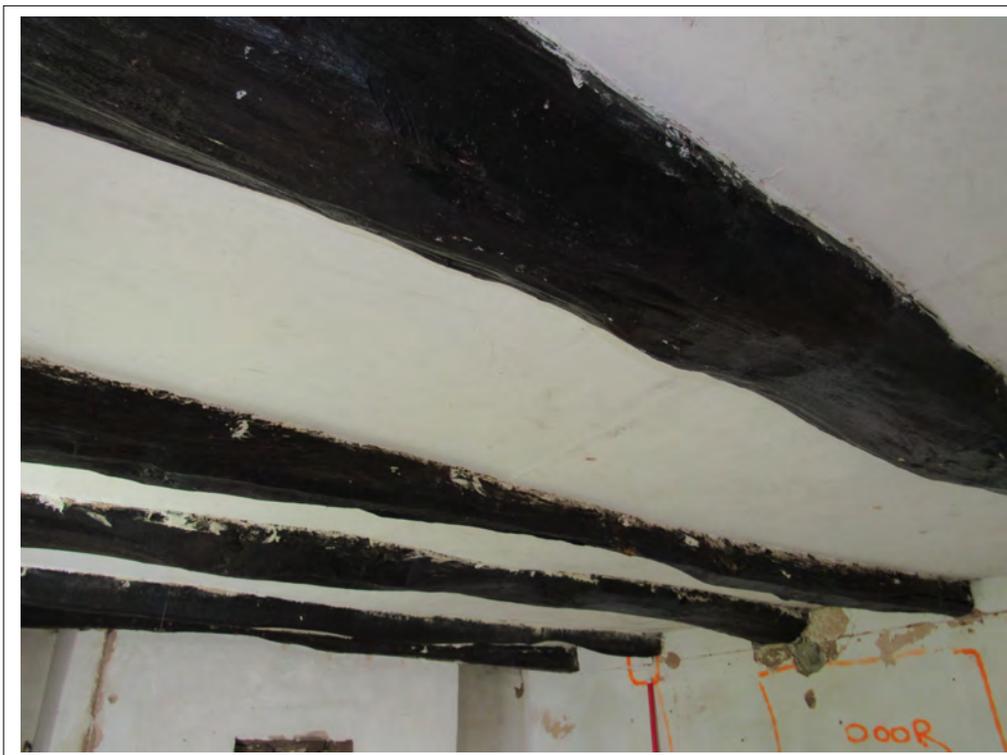
Plate 63. Lounge beams. View N. 2m scale

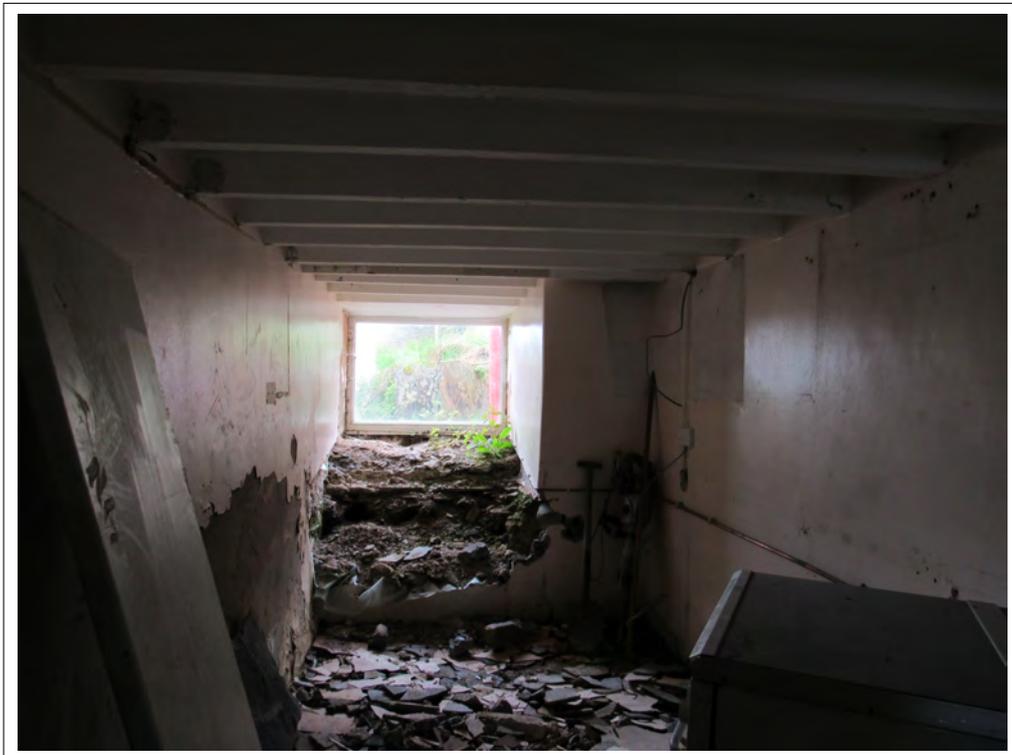
Plate 68. Kitchen extension. View NW. 2m scale

The kitchen room was in the 19th century extension, with machine-cut joists and a modern PVC window.

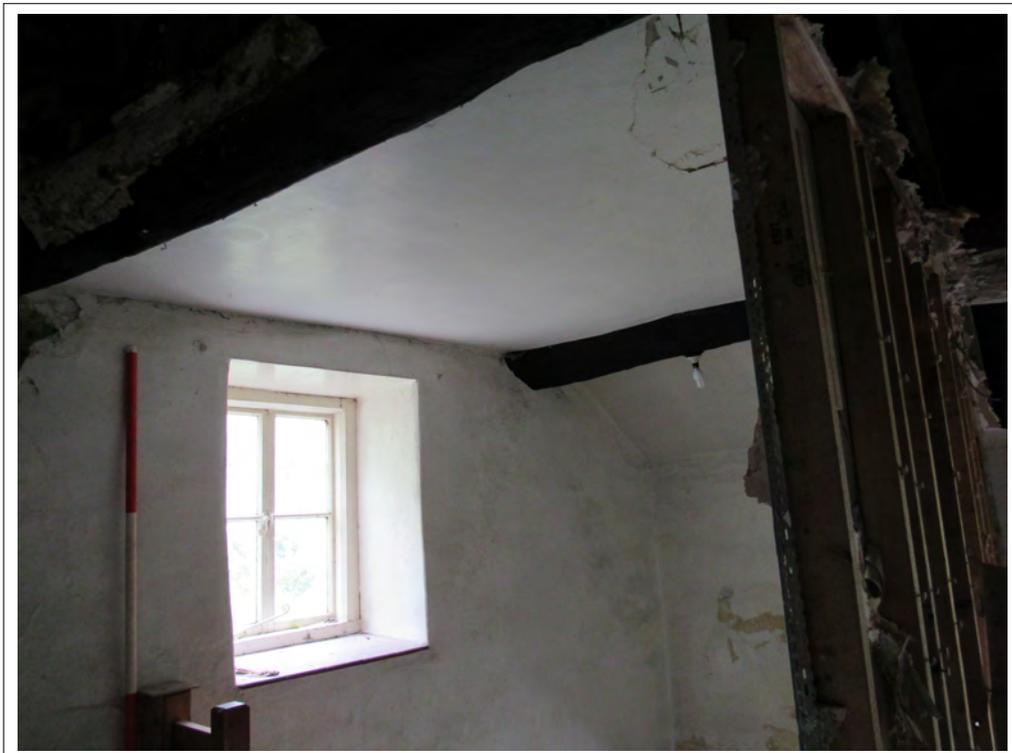
Plate 72. Stairs wooden first floor window. View NE. 2m scale

The staircase was of modern construction. The wooden casement window on the first floor was of traditional cottage style; four lights with wrought iron fittings of a spiral cockspur latch and spiral casement stay 18th century in character.

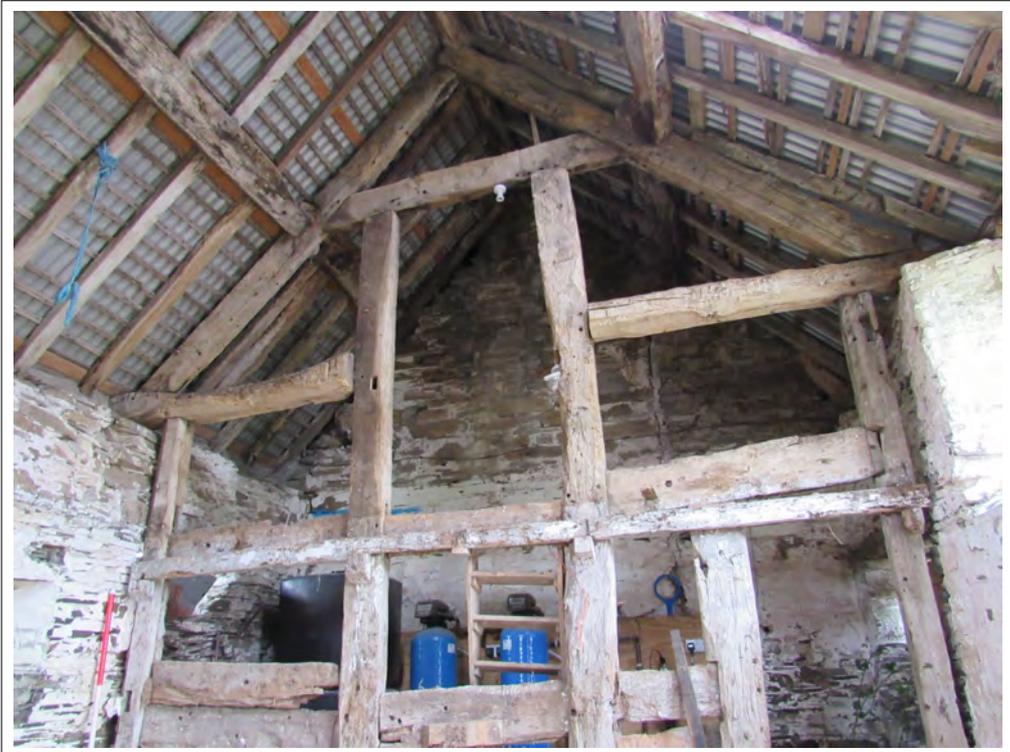
Plate 102. Barn interior with truss. View NE. 2m scale

The house and barn were constructed from shale walls and a traditional timber frame, with chamfered hand-cut beams, rafters and an inglenook fireplace characteristic of the early post-medieval periods. In the barn, a traditionally constructed roof truss with mortice and tennon pegged joints and a passage partition survived characteristic of the late medieval to early post-medieval periods. The barn is likely to have been a byre and from its layout and construction style may pre-date the house, which could have replaced a more simple building to the north-east of the central passage, although this theory is not conclusive. Remnants of post-medieval wooden-framed windows also remained in the barn, as well as a hatch to the hayloft on the first floor. The barn, present dining room and upstairs bedroom 1 and bathroom are within the footprint of the original build, with the major additions of the lounge and bedroom 2.

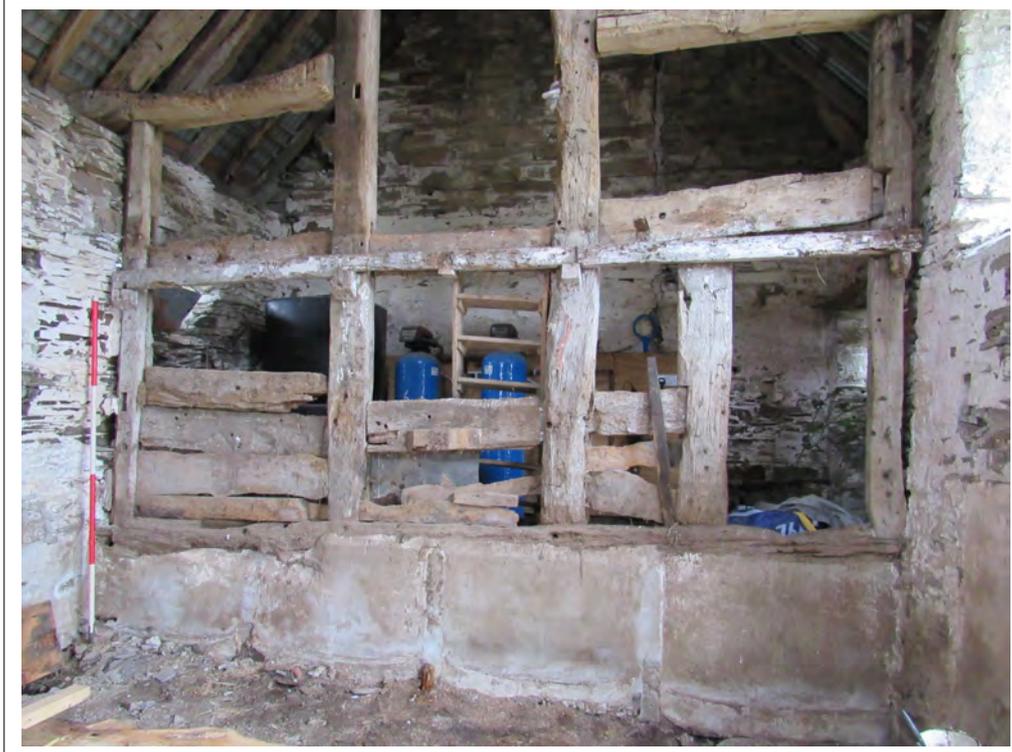
Plate 103. Barn interior with truss. View NE. 2m scale

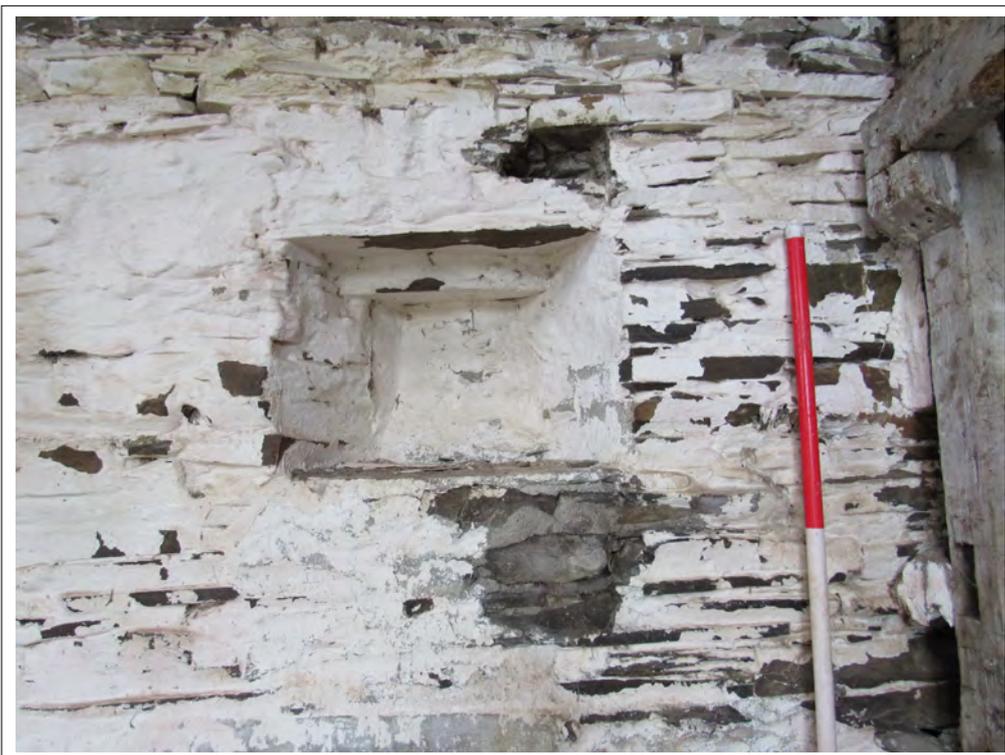
Plate 107. Barn interior blocked window on NW wall. View NW. 2m scale

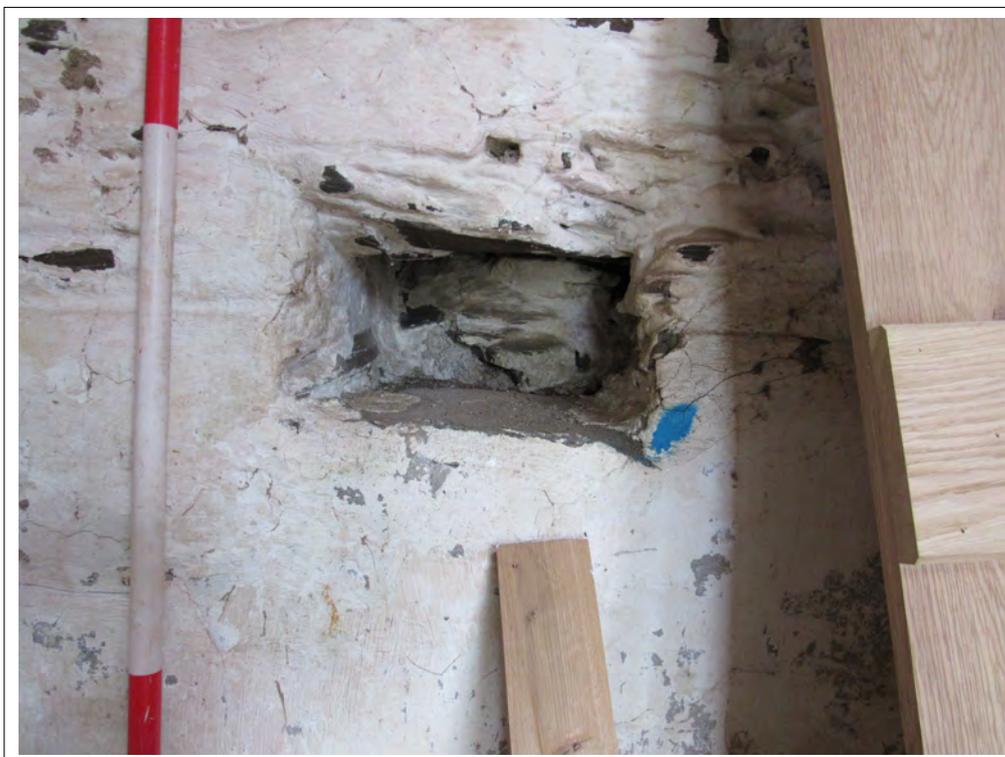
Plate 108. Barn interior blocked window on NW wall. View NW. 2m scale

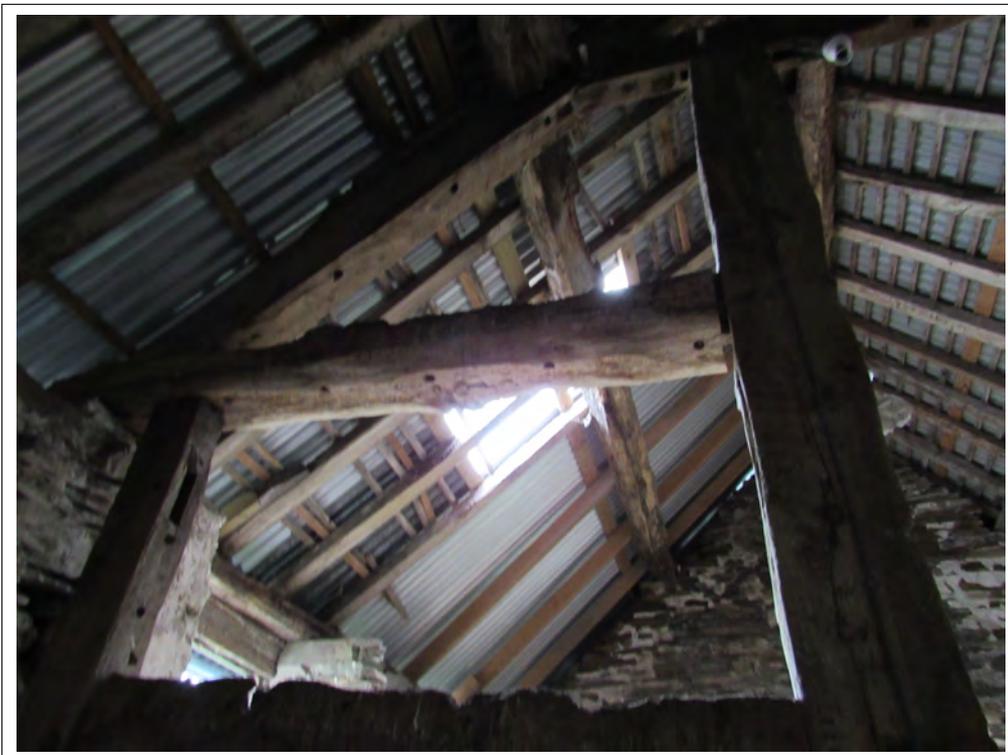
Plate 118. Barn interior, truss frame detail from passage. View SW.
