OLD GWERNYFED, VELINDRE, BRECON, POWYS

Historic Building Recording, Trial Trenching
and Documentary Research

commissioned by Iain Burgess

September 2015

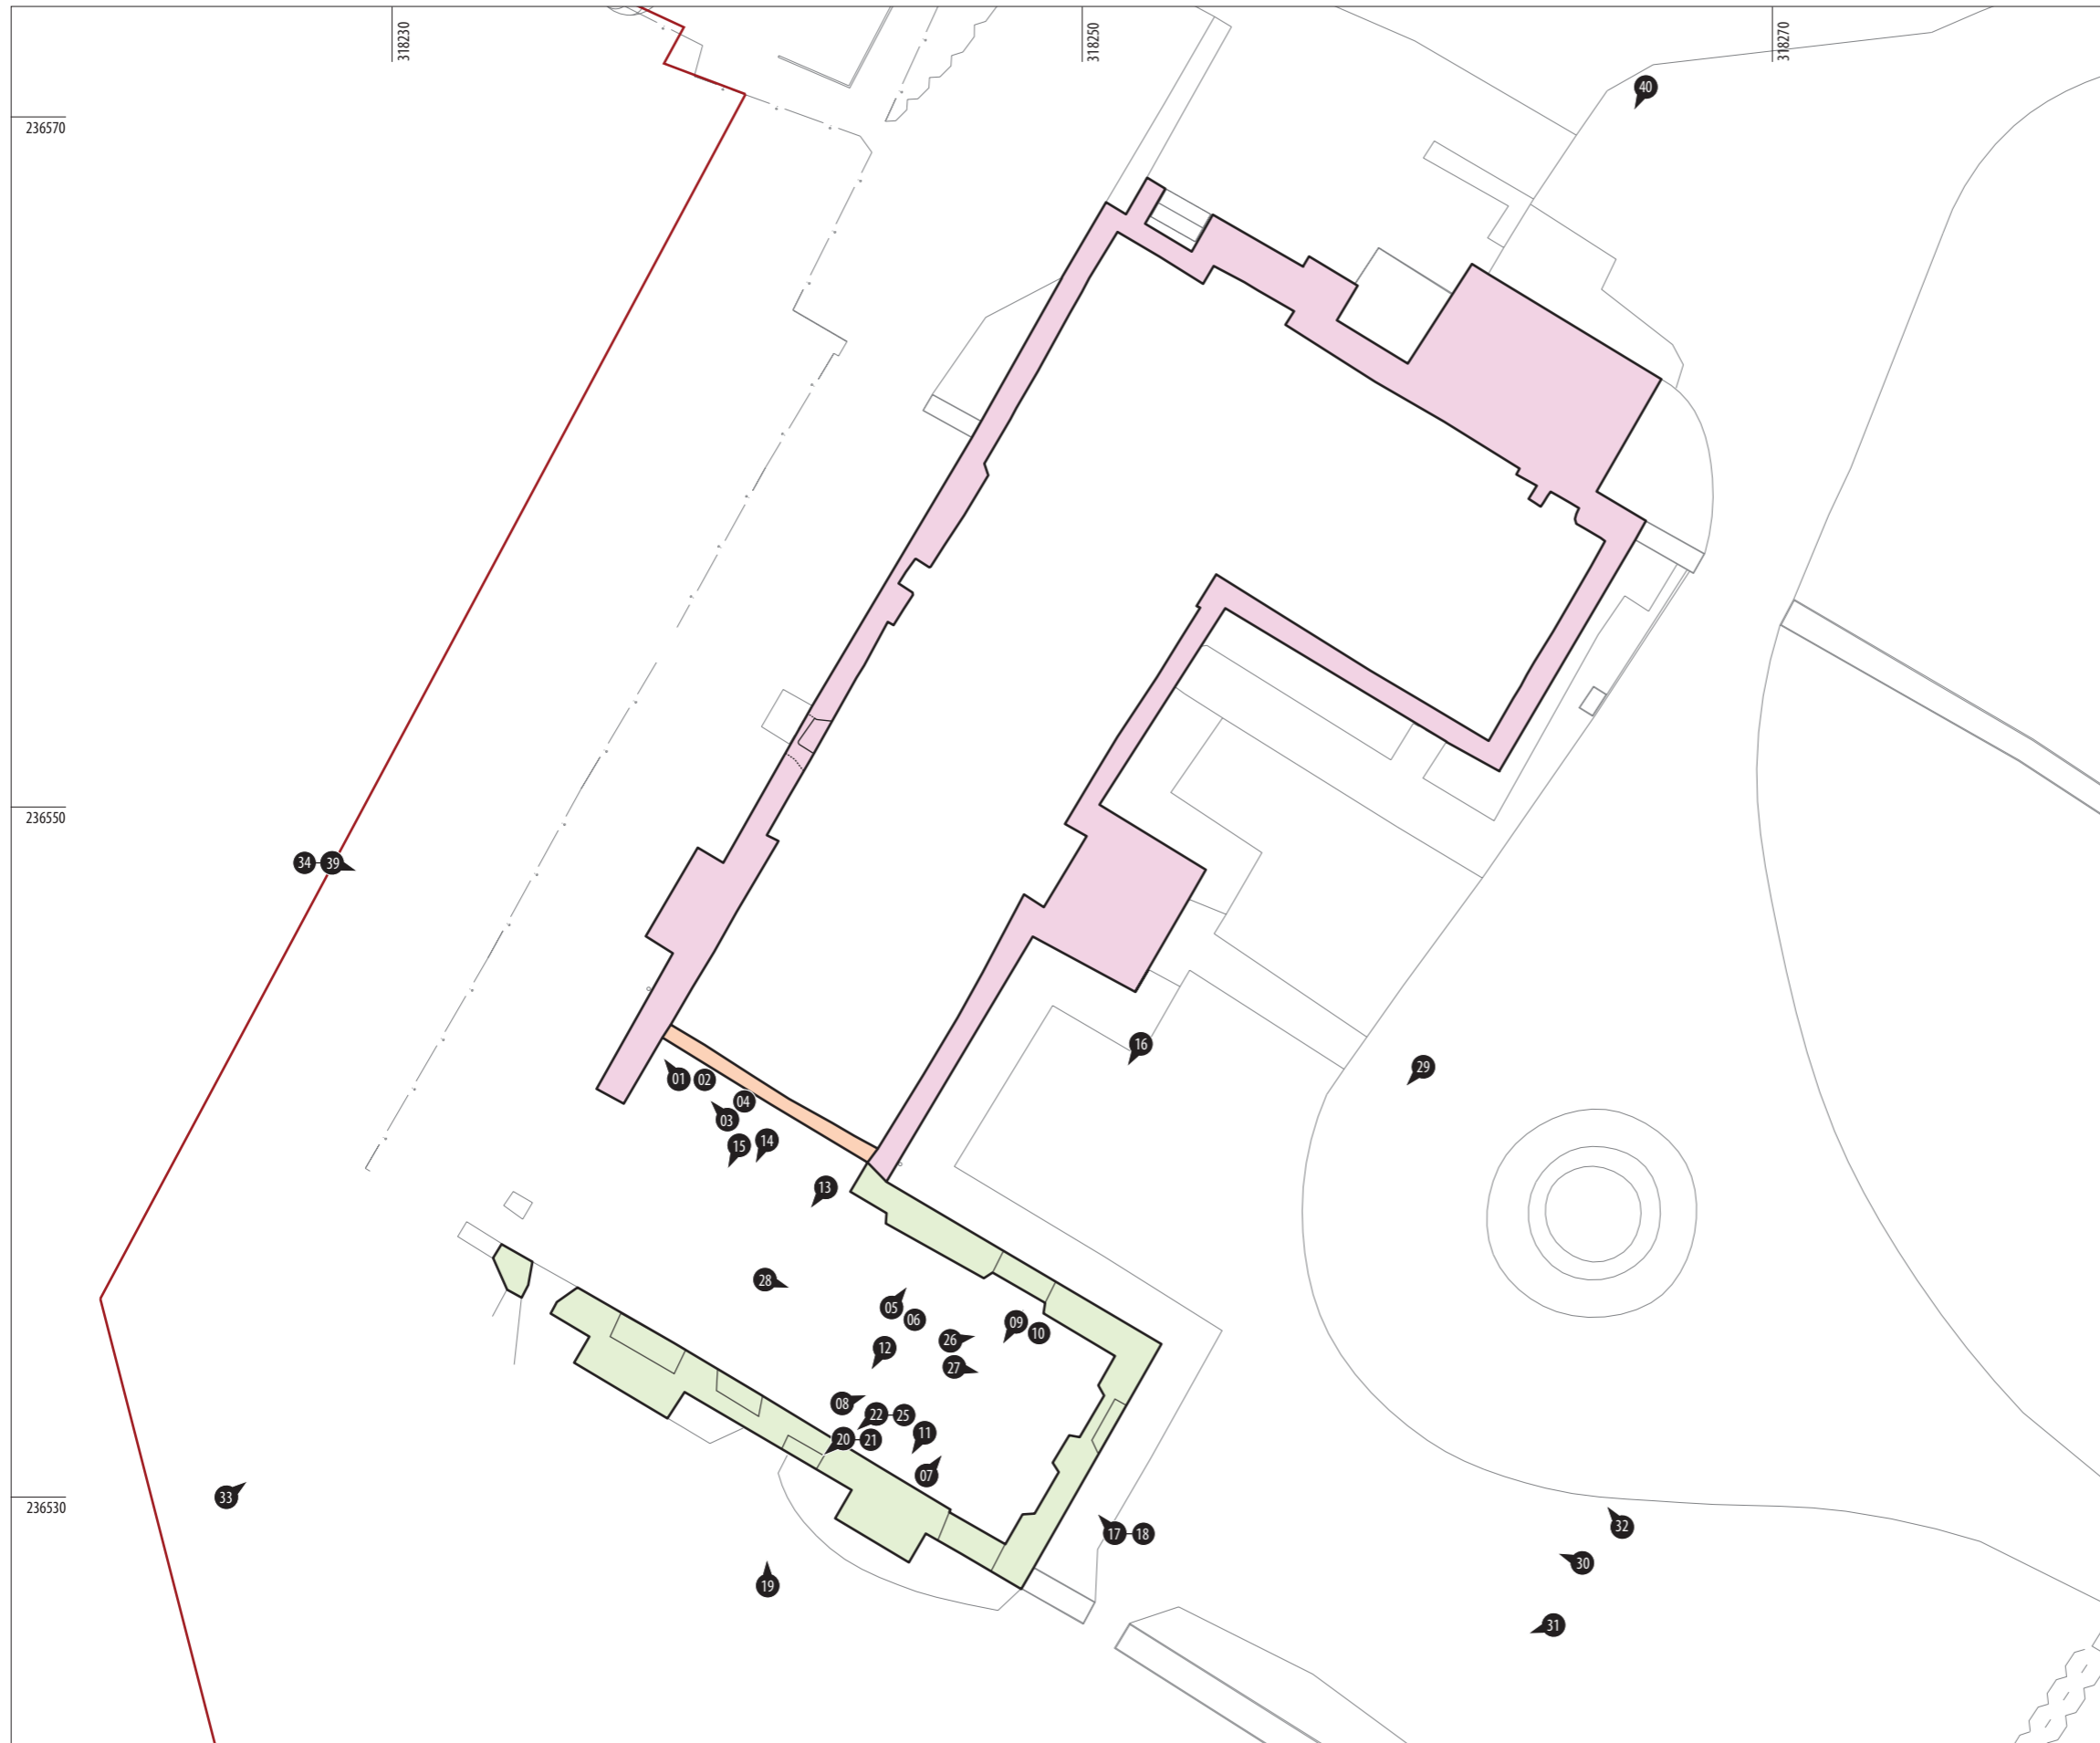
ILLUS 2
Annotated architect's plans

The south wing survives as three standing walls. No roof or internal structures survive and were, apparently, gutted by fire around 1780 (see **Illus 2**). The northern wall appears to abut the structure of the main north-south range of the manor house suggesting two separate phases of construction, at least on the frontage. The style of construction comprises rough shaped sandstone rubble which, at some time in the past, was covered with a lime-mortar render. Repairs to the structure are characterised by the use of modern machine-pressed and frogged engineering brick, at least two of which carry the Ebbw Vale stamps. Stone mullion windows are visible on all three elevations. A fragment of one of the mullion windows has been used to prop the breast-stone of one of the large fireplaces at the east end of the building.

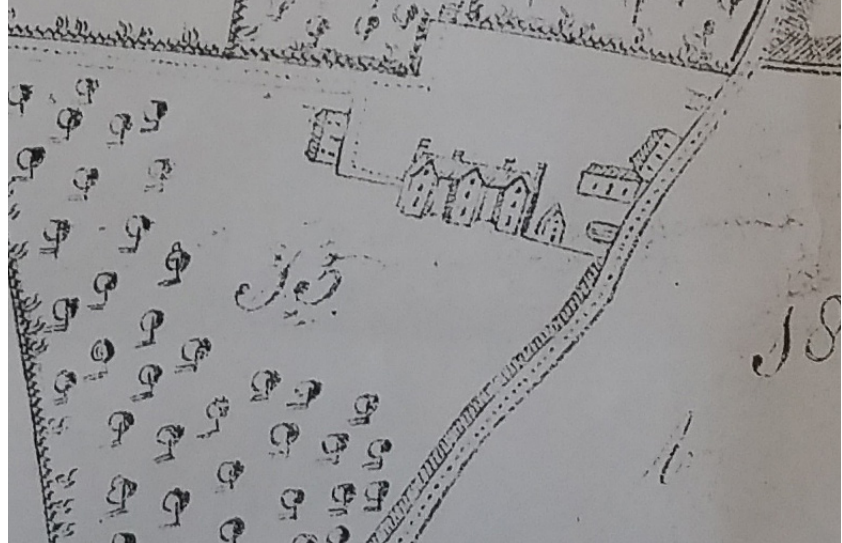
ILLUS 4
 Glasbury Parish Tithe Map (1844)

The tithe map for Glasbury parish (**Illus 4**) dated 1844, shows little change in the arrangement of buildings on the estate. Two buildings are situated to the south east of the main house, adjacent to the road, with the cottages still standing to the north. The two parcels of land to the north east of the main house remain as orchard. The gardens to the west of the house are depicted with a surrounding enclosure.

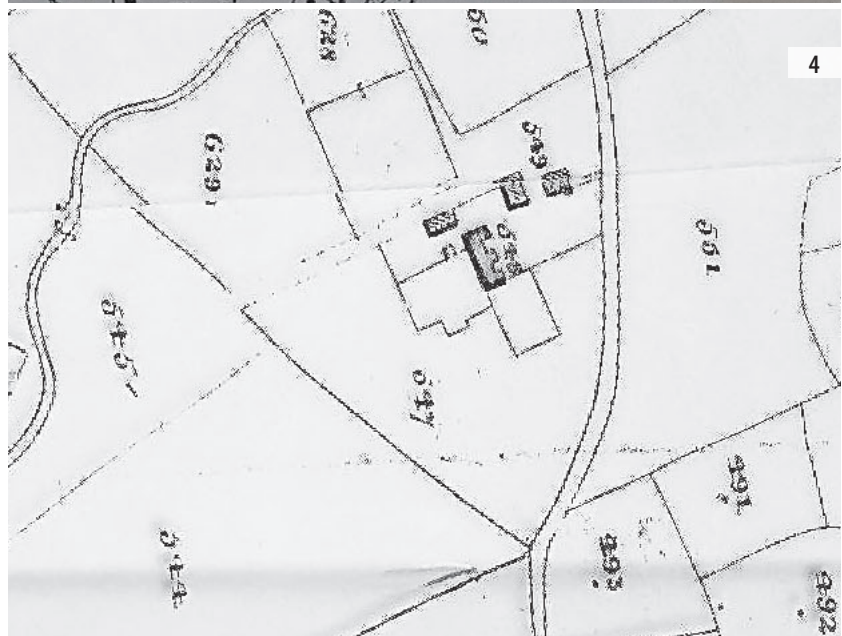
ILLUS 5
 Plan of Tyle-Glas and Pen Coed (mid-19th century)

The mid-19th century plan of Tyle-Glas and Pen Coed (**Illus 5**) is an excerpt from the tithe, and relates to the property of Thomas Wood, although it is unclear whether this refers to the father, son or grandson who owned Gwernyfed between 1804 and 1933. The plan shows the area to the south of Gwernyfed, its main purpose was to set out the boundaries between the property of Thomas Wood and the farms at Little Tyle-Glas and Penn Coed.

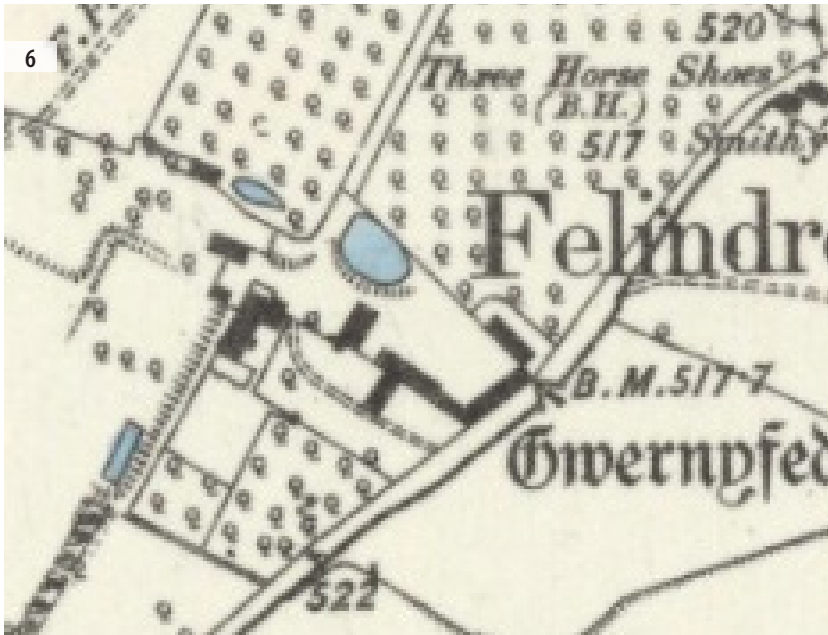
ILLUS 6

The six inch Ordnance Survey of 1888 (**Illus 6**) shows the situation of Old Gwernyfed in relation to the new estate at Gwernyfed Park. The farm buildings to the east of the house have been extended, and the south wing is depicted as un-roofed, this first time this distinction has been explicitly made. The gardens to the east of the house are clearly marked as earthworks, incorporated into the designed landscape around the new house. A walkway connects the new and old houses, running across a dam at the head of the former fish-pond, approaching the old house from the east, before turning away to the north. This would suggest that the old house and the ruined gateway continued to serve as an eye-catching folly, having been abandoned as a domestic building.

6in Ordnance Survey map (1888)

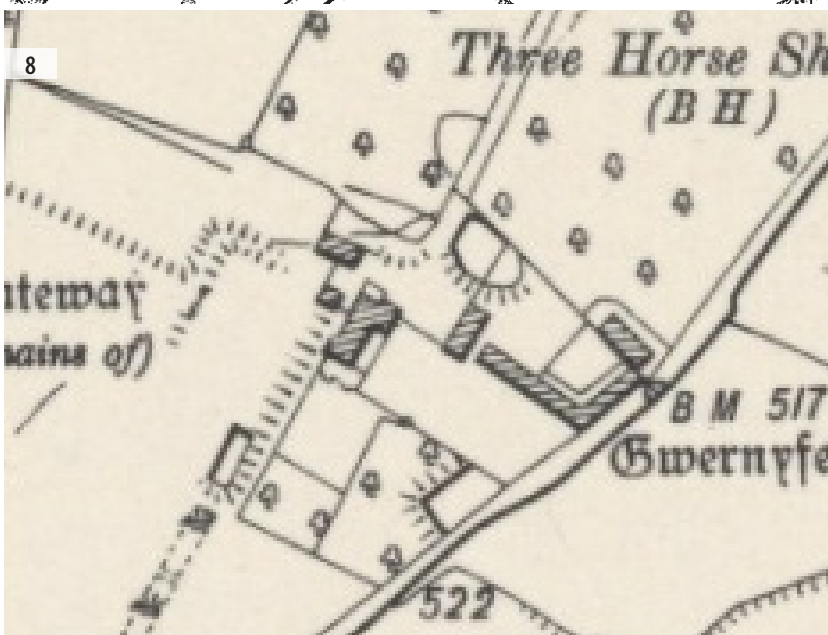
ILLUS 8

The twenty five inch Ordnance Survey dated 1905 (**Illus 7**) shows the same arrangement of buildings and remnants of the old gardens, suggesting that little development of the site happened after the 1880s. This map and the 1953 six inch survey (**Illus 8**) annotate the position of the gateway, otherwise the plan of the buildings appears to survive unaltered into the 21st century.

6in Ordnance Survey map (1953)

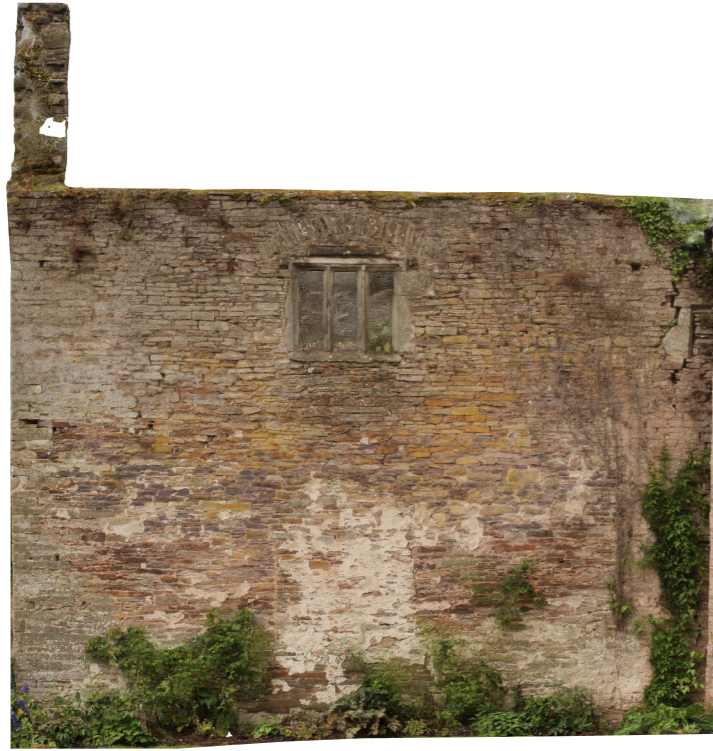
ILLUS 9
Exterior elevation of north wall

Exterior elevation of the north wall (**Illus 9 and 10**)

A three light mullioned window measuring 1.44 metres wide and 1.17 metres tall, survives on the first-floor exterior elevation of the north wall. The window frames are chamfered, bearing a strong resemblance to the style of cavetto moulding, which would suggest a late 16th century date. Inserts for window frames were visible on the inside surface, suggesting that they were of a similar style to the examples on the surviving portions of Old Gwernyfed. The load of the wall and roof above the window frame is supported by a relieving arch of rubble construction, while there is an extra reinforcing lintel sitting over the upper portion of the window frame.

The exterior of the north wall shows signs of modification, which suggests that Old Gwernyfed Manor was constructed in two distinct phases. At the top right hand side of the elevation (**Illus 9**) remnants of a blocked-in window, partially obscured by the construction of the main north-south wing, are visible. The window frame bears a simpler design, lacking the elaborate chamfer around the edges visible elsewhere. The position of a window on this part of the elevation suggests that it was once the exterior wall of a structure pre dating the main range of the building as it now stands. A ground floor window has also been blocked in, with the blocking stones covered by traces of lime-mortar render, suggesting that the modification happened when the building was still in use. Removal of a window on the ground floor may have reflected changes in the internal design of the house.

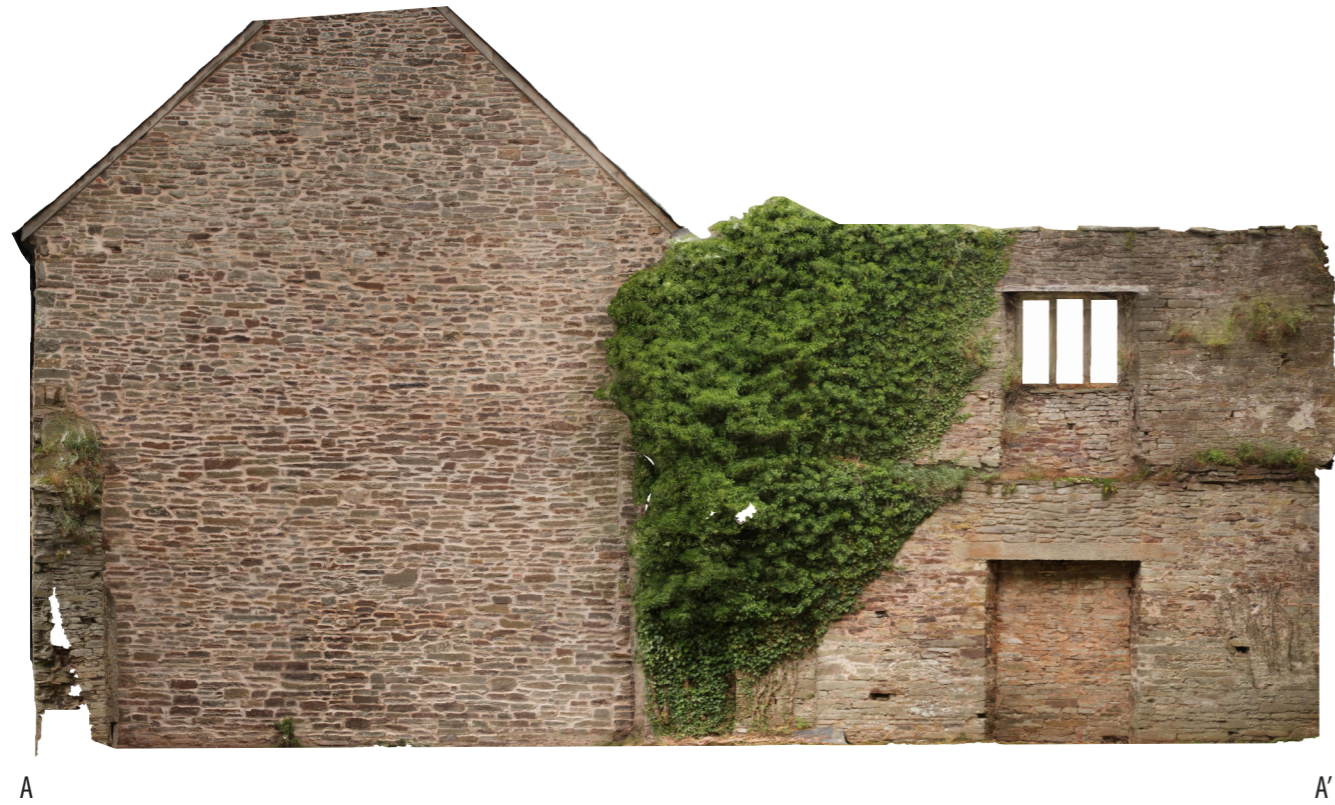
ILLUS 11
Interior elevation of north wall

Interior elevation of the north wall (**Illus 11 and 12**)

The interior elevation of the north wall shows evidence of stabilisation work in the early 1980s. The lintel over the ground floor window has been replaced with concrete. The insertion of new lintels involved the partial demolition and reconstruction of portions of the wall above, the new stonework has been re-pointed with a concrete render. Loose stonework, identified on the 1982 dyeline plans above the first floor window and along the head of the wall has also been restored and re-pointed.

A scarcement ledge is visible separating the ground and first floors. The internal stonework shows no sign of dowling to fix wood panelling, suggesting that the interior walls probably had a simple plaster render over the stonework. Some traces of lath and plaster are visible inside window frames and cupboards elsewhere on the internal elevations. The ground and first floor windows are both recessed into the wall, with a pronounced taper inwards.

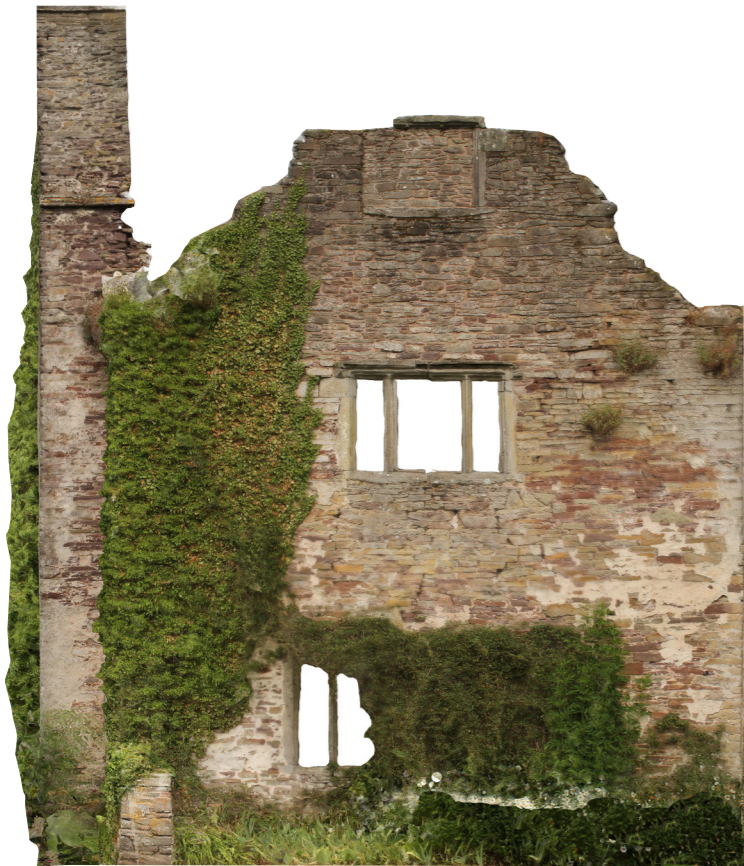
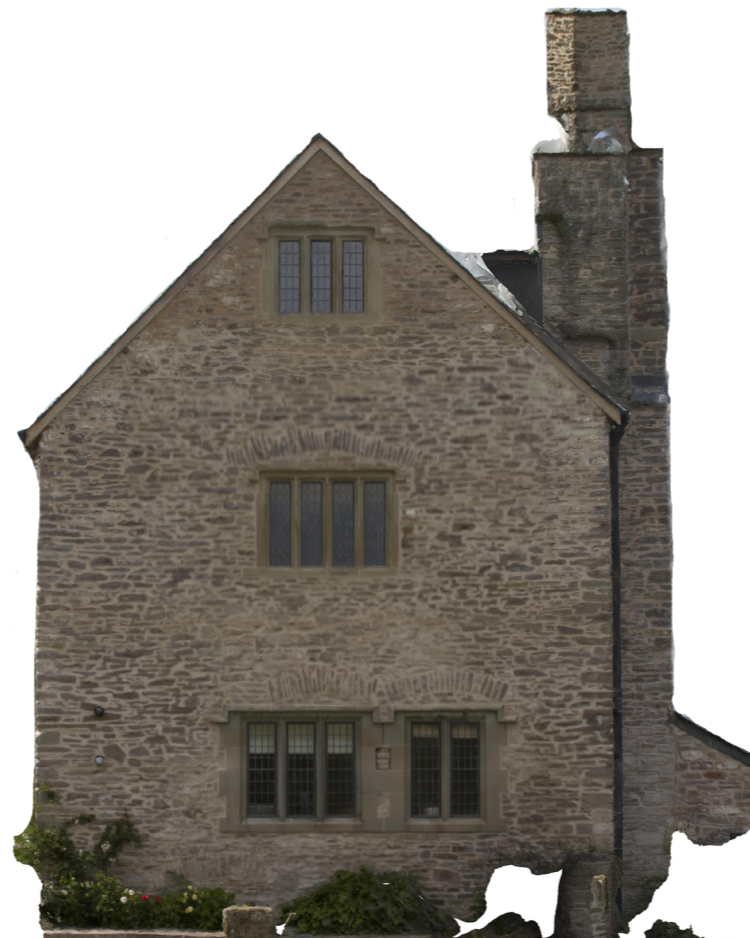
ILLUS 13

Exterior elevation of the east wall (Illus 13 and 14)

Three windows are visible on the exterior elevation of the east wall, two of which remain as openings, a fourth is obscured by ivy. The first floor window, measuring 2.01 metres wide and 1.31 metres tall, consists of three lights separated by two cavetto moulded mullions, and lacks a relieving arch similar to the other examples, notably the first floor window in the north wing gable. It probably originally had a central mullion too, since lost.

The ground floor would originally have had two, two light mullion windows set evenly across gable frontage one of which survives, and the other is obscured by ivy and has been blocked in. The position of these windows is not matched by those in the gable end of the north wing, although these latter windows appear to be modern replacements.

The attic window has been filled in with sandstone rubble and mortar to preserve the integrity of the eastern gable. The rubble infill also supports the remains of the upper window frame, which would have included three lights divided by two mullions. This matches the example in the gable end of the north wing.

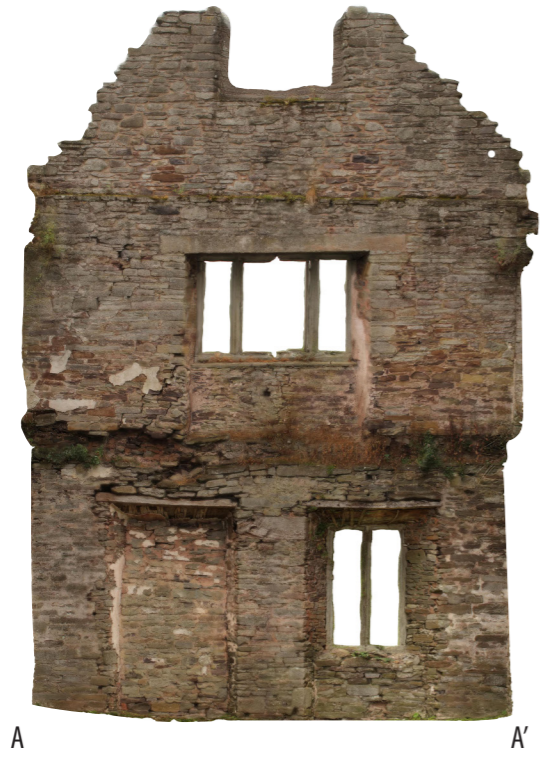
ILLUS 15
Interior elevation of east wall

Interior elevation of the east wall (Illus 15 and 16)

The interior elevation of the eastern wall is divided between the three floors by an upper scarcement supporting the attic floor, and a recessed slot in the stonework for the timber frame of the first floor (see photo 8). The interior of the first floor window shows alterations from the stabilisation work, with the insertion of a concrete lintel. The stonework of the upper gable has been repaired, most likely during the remedial works in the early 1980s. The rubble stonework has been re-pointed with a cement mix. The window is recessed into the wall with a pronounced inwards taper, the surfaces of which are still covered with patches of wall plaster.

The two ground floor windows, one of which has been completely blocked, have timber lintels which are both in an advanced state of decay. In the blocked window, the original wall plaster has been preserved behind the blocking stonework, with some laths visible also.

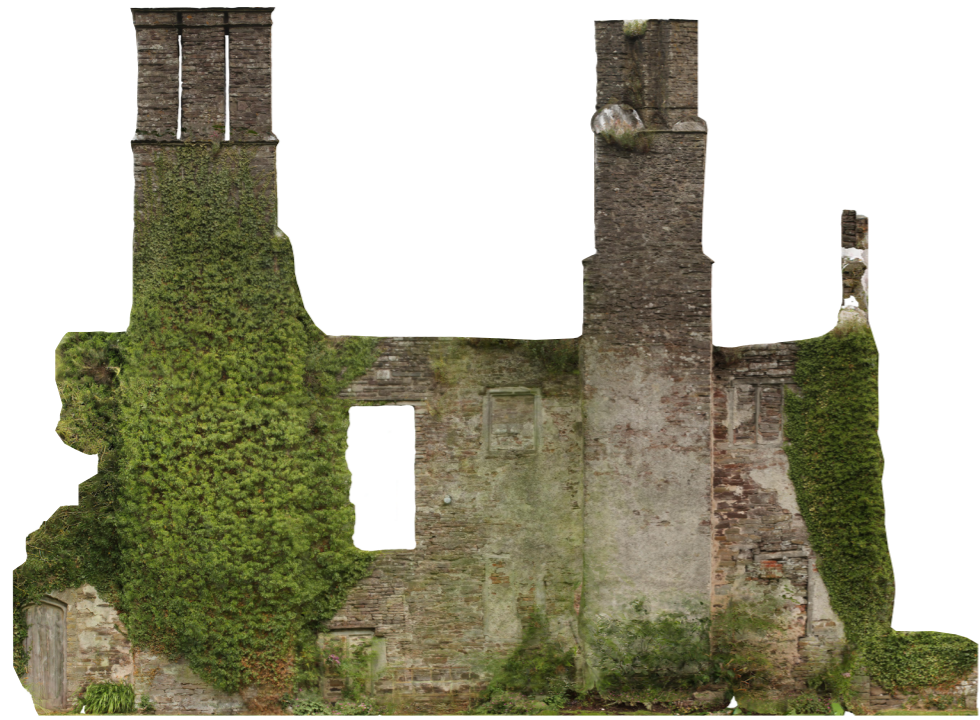
ILLUS 17

Exterior elevation of the south wall (Illus 17 and 18)

Five blocked in windows are visible on the south elevation, all constructed the same way as the examples on the northern and eastern elevations. A three light and a two light mullion window are visible on the first floor, both of which have been infilled with sandstone rubble and covered in a lime mortar render. On the ground floor three windows have been blocked in a similar fashion. The window at the eastern end of the elevation was noted as a particular issue during the 1982 works, and was highlighted on the dyeline elevation drawings as an area which was in the process of collapse. The blocking material appears to have been replaced with patches of engineering brick which lie underneath the lime render.

A large void was visible spanning the half the height of the ground and first floors, measuring 1.55 metres wide by 2.88 metres tall, which may indicate the position of a large window associated with a staircase. No traces of the window frame remain, suggesting the possibility that it may have been constructed from timber, and would appear to belong to a phase of alterations later than the stone mullions. One of the stone windows, situated directly below this possible stair window, has obviously been moved from its position on the ground floor, and lowered so that the bottom of the frame rests at ground level. This was thought to indicate the presence of a cellar underneath the south wing.

Two chimneys protrude from the south elevation, both of which are connected to hearths on all three floors. The easternmost chimney is a rectangular construction, measuring 2.45 metres across at the base, and projecting 0.60 metres from the wall. The total height of the chimney is 13.04 metres, including the stacks which are 2.07 metres tall. The chimney tapered two thirds from the top with a single step-in, and culminated in three diamond-shaped chimney stacks. This form is mirrored in the construction of the north wing, where the stacks are also arranged in a diamond pattern.

A second, larger chimney survives at the western end of the elevation, also rectangular at the base, measuring 3.10m across, and protruding 0.71 metres from the outer wall of the building. The height including the stacks is 14.01 metres, while the stacks alone measure 2.45 metres. The chimney tapers slightly from the base to its top, where it measures 2.89 metres wide. Three tall stacks protrude arranged in parallel squares. The north wing has a smaller chimney at its west end, however the stacks are short and squat at the top.

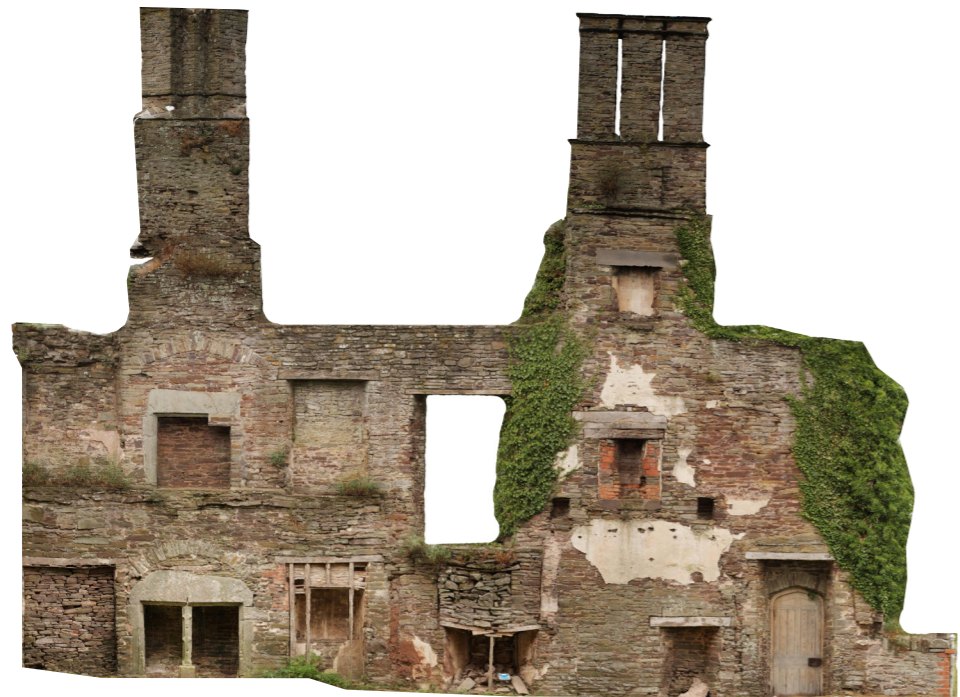
ILLUS 19
Interior elevation of south wall

Interior elevation of the south wall (Illus 19 and 20)

The first floor windows have been blocked in with sandstone rubble, bonded by lime mortar. The ground floor windows have also been blocked in. The window at the eastern end of the wall, is obscured by un-bonded sandstone rubble, while the central window has been blocked in and the recess re-used as a press-cupboard. The timber frame, plaster and laths which provided the internal structure of the cupboard still survive, with traces of graffiti showing mathematical calculations. The blocking of this window is thought to date to the 1980s remedial works to the structure. The large stair

window is also recessed into the wall and while on the vertical sides there is a pronounced taper, the sill and lintel are set horizontally and flush with the inner face of the wall. There are no internal traces of windows at the western end of the elevation although, like the outer elevation, there is a large concentration of ivy obscuring this area.

The scarcement visible on the interior elevation of the northern wall runs is matched by another on the interior elevation of the southern wall up to the point where the possible stair window has been inserted (a total length of 7.50 metres). Two recessed beam slots are visible beyond this point, measuring 0.35 x 0.50 metres, with the top surface of the beam level with the scarcement ledge. These two forms of support for the first floor, marked would appear to reflect a change in the design of the internal structure of the house.

The two chimneys are incorporated into the interior elevation of the south wall, remaining flush with the face of the wall. The ground floor hearth on the eastern chimney has remained open, although the lintel has cracked down the centre and is now supported with one of the stone window sills (see photo 9). The hearth measures 1.9 metres in width. A sandstone rubble relieving arch sits above the lintel stone. The surround to the fireplace is decorated with chamfered moulding along the outside edge, with a potted palm frond carved in relief visible at each side. The first floor hearth has also remained unaltered apart from a modification to the right hand side of the fire surround which has been removed and re-built in red sandstone rubble. It is formed from a large lintel stone, which is reinforced by a further relieving arch of sandstone rubble. This hearth is smaller than the opening below, measuring 1.5 metres in width.

The western chimney provides three flues. On the ground floor a substantial open hearth measuring 3.45 metres in width has been filled in, and replaced by a much smaller fireplace measuring 1.26 metres wide. On the first floor, a similar procedure has been followed, apparently in two stages, whereby the open hearth has been filled in to the dimensions of the new fireplace, which has then been lined with red bricks, producing an opening only 0.70 metres wide, while above the red-brick construction a wooden supporting lintel has been inserted underneath the old lintel. An attic fireplace also survives unaltered, measuring 1.05 metres wide. This change in hearth style may represent a change in the fuel being burned at Old Gwernyfed, possibly a move away from wood to coal. The decrease in the size of the hearths in the south wing certainly suggests that large hearths were no longer economically viable, and this may have been associated with a change in occupants. A hearth-stone supported the fire surround
