Mount Severn, Glan-y-nant Llanidloes, Powys

Heritage Impact Assessment

Report No. 1696

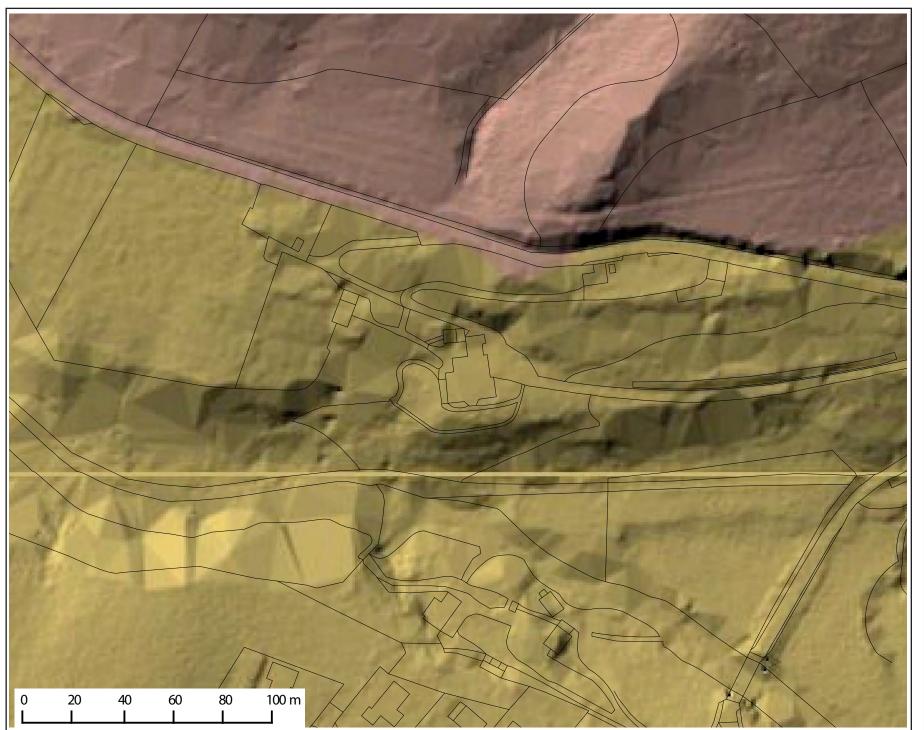
Figure 7: 1m resolution LiDAR DTM.

LiDAR imagery of the site is available at 1m resolution. The digital terrain model (DTM) gives a good impression of the topography and clearly shows the platform that the house, and potential gardens sit upon, but no distinct features are noted (Figure 7).

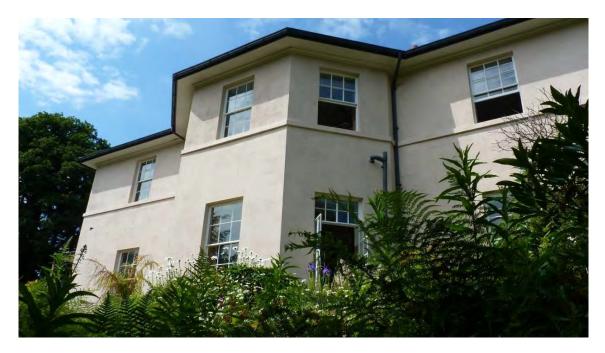
Photo 1: View northwest of the main southern elevation of Mount Severn.

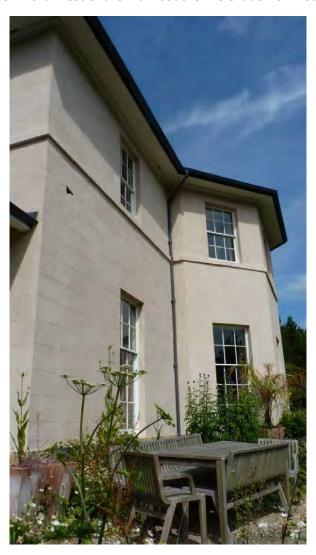
Photo 2: View ENE of the main southern elevation of Mount Severn.

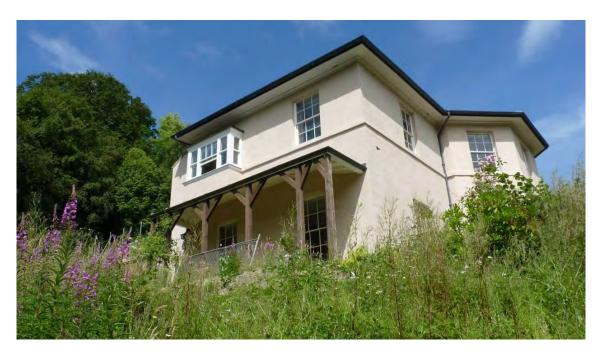
Photo 3: View northeast of the western elevation of Mount Severn, showing the projecting veranda.

Photo taken from scrub-covered falling ground to the southwest of the house.

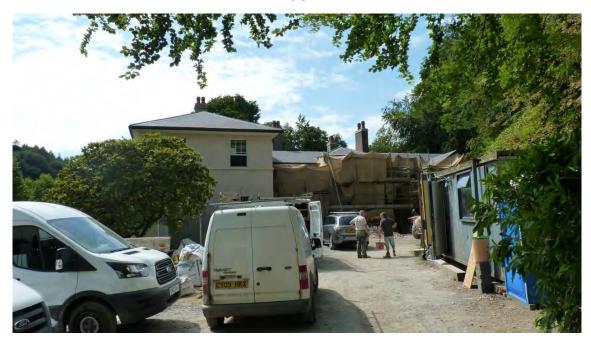
Photo 4: View west of the eastern elevation to Mount Severn, standing on the main approach drive to the house. The house entrance is covered by scaffolding.

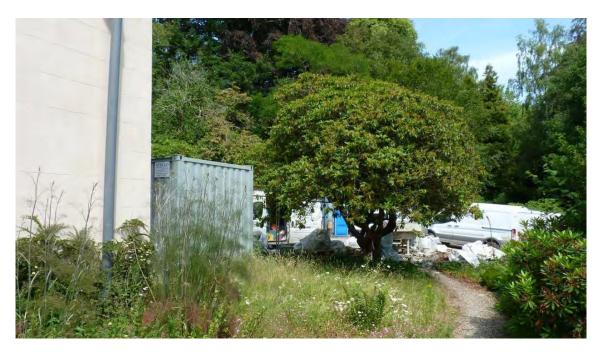
Photo 5: View northeast from the main garden area to the main entrance area on the east side of Mount Severn. The tree within the centre will be retained within the development proposals.

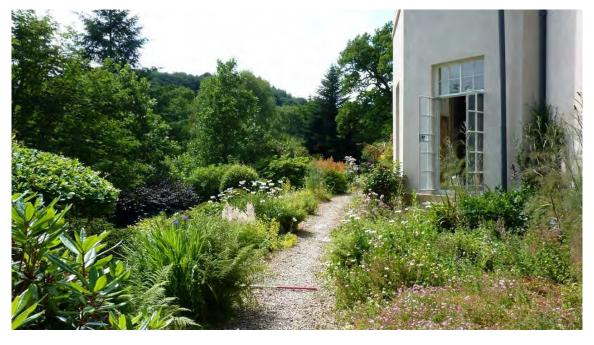
Photo 6: View west showing the path in front of the south elevation, with the garden area to the left.

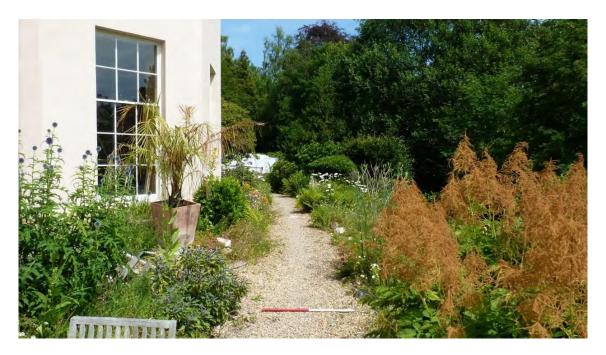
Photo 7: As above, view east, with the main garden area on the right. 1m scale.

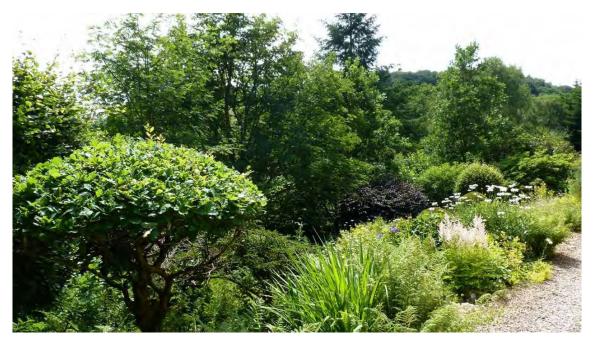
Photo 8: View southwest across the falling garden area in front of the south elevation of Mount Severn.

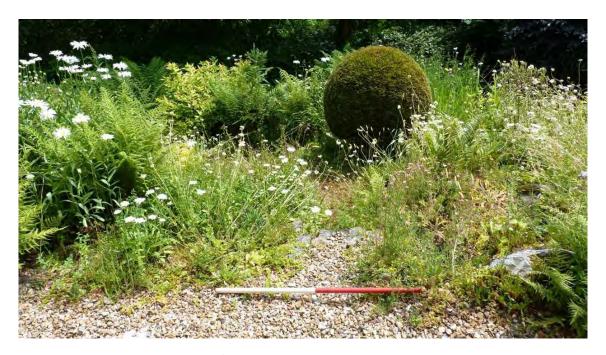
Photo 9: View south showing one of the small garden paths leading through the garden area south of Mount Severn. 1m scale.

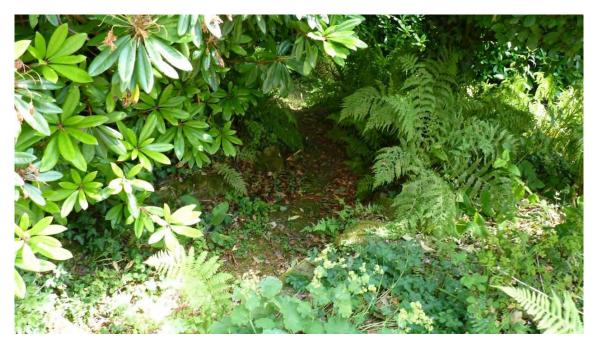
Photo 10: As above, showing the overgrown nature of these paths.

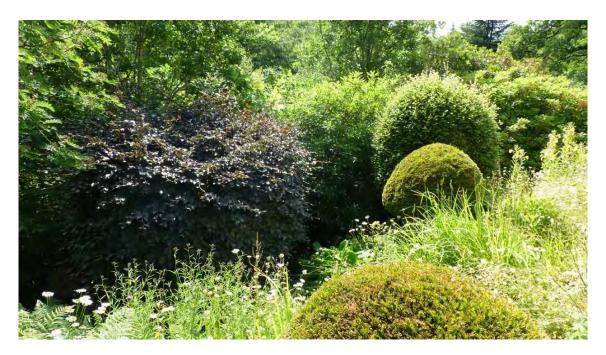
Photo 11: View southwest across the lower slopes of the garden south of Mount Severn, showing general planting.

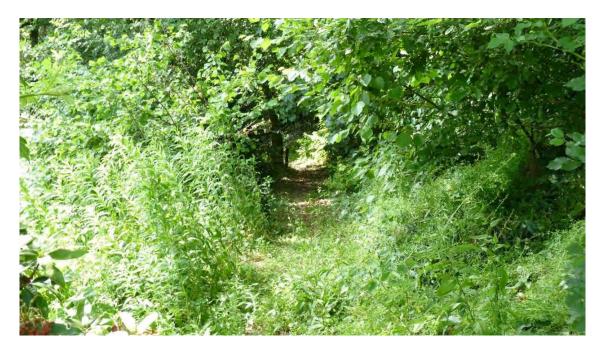
Photo 13: View WSW looking down the path to the south of the garden that traverses the valley side, eventually giving access to the former Croquet and Tennis lawns.

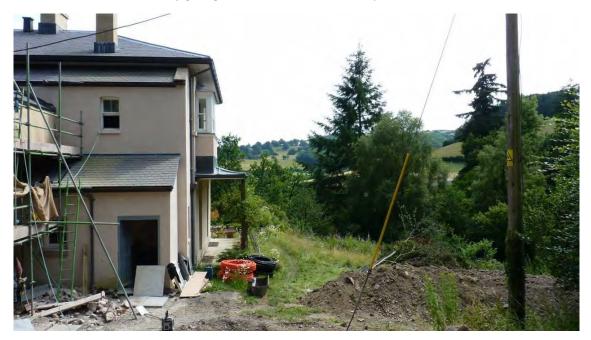
Photo 14: View south showing the area on the west side of Mount Severn, and the lack of any recognisable garden features.

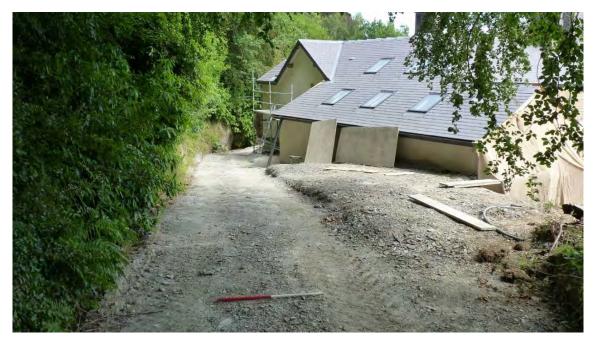
Photo 16: View ESE down the main tracks that runs around the north side of Mount Severn. The track is largely rock-cut. 1m scale.

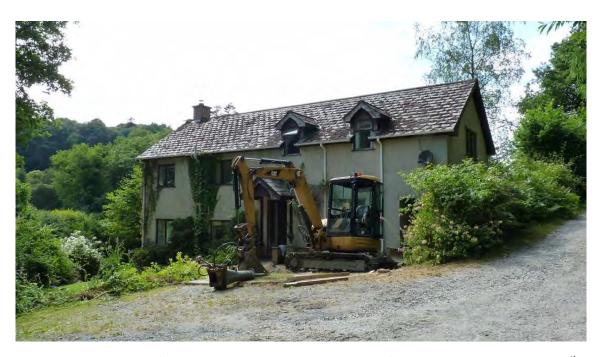
Photo 17: View west of the building that stands to the west of Mount Severn, marked on 19^{th} century mapping but with 20^{th} century alterations.

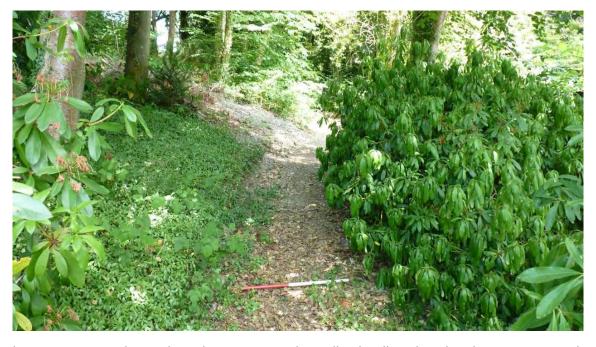
Photo 18: View northeast along showing a typical woodland walk path within the estate. 1m scale.

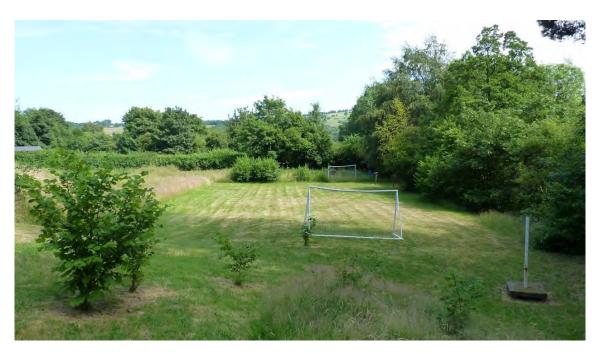
Photo 19: View southeast across the former croquet and tennis lawns in the base of the valley to the south of Mount Severn.

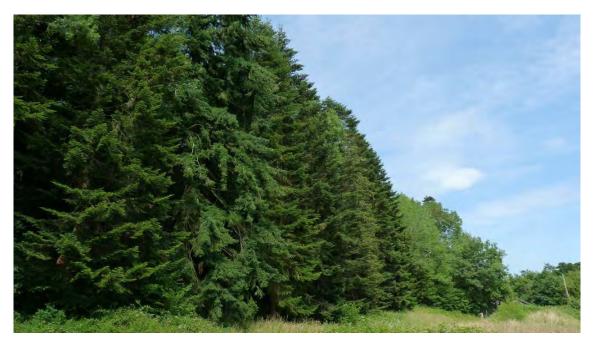
Photo 20: View northeast of the trees lining the base of the valley slopes, obscuring any views up towards Mount Severn.
