CPAT Report No. 1548

Hancock's Tramway Exchange Wharf, Buckley, Flintshire

Survey and recording 2017-18

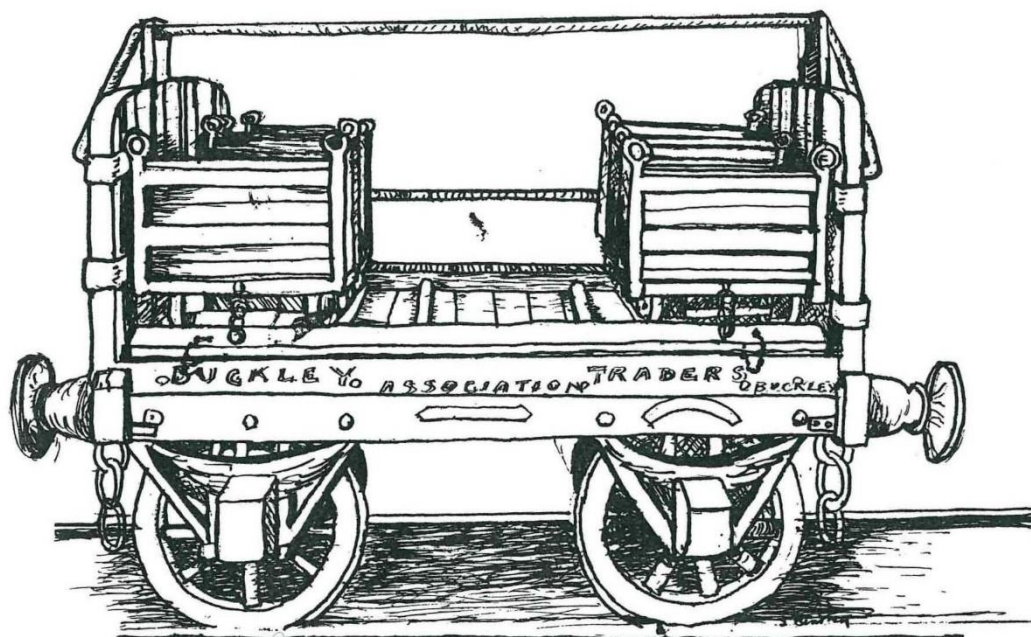
Fig. 5 A standard gauge shipping wagon used around 1870. This was capable of holding six 'shipping boxes' (illustration by J. Bentley, courtesy of the Buckley Society)

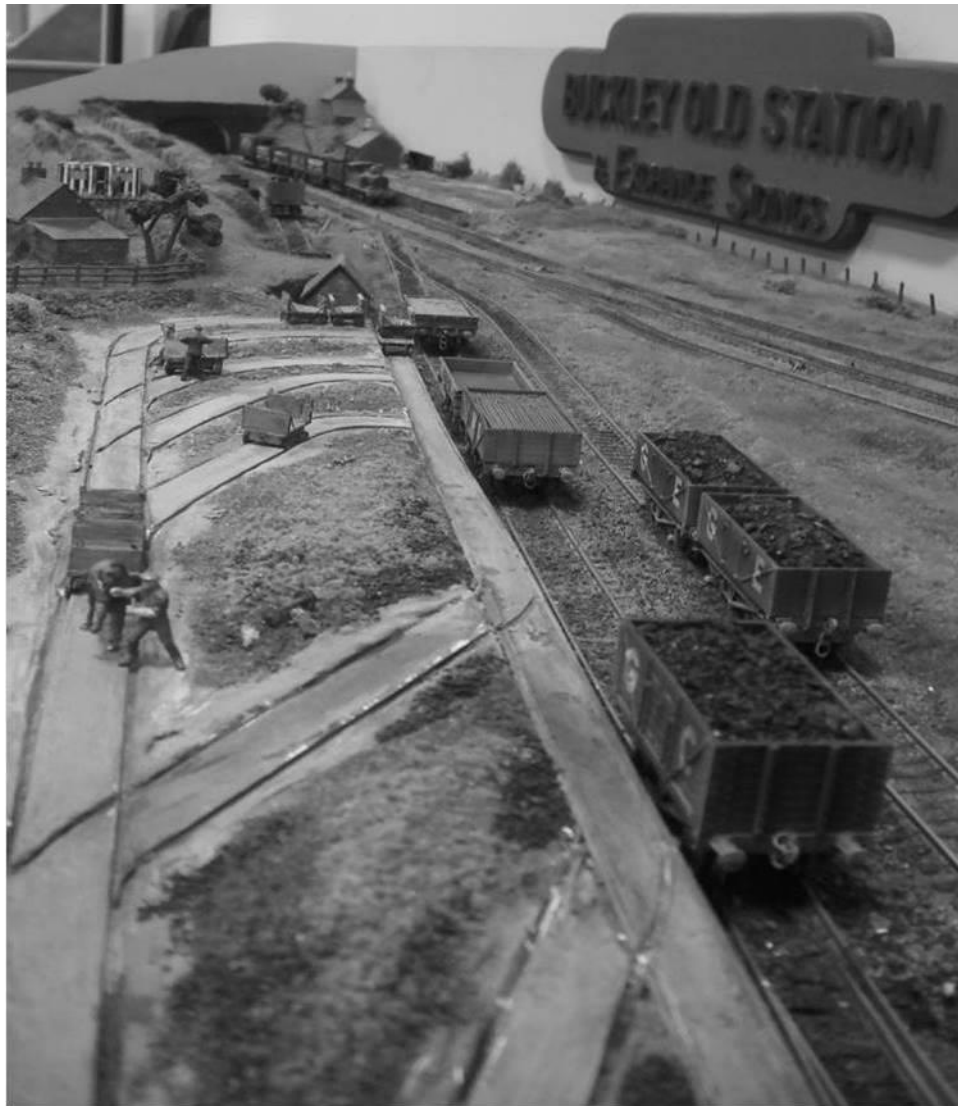
Fig. 6 A model of the Exchange Sidings, made by Paul Morrille of the Buckley Society. The standard gauge sidings are shown on the right, with the traverser tramway running alongside at a higher level. The tramway sidings on the wharf to the left are at a higher level again. The two sidings in the foreground descend to join the traverser tramway. Photo Paul Davies.

- 2.8. Specially constructed wagons, known as 'shipping boxes', were drawn by horse from the brickworks and onto the exchange wharf. The mainline wagons, known as 'shipping wagons', or 'shippers', were specially constructed, having three pairs of guide rails, the wagons being large enough to accommodate six of the smaller shipping boxes (see Fig. 6).

- 2.9. The transfer between the two systems was facilitated by use of a further tramway, which Bentley terms the traverser tramway, running across the face of the wharf at a lower level. The shipping boxes were pushed onto guide rails on the bed of flat trucks running along the traverser tramway. The bed of the traverser tramway was raised above that of the mainline siding so that the flat wagons were at the same level as standard gauge shipping wagons, enabling the shipping boxes to be then be pushed onto the wagons. The operation of the exchange sidings is best illustrated by a model made by Paul Morrille of the Buckley Society (Fig. 6).

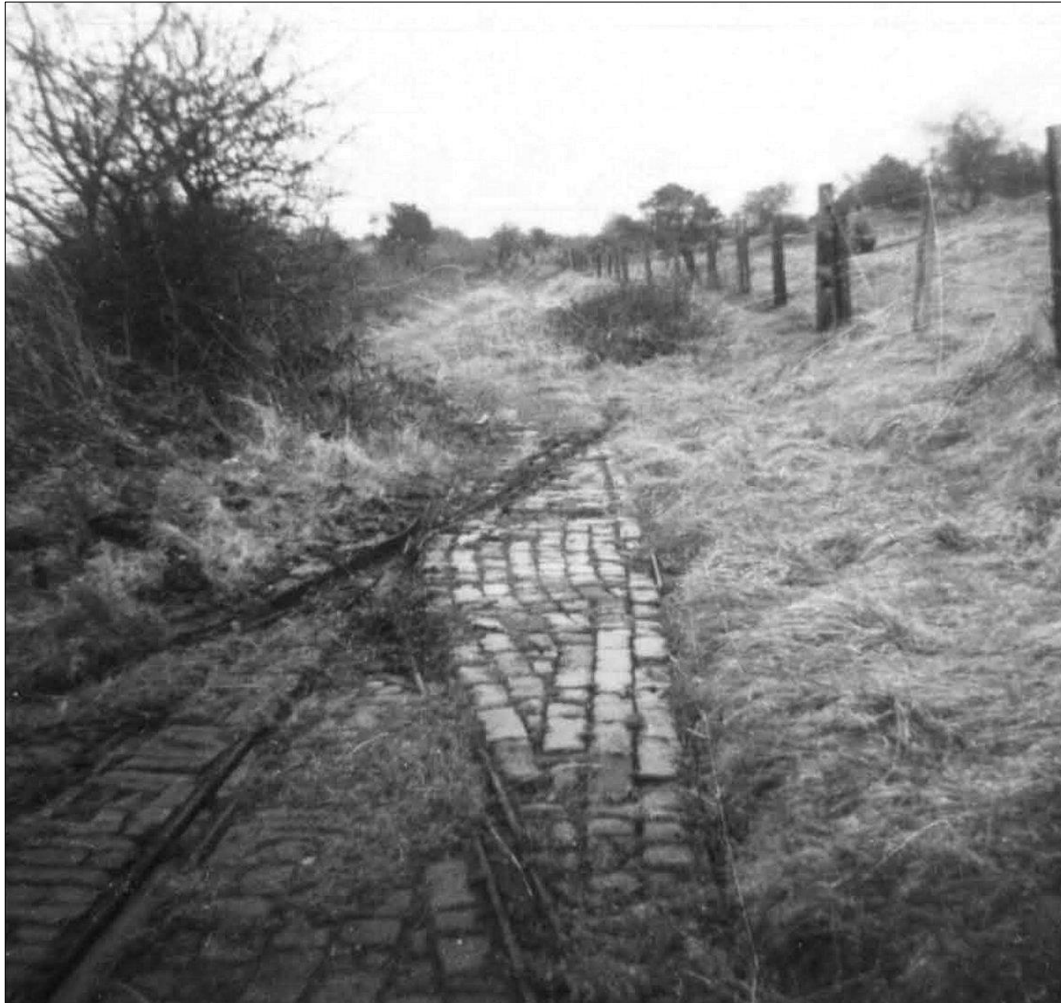
Fig.9 A section of tramway uncovered in 1967, showing the five-way junction, viewed from the north-north-west. Photo James Bentley (courtesy of the Buckley Society)

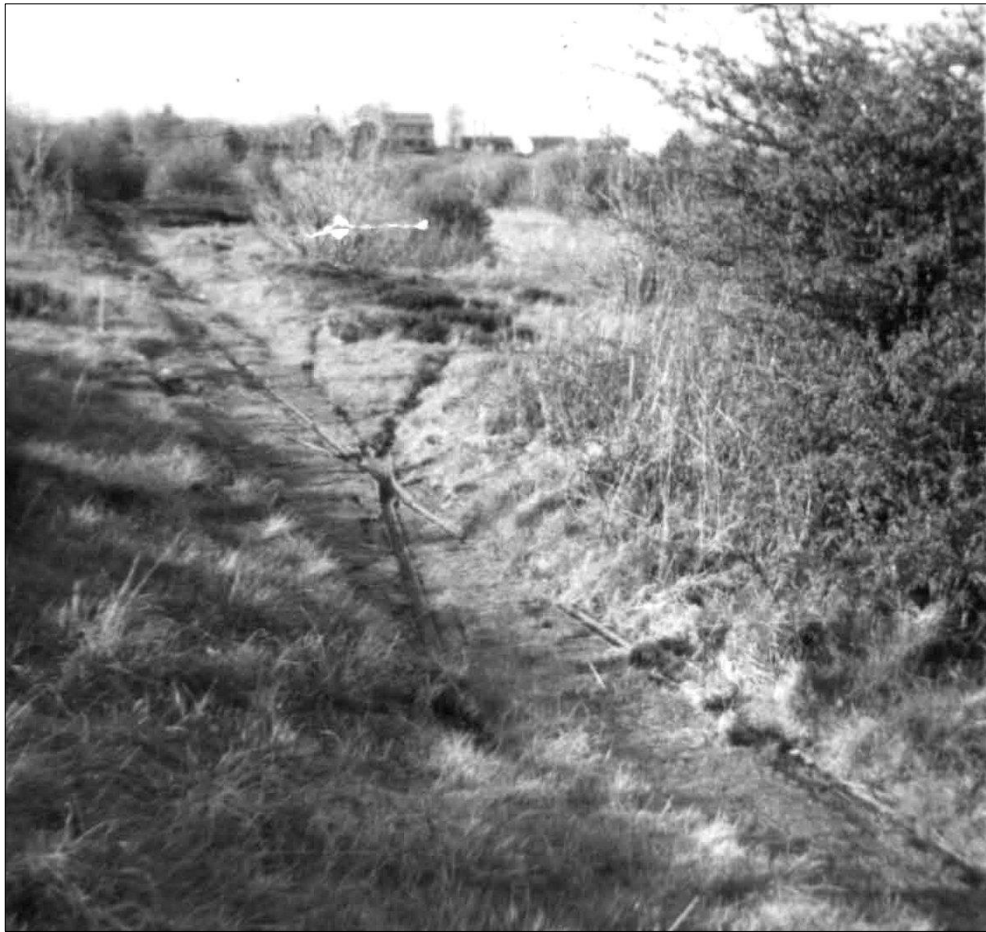
Fig. 10 A section of tramway uncovered in 1967, showing the five-way junction, viewed from the south-south-west. Photo James Bentley (courtesy of the Buckley Society)

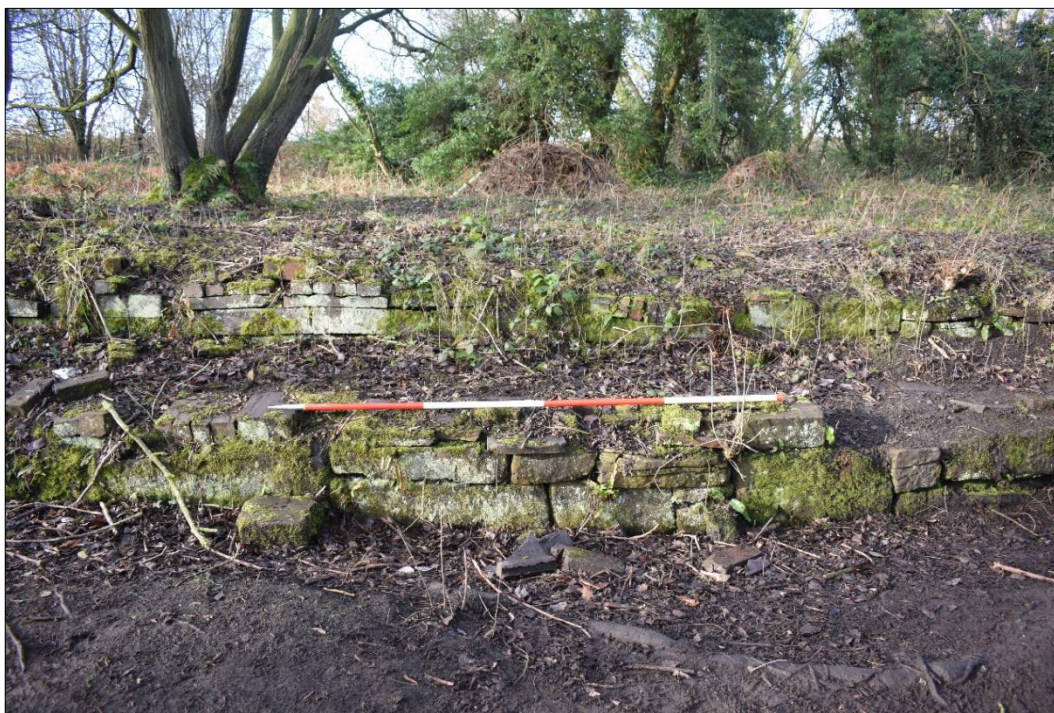
- 4.3. The exchange sidings occupy a level area, to the west of, and raised above, the standard gauge siding. The edge of the wharf is founded on large sandstone blocks, onto which are laid a variety of bricks and tiles, forming a terrace around 1.2m wide and 0.55m above the bed of the sidings. A tramway (Bentley's traverser tramway) ran along the terrace. A variety of industrial bricks were used to build a revetment along the inner edge of the terrace, forming the edge of the exchange wharf, a further 0.5m above the terrace (Fig. 13).

Fig. 13 A section of the tramway wharf with the scale resting on the traverser tramway. Photo CPAT 4446-0010

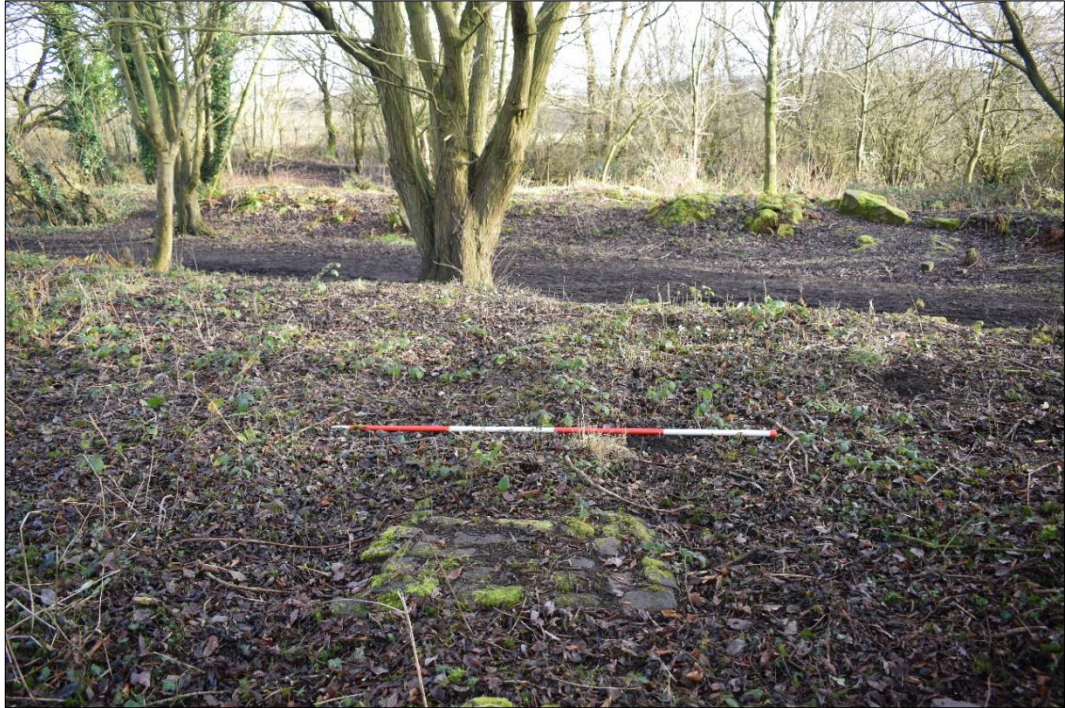
- 4.4. The tramway sidings survive as low brick 'paths', now mostly obscured by vegetation, the width of the brickwork indicating a gauge of 3'6".
- 4.5. The remains of two pairs of tramway sidings, and one single siding, can still be traced as low, curving, brick-paved ridges which are largely obscured by vegetation. It is evident that some short section of L-shaped iron rail still remain in situ. An area of large tiles lies on the wharf, marking the site of a small building.

Fig. 14 The brick base of a tramway siding approaching the standard gauge siding.
Photo CPAT 4446-0022

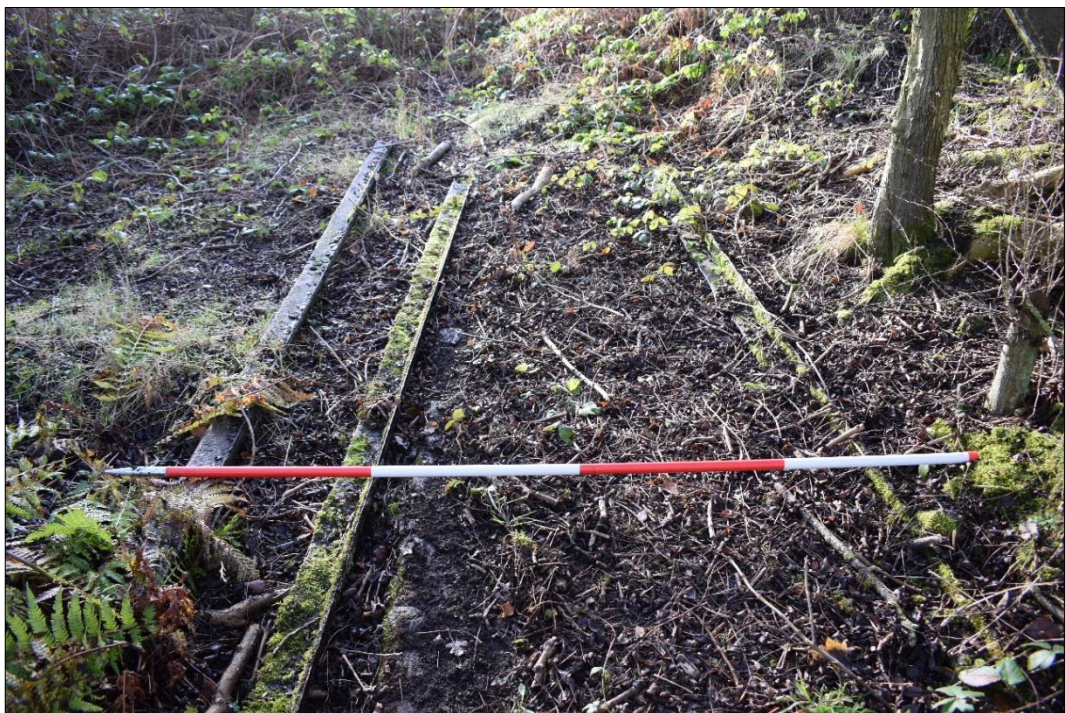
- 4.6. At the southern end of the wharf it is possible to trace two parallel tramways approaching the traverser tramway, the junctions with which still survive in part (Fig. 16), while displaced rails lie along the line of one of the tramways (Fig. 15).

Fig. 15 Displaced tramway rails along a siding approaching the traverser tramway.
Photo CPAT 4446-0027

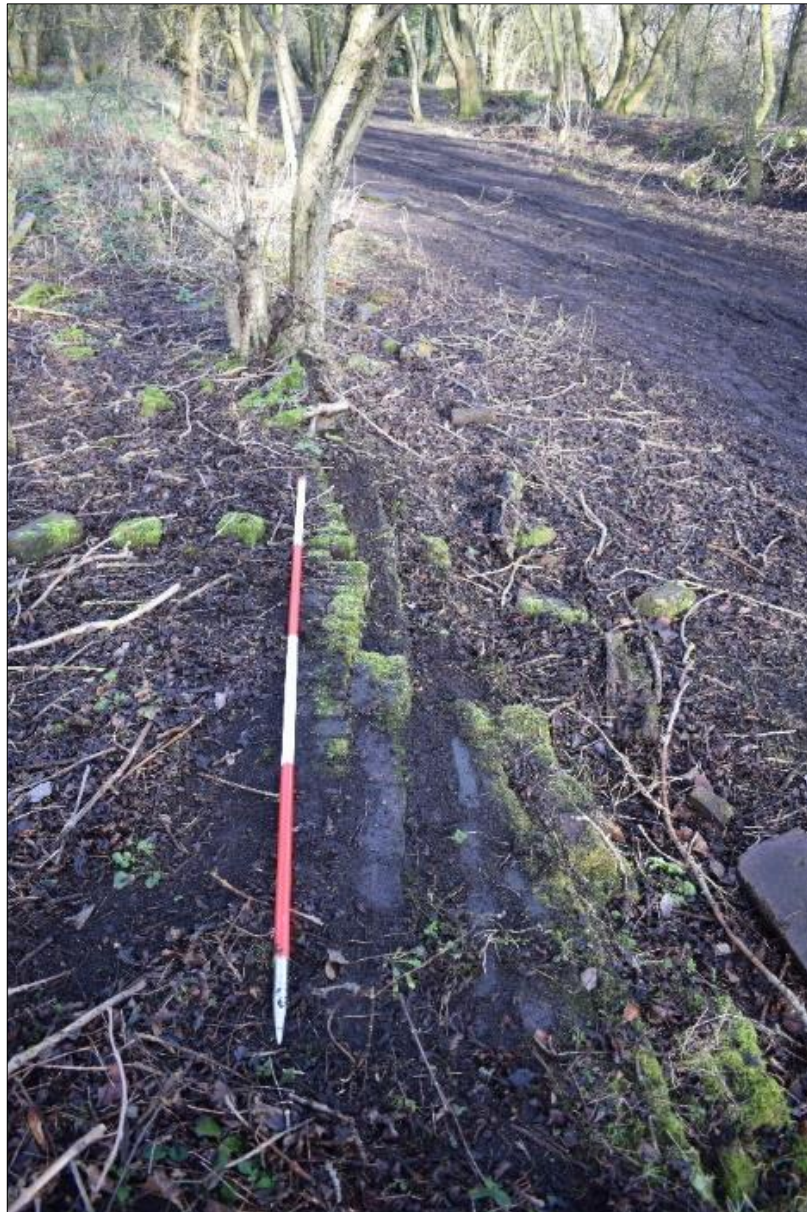
Fig. 16 The junction of one tramway with the traverser tramway. The standard gauge siding is to the right. Photo CPAT 4446-0030

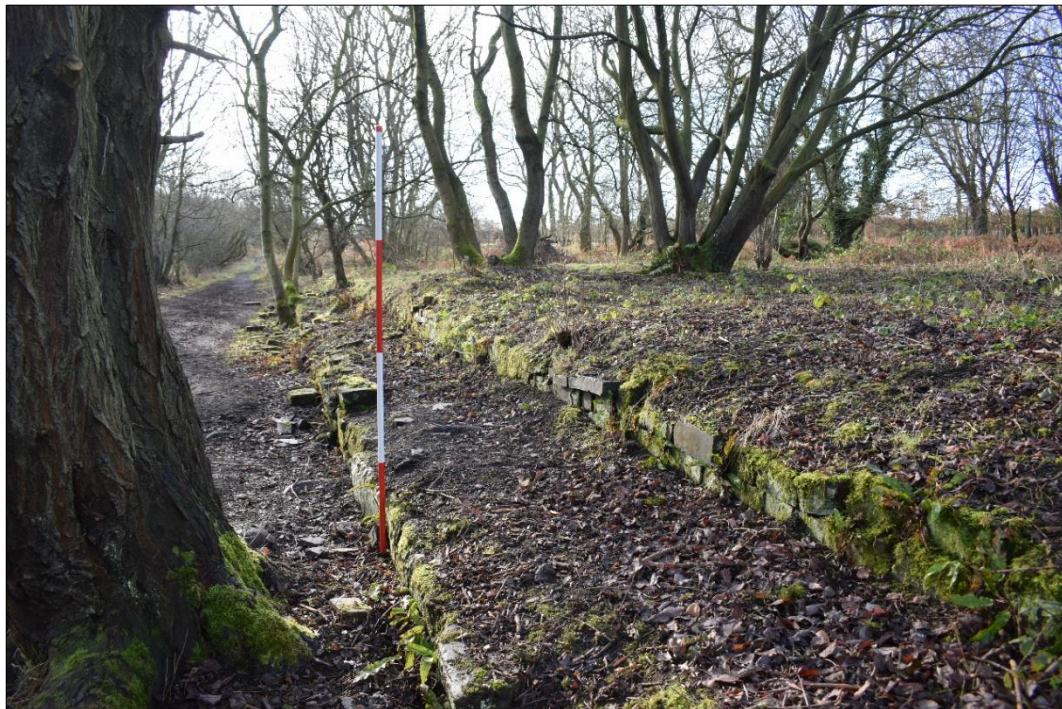
Fig. 18 A similar view of the traverser tramway in January 2018. Photo CPAT 4446-0024

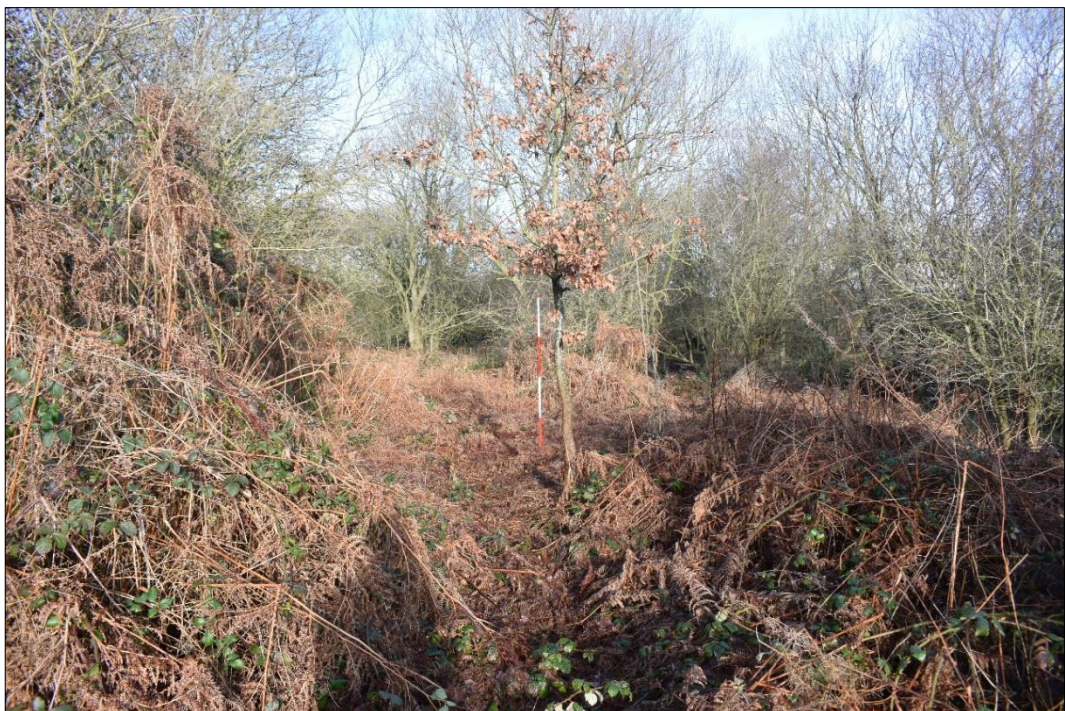
Fig. 20 View of the five-way points in January 2018. Photo CPAT 4446-0031

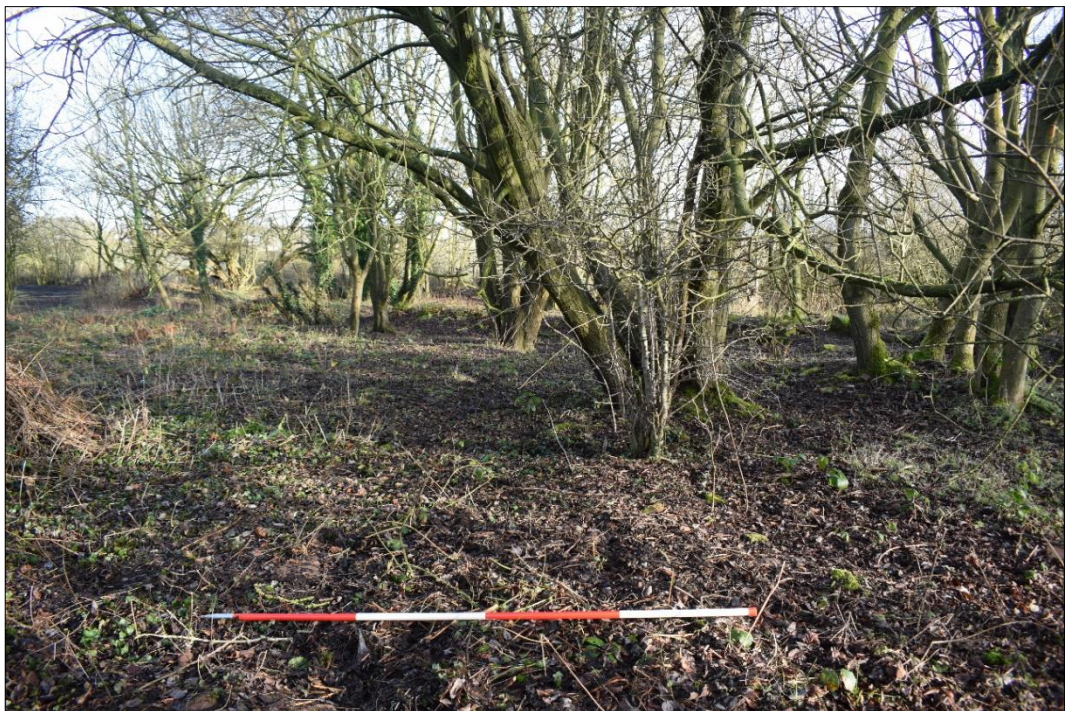
Fig. 22 The same view as above in January 2018. Photo CPAT 4446-0025

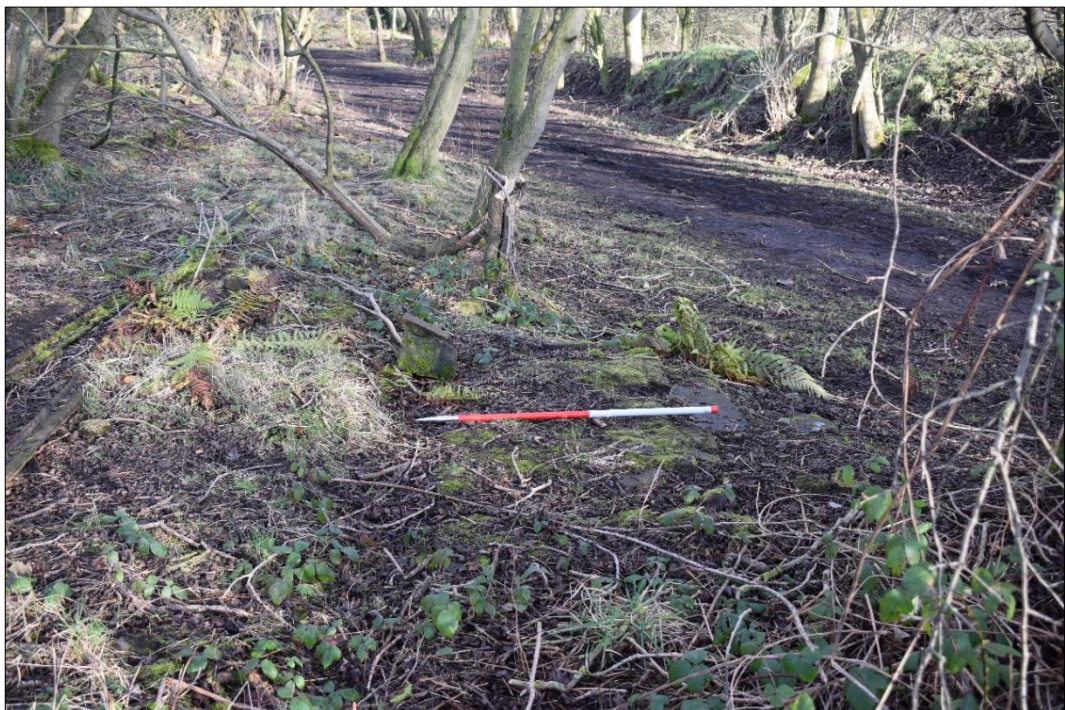
Fig. 24 The same view as above in January 2018. Photo CPAT 4446-0039

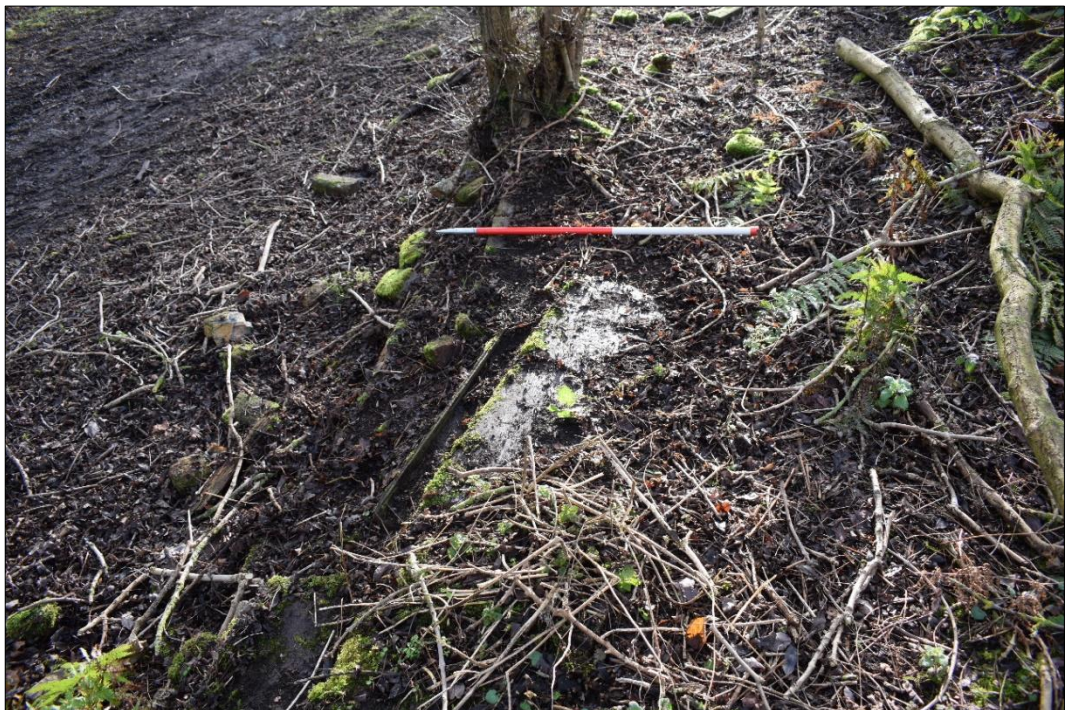
Fig. 26 The same view as above in January 2018. Photo CPAT 4446-0044

encroaching vegetation is, however, a cause for some concern since the action of roots will inevitably displace the brickwork of the tramways, as well as the revetment of the wharf. It would therefore be appropriate to control the growth of new saplings and also the encroachment of bracken.

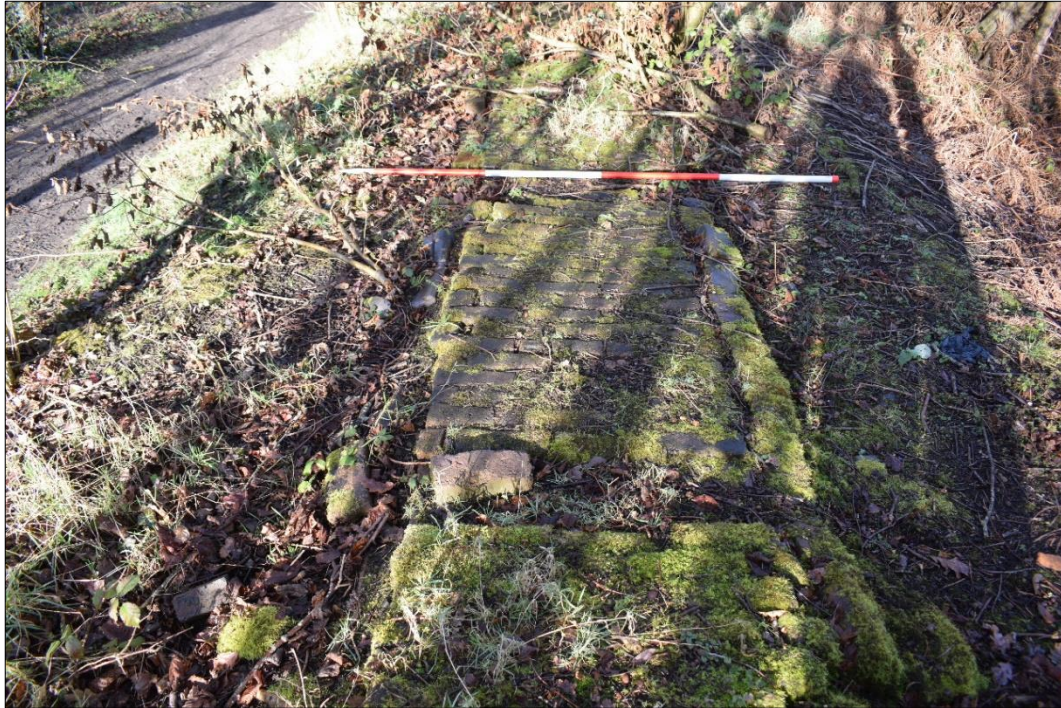
- 4.10. There are a number of sections of tramway alongside the main footpath where the brickwork and sleeper positions are still readily visible, giving at some impression of the construction (Fig. 27).

Fig. 27 A section of brick base for the tramway to the Mount Pleasant Brickworks, with the footpath to the left. Photo CPAT 4446-0034

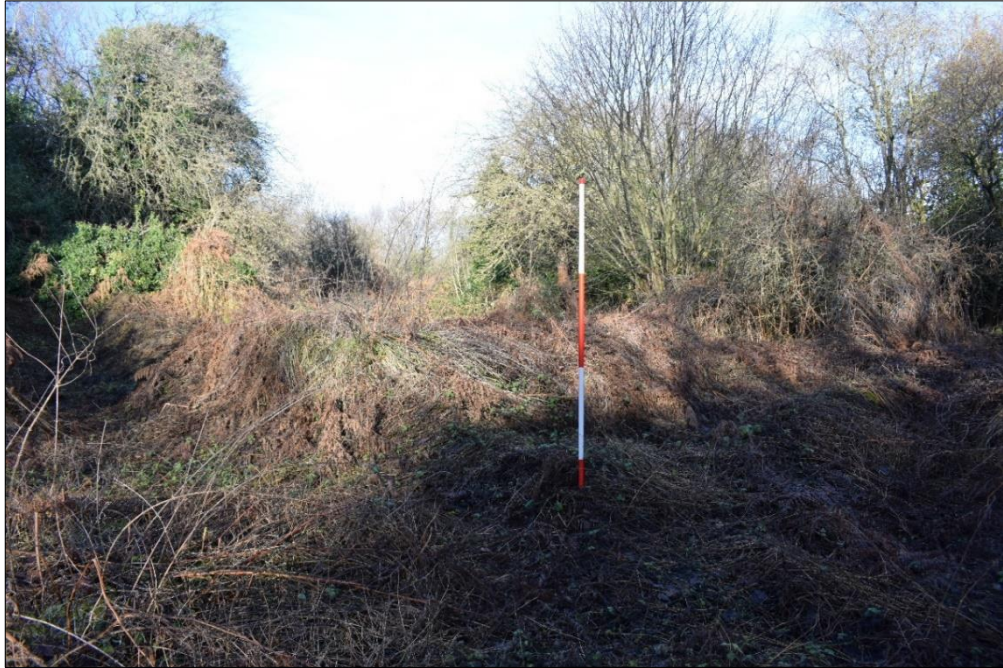
- 4.12. The masonry ruins of a cottage (PRN 126535) lie 45m north-north-west of the wharf, outside the scheduled area (Fig. 16). The walls survive in places to a height of around 0.9m, with internal walls defining four rooms. The building was still standing until at least the 1950s. There was also a small a small brick-built building (PRN 126536), perhaps a privy, immediately to the north, below a tramway embankment.

Fig. 28 The overgrown remains of the cottage. Photo CPAT 4446-0026

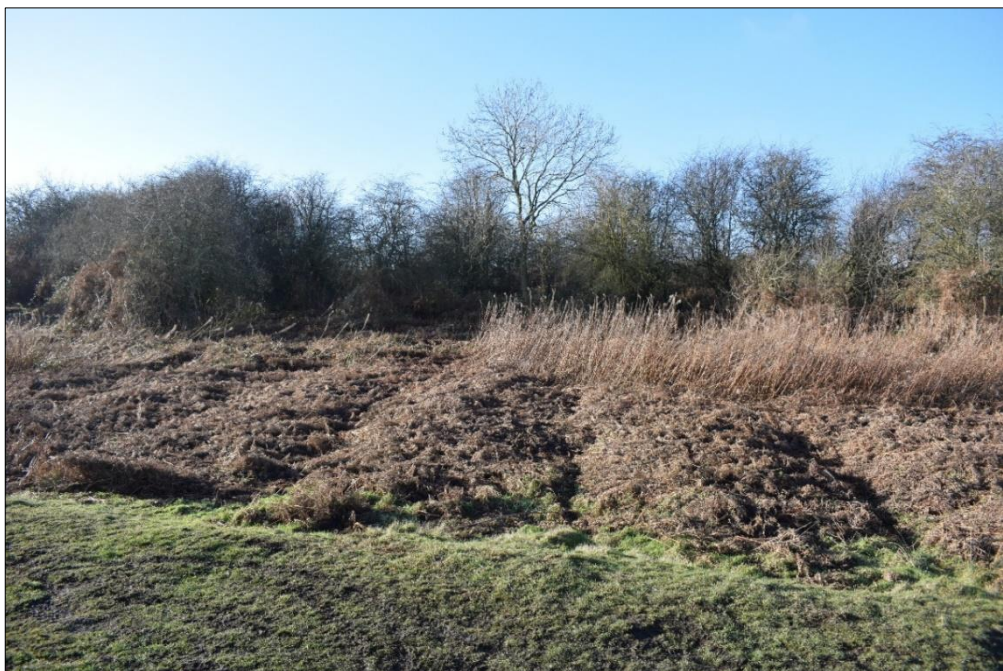
- 4.13. To the south of the engine shed there is a substantial embankment which carried a standard gauge siding southwards to a 19th-century colliery. To either side of the embankment there are a series of parallel ridges, around 3.4m apart, which have the appearance of cultivation ridges. There are also remnants of similar ridges further to the south, although these are no readily visible on the ground and can only be identified using the 1m-resolution LiDAR, but are also shown on a 1951 vertical aerial photograph (540/488/4425).

Fig. 29 The low earthworks of cultivation ridges alongside the embankment for the standard gauge colliery siding. Photo CPAT 4446-0043
