## **Pentwyncoch Ganol, Tir y Coed Road, Glanaman**

Archaeological Building Recording (Level 3)

Report No. 1601

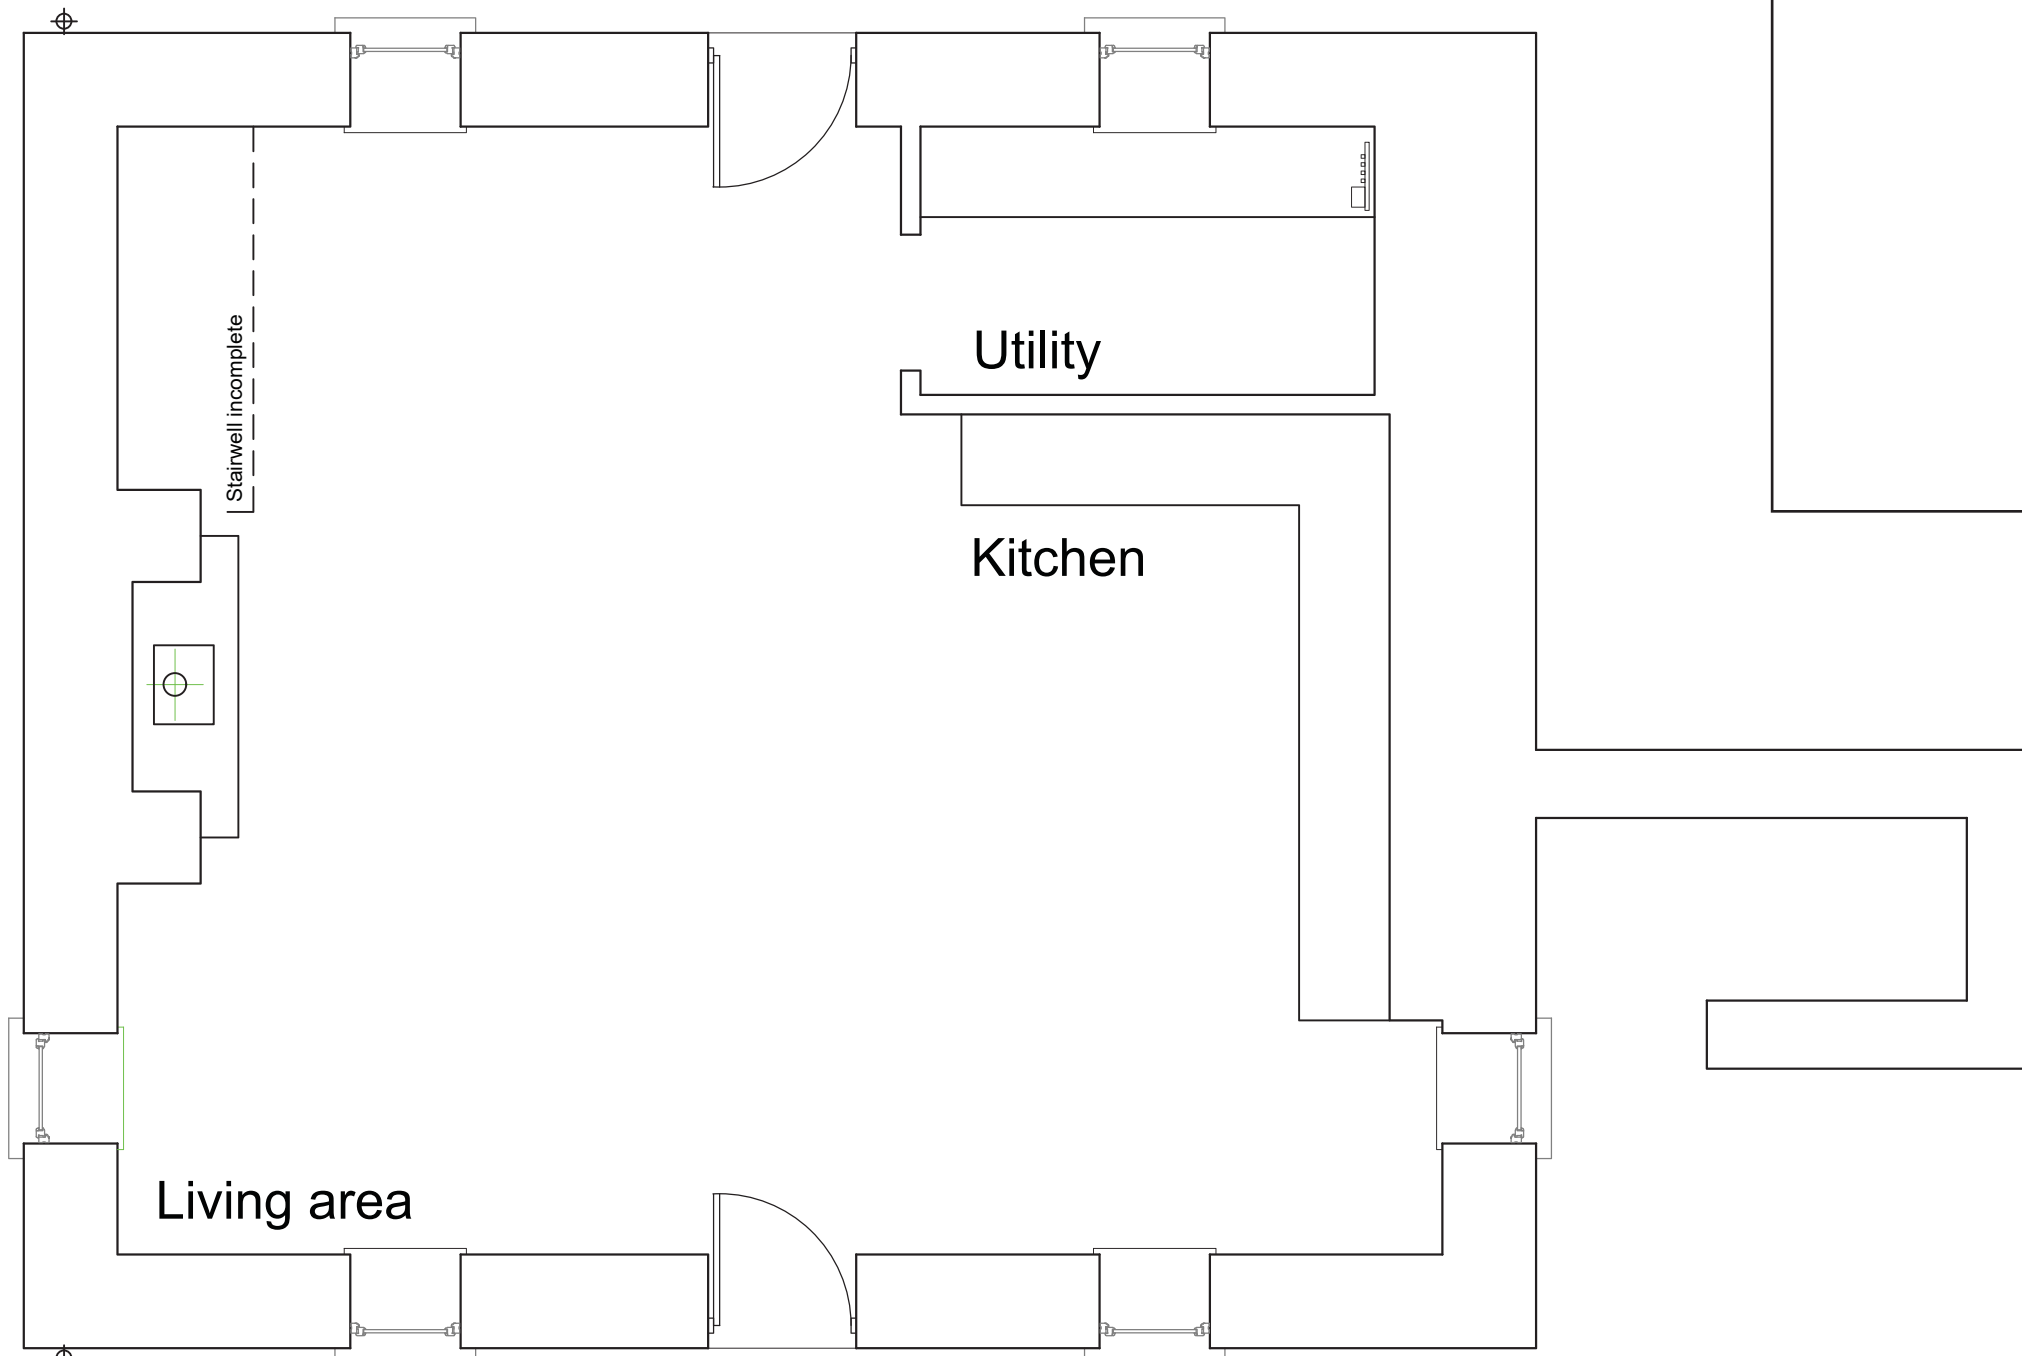
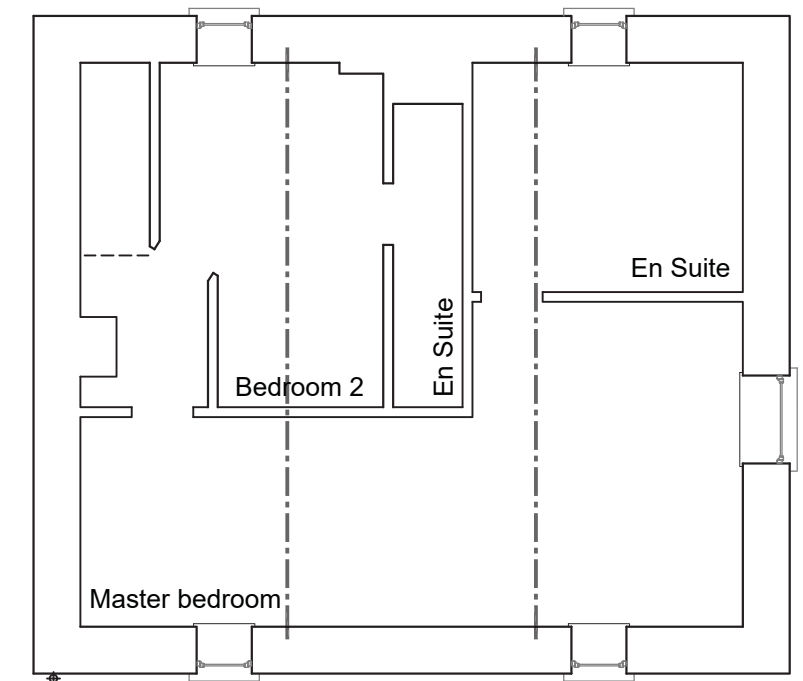
Ground floor layout as built

First floor layout as built

Figure 6: Ground floor plan of Pentwyngoch Ganol at 1:50. First floor plan (insert) at reduced scale (1:100) as all features at this level are modern.

- 6.1.1 Figure 6 shows the existing ground floor and first floor plan of the existing building, Figures 7 and 8 show the elevations and a profile of the existing building. Figures 9 and 10 also show the location and direction from which the photographic plates were taken. The number after each red arrow corresponds to the plate on which the photograph appears.

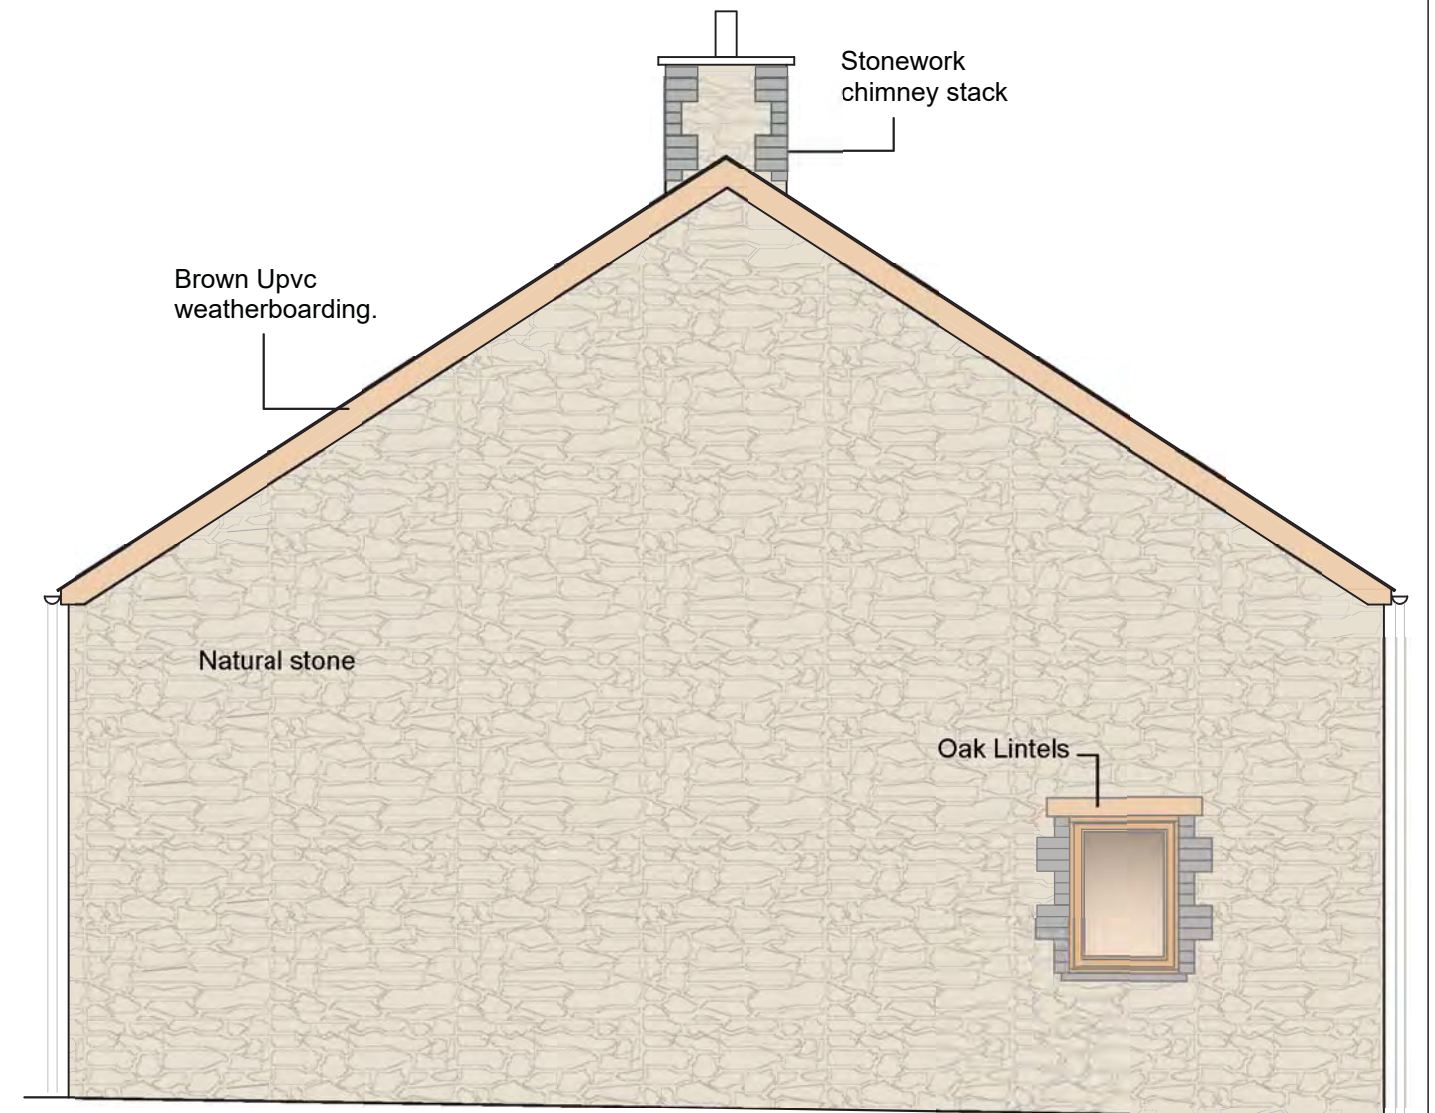
Front elevation as built - South

Side elevation as built - West

Figure 7: South and west elevations of Pentwyngoch Ganol at 1:50.

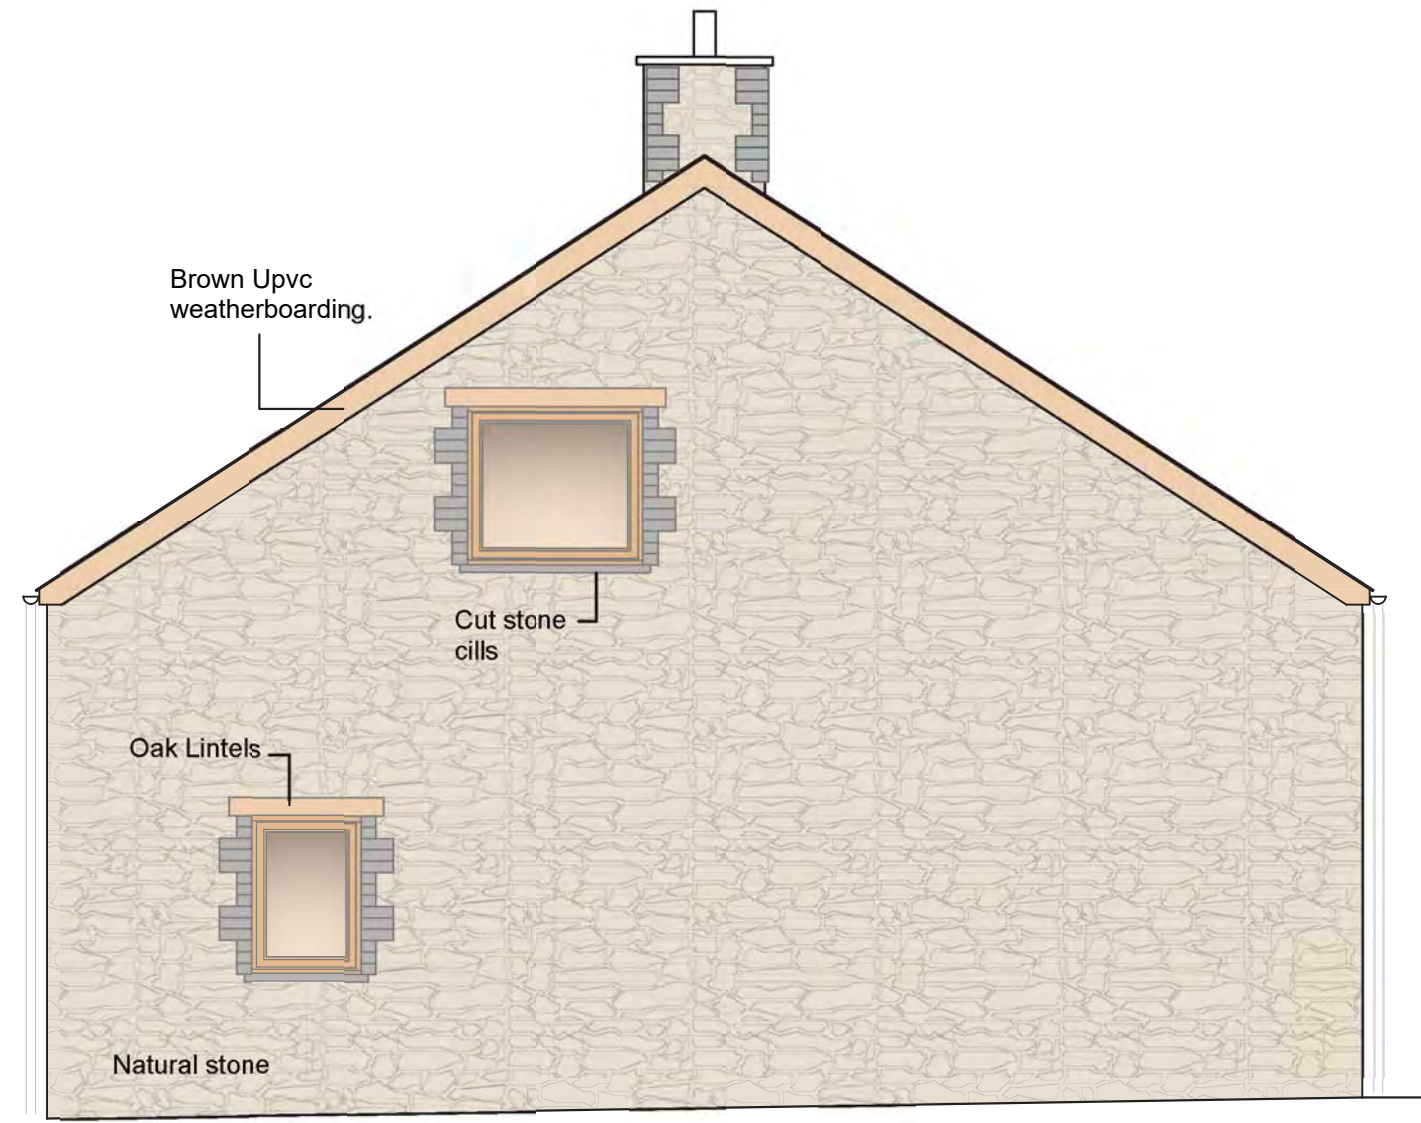
Side elevation as built - North

Side elevation as built - East

Figure 8: North and east elevations and profile of Pentwyngoch Ganol at 1:50.

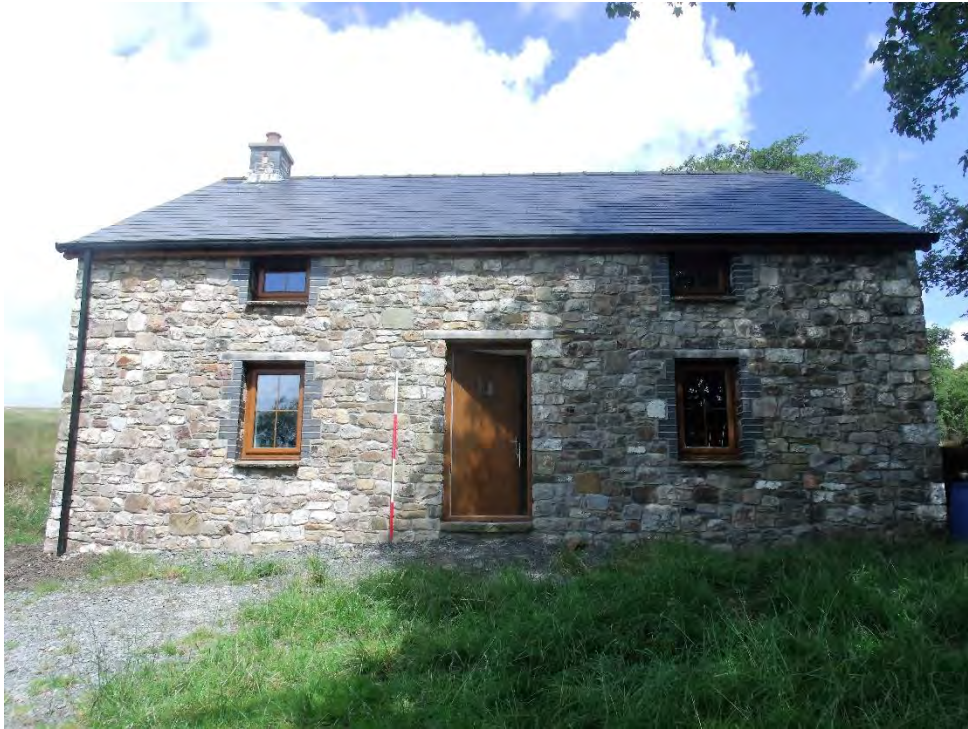
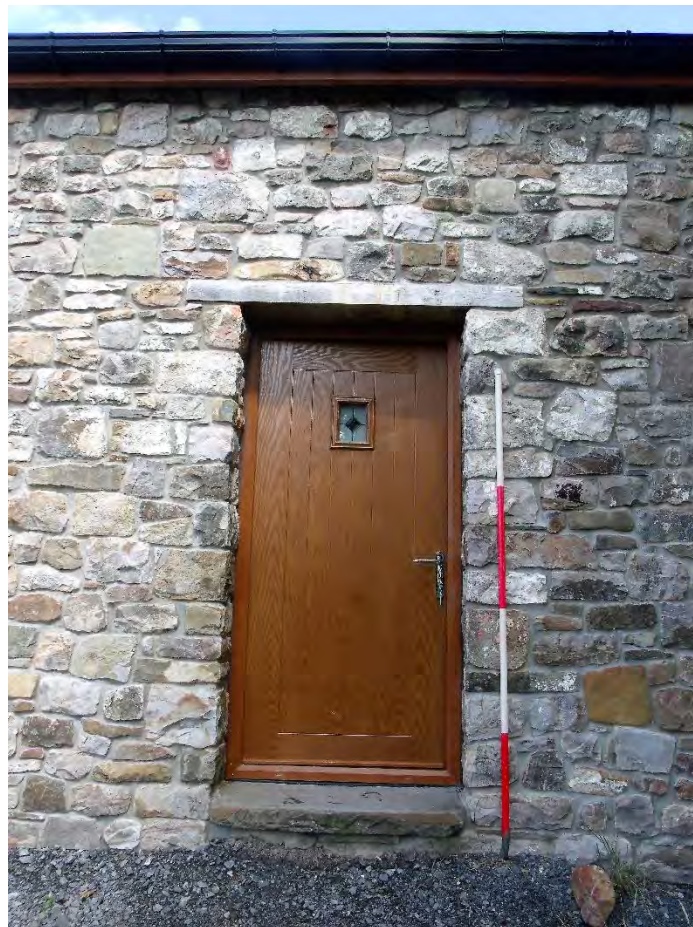
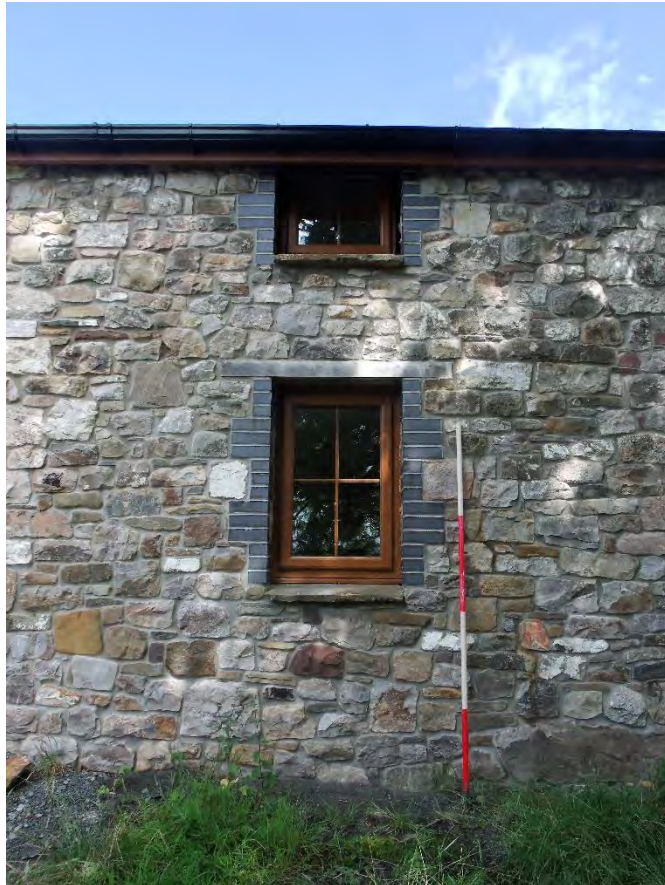
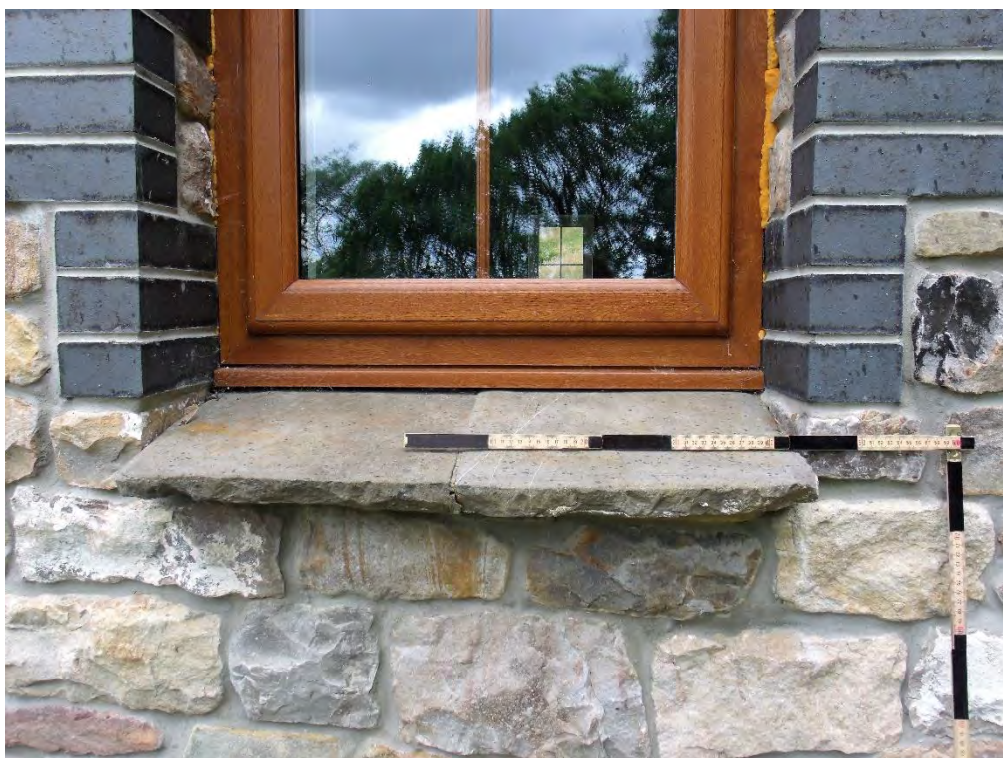
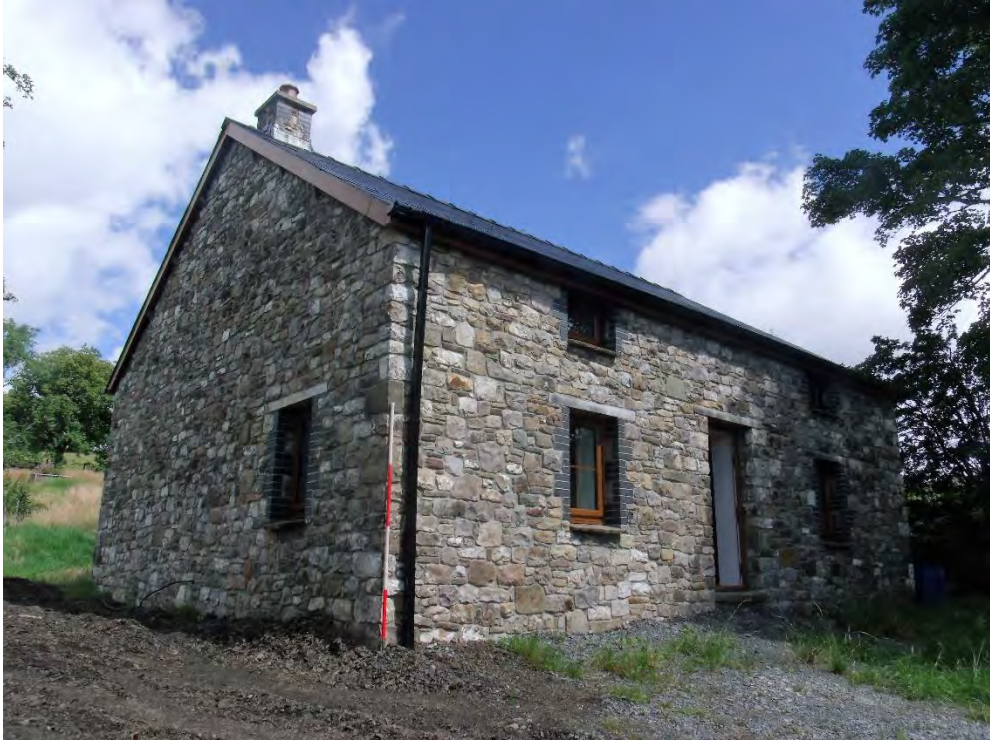
**Plate 1:** Front (south) elevation, general view; shot facing N. 2m scale.

**Plate 2:** Front (south) elevation, door view; shot facing N. 2m scale.

**Plate 3:** Front (south) elevation, windows view; shot facing N. 2m scale.

**Plate 4:** Front (south) elevation, window and slate sill; shot facing N. 0.5m scale.

**Plate 5:** West side and Front (south) elevations; shot facing NE. 2m scale.

- 6.2.4 The southern (front) elevation (Plates 1-5) contains a centrally-placed doorway, comprising the single front door to the property. The doorway is topped with a machine-cut, squared, oak lintel, replacing the original brick lintel, and a reused limestone step at the base. A new wood-effect resin door with a small window vent in the centre has been added to the original opening. There are four windows, two on each floor, all 0.8m wide, those on the ground floor being 1.2m high, and those on the first floor 0.6m high. The windows are four-panel awning windows in brown Upvc. The window openings have been rebuilt to the original sizes, with grey-brick edging and machine-cut, squared, oak timber lintels added. The original protruding slate sills have been re-incorporated in the new windows. The roofline projects over the upper windows. Black Upvc guttering runs along the roofline, with a downpipe to the west.

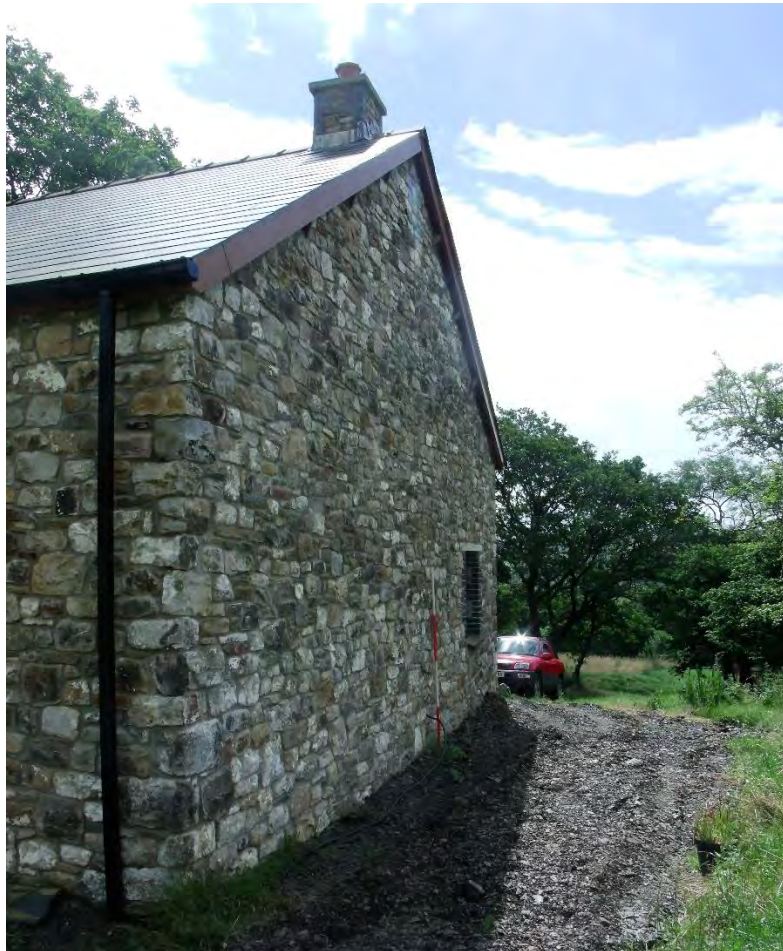
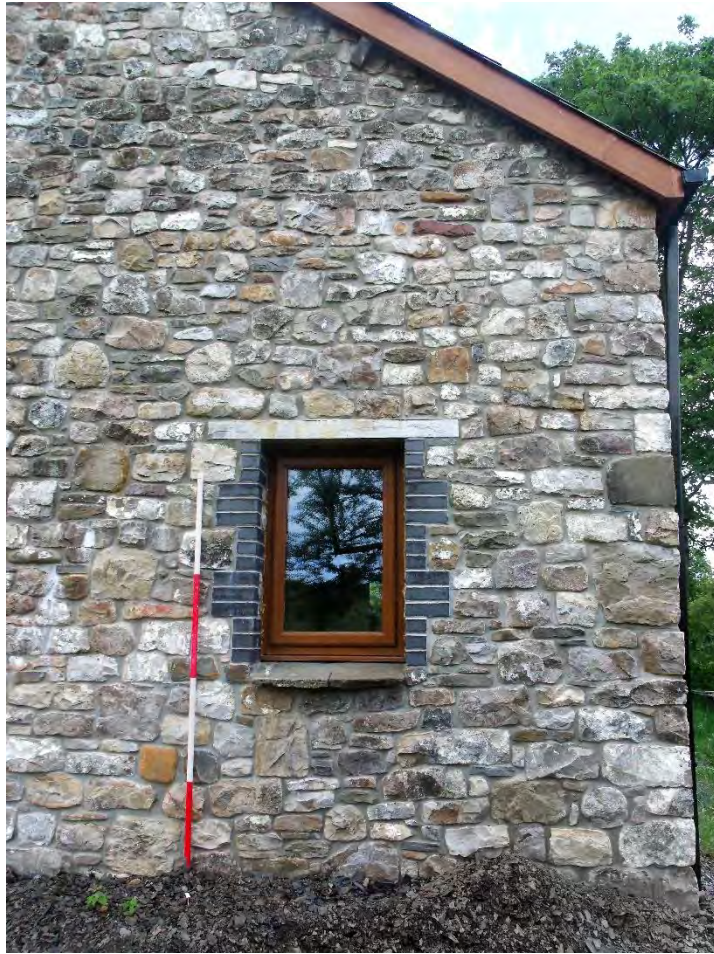
**Plate 6:** West side elevation; shot facing S-SE. 2m scale.

**Plate 7:** West side elevation, view of window; shot facing E. 2m scale.

- 6.2.5 The western gable (Plates 5-7) is built in the same style as the southern elevation. A new window opening has been inserted at ground-floor level, towards the southern end of the wall. The window measures 1.05m tall, by 0.7m wide, and is a plain awning window in brown Upvc. The window opening is edged in decorative grey-brick, with a modern oak lintel, and re-used slate projecting sill.

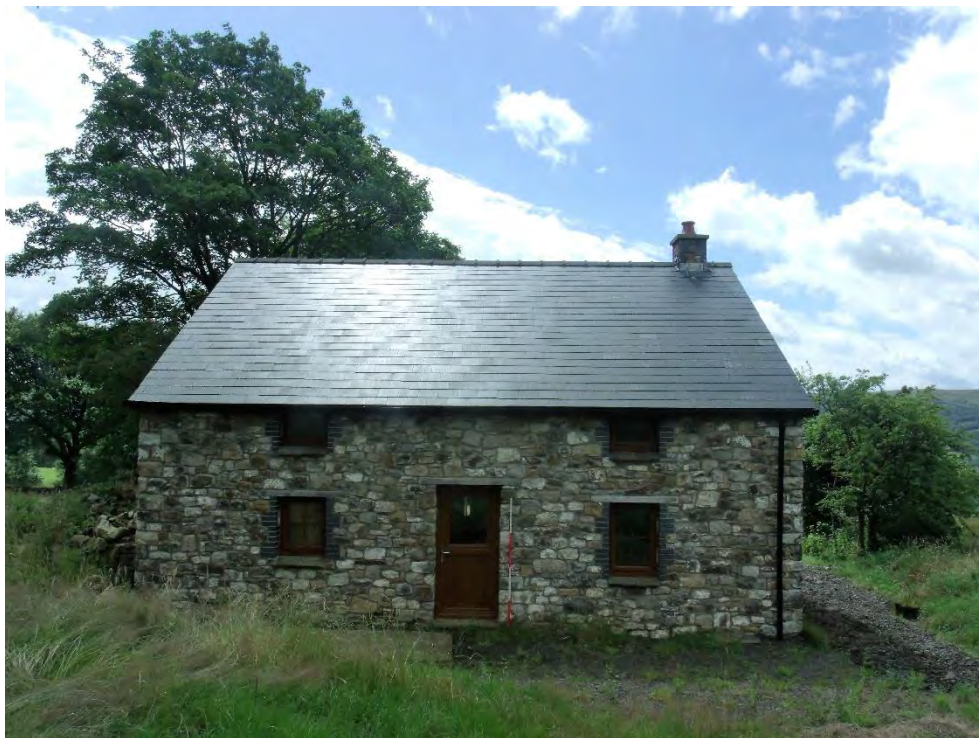
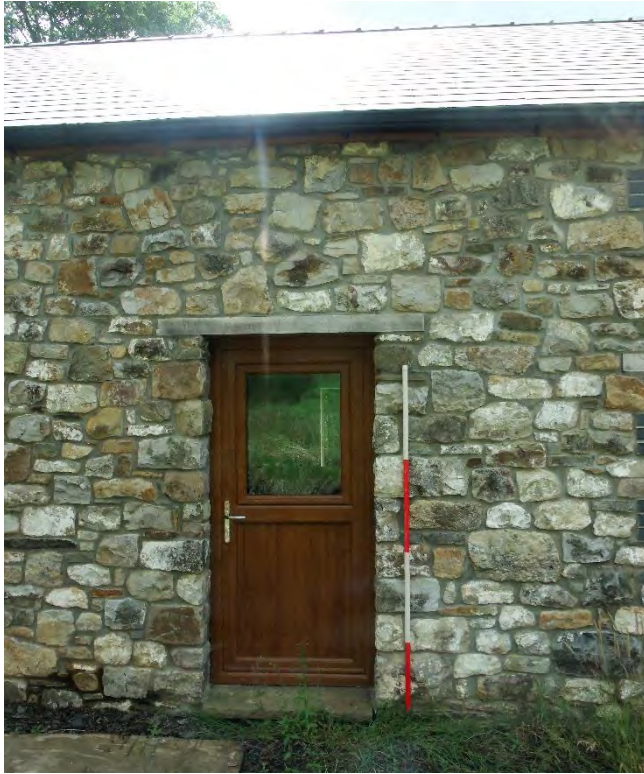
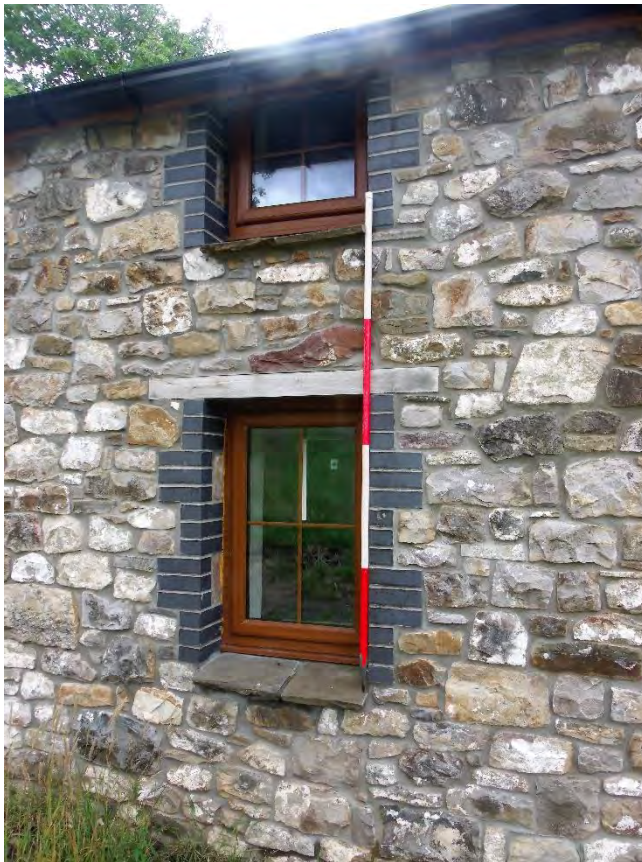
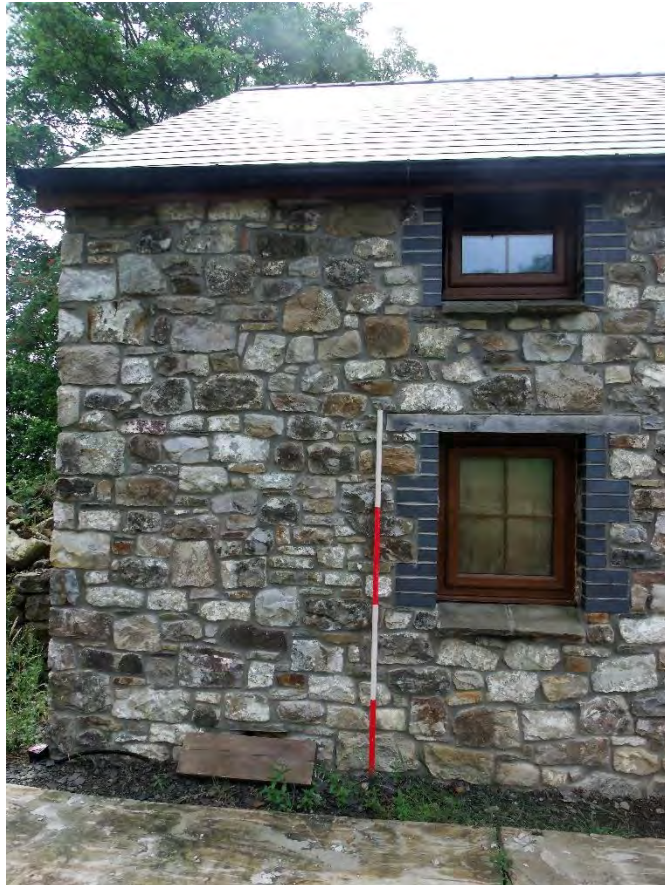
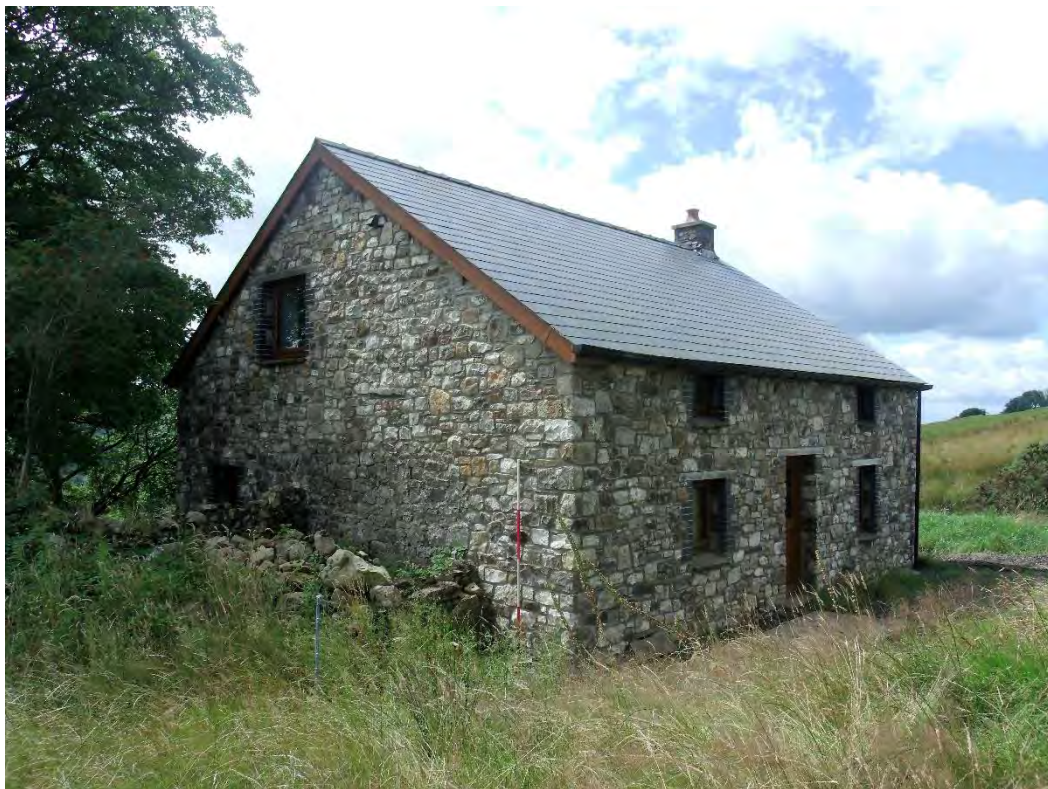
**Plate 8:** Rear (north) side elevation, general view; shot facing S. 2m scale.

**Plate 9:** Rear (north) side elevation, door view; shot facing S. 2m scale.

**Plate 10:** Rear (north) side elevation, Windows view; shot facing S-SE. 2m scale.

**Plate 11:** Rear (north) side elevation, windows view; shot facing S. 2m scale.

**Plate 12:** East side and Rear (north) elevations; shot facing SW. 2m scale.

- 6.2.6 The northern (rear) elevation (Plates 8-12) shows a continuation of the same building style, and mirrors the front elevation with a central doorway and four windows, two to each floor. The rear door is a similar brown wood-effect resin, but with a half-window opening. The door opening appears to be original, but with a modern oak lintel and re-used limestone step. The four windows are all 0.8m wide, those on the ground floor being 1.2m high, those on the first floor being 0.6m high. They are all modern brown Upvc four-panel awning windows, with decorative grey-bricks on the sides, modern wooden lintels and protruding slate sills.

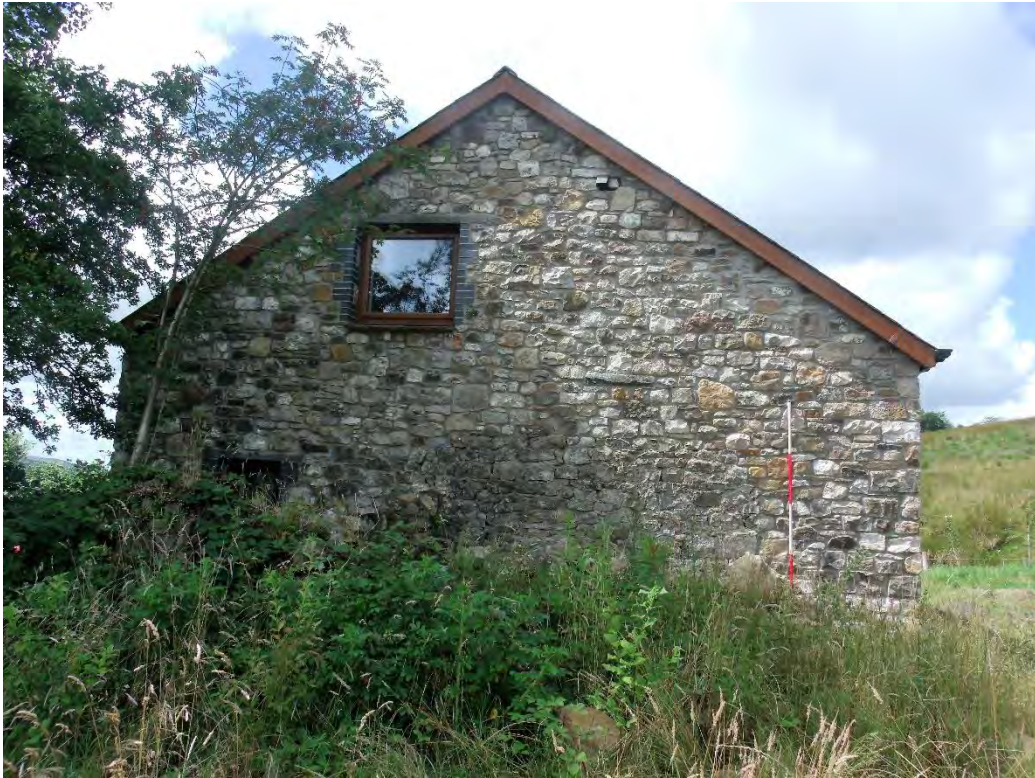
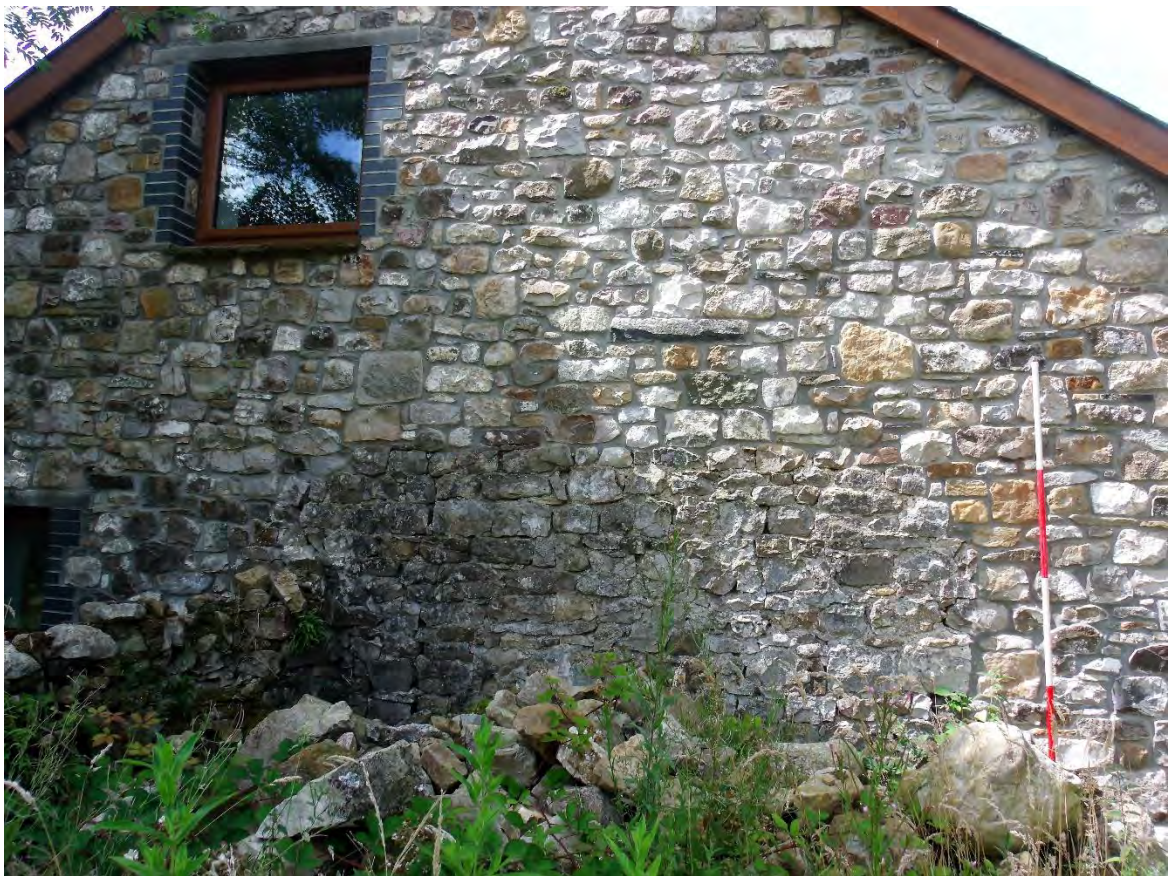
**Plate 13:** East side elevation, general view; shot facing W. 2m scale.

**Plate 14:** East side elevation, window and original wall detail; shot facing W. 2m scale.

- 6.2.7 The eastern gable (Plates 12-14) continues the same building style, with two newly inserted windows, one to each floor, and both in the southern half of the face. The ground floor window measures 0.7m wide, 1.05m high, and comprises a plain awning window in brown Upvc. The first floor window is 1.1m wide, 1.05m high, also comprising a plain awning window in brown Upvc. Both window openings are in the typical style with decorative grey-bricks on the sides, modern wooden lintel, and protruding slate sill. The eastern gable wall preserves a section of the original wall prior to repointing. This section, built in the typical randomly coursed, roughly faced, stonework, is bonded in a light buff lime-mortar (Plate 14).

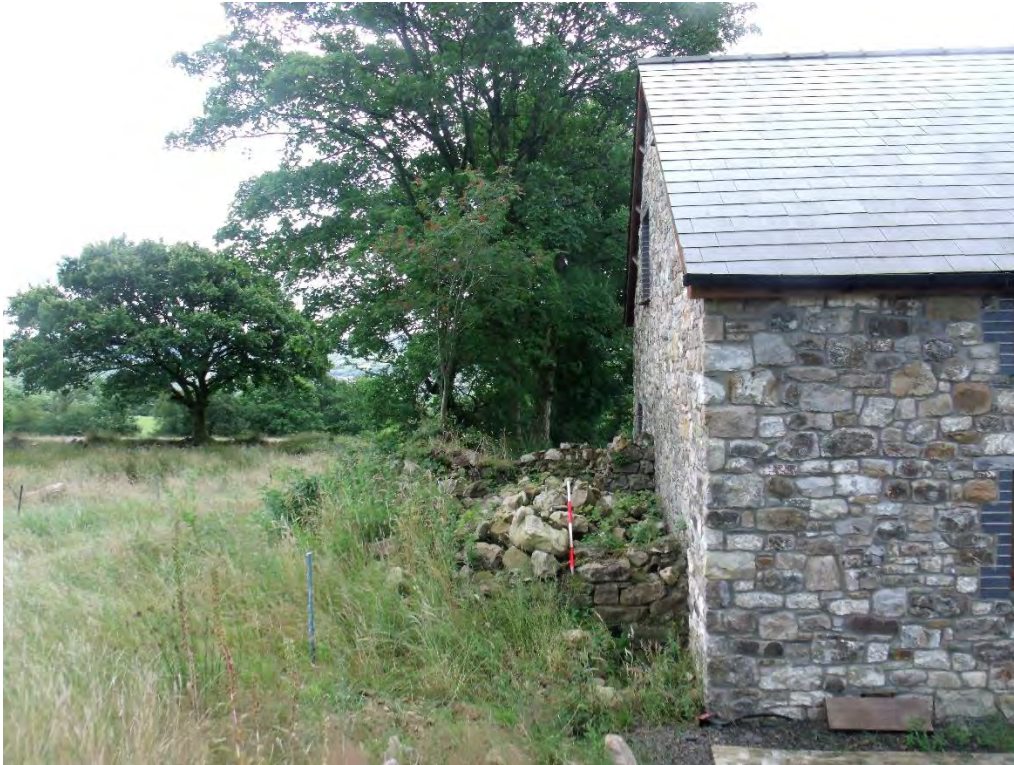
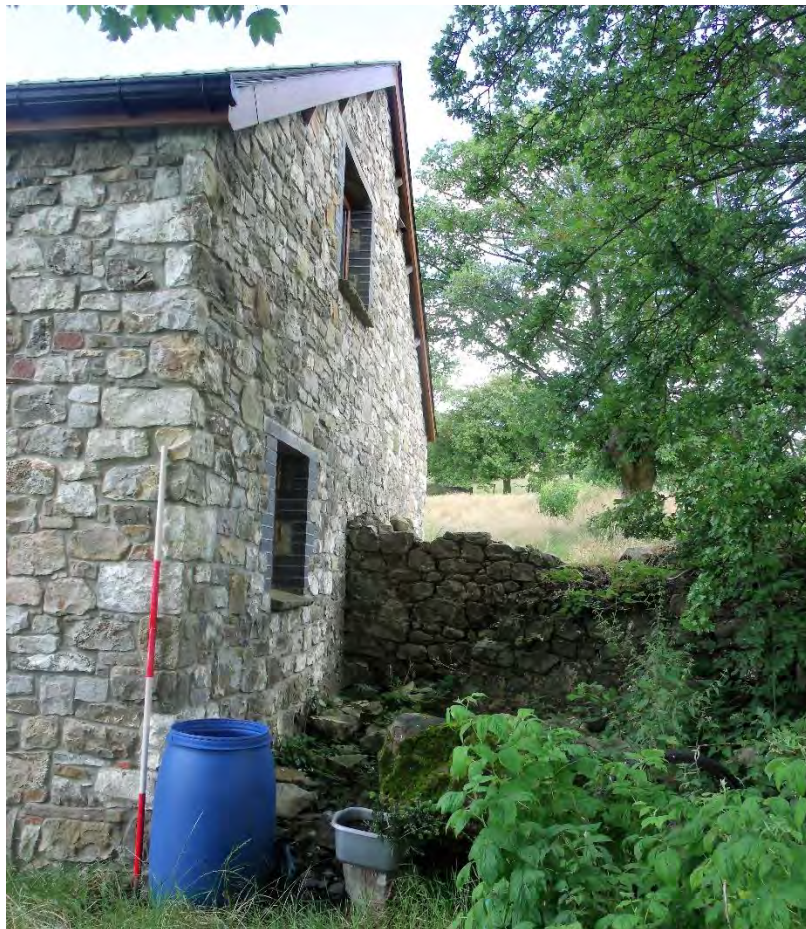
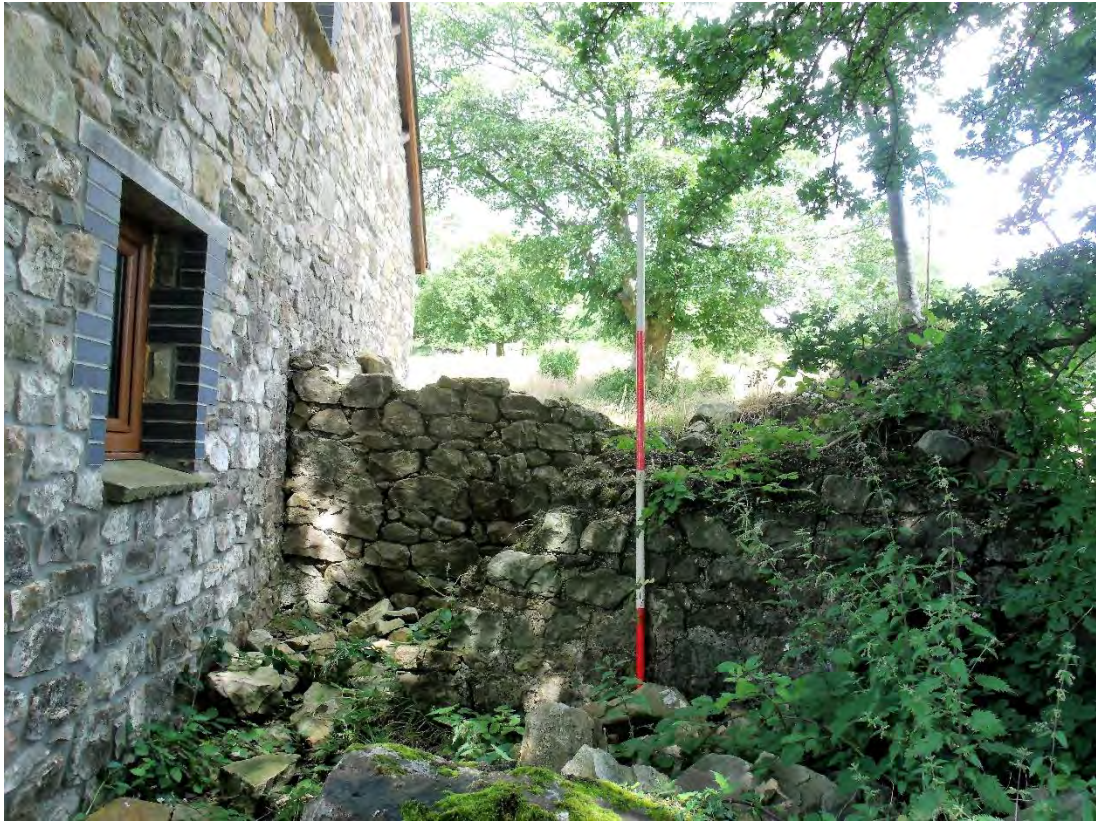
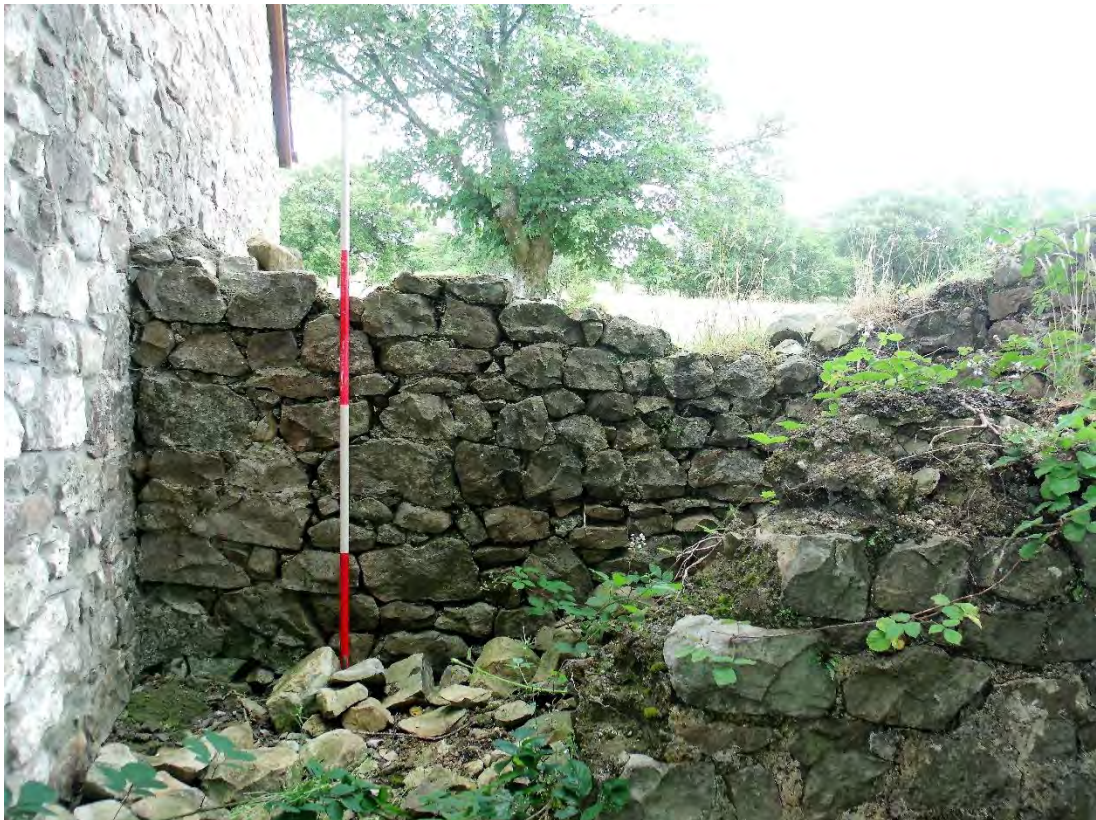
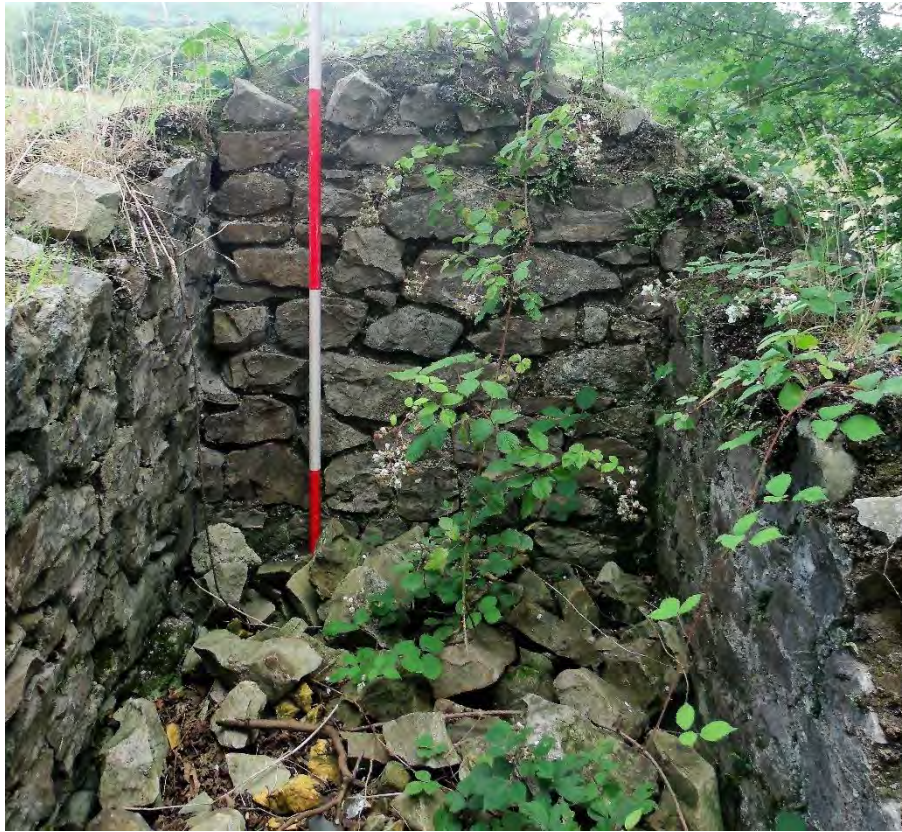
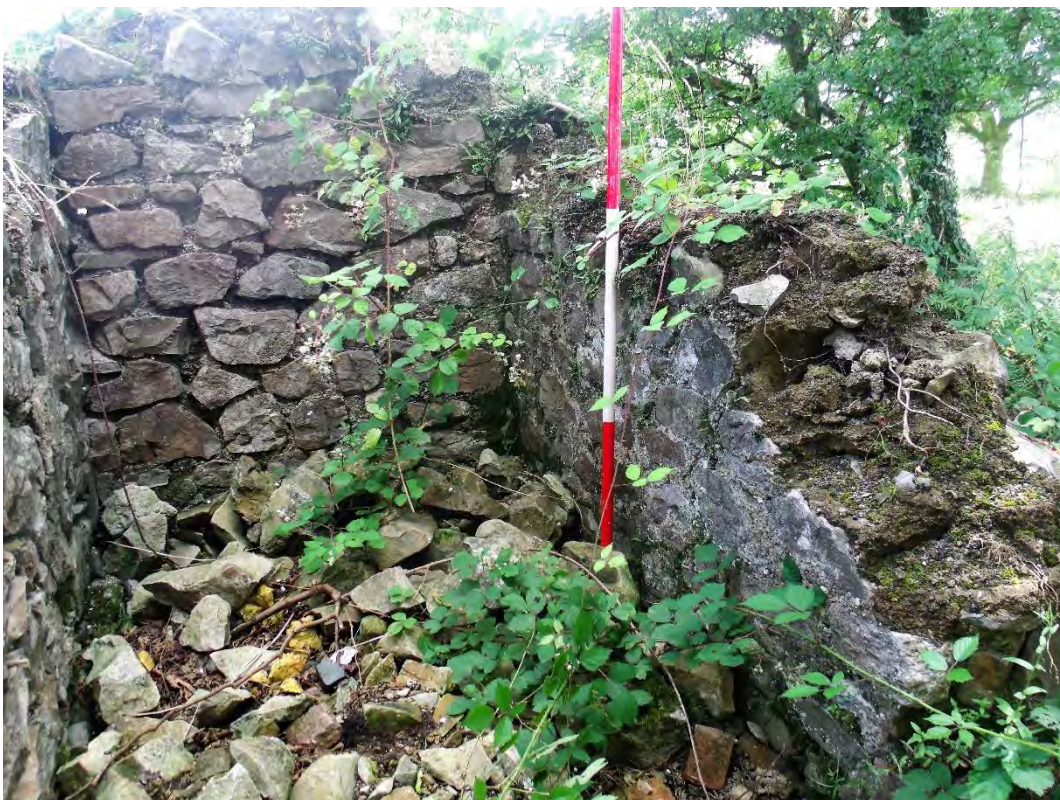
**Plate 15:** Lean-on structure and East side elevation, view from N; shot facing S. 2m scale.

**Plate 16:** Lean-on structure and East side elevation, view from S; shot facing N. 2m scale.

**Plate 17:** Lean-on structure general view from S; shot facing N. 2m scale.

**Plate 18:** Lean-on structure, detailed view from S; shot facing N. 2m scale.

**Plate 19:** Lean-on structure, detailed view from East side; shot facing E. 2m scale.

**Plate 20:** Lean-on structure, detailed view from East side; shot facing E. 2m scale.

- 6.2.8 An attached small outbuilding range (Plates 15-20) protrudes east from the eastern gable wall of the house, measuring approximately 6m by 2m in total.

It comprises a lean-to shed to the south and the ruins of an indeterminate structure to the north. The lean-to shed to the south (Plates 18-19) still consists of walls approximately 1.5m high, stone in a random-rubble style with mortar bonding, and traces of cement render on the interior of the southern face (Plate 20). This unit is accessed from the south, it does not appear to have been accessible from the interior of the original house building. The ruined indeterminate structure on the northern side is almost fully covered with vegetation. Both structures butt against the eastern gable wall of the main building.
