## **Pentwyncoch Ganol, Tir y Coed Road, Glanaman**

Archaeological Building Recording (Level 3)

Report No. 1601

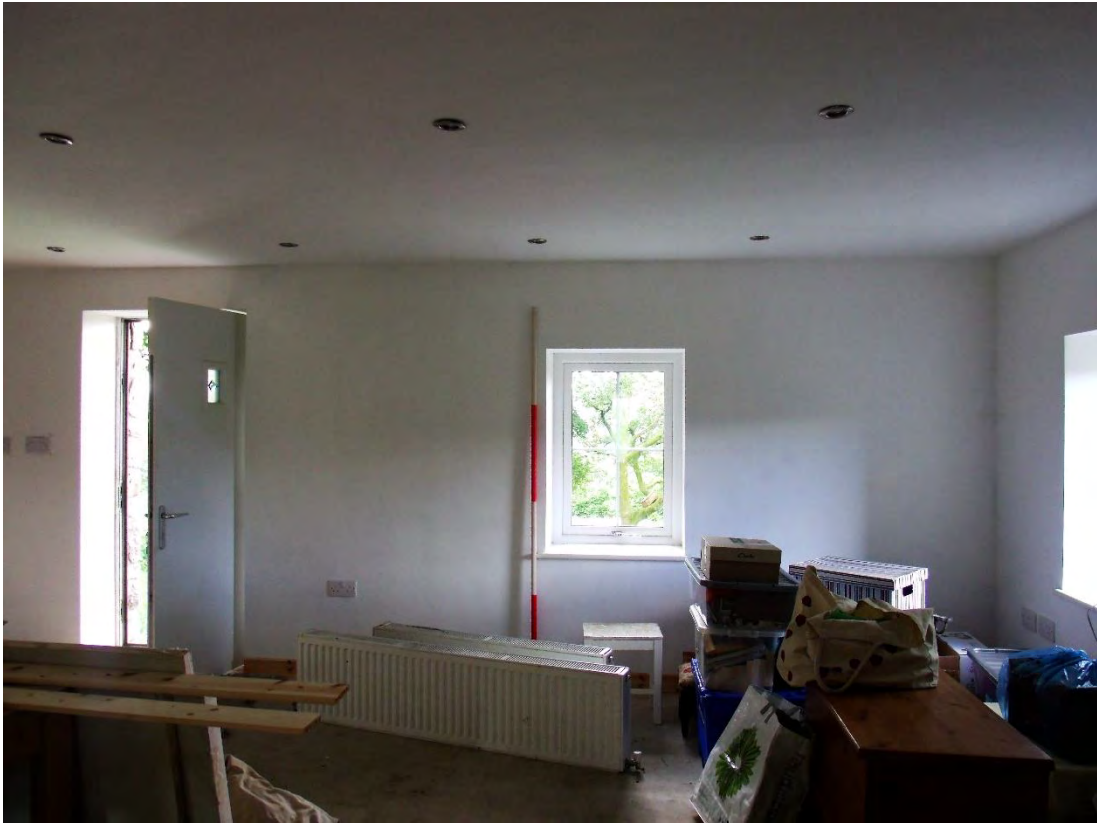
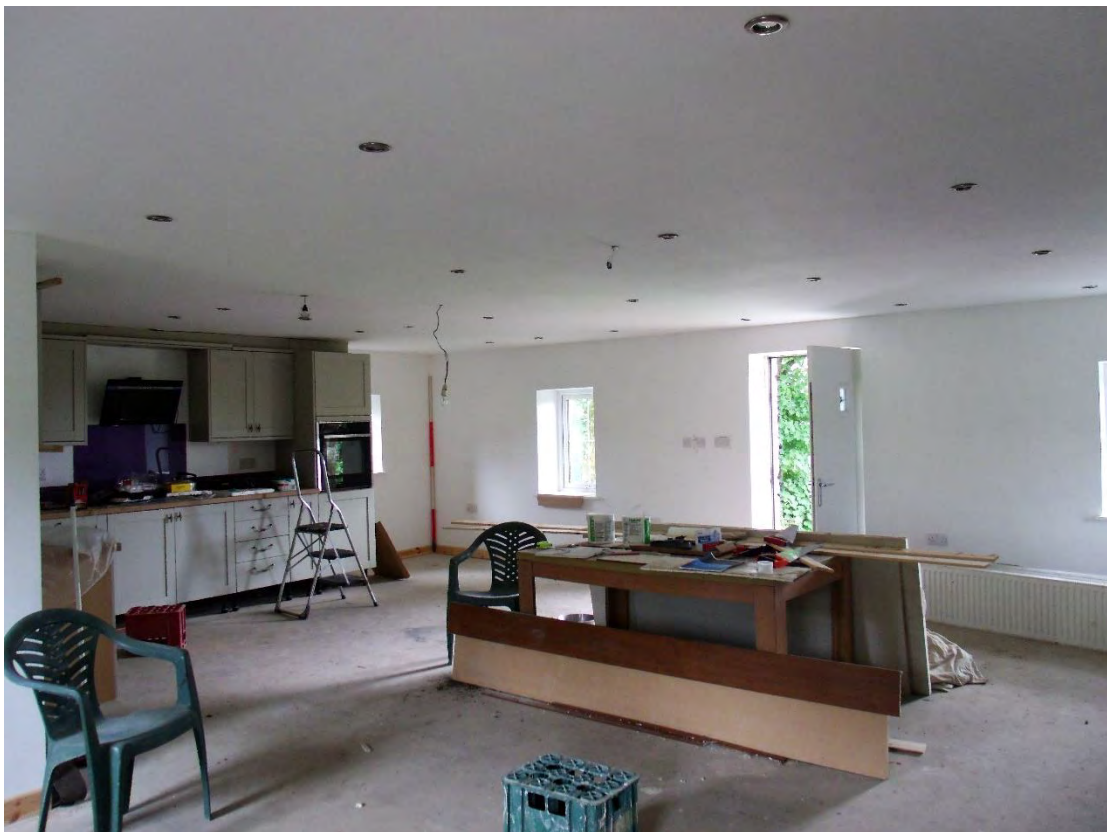
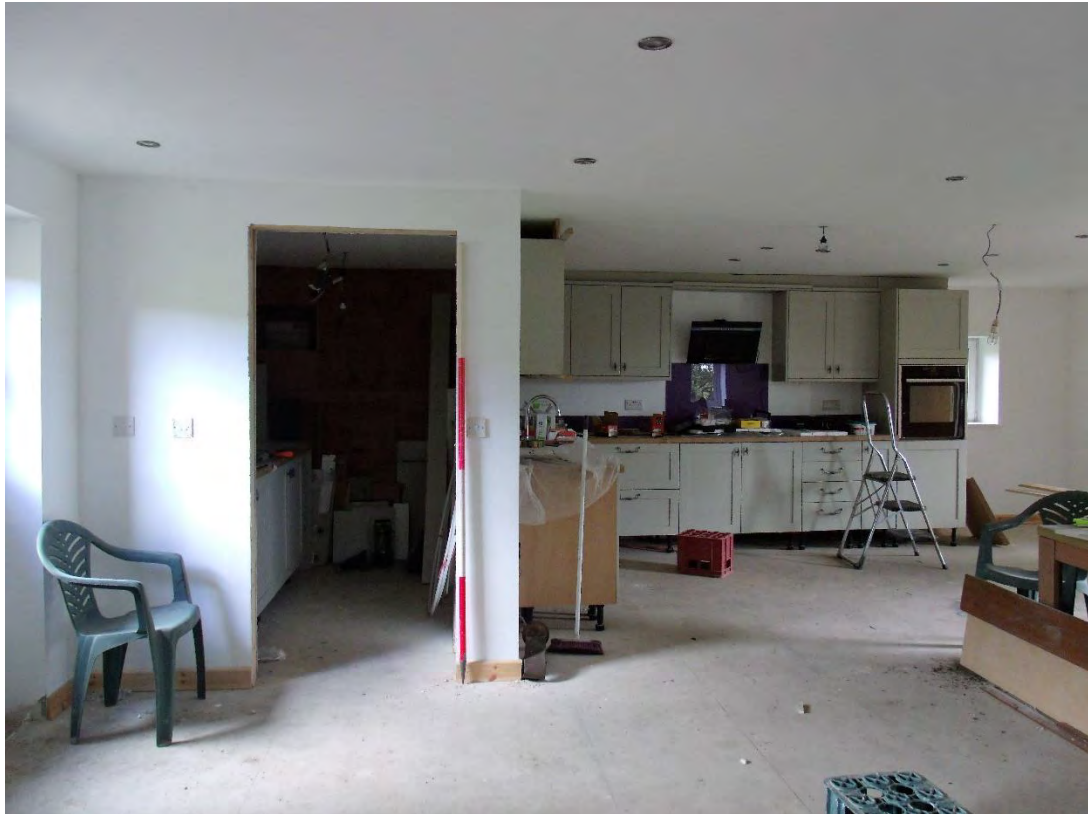
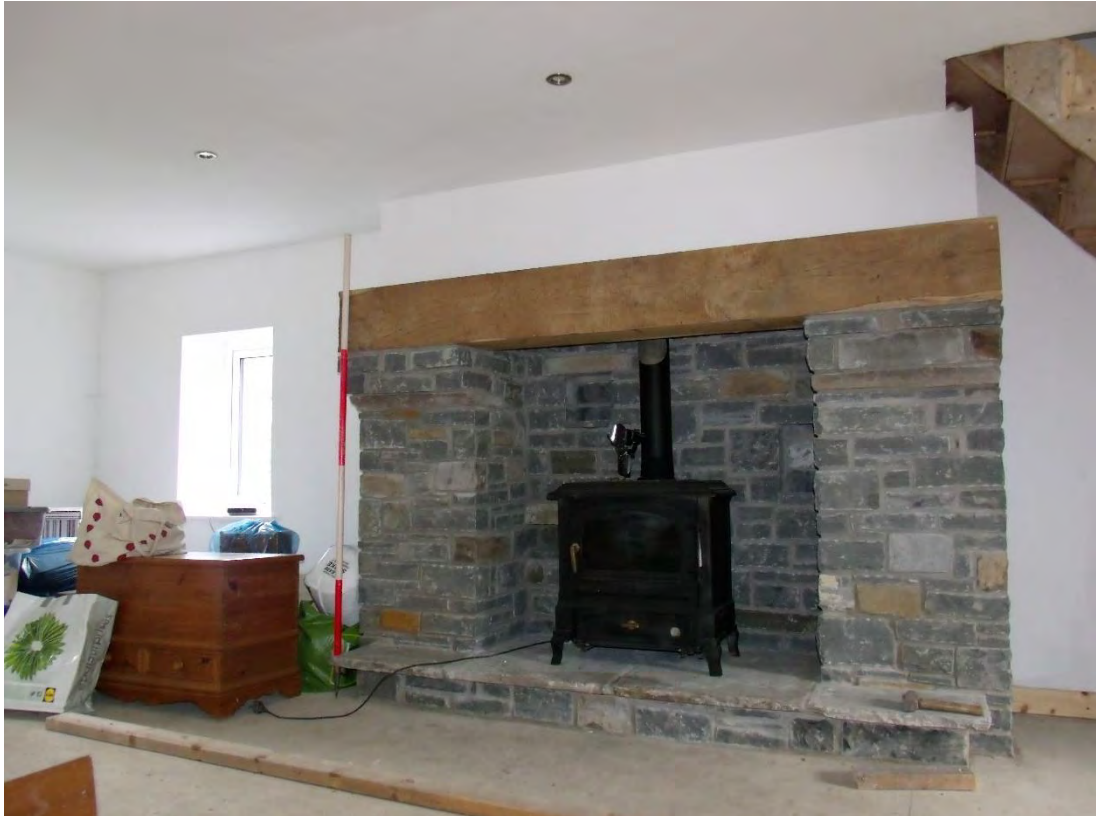
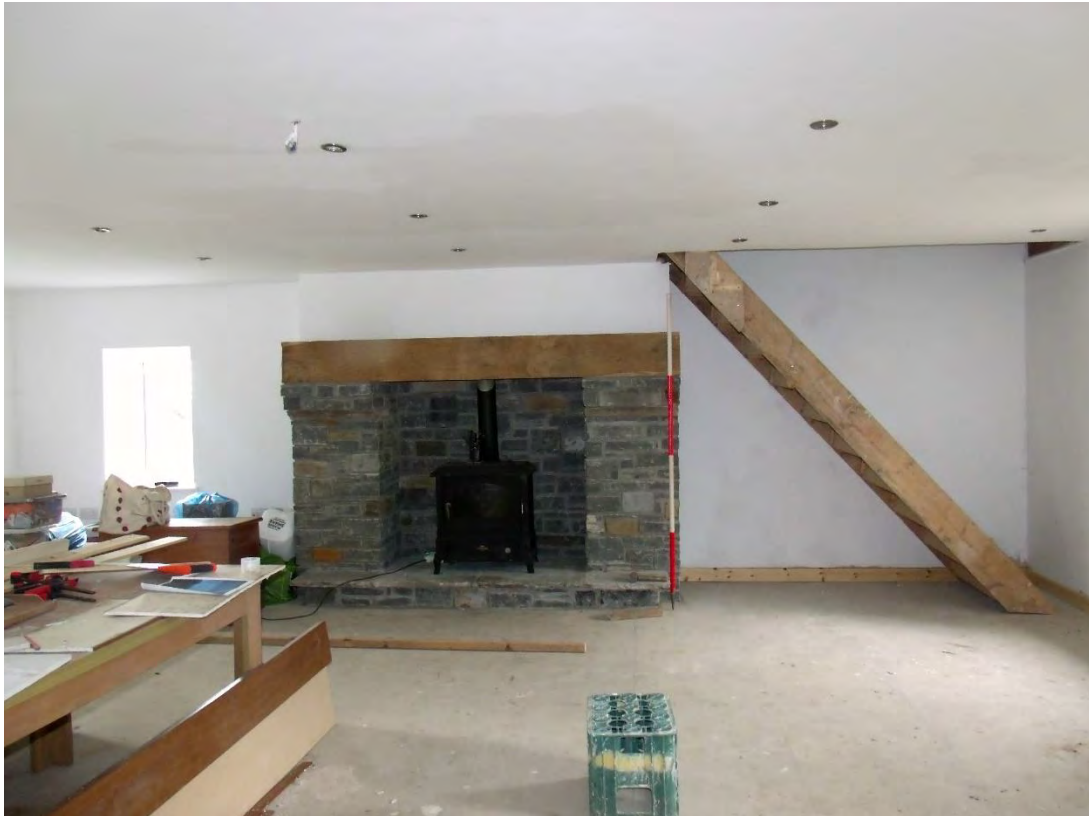
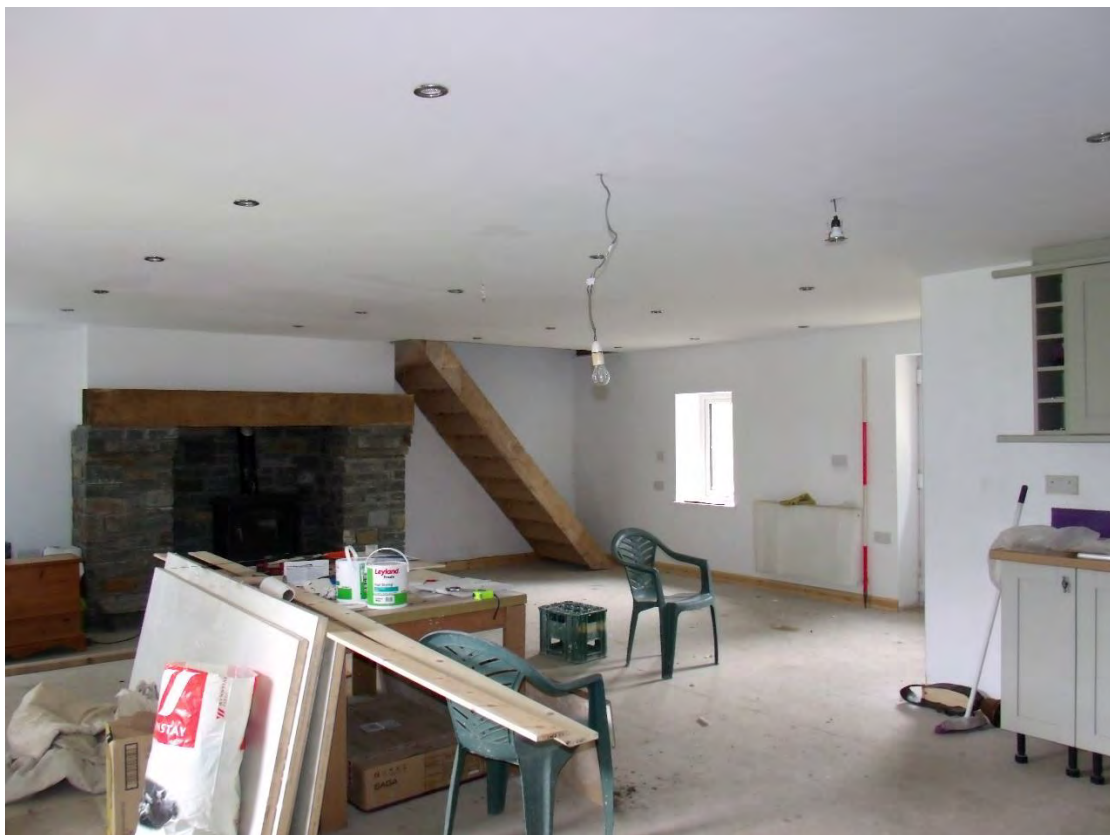
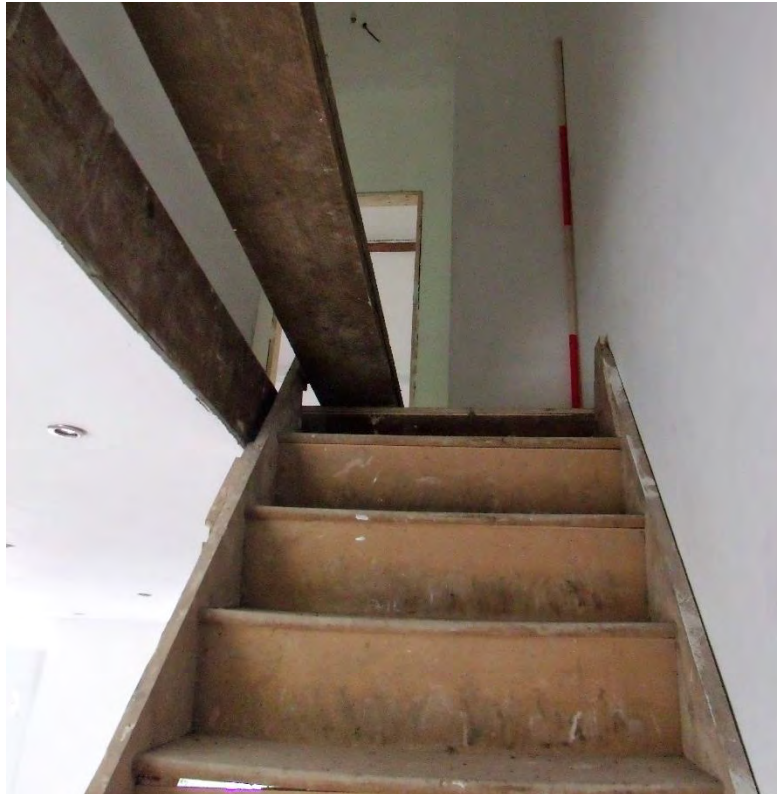
**Plate 21:** Interior, ground floor; view towards S. 2m scale.

**Plate 22:** Interior, ground floor; view towards SE. 2m scale.

**Plate 23:** Interior, ground floor; view towards E. 2m scale.

**Plate 24:** Interior, ground floor; view towards SW with rebuilt fire place in original location. 2m scale.

**Plate 25:** Interior, ground floor; view towards W with fire place and temporary staircase. 2m scale.

**Plate 26:** Interior, ground floor; view towards W with fire place and staircase. 2m scale.

**Plate 27:** Interior, staircase to first floor; view towards S. 2m scale.

- 6.3.2 The main door at the front (south) face entrance gives access to the main, open-plan living area of the ground floor. The entire space at the ground floor has been renovated, with wooden chipboard floor and white painted plaster on all wall and ceiling faces. New fittings for kitchen, heating and lighting have been incorporated, with kitchen unit places against the eastern gable wall. The single fireplace is located centrally on the western gable wall, in approximately the same location as an original fireplace. The squared fireplace has been built in slate with mortar bonding, and a large oak wooden lintel at the top. An iron wood-burning stove sits within the fireplace. There is a small utility room located at the north-east corner of the ground floor. At the north-west corner a provisional wooden staircase gives access to the first floor.

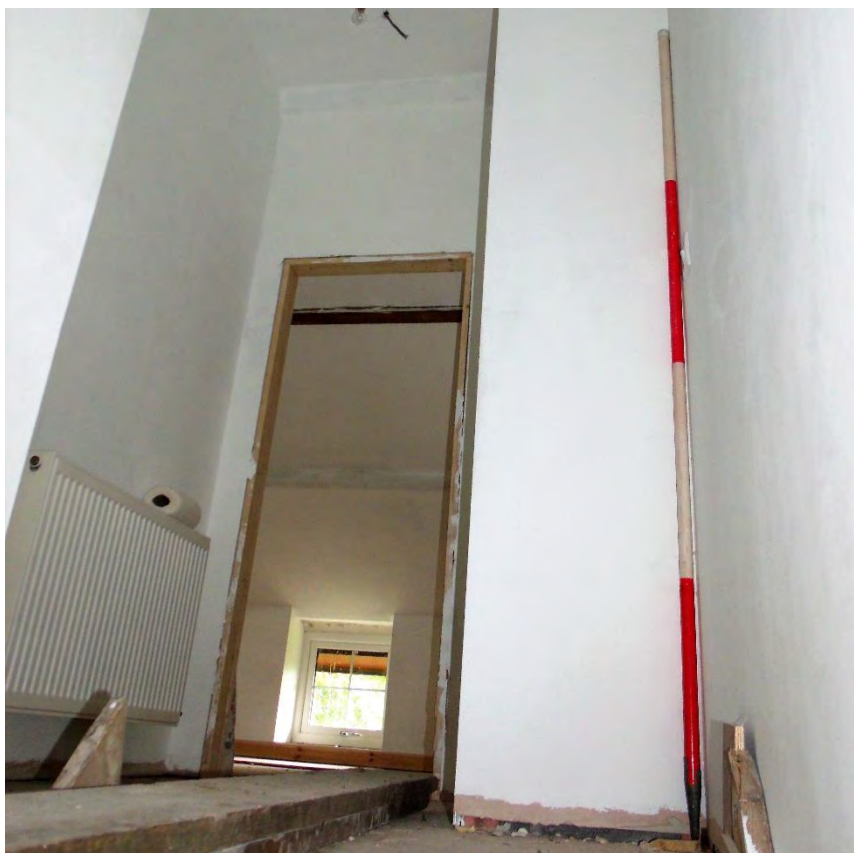
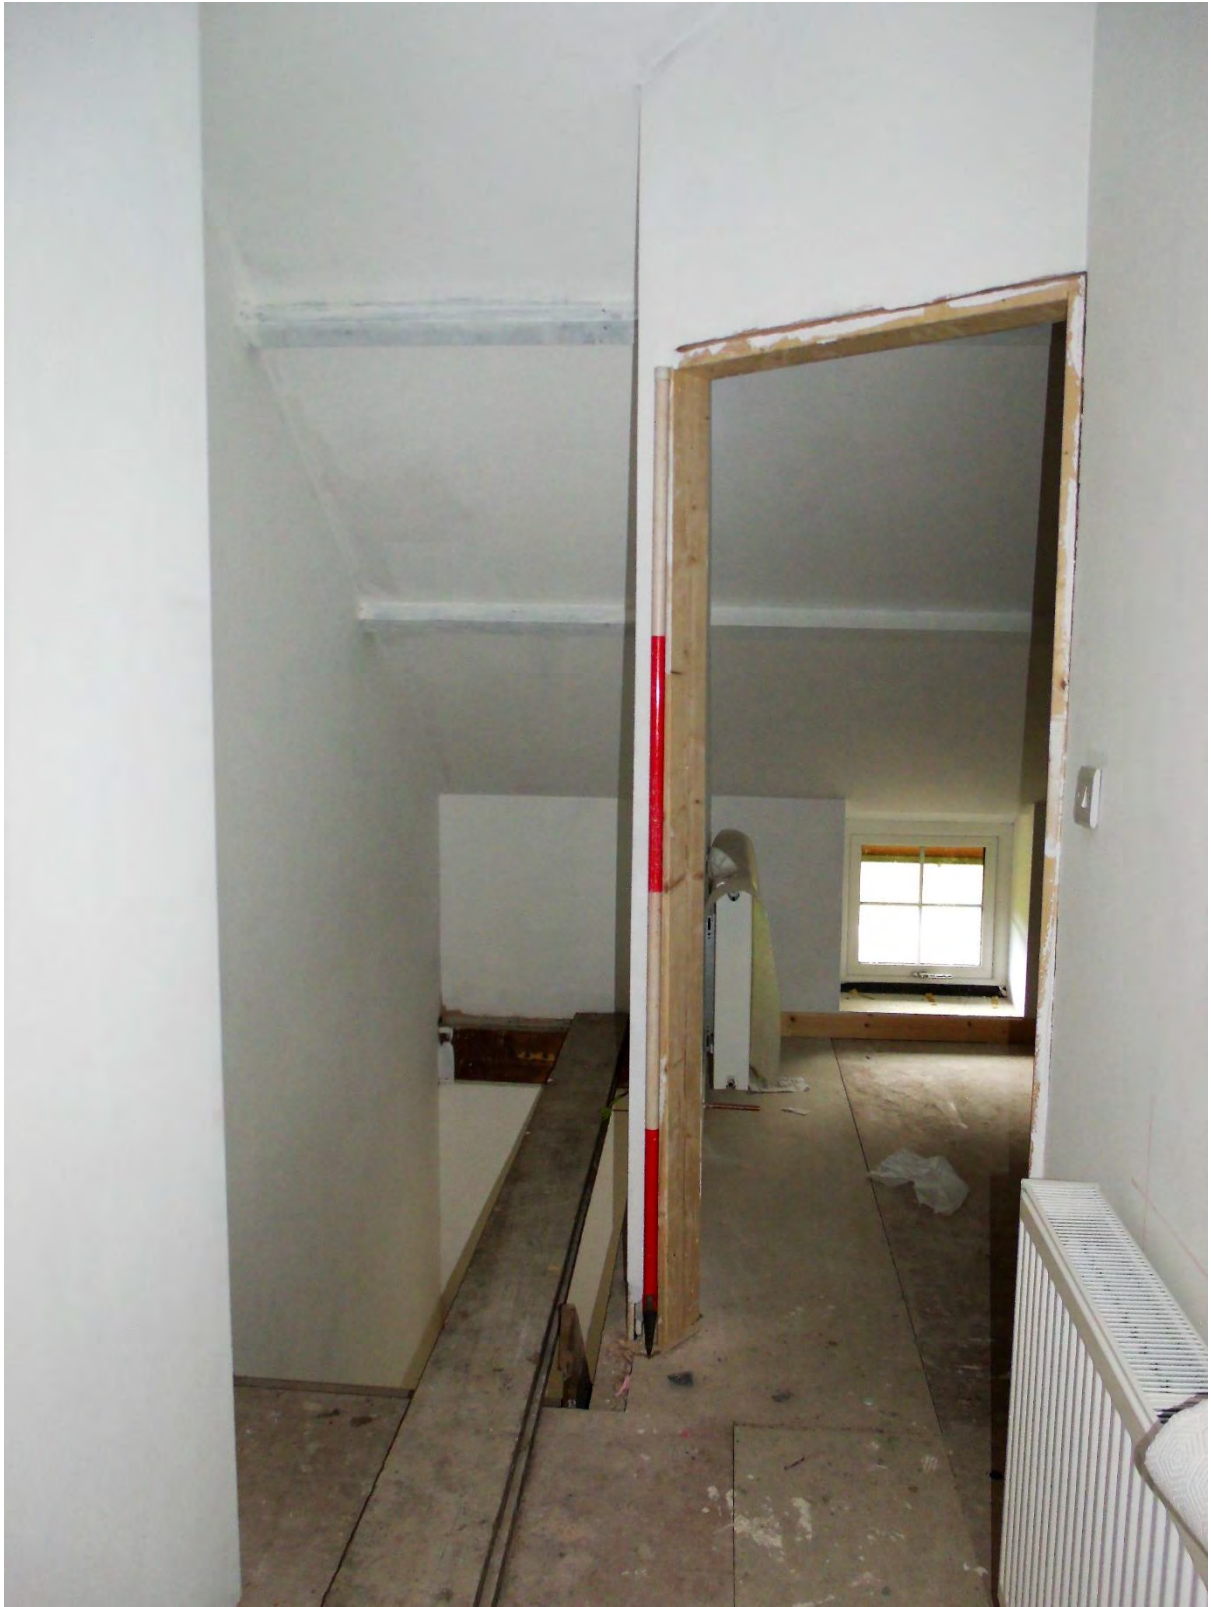
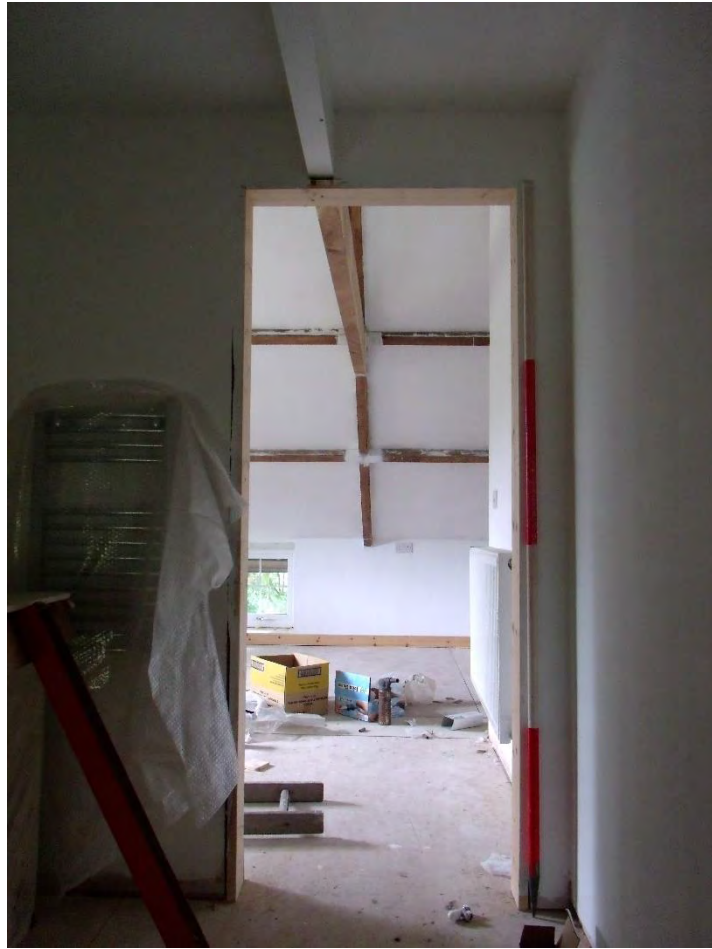
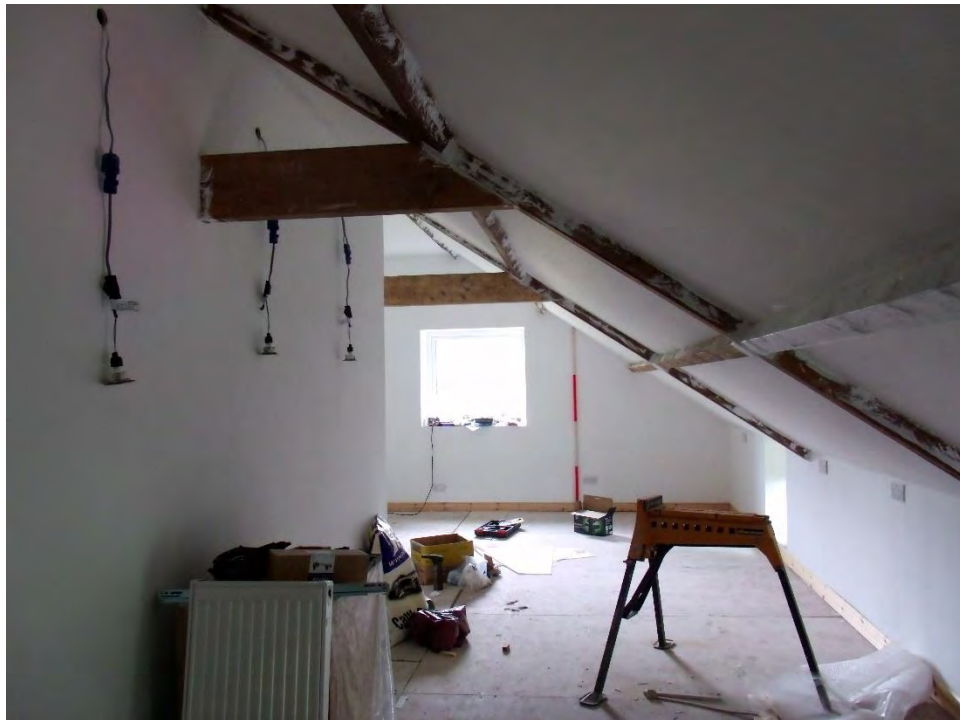
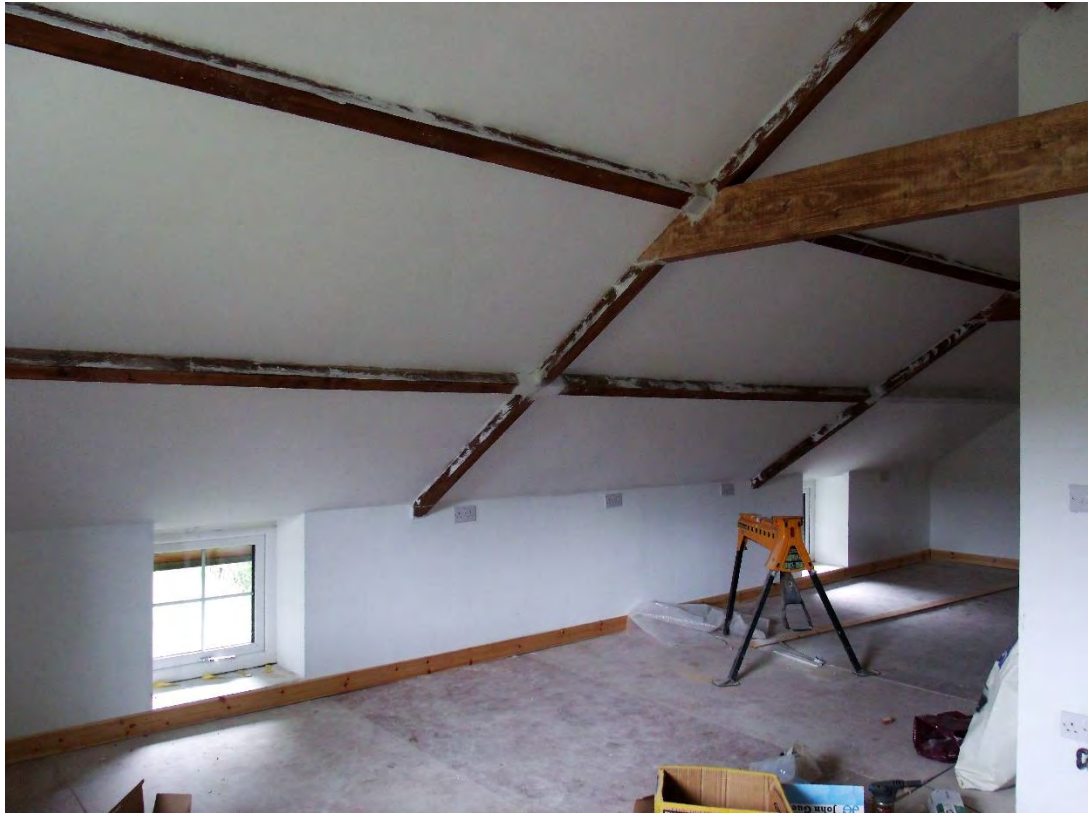
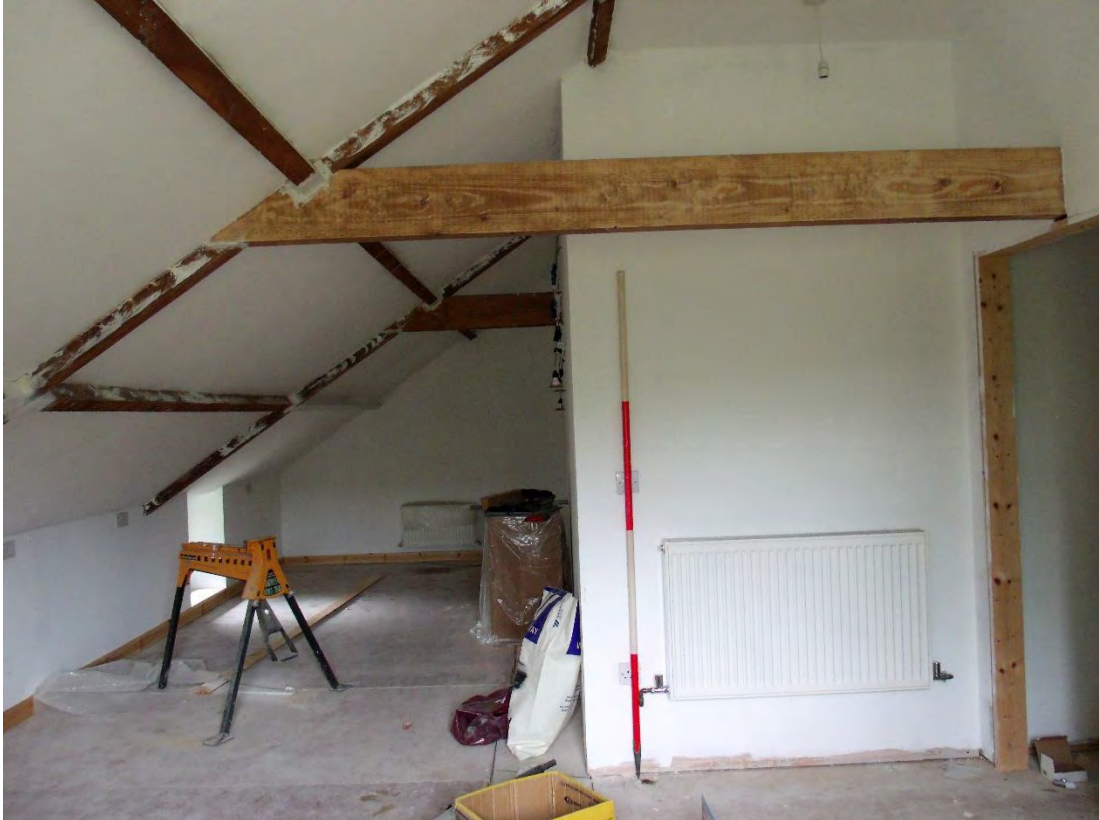
**Plate 28:** Interior, landing at first floor and entrance of Room 1; view towards S. 2m scale.

**Plate 29:** Interior, landing at first floor and entrance of Room 2; view towards N. 2m scale.

**Plate 30:** Interior, first floor, Room 1 entrance; view towards S. 2m scale.

**Plate 31:** Interior, first floor, Room 1 general view; view towards E. 2m scale.

**Plate 32:** Interior, first floor, Room 1 general view; view towards SW

**Plate 33:** Interior, first floor, Room 1, view of trusses; view towards W. 2m scale.

- 6.3.3 The provisional staircase gives access to a small landing (Plates 28-29) from which access can be gained to both Room 1 and Room 2. Room 1 (Plates 30-34) is located to the south of the house, with maximum dimensions of 10m x 8.5m in an L-shape, with 3.5m maximum width. A plaster wall has been built to create a partition with the *en-suite* area fitted to be converted into bathroom (Plate 34). This room has painted plastered walls and ceiling and wooden skirting, and wooden panel floors. The room is lighted by four windows, two at the front face, one at the eastern face, and one at the north face in the *en-suite* area. The room is open to the trusses and beams of the new roof, which are encased in painted plaster.

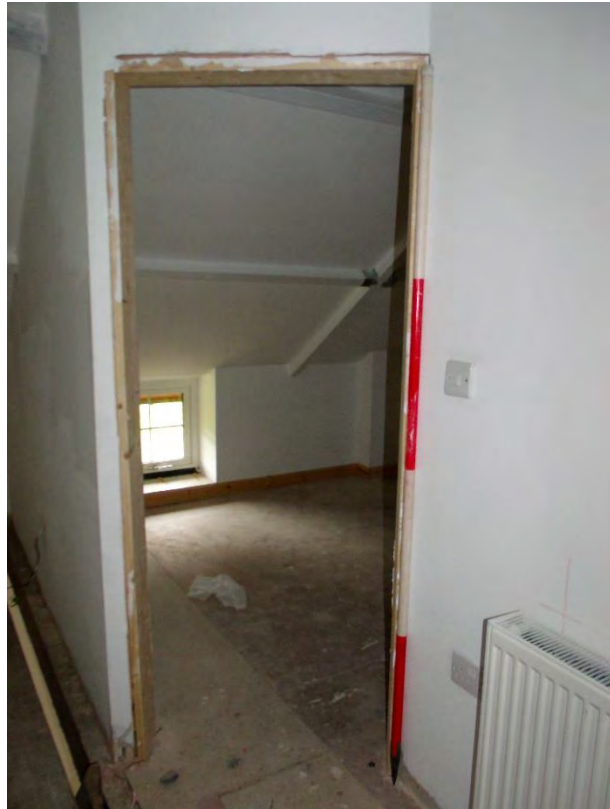
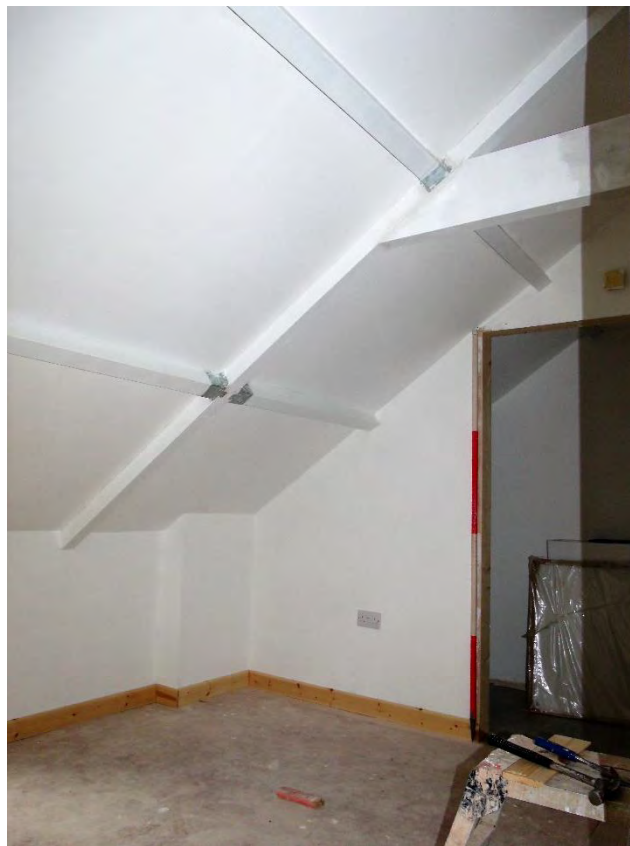
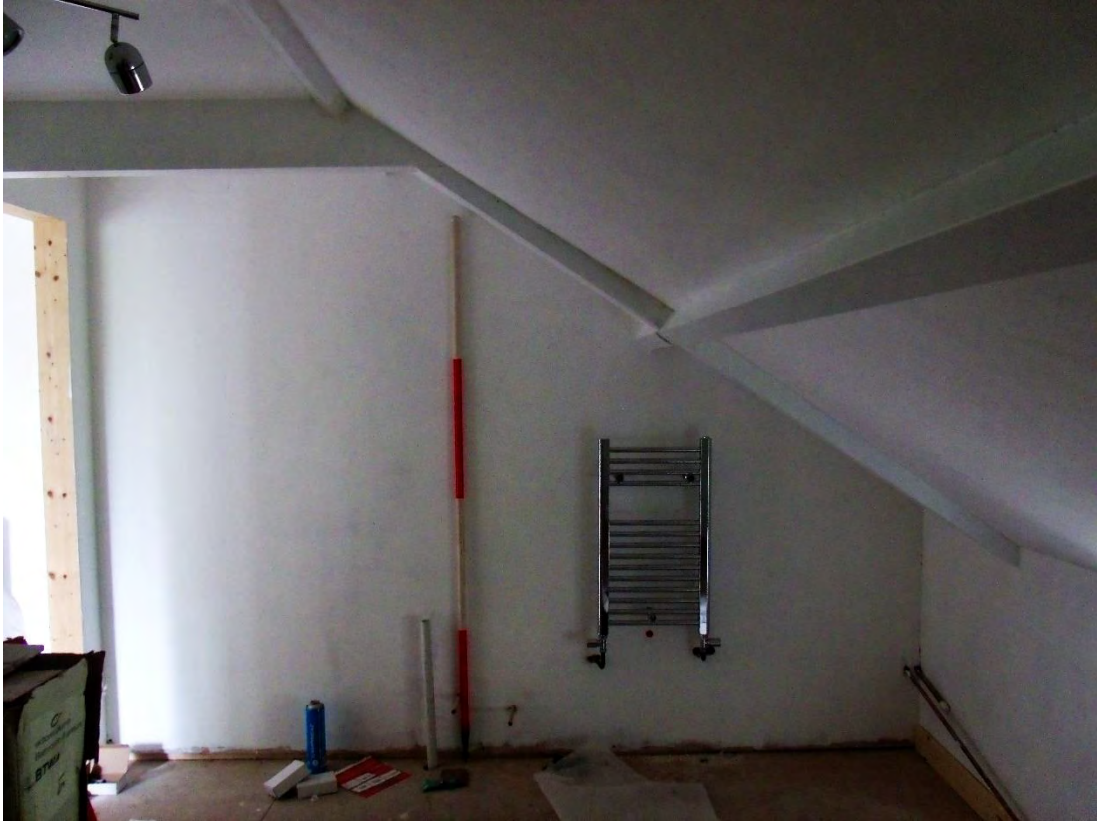
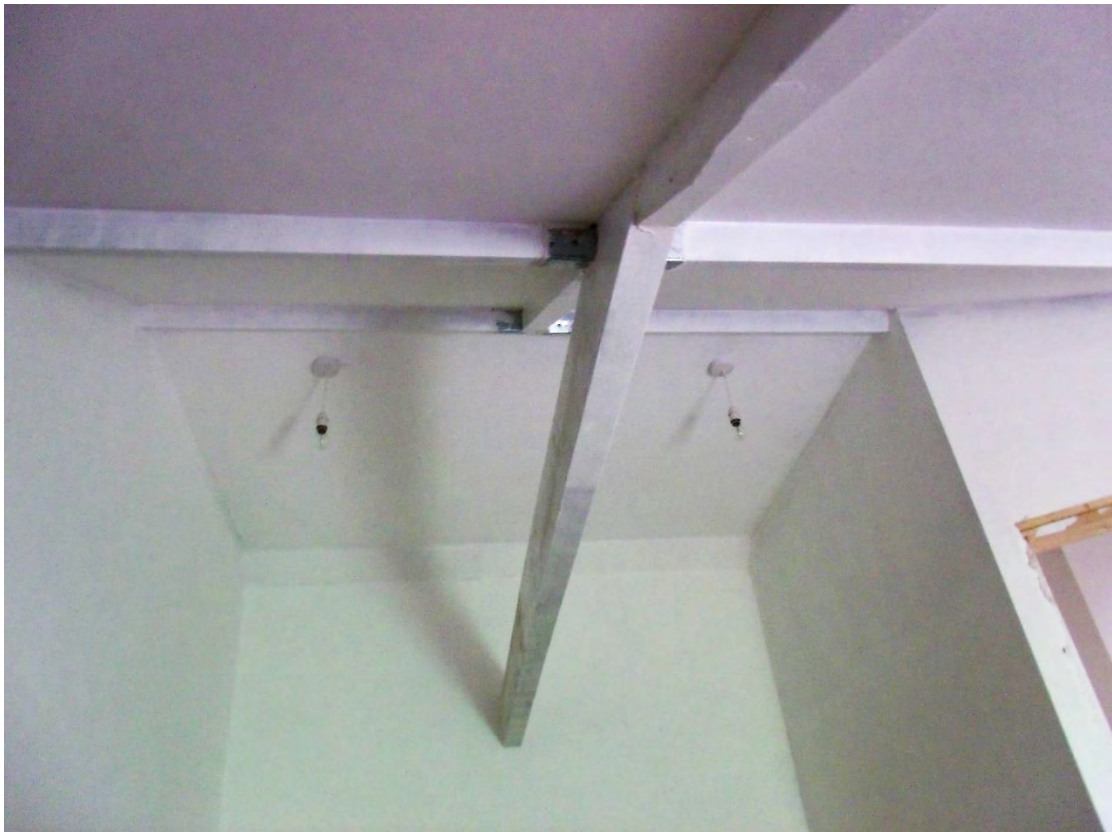
**Plate 34:** Interior, first floor, Room 2 entrance; view towards N. 2m scale.

**Plate 35:** Interior, first floor, Room 2 general view with wardrobe; view towards NE. 2m scale.

**Plate 36:** Interior, first floor, Room 2 general view towards W. 2m scale.

**Plate 37:** Interior, first floor, Room 2 detailed view of trusses; shot facing S-SW

- 6.3.4 Room 2 (Plates 35-37) is located to the northwest of the house, with maximum dimensions of approximately 4.5m by 3.5m orientated north-south, and one window at the north face. A plaster wall has been built to the

eastern side to create a small partition with the *en-suite* area, fitted in this case to be converted into a wardrobe. This room has painted plastered walls and ceiling and wooden skirting, and wooden panel floors.

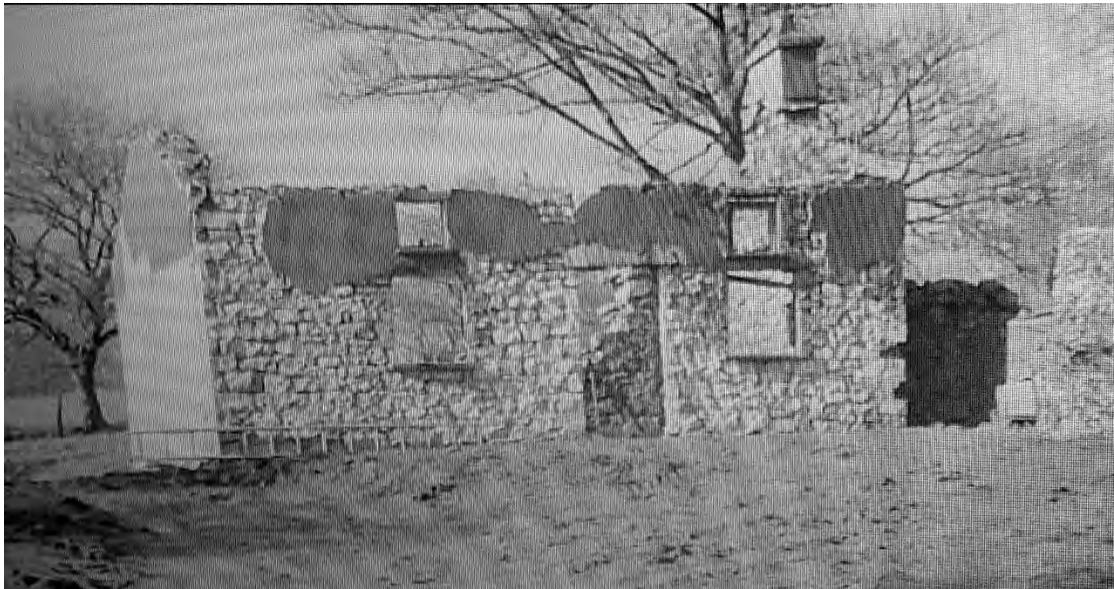
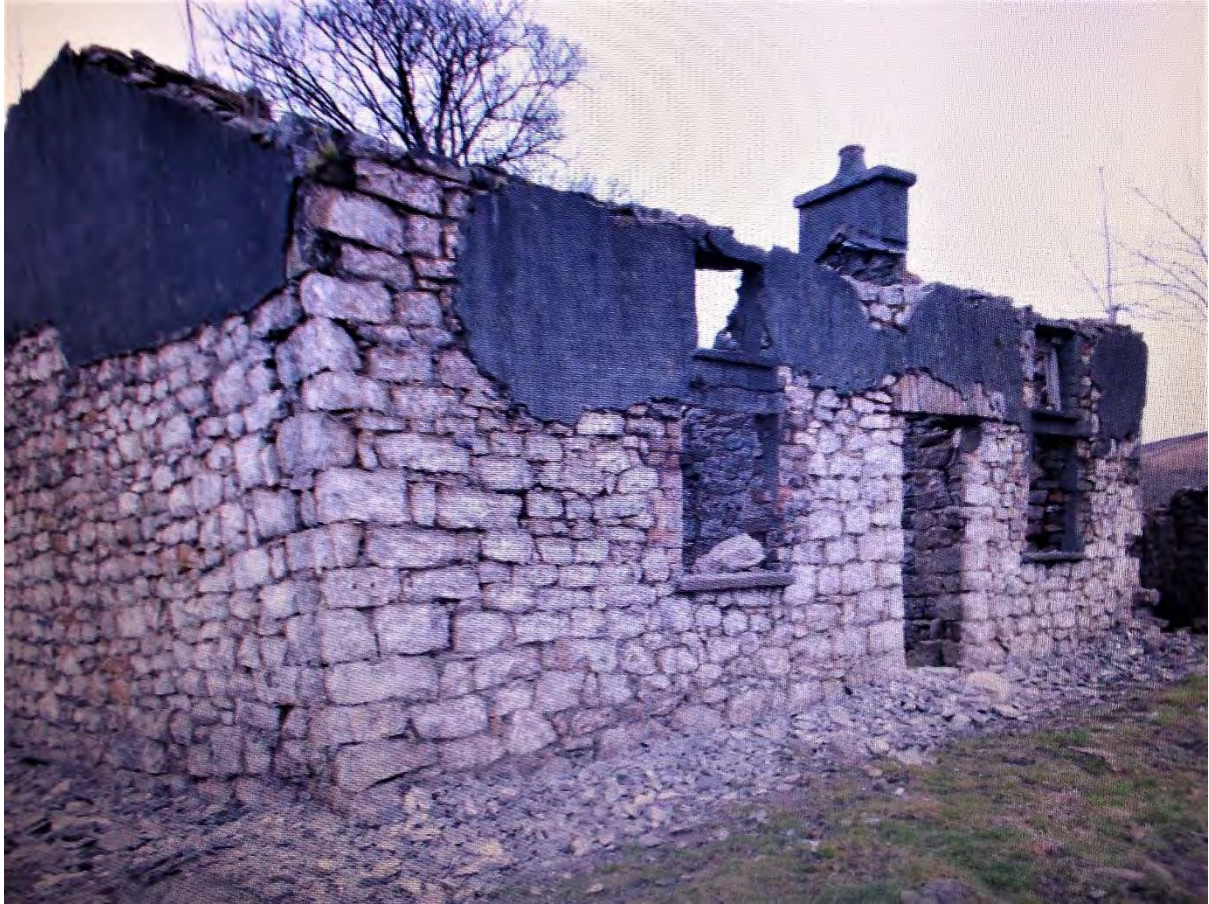
**Plate 47:** Photo of the house taken prior to renovation work, showing front (South) elevation. Shot facing NNE

**Plate 48:** Photo of the house taken prior to renovation work, showing front (South) elevation and part of the west elevation. Shot facing ENE

- Window inserts in east and west gable walls. Both walls appear originally to have been featureless.
- External wall render. Pre-renovation photos (plates 47 and 48) suggest the exterior faces of the walls were at one point covered in dark-grey cement render, which had partly detached prior to renovation. This render may not have been an original feature itself, although original lime-mortar render is a possibility. The walls are now un-rendered.

- Chimneys. Pre-renovation photos indicate a centrally-placed chimney stood against the interior of the eastern gable wall. The chimney stack was stone-built, and covered in cement render, obscuring any original detail. A single ceramic chimney pot topped the stack. This chimney appears to originally have been mirrored by a second chimney on the opposing gable wall, but this had collapsed prior to renovation. The eastern chimney has now been removed, and the western chimney rebuilt in its original position, using stone and grey-brick.

- Repointing. Pre-renovation photos indicate mortar had largely weathered and/or fallen out from many of the joints in the stonework. This is likely to have been lime-mortar throughout. The building has now been extensively re-pointed in modern grey mortar.
