A.P.A.C. Ltd.

Watching Brief

LAND ADJACENT, COLLIERS WAY
TONYPANDY

WB/TYY/13

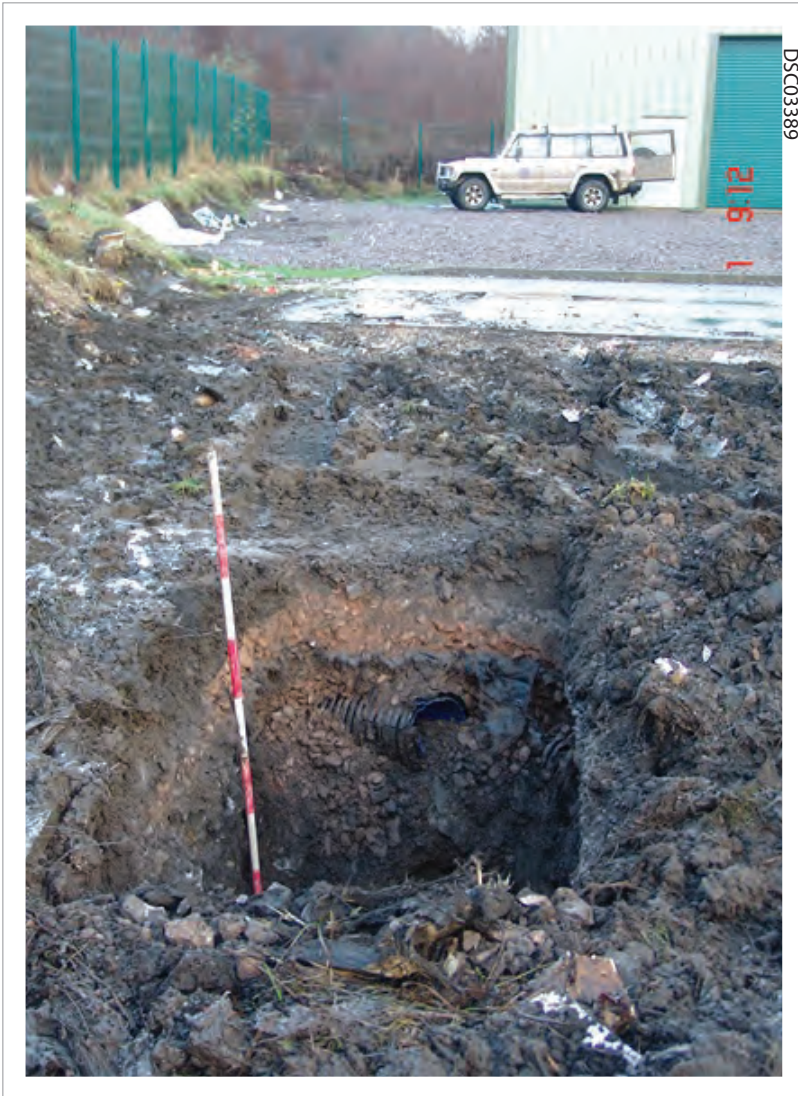
Plate 01: Soak-away 1. Various layers of land II and drain

The trench measured some 2m x 1.5m and reached a maximum depth of 1.75m, Plate 01.

On the far wall of the trench at about 600mm is a plastic land drain.

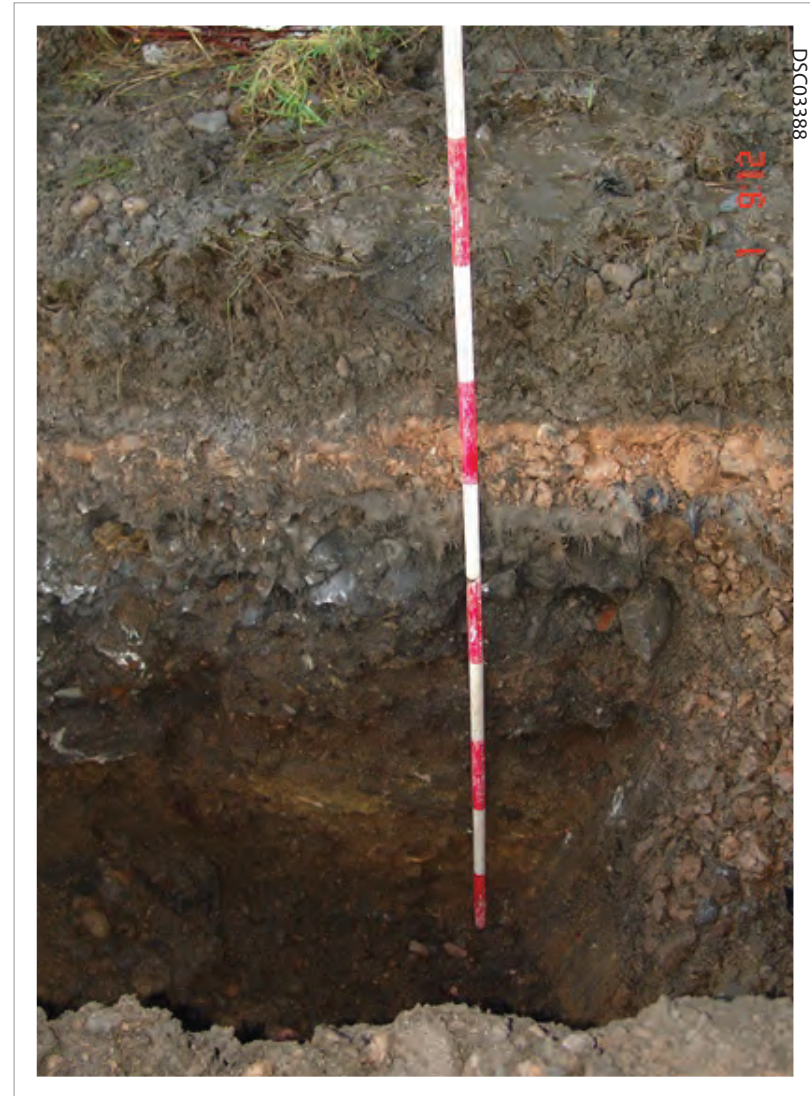
Plate 02: Soak-away 1. Various layers of land II

Plate 02 shows a make up of various deposits of land fill from the grey sandy rubble fill at the top, through orange chippings on 'Terram' to coarse grey rubble, fine reddish rubble and finally a boulder bottom in dark grey silt.

The trench revealed no significant artefacts other than occasional bits of clothing, a few bits of industrial metal and polythene sheeting. The latter in evidence from the bottom of the trench.

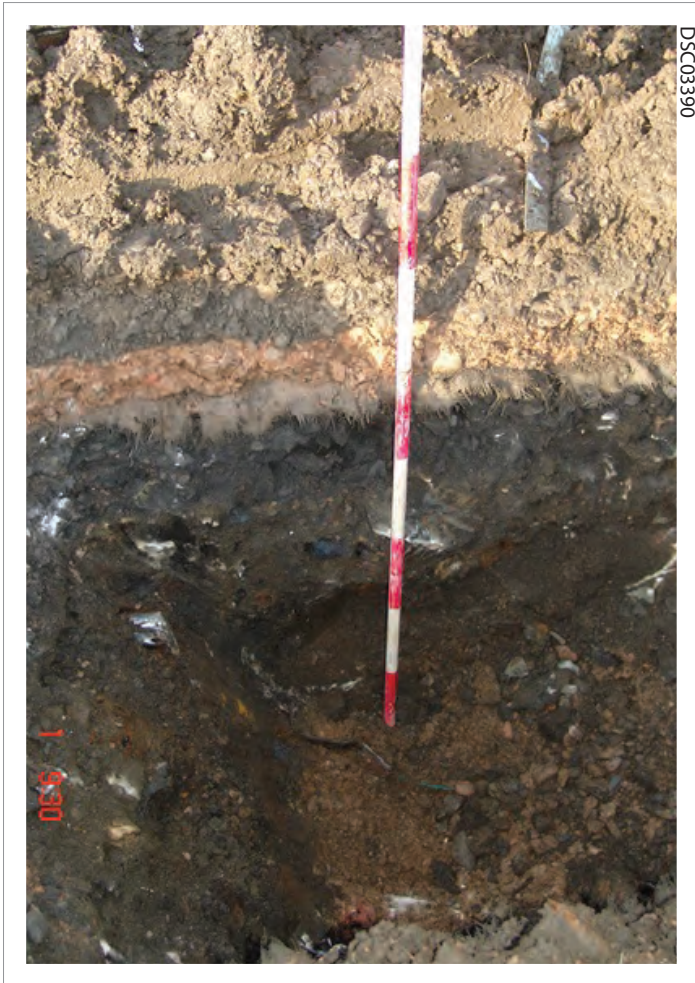
Plate 03: Soak-away 2. Various layers of land II

The second trench was excavated to the north of the 'T' roadway in the area of gravel, fig 02. This trench was similar in size to 1 but reached a depth of only 1.3m as required in the plans.

The sequence of land fill was identical to that of 1 with the exception of no land drain.

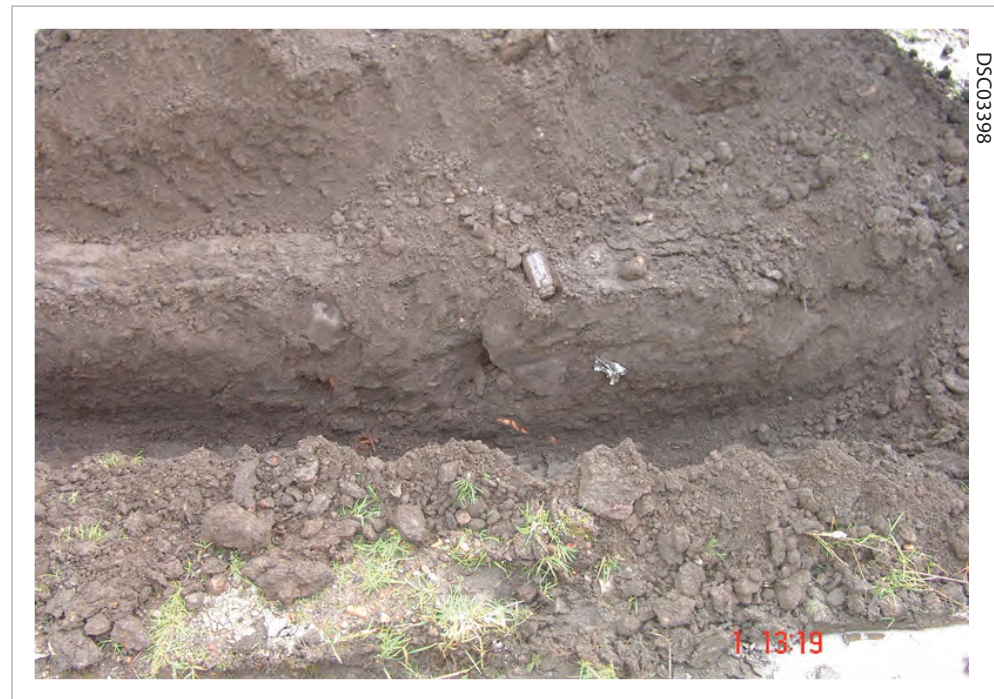
Plate 04: North end of TR3. Black clay/sand. (plastics, glass and brick)

The northern 10m of the trench, from the corner of the building to the front consisted of a black sandy soil with a few bits of glass and brick and plastic, Plate 04, however the deposit sequence changed abruptly after that, replaced by the same fill as seen in trenches 1 & 2.

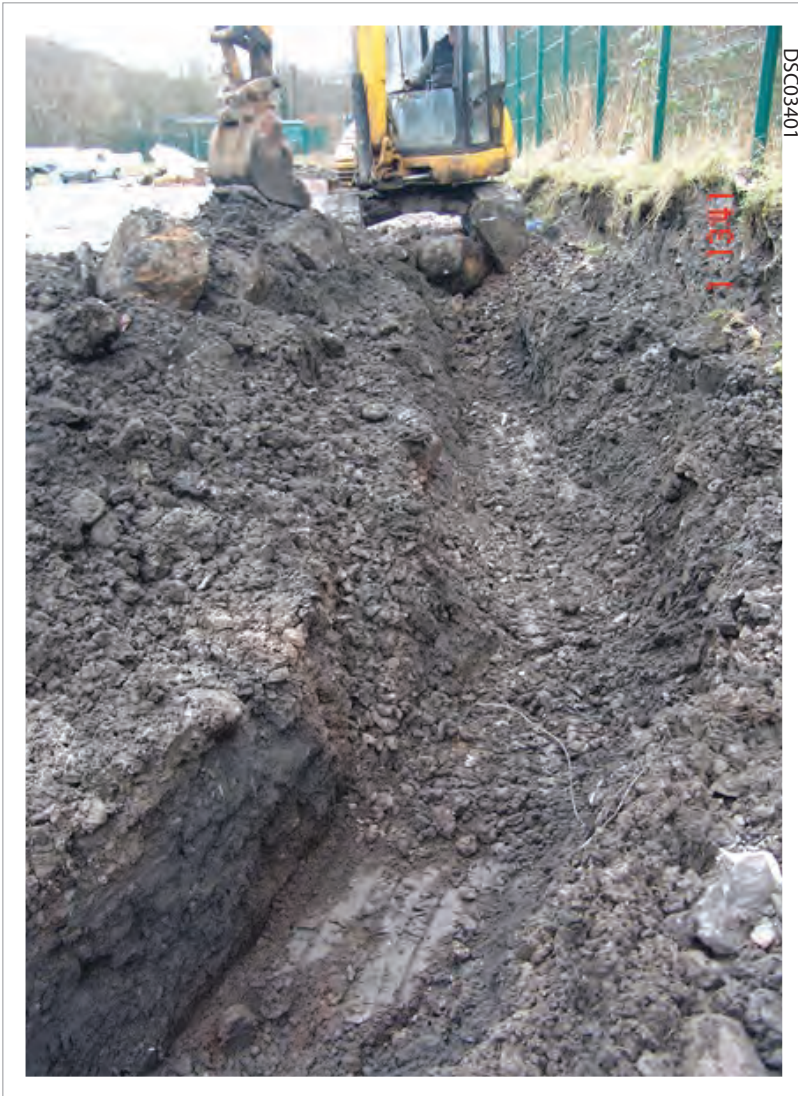
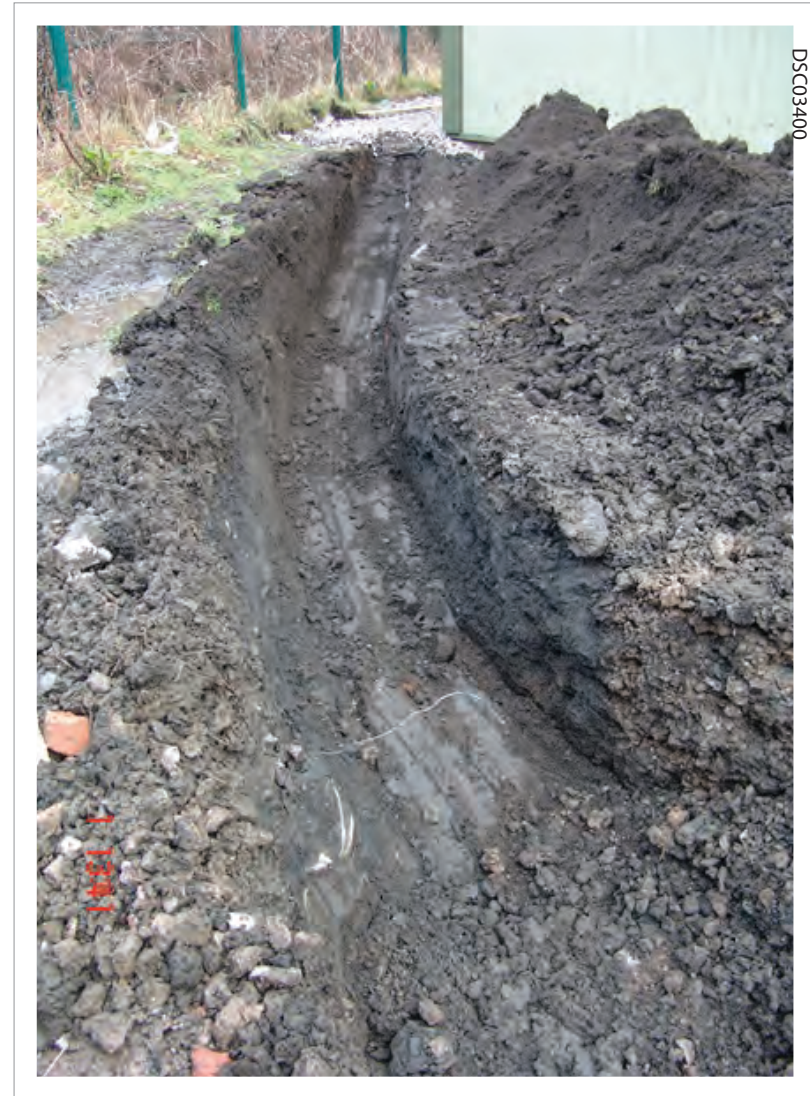
The abrupt change can be seen in Plates 05 & 06.

Plate 05: Overview of TR3, southern end, Cut line on left side of trench

Plate 06: Overview of TR3, northern end

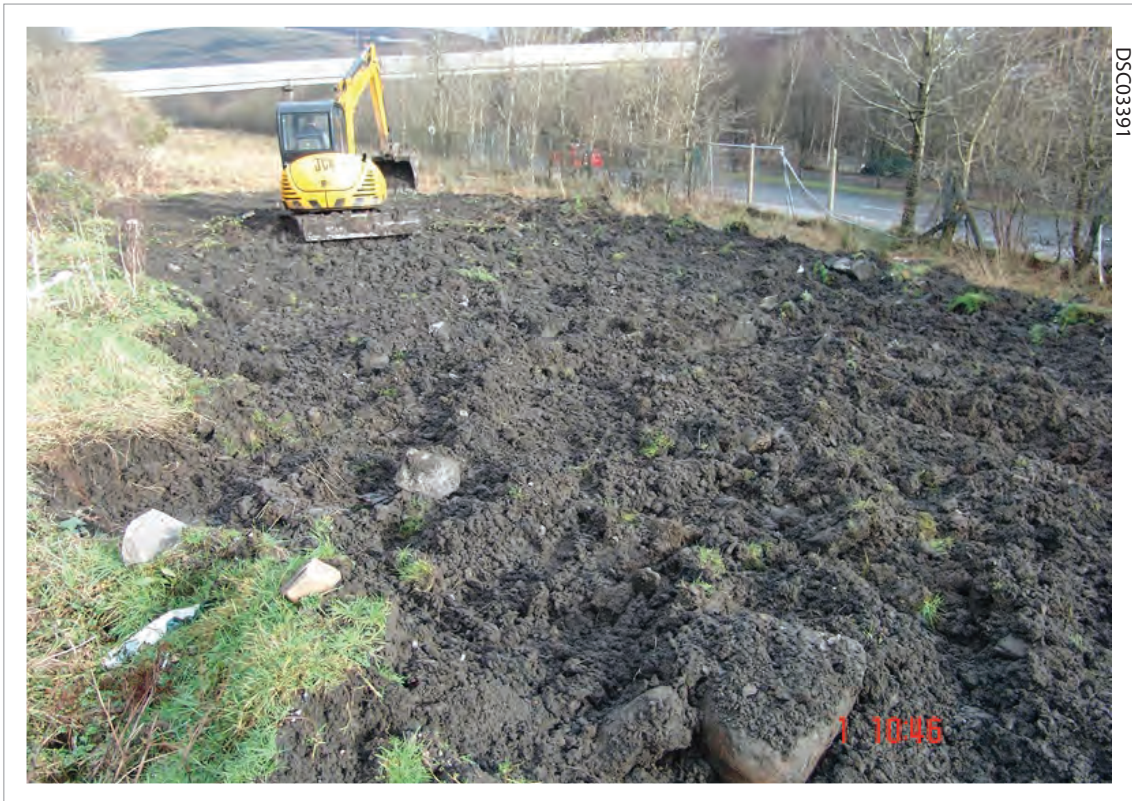
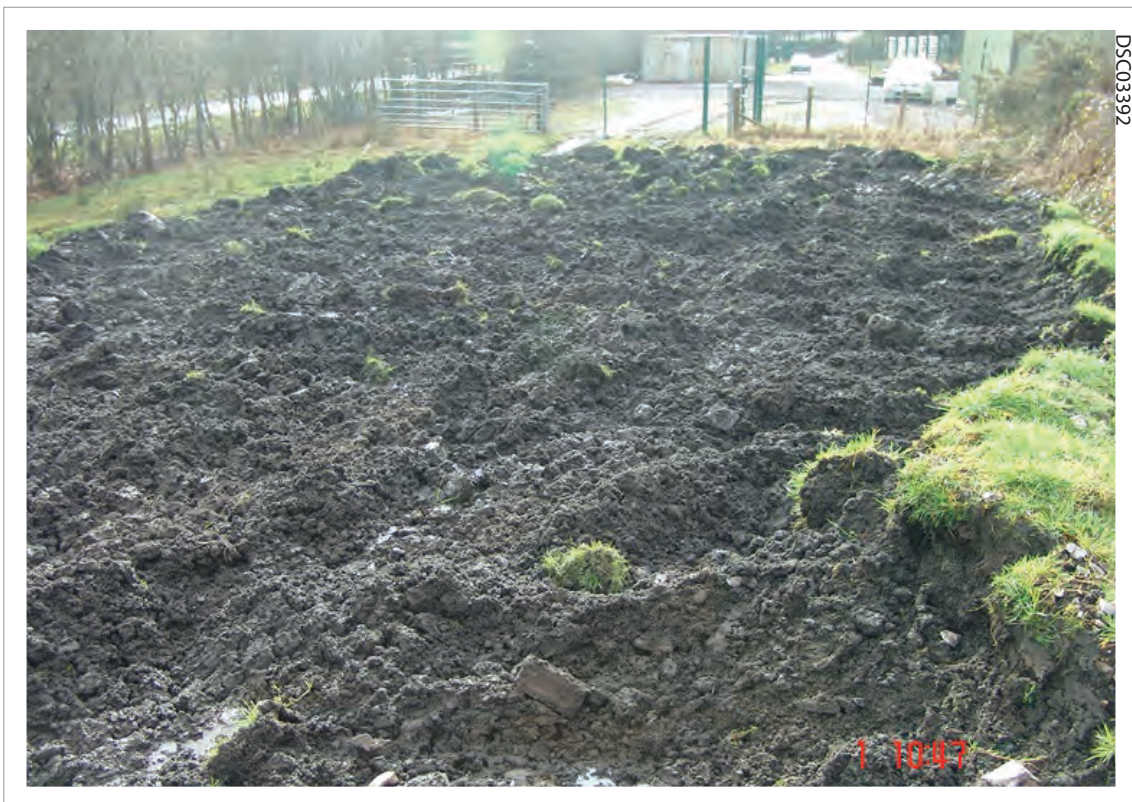
The spoil area consisted of a bank or bund along the fence line of the enclosed field to the north of the storage shed, fig 02.

Part of the bank can be seen to the left in Plate 07 and the right in Plate 08.

The spoil had been derived from earlier work at the site as well as the recent construction of the storage shed.

Plate 07: View over spoil area

Plate 08: View over spoil area

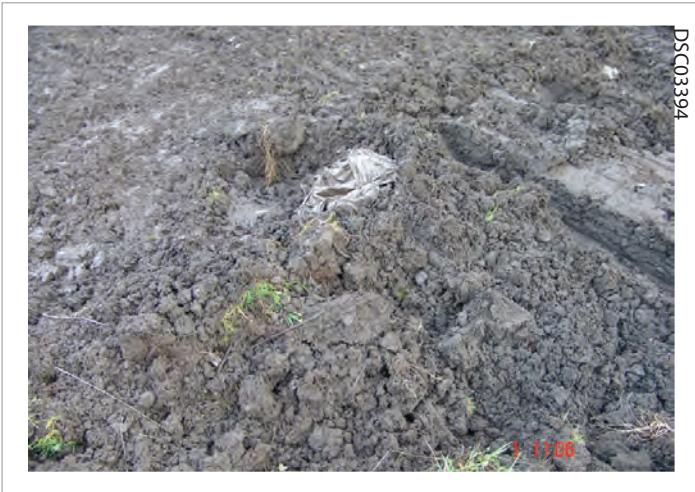
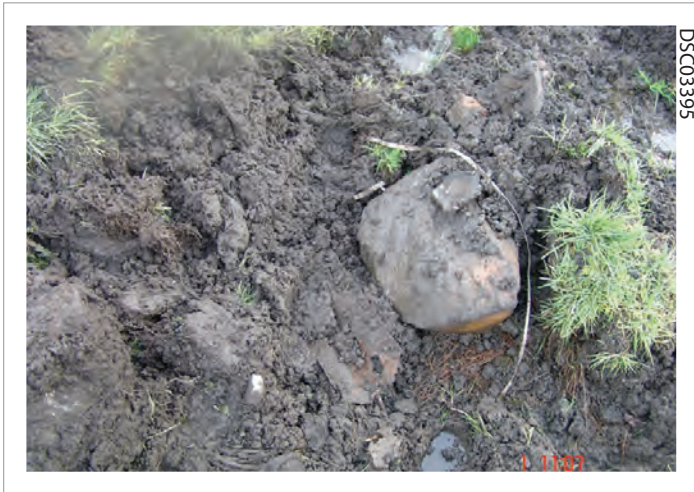
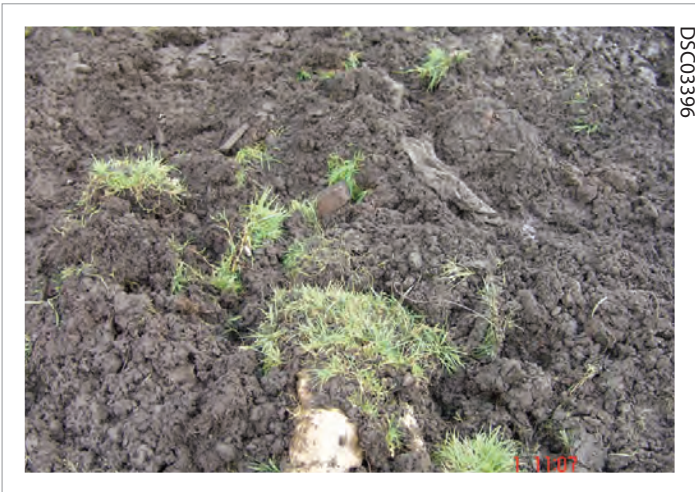
No finds of any archaeological significance were found and Plates 09, 10 & 11 show some instances of modern debris contained within the spoil.

Plate 09: Detail of spoil (plastics)

Plate 10: Detail of spoil (metal)

Plate 11: Detail of spoil (metal, plastic, foam and brick)
