Glandovan Mansion, Cilgerran, Cardigan

Archaeological Watching Brief
and Level 2 (equivalent)
Building Recording

Report No. 1885

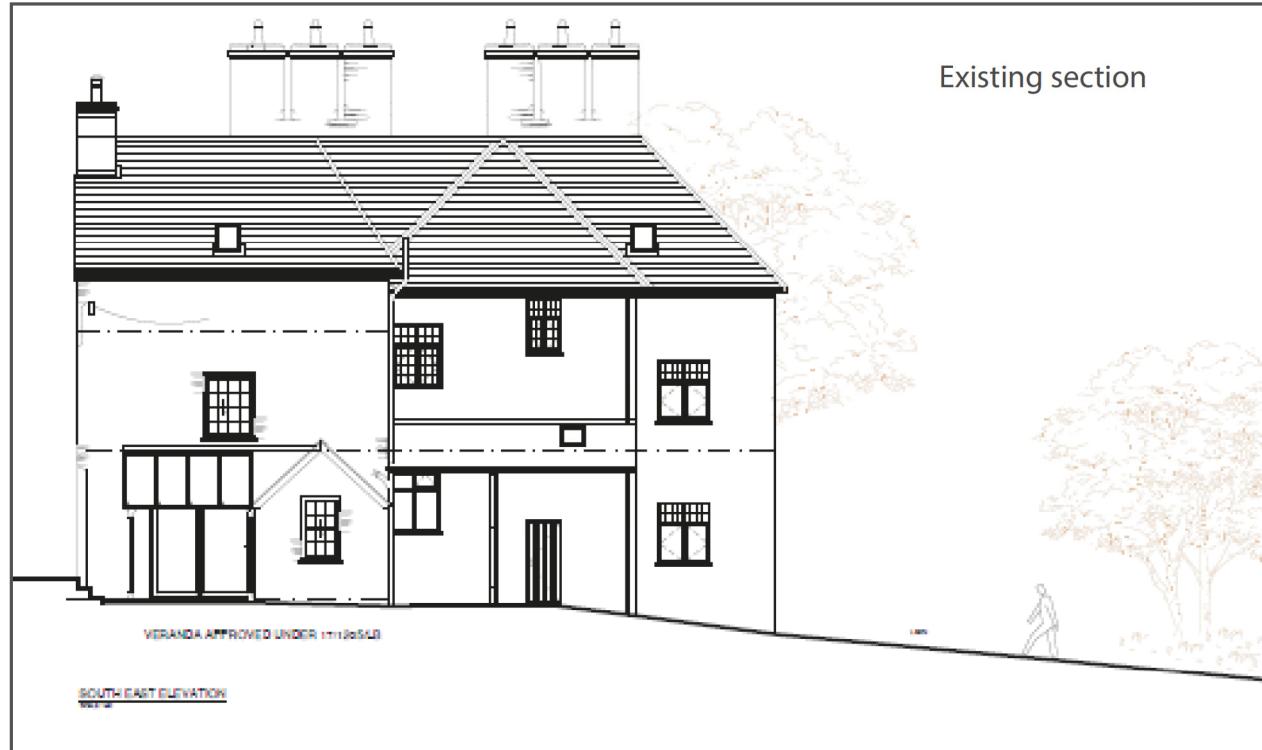
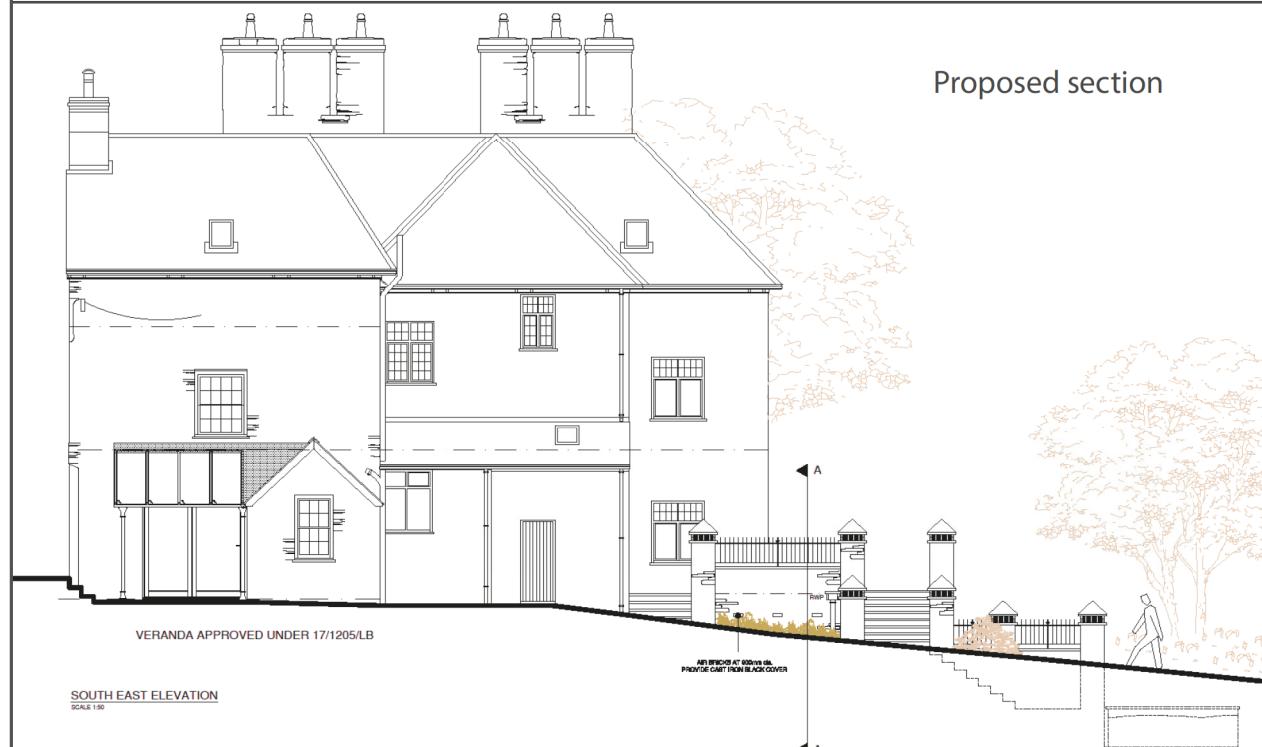
Figure 4 Existing and Proposed Sections

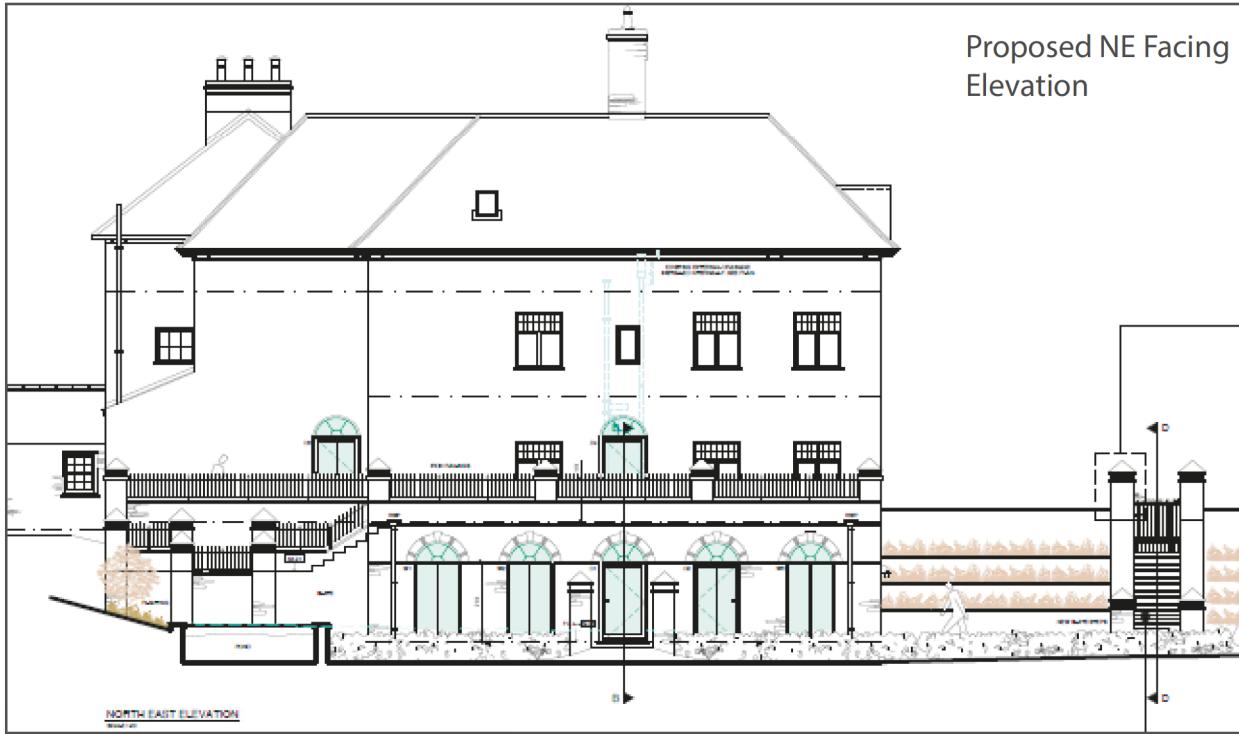
Figure 5 current and proposed NE Facing Elevations

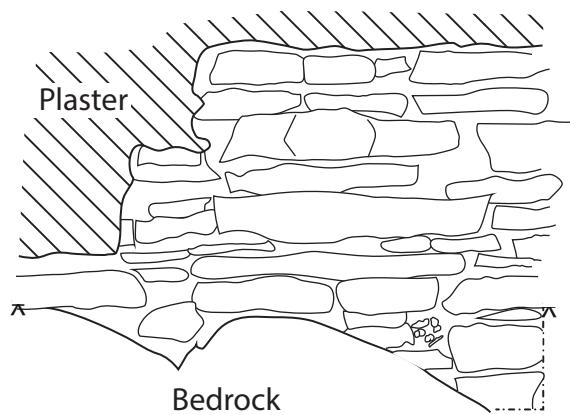
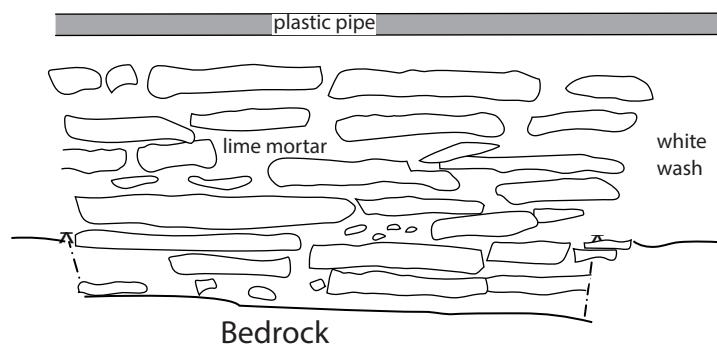
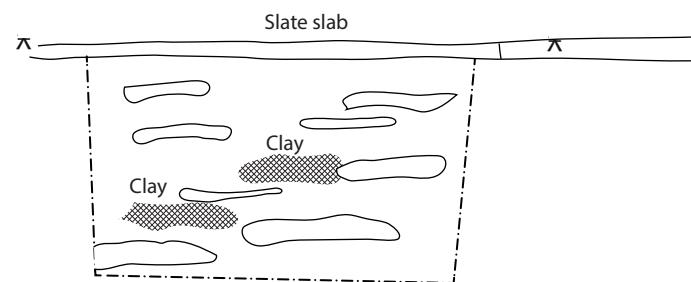
TP1, NE Facing section

TP2, SW Facing section

TP3, NE Facing section

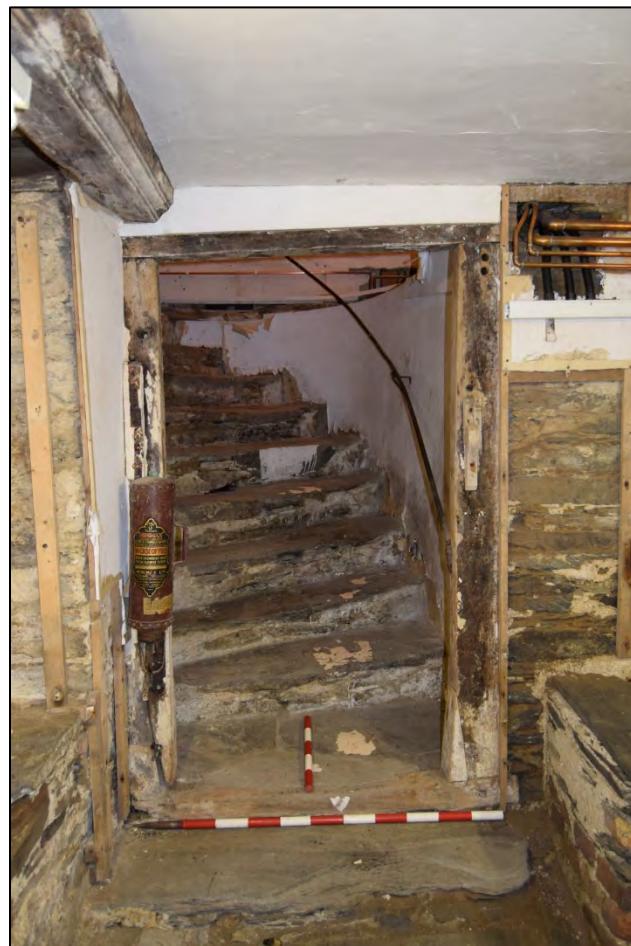
Plate 7: NE Facing Elevation of the Stair Hall, looking south west, 2m & 1m scale.

The first floor opening in the stair hall contains a four light casement window with each light comprising leaded panes made up of between 6 and 12 individual lights (plate 7). This opening will also be extended replaced by a new French door.

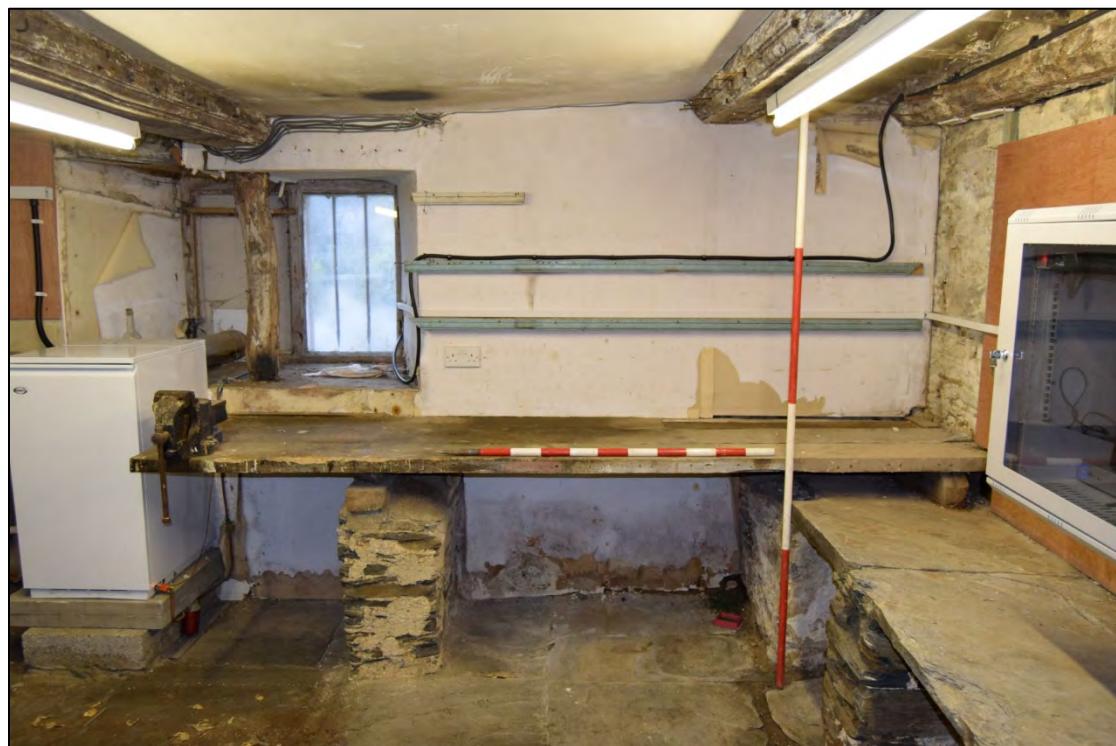
Plate 13: Basement corridor, lath and lime plaster partition wall looking south west, 2m & 0.5m scale.

The basement walls are of local uncoursed, faced, rubble stone covered variously with 20th century softwood battens and plasterboard or whitewash. The plasterboard has been damaged and removed from large parts of the basement exposing the bare stonework. On a wine cellar partition wall part of the modern battening and plasterboard has been removed to reveal an earlier, probably 19th century, covering of lath and lime plaster (plate 13).

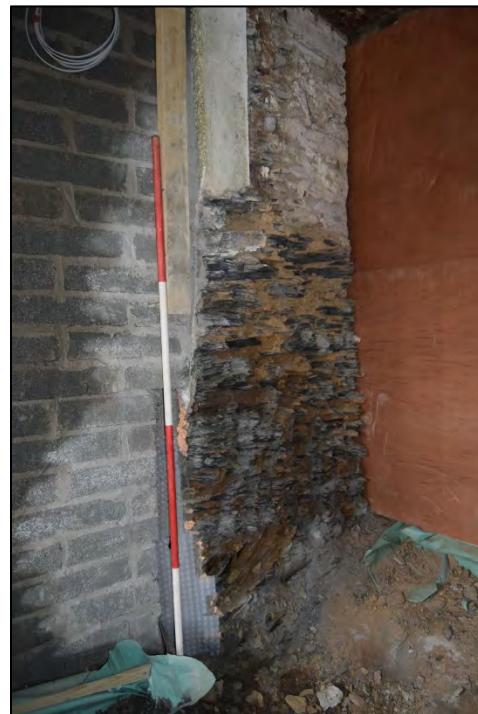
Plate 20: Basement, new doorway opening (north), looking south south-west, 2m scale.

The extension of three former window openings to the floor level to create new doors was observed by AW archaeologist Jerry Bond on 17th March 2020, following construction of the new terrace. Two of the extended openings were located in the NE wall of the Basement (plates 20-21) and the third was located in the NE wall on the First Floor of the stair hall (plate 22). It had been thought that the latter alteration may expose the original stonework and potentially provide evidence to whether the Stair Hall was from a different, possibly earlier, phase of construction than the main house.

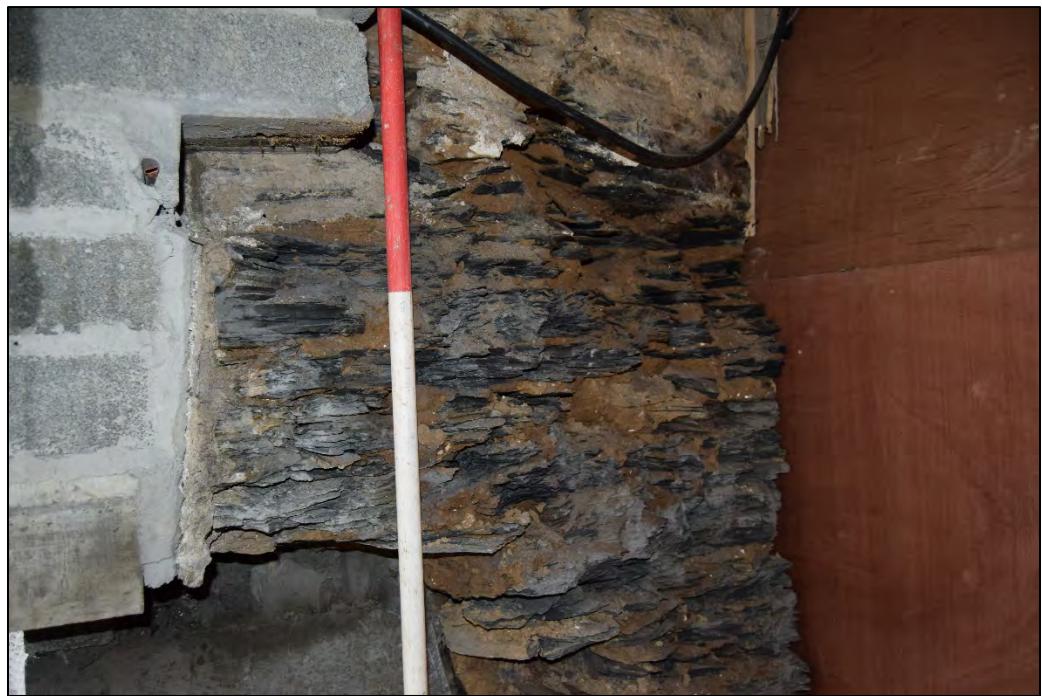
Plate 21: Basement, new doorway opening (south), looking south south-west, 2m scale.

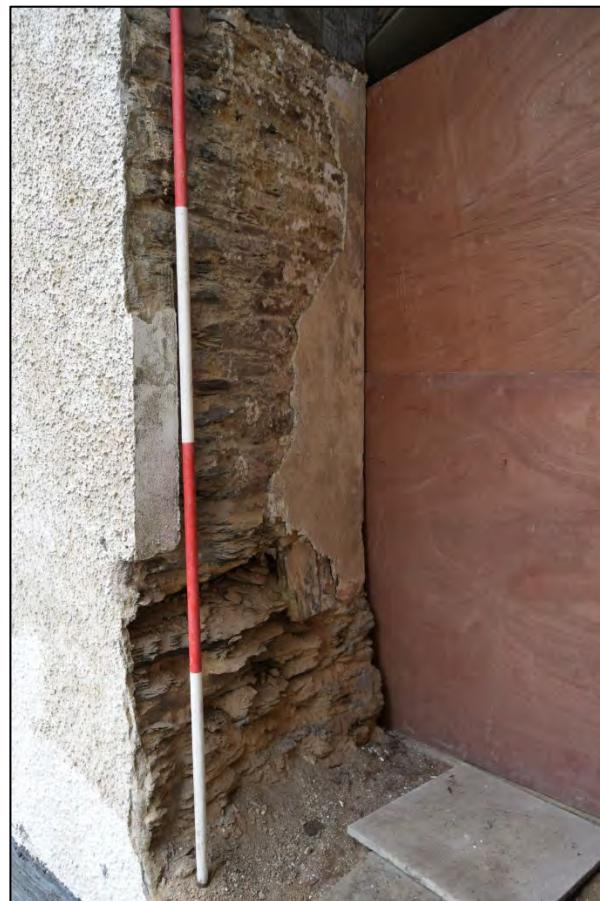
Plate 22: Stair Hall, first floor, new doorway opening, looking south south-west, 2m scale.

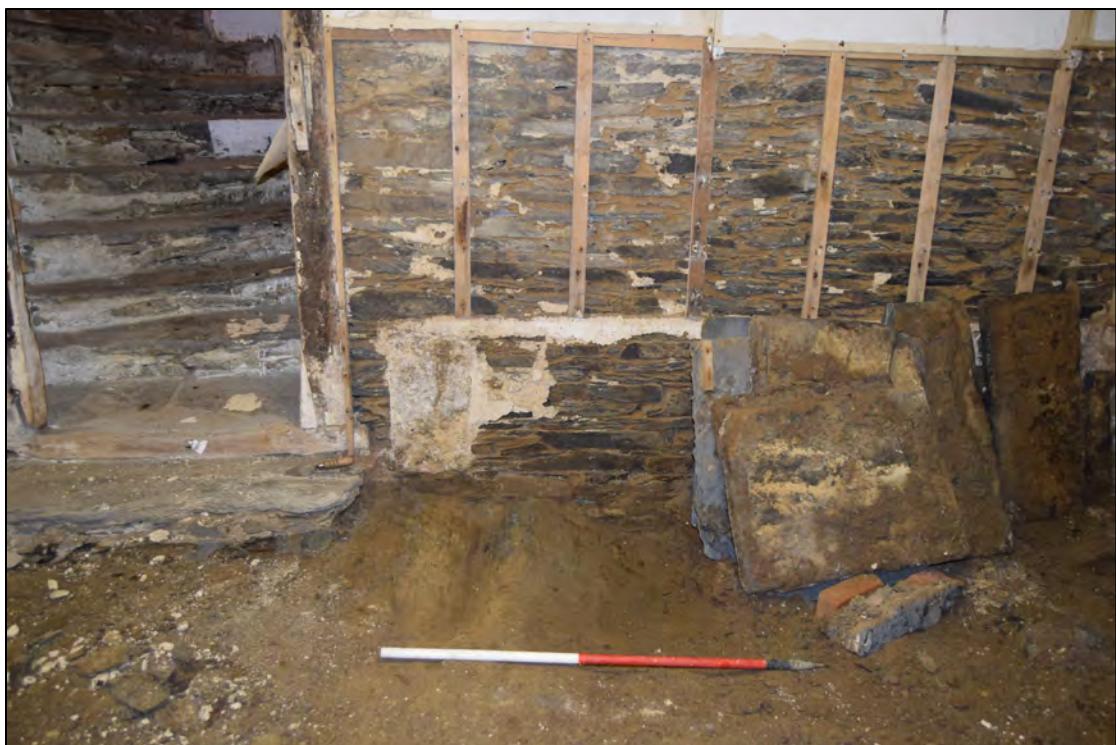
Plate 24: Basement, Test Pit 1 fully excavated, looking south-west, 1m scale.

No dating evidence was observed for the basement flag floor, although it appears broadly contemporary with the bottom step of the basement stair (plate 24) and pre-dates the slate benches and slate compartments built on top of it. It is assumed that both the slate compartments in the wine cellar and the flag floor date from the height of the Cilgerran Slate industry during the 19th century. The square wall niches appear to pre-date the compartmentation of the wine cellar. Another interesting feature of the wine cellar is the tally of contents chalked on the inside of the wine cellar door and dating from the late 1960's.

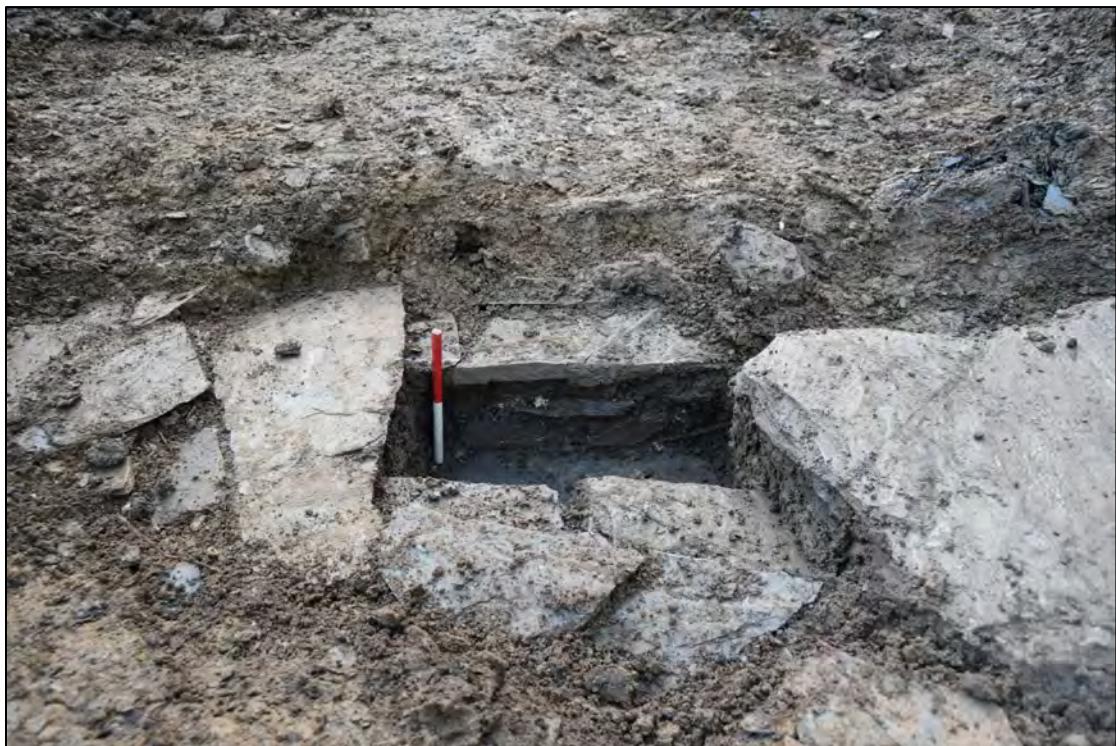
Plate 32: Watching Brief, Area 4, Box Culvert [4010] and Ceramic Pipe [4011], looking south-east, 2m & 0.5m scale.

The earliest feature encountered was a box culvert [4010], aligned almost exactly E-W. It ran from near the base of the extant guttering downpipes at the centre of the NE wall (4008), toward the lawn where its course continued beyond the excavated area (plate 32). Its cut [4003] was cut into the subsoil and had been lined with loose laid local slate stones (4005) on both base and sides and with a stone capping (4004), of the same local stone. It was exposed for a length of 6m and measured 0.6m wide with its internal channel having a width and a depth of 0.2m. The base was lined with flat slabs whilst the sides were of dry-stone construction (plate 33). The channel contained two fills, the lower fill, (4007) was a loose very dark brown fine silty clay from which sherds of glazed pottery and CBM were recovered as well as a fragment of mortar or wall plaster and a shard of glass from a window pane. It measured 0.06m to 0.08m thick. The upper fill, (4006) comprised a mid-brown loose silty clay of 0.1m to 0.14m thickness (plate 34).

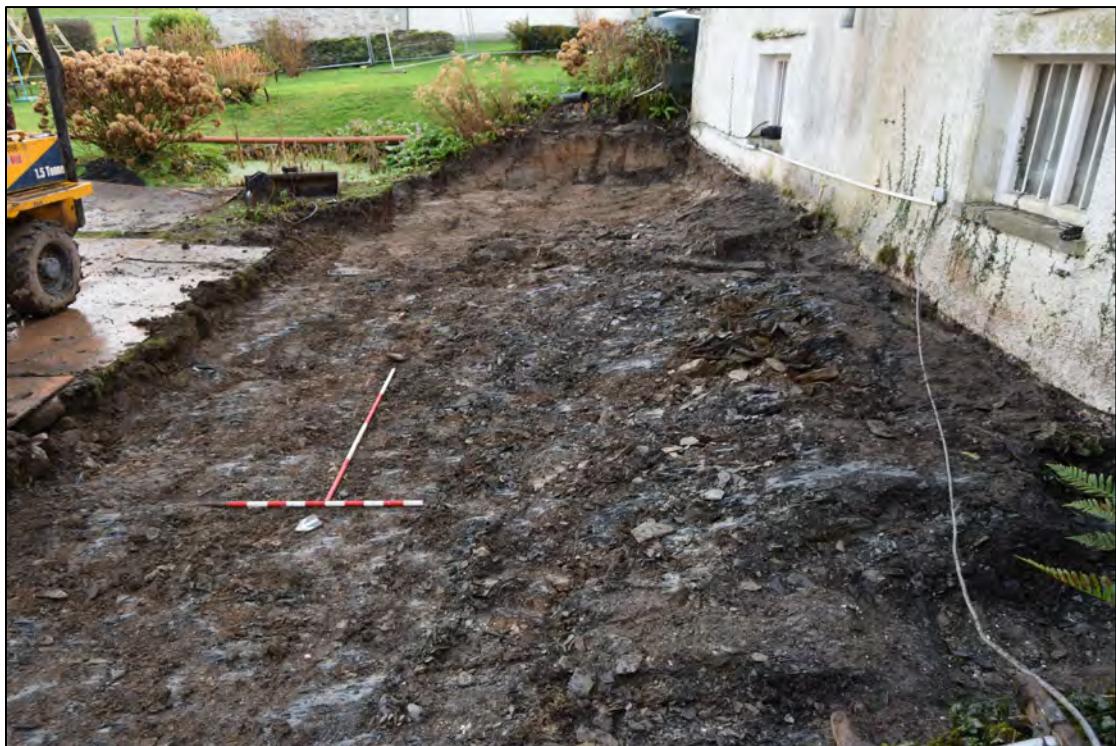
Plate 34: Watching Brief, Area 4, Box Culvert [4010]; (4006) & (4007) part removed, looking north-east, 0.5m scale.

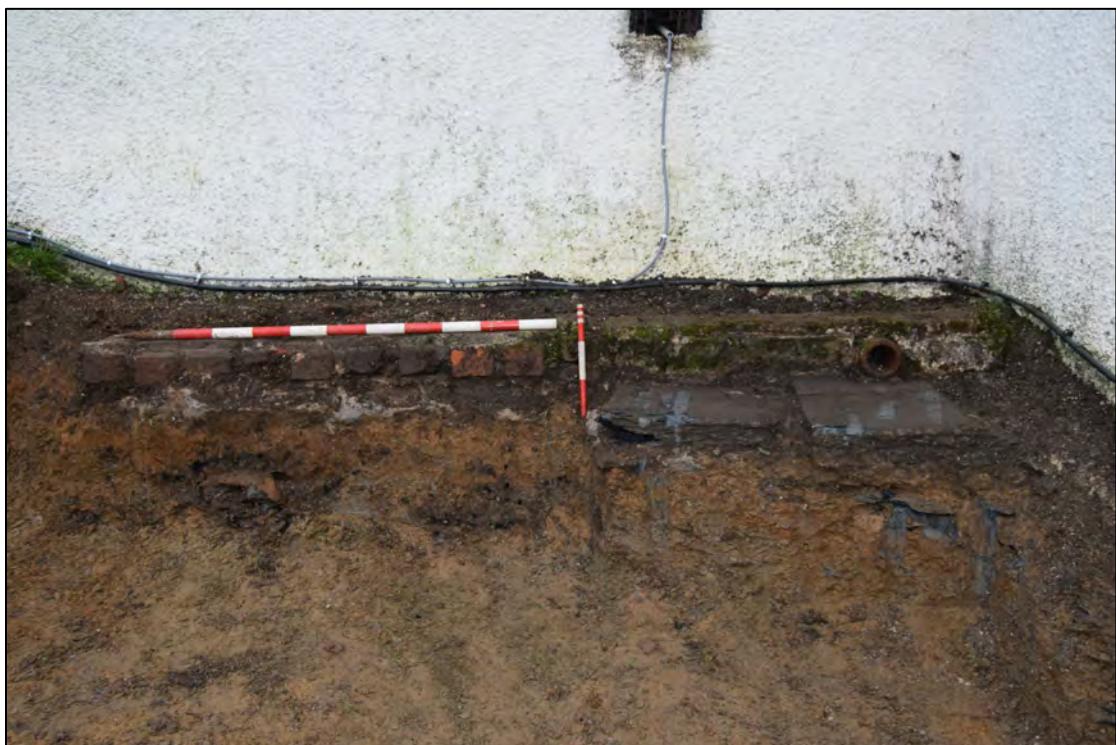
Plate 37: Watching Brief, Area 5, Brick Setting [5007], looking south-west, 0.5m scale.

The earliest feature appeared to be a setting of bricks [5007] measuring 0.7m x 0.1m, they were loose laid as a single course with no bond and comprised reused handmade bricks with traces of old mortar adhering to them (plate 37). Each brick measured 0.22m in length with a width of 0.08m x 0.08m. They were located beneath a ceramic foul water pipe which passed through the house wall. There was also a concrete setting and pipe connecting this to sewer pipe [4011], another sewer pipe outlet from the first-floor bathroom and the sewer main.

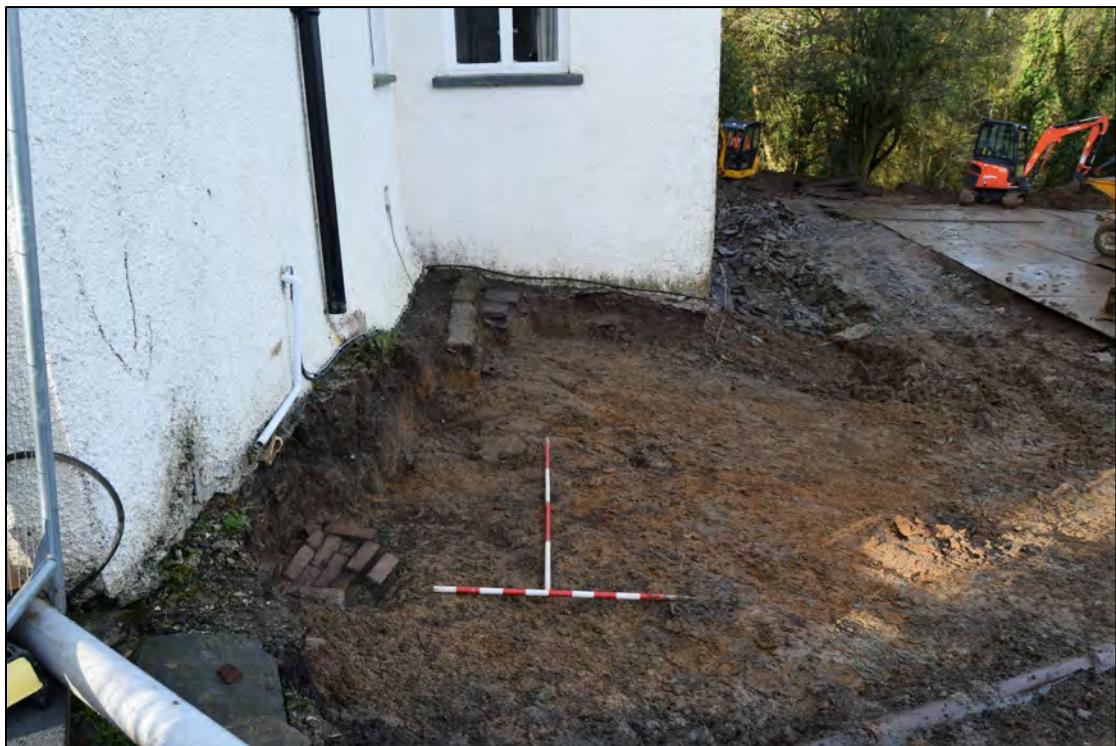
Plate 38: Watching Brief, Area 5, Brick and concrete setting [5006], looking south-west, 01m & 0.3m scale.

Feature [5006] comprised a brick and concrete setting at the junction of the main house and the Stair Hall. it measured 2.3m long x 0.22m wide and survived to a height of 2.22m. It was constructed of a single course of bricks, with a small diameter (0.08m) ceramic pipe set into it near the NE end with modern cement. At its SW end it sat upon a layer of modern concrete/cement whilst at its NE end it was laid upon a thin layer of cement upon a layer of loose laid slate stones in the vicinity of the outlet pipe (plate 38). It was set near to but away from the wall and was part of a rainwater runoff system channelling water away from the extension. Though no connection to the modern down pipes survived, it is assumed that it formerly was part of that system.

In area 5 at least two earlier rainwater management systems [5006] & [5003] were in evidence prior to the construction of the most recent system of open culvert [5008] feeding the pond. The sewer system had also been upgraded with the defunct system [5007] and its replacement [4011] whilst during the ground works a new plastic sewer system was inserted with a new pipe running south of the development area.
