# Demolition of Existing Dwelling, Tan-y-Bodran, Bodran Road, Llanfairtalhaiarn, Conwy LL22 8YY.

Historic Building Record Level 3

Project Code: A0274.1

Report no. 0263

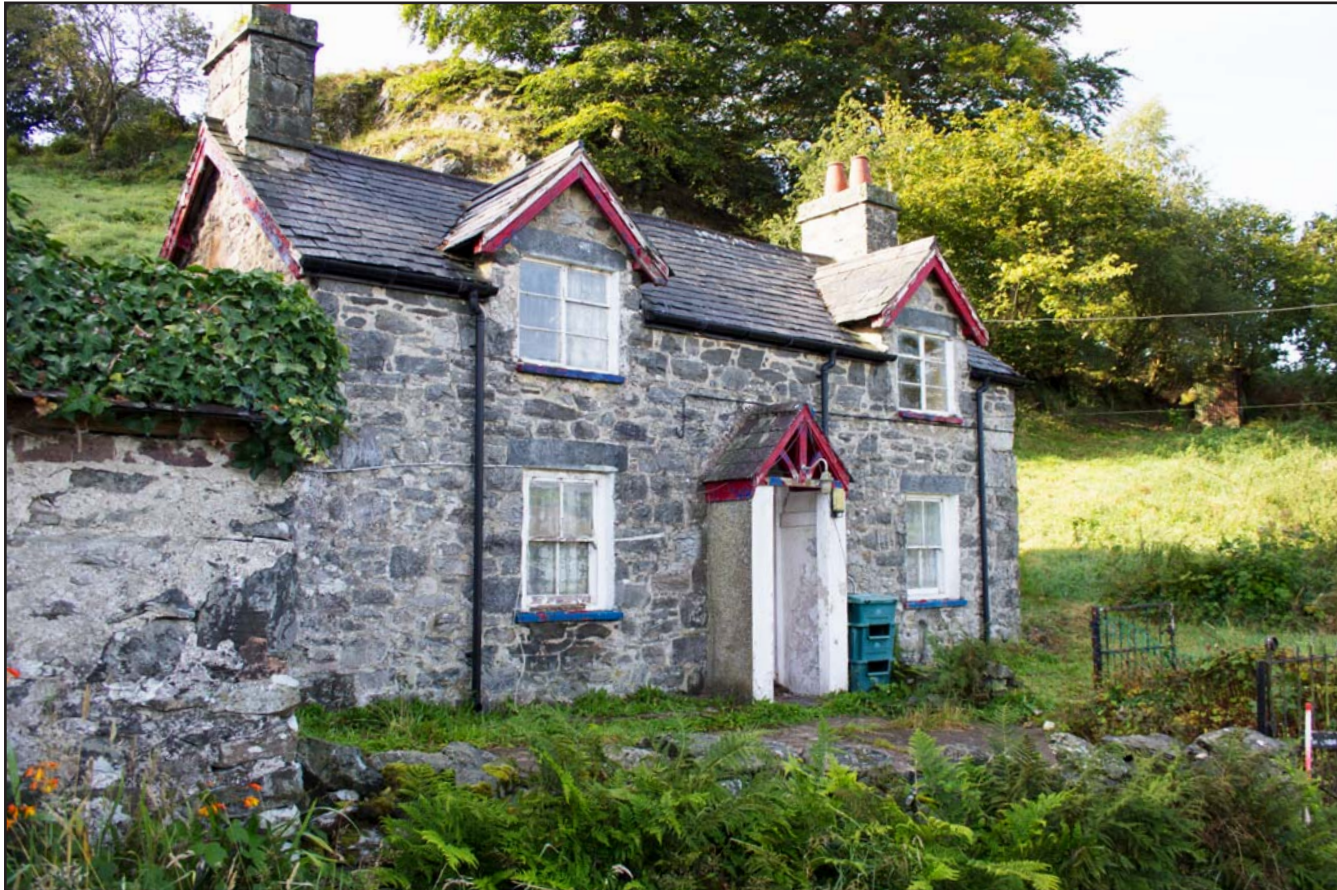
**Plate 01:** External shot - northern and eastern elevations of the Farmhouse, Tan Y Bodran, Bodran Road, Llanfairtalhaiarn, Conwy - from the northeast - scale 1m

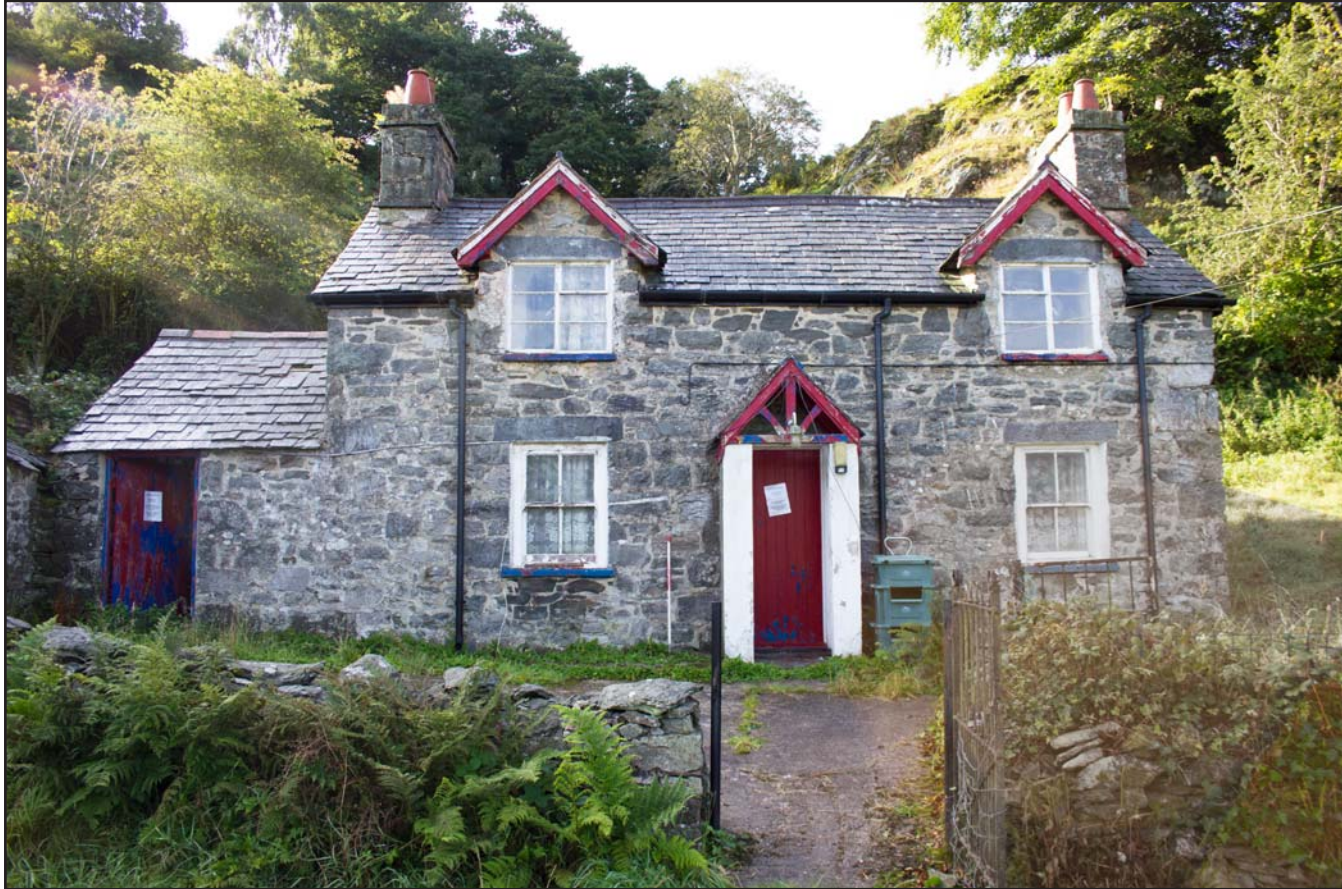
At first floor level, at the left- and right-hand ends of the elevation respectively are two dormer windows with metal casement window frames, painted white, with six window panes. A substantial slate lintel surmounts these windows and blue painted wooden sills are visible beneath. At ground floor level are two further windows symmetrically located to those found above on the first floor, to the left- and right-hand ends of the elevation respectively, these windows are however sash windows with white painted wooden frames, these are in possession of four glass panes and also have substantial slate lintels and blue painted wooden sills beneath.

**Plate 02:** External shot - northern elevation of the Farmhouse, Tan Y Bodran, Bodran Road, Llanfairtalhaiarn, Conwy - from the north - scale 1m

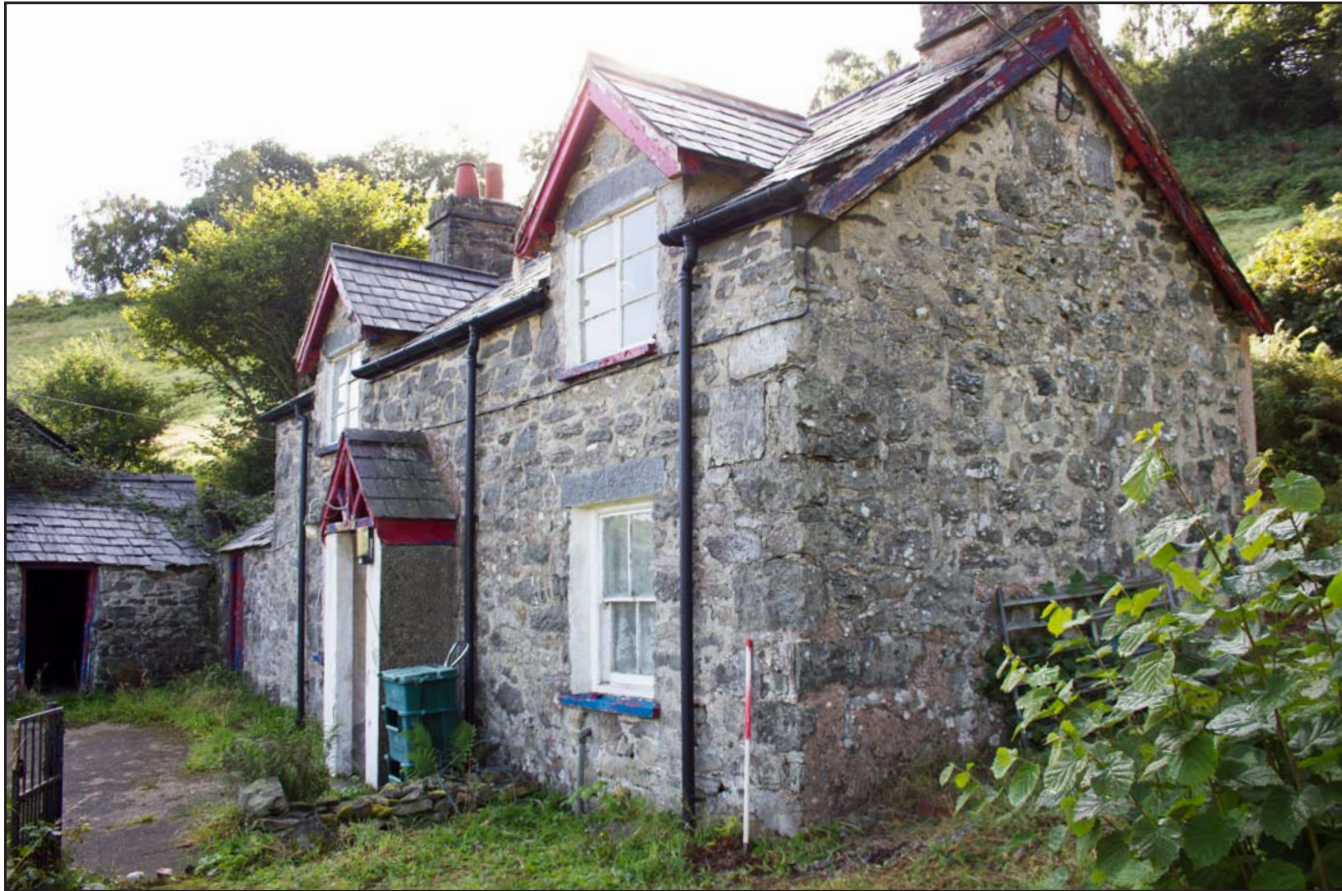
**Plate 03:** External shot - northern and western elevations of the Farmhouse, Tan Y Bodran, Bodran Road, Llanfairtalhaiarn, Conwy - from the northwest - scale 1m

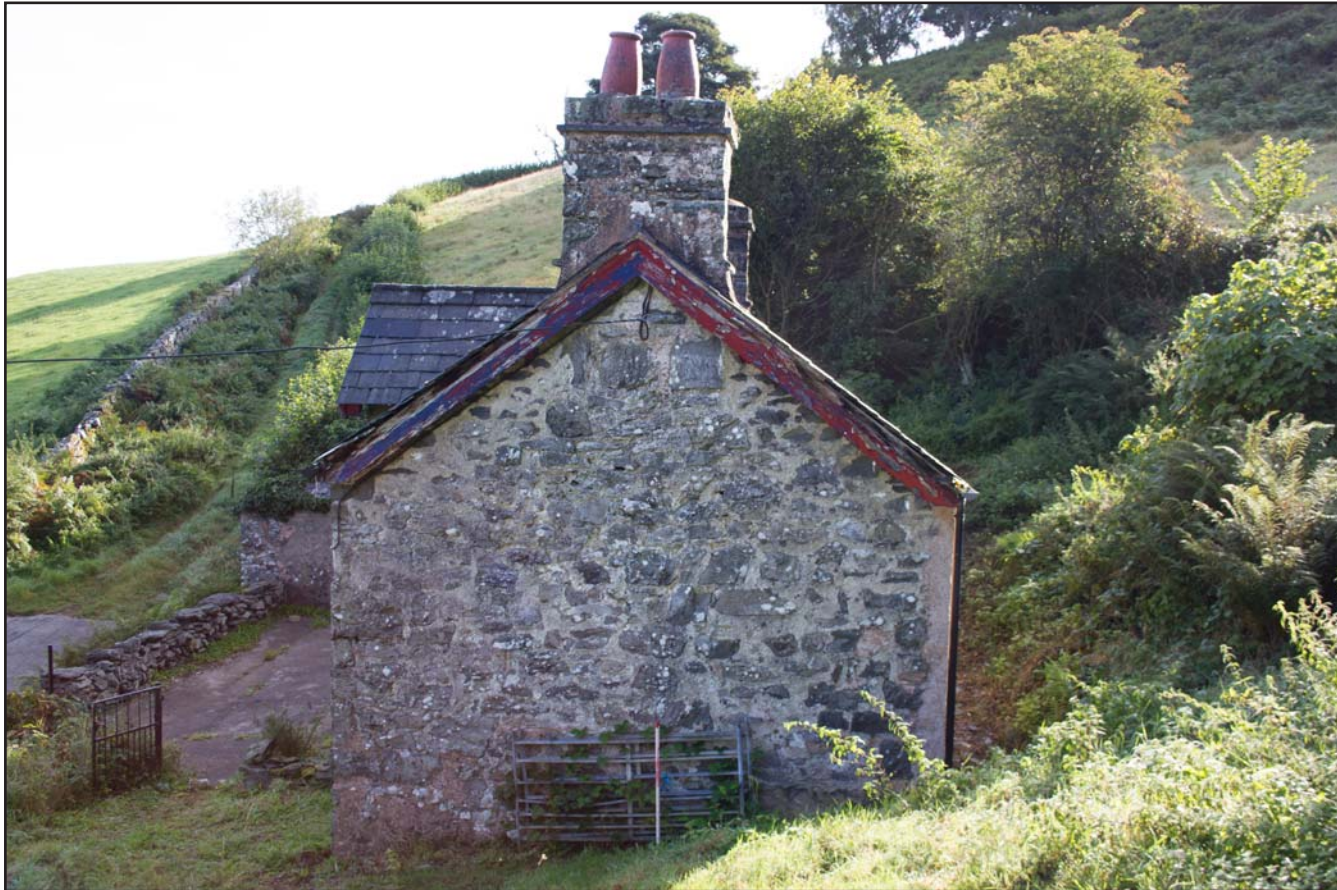
**Plate 04:** External shot - western elevation of the Farmhouse, Tan Y Bodran, Bodran Road, Llanfairtalhaiarn, Conwy - from the west - scale 1m

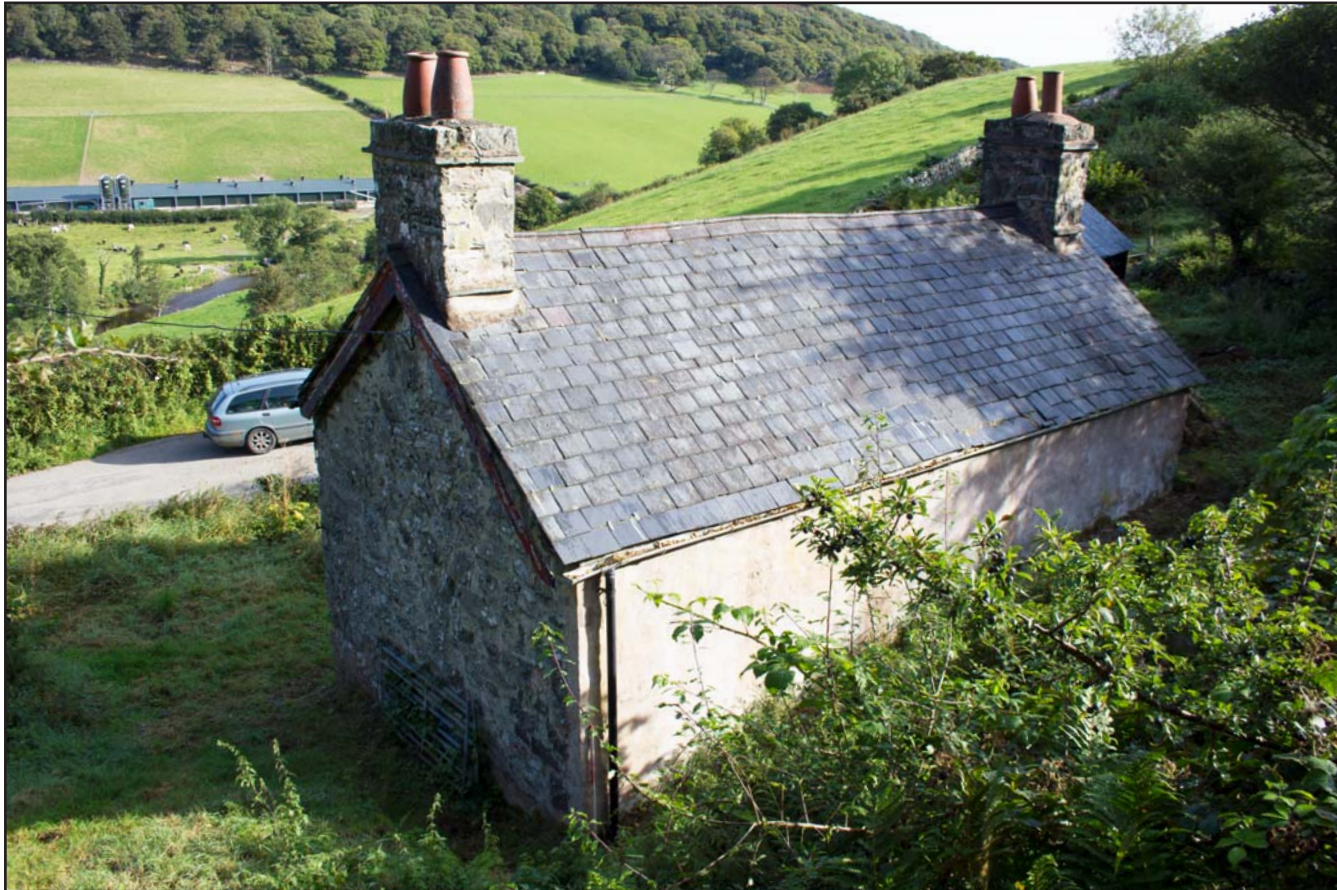
**Plate 05:** External shot - southern and western elevations of the Farmhouse, Tan Y Bodran, Bodran Road, Llanfairtalhaiarn, Conwy - from the southwest - scale 1m

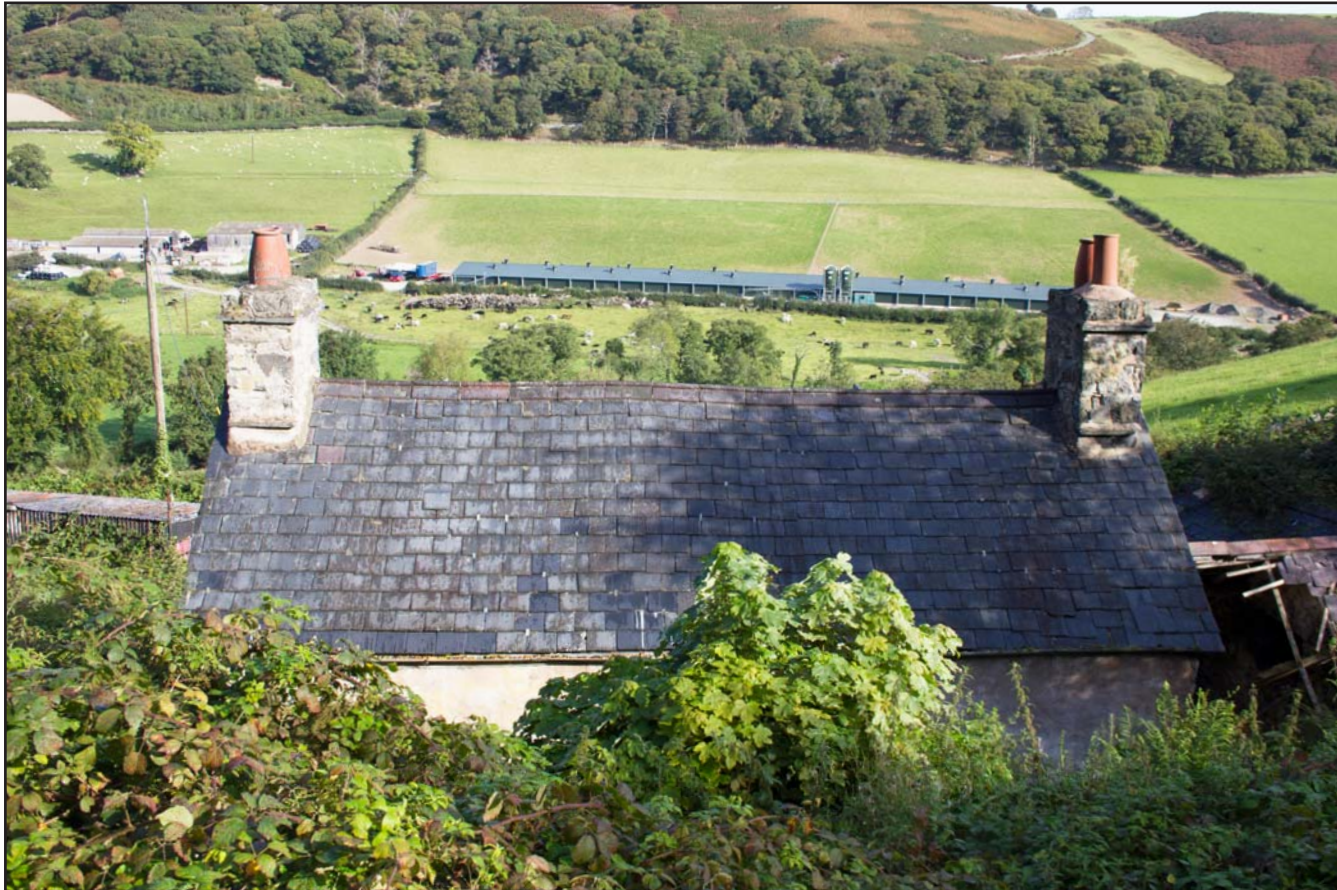
**Plate 06:** External shot - southern elevation of the Farmhouse, Tan Y Bodran, Bodran Road, Llanfairtalhaiarn, Conwy - from the south - no scale

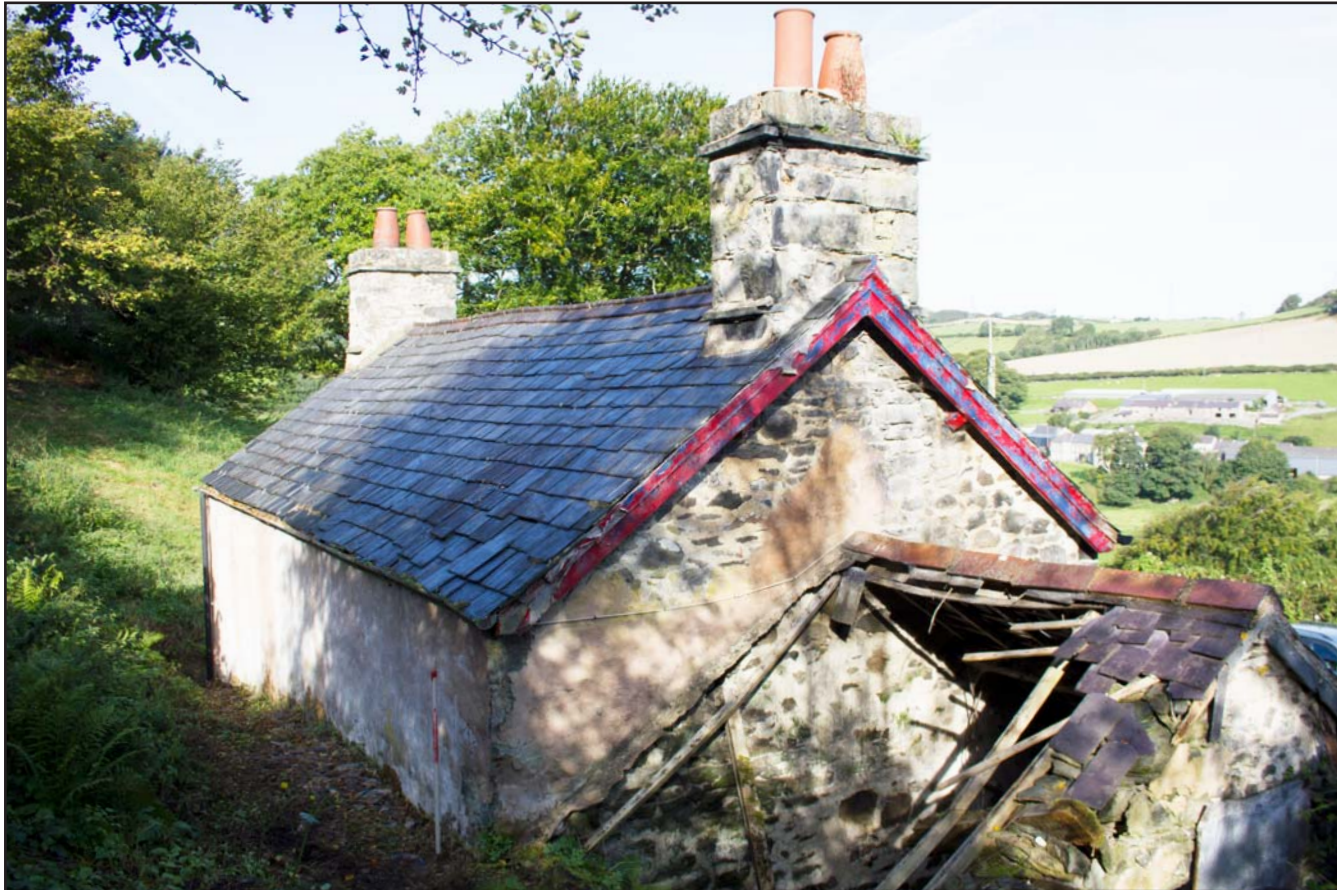
**Plate 07:** External shot - southern and eastern elevations of the Farmhouse, Tan Y Bodran, Bodran Road, Llanfairtalhaiarn, Conwy - from the southeast - scale 1m

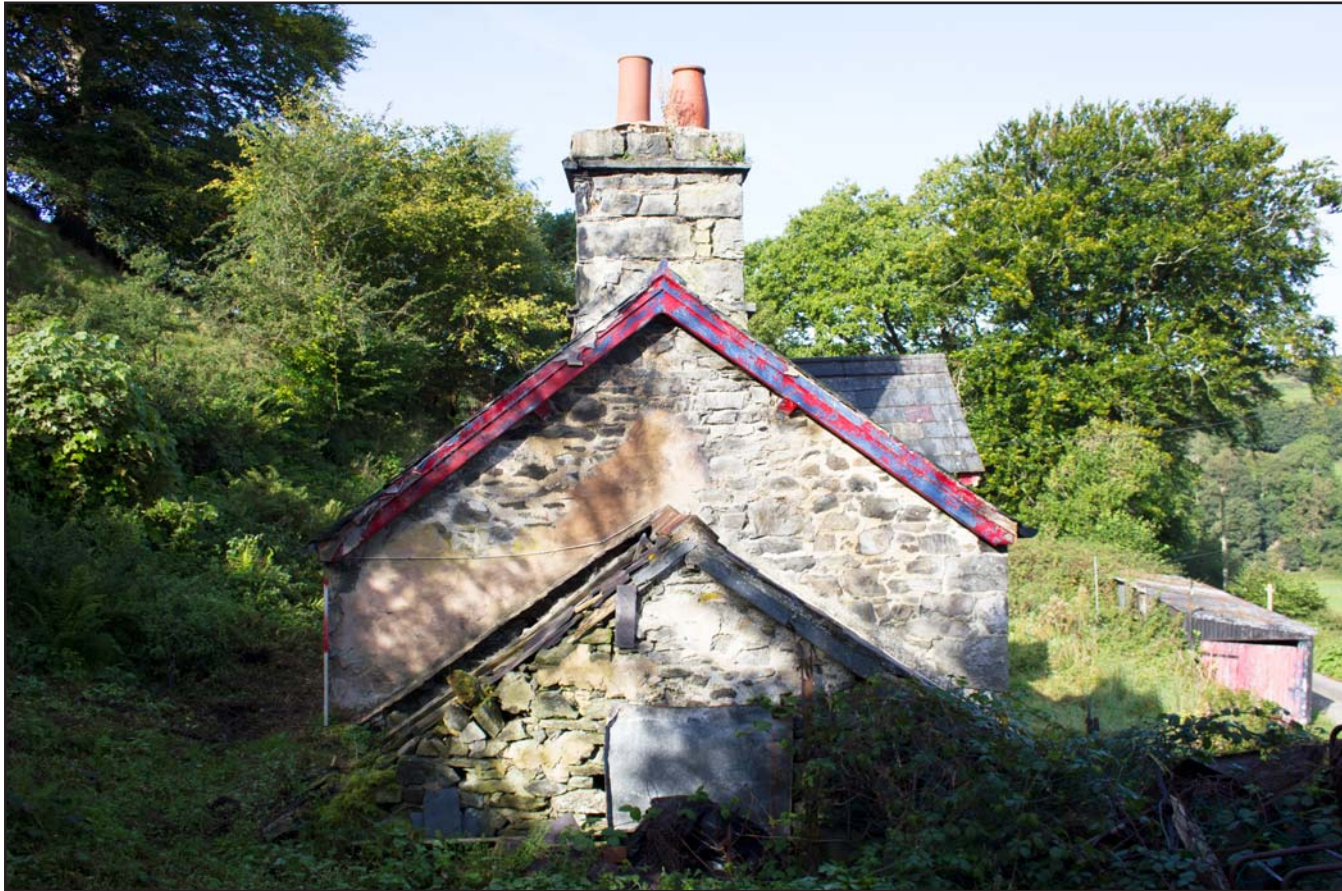
**Plate 08:** External shot - eastern elevation of the Farmhouse, Tan Y Bodran, Bodran Road, Llanfairtalhaiarn, Conwy - from the east - scale 1m

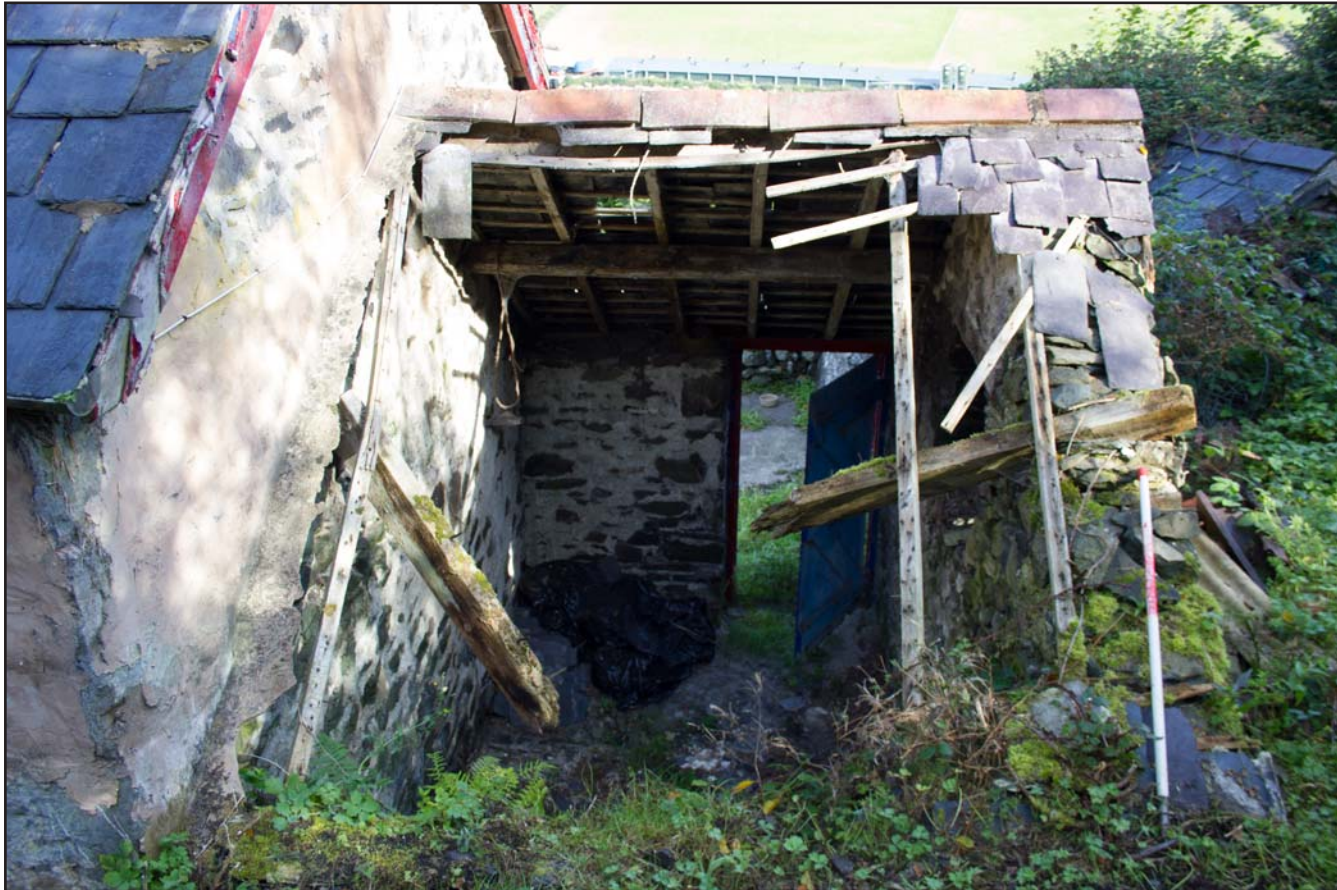
The south facing elevation of Store 1 is also largely obscured by the ground level as it has been constructed within a cut into the southern hillside. The southern elevation of store 1 was previously covered by a slate covered roof however, this has since collapsed and the interior of the building and is now visible. At the right-hand end the roof is situated directly on top of the stone rubble wall which forms the eastern elevation of the structure. Located within a slot in this wall is a single sawn timber purlin now since broken by years of water ingress. At the left-hand end of the elevation is a sloped mortar joint which was intended to force water away from the main building onto the now since disappeared slate roof of store 1.

**Plate 09:** External shot - southern elevation of Store 1, Tan Y Bodran, Bodran Road, Llanfairtalhaiarn, Conwy - from the south - scale 1m

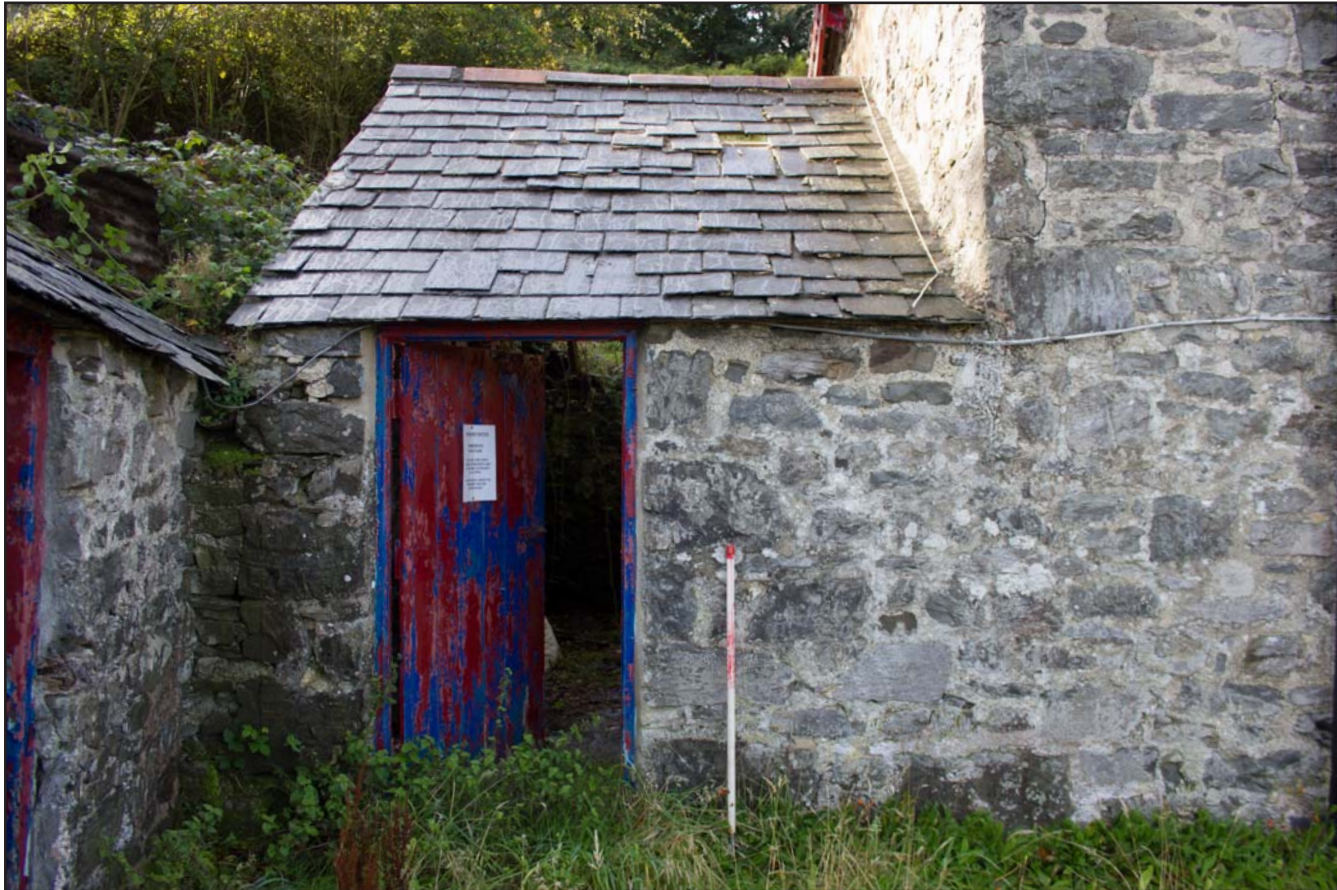
**Plate 10:** External shot - northern elevation of Store 1, Tan Y Bodran, Bodran Road, Llanfairtalhaiarn, Conwy - from the north - scale 1m

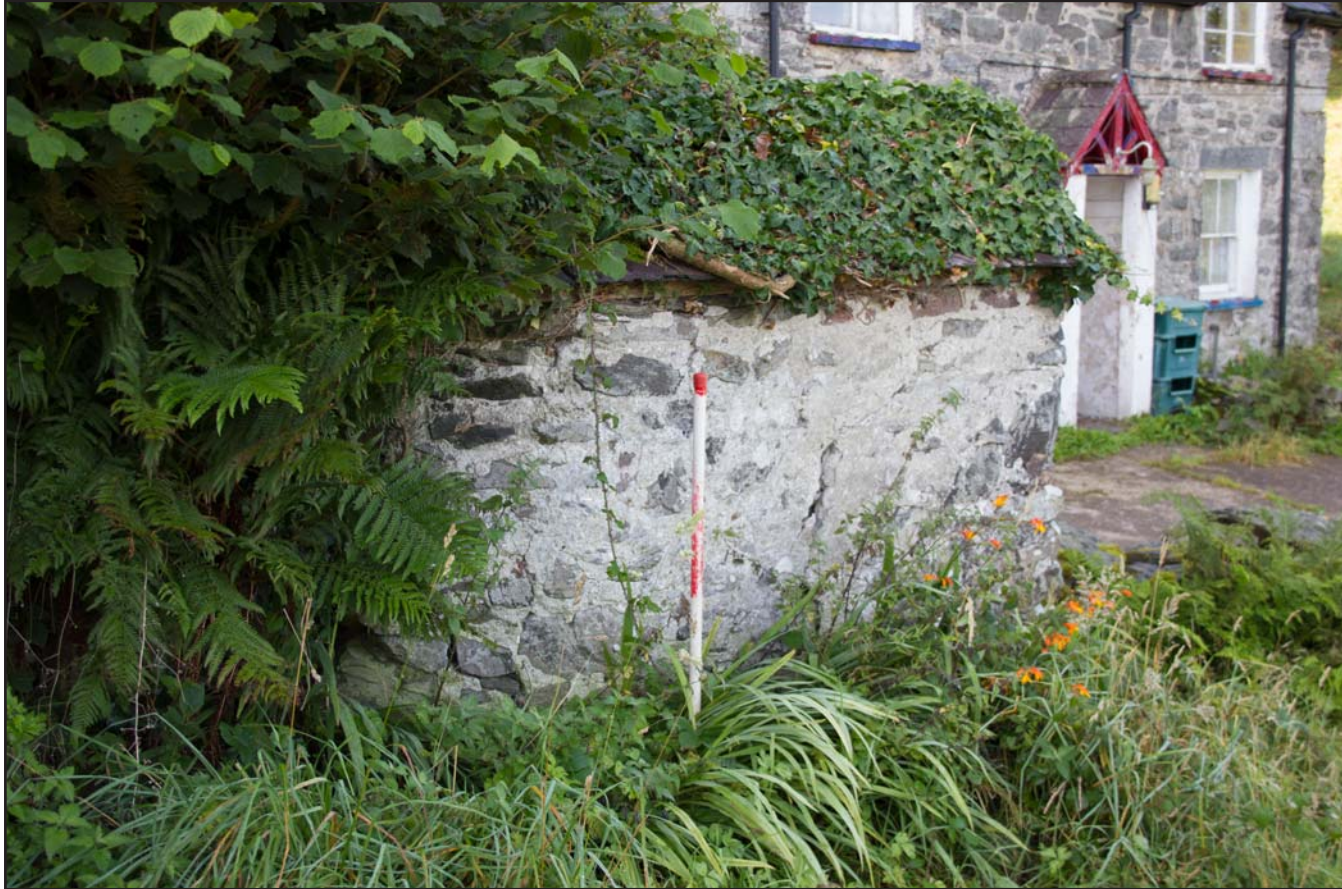
**Plate 11:** External shot - northern elevation of Store 2, Tan Y Bodran, Bodran Road, Llanfairtalhaiarn, Conwy - from the northeast - scale 1m

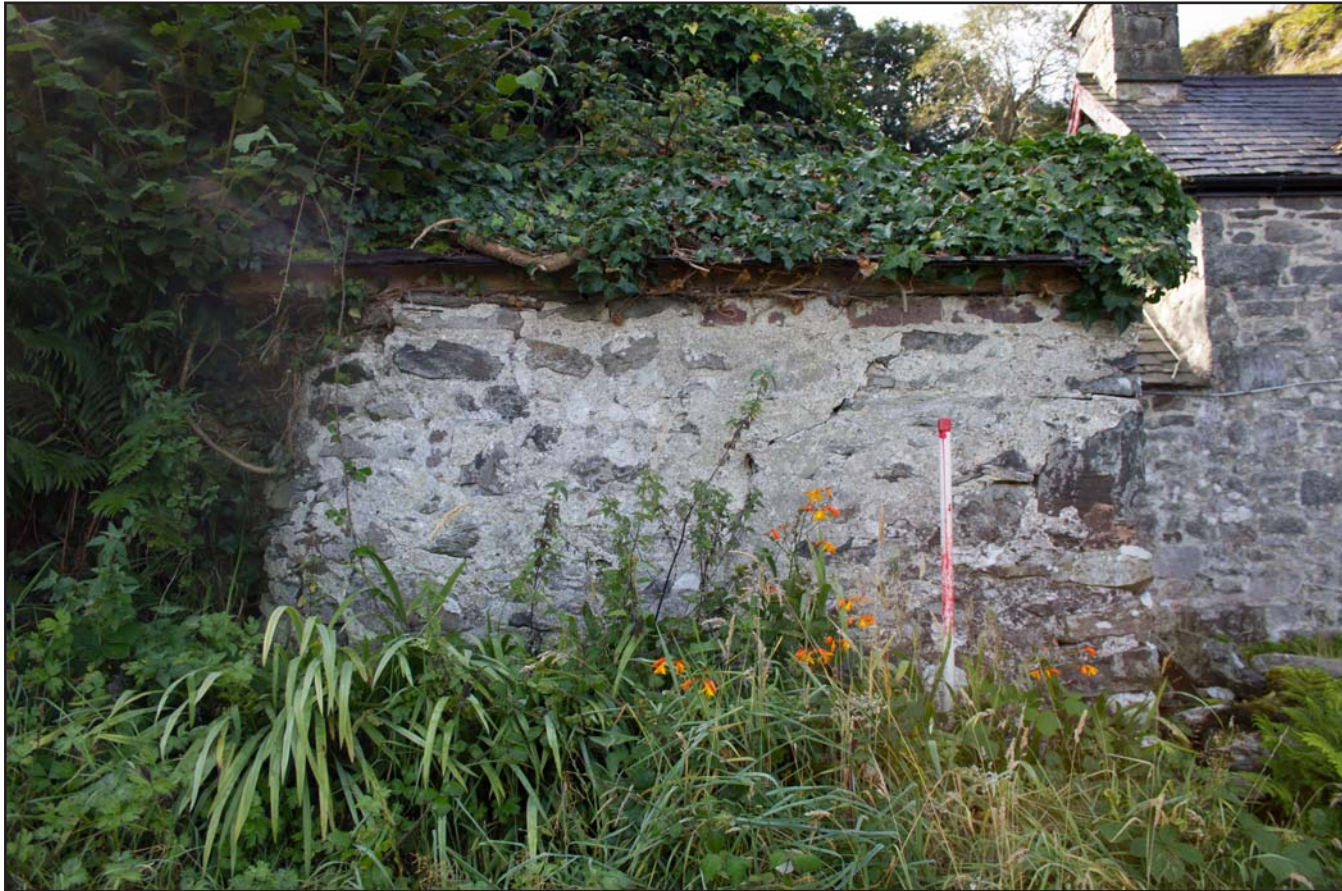
**Plate 12:** External shot - northern elevation of Store 2, Tan Y Bodran, Bodran Road, Llanfairtalhaiarn, Conwy - from the northeast - scale 1m

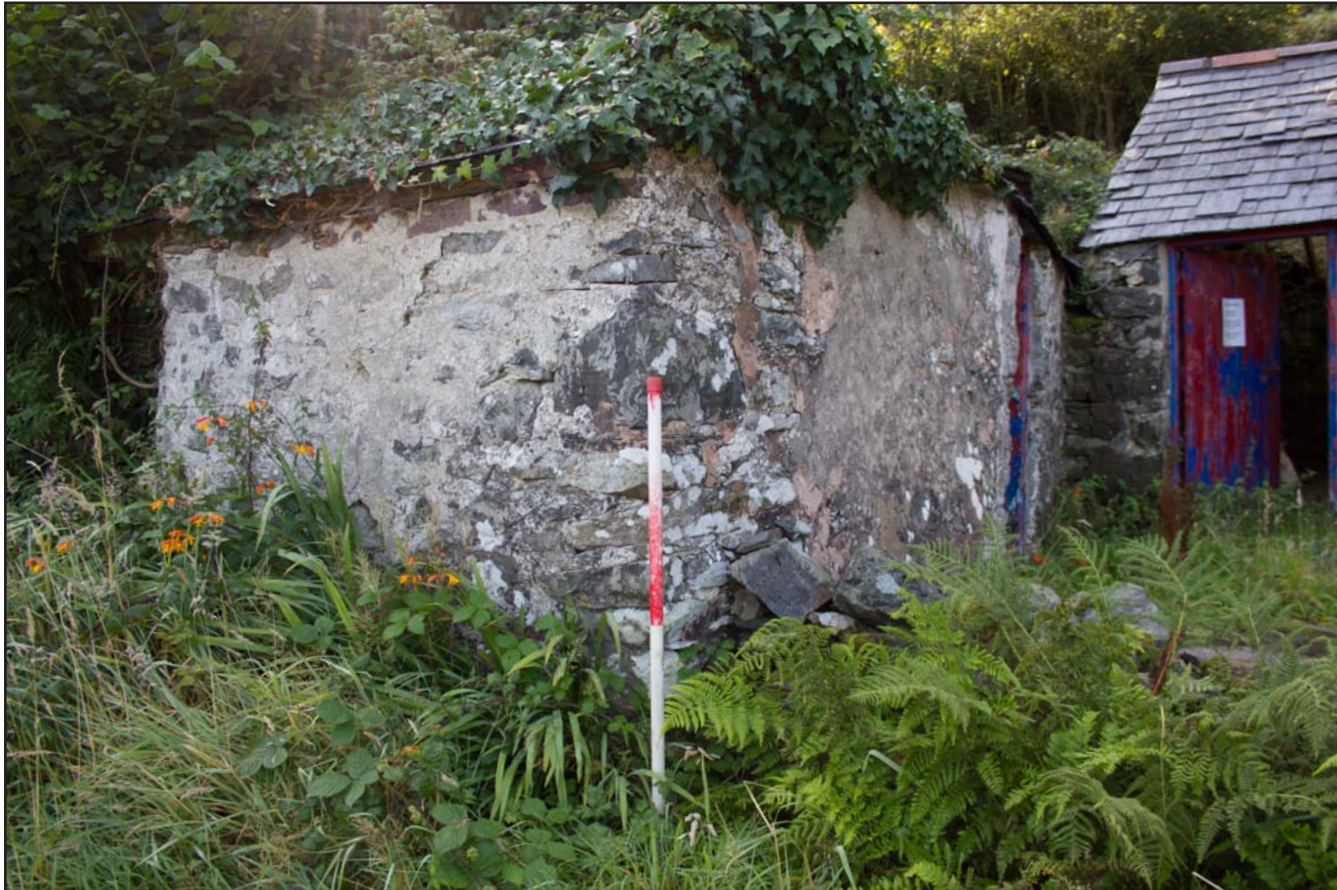
**Plate 13:** External shot - northern and western elevations of Store 2, Tan Y Bodran, Bodran Road, Llanfairtalhaiarn, Conwy - from the northwest - scale 1m

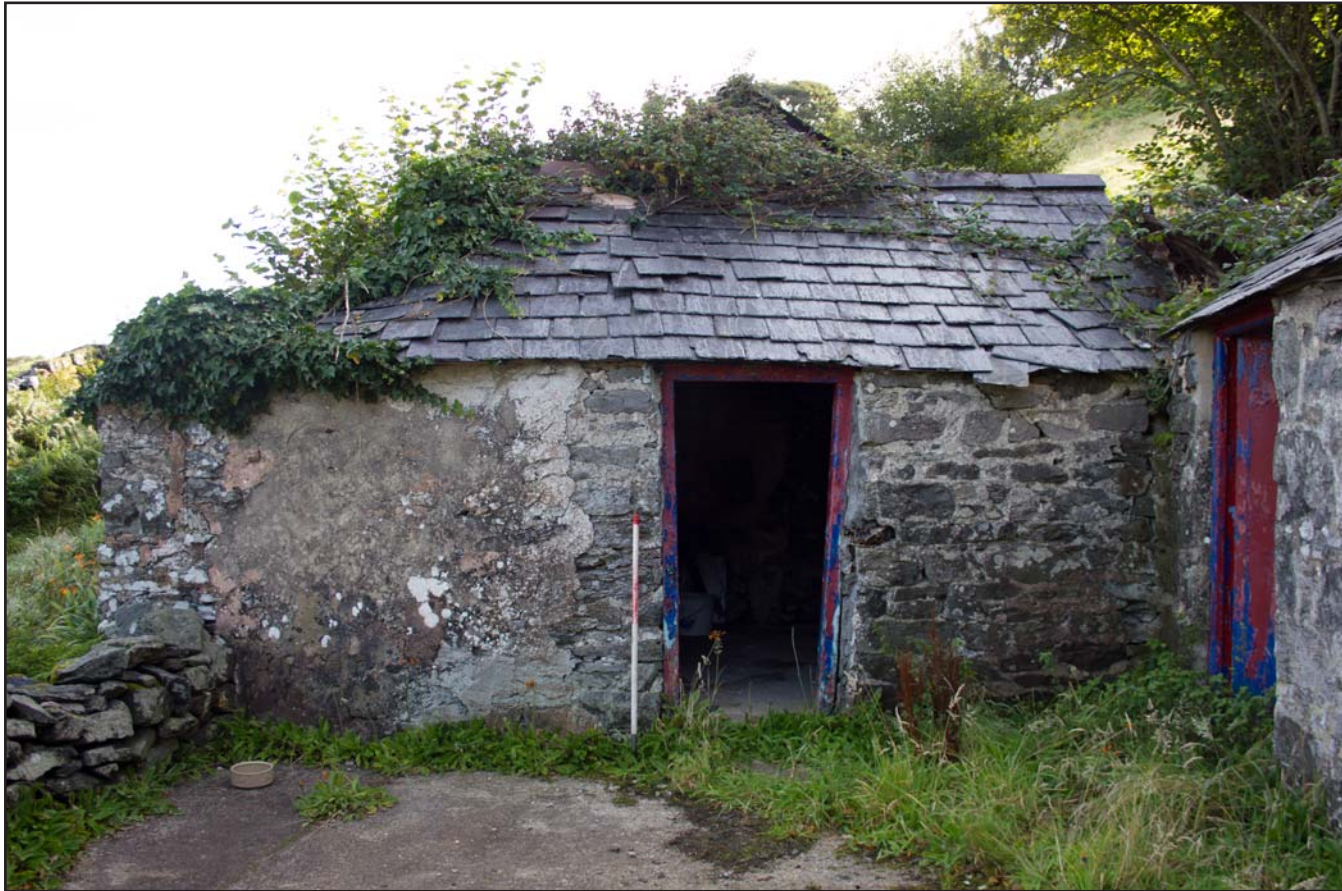
**Plate 14:** External shot - western elevation of Store 2, Tan Y Bodran, Bodran Road, Llanfairtalhaiarn, Conwy - from the west - scale 1m

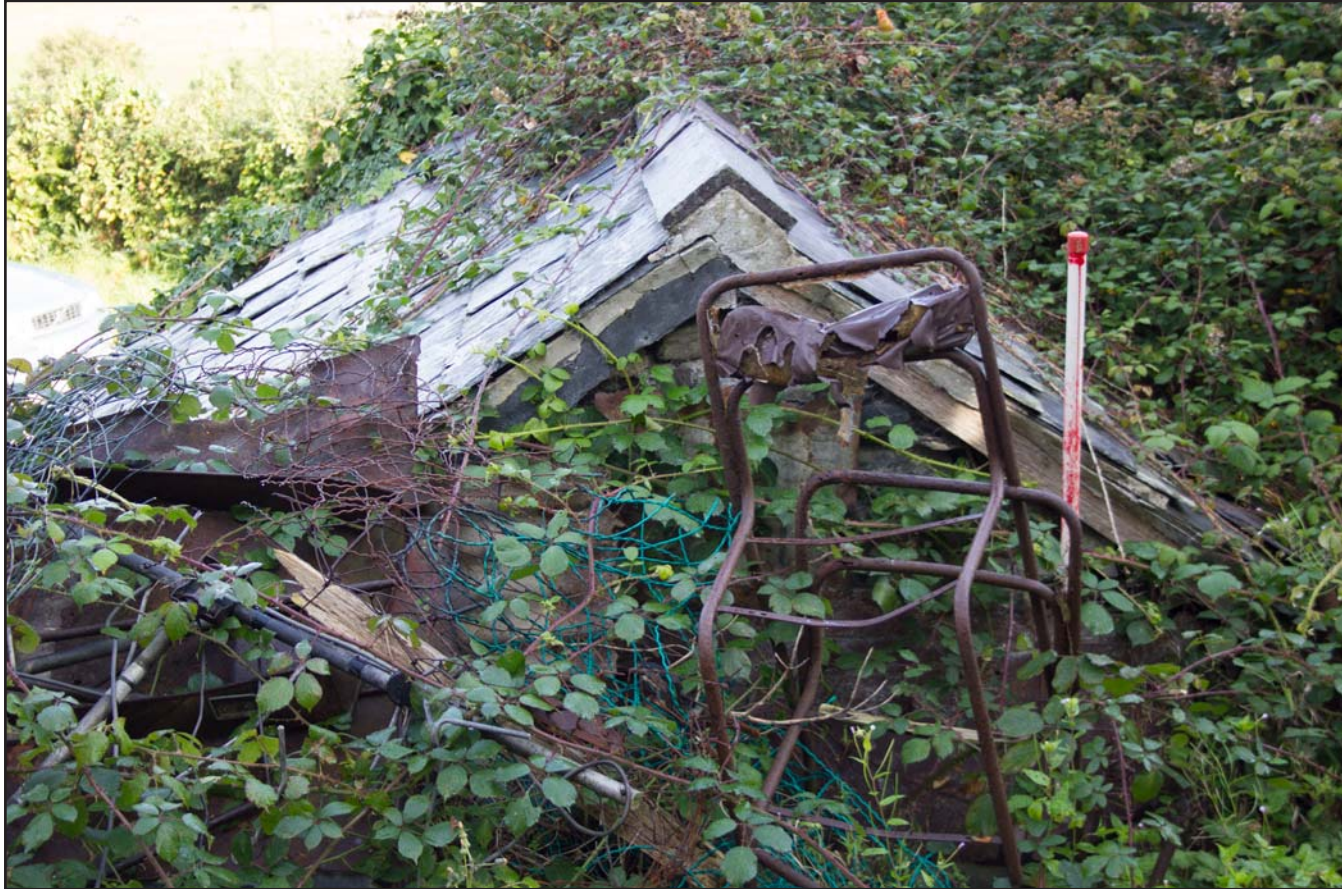
**Plate 15:** External shot - southern elevation of Store 2, Tan Y Bodran, Bodran Road, Llanfairtalhaiarn, Conwy - from the south - scale 1m

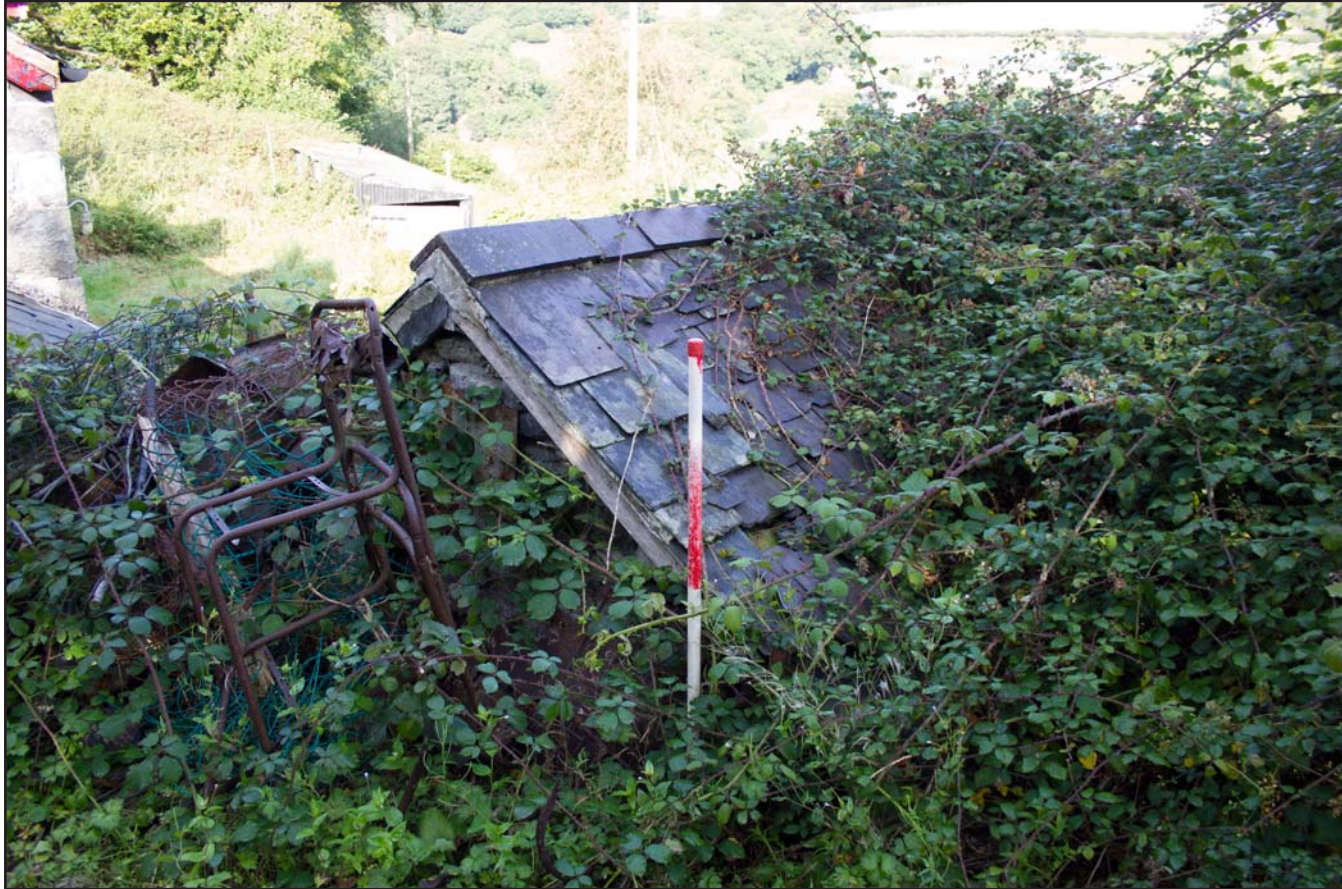
**Plate 16:** External shot - southern and eastern elevations of Store 2, Tan Y Bodran, Bodran Road, Llanfairtalhaiarn, Conwy  
- from the southeast - scale 1m

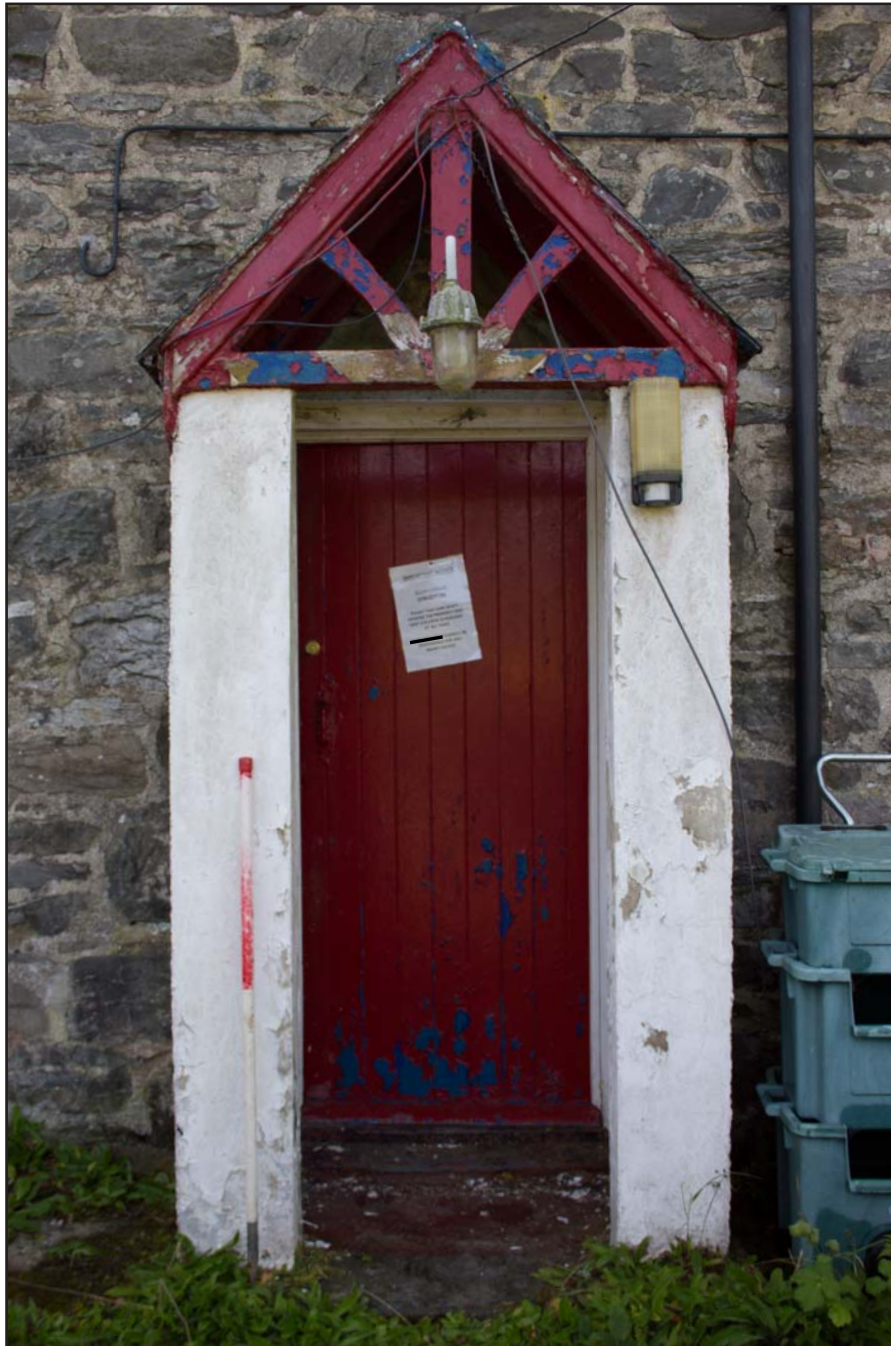
**Plate 17:** External shot - Porch on northern elevation of the Farmhouse, Tan Y Bodran, Bodran Road, Llanfairtalhaiarn, Conwy - from the north - scale 1m

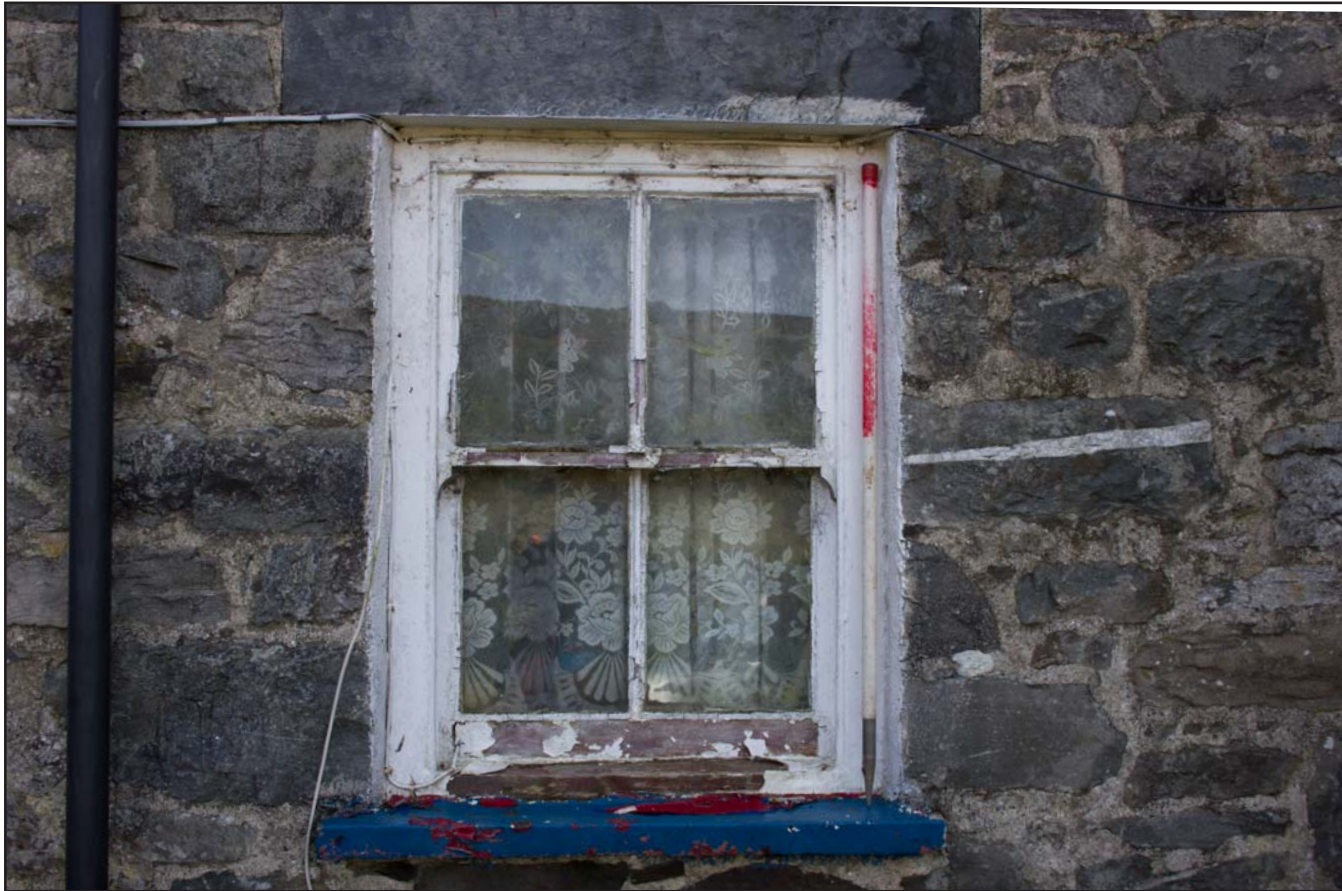
**Plate 18:** External shot - Ground floor window on northern elevation of the Farmhouse, Tan Y Bodran, Bodran Road, Llanfairtalhaiarn, Conwy - from the north - scale 1m
