# Demolition of Existing Dwelling, Tan-y-Bodran, Bodran Road, Llanfairtalhaiarn, Conwy LL22 8YY.

Historic Building Record Level 3

Project Code: A0274.1

Report no. 0263

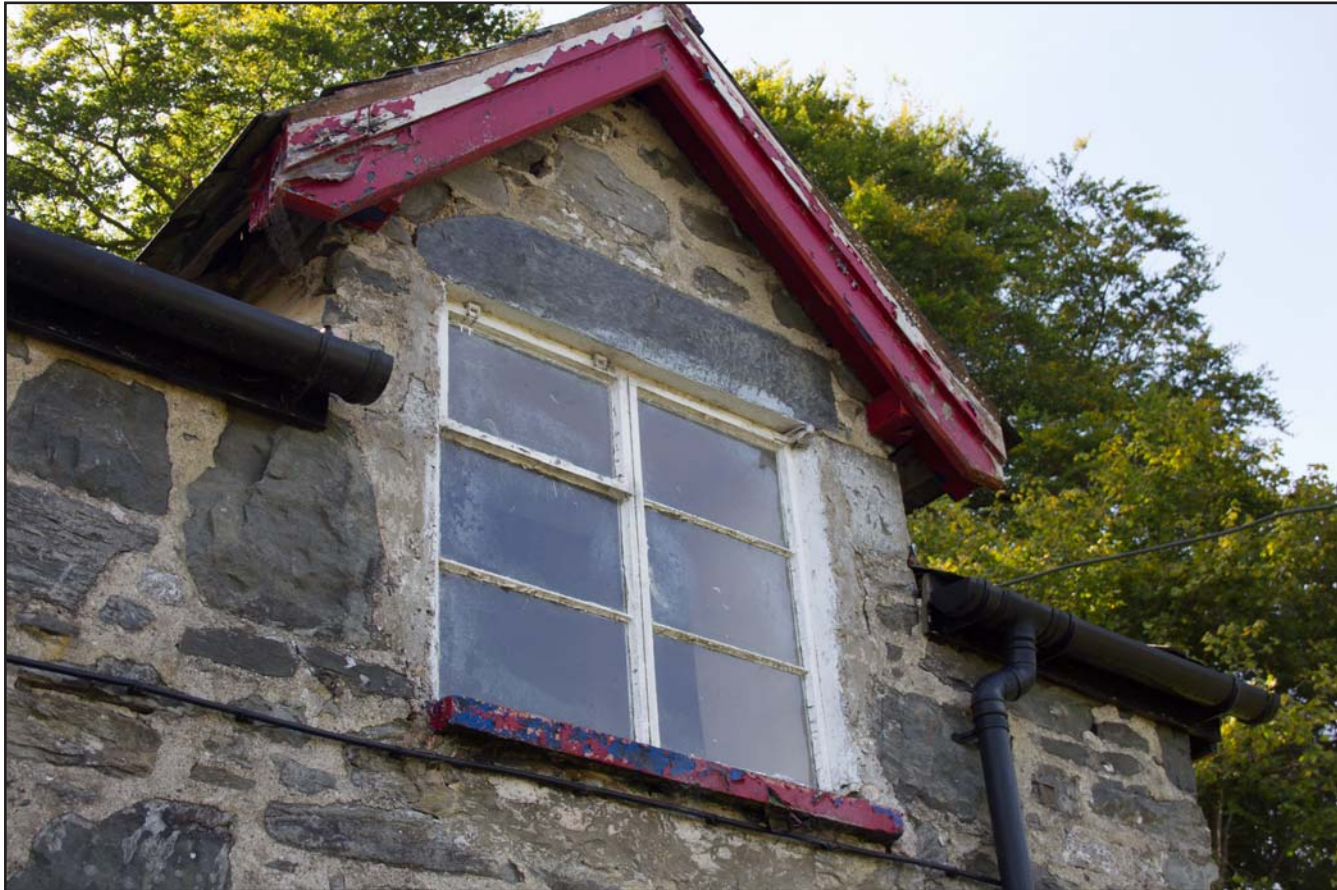
At first floor level, at the left- and right-hand ends of the elevation respectively are two dormer windows with metal casement window frames, painted white, with six window panes. A substantial slate lintel surmounts these windows and blue painted wooden sills are visible beneath. At ground floor level are two further windows symmetrically located to those found above on the first floor, to the left- and right-hand ends of the elevation respectively, these windows are however sash windows with white painted wooden frames, these are in possession of four glass panes and also have substantial slate lintels and blue painted wooden sills beneath.

**Plate 19:** External shot - First floor window on northern elevation of the Farmhouse, Tan Y Bodran, Bodran Road, Llanfairtalhaiarn, Conwy - from the north - scale 1m

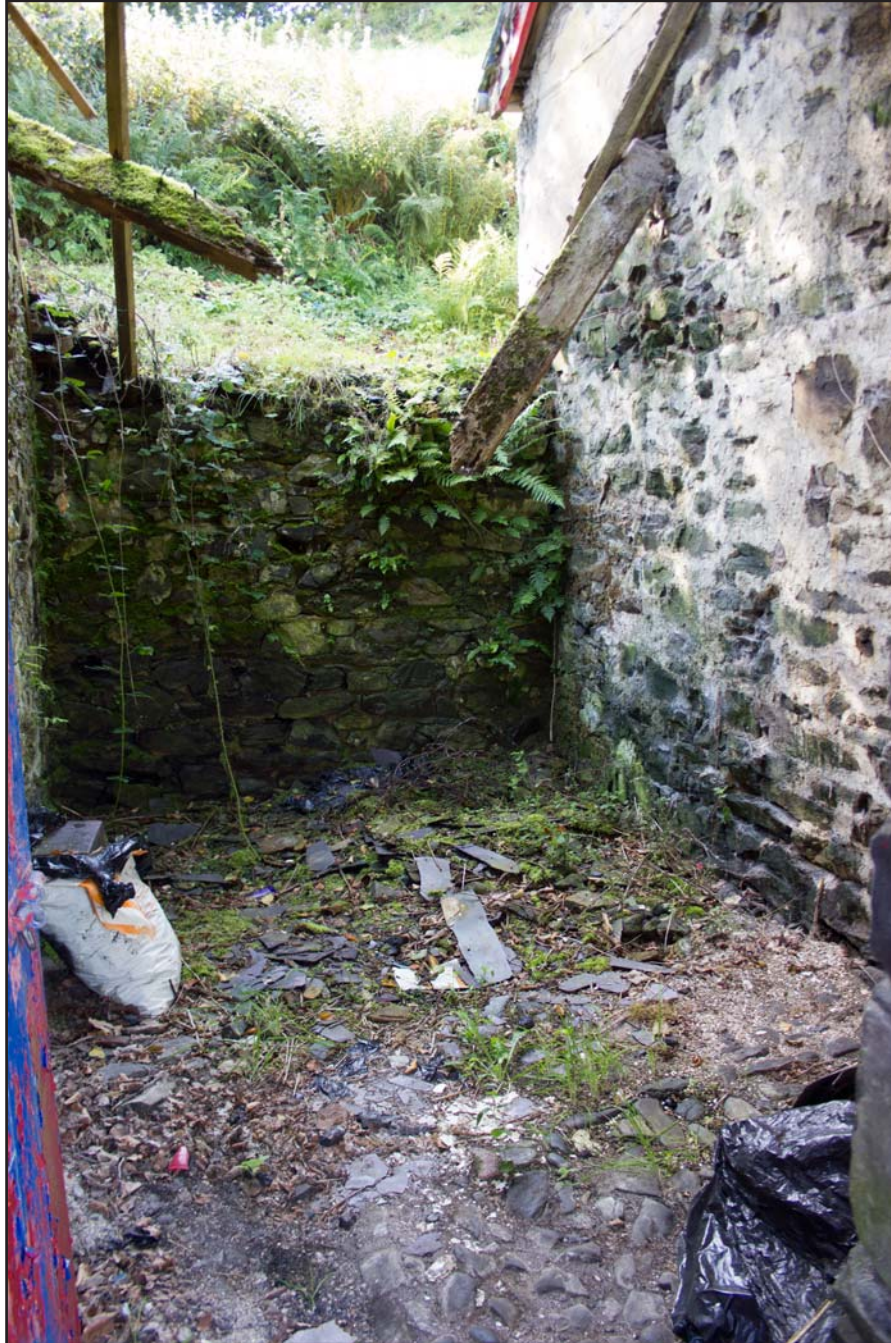
Store 1 is a rectangular room orientated north to south and measures (4.40m by 2.15m). The ceiling of store 1 is in an exceptionally poor state of repair. On the northern side where it remains intact it comprises of a single sawn timber purlin which is located within a slot in the eastern gable wall of the Cottage and another slot on top of the the eastern gable of store 1. This purlin supports six wooden rafters which in turn support timber batons upon which the slate roof has been placed. The southern expanse of the roof is now completely exposed to the elements as it has collapsed inward due to water ingress.

**Plate 20:** Internal shot - Floor and northern elevation of Store 1, Tan Y Bodran, Bodran Road, Llanfairtalhaiarn, Conwy - from the south - scale 1m

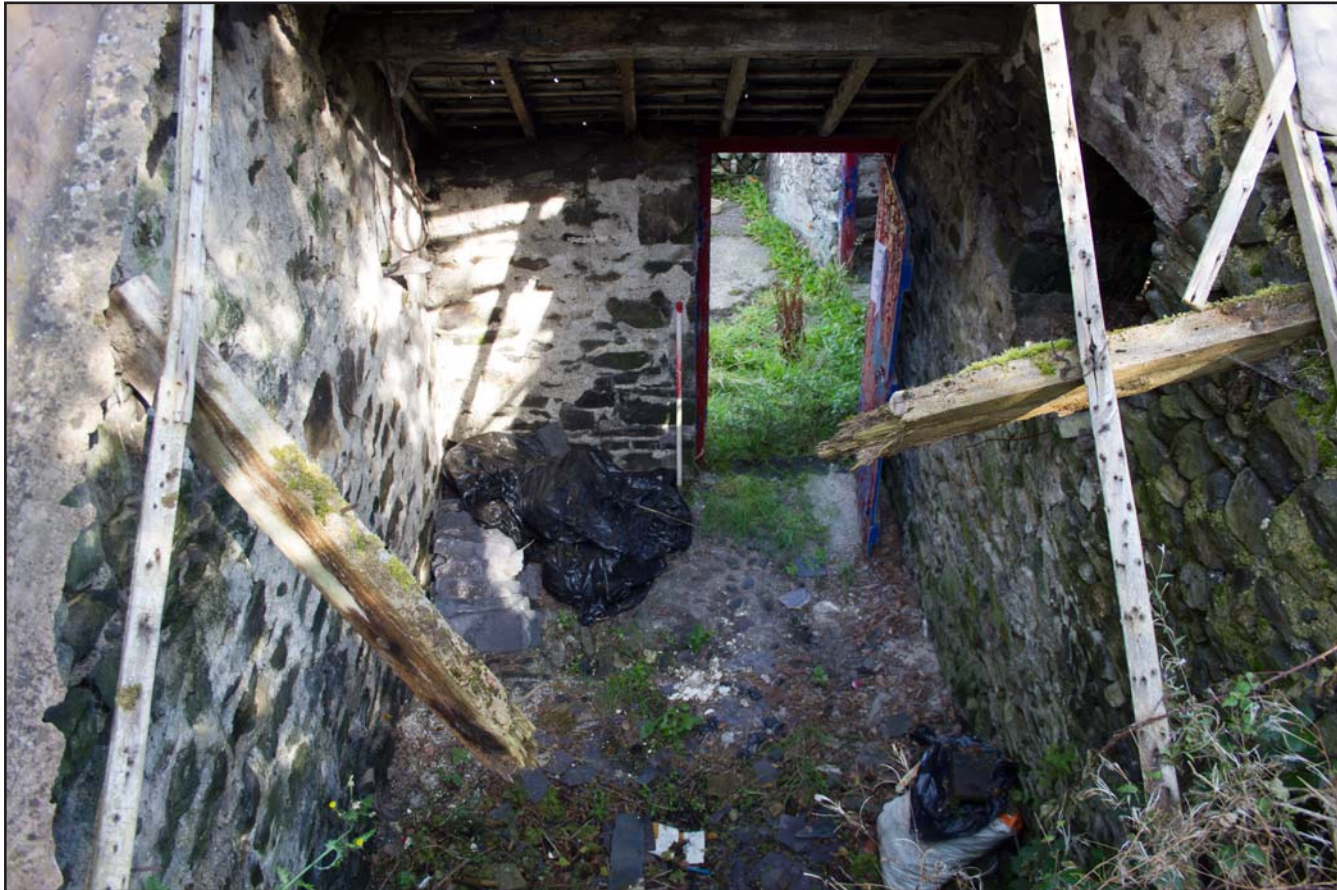
**Plate 21:** Internal shot - Southern elevation of Store 1, Tan Y Bodran, Bodran Road, Llanfairtalhaiarn, Conwy - from the north - no scale

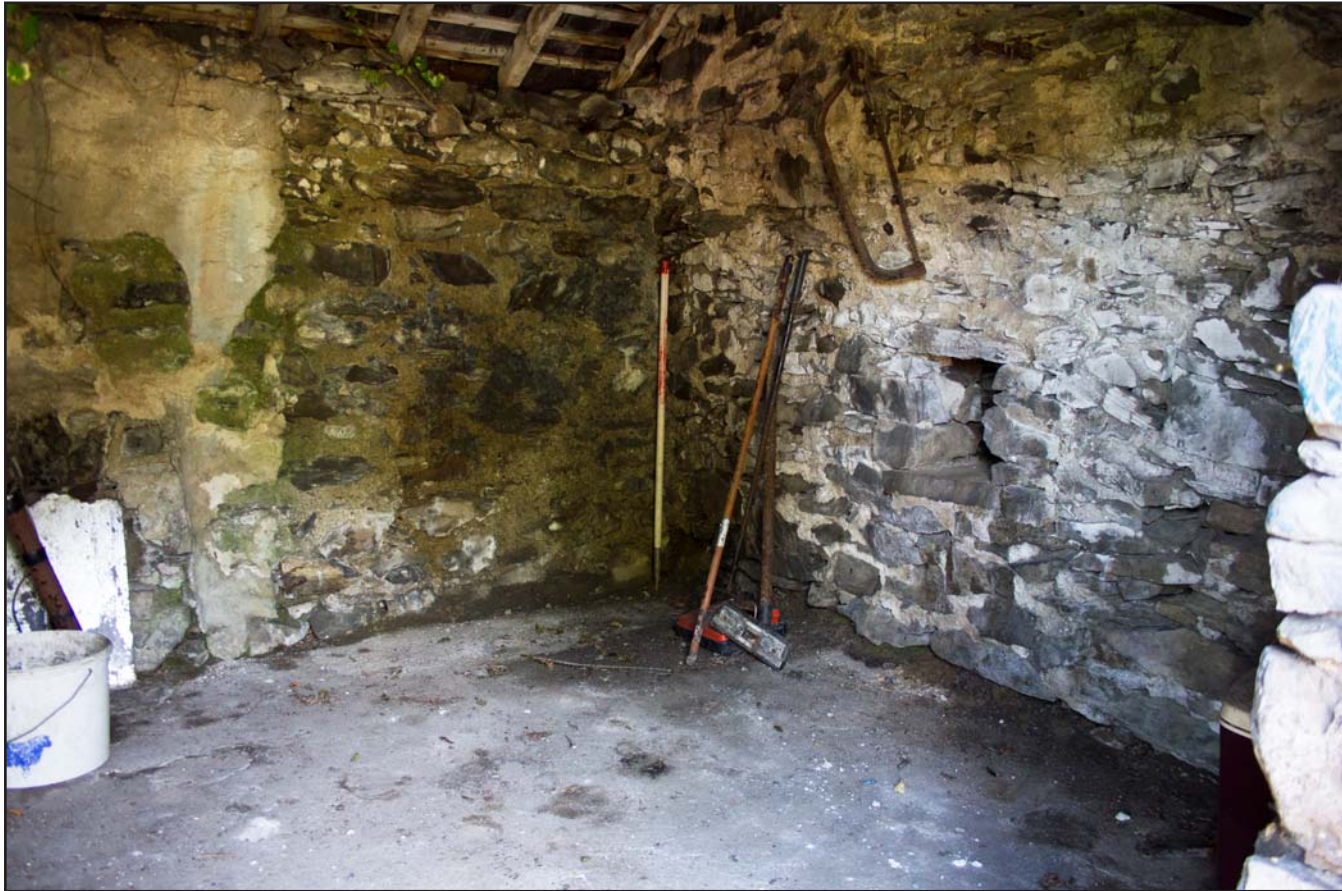
**Plate 22:** Internal shot - Oblique shot of Store 2, Tan Y Bodran, Bodran Road, Llanfairtalhaiarn, Conwy - from the southwest  
- scale 1m

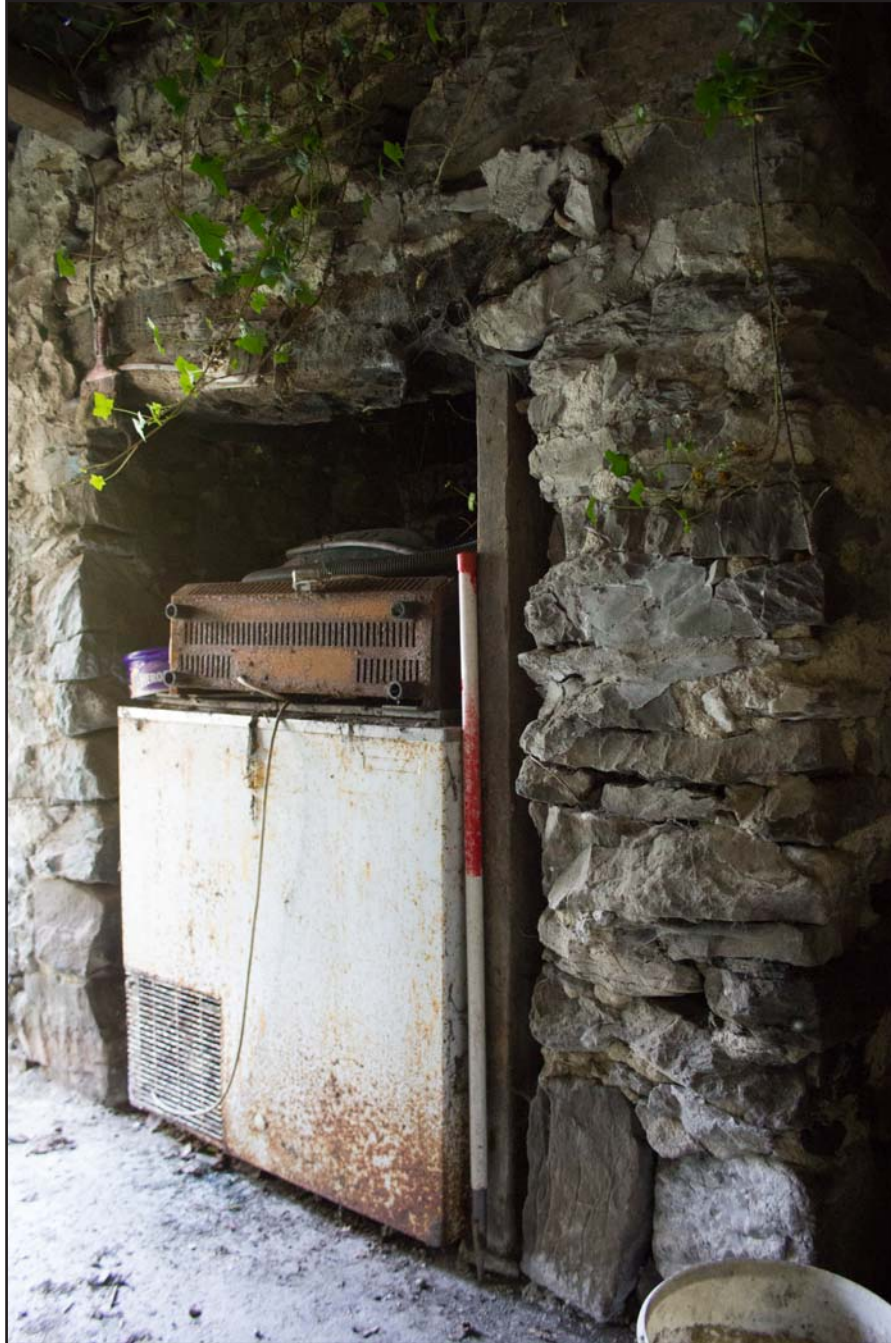
**Plate 23:** Internal shot - Northern elevation/Inglenook Oven in Store 2, Tan Y Bodran, Bodran Road, Llanfairtalhaiarn, Conwy - from the northeast - scale 1m

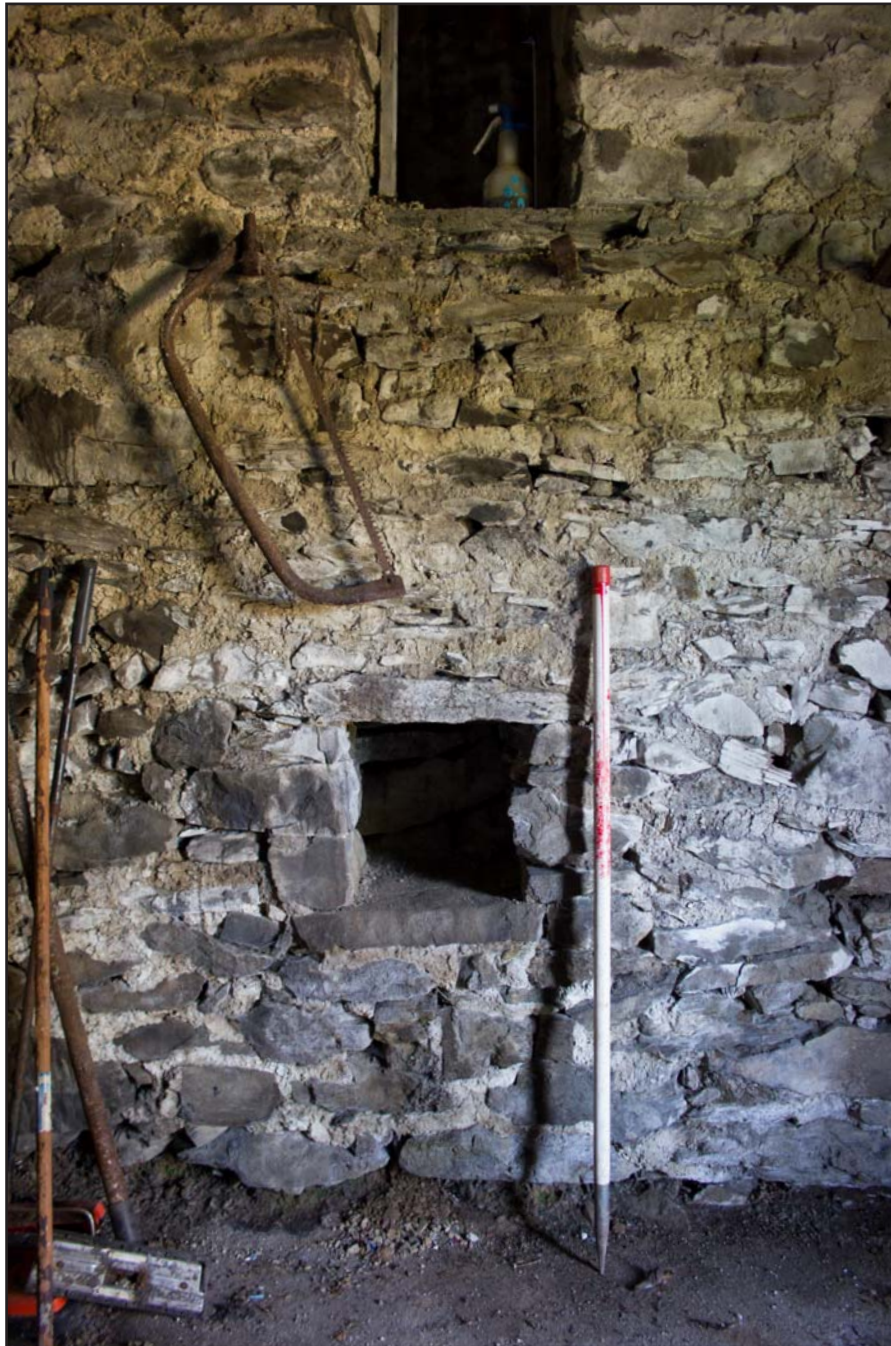
**Plate 24:** Internal shot - Southern elevation in Store 2, Tan Y Bodran, Bodran Road, Llanfairtalhaiarn, Conwy - from the southwest - scale 1m

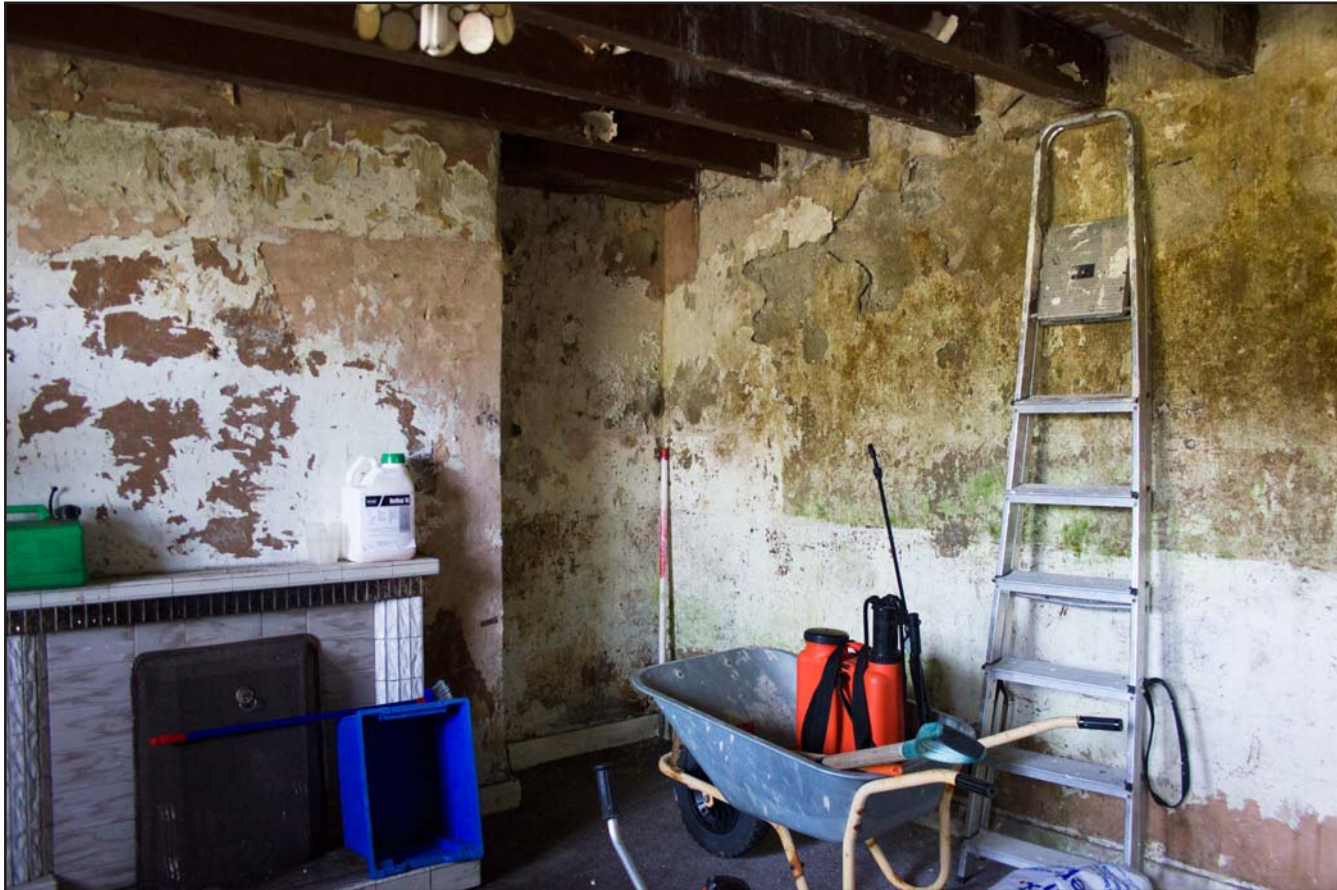
**Plate 25:** Internal shot - Lounge within the Farmhouse building at Tan Y Bodran, Bodran Road, Llanfairtalhaiarn, Conwy - from the southwest - scale 1m

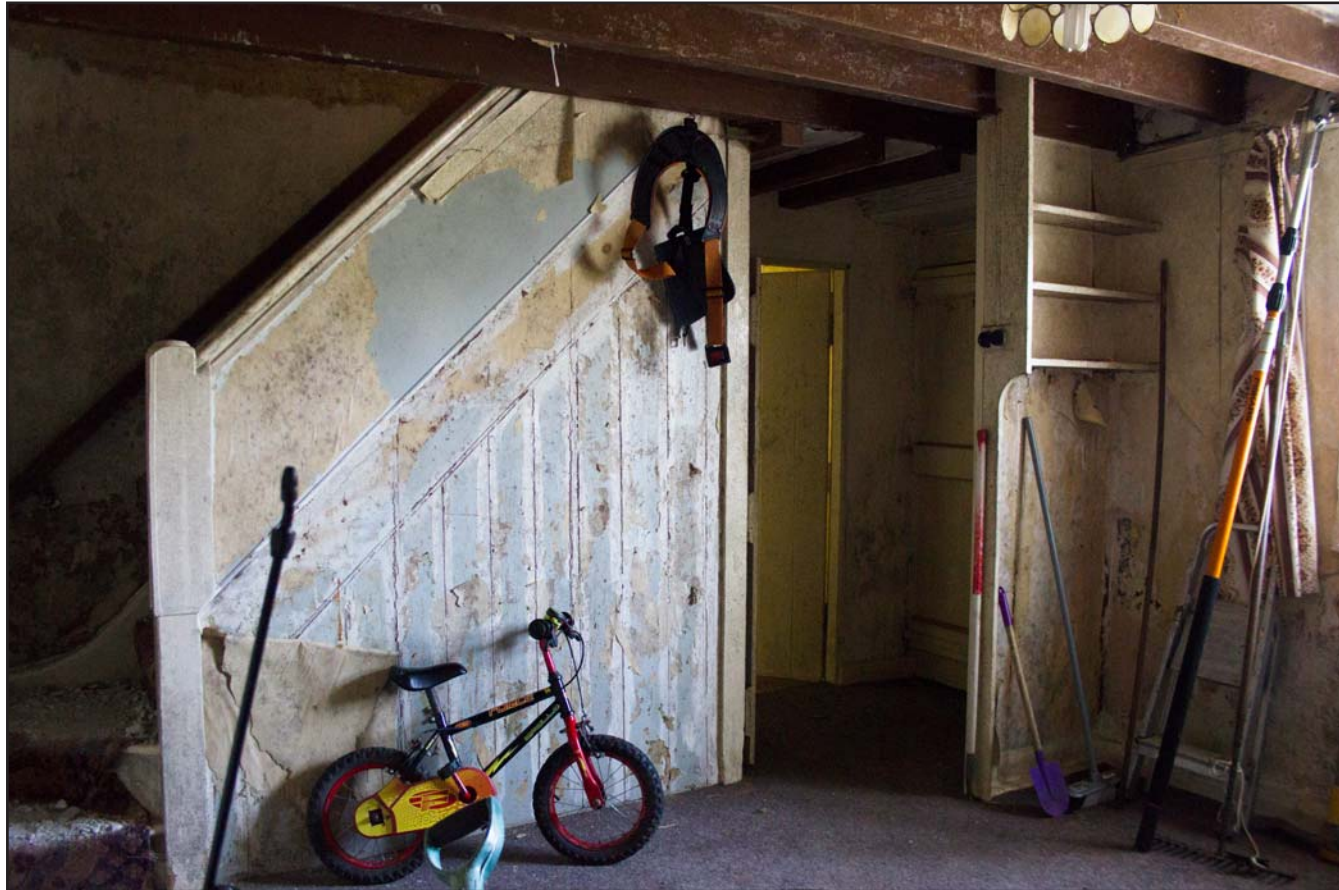
**Plate 26:** Internal shot - Lounge within the Farmhouse building at Tan Y Bodran, Bodran Road, Llanfairtalhaiarn, Conwy - from the northeast - scale 1m

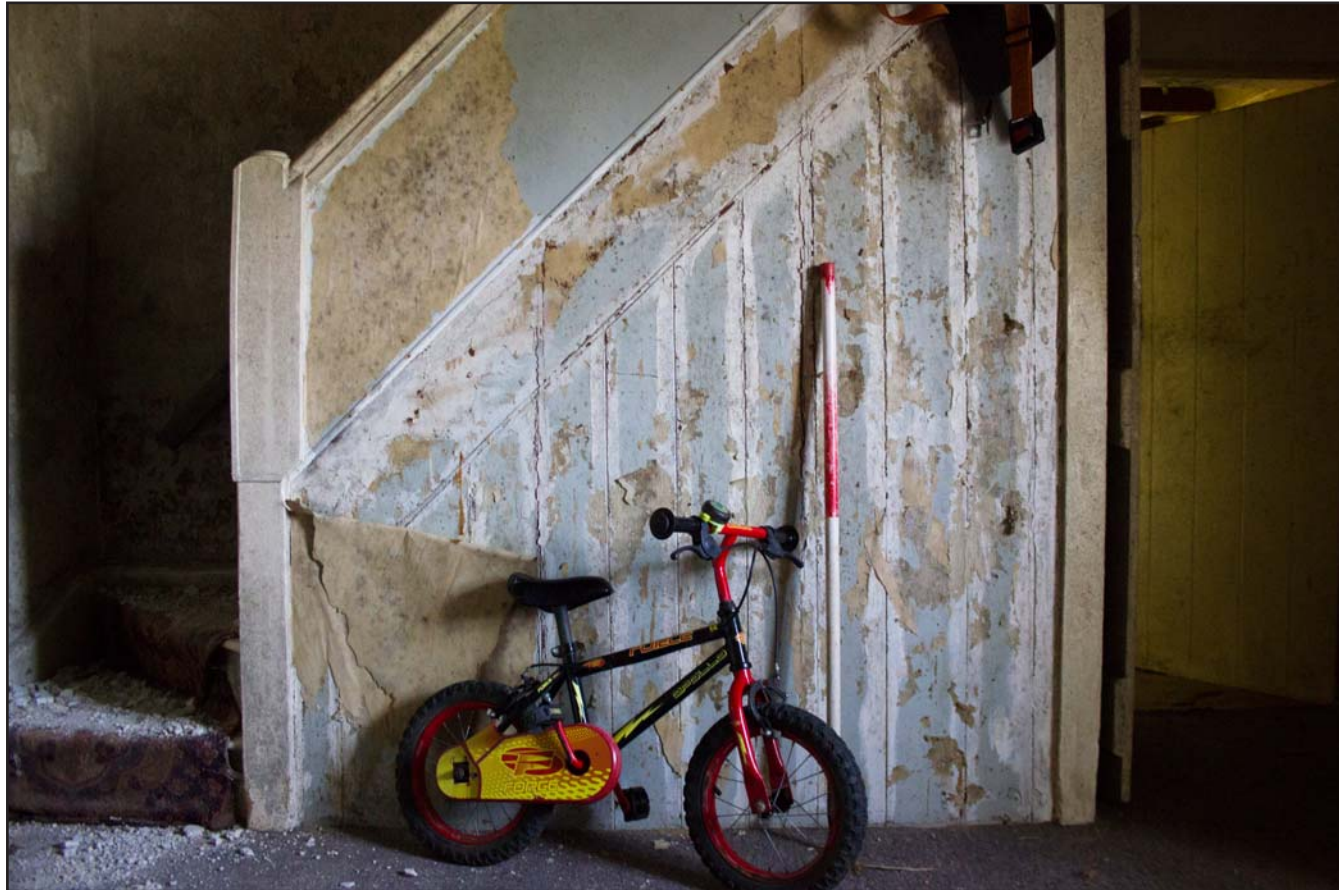
The western elevation is dominated by the timber staircase which alights to first floor level. This staircase consists of a white painted wooden newel post, a white painted wooden banister and white painted wooden boards which hide white painted balusters behind. The carpet of the stairs is of a brown and yellow floral design and the wooden treads (visible beneath) have also been painted white. When viewed from the north - below the staircase is a small cupboard (*twll dan stair*) replete with a white shelf and a linoleum floor with fake Parquet design. This space is closed off from the main room by a heavy wood panel door painted white. At the far right-hand end of the western elevation is a single doorway opening permitting access to the kitchen - this has a heavy wood panelled door, painted white set

**Plate 27:** Internal shot - Staircase within the Lounge , Farmhouse building at Tan Y Bodran, Bodran Road, Llanfairtalhaiarn, Conwy - from the northeast - scale 1m

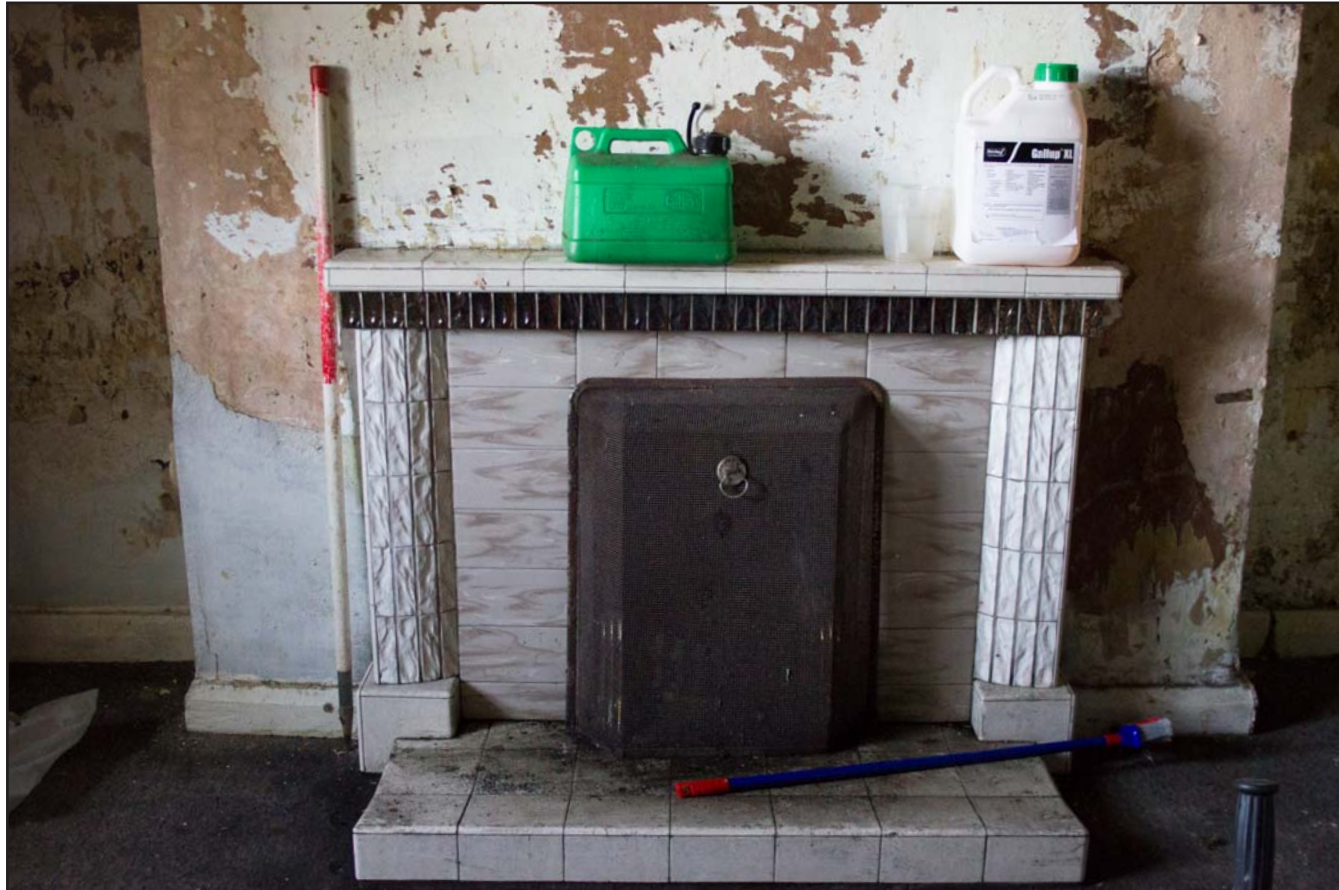
The eastern elevation has a centralised, substantial chimney breast, to the left and right of which two small alcoves are formed. Located on the chimney breast is a fireplace; with cream tiled mantle, cream tiled surround, cast iron grate and cream tiled hearth. The southern elevation has been rendered and partially painted white although most of this paint and render is in an extremely poor state of repair. Apart from this the elevation is featureless.

**Plate 28:** Internal shot - Fireplace within the Lounge , Farmhouse building at Tan Y Bodran, Bodran Road, Llanfairtalhaiarn, Conwy - from the northeast - scale 1m

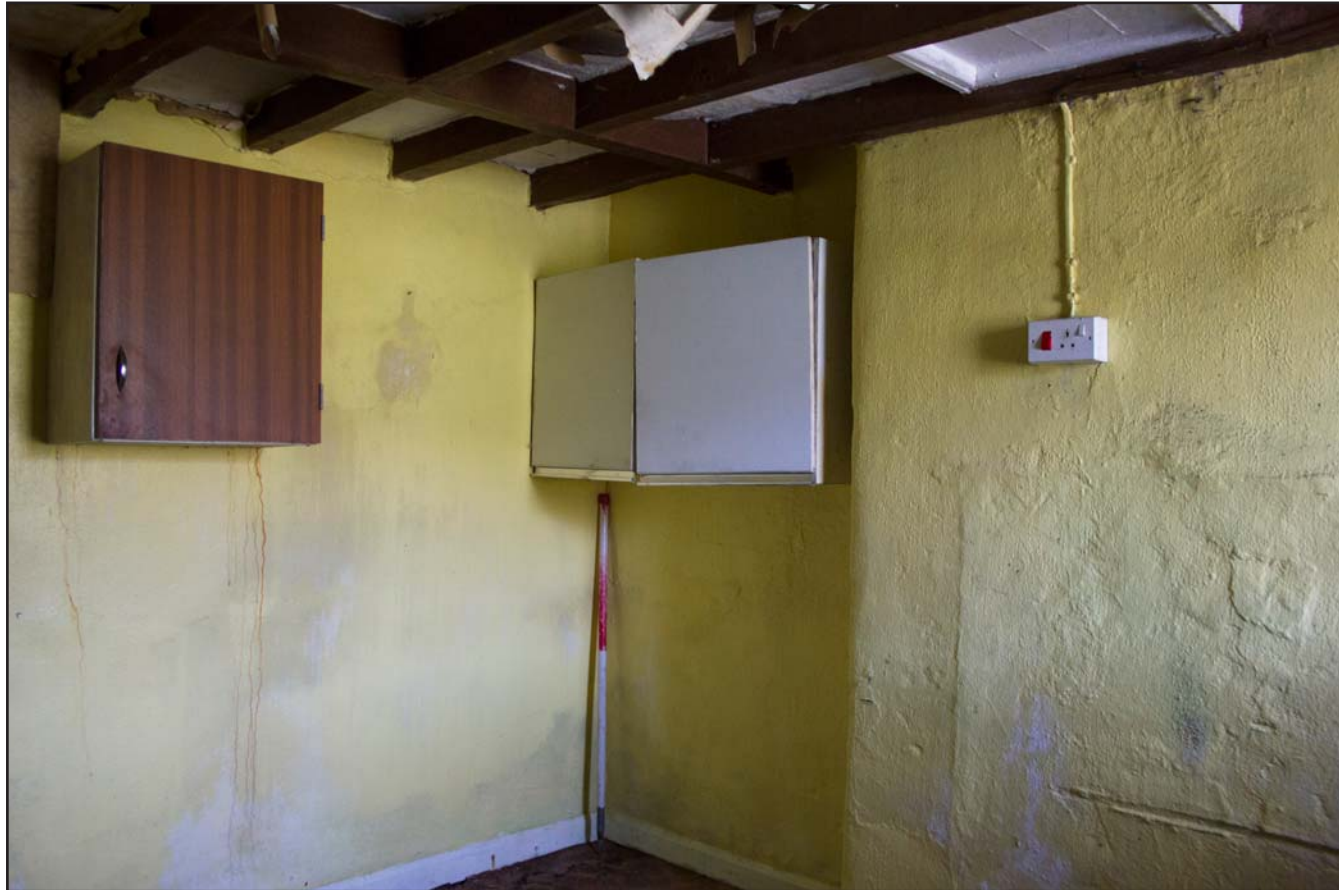
**Plate 29:** Internal shot - Kitchen within the Farmhouse building at Tan Y Bodran, Bodran Road, Llanfairtalhaiarn, Conwy - from the northeast - scale 1m

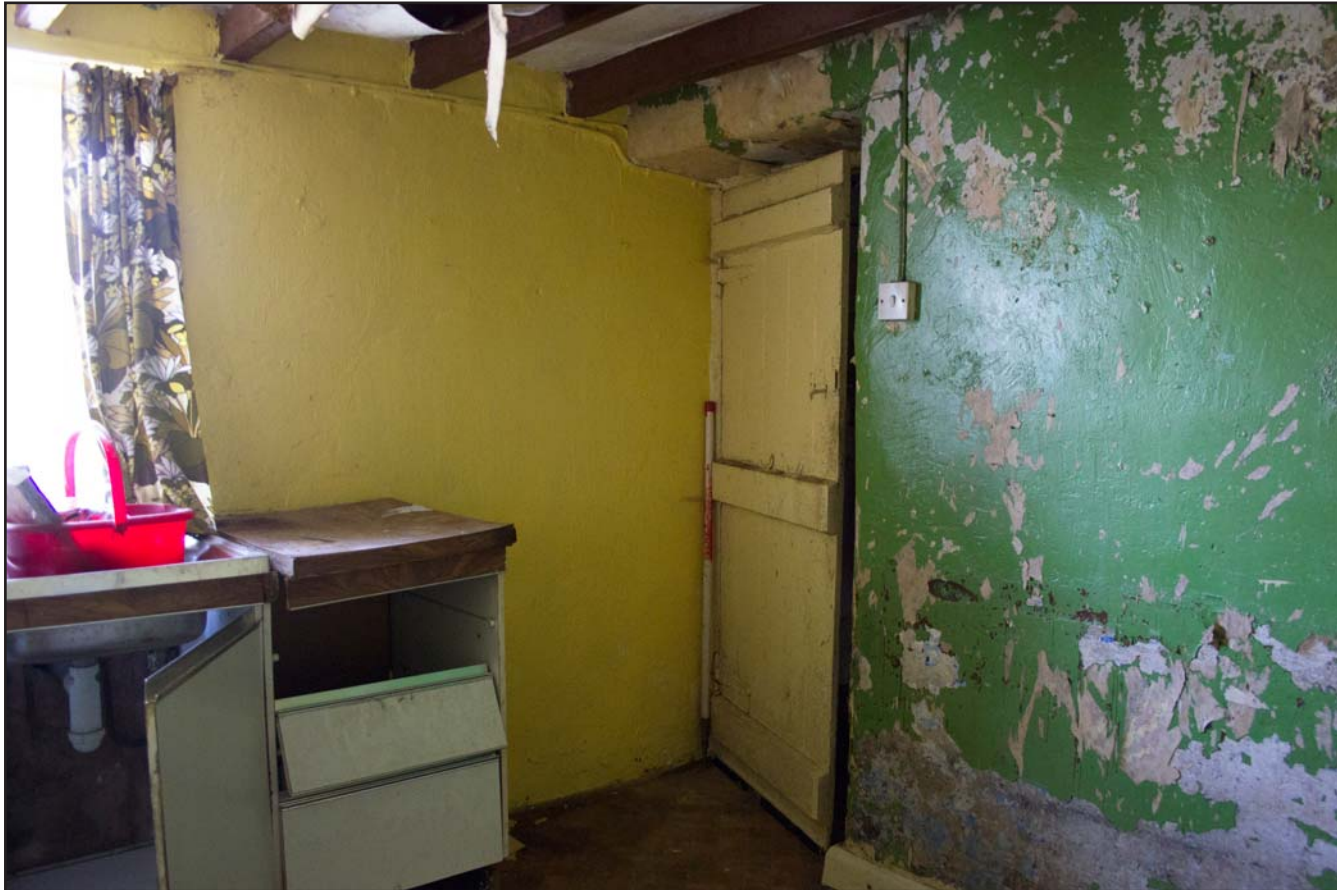
**Plate 30:** Internal shot - Kitchen within the Farmhouse building at Tan Y Bodran, Bodran Road, Llanfairtalhaiarn, Conwy - from the southeast - scale 1m

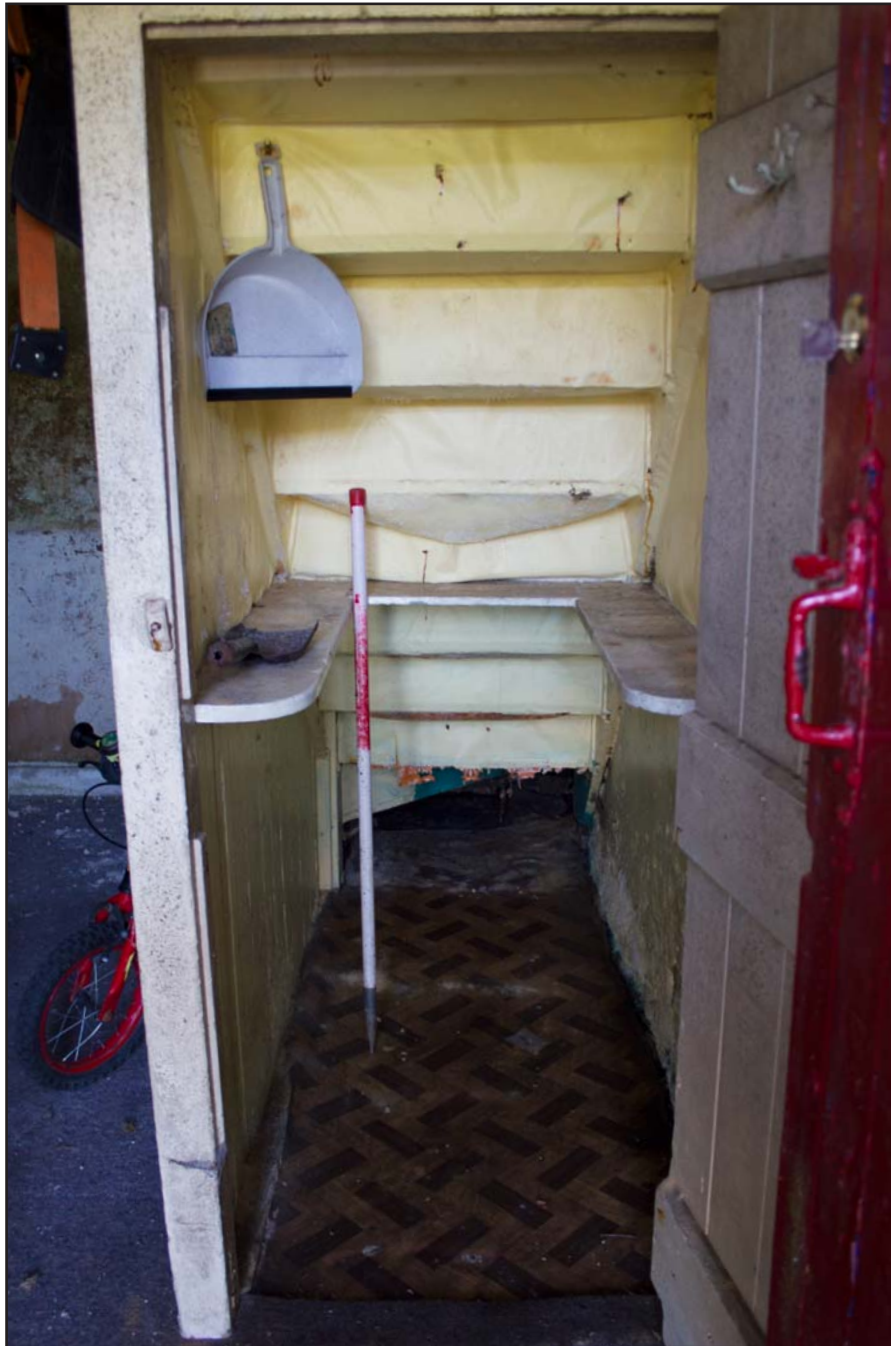
**Plate 31:** Internal shot - "Twill dan Stair" beneath stairwell within the Farmhouse building at Tan Y Bodran, Bodran Road, Llanfairtalhaiarn, Conwy - from the north - scale 1m

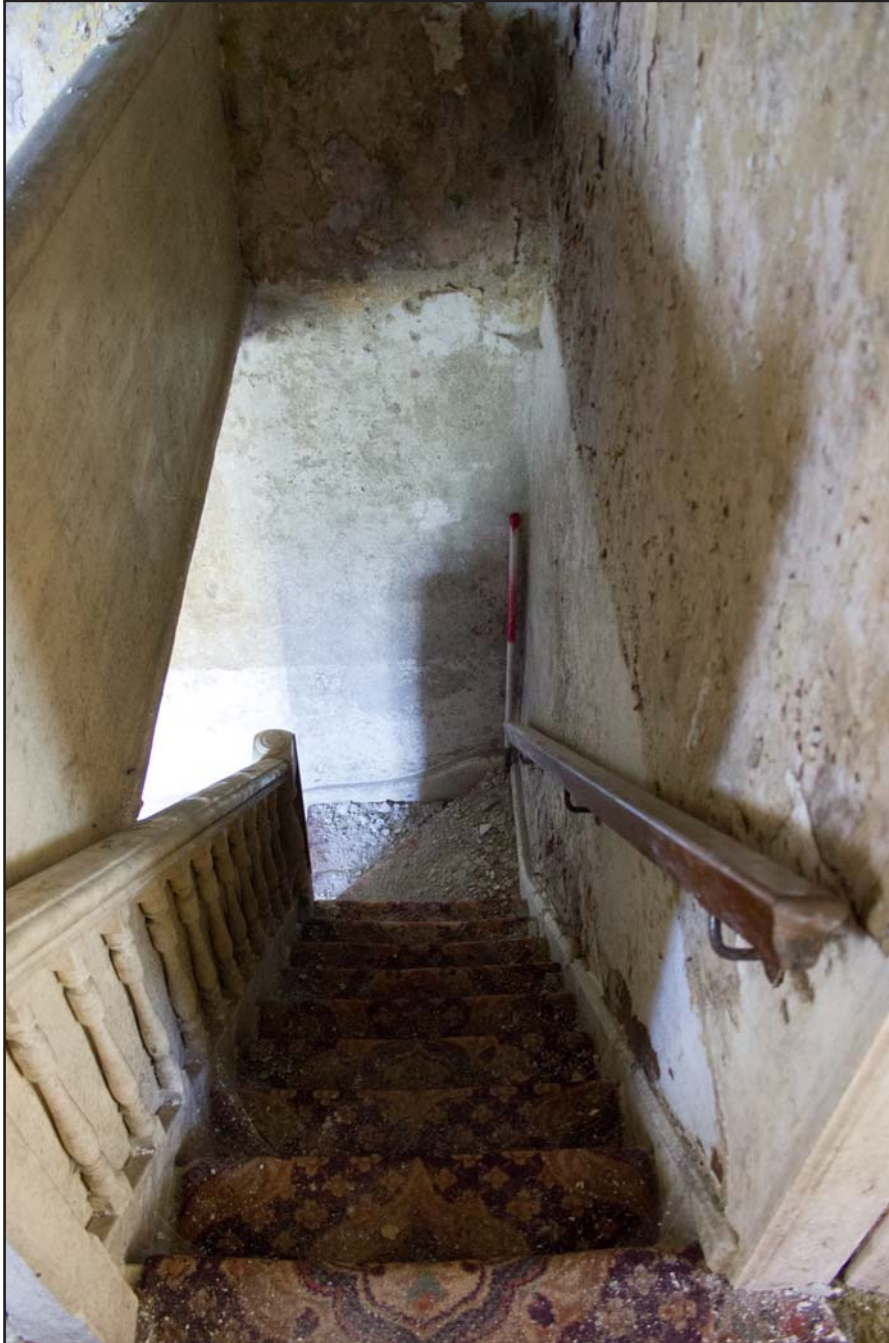
**Plate 32:** Internal shot - Stairwell from first floor within the Farmhouse building at Tan Y Bodran, Bodran Road, Llanfairtalhaiarn, Conwy - from the north - scale 1m

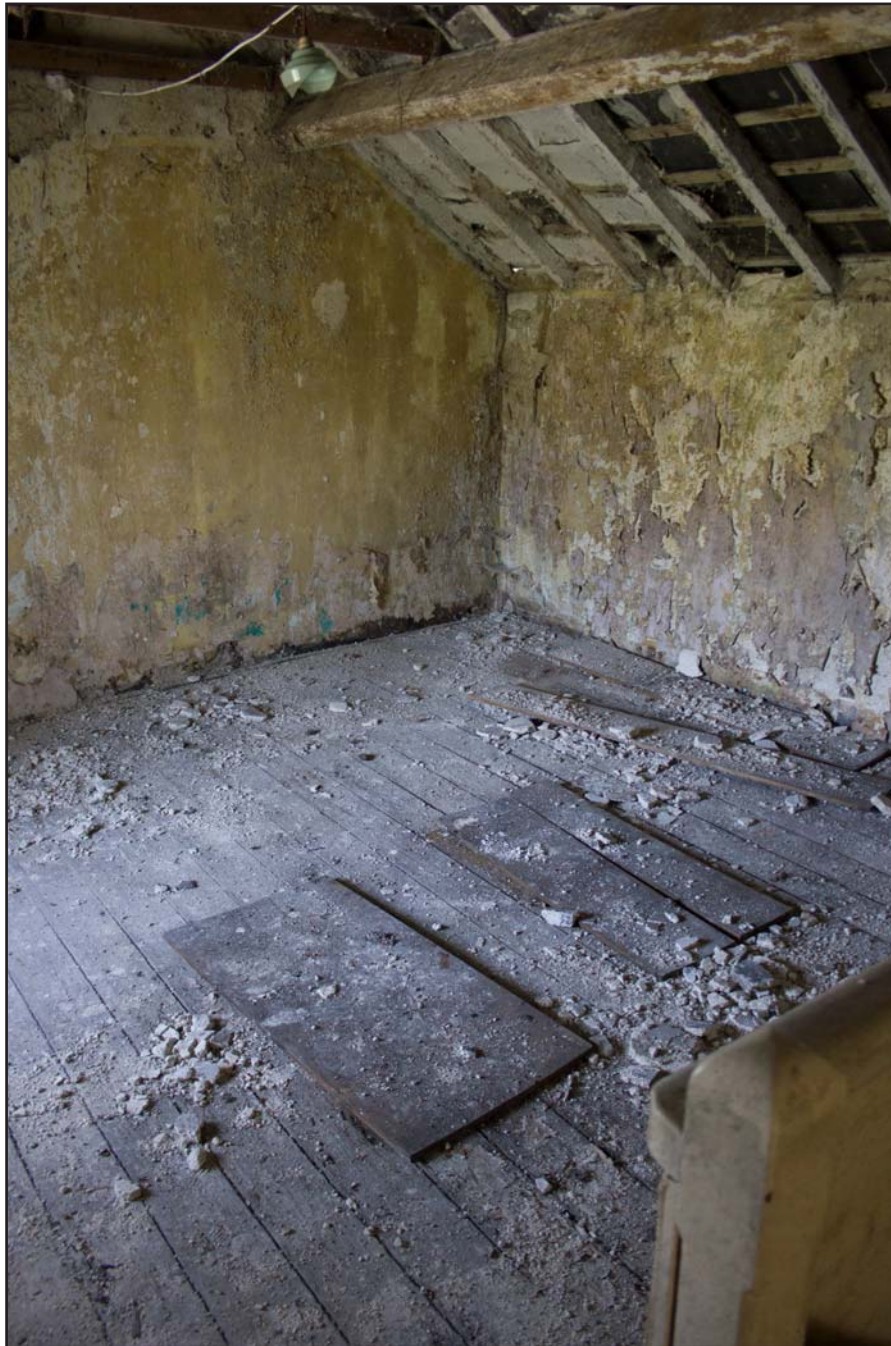
**Plate 33:** Internal shot - Bedroom 1 on first floor, within the Farmhouse building at Tan Y Bodran, Bodran Road, Llanfairtalhaiarn, Conwy - from the northwest - no scale

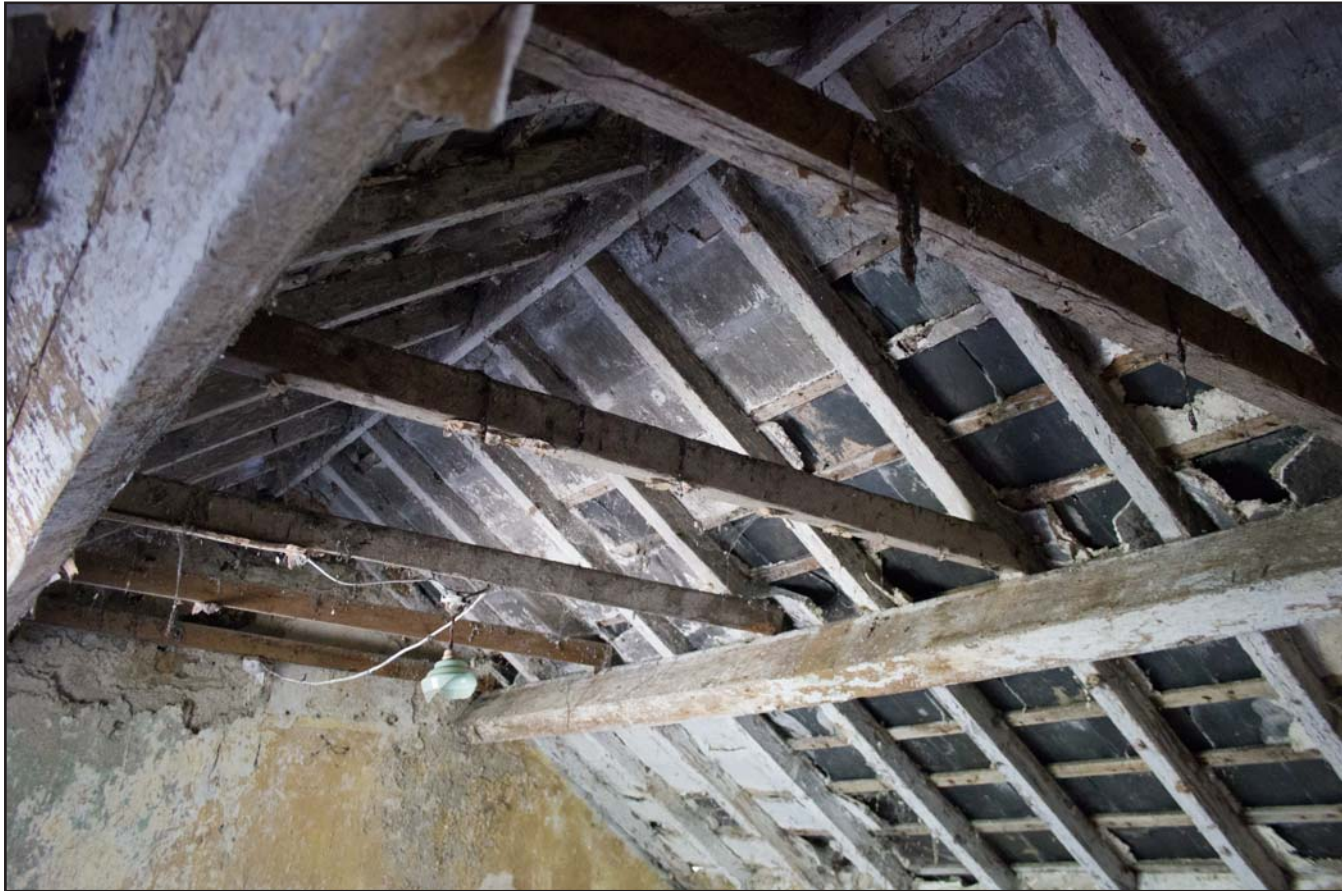
**Plate 34:** Internal shot - Bedroom 1 ceiling, within the Farmhouse building at Tan Y Bodran, Bodran Road, Llanfairtalhaiarn, Conwy - from the northwest - no scale

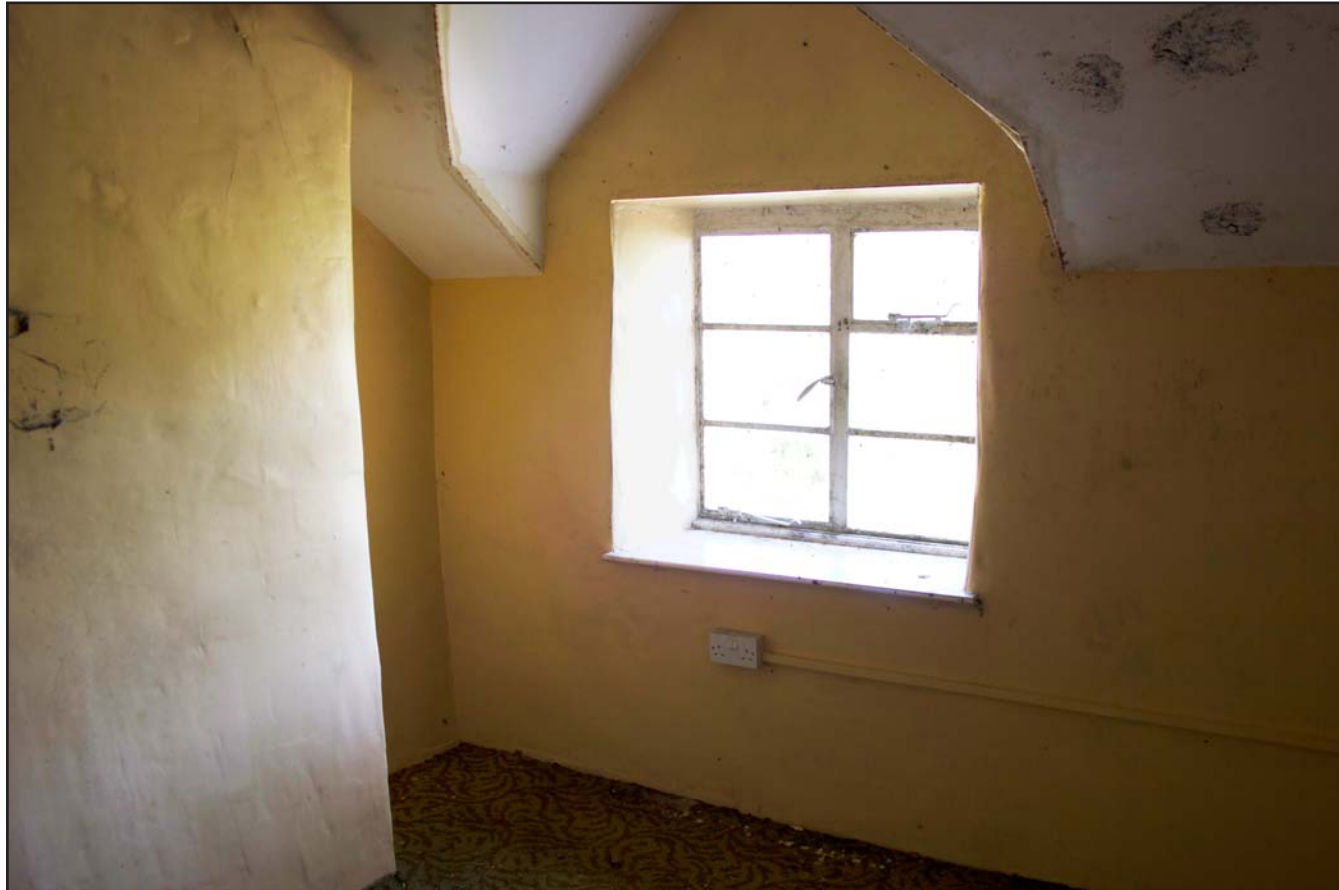
**Plate 35:** Internal shot - Bedroom 2, within the Farmhouse building at Tan Y Bodran, Bodran Road, Llanfairtalhaiarn, Conwy - from the southeast - no scale

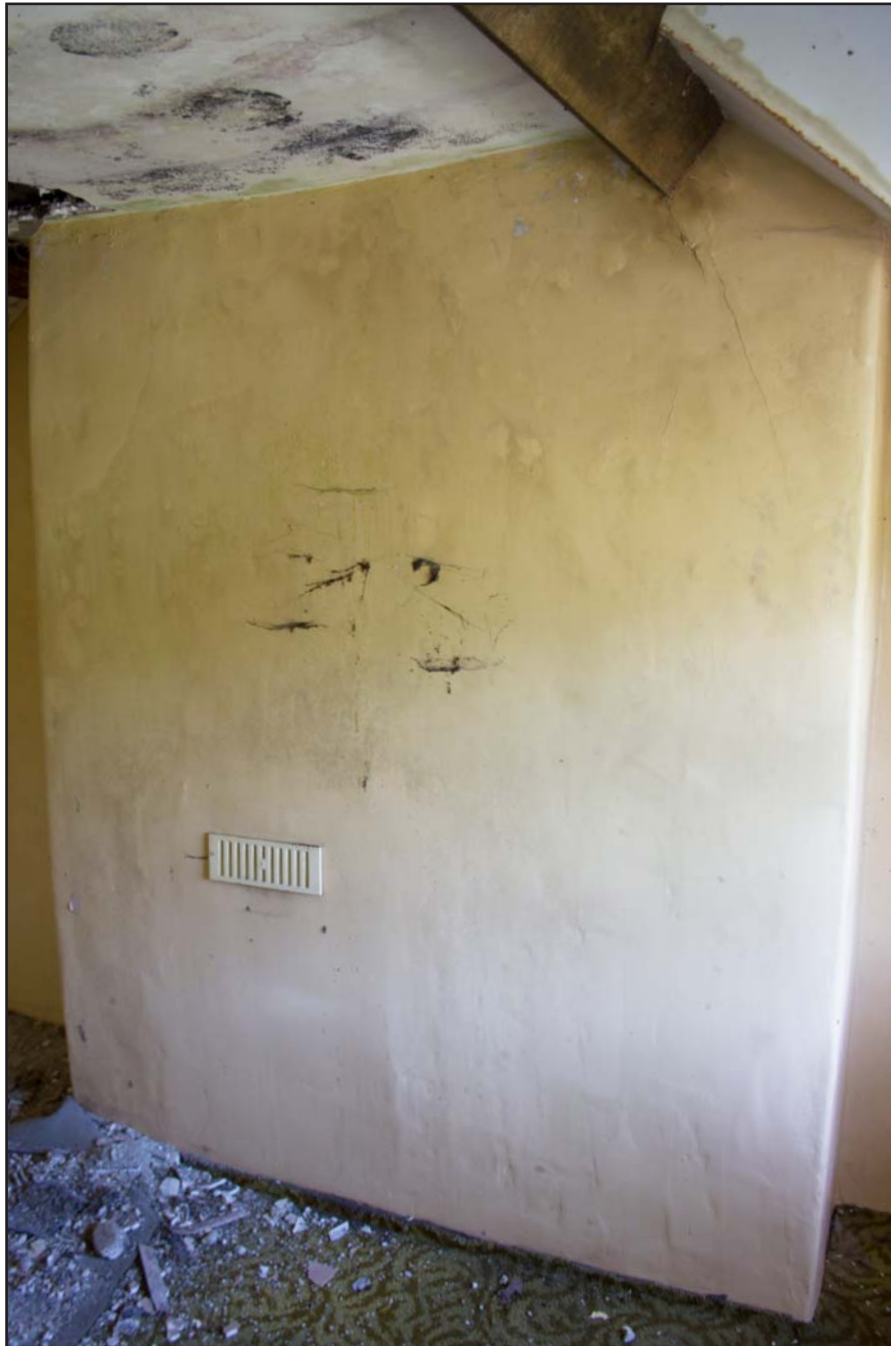
**Plate 36:** Internal shot - Bedroom 2, within the Farmhouse building at Tan Y Bodran, Bodran Road, Llanfairtalhaiarn, Conwy - from the northeast - no scale
