Pwll Fanog Wreck,
Menai Strait, Anglesey

Designated Site Assessment:

Archaeological Report

Ref: 53111.03vv

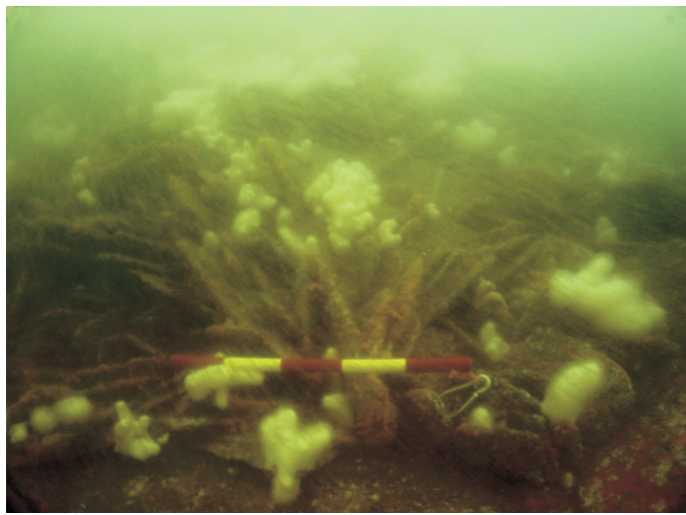
MP1a - Mound from north looking roughly south

- 3.6.1. A total of five site features have been selected for the purposes of future monitoring of erosion, deposition, damage and stability (**Figure 4**). The location of the photographer and direction, as well as monitoring photographs 1-5 (**MP1-5**) are shown in **Figure 4**. Two sets of photographs were selected for **MP1 (a-b)**, **MP2 (a-b)** and **MP4 (a-b)** in order to compensate for the bad visibility combined with the scarcity of easily recognisable features on site. It is recommended that the monitoring photographs should be repeated at no greater than annual or biannual intervals.

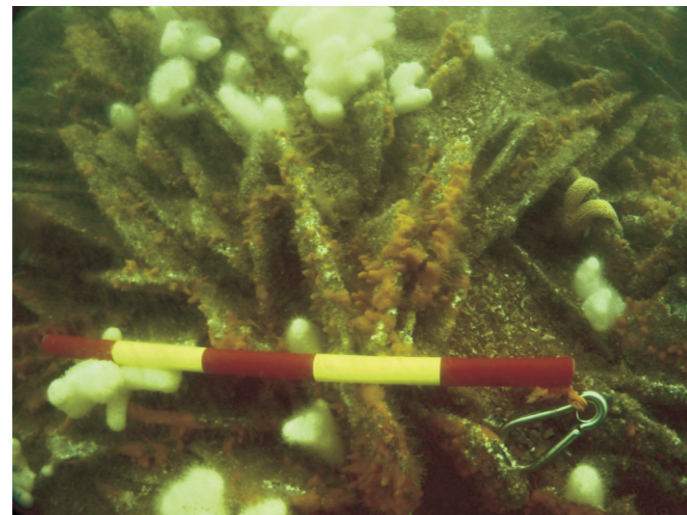
MP1b - Mound from north looking roughly south

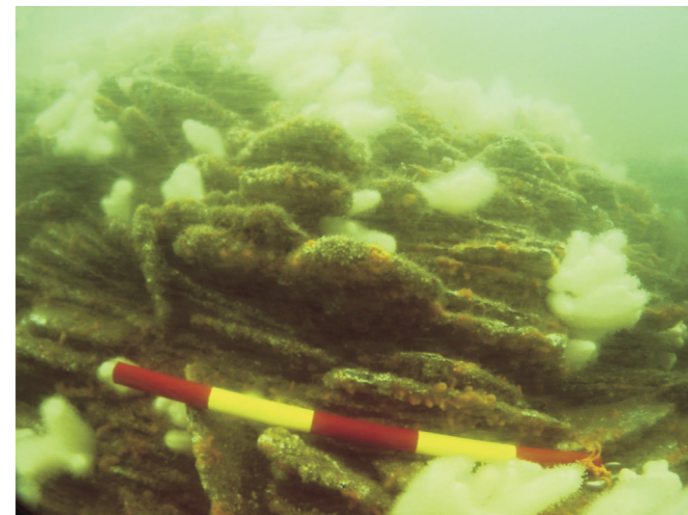
- 3.3.1. An initial site inspection showed that the mound is clearly visible with a distinctive 'wall' of slate in the north of the site which is c. 2m high. The mound is built of bunches of tiles (i.e. groups of tiles lying in the same direction) with no evident pattern. An old datum (a pole in a concrete-filled bucket) and broken survey lines were also observed on site.

MP2a - 'Wall' from north looking roughly south

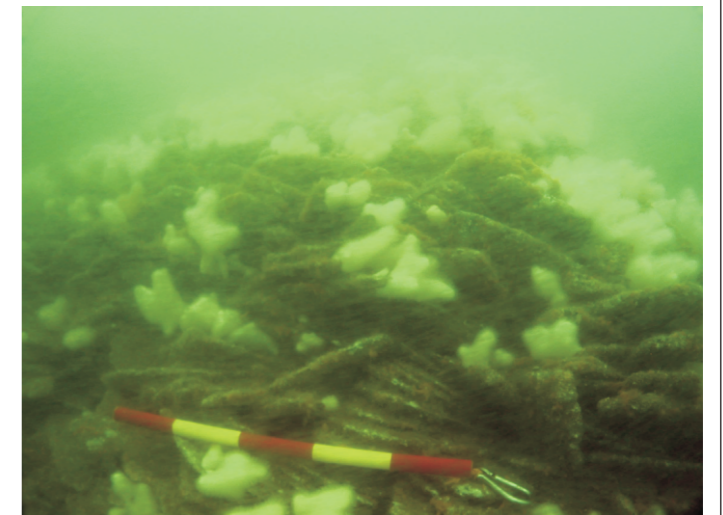
MP2b - 'Wall' from north looking roughly south

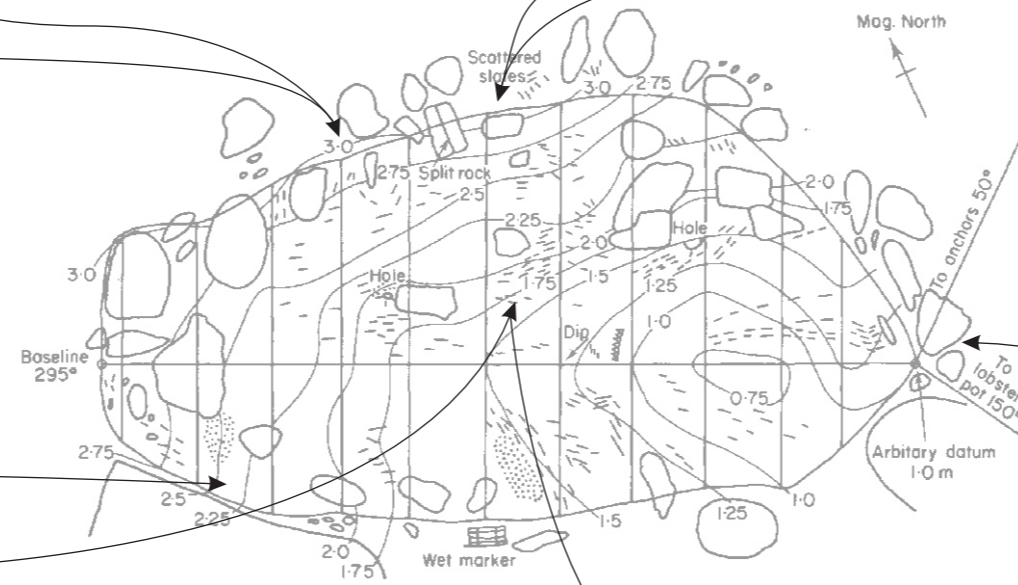
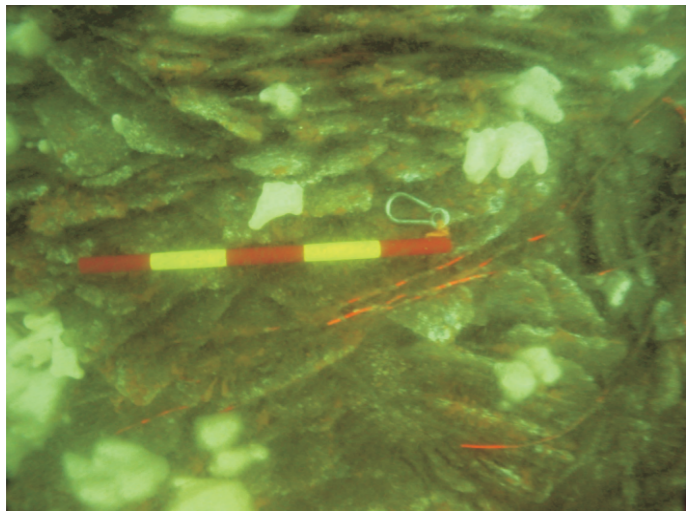
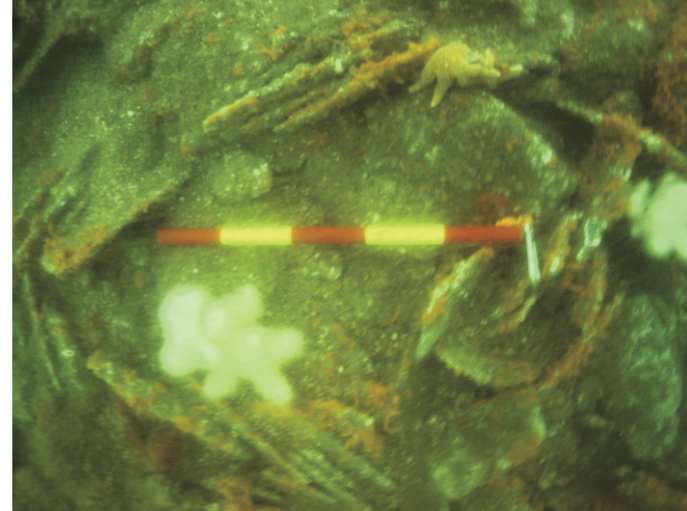
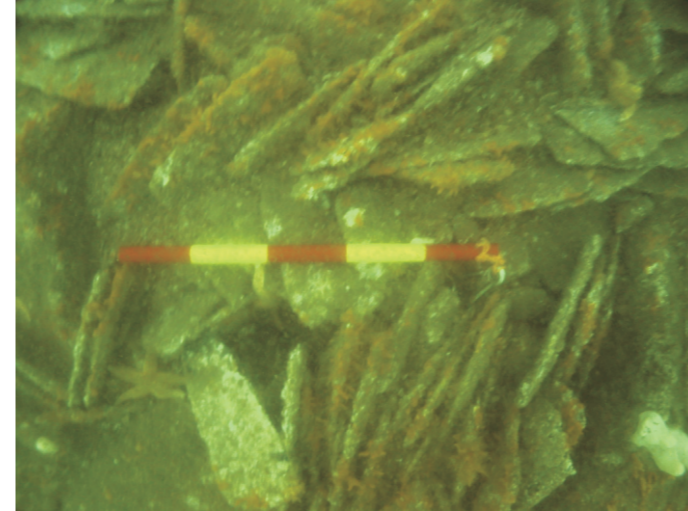
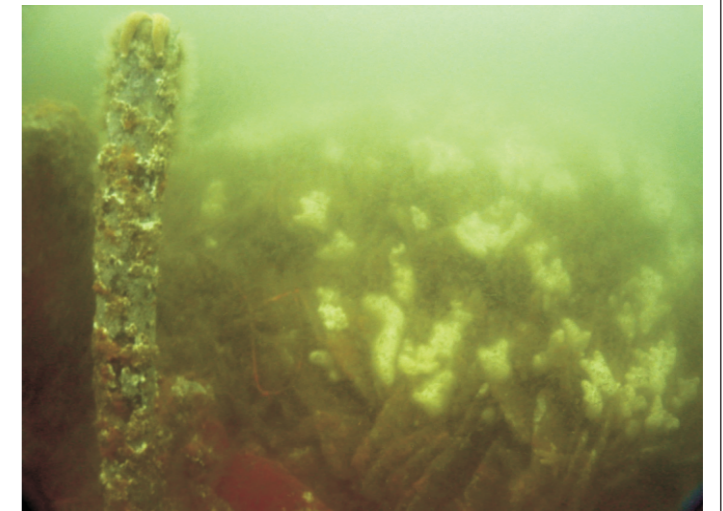
MP5 - In roughly south-west of site from above

MP4b - Slates roughly in centre of mound from above

MP4a - Slates roughly in centre of mound from above

MP3 - Old datum from east looking roughly west
