CPAT Report No. 1768

Machynlleth Hospital, Powys

Building Survey

Client name: Willmott Dixon
 CPAT Project No: 2505
 Project Name: Machynlleth Hospital, Powys
 Grid Reference: SH 7508 0088
 County/LPA: Powys
 Planning Application: 20/0858/CAC
 CPAT Report No: 1768
 Event PRN: 140352
 Report status: Final

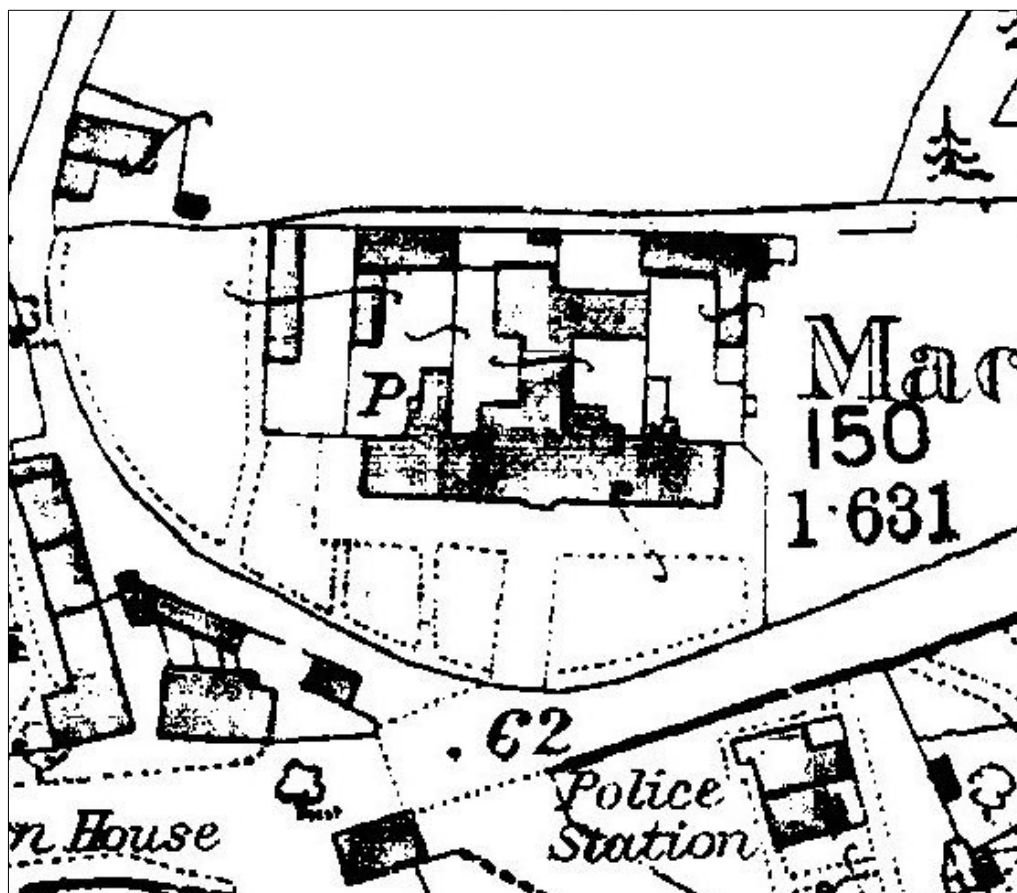
Fig. 2 Extract from the Ordnance Survey map of 1889 showing the layout of the workhouse.

- 2.3. Machynlleth Workhouse was built on a plot fairly centrally within the town and comprised a T-shaped plan with the principal elevation facing onto the junction of Maengwyn Street, Newtown Road and Forge Road (Fig. 2). A number of ancillary buildings were constructed to the rear of the plot.

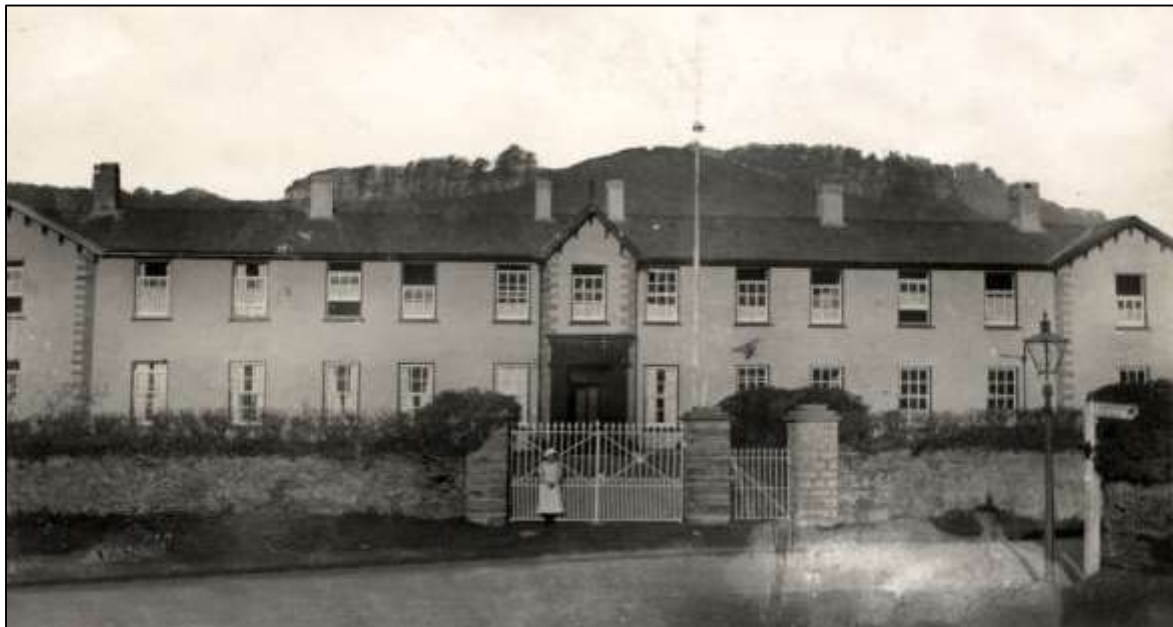
Fig. 3 King Edward VII Welsh Memorial Hospital post 1920. Reproduced from www.workhouses.org.uk

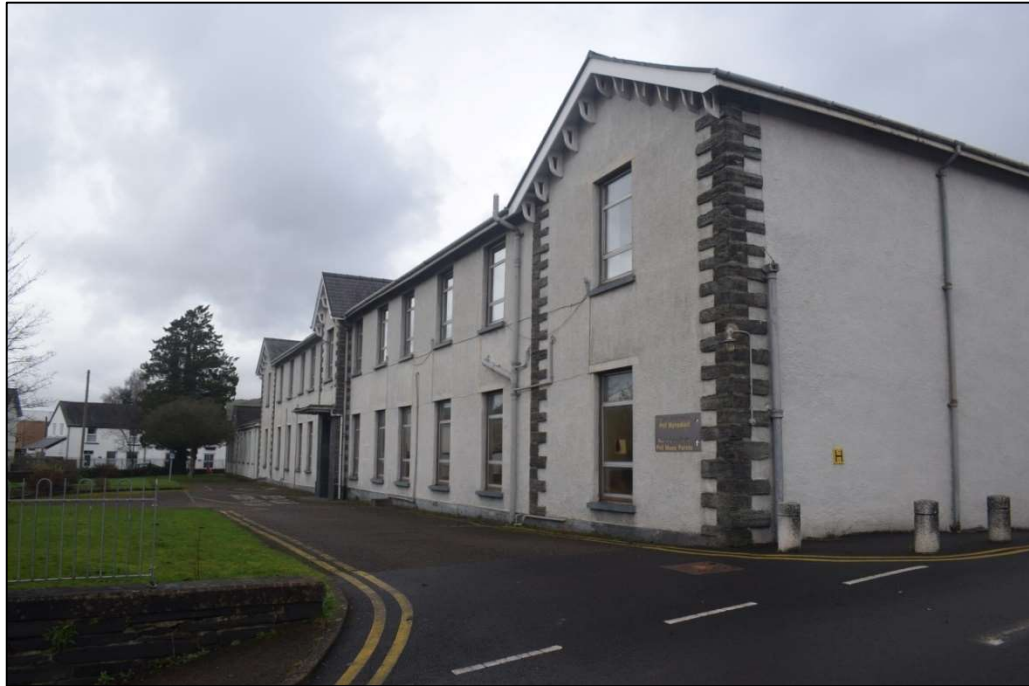
- 3.4. Building 1 comprised the main workhouse building and was a large two storey block oriented east-west, with the principal elevation facing south. The building was constructed from thin,

roughly shaped shale or sandstone pieces, covered externally with render, with sandstone blockwork quoins on the corners. The windows had slate sills and the original frames had been replaced. The gables at either end of the principal elevation had decorative timber purlin ends where they protruded under the bargeboards. A lift had been installed near the main stairs in the centre of the building, which required the construction of a brick-built machine room above the lift shaft.

Fig. 4 View from the south-east of the principal elevation of Building 1 Photo CPAT 4849-116.

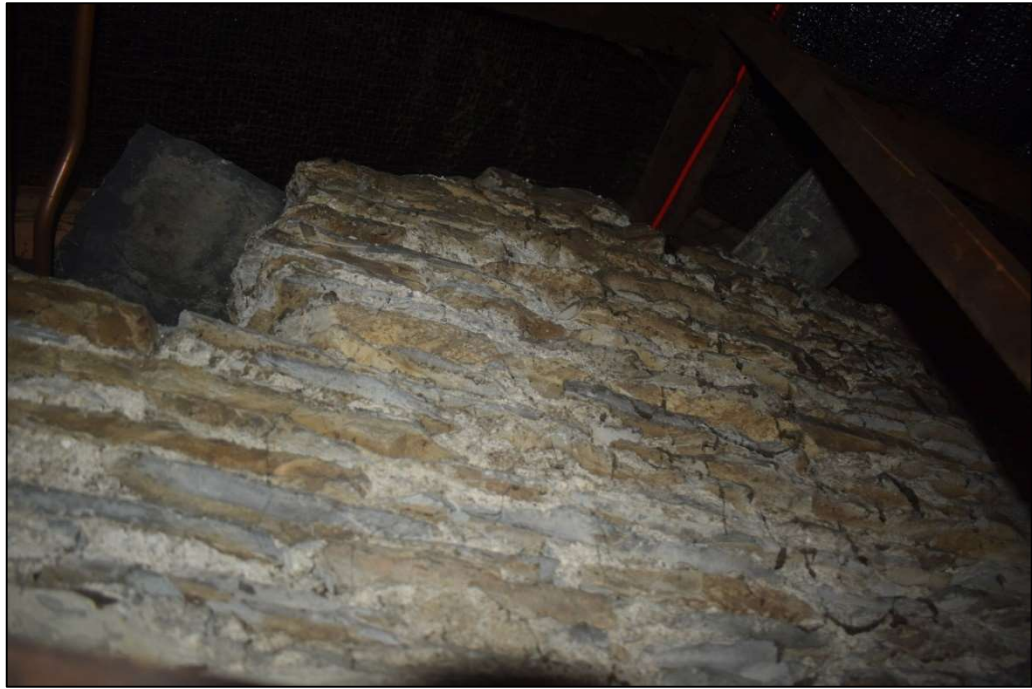
- 3.5. An investigation within the roof space suggested that some if not all the stone chimney stacks were still extant although the external chimneys had been taken down. The slate roof, felting and rafters looked quite recent. The roof frame was a common type timber frame. Traces of the original lath were visible through the modern suspended ceiling in the corridor on the upper floor.

Fig. 5 Upper remnant chimney stack in eastern extent of Building 1 Photo CPAT 4849-072

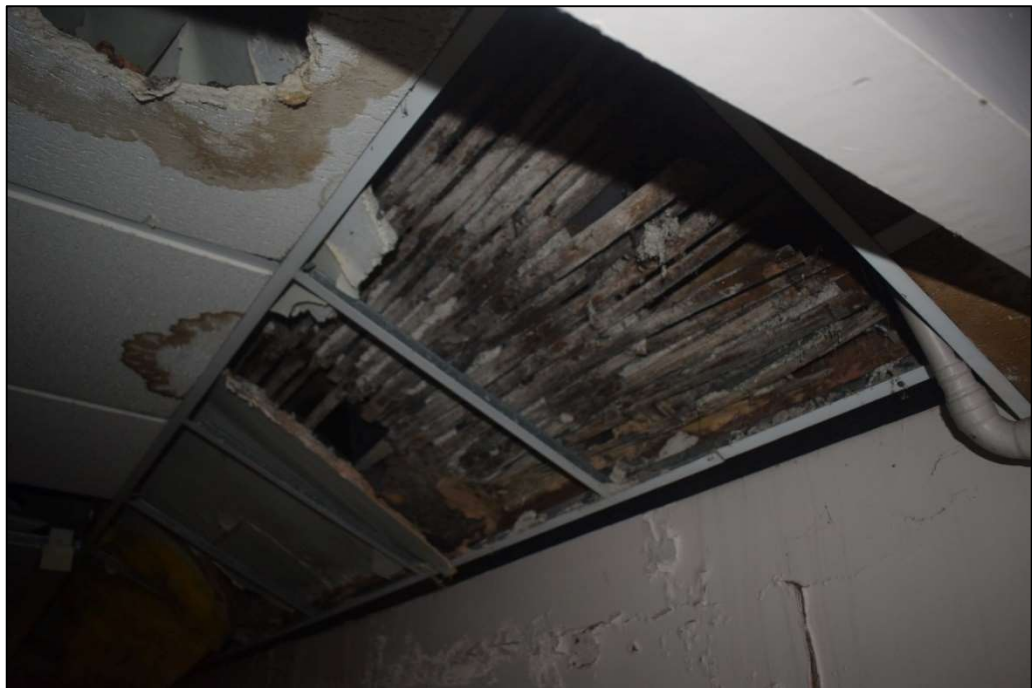
Fig. 6 Roof lath visible in corridor on northern side of Building 1 Photo CPAT 4849-070

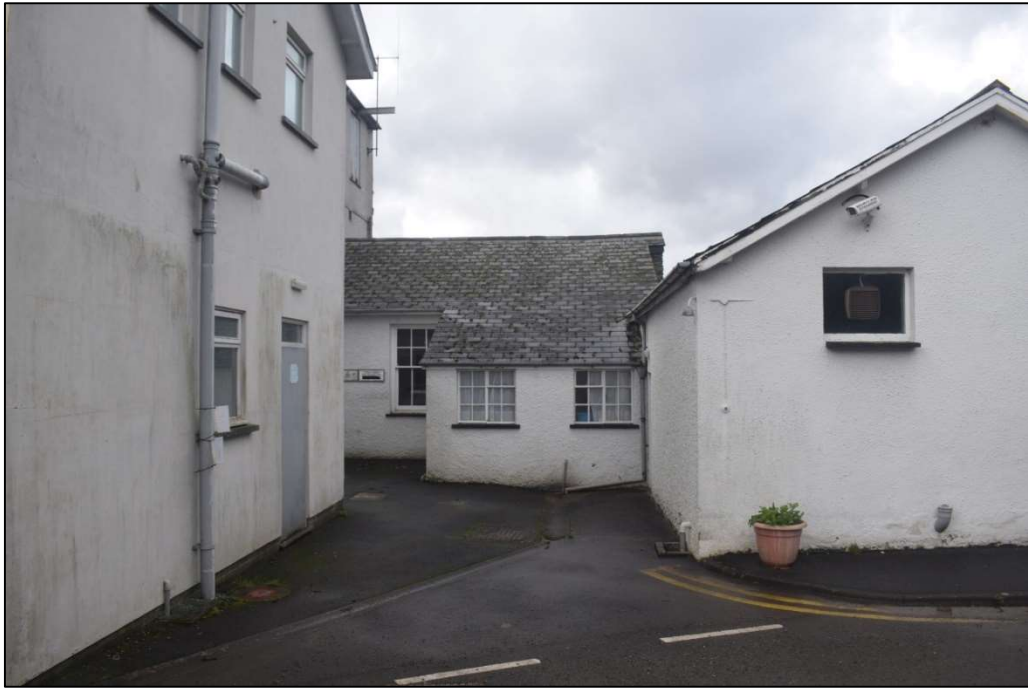
- 3.6. Building 2 was an intermediate building between Building 1 and Building 3 oriented north-south. It was a low single storey building with a later lean-to extension on the east elevation. Two sash windows were visible on the east elevation which may have been original features.

Fig. 7 Building 2 viewed from the east Photo CPAT 4849-122

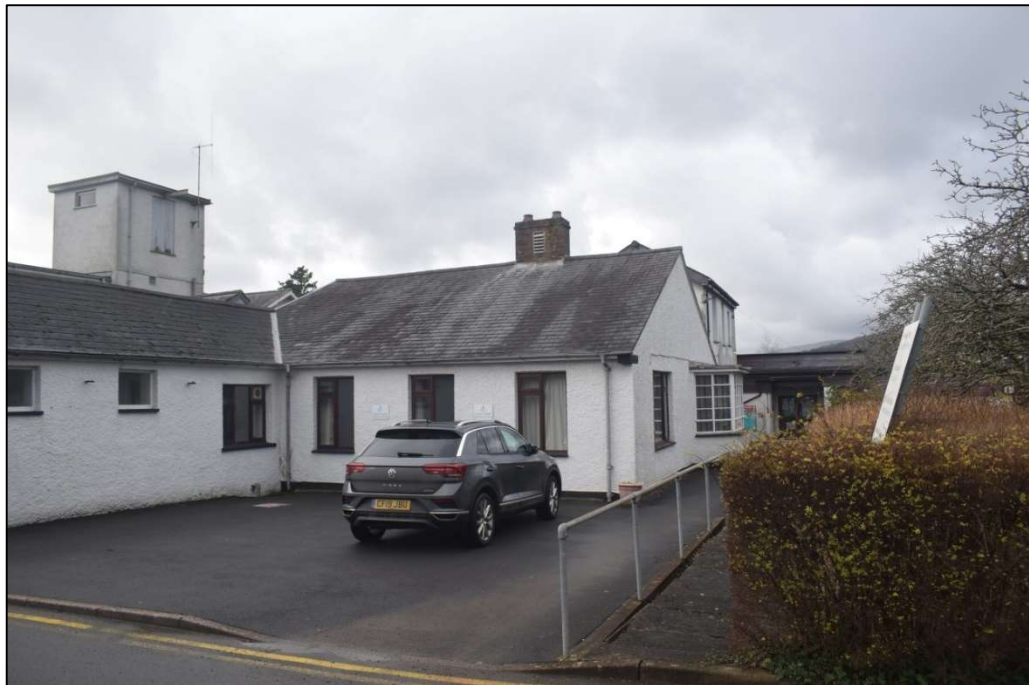
- 3.7. Building 3 was located to the north of Building 2 and accessed via an internal doorway. It was a single storey building oriented east-west. A modern extension with a bay window had been constructed on the north side of the building. A chimney stack on the apex of this building was also modern.

Fig. 8 View from the north-east of Building 3 (to the east of shot) and the modern extension (to the west of shot) Photo CPAT 4849-124

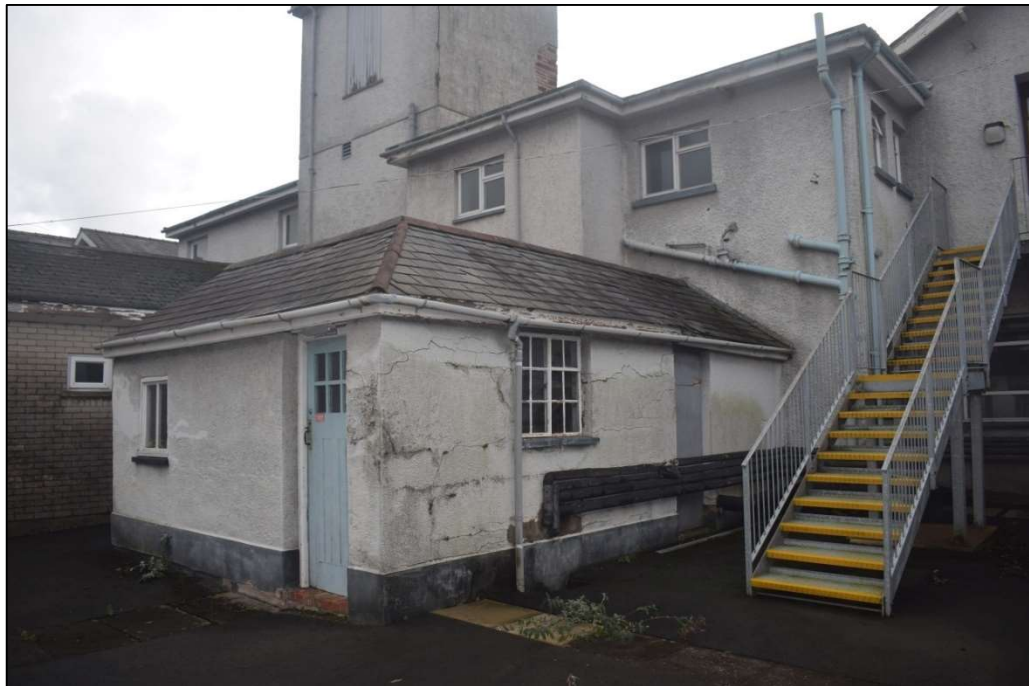
- 3.8. Building 4 was a small L-shaped, single-storey outbuilding oriented north-south on the north elevation of Building 1, to the west of Building 2. No 19th-century architectural features were

visible internally, and the doors and windows, with the exception of a single metal casement on the west elevation, were 20th-century in date.

Fig. 9 View from the north-west of Building 4 Photo CPAT 4849-130

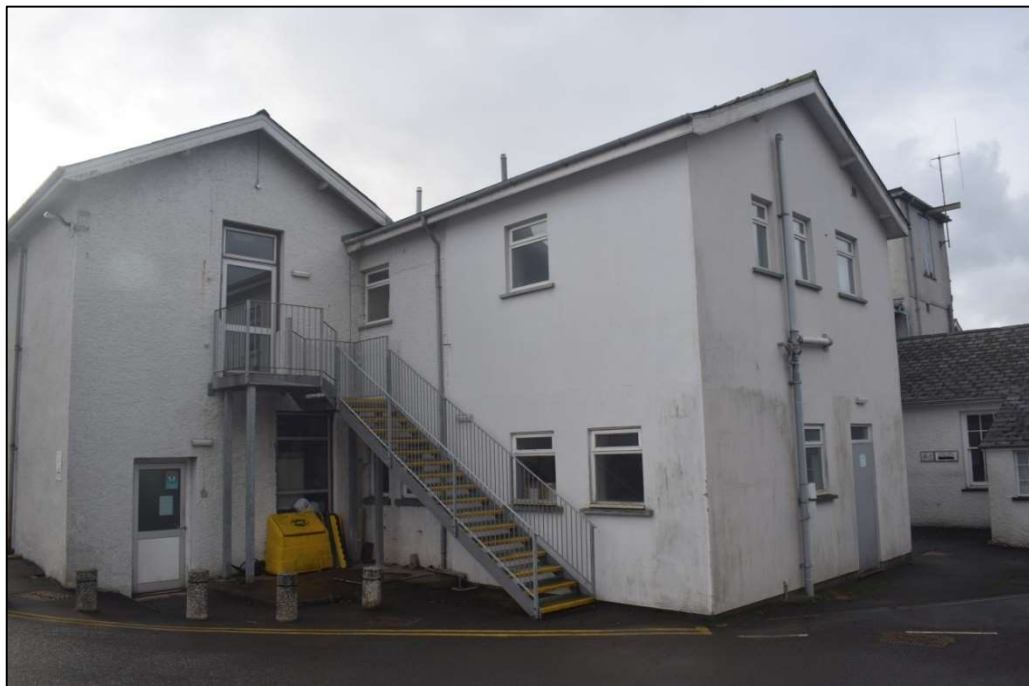
- 3.9. Building 5 was located to the east of Building 2 and oriented north-south. It probably comprised a small single storey outbuilding similar to Building 4. No evidence of this building was apparent in the much larger two storey building extant in this location, suggesting that the earlier structure had been completely taken rather than incorporated into the later fabric.

Fig. 10 View from the north-east of Building 5 Photo CPAT 4849-121

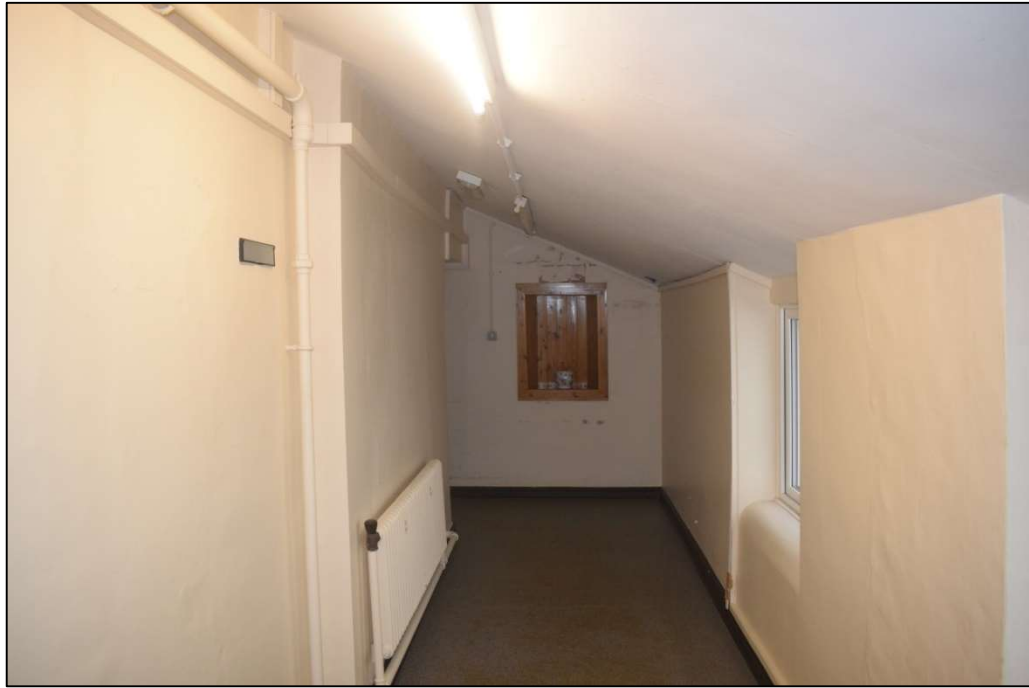
- 3.10. Building 6 was a freestanding, single-storey building, oriented north-south. It was located to the north of the west end of Building 1. It had an unusual asymmetrical roof pitch and a covered porch at the south end with a side entrance. The building had evidently been much altered, especially internally to allow it to function as offices with an internal corridor between Building 1 to the south and the hospital wards to the north. As with elsewhere in the complex, much of the original fabric was obscured by modern interior cladding. A possible former window aperture used a decorative niche was located at the south end of the building.

Fig. 11 Possible window opening in south end of Building 6 Photo CPAT 4849-101

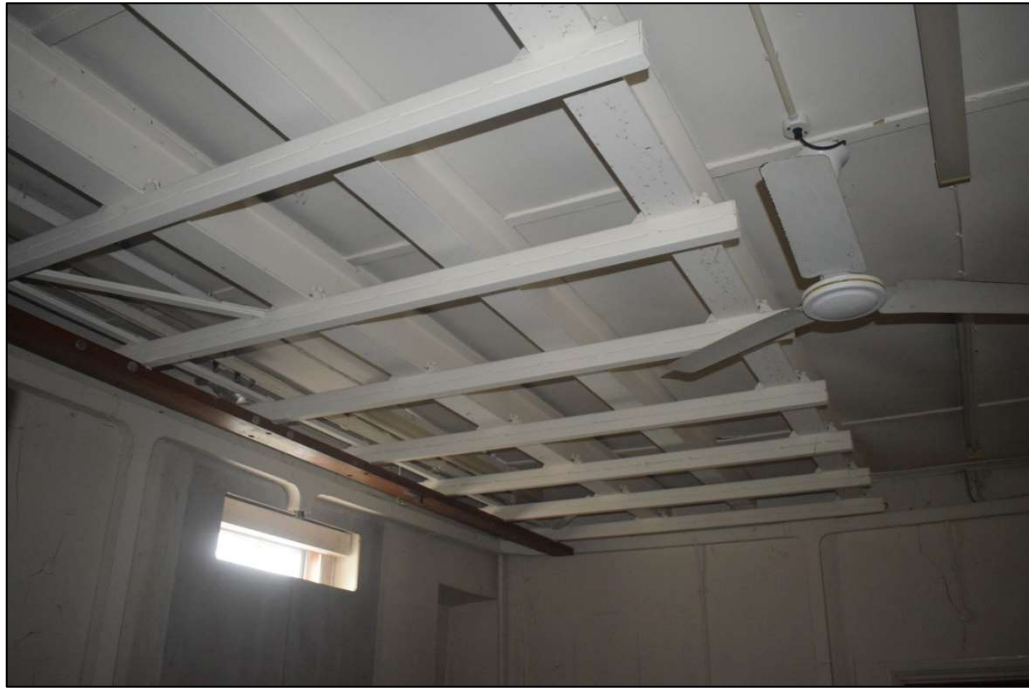
- 3.11. Building 7 was a two-storey building located to the north of Building 8 and apparently linked to it by a corridor. It was oriented east-west. The ground floor retained a parquet floor surface. A clothes-drying apparatus was attached to the ceiling and there was an infilled doorway in the south elevation. A lean-to on the east elevation was a later feature.

Fig. 12 Drying apparatus on ceiling of ground floor room Photo CPAT 4849-106

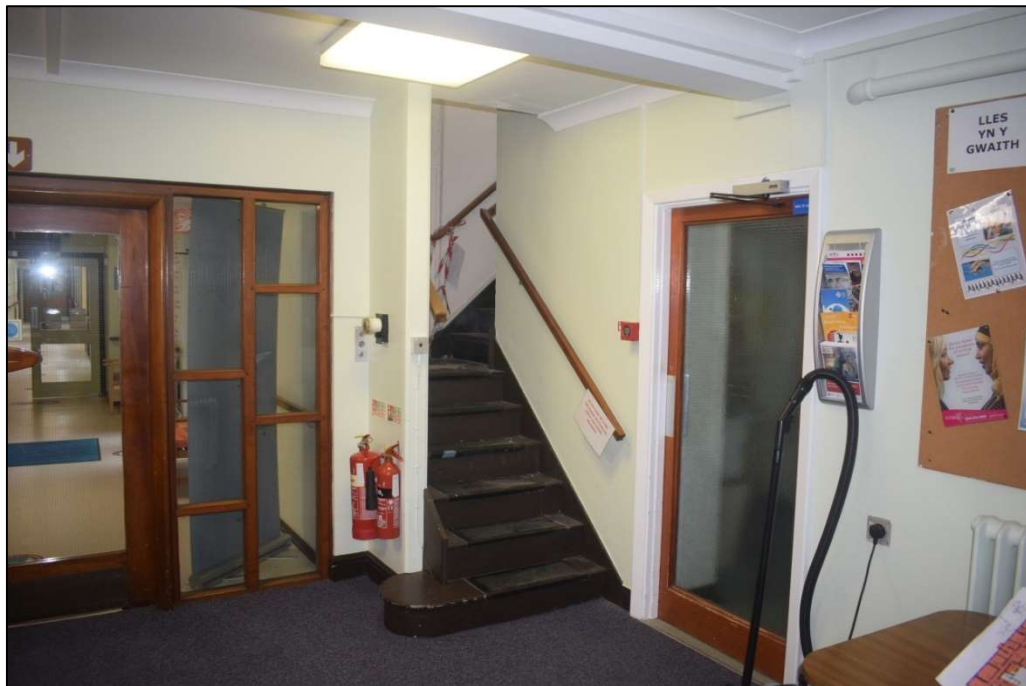
Fig. 13 Wooden stairs to upper floor of Building 7 Photo CPAT 4849-103

- 3.12. The stairs to the upper floor were wooden and possibly 19th-century in date, as were the floorboards on the first floor level. A truncated chimney stack was visible through a loft aperture, this was made of stone and similar to those in Building 1. An examination of the interior of the west gable showed the building was stone but that part of the upper structure had been repaired in brick. Building 7 had sash windows but these were of uncertain date.

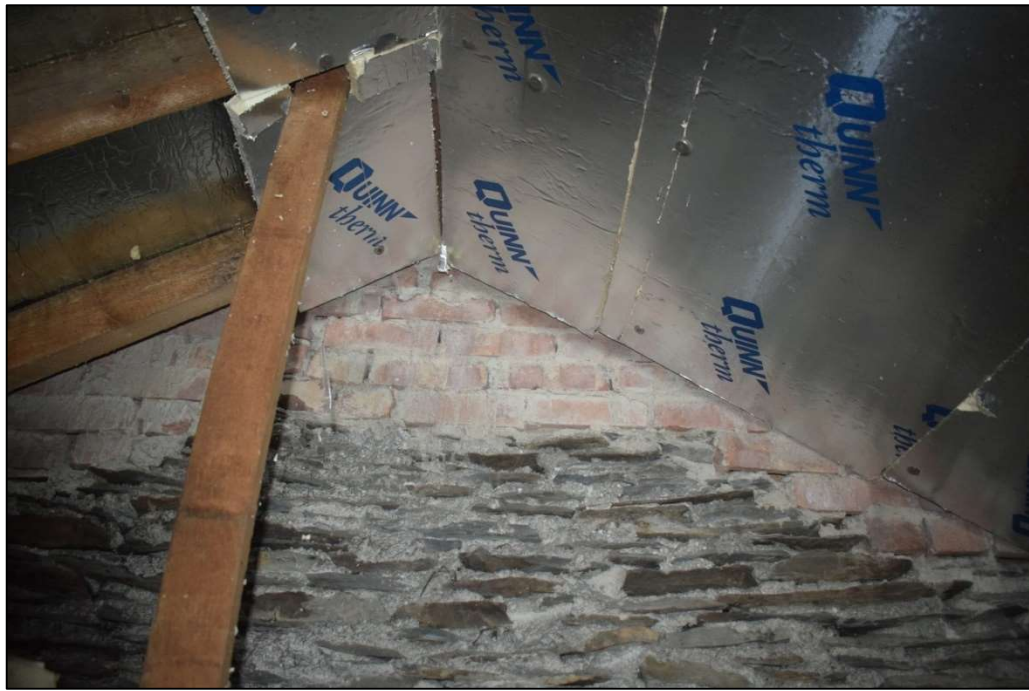
Fig. 14 Internal western gable end of building 7 Photo CPAT 4849-115

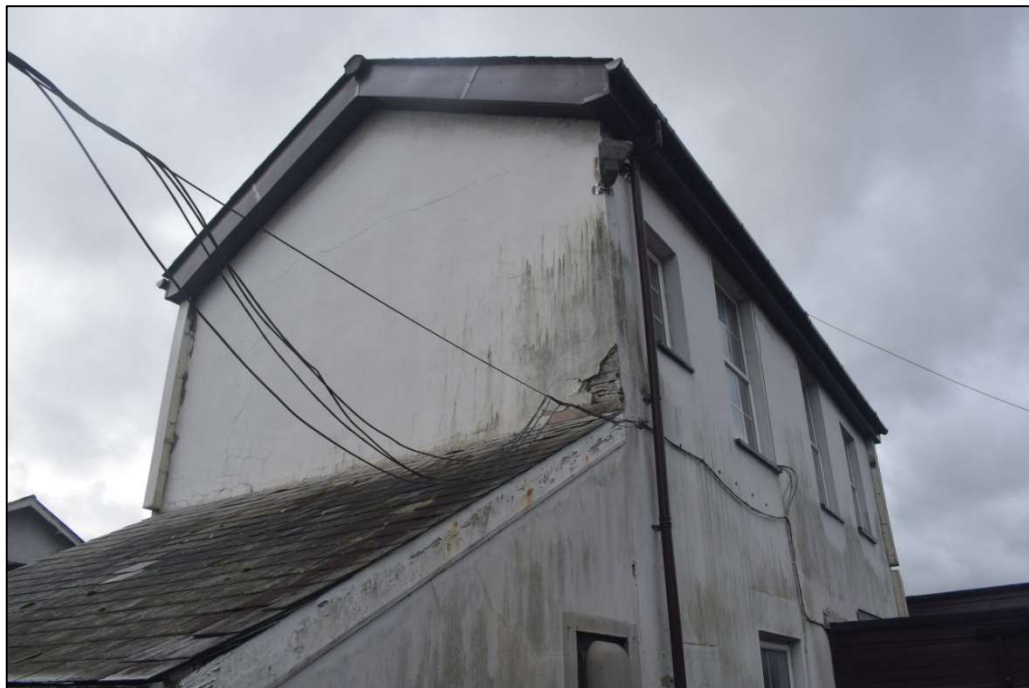
Fig. 15 View from the north-east of Building 7 and later lean-to Photo CPAT 4849-127

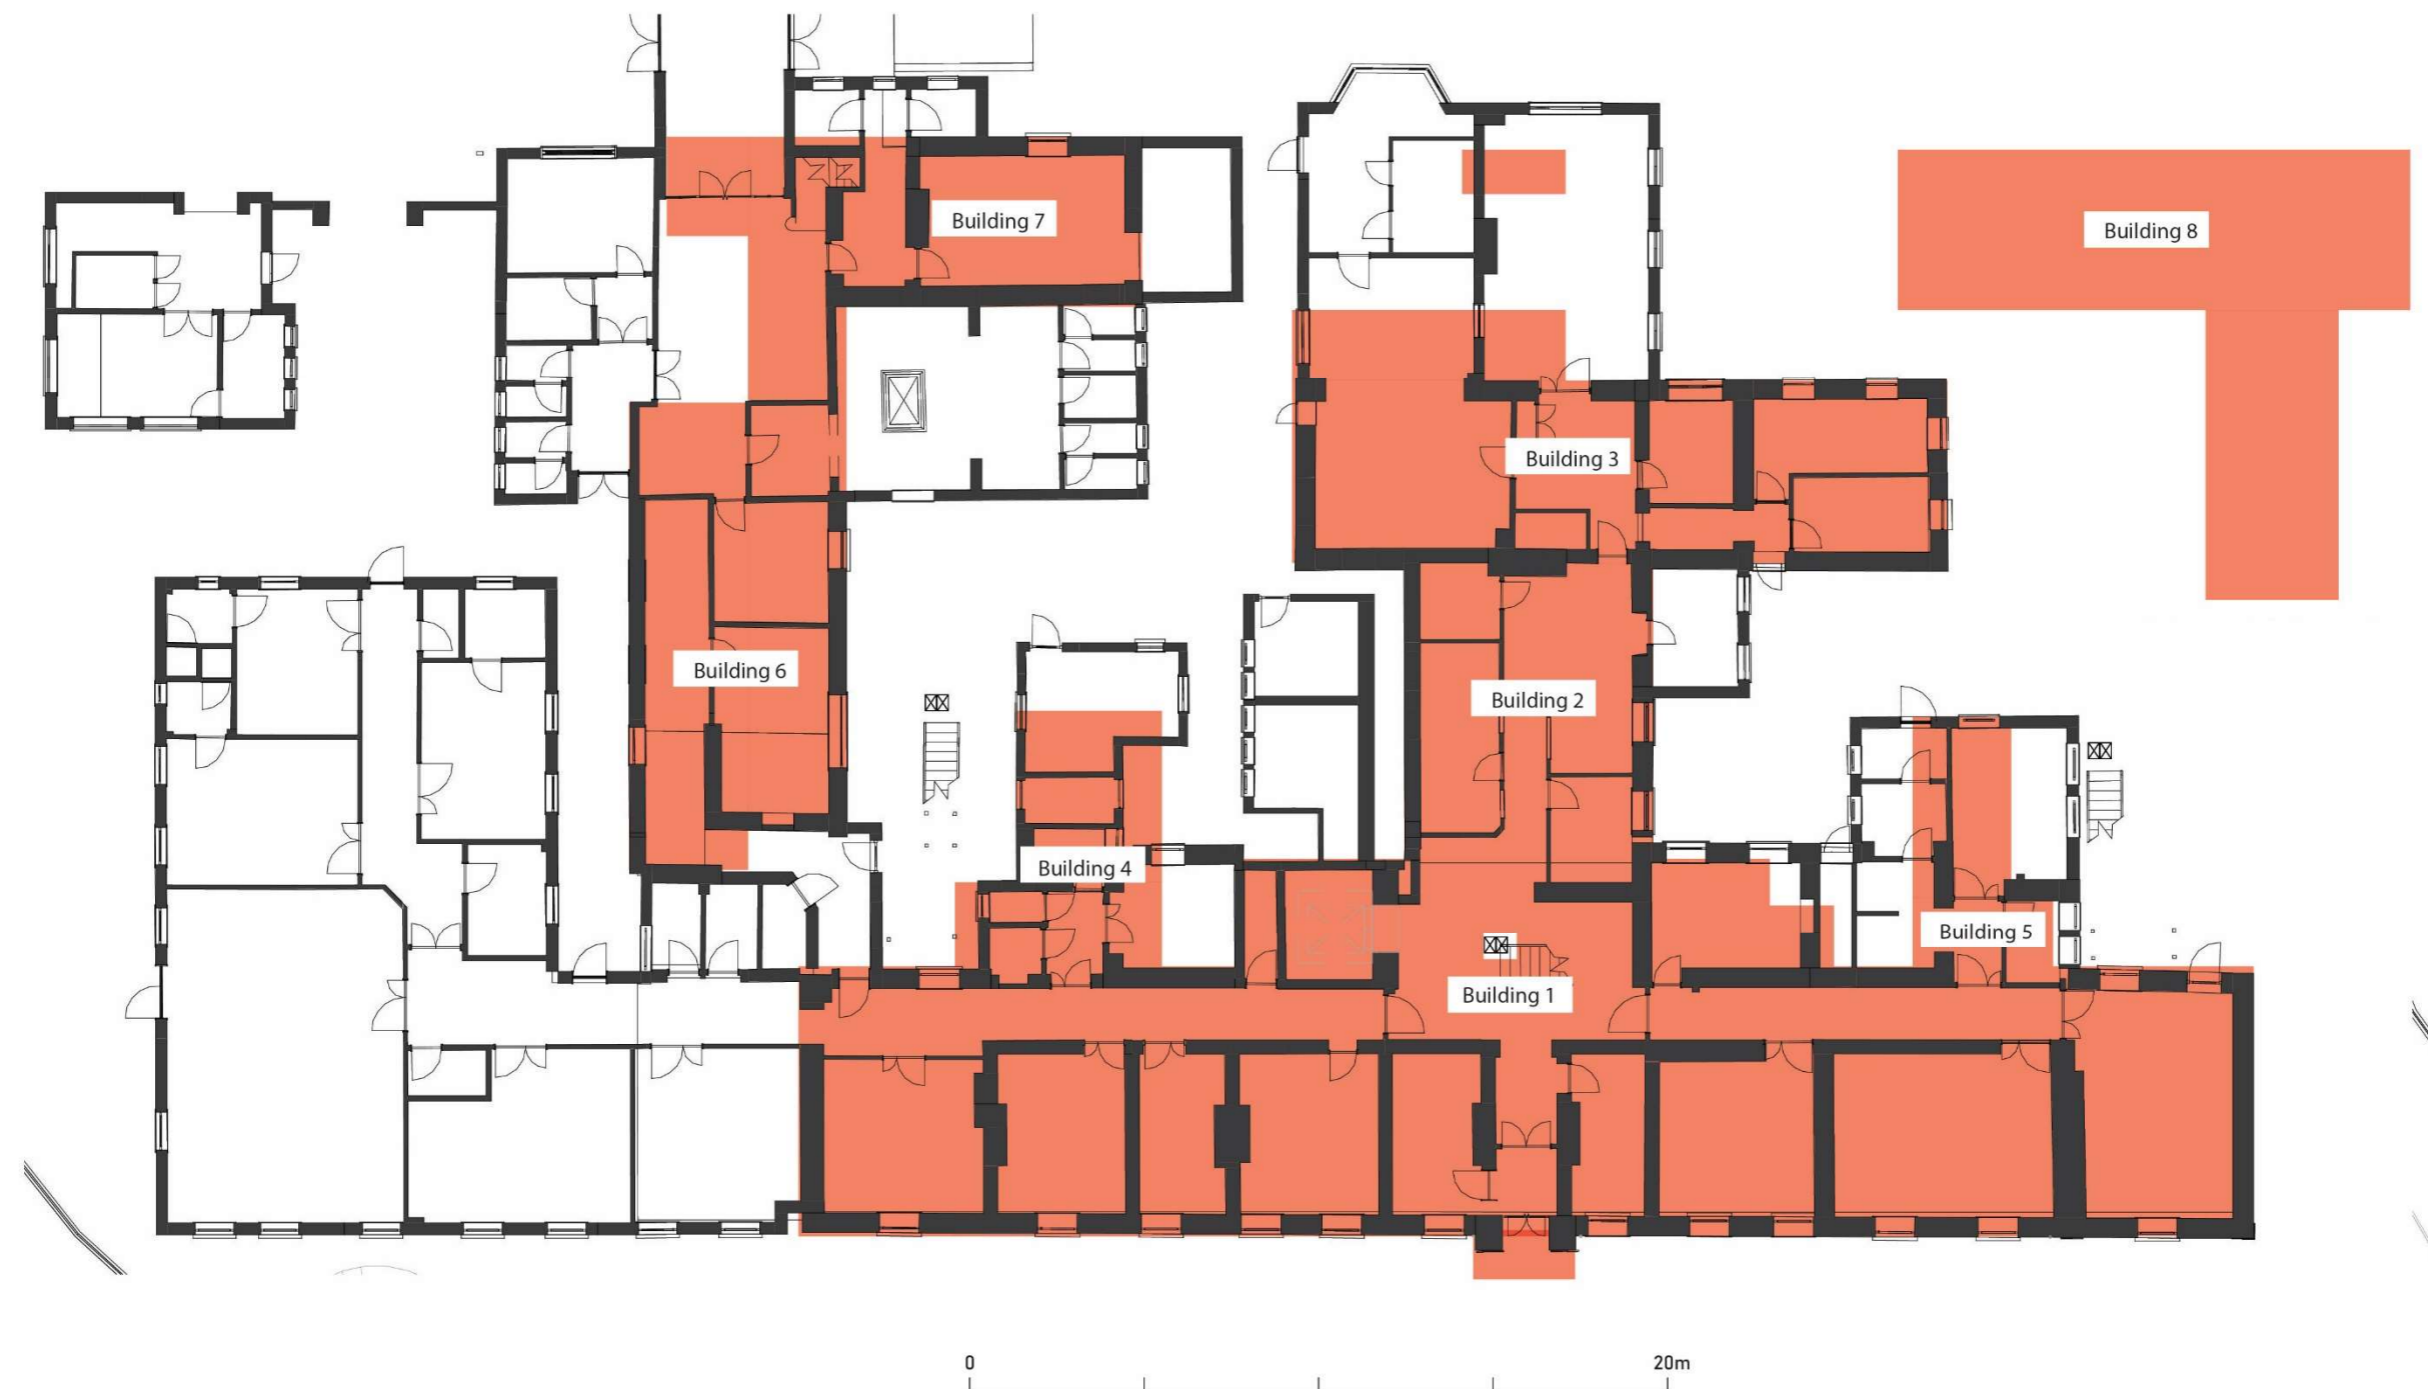
Fig. 16 Extract from a ground-floor plan of the hospital showing in red those parts which were recorded on 19th-century historic mapping and buildings identified during the survey

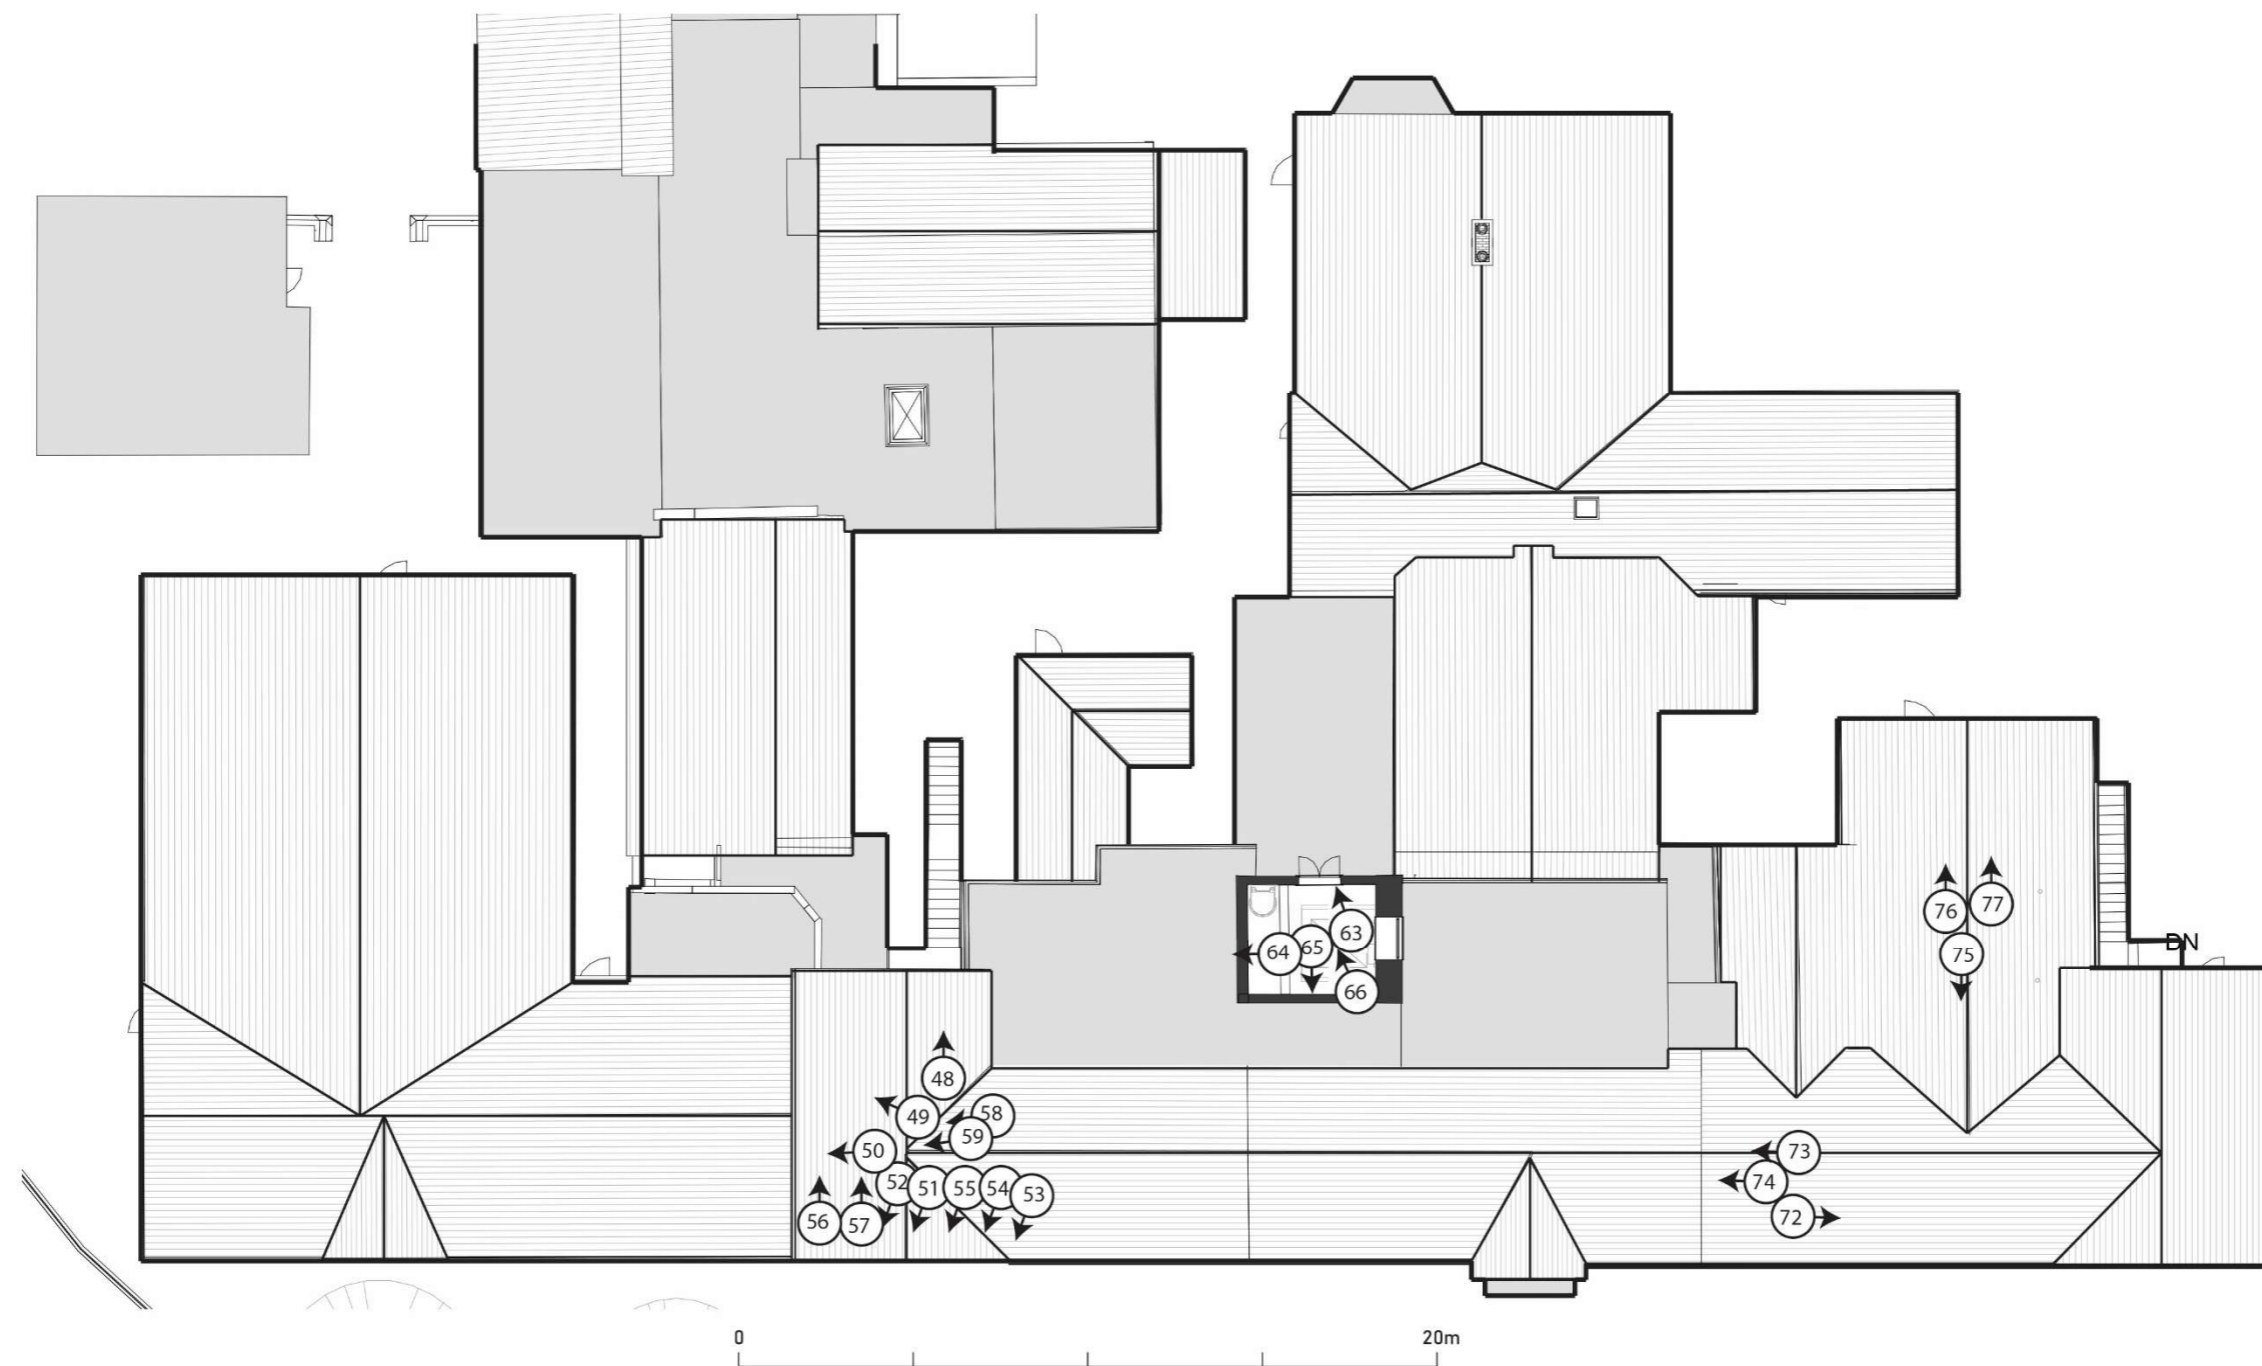
Fig. 17 Plan showing photograph locations within the roof space

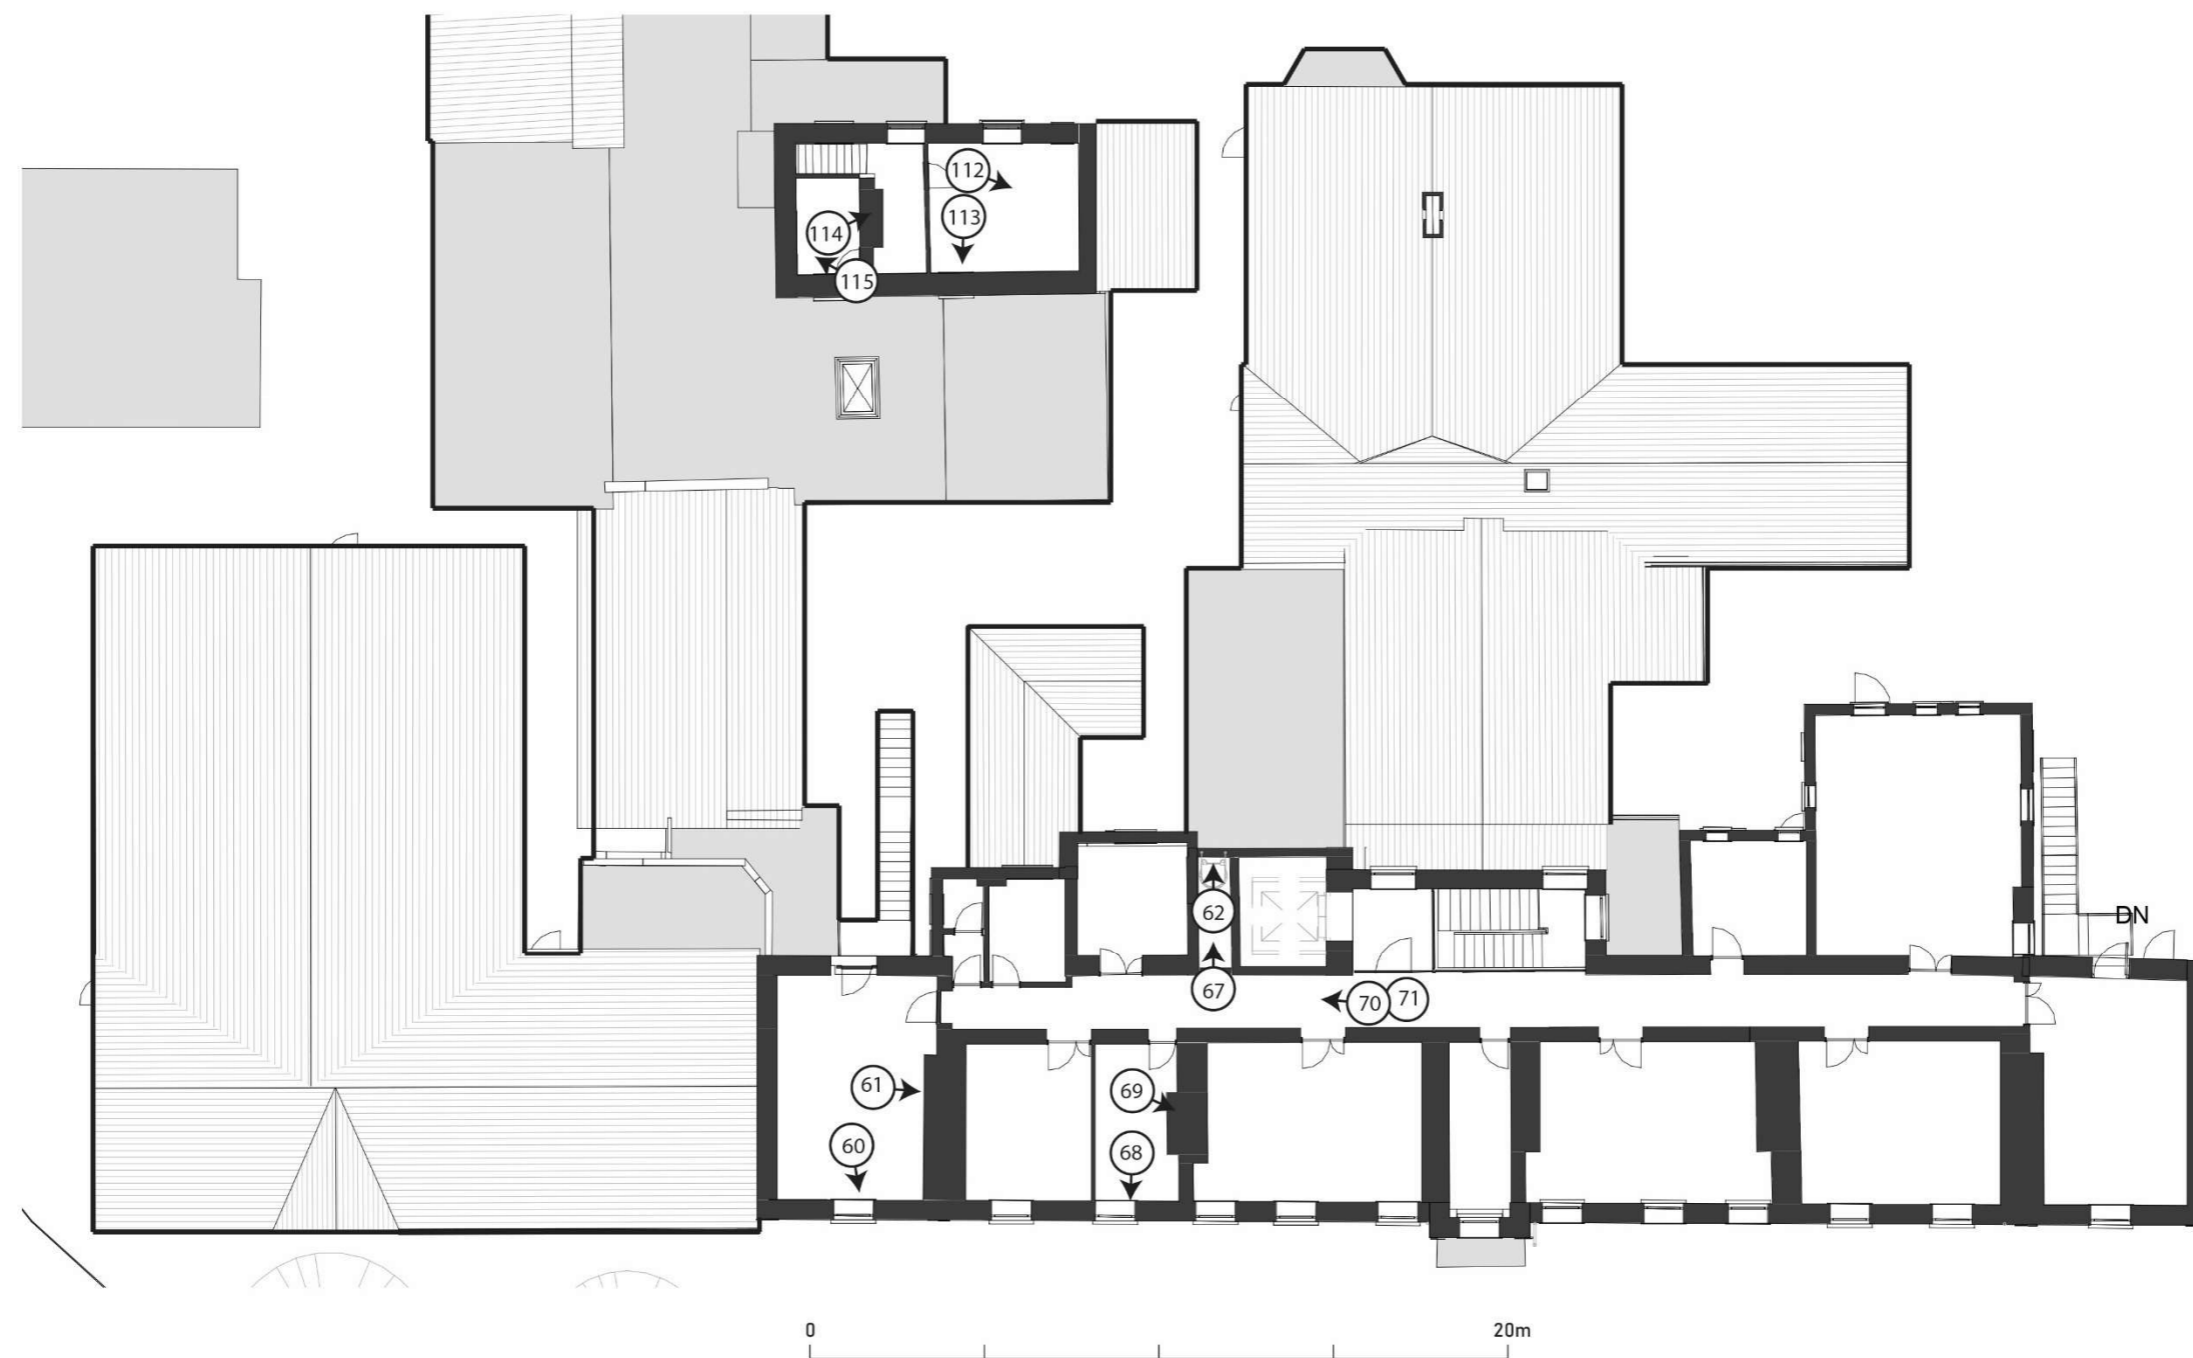
Fig. 18 Plan showing photograph locations on the upper floor
