CPAT Report No. 1768

Machynlleth Hospital, Powys

Building Survey

Client name: Willmott Dixon
 CPAT Project No: 2505
 Project Name: Machynlleth Hospital, Powys
 Grid Reference: SH 7508 0088
 County/LPA: Powys
 Planning Application: 20/0858/CAC
 CPAT Report No: 1768
 Event PRN: 140352
 Report status: Final

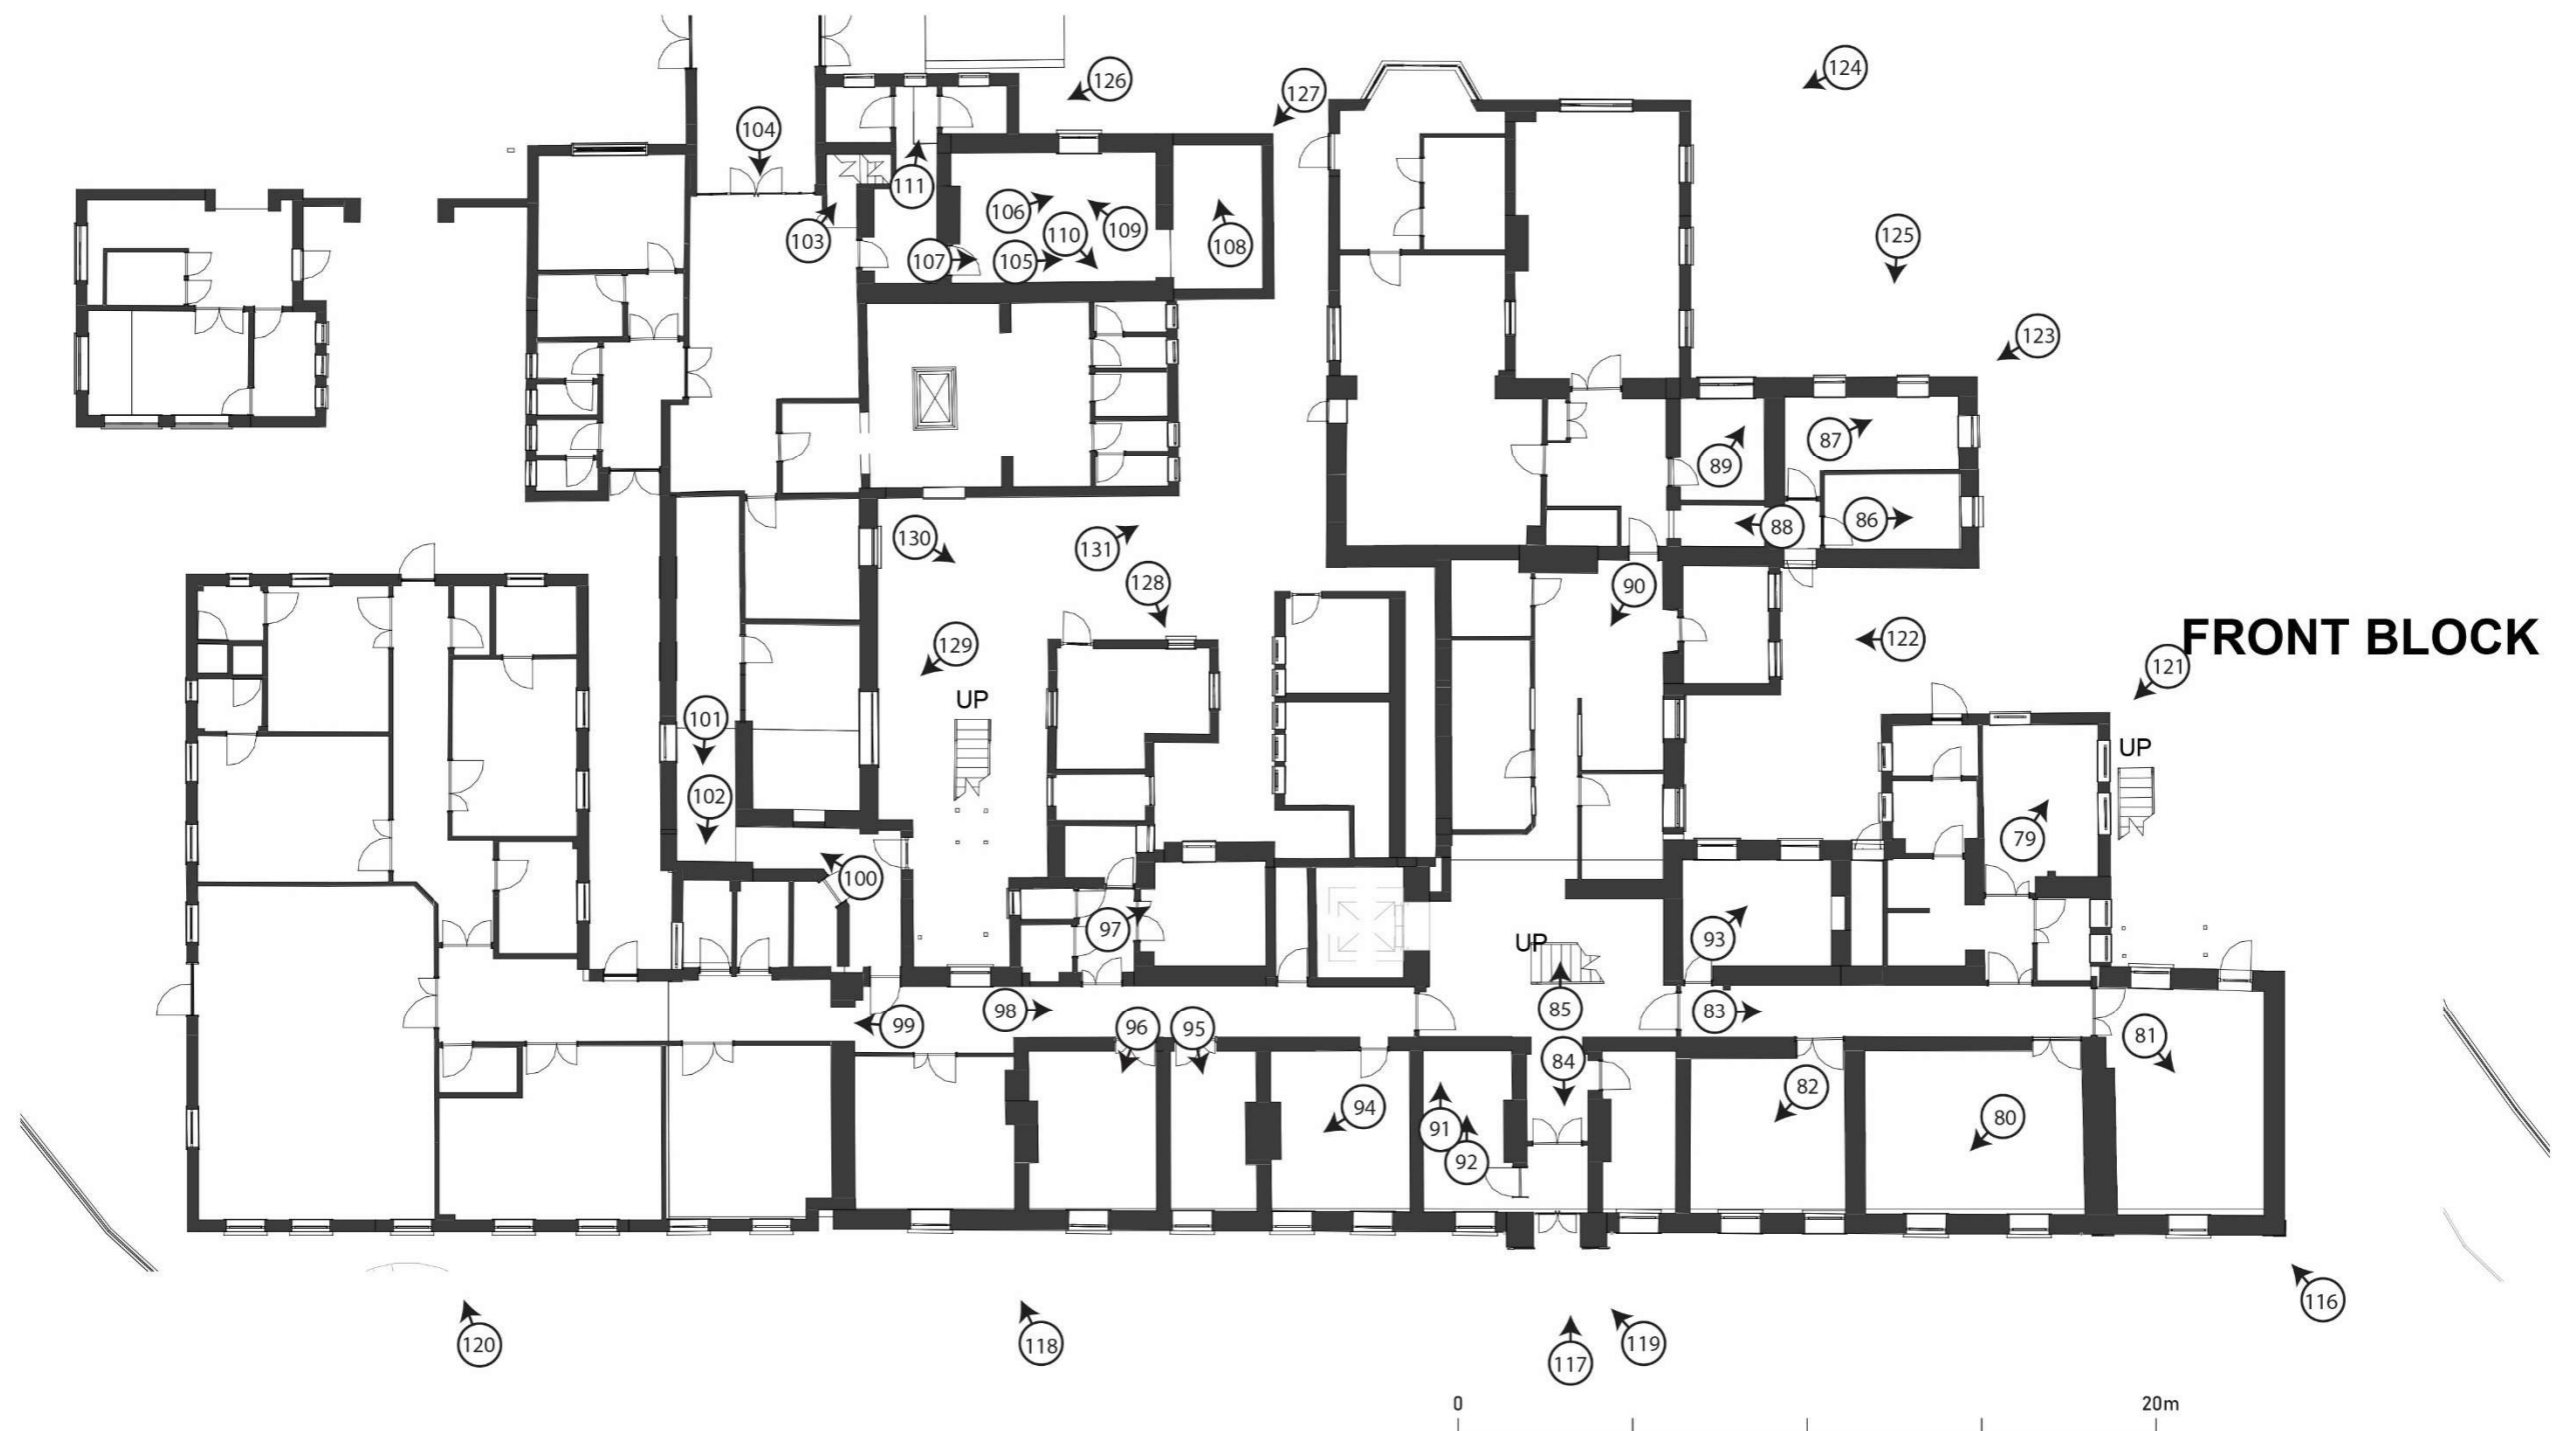
Fig. 19 Plan showing photographs locations on the ground floor

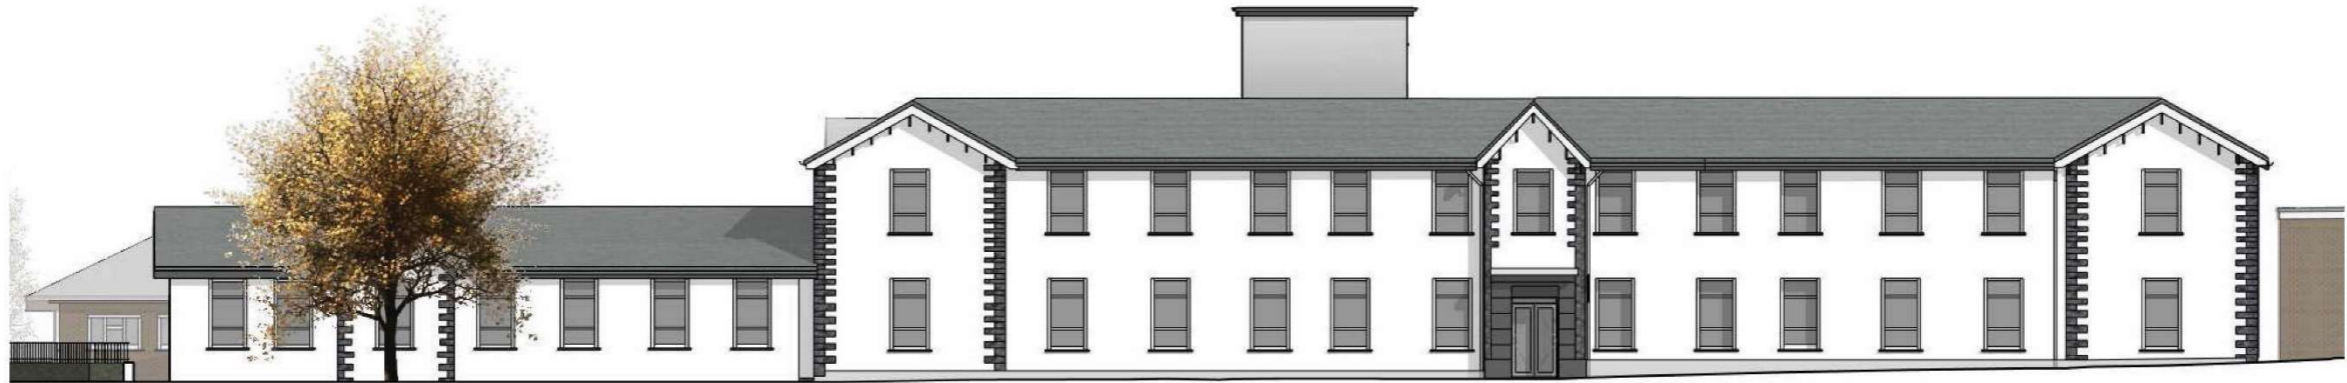
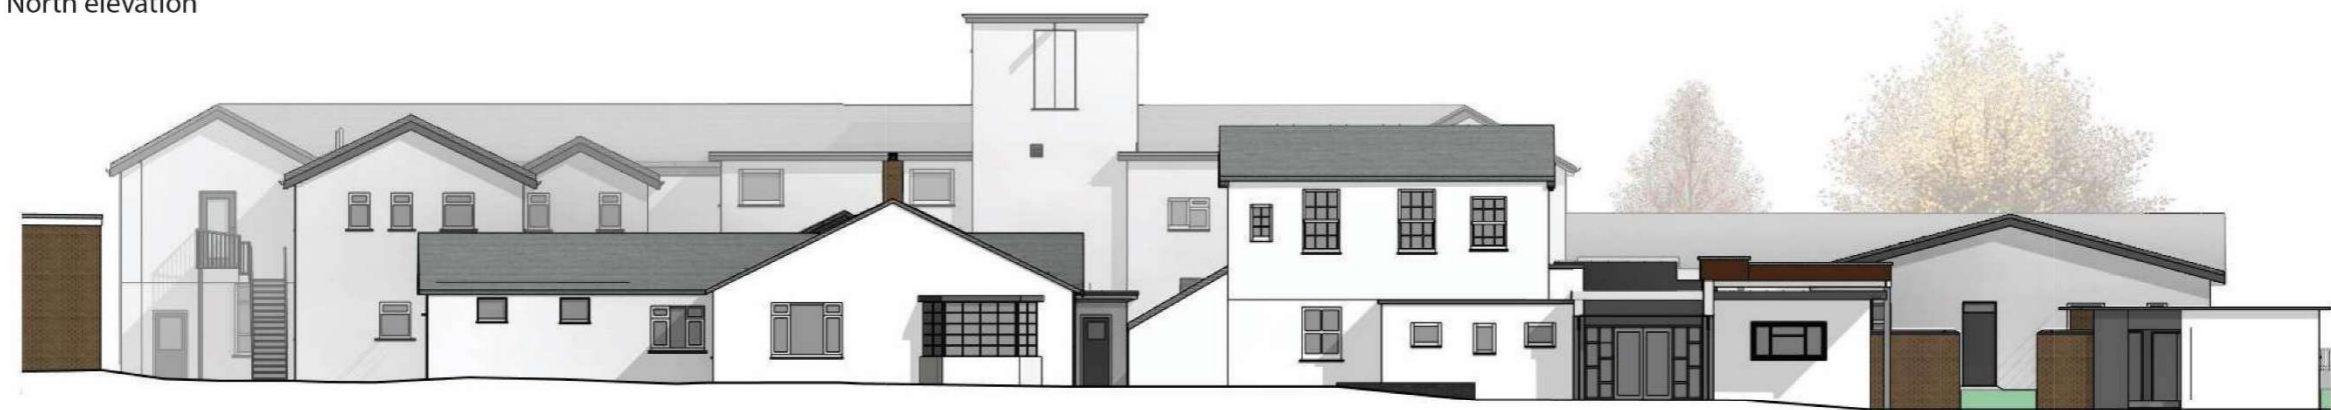
Fig. 20 South (principal) and North elevations of the former workhouse (reproduction of drawing supplied by Willmott Dixon)

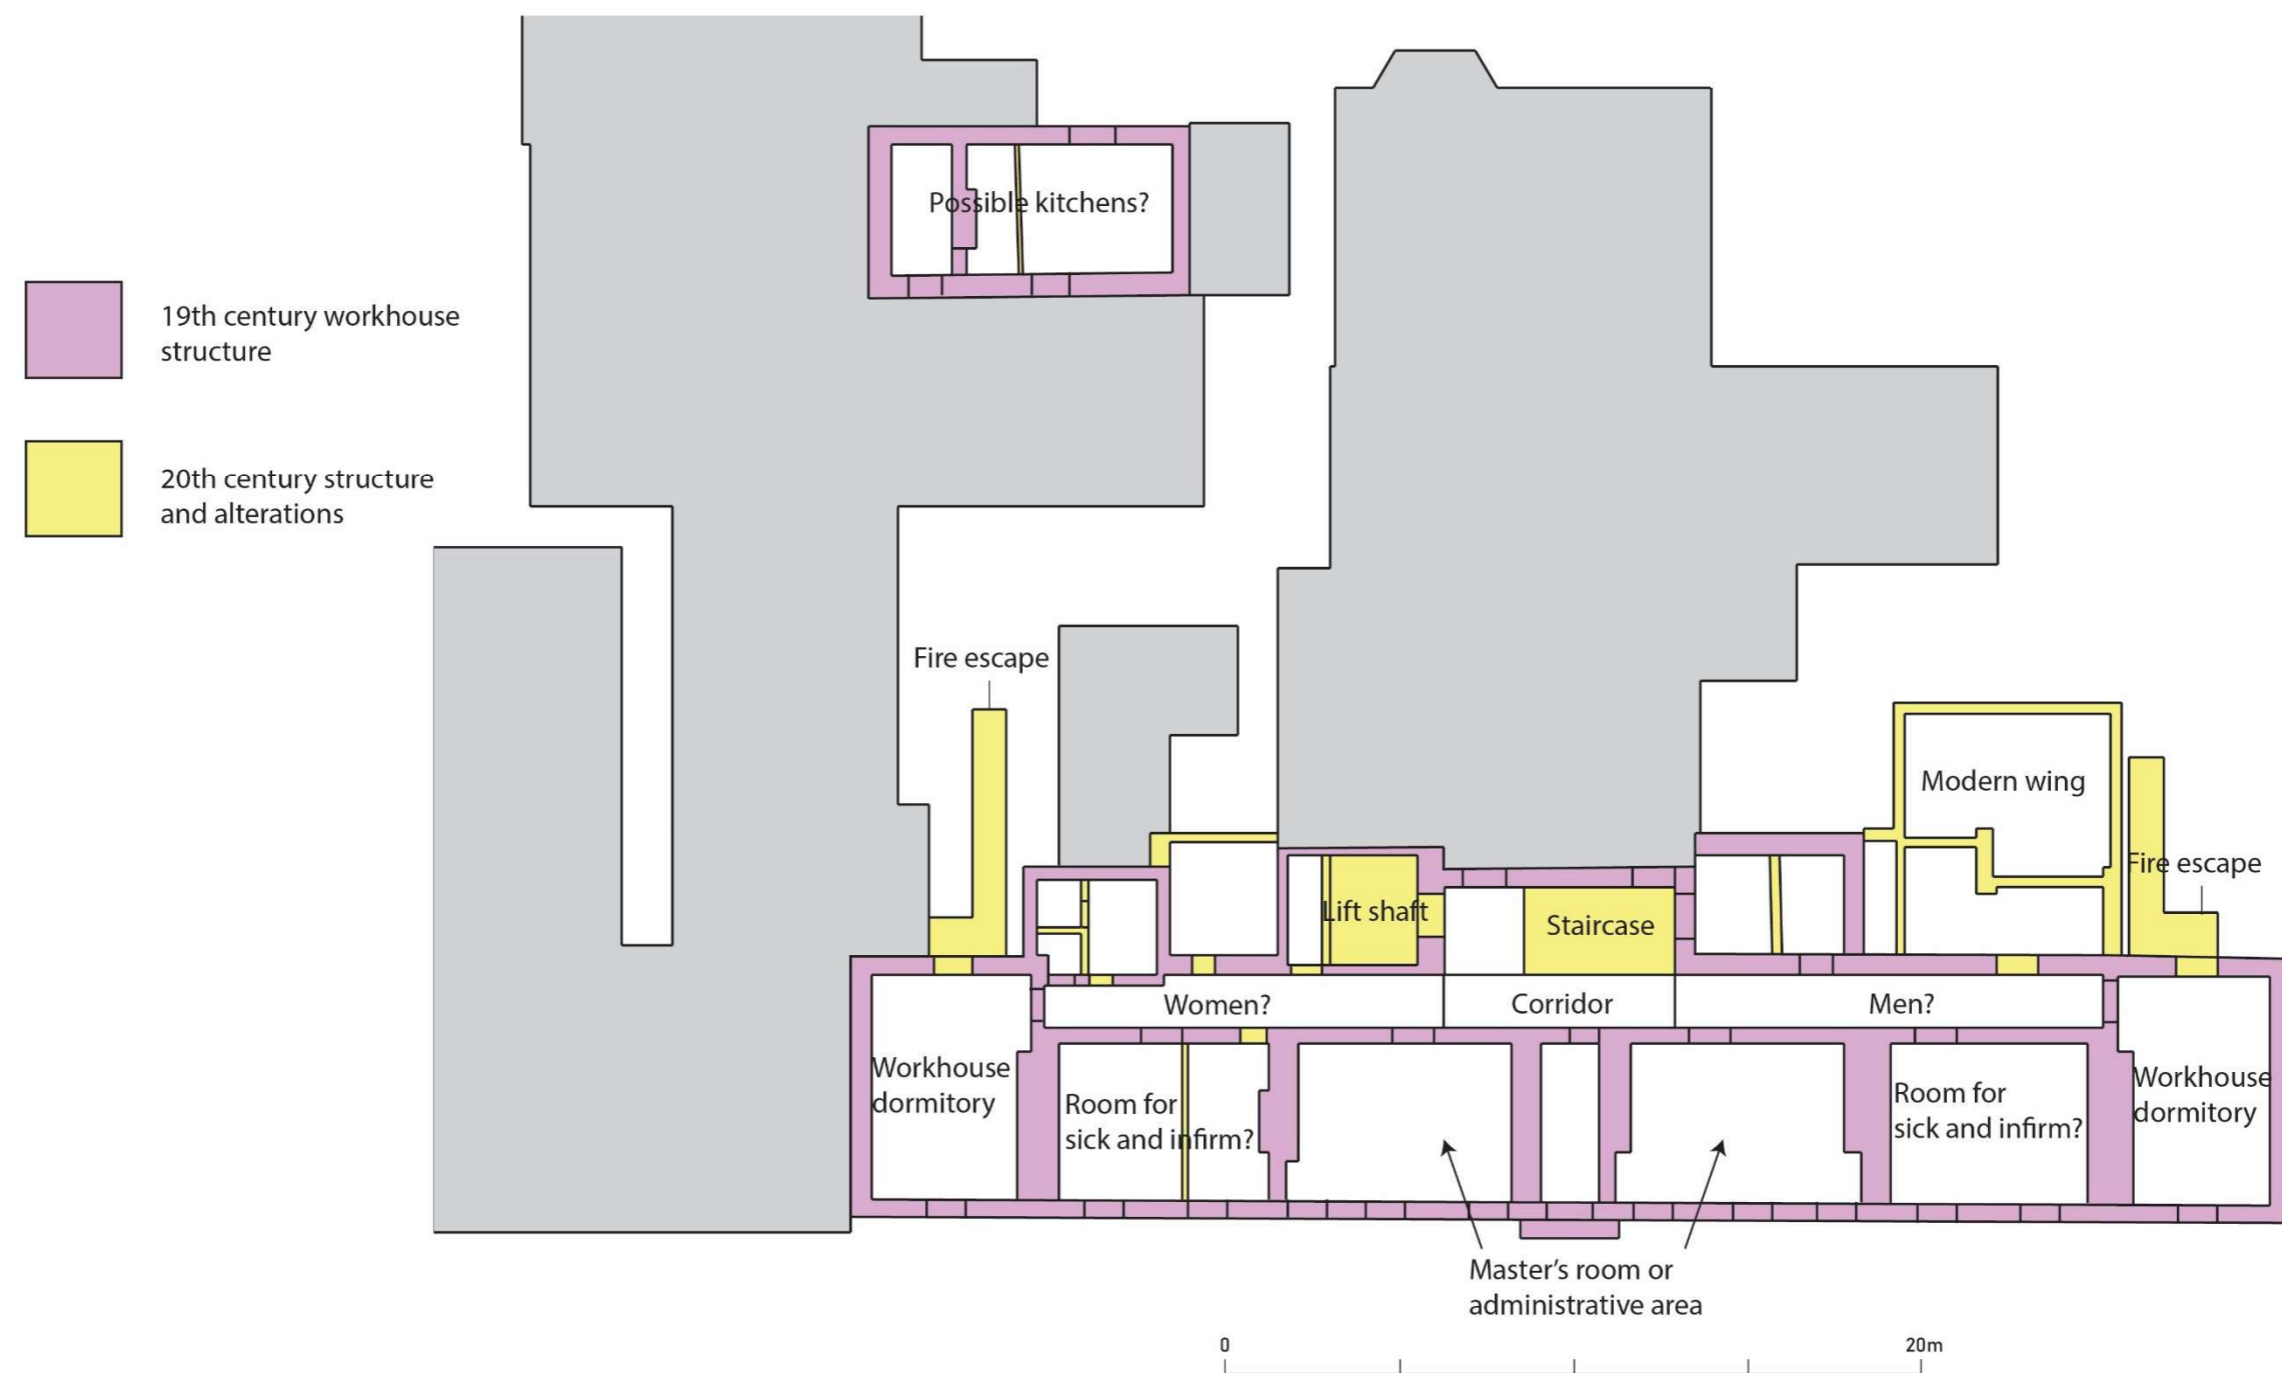
Fig. 21 Upper floor plan showing construction phases

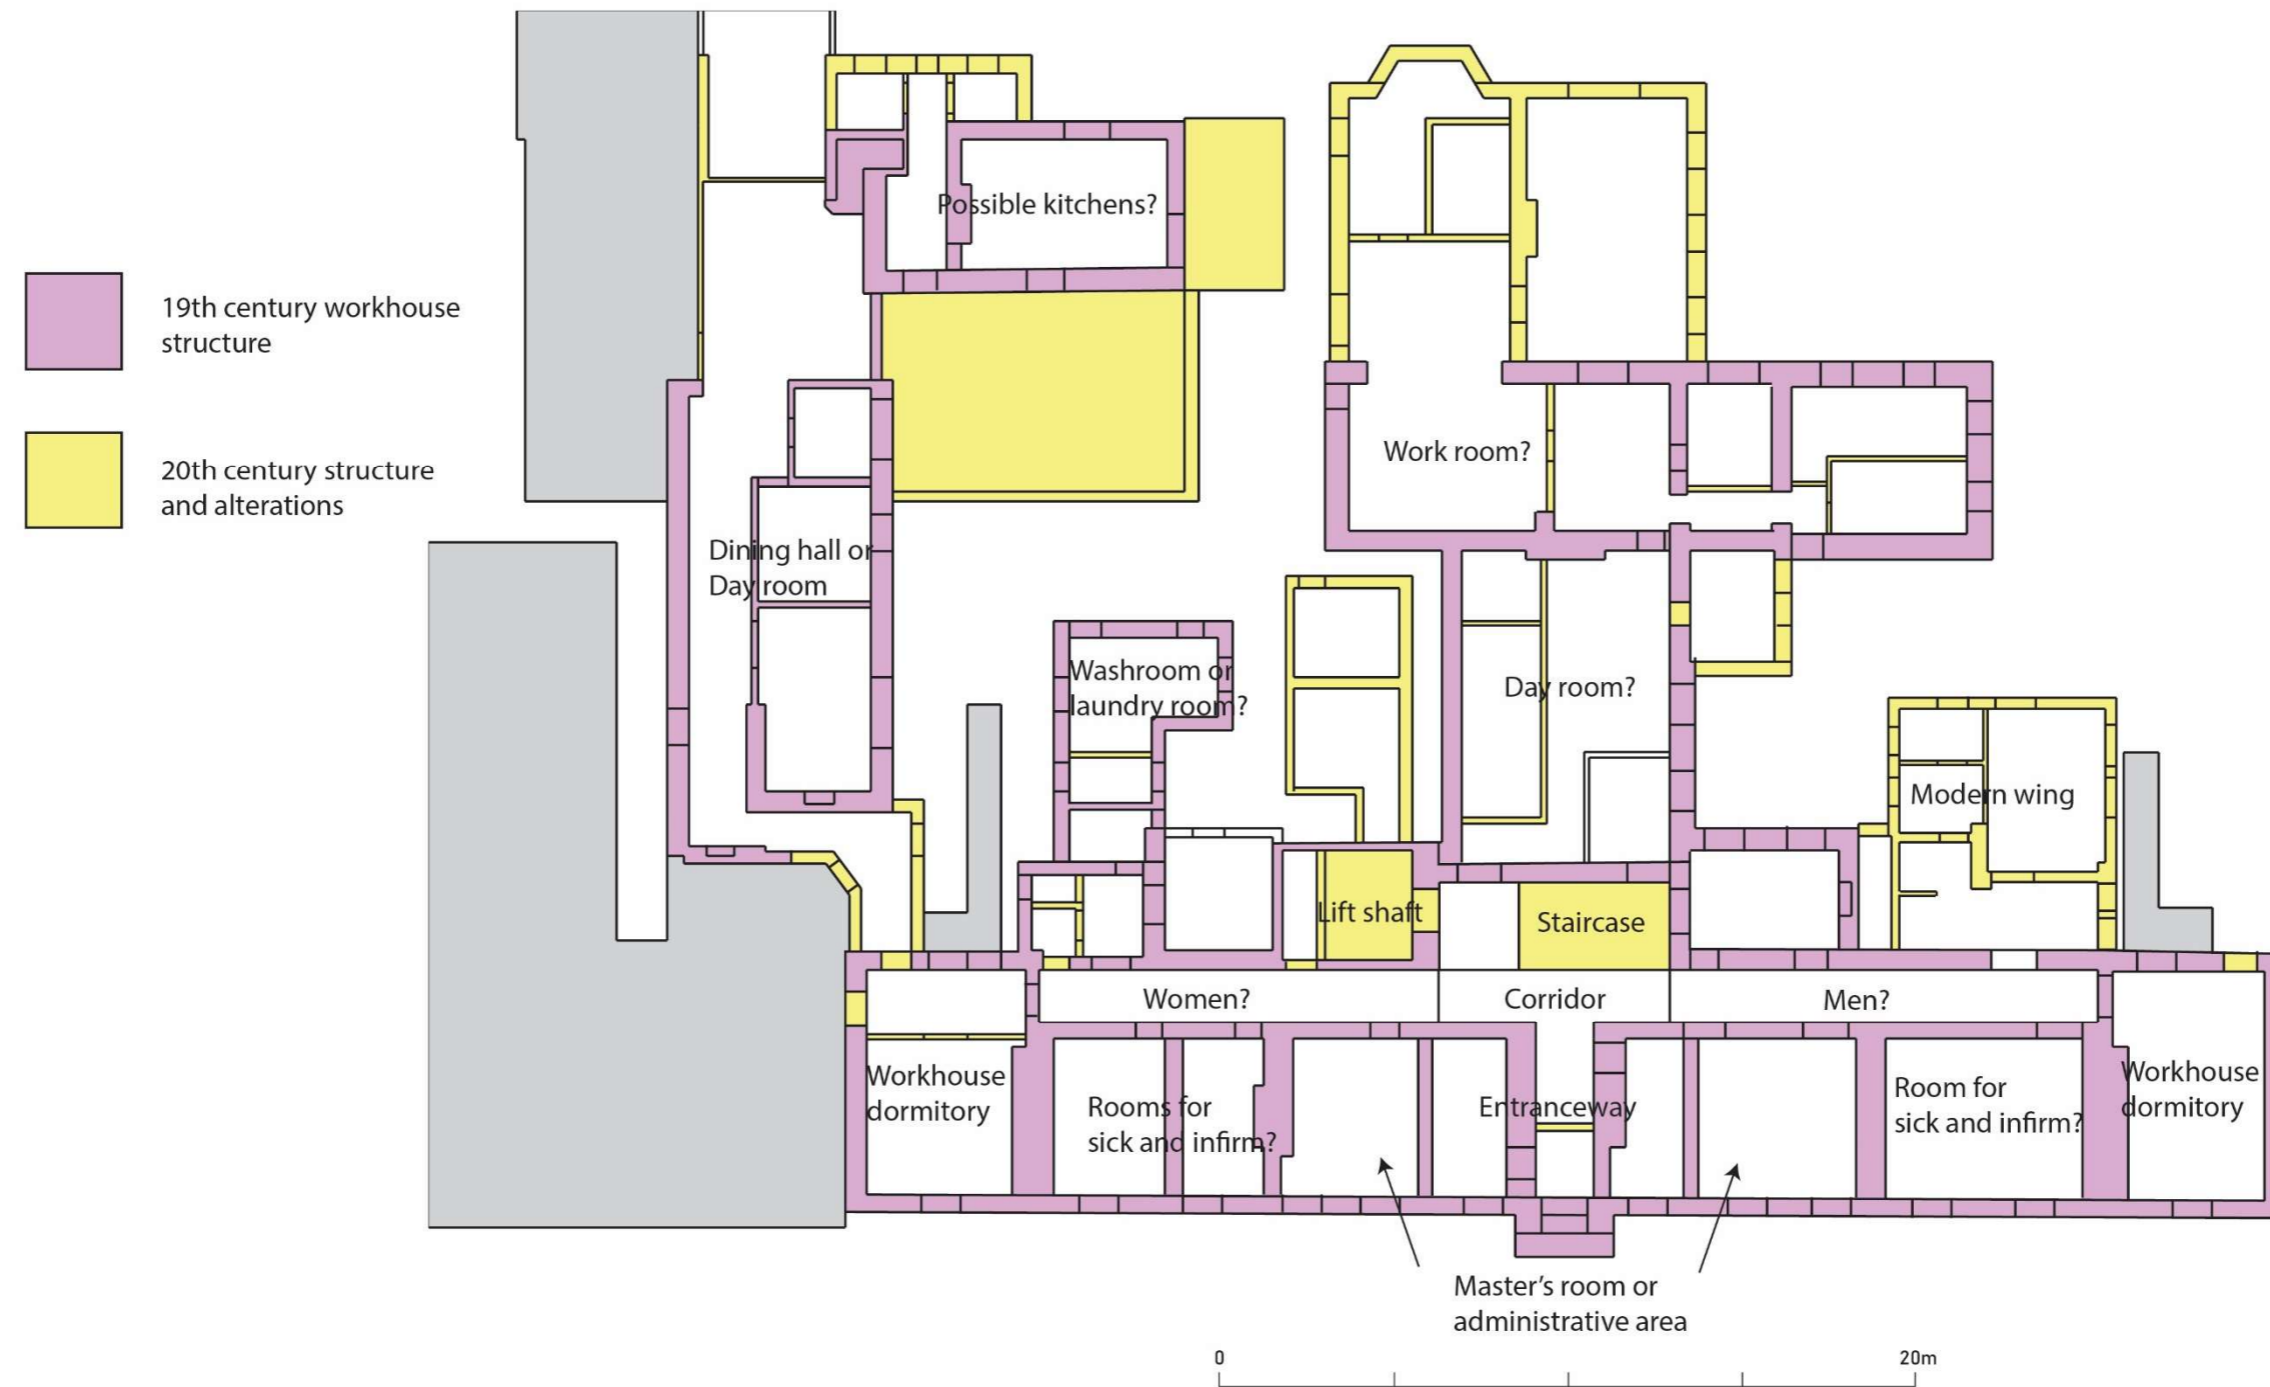
Fig. 22 Ground floor plan showing construction phases
