# CHURCH GATES, CHURCH STREET, RHUDDLAN

Cofnodi adeiladau ffotograffig /  
Photographic building recording

Rhif Prosiect / Project No. G2776

Rhif Adroddiad / Report No. 1704

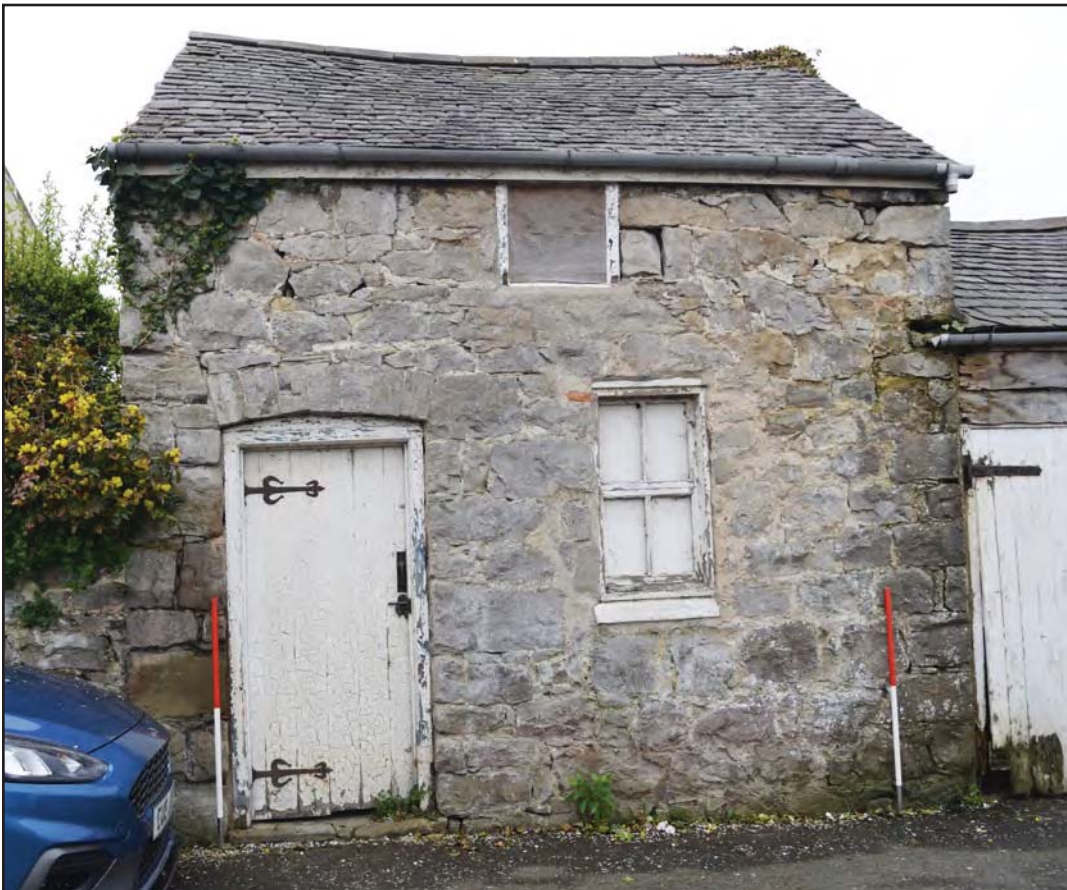
Plate 2: North-east elevation of outbuilding, from the north-east; scale: 2x1m (archive reference: G2776\_007)

This is a small square two-storey building of stone with lime mortar (Plate 2). It faces the street and the garden wall to the south-east abuts the wall of the outbuilding, which has roughly shaped quoin stones forming the corners and unshaped, uncoursed stone facing its walls. The roof is of small slates, of varying sizes, with ridge tiles that are presumably ceramic. The north-western and south-eastern walls form the gable ends.

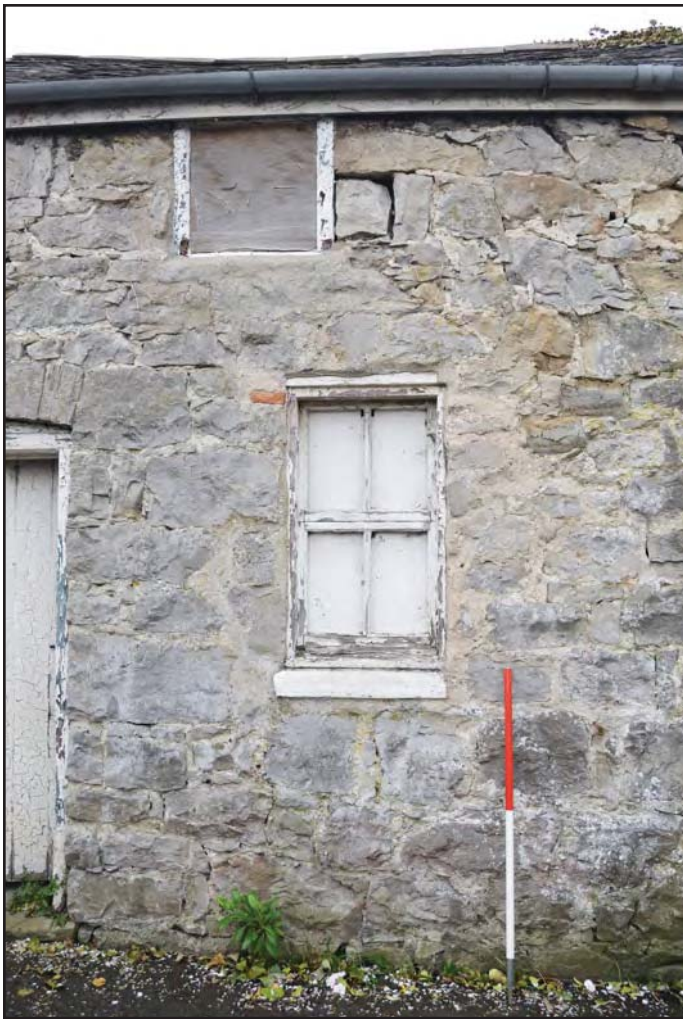
Plate 3: Detail of outbuilding windows, from the north-east; scale: 1x1m (archive reference: G2776\_009)

It has a single room on each of the ground and first floors, each with windows in the north-east wall (Plate 3). The ground floor room has a concrete floor (Plate 4) and a white-washed ceiling supported on old joists (Plate 5). The walls are white-washed, but not rendered. There is a doorway to the street with a wooden door, which has been rehung or reused as there is the mark of earlier hinges on the back (Plate 6). The door has decorative false hinges on the outside, and the doorway has a shallow stone arch above it (Plate 7), though internally there is a wooden lintel over the door. There is one window in the north-eastern wall with a wooden lintel and a plastered sill (Plate 3). This still has the original window frame. Along the north-west wall is a brick-built shelf, 390mm high, with a stone slab surface (Plate 8) and under the window there was originally another brick-built structure. Traces of three brick supports on the concrete floor indicate the location of this now demolished structure (Plate 9). There is no fireplace or any evidence that there ever was one. A hatch, measuring 730mm wide and 650mm high, allows access through the north-western wall into the garage (Plates 10 and 11). The hatch is lined with timber and has been inserted into the wall. Although obscured by whitewash pieces of brick can be seen to fill the gaps around the hatch after it was inserted. On the north-western side this brick infilling can also be seen.

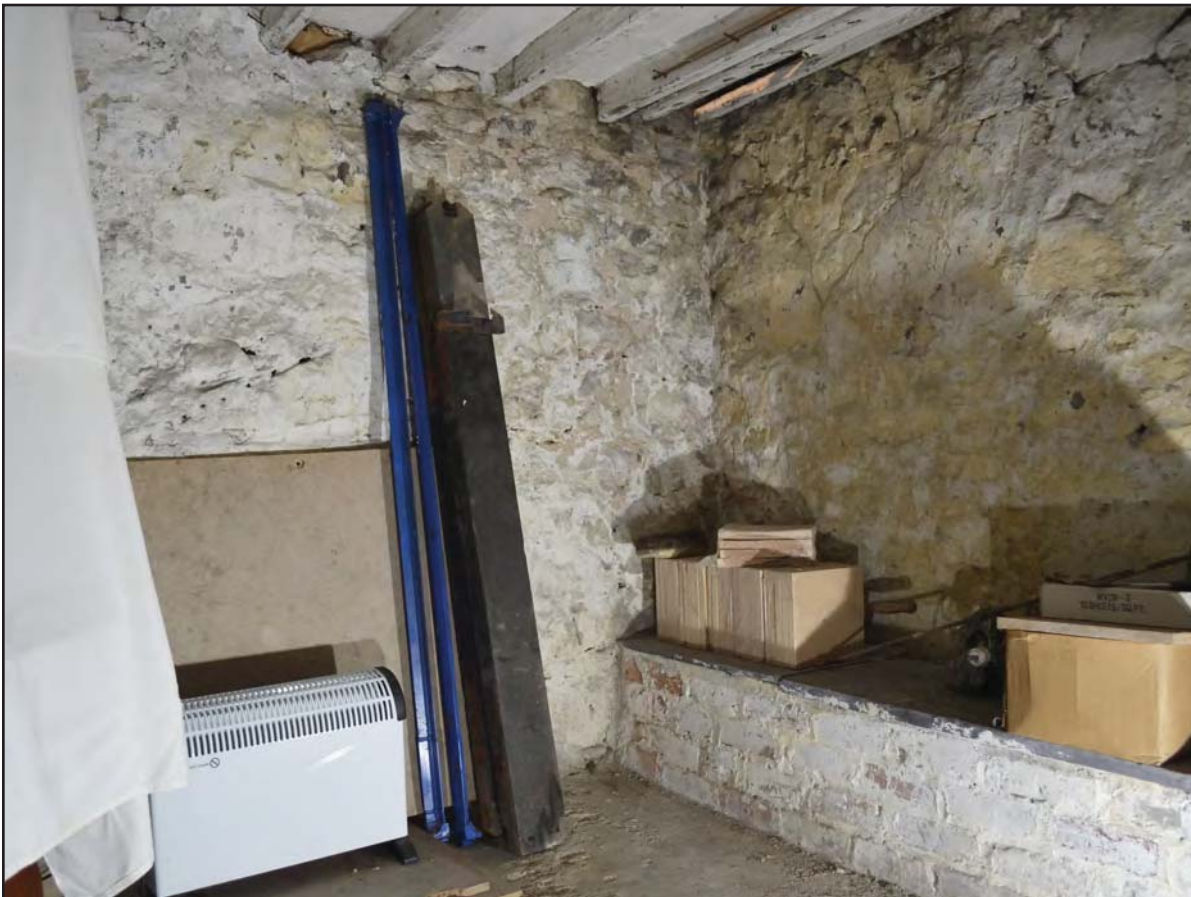
Plate 4: Interior of ground floor room in outbuilding, from the east (archive reference: G2776\_101)

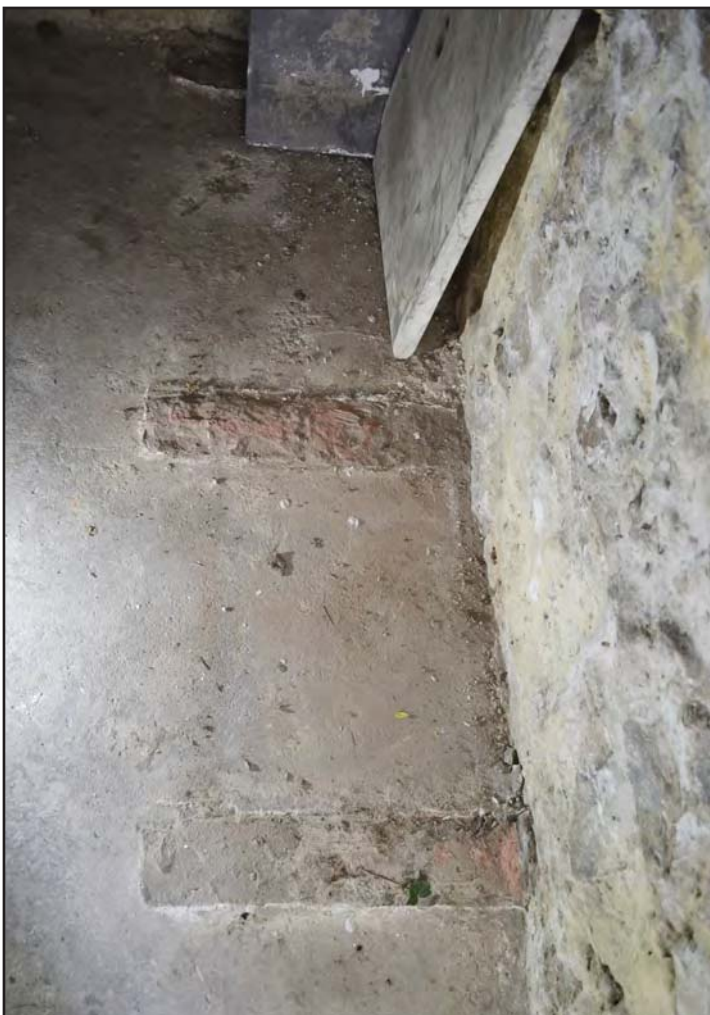
**Plate 9: Traces of demolished brick structure in ground floor room in outbuilding, from the south-east (archive reference: G2776\_116)**

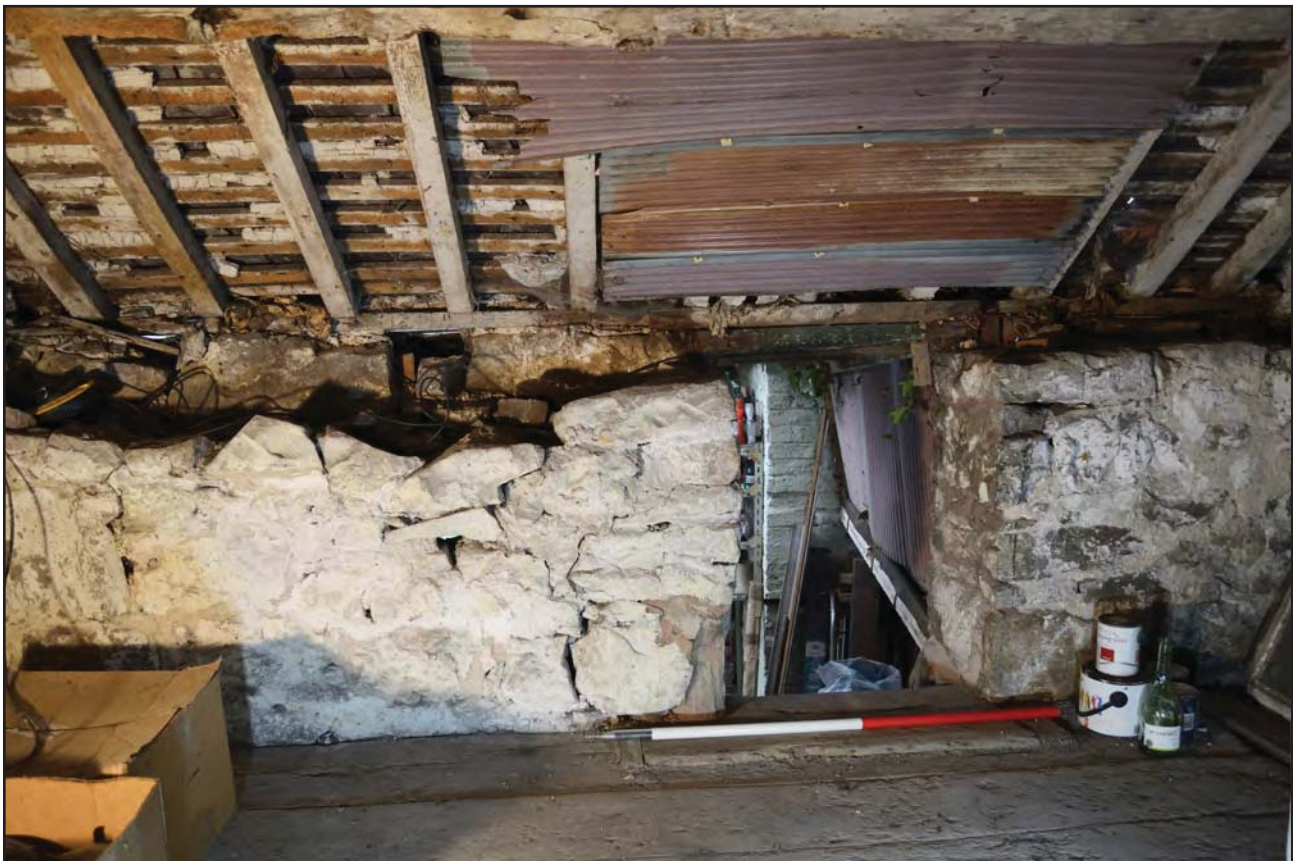
Plate 13: South-west wall and roof of upper room of outbuilding with entrance, from the north-east; scale: 1x1m (archive reference: G2776\_073)

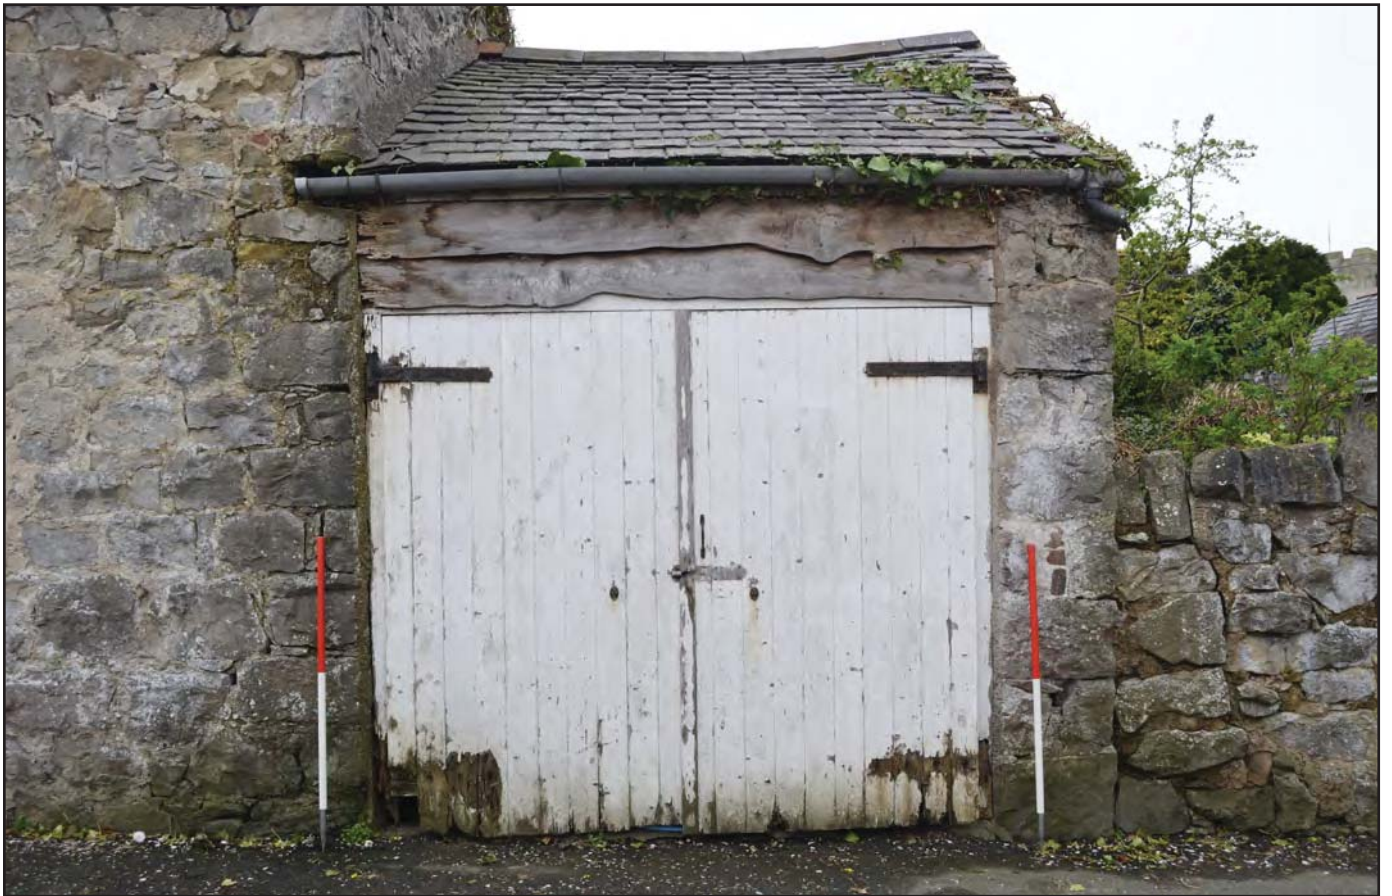
Plate 16: North-east elevation of the garage, from the north-east; scale: 2x1m (archive reference: G2776\_011)

The garage has a stone gable end forming the north-western wall but directly abuts the wall of the outbuilding on the south-eastern side (Plate 16). Its north-eastern side is formed entirely by the double doors leading off the street (Plate 17). The rear wall is damaged and confused. The stone north-western wall turns to form part of the rear wall, but it seems to have been largely demolished (Plate 18). There were windows set in the upper part of this wall, but these are now in a very poor condition and most of this side of the garage would be open apart from a single-skin brick wall that has been built to partially block the gap.

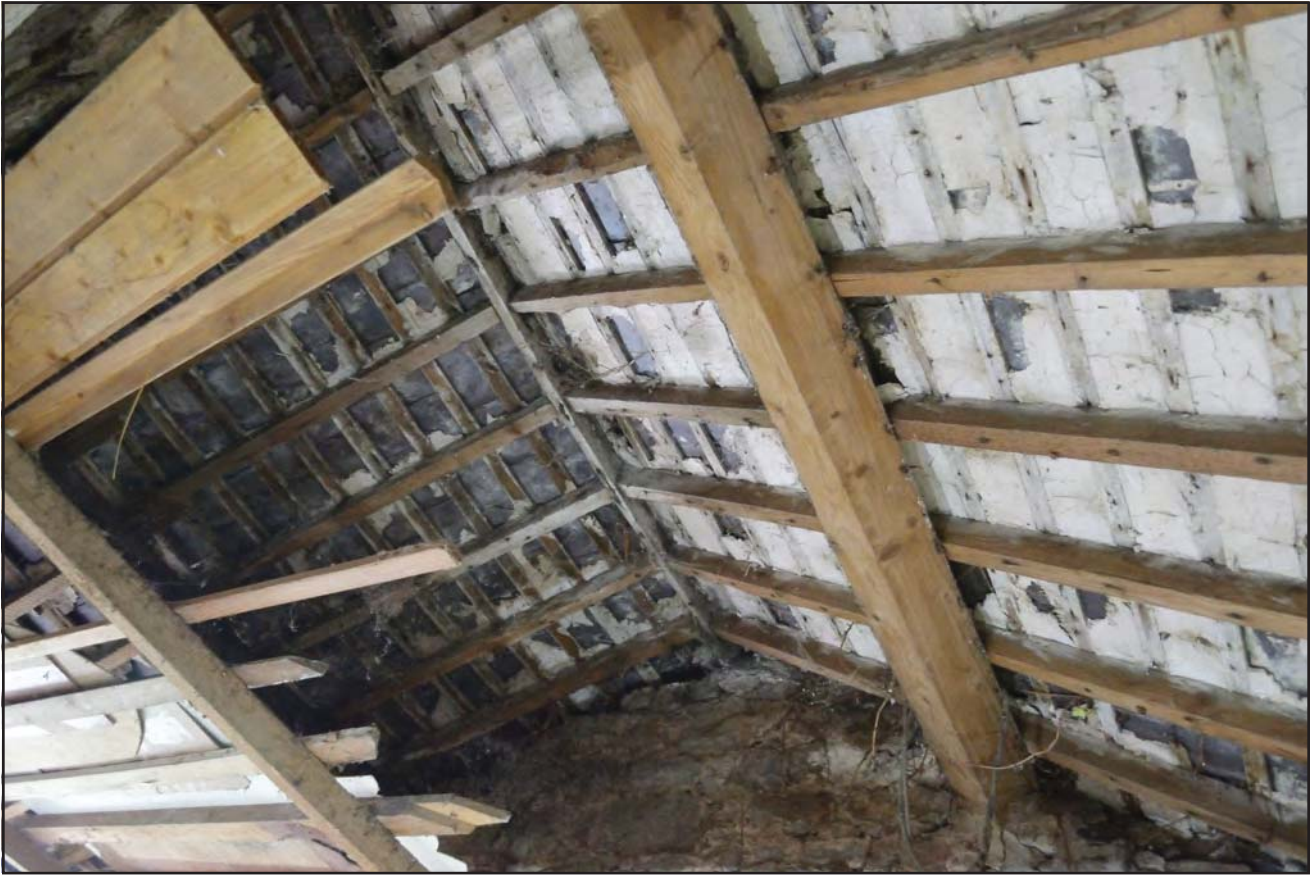
Plate 21: Inside roof of garage, from the east (archive reference: G2776\_121)

The roof is of small slates similar to the outbuilding but more regular in size. There are ceramic ridge tiles. The garage extends further south-west than the outbuilding and the extension in the southern corner is formed by rusticated breeze blocks (Plate 19). The floor of the garage has square, rough ceramic tiles (Plate 20). The rafters and purlins inside the roof appear relatively new (Plate 21).

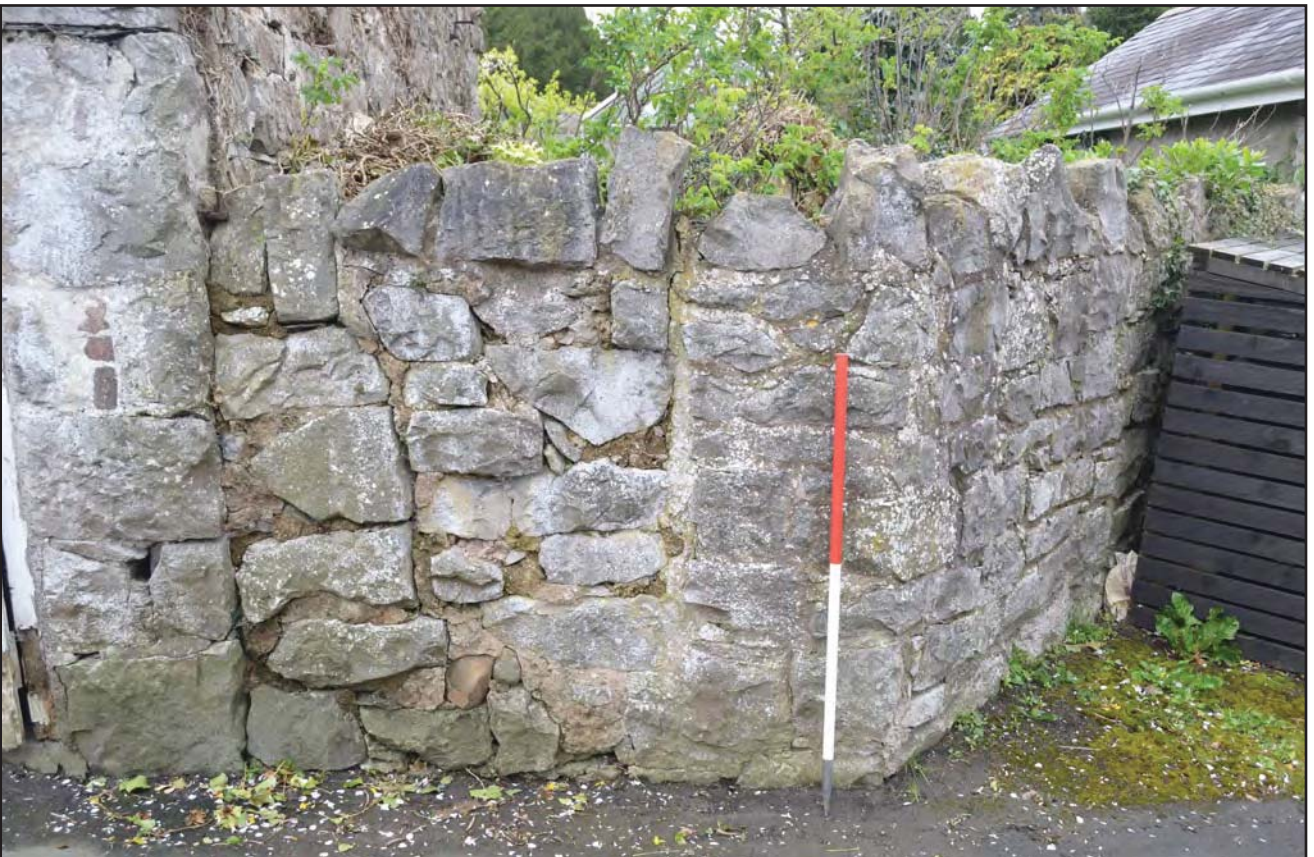
Plate 22: Blocked gateway to north-west of garage, from the north-east (archive reference: G2776\_014)

To the north-west of the garage there was an entrance through the garden wall that was infilled with stone (Plate 22). A hinge still survives in the wall of the garage where a gate hung across this entrance. A hinge at a higher level further south-west down the gable end wall suggests another gate or door.

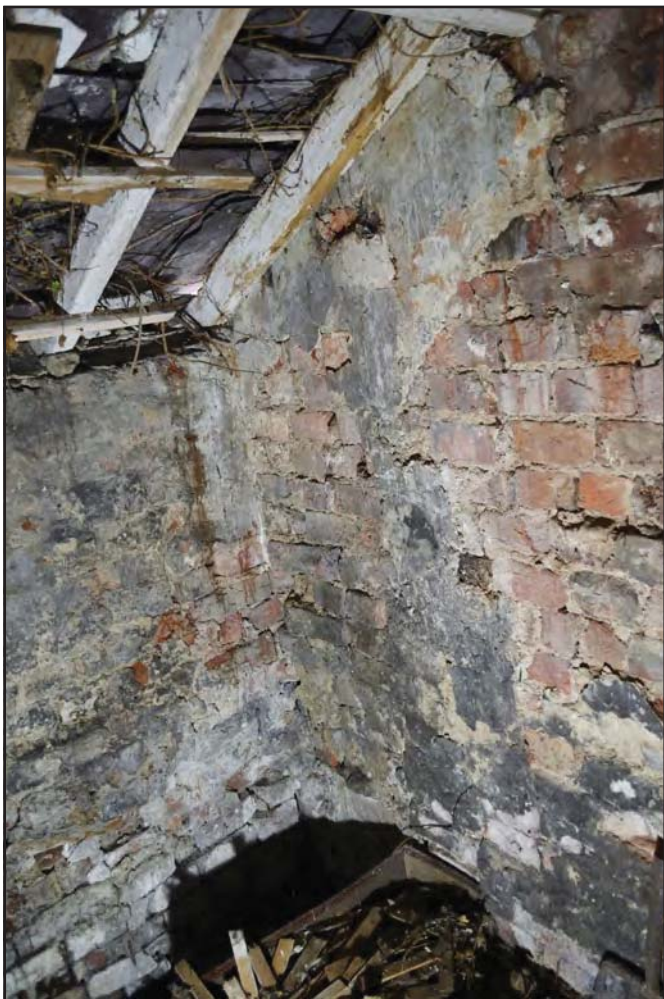
Plate 24: Interior of outside toilet 1 (archive reference: G2776\_090)

The interior walls are rendered and were white-washed (Plate 24). The floor is of brick and there is a deep slot along the back of the building, which was full of rubbish and soil, but has been partially dug out (Plate 25). This was presumably the pit to hold the waste in a pit latrine and there would have been a seat over the top. The roof slopes down from south-east to north-west and is covered by slates (Plate 26). The brick toilet is built on a considerable built-up of earth at a much higher level than the garage floor (Plate 27). There appears to have been a brick wall linking the toilet to the outbuilding, but this has been largely removed and this area is difficult to see because of the shed built over it.

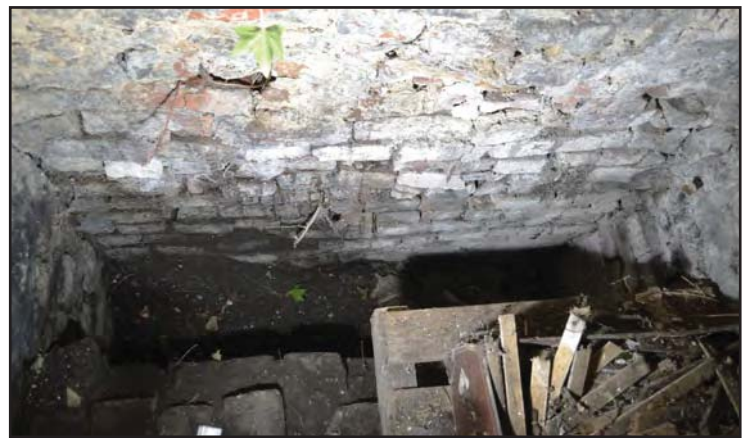
Plate 25: Pit latrine in outdoor toilet 1 (archive reference: G2776\_093)

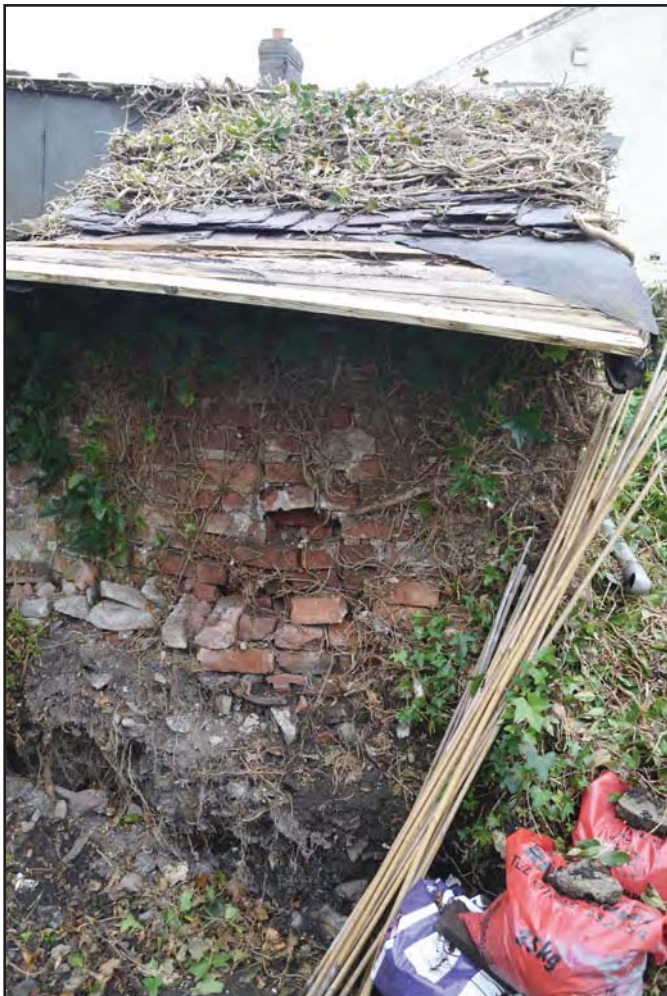
Plate 27: Outside toilet 1 built on thick deposit of earth, from north-west (archive reference: G2776\_033)

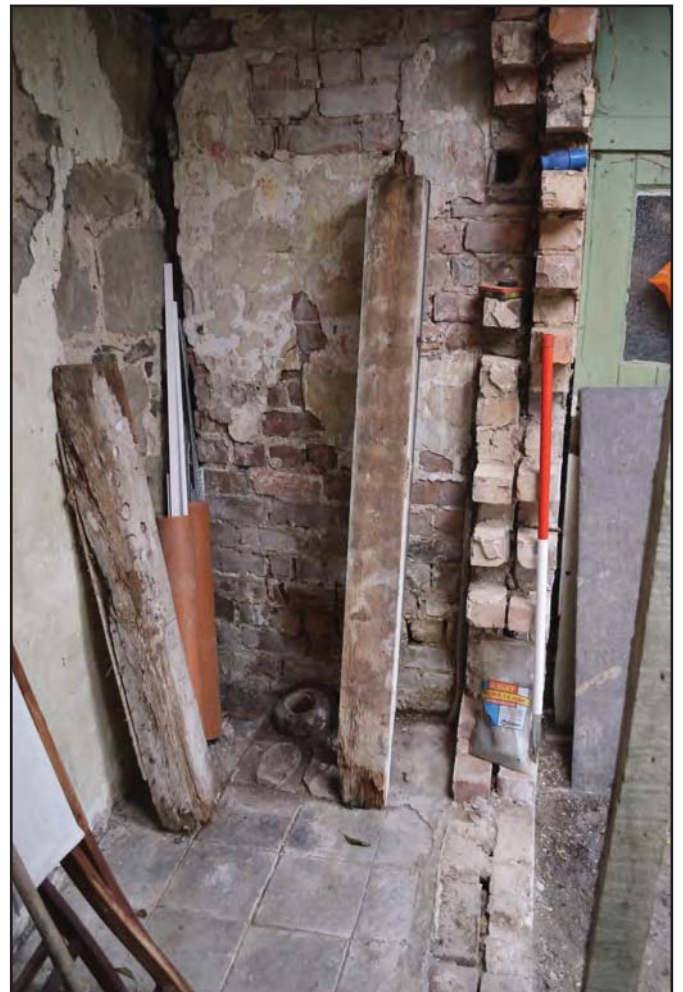
Plate 28: Partially demolished outside toilet 2, from the north-west (archive reference: G2776\_048)

Another brick toilet building (toilet 2) abutted the south-western wall of the outbuilding. Only the south-eastern wall of this remained with other walls having been demolished to form the shed (Plate 28). The foundation of the south-western wall can be seen in the floor of the shed, as well as the floor of the toilet which was covered with square ceramic tiles like those in the garage. There is a broken waste pipe in the floor showing that this building had a flush toilet. Remains of bricks in the floor immediately next to this structure indicated that there had been another brick structure, possibly an earlier, larger version of the toilet building or another cubicle (Plate 29), but very little of this survived and what could be seen was partly obscured by concrete.

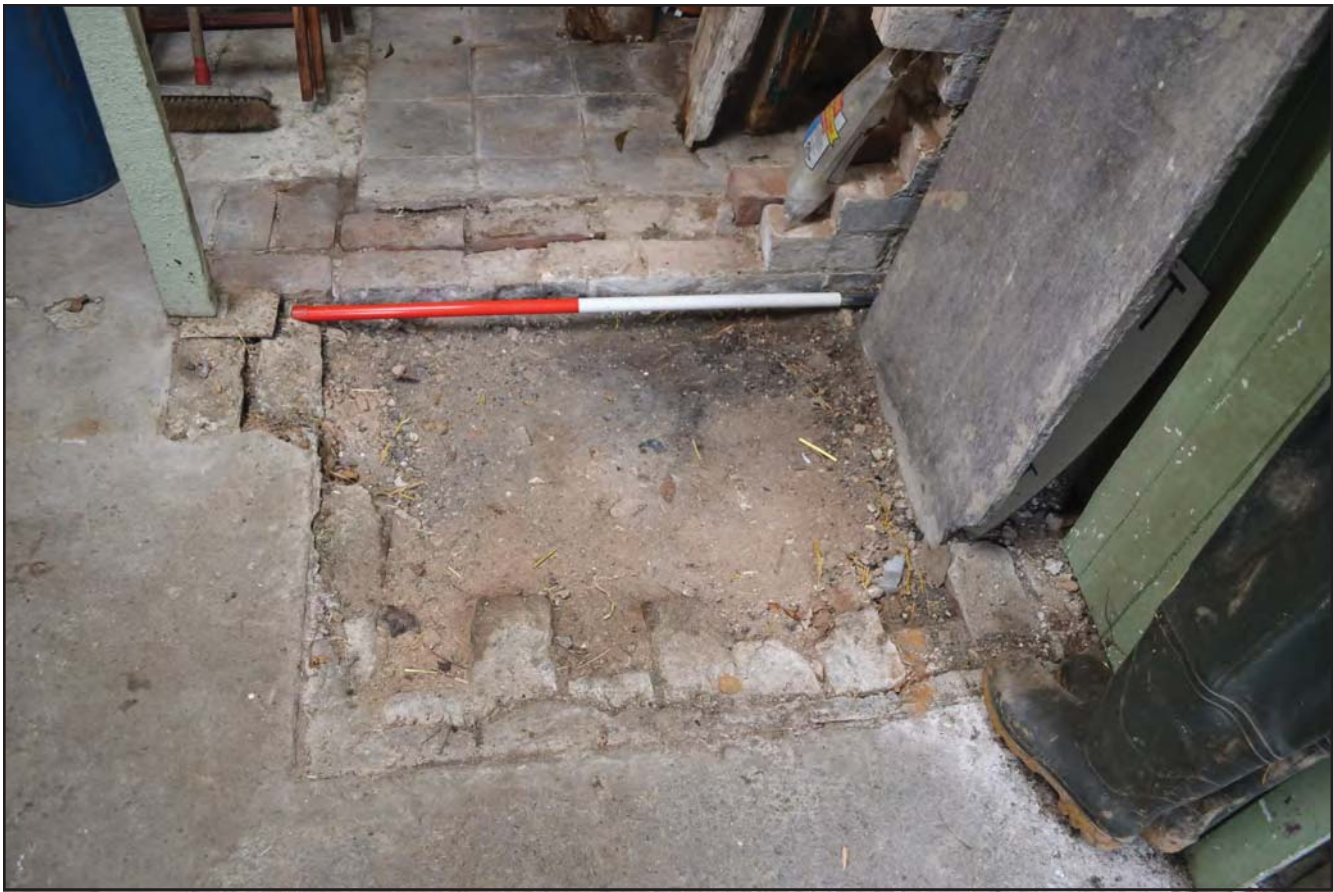
Plate 29: Remains of brick structure in the floor next to outside toilet 2, from the north-west (archive reference: G2776\_052)

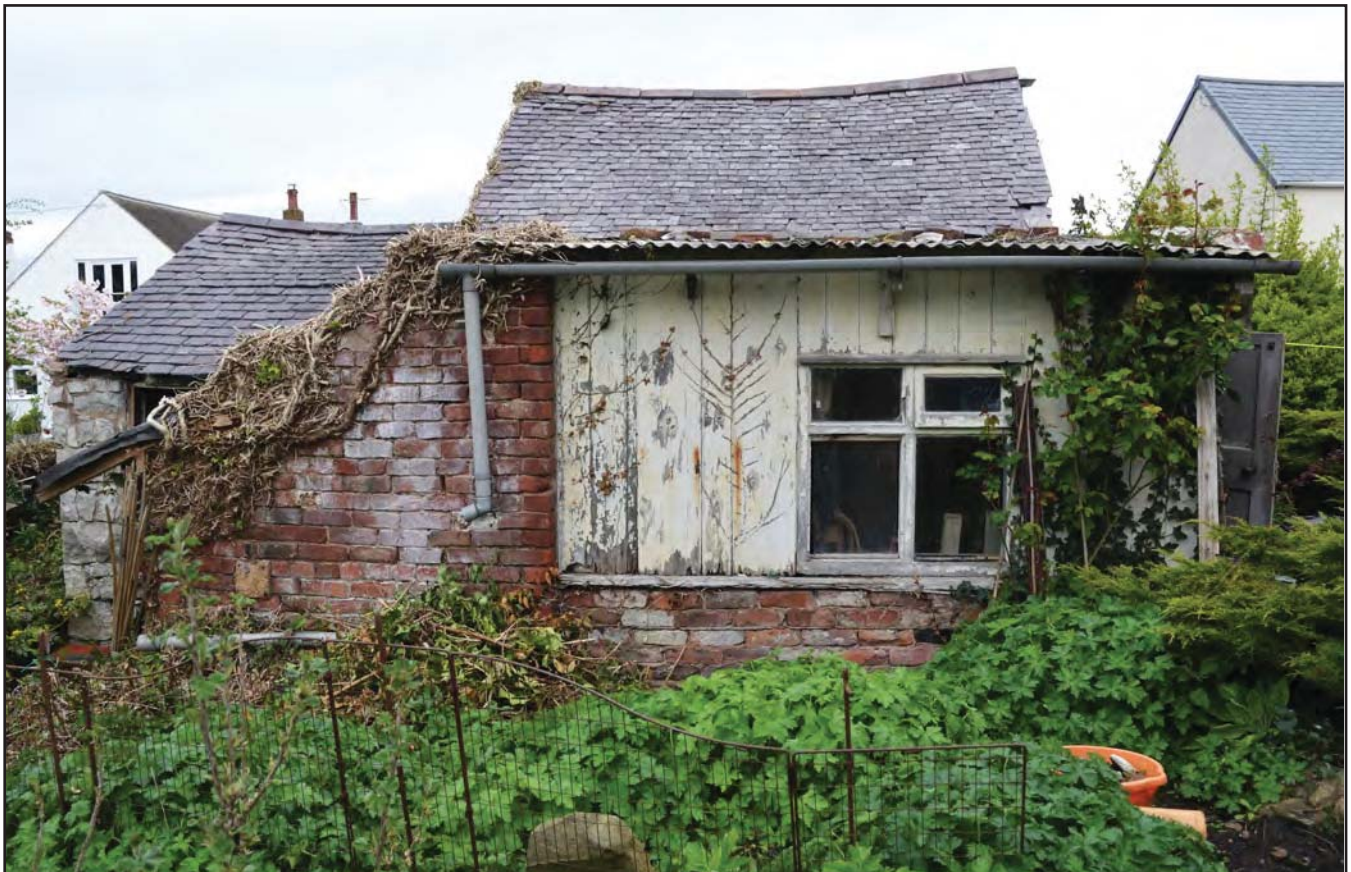
Plate 30: South-western elevation of outside toilet 1 and shed (archive reference: G2776\_027)

Both toilet buildings were incorporated into a shed using wood panelling and reused doors to form walls between the toilet walls (Plate 30). There is a door in the south-eastern wall (Plate 31) and the south-western wall has reused brick forming the lower part of the wall and windows in the upper part. The floor of the shed is concrete, and its roof is of corrugated sheets, possibly asbestos, with a clear plastic corrugated sheet as a roof light (Plate 32). The shed was probably built in the 1970s.

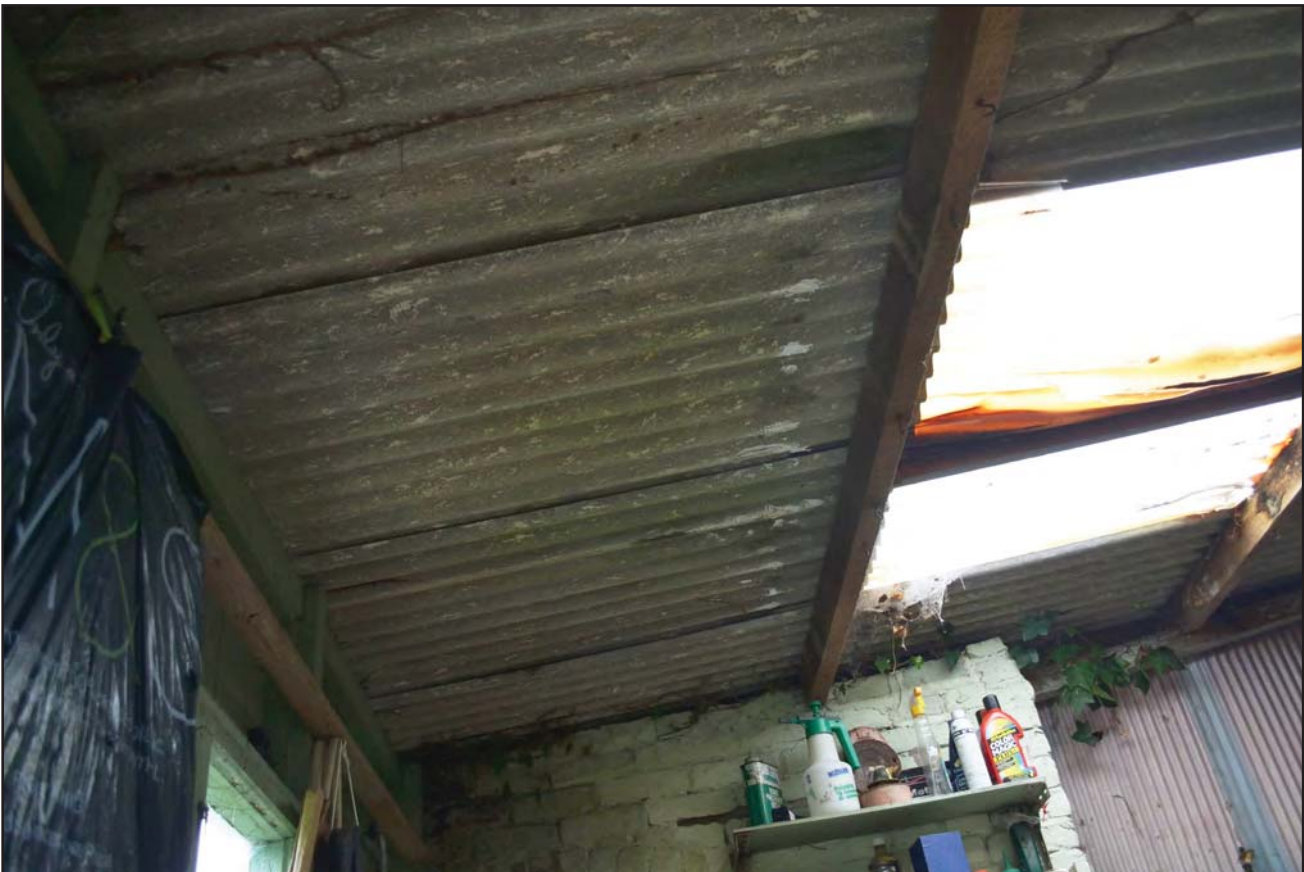
Plate 32: Inside of shed roof (archive reference: G2776\_057)

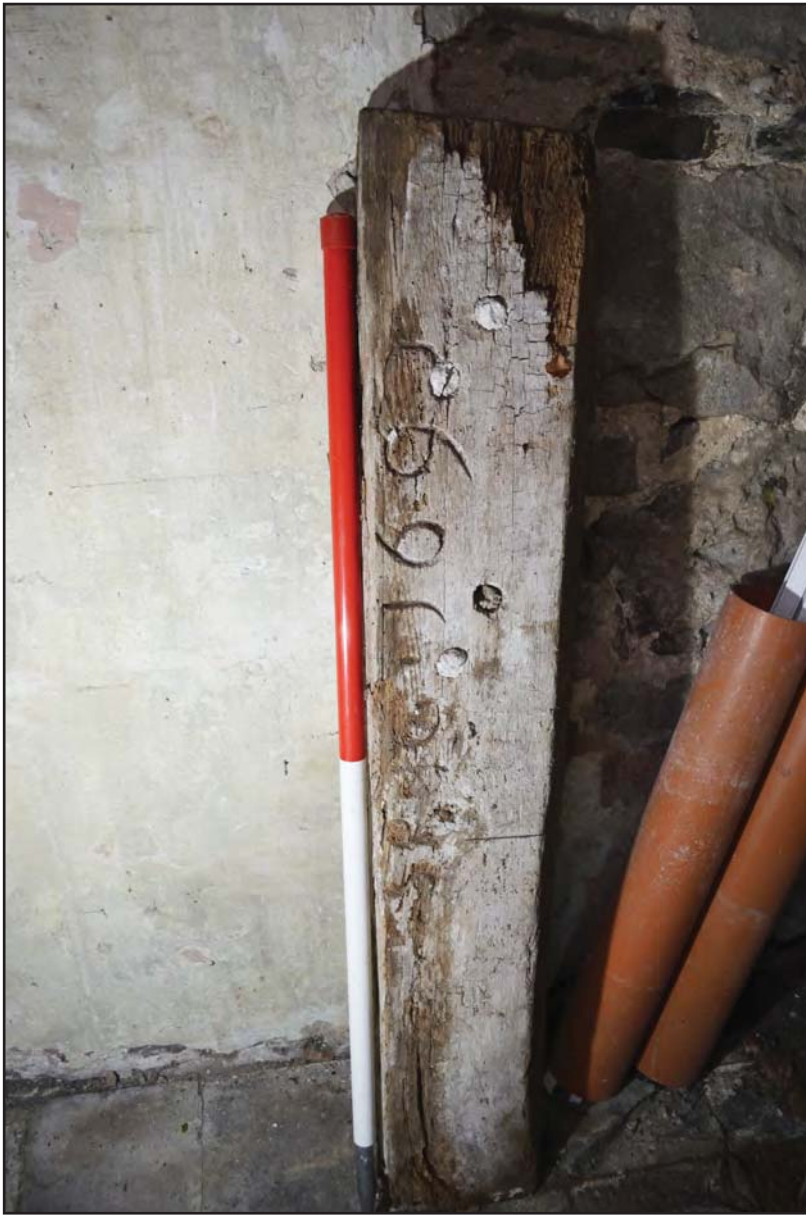
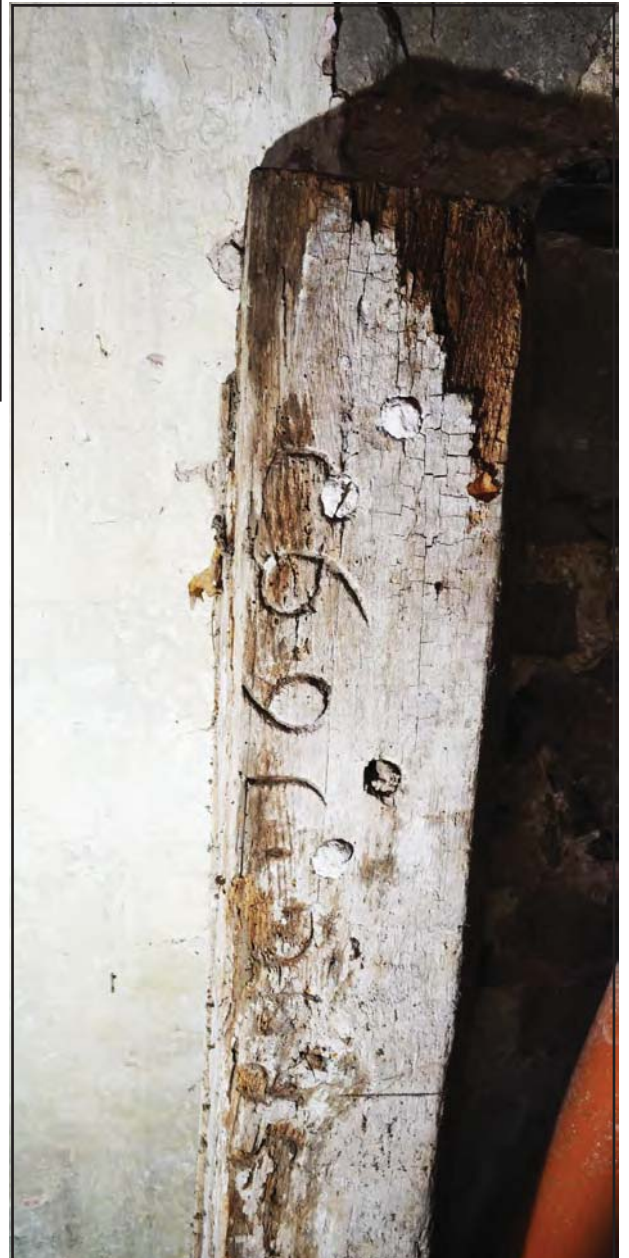
Plate 33: Carved beam in shed with date 1690 (archive reference: G2776\_086)

Plate 34: Carved beam in shed with date 1690 (archive reference: G2776\_085)

Inside the shed is a beam carved with the date 1690 and what appear to be the letters SPTG (Plates 33 and 34). This was found by the current owners, but they don't know its origin. It is presumably not from Church Gates, which appears to be entirely late 19<sup>th</sup> century in date, but there was no opportunity to investigate the history of the house or the property in general.
