## **B33-2.4 Glascoed WTW to Bodelwyddan Castle, 450mm GRP Main Renewal, Abergele.**

Archaeological Evaluation

Project Code: A0126.3

Report no. 0273

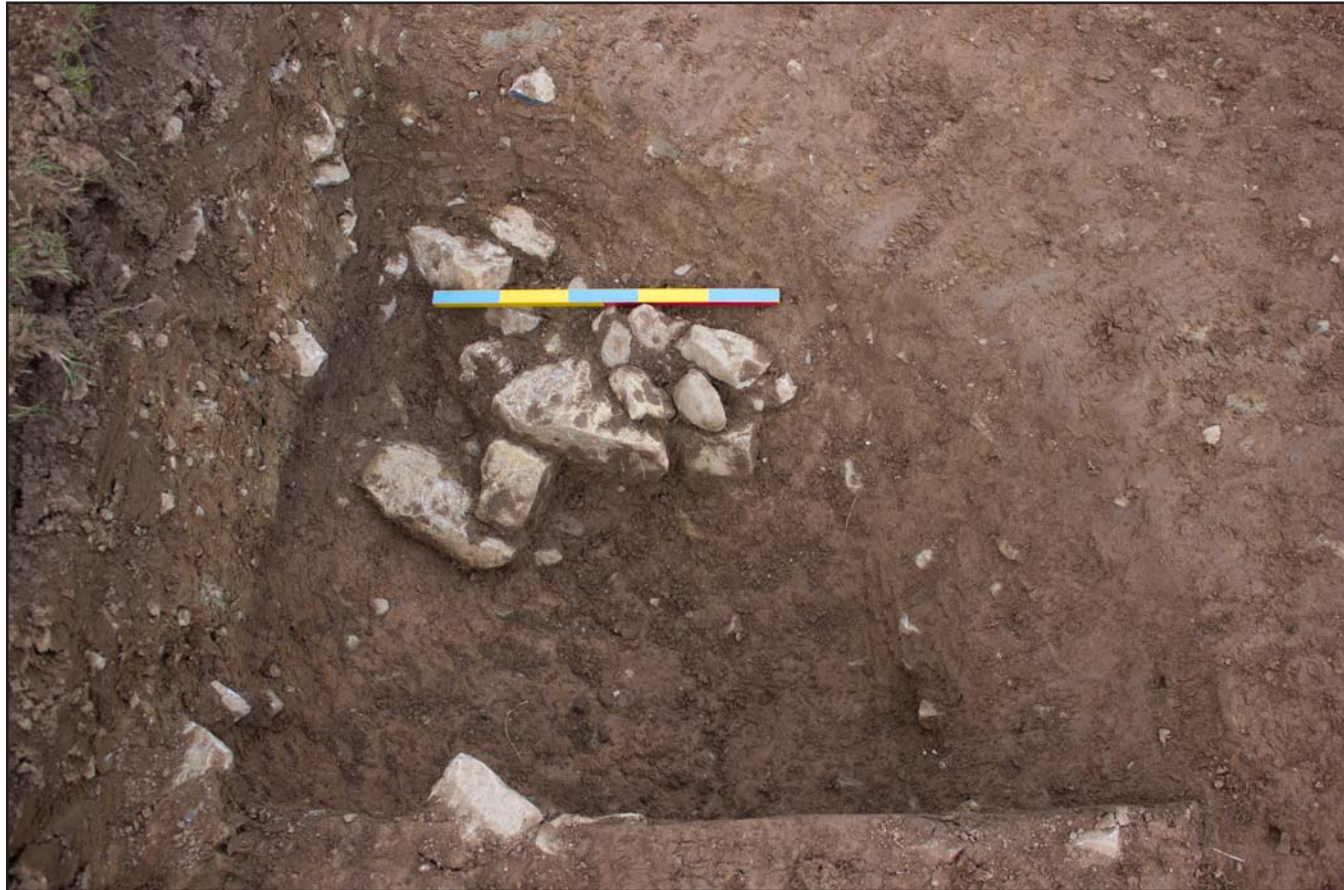
**Plate 28:** Trench 1 trench arm E showing stones (104), from the south. Scale 0.5m.

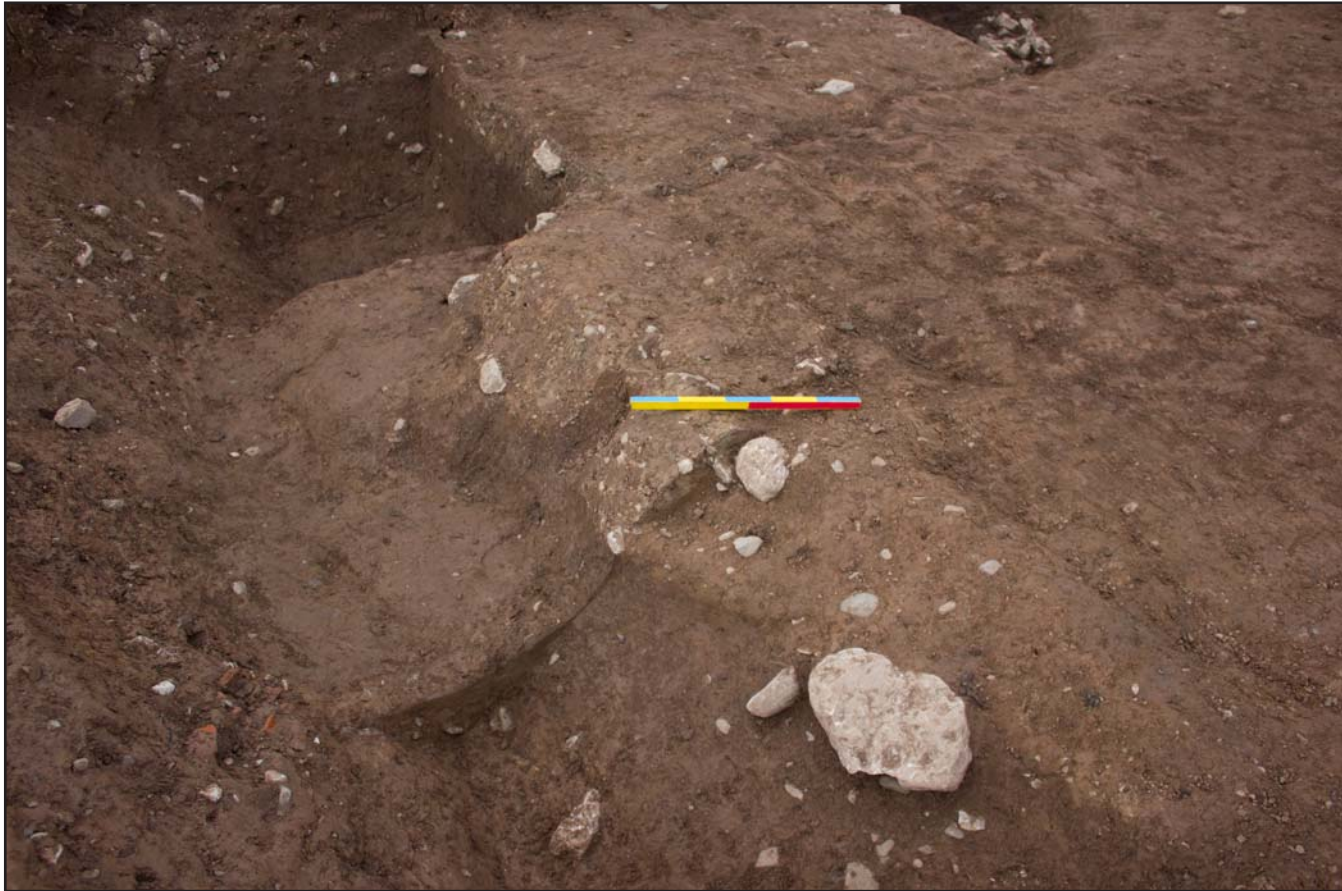
**Plate 29:** Trench 1 trench arm D showing area of slumping (105), from the southwest. Scale 0.5m.

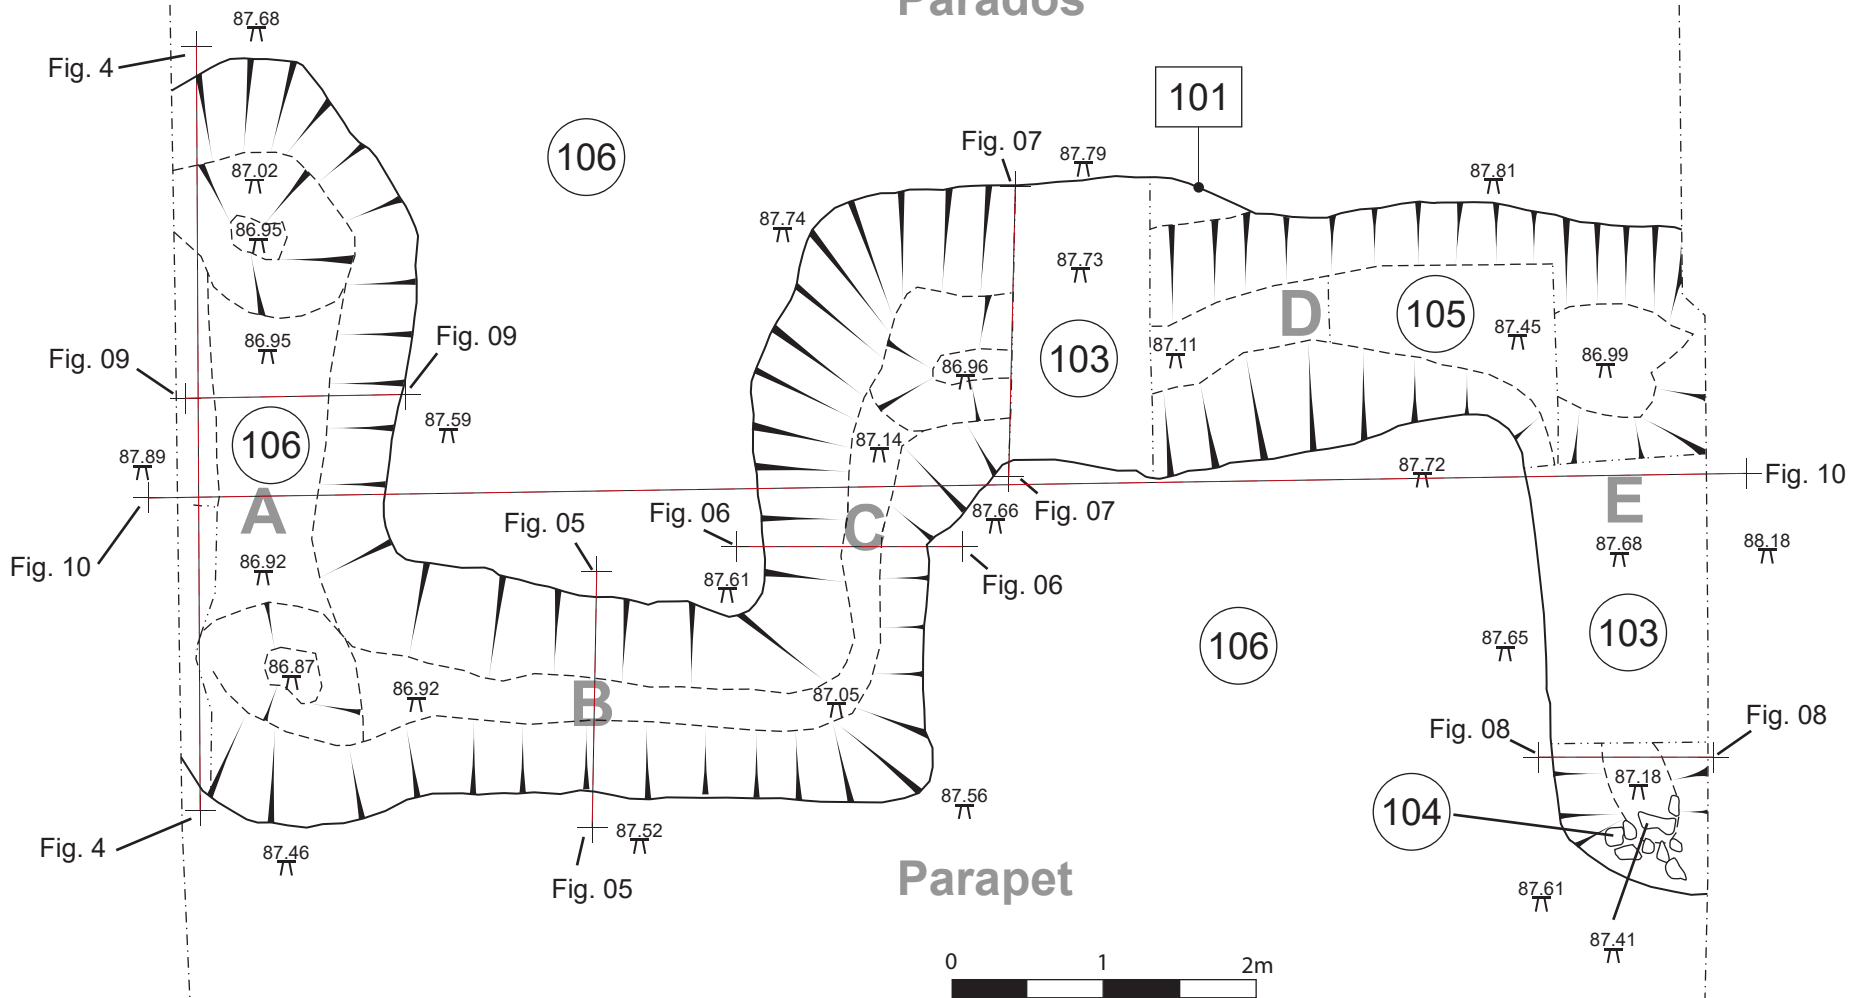
Figure 03. Plan of trench 1. Scale 1:50 at A4.

Trench 1 measured 10m in length by 10.0m in width, and was excavated to a maximum depth of 1.12m below ground level (BGL) (86.87m OD). It was excavated through a 0.2m deep deposit of very soft, dark grey-brown clay-silt turf and topsoil (107), which produced three pieces of corroded iron wire, most probably barbed wire (SF 1). This deposit lay above a 0.33m deep deposit of firm, mid orange-brown silt-clay subsoil with occasional small, sub-rounded pebble inclusions (106).

Evaluation trench 1 succeeded in revealing the remains of the targeted traverse fire trench identified from low earthworks and historic aerial photography. The trench occupied a ridge of east-west aligned high ground with the concentration of associated practice trenches being located to the north, thus suggesting that this fire trench was intended to face northward and down-slope. In support of this theory, the three recovered .303 cartridges (SF 2, 3 and 7) were all found within the forward facing east-west aligned trench arm B, suggesting that this was the area of action.

The fire trench appears to have been deliberately excavated slightly deeper in the corners, presumably to create drainage sumps for water, and also with a slope bias towards the southern rear-facing side of the trench to drain water away from the forward facing trench arms.

The trench, although vertically truncated by ploughing and erosion / slumping, is unlikely to have been of sufficient depth for combat practice. Even with the mounding of excavated material to form a parapet and parados it is challenging to envisage the trench being much more than 1m in depth. This would suggest that sandbags were used to increase the trench 'depth' of which now no trace survives.

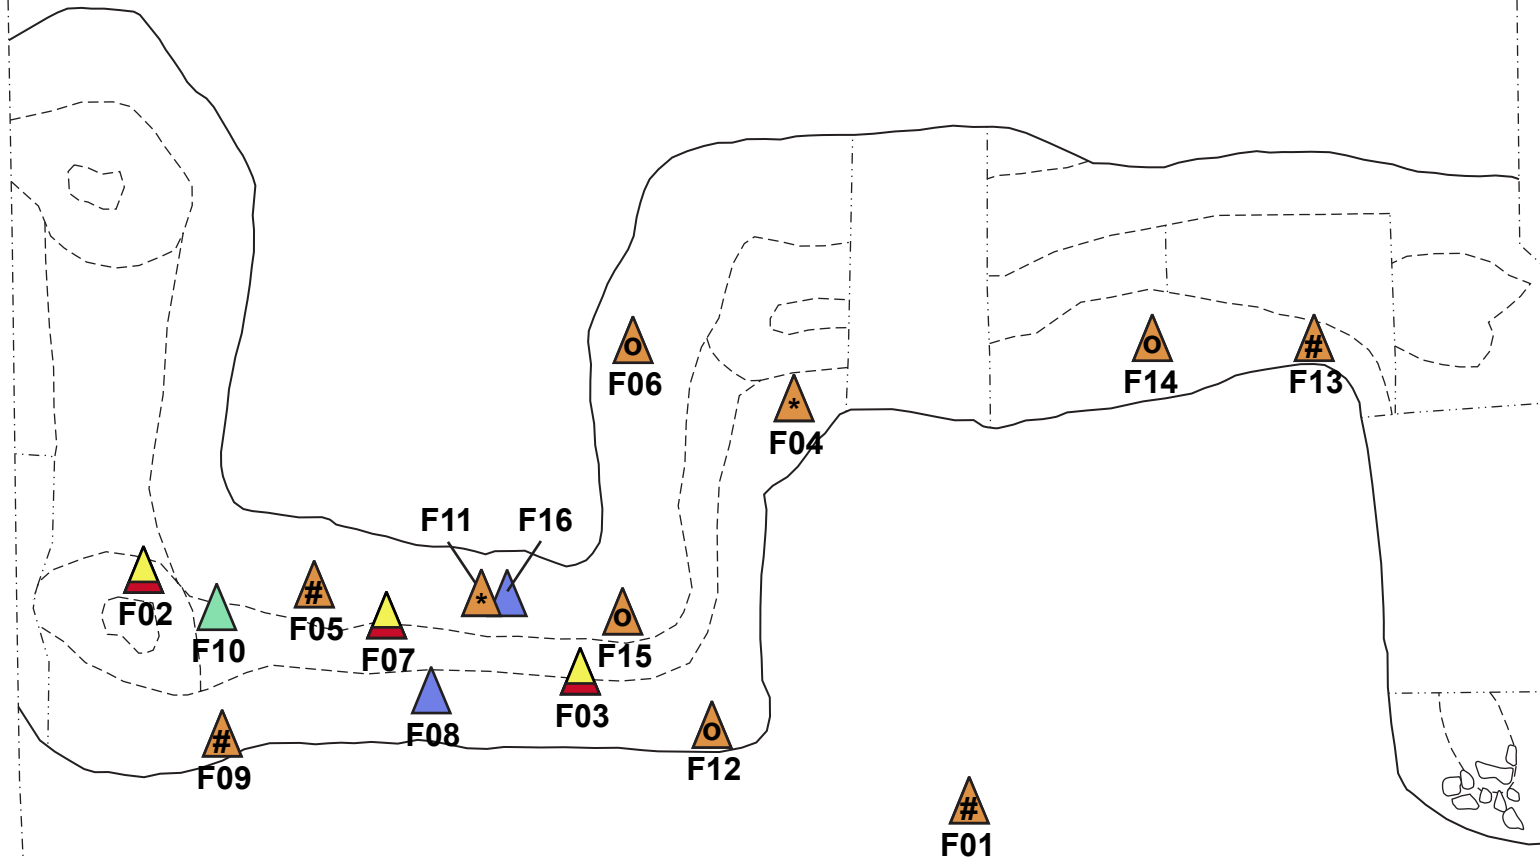
Figure 11. Location of archaeological finds plotted on Plan of Trench 1. Scale 1:50 at A4.

Six separate .303 service spent rounds (finds no. 2, 3, 7, 21, 22 & 24) were recovered during the evaluation. Small finds no's 2, 3 and 7 were found within trench 1 in both the upper and lower fills (102 and 103) while small finds no's 21, 22 and 24 were found within trench 3, again within the upper and lower fills (302 and 303) as well as unstratified. This is interesting; as past interpretation of the zig-zag shaped trenches seen in evaluation trench 3 (see CPAT report 1303) has focused on the premise that these were 'communication' trenches as opposed to 'fire' trenches. However, the discovery of spent cartridges within trench 3 shows that these communication trenches were also being used for combat exercises.

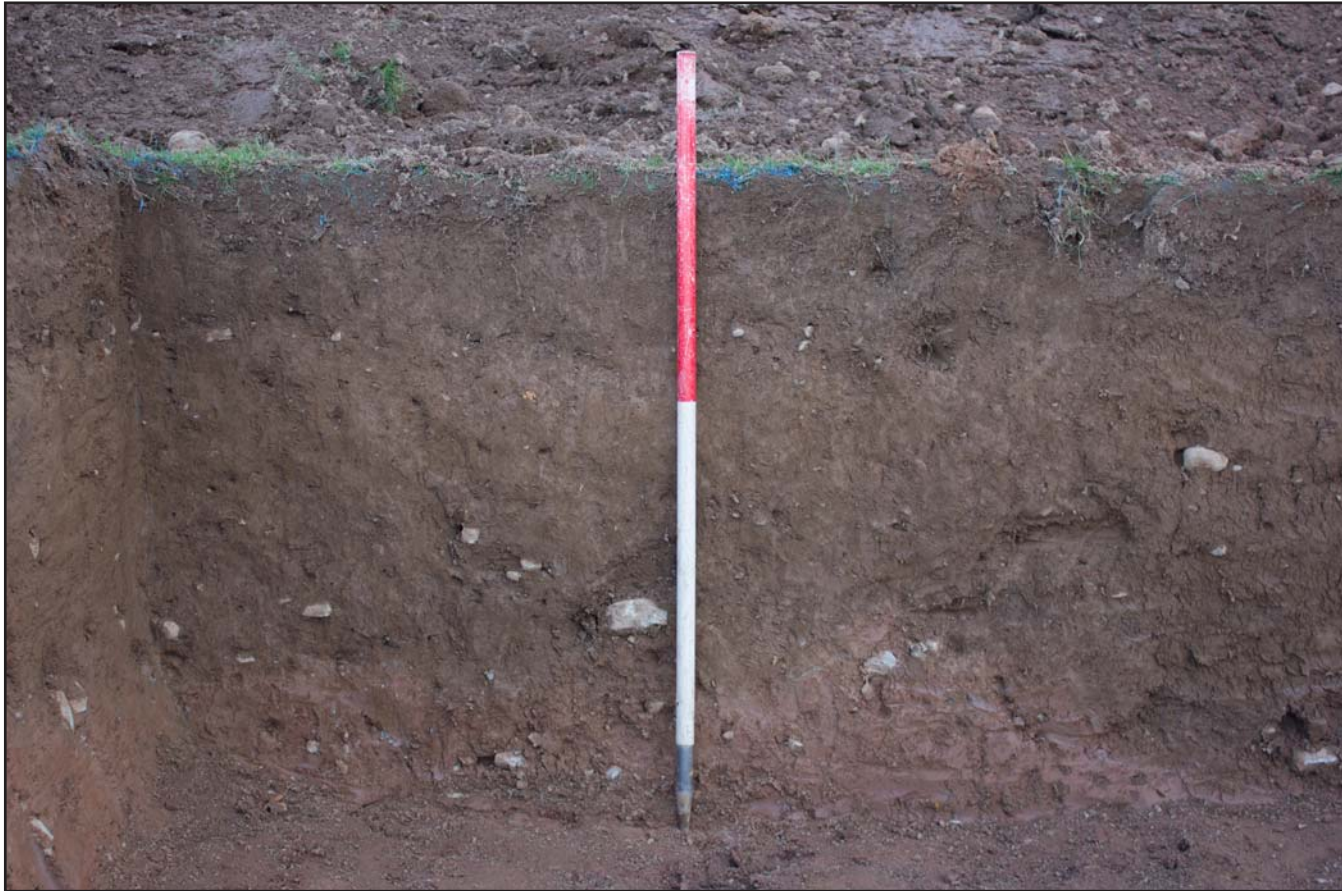
Evaluation trench 2 failed to uncover any remains associated with the linear earthwork identified from historic aerial photography and recorded by CPAT as part of the Cadw Scheduling Enhancement Program of 2015 (report 1384). It is possible that due to farming across the site this particular trench has not survived and therefore could not be identified upon evaluation. Indeed, heavy mixing of the topsoil and subsoil deposits was recorded on site, and if the trench was only of shallow depth to begin with then it is possible that ploughing has removed all trace.

Alternatively, it may be the case that this feature was never a First World War trench to begin with and was merely a scarp running along the top of the slope which presented as a possible trench feature on the interpretation of the RAF photograph of 1946.

**Plate 45:** Trench 2 east facing trench section, from the east. Scale 1.0m.

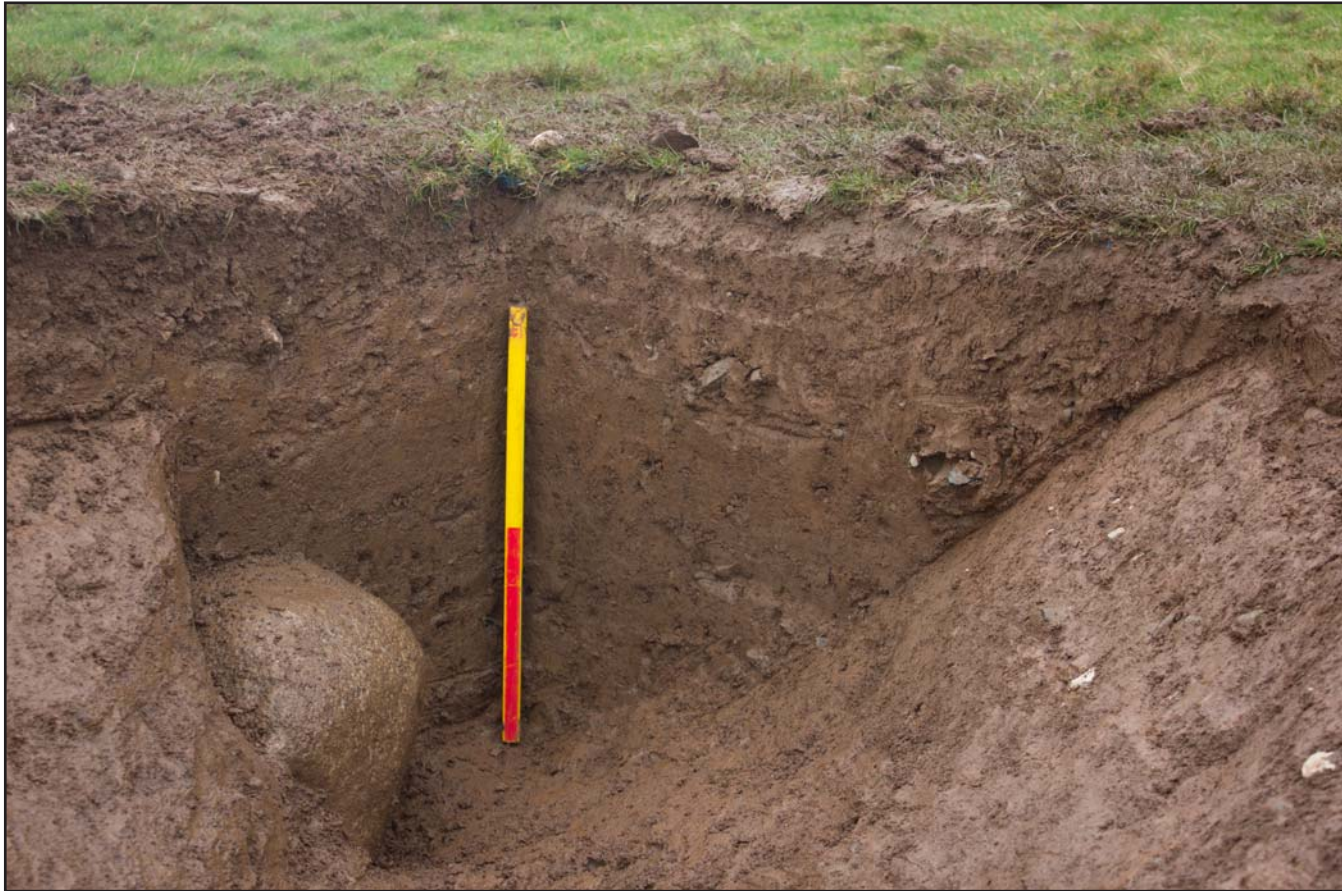
**Plate 56:** Trench 3 northwest facing section of [304] showing fills (303) and (302), from the northwest. Scale 0.5m.

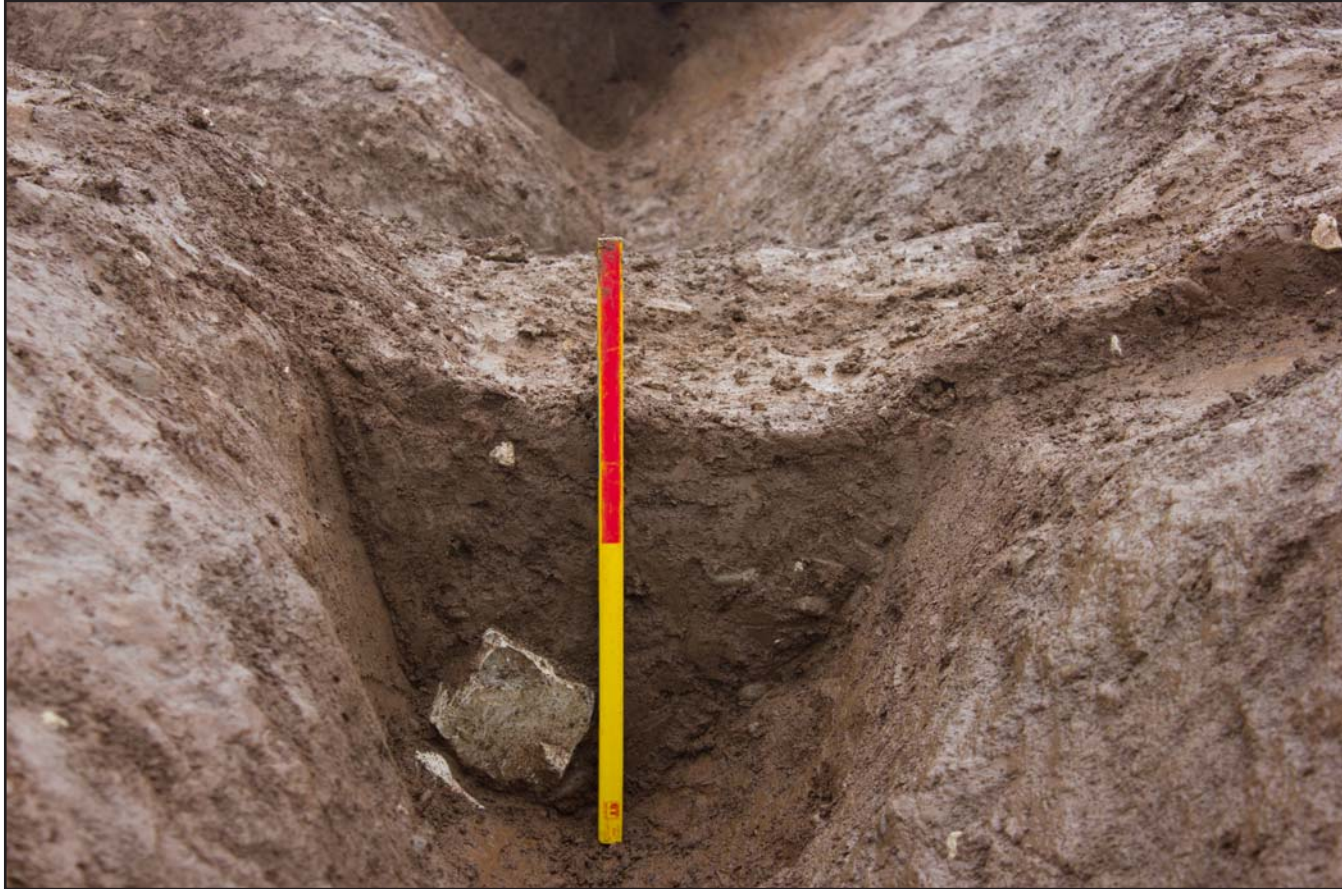
**Plate 57:** Trench 3 southeast facing section of [304] showing base fill (303), from the southeast. Scale 0.5m.

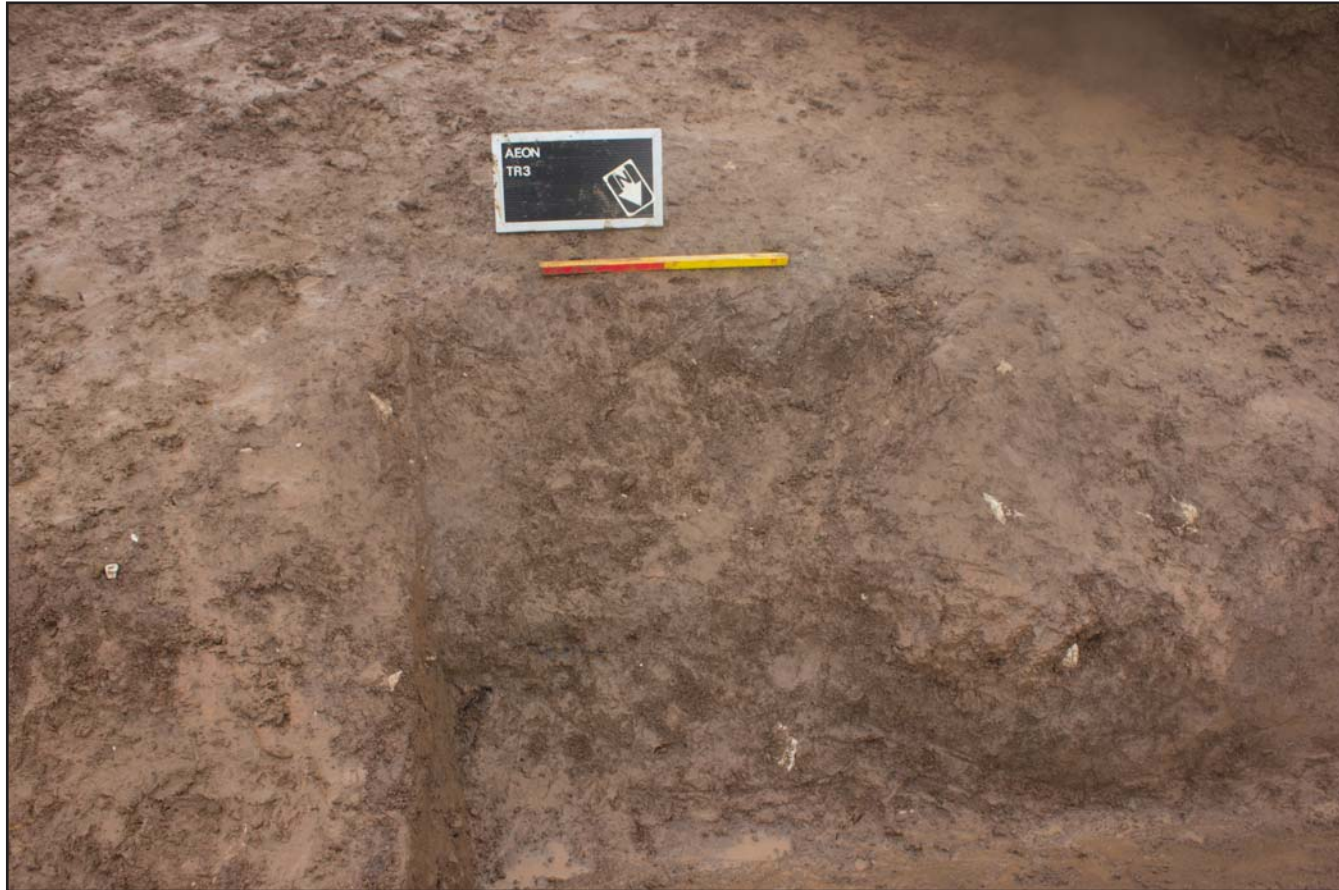
**Plate 59:** Trench 3 showing possible entrance into trench [304], from the northeast. Scale 0.5m.

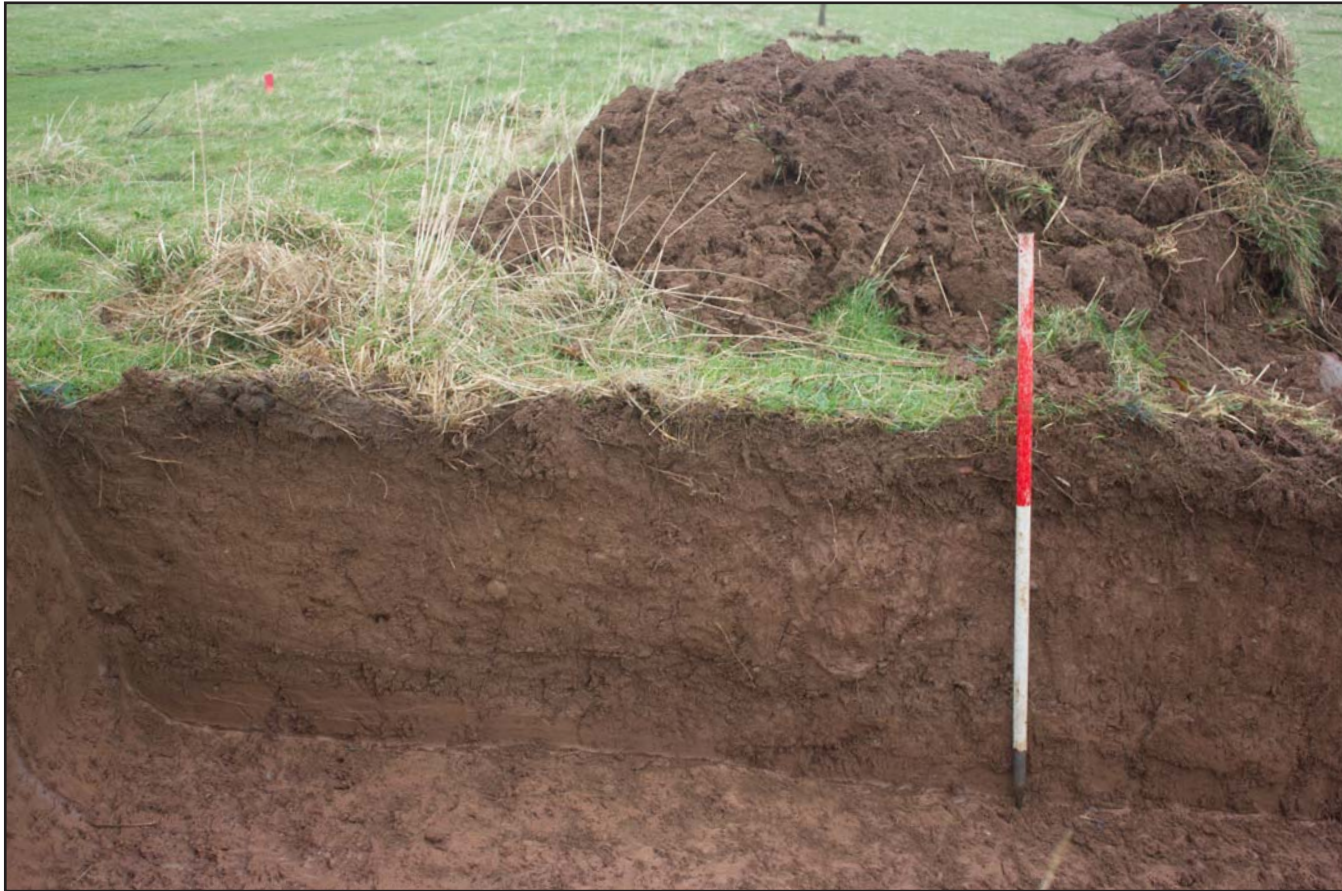
There were no archaeological features observed in plan, however upon cleaning and inspection of the north and south facing trench sections, a gently curving cut [404] was visible in section c.1.75m from the west end of the trench. This cut measured >2.0m in length by >2.0m in width, continuing into the northern, southern and western limits of excavation, by 0.3m in depth. This cut through subsoil deposit (402), almost but not quite to the level of the natural clay substrata (401). The cut had a steep top break of slope, a gently concaved side, and a flat base. The cut was initially filled by a 0.3m deep, firm mid red-brown clay (405) at its eastern end, before being entirely infilled by a 0.35m deep, soft dark orange-brown silt-clay (406) and then overlaid with topsoil (403).

**Plate 67:** Trench 4 south facing trench section showing terrace [404], from the south. Scale 1.0m.

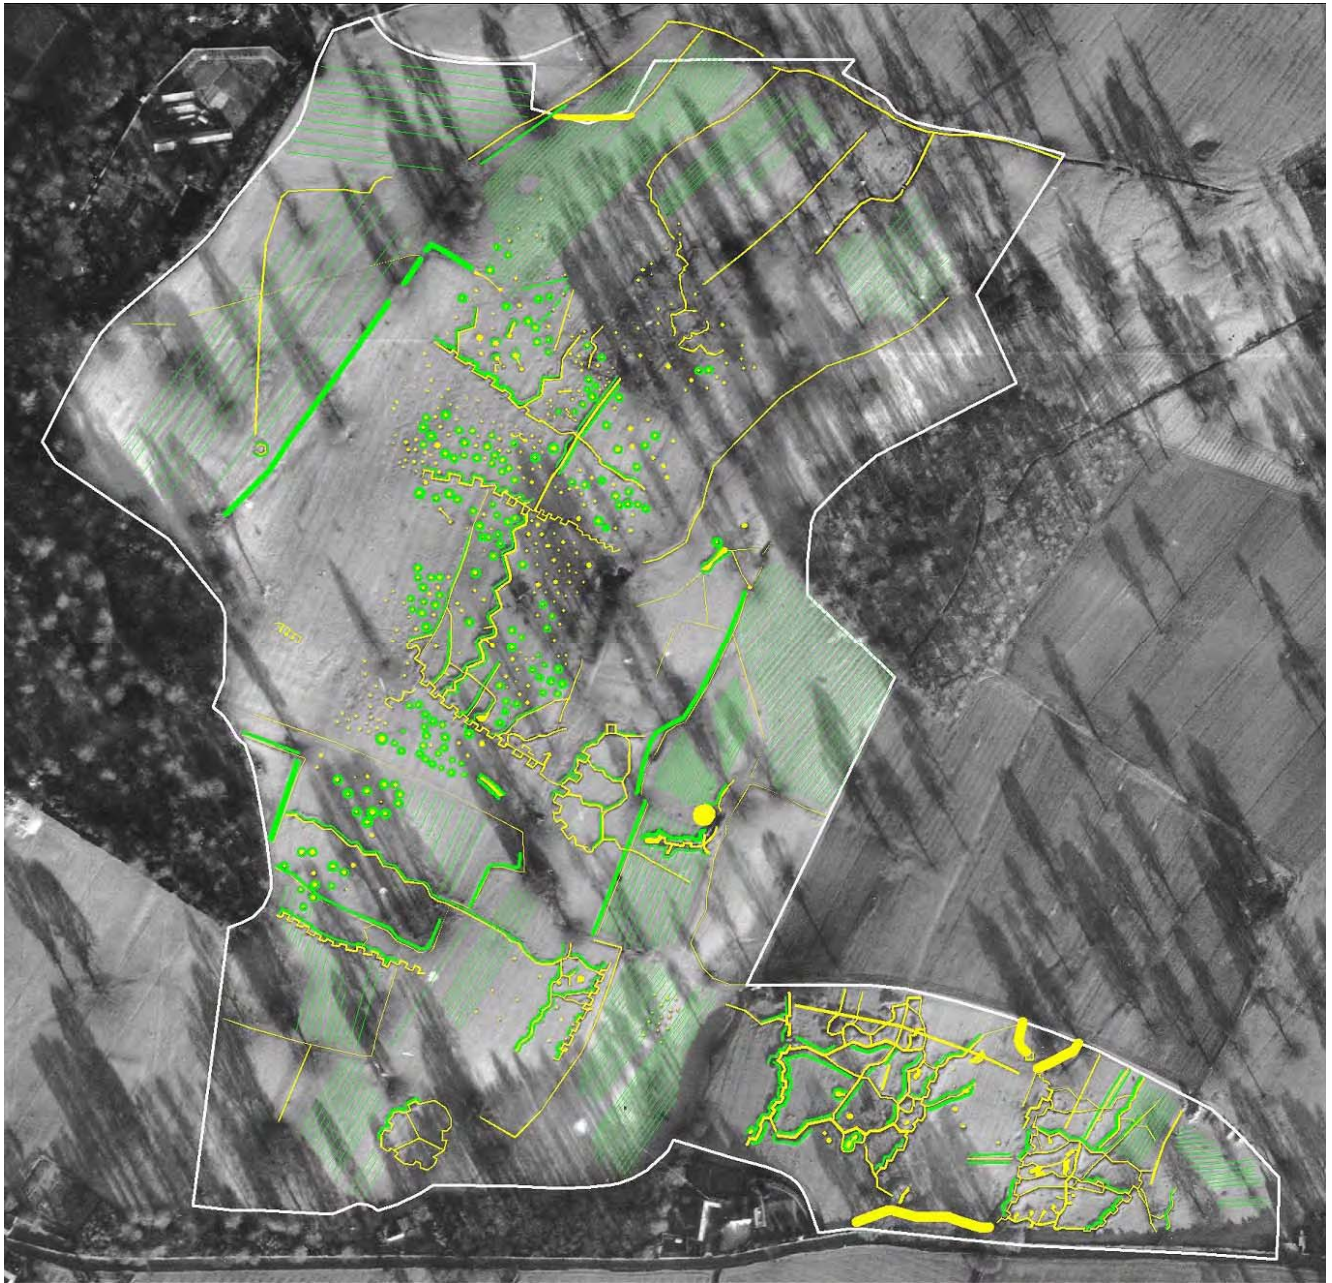
**Figure 31:** 1946 RAF aerial photograph of Bodelywyddan Park showing WW1 trenches and earthworks as undertaken by CPAT and Cadw in 2015. (Yellow signifies an excavated feature, green upstanding) (3G.TUD.UK.33.5421)

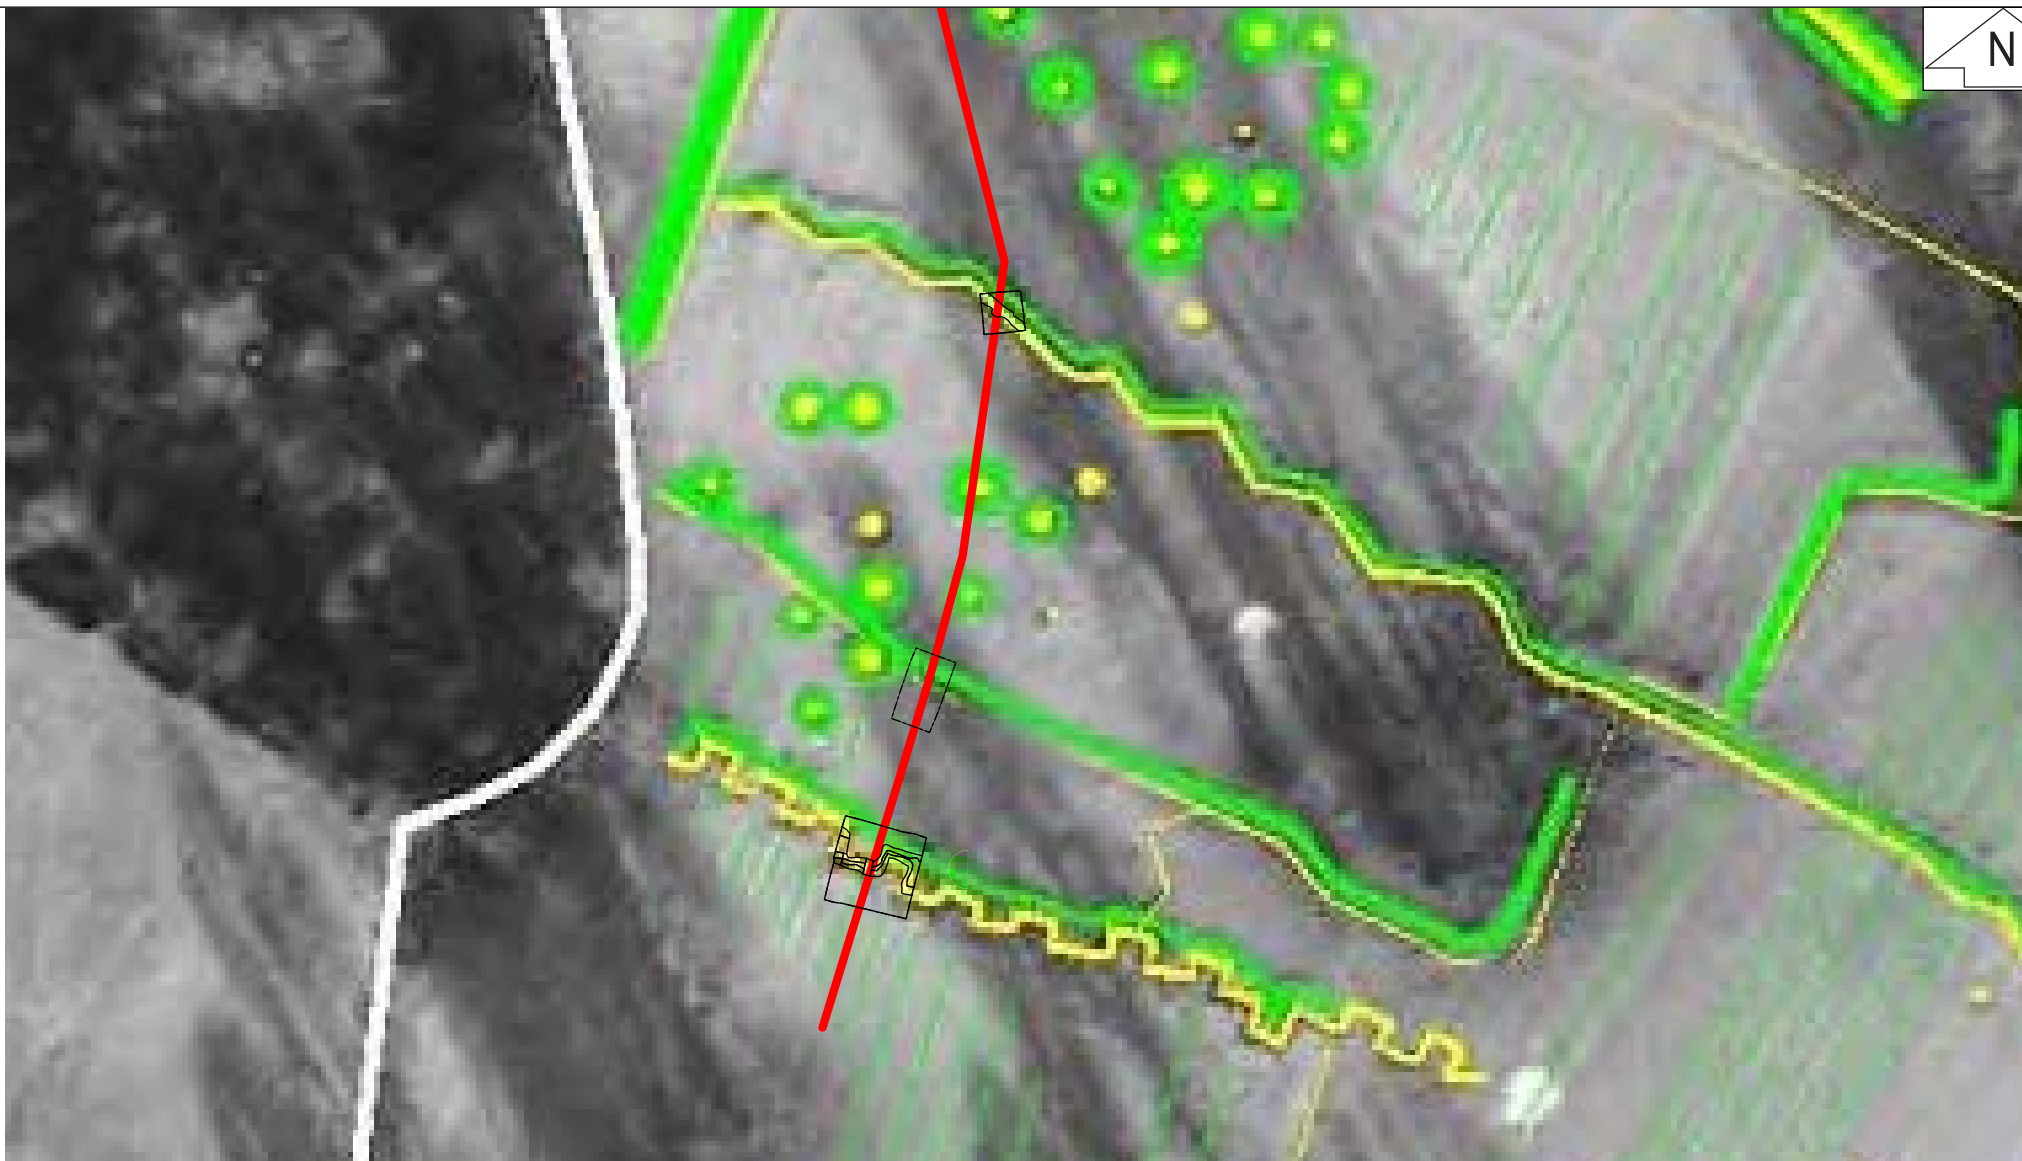
**Figure 33:** Trenches (1-3) overlaid on the CPAT / Cadw earthworks survey of 2015.  
Scale 1:1,000 at A4 (3G.TUD.UK.33.5421).
