Clydach Dingle, Brynmawr, Ebbw Vale

Archaeological Desk Based Assessment
Data Collection

Report No. 1578

May 2017

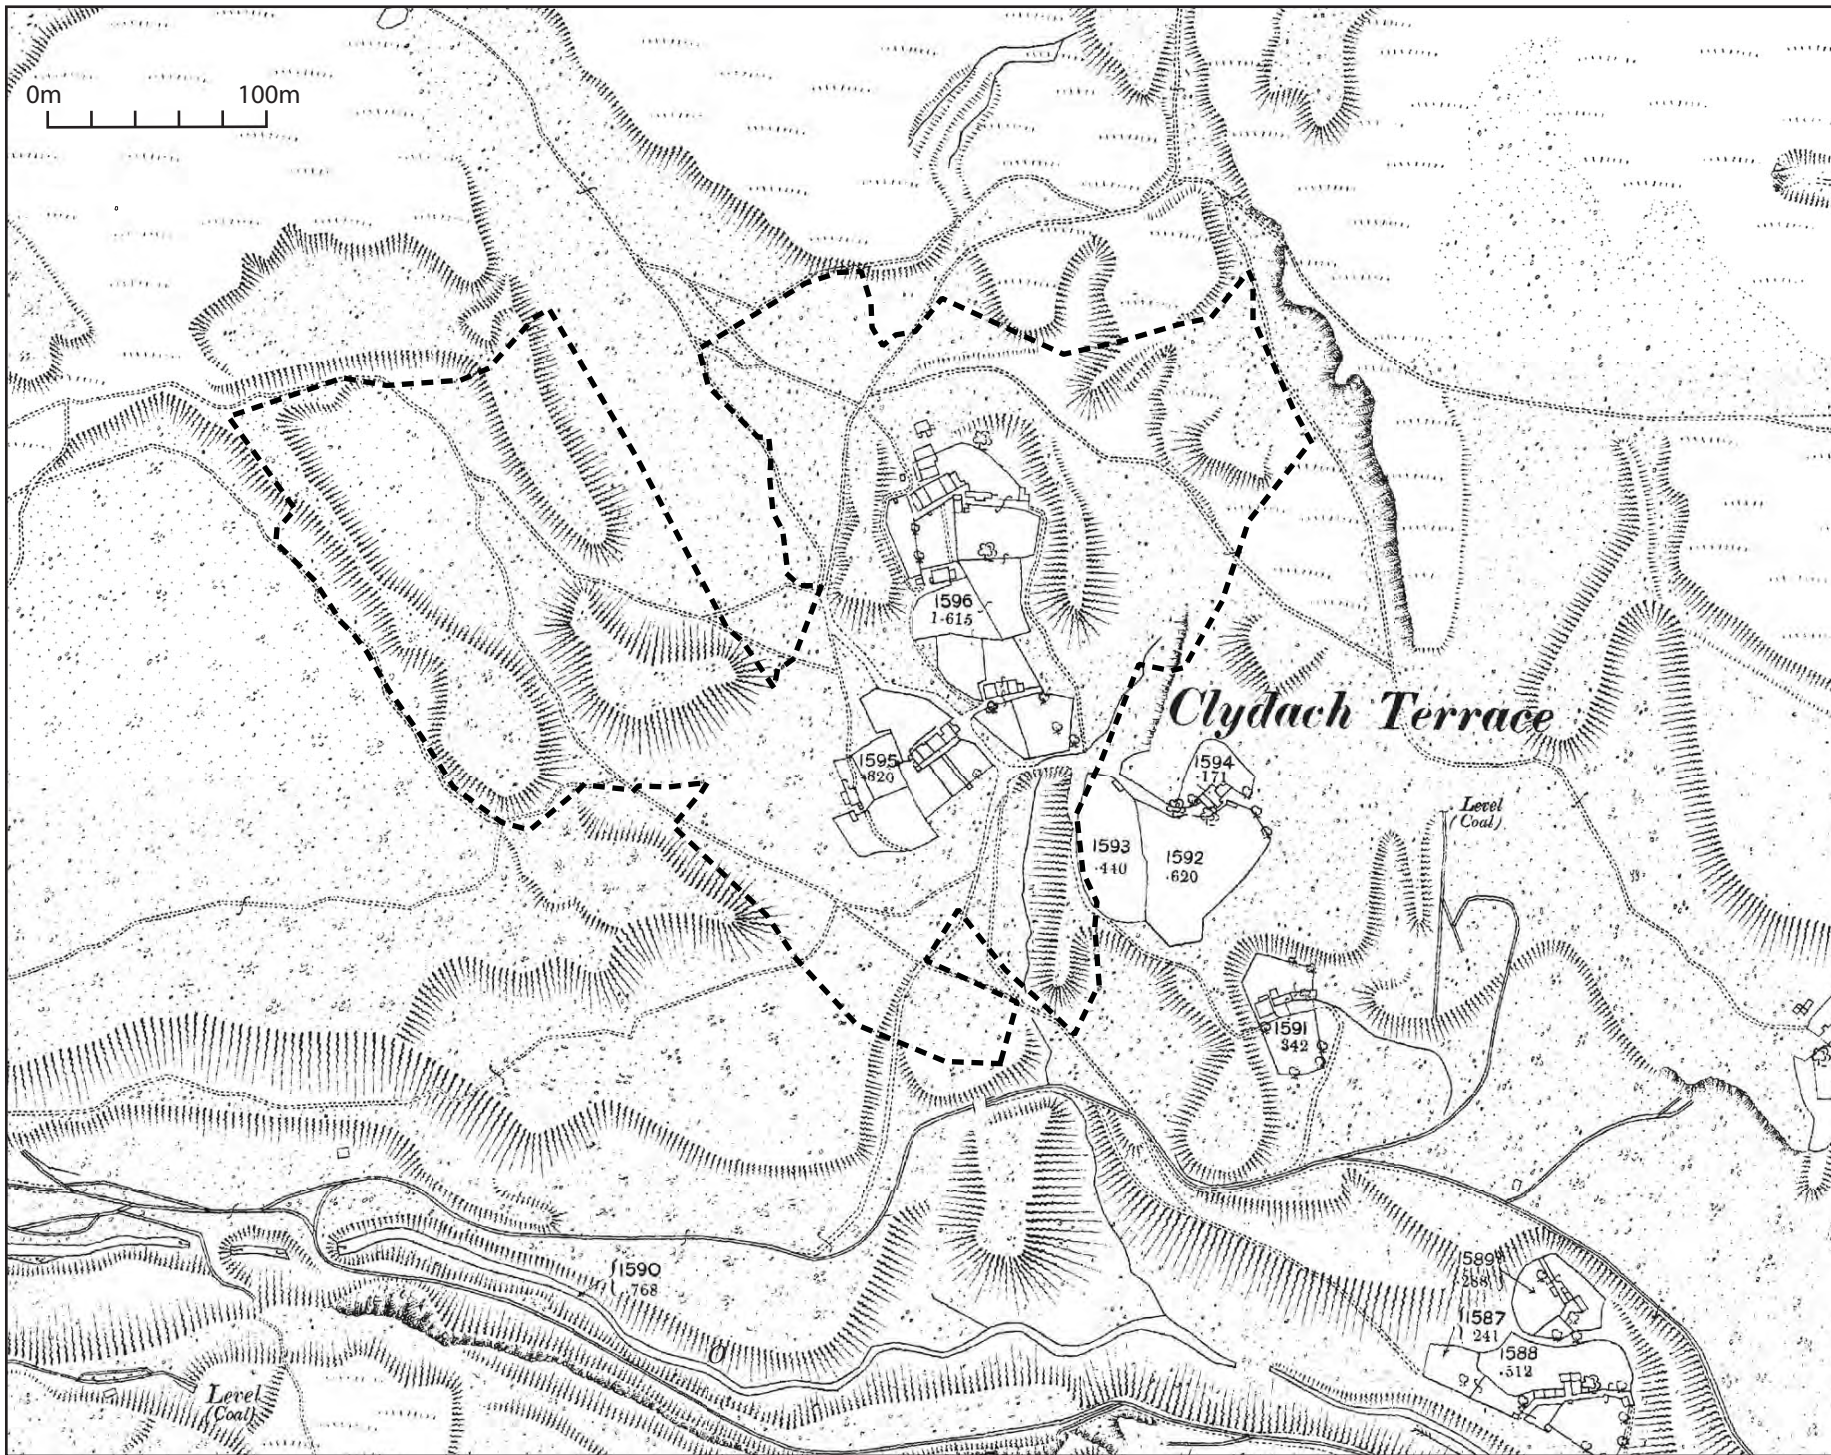
Figure 9: Extract from the 1st edition Ordnance Survey 1:2500 map of Brecknockshire, dated 1880. Approximate outline of site highlighted.

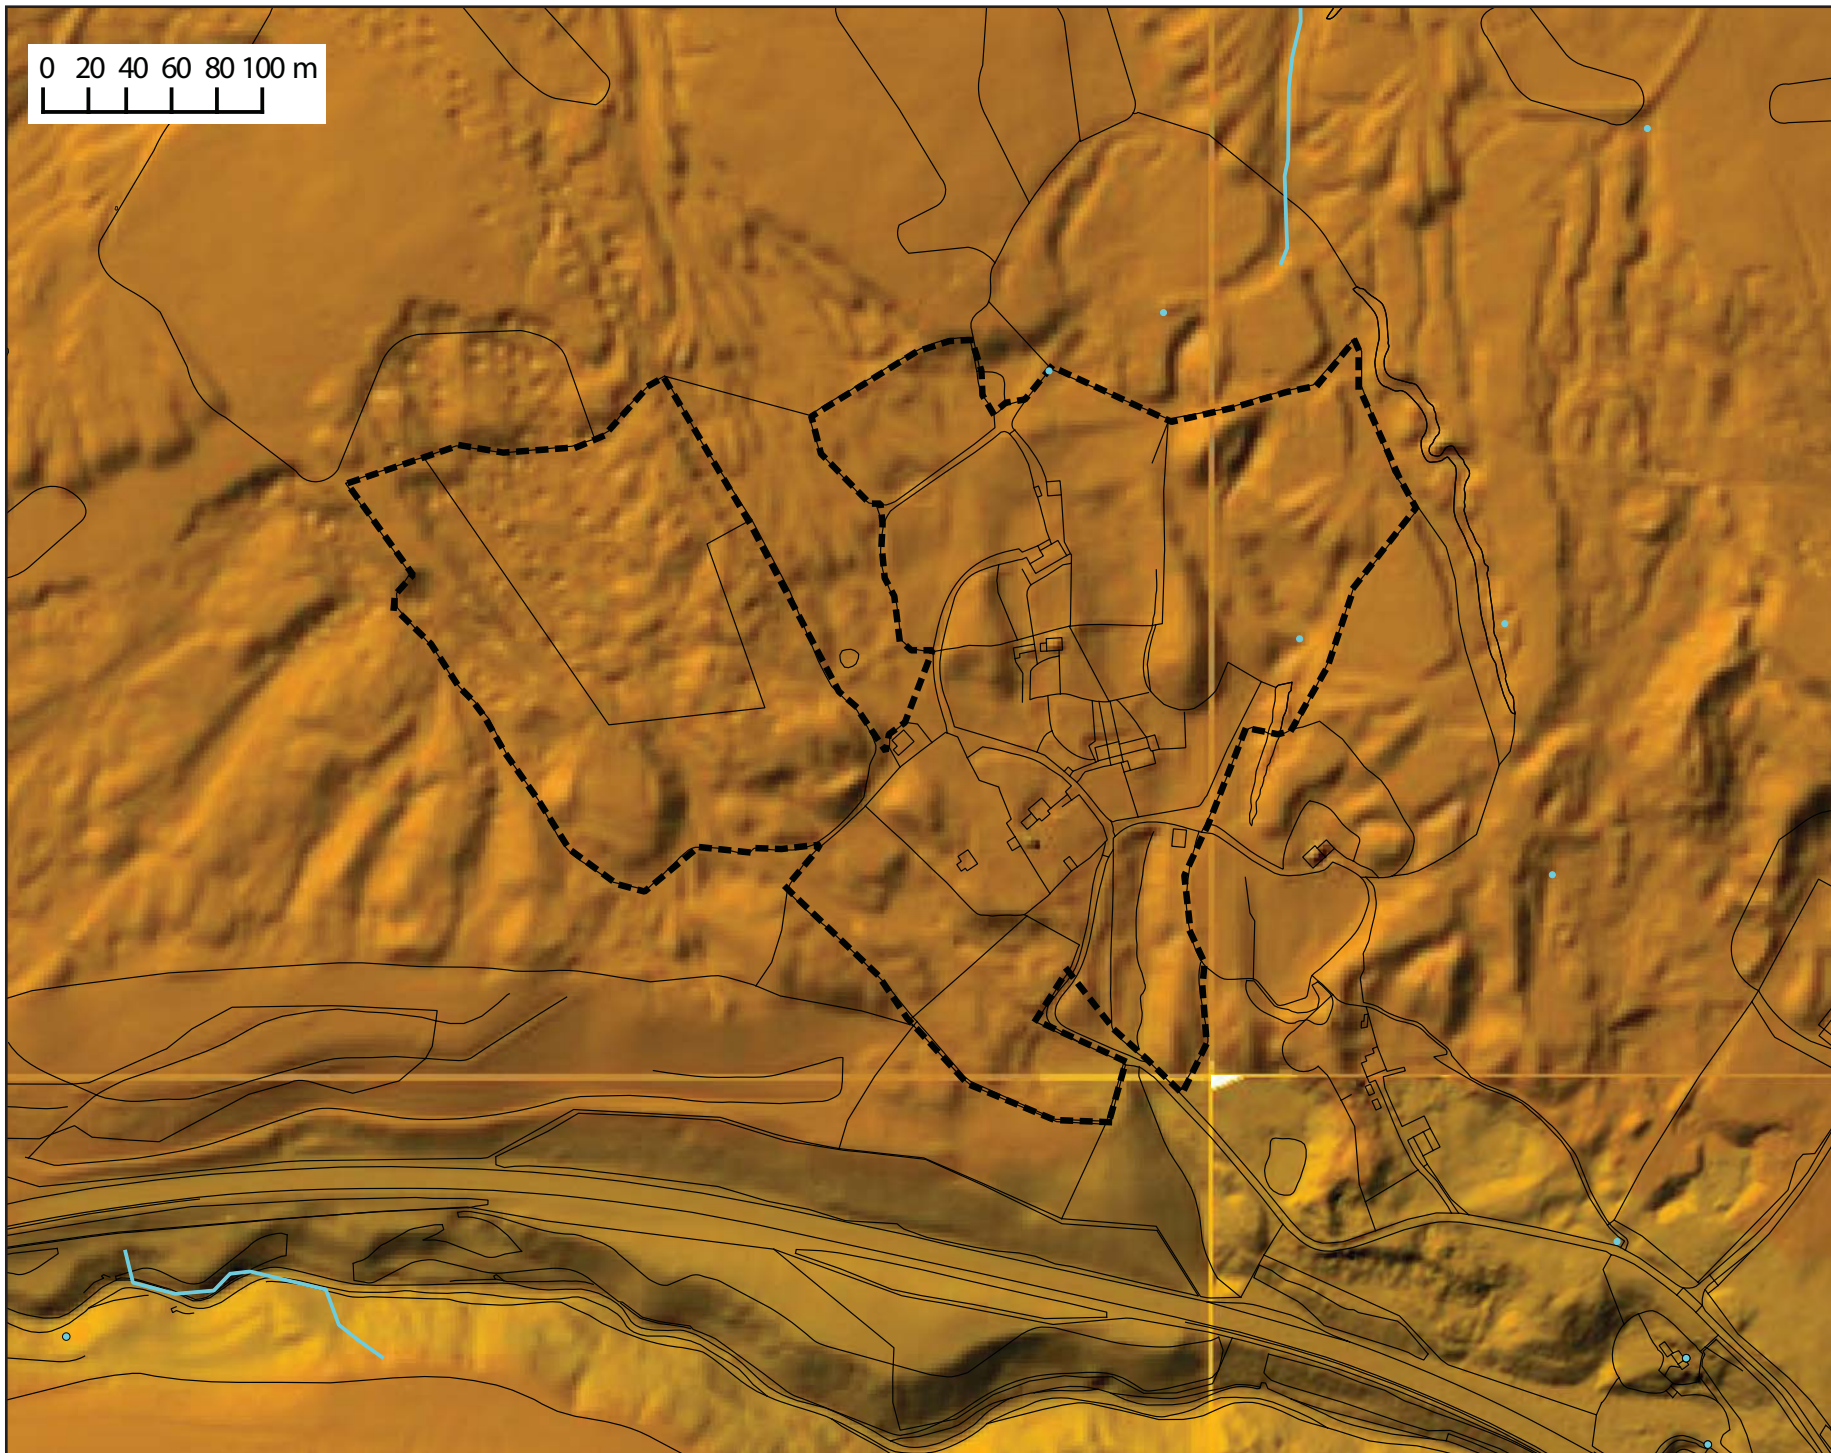
Figure 10: Lidar data at 2m DTM. Overlaid with mapping detail, site location and recorded archaeological features (blue).

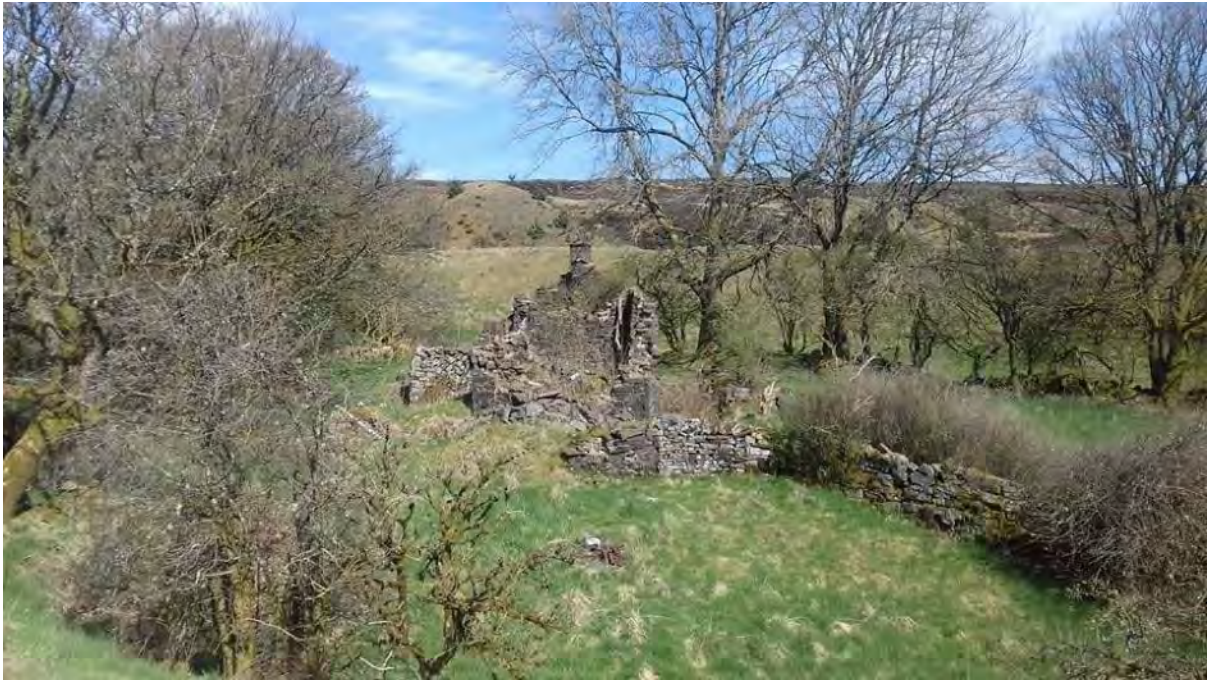
Photo 1, Row of stone-built cottages aligned east-west (NPRN 292019)

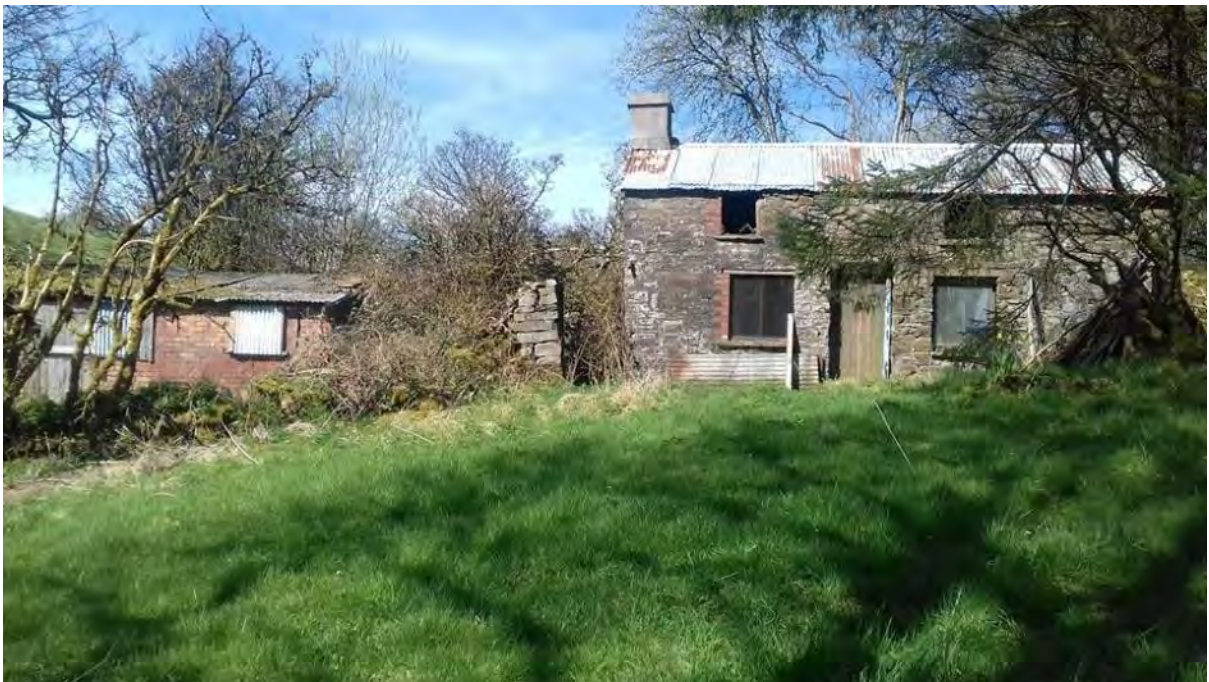
Photo 2, house with pitched roof of corrugated sheets, outbuildings to west (NPRN 292023)

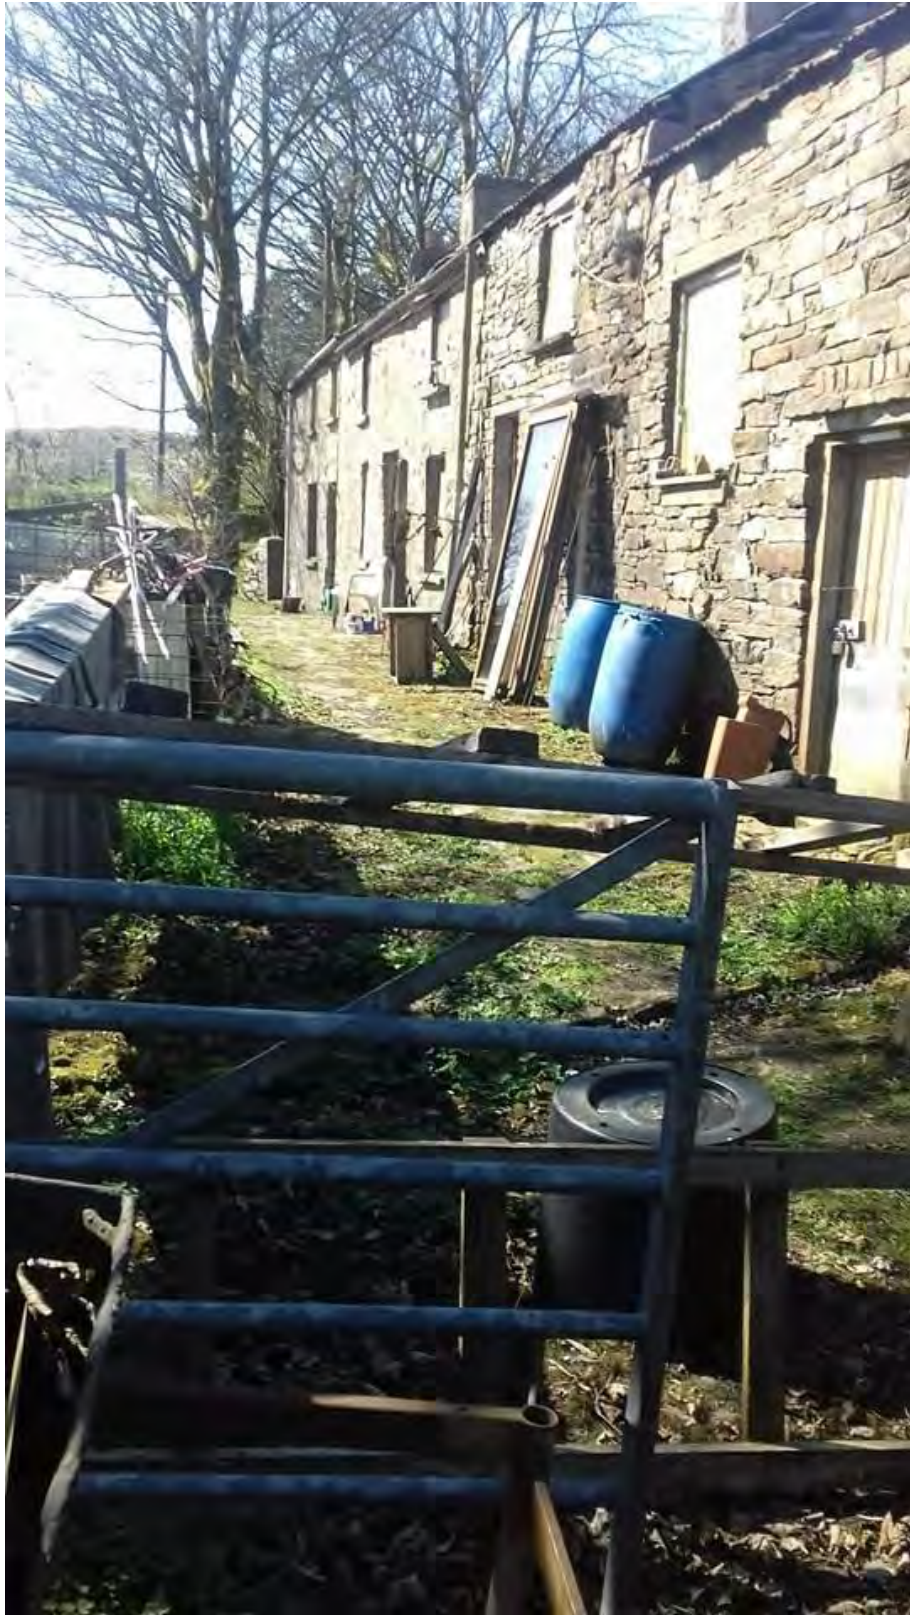
Photo 3, row of two storey cottages (NPRN 292022).

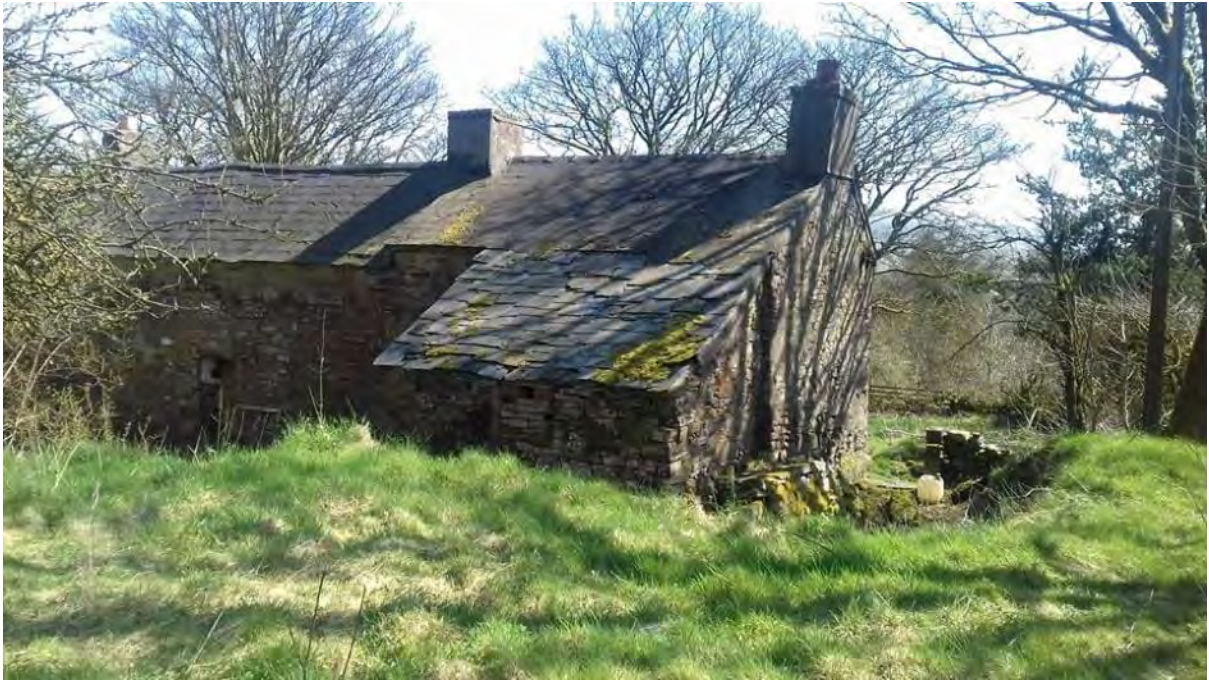
Photo 4, rear of (NPRN 292022).

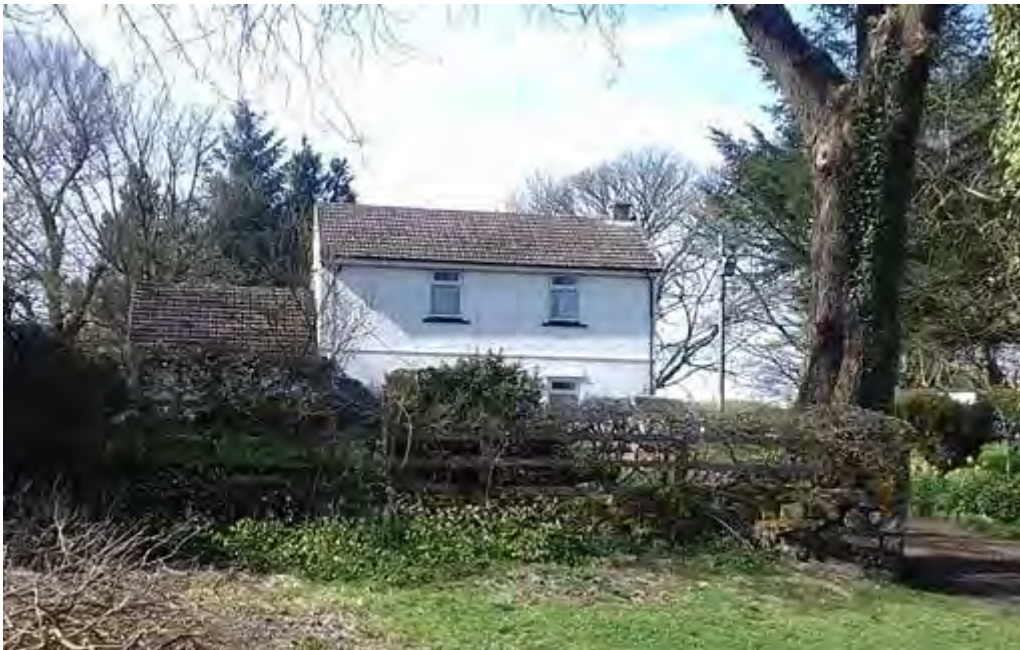
Photo 5, house (NPRN 292020).

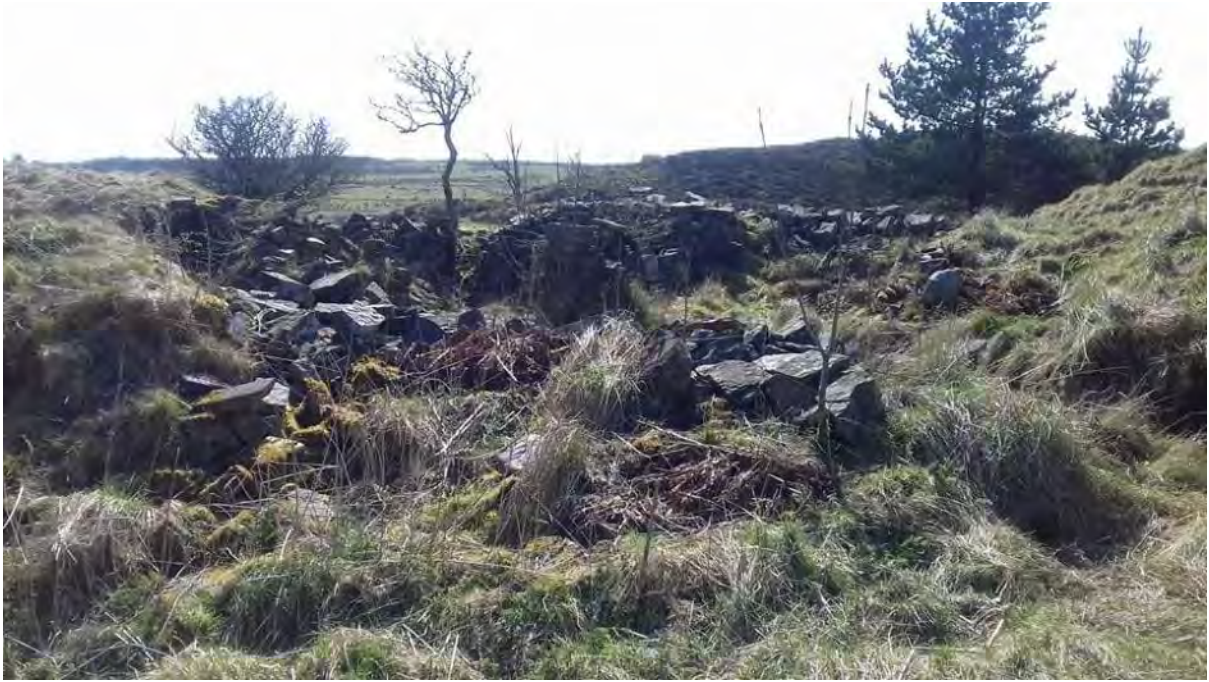
Photo 6, ruins of a pair of semi-detached cottages, (NPRN 291989).

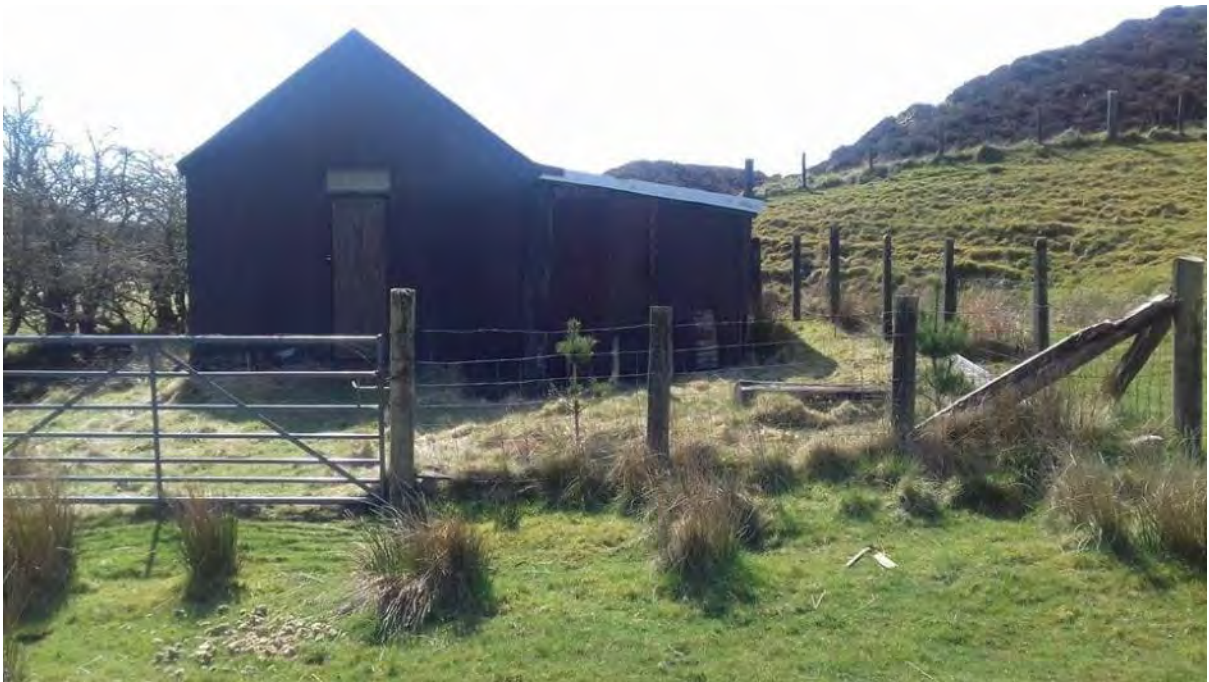
Photo 7, former chapel (NPRN 292011)

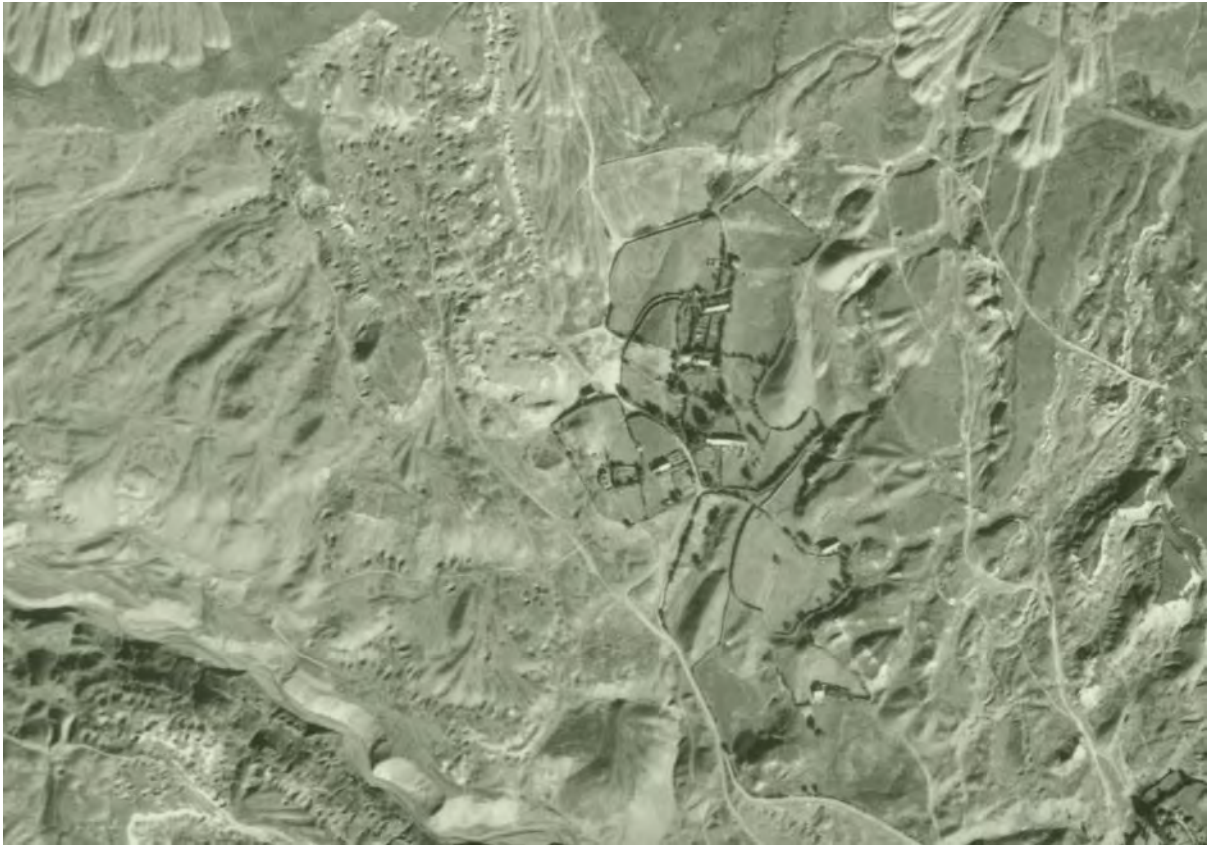
Photo 8, Medmenham 4408_5050 August 1944, Aerial Photograph of the mining landscape which is heavily scarred with scouring and pitting.

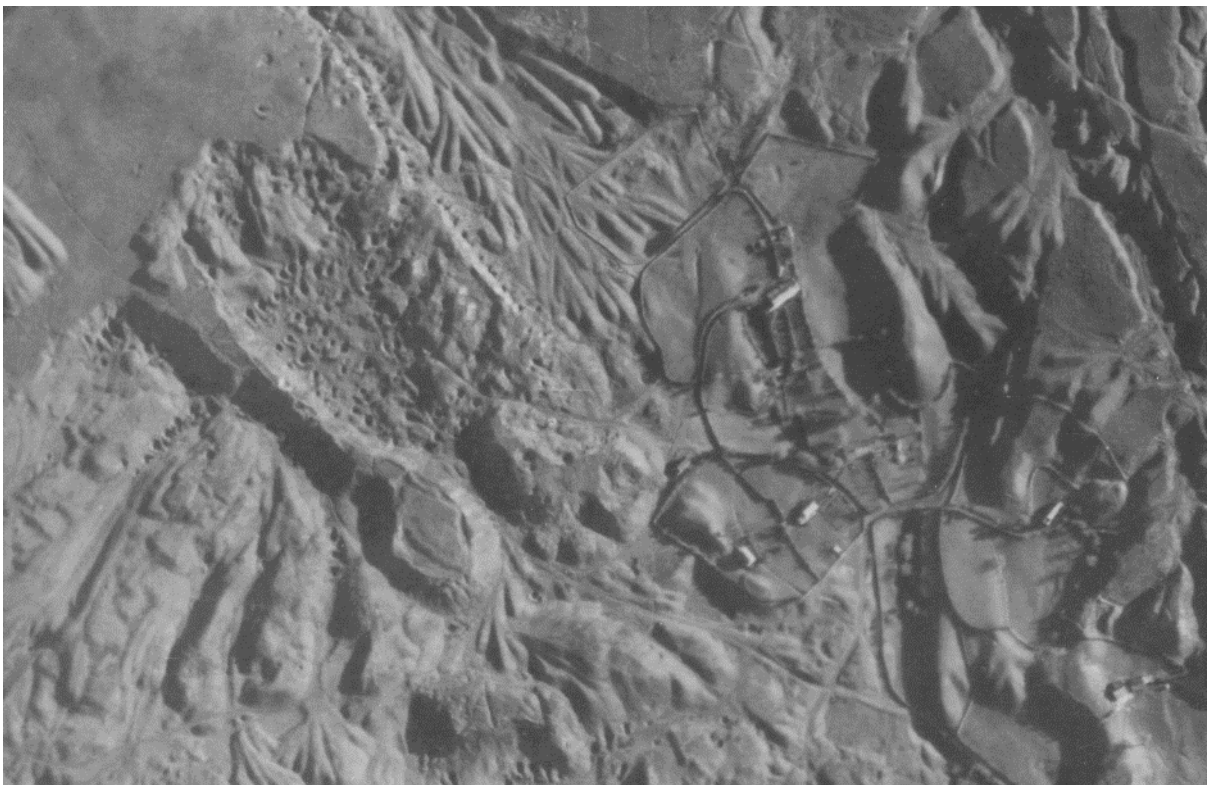
*Photo 9, RAF 4713 CPE UK_2079 2029 May 1947
The western area of the site is heavily pitted with shallow mine shafts..*

The site contains a number of structures in various conditions and a large area of old mine workings. The area has been included in two broader archaeological surveys and whilst the features have been recorded the extent of the mine workings in the western part of the site is not apparent from these. It has been noted that the dating of mine workings can be problematic as earlier activity can be hidden or destroyed by later mining.
