## Ty'n y Coed House, Llandudno

Archaeological Desk Based Assessment

Report No. 1242

**July 2014**

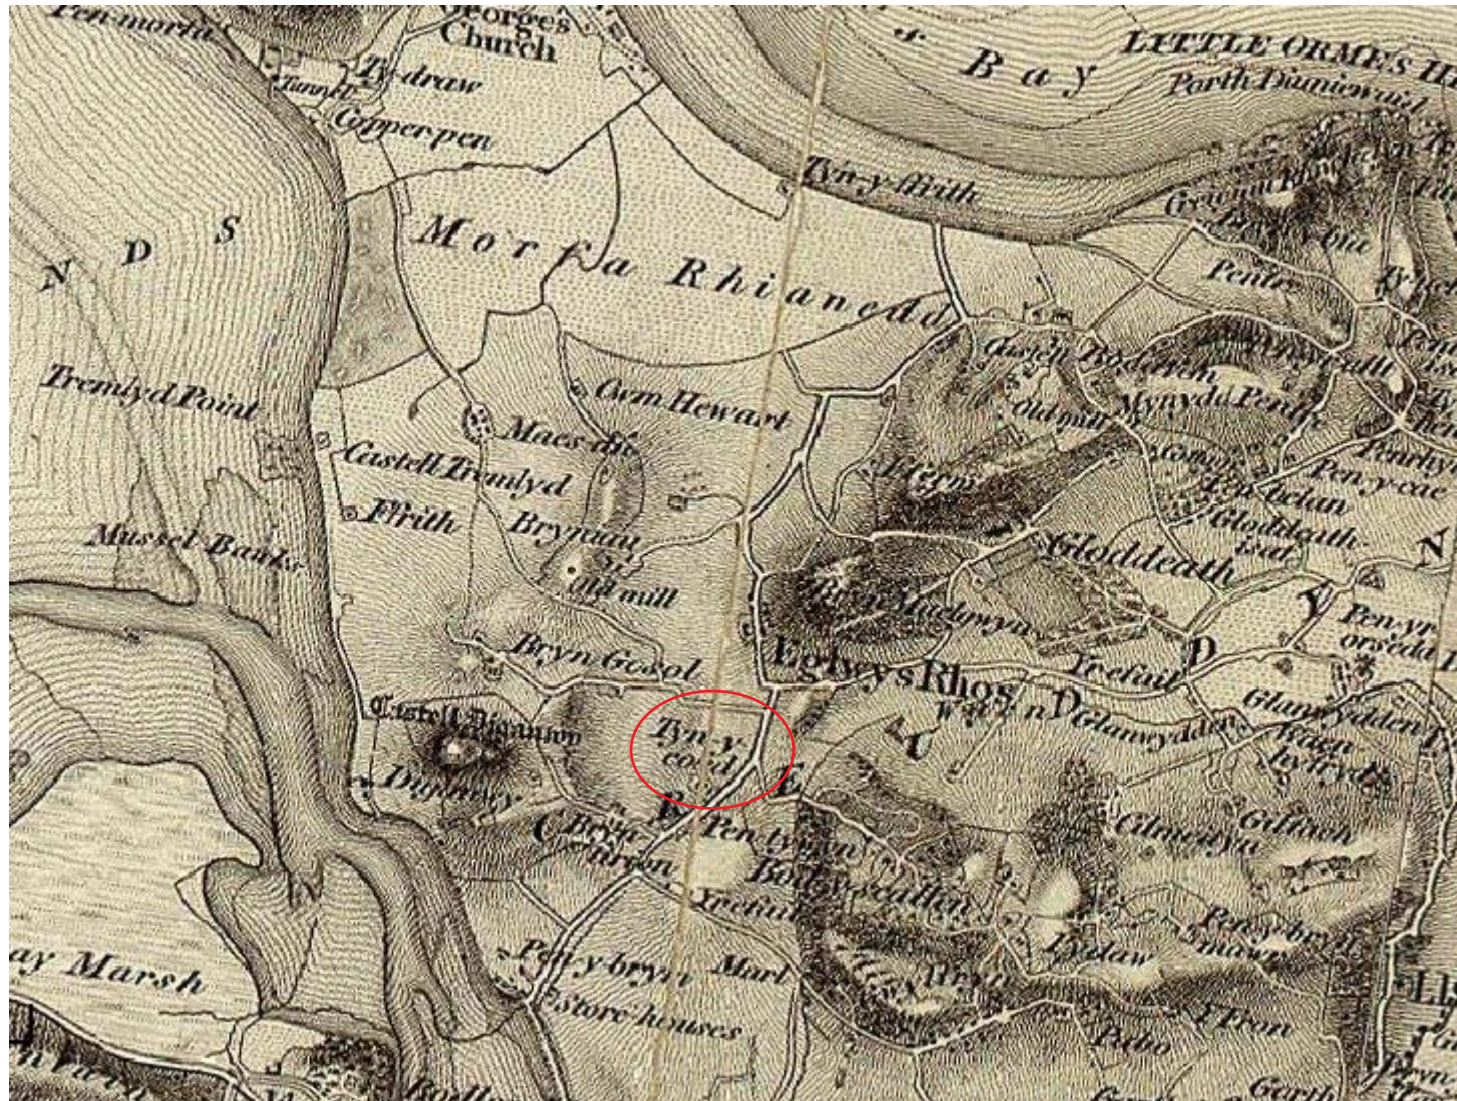
Fig. 5  
OS 1st Series map  
of 1841 showing the  
presence of a house  
at Ty'n y Coed
