Blackfriars Priory, Bute Park, Cardiff

Archaeological Evaluation

Report No. 1062

Prepared For: Bute Park Restoration Project

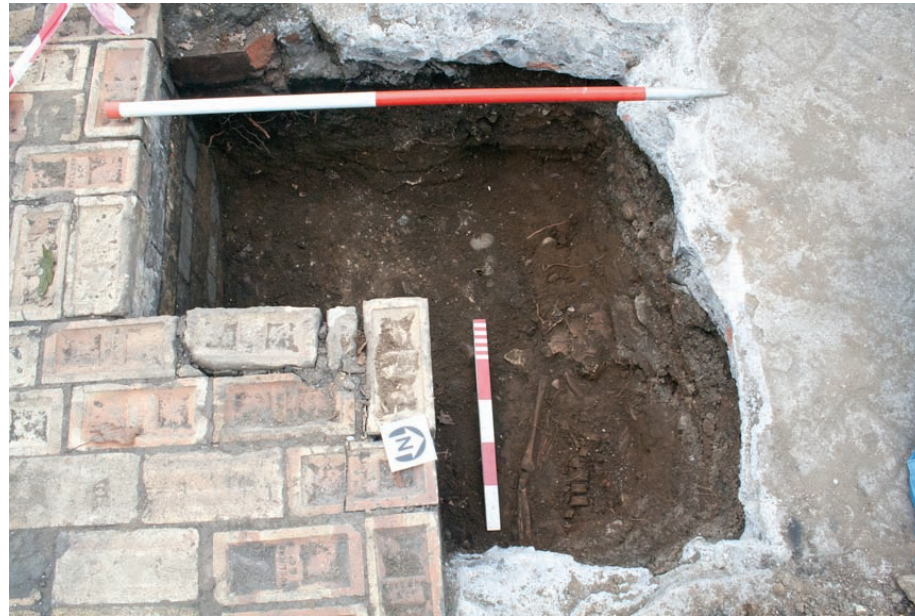
Fig. 5
Test Pit 1

Fig. 5a. Plan of Test Pit 1

Fig. 5b. Post-excavation view of Test Pit 1 from the east showing burial next to cut [107]

Underlying the landscaping deposit (106) on the northern side of the trench, and cut through by the construction cut [107], was yellowish-brown silty-sand (105) the upper surface of which contained some dark mortar fragments, probably derived from context (106) above. This deposit contained 10% stone pebbles measuring between 0.05-0.2m. The deposit was excavated to a maximum depth of 0.4m (fig. 5).

On the north-eastern side of the trench the head, arms and torso of a human burial were identified within the yellow silty-sand (105) (fig. 5). No grave cut was identified, and the burial was only 0.4m below the modern ground surface and consequently it is not known whether this represents a burial contemporary with the medieval or Victorian activity on the site. The construction cut [107] was positioned extremely close to the right arm. The burial was that of a small adult lying supine with its arms extended by its side. It was aligned east-west (head to the west) in typical Christian burial tradition. The skull had been crushed and only the teeth of the lower mandible were visible. Most of the right humerus (0.26m long) was visible although the head appeared degraded whilst the radius and ulna were only clearly visible at the elbow joint. A section of the pelvic girdle was also visible in the eastern section. Seven vertebrae as well as a number of ribs could also be identified. The teeth demonstrated that the burial was an adult, although the size of the body was more reminiscent of a pre-teenage child. The burial lies close to one marked on Fowler's 1897 priory plan. Due to the limited dimensions of the trench the burial could not be fully investigated and its relationship to the Victorian works on the site is not known. The Coroner and South Wales Police were informed of the discovery and, following consultation with Cadw and the Bute Park Restoration Project, it was decided to leave the burial in situ.

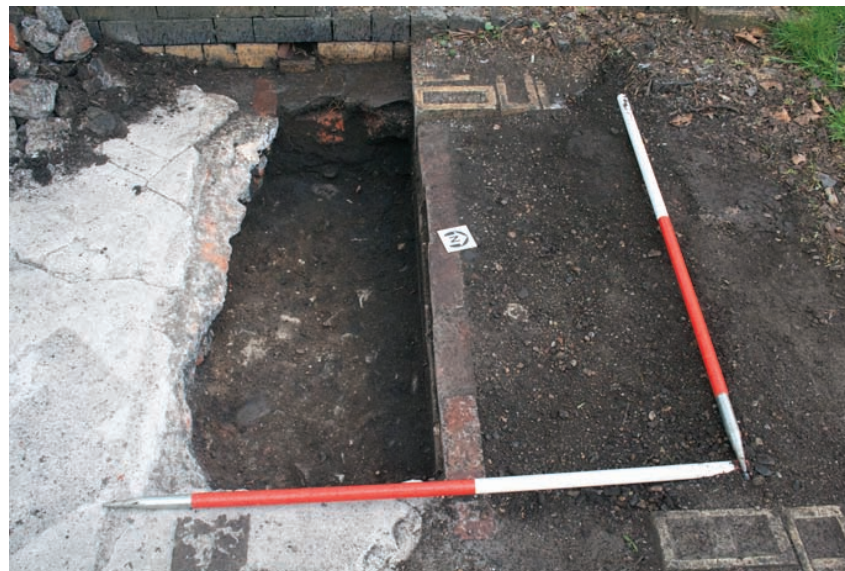
Fig. 6
Test Pit 2

Fig. 6a. Post-excavation plan of Test Pit 2

Fig. 6b. Mid-excavation view of the north-west Priory entrance from the east, showing in situ threshold deposit (205) and linear red brick threshold [211]

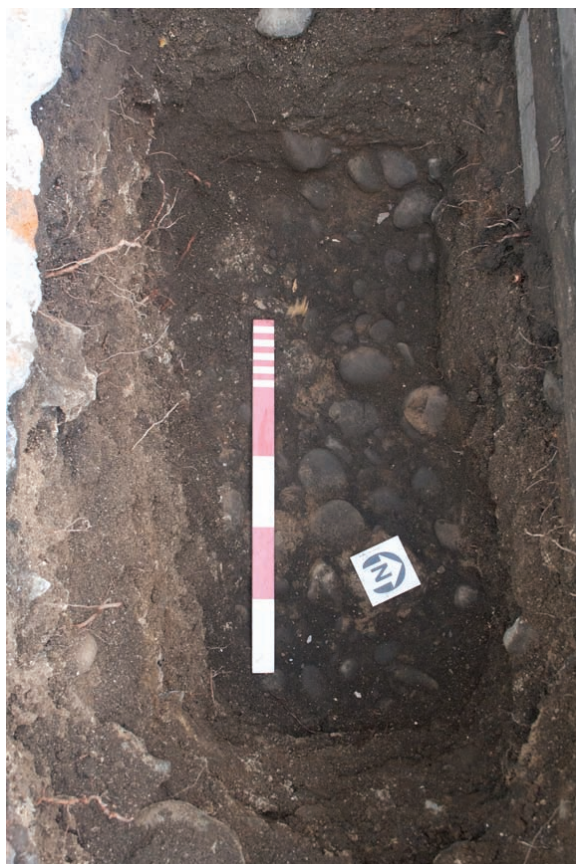
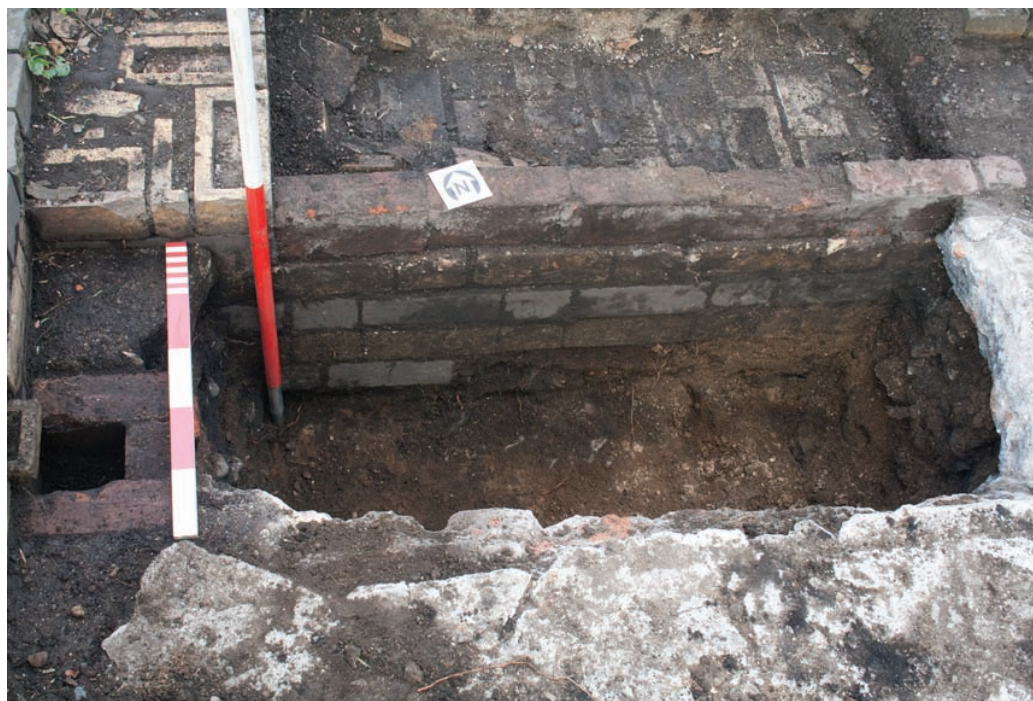
Fig. 7
Test Pit 2

Fig. 7a. Eastern view of cobbled surface (214) at the base of Test Pit 2

Fig. 7b. Southern full depth view of wall [204] (with threshold deposit removed) under linear brick feature [211]. Drain [208] is seen at the west end (left)

The full depth of the Victorian wall (204) was revealed on the northern side of the trench. As with the wall in trench 1, it was substantial, 0.5m wide and built of alternating courses of grey/blue and yellow bricks. On the western and eastern sides of the trench the wall was four courses (0.3m), while the section below the threshold was only three courses (0.23m) deep (fig.7). The threshold was marked by a 1.22m wide gap in the northern church wall (fig. 6). On the southern side of the threshold gap a line of 5.5 red bricks (211) had been set, standing on edge – it is thought likely that a similar line of red bricks exists on the northern side of the threshold although this was not revealed during the excavation. Within the threshold area was a deposit of dark brown silt containing fine gravel and crushed tile (205). This overlay a deposit of crushed tile and broken brick (210) which had been set on the surface of the underlying wall (204). The threshold therefore appears to have been defined using red brick and gravel, and was constructed so that the surface was on the same level as the concrete slab within the Church.

On the western side of the trench the Victorian wall was not exposed, although the removal of the concrete revealed a probable drain (208) built into the brickwork. This comprised hollow box measuring 0.23m by 0.27m, formed using red bricks with what appeared to be a crude spout constructed from a brick split in half, designed to move the water away from the surface of the wall.

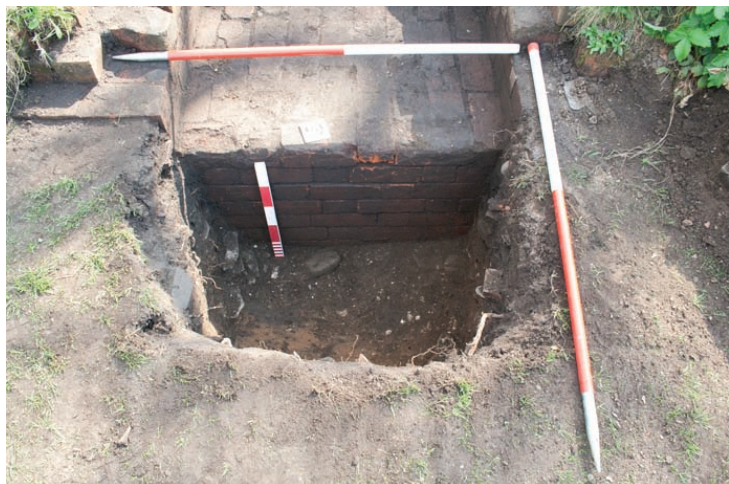
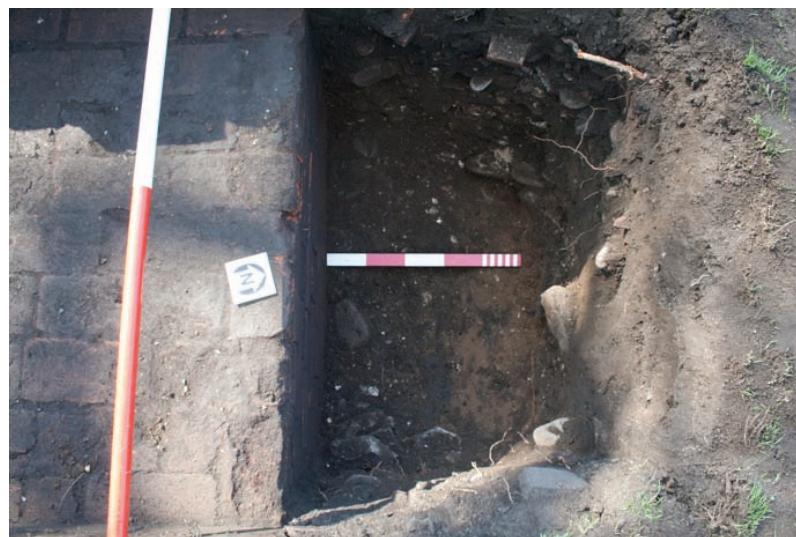
Fig. 8
Test Pit 3

Fig. 8a. Test Pit 3 view from the north showing excavated depth of wall [305]

Fig. 8b. Closer view of Test Pit 3 showing wall cut [303] and dark back fill (302)

0.90m long (east to west), and comprised a surface of machine pressed red bricks measuring 0.23m x 0.1m x 0.075m (9" x 4" x 3") bonded by a black course mortar. Seven courses were revealed, 0.57m deep, but the base was not reached owing to the constraints of the size of the trench. The walling was substantial and robust and in good condition (fig. 8).

The wall was found to have been built in a construction cut [303] that measured 0.66m wide from the northern edge of the wall (305). The cut [303] was filled with a dark brown silt (302) containing 25% Victorian tile fragments, 10% brick fragments and 15% small sub-rounded pebbles, some with adhering mortar (fig. 8). Clay pipe stems and sherds of modern pottery were also recovered. The construction cut cut through a soft orange/brown sandy silt (304) containing 5% mortar fragments. It was exposed for 0.25m on the northern edge of the trench and evidently pre-dates the Victorian activity on site.

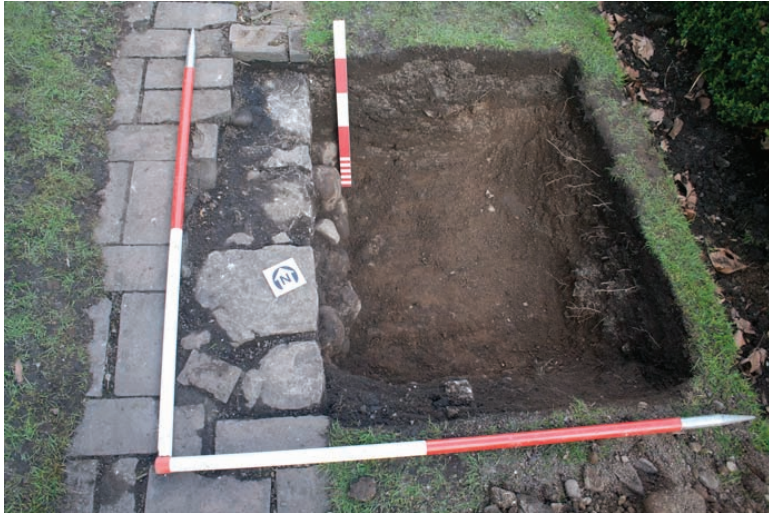
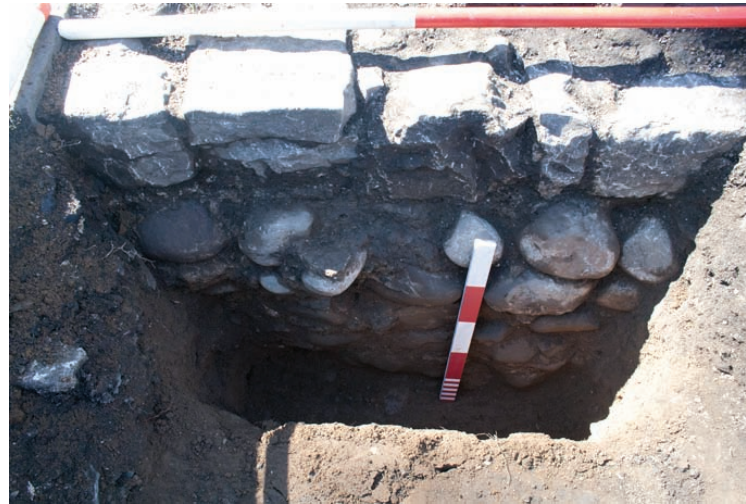
Fig. 9
Test Pit 4

Fig. 9a. View from the south of Test Pit 4 showing the rounded medieval wall [404] stones projecting eastwards under the current ground level

Fig. 9b. View from the east of the full depth of medieval wall [404] and showing the contrasting square and rounded stones

The exposed stone wall structure formed part of a wall (404) combining both presumed medieval and Victorian elements that separated the Cloister Garth from the west alley of the Cloisters (fig. 9). It measured 0.52m wide and was orientated north/south. The eastern side of the wall comprised squared limestone blocks (possibly Blue Lias) bonded by a light brown lime mortar, overlying several courses of undressed, rounded, pebbles and thick spreads of mortar. The total depth of the stone wall was 0.7m, and it was found to have been built on a soft orange/brown silty sand deposit (403) which contained frequent pebbles. No cut for the stone wall was identified. This wall is thought very likely to be the remains of the medieval structure. It is robust and survives in good condition below ground. It is important to note that the medieval wall extends eastwards beyond the edge of the Victorian bricks on the surface.

On the western side the wall comprised courses of alternating yellow and grey/blue bricks, as seen elsewhere on the site. Four courses were exposed, up to 0.33m deep, although the base of the wall was not reached. The brickwork below ground was substantial and robust, while the bricks on the surface were relatively poorly preserved (fig. 9).

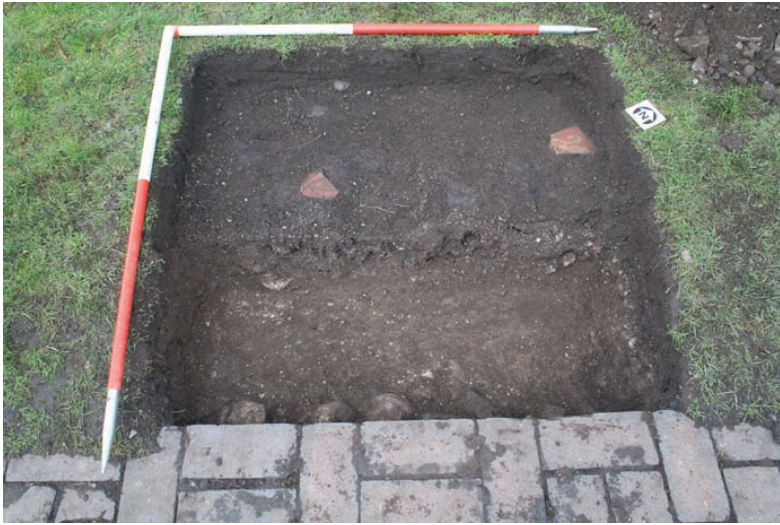
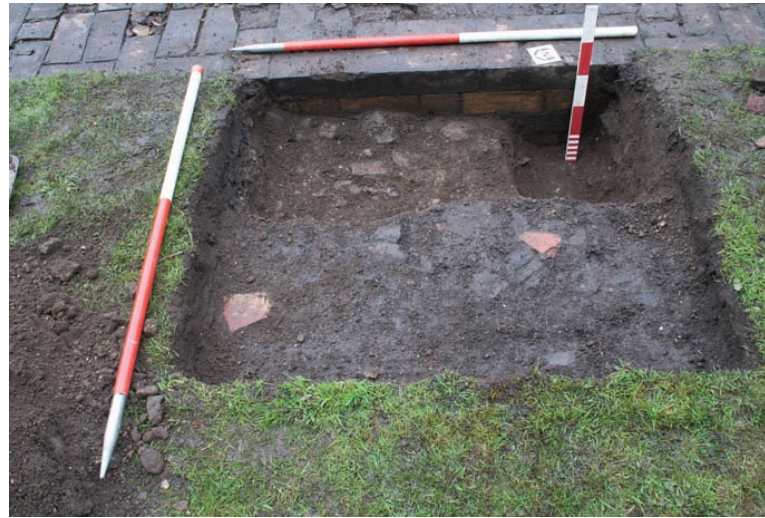
Fig. 10
Test Pit 4

Fig. 10a. View showing depth of path deposit (1202) on the western side of wall [404]

Fig. 10b. View from the east of the excavated depth of wall [404] on its western side

On the western side of the wall (404) a loose dark brown silty topsoil (1201) was identified. This overlay a compact layer of grey/brown gritty silt deposit (1202) containing damaged Victorian tiles, yellow brick fragments and a shingle-type pea gravel (70%). The compact deposit was up to 0.1m deep and was found to overlie a firm orange/brown clay silt (1203) containing fragments of decorated tiles, small stones and chunks of white mortar (fig. 10). A small brown glazed pot-herd was recovered from this deposit. The gritty shingle deposit is thought to be the surface of the Victorian pathway leading through the west alley of the Cloisters.

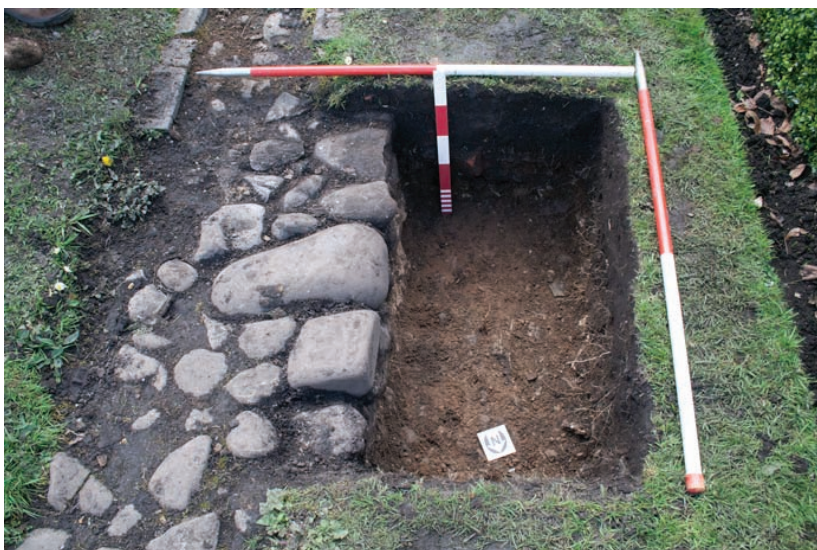
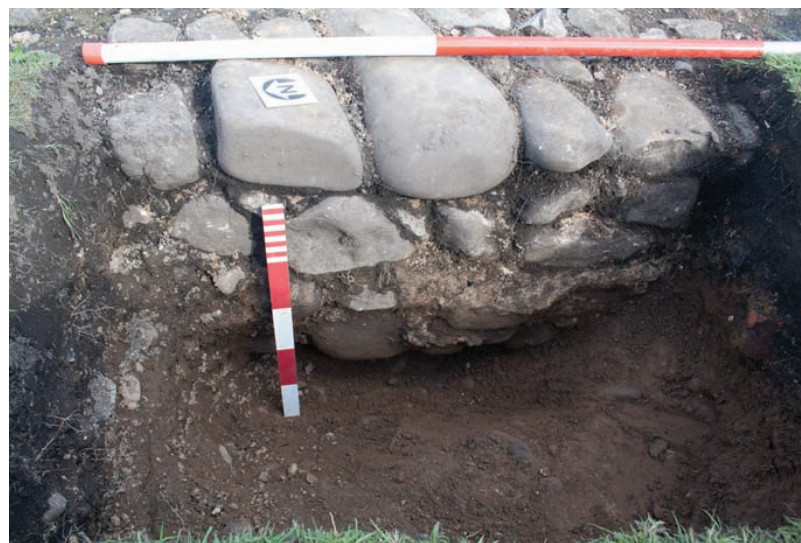
Fig. 11
Test Pit 5

Fig. 11a. View from the north of Test Pit 5 showing medieval wall [504] and surface of deposit 503

Fig. 11b. View from the west of the full depth of medieval wall [504], showing mainly rounded stones and light brown mortar

The exposed stone wall (504) was 0.7m wide and orientated north/south between the Cloister Garth and the east alley of the Cloisters. It comprised four courses of undressed rounded stones bonded with a light brown lime mortar, and was 0.56m in depth (fig. 11), and was robust and well preserved below ground. A thick layer (0.11m deep) of this lime mortar was identified between the third and fourth courses of the wall and appears to form a foundation deposit for the wall. The wall had been constructed on top of a soft orange/brown silty sand (503) containing rounded pebbles. No construction cut for the wall was identified. A layer of blue/grey Victorian bricks had been laid over the medieval wall on the northern side of the trench, forming the lowest surviving level of the Victorian reinterpretation in this area. It is important to note that, as in test pit 4, the medieval wall extends outwards on both the eastern and western side further than the line of Victorian bricks on the surface suggests.

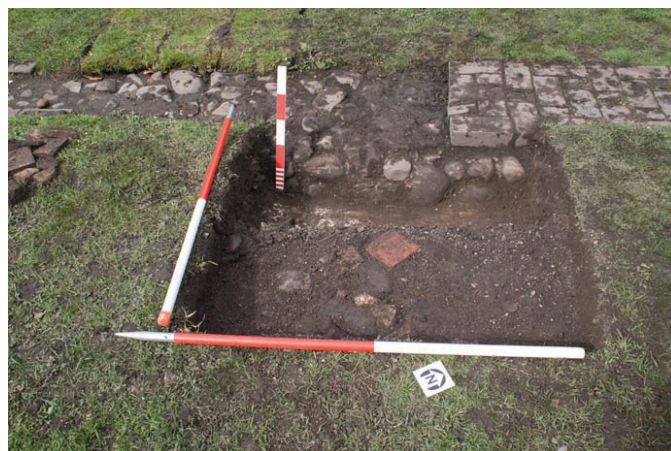
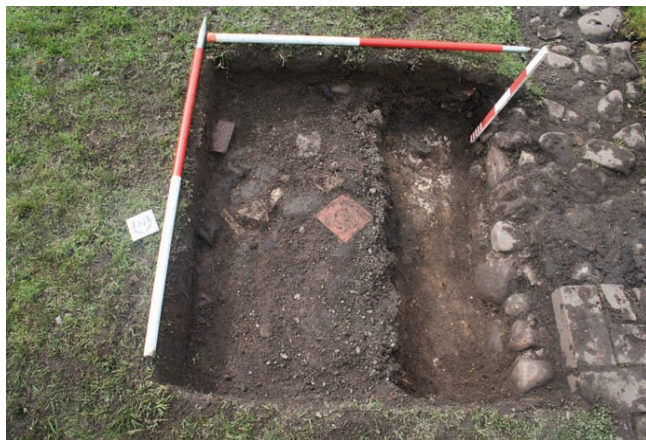
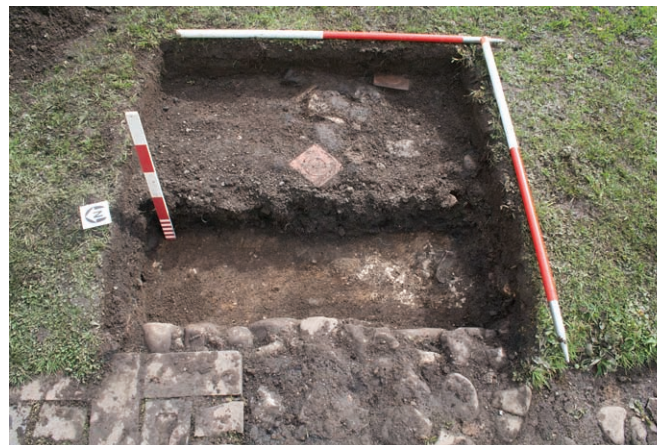
Fig. 12
Test Pit 5

Fig. 12a. View of the east side of wall [504]

Fig. 12b. View from the south of the east side of wall [504]

Fig. 12c. View of the east side of wall [504] showing depth of deposit 1102

On the eastern side of the wall a dark brown silty topsoil (1101) up to 0.12m deep was identified below the turf. Underlying the topsoil was a compact dark brown gritty silt deposit (1102) which contained pea gravel (65%), damaged fragments of Victorian tile, a single Ruabon brick, sub-angular stones and lumps of dark mortar (fig. 12). This deposit was 0.13m deep and comprises the surface of the Victorian Cloister path.

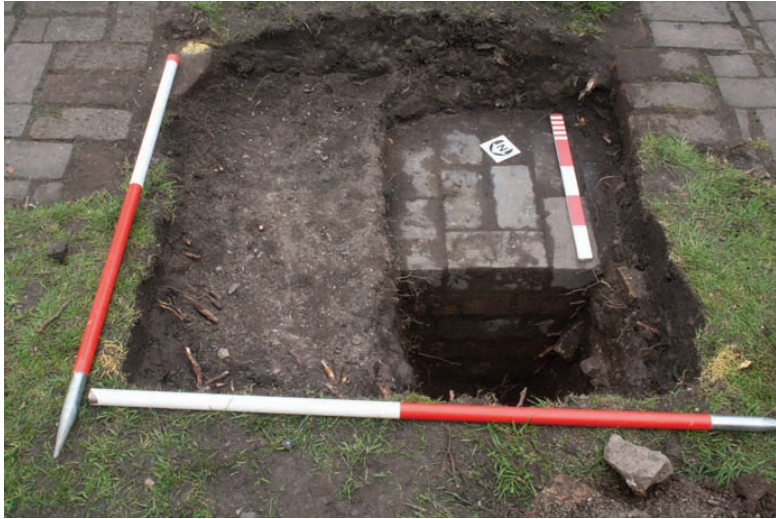
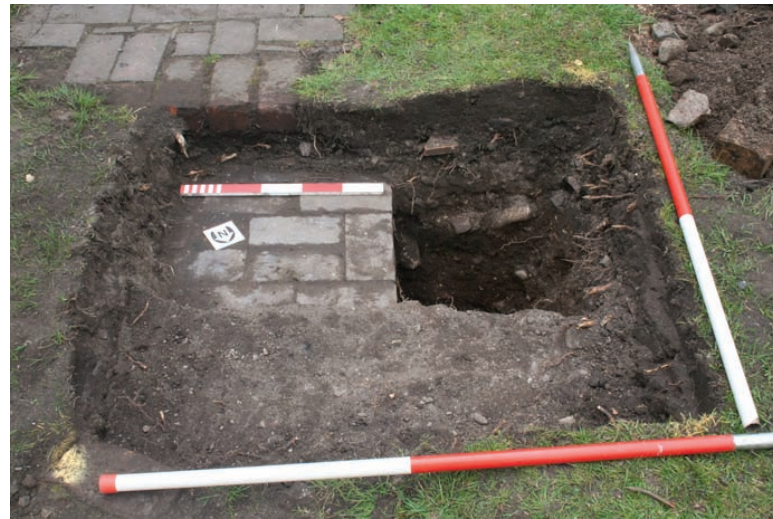
Fig. 13
Test Pit 6

Fig. 13a. View of Test Pit 6 from the west showing extent and excavated depth of the Victorian wall [603]. Red bricks (601) seen at top right

Fig. 13b. View from the north of the red brick deposit (601) at the southern end of Test Pit 6 (top left)

The Victorian wall comprised at least six courses (not bottomed) of alternating yellow and blue/grey bricks bonded with dark grey lime mortar, and was at least 0.53m deep. On the southern side of the test pit was a line of red bricks marking the southern edge of the threshold. Between this line of bricks and the northern edge of the test pit a deposit of light grey sandy silt (602) containing black mortar and 50% pea gravel was discovered immediately below the turf (fig. 13). This was up to 0.08m deep and overlay the width of the Victorian wall (603). The base of the threshold was one course below the modern surface of bricks. The line of red bricks and the gravel deposit were deliberately designed to highlight the entrance threshold. The upper surface of the wall had been disturbed and lifted by tree roots, but otherwise the wall was substantial and in good condition.

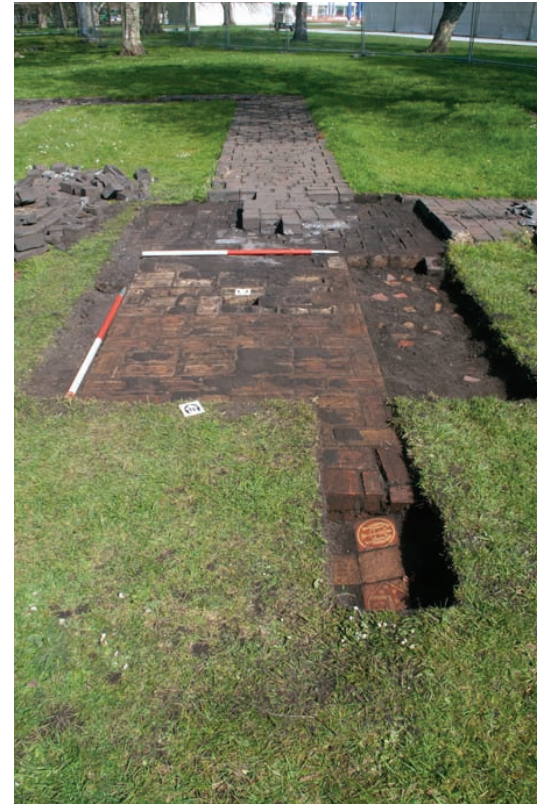
Fig. 14
Test Pit 7

Fig. 10a. Pre-excitation view from the south of the north west corner of the Priory Calefactor, showing loose surface bricks of the wall [703]. The remainder of the wall is under the turf (foreground)

Fig. 10b. View from the south of the partially excavated wall [703] surface showing Drain 2 (in the centre), surface of deposit 702 (right) and a section of the threshold with in situ Victorian tiles (foreground)

The wall [S703] was 8 courses deep (0.72m) and comprised alternating yellow and blue/grey bricks bonded with dark grey/black mortar. The wall was 1.2m wide at the entrance threshold and was partly covered by a thin layer of turf. A number of different bricks had been used in the construction of the wall (fig. 16):

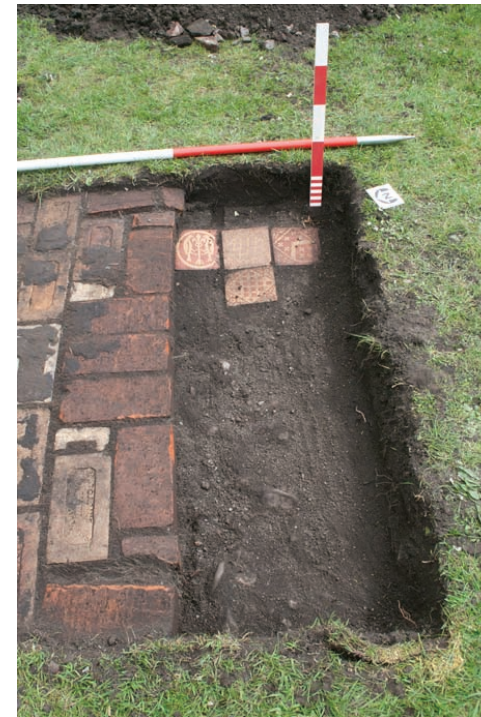
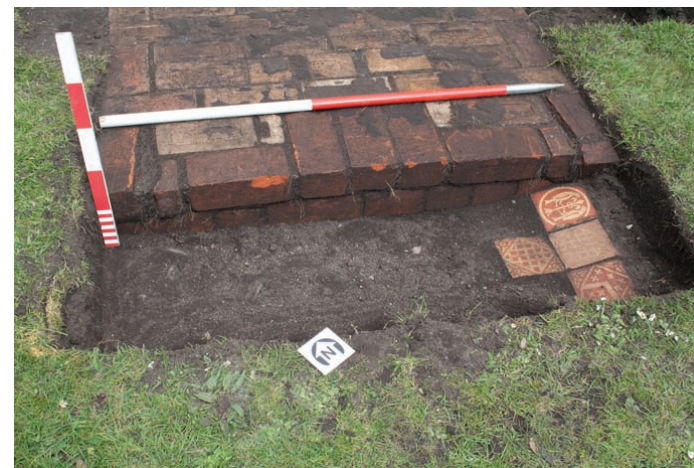
Fig. 15
Test Pit 7

Fig. 15a. Plan of Test Pit 7

Fig. 15b. View from the south of the threshold into Calefactor, showing deposit 705, onto which decorated tiles had been placed

Fig. 15c. View of same threshold from the west

The southern end of the western wall was edged by a line of red bricks marking the threshold (fig. 15). Three red bricks were laid lengthways and at right angles to the remainder marking the centre of the threshold (fig. 15). The excavation revealed that this single line of red bricks had been built into the three courses of brickwork that survived above the threshold level. The threshold itself comprised a firm dark brown silty gravel (705) containing lumps of dark mortar, glass fragments and rounded stones. It was up to 0.23m deep and overlay the width of the wall. Four decorated Victorian tiles were set into the eastern side of the threshold deposit – the designs included heraldic symbols and birds and are comparable to those tiles in situ elsewhere on the site (fig. 15). The tiles appear to be in their original position, although they have subsided, and were evidently laid to define the inner edge of the threshold. It is possible that originally more tiles were laid on the gravel deposit within the threshold.

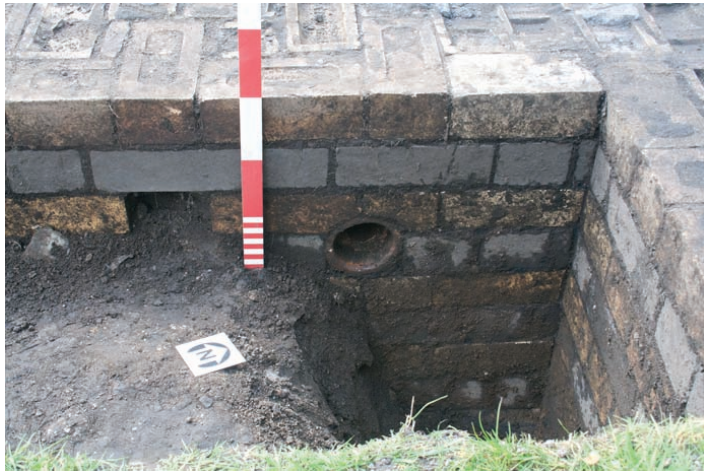
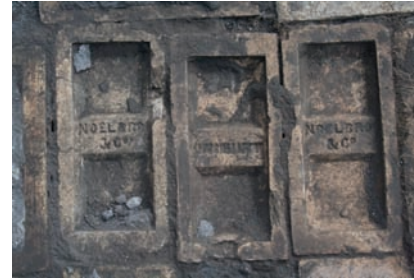
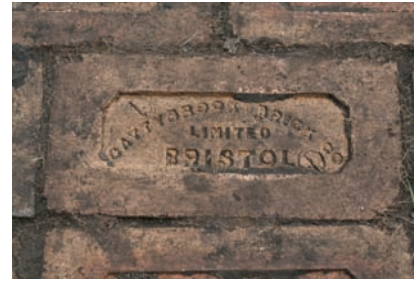
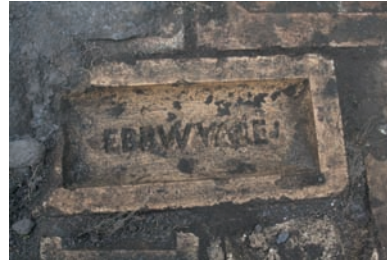
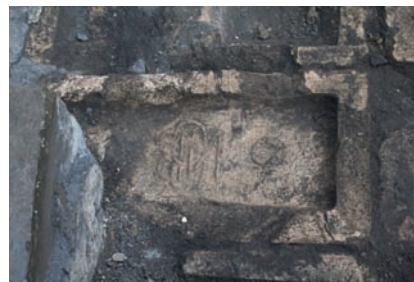
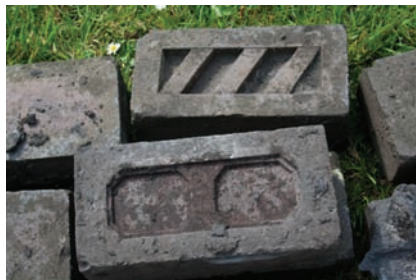
Fig 16
Test Pit 7

Fig. 16 a. View from the east of below ground drain outlets in north east corner of wall [703].

- Fig.16b. Noel Brothers & Co. brick
- c. Cattybrook Brick Co. Ltd, Bristol
- d. Ebbw Vale brick
- e. Unidentified brick
- f. Bricks on surface of 703

- The top most surface consisted of a number of loose red/grey two-tone machine pressed unmarked bricks which were bonded on the top surface. The bonding material (dark mortar) was weathered and many of these bricks were loose.
- The second brick surface consisted of yellow bricks. The majority were marked Cattybrook, Bristol, with a smaller number of Noel Bros and Ruabon bricks. There was one example of an Ebbw Vale brick and a single example with an unidentifiable design rather than plain lettering.

The marked yellow bricks all derive from brick makers active in the late nineteenth century and are therefore thought to be contemporary with the original construction of the garden feature. The grey/red bricks are comparable to mass produced house and paving bricks in use in the late nineteenth and early twentieth century and are also thought to be contemporary with the original construction.

A number of drainage features were observed within wall, evidently original features built at the time of construction. Two drain features were visible in the upper surface of yellow bricks. These comprised square voids filled with fragments of air bricks. Drain 1 was located near the centre of the external north-west corner of the Calefactor whilst Drain 2 was located near the centre of the wall 1.3m from the southern threshold of the western wall. The outlet for Drain 2 was located on the east facing side of the wall where a half-brick void was located two courses below the surface. A small circular ceramic drain outlet was also located adjacent to this void approximately one course lower and 0.15m to the north (fig. 16).

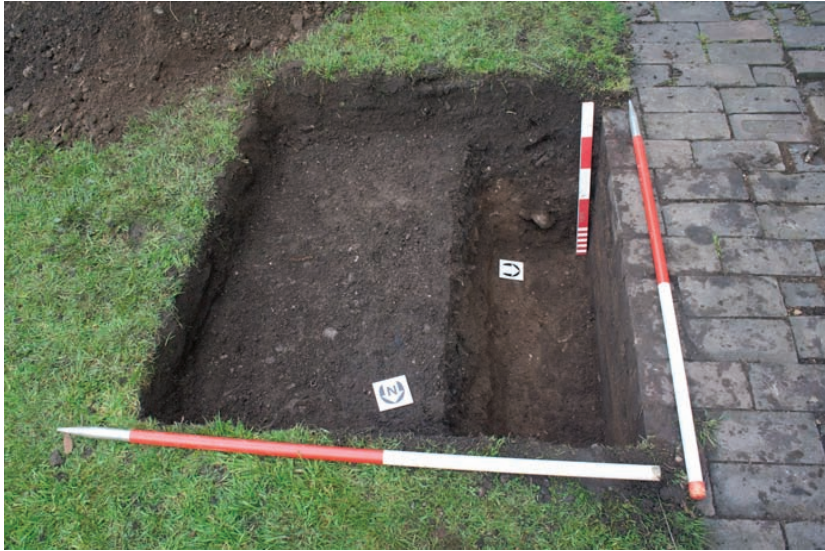
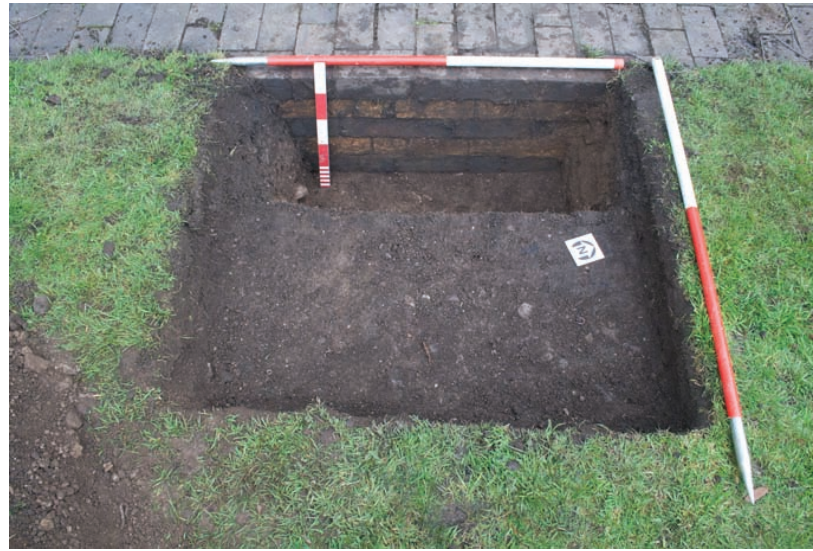
Fig. 17
Test Pit 8

Fig. 17a. View from the north of Test Pit 8 showing wall [806] and cut [804] and related back fill deposit (805) and surface and half-sectioned deposit 802

Fig. 17b. View from the east of Test Pit 8 showing excavated pre-sondage depth of the wall [806]

The trench was positioned on the eastern side of the Victorian Cloister wall [806], and a presumed entrance point. Below the turf a dark brown silty topsoil (801) was identified. This was 0.13m deep and overlay a compact dark-grey/brown gritty silt (802) containing broken tile fragments, dark mortar, rounded stones and 60% pea gravel. It was between 0.13-0.15m deep and is thought to be the remains of the Victorian Cloister path. Below the path layer (802) was a loose light brown sandy silt containing frequent fragments of lime mortar. A linear cut [802], orientated north/south cut was identified 0.17m from the wall [806], and is thought to be a construction cut. This contained a loose dark brown/black silty sand with frequent fragments of white/brown lime mortar (805).

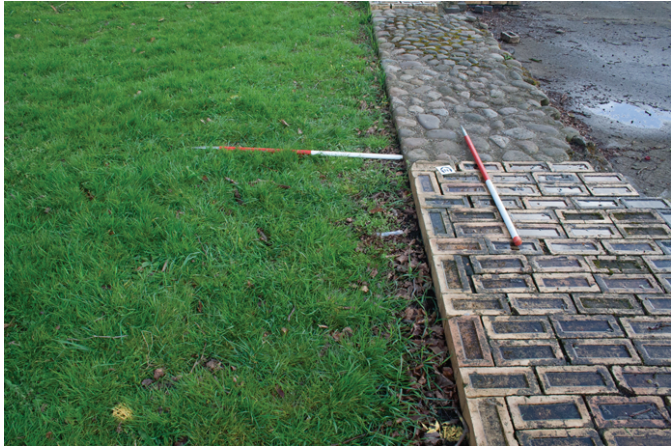
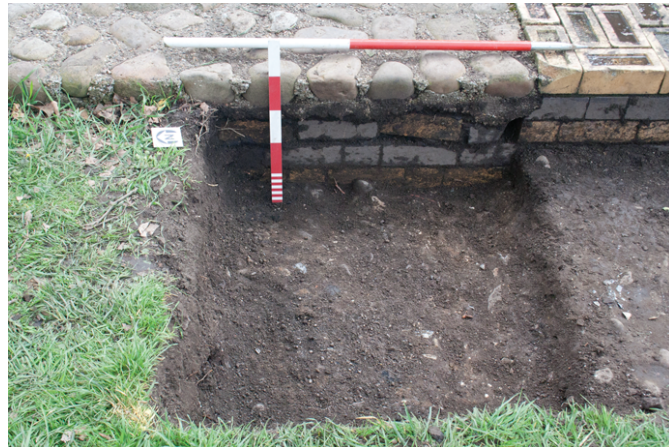
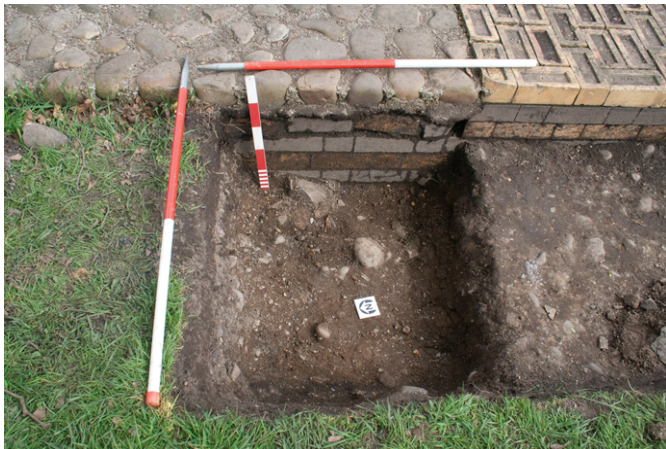
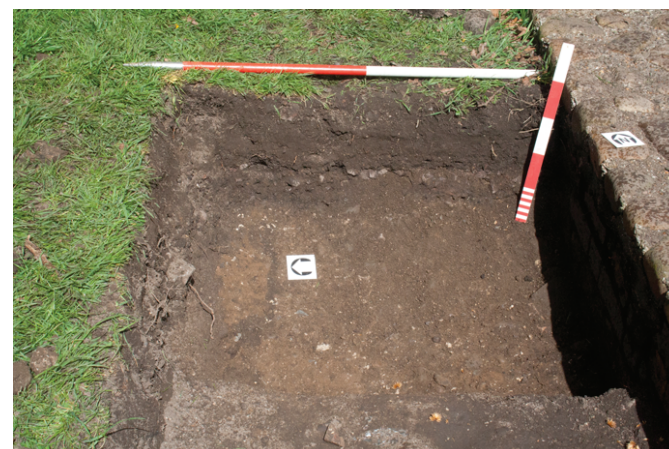
Fig. 18
Test Pit 9

Fig. 18a. Pre-excavated view from the south of the Priory Church's western entrance

Fig. 18b. View from the west of the entrance wall and surface of deposit 903

Fig. 18c. View from the west of wall [905], showing possible entrance modifications and (foreground) deposit 904

Fig. 18d. View of northern sondage within Test Pit 9 showing base of deposit 904 and (indicated by arrow) cut 906

Underlying the turf was a loose clay silt topsoil (901) up to 0.17m deep, which overlay a compact grey/brown silt (902). This deposit was 0.09m deep and contained frequent angular and sub-rounded stones that are thought to represent the surface of a path following the exterior of the church. Underlying the path was a compact grey silty grit (903) containing mortar fragments and pieces of slate tile. This was 0.11m deep and overlay a loose orange/brown sand (904) containing fragments of light brown lime mortar and rounded stones. This deposit was not fully excavated but appeared to be cut on the north-western side by an irregular feature [906] 0.08m wide (east/west) and 0.8m long (north/south) that contained a dark brown sandy silt (907). This feature was not excavated.
