Archaeology Wales

Old School, Garn Road Blaenavon

Building Recording

Report No: 1066

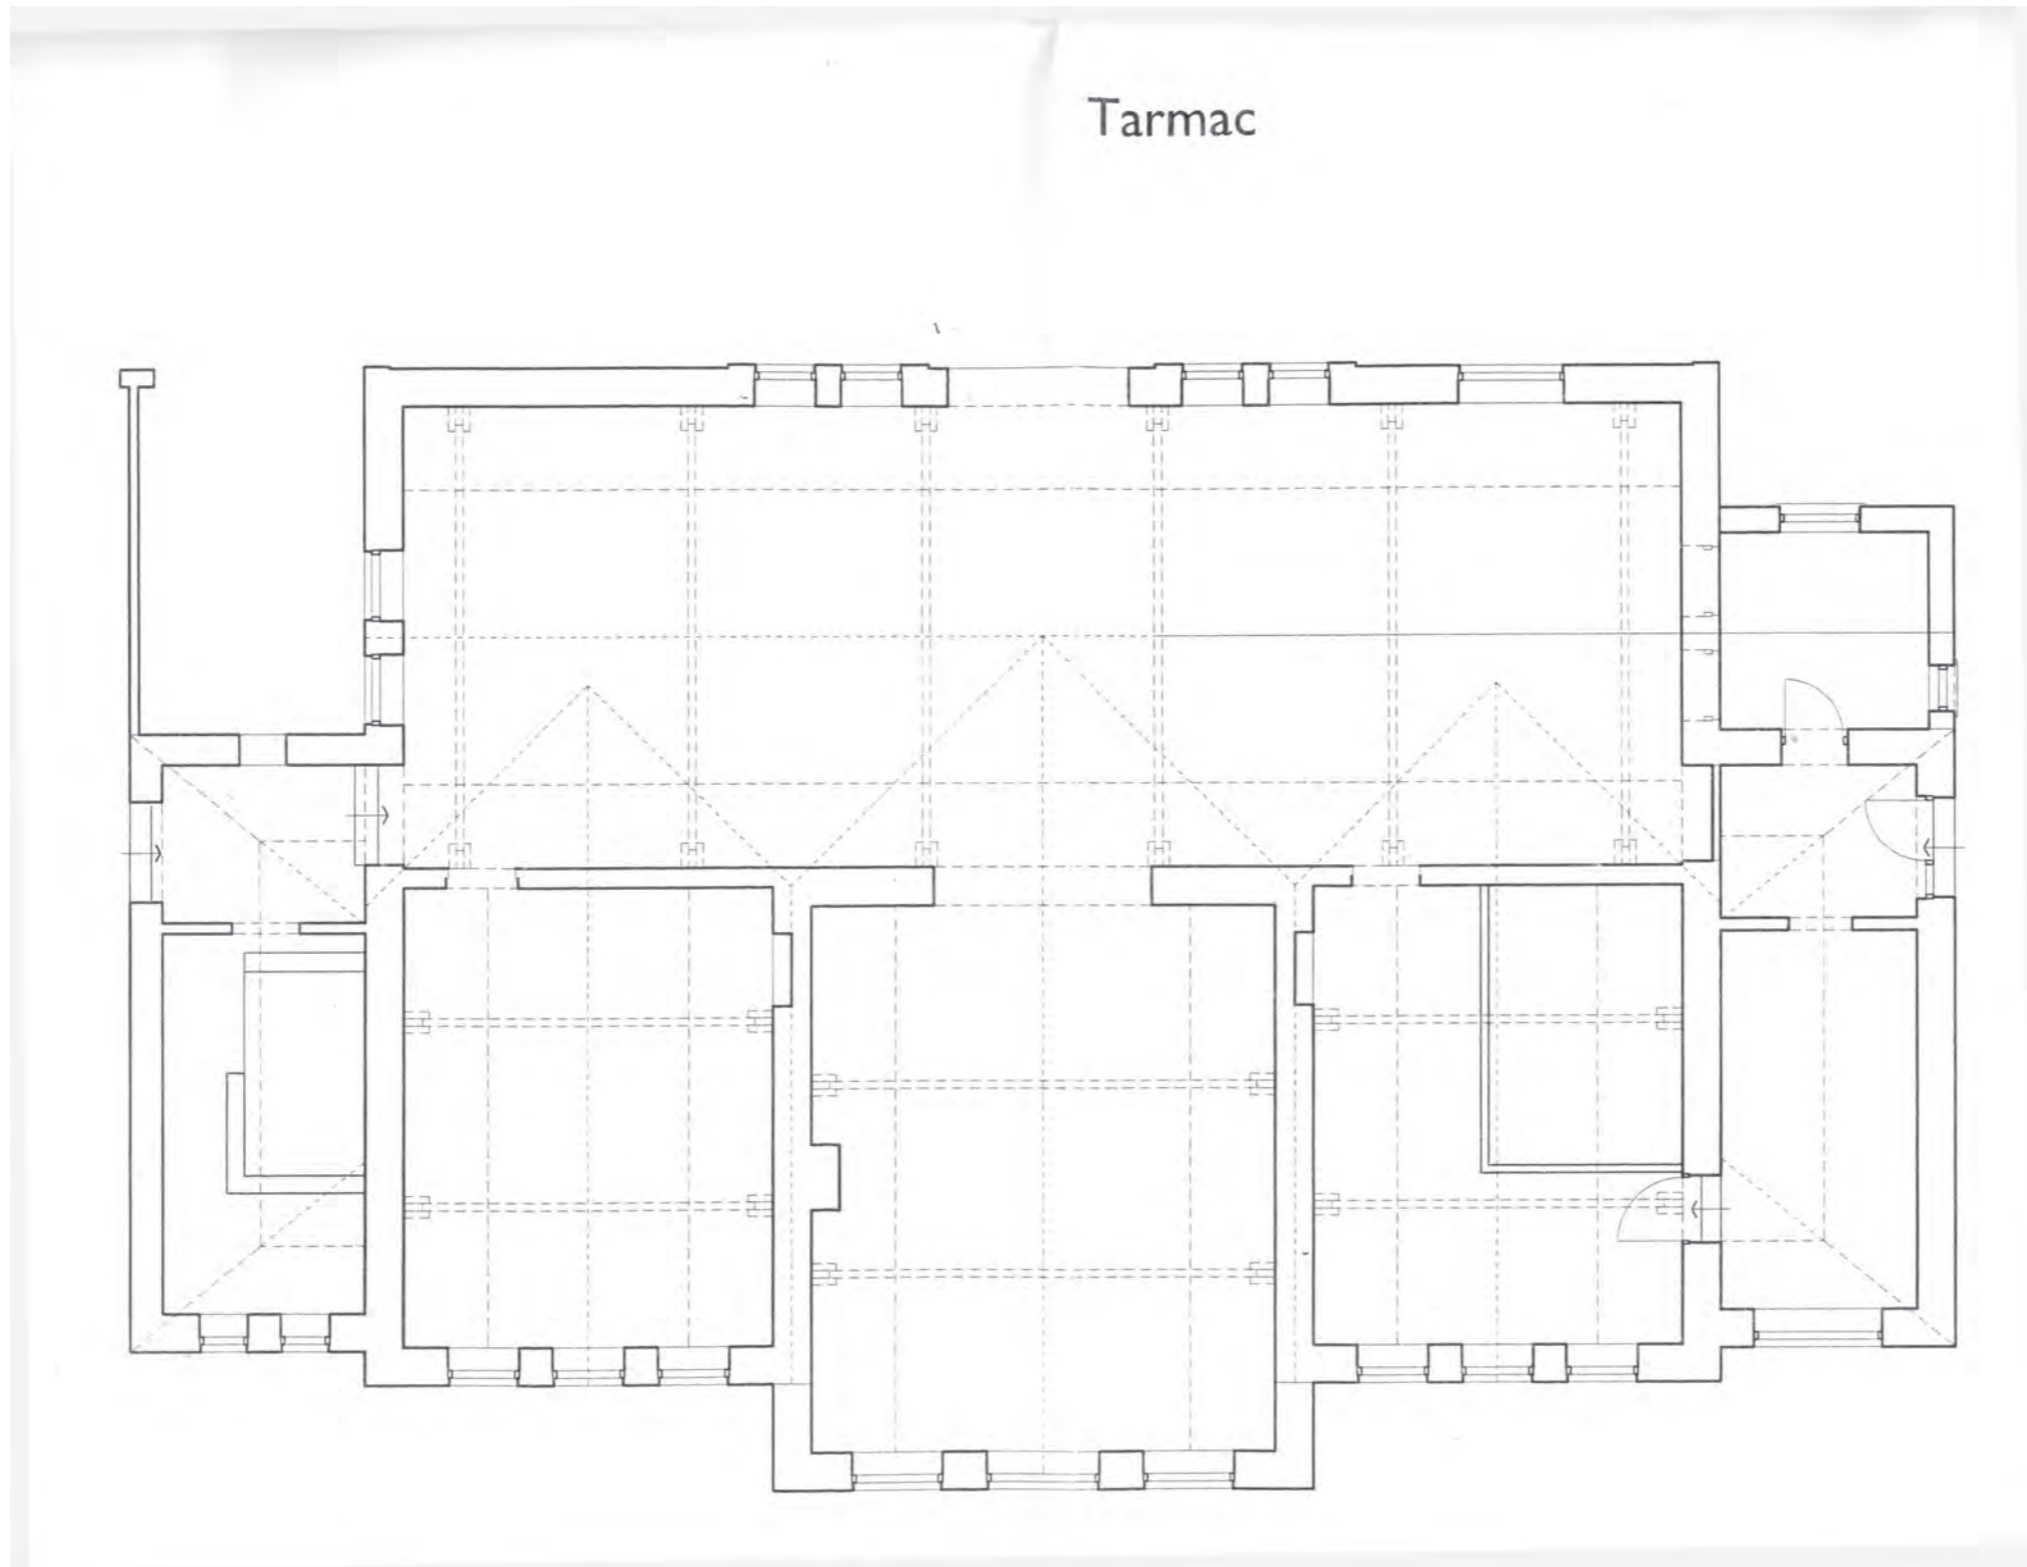
Figure 03:

5.1.1 Figures 3 to 5 show the plans and elevations of the existing structure and are taken from the current architect's plans. Figure 6 shows the locations and directions in which the photographs reproduced in plates 1-52 were taken.

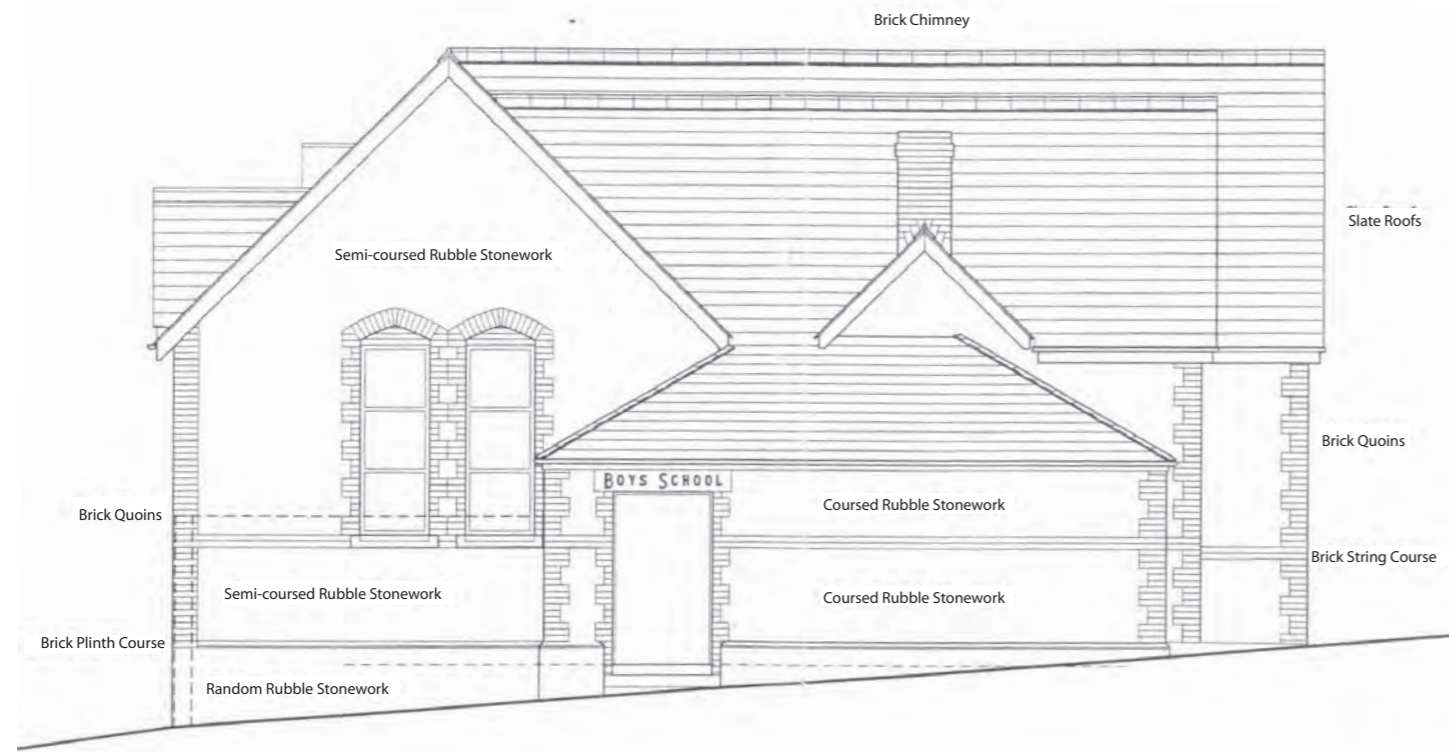
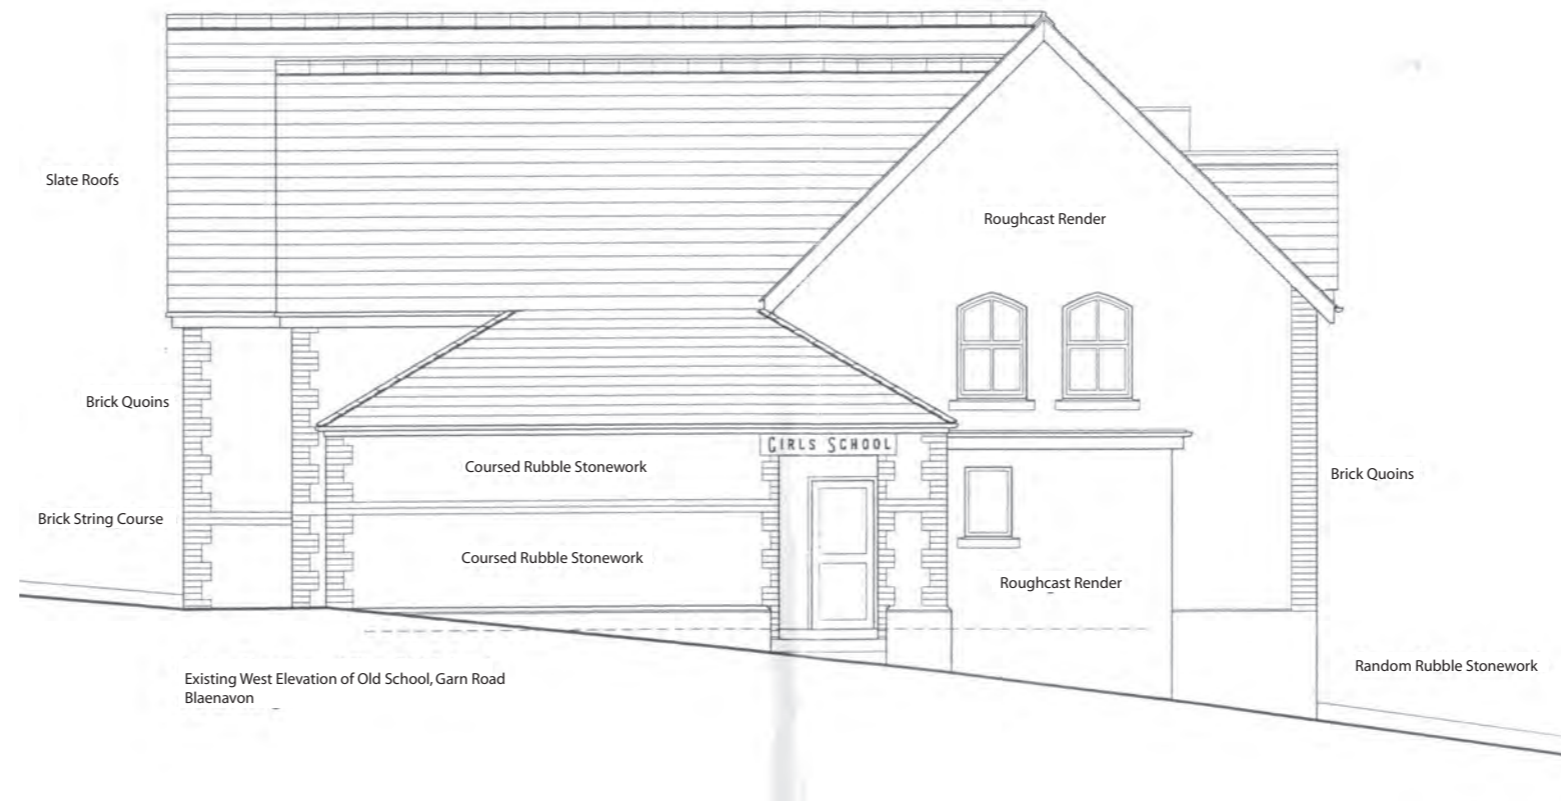
Figure 04:

Existing East Elevation of Old School, Garn Road, Blaenavon

Existing West Elevation of Old School, Garn Road Blaenavon

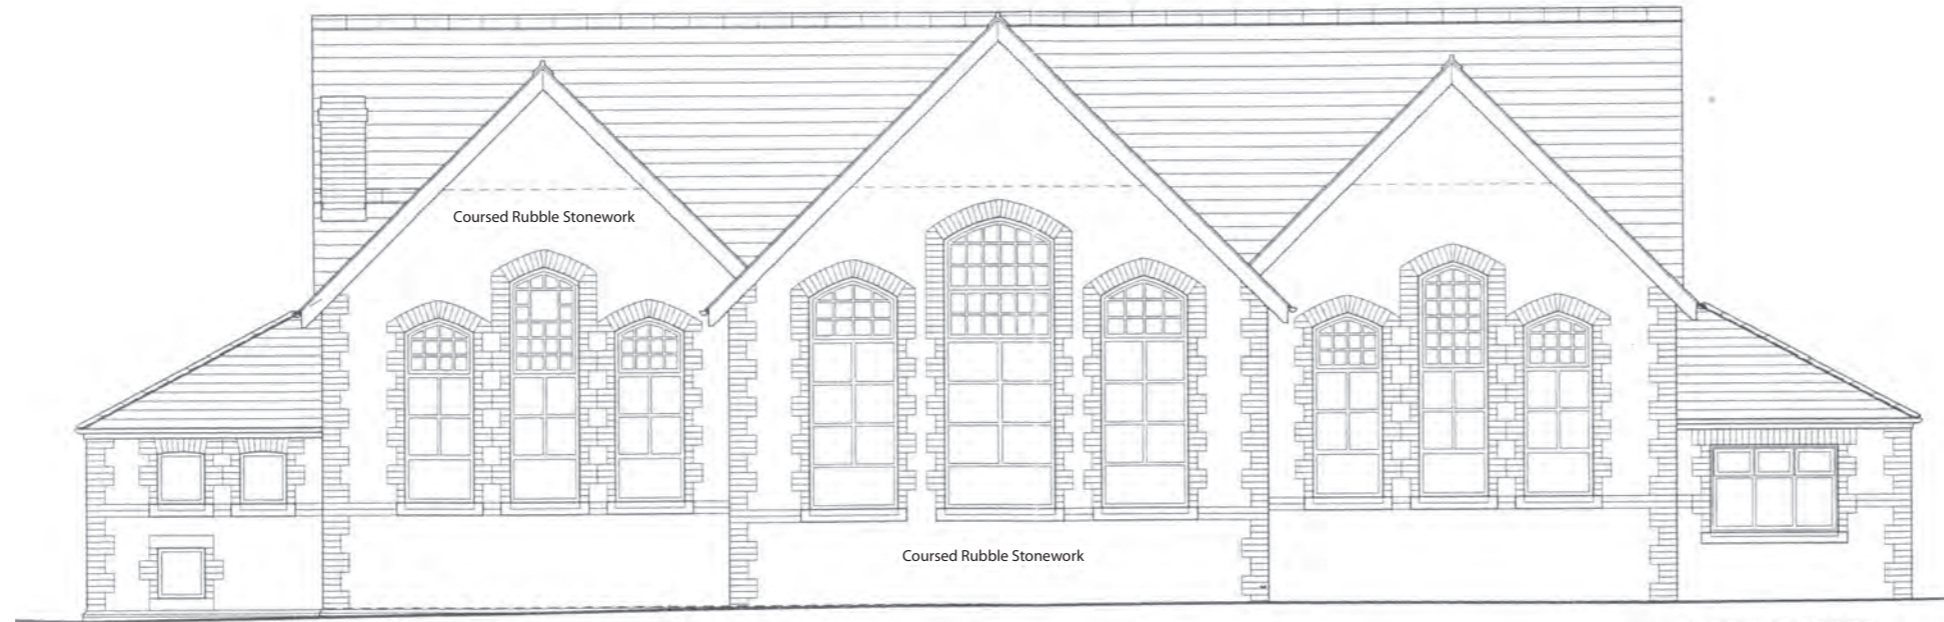
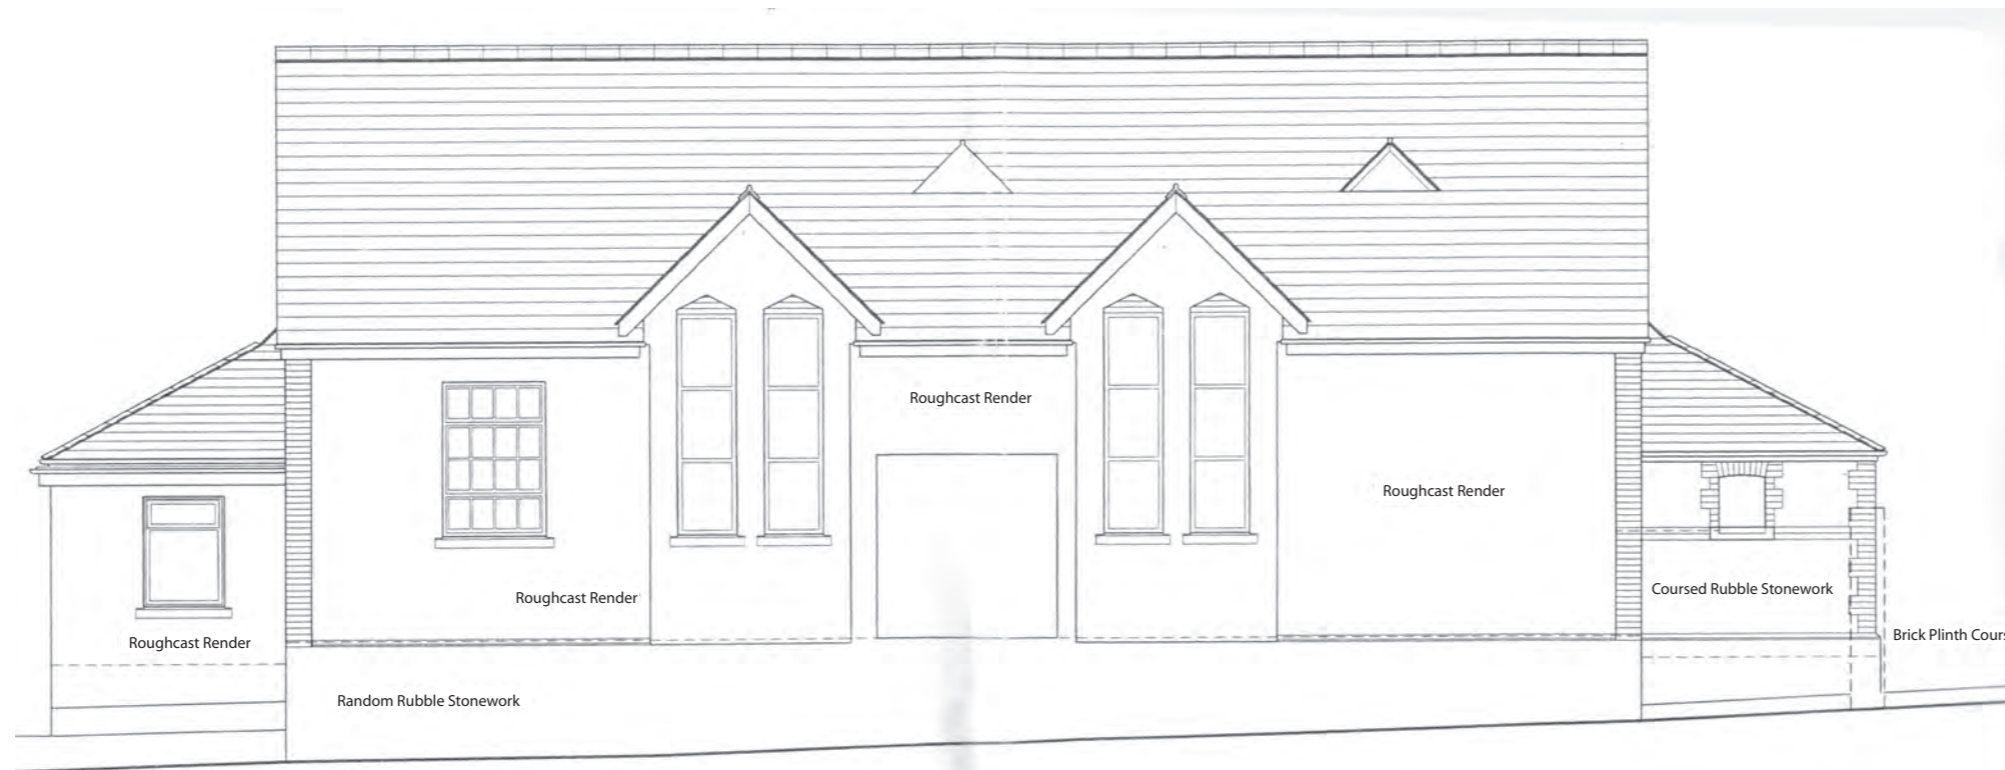
Figure 05:

Existing North Elevation of Old School, Garn Road, Blaenavon

Existing South Elevation of Old School, Garn Road, Blaenavon

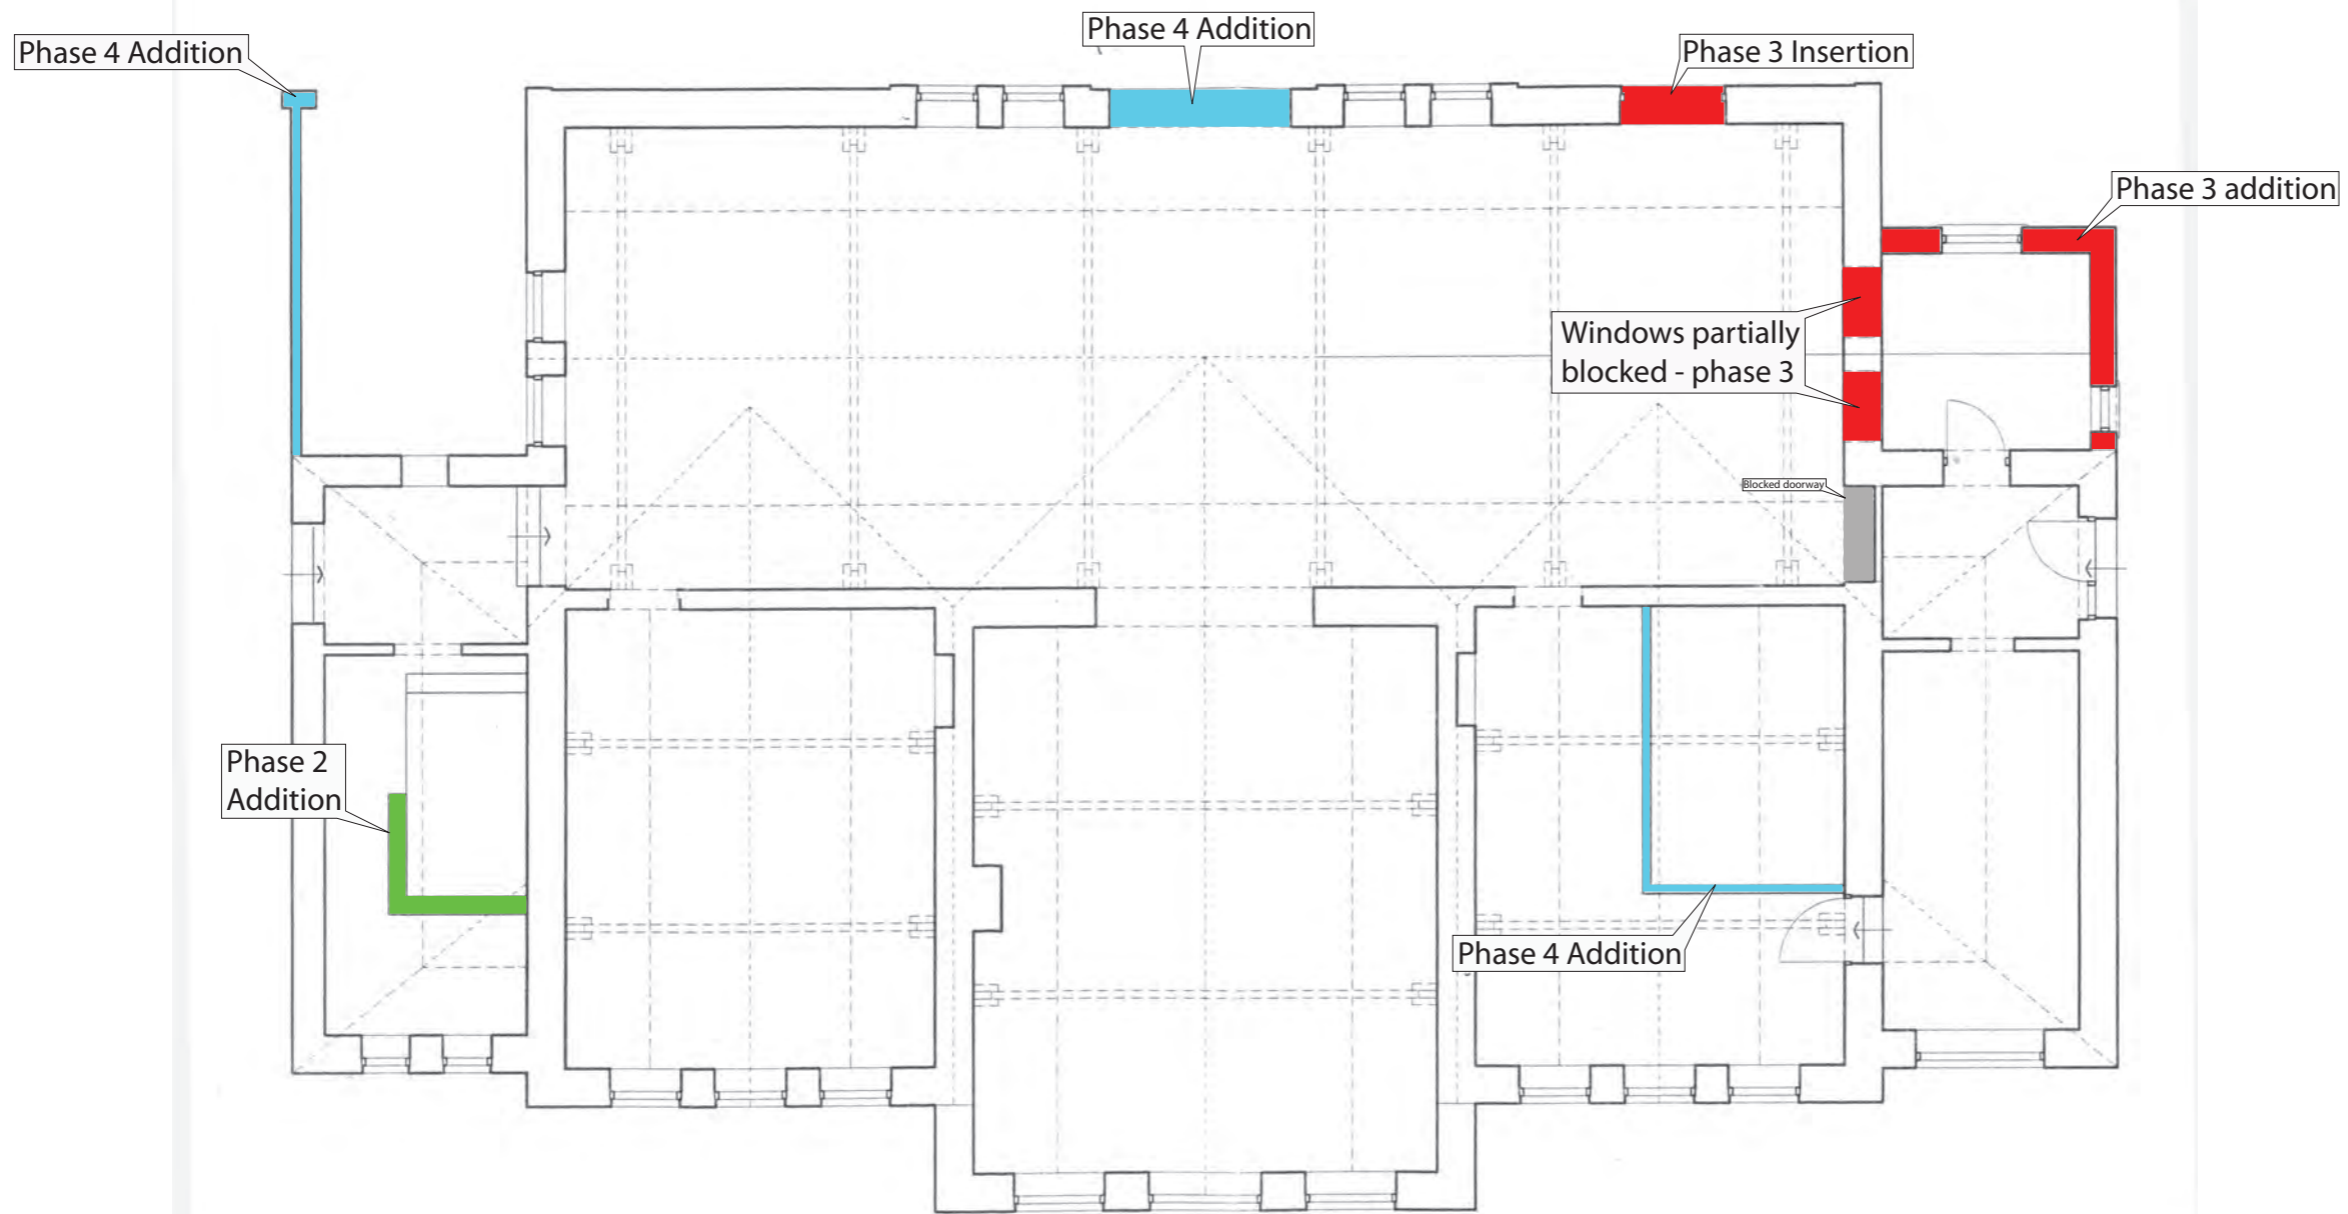
- 5.12.1 The building recording has identified four phases of building work at Old School, Garn Rd, Blaenavon. These are as follows:
- 1 Initial erection of the Old School building, 1894.
 - 2 Additions to the boiler room, Room 9, post-1922.
 - 3 Addition of Room 1, blocking of windows/door in the west wall, insertion of new window in the south wall plus rendering, between 1920 and 1962.
 - 4 Breeze block wall length added to the external east wall, 1963 or later.

Phase 4 Addition

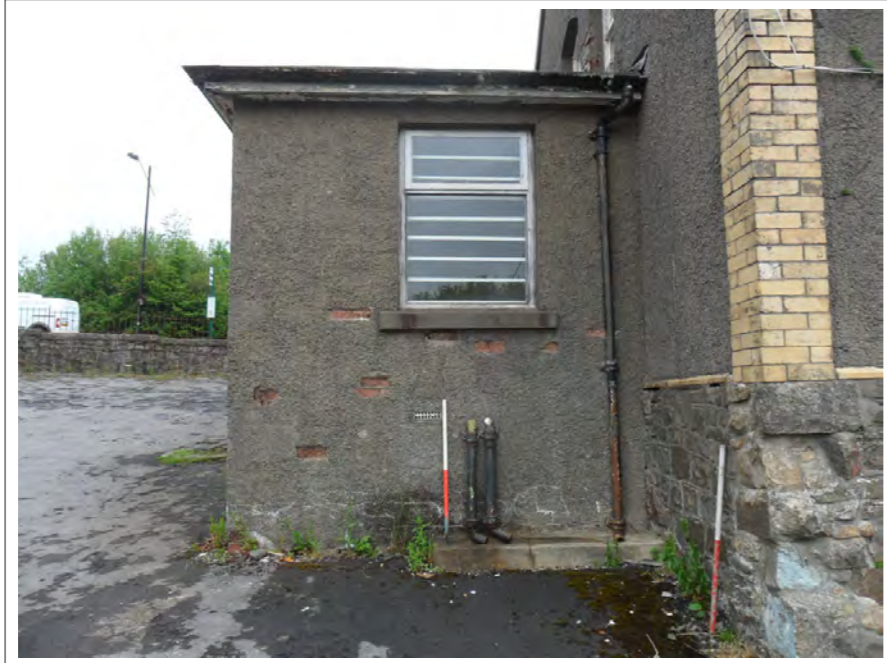
5.2.1 Room 1 (Plates 1-5) is a small reception room located on the western side of the building. It is of brick construction though the bricks have been completely covered by concrete render. A small window exists in the west wall with a slightly larger window in the south wall. Both are seemingly of mid-20th century origin.

Plate 1: View of southern wall of room 1. Looking north
Scales 2x1m

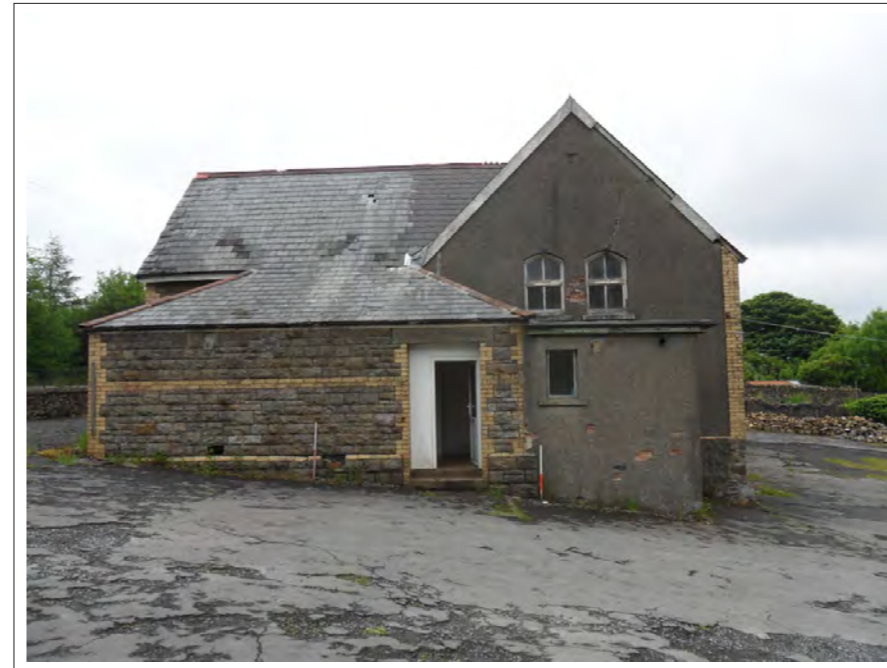
5.2.2 Room 1 has a flat roof, the design of which probably reflected the need not to block two earlier windows located in the main building (Plate 2). Internally, modern plaster and carpet has served to mask any original architectural features that may still survive.

Plate 2: View of west wall of rooms 1-3. Looking east, Scales 2x1m

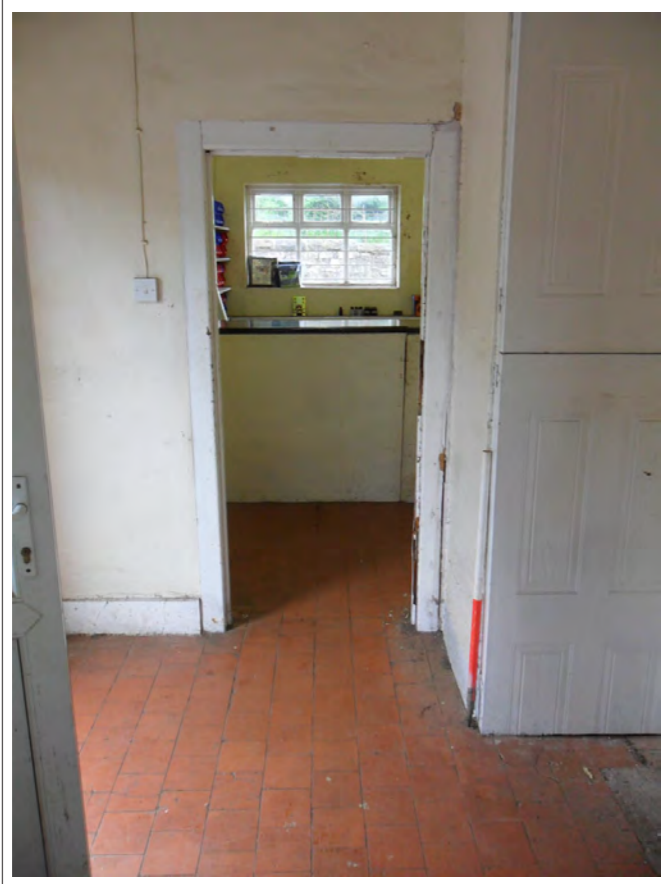
5.3.1 Room 2 (Plates 2 & 5) appears to have served as the original entranceway into the school. The lintel above the door is marked 'Girls School'. Within Room 2 is a small cupboard, which could be an original feature serving as the girl's cloak room. The floor in Room 2 is finished in plain square orange clay tiles which may also be original.

Plate 5: Internal view of Room 2. Scale 1x1m

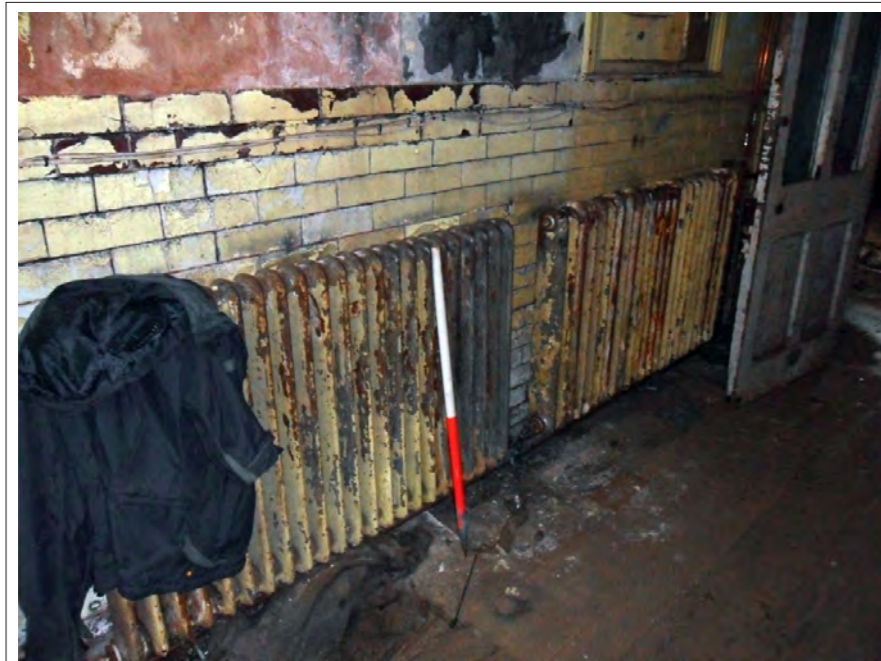
5.5.1 Room 4 (Plates 10-18) is a much larger room with a higher ceiling and many original features still *in situ*. However, approximately two thirds of the room is obscured by a modern office partition associated with the Towbar Centre. Located against the east wall of the room are two original radiators (Plates 11 & 12), whilst recessed within the east wall is an original cupboard (Plate 13). The north wall has three large original windows, though these are in a poor state of repair. The high ceiling shows exposed roofing beams of dark timber (Plate 14), the ornate nature of which suggests they were designed to be displayed within the original building. No further details could be seen owing to the presence of the modern partition. It should be noted that a further original radiator is located within Room 3, though this has been moved against the wall of the modern office.

Plate 11: View of original radiators fitted to east wall of Room 4
Scale 1x1m

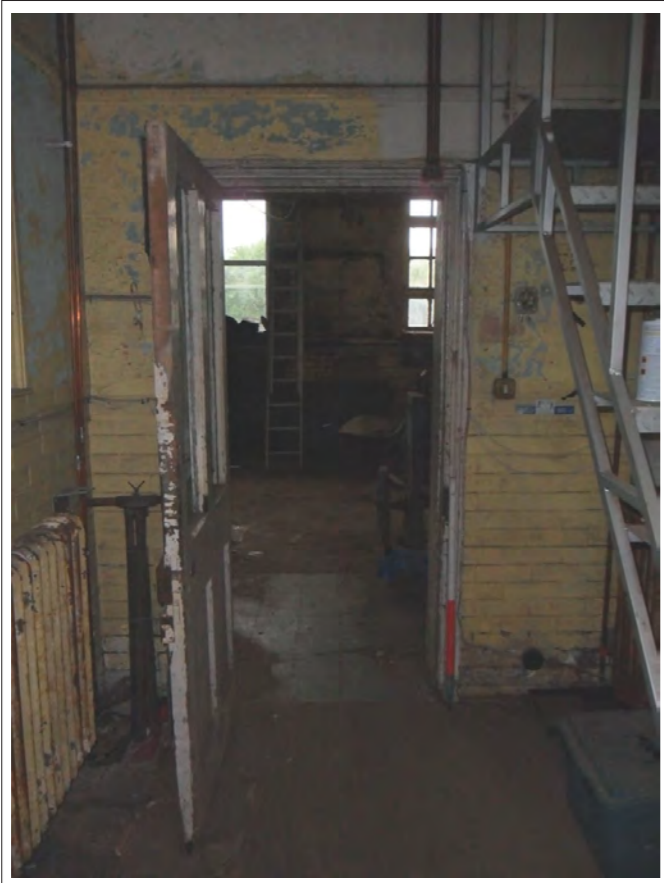
and worn wooden planks. Within the south wall, a doorway leads into the main open area of the Old School building (Plate 15).

Plate 15: Doorway from Room 4 into Room 5. Scale 1x1m

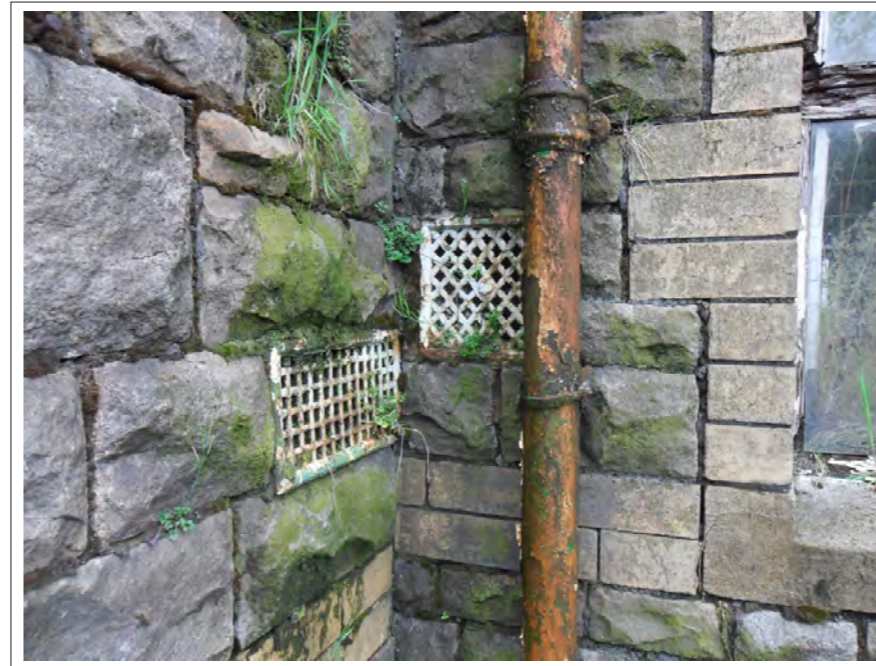
5.5.2 Other original features such as air vents are evident in the external face of the north wall of Room 4 (Plate 18), while the floor within the room is composed of warped

Plate 18: View of original late 19th century air vents within north wall of Room 4

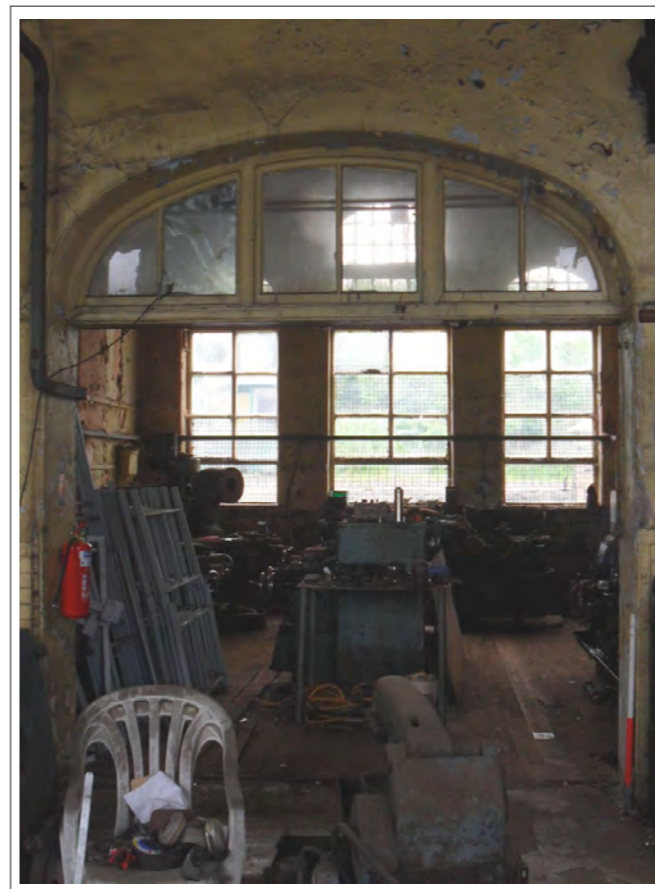
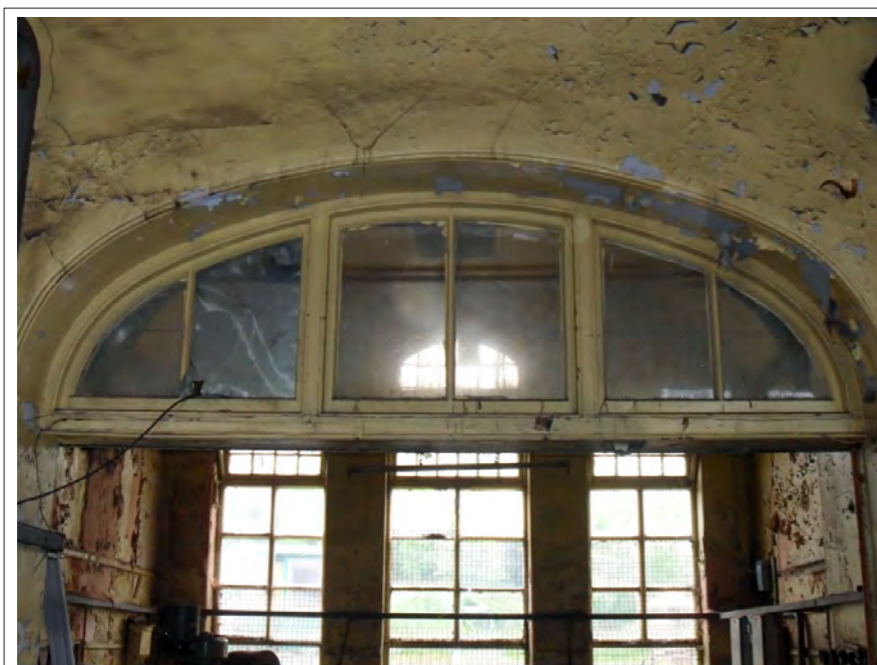
5.7.1 Room 6 (Plates 32-35) is accessed from Room 5 via a large archway (Plates 22-24). The archway is reasonably ornate in its design and is likely to have been located above doors, which have since been removed.

Plate 22: View of archway entrance into Room 6 from Room 5. Scale 1x1m

Plate 23: Detail view of archway entrance into room 6

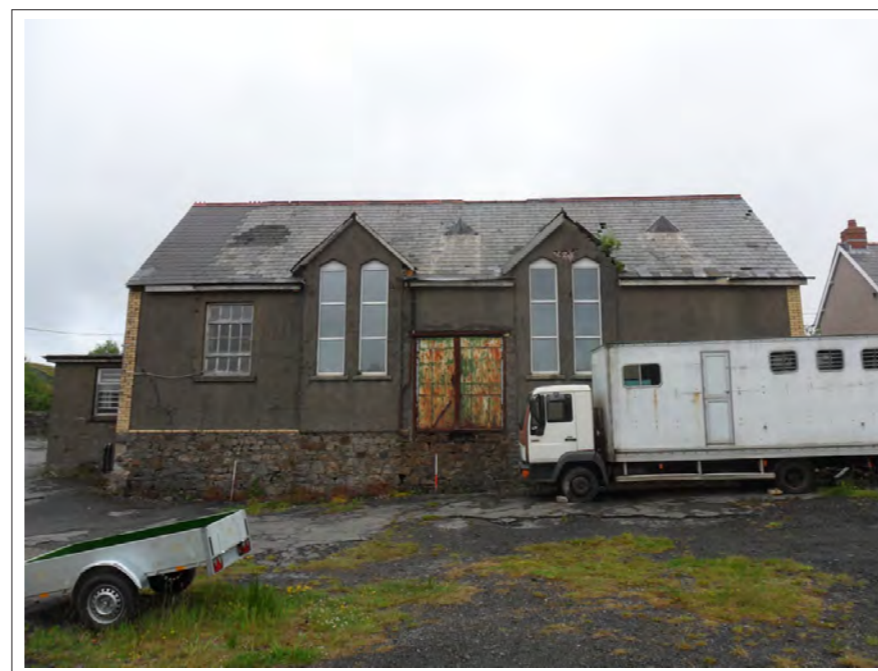
- 5.11.1 The roof of the building is finished in slate and is topped with orange clay ridge tiles. The ridge tiles vary between plain examples and versions with three decorative vertical 'spikes'.
- 5.11.2 Plate 28 shows, two possible blocked windows or vents within the roof. A third example, on the left of the picture, appears to have been removed, and new slates are discernible here. New slates are also evident along the western edge of the roof suggesting recent repair work.
- 5.11.3 Plates 49, 50 and 52 show the enclosure and gates of the original school yard. All of these features appear to be original.

Plate 28: External view of Room 5 from rear of building. Looking north. Scales 2x1m

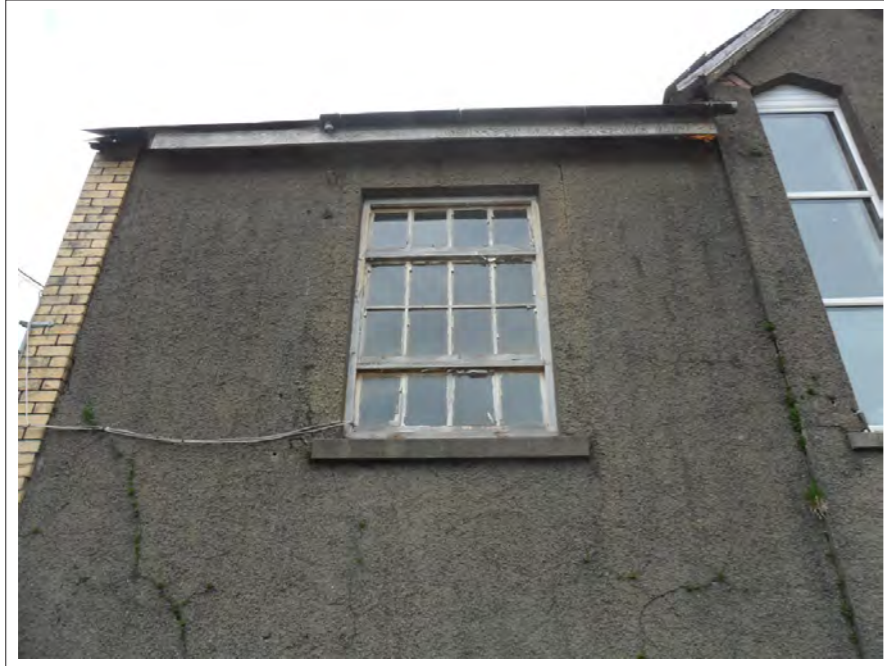
5.6.3 Original window openings in the form of rectangles with arched tops are evident in the south and east walls. The original windows have been replaced with versions in UPVC. The window openings within the west wall have clearly been modified to accommodate the later addition of Room 1. The rectangular windows have been truncated so that only the top third remains, with the lower two thirds being blocked (Plates 2 & 20). The reduction in light caused by the partial blocking of the two windows in the western wall appears to have been compensated by the addition of a large rectangular window in the western end of the south wall. This is clearly a mid-20th century addition, and no similar window exists at the eastern end of the south wall.

Plate 29: View of modern window inserted into west end of south wall

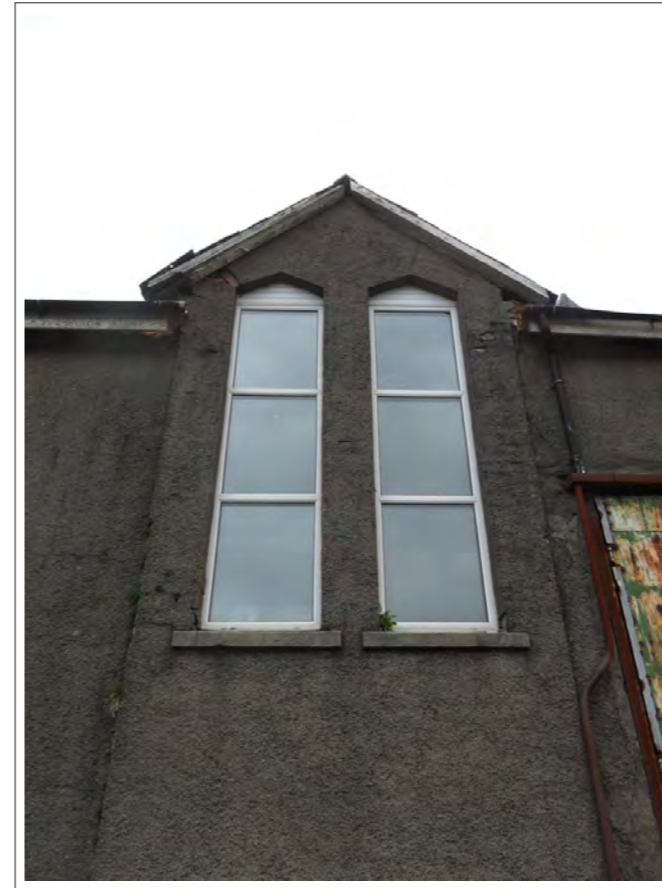
- 6.2.3 Whilst many of the original late 19th century windows remain, those in the south and west walls have been replaced with modern versions in UPVC. This was undertaken approximately 10 years ago as an emergency measure (Hardwick, Pers comm.)

Plate 30: View of UPVC replacement windows within Room 5

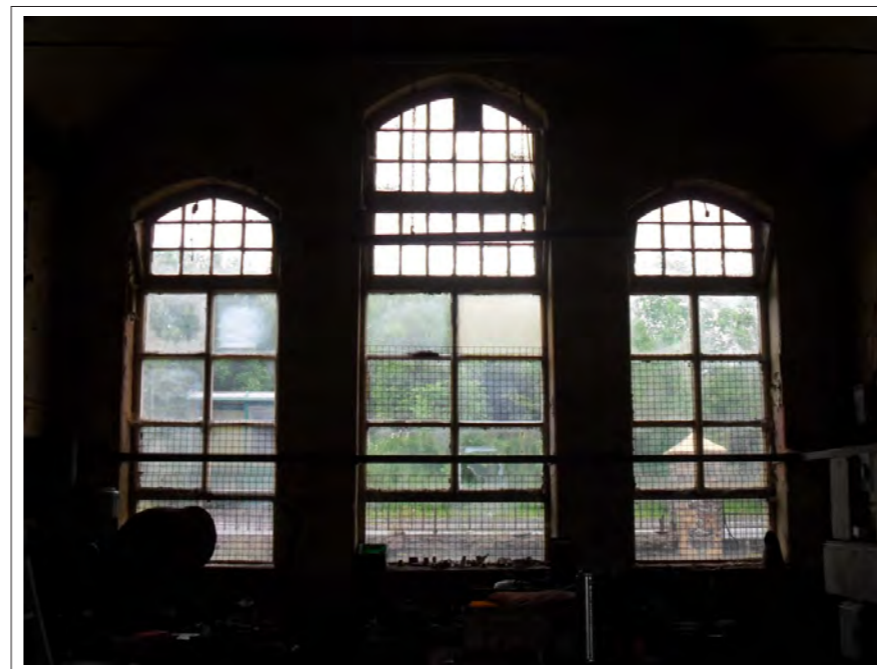
5.7.2 Three original windows remain in the north wall of the room (Plates 32-35). A very worn and warped wooden floor is present throughout.

Plate 32: View of original windows from within Room 6

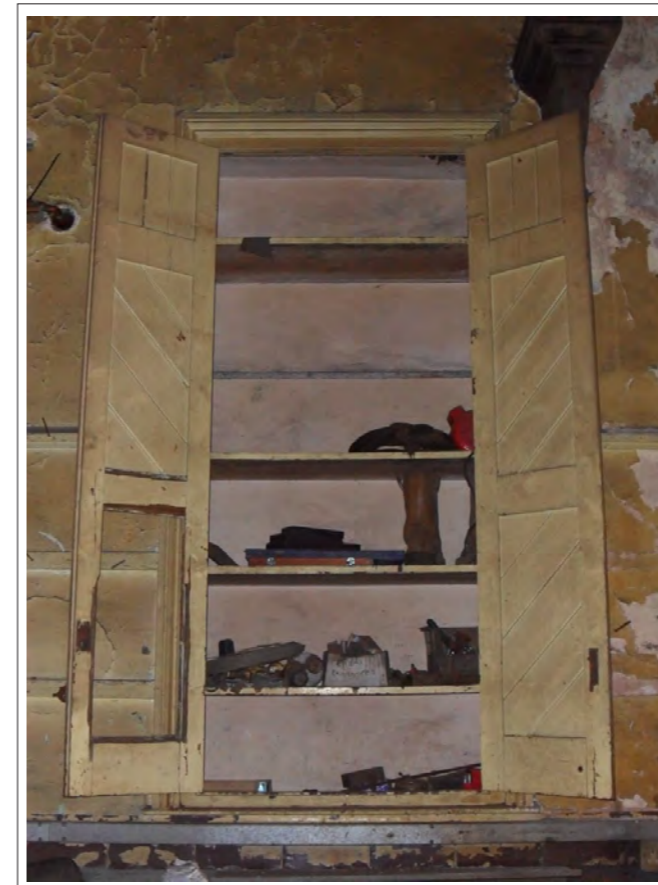
5.8.1 Room 7 (Plates 36-41) is accessed via a doorway at the eastern end of Room 5. In plan the room mirrors Room 4, a symmetry that is also seen in the location of a recessed cupboard identical to that previously noted in Room 4. The only observable difference is that no doorway exists in the east wall to mirror that seen in the west wall of Room 4.

Plate 40: View of recessed cupboard within west wall
of Room 7

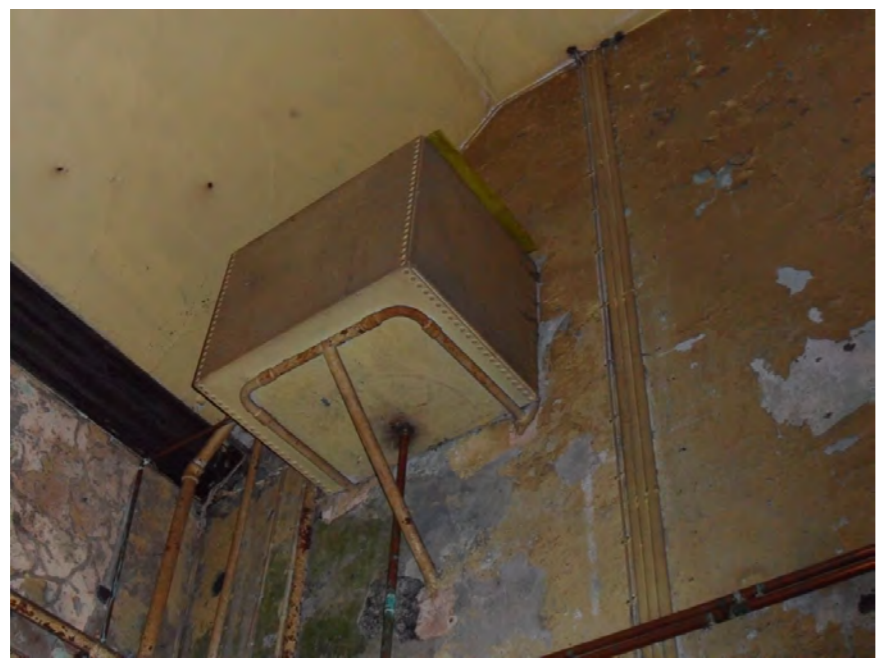
5.8.2 The original function of Room 7 is uncertain. The door between it and Room 5 is thick with angled slats, perhaps suggesting that it was associated with the boiler room (Room 9) and not used as a classroom. The floor in Room 7 is composed of wooden tiles in a decorative 'herring bone' pattern, which survives *in situ* though in a poor state of repair. An original water tank is located above the door.

Plate 41: View of metal water tank above doorway in Room 7

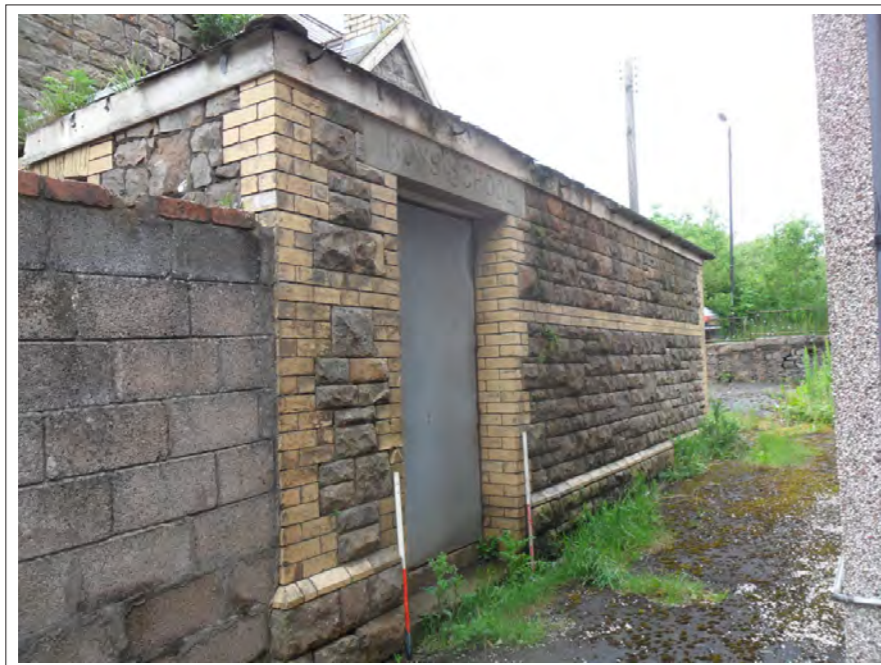
5.9.1 Room 8 (Plates 42-43) was the entranceway to the boys school, this information being depicted on the external lintel (Plate 43). The doorway is currently blocked by a modern steel door. A doorway within the north wall of the room leads into Room 9.

Plate 43: External view of Room 8. Looking north east
Scales 2x1m

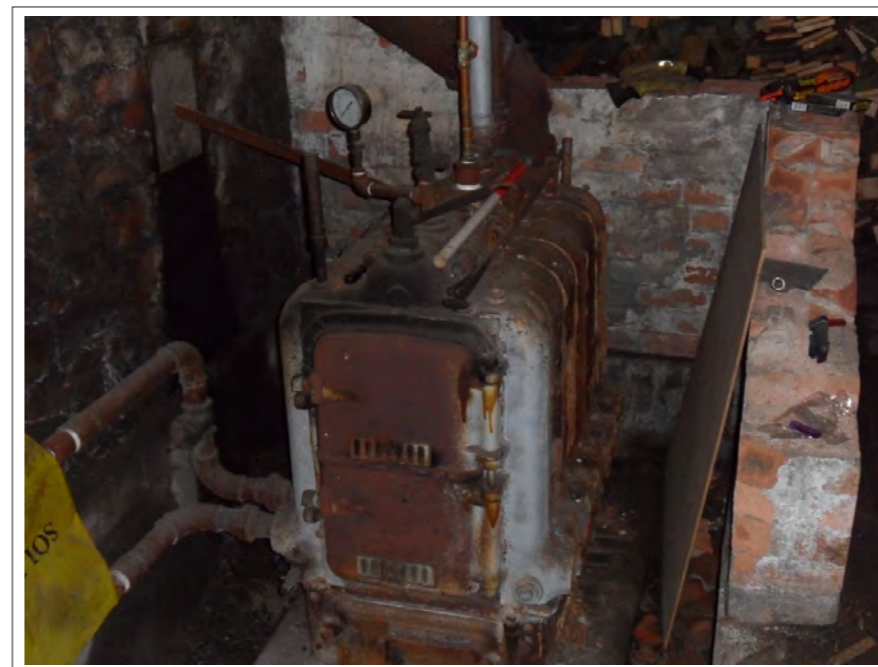
5.10.1 Room 9 (Plates 44-46) was the school's boiler room. It is very small and dark, and in the centre occupied by a wood burning stove that is still working and in use. The stove is located within a rectangular recess in the floor and is enclosed on its east and north sides by a thin brick wall surround.

Plate 44: View of boiler/stove located within brick surround and recess within Room 9, Scale 1x1m
