Archaeology Wales

Old School, Garn Road Blaenavon

Building Recording

Report No: 1066

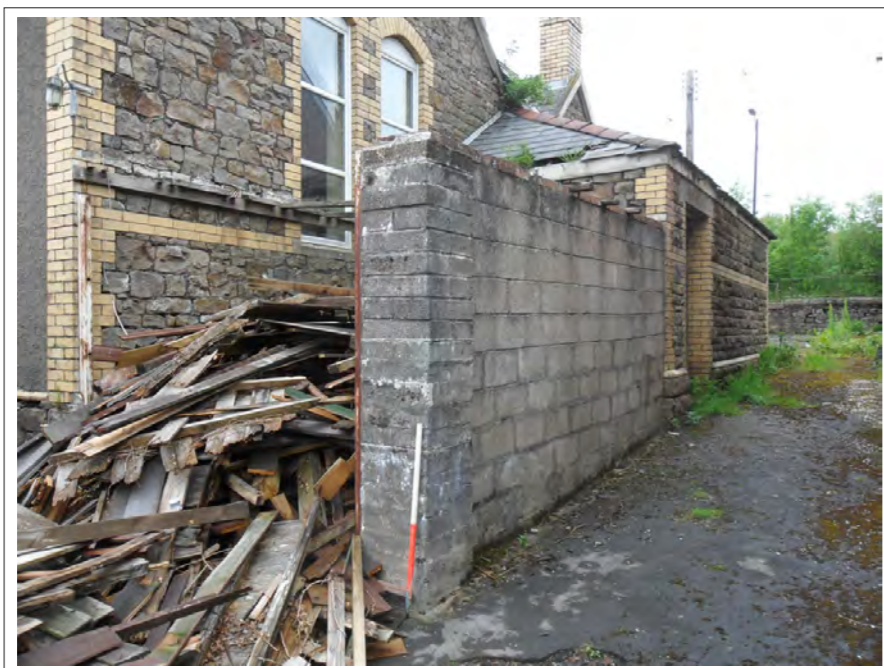
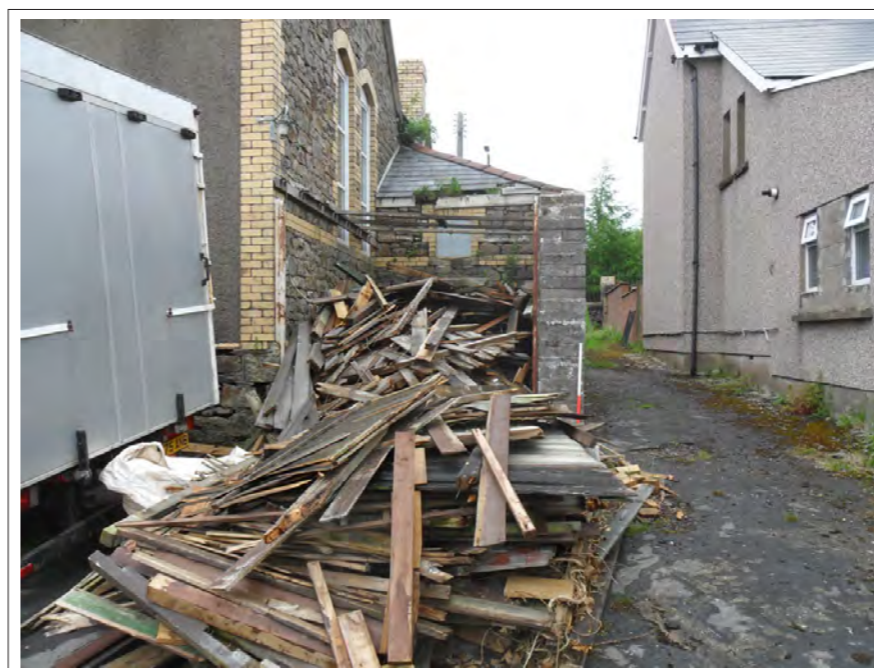
5.9.2 Adjacent to the east wall of the Old School building, and projecting southwards from it, a seemingly modern breeze block wall has been erected (Plates 43, 47-48). This appears to have been constructed in order to create an external storage area for wood to be used as fuel.

Plate 47: View of modern breeze block addition.
Looking north west. Scale 1x1m

Plate 48: View of stored wood fuel bound by modern breeze block wall
Looking north. Scale 1x1m

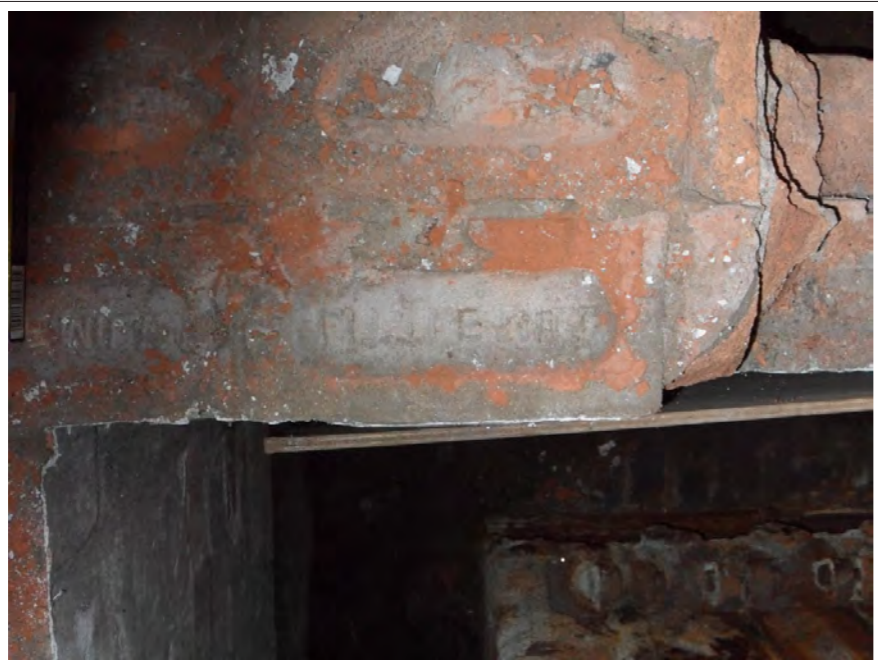
5.10.2 The bricks located within the boiler surround are stamped 'Little Mill' (Plate 51) in recessed lettering within a shallow oblong frog. The brickworks at Little Mill, between Pontypool and Usk, are first listed as a company in 1922, so this feature is therefore not original. The use of Little Mill bricks within a boiler room is a common occurrence in the area (Phillips, Pers comm). The boiler itself is of unknown date, although it appears smaller than the recess in which it is located. It may, therefore, be a replacement boiler contemporary with the post-1922 bricks surrounding it.

Plate 51: View of 'Little Mill' bricks within Room 9 Boiler surround

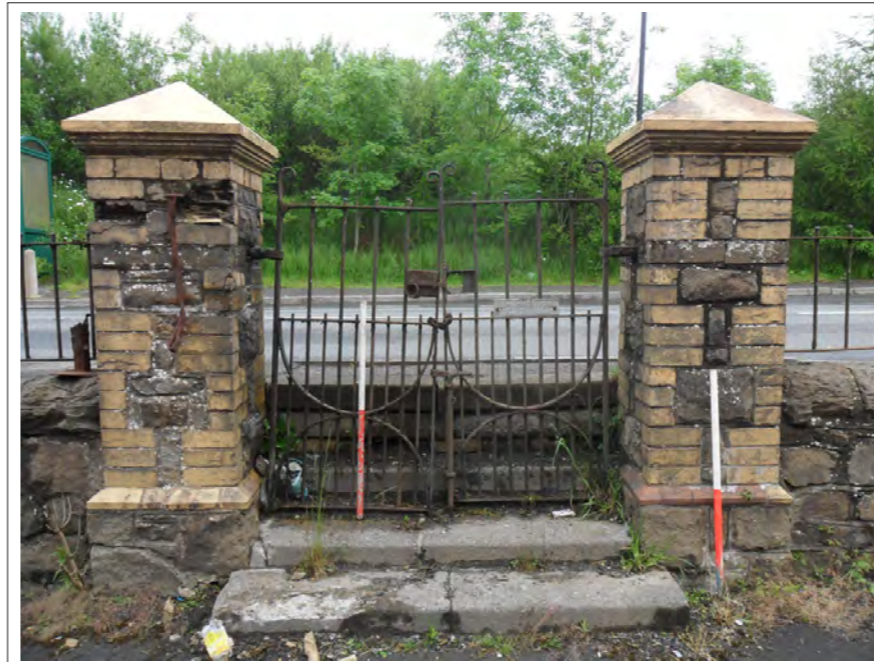
Plate 52: View of original gate into school yard from main road
Looking north, Scales 2x1m
