**HVERFORDWEST THE CRYPT,
PEMBROKESHIRE
(SM 95226 15560)
ARCHAEOLOGICAL WATCHING BRIEF**

December 2009

RHIF YR ADRODDIAD / REPORT NO. 2010/5
RHIF Y PROSIECT / PROJECT RECORD NO. PRN 98681

HAVERFORDWEST, THE CRYPT ARCHAEOLOGICAL WATCHING BRIEF

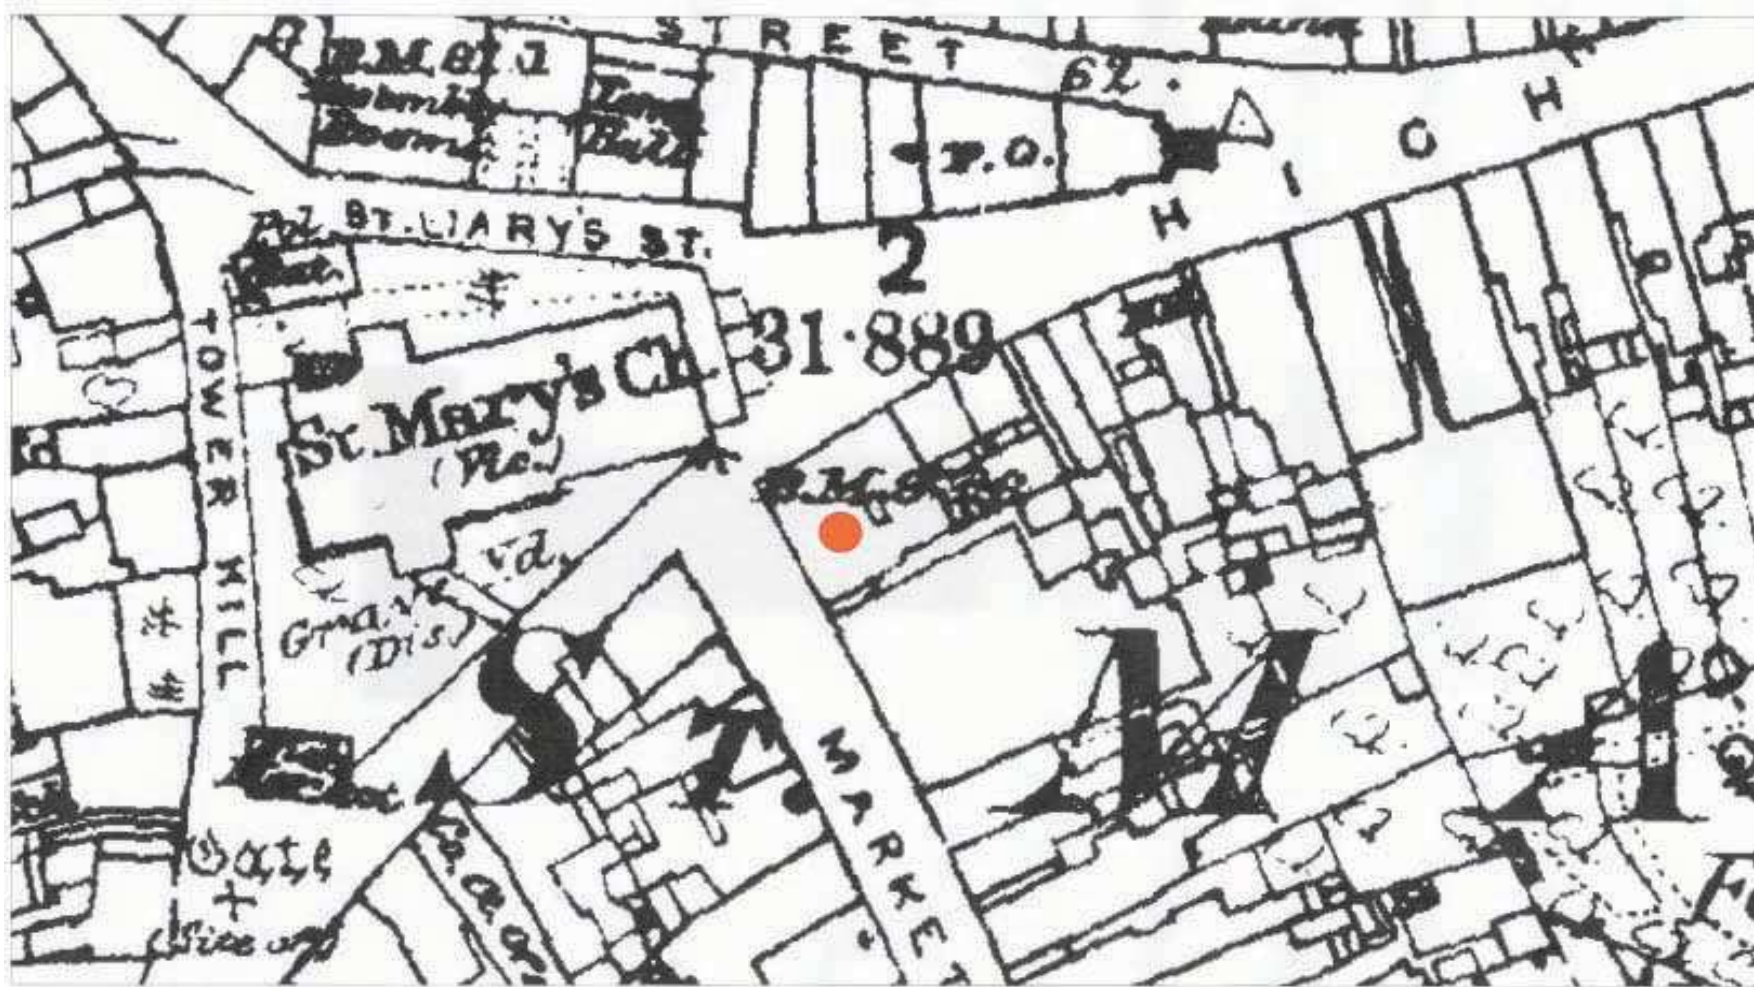
Figure 1: Pembrokeshire 1st edition map showing Crypt location as red spot.

The building known as 'The Crypt' (PRN 6503) lies beneath pavement level at the junction of High Street and Market Street, Haverfordwest, 8.5 metres southeast of the southeast corner of St Mary's parish church. Through viewing the 1st and 2nd edition Ordnance Survey maps, it can be seen that there is a town house built over the undercroft (see figures 1 and 2).

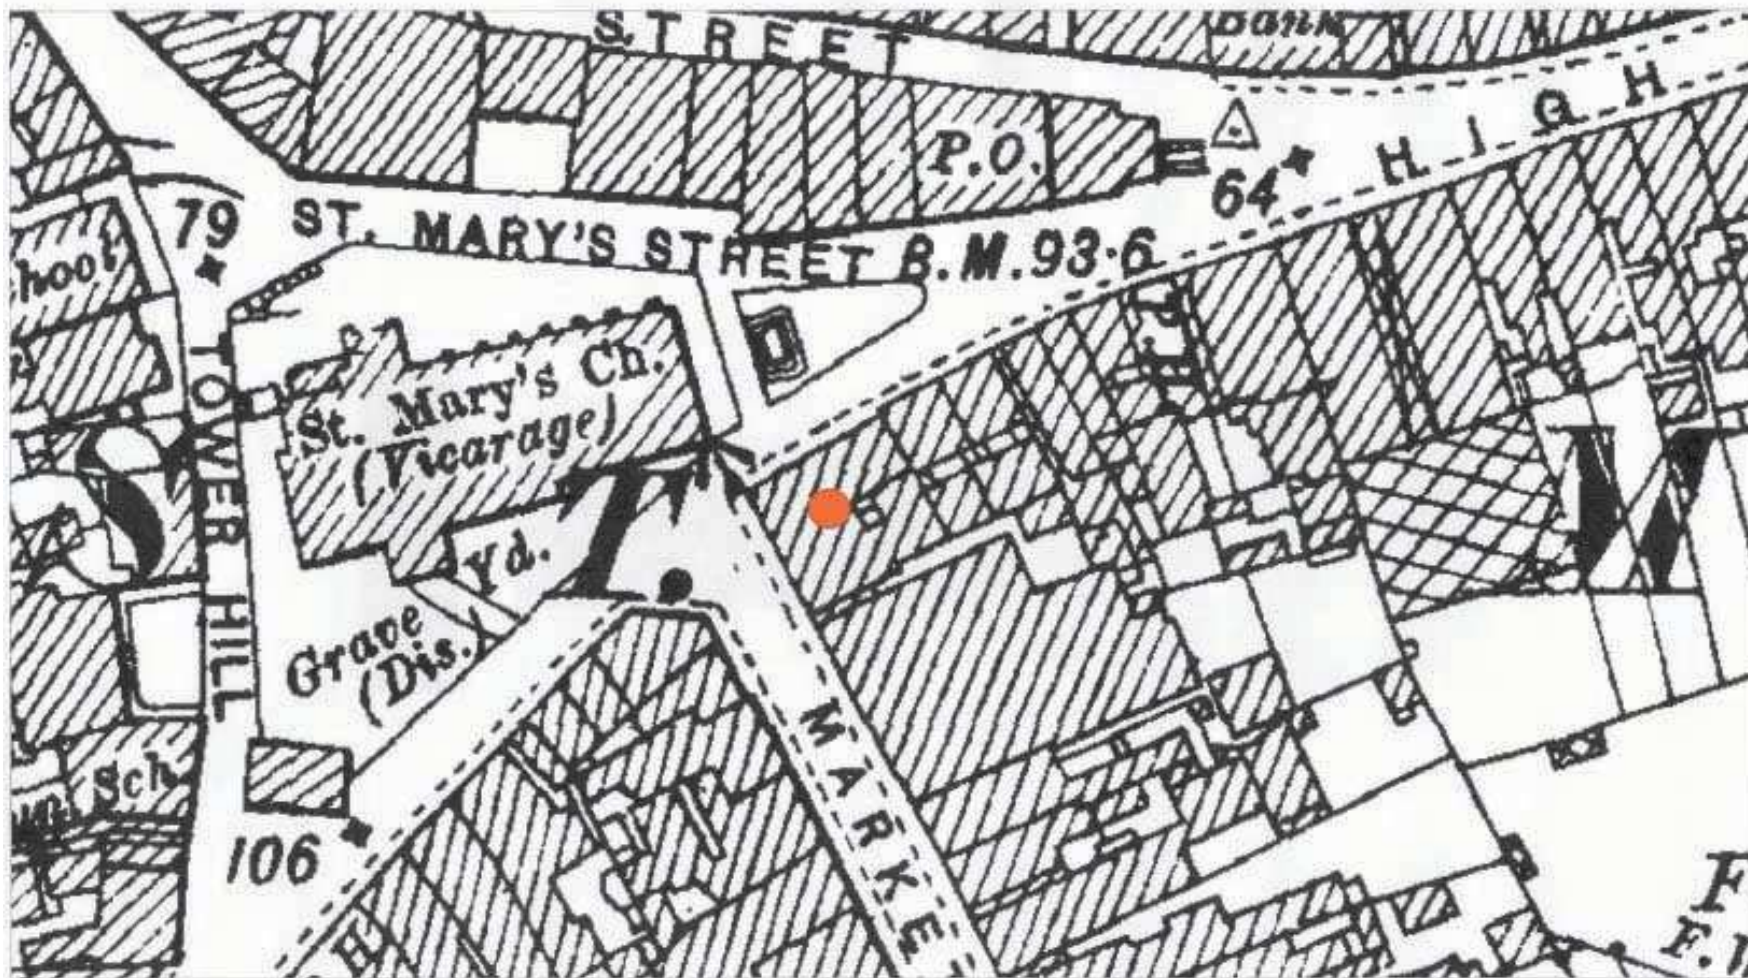
Figure 2: Pembrokeshire 2nd edition map showing Crypt location as red spot.

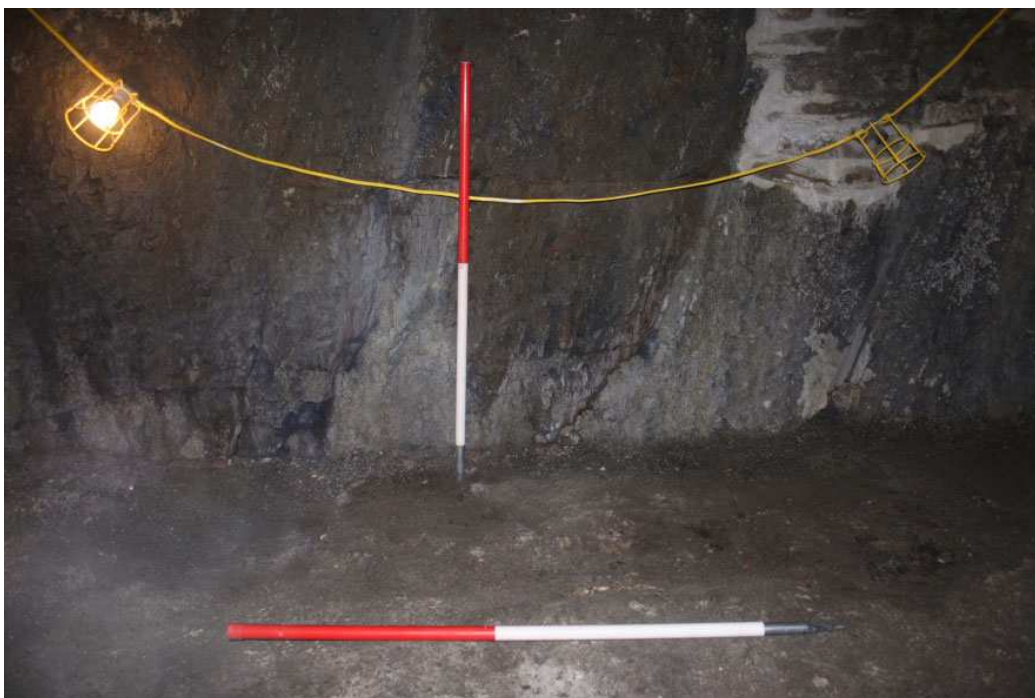
Following the removal of the existing gravel surface (0.04m thick), a number of large flagstones were revealed around the edges of the room. These were at first thought to be the remains of a floor surface. Closer examination, however, demonstrated that the stones were capping for a drain running along the base of all four internal walls of the undercroft. The drain consists of a rock cut channel measuring 0.20m in deep and 0.43m wide in the southwest corner and 0.23m deep and 0.54m wide in the northwest corner.

Photo. 1: Pre-ex photo showing drain situated at west wall of crypt.

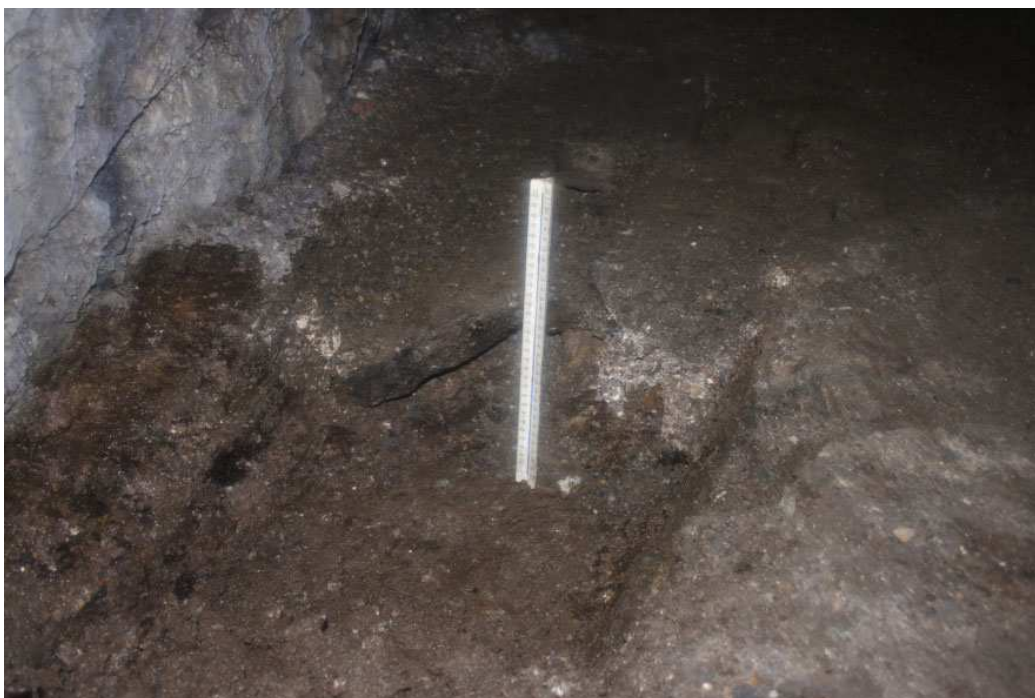
In the centre of the room a layer of blackish brown silty clay underlay the gravel layer. Below this was a thin and patchy spread of mortar fragments lying directly on shale bedrock.

Photo. 2: North facing photo-showing rock cut gully and bed rock either side.

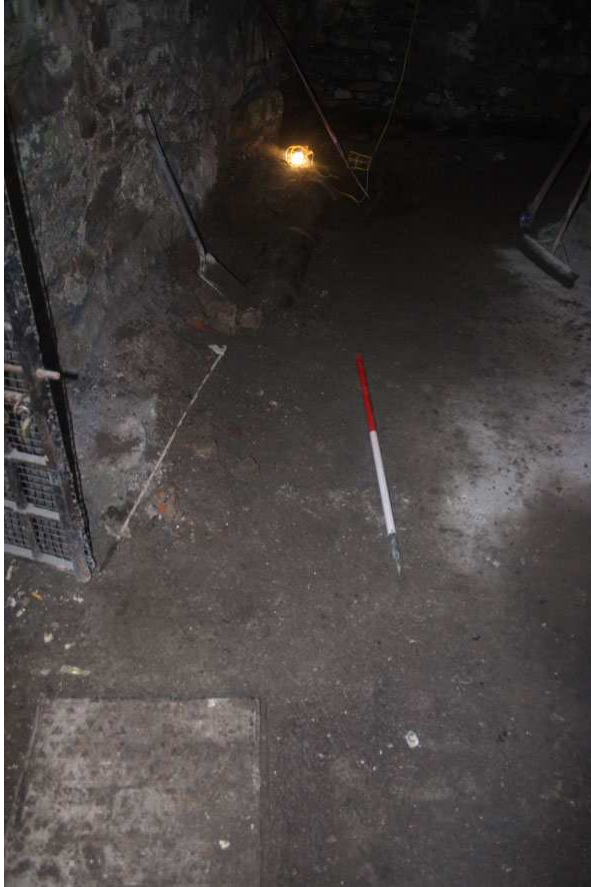
On the eastern wall and part of the southern wall the drain was cut by modern services. The modern services may have destroyed evidence for the drain exiting through the north wall to link with a drain elsewhere.

Photo. 3: Looking along eastern wall of undercroft showing modern services.

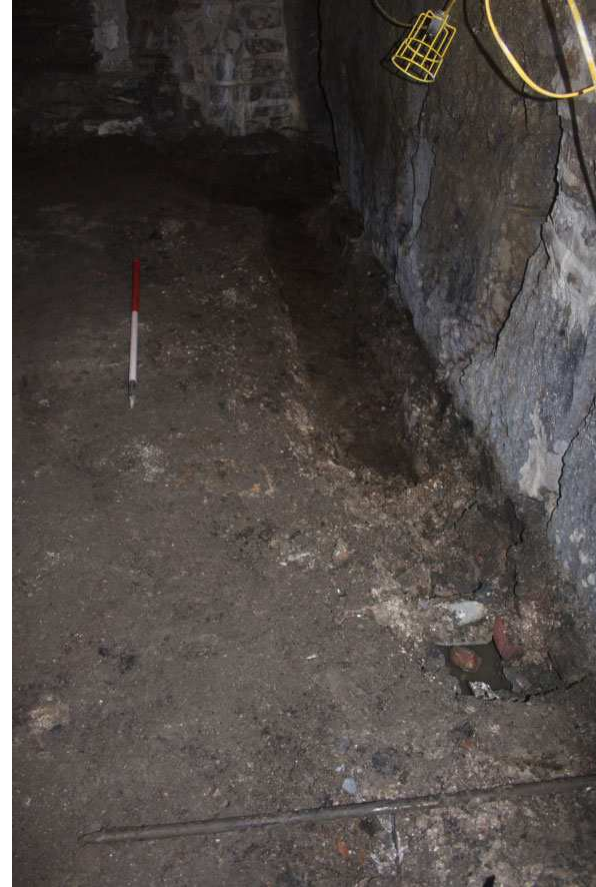
The drain cut was lined with mortared vertical stone slab sides, and was capped with stone slabs and occasionally roofing slates.

The drain contained a dark brown silty clay with occasional animal bone and fragments of post medieval glass and ceramics. Modern food wrappers were also noted, but these may have been introduced to the drain by rodent activity.

Photo. 4: Looking south along western wall of undercroft showing partly excavated drainage channel.

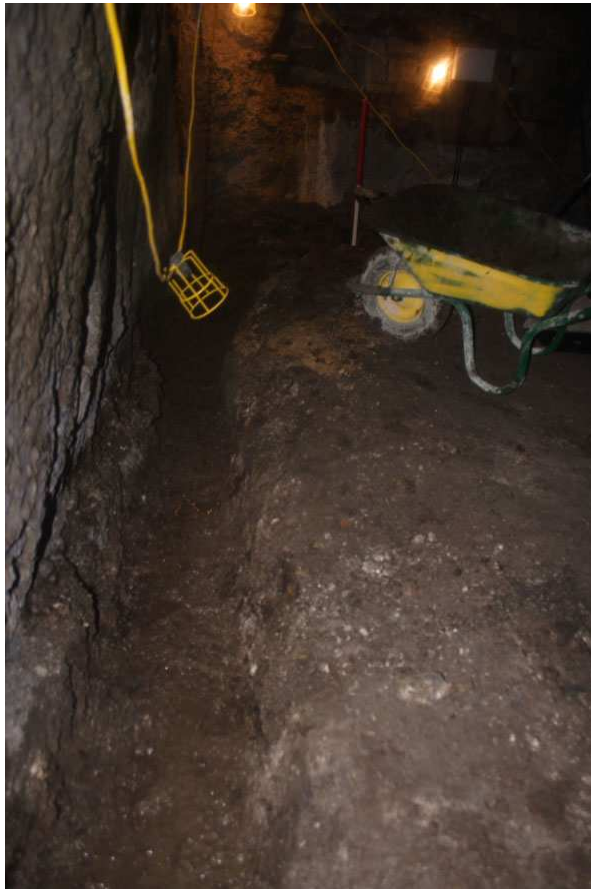
Photo. 5: Looking north along western wall of undercroft showing rock cut drainage channel.

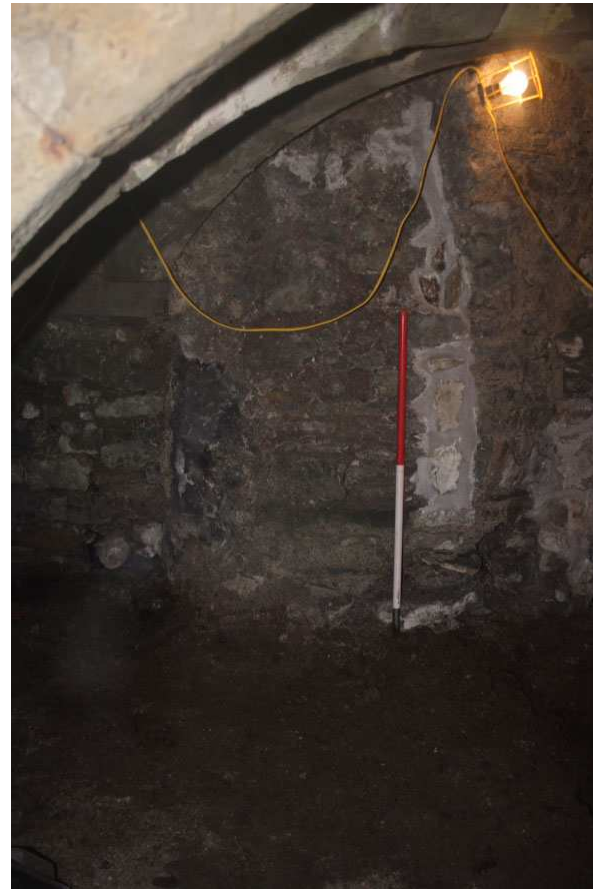
Although impossible to date with certainty, the drain running along the base of the undercroft walls appears to be a post medieval modification, presumably intended to dry out the cellar. Ludlow (2005) mentions that there is a possible door situated in the south west corner of the undercroft which may have been the original entrance to the undercroft. The blocking up of this entrance, and other changes around the undercroft may have caused drainage problems, which the drain was intended to alleviate.

Photo. 6: Looking south at possible medieval doorway.

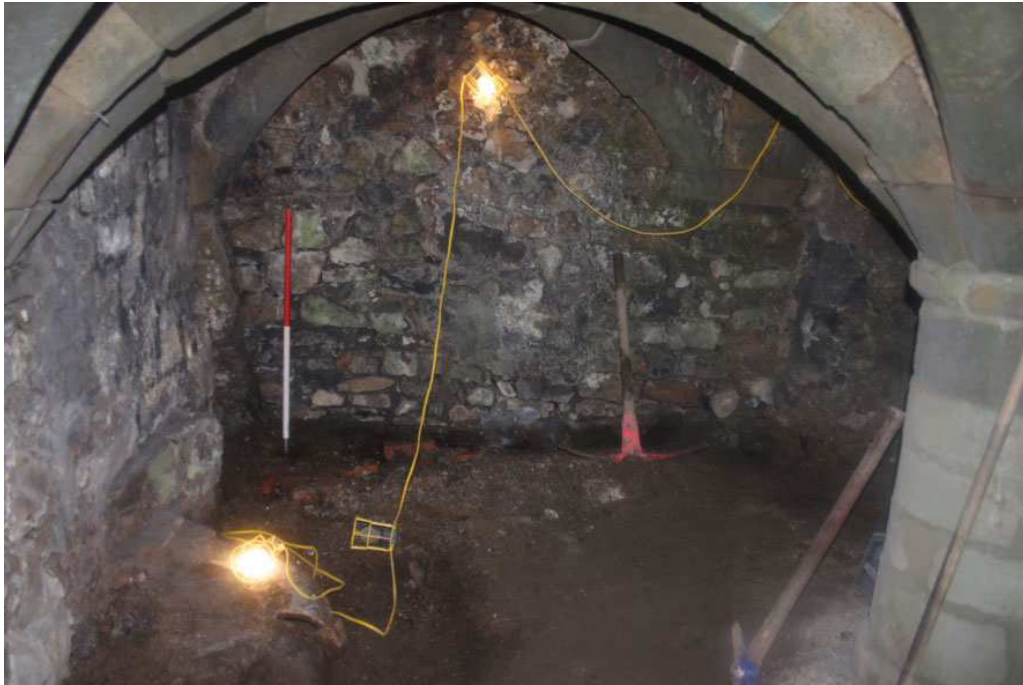
Photo. 7: Photo looking towards southern wall of undercroft
