North West Wales Dendrochronology Project Blaen Glasgwm Uchaf, Penmachno, Gwynedd

**North West Wales Dendrochronology Project
Blaen Glasgwm, Penmachno,
Gwynedd**

EAS Client Report 2012/05

**By
I.P. Brooks**

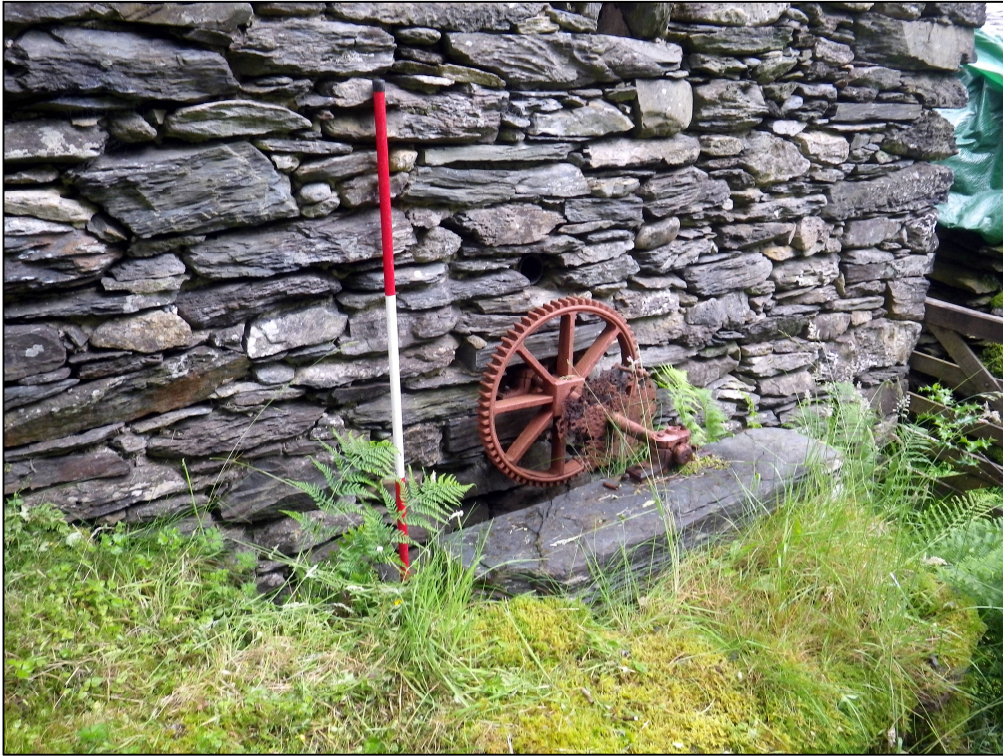
Plate 7: Iron drive wheel on rear elevation of the eastern extension

A single bay building is added on the east end, sharing a common roof. This has an arched opening to the front and an iron drive wheel over a leat at the rear.

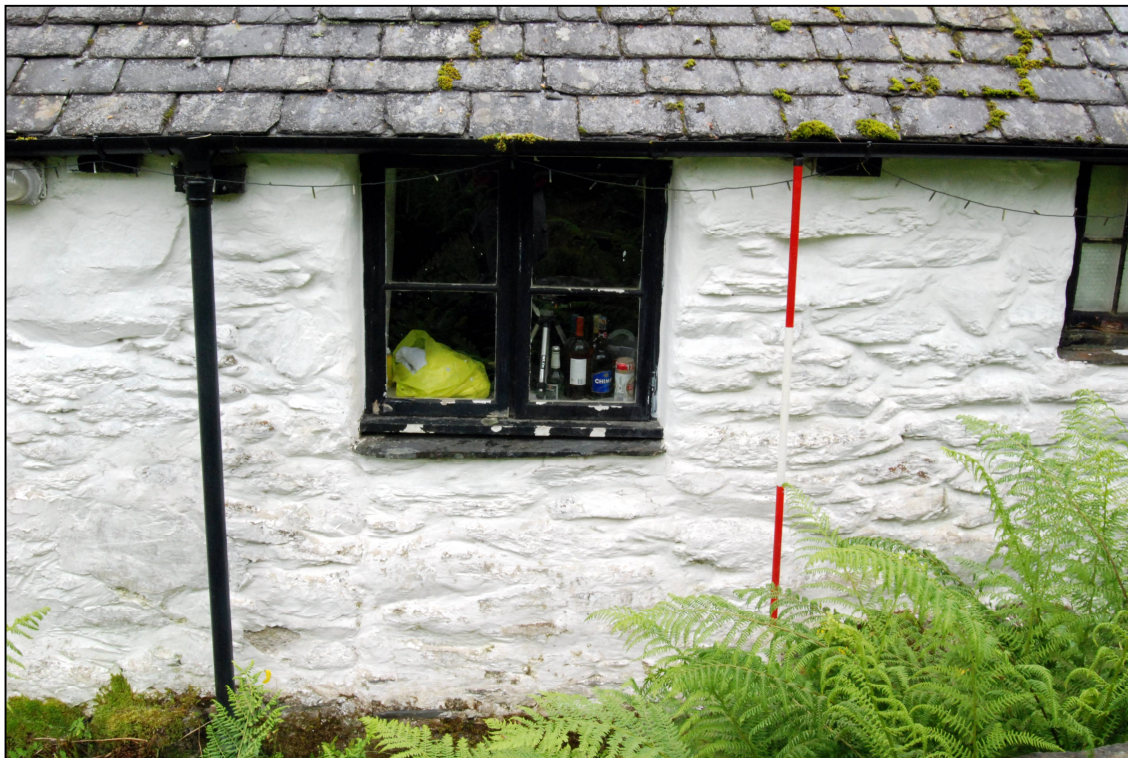
Plate 8: Partially blocked doorway in the front elevation

The front elevation has three windows and two doorways (Plates 1 and 2). The central door is a later insertion replacing a doorway further to the west which is now occupied by one of the windows (Plate 8). Whilst the two eastern windows are of a size with four pane casement windows, the western window is much smaller and it may represent the original size of the windows for this house. The rear elevation (Plate 3 and 4) has three window openings, the two eastern openings having four pane windows, whilst the western window is smaller and has only recently been revealed (A. Brown *pers. comm.*). The scar at the base of the rear elevation marks the position of a leat which supplied water to the water wheel on the later, agricultural extension.

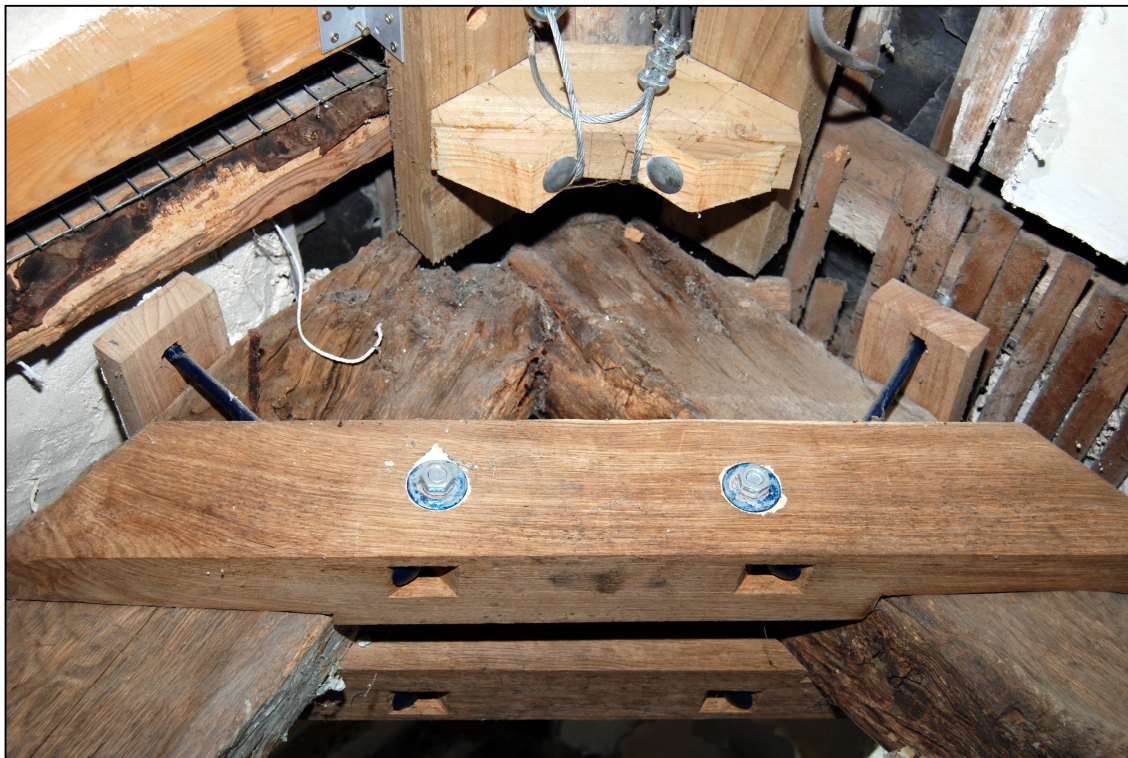
Plate 12: Peak of Truss 1

The bulk of Truss 1 is exposed in the attic above (Figure 5, Plates 11, 13 and 15). This is a cruck frame of Alcock type E (Alcock 1981, 95) with the blade jointed together diagonally and the socket for a ridge purlin (Plate 12). The current ridge piece is a round timber which appears to relate to a later roof structure. There was a collar on this truss which has been cut, leaving the stubs of the timber still in place. (Plates 13 – 16) This timber was held in place with a halved lap joint which had two pegs driven through each of the joints (Plate 14, 16 - 18). There are a series of peg holes driven through the width of the cruck blades which mark the original position of the purlins associated with this truss. The upper purlins sat within slight trenches whilst the lower purlins would appear to have sat directly on the principal rafters. There is a burn mark on the northern principal rafter which is assumed to be the result of a candle being placed near to the truss (Plate 19). There is also a large iron nail on each of the principal rafters, above the level of the collar, the function of which is unknown (Plate 20).

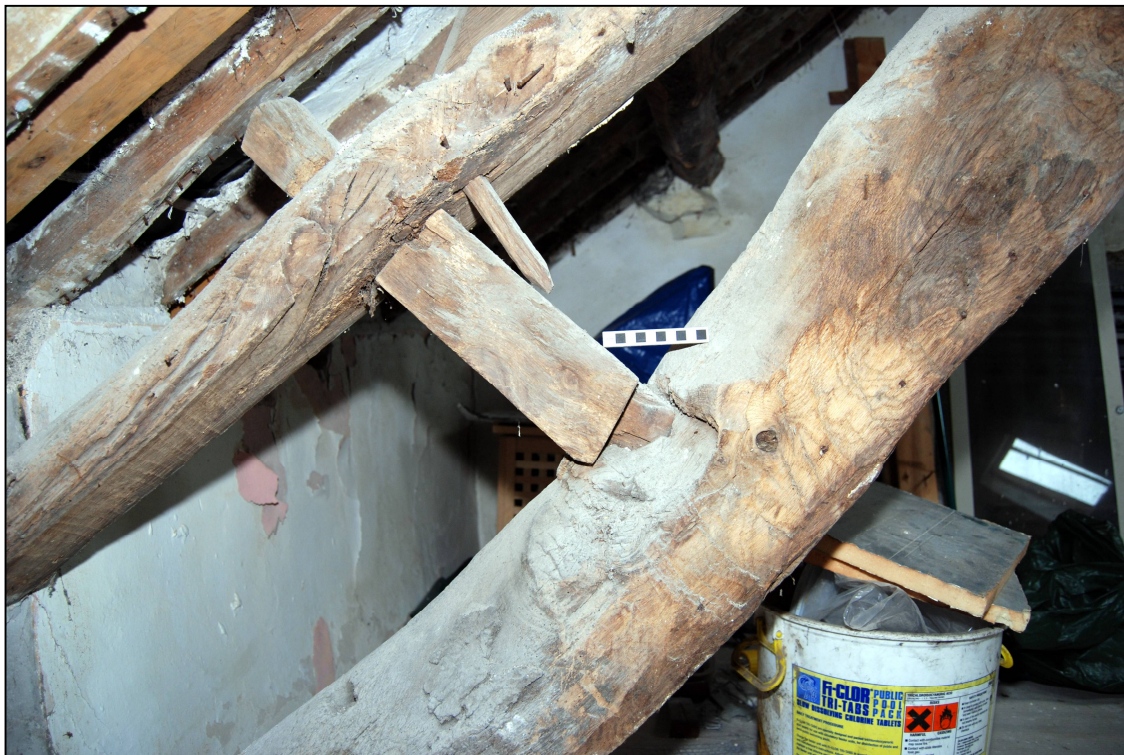
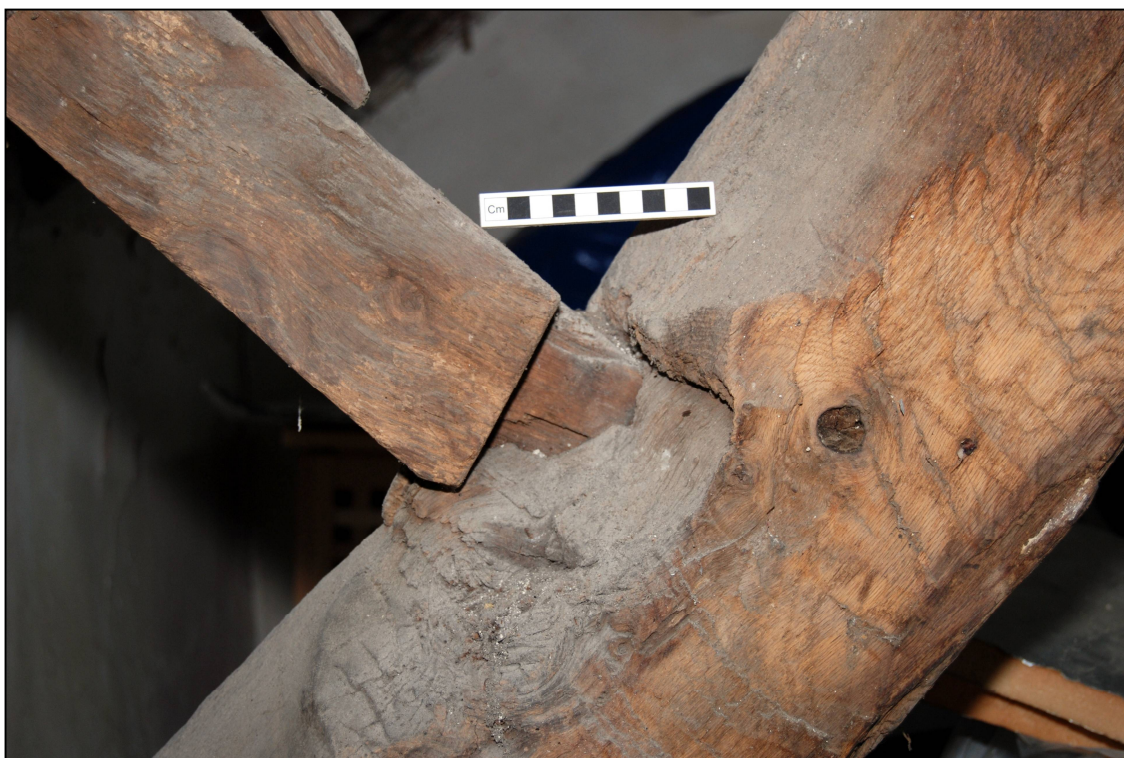
The angle of the roof has been reduced at some point in its history with addition of secondary rafters. On the northern side of the roof this was achieved by resting the secondary rafter on the cruck blade and the top of the stone wall on the north side of the building. On the southern side, however, short timber was used to support the secondary rafter with mortice and tenon joint to both the principal rafter and the secondary rafter (Plates 21 and 22). The purlins sit on top of the

Plate 21: Support for the secondary rafter on the southern side of Truss 1

Plate 22: Detail of the joint between the southern principal rafter and the support for the secondary rafter of Truss 1

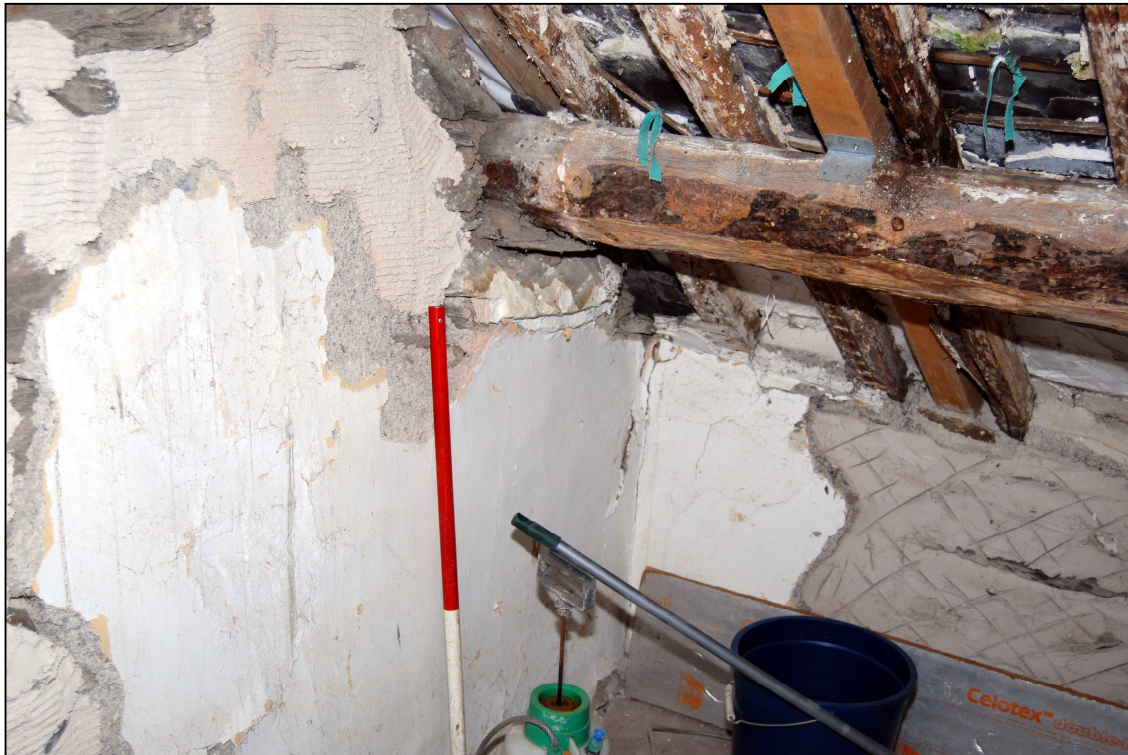
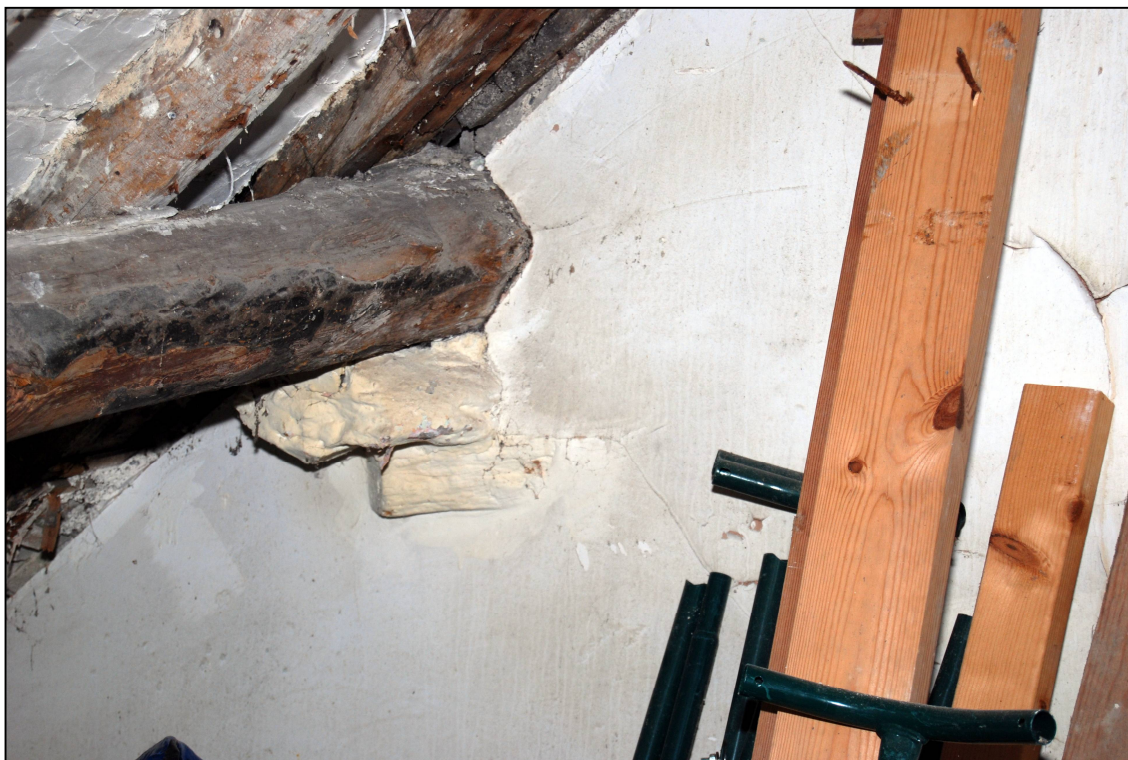
secondary rafters, three of which are supported by cleats. The lower northern purlin is also supported at each end of the room by rough stone corbels (Plates 23 and 24)

Plate 23: Rough corbel supporting the western end of the northern lower purlin

Plate 24: Rough corbel supporting the eastern end of the northern lower purlin

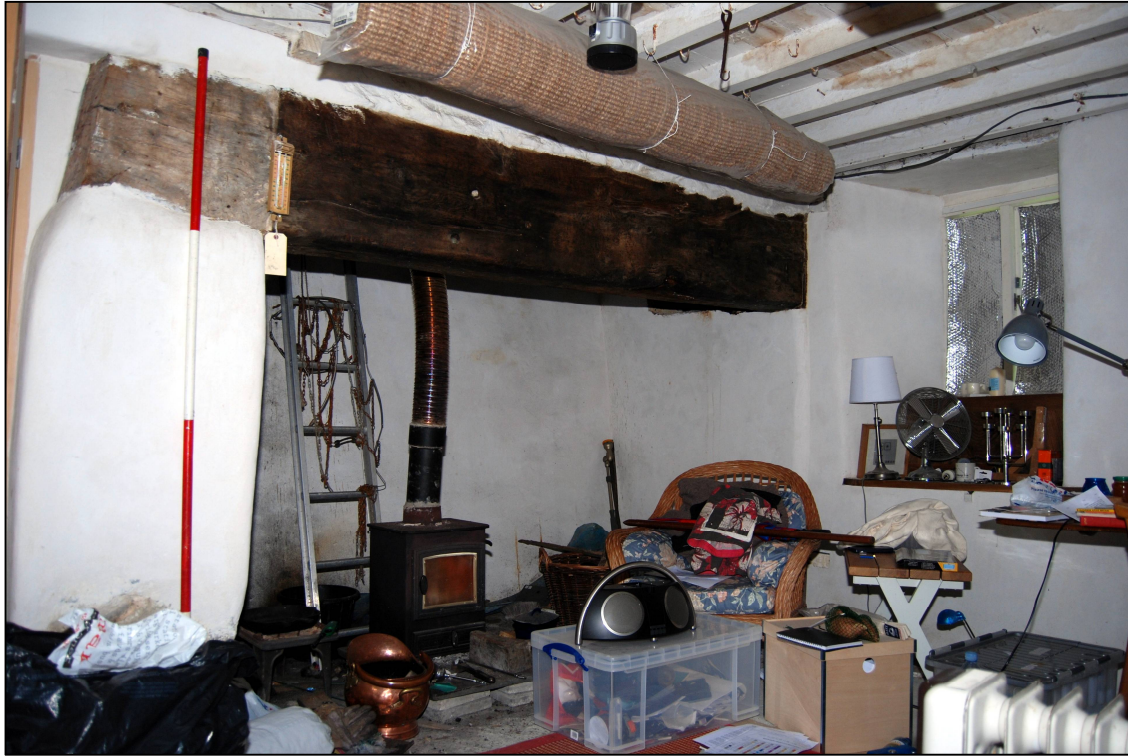
Plate 25: The fireplace

The lower western room is dominated by the inglenook fireplace under large straight bressumer (Plate 25). This bressumer is 430 mm deep and up to 350 mm thick although it is thinner along its lower edge (170 mm) with all of the tapering occurring on the back face of the bressumer (Figure 7). In the south western corner of the room is a recently revealed window (Plate 26, Figure 7). This has the remains of a wooden frame, the top rail of which appear to extend into the wall possibly suggesting the presence of an earlier timber frame. The window frame has a series of mortice holes suggesting the presence of central mullion and two vertical bars (Plate 27). The lower portions of Truss 2 extend into this room with the lower section of the cruck blades partly embedded in the walls (Plates 28 – 31). When these blades were exposed in the restoration work the sockets for lateral rails was noted suggesting the building may have originally been timber framed (A. Brown *pers. comm.*). The northern blade would appear to have been modified (Plate 29) to allow greater access to this point of the room. Adjacent to southern blade of the truss a timber set in the wall and an uneven surface would suggest the presence of a blocked doorway (Plate 32). This doorway is roughly opposite the partly blocked doorway in the northern wall; however the two doors do not align completely.

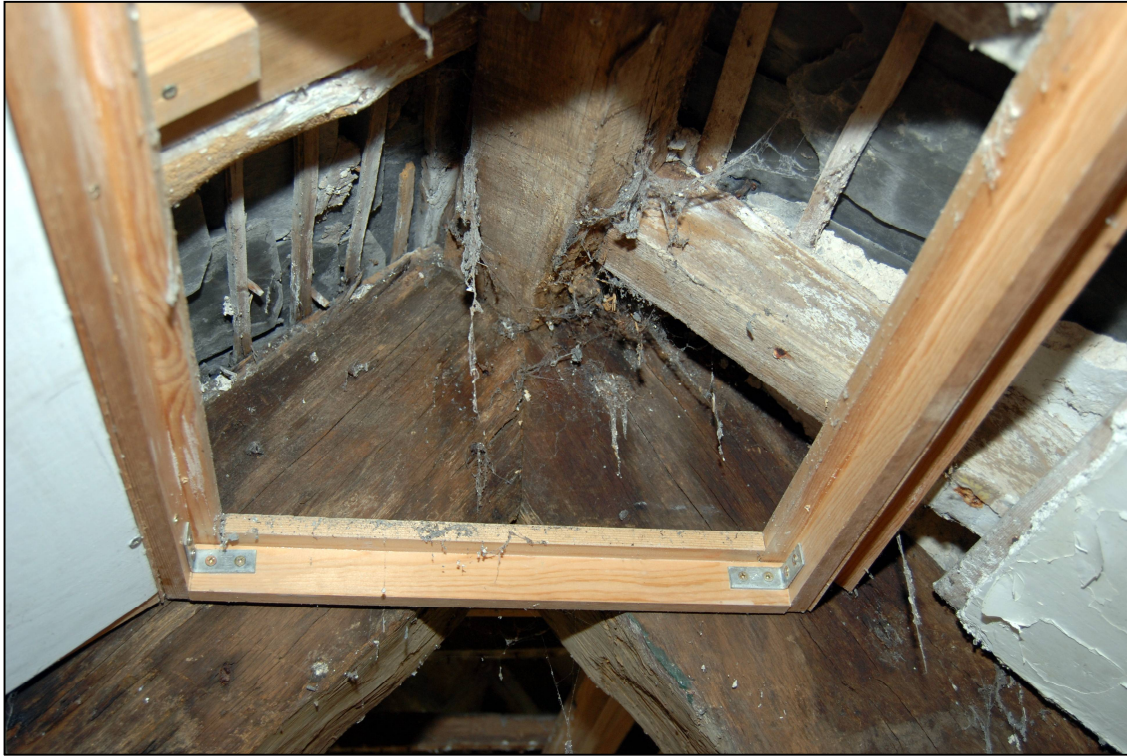
Plate 33: Peak of Truss 2

Truss 2 (Figure 6) is exposed in the attic above the western room (Plates 33 – 35). This is a cruck frame of Alcock's Type B (Alcock 1981, 95) with blades that meet on a vertical line, with a collar below the apex (Plate 33) and a ridge purlin in a trench. The collar for this truss has been removed; whilst the northern lap joint is straight (Plate 37) the southern joint is shaped (Plate 36). The upper purlins are still within trenches on the top surfaces of the principal rafters, however the lower purlins are associated with secondary rafters on the lower sections of the truss (Plates 38 and 39). The lower southern purlin is supported by a cleat, whilst the lower, northern purlin is trenched. The cruck frame is smoked blacked in places suggesting it may have been in an open "hall".

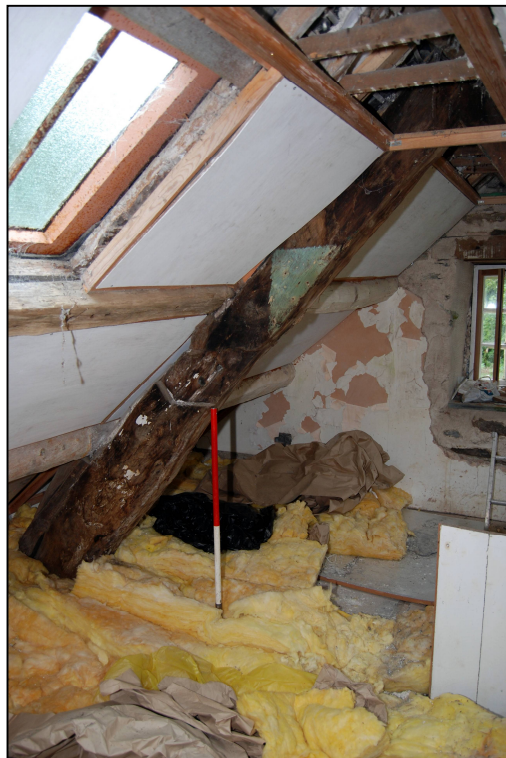
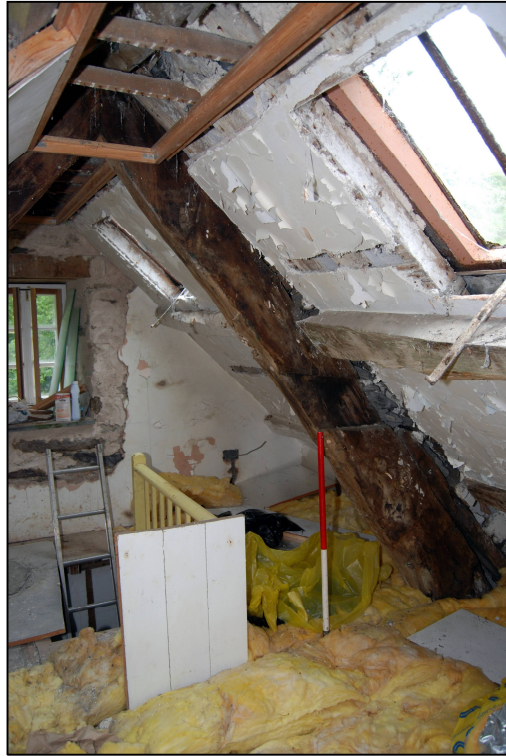
Plate 34: The southern blade of Truss 2

Plate 35: The northern blade of Truss 2
