***Archaeological Assessment of 11 Castle Street, Conwy***

***Engineering Archaeological Services Ltd  
Client Report 2009/7a***

***October 2012***

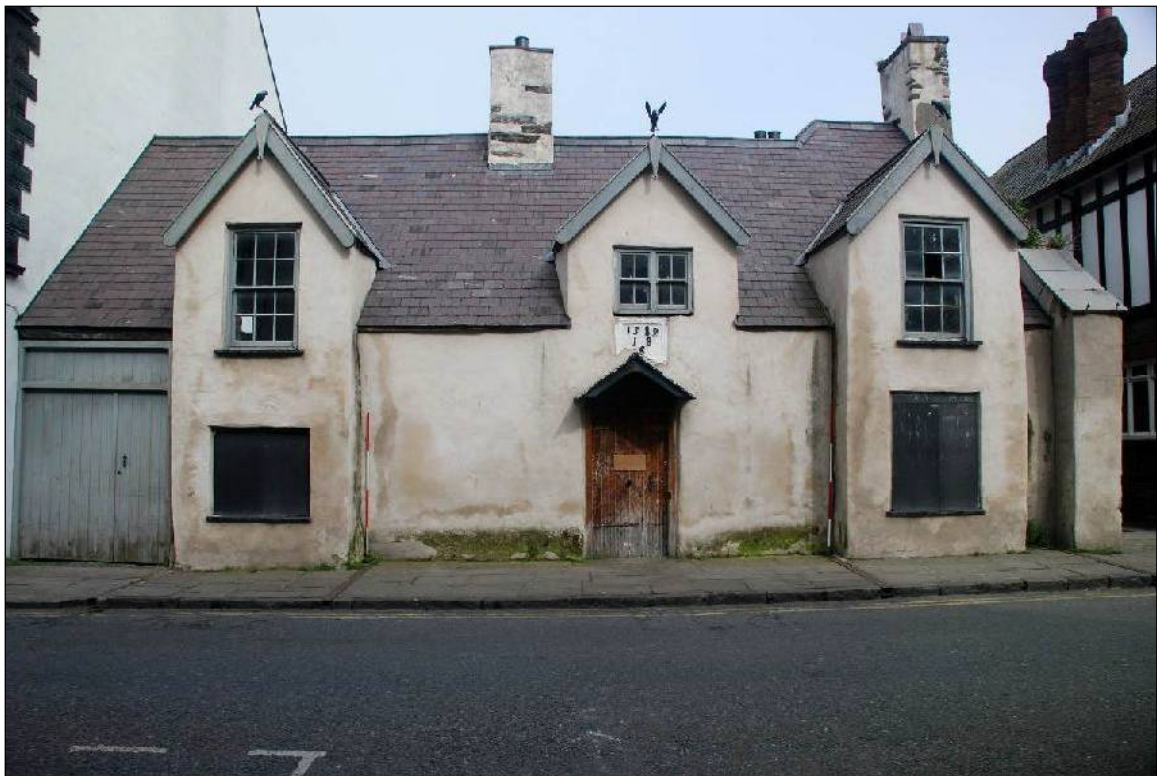
Plate 1: 1885 Photograph (Source Peoples Collection Wales)

Identified published and other sources in CRO, LIRO and NLW were not found to be extensive. This reflects the probability that the house was the vicarage and did not form part of a landed estate. Given that the town of Conwy does not seem to have been subject to tithe, there is no information about the property in the tithe map or apportionment of 1846. No historic maps show the property in any detail and the only historic photograph dates from c. 1885 (Plate 1).

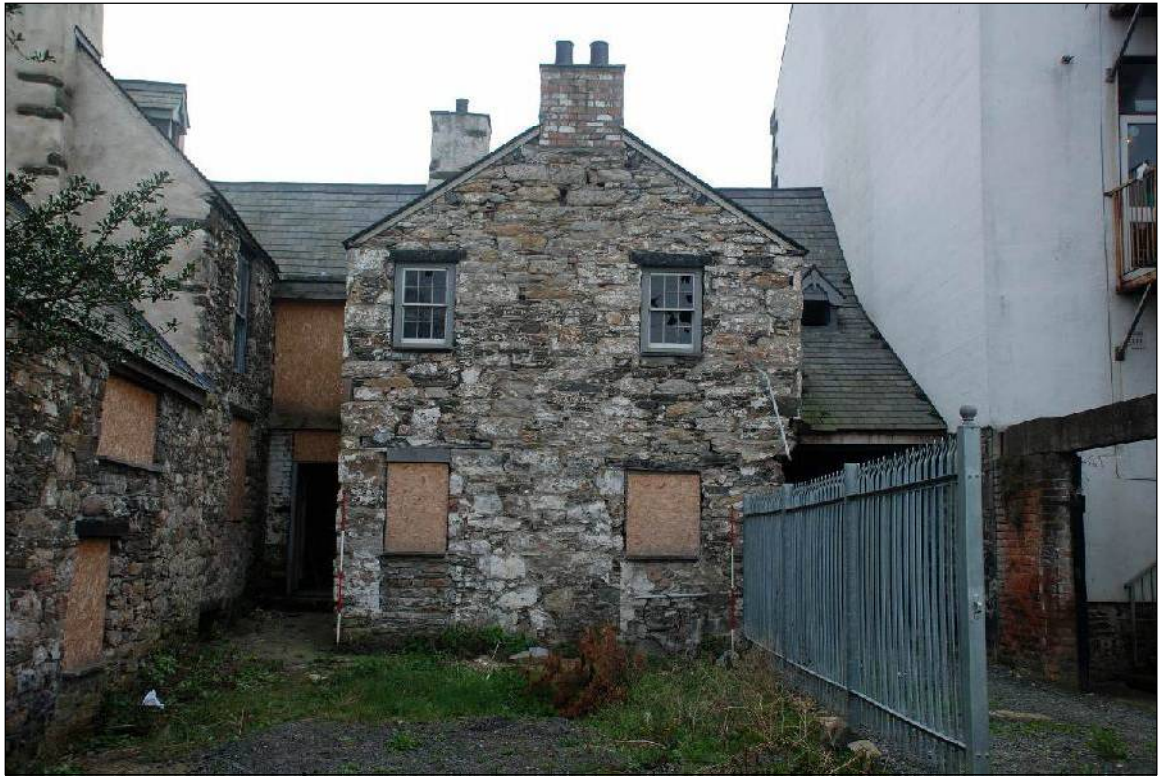
Plate 13: New Kitchen range.

The added kitchen range has random rubble wall construction with a pitched roof running at right angles to the main domestic range (Plate 13). The northern gable has four window opening, a brick chimney stack and exposed purlins. The upper windows have twenty first century replacement sash windows, presumably in original opening and the lower windows are boarded, but also contain modern replacement windows. The eastern ground floor window has a blocking of random rubble, possibly indicating the position of a doorway. There are slight cracks between each of the pairs of vertically aligned windows, possibly relating to a change in window style. There is also the scar of a twentieth century toilet block on this gable wall. One other blocked opening occurs on the east facing wall of the kitchen range which was probably a window opening.

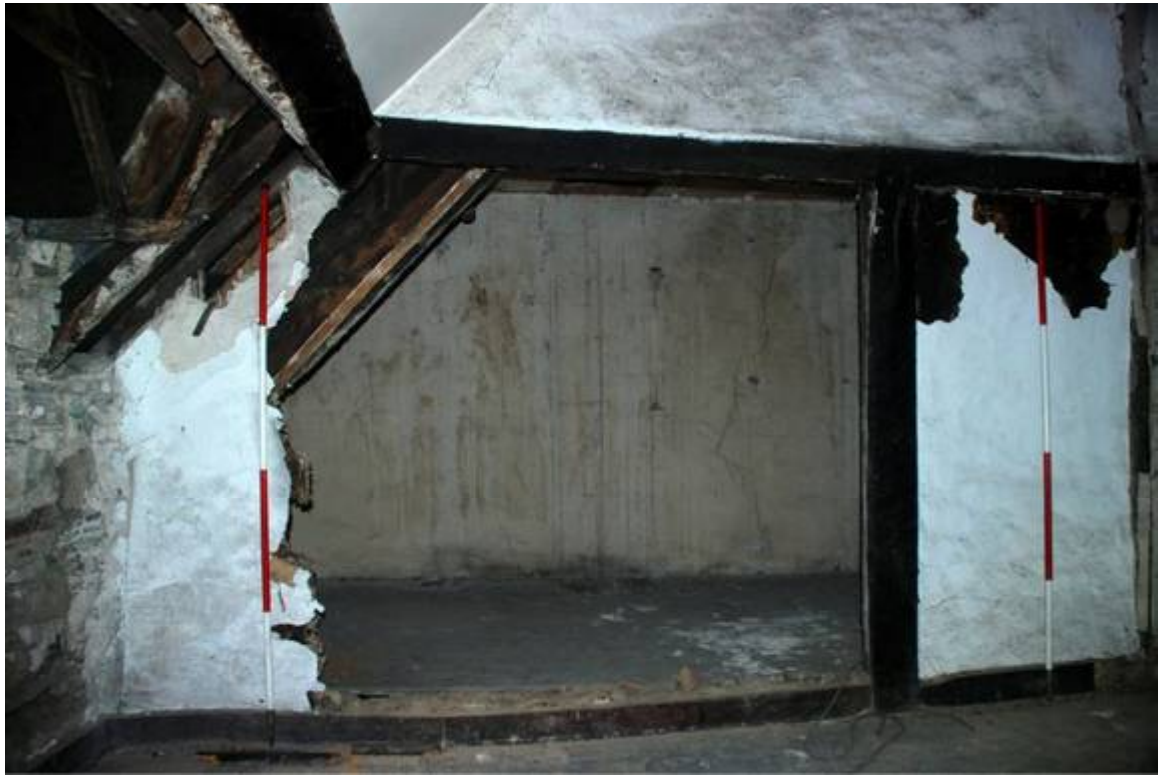
Plate 51: The partition below Truss 1

The partition below Truss 1 (Plate 51) consists of wattle and daub (Plate 52). A series of roughly shaped staves are supported in a wooden plate, around which split round-wood wattles are woven. The daub used to produce a smooth wall was found to contain animal hair as part of its makeup. An opening through this partition existed at its northern end. Surviving on this partition is the evidence for at least four decorative schemes with differing layers of wall paper surviving in patches (Plates 43 – 55). The date of partition is uncertain, however, it appears to be soot blackened in places, suggesting it may be of some antiquity.

3. There are some vulnerable features such as wattle and daub partitions within the house. These should be preserved if possible and protected from further damage. Specialist advice should be sought on the conservation of these panels.

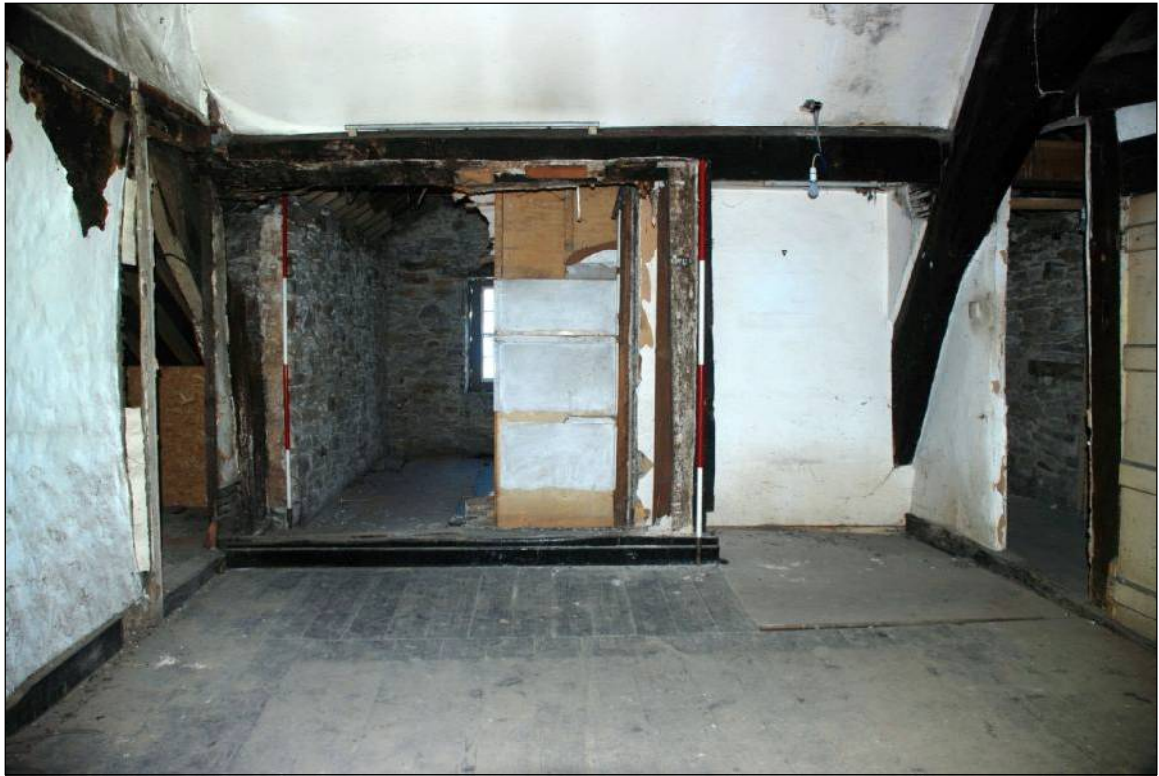
Plate 61: Room 4 looking north

The hole for a now missing staircase is within the north eastern corner of the room, adjacent to the wall with Room 6 (Plate 61). This appears to be associated with the remains of a partition which ran from these stairs to the partition below Truss 1, thereby forming a short corridor parallel with the rear wall of Room 4. This partition survives only as a plate with a series of mortice holes suggesting a plank construction (Plate 62)

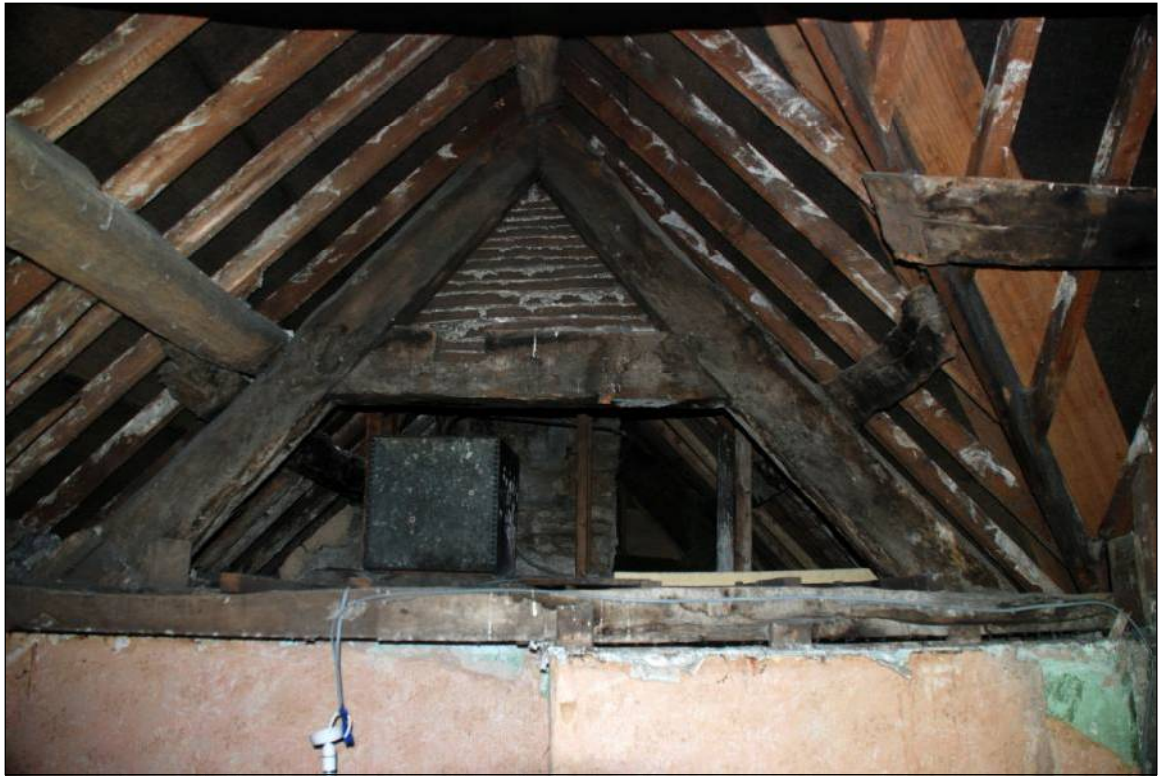
Plate 67: Staggered overlap on upper front purlin in Room 5

At the front of the property the two purlins noted in Room 4 continue to the gable wall. The upper, front, purlin has a staggered overlap (Plate 67) with a possibly newer timber. The lower front purlin has been modified to allow easier access to the bay window (Plate 68). To the rear of the truss the purlins have been truncated to allow for the join to the roof running over the range running at right angles to the road. The earlier roof line is partly preserved by the short lengths of the common rafters surviving either side of the bay window (Plate 69).

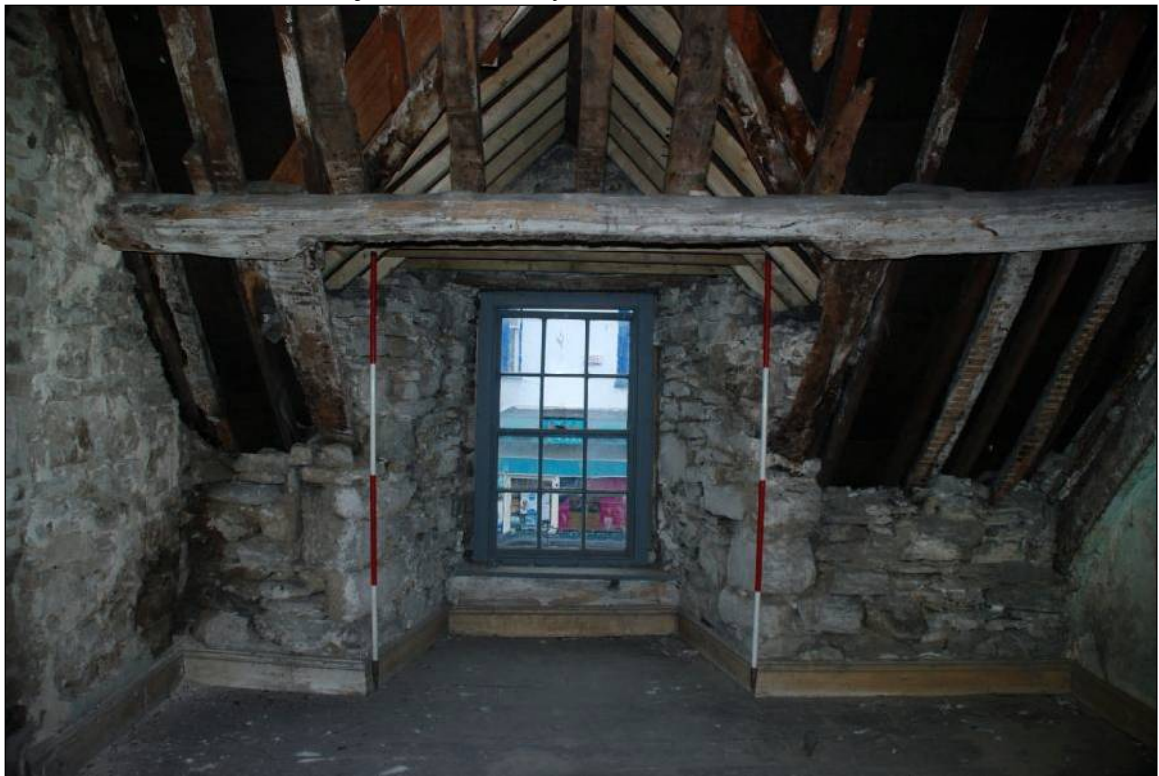
Plate 70: Bay window in Room 5

As in Room 4 it is clear that the bay window in the front wall has been inserted (Plate 70) and, as has been noted above, this also involved the modification of the purlin crossing the line of the window.

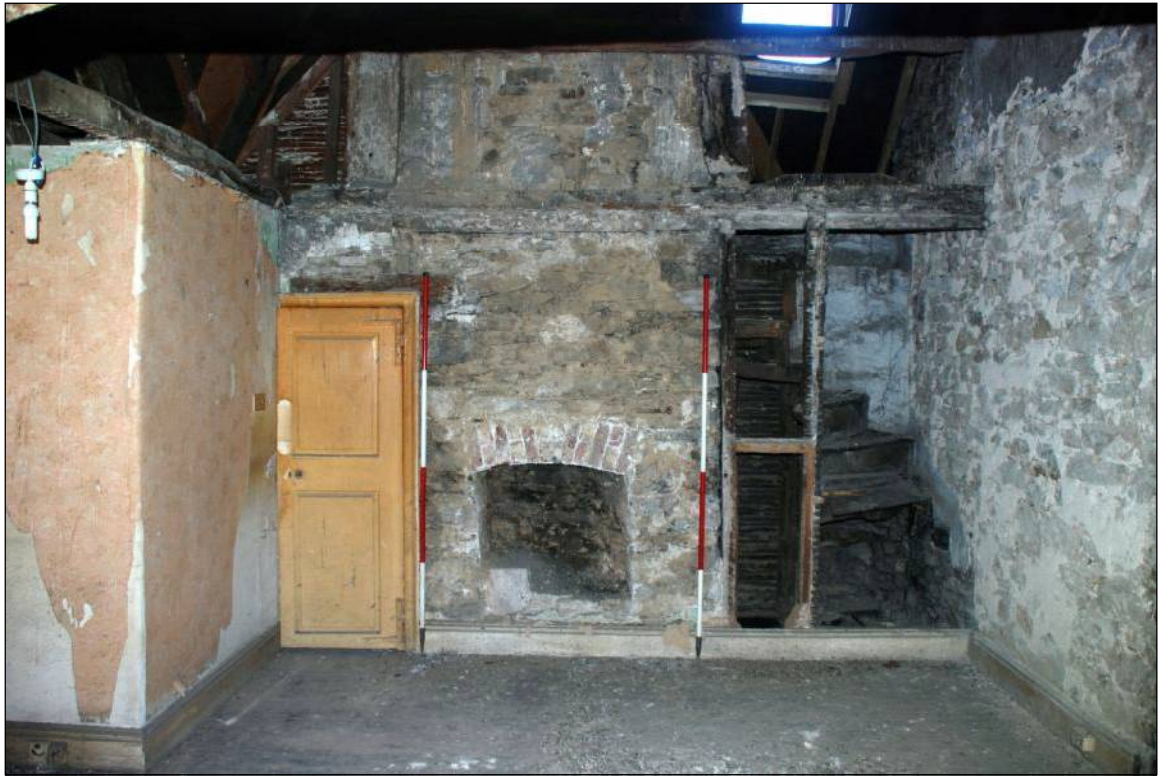
Plate 71: Chimney on north side of Room 5

On the northern side of the room is the chimney noted in Room 2 (Plate 71). Whilst this must be inserted into the original building it incorporates two large studs which supports the remains of the purlins which originally ran to the north into the wing set at right angles to the road (Plate 72). It is not certain as to whether the chimney was constructed so that it fitted between the purlins, or that the construction of the chimney and the roof for the axial range are contemporary. There is also evidence for a second chimney having been inserted into the eastern gable wall (Plate 73).

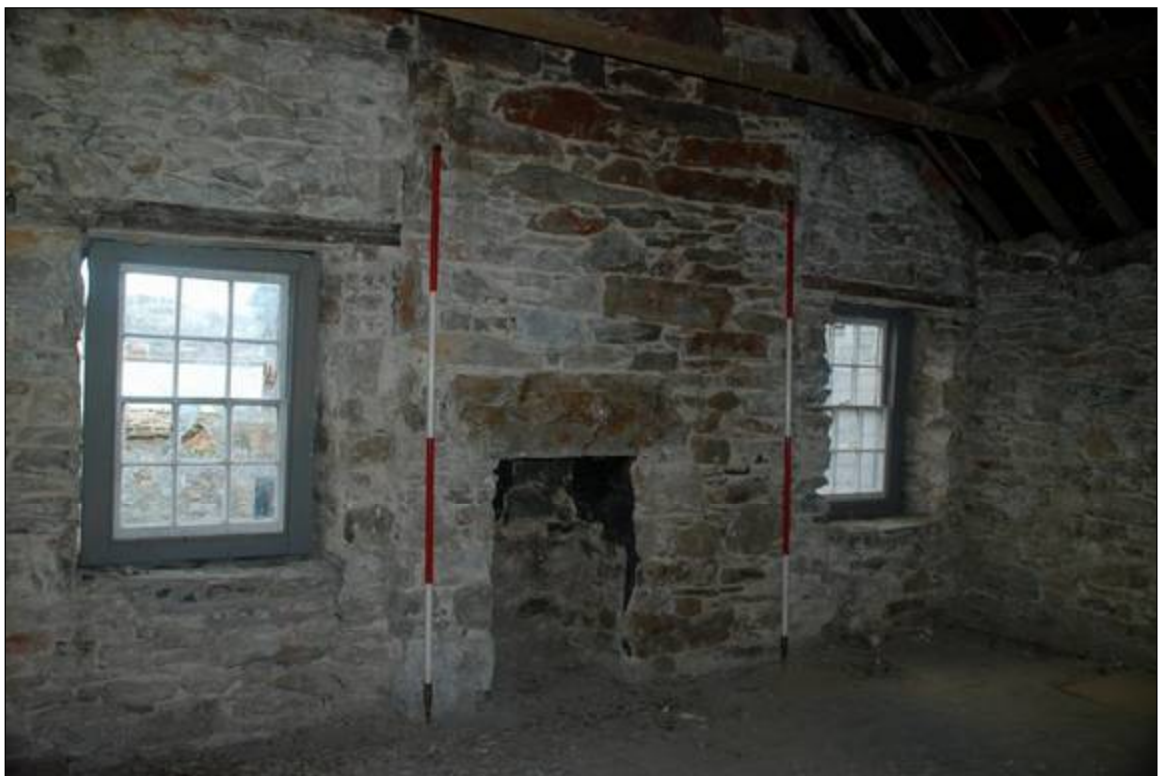
Plate 76: Room 6, chimney and fireplace

Room 6 is directly above the “New Kitchen” to the rear of Room 4. The room has the chimney from the kitchen below passing through its northern wall and has a fireplace incorporated into the chimney breast (Plate 76). This has a stone lintel and is slightly offset in the chimney breast to the west. Either side of the chimney are window openings which contain twenty first century replacement windows.

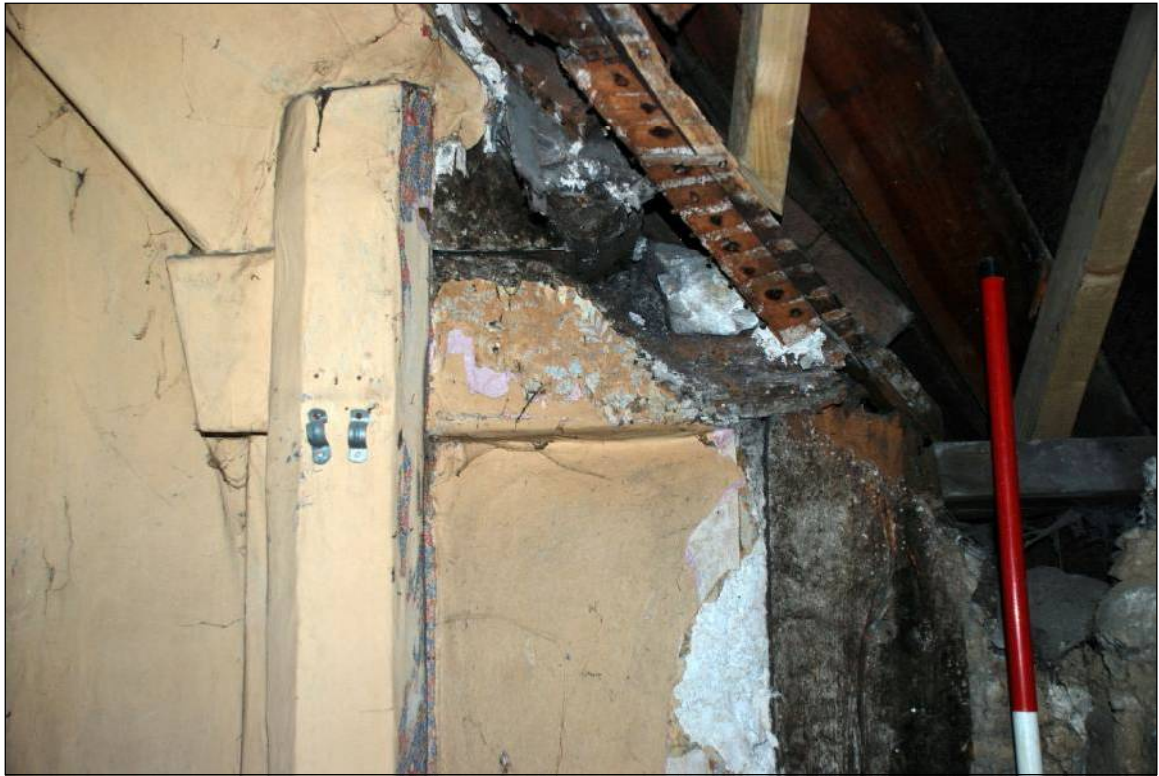
Plate 85: Base of Truss 3, Room 7

The foot of Truss 3 is visible in the partition wall between Rooms 7 and 5. It sits on top of a collar which in turn was supported by a post adjacent to the front wall of the property (Figure 18.1, Plate 85). Both the collar and the post are assumed to be part of the repairs to the truss noted in Room 7. The collar was further modified when the staircase was inserted into the building, when it was cut off and the loose end supported by another post. It is possible that this new post may have been made from the section cut off the collar.
