DAVID CLEMENTS ECOLOGY LTD

**CATHAYS LIBRARY, CARDIFF,
SOUTH WALES**

SURVEY FOR BATS

September 2008

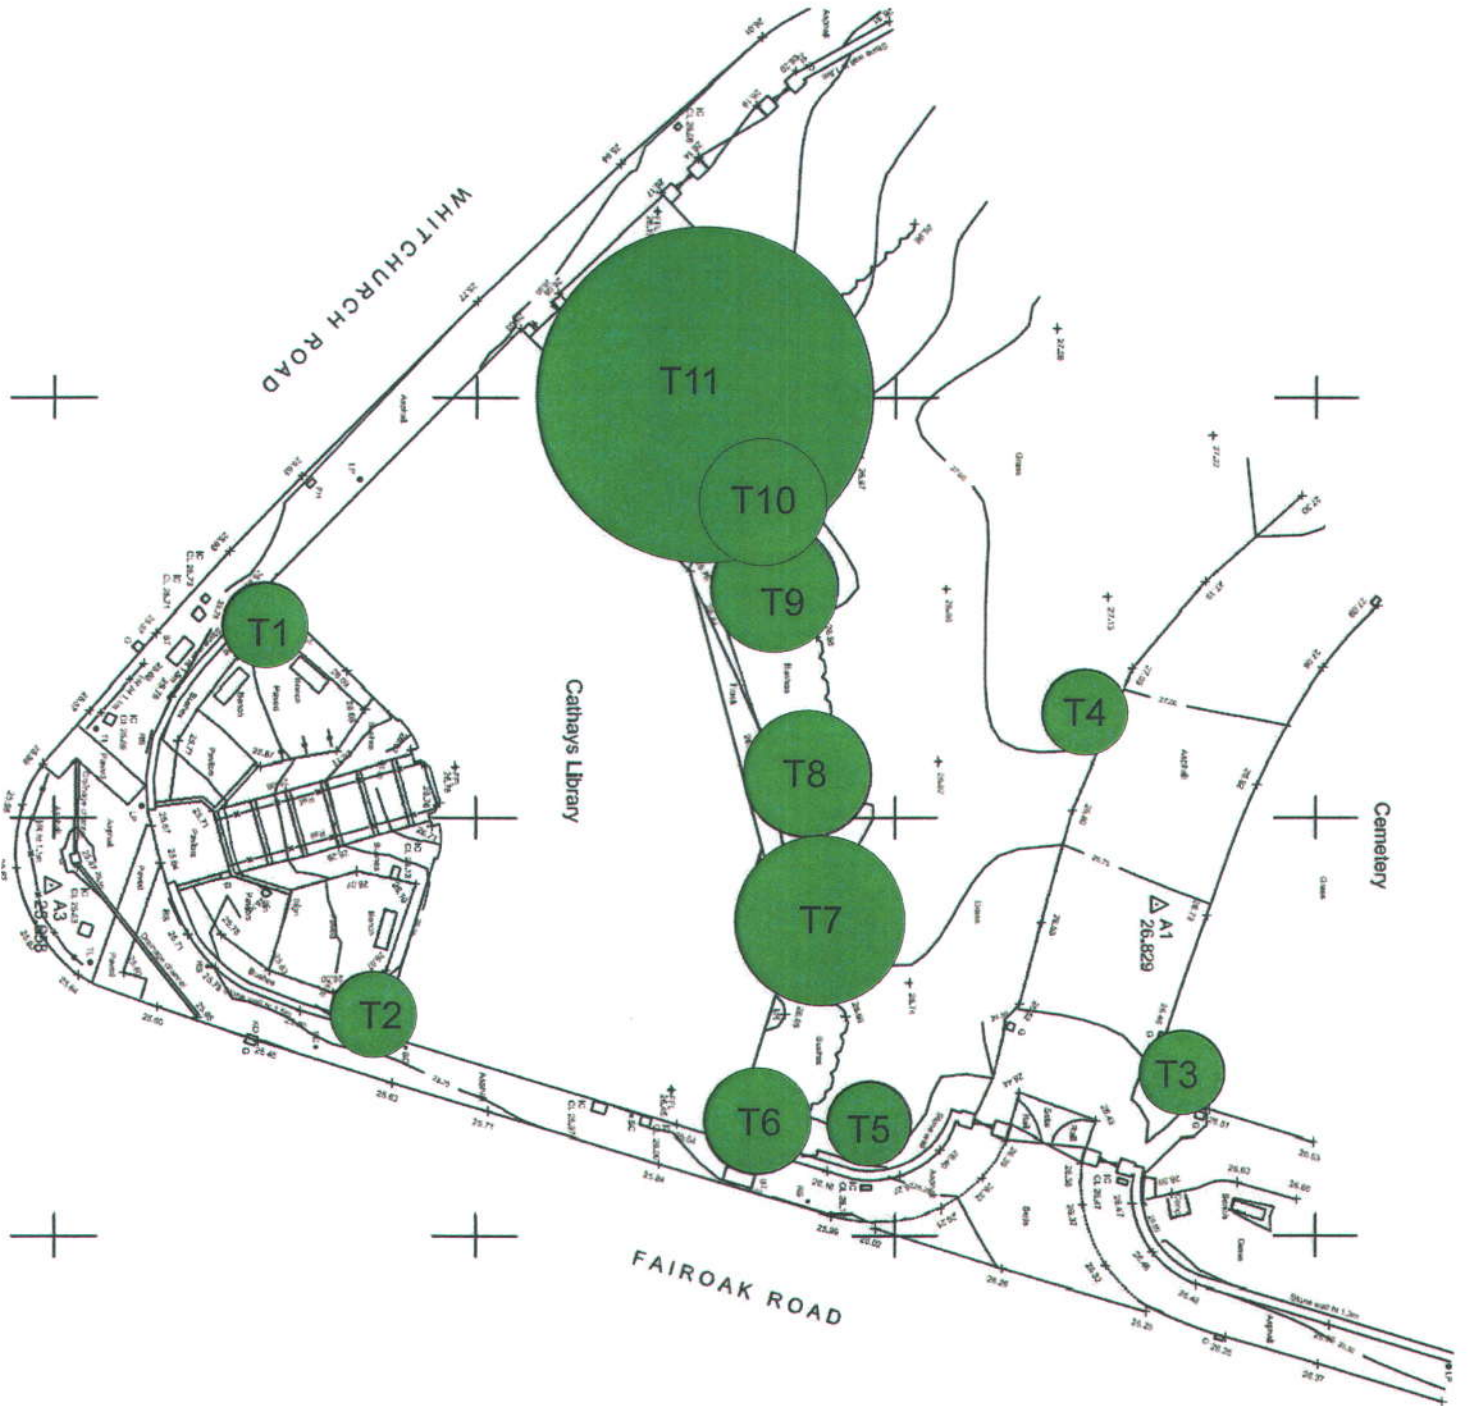
Plan 1: Tree Survey Results

- 3.1.11 The results of the tree survey were as follows:

No.	Description	Evidence of Bats	Potential for Bats
T1	Leyland cypress (x <i>Cupressocyparis leylandii</i>), twin-stemmed from base with DBH's of c18m and c13cm; no obvious crevices or cavities; no obvious fungal growth or decay; no obvious split limbs or broken branches; no ivy cover.	Nil	Low

No.	Description	Evidence of Bats	Potential for Bats
T2	Group of 3 Leyland cypress (<i>x Cupressocyparis leylandii</i>) trees growing close together. The trees have DBH's of c16cm, c16cm and c20cm, none of the trees have any obvious fungal growth or decay; no obvious split limbs or broken branches; no ivy cover.	Nil	Low
T3	Ornamental cherry (<i>Prunus</i> sp); 17cm DBH; no obvious crevices or cavities; no obvious fungal growth or decay; no obvious split limbs or broken branches; no ivy cover.	Nil	Low
T4	Ornamental cherry (<i>Prunus</i> sp); 14cm DBH; no obvious crevices or cavities; no obvious fungal growth or decay; no obvious split limbs or broken branches; no ivy cover.	Nil	Low
T5	Ornamental cherry (<i>Prunus</i> sp); 17cm DBH; no obvious crevices or cavities; no obvious fungal growth or decay; no obvious split limbs or broken branches; no ivy cover.	Nil	Low
T6	Leyland cypress (<i>x Cupressocyparis leylandii</i>); 17cm DBH; single-stemmed to a height of c1.5m before branching to give a twin-stemmed mid crown; extensive flaking bark; no obvious crevices or cavities; no obvious fungal growth or decay; no obvious split limbs or broken branches; no ivy cover.	Nil	Low

T7	Scot's pine (<i>Pinus sylvestris</i>); c65cm DBH; very tall tree with one main limb with almost no forks or side branches; extensive flaking bark which is moderately rugose.	Nil	Low - Moderate
T8	Leyland cypress (<i>x Cupressocyparis leylandii</i>); c65cm DBH; the trunk is surrounded by dense ivy growth which itself has a large girth of up to 15cm; ivy cover extends into the canopy.	Nil	Low
T9	Leyland cypress (<i>x Cupressocyparis leylandii</i>); c45cm DBH; dense ivy cover extending into canopy; no obvious crevices or cavities; no obvious fungal growth or decay; no obvious split limbs or broken branches.	Nil	Low
T10	Leyland cypress (<i>x Cupressocyparis leylandii</i>); c50cm DBH; dense ivy cover extending into canopy and fruiting extensively at top of canopy; no obvious crevices or cavities; no obvious fungal growth or decay; no obvious split limbs or broken branches.	Nil	Low - Moderate
T11	Lime species (<i>Tilia</i> sp); c65cm DBH; single-stemmed to a height of 1.75cm before stem trifurcates to give triple-stemmed mid crown with DBH's of c35cm, c30cm and c25cm; all of the forks high up in the canopy are narrow, acutely angled and v-shaped, as is typical of this species. There is one fork with occluded bark and possibly a small cavity within the fork; bark smooth with no significant delamination; no obvious fungal growth or decay.	Nil	Moderate

- 3.2.4 No evidence of roosting bats was found in any of the inspected trees, and the majority were assessed as having low potential for use by roosting bats. One tree (T11) was considered to have moderate potential for use by roosting bats, and two trees (T7; T10) were assessed as having low-moderate potential, but none of these were considered to be in any way exceptional in this regard.

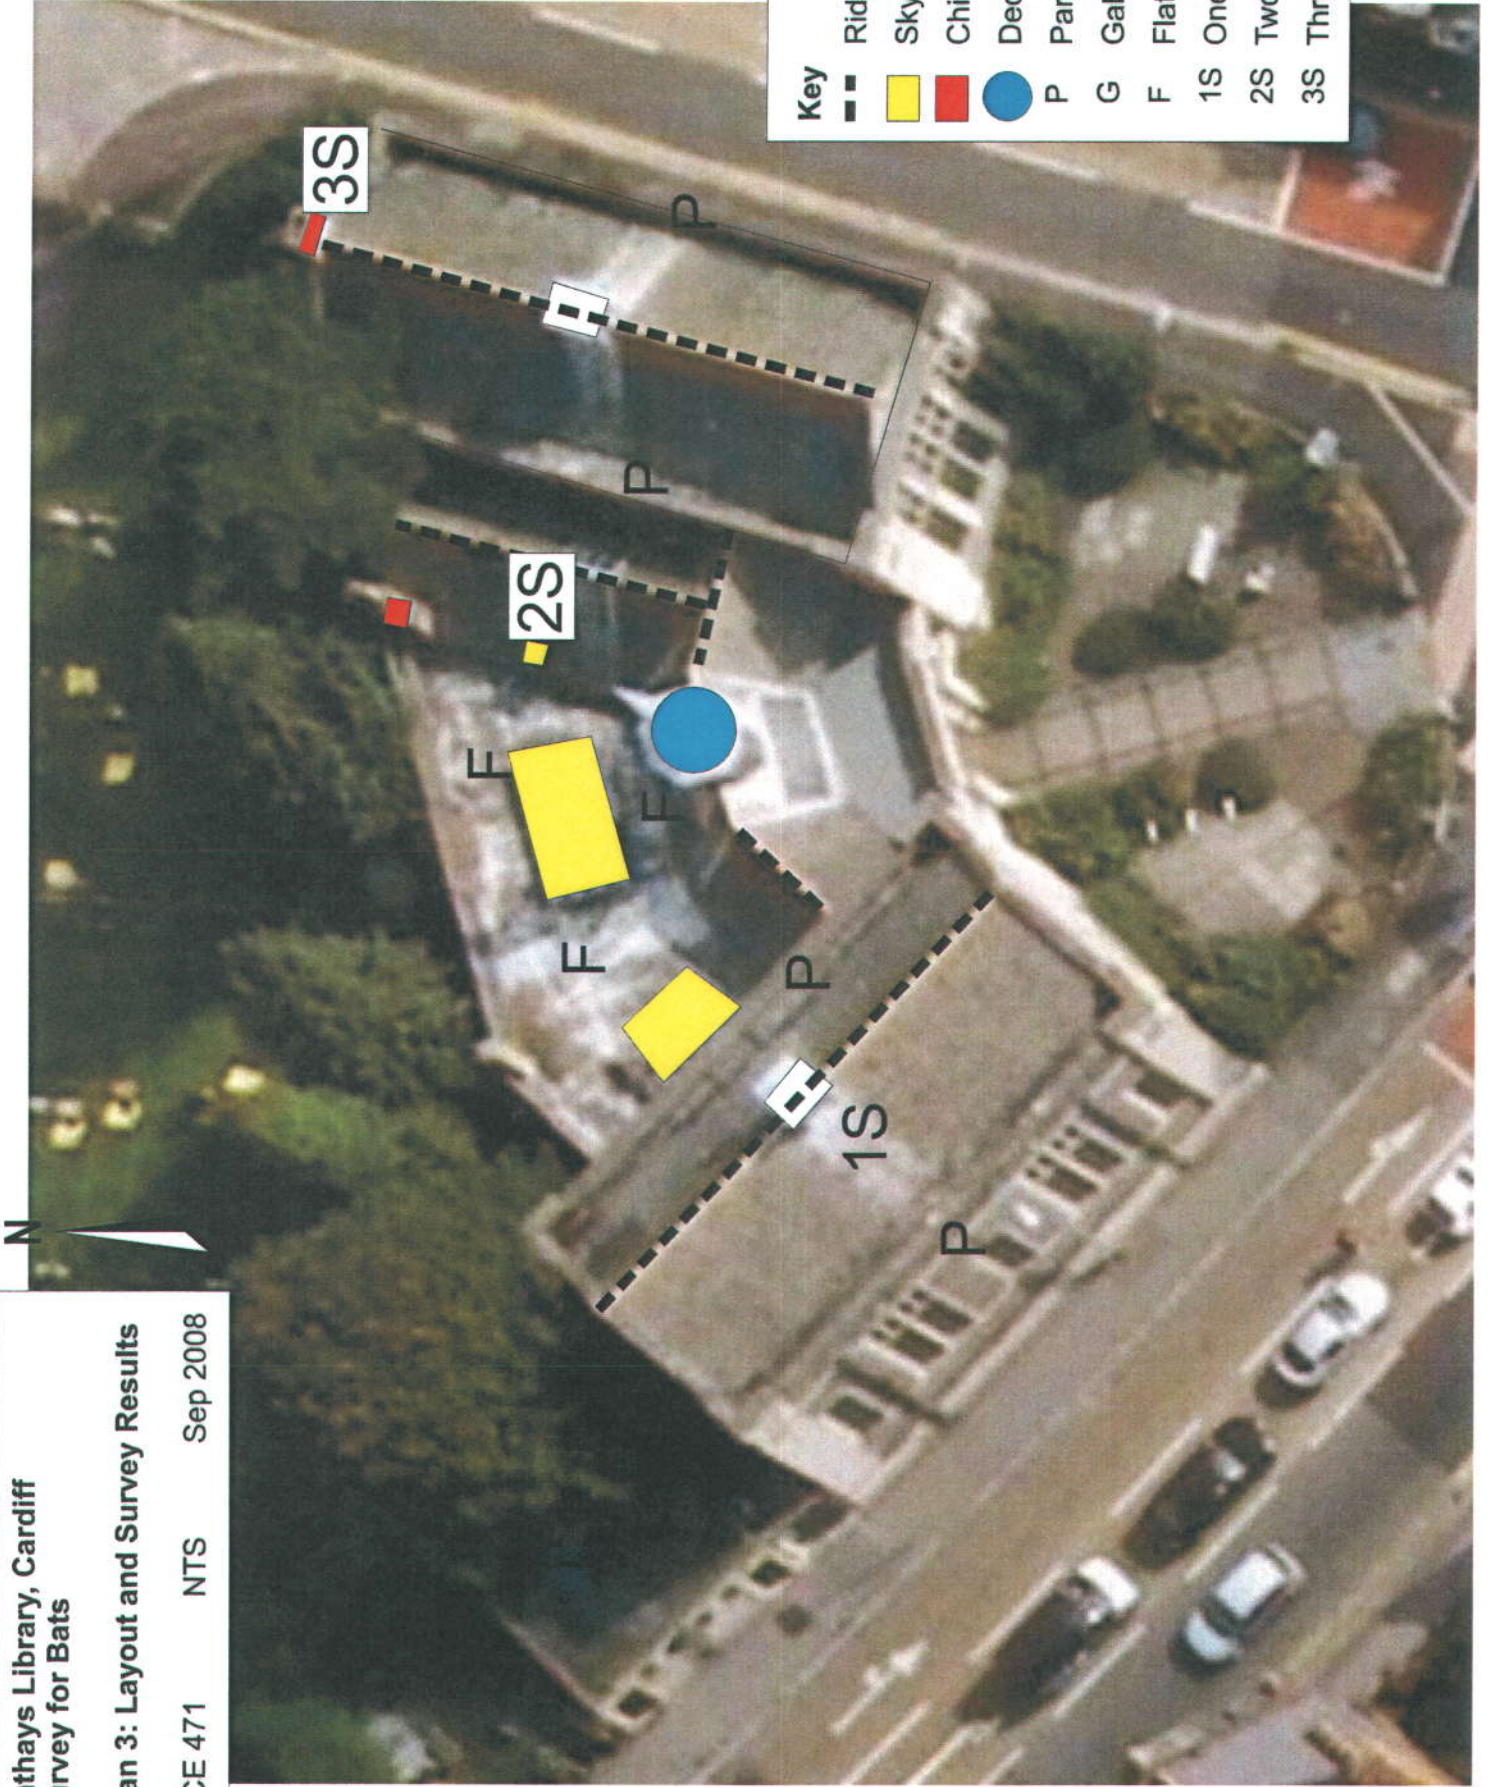
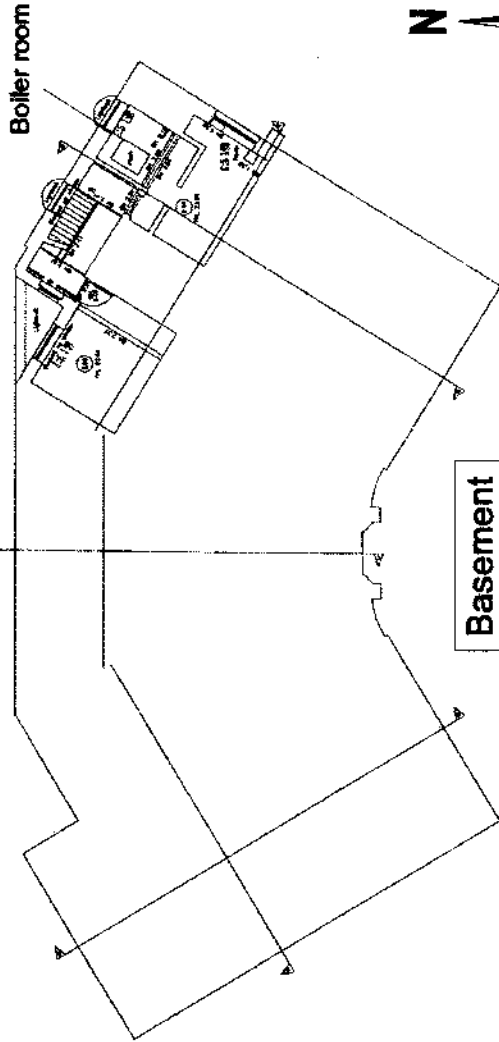
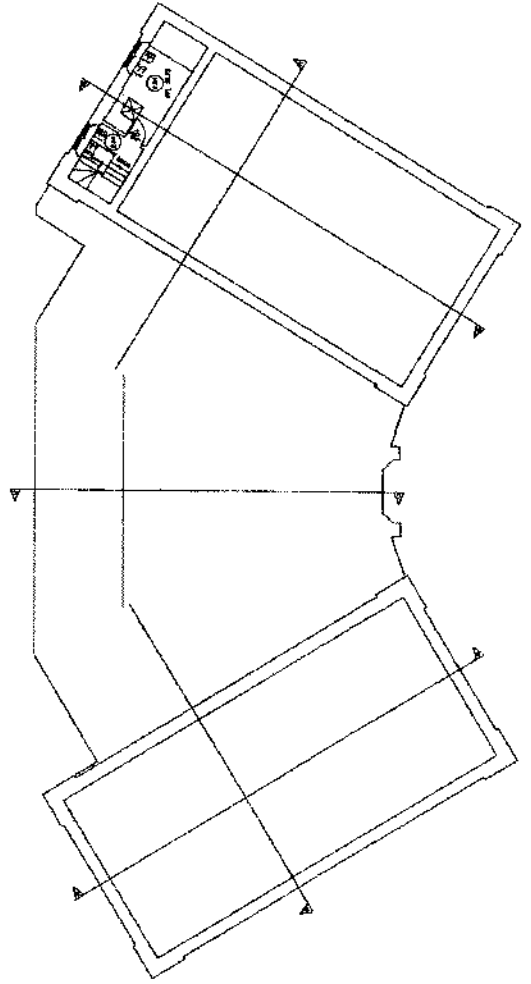
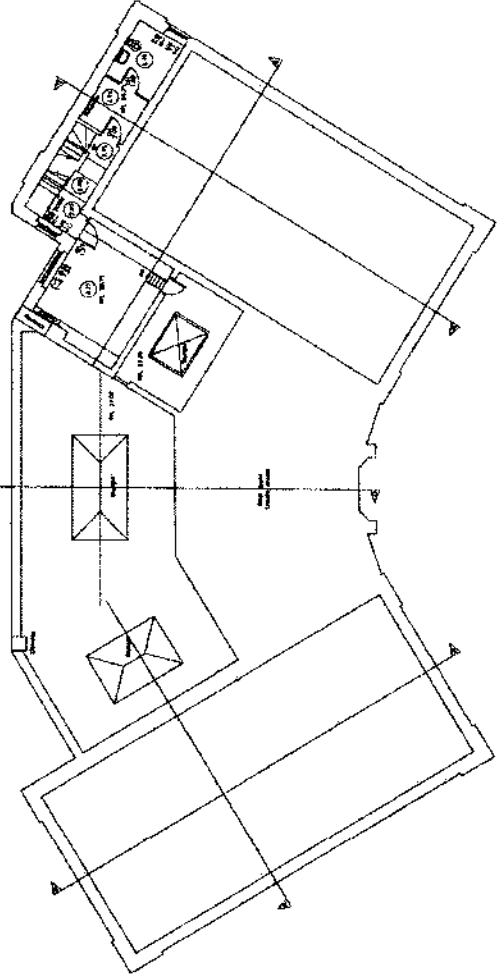
Plan 2: Layout and Survey Results

- 3.1.2 The building comprises three connected parts. The central part of the building is low and single storey, and houses the main library. This part has a flat roof over the northern section, with associated hipped glass skylights, and a ridged roof over the southern section with a decorative circular 'spire' to provide illumination into the area. At the eastern and western sides of this central building there are two identical hall-type wings, each lit by lofty church-like windows. Both of these contain rooms with high vaulted ceilings below ridged roofs, one of which run broadly from north to south, whilst the other runs broadly from north-west to south east. The northern part of the eastern wing has a set of stairs giving access to two further floors and a basement.

- 3.2.1 No signs of bats were found anywhere in or around the building. The building was assessed as being moderately suitable and attractive for roosting bats. The apparent absence of bats may be due to the lack of potential access points within the attic spaces, and possibly also thermal instability as a result of poor insulation and lack of lining.
- 3.2.2 No signs of any other protected species were found anywhere in the buildings. It is, however, possible that birds such as house sparrows nest on the exterior in some years.

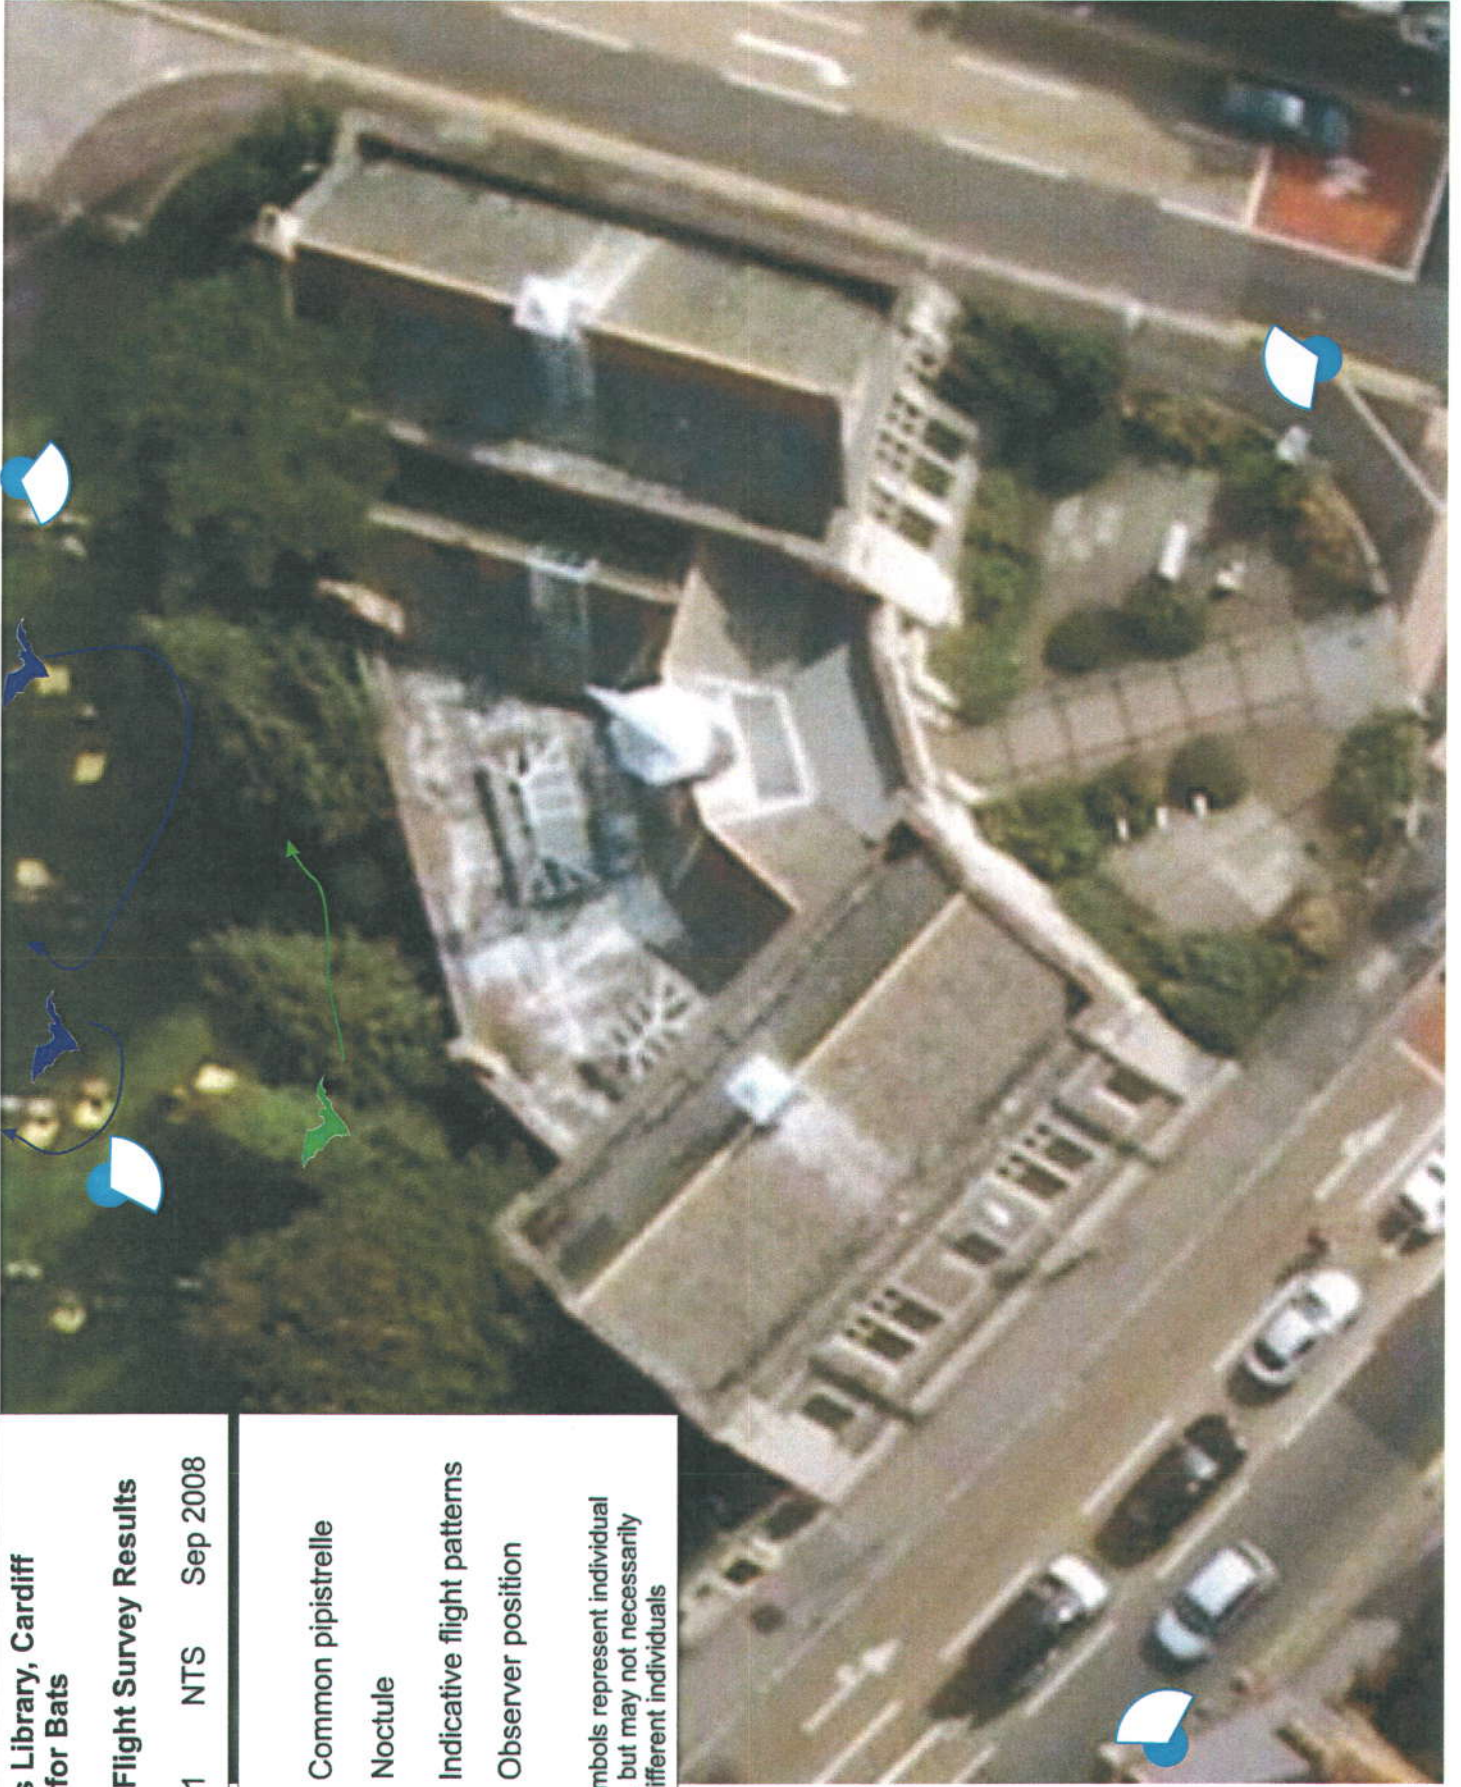
Plan 4: Flight Survey Results

- 3.3.1 The flight/emergence survey did not detect any bats emerging from the building or the trees. individual common pipistrelles were detected flying to the north of the building within the adjacent Cathays Cemetery, but no activity was recorded around the building itself. The survey also detected occasional noctule bats (a tree-roosting species) flying high over the site. All of the bats recorded clearly originated from off-site, however.

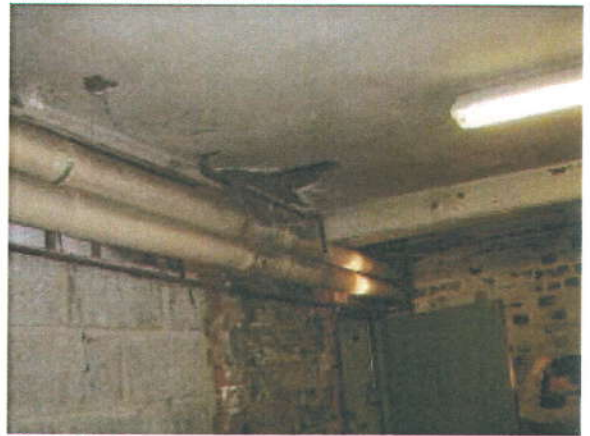
Photo 10: Basement

- 3.1.3 The northernmost part of the eastern wing of the building has a sub-floor space (basement). This is head-height, and extends across the eastern side of the building. The basement is accessed by a flight of stairs and is divided into two main rooms, one of which is further divided into two and houses the boiler. All of the rooms and the associated hallway were flooded and waterlogged at the time of the survey, holding approximately 5cm of water throughout. The boiler room is believed to be used and disturbed quite regularly, but the other two basement rooms are neglected and no longer in current use.

- 3.1.4 The walls of each of the basement rooms comprise a combination of brick and stone. One of the rooms has a former window which has been filled in with breeze block. A former coal chute, now boarded with a metal panel, is present on the eastern wall of the basement where it adjoins Fair Oak Road. A window boarded with timber is also present on this wall. A wooden louvered vent is present in the boiler room on the northern wall of the basement. The ceilings are all of lathe and plaster supported on steel girders. The boiler room has various pipes covered with plastic lagging. One of the basement rooms has several large gaps in the ceiling. These rooms all have a moderate degree of cobwebbing, particularly in the corners.

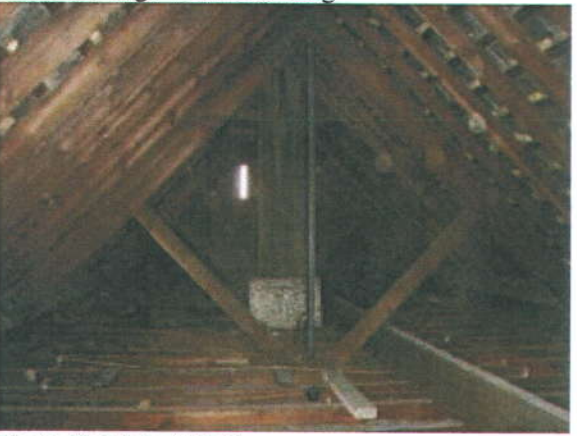
Photo 13: Main Attic Space

- 3.1.6 There is a large attic space over each of the two high vaulted wings, although only that of the eastern wing adjoining Fair Oak Road could safely be accessed. Both attics appear superficially to be identical.

- 3.1.7 The roof of the eastern wing is supported on a standard king post timber construction, with tie beams and the usual purlins, rafters and battens. There is a slate roof, although there is no felt, sarking or other lining under the tiles. The void lacks decking, is unlined and contains electrical wiring throughout. A decorative metal structure is present in the central part of the ridge. It is assumed that the attic of the western wing has a similar construction. The exterior of the roofs of these parts of the building have parapets and turrets on the side walls.

- Cobwebs should be removed from all roof voids wherever possible.

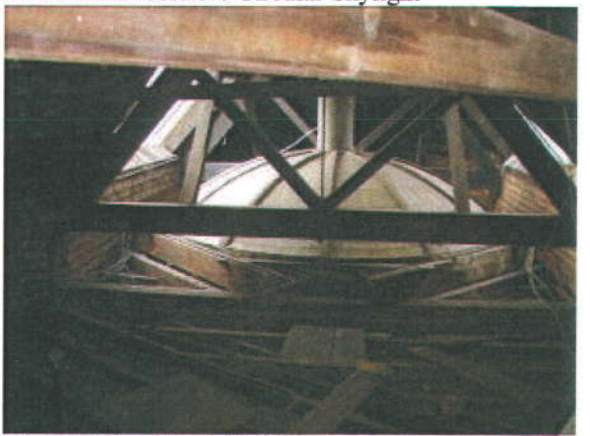
Photo 14: Smaller Attic Space

- 3.1.8 Another attic space is present to the north-west of the eastern wing. This is ridge roofed, but could only be accessed in part during the present survey. This adjoins another attic space to the south which has a complex arrangement of intersecting ridges and valleys, giving rise to a complex attic void. The part of the roof leading towards the central decorative circular skylight has a modified queen post construction. Elsewhere the construction is of old A-frame timbers. The void lacks decking and is unlined.

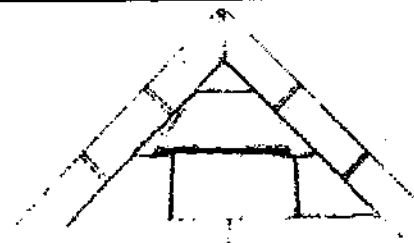
LEAD SADDLE IN PLACE OF A SLATE TO ALLOW BATS ACCESS TO RIDGE OR ROOF VOID

- Measures should ideally be incorporated to enable and encourage the future use of the redeveloped buildings by roosting bats and nesting birds. This could, for example, take the form of dedicated bat voids of appropriate design within the re-roofed building. Suitable access could be provided either through the gable walls (eg by removing the wire mesh blocking the vents) or alternatively through modified roof tiles etc (see Appendix 2). Any bat access points should not be illuminated at night (eg by security lighting or street lighting etc).
